**Federal Railroad  
Administration**

## **A New Method for Detecting the Onset of Scour and Managing Scour Critical Bridges**

9. SPONSORING/MONITORING AGENCY NAME(S) AND ADDRESS(ES) U.S. Department of Transportation Federal Railroad Administration Office of Railroad Policy and Development Office of Research, Development and Technology Washington, DC 20590			10. SPONSORING/MONITORING AGENCY REPORT NUMBER  DOT/FRA/ORD-19/32

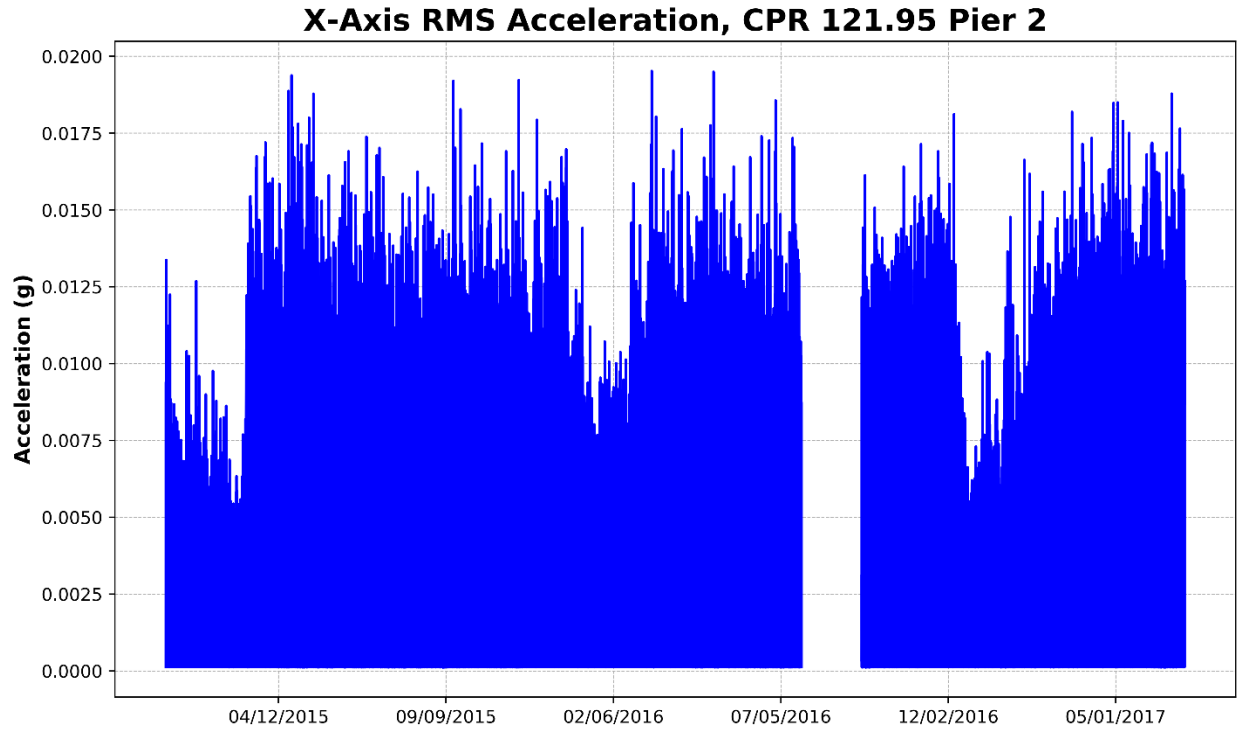
**Figure 132 – Pier 2, X-Axis RMS Acceleration**

The acceleration charts are shown in [Figure 129](#) through [Figure 136](#). Various outliers in acceleration were recorded by the East and West abutments. Despite the outliers, no alarming trends in the acceleration data are identified.

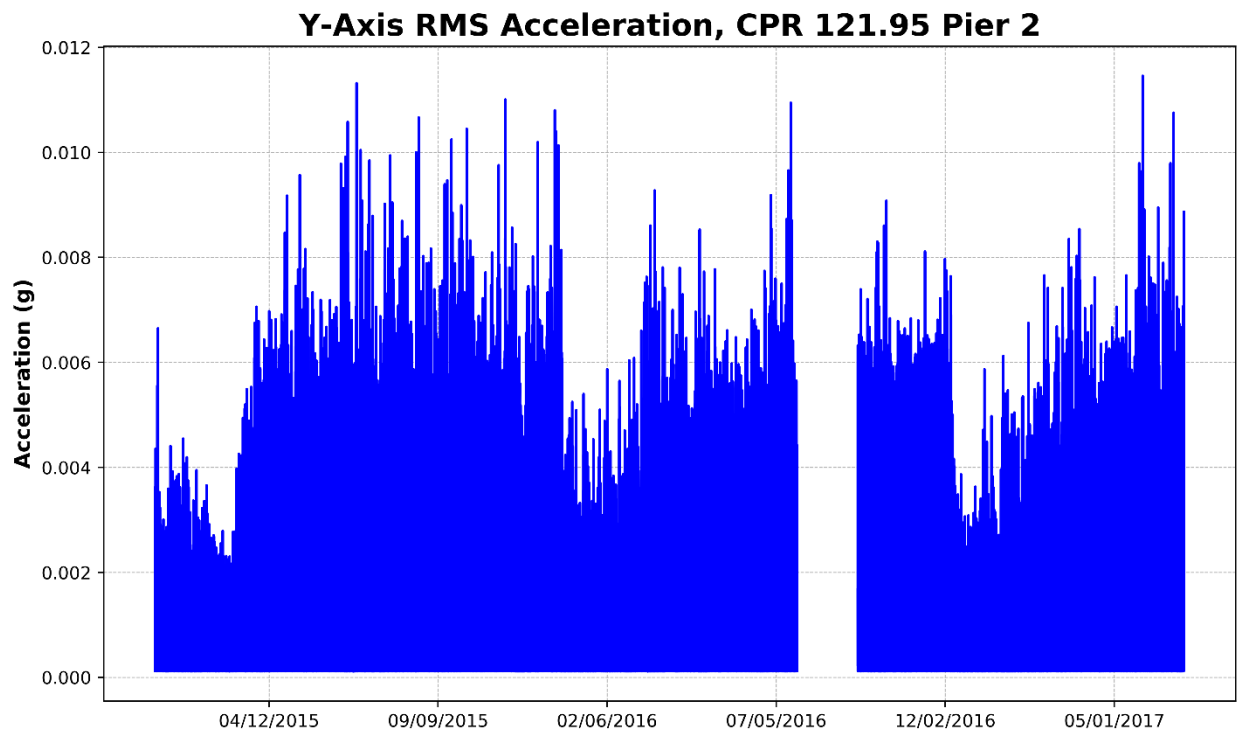
**Figure 133 – Pier 2, Y-Axis RMS Acceleration**

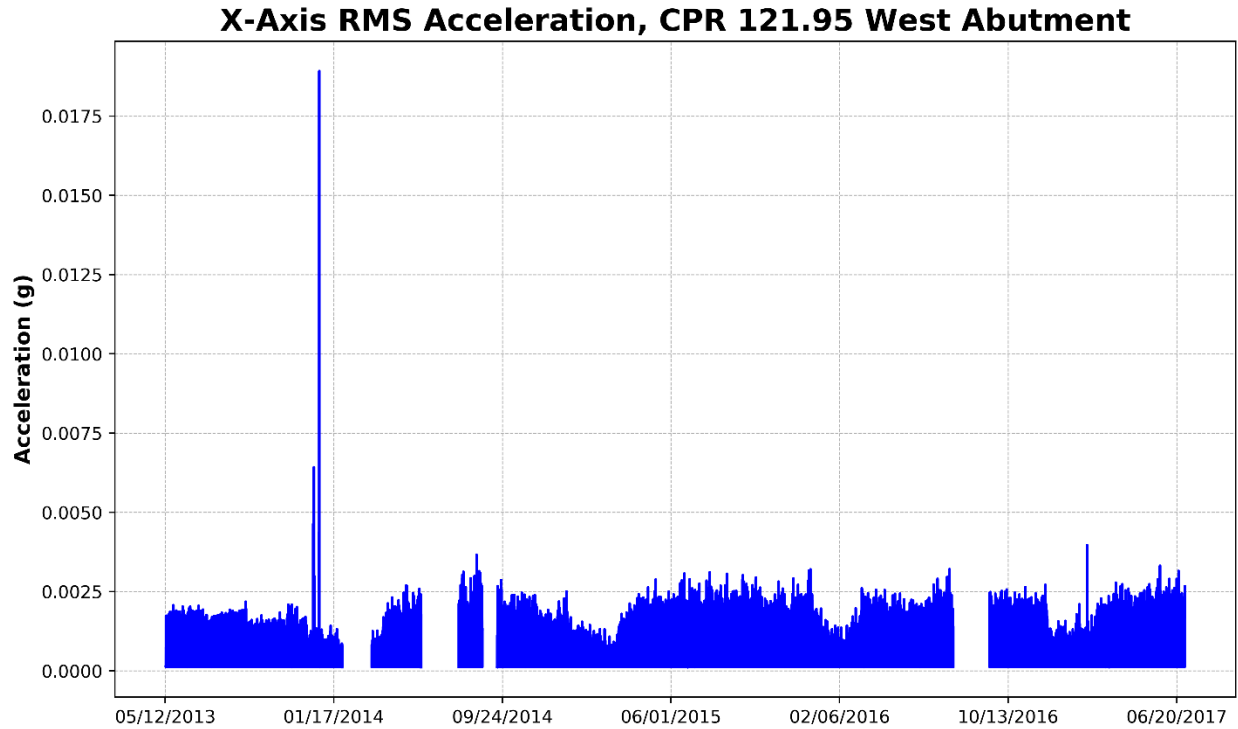
**Figure 134 – West Abutment, X-Axis RMS Acceleration (Perpendicular to Track)**

The West abutment of the Watertown bridge has shifted over 0.15 degrees since monitoring began in 2013. This is the largest shift of a substructure element measured as part of this project. Continued monitoring of the West abutment is recommended to determine if the movement will continue. The other piers monitored have not shown any alarming data.

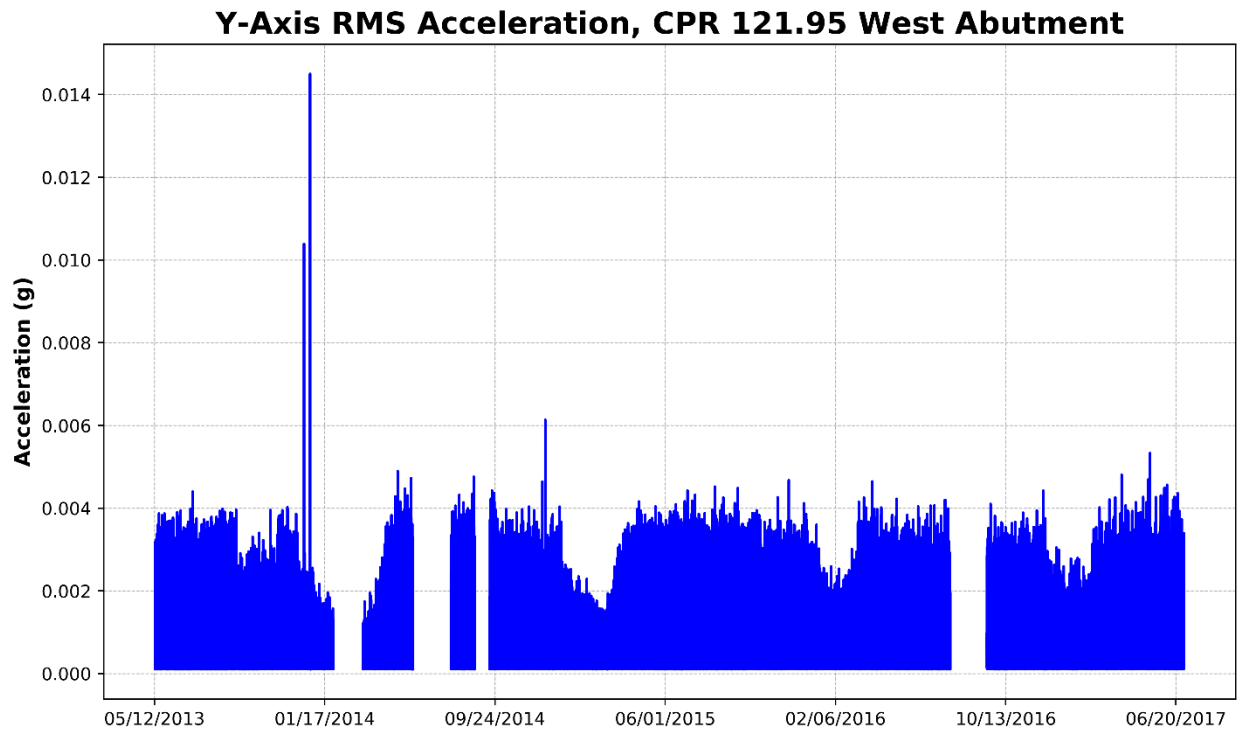
**Figure 135 – West Abutment, Y-Axis RMS Acceleration (Parallel to Track)**

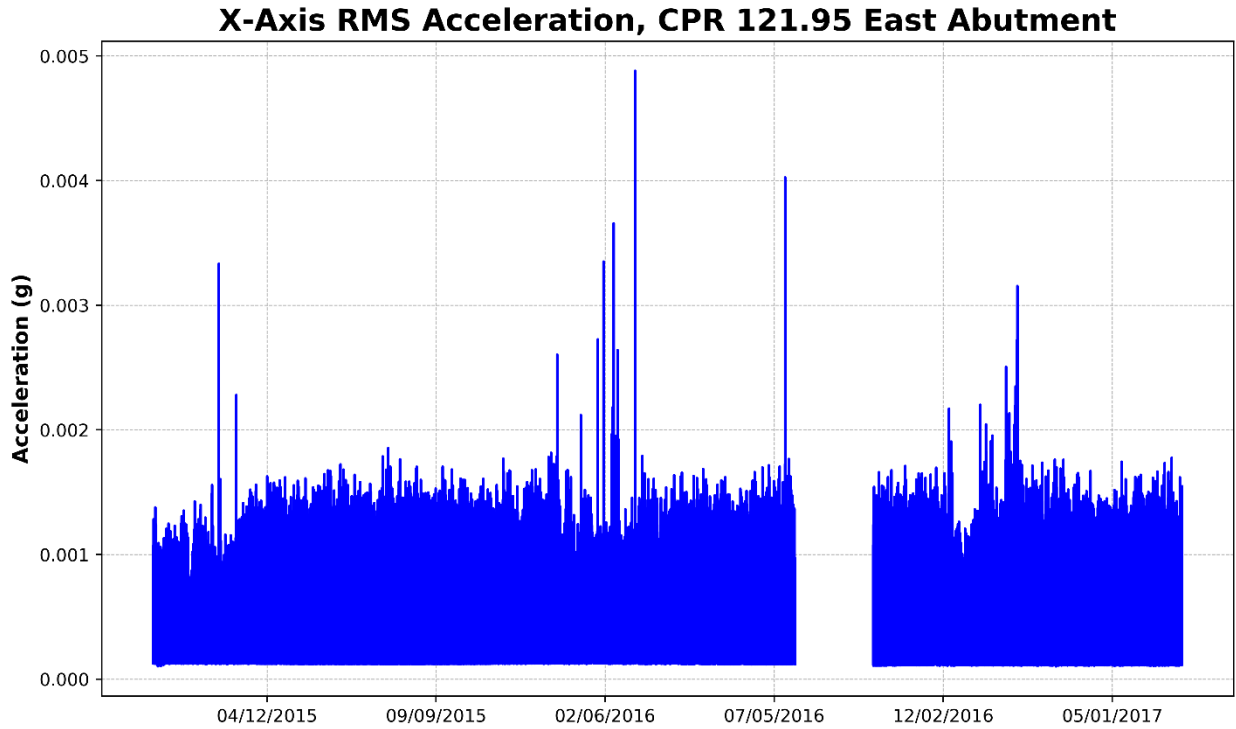
**Figure 136 – East Abutment, X-Axis RMS Acceleration (Perpendicular to Track)**

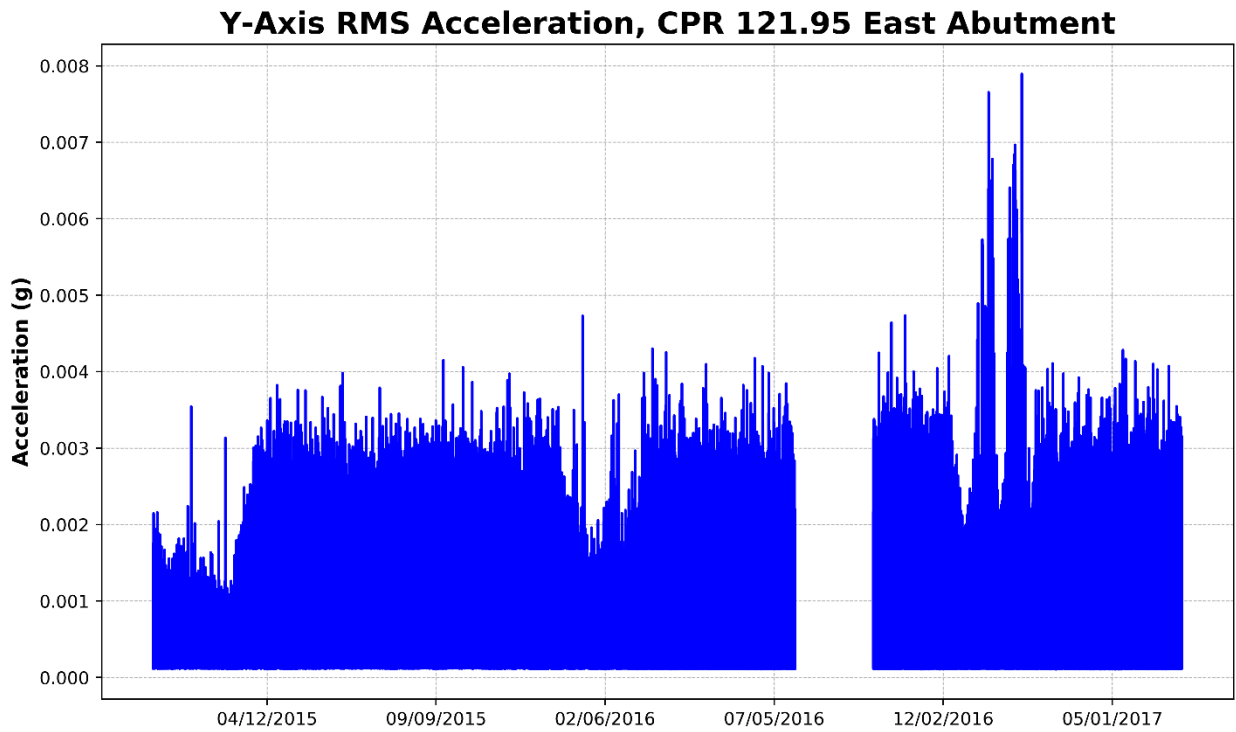
**Figure 137 – East Abutment, Y-Axis RMS Acceleration (Parallel to Track)**

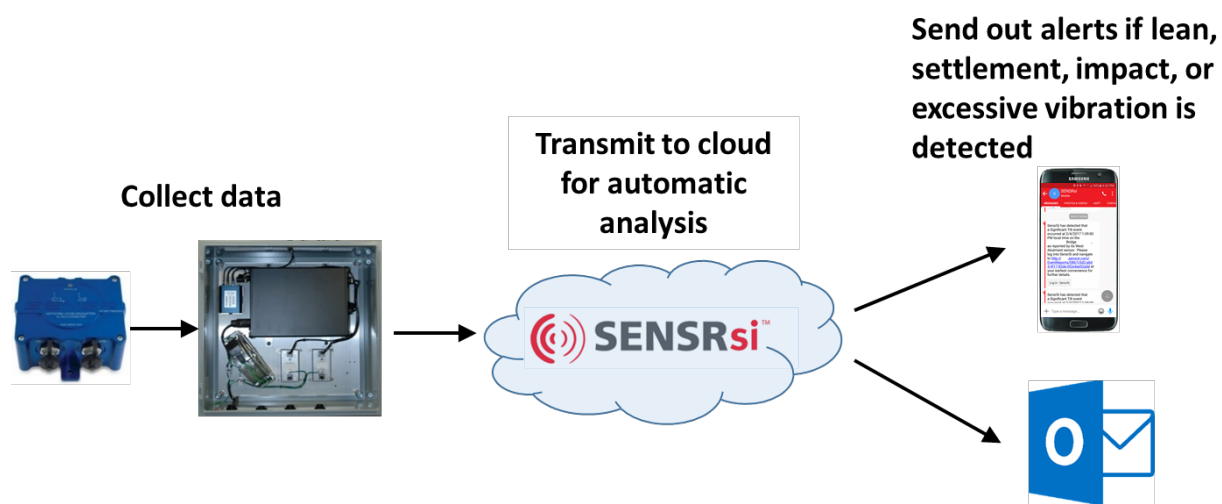
Figure 138 – Alert System Data Flow

For the alerts to be reliable, the monitoring system should be capable of automatically generating incident reports without direct human intervention. The incident report can be sent to key personnel via email, text message, or phone call. The report should provide a time stamp of the event and any key data required to understand the event.

The overall data flow for the alert system is shown in [Figure 137](#), and an example email alert is shown in [Figure 138](#).
