Steel Bridge Design Handbook

Design for Fatigue

Publication No. FHWA-HIF-16-002 - Vol. 12

December 2015

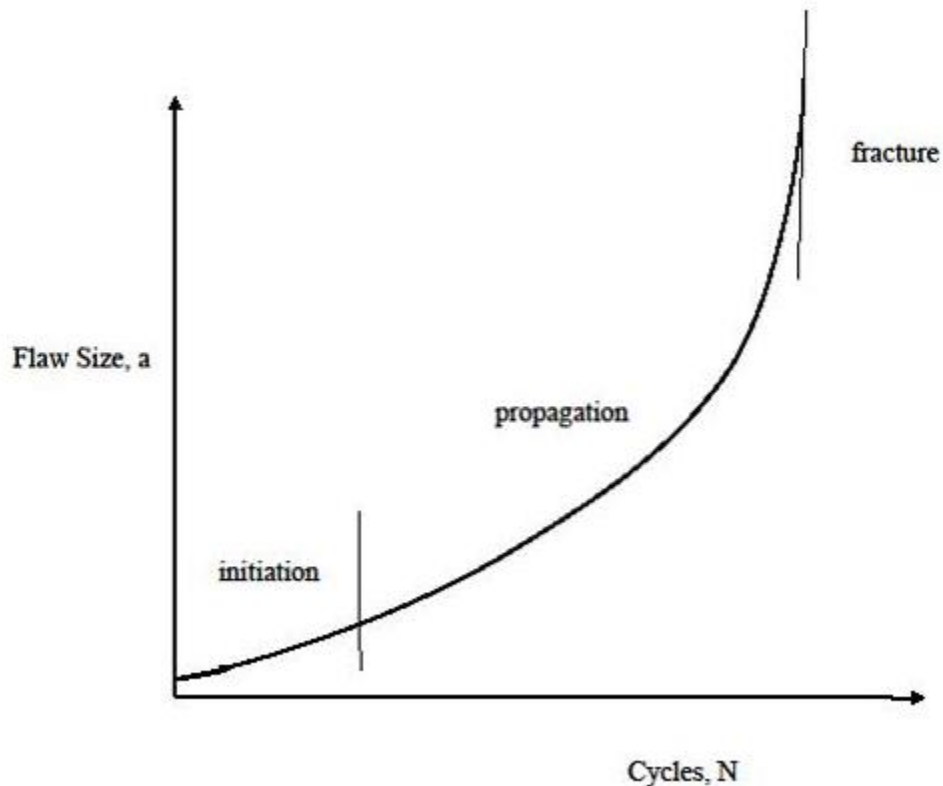
Crack growth in metals requires two existing conditions: existing flaws and tensile stresses. This crack growth can be delineated into three distinct regimes: initiation, steady-state propagation and unstable fracture, as illustrated in Figure 1.

Figure 1 Regimes of Crack Growth

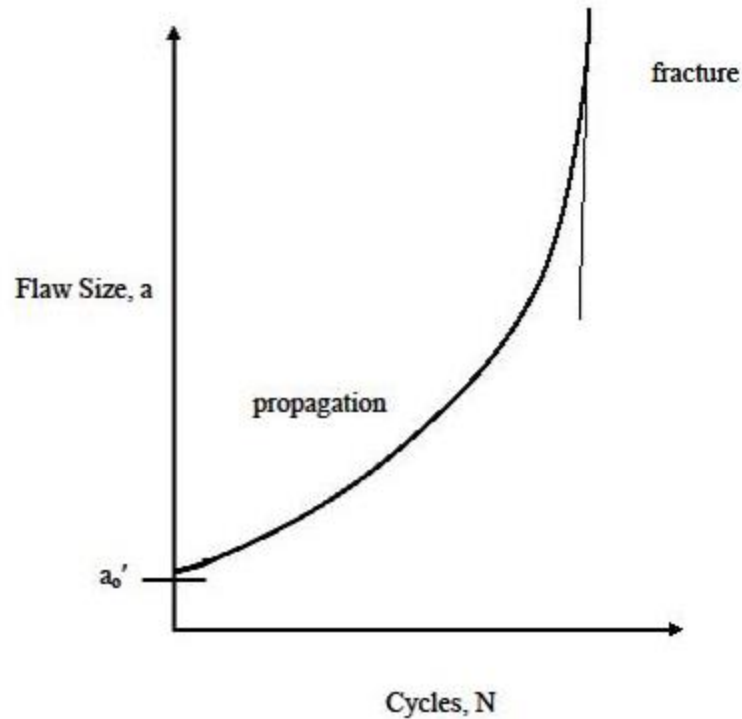
As has already been noted, the initiation portion of general crack growth in which existing flaws are sharpened into cracks is essentially non-existent for all fabricated steel structures and can conservatively be ignored. Thus, crack growth in bridges is delineated into two regimes: stable fatigue cracking and unstable fracture. Figure 2 graphically illustrates crack growth in bridges.

Figure 2 Regimes of Crack Growth in Bridges

The propagation regime of crack growth represents steady-state fatigue cracking. When a critical flaw size is achieved, the stable crack fractures in an unstable manner without an increase in stress. Unstable crack propagation can be in the form of a low energy brittle type fracture or if the material has sufficient toughness, a ductile tear. The critical flaw size is proportional to fracture toughness of the material which varies with rate of application of the load and the temperature of the material. The fracture toughness of the material is controlled by the Charpy V-notch toughness specified in the material specification.

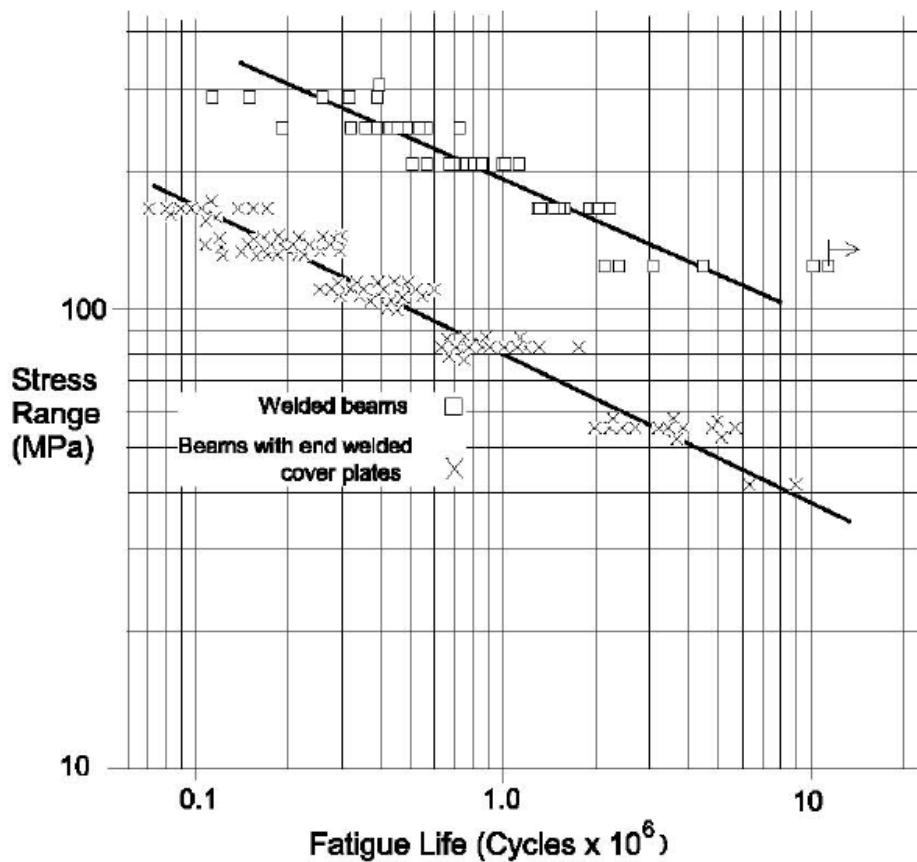
It should be noted that cover-plated rolled beams exhibit relatively low fatigue resistance. If a designer found that a rolled beam did not have adequate section properties for strength consideration, using a built-up section plate girder would have a much higher fatigue resistance than adding a cover plate to the rolled beam. At a stress range of 100 MPa, the average fatigue life of a cover-plated rolled beam is 1 million cycles while the built-up girder life would be over 8 million cycles.

Figure 10 Fatigue Strength of Welded and Cover-plated Beams

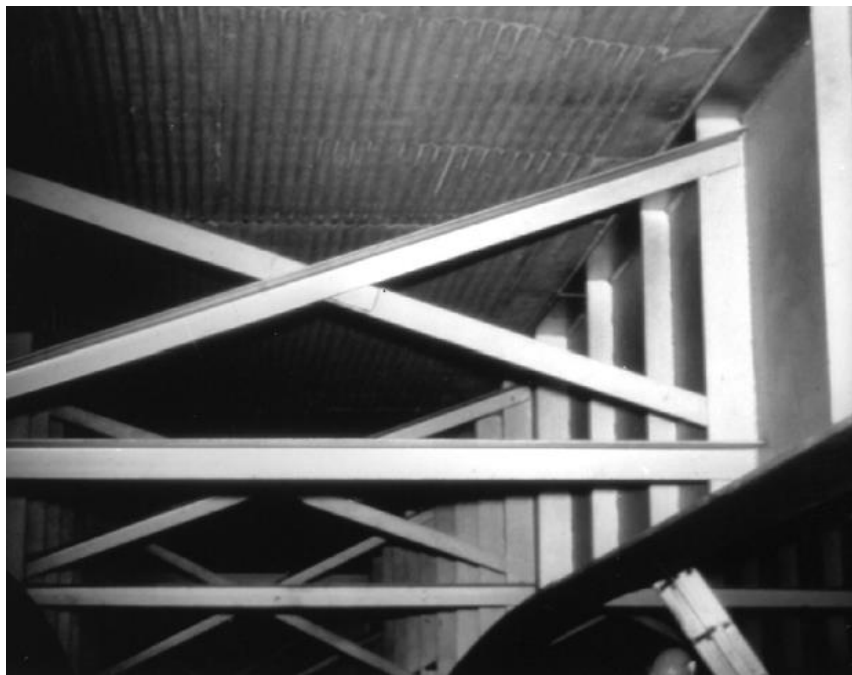
Various types of diaphragms are used, ranging from rolled sections to simple X-bracing made of angles. Figure 14 shows the underside of a multiple girder bridge that has an X-type cross-frame bracing system. In the web gap, cracking developed in the negative moment region (i.e., top flange in tension) of this continuous span structure. This cracking is illustrated in Figure 15, which is a view along the length of the bracing toward the girder and its transverse stiffener. The transverse stiffener to which the X-bracing is attached was not welded to the top (tension) flange for the reasons described earlier. This permitted out-of-plane displacement to occur in the web gap and, consequently, cracks formed along the web-to-flange fillet weld and at the top of the connection plate.

Figure 14 X-Bracing and Girders

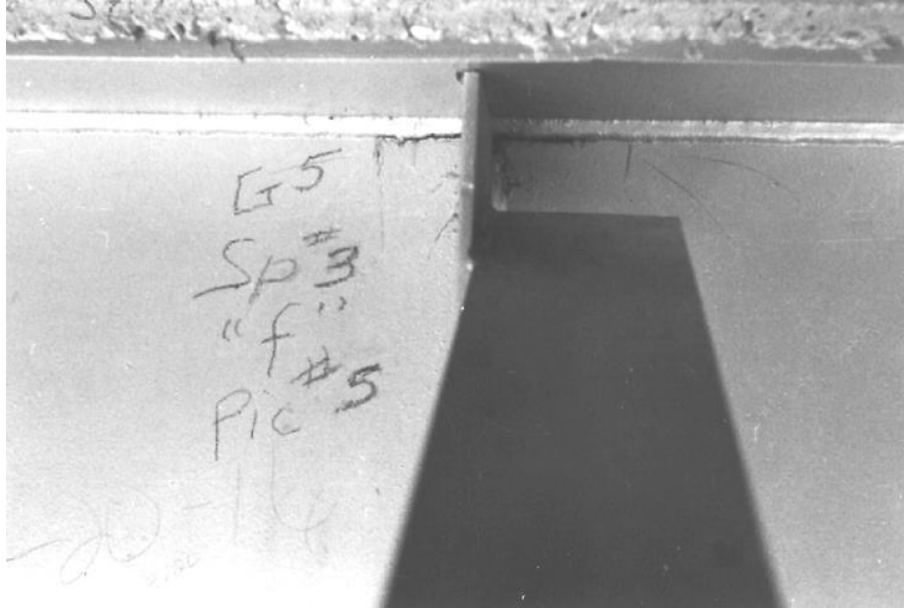
Figure 15 Fatigue Cracks in Web Gap of Diaphragm Connection Plate
