Final Report

**Field Study of Recycled Concrete Aggregate in French Drain**

FDOT Contract No.: BDV24-977-19

January, 2019

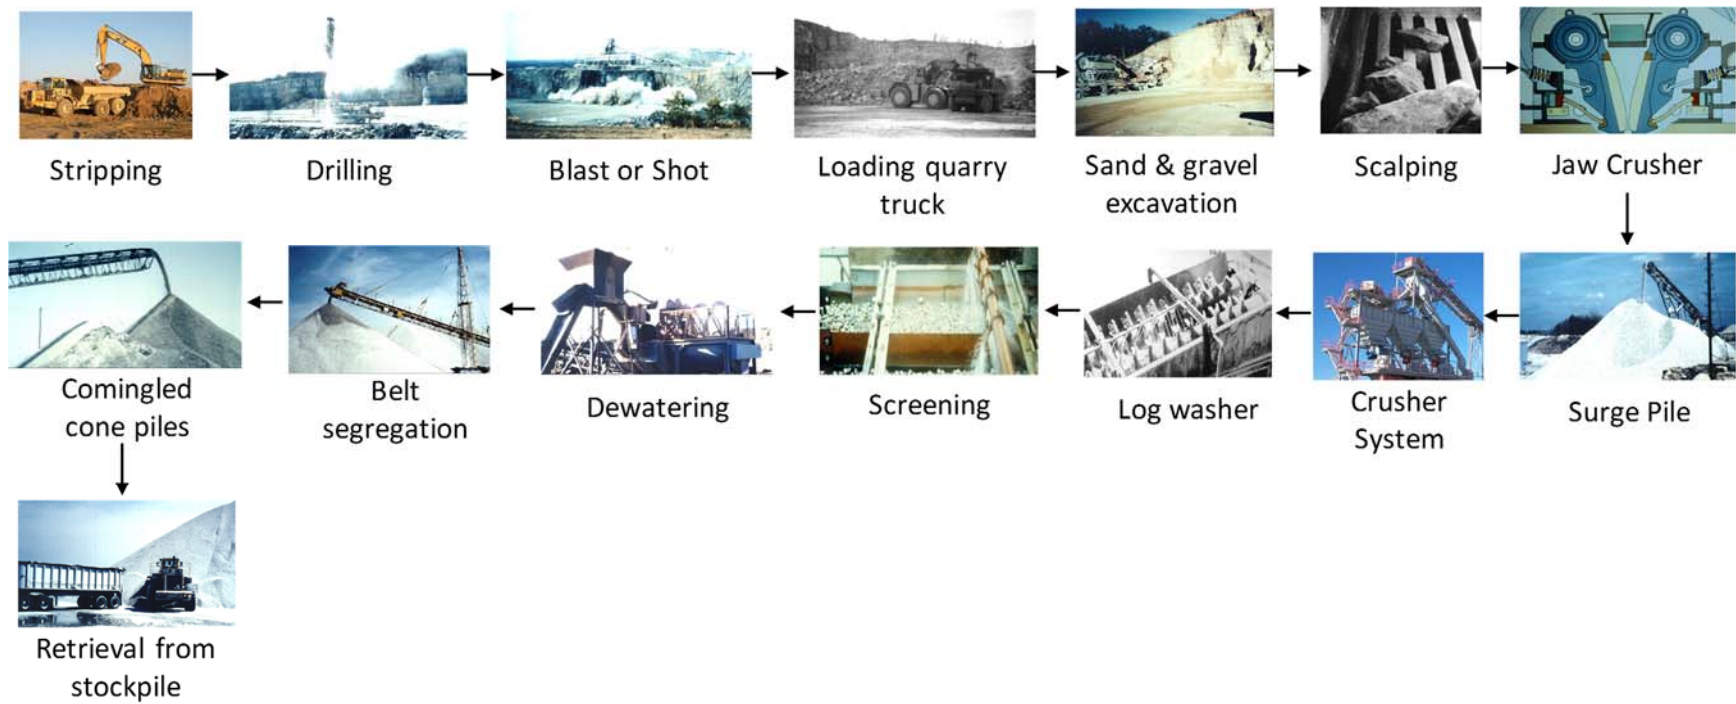
Figure 2.1: Flow chart of conventional aggregate preparation process

Figure 2.1 describes the total process of natural aggregate production from extraction (or stripping) through stockpiling. Figure 2.2 shows the entire process steps of concrete recycling method from construction waste to stockpiling. Based on the flow charts in Figures 2.1 and 2.2, the tools used under each of the aggregate production phase are summarized in Table 2.1. The main sources of CO<sub>2</sub> emissions throughout the aggregate production are generated from the combustion of fuels used by on site electricity generators, production equipment and transport vehicles. Atmospheric emissions which include dust emission have multiple sources such as blasting, drilling, crushing and traffic on unpaved road, etc. One of the benefits of using either recycled or secondary aggregate is the reduction of CO<sub>2</sub> emissions. As can be seen in Table 2.1, recycled aggregate production uses lesser tools than conventional aggregate production.

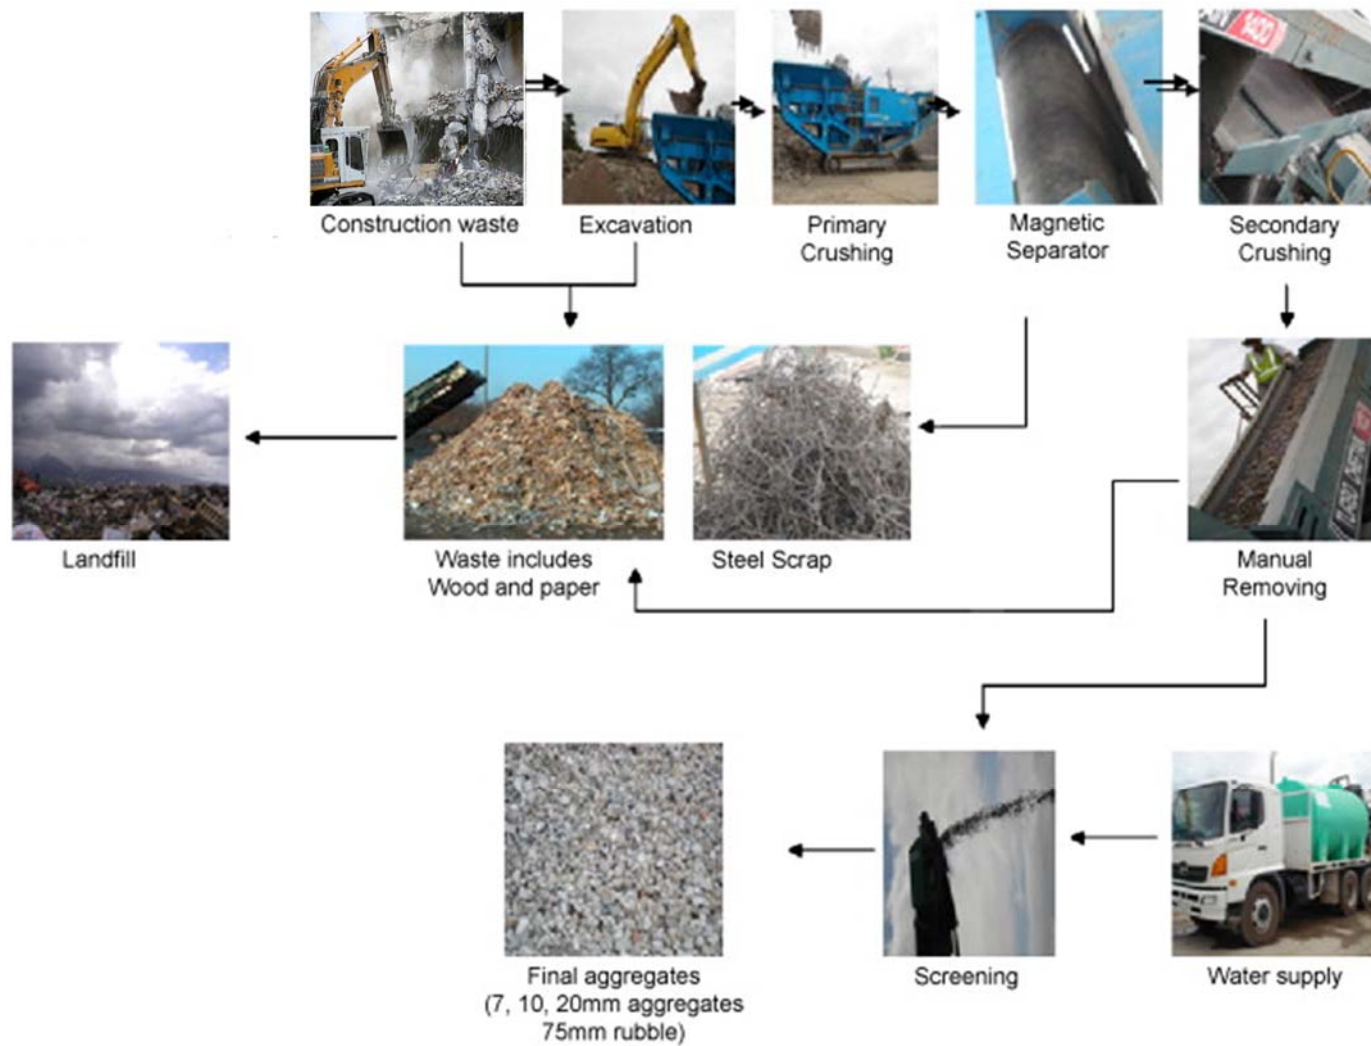
Figure 2.2: Flow chart of RCA preparation process (Tam, V. W. Y., 2008)

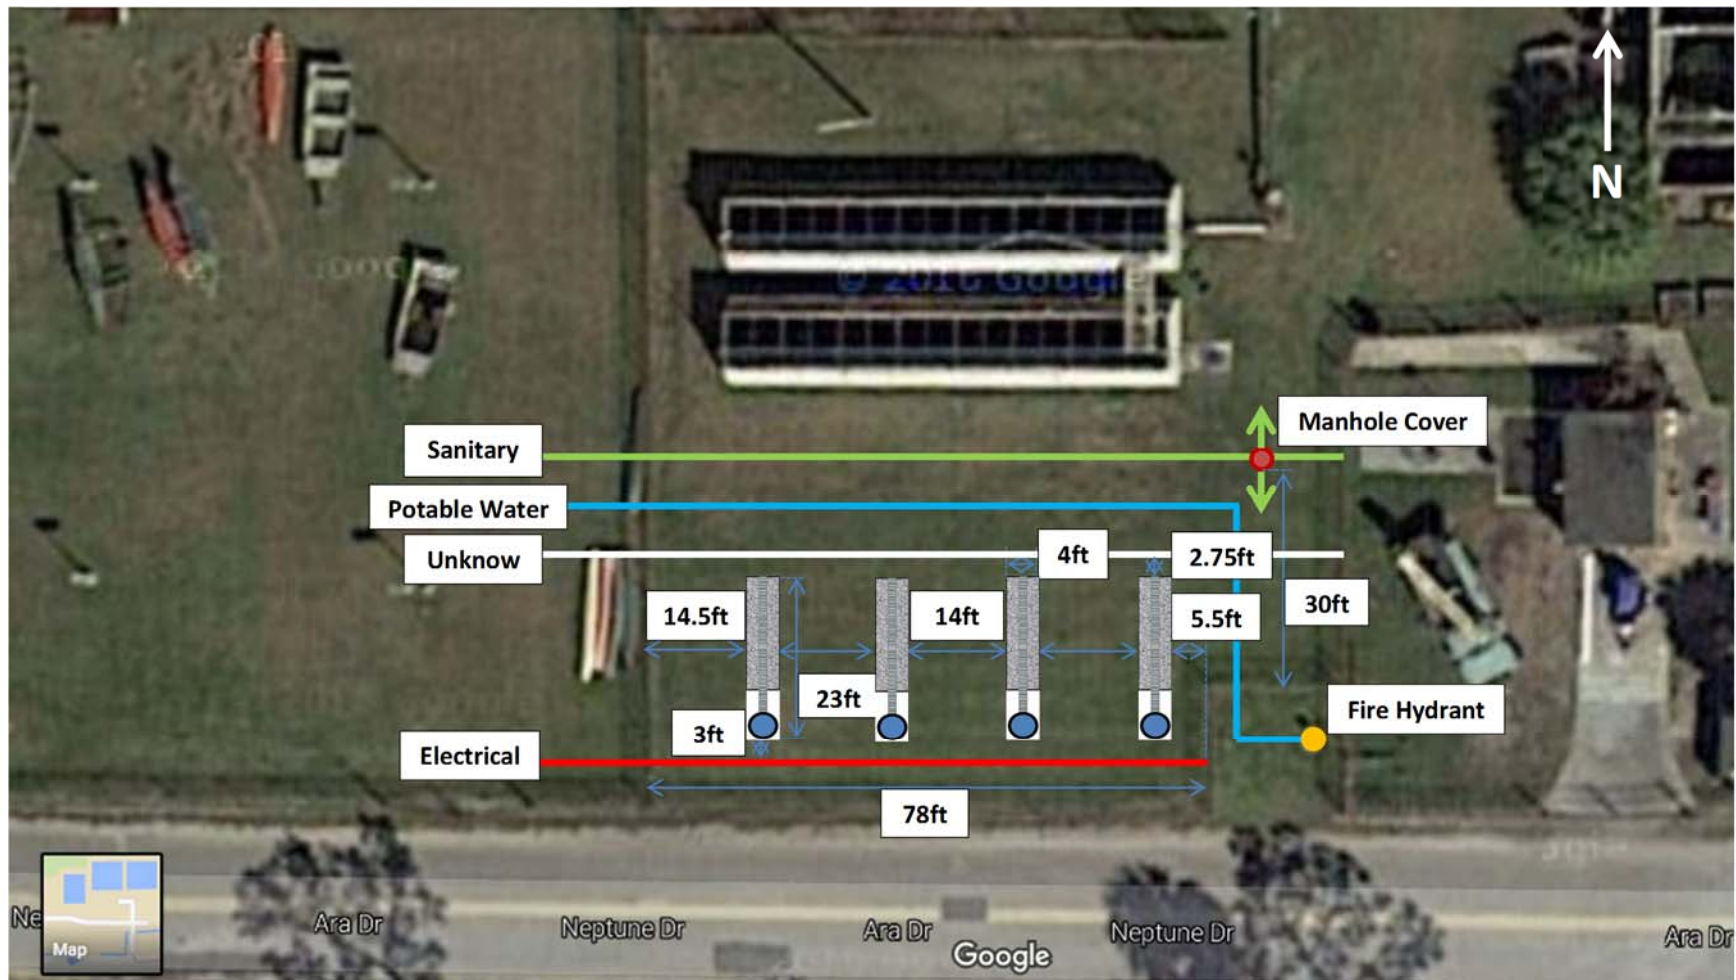
Figure 3.2: Project site location and description

Sunshine 811 performed a subsurface survey (Ticket #: 162606535) to locate existing underground utilities at the site, the results of the survey are shown in Figure 3.2. Information regarding utilities and fence location was then used as design considerations. The dimensions and the separation distances of the French drain systems were dependent upon the available area confined by the unknown utility to the north, electrical utility to the south, and fencing to the east and west. A French drain system length of 23 ft allows for approximately 3 ft of clearance between each end of the system and the electrical and unknown utility lines. A drain width of 4 ft allows the drains to be spaced out 14 ft apart. The plan view with detail spacing information is also shown in Figure 3.2. A finite element analysis was performed in Section 3.2 to check if 14 ft was sufficient spacing between the French drains.

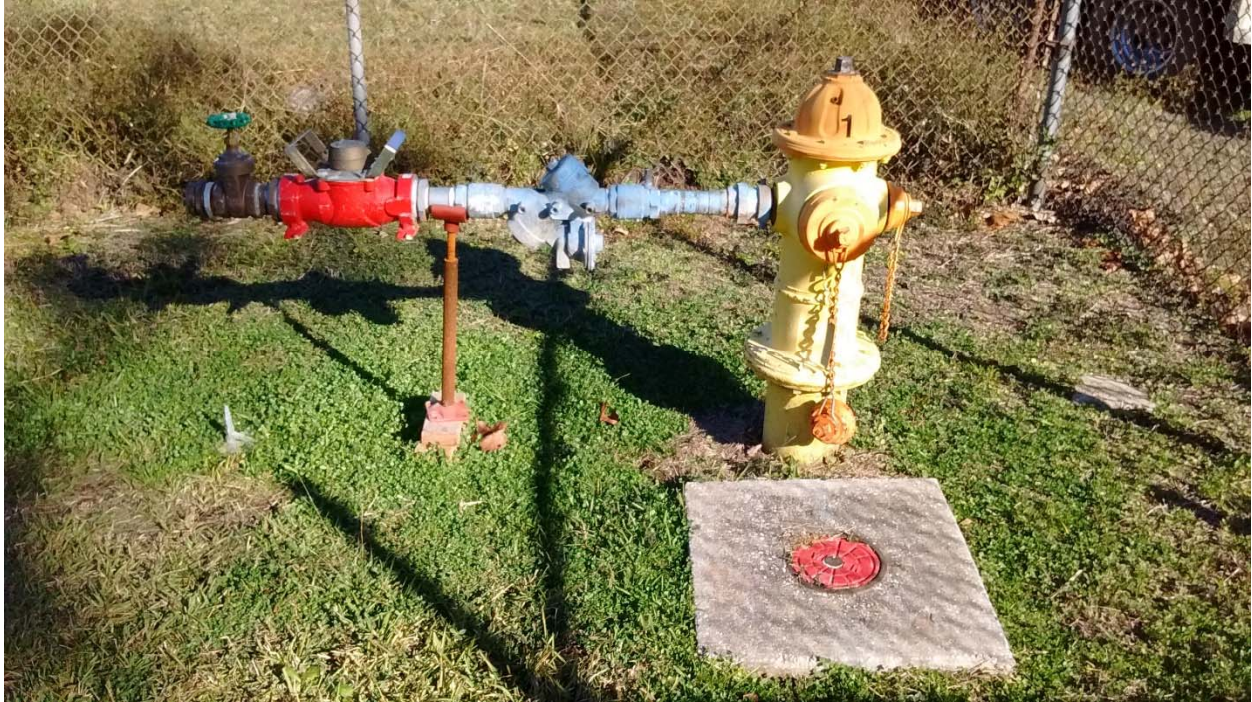
Figure 3.3: On site fire hydrant with Badger flow meter and Watts backflow prevent

Water supply was a key component of the in situ French drain experiment. The site had access to a fire hydrant which was located to the east of the site on the other side of the fence, see Figure 3.3. Being an orange top fire hydrant, the flow rate was rated between 500-999 gpm. Permission to use the fire hydrant for experimental purposes was requested to and granted by the University of Central Florida Utilities and Energy Services department, who also supplied a flow meter and backflow preventer for the fire hydrant.

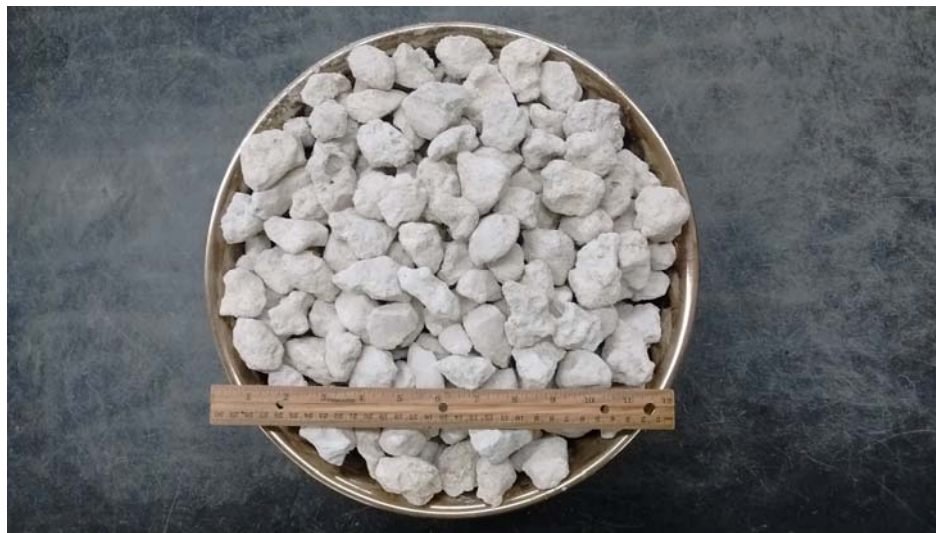
Figure 3.12: Limestone aggregate (1-ft ruler used for scale)

The limestone was tested, and its material properties are presented in this section. Figure 3.12 shows a photo of the limestone as received. Sieve analysis (AASHTO T 27/T 11/M 145) on the limestone (used in the control trench) was conducted, and the results are presented in Table 3.4 and Figure 3.13. The limestone met the specification requirements for an FDOT No. 4 aggregate.

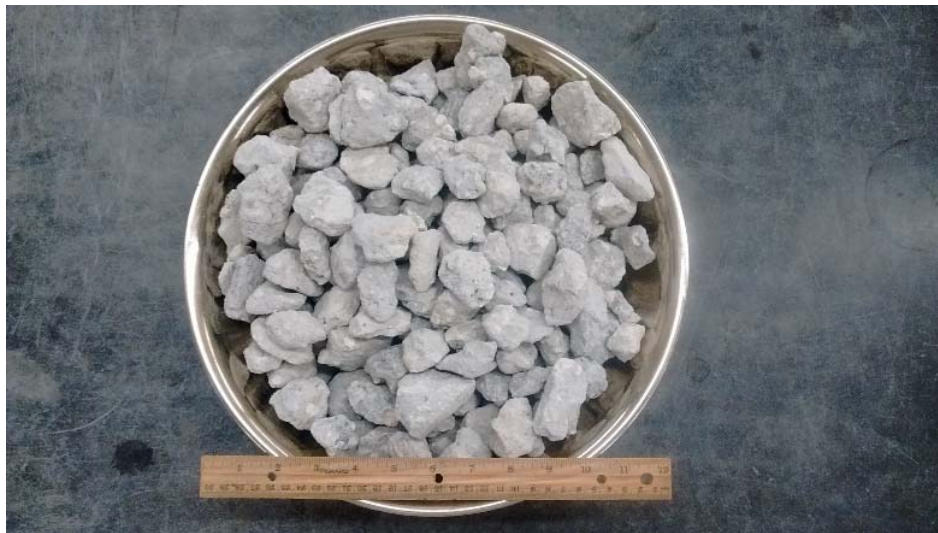
Figure 3.14: RCA aggregate (1-ft ruler used for scale)

The RCA was tested and its material properties are presented in this section. Figure 3.14 shows the photo of RCA as received. Sieve analysis (AASHTO T 27/T 11/M 145) on the RCA was conducted and the results are presented in Table 3.7 and Figure 3.15. The RCA met the specification requirements for an FDOT No. 4 aggregate.

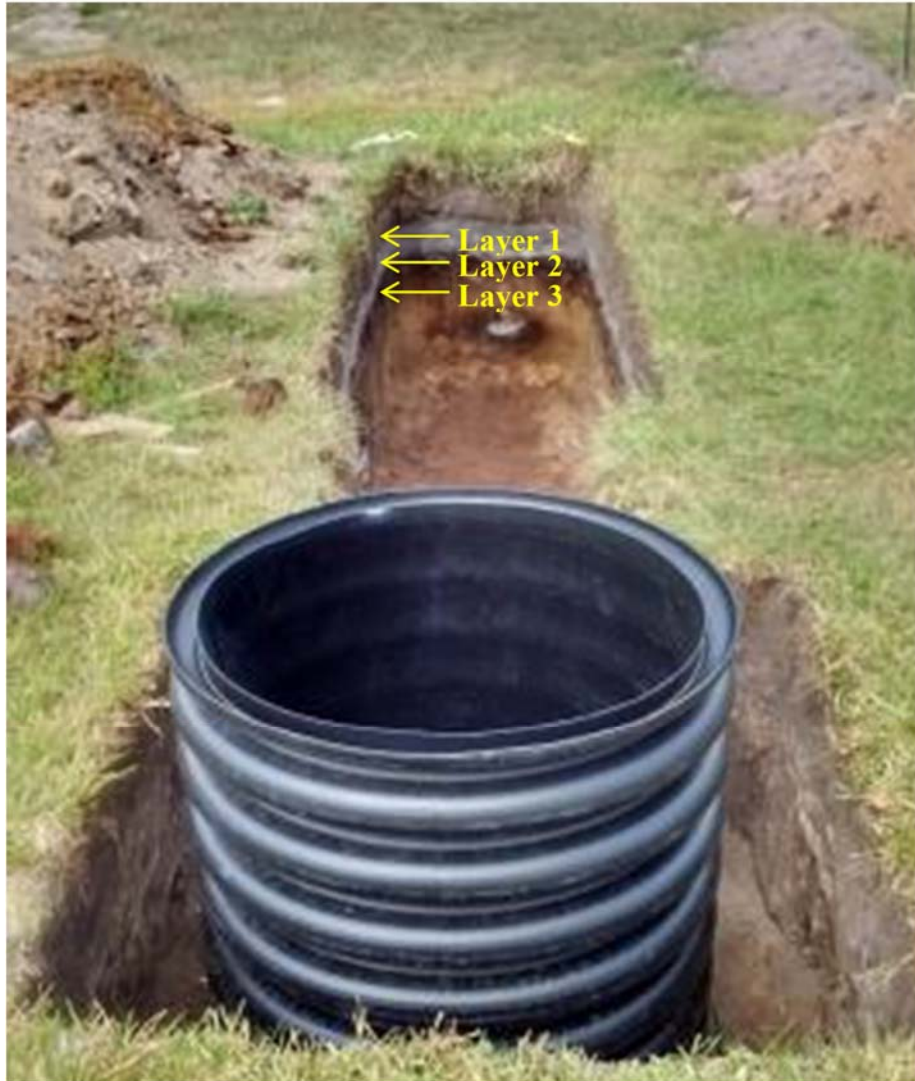
Figure 3.16: Photo showing the three layers of soil at the project site

Material Properties: The material properties of the in situ soil were obtained through an open excavation test trench in the field. As mentioned in Section 3.3, the in situ soil profile was found to contain three layers along the depth of the excavation. The weighted average based on layer thickness produced an average hydraulic conductivity of  $7.93 \times 10^{-5}$  ft/sec and an average porosity of 0.46. The No. 4 aggregate was assigned typical values found for gravel, a hydraulic conductivity of 0.328 ft/sec and a porosity of 0.3. The seepage rate of the French drain was more sensitive to changes in the properties of the in situ soil as compared to the No. 4 aggregate because the in situ soil was approximately three to four orders of magnitude more restrictive to flow, thus controlling the equivalent hydraulic conductivity of the French drain system. The pipe was not assigned any material properties because it was considered a boundary condition. The effect of partial saturation on the in situ soil was omitted from the analysis. The hydraulic conductivity of the in situ soil and aggregate was assumed to be isotropic.

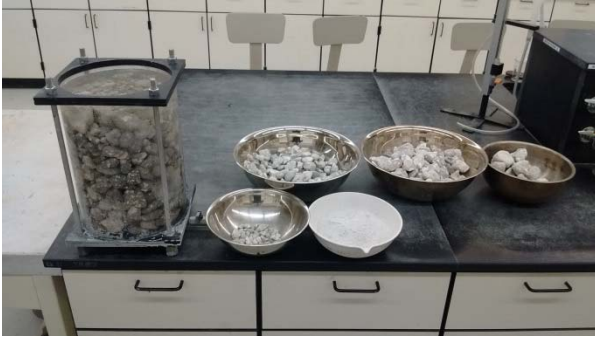
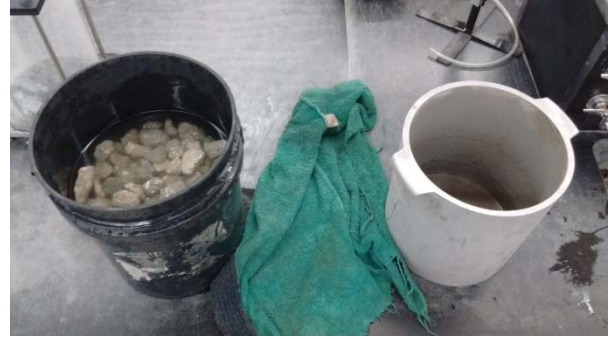
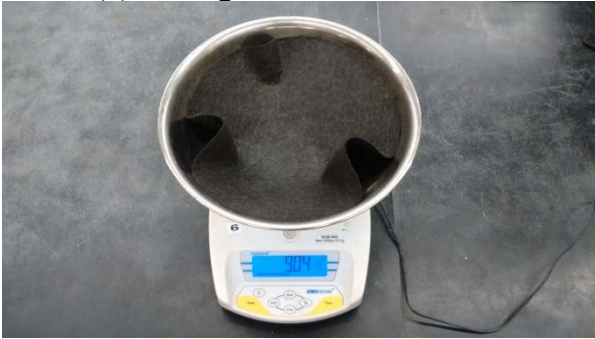
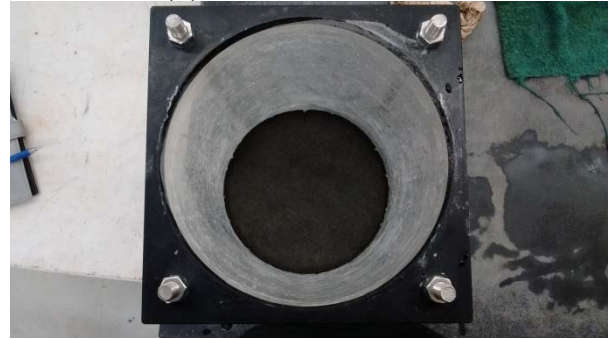
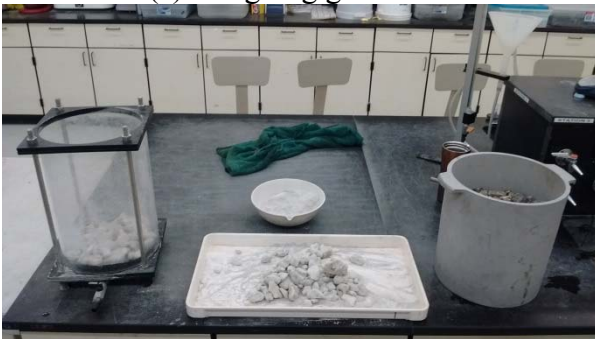
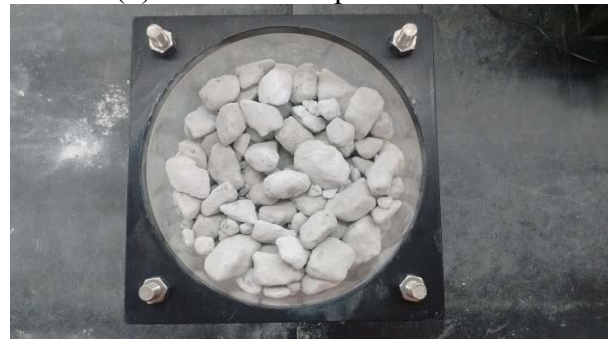
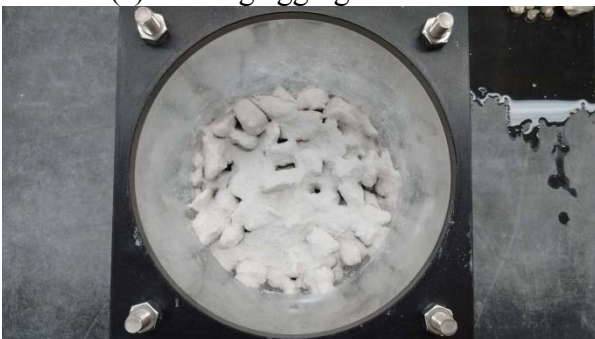
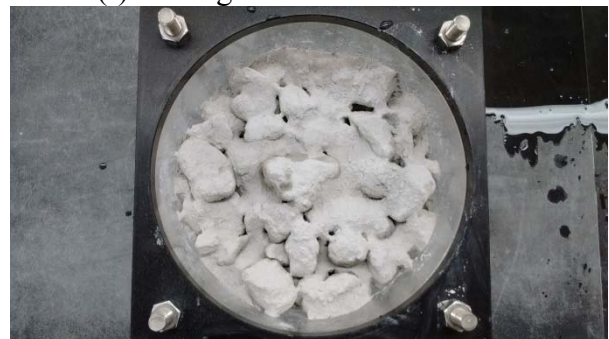
(a) No. 4 gradation construction

(b) SSD determination

(c) Weighing geotextile

(d) Geotextile in permeameter

(e) Coating aggregate in fines

(f) Homogeneous 5.1% fines test

(g) Heterogeneous 5.1% fines test 6"

(h) Heterogeneous 5.1% fines test 12"

Figure 3.18: Experiment procedures of fine migration test

Two fine migration tests were conducted to observe how fines migrate under two different dispersal conditions within the aggregate: 1) homogenous dispersal and 2) heterogeneous dispersal. The homogenous dispersal involved the fines adhering to the surface of the aggregate, thus the fine concentration was distributed/homogenous throughout the whole aggregate mass. The heterogeneous dispersal involved the fines being applied to the top of clean 6" lifts of aggregate, thus the fines were concentrated/heterogeneous within thin layers in the whole aggregate mass. Fines are defined as soil passing the No. #60 sieve because production and collection of soil passing the #200 sieve was not feasible for this scale of a project. It was observed that the heterogeneous dispersal resulted in an accelerated reduction in the flow performance of the geotextile.

1. Cut a piece of geotextile to line the bottom of the permeameter and record the weight
2. Place the geotextile in the permeameter
3. Take the batch and record the weight in the SSD condition
4. Roll the batch in the oven dried fines
5. Place the aggregate covered in fines in the permeameter, then record the weight
6. Calculate the percentage of fines that stuck to the surface of the aggregate
7. Place the constant head system at a 3.5-ft head differential
8. With the permeameter outlet closed and the stop cock opened, allow the water to percolate through the aggregate until the permeameter is saturated (top-down saturation)

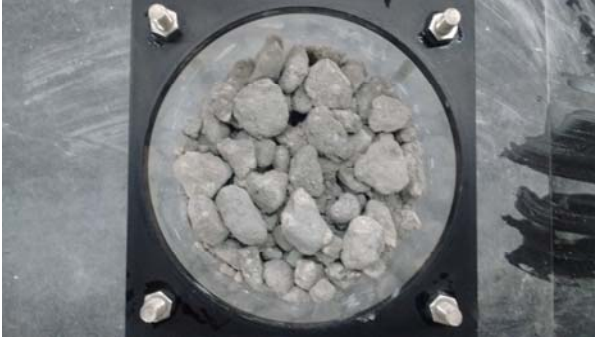
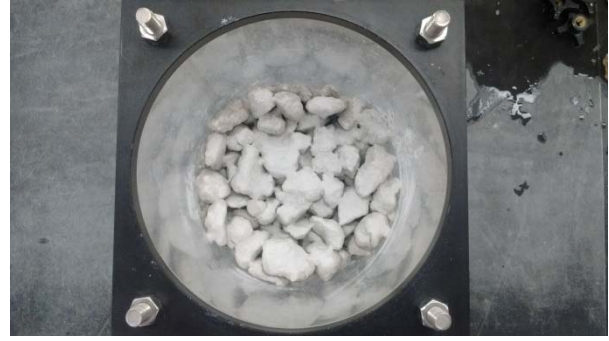
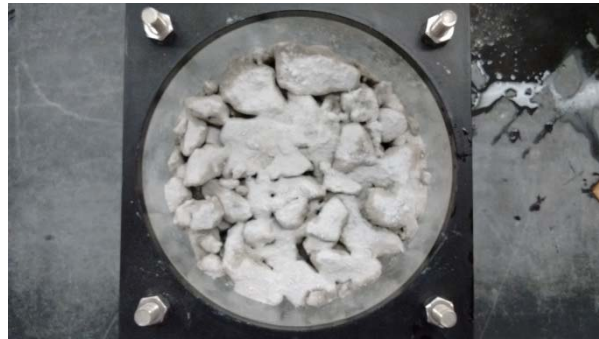
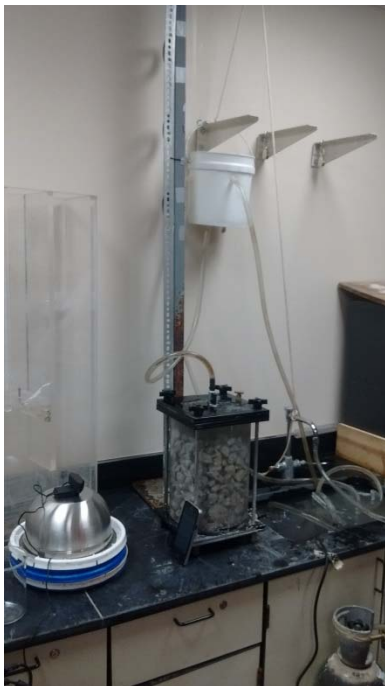
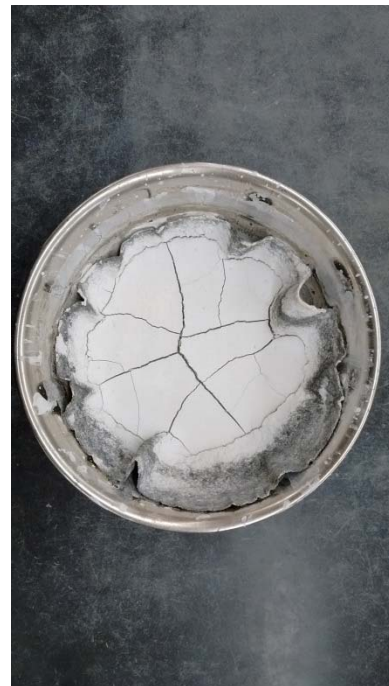
(i) Homogeneous 2% fines test

(j) Heterogeneous 2% fines test 6"

(k) Heterogeneous 2% fines test 12"

(l) Constant head setup

(m) Fines deposits

Figure 3.18: Experiment procedures of fine migration test, (continued)

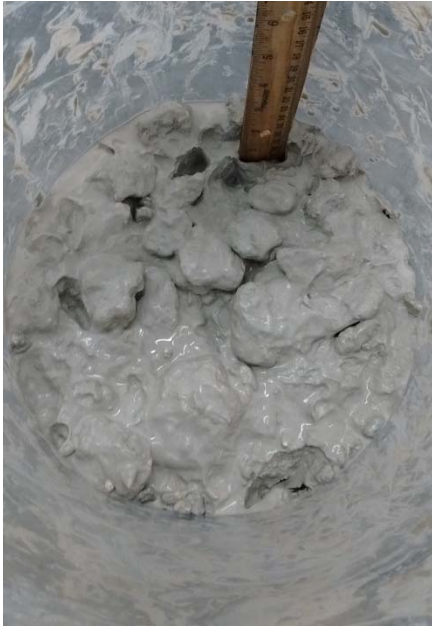
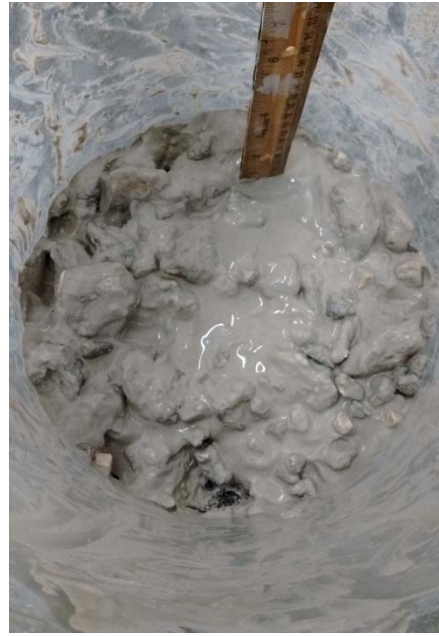
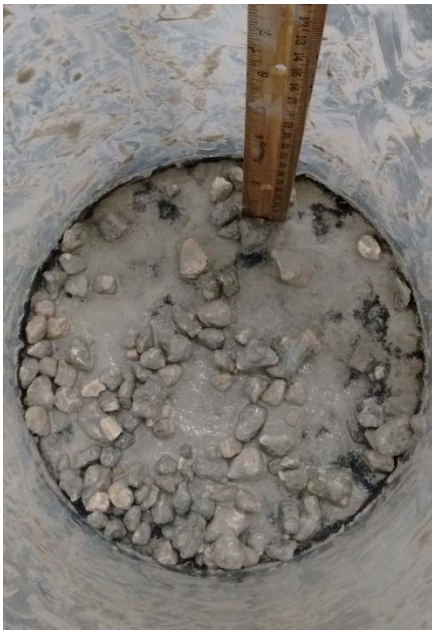
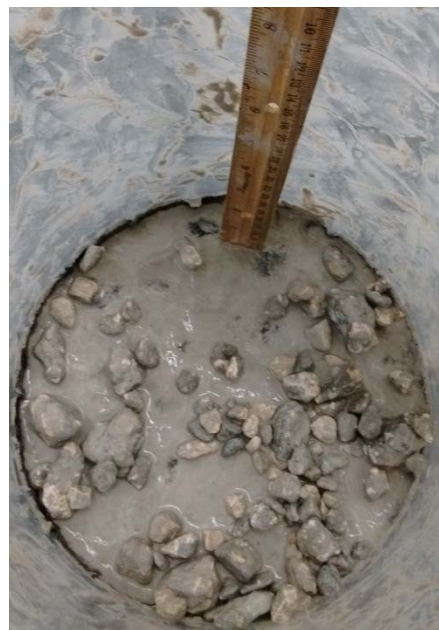
(a) Deposits (Homogeneous; 5.1% fines)

(b) Deposits (Heterogeneous; 5.1% fines)

(c) Deposits (Homogeneous; 2% fines)

(d) Deposits (Heterogeneous; 2% fines)

Figure 3.23: Fines deposited on geotextile

Measurement	Homogeneous 5.1% fines	Heterogeneous 5.1% fines	Homogeneous 2% fines	Heterogeneous 2% fines
Weight of Dry Fines Deposited (oz)	13.7	13.9	1.5	3.1
Thickness of Layer (in)	0.75	0.5	≈0	≈0

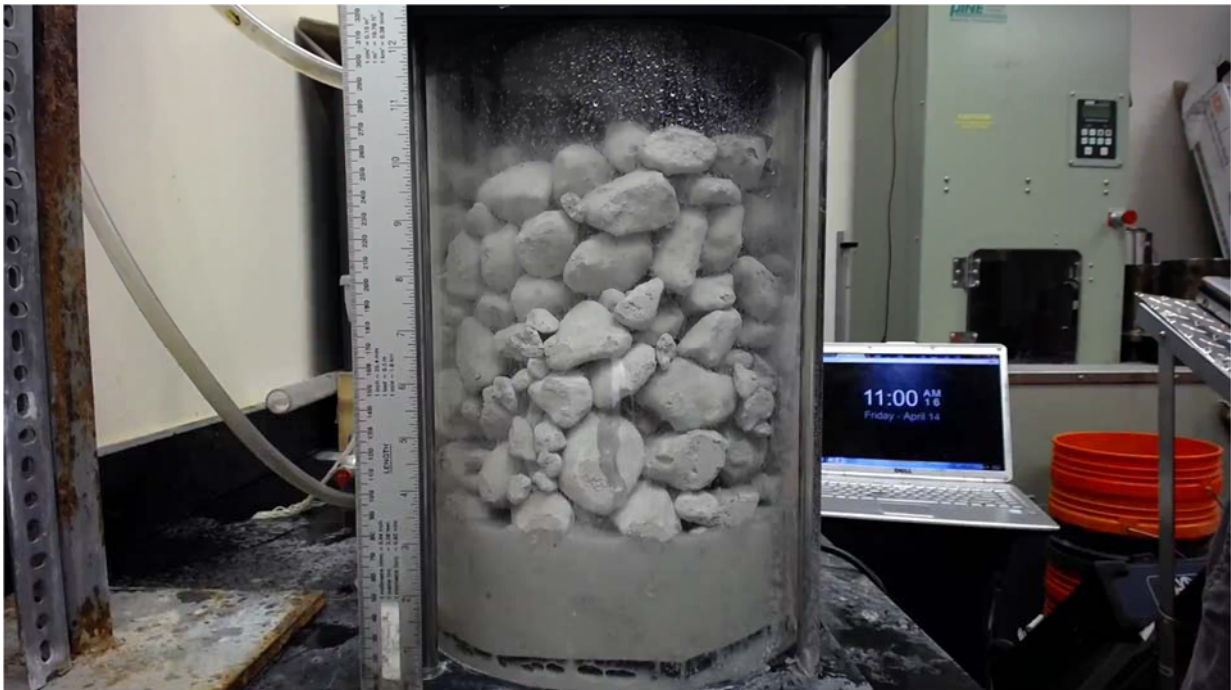
(b) Water percolation

Figure 3.24: Percolation test: homogeneous dispersal; 5.1% fines

At a relatively high fines content, it was observed that the heterogeneous dispersal method, when compared to the homogeneous dispersal method, showed signs of an accelerated reduction in the flow performance of the geotextile. The initial flow rate of the heterogeneous dispersal was half of the homogeneous dispersal. Performance of the homogeneous sample geotextile was decreased by 38% over an hour period versus 25% for the heterogenous sample, but at the end of the testing period, the homogenous samples still maintained a higher flow rate over the heterogenous sample.

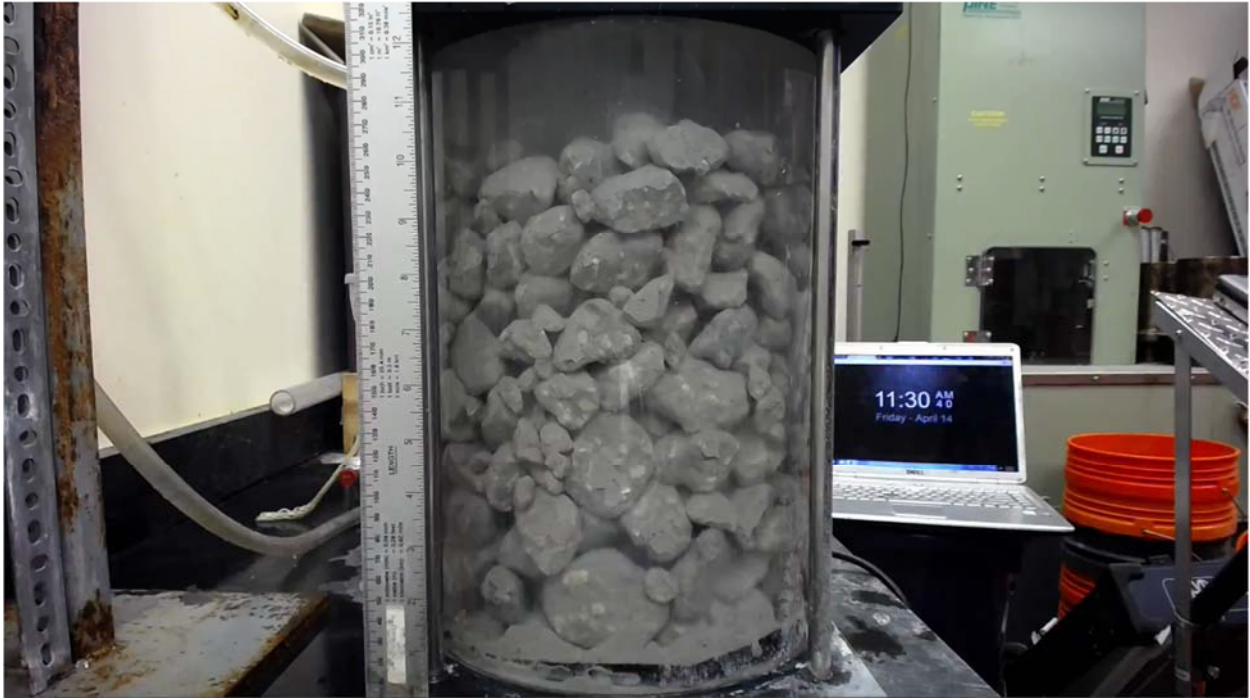
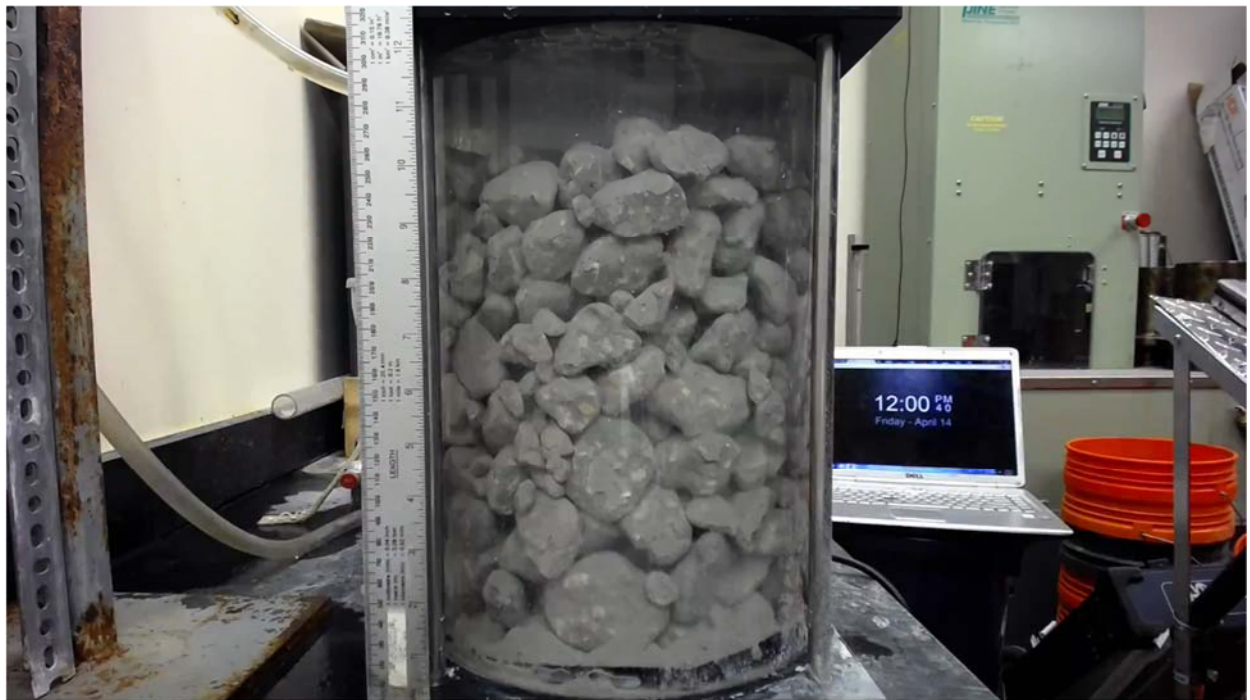
(e) 30 minutes into experiment

(f) 60 minutes into experiment

Figure 3.24: Percolation test: homogeneous dispersal; 5.1% fines (continued)

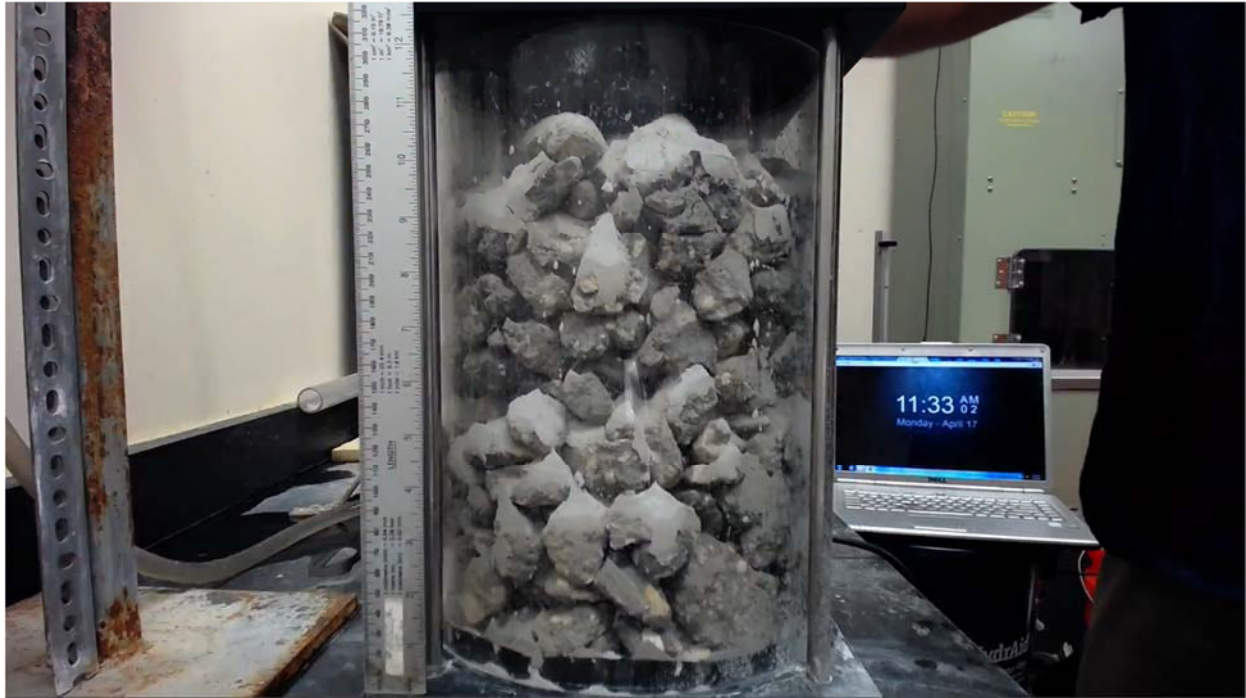
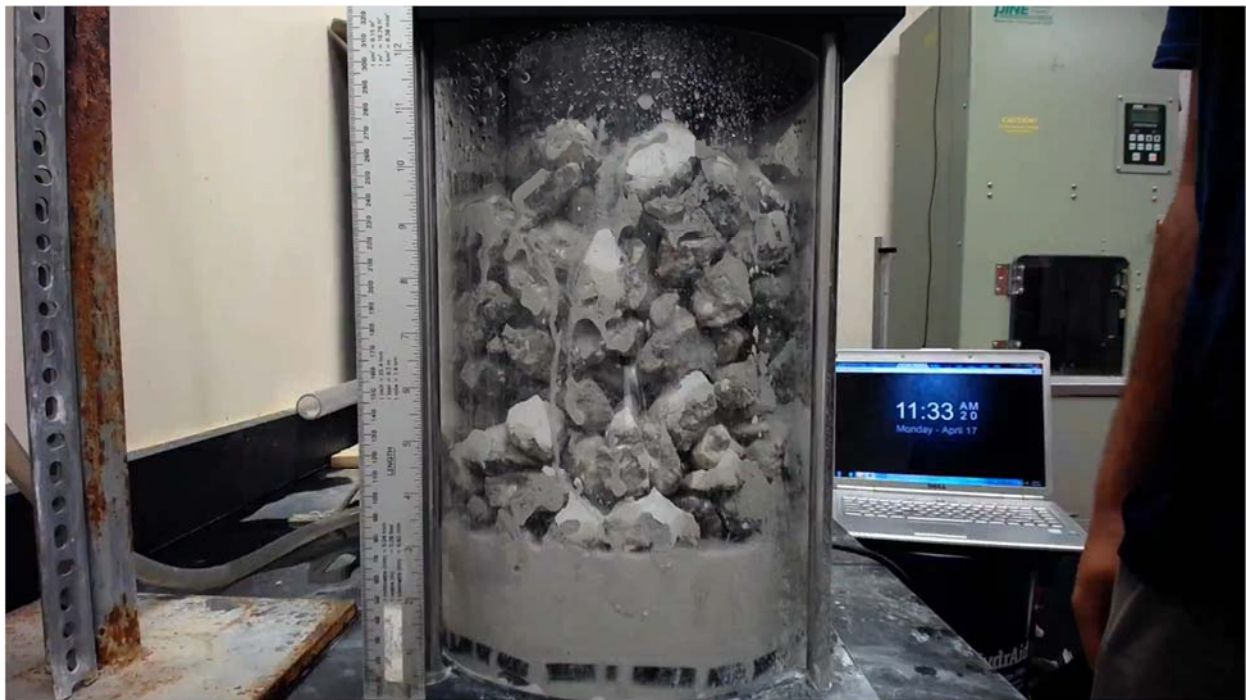
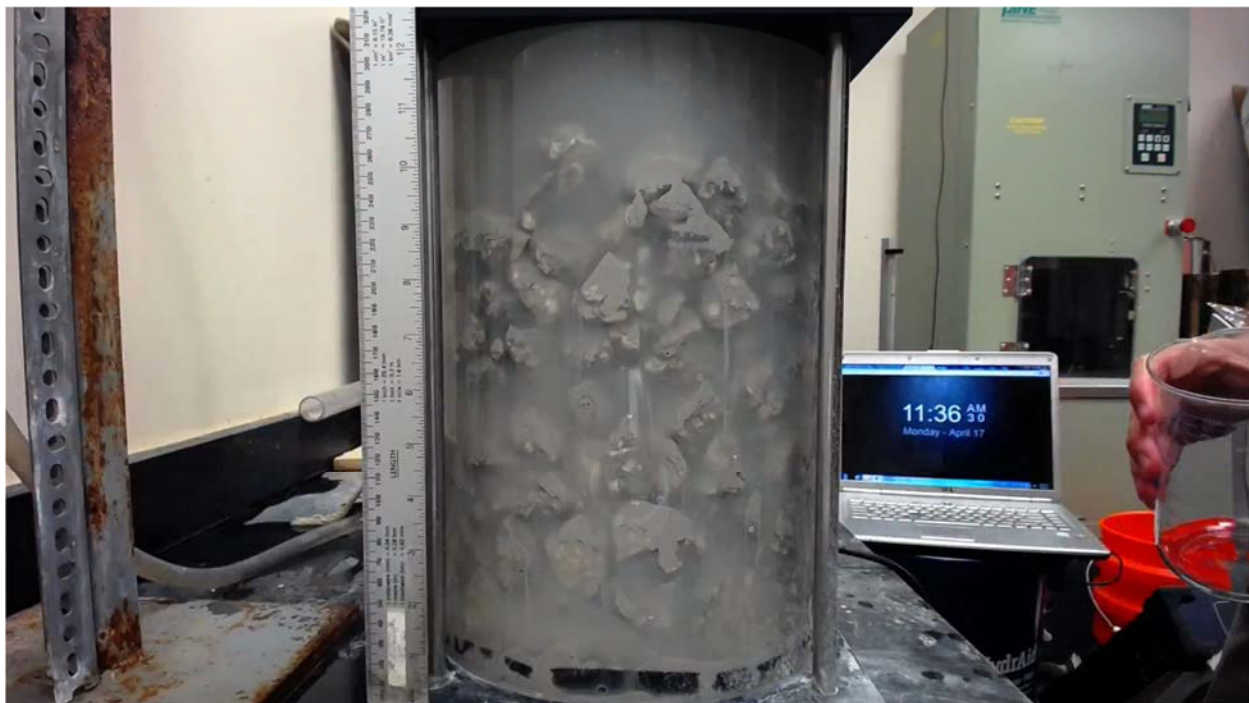
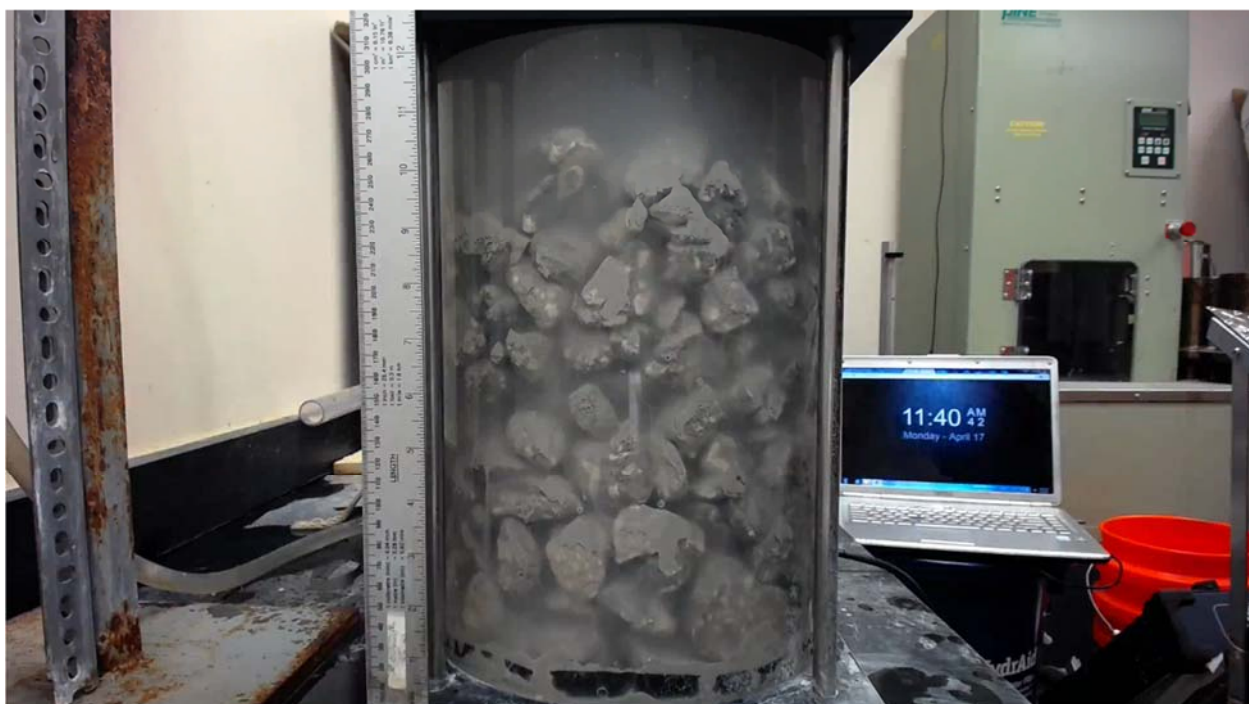
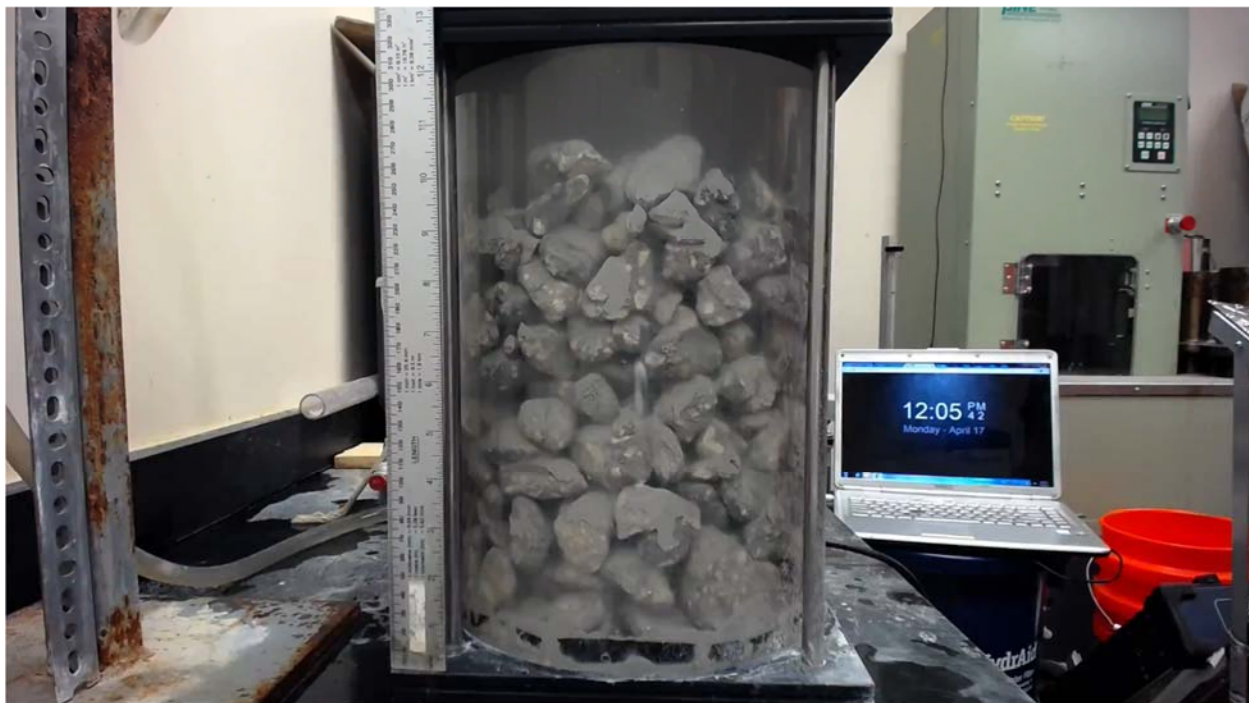
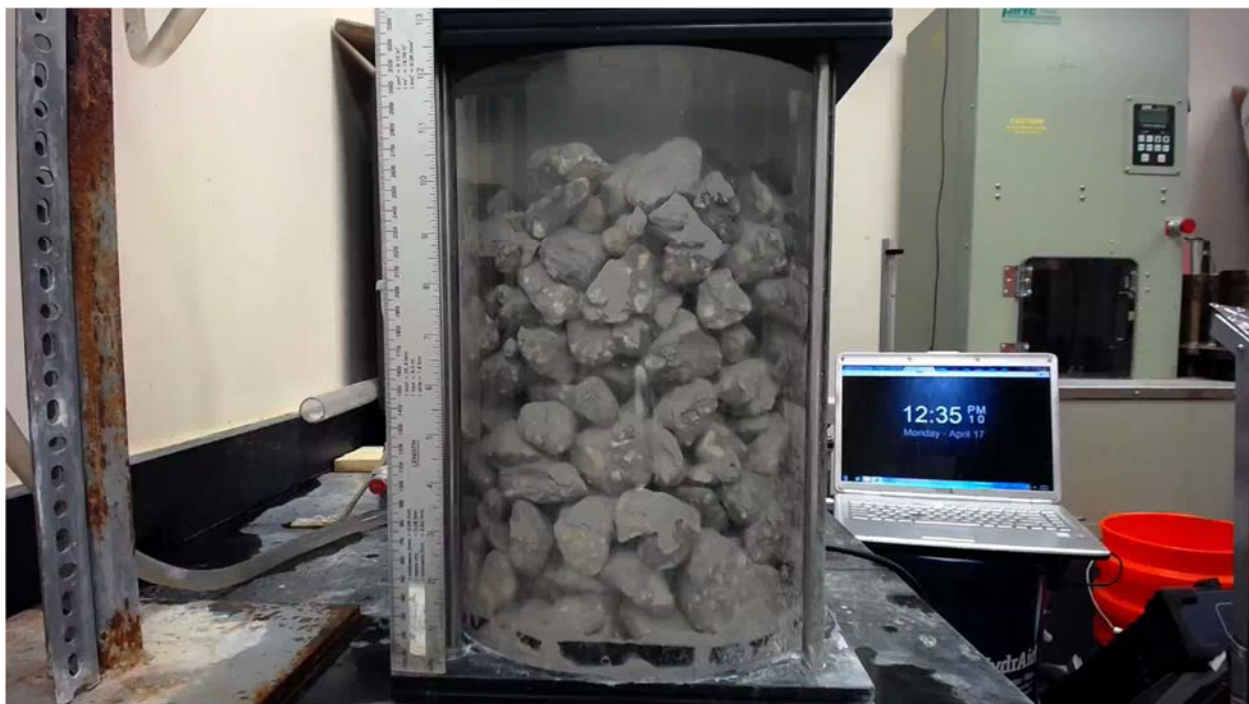
Figure 3.25: Percolation test: heterogeneous dispersal; 5.1% fines
