Final Report

**Field Study of Recycled Concrete Aggregate in French Drain**

FDOT Contract No.: BDV24-977-19

January, 2019

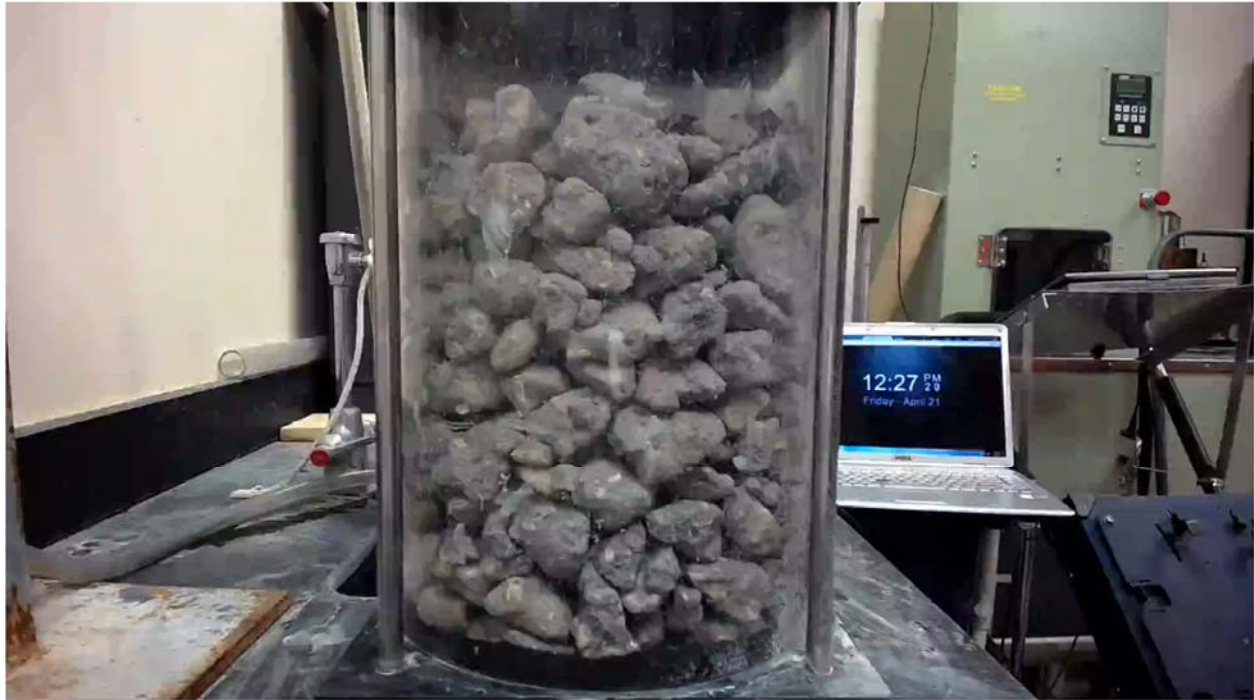
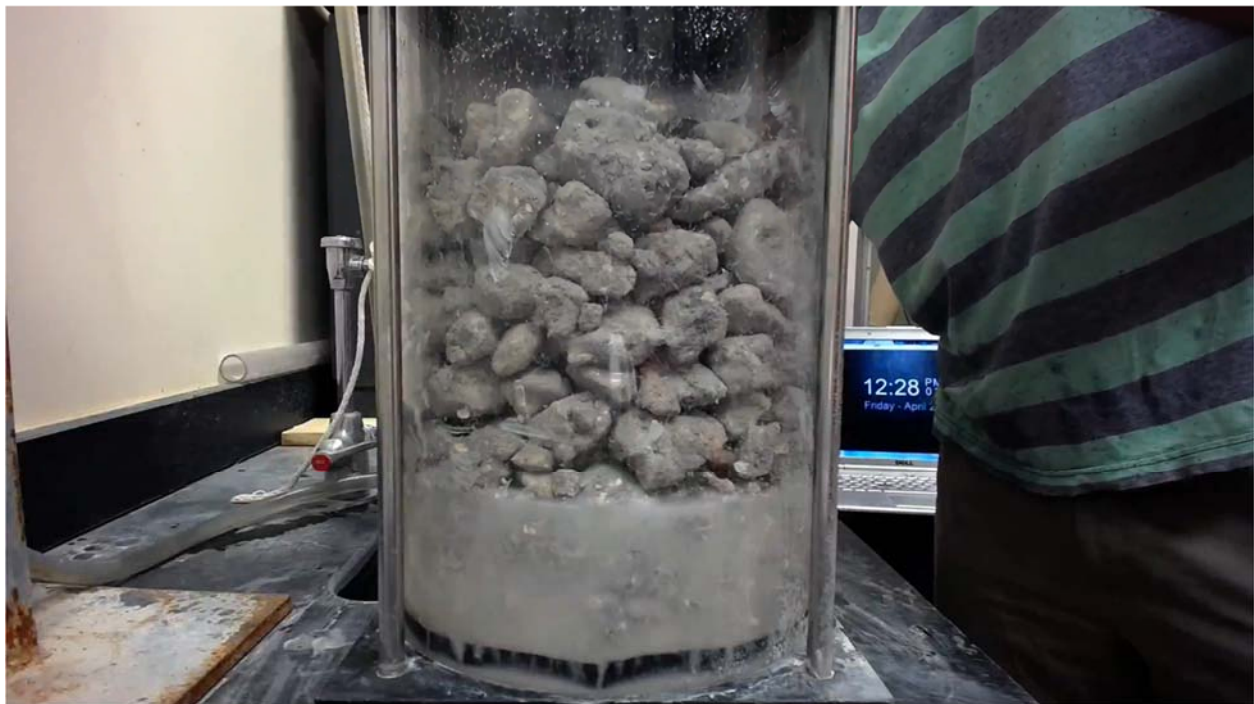
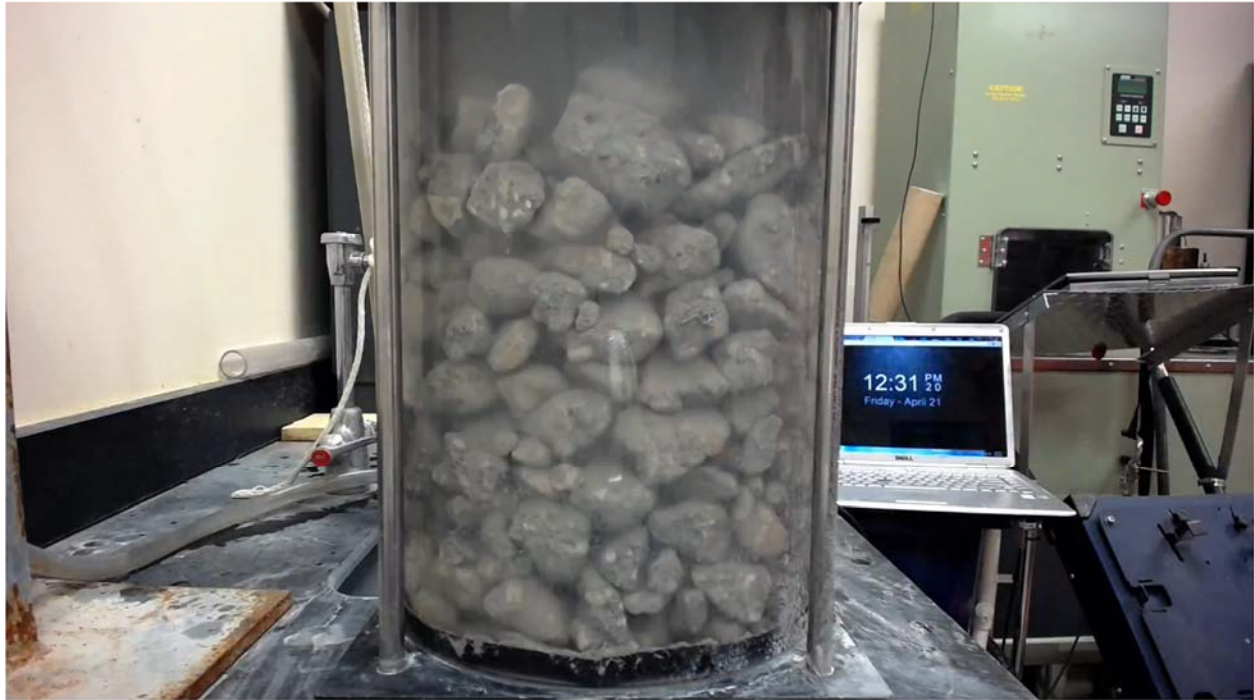
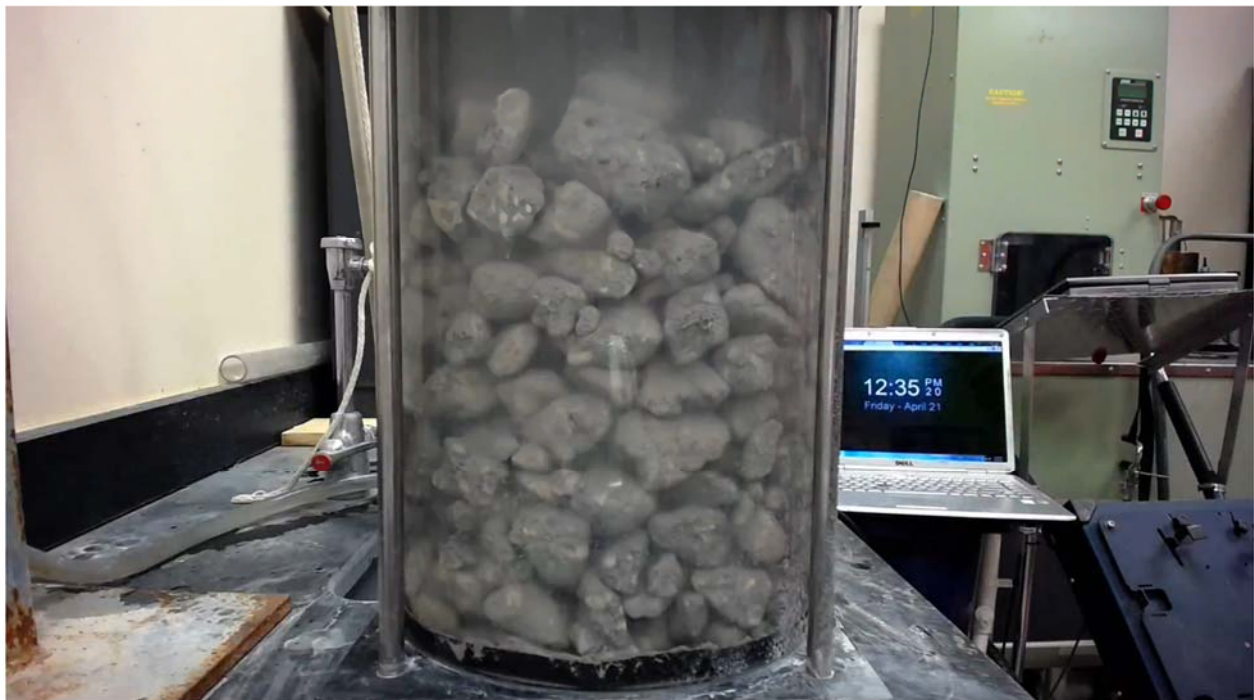
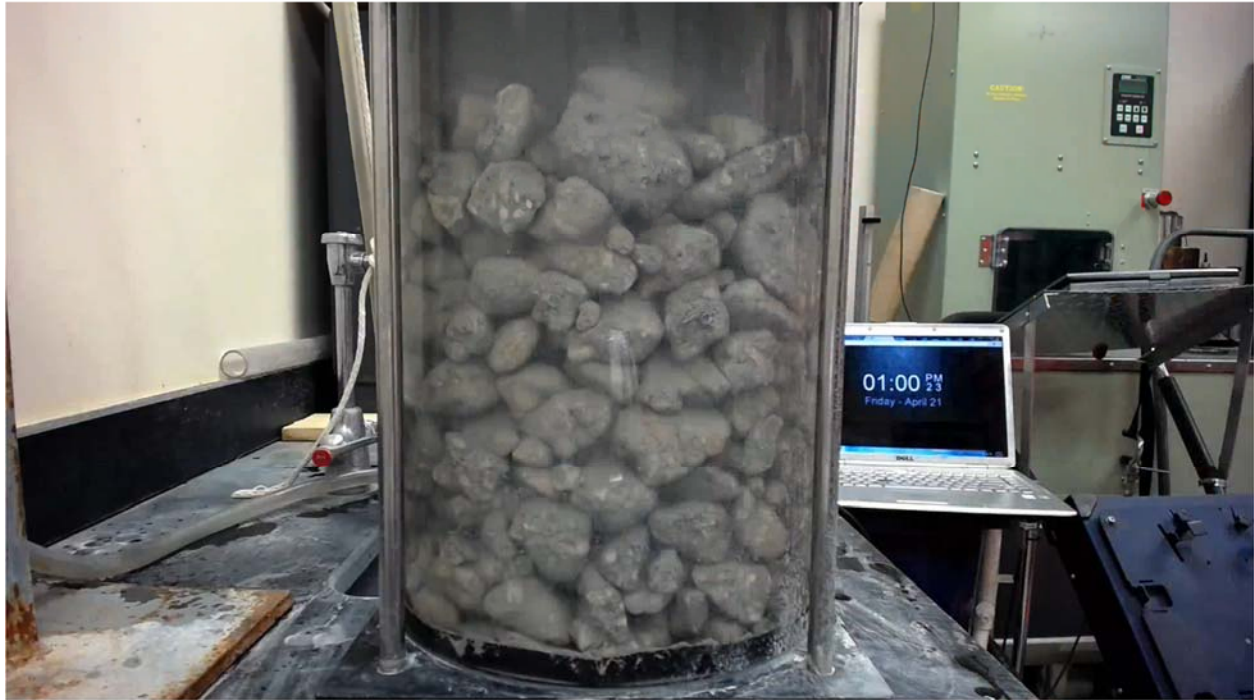
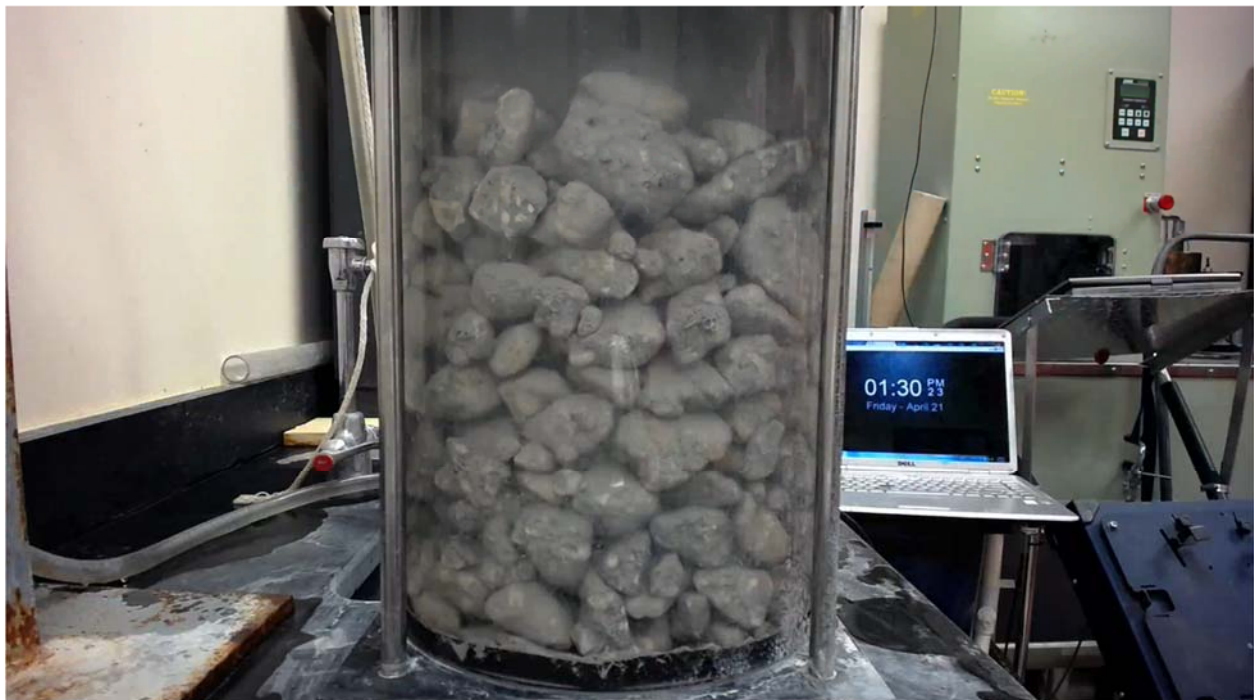
Figure 3.26: Percolation test: homogeneous dispersal; 2% fines

Two fine migration tests were conducted to observe how fines migrate under two different dispersal conditions within the aggregate: 1) homogenous dispersal and 2) heterogeneous dispersal. The homogenous dispersal involved the fines adhering to the surface of the aggregate, thus the fine concentration was distributed/homogenous throughout the whole aggregate mass. The heterogeneous dispersal involved the fines being applied to the top of clean 6" lifts of aggregate, thus the fines were concentrated/heterogeneous within thin layers in the whole aggregate mass. Fines are defined as soil passing the No. #60 sieve because production and collection of soil passing the #200 sieve was not feasible for this scale of a project. It was observed that the heterogeneous dispersal resulted in an accelerated reduction in the flow performance of the geotextile.

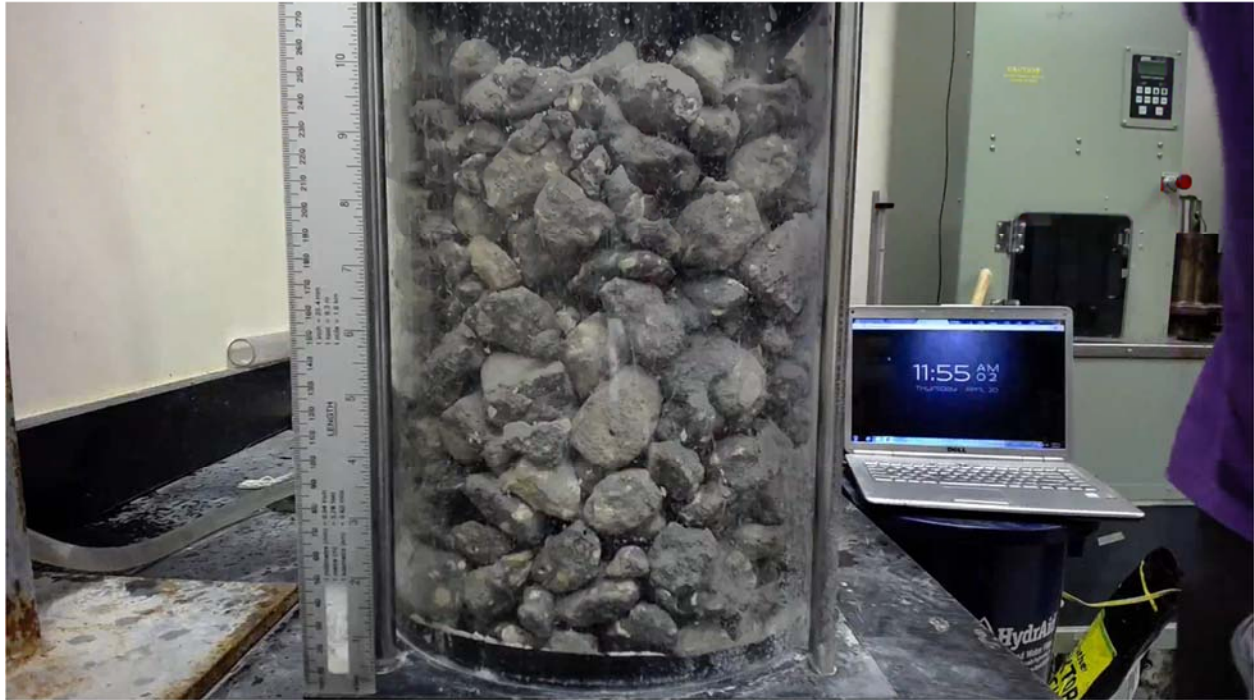
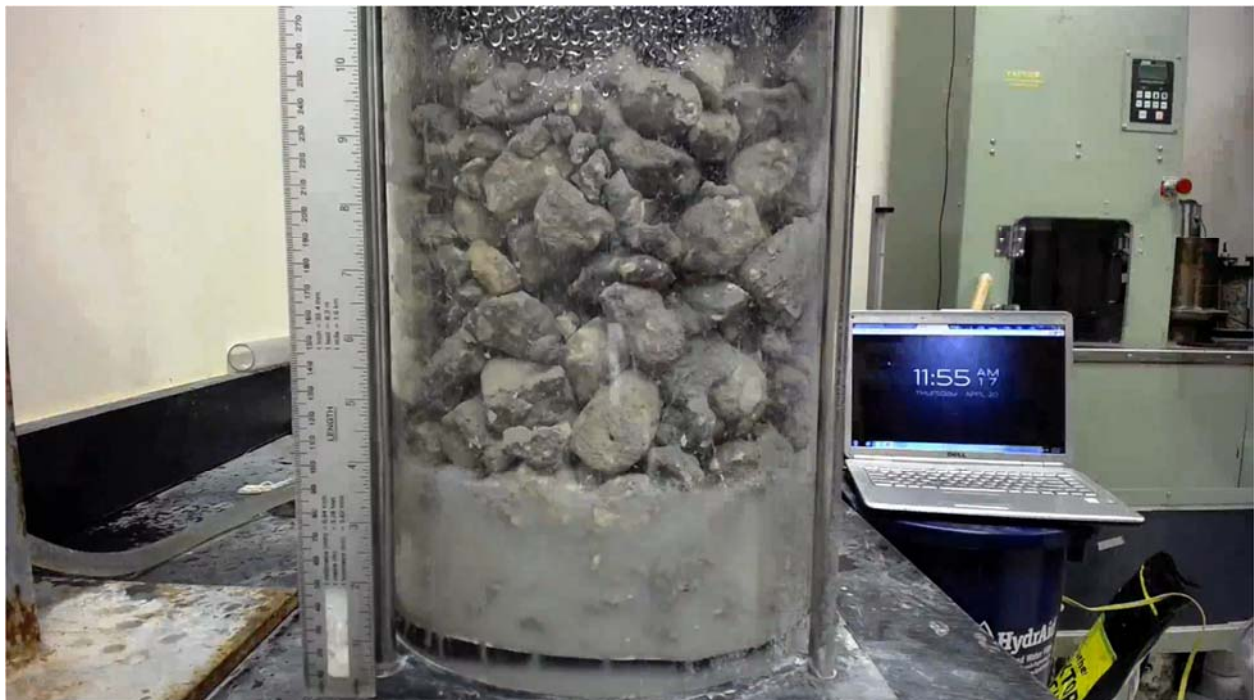
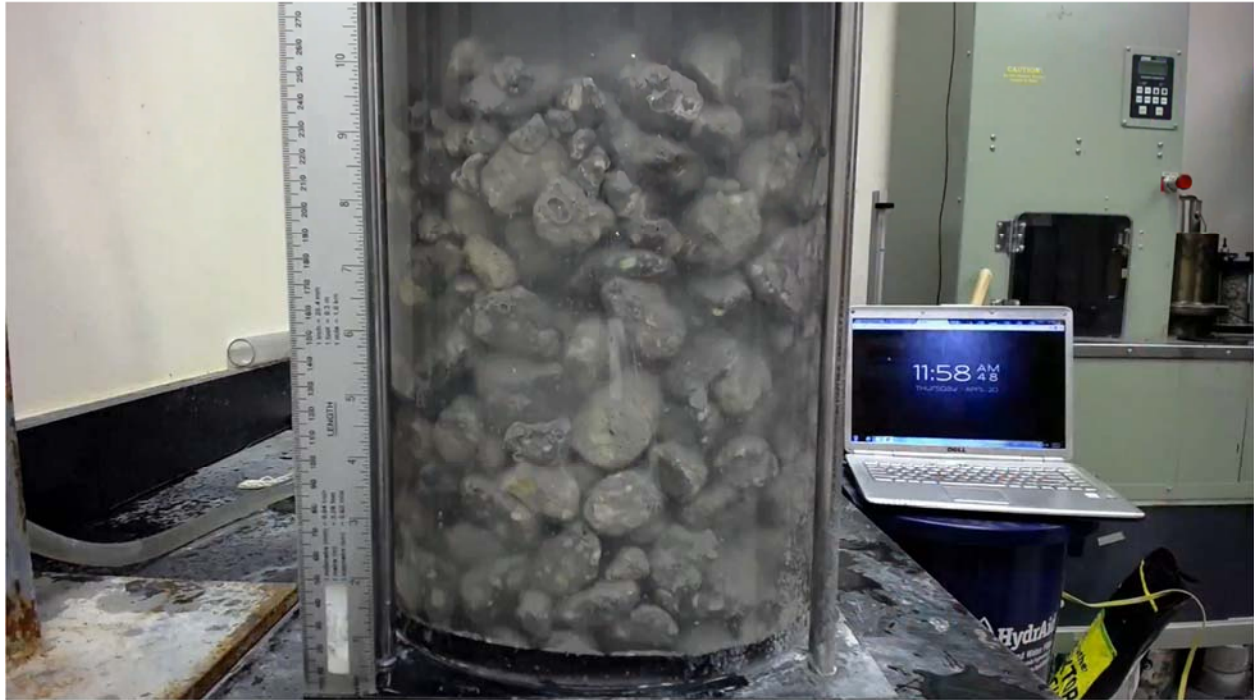
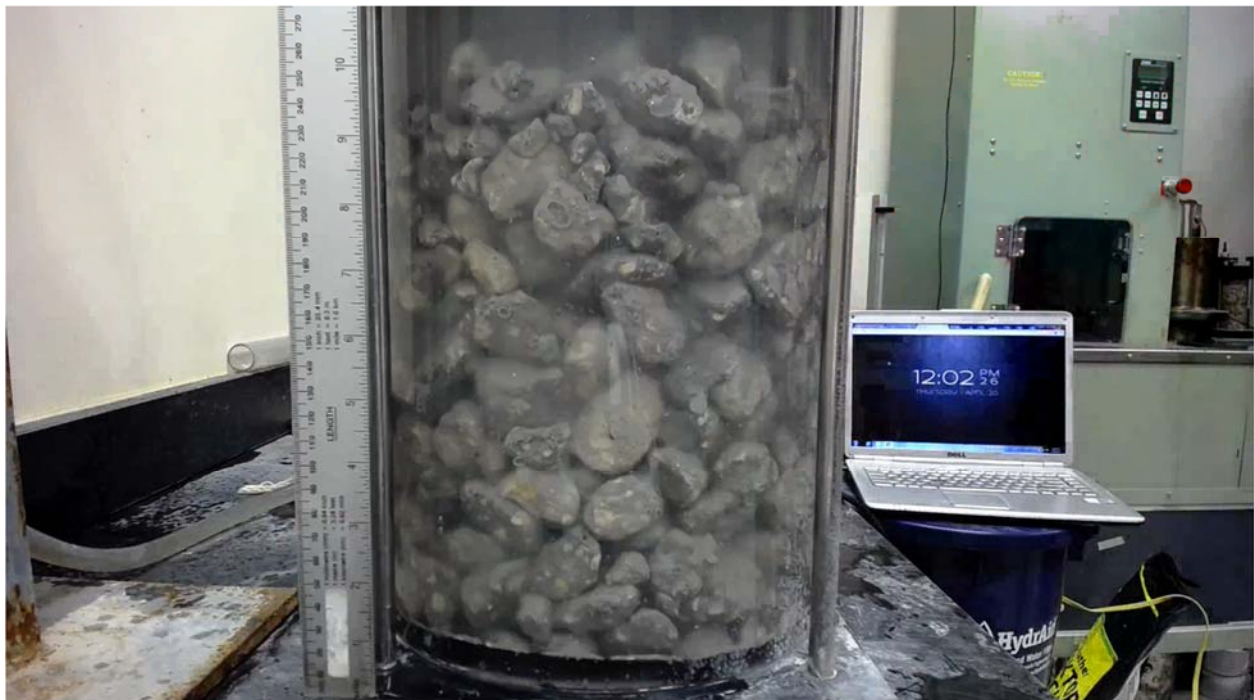
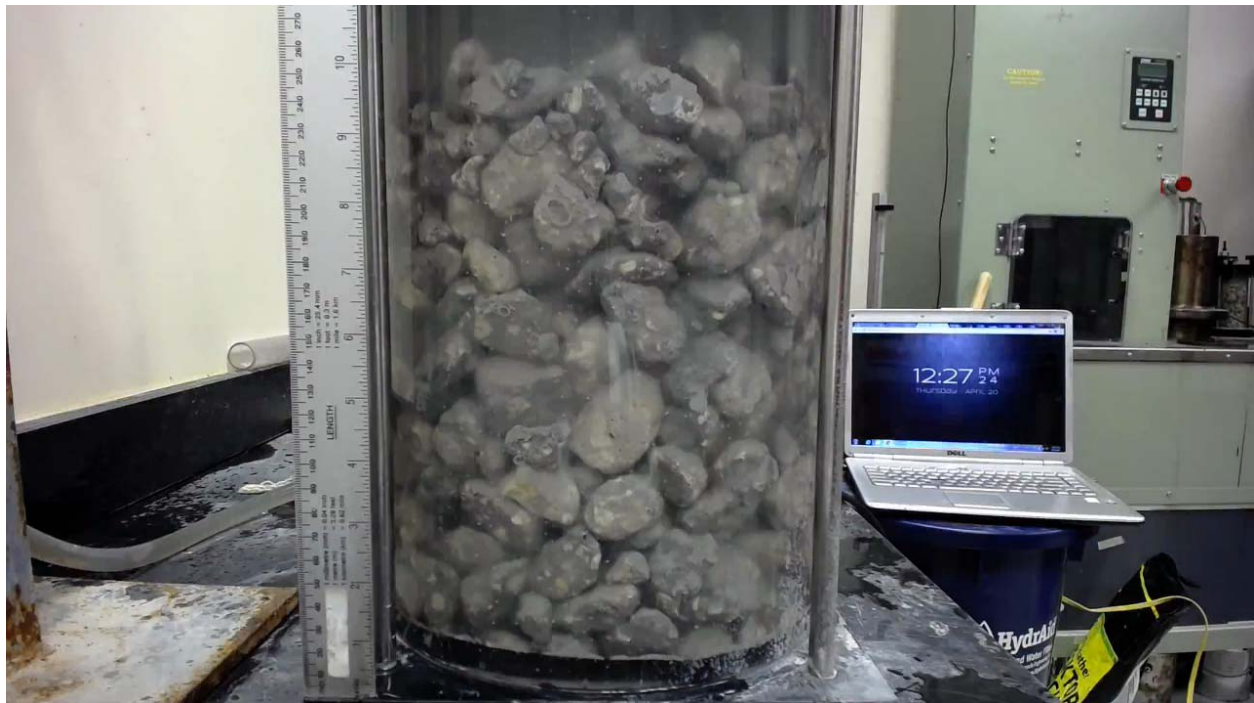
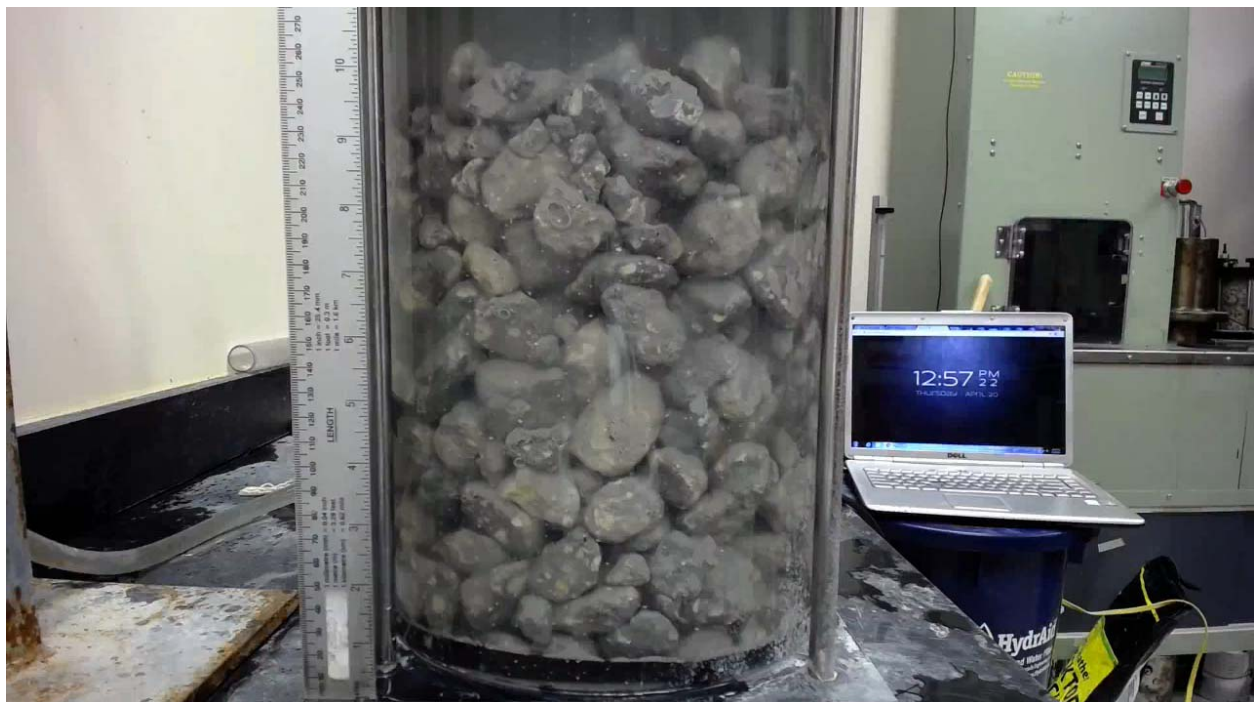
Figure 3.27: Percolation test: heterogeneous dispersal; 2% fines

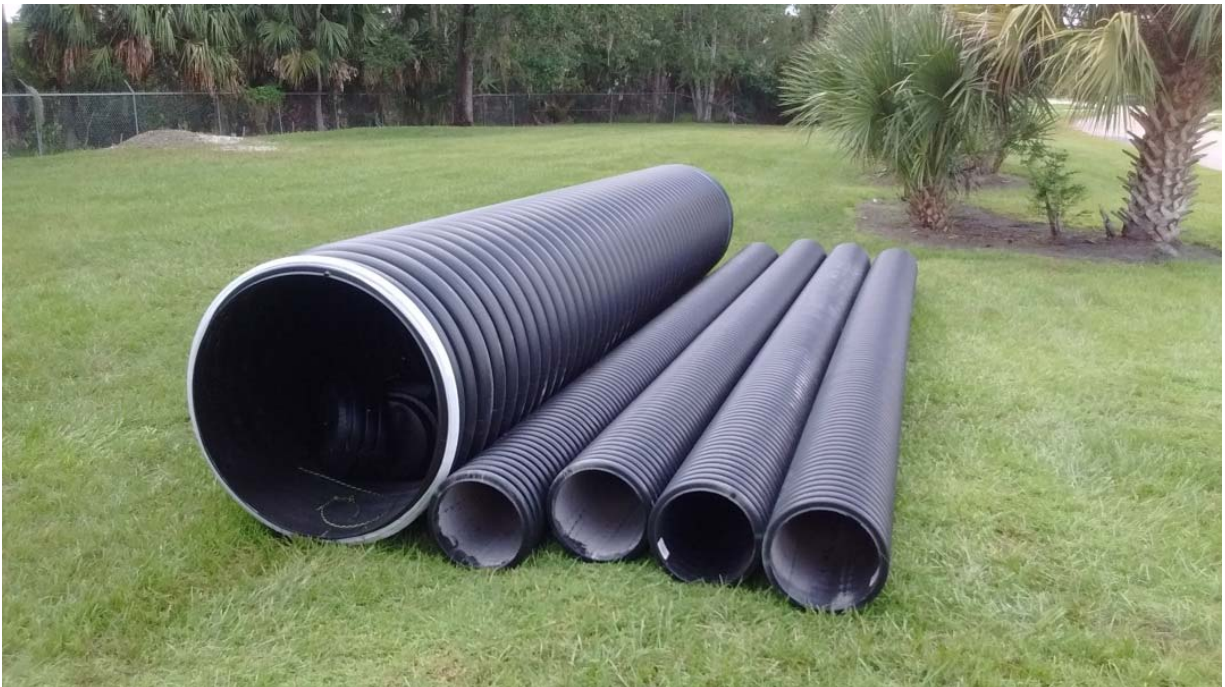
Figure 3.29: Pipes for sumps and French drains

The HDPE pipes were purchased from Advanced Drainage Systems (ADS), Inc., see Figure 3.29. The perforation design for each 12-inch diameter pipe (FDOT Standard Specifications for Road and Bridge Construction, Section 443-2.1(5)) was adjusted from 3/8-inch diameter holes to 1/2-inch diameter holes with an equivalent perforated area. The ADS engineer recommended this change because the 3/8-inch diameter perforation required more holes and risked the structural integrity of the 12-inch diameter pipe. Four sumps were constructed from the one 36-inch diameter pipe. Each French drain consists of a 12-inch diameter pipe with a welded end cap and a 36-inch diameter sump. The product information is shown in Table 3.16.

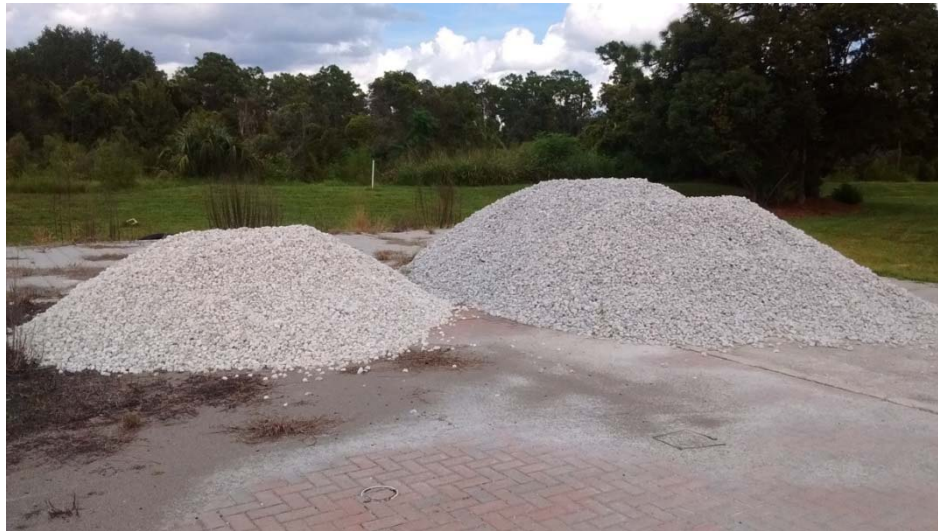
Figure 3.31: No. 4 virgin limestone and No. 4 RCA aggregates

Four French drains were constructed, consisting of one with virgin limestone and three with RCA. RCA French drains contained varied fine contents at as received, 2% and 4%. The drain with No. 4 limestone was used as a control system for comparison purposes. The Researchers purchased 8 tons of No. 4 virgin limestone (2.2% fines as is) from Vulcan Materials Company and were donated 24 tons of No. 4 RCA (0.8% fines as is) from Independence Recycling of Florida, Inc. The aggregate wet sieving was complied with the FM 1-T 011 method. Figure 3.31 shows the aggregates stored at the UCF site. For RCA with varied fine contents, the researchers mechanically conditioned the No. 4 RCA. A concrete mixer was used for the fine generation, Figure 3.32.

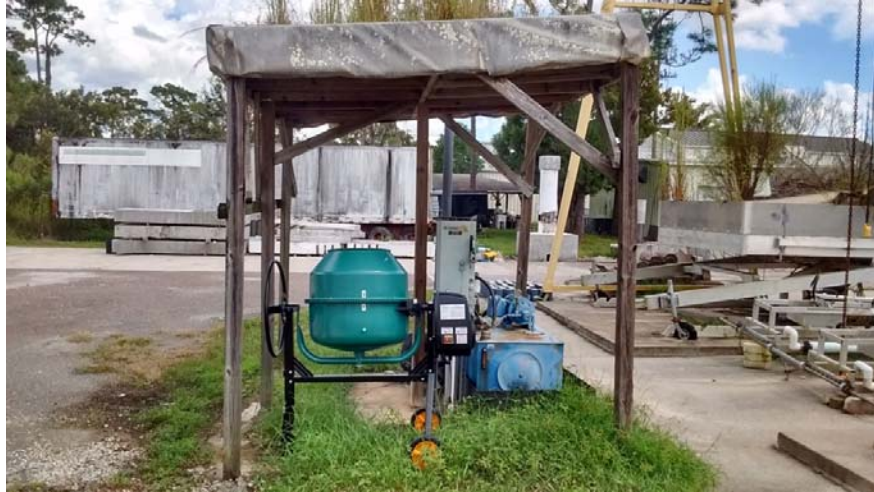
Figure 3.32: Concrete mixer for fines generation prior to the placement of aggregates

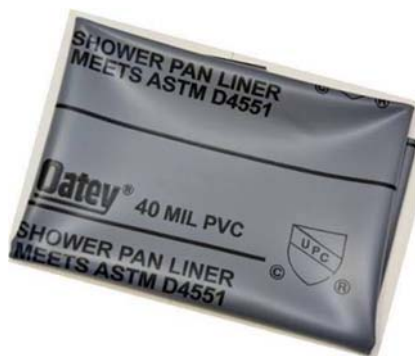
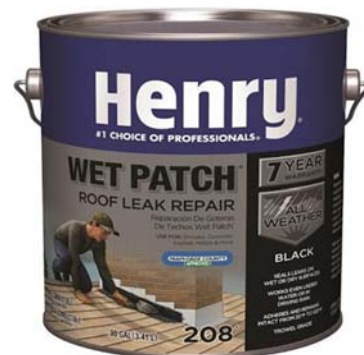
Figure 3.33: Materials for waterproofing sump

The bottoms of the sumps were sealed with a 40 mil PVC liner and a bituminous sealant applied to all joints, Figure 3.33. Because the exterior corrugation on the sump had to be cut an expansion foam was used where the French drain pipe mounted to the sump, Figure 3.34.

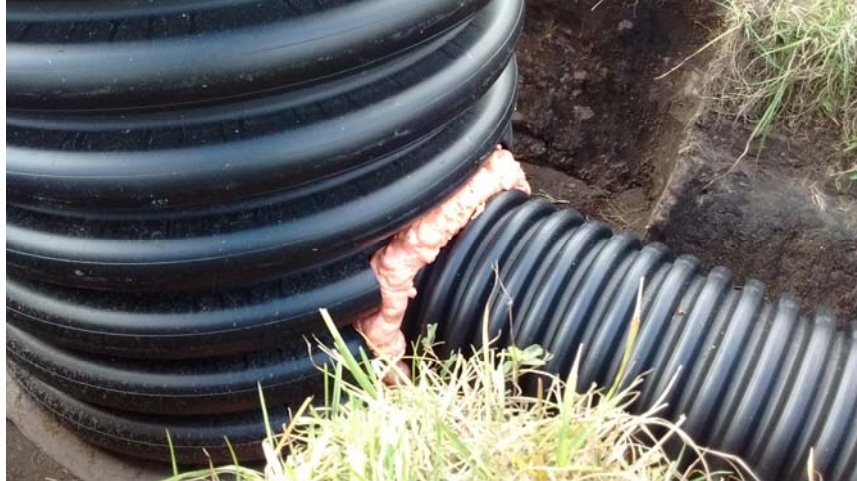
Figure 3.34: Sump-French drain interface

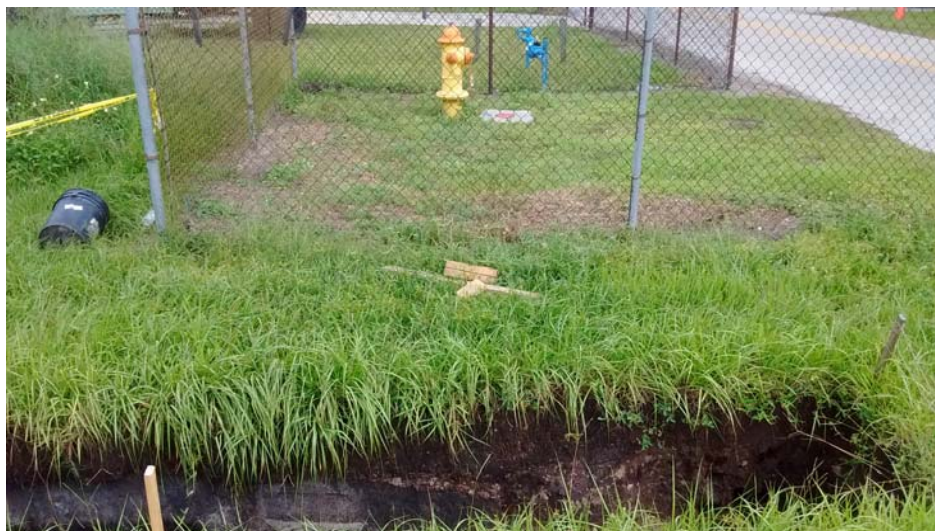
Figure 3.36: On-site fire hydrant

The fire hydrant on site (Figures 3.36 and 3.37) was rated orange (500 – 999 gpm) and served as the water supply when running the French drain experiment. The University’s Utilities & Energy Services department performed the flow meter and backflow preventer installation. The fire hose connected to the flow meter and supplied water to the individual French drain under testing.

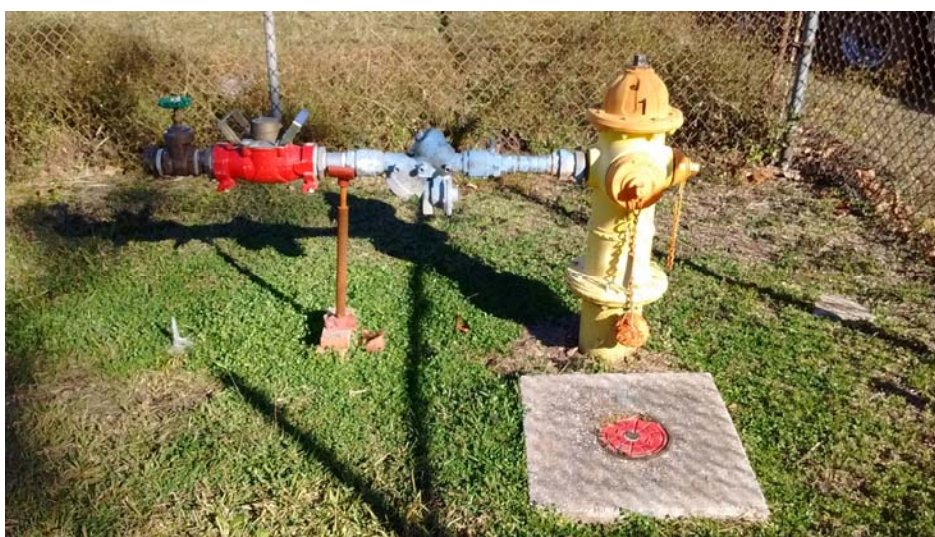
Figure 3.37. Badger meter and Watts backflow preventer installed on the fire hydrant

The fire hydrant on site was rated orange (500 – 999 gpm) and served as the water supply when running the French drain experiment. The University's Utilities & Energy Services department performed the flow meter and backflow preventer installation, Figure 3.37. Table 3.21 shows the description of the flow meter and backflow preventer. The fire hose connected to the flow meter and supplied water to the individual French drains.

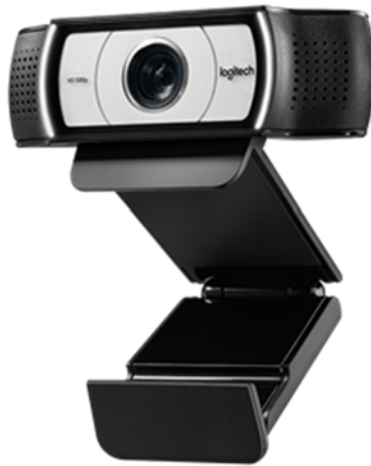
Figure 3.38: Camera to inspect inside pipe

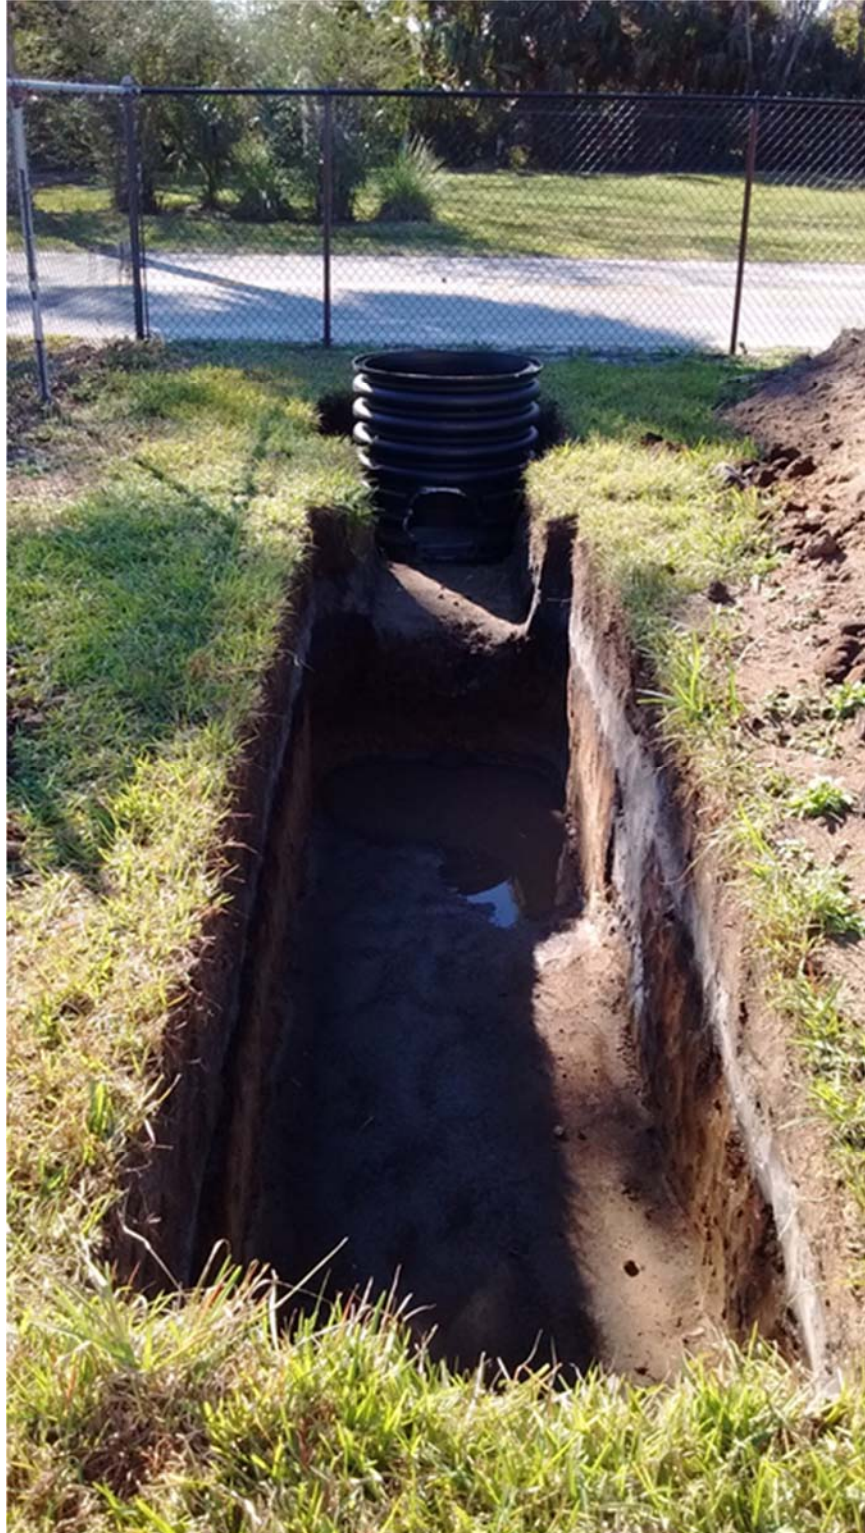
Figure 3.39: Construction of trench

Once a trench was excavated, a sump was then prepared by cutting a segment off the 20-ft-long 36-inch inner diameter HDPE pipe. Once segmented, a hole was then cut into the sump to allow the perforated 12-in inner diameter pipe to be inserted (see Figure 3.40). Before placing the sump into the trench, a tailored section of the PVC pipe was first placed between the in situ soil and sump bottom. The sump was then placed on top of the PVC pipe, then sealed with a bituminous sealant (see Figure 3.42). Next, the drainage portion of the trench was lined with geotextile, and aggregate was poured to an elevation that would be level with the bottom of the horizontal 12-inch inner diameter perforated pipe, once it was installed (see Figure 3.44). For the washed RCA and limestone trenches, the aggregate was placed directly into the trench, but for the RCA with 2% fines and RCA with 4% fines trenches, the fines had to be added to the aggregate before placement into the trench because the only source of RCA was washed RCA, which has a negligible fines content. Fines were generated by taking a sacrificial portion of the RCA stockpile and grinding it in a Los Angeles (LA) abrasion machine. The generated fines and washed RCA were both placed into a concrete mixer located at the edge of the trench, with specific proportions of each to obtain the desired fines content for a specific French drain. Water was also added to the aggregate to prevent the fines from producing a hazardous vapor during mixing. After approximately a minute of mixing to obtain a near homogenous dispersion of the fines, the contents of the cement mixer were then poured into the trench (see Figure 3.43). Once the aggregate was poured to an elevation that would be level with the bottom of the horizontal 12-inch inner diameter perforated pipe, the pipe was then installed through the hole in the sump and placed on top of the bed of aggregate (see Figure 3.45). The 12-inch inner diameter pipe was then sealed to the sump with expansion foam on the exterior and bituminous sealant on the interior. Any excess of the 12 in inner diameter pipe extending more than 6 in into the sump was removed. After the geotextile was secured around the unperforated portion of the 12-inch inner diameter pipe, the aggregate was further poured until it was within three inches of the ground surface. Lastly, the geotextile was folded over to cover the top of the aggregate (see Figure 3.46) and backfill was then placed and compacted (see Figure 3.47).

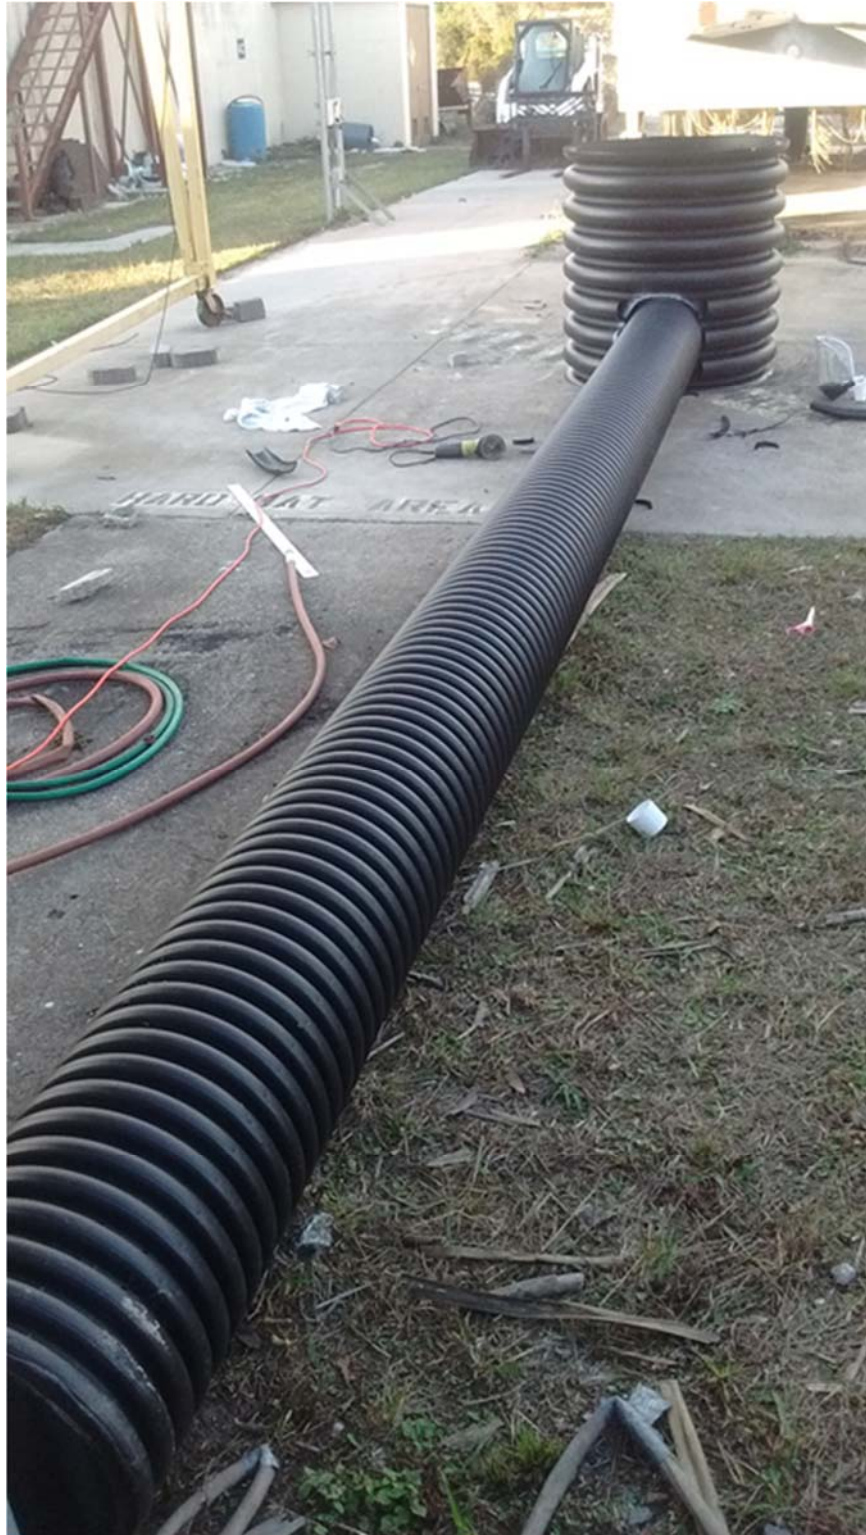
Figure 3.40: French drain plumbing

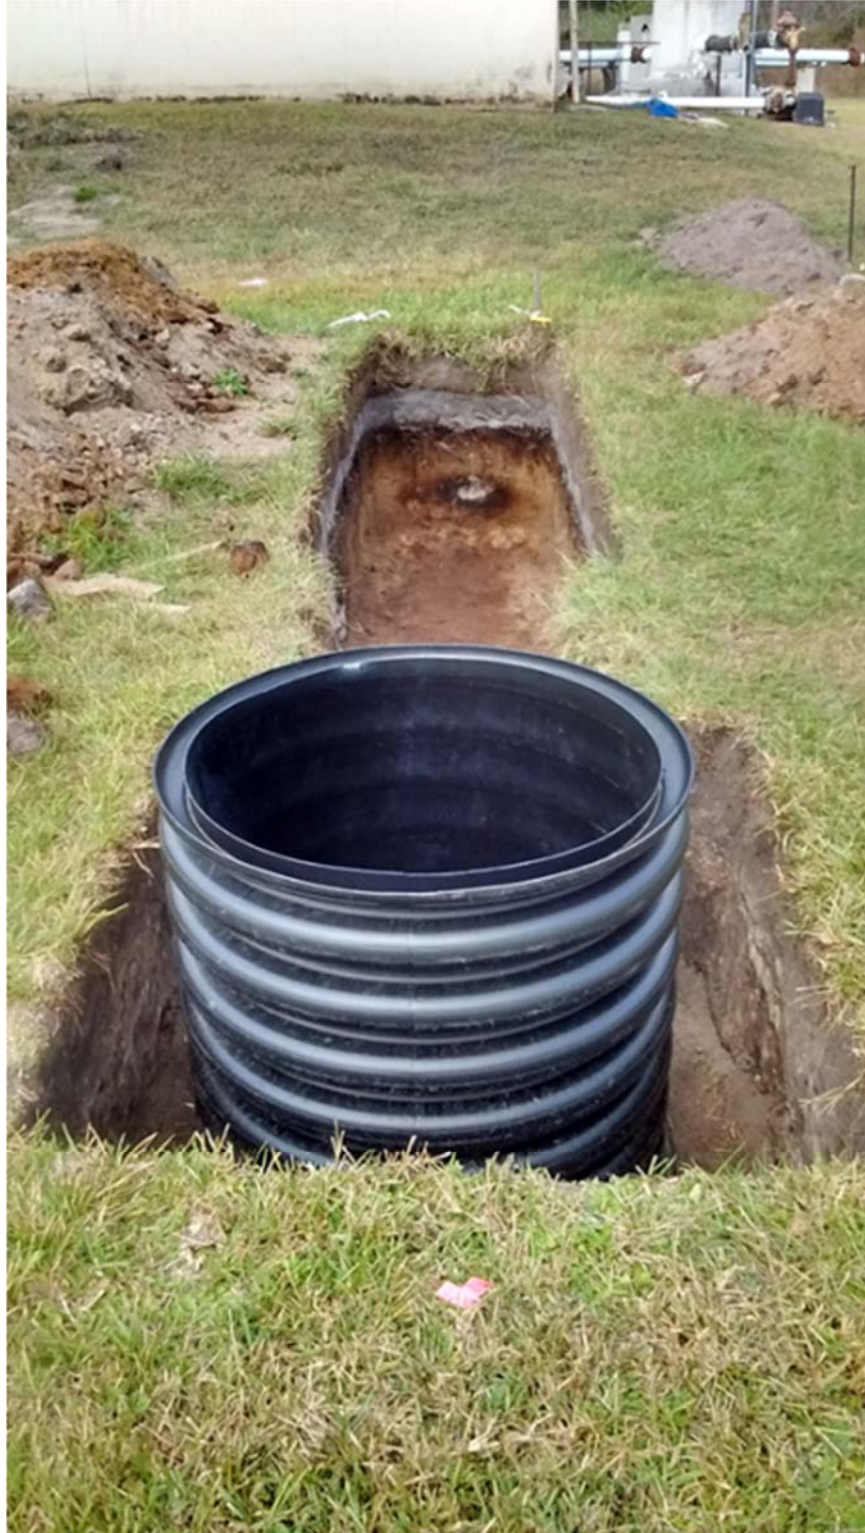
Figure 3.41: The sump placed in the trench

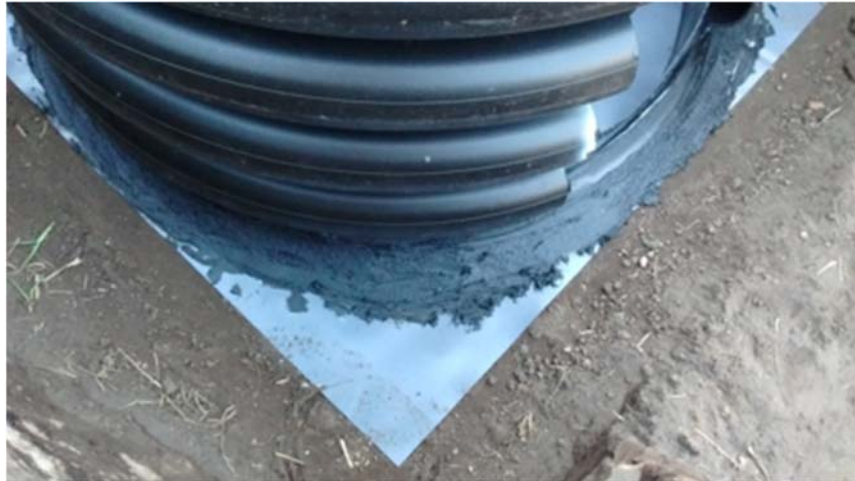
Figure 3.42: Sealing the sump

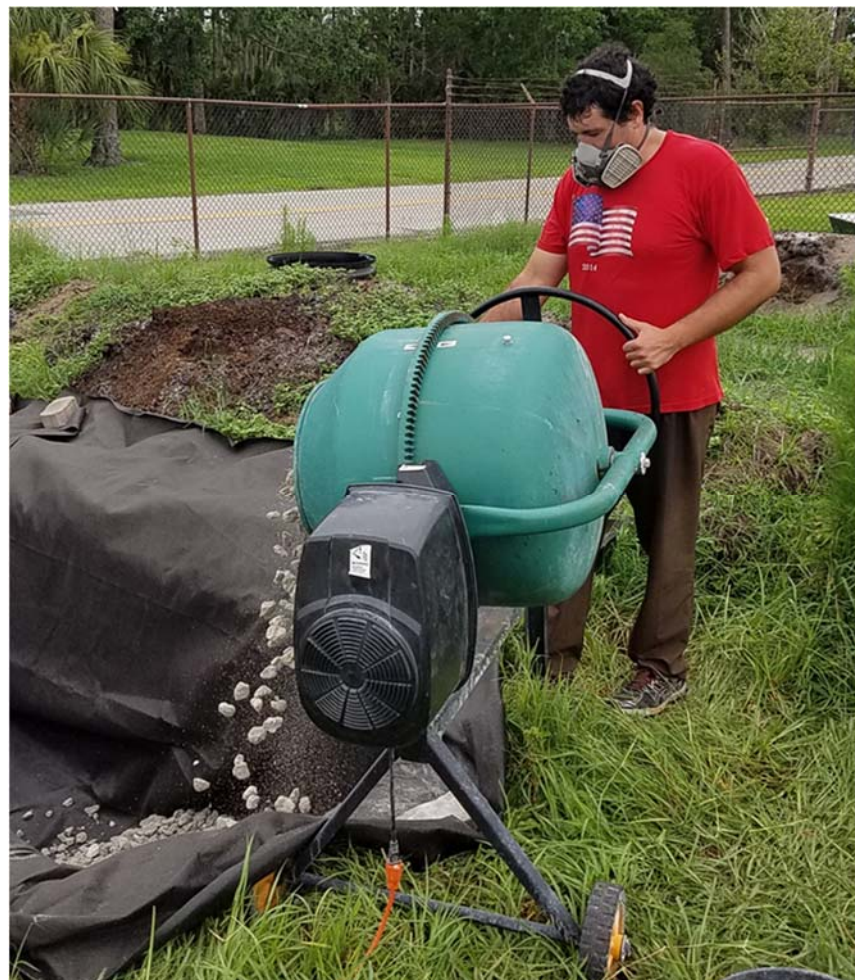
Figure 3.43: Mixing fines and aggregate

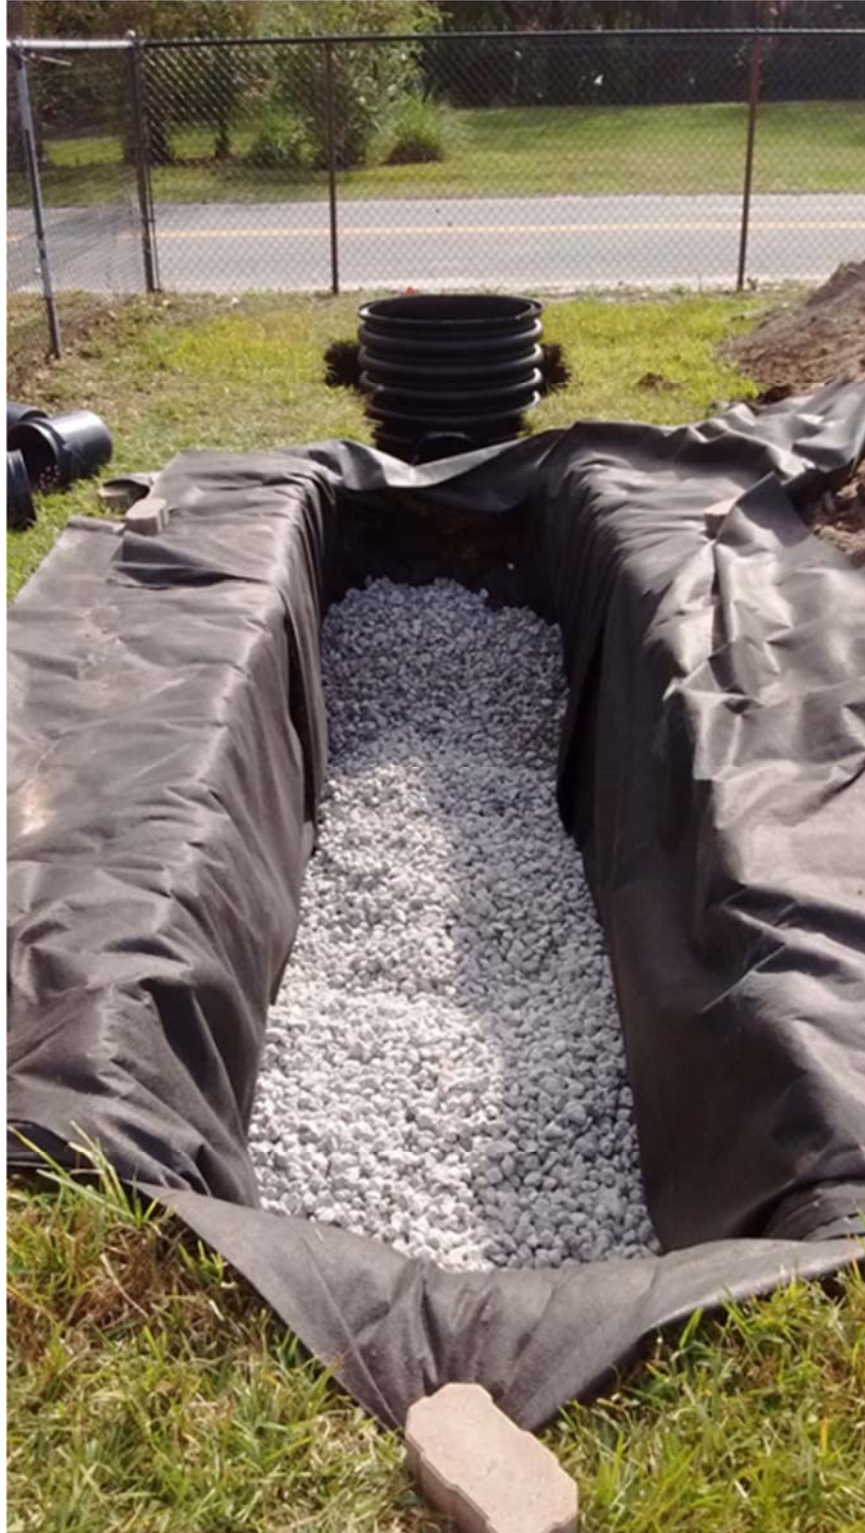
Figure 3.44: Placement of aggregate in trench
