Final Report

**Field Study of Recycled Concrete Aggregate in French Drain**

FDOT Contract No.: BDV24-977-19

January, 2019

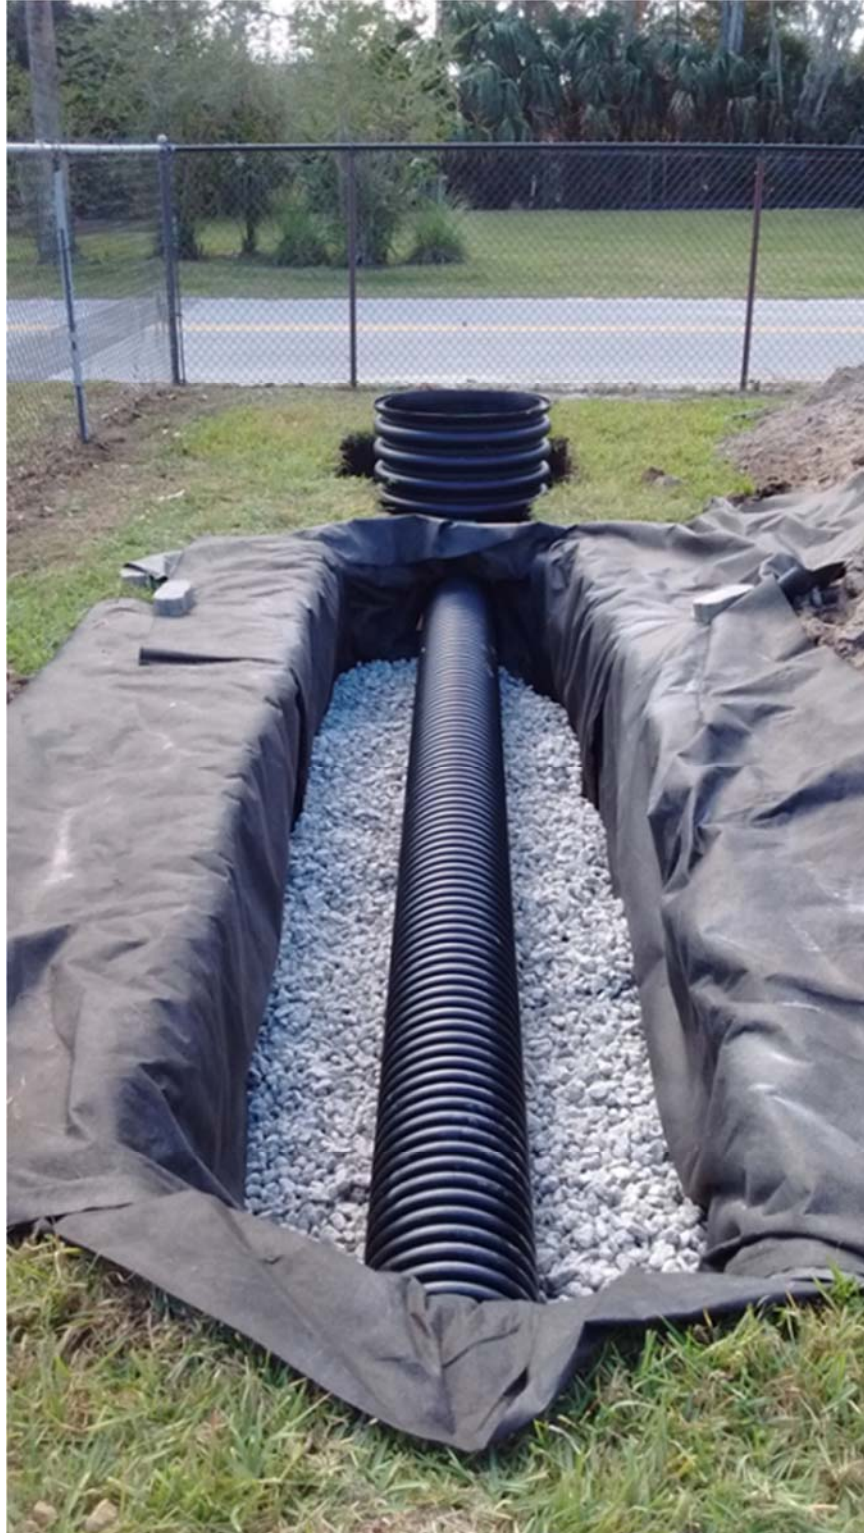
Figure 3.45: Placement of HDPE pipe in trench

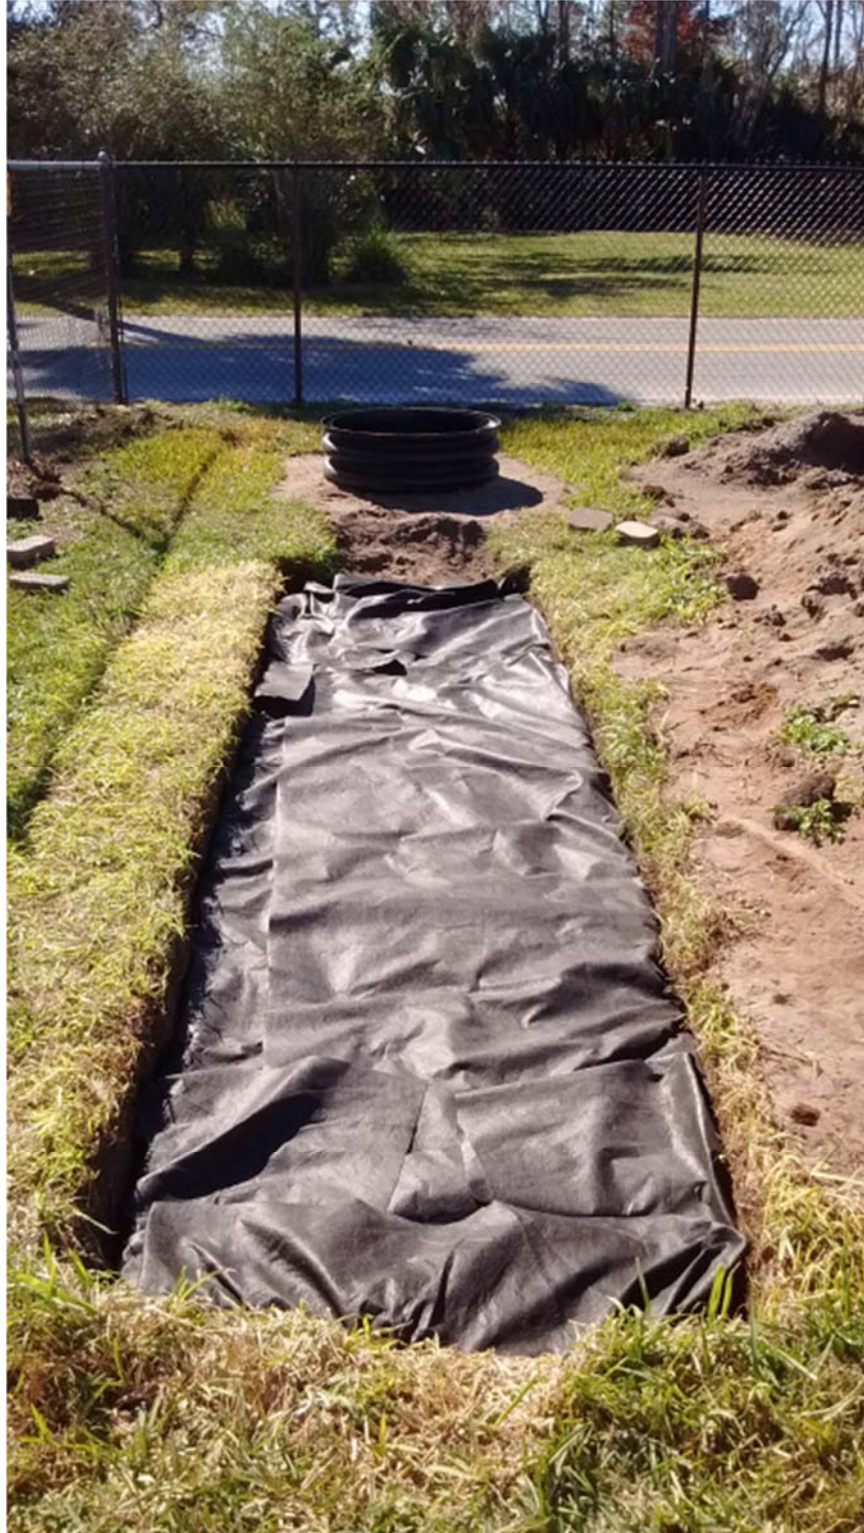
Figure 3.46: Geotextile covering aggregate

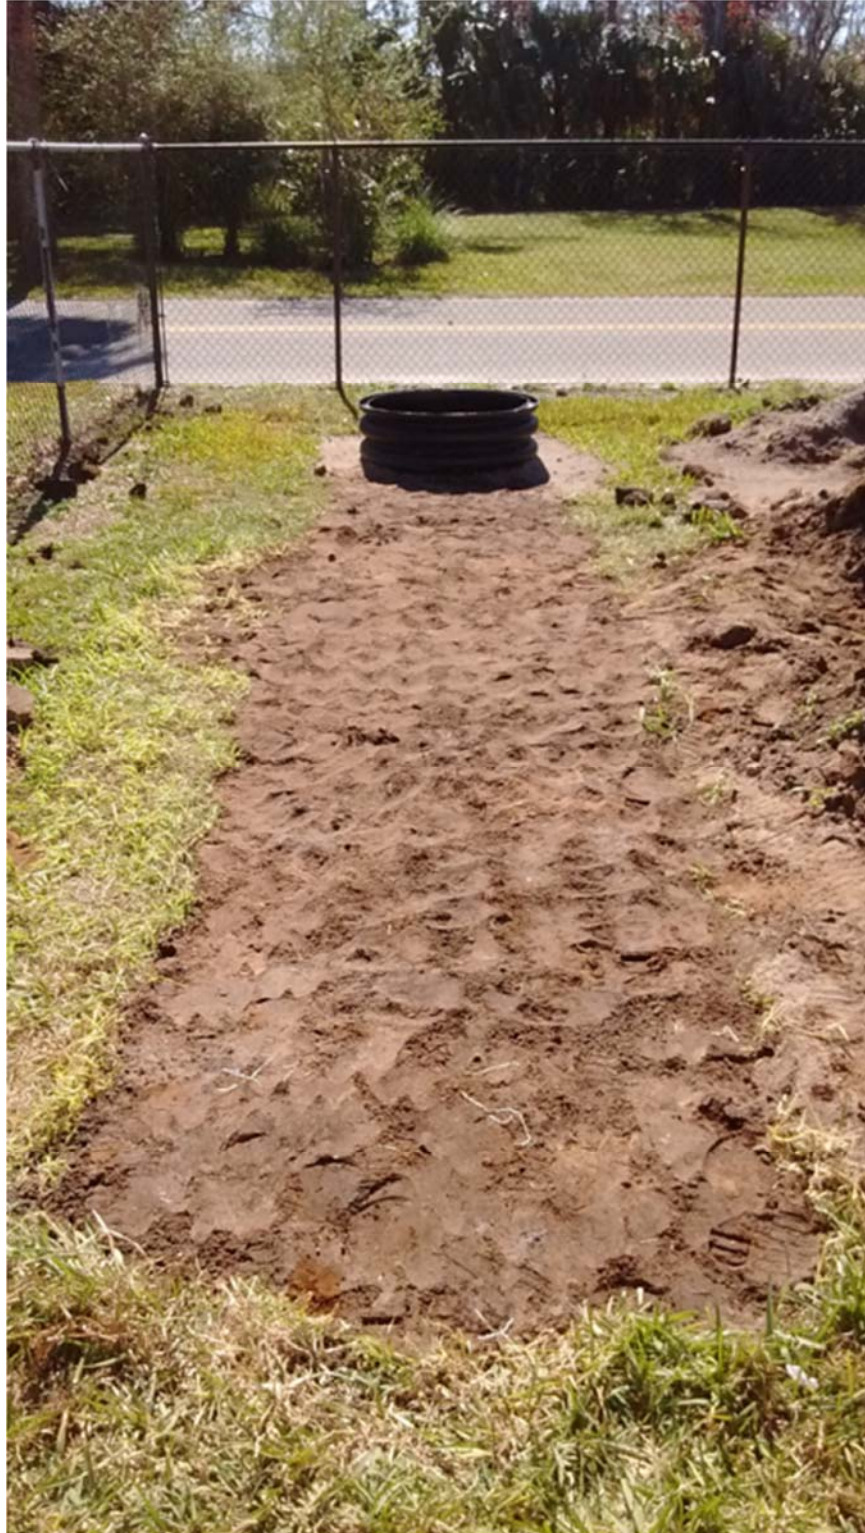
Figure 3.47: Completion of French drain 1 (RCA "as is") construction

Once a trench was excavated, a sump was then prepared by cutting a segment off the 20-ft-long 36-inch inner diameter HDPE pipe. Once segmented, a hole was then cut into the sump to allow the perforated 12-in inner diameter pipe to be inserted (see Figure 3.40). Before placing the sump into the trench, a tailored section of the PVC pipe was first placed between the in situ soil and sump bottom. The sump was then placed on top of the PVC pipe, then sealed with a bituminous sealant (see Figure 3.42). Next, the drainage portion of the trench was lined with geotextile, and aggregate was poured to an elevation that would be level with the bottom of the horizontal 12-inch inner diameter perforated pipe, once it was installed (see Figure 3.44). For the washed RCA and limestone trenches, the aggregate was placed directly into the trench, but for the RCA with 2% fines and RCA with 4% fines trenches, the fines had to be added to the aggregate before placement into the trench because the only source of RCA was washed RCA, which has a negligible fines content. Fines were generated by taking a sacrificial portion of the RCA stockpile and grinding it in a Los Angeles (LA) abrasion machine. The generated fines and washed RCA were both placed into a concrete mixer located at the edge of the trench, with specific proportions of each to obtain the desired fines content for a specific French drain. Water was also added to the aggregate to prevent the fines from producing a hazardous vapor during mixing. After approximately a minute of mixing to obtain a near homogenous dispersion of the fines, the contents of the cement mixer were then poured into the trench (see Figure 3.43). Once the aggregate was poured to an elevation that would be level with the bottom of the horizontal 12-inch inner diameter perforated pipe, the pipe was then installed through the hole in the sump and placed on top of the bed of aggregate (see Figure 3.45). The 12-inch inner diameter pipe was then sealed to the sump with expansion foam on the exterior and bituminous sealant on the interior. Any excess of the 12 in inner diameter pipe extending more than 6 in into the sump was removed. After the geotextile was secured around the unperforated portion of the 12-inch inner diameter pipe, the aggregate was further poured until it was within three inches of the ground surface. Lastly, the geotextile was folded over to cover the top of the aggregate (see Figure 3.46) and backfill was then placed and compacted (see Figure 3.47).

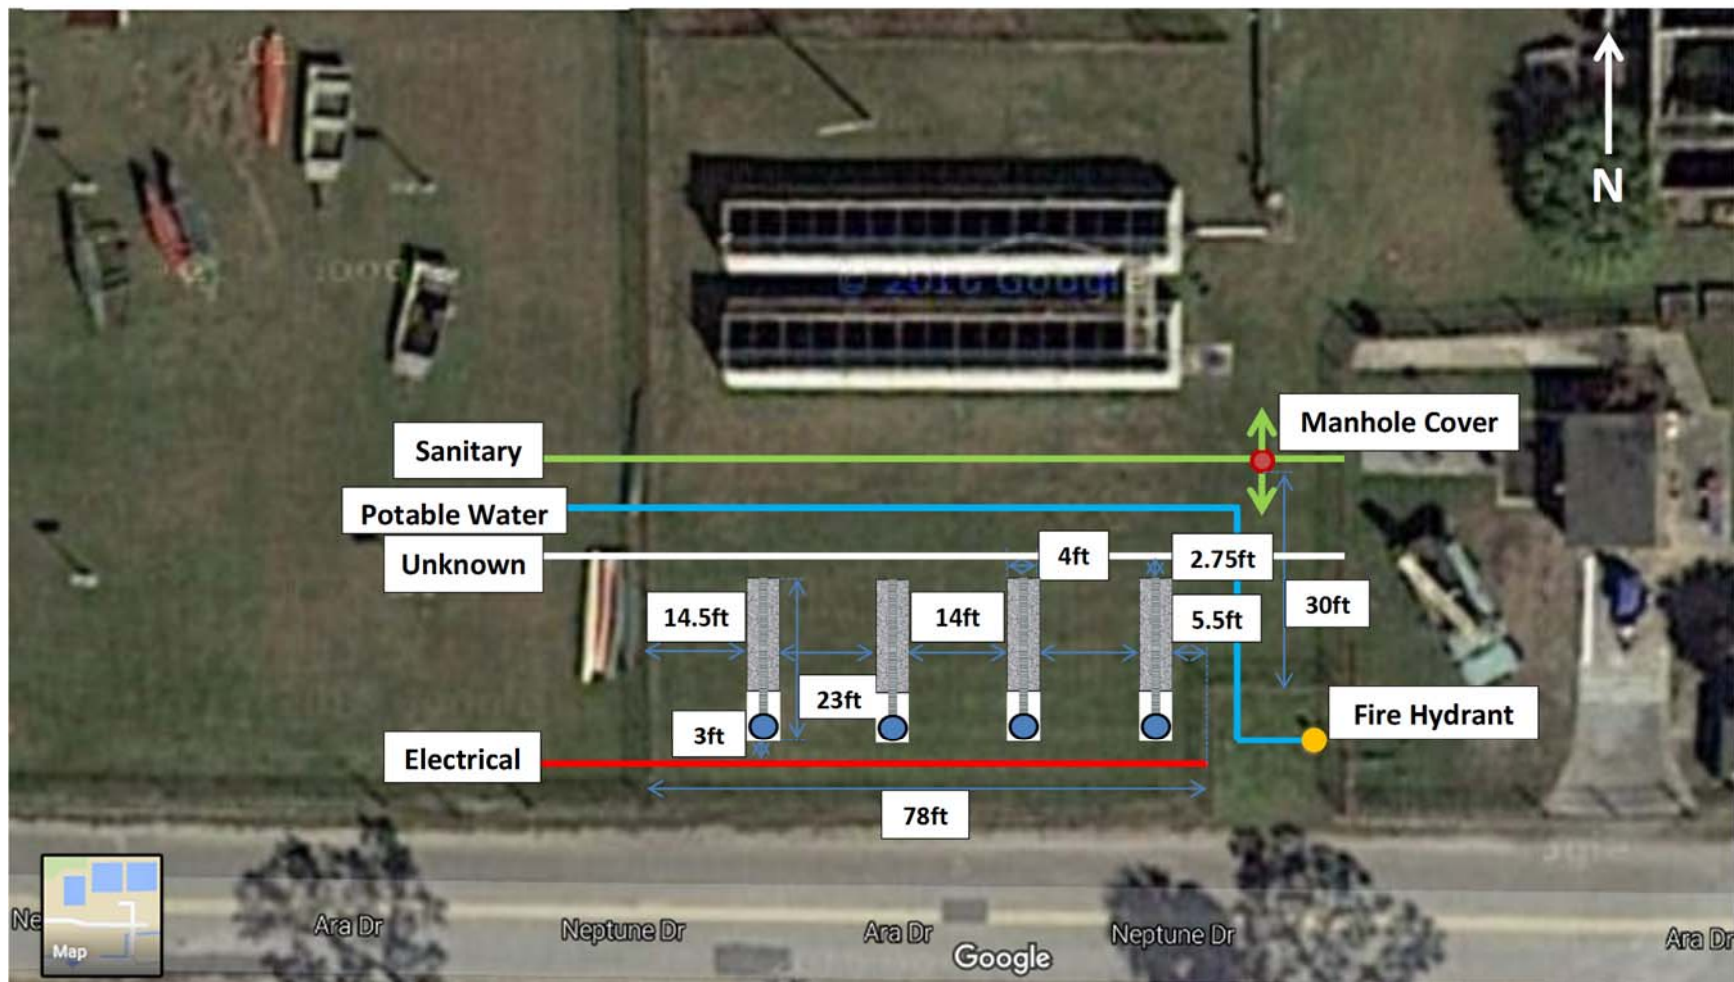
Figure 3.48: French drain site plan view

The site plan view showing the locations of four French drains and the fire hydrant is presented in Figure 3.48. The schematic diagrams showing the water level measuring system design are presented in Figures 3.49 and 3.50 (top and cross-sectional views, respectively). Three monitoring wells were at a distance of 1 ft from the edge of the French drain to the centerline of the well, with one being at the tip of the drain and the other two being along the lateral center line of the drain, with one well on each side of the drain. Four additional wells were placed along the lateral center line of the drain at 3 ft increasing increments away from the 1-ft well, with two of these additional wells being on each side of the drain. If the outermost lateral well (7 ft from the French drain) was the half way point between two drains, then this well was shared between the well systems of both drains. The data logging piezometers were manufactured by Onset Computer Cooperation and were the (HOBO U20L-04) model, a single data extracting device known as the HOBO Waterproof Shuttle model (U-DTW-1) was also purchased, as well as the data analysis software labeled HOBOWare PRO v.3.x for PC & Mac item number (BHW-PRO-CD).

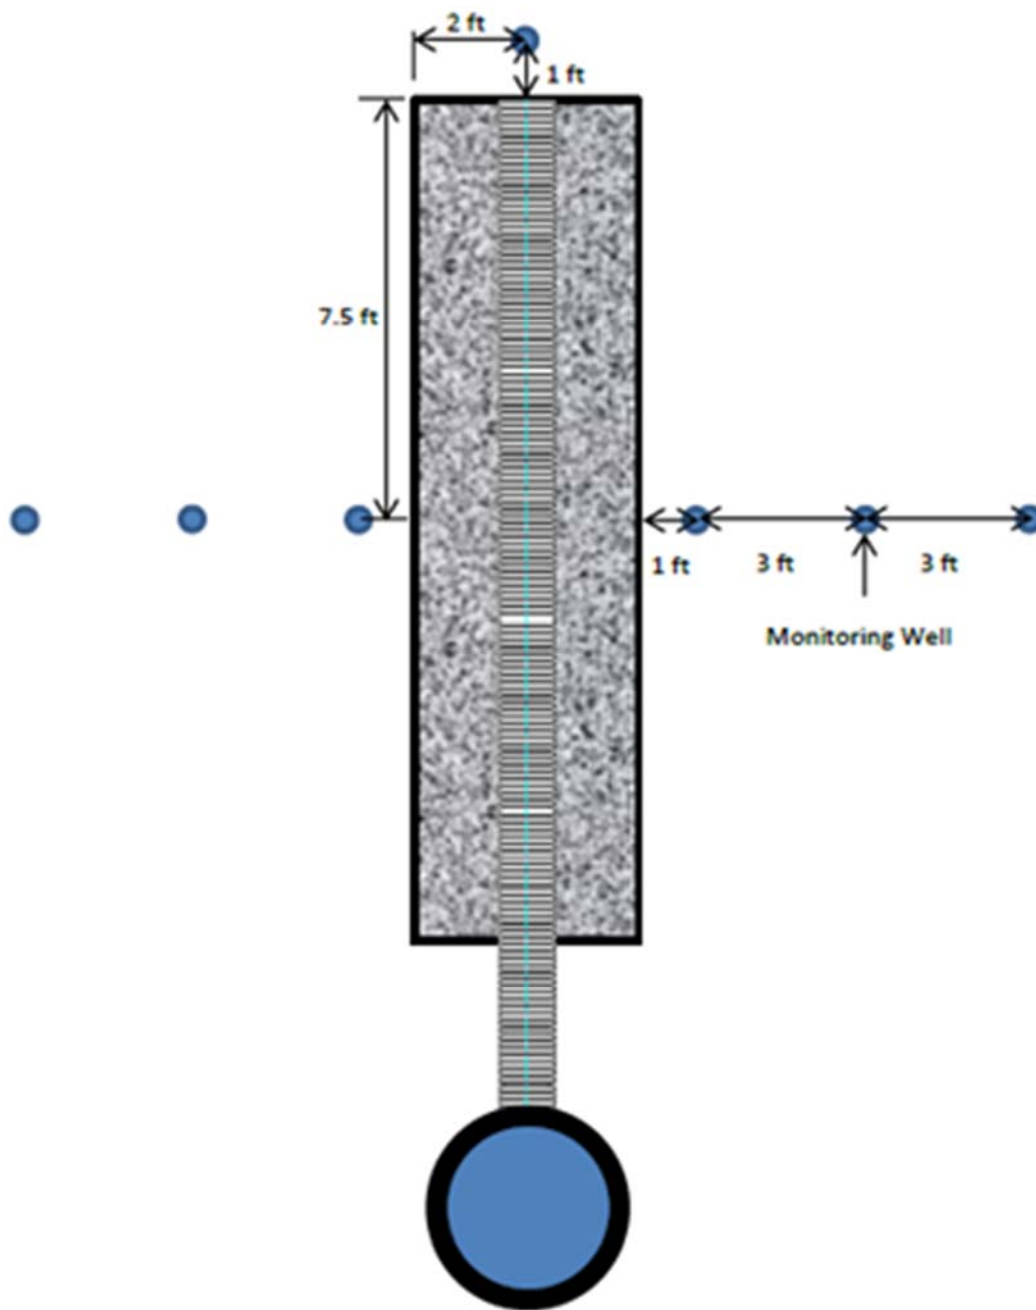
Figure 3.49: Field water level system plan view

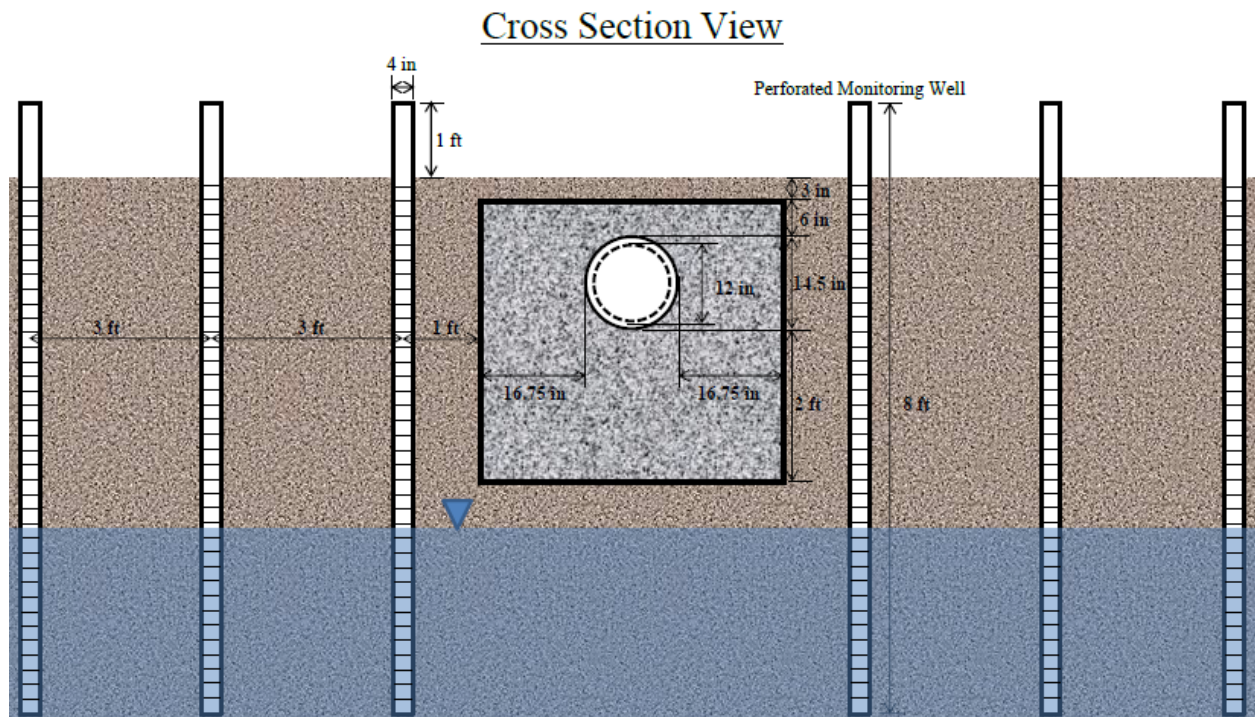
(b) Expanded view

Figure 3.50: Design of in situ water level measuring system: (a) cross-sectional view of two adjacent French drains and (b) expanded view with dimensional information

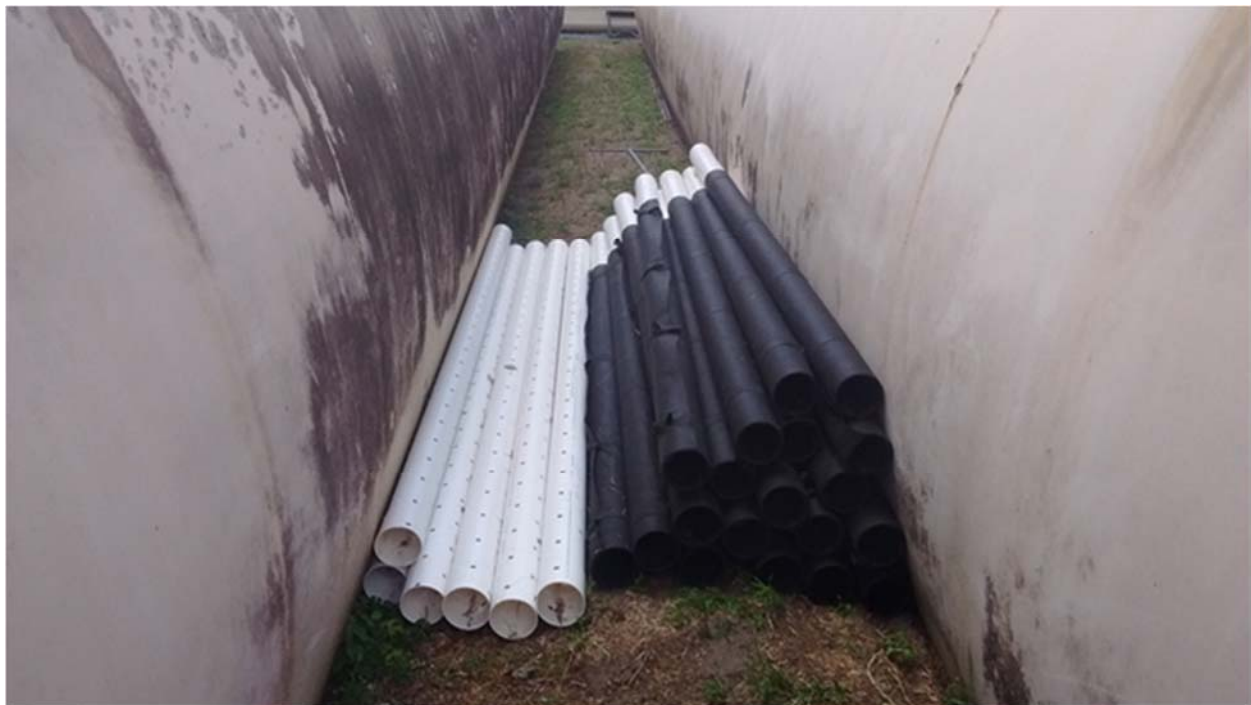
Figure 3.51: Prepared and unprepared wells

Well installation followed well preparation. Each well point was bored to a depth of at least 7 ft with a hand auger. The hole diameter created by the hand auger nearly matched the outer diameter of the monitoring wells wrapped in geotextile, which prevented the wells from simply being placed into the boreholes. To install the wells required dynamic driving, which was accomplished by hammering the top of the well until the desired depth was reached. Depth of well installation was verified by ensuring the portion of the 10-ft well exposed at the ground surface was less than 3 ft (see Figure 3.52). Once all wells were installed into the ground, then the exposed portion was cut down to approximately 1 ft and capped. Screw eyes were installed on the inside of the well, caps to allow piezometers to be suspended by braided fishing line, and swivels. The completed system is shown in Figure 3.53.

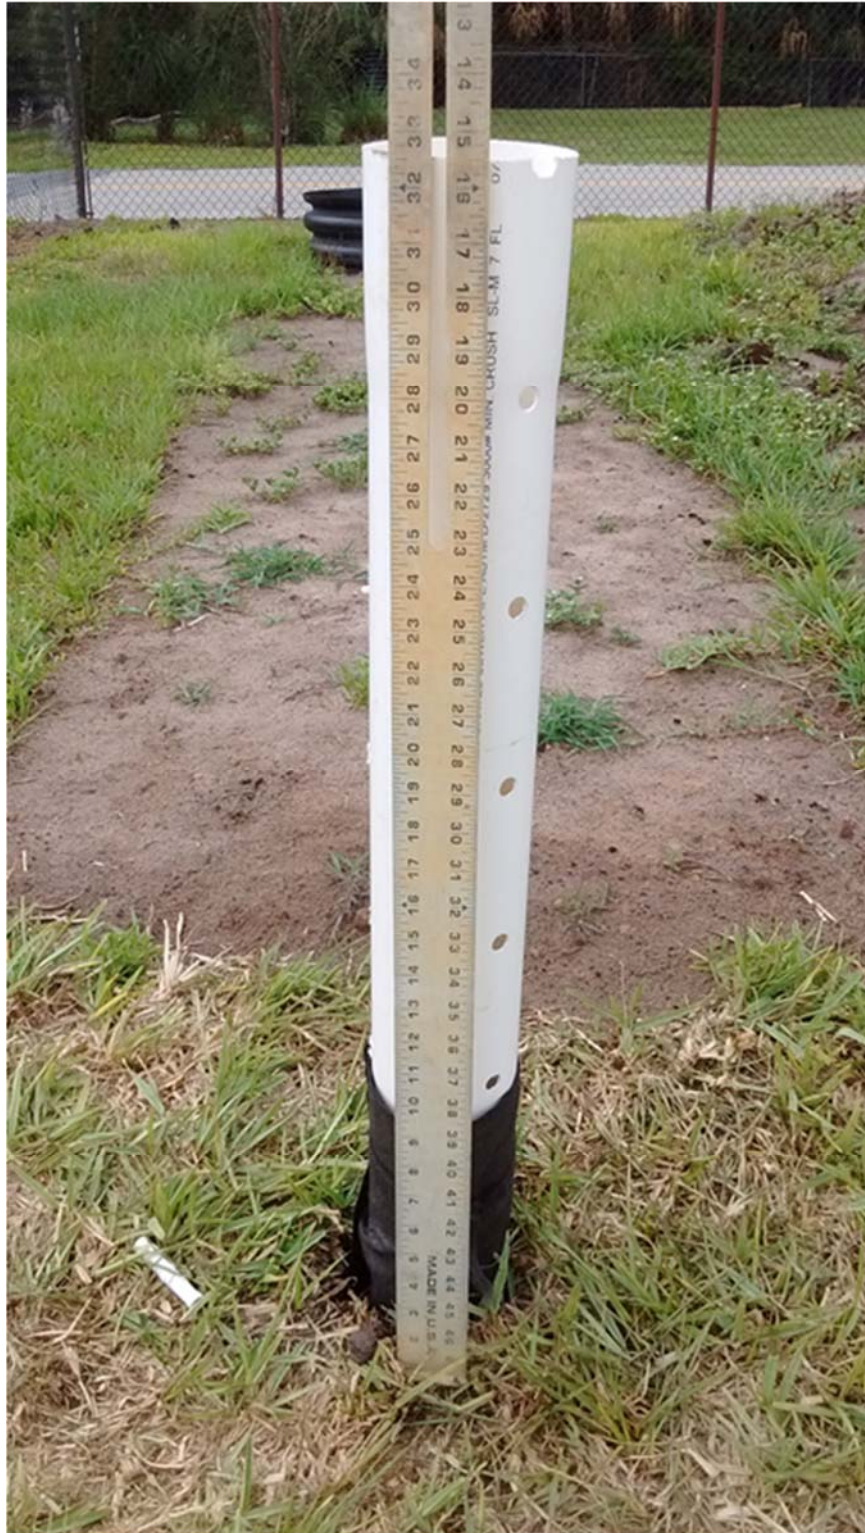
Figure 3.52: Verification of well placement depth

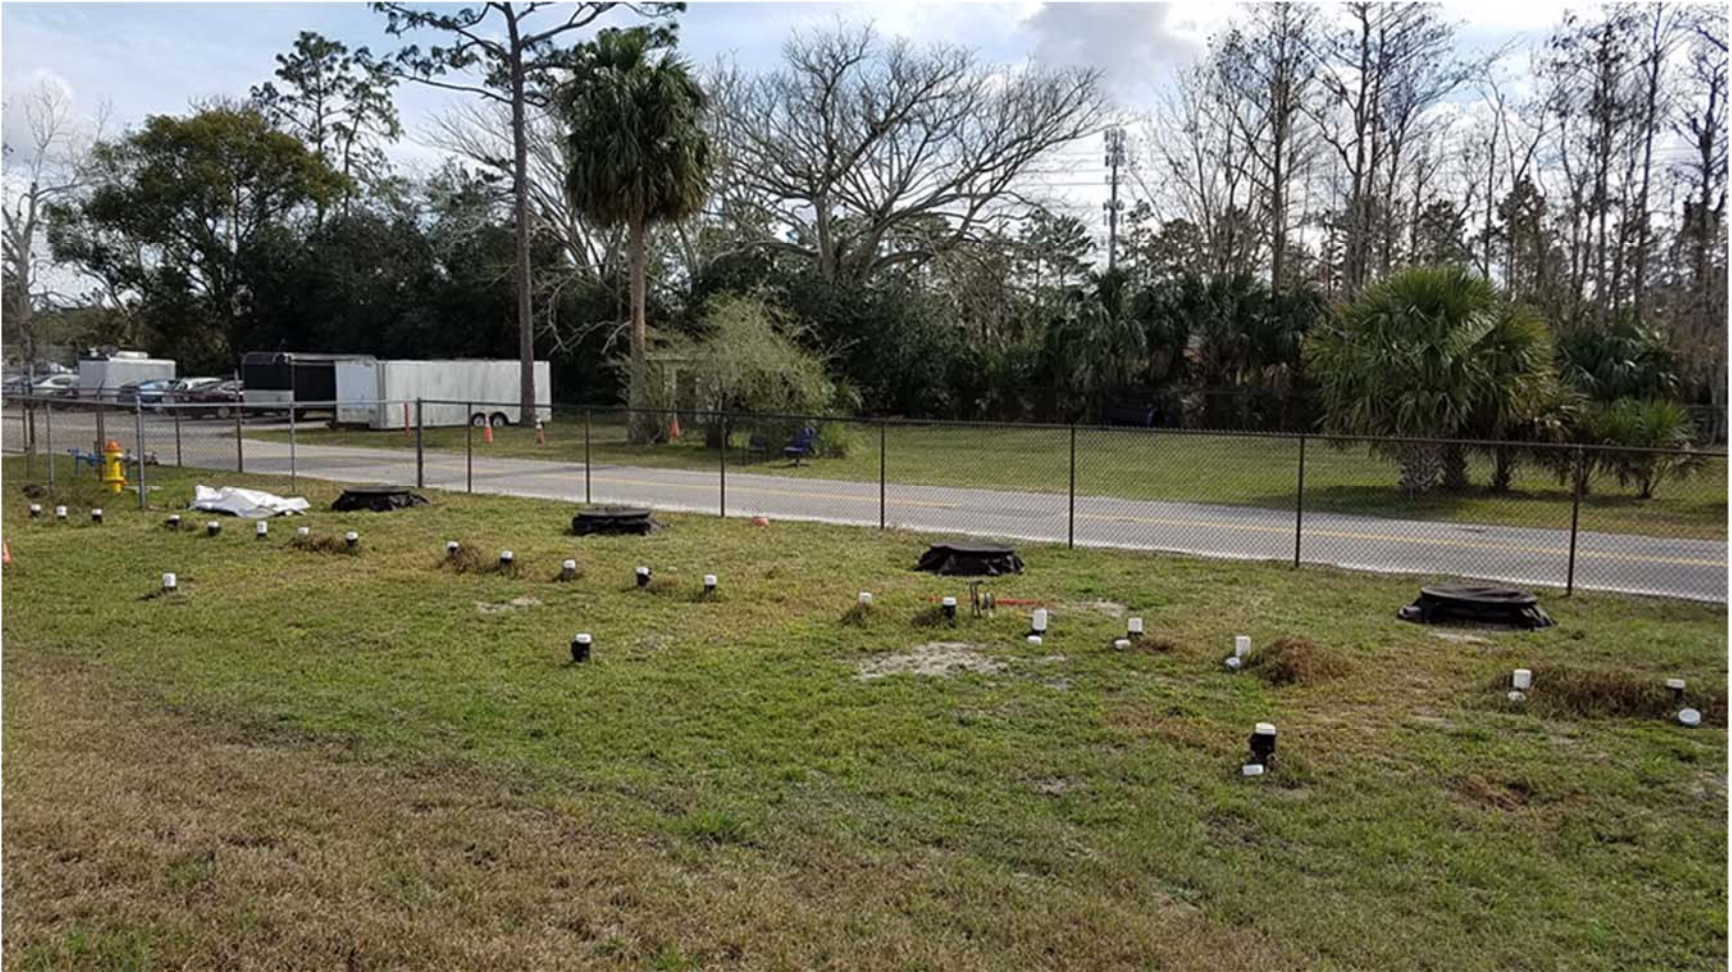
Figure 3.53: Completed system

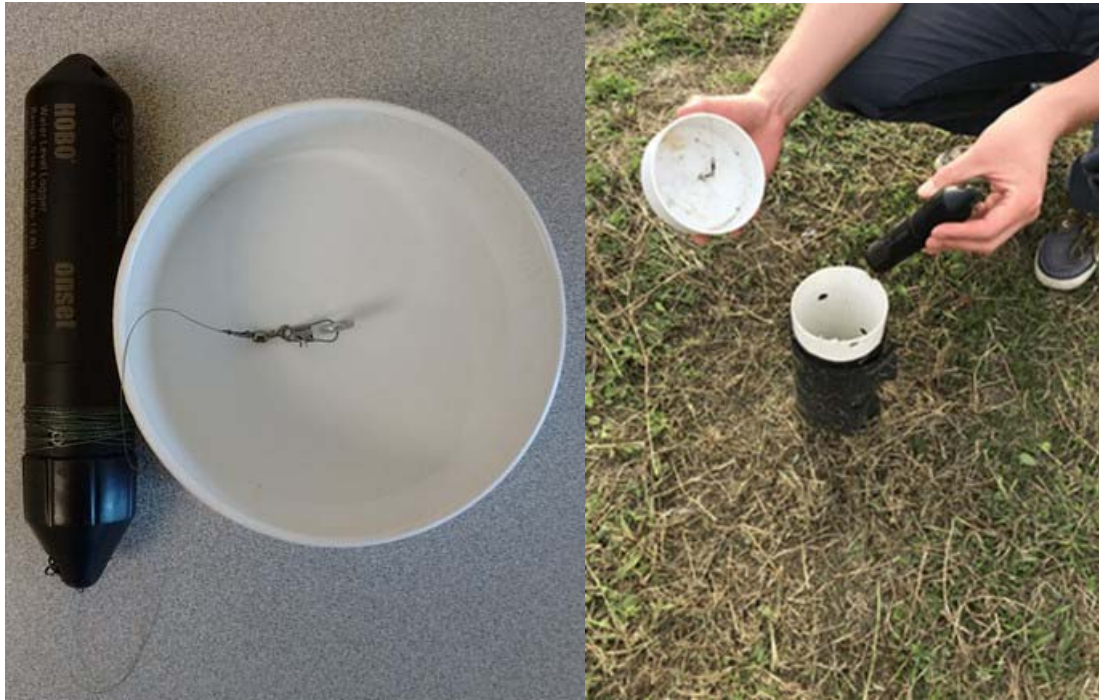
Figure 3.55: Sensor attachment to well cap

After the sensors were launched, they were attached to their monitoring well cap lanyard and were submerged under the initial groundwater table. These lanyards have been constructed from braided fishing line and swivels, Figure 3.55. Once the sensors were suspended within the wells and before the water was turned on to the French drain, the first data point was taken at the designated delayed start time. The first data point when used in combination with the water level meter reading for that monitoring well was used to determine the position of the piezometer with respect to the ground surface.

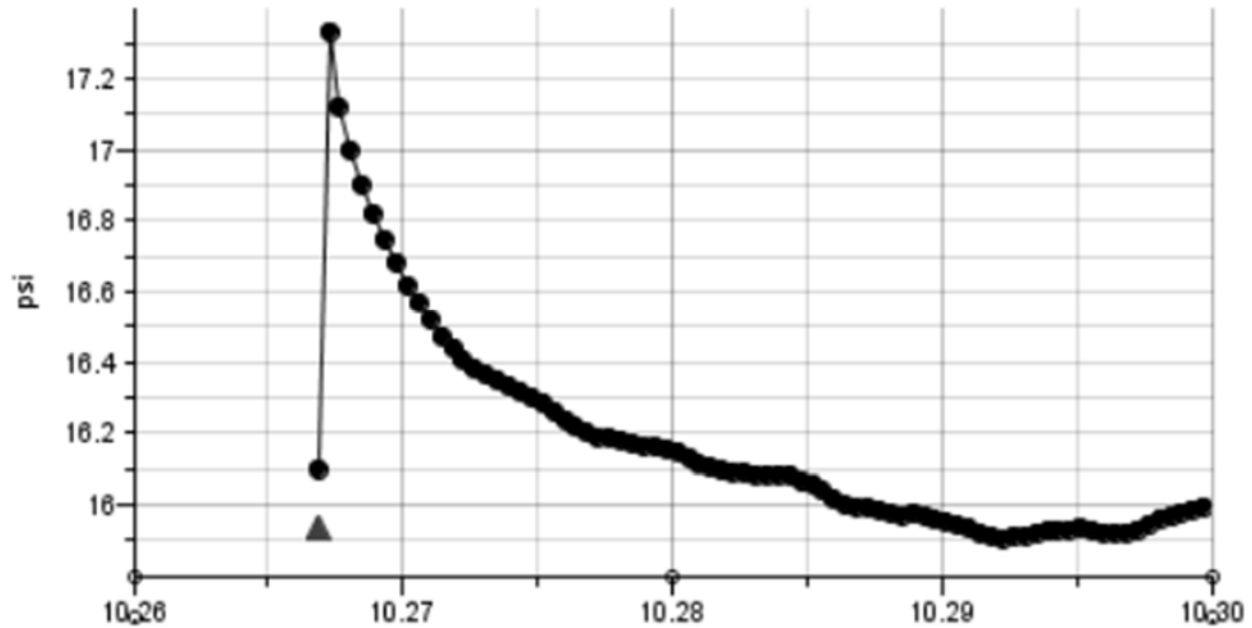
Figure 3.56: Typical sensor readout of absolute pressure versus time

After the 72-hr monitoring period the piezometers were removed from the monitoring wells and then placed back into the HOBOTOUCH waterproof shuttle. Data was uploaded to the computer by selecting the “readout device” option in the HOBOWare Pro software. Readings from the sensor allowed the user to save the data on the computer, plot the data in the software, and provided the option to export the data as a comma-separated values (CSV) file. Figure 3.56 showed the typical readout of an individual sensor.

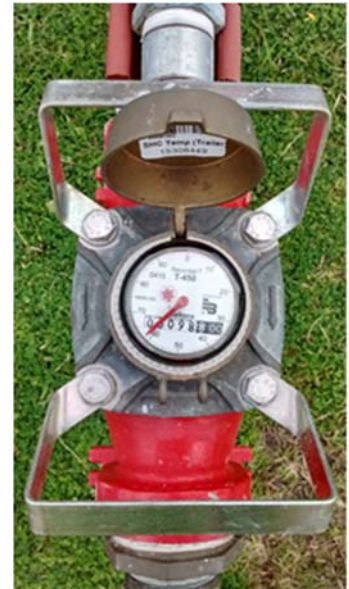
(b) badger flowmeter

Figure 3.57: (a) Accuracy chart and (b) Badger flowmeter

The flow rate measurements were taken once a steady-state had been reached and a constant head was being applied throughout the system. Through initial testing it had been determined that typical flow rate values for the French drain systems had been found to be on the order of 5 gal/min. Because the Badger flow meter had an operable flow rate lower limit of 4 gal/min, Figure 3.57 (a), a second method for determining the flow rate was also employed to ensure the accuracy of the Badger flow meter reading, which was determined as the time it takes for the dial to display a 5-gallon flow through the meter, Figure 3.57 (b). The second method involved timing how long it took for the water supply hose to fill up a 5-gal bucket (filled to the rim the volume was 5.45 gal), Figure 3.58. The water collection method directly measured the amount of water per unit time, which made it inherently more reliable than the Badger flow meter, which indirectly measures the flow rate by the spinning of an impeller. Both flow rates were recorded, but emphasis was given to the water collection method.

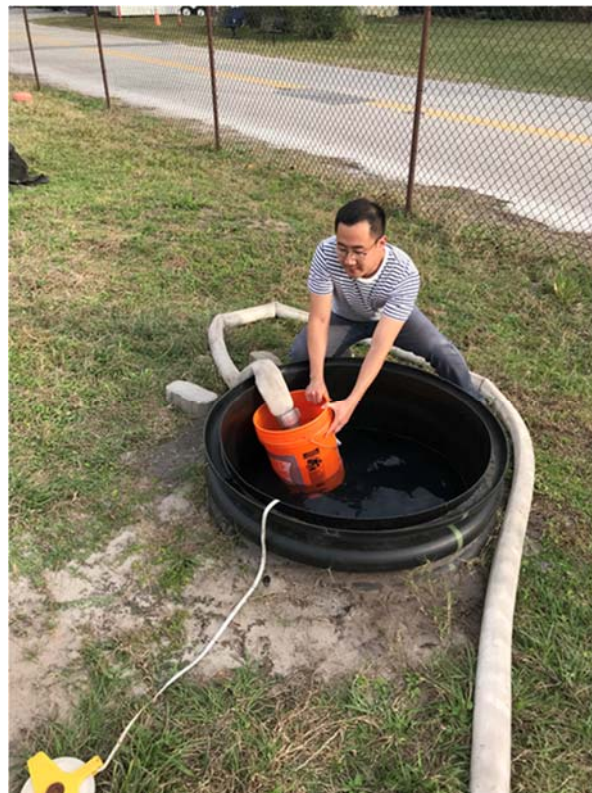
Figure 3.58: Water collection method

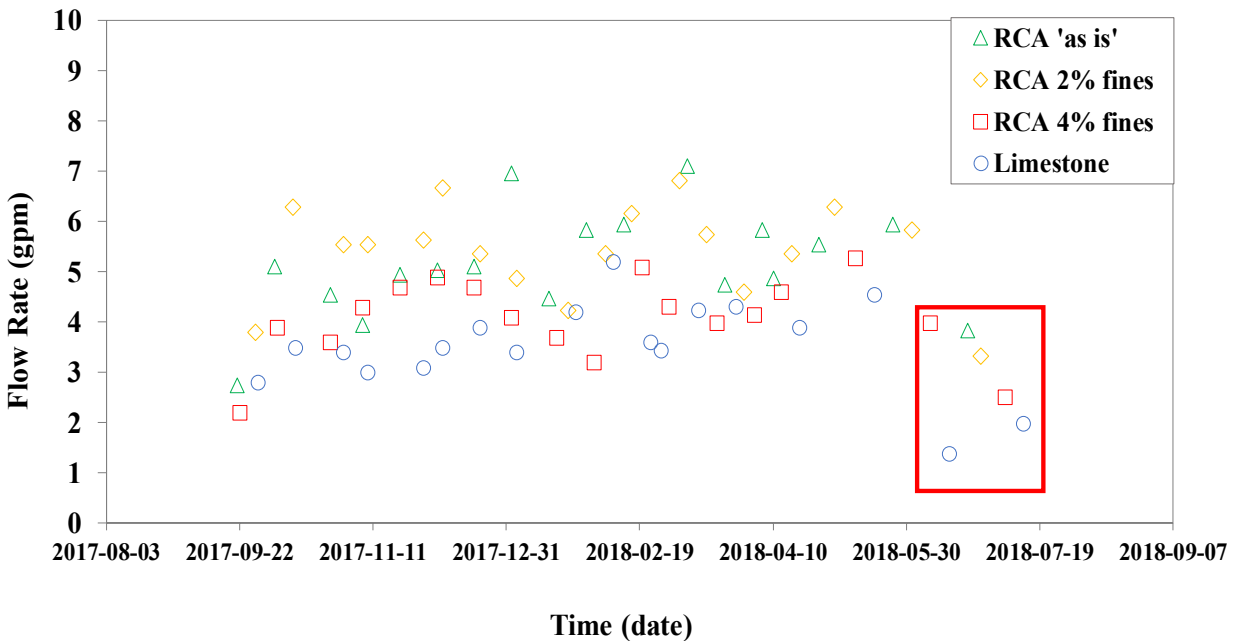
Figure 4.2: Flow rate measurement with time

Upon initial observation, the monitored flow rates from the French drains showed a clear trend. The flow rate did not decrease with elapsed time, suggesting no significant clogging in the drain systems occurred over the monitoring period. It is important to note that other factors relating to in situ site conditions were more impactful on flow rate. Figure 4.3 shows the aerial view layout of the four French drains. Trench 2 (RCA with 2% fines) and Trench 3 (RCA with 4% fines) were interior drains and Trench 1 (RCA 'as is') and Trench 4 (limestone) were exterior drains.

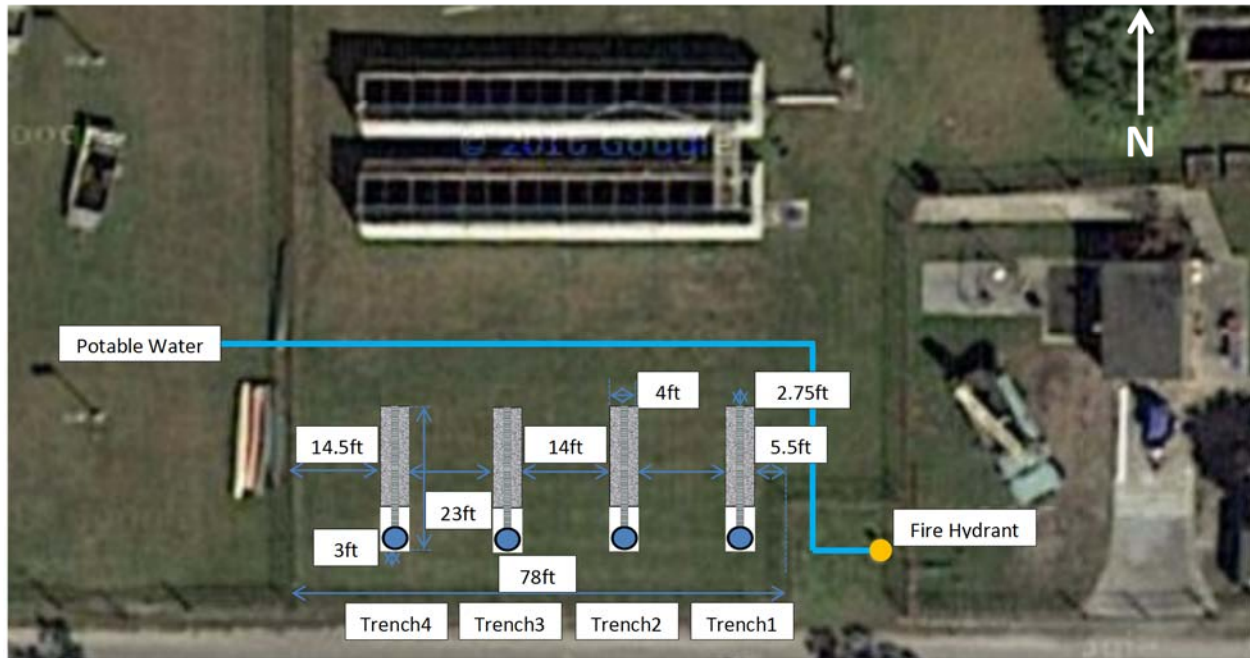
Figure 4.3: Site view showing the layout of French drains.  
 (note: Trench 1=RCA “as is”, Trench 2=RCA with 2% fines, Trench 3=RCA with 4% fines, and Trench 4=limestone)

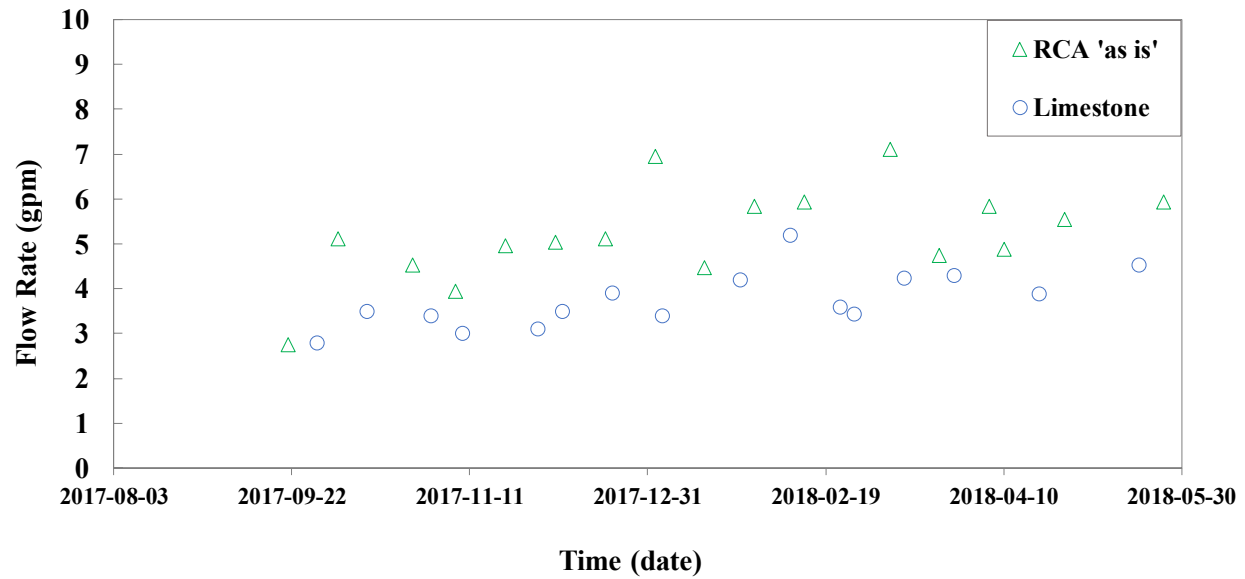
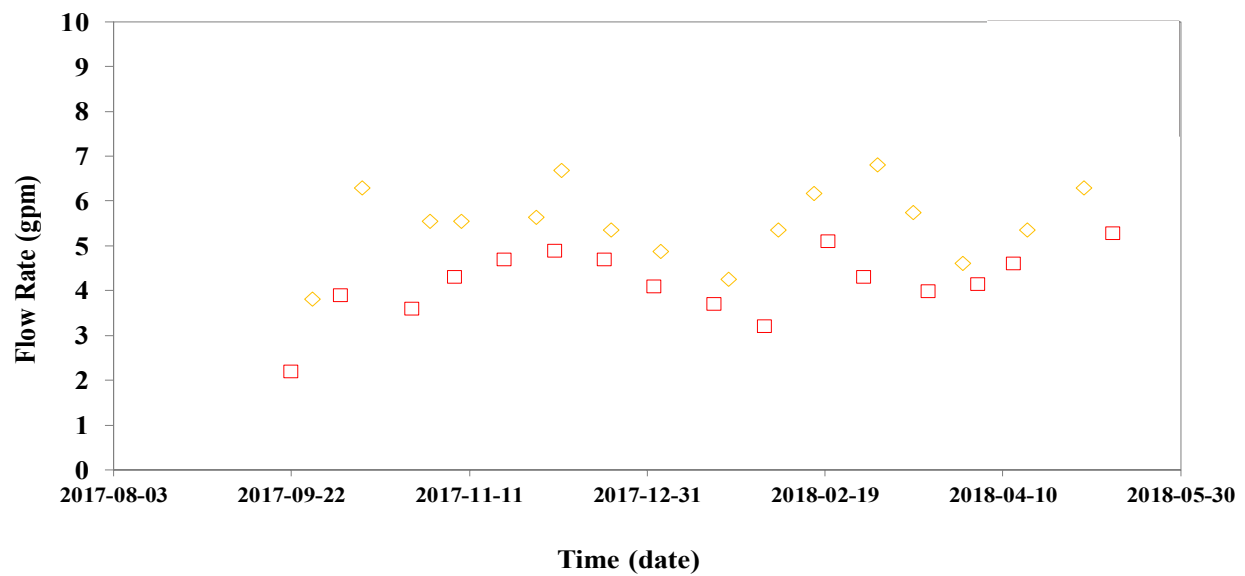
(a) Exterior drains

(b) Interior drains

Figure 4.4: Flow rate measurements with different drainage conditions

The coarse aggregate used in French drains allowed much higher drainage (discharge) than existing in situ soils (e.g. fine sand, A-3). As a result, the interior drains had “double-sided” drainage paths because of adjacent French drains. The exfiltration flows from the two exterior drains were to some extent limited by the in situ soils, which had much lower permeability than the coarse aggregate. In order to compare the drainage performance of French drains under similar site conditions, the interior and exterior drains were separately analyzed. Figures 4.4a and 4.4b show the measured flow rates of the interior and exterior drains, respectively. It was clearly observed that a greater quantity of fines resulted in a lower flow rate. RCA ‘as is’ contained 0.8% fines, whereas limestone had 2.2% fines.

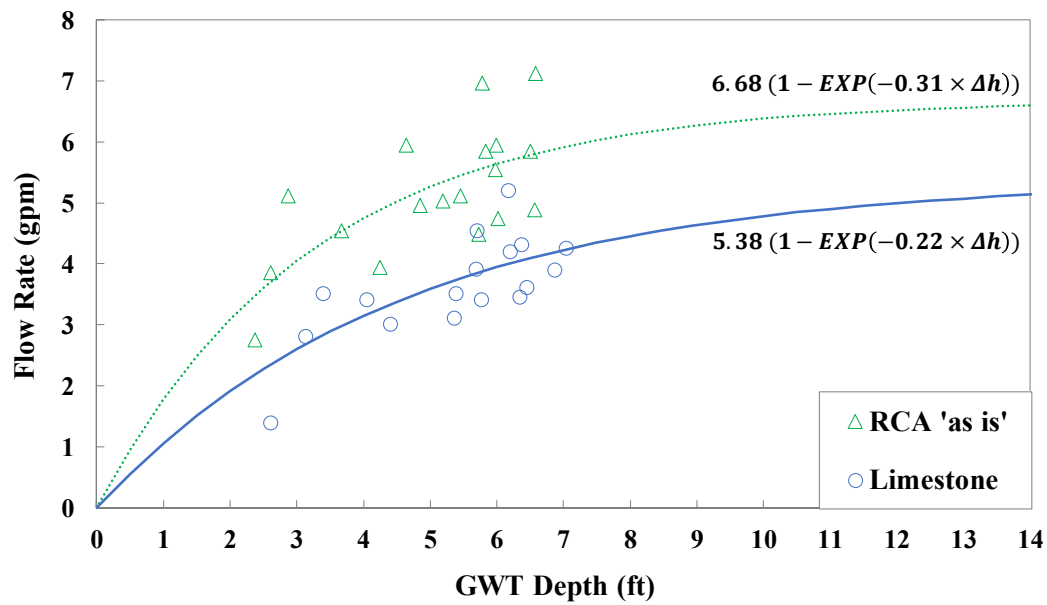
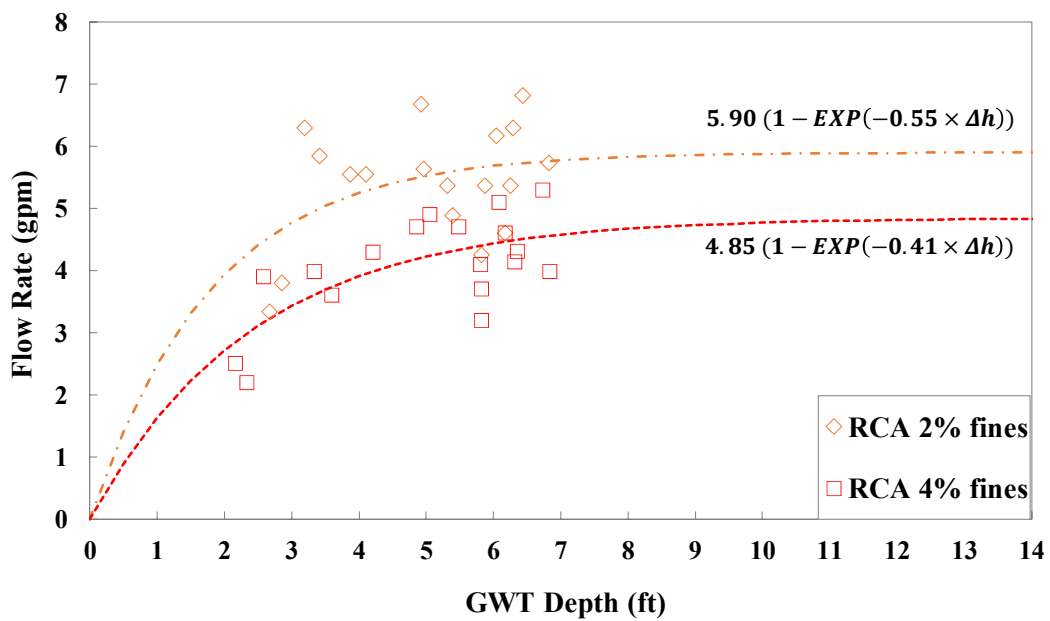
(a) Exterior drains

(b) Interior drains

Figure 4.5: Flow rate versus GWT depth relationship with different drainage conditions

comparing between exterior and interior drainage groups can be attributed to the drainage conditions.

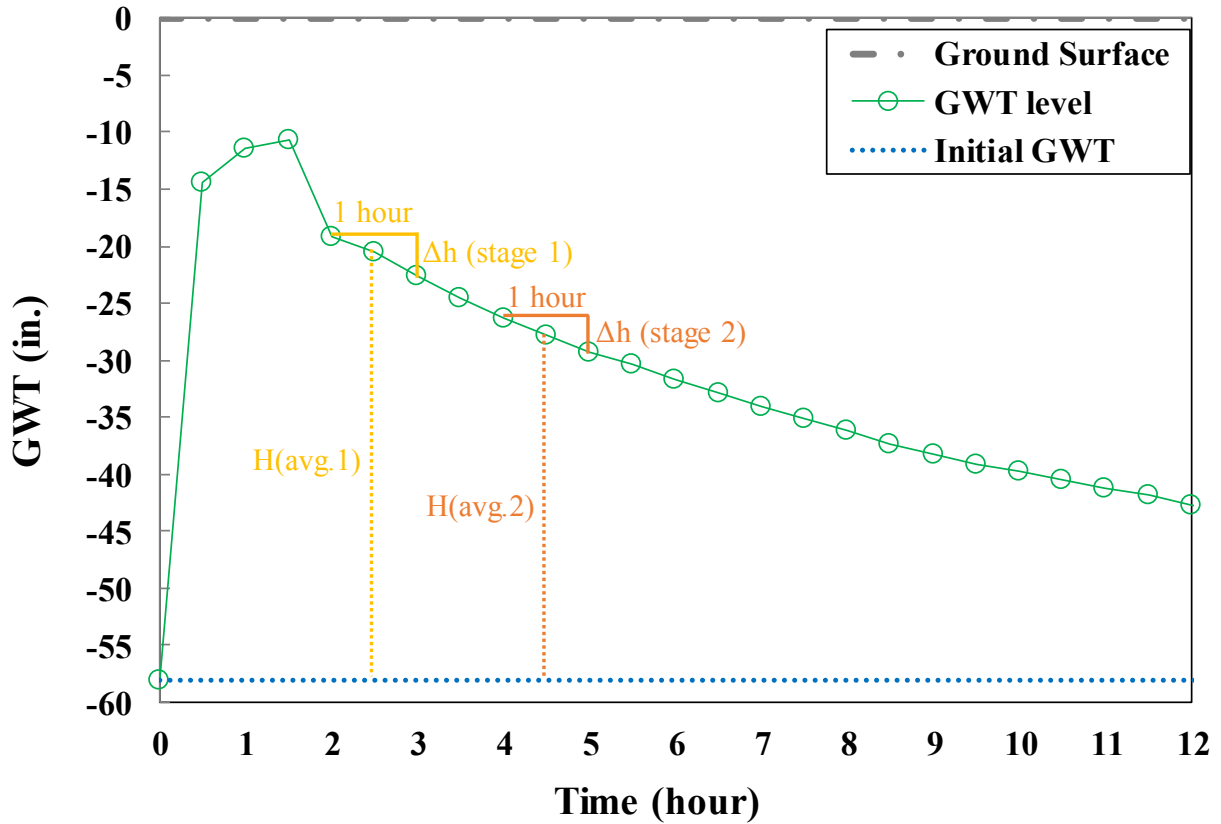
Figure 4.7: Methodology for secant slope analysis

The rate of drop in the monitoring wells, as representing the discharge of the storage within the French drain, was calculated by measuring the head drop in both wells over a specific time interval and averaging the values together. Two time intervals were chosen for the measurement: from 2 hr to 3 hr and from 4 hr to 5 hr after the flow test began. The first interval (2 hr to 3 hr), designated as Stage 1, was selected as this corresponded to the exfiltration behavior 30 minutes after the water supply to the trench was turned off. This 30-minute waiting period allowed the full storage volume to shift to a stable discharge. The second interval (4 hr to 5 hr), designated as Stage 2, was selected as this provided information about how the trends changed as the water level within the trench lowered. In addition, the two stages covered the measurements when the water level in the drain was at both an upper level (Stage 1) and lower level (Stage 2) relative to the French drain bottom.
