Final Report

**Field Study of Recycled Concrete Aggregate in French Drain**

FDOT Contract No.: BDV24-977-19

January, 2019

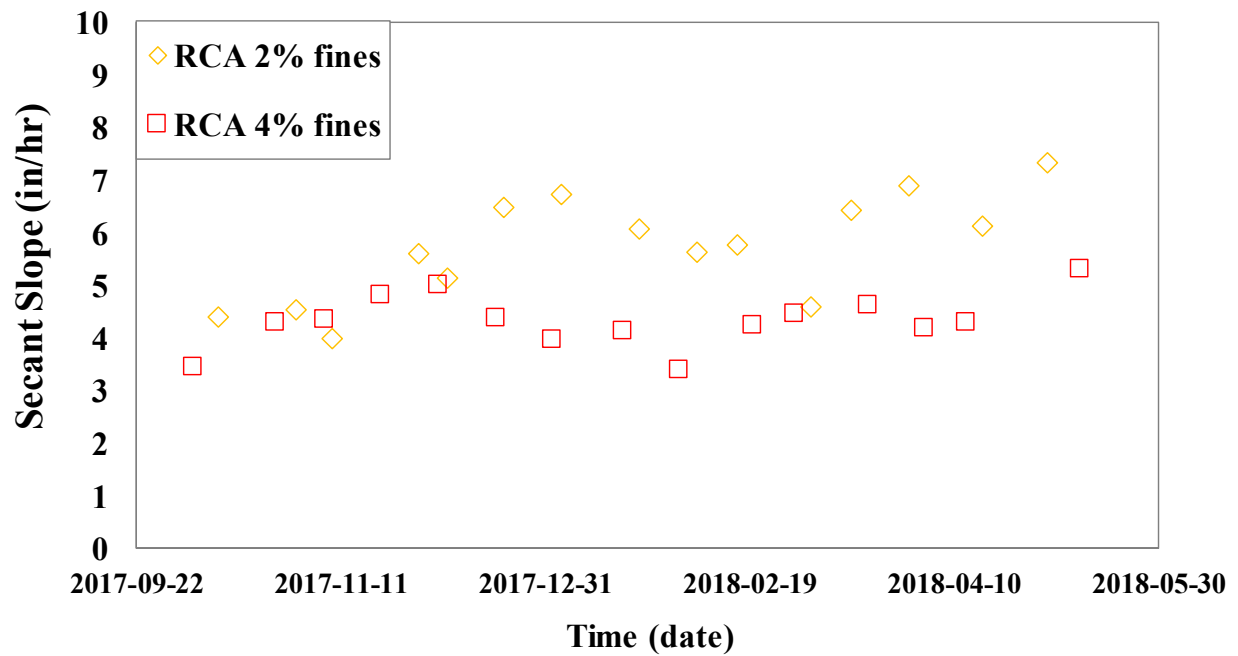
(b) Interior drains

Figure 4.8: Discharge behavior (secant slope) with different drainage conditions (Stage 1)

The discharge performance is expressed as the slope of the relationship of GWT versus time, which indicates the discharge rate. The concept behind the secant slope is that the more a French drain became clogged, then the slower the storage level drop was, thus a flatter slope in the relationship between GWT level and time. Figures 4.8 and 4.9 show the change in slope for Stages 1 and 2, respectively. The interior and exterior drains were separately plotted. As seen in the figure, the slope increased with time, which was due to the increase in GWT depth shown in Figure 4.1. The drain with limestone aggregate showed lower discharge rates than RCA ‘as is’ over the monitoring period because of the greater amount of fines within the drain. In the same way, the drain with RCA 4% fines had lower slope values than RCA with 2% fines.

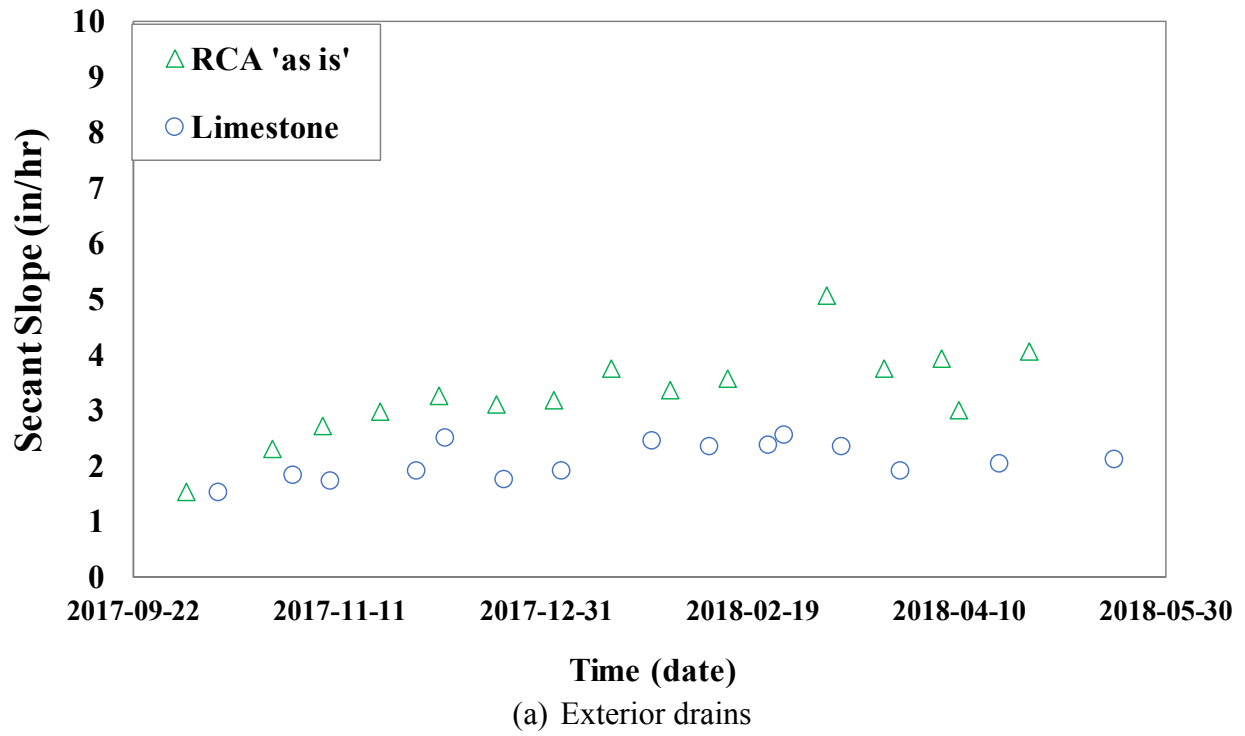
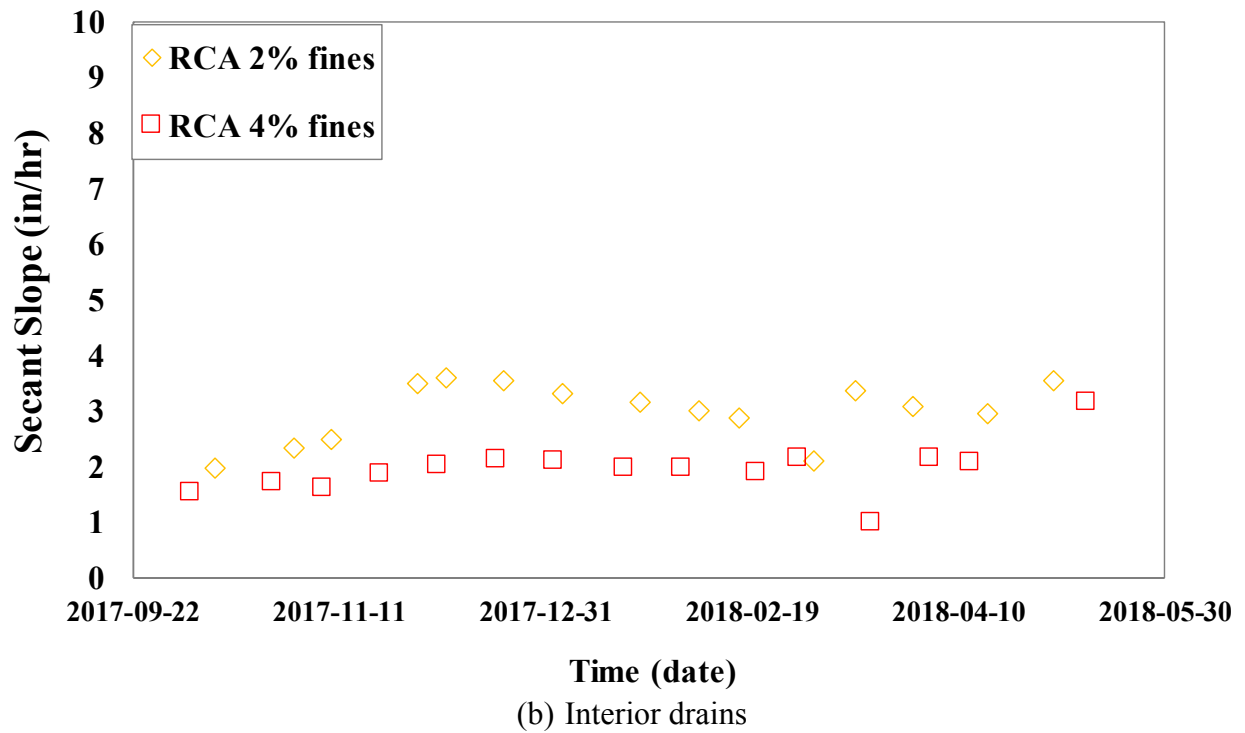
Figure 4.9: Discharge behavior (secant slope) with different drainage conditions (Stage 2)

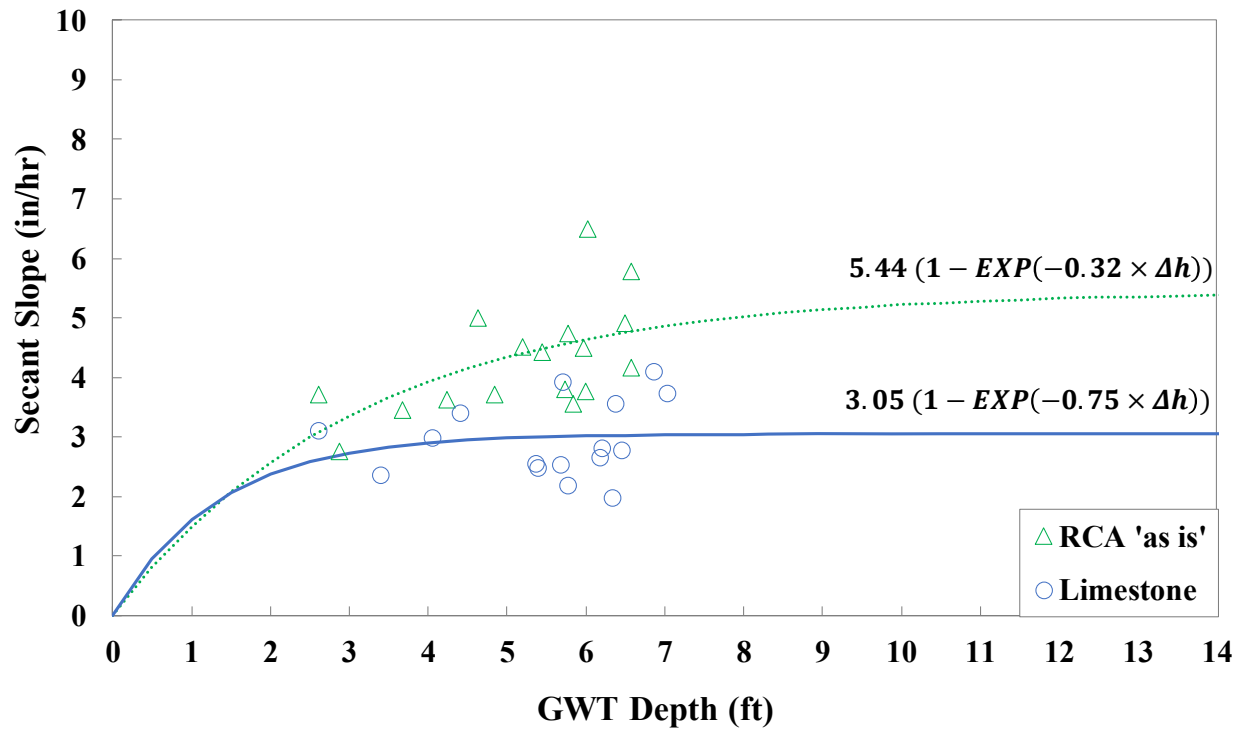
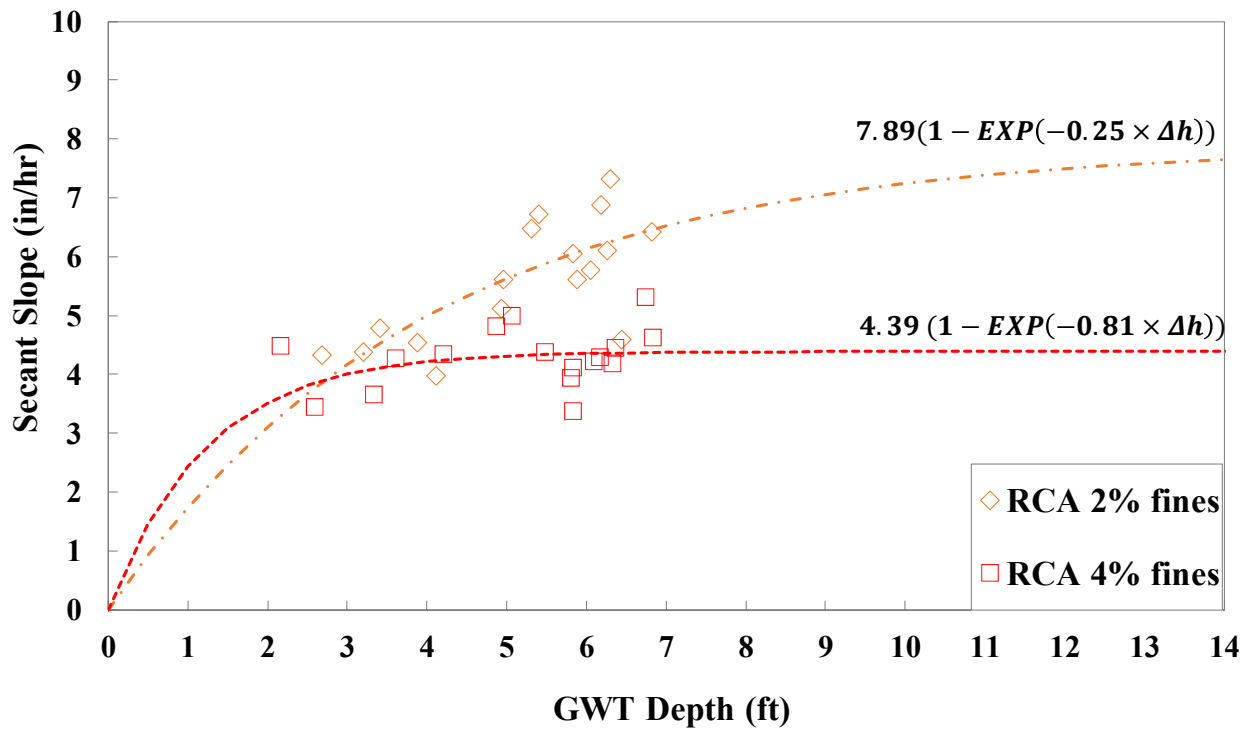
(a) Exterior drains

(b) Interior drains

Figure 4.10: Secant slope versus GWT depth (Stage 1)

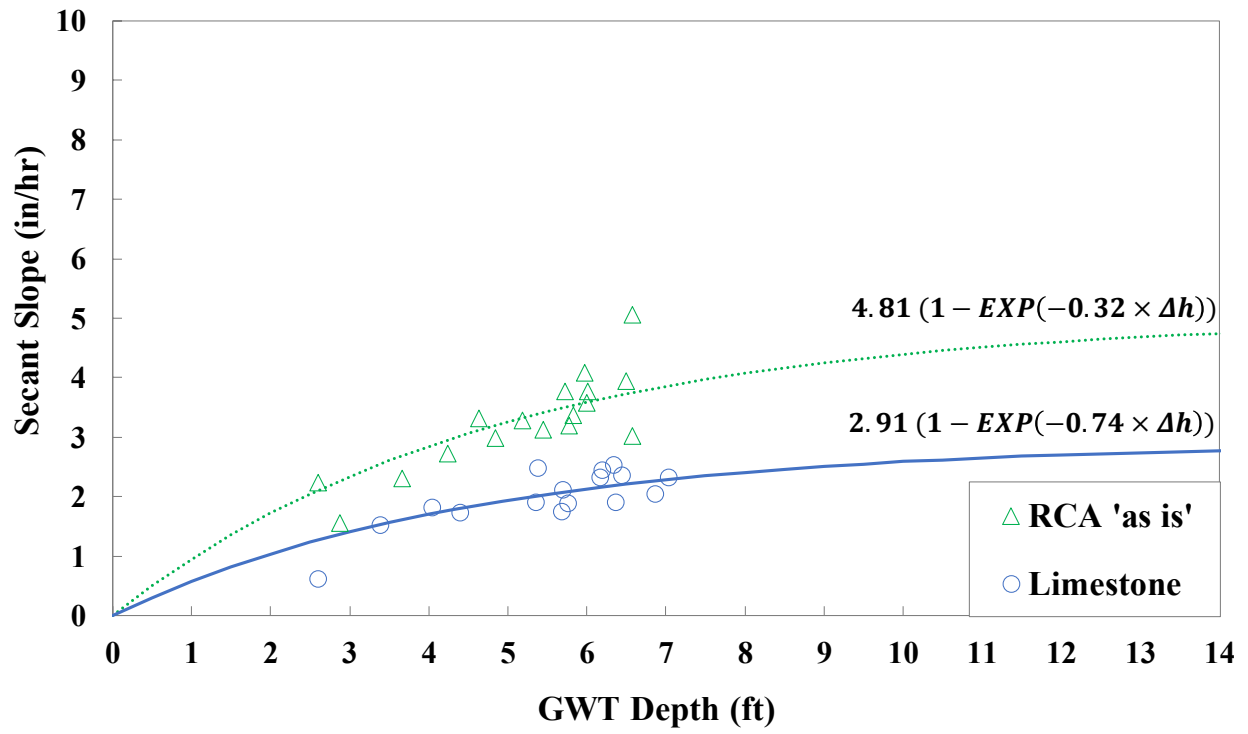
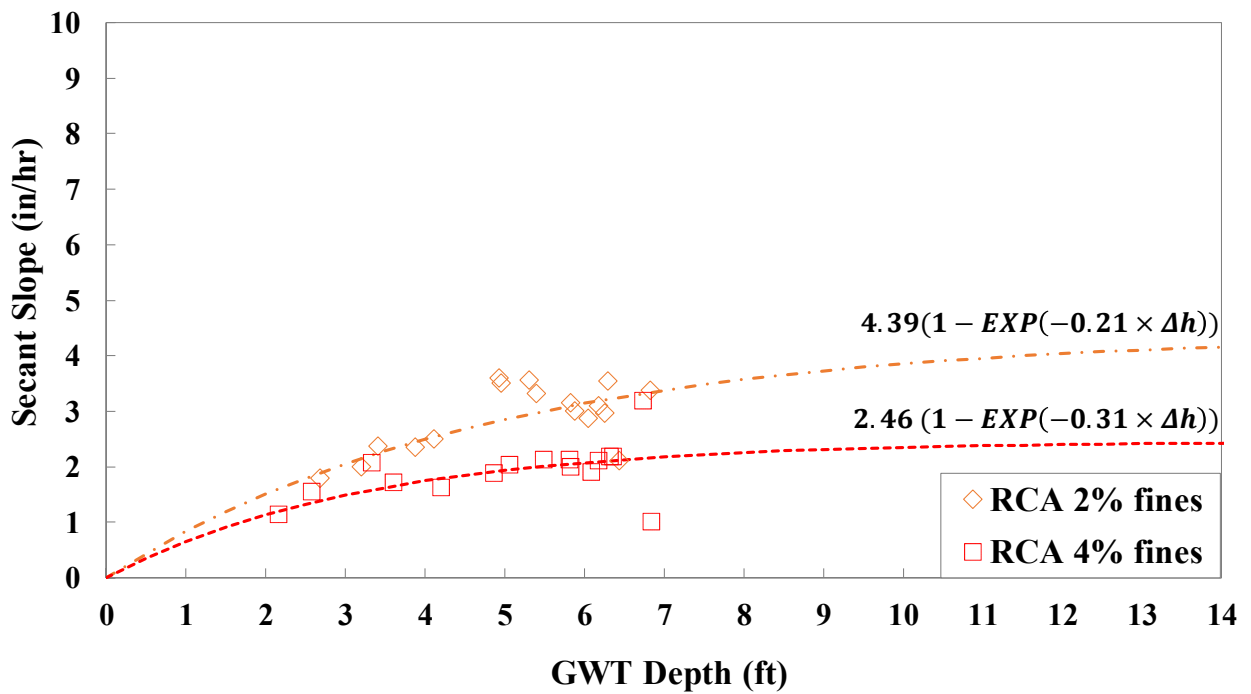
(a) Exterior drains

(b) Interior drains

Figure 4.11: Secant slope versus GWT depth (Stage 2)

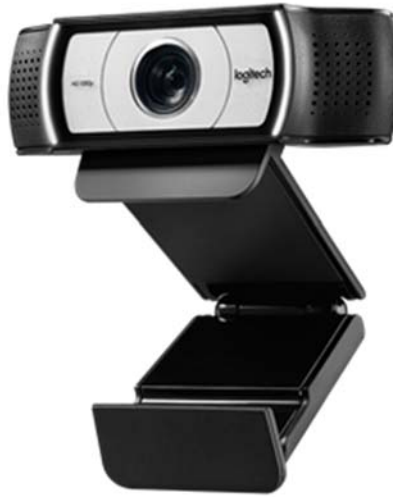
Figure 4.14: Camera to inspect inside pipe

A camera was used to inspect the inside of each French drain over the duration of the experiment. The Logitech webcam (C930e) with 1080p HD capability, shown in Figure 4.14, was used. The camera and a portable light were attached to an extendable rod and inserted into the pipe of each French drain during inspection. The purpose of the camera investigation was to ensure that aggregate was not eroding into the horizontal drainage pipe, as well as to detect any scaling on the interior walls of the pipe, possibly indicating precipitation or re-cementation of the aggregate fines. The camera inspection was performed every three months on all four French drains and served as a qualitative performance indicator (see Figures 4.15 through 4.18).

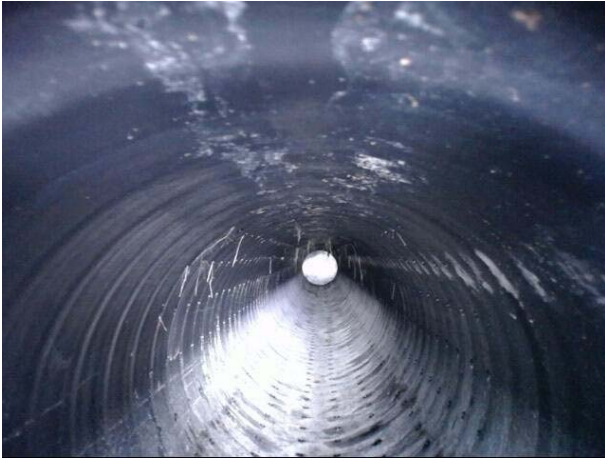
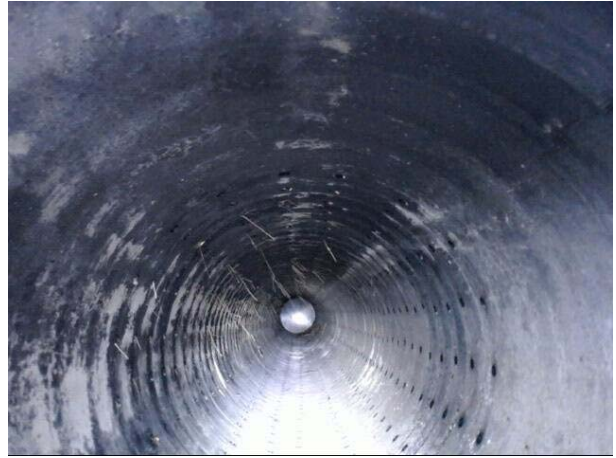
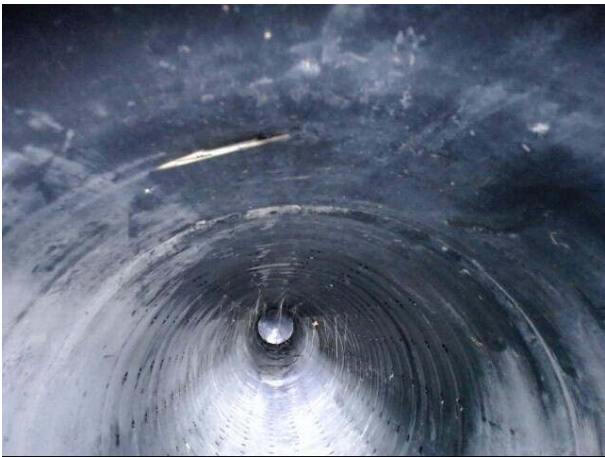
(a) French drain RCA 'as is'

(b) French drain RCA with 2% fines

(c) French drain RCA with 4% fines

Figure 4.15: Camera inspection images (inside pipes) at 3 months

Upon the camera inspection, it was concluded that no surrounding aggregate deposited into the pipes (see Figures 4.15 through 4.18); however, the crowns of the pipes seemed to be within the root zone of the overlying vegetation, which can be seen entering the pipes. Based on observations made during exhuming the geotextile samples, some roots traveled between the 1-foot overlaps in the geotextile, and even in some locations punctured the geotextile. However, the presence of the roots was not severe enough to hinder the exfiltration of water.

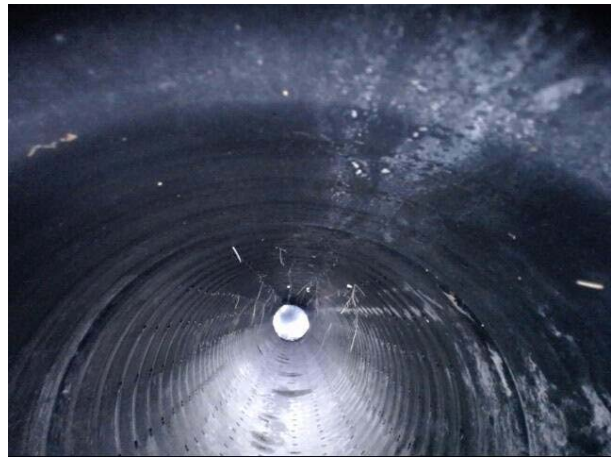
(d) French drain limestone

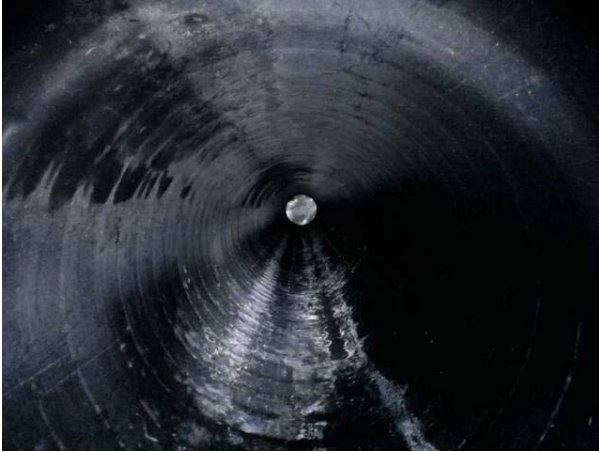
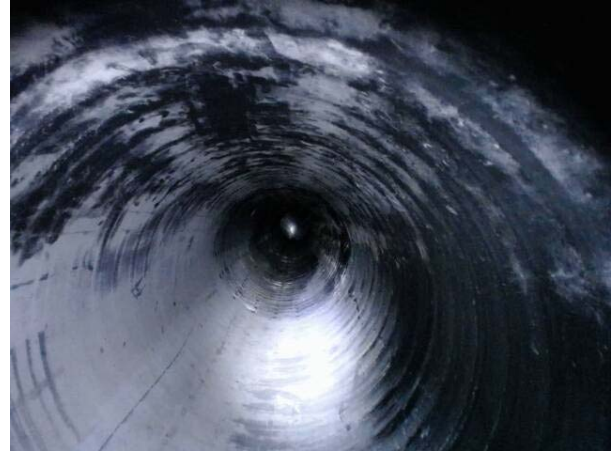
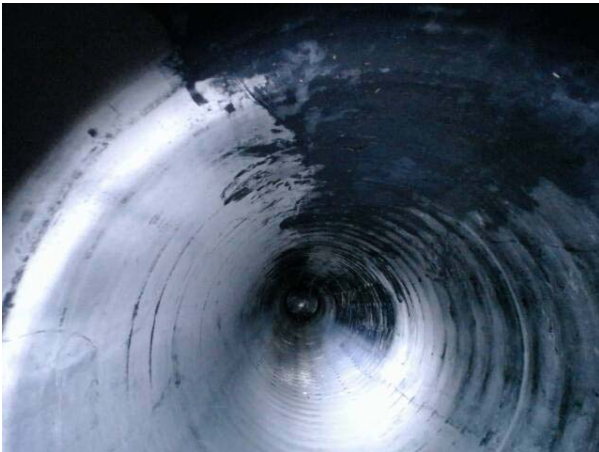
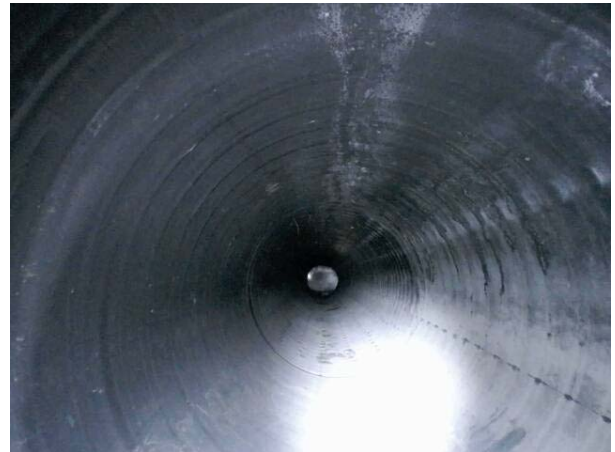
Figure 4.16: Camera inspection images (inside pipes) at 6 months

(c) French drain RCA 'as is'

(b) French drain RCA with 2% fines

(d) French drain RCA with 4% fines

(d) French drain limestone

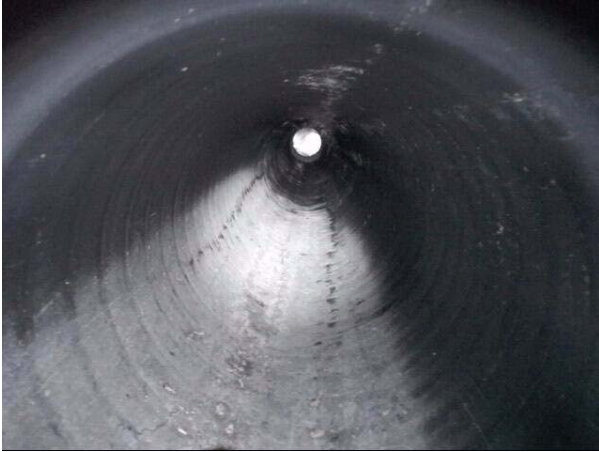
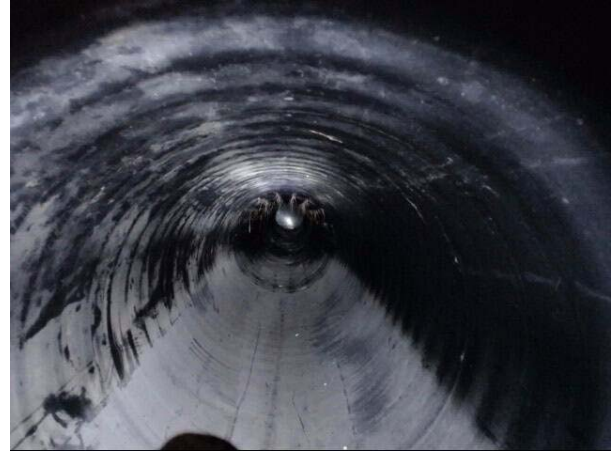
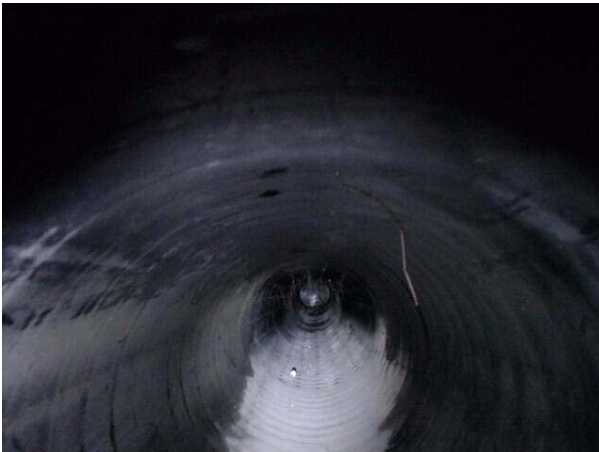
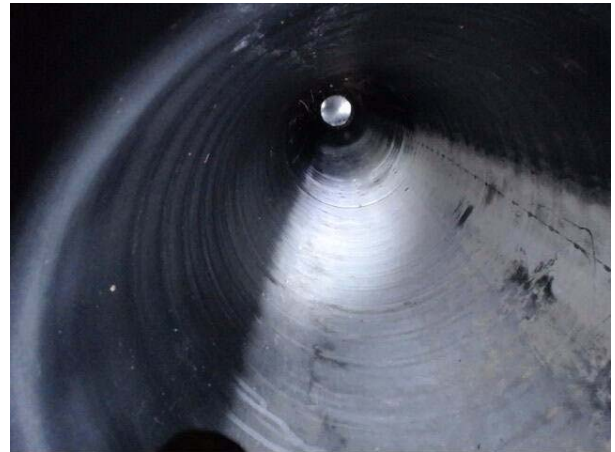
Figure 4.17: Camera inspection images (inside pipes) at 9 months

(e) French drain RCA 'as is'

(b) French drain RCA with 2% fines

(f) French drain RCA with 4% fines

(d) French drain limestone

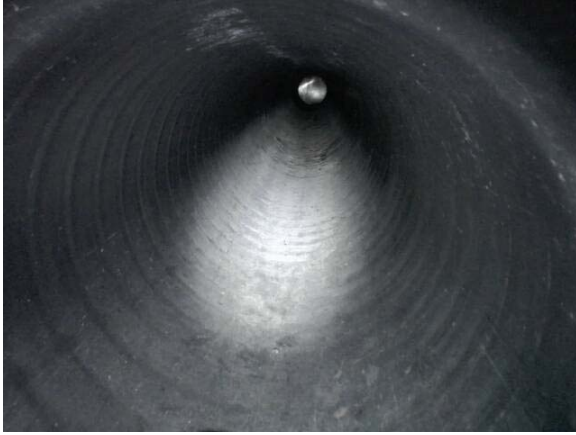
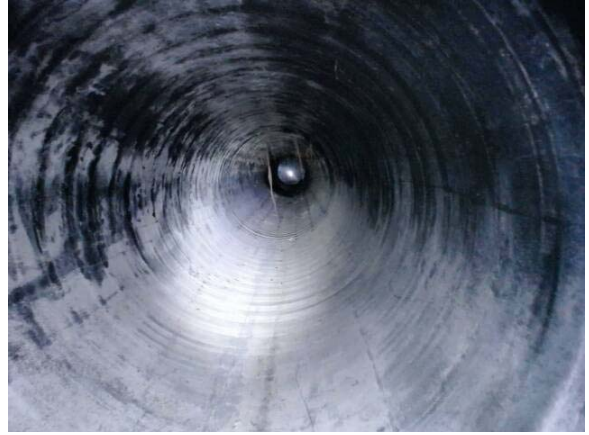
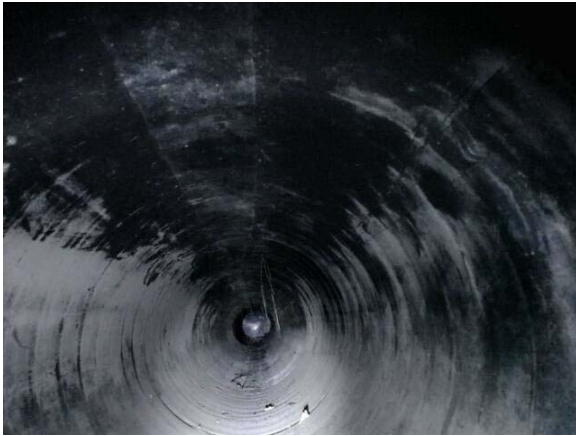
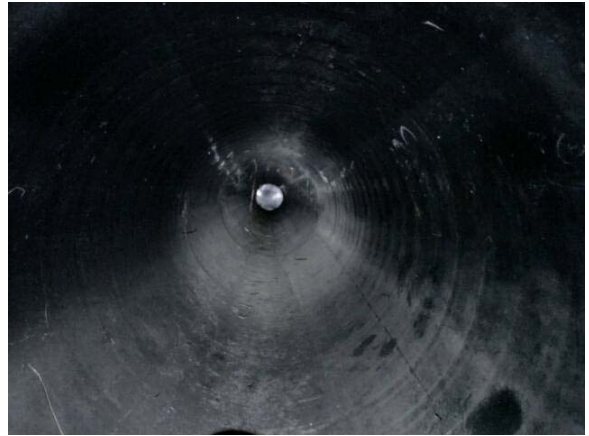
Figure 4.18: Camera inspection images (inside pipes) at 12 months

(a) French drain RCA 'as is'

(b) French drain RCA with 2% fines

(c) French drain RCA with 4% fines

(d) French drain limestone

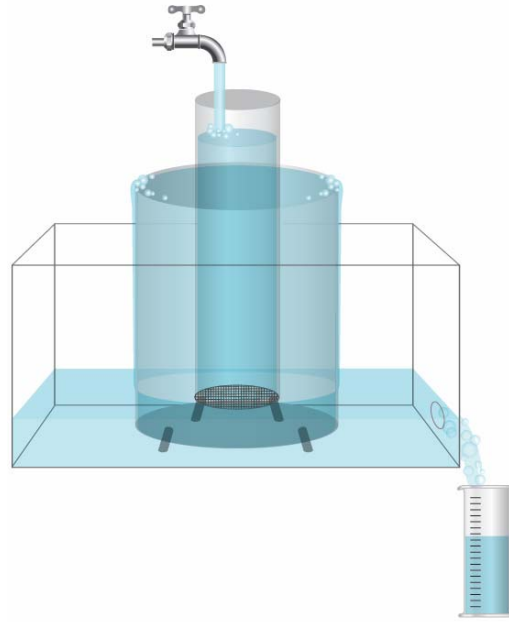
Figure 4.19: Test setup for determining geotextile permittivity

The researchers conducted permittivity testing on unused geotextile samples to confirm the geotextile permittivity from the manufacturer of  $1.6 \text{ sec}^{-1}$ . Exhumed samples collected after completion of field testing are compared with the control samples. The reduction in geotextile permittivity can be used as a means to quantify any clogging that may have occurred within the French drains over the experiment period. Figure 4.19 shows a schematic diagram of geotextile permittivity testing. The apparatus design is in general compliance with ASTM 4491. The design philosophy of the apparatus is to construct a flow system where nearly all the head loss of the system occurs as a result of the water flowing across the geotextile sample. This is achieved by having the cross-sectional area of the geotextile being the smallest cross-sectional area normal to flow within the system. Having a system designed this way makes the geotextile the controlling element for flow rate. Use of pipes and pipe fittings with significantly smaller cross-sectional areas than the geotextile should be avoided because these components may produce local head losses and possibly control the flow rate of the entire system, resulting in erroneous permittivity values. The diameter of the geotextile samples used in this device is 3 inches. The head difference across this system is created by adjusting the flow rate at the inlet (the faster the flow rate the higher the buildup of head) while maintaining a permanent lower elevation head at the weir.

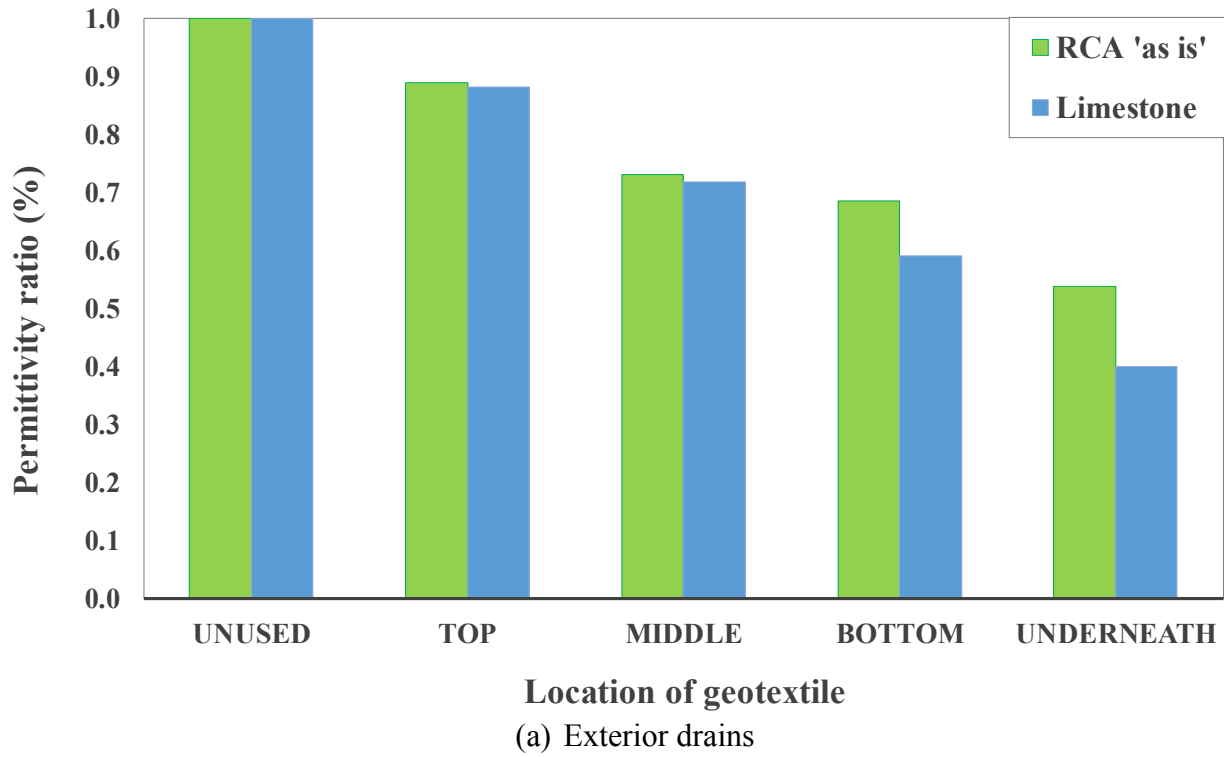
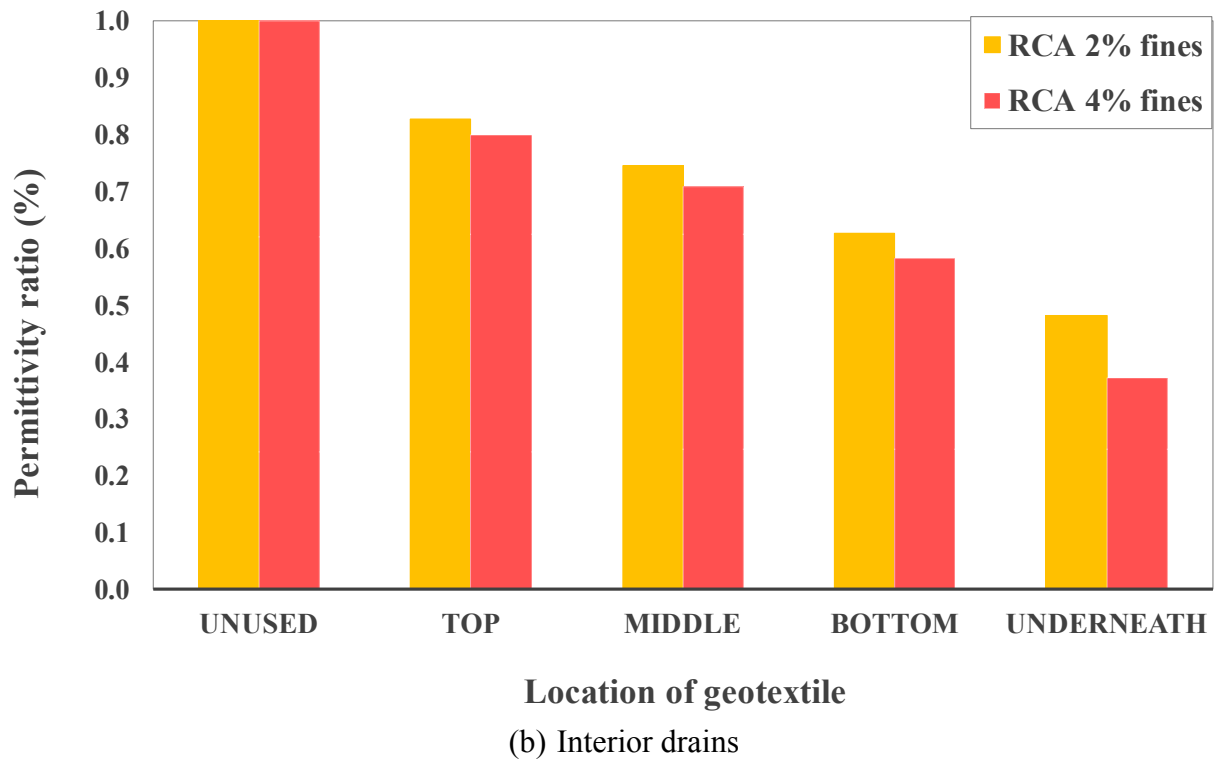
Figure 4.21: Permittivity ratio of in situ geotextiles

The ratio for an unclogged geotextile is equal to 1.0, indicating no change in flow capacity of the geotextile. The comparison of permittivity ratio for each sample is presented in Figure 4.21. For the exterior drains, the reduction of permittivity for RCA ‘as is’ is similar to limestone for the locations of Top and Middle; however, limestone shows larger reduction than RCA ‘as is’ in the locations of Bottom and Underneath. Because limestone has more fines (about 2.2%) than RCA ‘as is’ (about 0.8%), fines migrate downward and build up along the bottom portion of the French drain. The photos of the in situ geotextiles (Bottom and Underneath) of limestone (see Figure 4.20) clearly show more fines in comparison with exhumed geotextiles of RCA ‘as is’. In case of the interior drains, both RCA with 2% and 4% fines exhibit overall reduction in permittivity ratio, but RCA 4% fines shows a larger reduction than RCA with 2% fines. Unlike the exterior drains, higher fines content (4% in this study) caused clogging along the all depths.

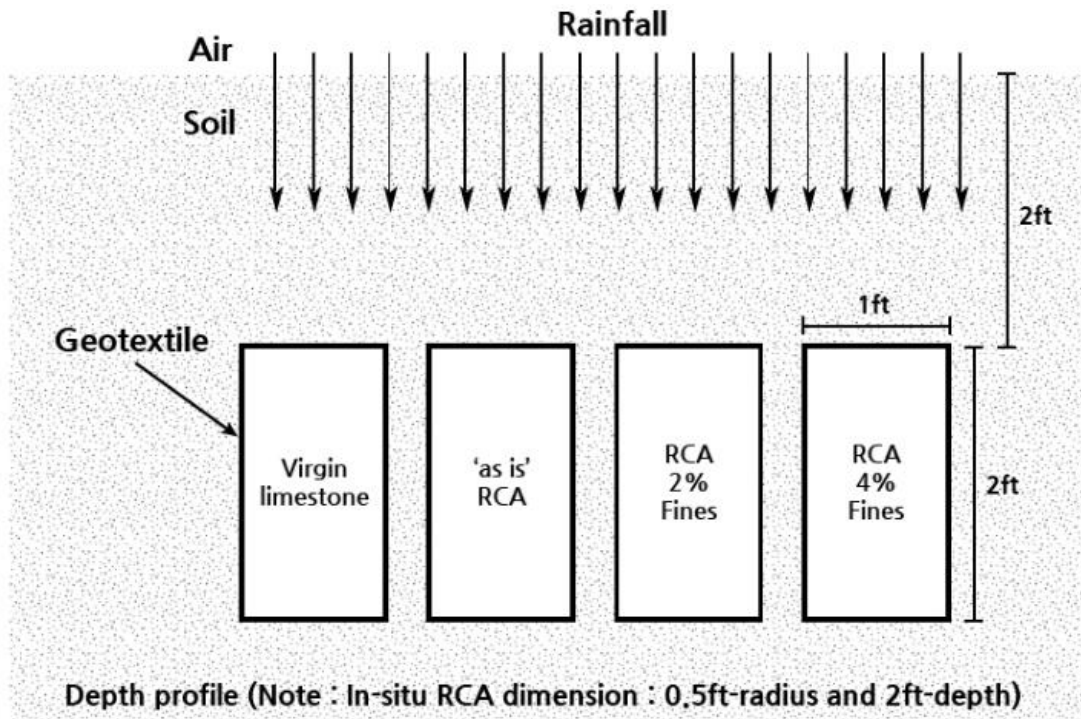
(a) Depth profile (cross-sectional view) of the *in situ* RCA test setup

For the RCA field model, four different types of aggregate were prepared and embedded underground in a loose condition. The aggregate types included: virgin limestone, RCA 'as is' (0.8% fines), and RCAs with additional 2% and 4% fines. Three specimens for each setup were prepared for testing at 6, 12, and 18-month intervals. The schematic diagram of the test setup is shown in Figure 5.1. Figure 5.1 (a) shows the depth profile (cross-sectional view) of the *in situ* RCA test setup. Figure 5.1 (b) shows the top view of the *in situ* RCA test setup. The volume of aggregate placed in each setup was 1.57 cubic ft. All aggregate specimens were wrapped in geotextile and placed into the same soil type as the constructed French drains. Non-woven D-3 geotextile was purchased from ACF Environmental Inc. and approved by the State Materials Office (SMO). The samples in each row shown in Figure 5.1 (b) were tested at different times. For example, Specimens 1-1 through 1-4 were tested at 6 months and Specimens 2-1 through 2-4 were tested at 12 months. Specimens from 3-1 through 3-4 were tested at 18 months.

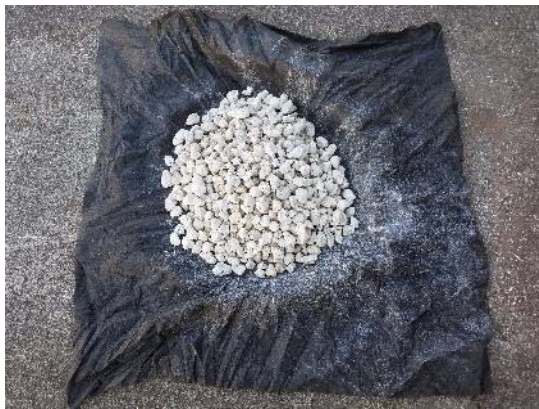
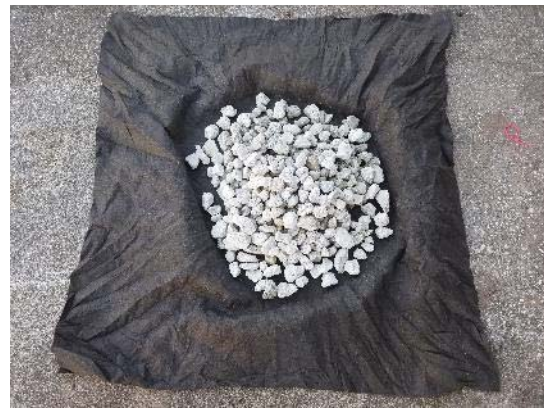
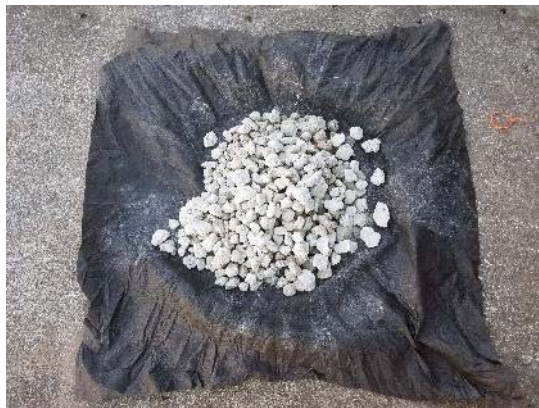
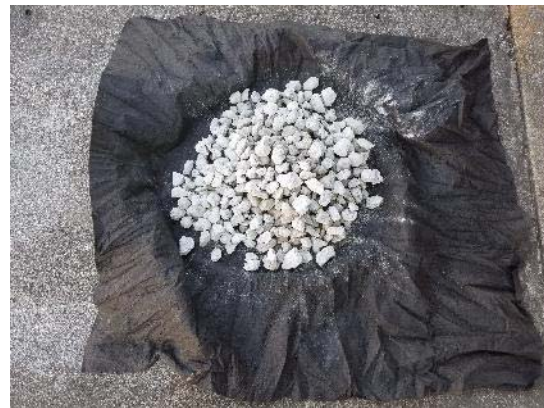
Figure 5.2: Limestone and three different types of RCA after 6-month period

(a) Limestone

(b) RCA "as is"

(c) RCA with 2% fines

(d) RCA with 4% fines

Limestone and RCA samples ('as is', 2% and 4% additional fines) were kept under *in situ* conditions for 6, 12, and 18 months respectively and were prepared for evaluation of the potential for short- and long-term re-cementation and calcite precipitation. The samples conditioned for 6, 12, and 18 months were removed from the ground and the aggregates were pulverized for the XRD test. XRD was used to identify crystalline structures in the RCA, which provided information on the basic chemical/mineralogical components of RCA. Figures 5.2, 5.3 and 5.4 show limestone and RCA samples in geotextile removed from the ground after 6, 12, and 18 months. Visual inspections did not show any noticeable changes between limestone and RCA samples.

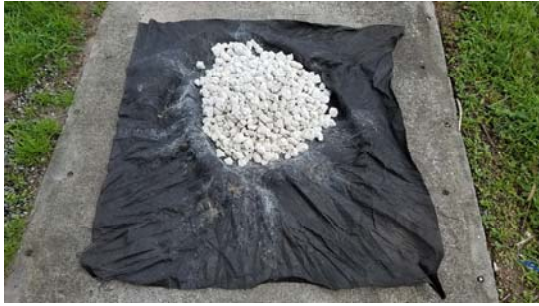
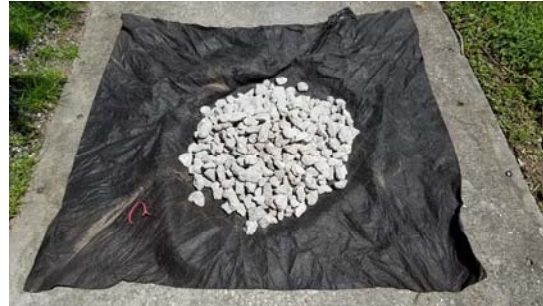
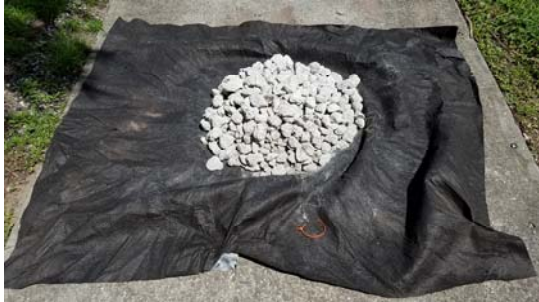
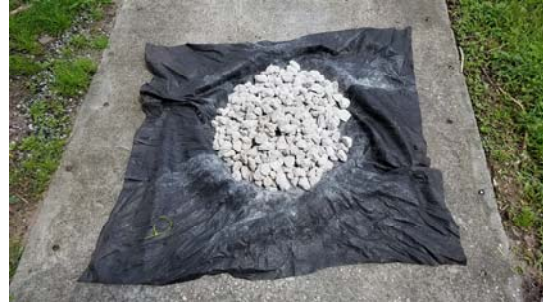
Figure 5.3: Limestone and three different types of RCA after 12-month period

**(a)** Limestone

**(b)** RCA "as is"

**(c)** RCA with 2% fines

**(d)** RCA with 4% fines

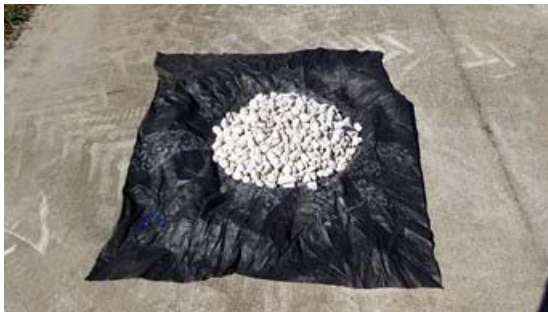
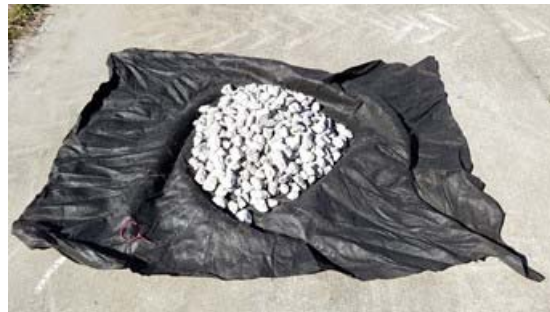
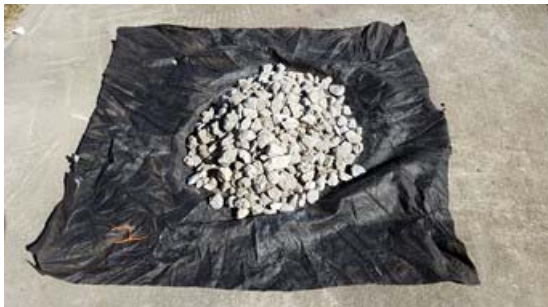
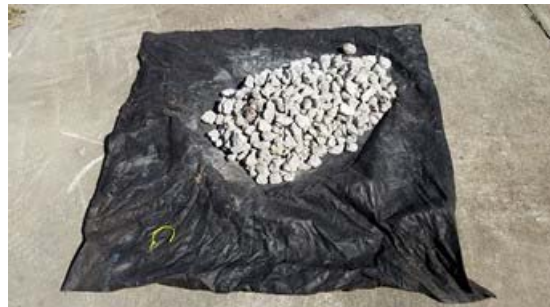
Figure 5.4: Limestone and three different types of RCA after 18-month period

**(e)** Limestone

**(f)** RCA "as is"

**(g)** RCA with 2% fines

**(h)** RCA with 4% fines

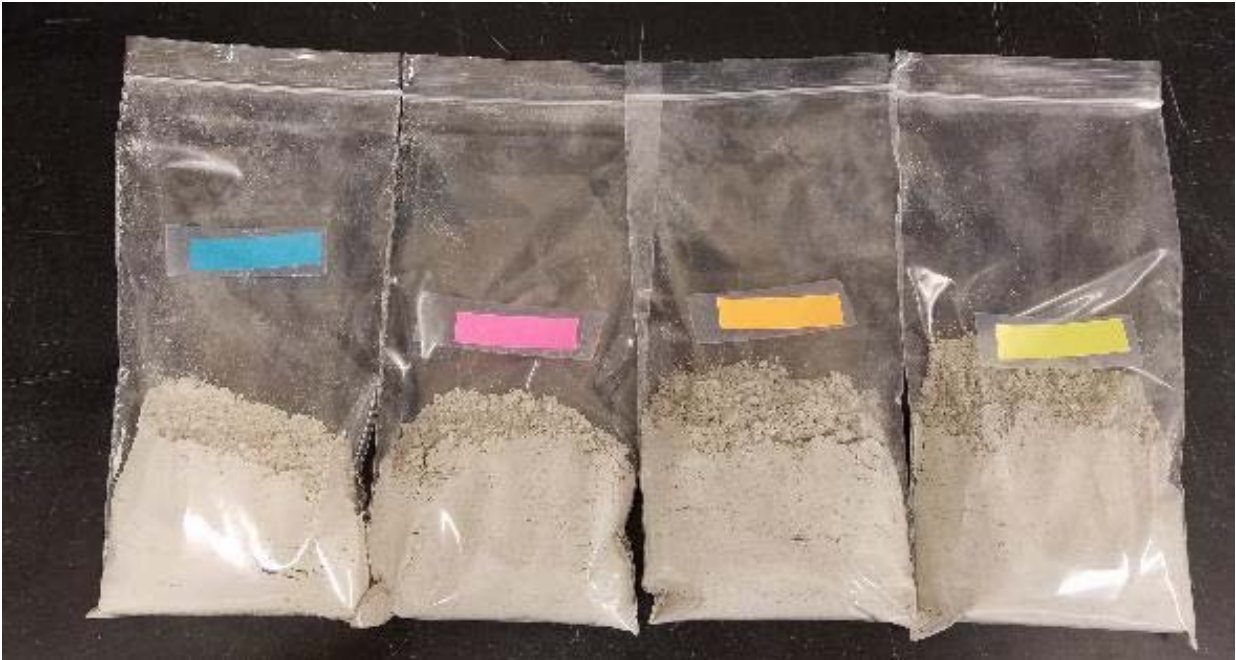
Figure 5.5: Ground limestone and RCAs (as is, 2% fines, and 4% fines) at 6-months.

Powder X-ray diffraction (XRD) analysis was conducted on all aggregate samples for further investigation. To perform XRD analysis, the samples conditioned for 6, 12, and 18 months were removed from the ground and pulverized to fine particles by using a ball mill. The powder samples were then chemically/mineralogically characterized by XRD according to ASTM C295. The powdered *in situ* samples for 6, 12, and 18-months are shown in Figures 5.5, 5.6, and 5.7. The sample with blue mark indicates the pulverized limestone. Samples with pink, orange and yellow marks represent that those samples are RCA 'as is', RCA with 2% fines, and RCA with 4% fines, respectively.

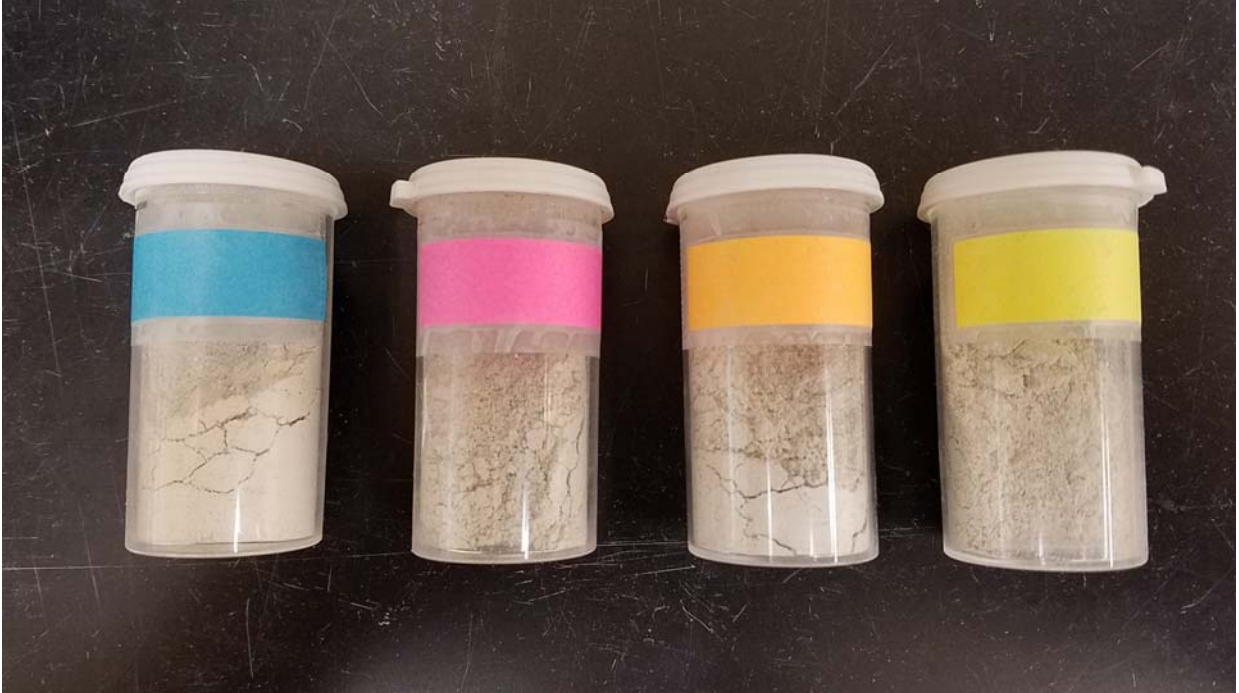
Figure 5.6: Ground limestone and RCAs (as is, 2% fines, and 4% fines) at 12-months.

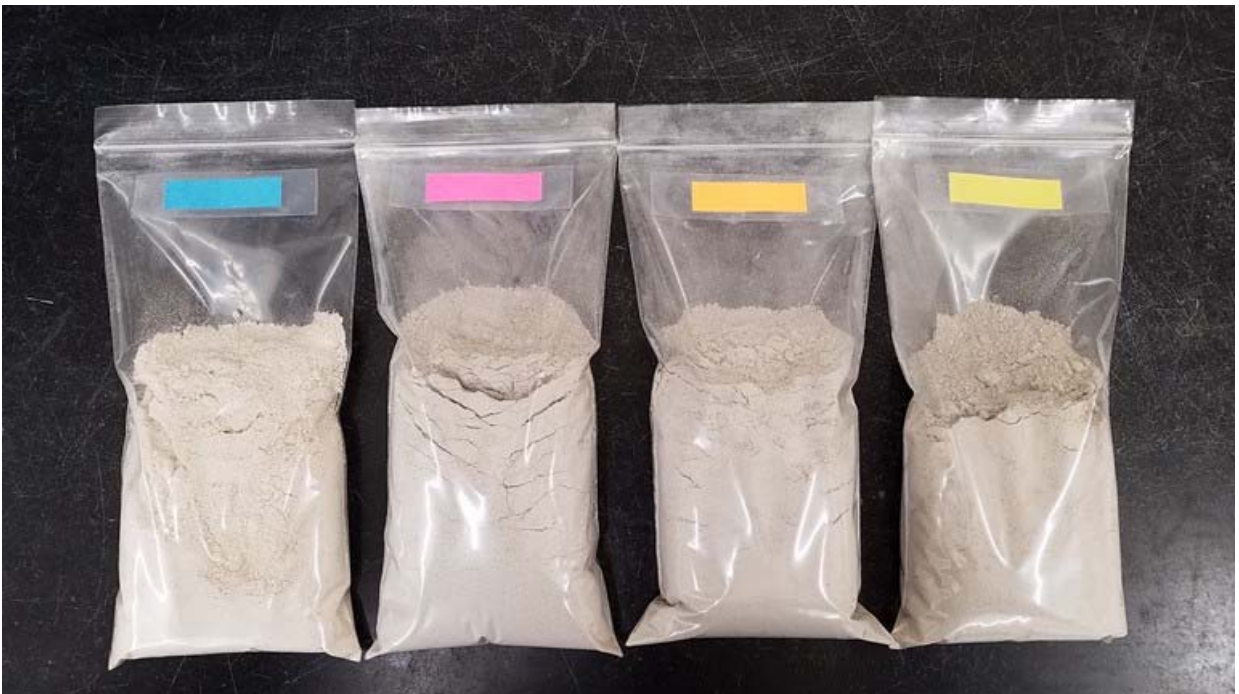
Figure 5.7: Ground limestone and RCAs (as is, 2% fines, and 4% fines) at 12-months.

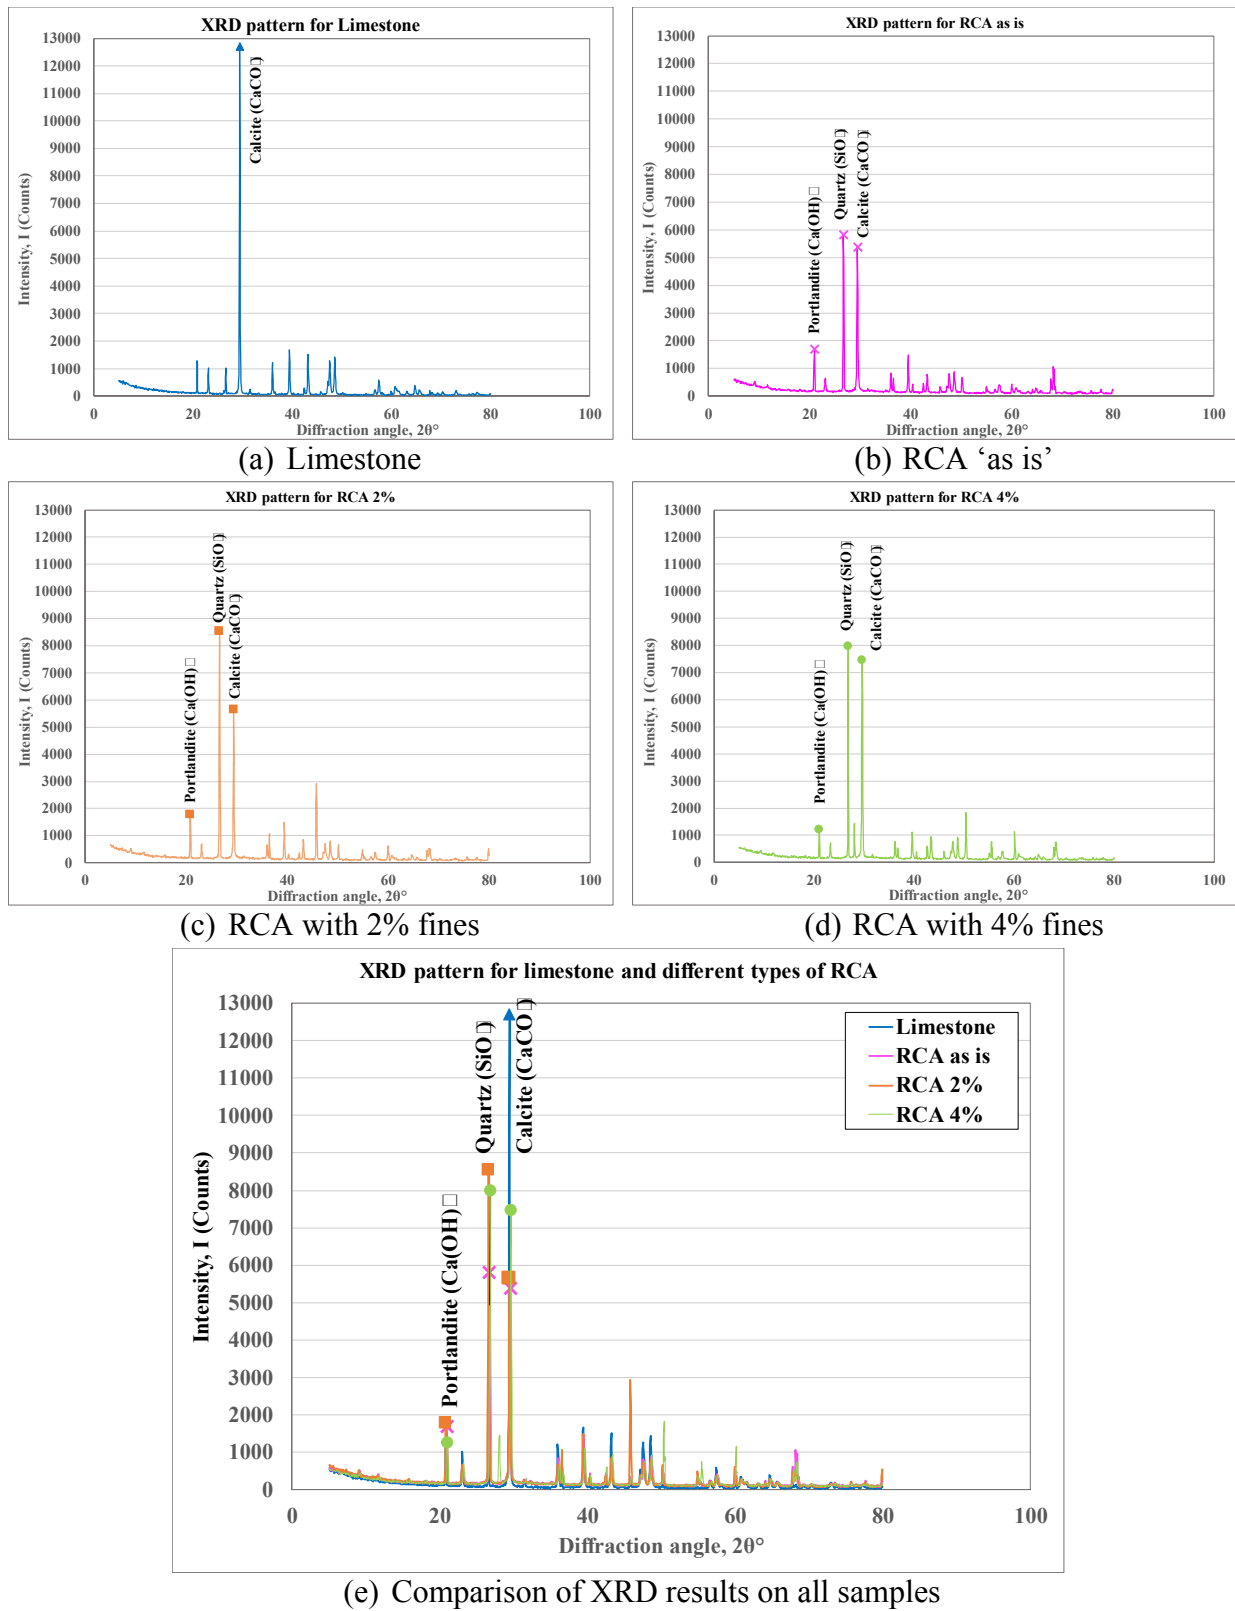
Figure 5.9: XRD results of ground limestone and RCAs at 12-months
