Final Report

**Field Study of Recycled Concrete Aggregate in French Drain**

FDOT Contract No.: BDV24-977-19

January, 2019

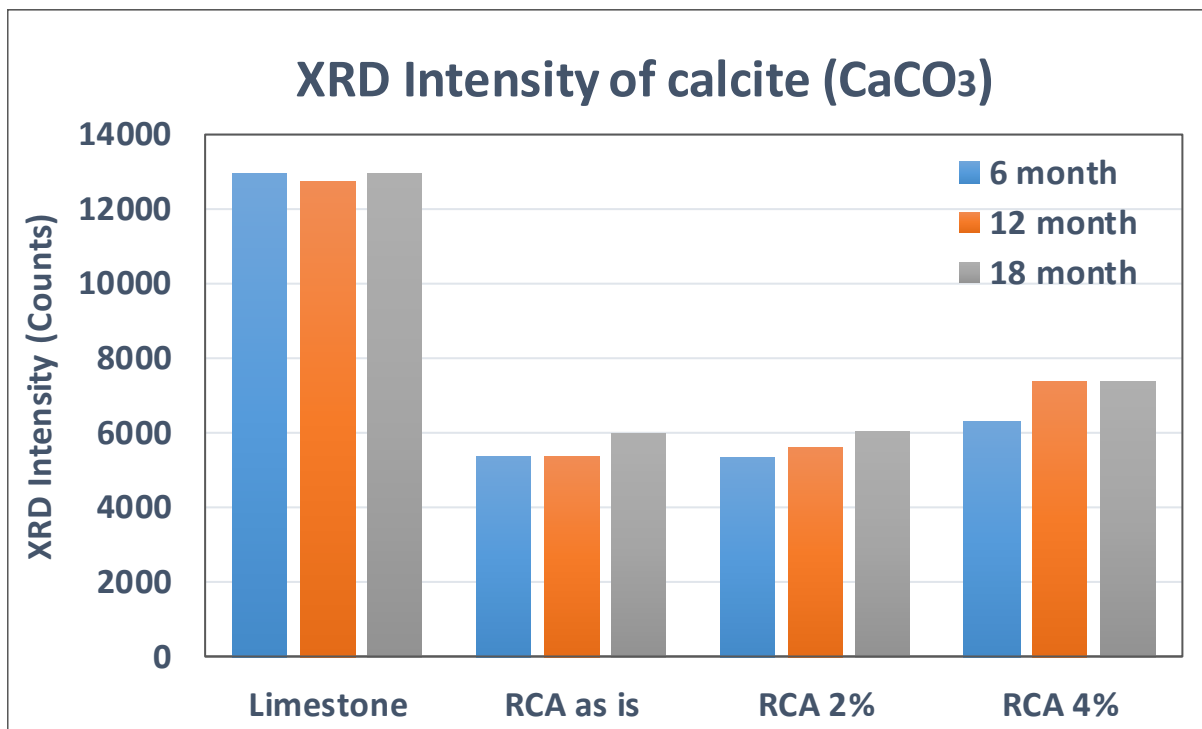
Figure 5.11: Comparison of XRD intensity results (calcite)

Figures 5.11 and 5.12 show the XRD results on calcite and portlandite, with the different elapsed times (6, 12, and 18 months). Figure 5.11 indicates that limestone samples had the highest calcite intensity at all times among all samples because its main chemical compound is calcite. In addition, the limestone showed no noticeable change of intensity with different elapsed times. For the RCA samples, the results showed a slight increase in calcite with increasing elapsed time (see Figure 5.11). However, this increase is not significant considering the range of variations by material and test. RCA with 2% fines shows a similar level of calcite, while RCA with 4% fines shows somewhat higher calcite peaks than other samples. This data (see Figure 5.11), suggests that RCA with 4% fines with large surface area and more portlandite may have produced faster and higher calcite precipitation than other RCA aggregate. Figure 5.12 shows the XRD intensity of portlandite for RCA samples. The XRD results show a tendency for decrease in portlandite with the increasing elapsed times. This decreasing tendency indicates that carbonation of portlandite in RCA samples was occurring with time.

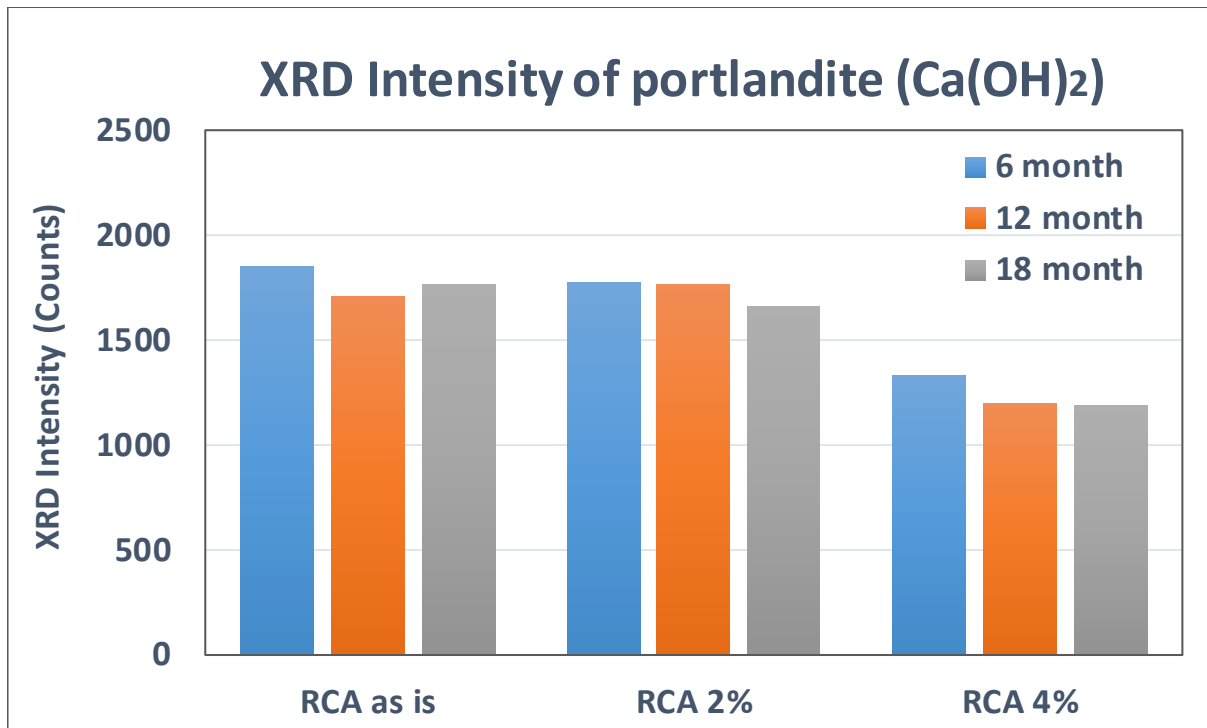
Figure 5.12: Comparison of XRD intensity results (portlandite)

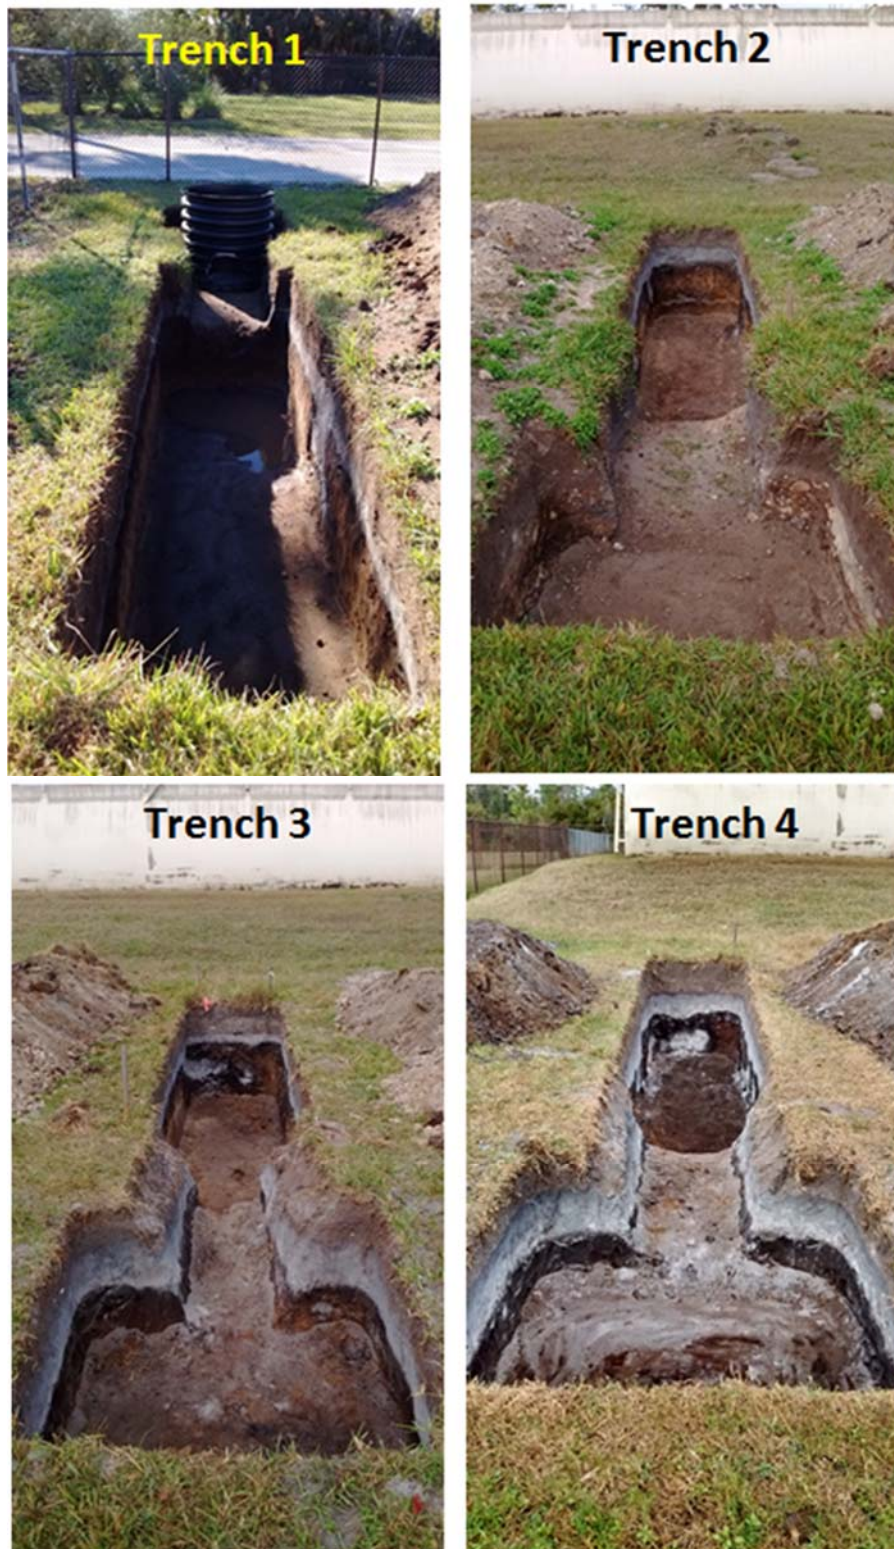
Figure A1. Photos of four trenches

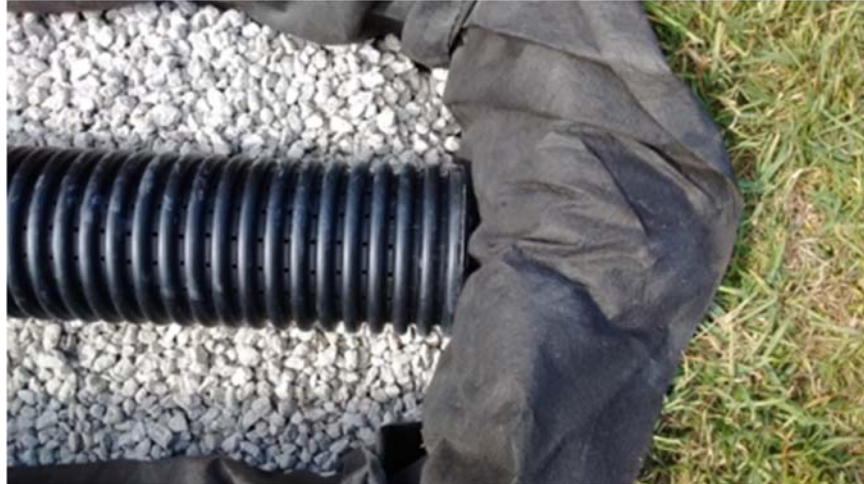
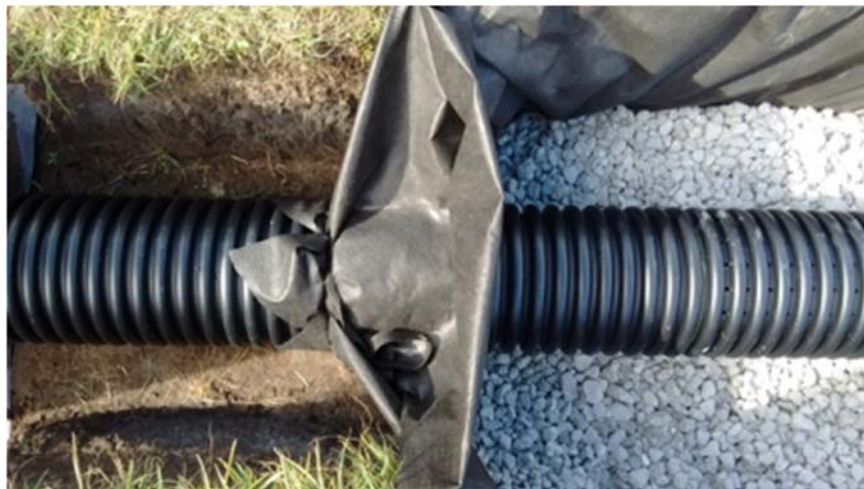
Figure A2. End cap (up) and start of French drain (bottom)

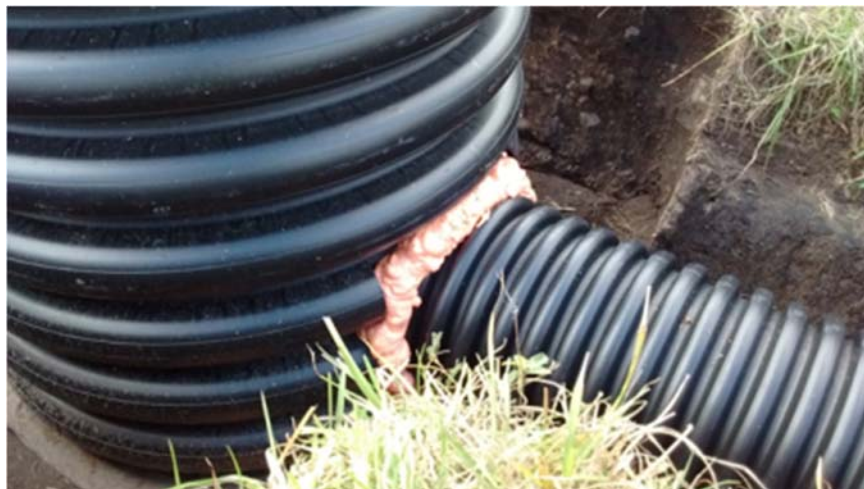
Figure A3. Connection between French drain and sump

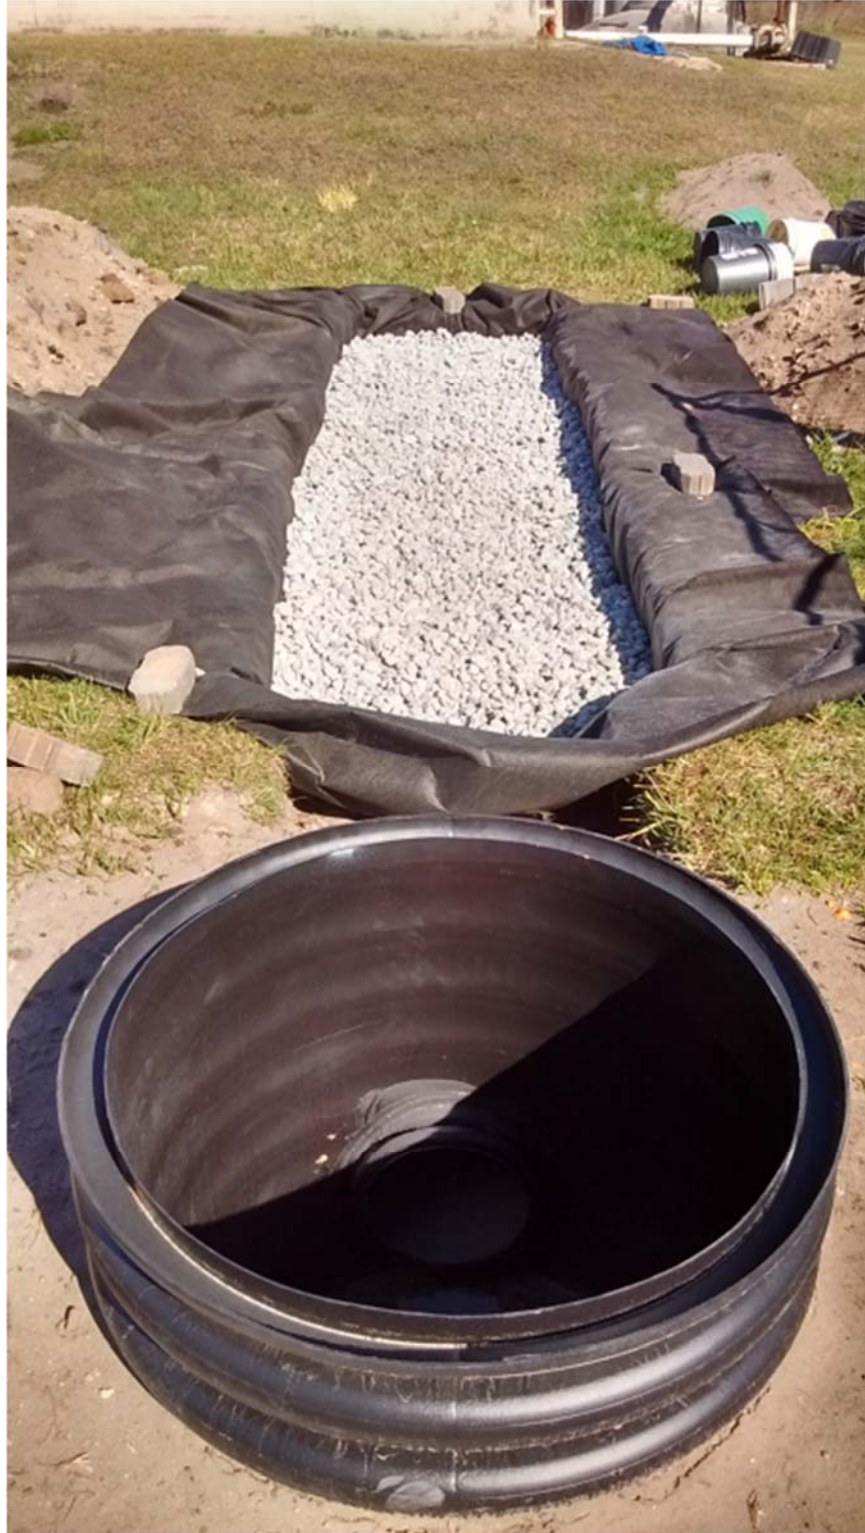
Figure A4. Construction of French drain
