MPC 18-362 | H. Mahmoud, M. Memari, and R. Atadero

Experimental Fatigue Assessment of CFRP-Retrofitted Reinforced Concrete Beams Subjected to Service Temperatures

August 2018

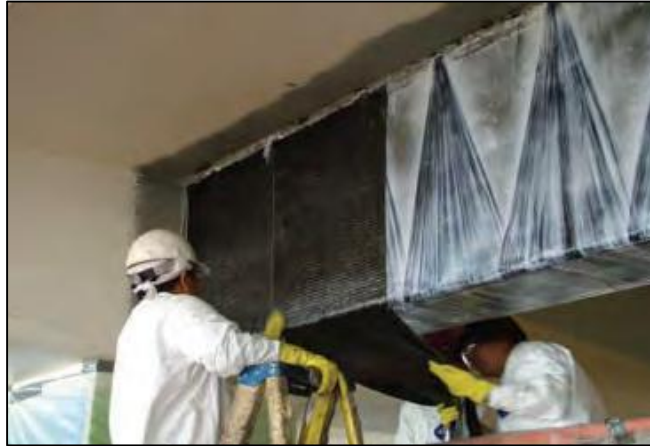
Figure 1.5 CFRP fabric sheet wet layup application to girder (CPS Construction Group, 2011)

Wet layup FRP systems are often used on structures where the application surface is relatively smooth, but has an abrupt or curved geometry, as shown in Figure 1.5. The smooth surface is a requirement of this system. It ensures proper bonding of the FRP to the structure substrate so an ideal composite action can take place. The wet layup system consists of either a unidirectional or bidirectional fabric, and a polymer resin. In the case of a wet layup system, the resin used acts not only as the composite matrix, but also as the adhesive securing the FRP to the structure. The fabric is saturated with the resin in the field by hand. It is then applied and allowed to cure on the structural surface.

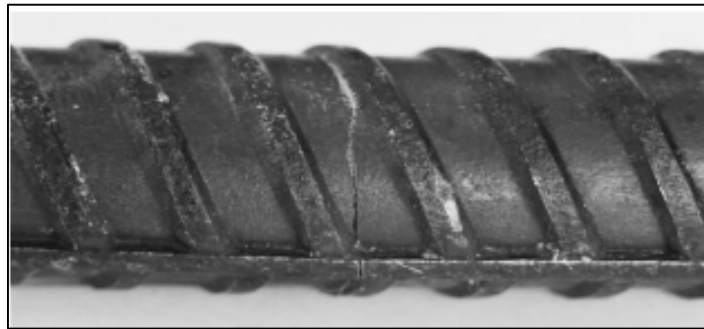
Figure 1.6 Fatigue crack in rebar with initiation at intersection of longitudinal and transverse ribs (Derkowski, 2006)

Fatigue failures have three stages: crack initiation, crack propagation, and sudden fracture. While on the macro scale steel is considered isotropic, at a micro scale it is quite anisotropic with different crystal grains present. For ductile metals, like those composing steel reinforcing bars, the crystal grains are oriented in a fashion in which slip bands easily occur at the grain boundaries due to the applied stress. As the applied stress is cycled, these slip bands extend leading to initiation of a crack (Barsom and Rolfe, 1999). These cracks initiate more quickly at locations where stress concentrations are present. Stress concentrations can appear in many forms especially in welded components; however, for fully intact straight deformed steel reinforcing bars, stress concentrations naturally occur at the intersection of the transverse and longitudinal ribs as shown in Figure 1.6.

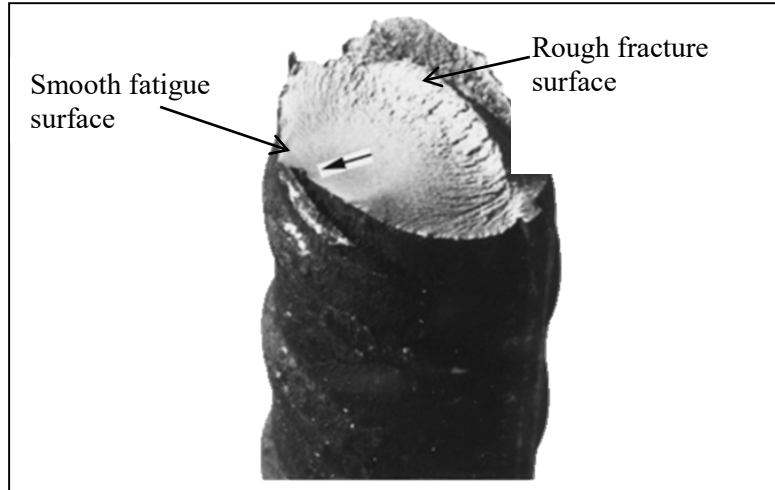
Figure 1.7 Fatigue failure of a steel reinforcing bar with crack initiating from a sharp identification mark (Zheng & Abel, 1998)

After the crack propagates a sufficient degree, the cross-section of the component is effectively decreased to the point where the applied load induces a stress no longer below the ultimate strength of the material, and fracture occurs. The fracture stage of fatigue failure frequently occurs with no warning. In contrast to the smooth surface produced by crack propagation, the fracture surface is rough as shown in Figure 1.7.

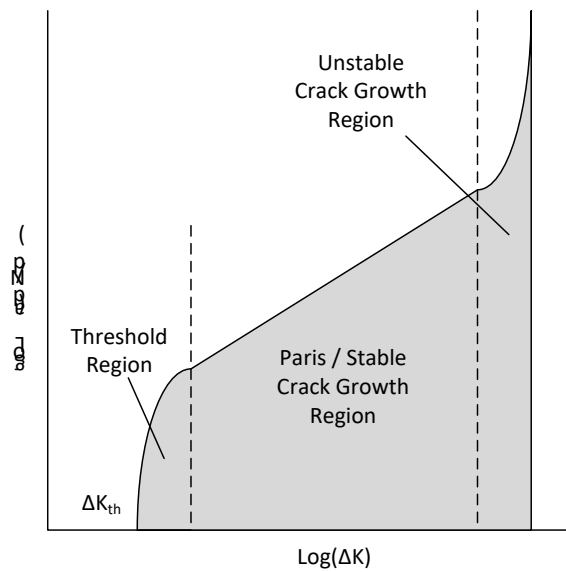
Figure 1.1 Typical crack growth rate vs. stress intensity factor range

Due to the nature of a growing crack in metallic components, the $\log(da/dN)$ versus $\log(\Delta K)$ plot has a distinct S-curve shape. When a small flaw is stressed such that the stress intensity factor range is just above the threshold value, crack growth is initially quite rapid, with the curve generally having a steep slope approaching a vertical asymptote at the threshold stress intensity factor range. (Dowling, 1999). Again, this threshold value is generally the value at which cracks typically won't propagate. The next segment is the stable crack growth region described by the Paris Law. On a log-log plot, this segment should be fairly linear with the crack growth rate and stress intensity factor range increasing at the same rate. The growth rate again accelerates unstably as the stress intensity factor range becomes large, typically as the crack reaches its critical length and fracture occurs.

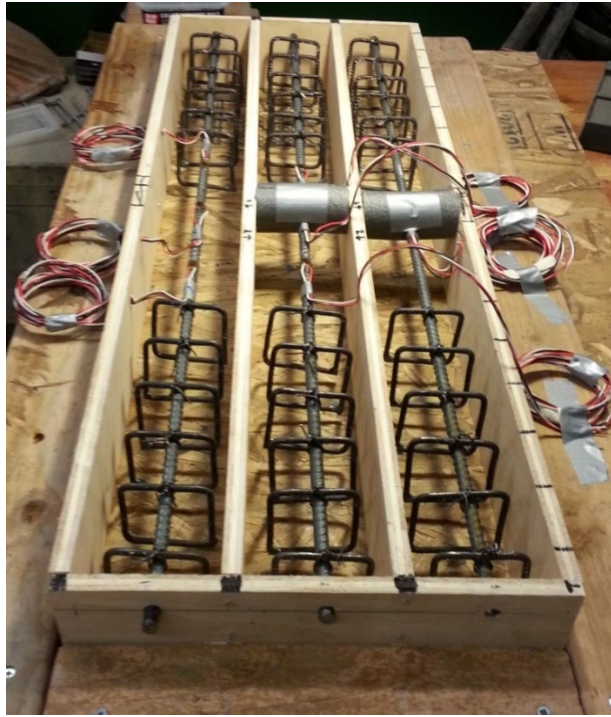
Figure 2.3 Small-scale beam forms with foam cylinders for access holes

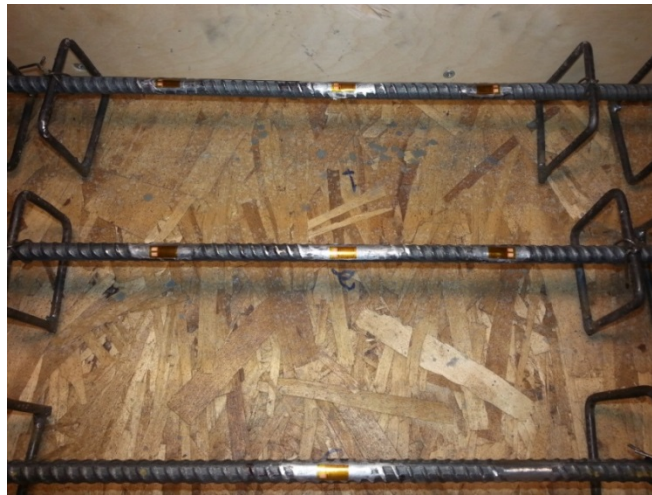
Figure 2.6 Strain gage layout

A picture of the strain gage layout on each beam is shown in Figure 2.6. The strain gage layout was used so tensile stresses developed in the reinforcement could be determined in and outside of the removed concrete section to ensure stresses in the beams with and without access holes were acceptably close in value. Theoretically the stresses should be the same, up to yielding of the reinforcement, since the beam was loaded in four-point bending and the gages were all in the constant moment region.

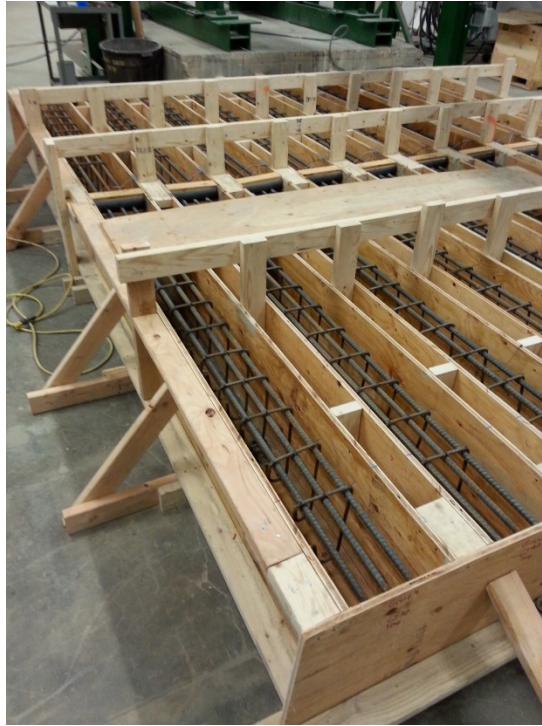
Figure 2.10 Braced plywood and lumber form-work

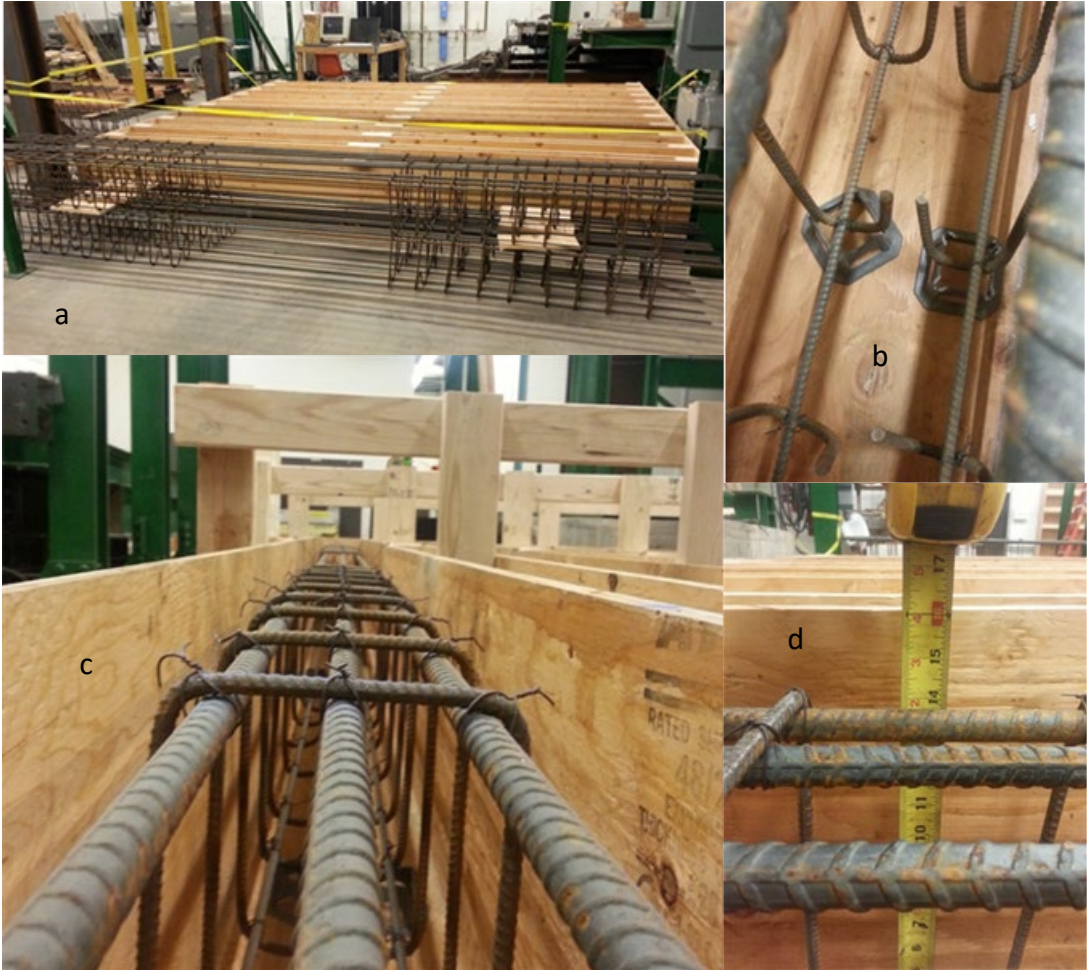
Figure 2.12 a) Rebar cages, b) 40mm plastic rebar chairs, c) position of rebar cage in form, d) depth of tensile reinforcement once supported on 40mm rebar chairs

The steel rebar cages were tied up and lowered into the forms with the No. 19 rebar on the relative top. The cages rested on plastic rebar chairs to achieve the concrete cover needed shown in Figure 2.12b. Once the cages were in the forms, the ribs on the No. 19 rebar were removed for a length of 150mm at midspan and in beams 2 and 3 at an additional location 230mm away. The purpose for these additional smoothed portions is explained later in the Instrumentation section. The ribs were removed and the surface polished not only to give the strain gages a smooth surface to attach to, but also to make propagation of a fatigue crack from the cut notch more easily visible. The notches were cut into the outer most No. 19 rebar after polishing using a Dremel tool with a silicon carbide cutoff wheel with marking of 2mm to ensure all notches were cut to approximately the same depth. A rounded notch tip was left by the cutting wheel; therefore, a utility knife blade was used to sharpen the notch tip to preserve the higher stress intensity.

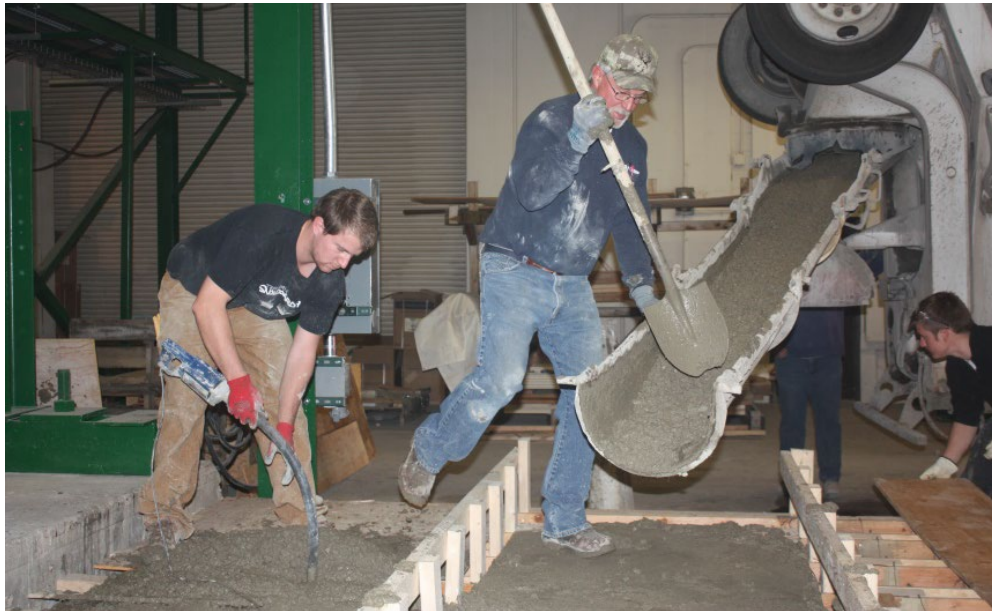
Figure 2.13 Concrete placement

Concrete was supplied by a local concrete batch plant and placement of the concrete for all beams was performed in the same day. A concrete vibrator, shown in Figure 2.13, was used to ensure minimal voiding between the rebar cages and form walls, and around and in the rebar chairs. The concrete was allowed to cure 28 days before the form-work was removed and testing began.

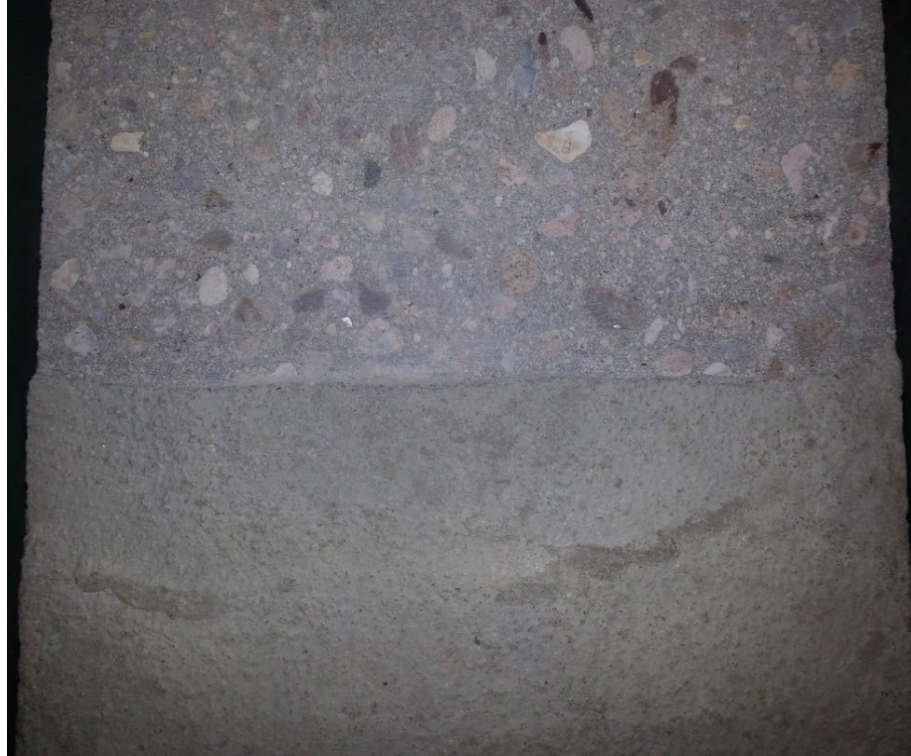
Figure 2.14 Concrete surface, top; removed laitance layer exposing aggregate, bottom; concrete surface left by finishing of wet concrete

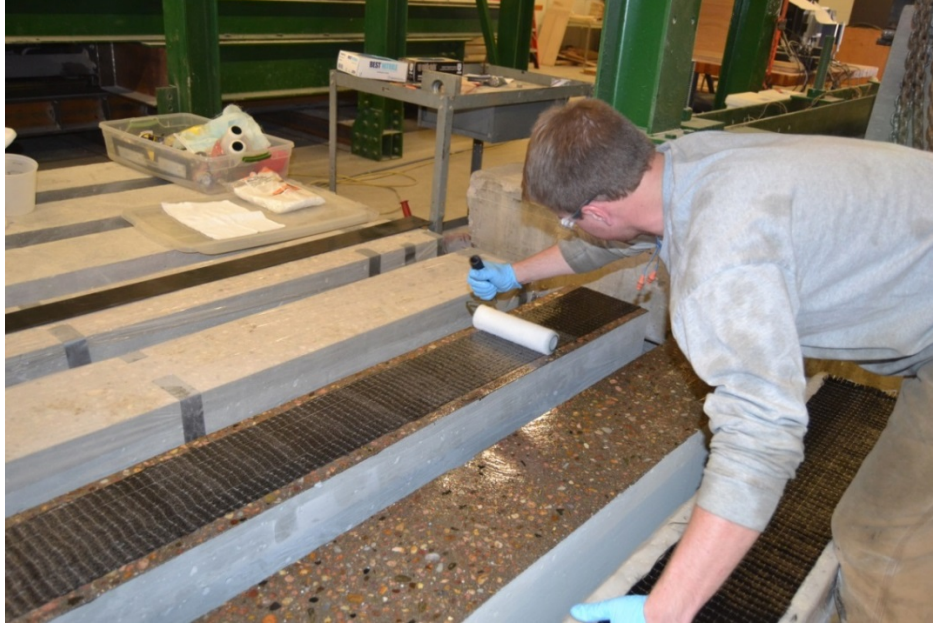
Figure 2.15 Hand-layup process of Tyfo SCH-41 CFRP sheets and beams 4 and 5

Application of the CFRP didn't occur until the concrete reached the 28-days compressive strength. Four beams were externally strengthened with commercially available CFRPs produced by Fyfe Co. Prior to application of any CFRP, a diamond cup grinding wheel was used to remove the concrete laitance layer (about 5mm) from the soffit of each beam to expose the aggregate and promote a stronger bond between the concrete and CFRP, Figure 2.14. Beams 4 and 5 were strengthened with a 190mm wide Tyfo SCH-41 unidirectional carbon fabric sheet and Tyfo S Epoxy. The fabric sheet was saturated with the epoxy and applied to the prepared beams via a hand lay-up process shown in Figure 2.15. Beams 6 and 7 were strengthened with a single Tyfo UC strip, which is a high modulus, high tensile strength, pultrusion fabricated carbon-epoxy laminate. The Tyfo UC strips were adhered to the concrete substrate with Tyfo TC Epoxy, shown in Figure 2.16.

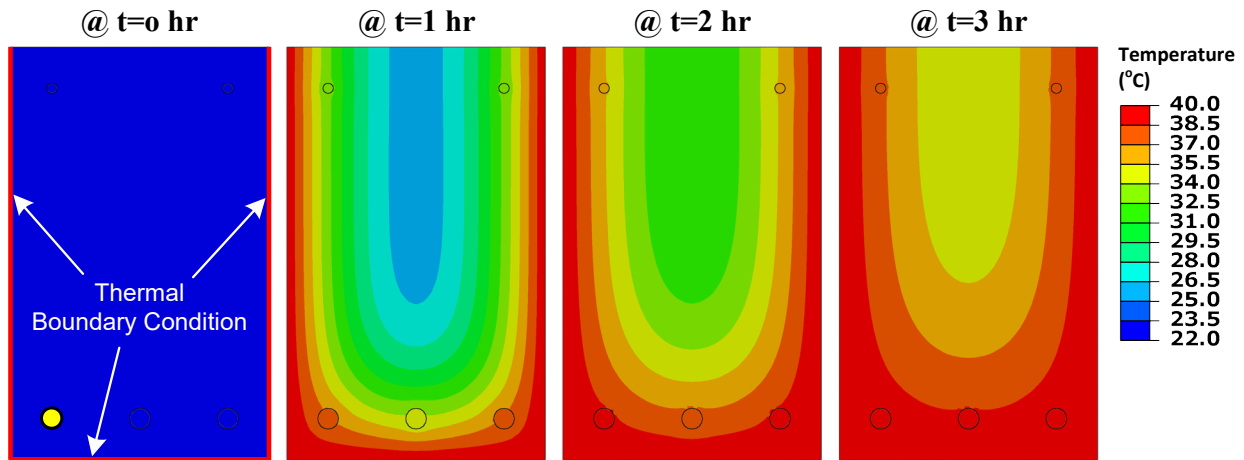
Figure 2.20 Temperature contour in the concrete at different time intervals

In the experimental study, thermal panels were used, as will be discussed later in more details, to apply the desired temperature in the steel rebar in the presence of the void. To evaluate validity of this approach in comparison to reality where there is no void, numerical simulations were conducted. Specifically, numerical transient heat transfer analysis was conducted using ABAQUS 6.14 (ref.) to 1) evaluate heat penetration into the steel rebar through the concrete, 2) the expected time required to reach the applied temperature, and 3) the temperature variation between the steel and the concrete. The numerical model comprised of 4-node heat transfer quadrilateral shell elements (DS4). Thermal conductivity, specific heat, and density were considered as 1.75 W/m.K, 0.92 KJ/kg.K, and 2300 kg/m³, respectively, for the concrete and 54 W/m.K, 0.49 KJ/kg.K, and 7850 kg/m³, respectively, for the steel. Three edges of the concrete beam, as highlighted in Figure 2-20, are exposed to 40, 38, and 31° C to represent Beam 6, 7, and 8, respectively. Figure 2.20 shows the heat propagation contour throughout the concrete at one-hour intervals. Additionally, Figure 2.21 shows the temperature versus time at the location of the highlighted rebar. It was observed that the temperature in the rebar reaches the desired temperature, which was applied to the concrete external surfaces in approximately three hours, although the temperature of the exterior rebar is at 90 percent of the ultimate value in an hour. In other words, in the absence of a void, representing reality, the steel rebar is expected to reach the concrete surface temperature in the range of one to three hours. Therefore, applying such temperature in the presence of a void is a reasonable representation of reality.

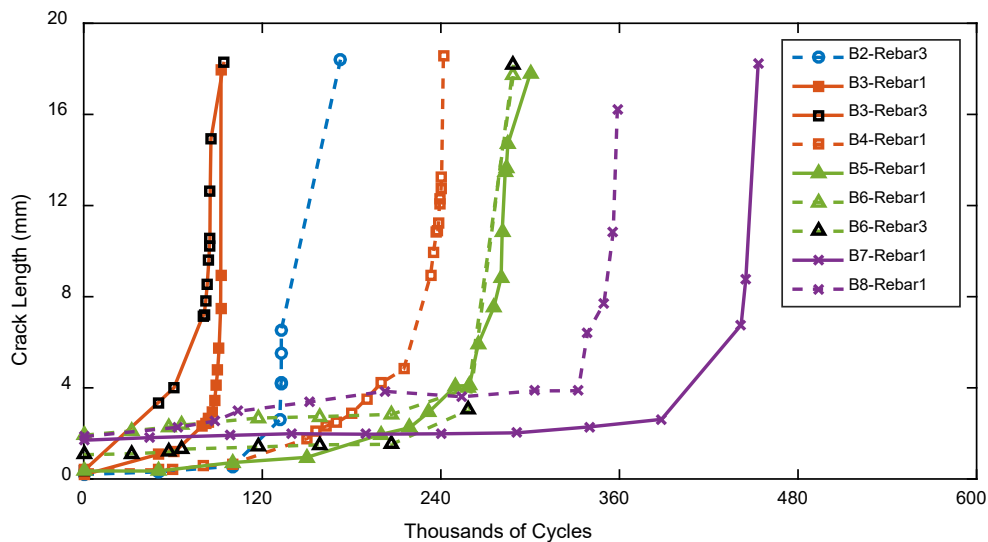
Figure 3.7 Crack length versus number of cycles when the crack is visible

Figure 3.6 shows the crack length versus number of cycles for each beam over the entire test from the point where the crack first becomes visible, respectively. A general trend of increased fatigue life and slowed crack growth rate with the addition of CFRP can be seen per Figure 3.6. The fatigue life and crack growth rate for the SCH-41 sheet strengthened beam (4 and 5) are consistent as shown in Figure 3.7. Beam 6 shows improved performance over the SCH-41 system with a longer fatigue life and slowed crack growth rate, per Figure 3.7. Beam 7 and Beam 8 exhibit the best performance in terms of prolonged fatigue life, as seen in Figure 3.7. In general, the results show the benefit of adding CFRP for slowing down crack growth. Furthermore, the applied service temperature, in the tested range, appears to provide beneficial effect for increasing the fatigue life. This is because the increase in rebar temperature causes the rebar to want to axially strain and extend, which is naturally prevented by the surrounding concrete, which in turns imposes compressive forces on the rebar, promoting crack closure.

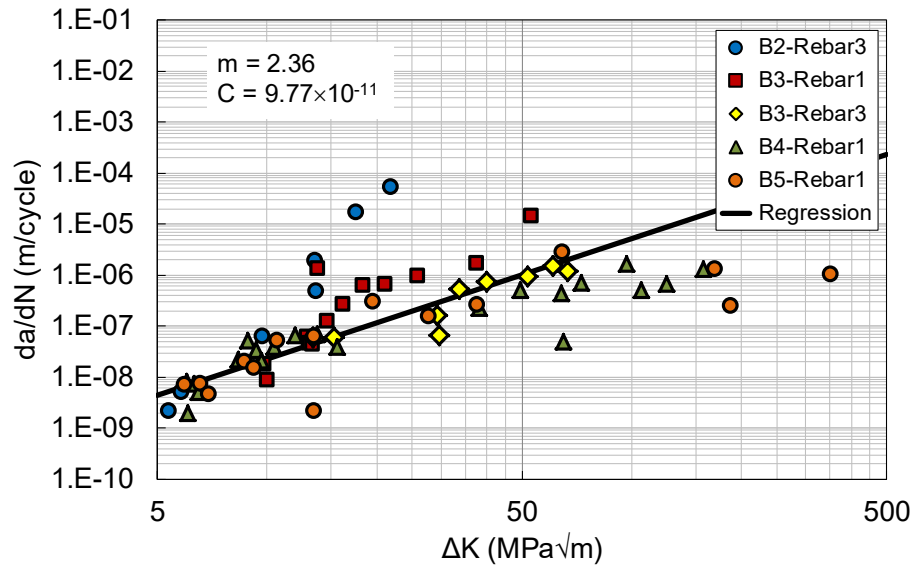
Figure 3.8 Crack propagation rate versus stress intensity factor range for beams tested at the room temperature

Determination of the Paris Law parameter, constants C and m in Eq. (4), is useful for developing analytical solutions that can be used to predict the crack growth rate. The constants were determined from a log-log plot of the crack growth rate, da/dN , versus the stress intensity factor range, ΔK , for Beams 2 to 5 shown in Figure 3.8 and Beams 6 to 8 shown in Figure 3.9. The values for C and m are the y-intercept and slope of the power trend line shown on the plots, respectively. For Beams 2 to 5, the value for C is found to be 9.77×10^{-11} , while the value for m is 2.36. For beams 6 to 8 tested at high service temperatures, the value for C is determined as 2.51×10^{-11} , while the value for m is 2.99.

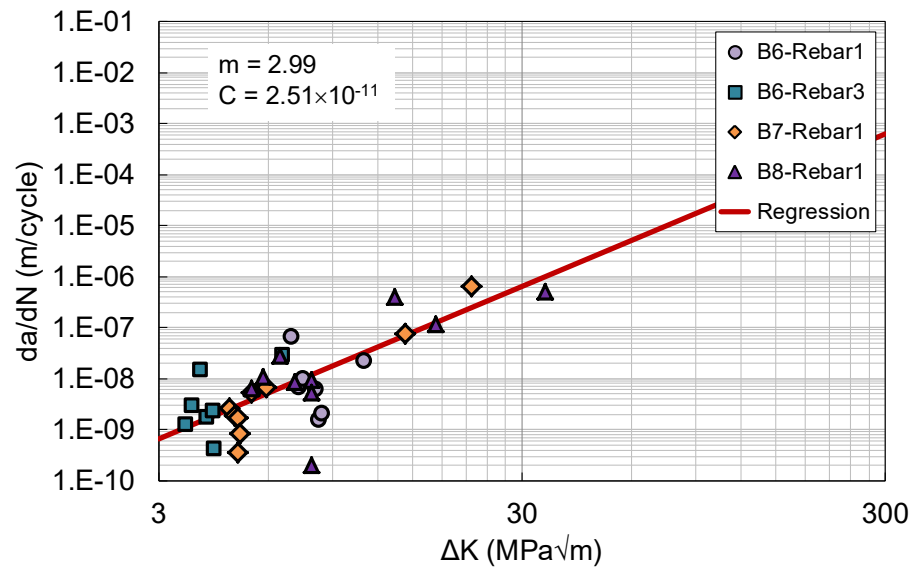
Figure 3.9 Crack propagation rate versus stress intensity factor range for beams tested at high service temperatures
