NATIONAL HIGHWAY SYSTEM CONNECTORS TO FREIGHT FACILITIES

IN THE DELAWARE VALLEY REGION

**DELAWARE VALLEY REGIONAL PLANNING COMMISSION**

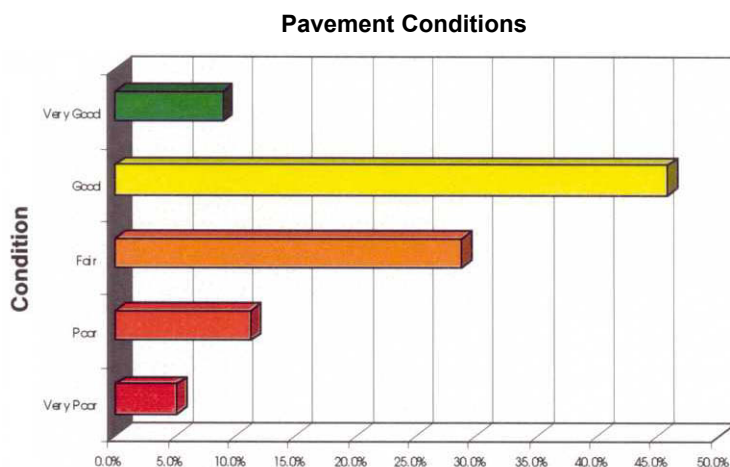
**Percent of Total Regional NHS Connector Mileage
(serving Intermodal Freight Facilities)**

Roadway surface conditions throughout the connector highway network are considered to be in fair to good repair. Where fair, poor or very poor conditions exist, they are most frequently associated with connector roadways serving ports.

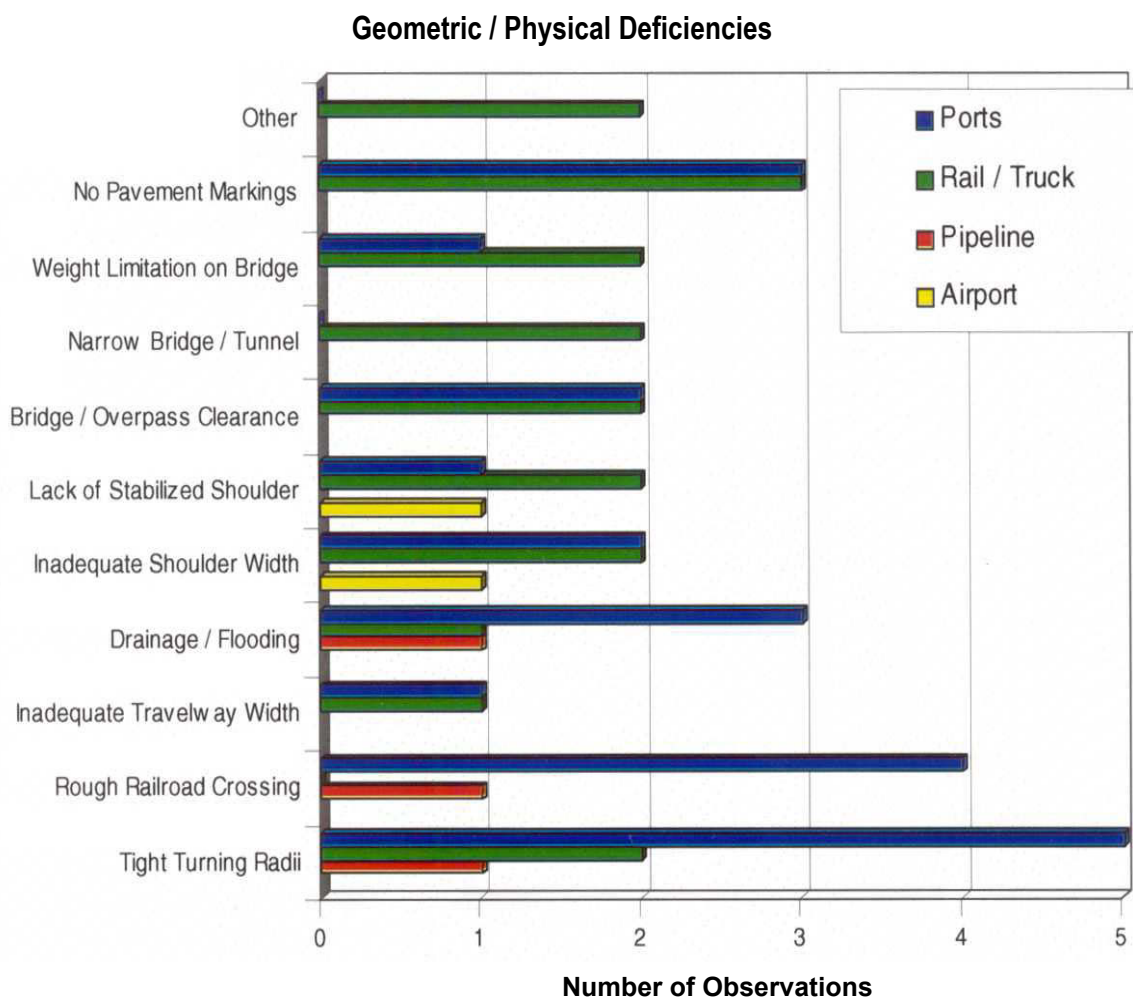
The most frequently encountered physical deficiency along the connector network is tight turning radii. Second tier deficiencies throughout the network are: inadequate shoulder widths, missing pavement markings, drainage problems and rough highway / railroad at-grade crossings. Finally, bridge / overpass clearances and inadequate cartway widths (roadway and suitable shoulder) are identified as the least frequently occurring deficiencies affecting the connectors serving all freight facilities.

Here again deficient physical connector conditions seem to predominate around port facilities, although rail / truck terminals are also affected.

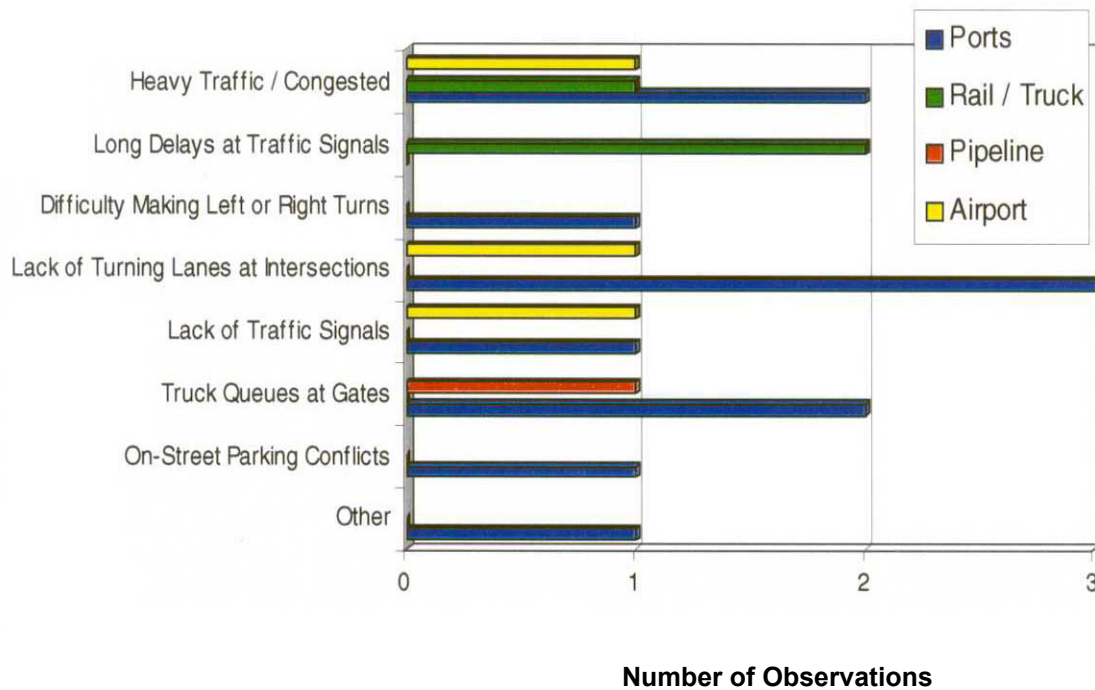
**Traffic Operations / Safety Problems / Delays
(along the connector)**

Congestion resulting from heavy traffic volumes and a lack of turning lanes at intersections were identified as the most common reasons that traffic operations were compromised along the connector network. Delays at intersections due to inordinately long traffic signal cycles, inadequate traffic signal phasing and/or the absence of traffic signal control at key intersections were also frequently identified. Finally, the queuing of trucks at the facility gates was identified as a common problem along the connectors.

All of the operational problems are present for the connectors serving the ports.

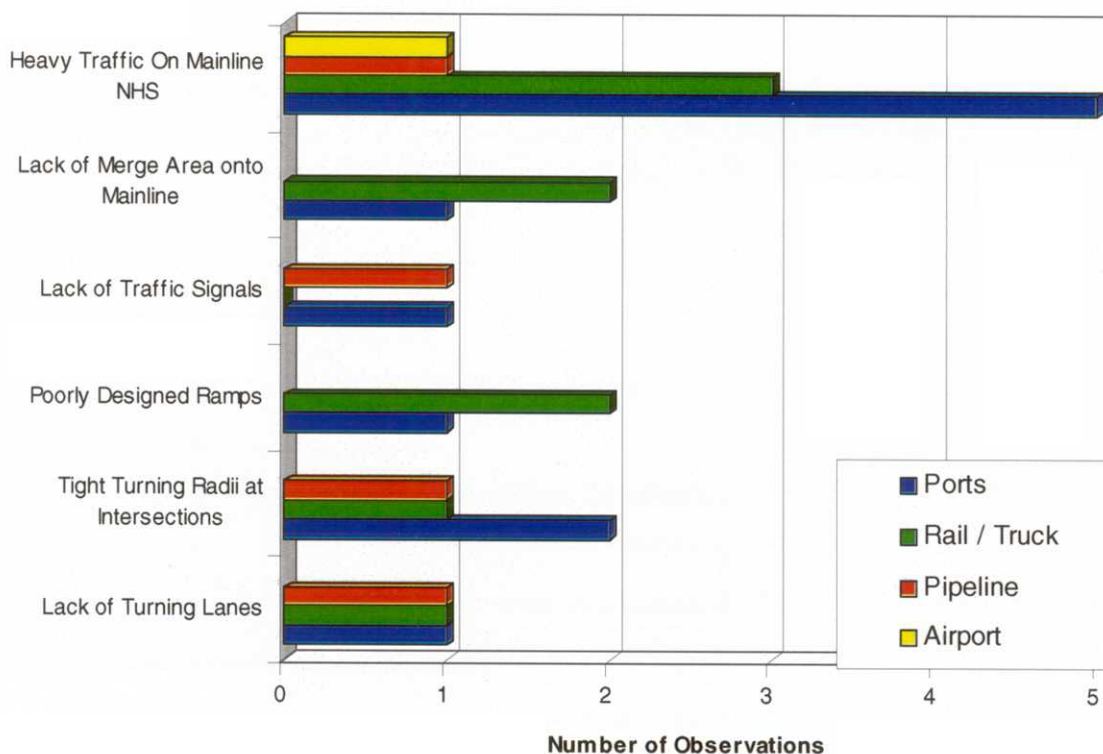
**Traffic Operations / Safety Problems / Delays
(at the junction of the connector and mainline highway)**

Heavy mainline volume is the most often encountered problem at the junctions of the connectors and the mainline highway facility.

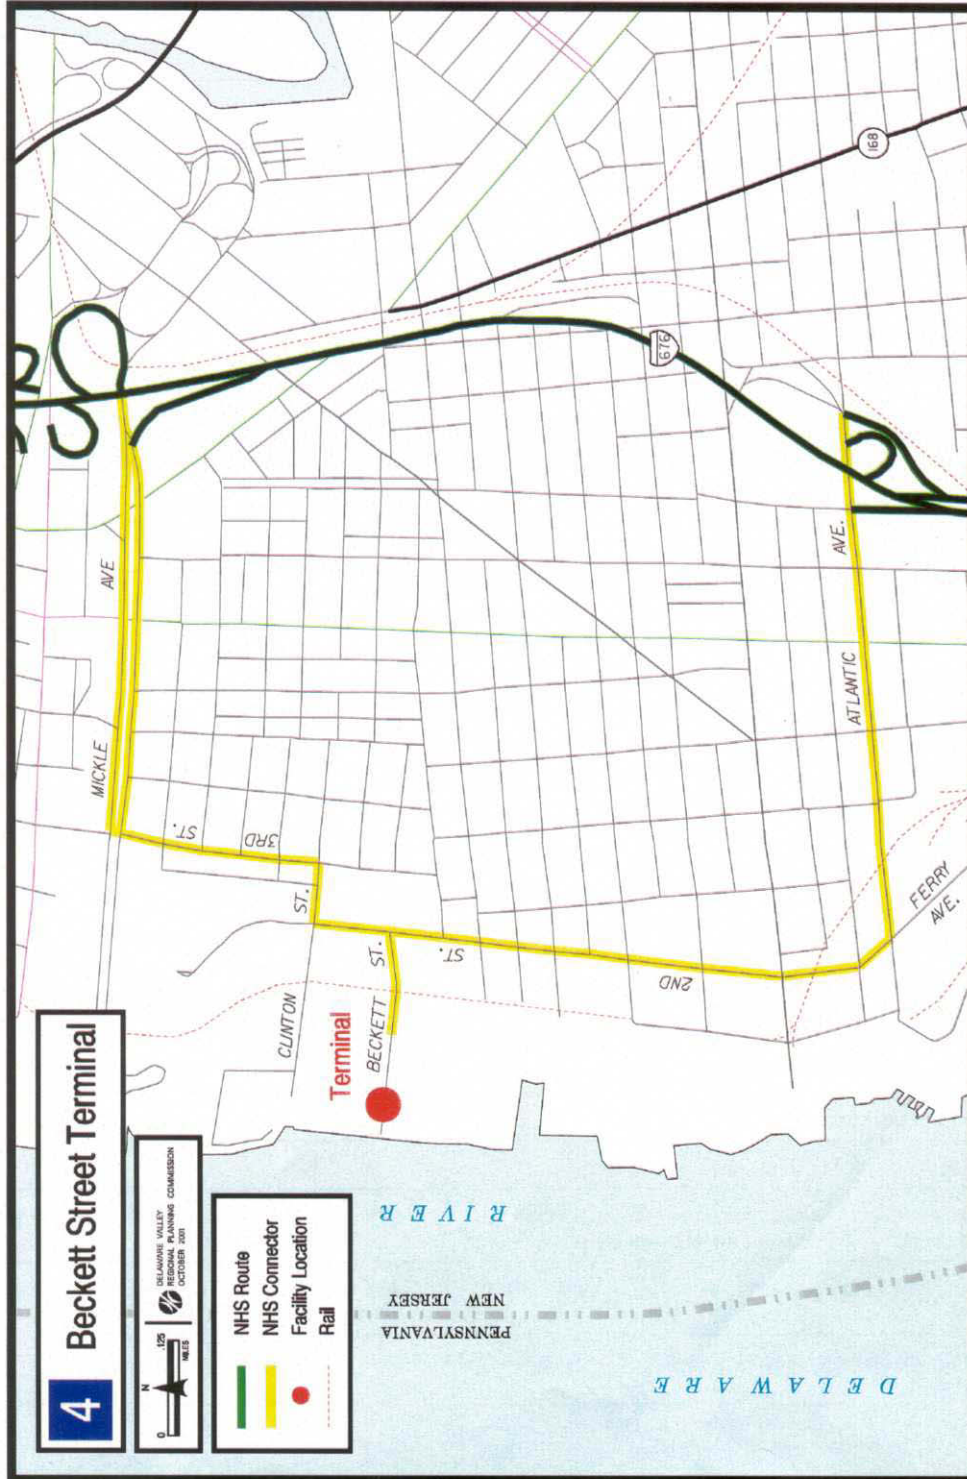
4

Problem	1	2	3	Description
Delays at Railroad Crossing				
Switching / Make-up Operations				
Crossing Warning Devices	✓	✓	✓	There are no warning devices at all of the crossings
Inadequate Sight Distance at Crossing				
Rough Railroad Crossing Surface	✓	✓	✓	All of the crossing are very rough
Vehicle Underclearance (Humped Crossing)				
Lack of Alternate Route				
Other <u>No pavement markings</u>

Condition	Description	Percent	Location
Very Good	Newly built or resurfaced and distress free.		
Good	Smooth surface with little to no cracking or rutting.		
Fair	Serviceable with shallow rutting and moderate cracks beginning to occur, but does not affect travel speed.	50 %	Mickle Ave. Atlantic ave (Ferry Ave. to Broadway)
Poor	Same problems as fair but worse, cause some reduction in speed.	40%	3 rd Street, Clinton St., 2 nd Street, Beckett St.
Very Poor	Major problems with potholes, etc., causing substantial reductions in speed	10 %	Atlantic Ave. (Broadway to I-676)

Geometric / Physical Features				
Problem	No Problem	Short Section	Most of Length	Description
Inadequate Travelway Width	✓			
Inadequate Shoulder Width	✓			
Lack of Stabilized Shoulder	✓			
Tight Turning Radii at intersection		✓		At Beckett St. / 2 nd St. Intersection
Road not Paved	✓			
Bridge / Overpass Vertical Clearance	✓			
Weight Limitation on Road / Bridge	✓			
Narrow Bridge / Tunnel	✓			
Rough Abandoned Railroad Crossing		✓		Possibility that the rough grade crossing are abandoned
Drainage / Flooding		✓		Flood Area on Atlantic Ave.
Other _____

New / Replacement Signs Recommended	Location
Trailblazers from I-676 and NJ 30 to terminal	All appropriate intersections
Trailblazers from terminal to I-676	All appropriate intersections
Trailblazers from terminal to NJ 30	All appropriate intersections
Consistent signing for Mickie Blvd. / Martin Luther King Blvd. / Alicia Santos Blvd.	Along Mickie Blvd.
Larger street name signs - current signs are very small	Along all connector roadways

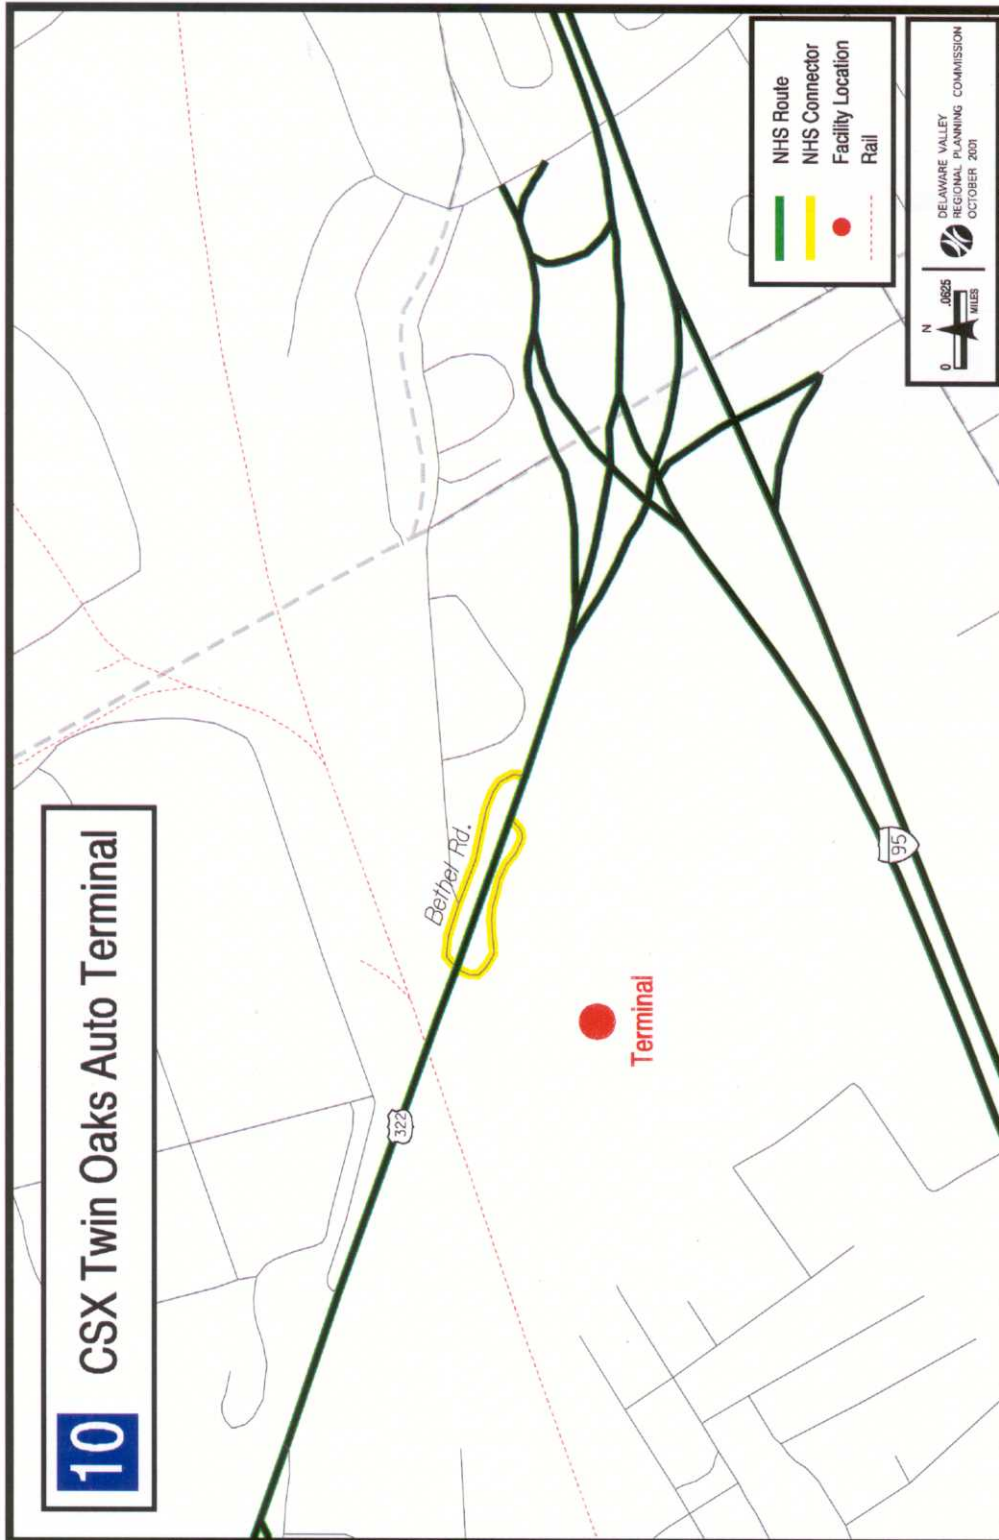
10

From terminal to US 322 (Conchester Highway) via Bethel Rd.
0.492 miles
