Rectangular Rapid Flash Beacon (RRFB)

This summary is one in a series describing Innovative Intersection Safety Treatments. The summaries identify new technologies and techniques to improve intersection safety developed since NCHRP Report 500, Volumes 5 and 12, were published in 2003 and 2004, respectively. These treatments show promise for improving safety but comprehensive effectiveness evaluations are not yet available.

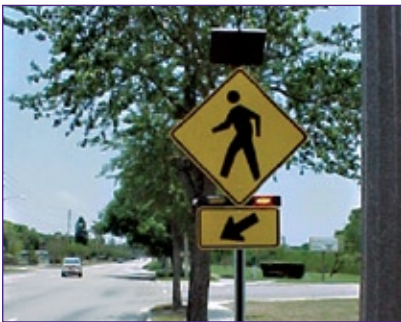
Figure 2: Activated, solar-powered, roadside RRFB at a mid-block crosswalk
