Steel Bridge Design Handbook

Design for Fatigue

Publication No. FHWA-IF-12-052 - Vol. 12

November 2012

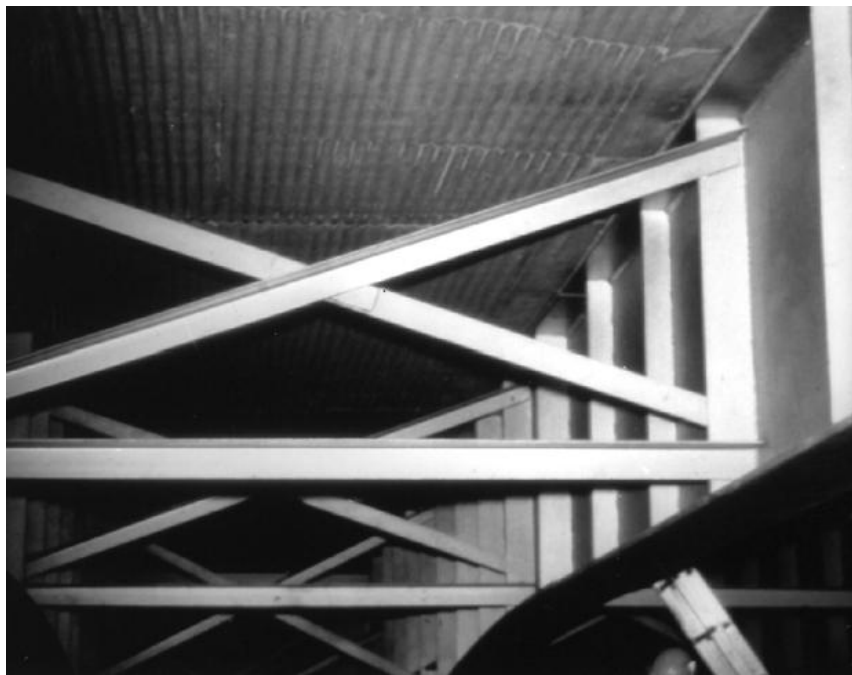
Various types of diaphragms are used, ranging from rolled sections to simple X-bracing made of angles. Figure 14 shows the underside of a multiple girder bridge that has an X-type cross-frame bracing system. In the web gap, cracking developed in the negative moment region (i.e., top flange in tension) of this continuous span structure. This cracking is illustrated in Figure 15, which is a view along the length of the bracing toward the girder and its transverse stiffener. The transverse stiffener to which the X-bracing is attached was not welded to the top (tension) flange for the reasons described earlier. This permitted out-of-plane displacement to occur in the web gap and, consequently, cracks formed along the web-to-flange fillet weld and at the top of the connection plate.

Figure 14 X-Bracing and Girders

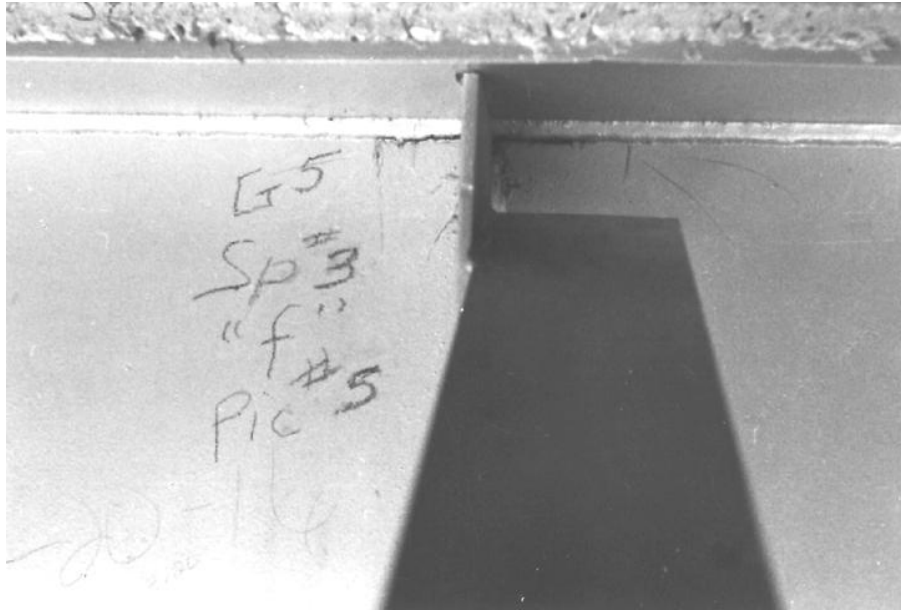
Figure 15 Fatigue Cracks in Web Gap of Diaphragm Connection Plate

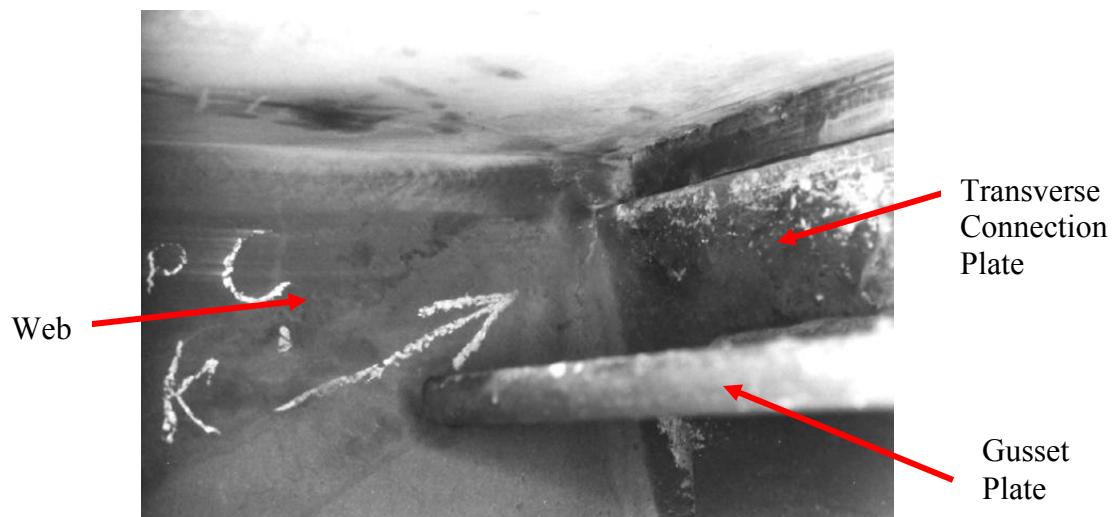
An example of this type of cracking is shown in Figure 17. The structure is an elevated, curved continuous span structure. Two curved steel box girders with internal diaphragms support the reinforced concrete deck. Fatigue cracking occurred in the top web gaps (negative moment region) near the piers and in the bottom web gaps (positive moment region) at the diaphragm locations. In both cases, the cracking was the result of out-of-plane movement in the web gap. This resulted from the box girder distortion and the resultant diaphragm forces.

Figure 17 Web Cracking at Box Girder Diaphragm Connection Plate

The cracking that occurred at the top web gap is shown in Figure 17. The photograph, which was taken inside the girder, shows the (sloping) girder web in the left-hand portion of the figure, a transverse connection plate welded at right angles to it, and a gusset plate (horizontal) that formed part of the lateral bracing used for shipping and construction. The gusset plate is about 80 mm below the top of the connection plate and there is a small gap between the top of the transverse connection plate and the underside of the girder flange. (The photograph shows that a loose plate has been placed in this gap above the connection plate. It was later fastened in place in order to prevent further movement of the girder web in this region.)
