Performance and Policy Related to Aluminum Culverts in Wisconsin

Simpson Gumpertz & Heger Inc.

WisDOT ID no. 0092-17-05

May 2019

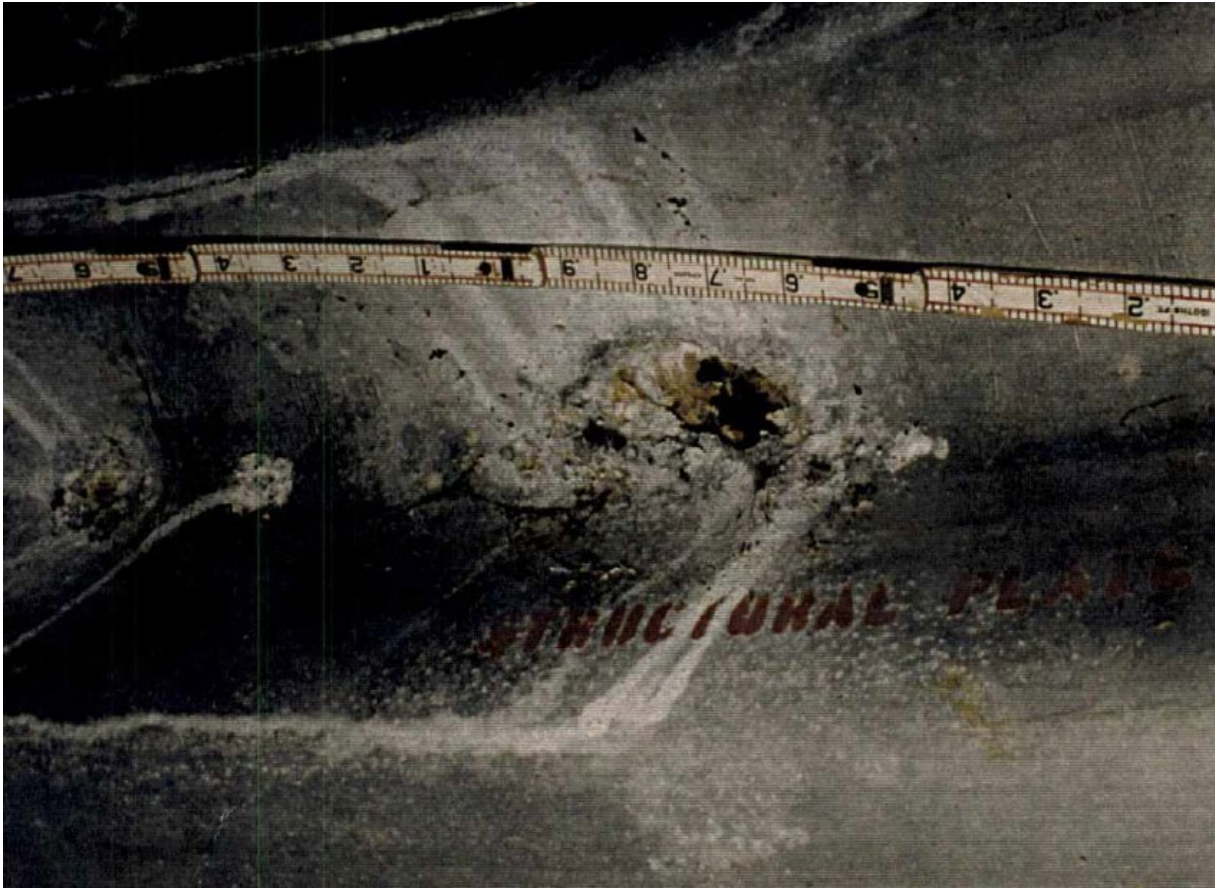
Figure 1 – Aluminum Structural Plate Culvert Installed in 1969 with 2 In. Perforation from Corrosion Observed in 1993 (Reproduced from [6])

Of ten aluminum drainage structures examined on State Highway 82 west of Mauston in southwestern Juneau County, nine were in an advanced state of deterioration at the crown, particularly near the center of the pavement. There were typically perforations with white precipitate found (Figure 1). These structures were covered with cracked flexible pavement and were at a range of soil cover depths. Based on the wide geographic distribution of aluminum culvert sites exhibiting corrosion, composition of soil was not considered to be strongly correlated to corrosion. Having the inverts of the structures below the flow lines of many pipes indicated that the corrosion was not related to chemistry of the water flowing through the pipes. Conclusions from review of the ten structures included that the corrosion was more severe on more heavily traveled and heavily salted roads and that the corrosion correlated well with extensive pavement cracking. Soil cover height and soil type did not correlate well with corrosion. The report noted that collapse of the top of a structure may be potentially more serious than collapse of the invert. Based on the findings, the report recommended that use of aluminum culverts be restricted on heavily salted roads unless the installation included protection for the outer surface of the structures from road salt.

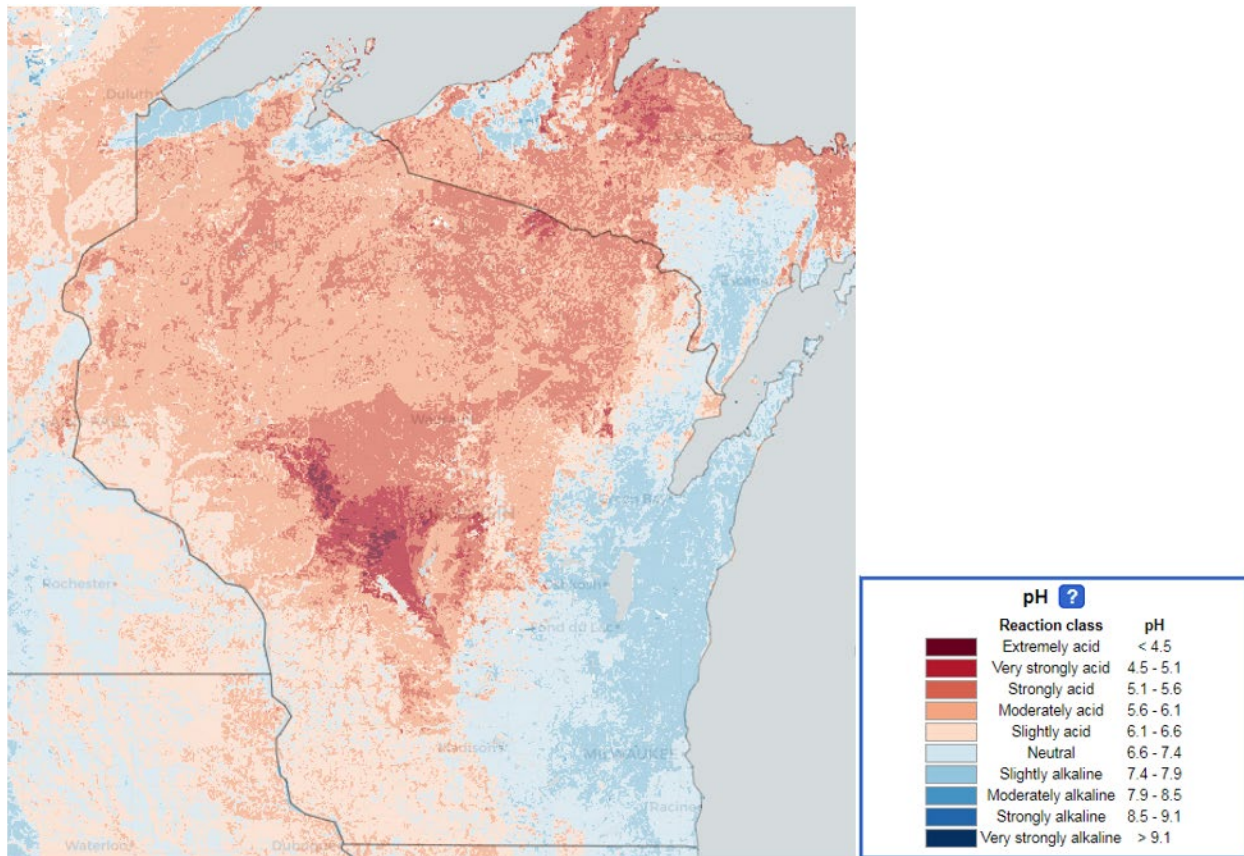
Figure 2 – Wisconsin Soil pH (Reproduced from [8])

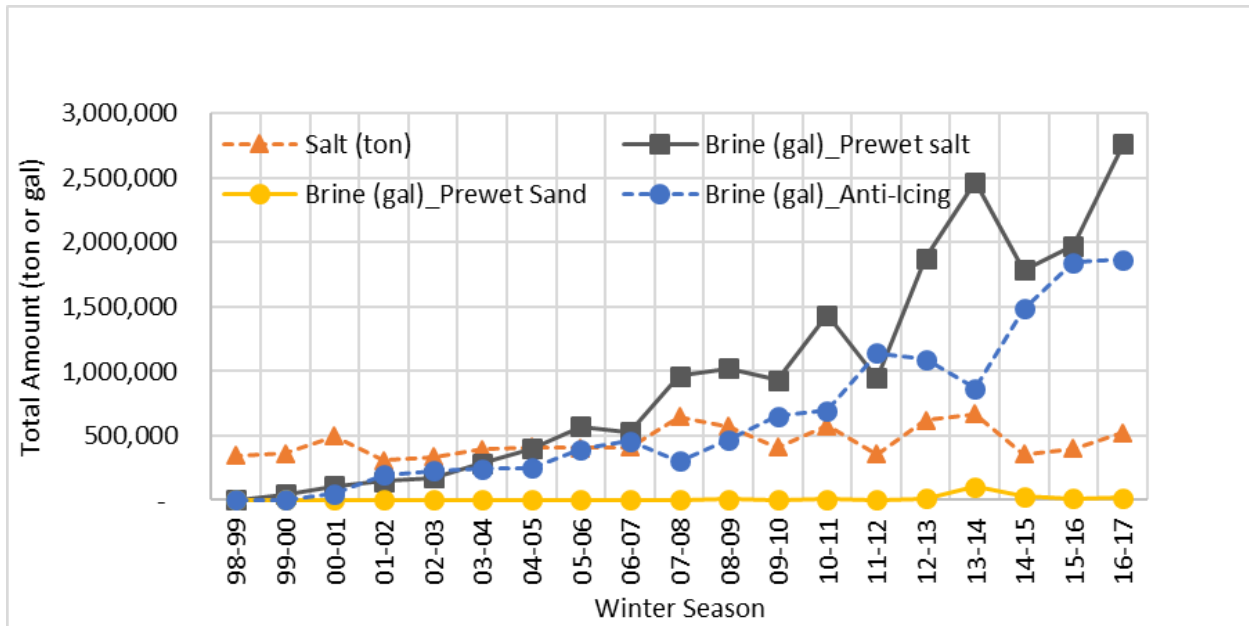
Per Figure 3, salt usage has remained steady over the last two decades and brine usage has increased by several (two to three) orders of magnitude. Liquid brine materials, including salt brine, CaCl_2 , Freeze Guard (MgCl_2), and Beet 55 beet juice, account for more than 98% of brine usage. Salt brine accounts for between 92% and 95% of usage depending on whether usage is for prewetting salt or sand or for anti-icing. Review of product information for Beet 55 and other potentially noncorrosive products identifies them as typically being used as additives to existing chloride-based deicers.

Figure 3 – Salt and Brine Application to Wisconsin Roadways (Reproduced from [9])

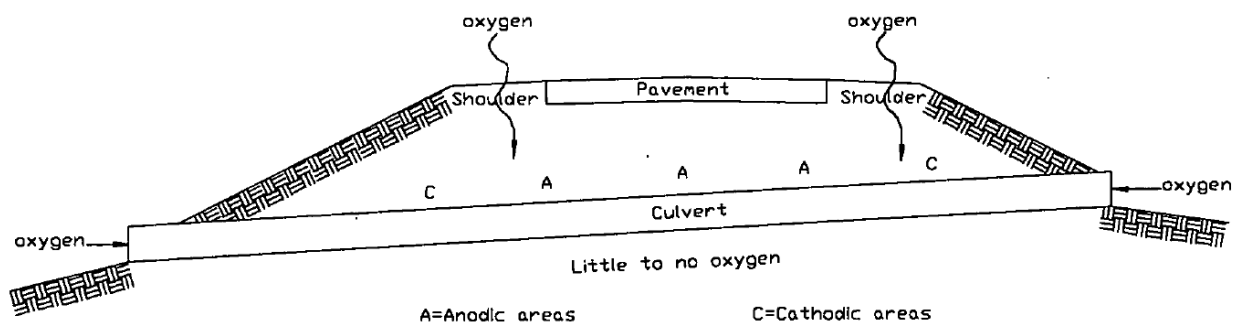
Gabriel [20] notes that oxygen-starved or -concentrated locations create sites along the culvert with different electrical potential. Areas with greater access to oxygen become cathodic, and the oxygen-starved areas become anodic. Pipes are usually placed on compacted or undisturbed soil at the bottom of a trench (the trench may be in native soil or previously formed embankment). Backfill materials are typically more permeable than surrounding soils, which provides a less resistive pathway to the top of the structure, making the surface more accessible to diffused oxygen. The portion of a culvert under pavement usually has less access to oxygen than other parts of the culvert, such as under unpaved shoulders. The electrolyte can be soil moisture or groundwater. The conductor can be the metal culvert. Corrosion would be accelerated where moist soil contains chloride ions. In this situation, the most aggressive corrosion will occur near the pavement edges, where there is a high gradient between soil-side oxygen concentrations coupled with likely increased chloride content from ingress through shoulders or adjacent embankment. This process is illustrated in Figure 4.

Figure 4 – Oxidation Corrosion Cells in a Buried Metallic Culvert (Reproduced from Figure 1 of [20])

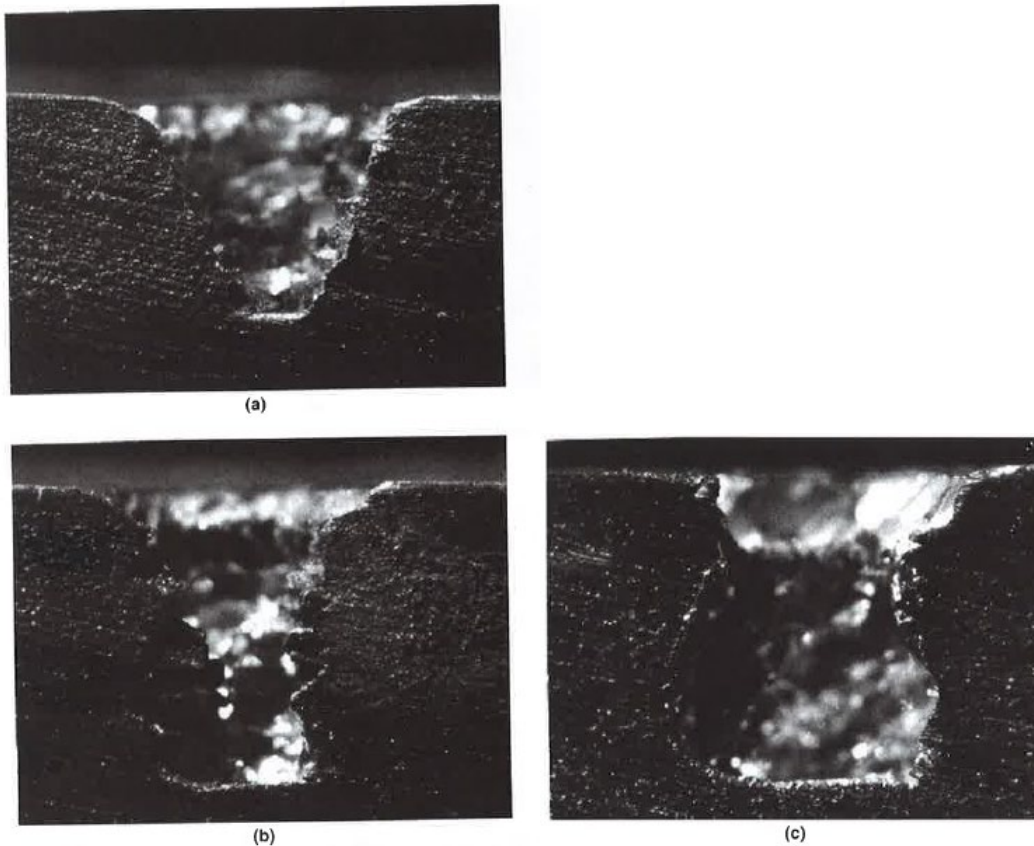
Figure 5 – Pit Growth in Pure Aluminum Subject to NaCl and NaNO₃ Solution and Constant Voltage Potential of 0.8 V from a Saturated Calomel Electrode after 2 Hrs, 4 Hrs, and 6 Hrs of Exposure (Reproduced from Figure 3.11 of [23])

Pit growth on pure aluminum in aqueous 0.1M NaCl + 0.3M NaNO₃ solution is shown in Figure 5. The ASM Handbook [18] notes that components of natural waters that increase likelihood of pitting in aluminum include copper ions, bicarbonate, chloride, sulfate, and oxygen.

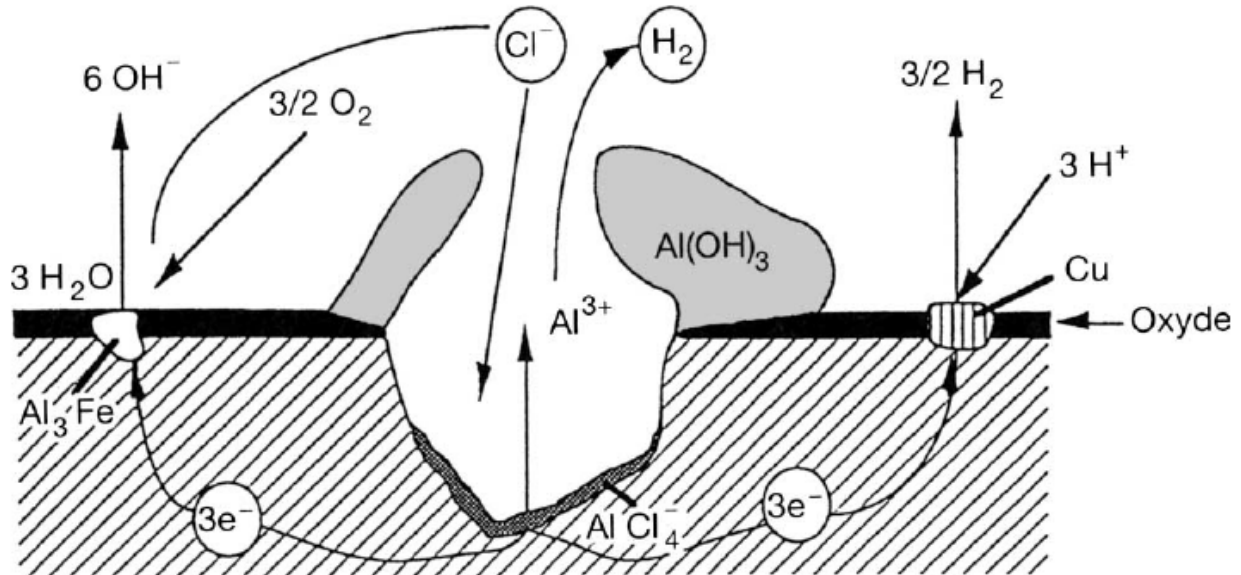
Figure 6 – Mechanism for Pitting Corrosion in Aluminum (Reproduced from Figure B.2.2 of [19])

The chemistry and mechanism for pitting corrosion of aluminum and its alloys are best displayed in Figure B.2.2. of Vargel [19], reproduced here as Figure 6. While the figure shows the mechanism with an alloy that includes copper and/or iron, copper and iron are not necessary for the reaction, though, if present, they would accelerate pit growth.

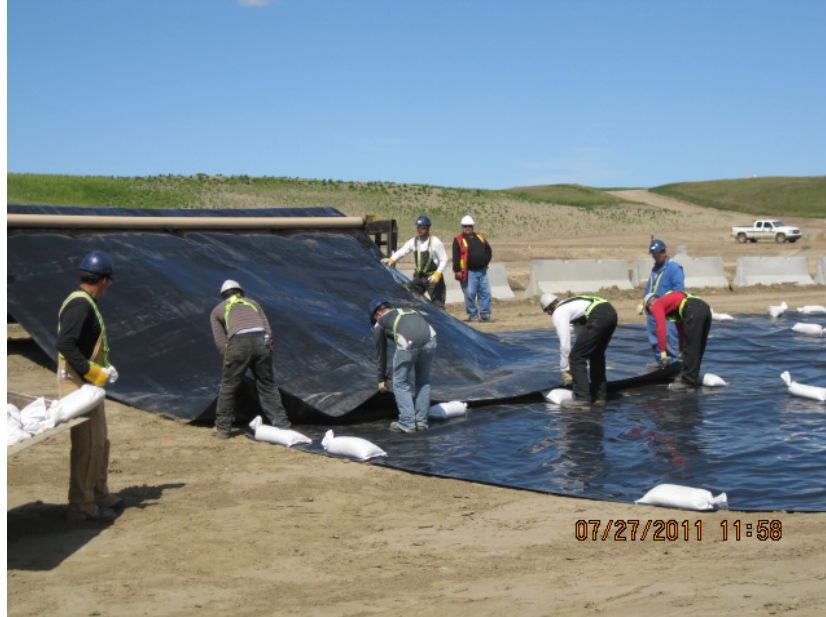
Sample membrane installation photos from a similar installation of a buried corrugated steel culvert are shown in Figure 8. Berg et al. [34] specified a similar approach to AASHTO for MSE walls in FHWA-sponsored research developed for FHWA training courses. Minimum tear

Figure 8 – Membrane Installation Adjacent To and Over Culvert (Courtesy of Big R Bridge)

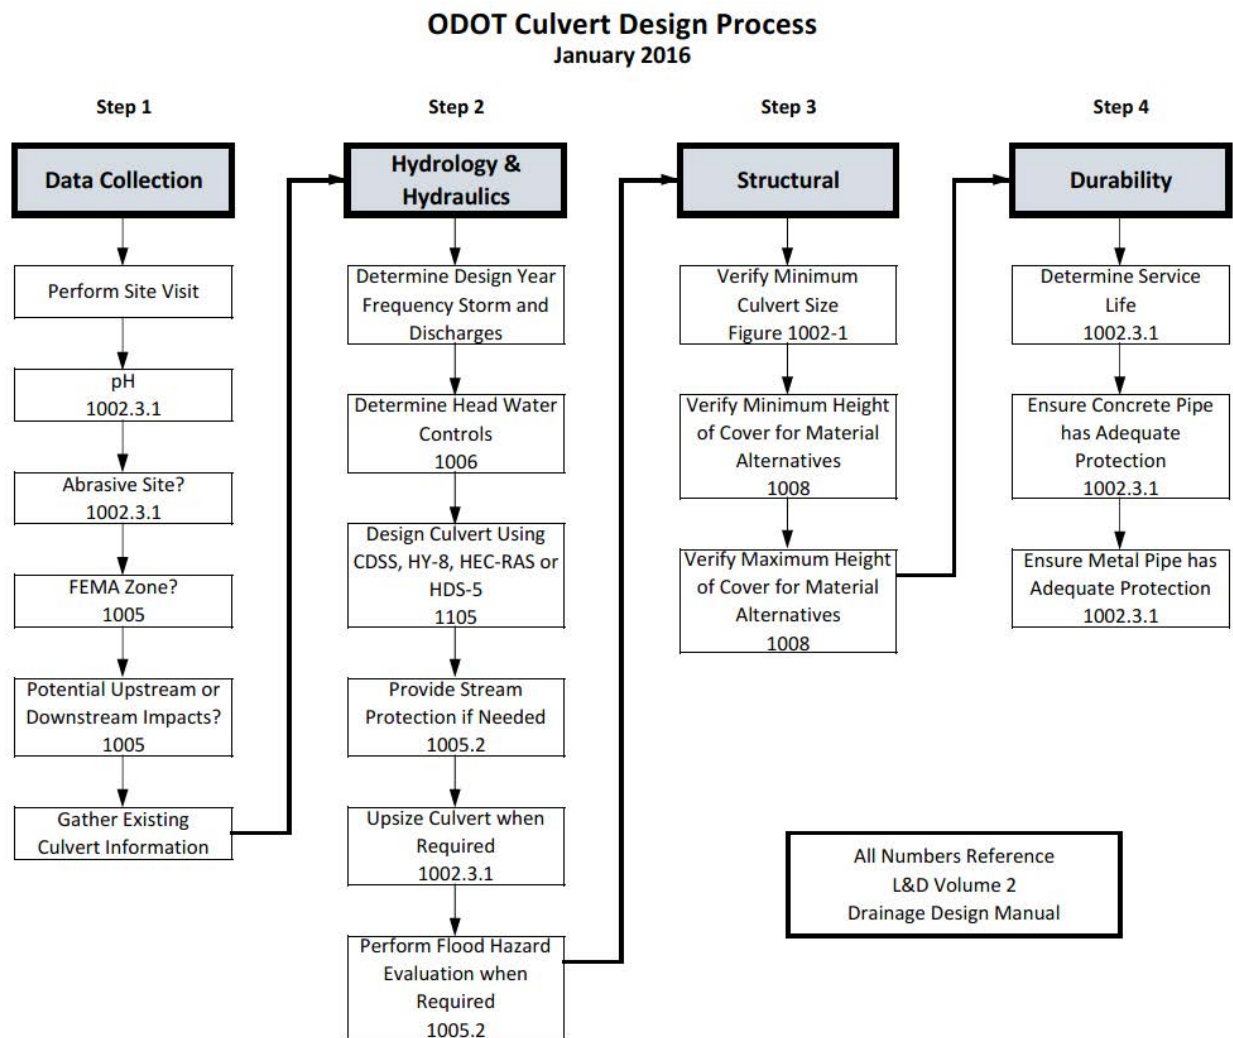
Figure 9 – Ohio DOT Culvert Design Process Flow Chart [51]

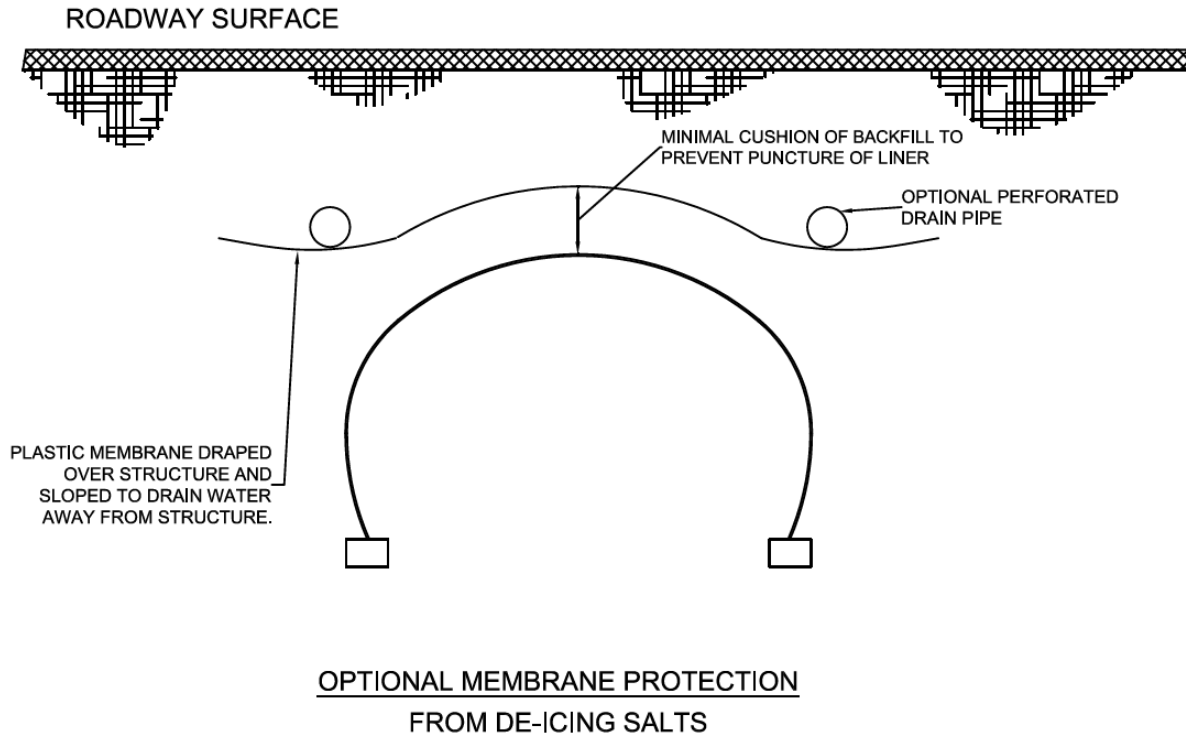
Figure 11 – Manufacturer Detail for Buried Metal Culvert Isolation Membrane to Protect Culvert from Infiltration of Deicing Salts (Reproduced from [56])

The Contech Corrugated Metal Pipe Design Guide [55] recommends aluminum alloy for use at sites where soil and water pH range from 5 to 9 and where the minimum resistivity is 500 Ω-cm. It includes abrasion limitations based on FHWA Abrasion Levels 1 to 4 with flow velocities based on a 2 yr storm event and provides minimum thickness requirements based on site abrasion level. The Contech Structural Plate Design Guide [56] recommends protection of buried metal culverts from deicing chemicals through either an asphalt coating on the exterior of the structure or a polymeric membrane embedded in the backfill; it notes impermeable clays as another option. Ref. [56] provides a detail (Figure 11) for installation of such a membrane. In tidal brackish and saltwater environments, the manufacturer [56] recommends backfilling with free-draining backfill material. It also identifies galvanized steel fasteners as compatible with aluminum culverts, while noting that ungalvanized “black” steel must be isolated from aluminum.

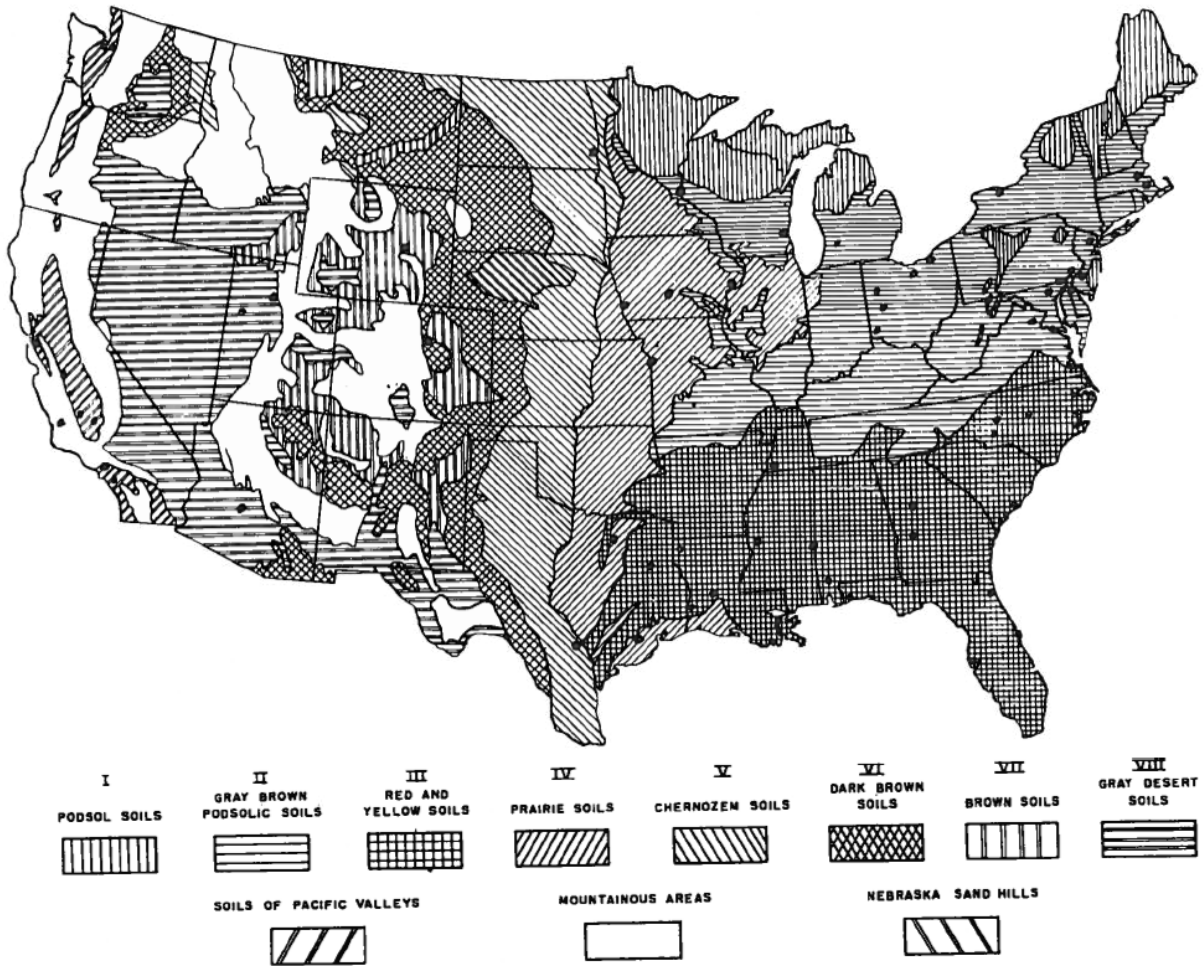
A major 1957 study by Romanoff [67] for the US National Bureau of Standards appears to be the seminal research on underground corrosion of buried metals and is referenced in a variety of other work. The study presents a map of eight major soil groupings in the U.S. (after Marbut, 1935), referred to as the "Great Soil Groups," and includes dots locating the buried metal corrosion test sites that were part of the study. The eight soil groupings are referenced in several other documents reviewed in the current work. Note that Wisconsin has two groups, Group I podsol soils to the north, and Group II gray-brown podsol soils to the south. These soil groups are also found in Ohio (only Group II), Maine, Michigan, Minnesota, and New York, which were the other states whose specifications were reviewed above. The map showing the major soil groupings of the US is reproduced here as Figure 12.

Figure 12 – Major Soil Groupings in the US (Reproduced from Figure 1 of [67] after Marbut)

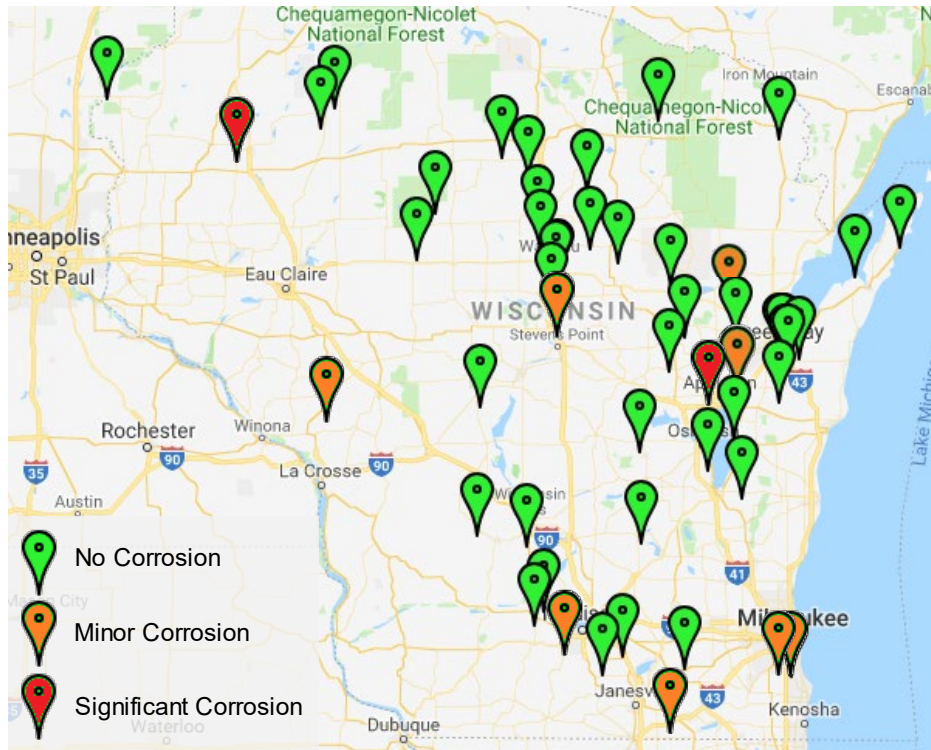
The geographic distribution of aluminum culverts in the HSIS database that are classified as having No Corrosion, Minor Corrosion, or Significant Corrosion as of their most recent inspection report is shown in Figure 13.

Figure 13 – Geographic Distribution of Aluminum Culverts in Wisconsin HSIS Database with Corrosion Level Based on Most Recent Inspection Report (Figure Generated from HSIS [70] July 2018 Output)

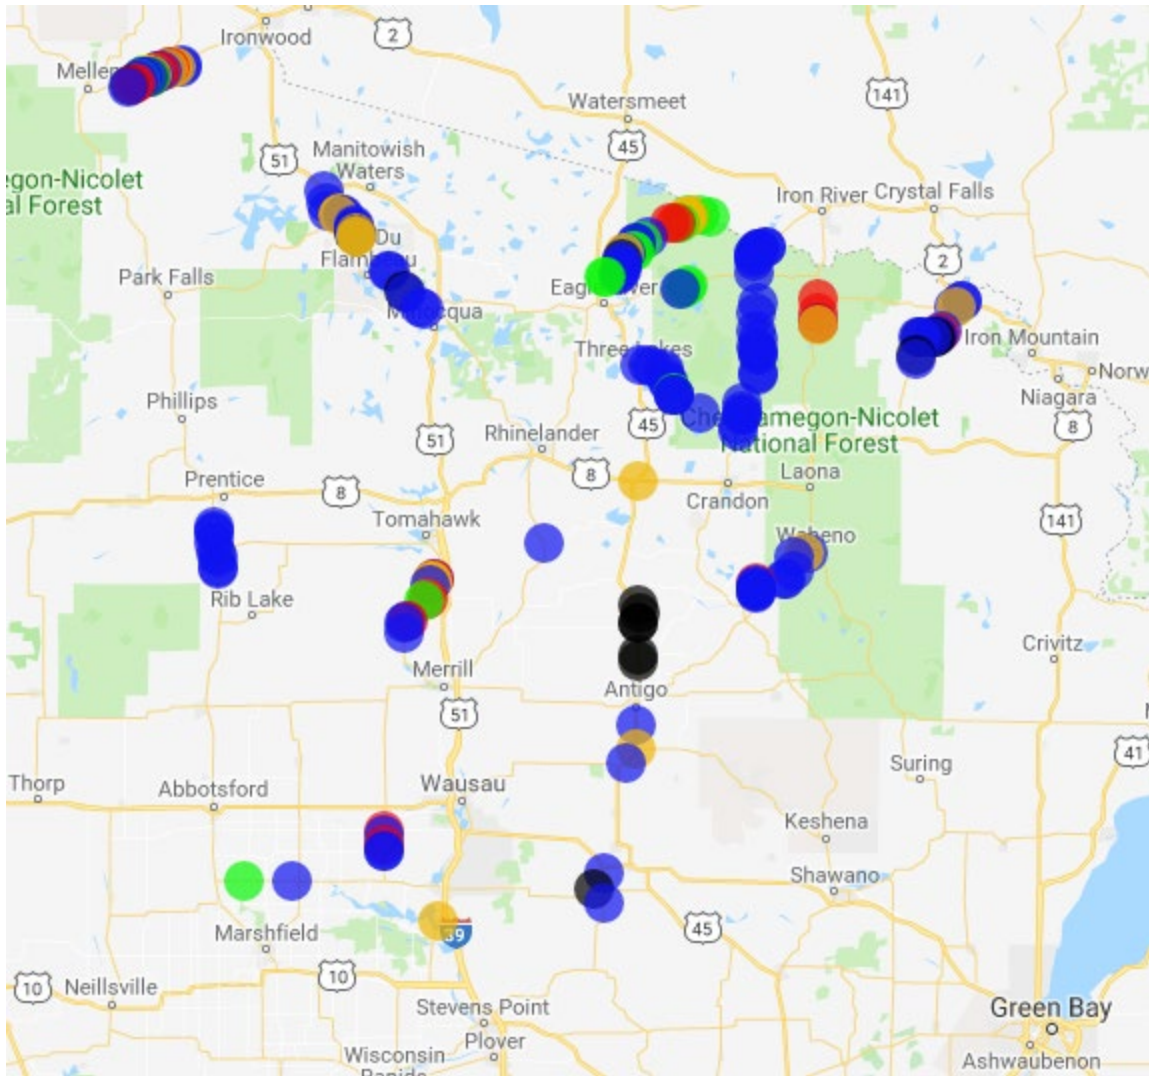
Figure 14 shows the geographic distribution of culverts in the North-Central District Inventory (NCI) spreadsheet. Culverts with Corrosion Condition States 1 to 4 are shown with green, blue, orange, and red circles, respectively. Unknown Corrosion Condition State culverts are shown with black circles. One additional culvert had a Corrosion Condition State of 1 but did not have latitude and longitude listed and is not plotted.

Figure 14 – North-Central District Aluminum Culvert Inspection Inventory with Corrosion Condition States 1 to 4 Shown as Green, Blue, Orange, and Red, Respectively (Culverts with No Rating are Black) [70, 73]

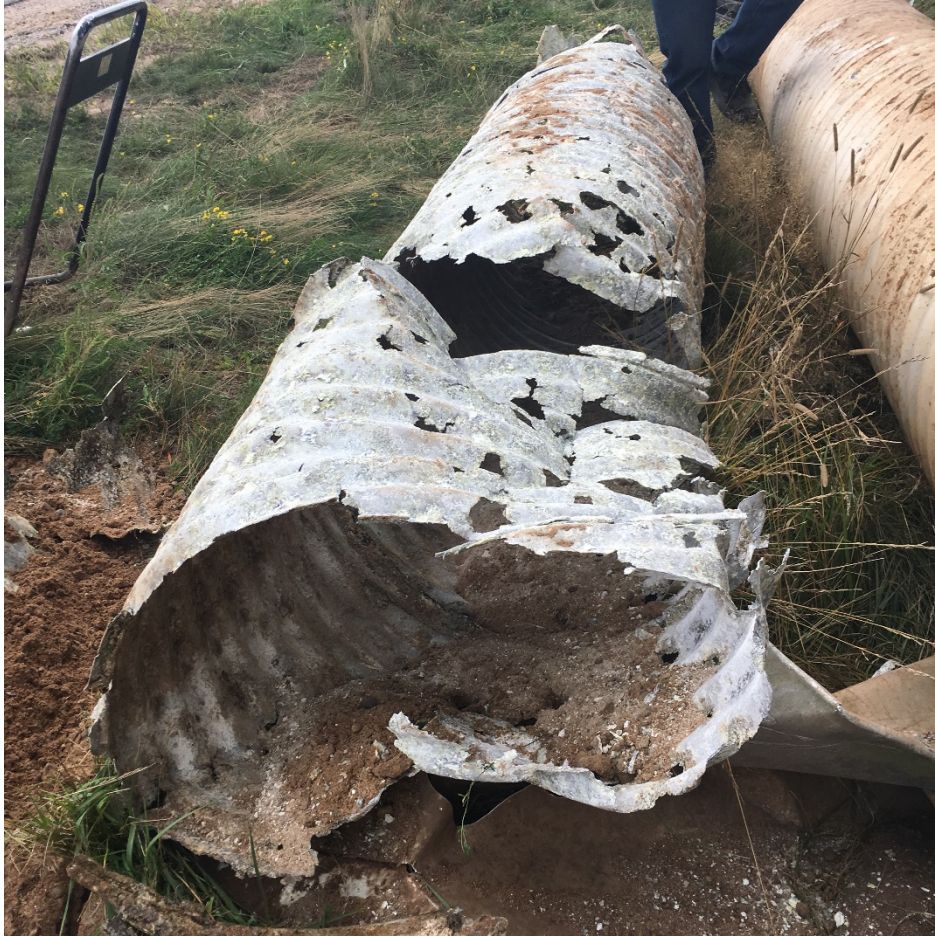
Figure 15 shows a photo of a severely corroded aluminum pipe after removal for replacement in north-central Wisconsin in August 2018, submitted by a North-Central District maintenance engineer. The pipe was located on State Highway 32 and shows characteristics of pitting corrosion and white precipitate consistent with the aluminum oxide corrosion products observed by Patenaude [7] and in our field investigation.

Figure 15 – Photo of Corroded Aluminum Pipe after Removal for Replacement in North-Central Wisconsin in August 2018 on State Highway 32 (Wisconsin DOT Photo)

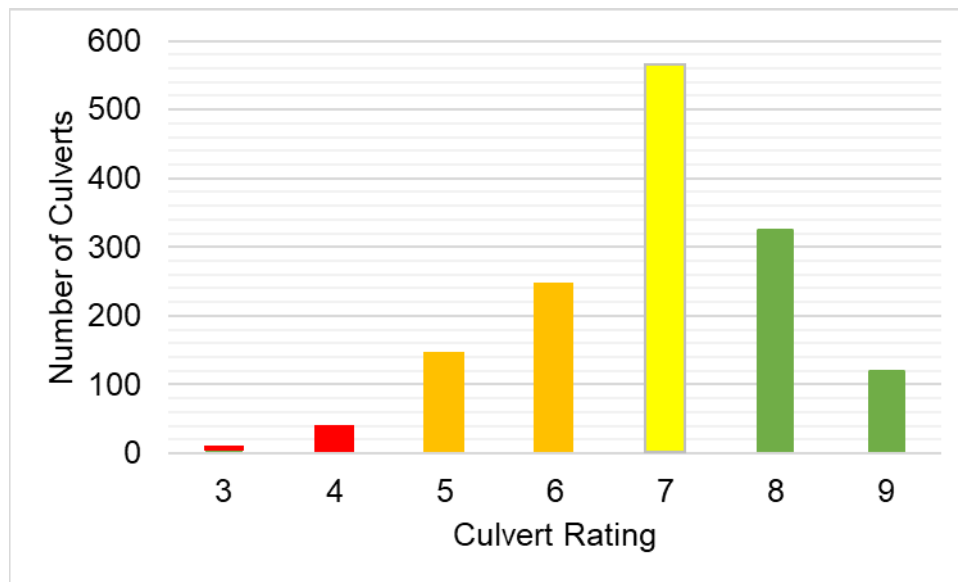
Culvert ratings for the 1,442 likely aluminum culverts ranged from 3 to 9, with an average culvert rating of 6.9 and median of 7. Note that culverts may receive a particular rating for a variety of factors including but not limited to corrosion, settlement, holes, wingwall or headwall deficiencies, scour, or erosion. Observations specifically related to metal culvert barrels that may result in a particular culvert rating are identified in Table 5. Note that it is impossible to know from the data whether individual culverts received their rating based on barrel distress or corrosion or on any of the other numerous factors identified above, as the database does not provide a direct indication of corrosion. The number of culverts versus culvert rating for the 1,442 likely aluminum culverts is plotted in Figure 16. An LTBP database-generated map with average rating by state is shown in Figure 17.

Figure 16 – Number of Likely Aluminum Culverts by Culvert Rating from LTBP Database

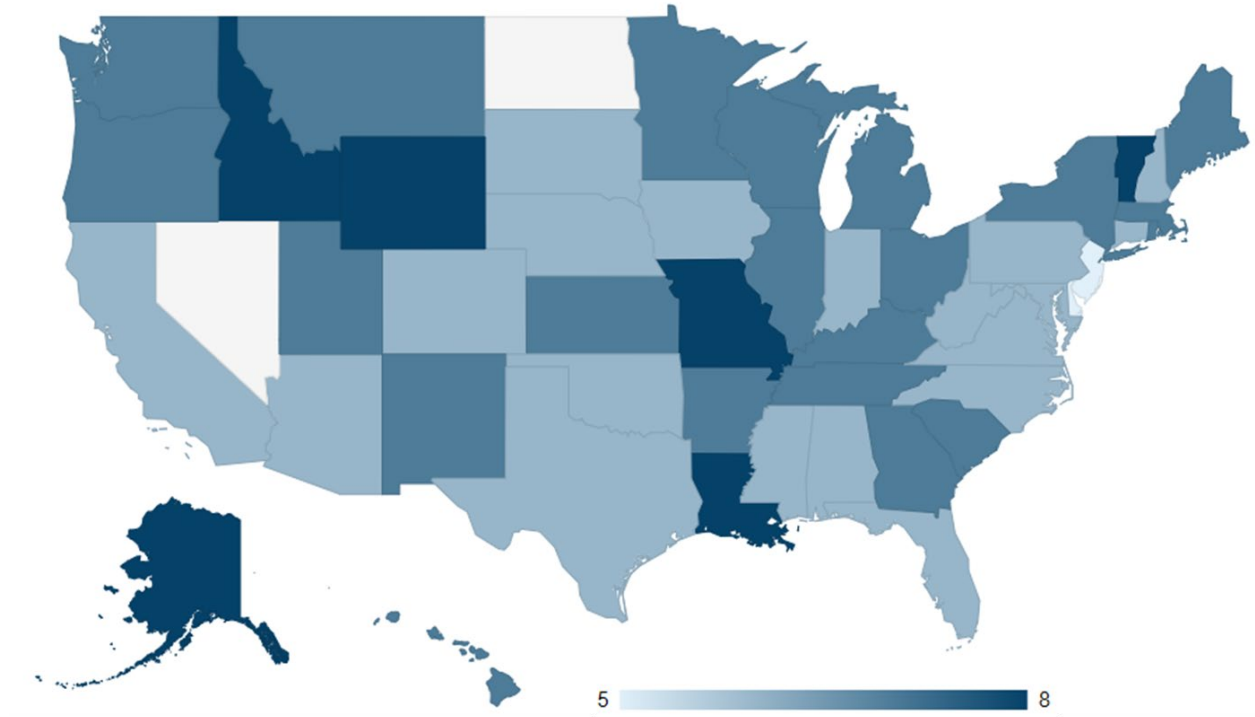
Figure 17 – FHWA LTBP Database Map [74] for Average Culvert Rating by State of Likely Aluminum Culverts (Darker Shading is More Favorable Rating)

Note that Washington State, which does not allow metal culverts in the state DOT right of way, does have likely aluminum culverts in its inventory. The LTBP data includes information from several sources, including other custodians, such as counties and local agencies, with structures not in the state DOT right of way. It is also possible the aluminum culverts were installed through a special provision, or prior to the DOT prohibition of metal culverts if they were allowed at some prior time.

- **Geographic Distribution (Figures 17 and 18 above and C.20 and C.21 in Appendix C):** The geographic distribution of likely aluminum culverts with Low, Medium, Good, and High Culvert Ratings appears to be random, with no particular geographic region appearing to have a higher likelihood of culvert distress.

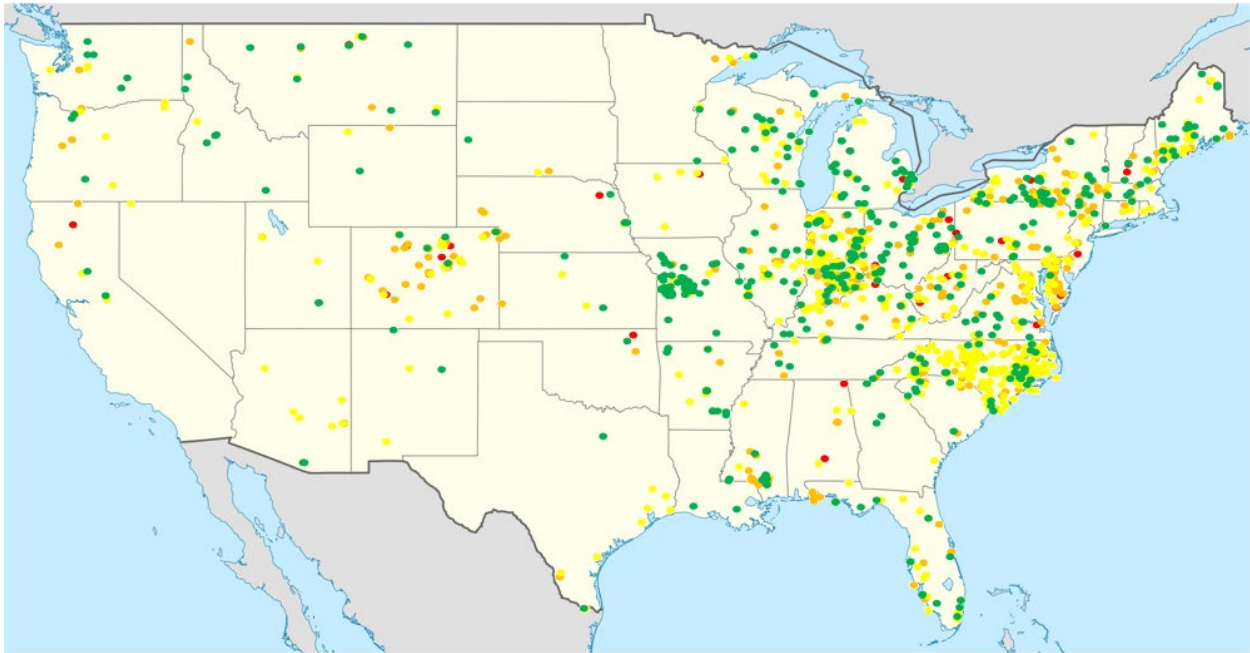
The geographic distribution of likely aluminum culverts in the LTBP database with culvert ratings classified as Low (red), Medium (orange), Good (yellow), and High (green) superimposed based on their latitude and longitude on an equirectangular map of the US is shown in Figure 18.

Figure 18 – Geographic Distribution of Likely Aluminum Culverts in LTBP Database with Low, Medium, Good, and High Culvert Condition Ratings (Culvert Locations Superimposed on Equirectangular Map from [75])

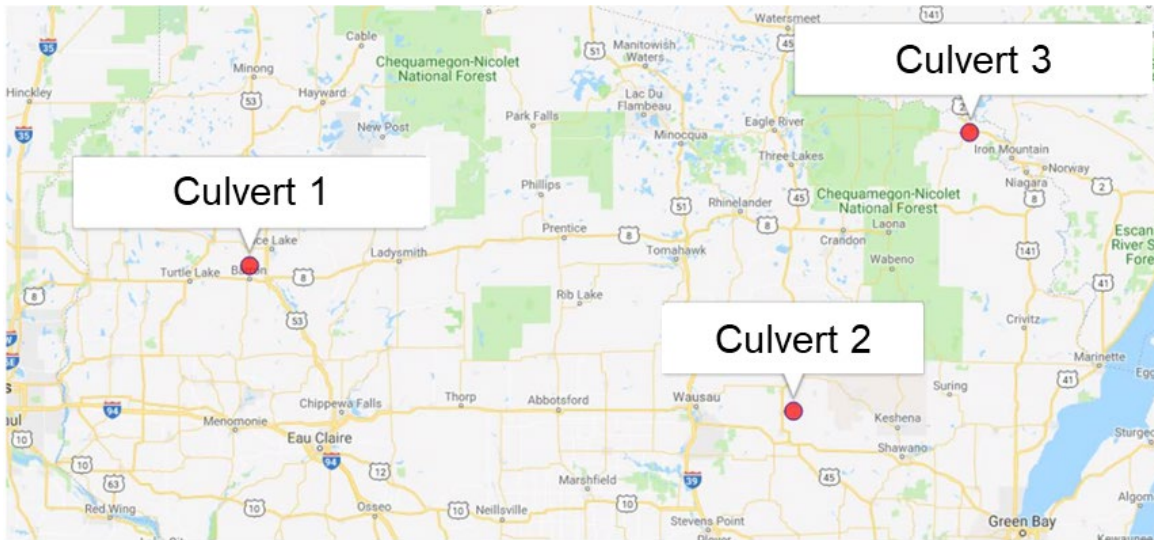
The three structures are shown on a map in Figure 19, and information from above is summarized in Table 6. Inspection results are discussed in the following sections, and detailed inspection results and photographs are provided in Appendix D. Results from laboratory testing of soil and water samples collected during inspection are included in Appendix E.

Figure 19 – Geographic Distribution of Three Culverts Selected for Field Inspection [73]

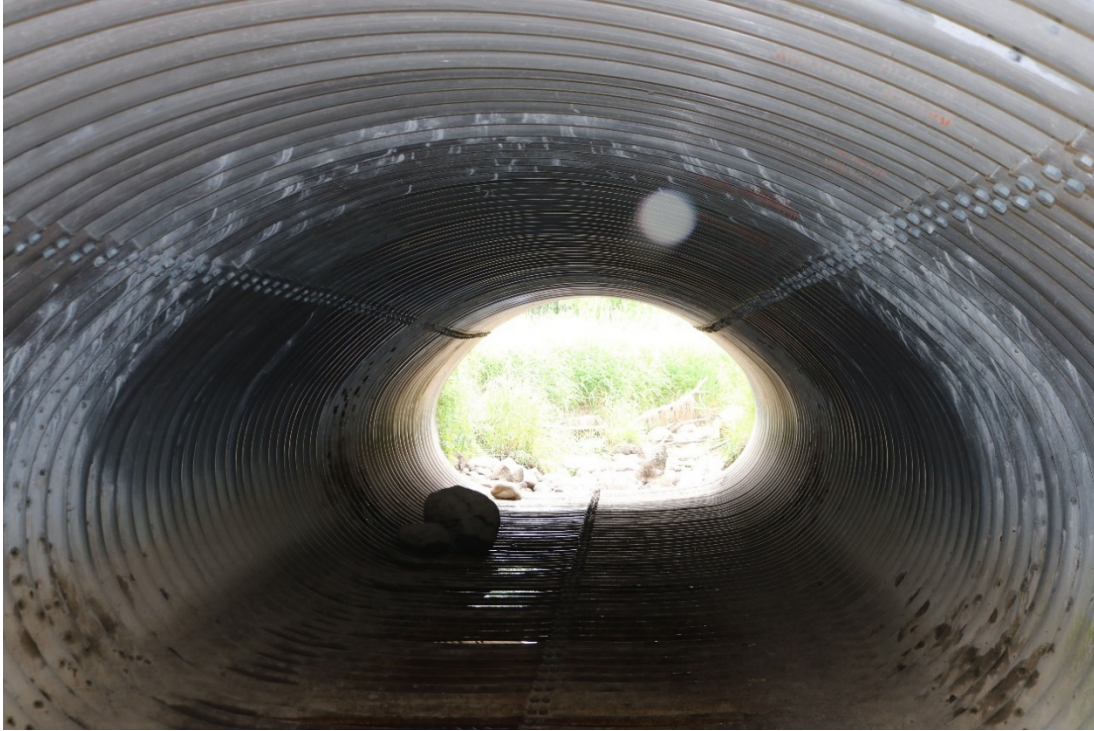
Figure 20 – Pitting Corrosion with White Staining below West Roadway Shoulder in Culvert 1; Similar Area Exists at Far Shoulder in Photo

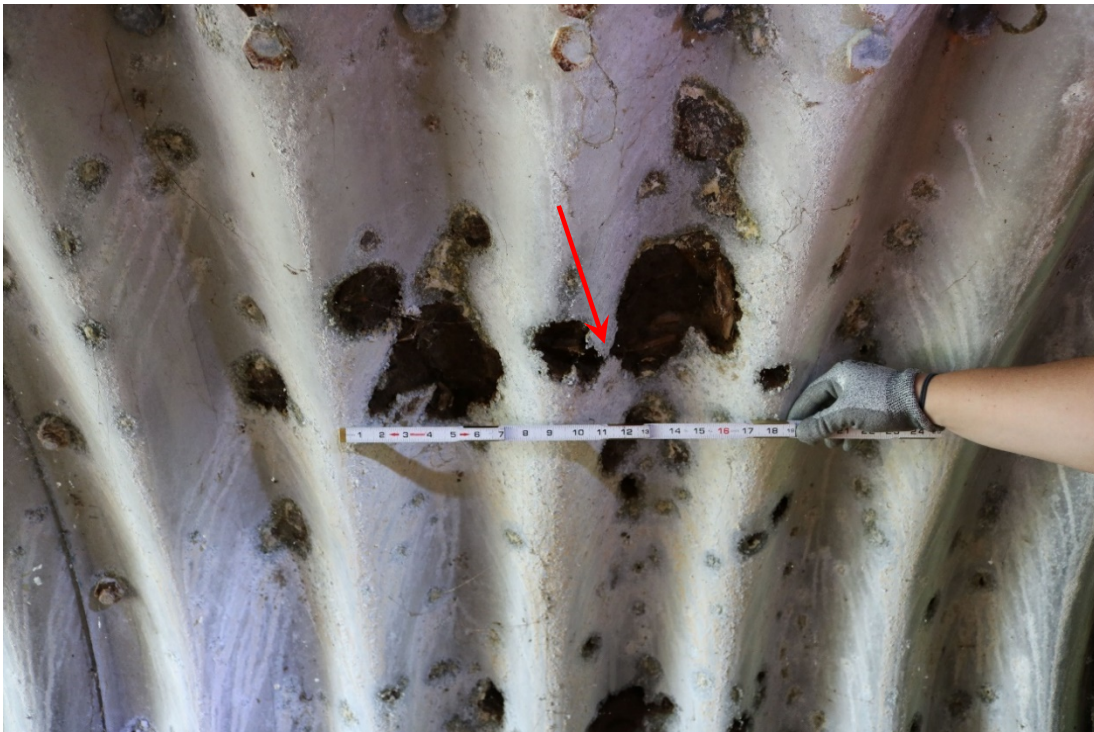
Figure 21 – Coalesced Through-Wall Pitting Corrosion below Roadway Shoulders at Springline of Culvert 1 (East Shoulder Shown); Red Arrow Indicates Location where Small Sample of Corrosion Products and Corroded Aluminum Was Removed for Laboratory Examination (see Section 5.4)

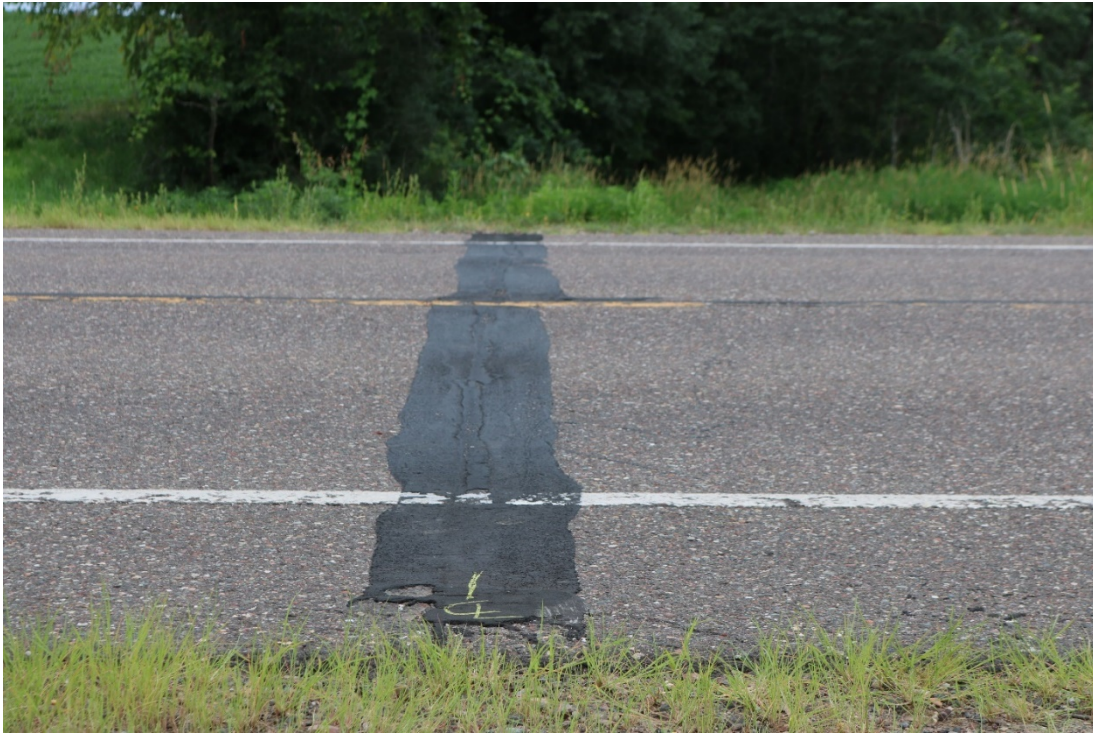
Figure 22 – Pavement Condition with Sealed Cross Crack Directly above Culvert 1, with Additional, Smaller Cracks Nearby

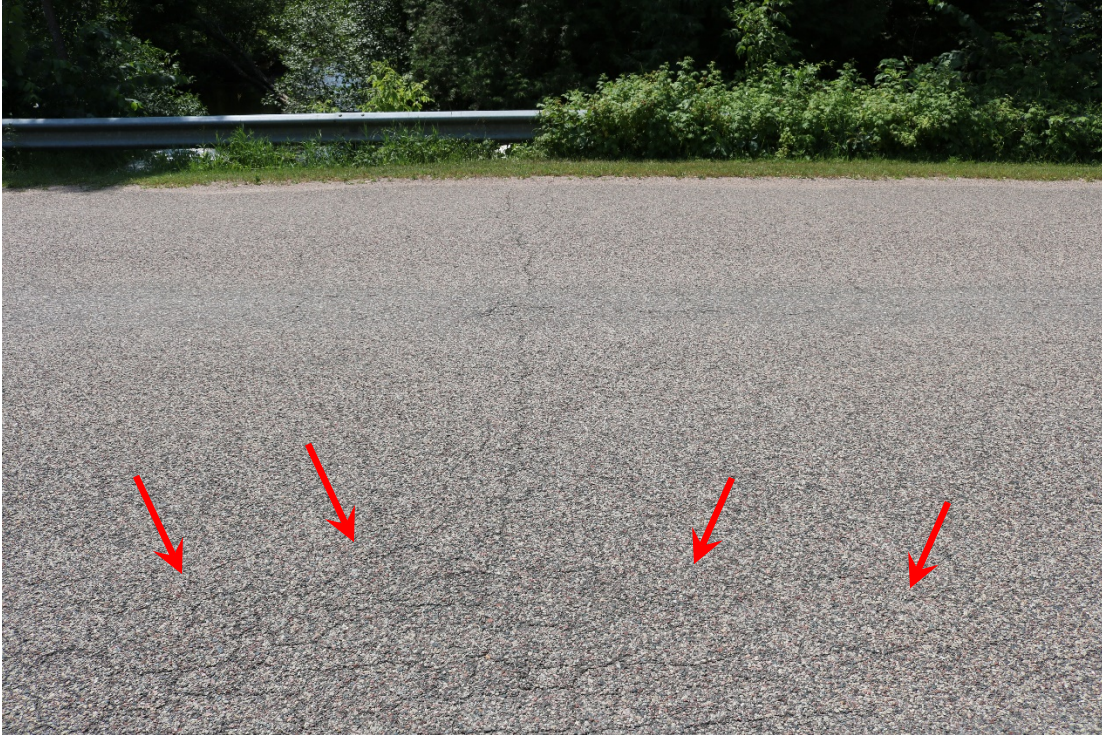
Culvert 2 is a three-barrel culvert of similar corrugated aluminum structural plate pipe arch construction to Culvert 1. Culvert 2 is below a local road and carries a river branch that had active flow through each of the three barrels at the time of inspection. We measured the fill depth above the culvert to range from 0.75 to 1.5 ft including slight roadway crown and variation in fill depth over the width of the road. The pavement above had narrow, unsealed cross cracks and slight rutting of the wheel paths with map cracking in the wheel paths (Figure 23). The pavement cracking directly above the culvert was less severe than the more prominent map-type cracking and deeper rutting observed on the roadway about 100 ft away from the culvert.

Figure 23 – Pavement Cracks above Culvert 2 Including Pavement Transverse Crack above Culvert Barrel (Center of Photo) and Map Cracking in a Wheel Path (Red Arrows at Lower Portion of Photo)

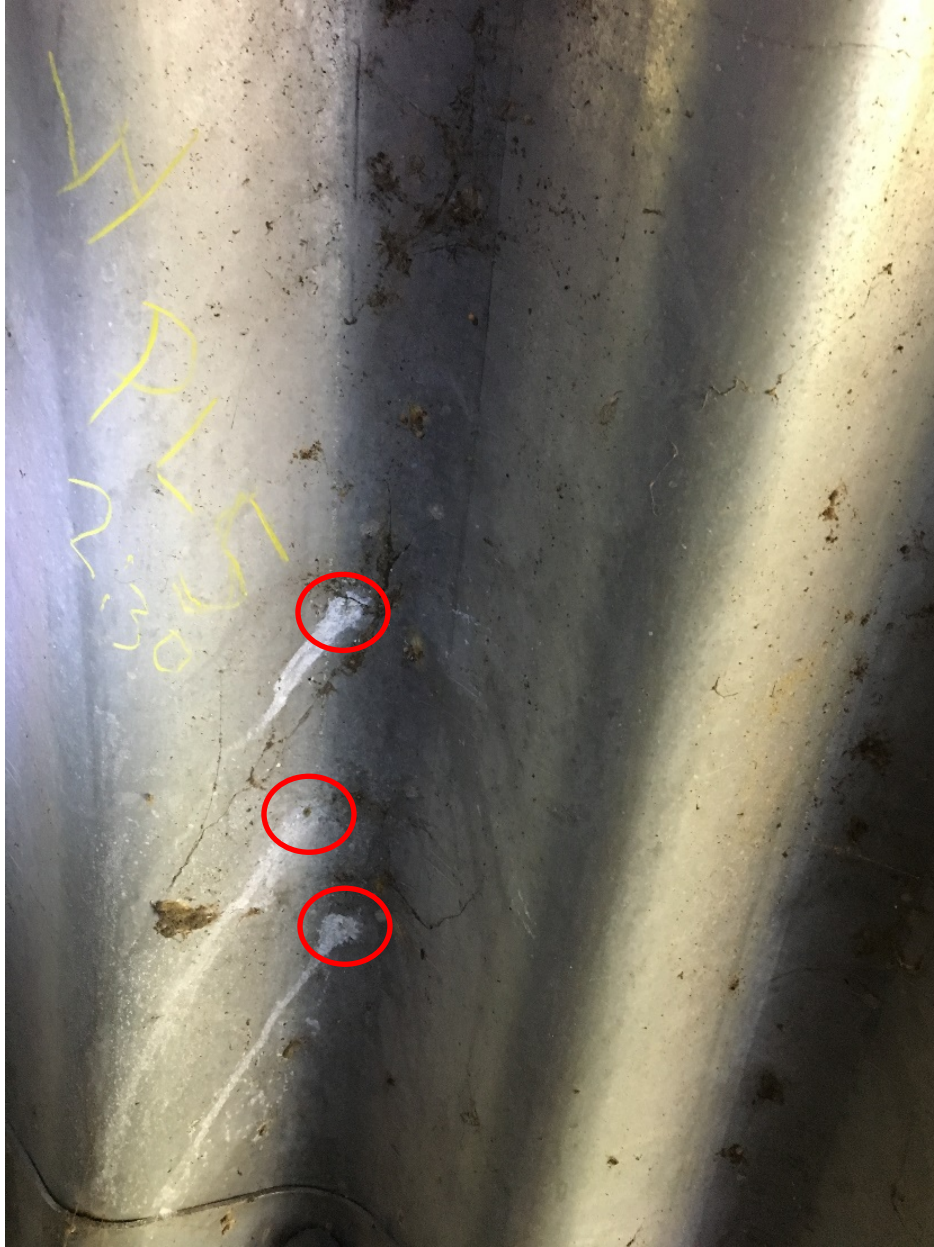
Inside the culvert barrels, we observed quarter-sized white corrosion stains on the east and west barrels below the approximate centerline of the roadway, with about an 8 in. distance between the quarter-sized stains (Figure 24). The corrosion staining was in the upper portions of the culvert, between the 10:00 and 2:30 clock positions. There was no evidence of corrosion staining below the springlines.

Figure 24 – White Corrosion Staining Emanating from Approximately Quarter-Sized Areas of Likely Pitting Corrosion (Red Circles) Near Mid-Length of West Barrel at 2:30 Clock Position (Looking Downstream)
