Performance and Policy Related to Aluminum Culverts in Wisconsin

Simpson Gumpertz & Heger Inc.

WisDOT ID no. 0092-17-05

May 2019

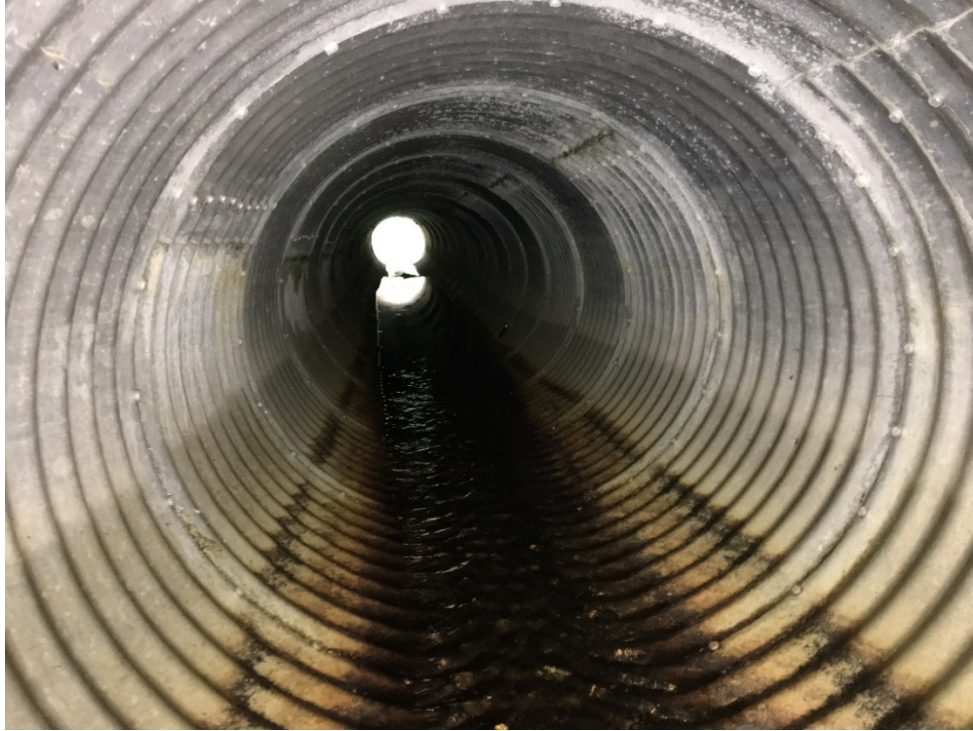
Culvert 3 was a single-barrel 36 in. diameter riveted corrugated aluminum pipe that appeared to have extensions at the upstream and downstream ends, likely from road widening. The culvert had active flow at the time of our inspection. The main portion of the barrel had riveted circumferential seams at 24 in. on center, with one longitudinal seam in each 24 in. long ring (Figure 25). The galvanized steel end structures, upstream and downstream of the aluminum barrel extensions, were corroded through without any remaining material below the flowline (5:00 to 7:00 position across invert). A 20 ft length of the culvert below the center of the roadway had heavy white corrosion staining widespread over the inside surface at the upper portion of the circumference that appeared to be emanating from the seams (Figures 26 and 27). The seams alternated for each 24 in. long culvert section, present at either at the 10:30 or 1:00 clock positions. No white corrosion staining was visible in the lower flow area of the culvert.

Figure 25 – Typical View Inside Culvert 3 with Riveted Circumferential Seams at 24 In. On Center and One Longitudinal Seam per 24 In. Long Ring; Note White Staining Emanating from Seams

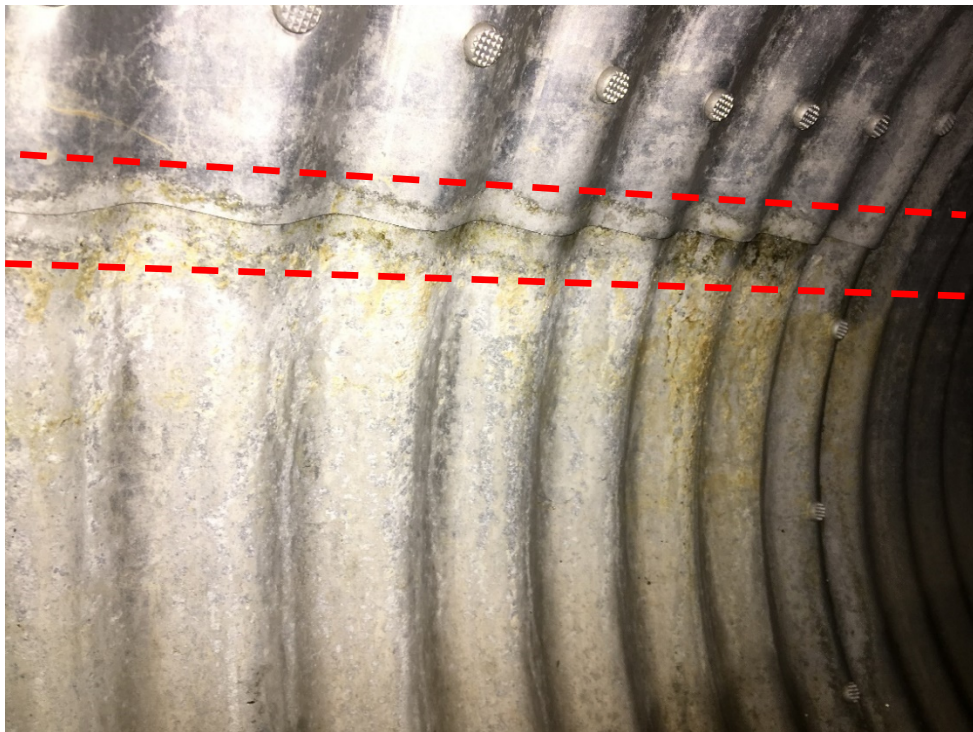
Figure 26 – Heavy White Corrosion Staining below Longitudinal Seam (between Dashed Red Lines) where Upper Section Nests Inside Lower Section at the 10:30 Clock Position near Center of Roadway

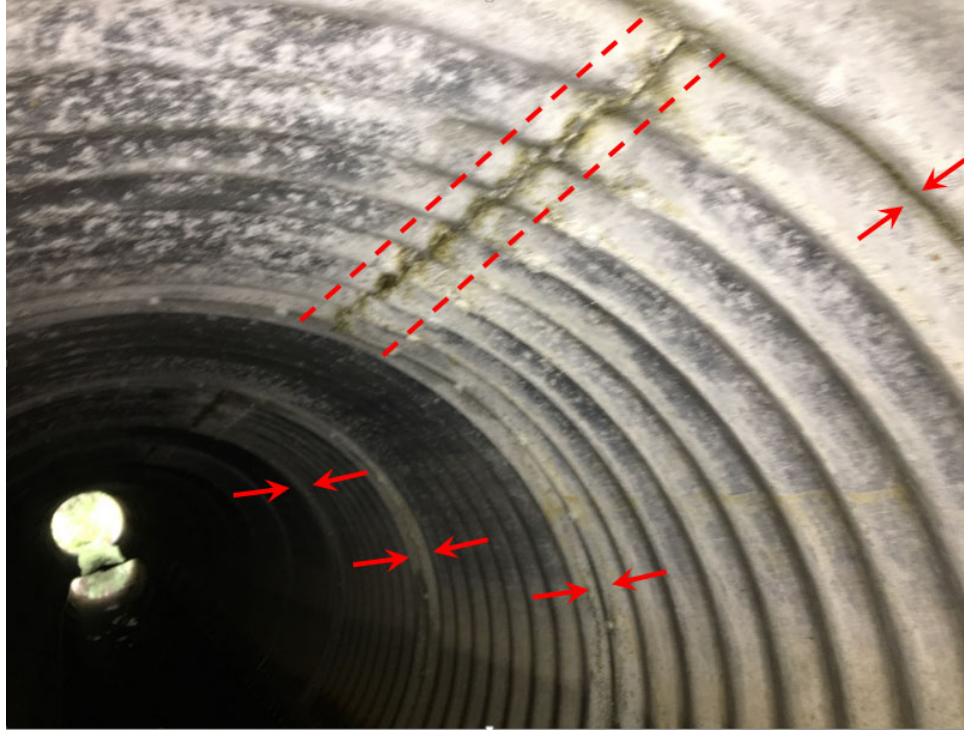
Figure 27 – Heavy White Corrosion Staining Emanating from Longitudinal Seam (between Dashed Red Lines) and at Circumferential Seams (between Pairs of Red Arrows) Further Into Photo; Photo Location Is Below Roadway Travel Lane

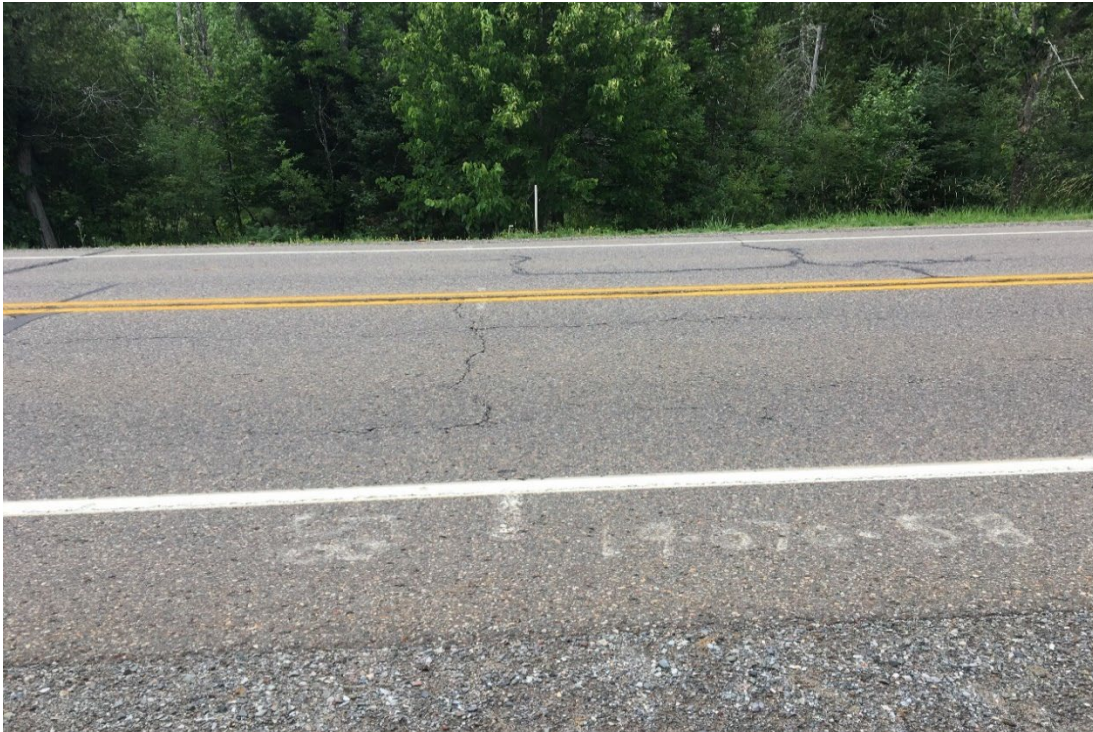
Figure 28 – Pavement Condition over Culvert 3 Showing Unsealed Cracks Across and Along Roadway

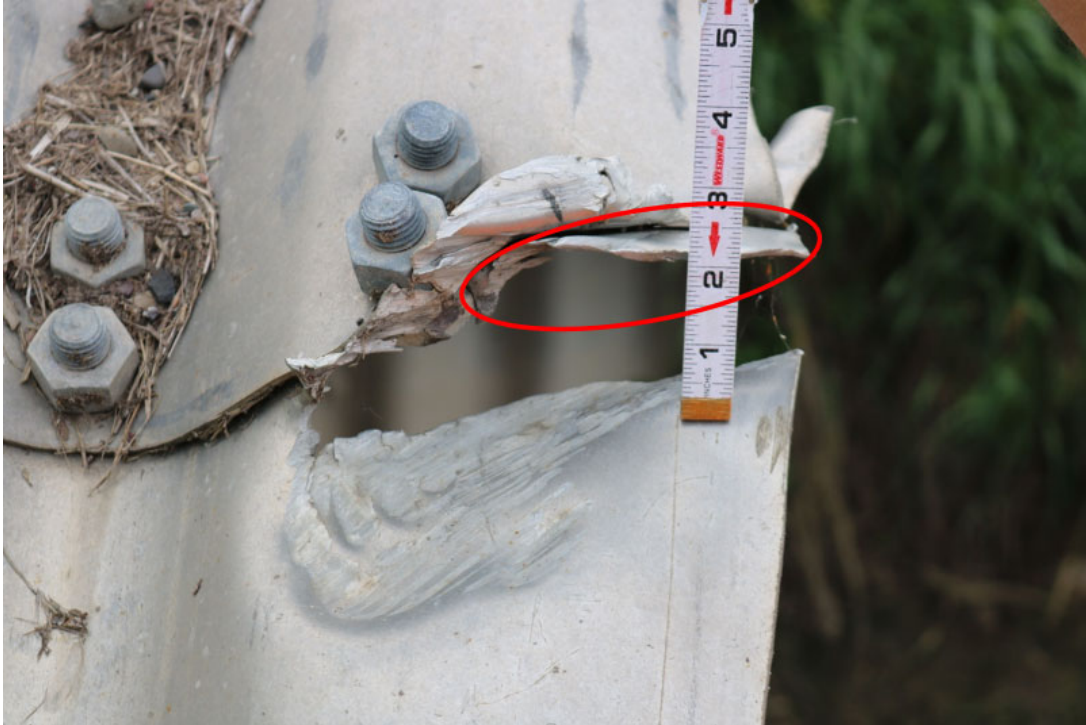
We removed two small samples from previously damaged areas of Culvert 1. One sample was from the downstream end of the culvert, where the top of the culvert was exposed and not in contact with soil and had been previously damaged by impact from some sharp object, potentially a mower blade (Figure 29). The second sample was taken from the edge of the through-wall corrosion at the location indicated by the red arrow in Figure 21 and included white corrosion products and a small fragment of corroded aluminum.

Figure 29 – Previously Damaged Location from which Small Sample of Uncorroded Aluminum Was Removed from Culvert 1 for Laboratory Examination (Red Oval)

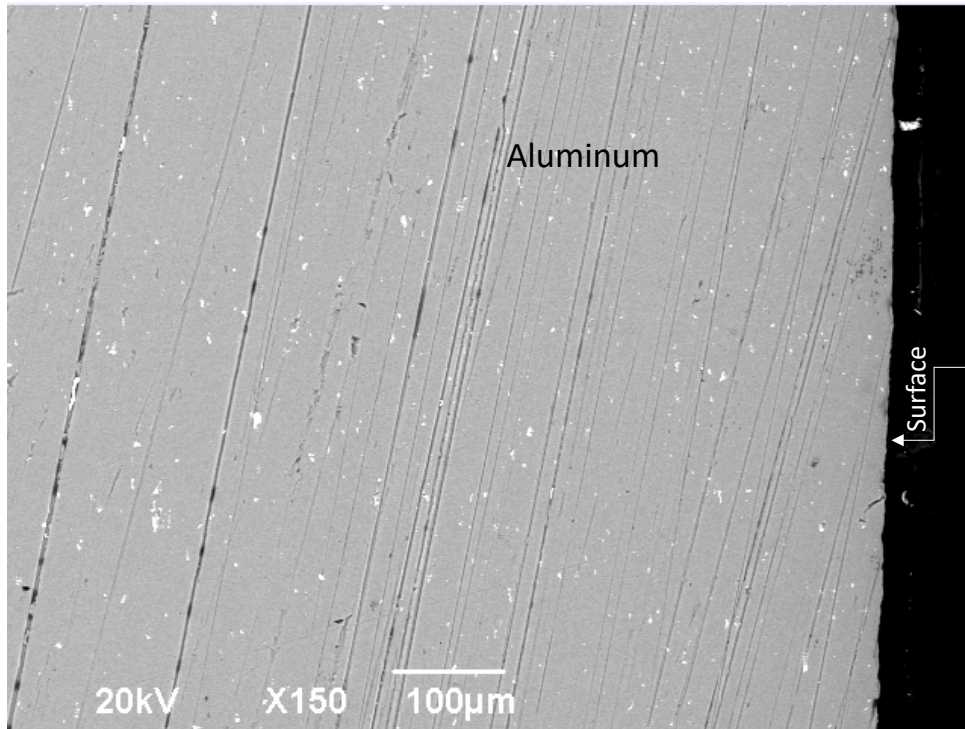
EDS analysis on the corroded aluminum and its corrosion products revealed a relatively high level of chloride, indicating exposure of aluminum to a corrosive medium in the areas from where the corroded samples were taken. EDS analysis showed 12.75% silicon (likely from comingling of corrosion products and backfill in the sample, taken from the edge of the corroded area at a through-hole), 0.22% copper, 0.15% manganese, 1.24% magnesium, 1.6% sodium, 1.4% chlorine, 0.42% sulfur, and the balance consisting primarily of aluminum. The measured sodium content in this sample is as high as chlorine, suggesting presence or accumulation of sodium chloride salt in these areas.

Figure 30 – Scanning Electron Microscope View of Uncorroded Aluminum Sample from Culvert 1 Showing No Visible Evidence of Corrosion or Cladding

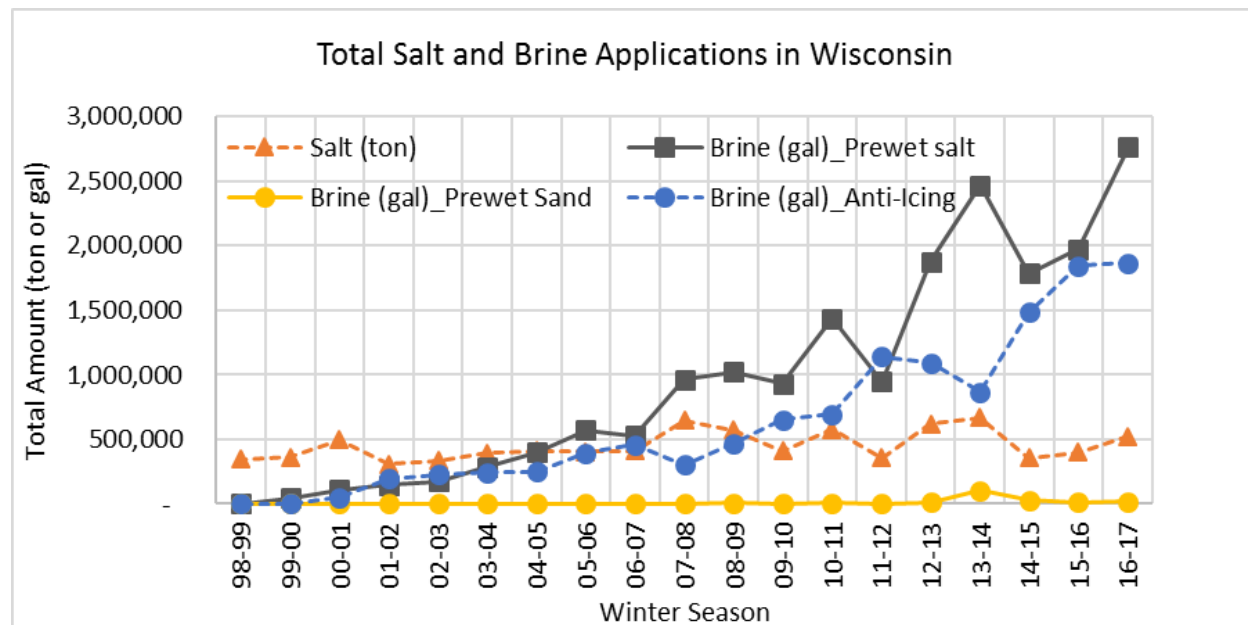
- Per the plot below, while salt usage has remained steady over the last two decades, brine usage has increased by several (two to three) orders of magnitude. Of the liquid brine materials used, salt brine, CaCl_2 , Freeze Guard (MgCl_2), and Beet 55 beet juice account for more than 98% of brine usage, and salt brine alone accounts for between 92% and 95% of usage, depending on whether usage is for prewetting salt or sand, or for anti-icing.

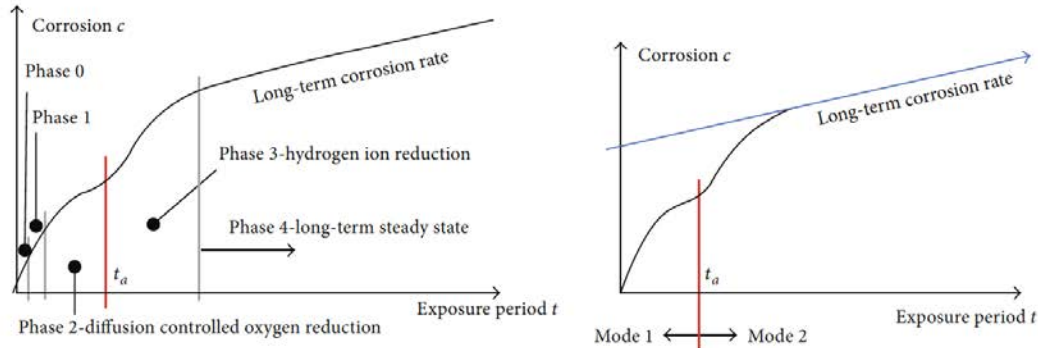
- Other metals such as low carbon steels, weathering steels, and cast iron tend to exhibit a bimodal corrosion behavior, which has a relatively high rate of early corrosion that eventually slows. The bimodal model has a scientific basis and recognizes that the mechanics of corrosion can change as corrosion progresses.
- Figure 1 from the paper, reproduced here, identifies four phases for the bimodal model, with the model resulting in a relatively constant long-term corrosion rate.

FIGURE 1: Schematic bimodal model for long-term corrosion loss and pit depth in marine environments showing brief descriptions for each of the phases involved and the linear idealization for long-term corrosion. The change from mode 1 with predominantly oxidic corrosion conditions to mode 2 with predominantly anoxic conditions occurs at t_a .

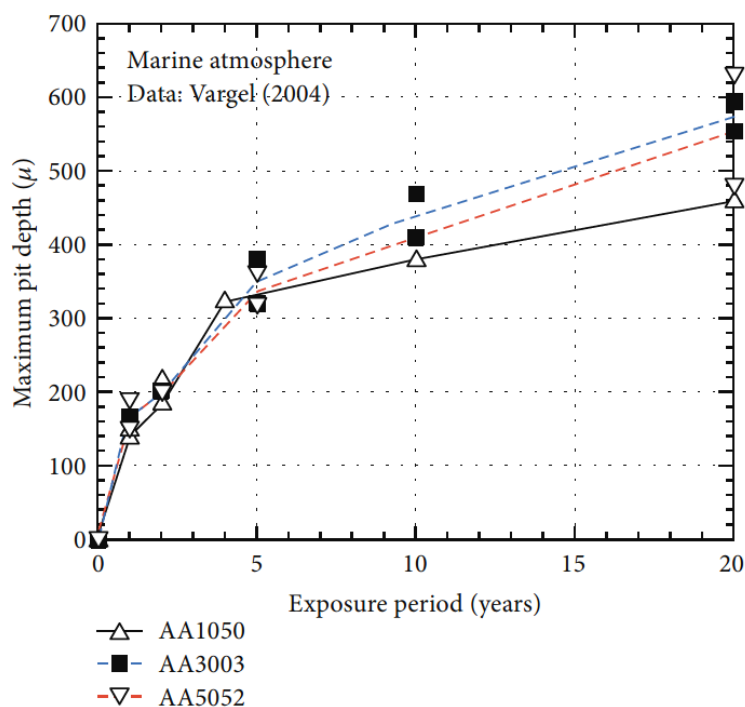
- The bimodal parameters and influences in the early stage are different than from those in the longer stages.
- The author also notes that aside from some “very specialized” cases involving algae, microbial corrosion of aluminum has not been observed.
- Maximum pit depth data from 20 yr exposure in a marine environment with bimodal curves fit for alloys 1050, 3003, and 5052 is presented in the paper’s Figure 6, reproduced here.

FIGURE 6: Data for maximum pit depth of aluminium alloys AA1050, AA3003, and AA5052 exposed in unspecified marine atmospheres for up to 20 years. The trends for maximum pit depth are shown and are bimodal. The changeover to mode 2 occurs at about 2-year exposure. Data from Vargel [4].

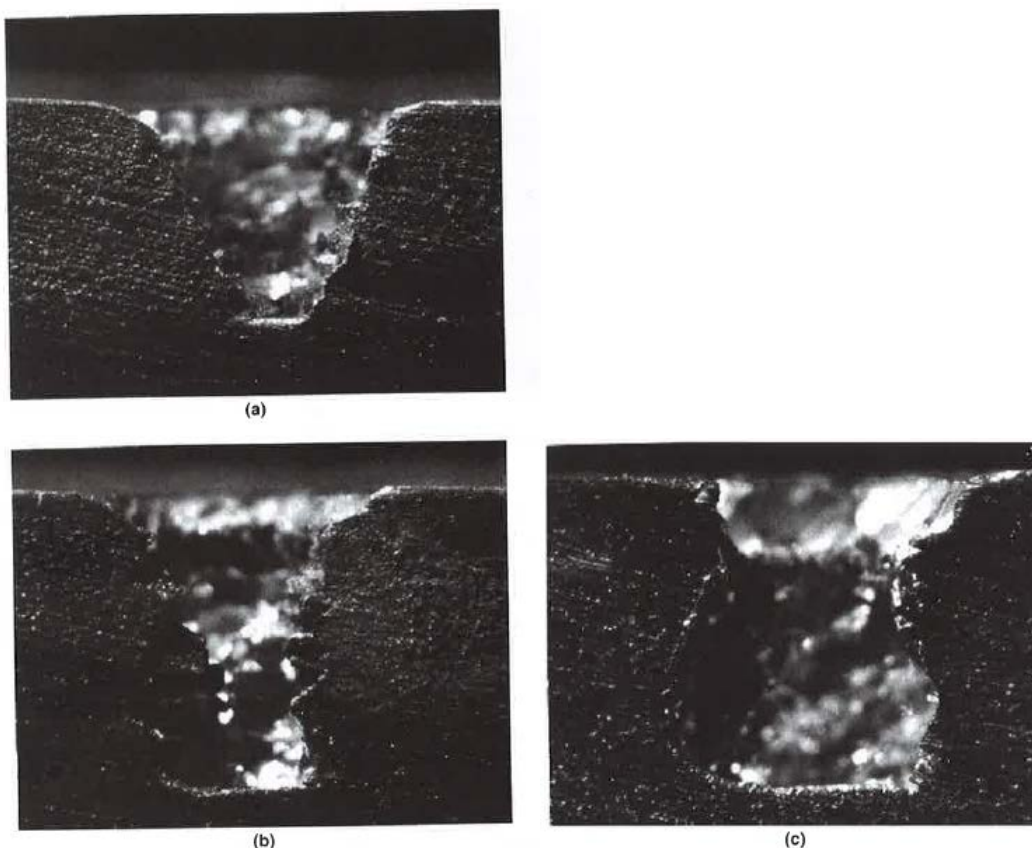
- Images are provided showing pit growth in pure aluminum in aqueous 0.1M NaCl + 0.3M NaNO₃ solution when subjected to a constant potential of 0.8V_{sce} for 2 hr, 4 hr, and 6 hr, reproduced below. This identifies that even pure aluminum can be subject to pitting when subjected to the right solution and electrical potential.

FIGURE 3.11 Cross-sectional views of the grown artificial pits of pure Al subjected to a constant anodic potential of $0.8 V_{SCE}$ in aqueous $0.1 M NaCl + 0.3 M NaNO_3$ solution for (a) 2 h, (b) 4 h, and (c) 6 h. Source: S. I. Pyun, K. H. Na, W. J. Lee, J. J. Park, *Corrosion*, 56 (2000): p. 1015.

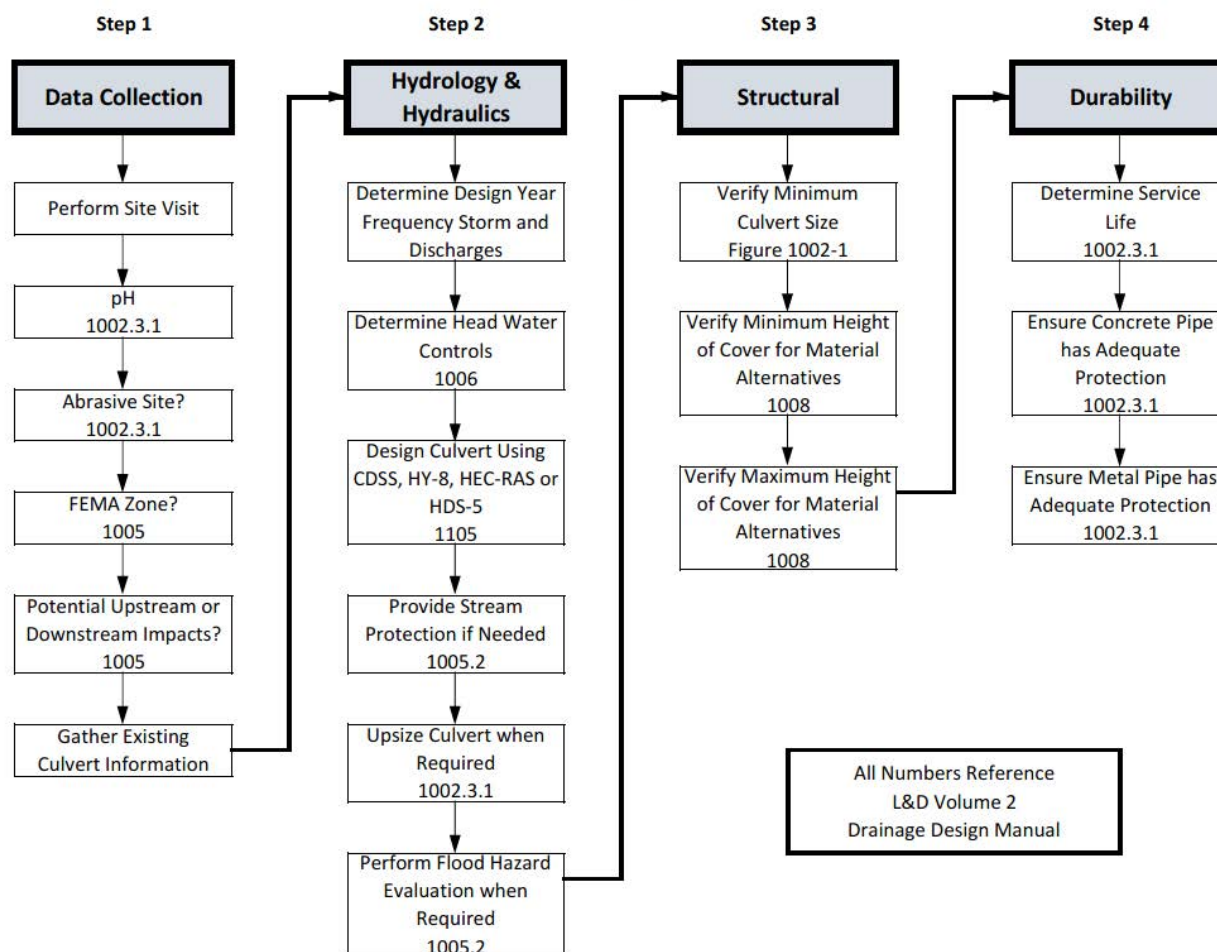
ODOT Culvert Design Process
 January 2016

We reviewed the ODOT Culvert Design Process Flow Chart downloaded from <http://www.dot.state.oh.us/Divisions/Engineering/Hydraulics/Additions/20Resources/Pages/default.aspx> and reproduced below. Numerical references in the flow chart refer to sections in the Location & Design Manual, Volume Two Drainage Design, reviewed above.

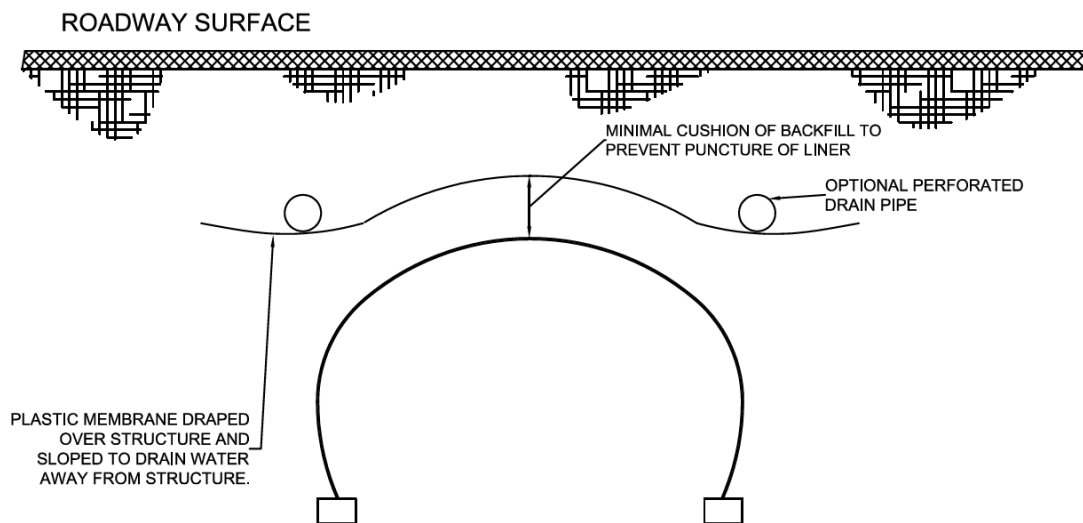
- The potential for use of deicing salts on roadway surfaces above structural plate must be addressed during the design phase. Calcium chloride and magnesium chloride as well as other deicing materials can cause corrosion of galvanized steel and aluminum. It is recommended that the designer consider the use of either an asphalt coating on the exterior of the structure or a polymeric membrane over the structure. In addition, impermeable clay layers above the select backfill have been used to shed water from the crown of the structure. Sketches showing membrane installation for protection from deicing salts and recommended details for paved invert installation are pasted below.

OPTIONAL MEMBRANE PROTECTION
FROM DE-ICING SALTS

Membrane Protection of Structure from Deicing Salts from Contech Structural Plate Design Manual

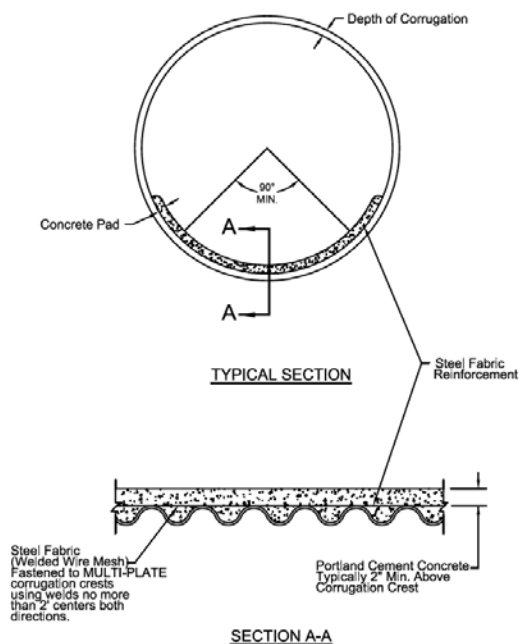
Paved Invert Detail from Contech Structural Plate Design Manual.

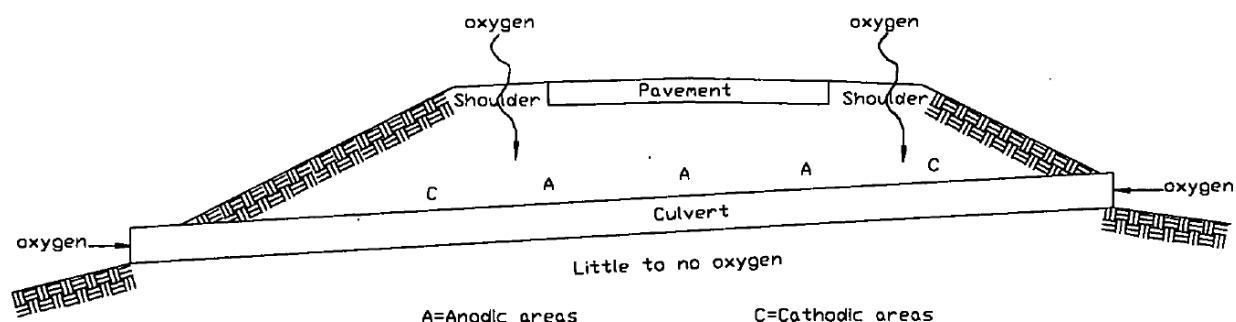
- For metal culverts, the electrolyte can be soil moisture or groundwater. The anode and cathode can be oxygen-starved and oxygen-rich air pockets, respectively, along the length of the culvert. If the midlength of pipe is below pavement, the soil will get less oxygen access, than at the exposed end of the pipe. The conductor can be the metal culvert. The corrosion would be accelerated where moist soil contains chloride ions. In this situation, corrosion will occur at the top of the culvert, with the most aggressive corrosion occurring near the pavement edges.

FIGURE 1 Oxidation corrosion cells in pavement drainage structures (after 2).

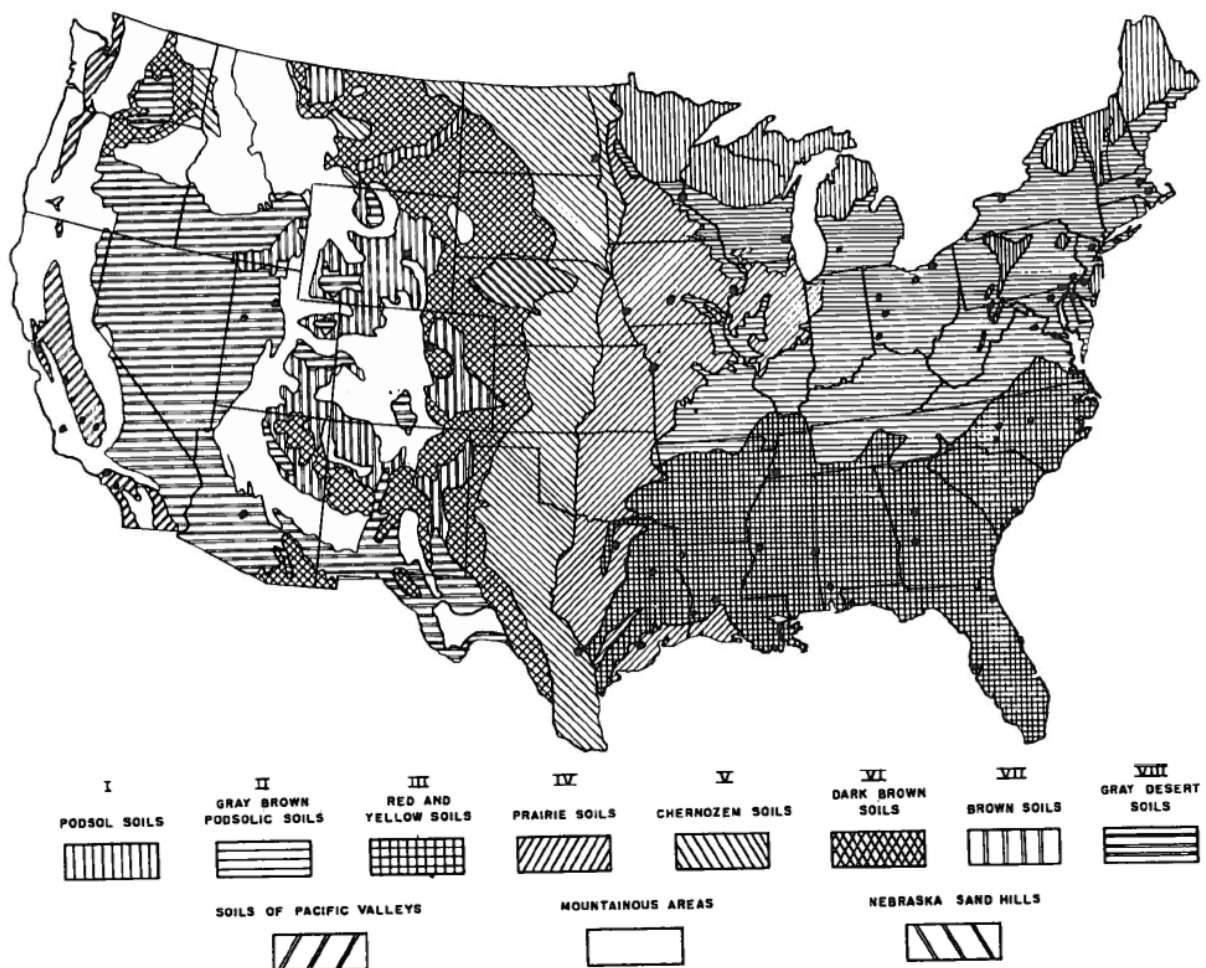
- In Figure 1, the study presents a map of eight major soil groupings in the U.S. (after Marbut, 1935), referred to as the “Great Soil Groups,” and includes dots locating the buried metal corrosion test sites that were part of the study. The eight soil groupings are referenced in several other pieces of literature reviewed in the current work. Note that Wisconsin has two groups: Group I podsol soils to the north, and Group II gray-brown podsol soils to the south. These soil groups are also found in Ohio (only Group II), Maine, Michigan, Minnesota, and New York, which were the other states whose specifications were reviewed above.

FIGURE 1. Soil groups of the United States. Marbut [60].
The dots show the location of the National Bureau of Standards test sites.

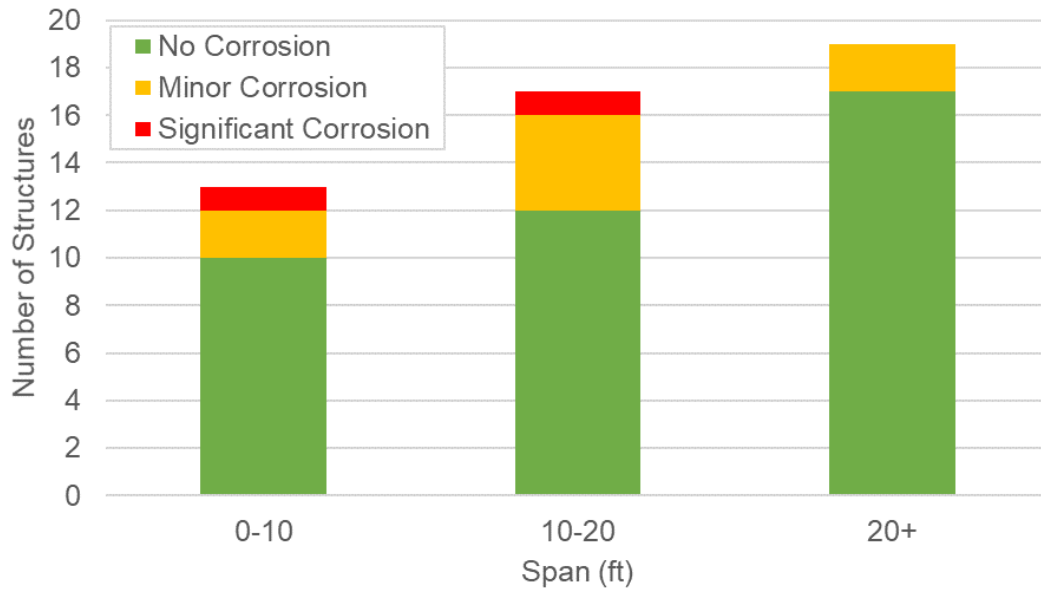
Figure C.3
Histogram of culvert spans with corrosion level based on review of most-recent inspection report.

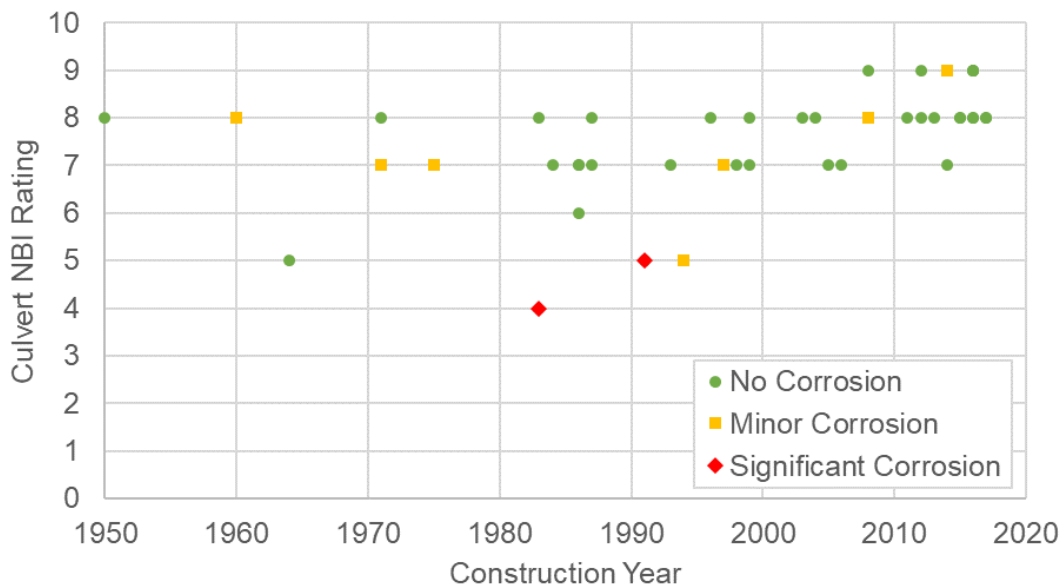
Figure C.4
Culvert NBI rating vs. construction year with corrosion level based on review of most-recent inspection report.

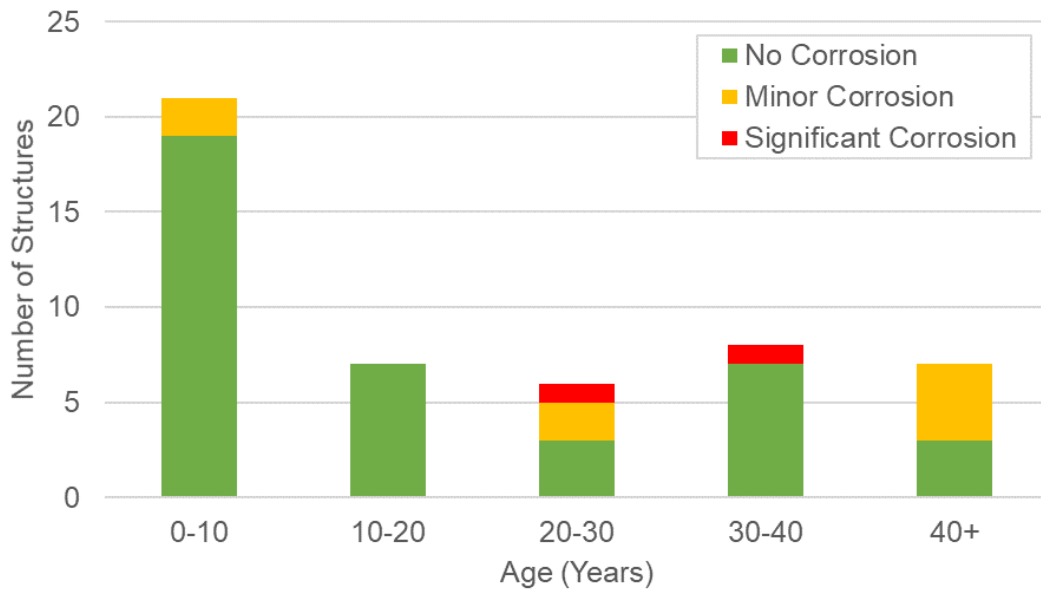
Figure C.5
Histogram of culvert ages with corrosion level based on review of most-recent inspection report.

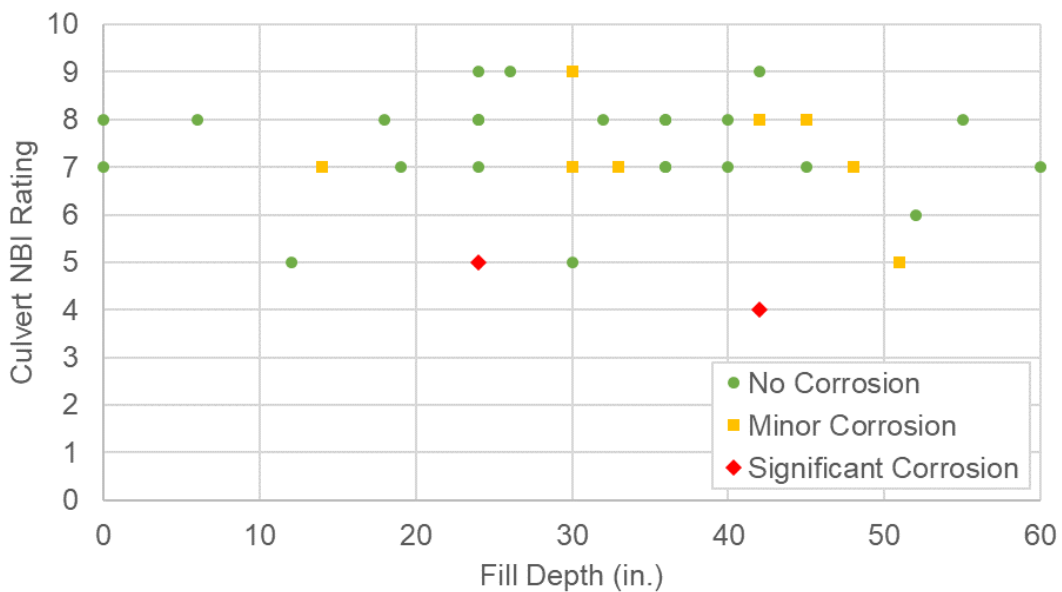
Figure C.6
Culvert NBI rating vs. fill depth with corrosion level based on review of most recent inspection report.

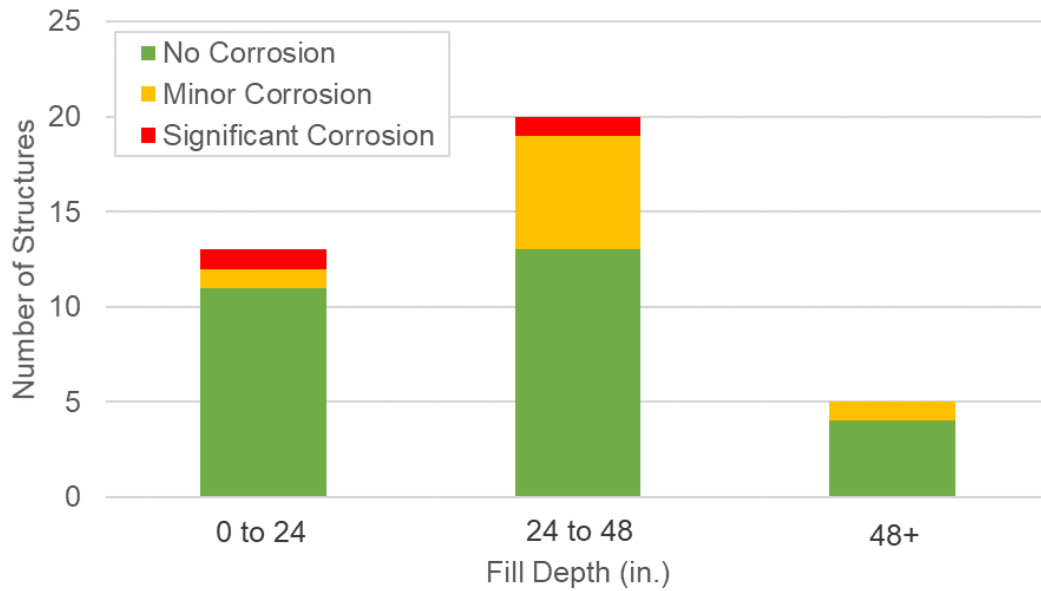
Figure C.7
Histogram of culvert fill depth with corrosion level based on review of most-recent inspection report.

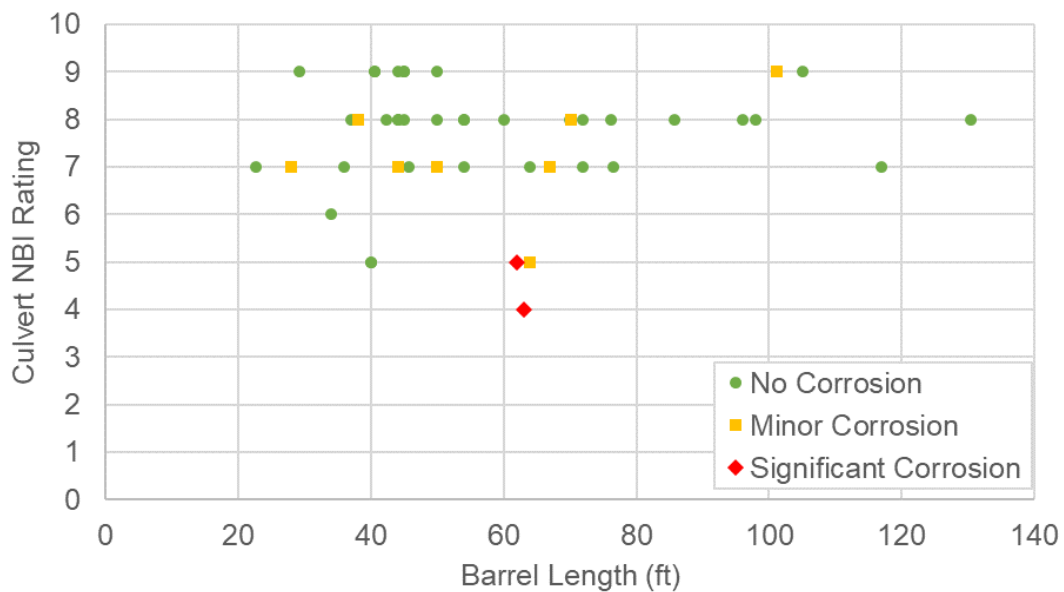
Figure C.8
Culvert NBI rating vs. barrel length with corrosion level based on review of most-recent inspection report.

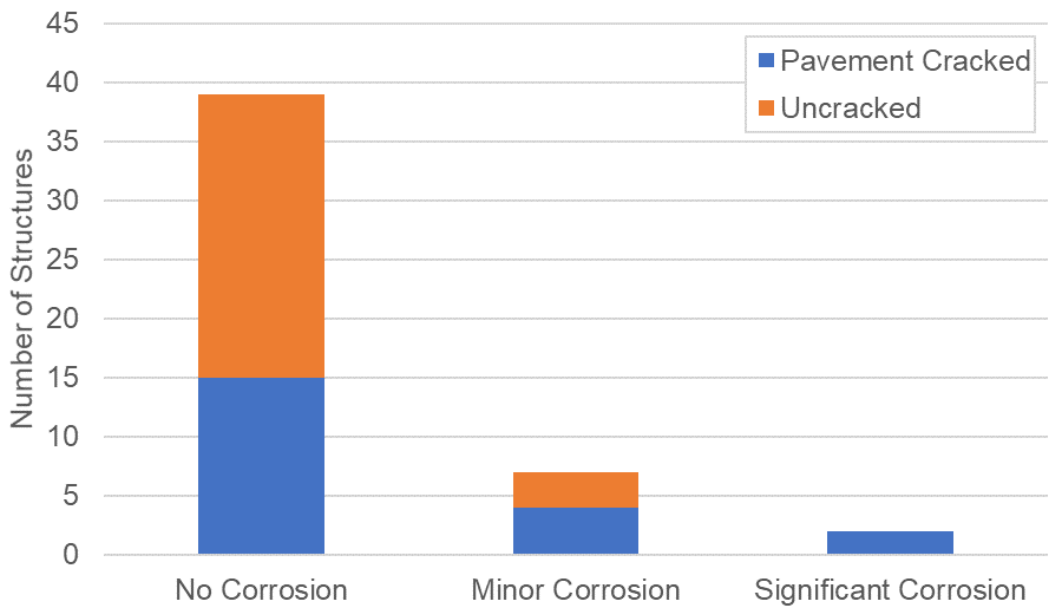
Figure C.11
Histogram of culvert corrosion level and identification of cracked or uncracked pavement both based on review of most-recent inspection report.

- **Pavement Cracking (Figures C.11 and C.12):** The data show increased corrosion in culverts where the pavement condition was noted as cracked in culvert inspection reports. The data do not provide pavement history, preventing direct correlation of pavement condition over time with levels of corrosion.

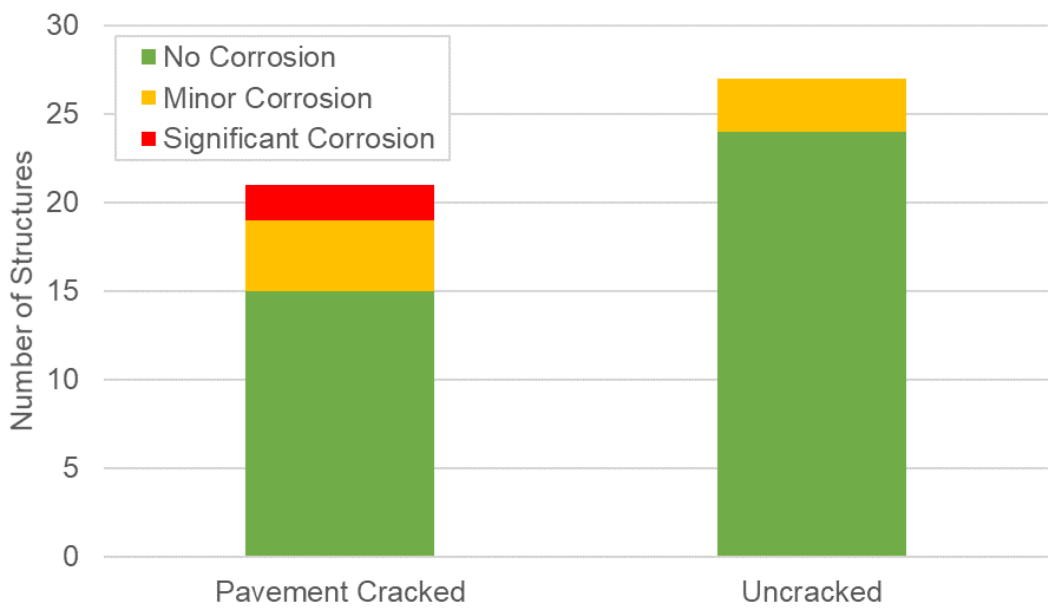
Figure C.12
Histogram of culverts identified with cracked or uncracked pavement with corrosion level based on review of most-recent inspection report.

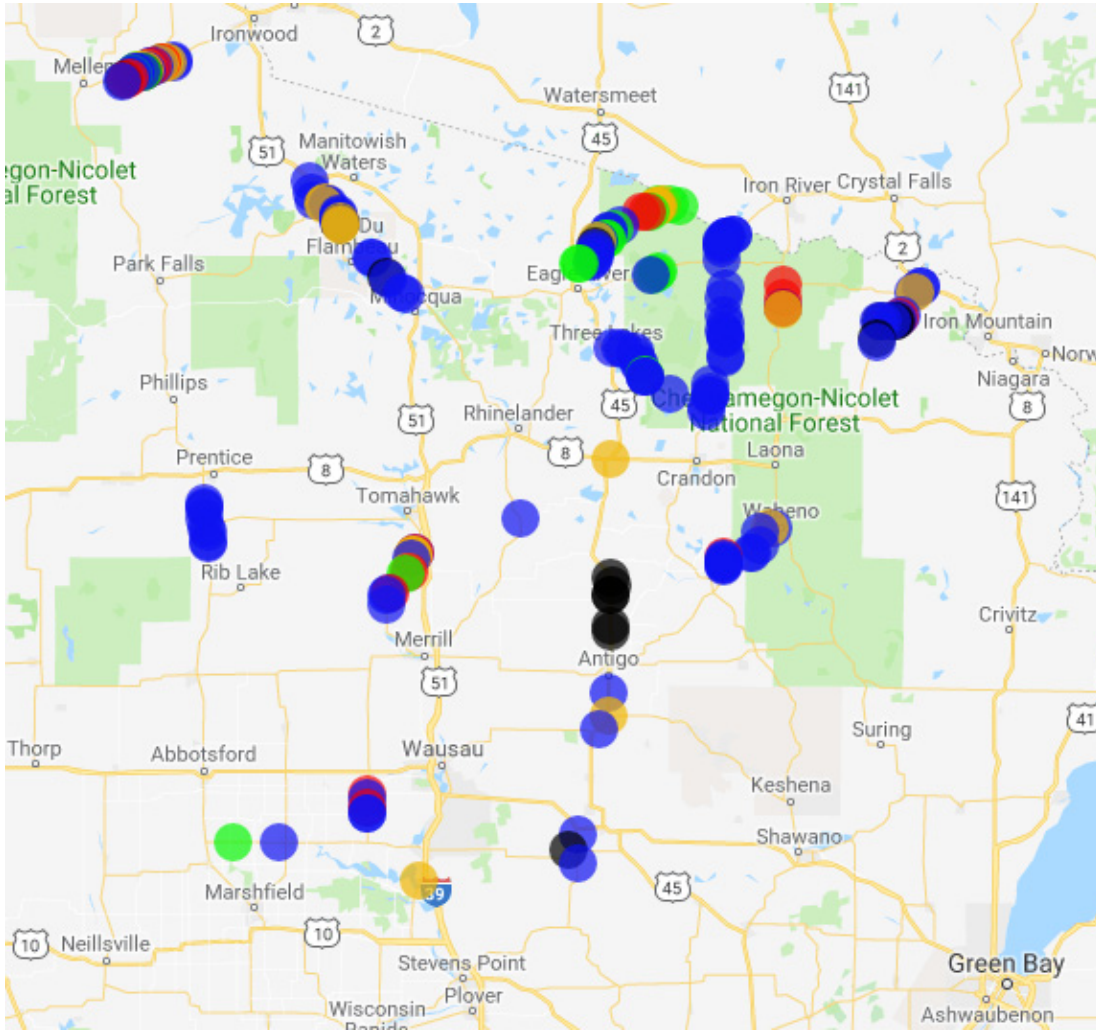
Figure C.13
 Geographic distribution of aluminum culverts in Wisconsin NCI data with corrosion ratings of 1 to 4 shown as green, blue, orange, and red, respectively, and culverts with unknown corrosion ratings as black.

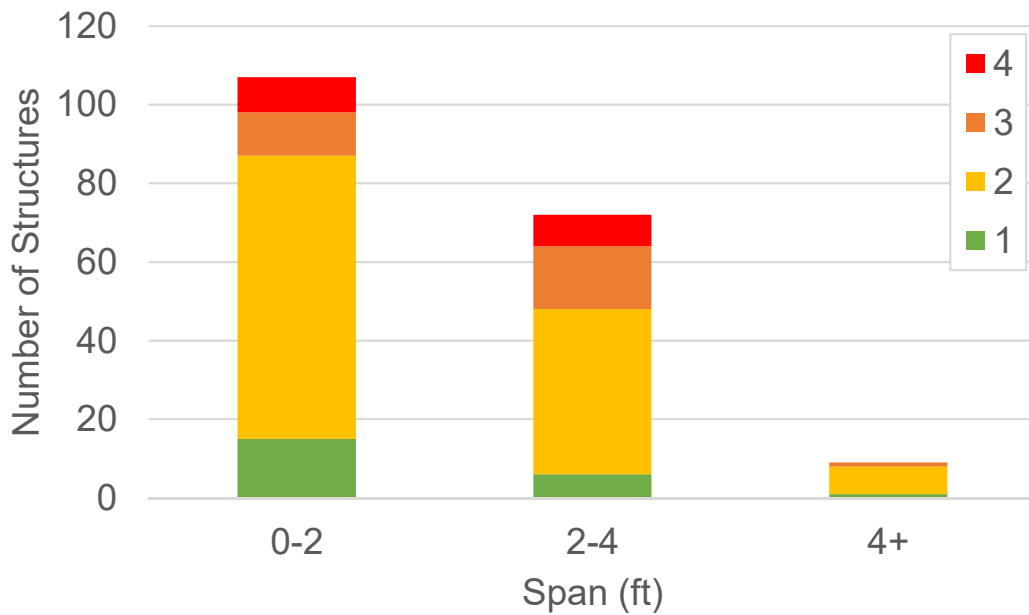
Figure C.14
 Histogram of reported culvert span with reported corrosion rating.

- **Span (Figure C.14):** Almost all culverts in the NCI data (94%) have a span of 3 ft or less. For this small range of spans, there is no significant correlation between span and level of corrosion. None of the larger spans, greater than 4 ft, are severely corroded, but there are only 9 culverts of this size in the data (4% of total).

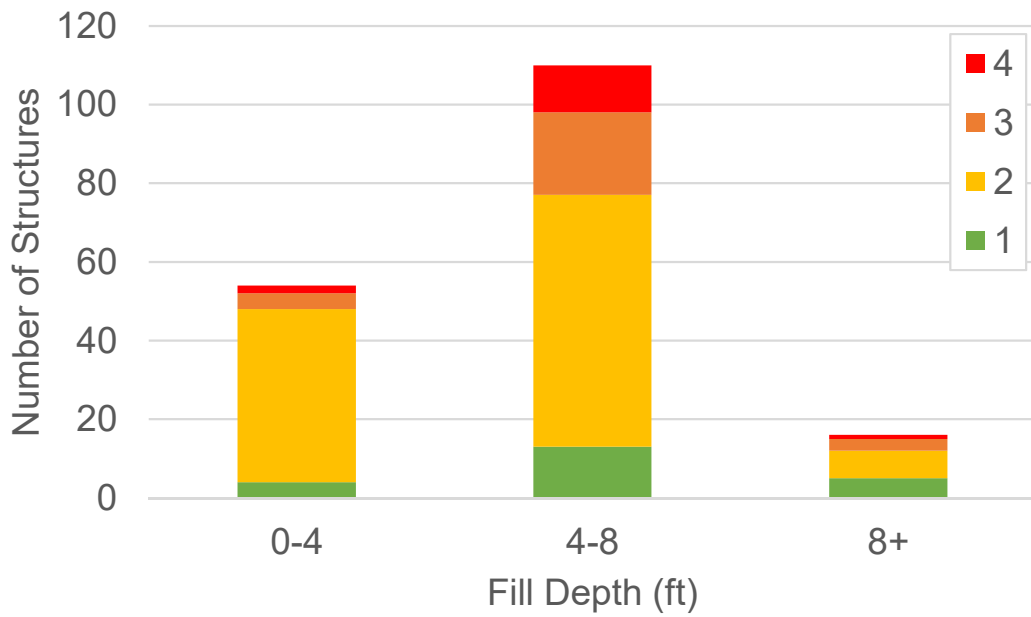
Figure C.15
Histogram of reported fill depth with reported corrosion rating.

- **Fill Depth (Figure C.15):** There does not appear to be a strong correlation between fill depth and corrosion rating.
- **Length (Figure C.16):** There does not appear to be a significant correlation between barrel length and reported corrosion rating. While the 50 to 70 ft range of barrel length has the greatest number of culverts with corrosion ratings of 3 and 4, this range also has the greatest number of culverts with a corrosion rating of 1.

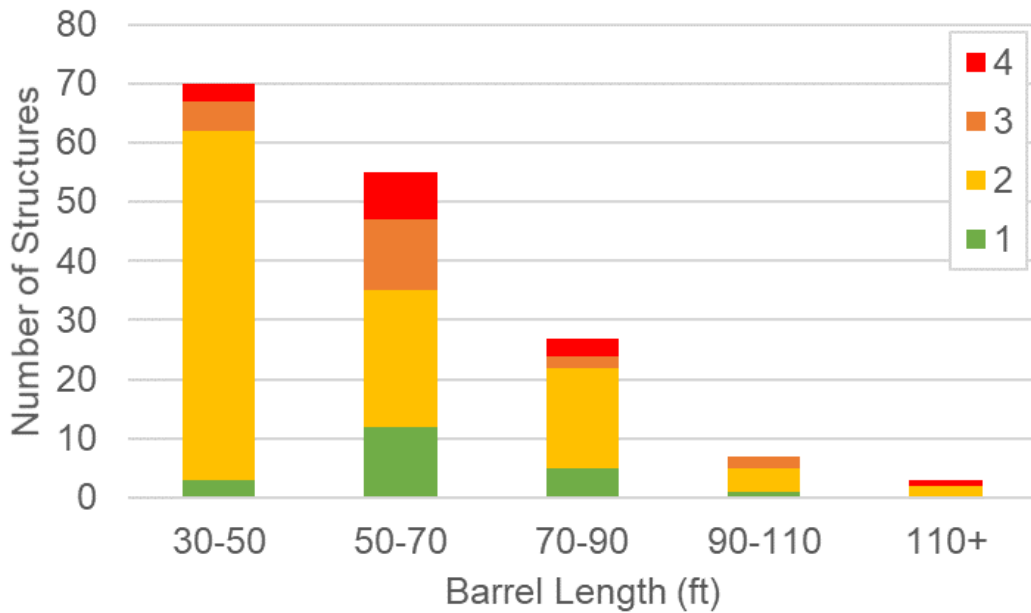
Figure C.16
Histogram of reported pipe length with reported corrosion rating.

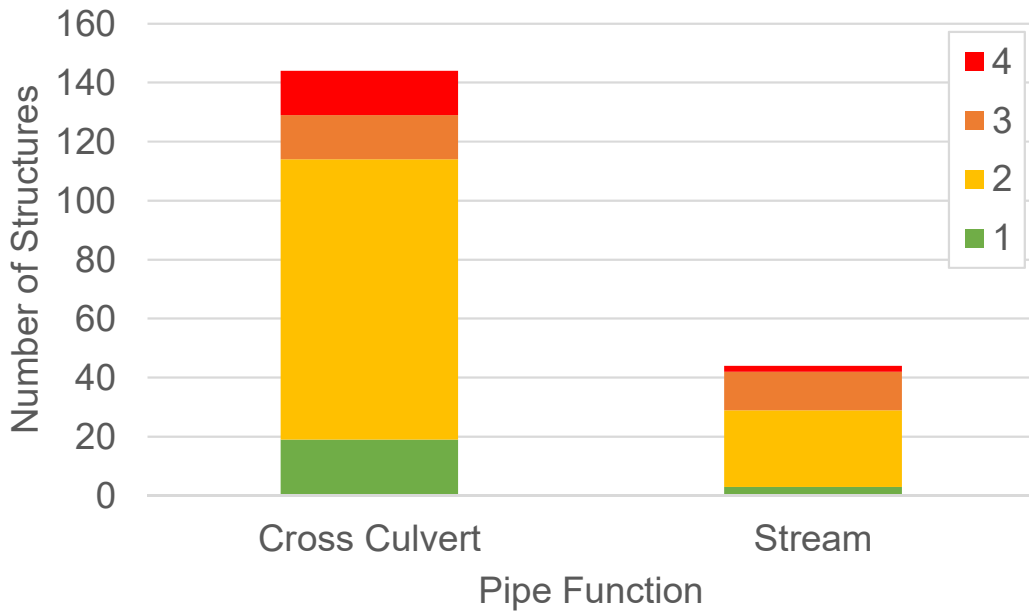
Figure C.17
Histogram of reported pipe function with reported corrosion rating.

- **Culvert Function (Figure C.17):** The reported function of the culvert (cross culvert or stream) does not have significant correlation with the reported corrosion rating.
