Performance and Policy Related to Aluminum Culverts in Wisconsin

Simpson Gumpertz & Heger Inc.

WisDOT ID no. 0092-17-05

May 2019

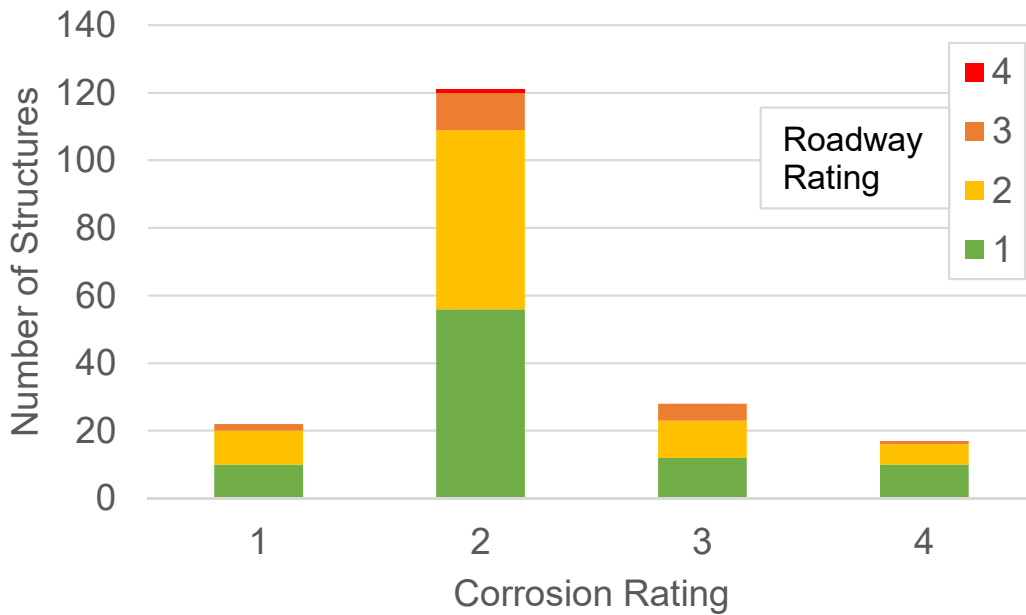
Figure C.18
Histogram of reported roadway and corrosion ratings.

- **Pavement Cracking (Figures C.18 and C.19):** There is no significant correlation between roadway rating and corrosion rating. However, culverts with higher corrosion rating are more likely to have higher cracking rating. The discrepancy between roadway rating and cracking rating correlation may be due to other factors considered in roadway rating beyond pavement cracking.

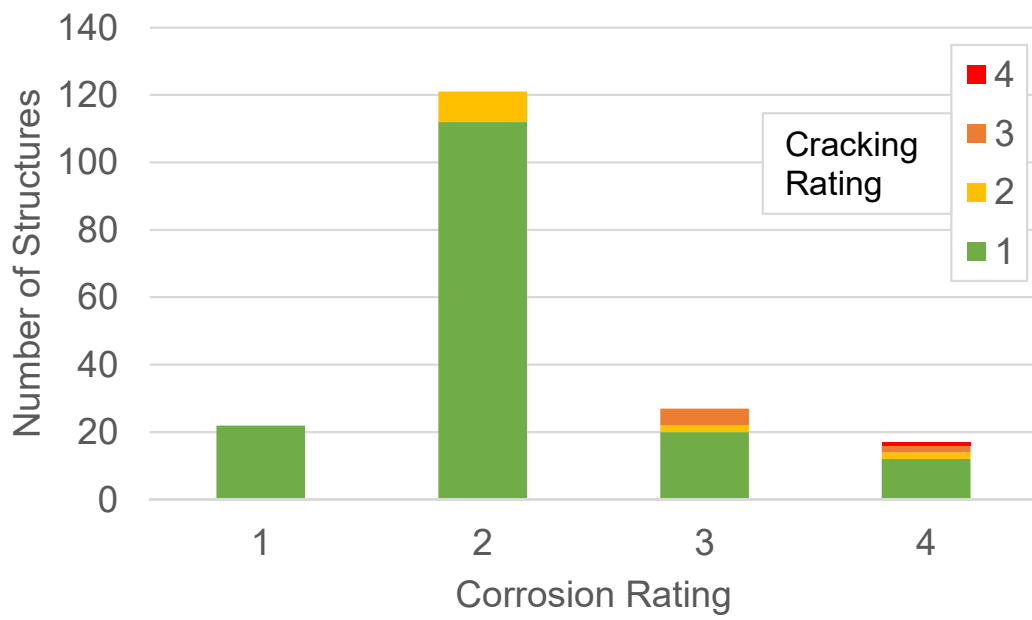
Figure C.19
Histogram of reported cracking and corrosion ratings.

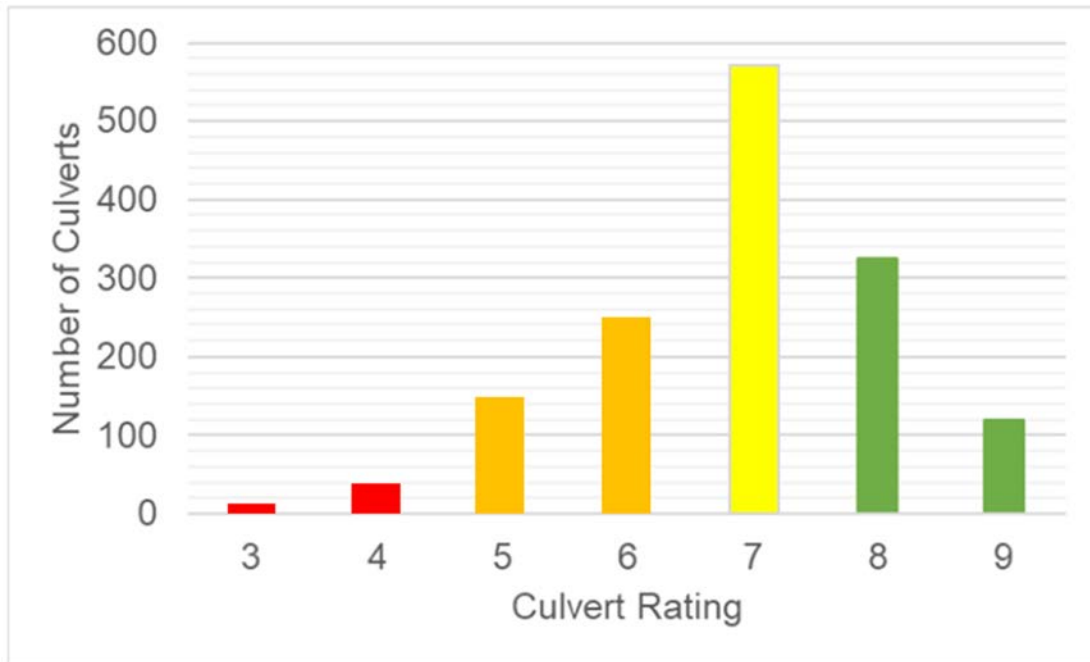
Figure C.20
 Number of likely aluminum culverts in LTPB database by culvert rating.

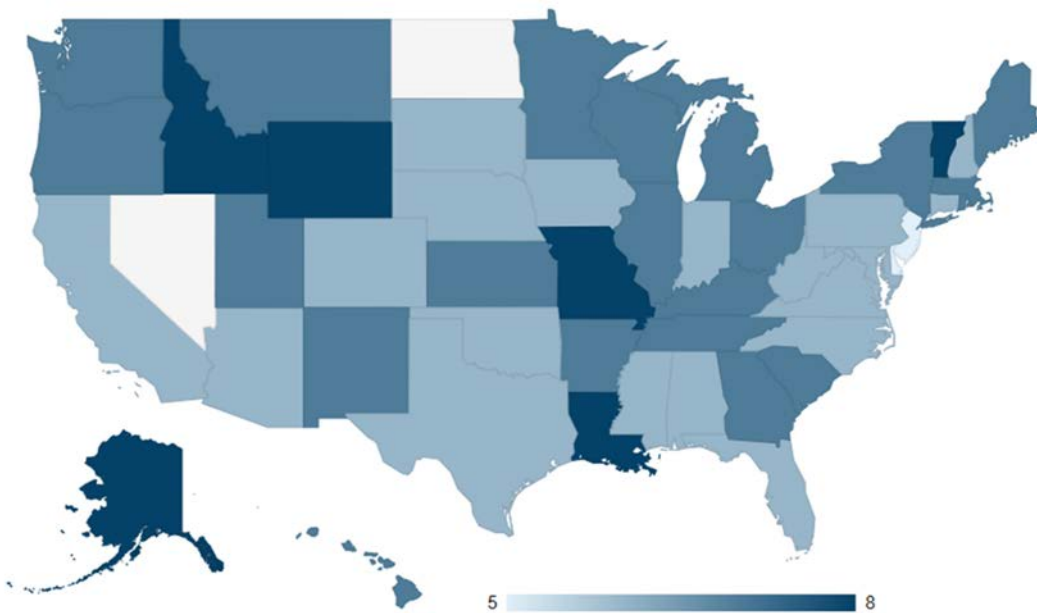
Figure C.21
 FHWA LTPB database map for average culvert rating by state of likely aluminum culverts (darker shading is more favorable rating).

- **Geographic Distribution (Figures 17 and 18 above and C.20 and C.21 in Appendix C):** The geographic distribution of likely aluminum culverts with Low, Medium, Good, and High Culvert Ratings appears to be random, with no particular geographic region appearing to have a higher likelihood of culvert distress.

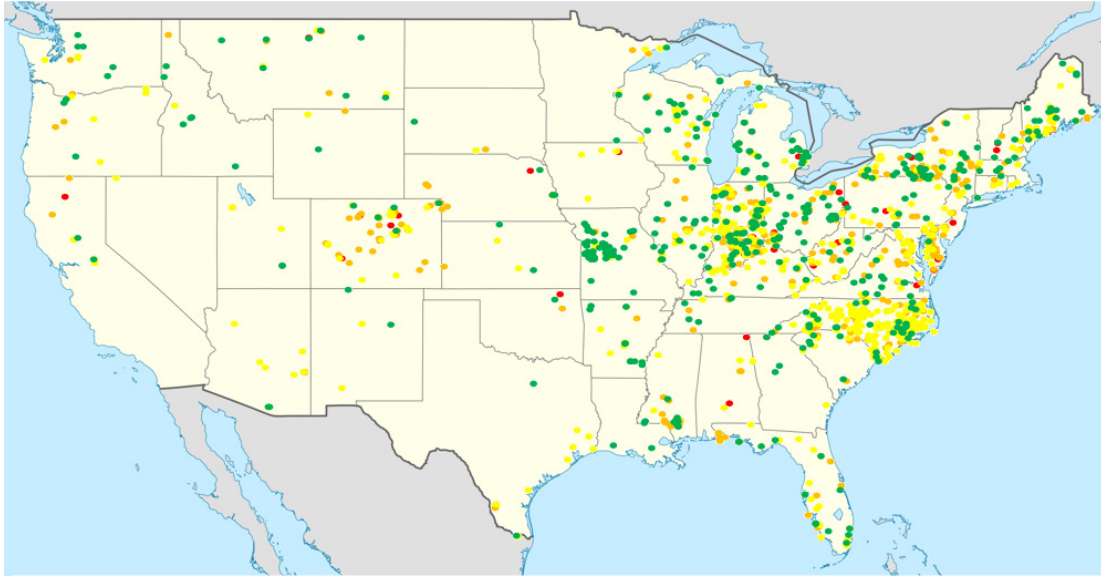
Figure C.22
 Geographic distribution of likely aluminum culverts in LTBP database with low, Medium, Good, and High culvert condition ratings.

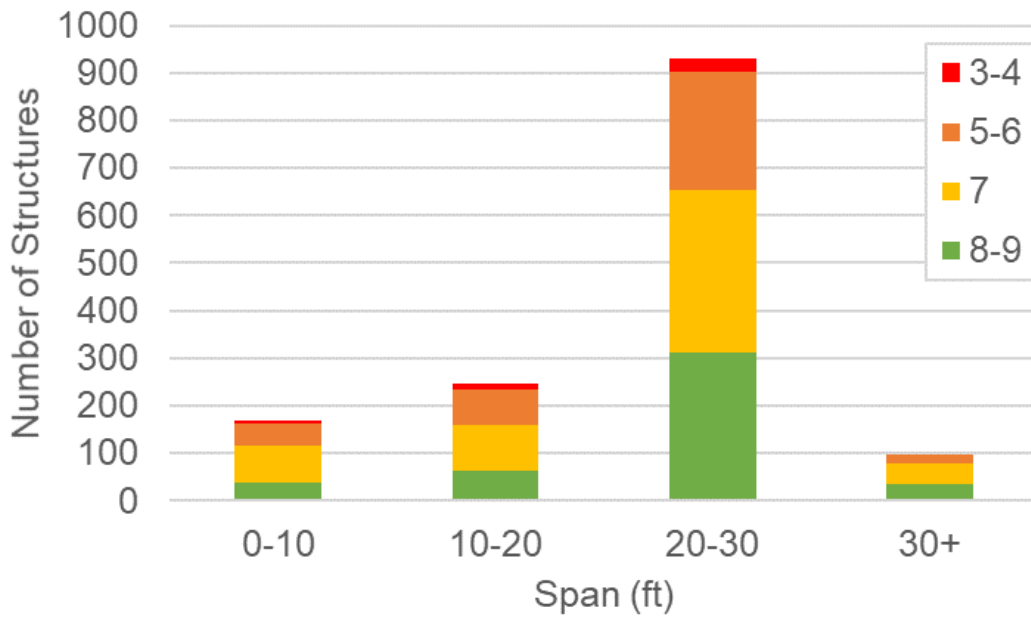
Figure C.23
 Histogram of span with culvert rating.

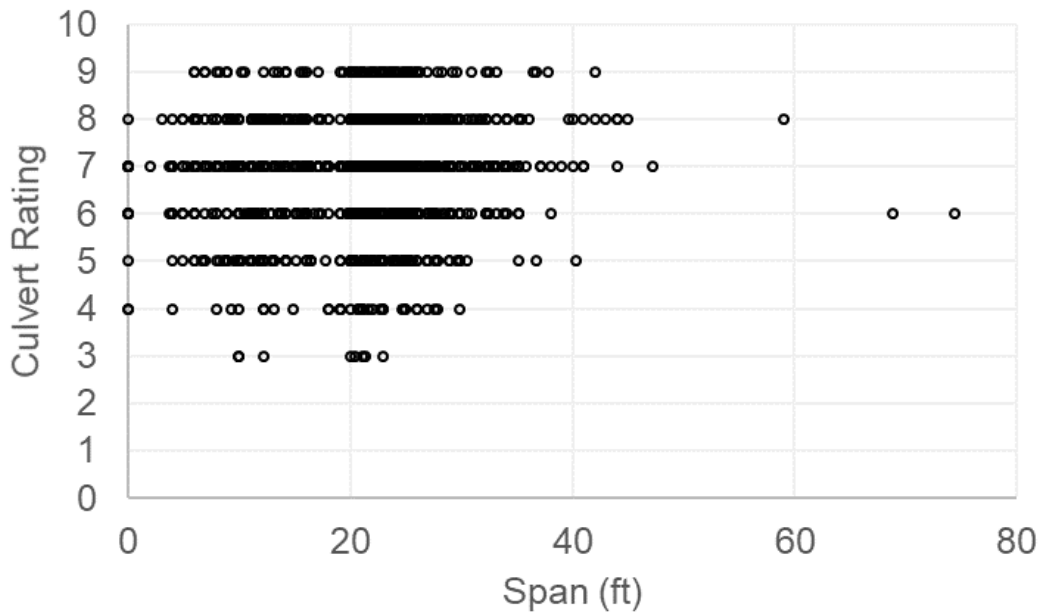
Figure C.24
Culvert Rating vs. Span.

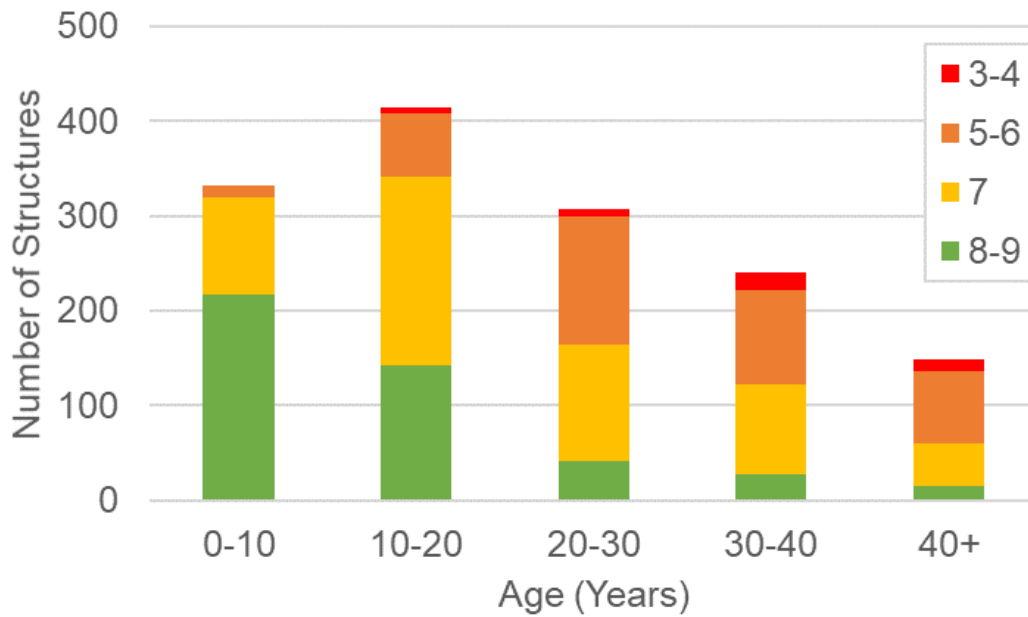
Figure C.25
Histogram of age with culvert rating.

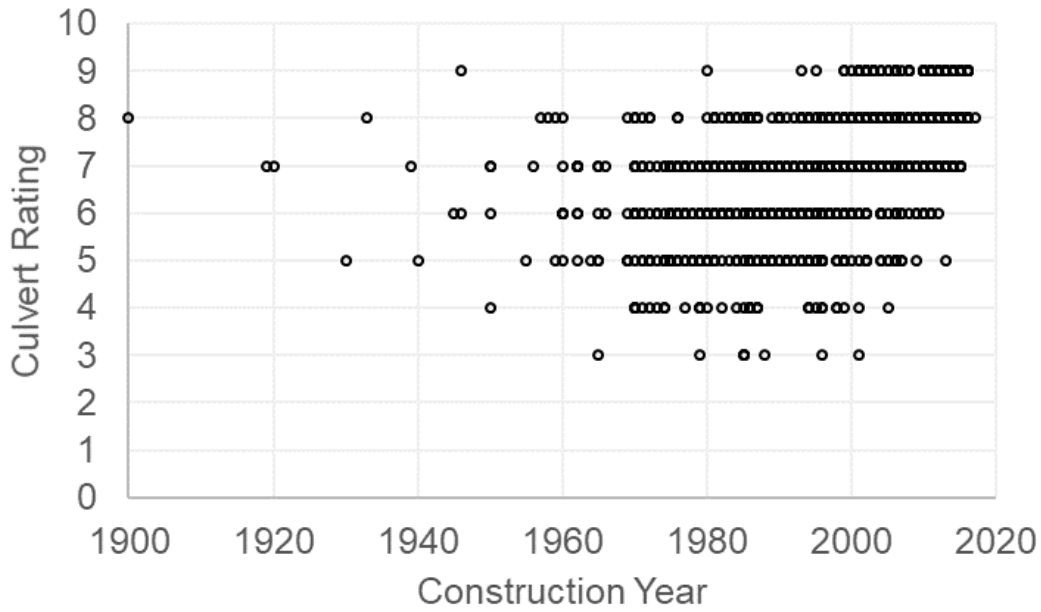
Figure C.26
Culvert rating vs. construction year.

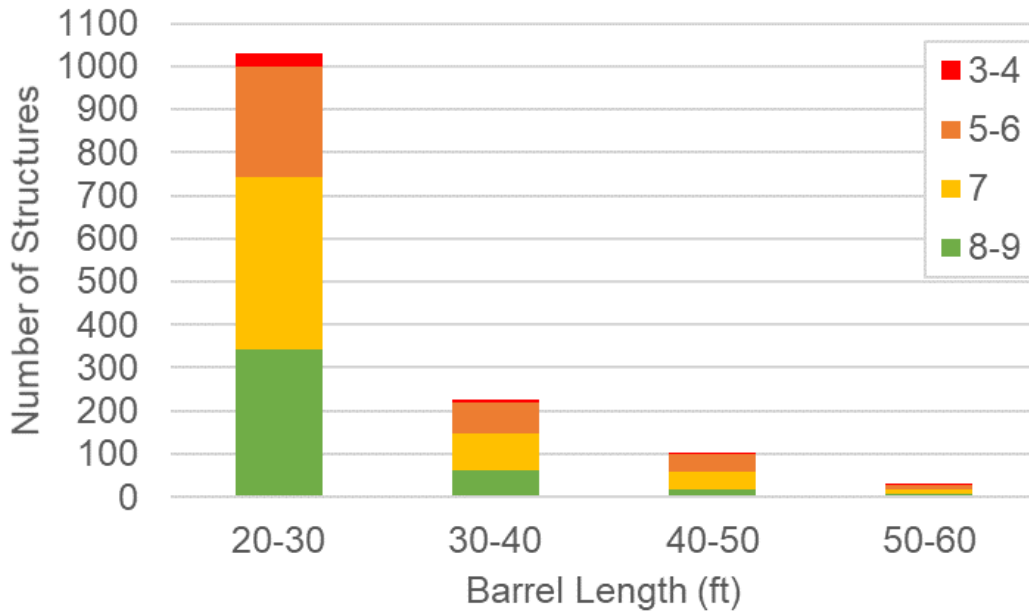
Figure C.27
Histogram of barrel length with culvert rating for barrels up to 60 ft in length.

- **Length (Figures C.27 to C.29):** Barrel lengths range from 20 to 600 ft, with an average of 30.4 ft and median of 24.9 ft. The proportions of low, medium, good, and high ratings on the histograms in Figures C.27 (lengths up to 60 ft) and C.28 (lengths greater than 60 ft) appear evenly distributed aside from the two structures listed with barrel lengths in the 140 to 180 ft range, which both have a culvert rating of 8. The distribution of culvert ratings by barrel length is shown in Figure C.29.

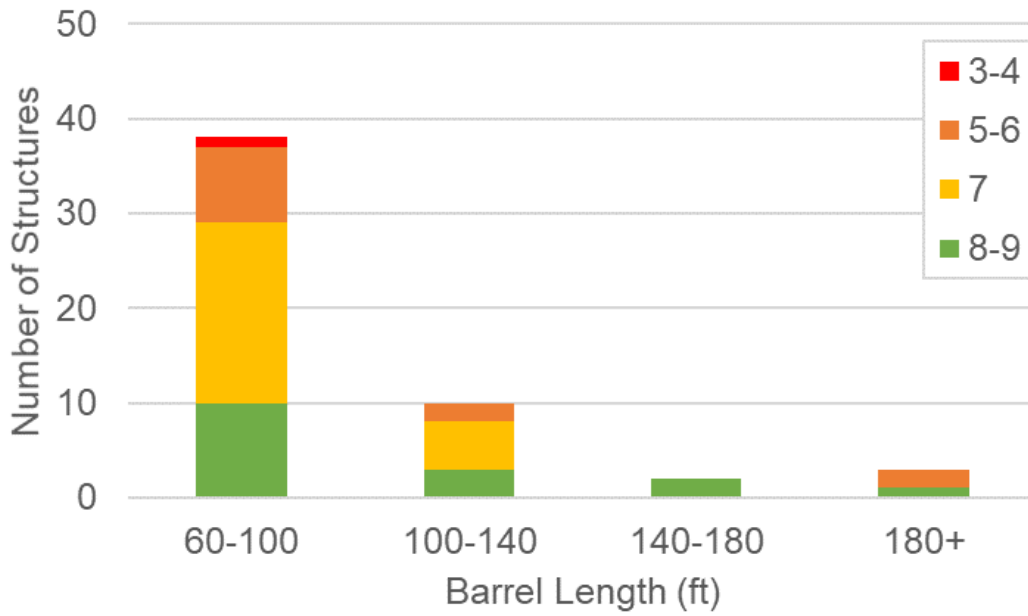
Figure C.28
Histogram of barrel length with culvert rating for barrels greater than 60 ft in length.

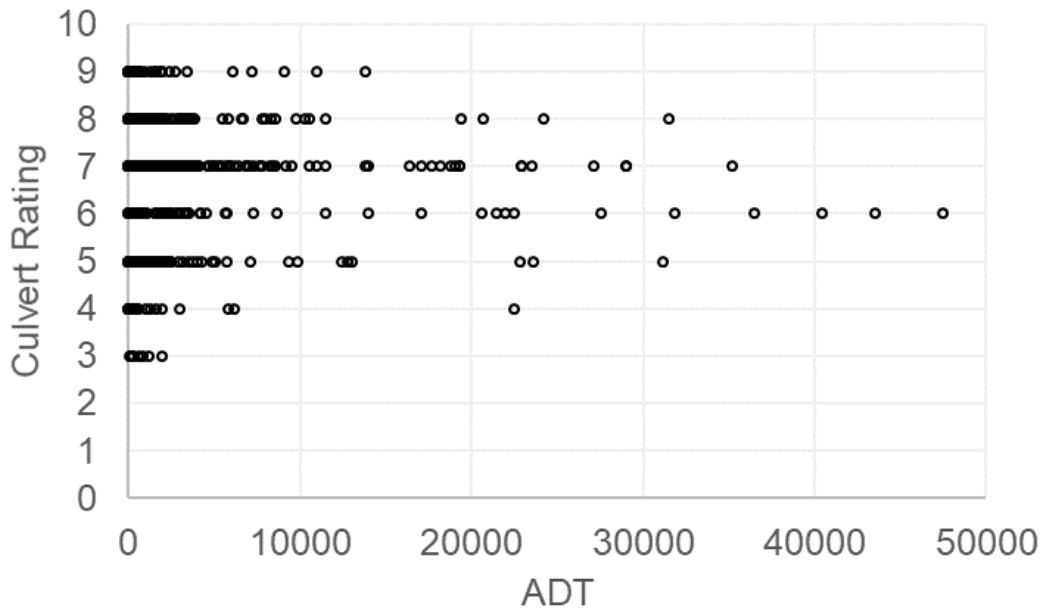
Figure C.30
Culvert rating vs. ADT.

- **Average Daily Traffic (ADT, Figures C.30 and C.31):** ADT ranges from 0 to 139,500 vehicles, with an average of 1,547 vehicles and median of 220 vehicles. The data shows that the lowest-rated structures also have relatively low ADT. Figure C.28 provides an adjusted scale limited to a maximum ADT of 10,000; this figure shows that the majority of the culverts with lowest ratings have 2,000 or less vehicles ADT. This is surprising, considering the likelihood for increased use of deicing salts and chemicals on roadways with higher ADT.

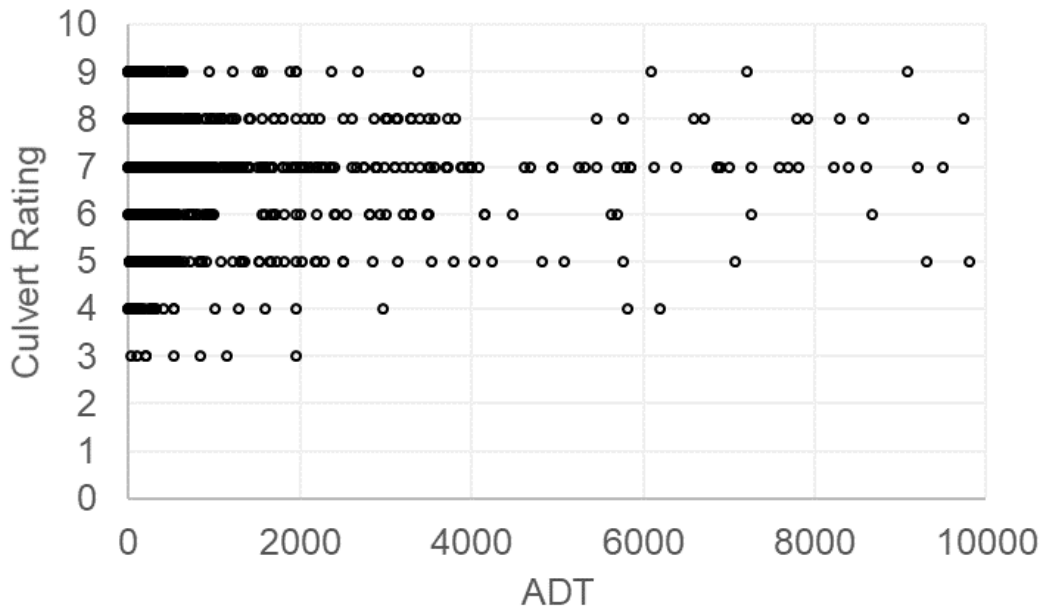
Figure C.31
Culvert rating vs. ADT, horizontal scale limited to 10,000 vehicles ADT.

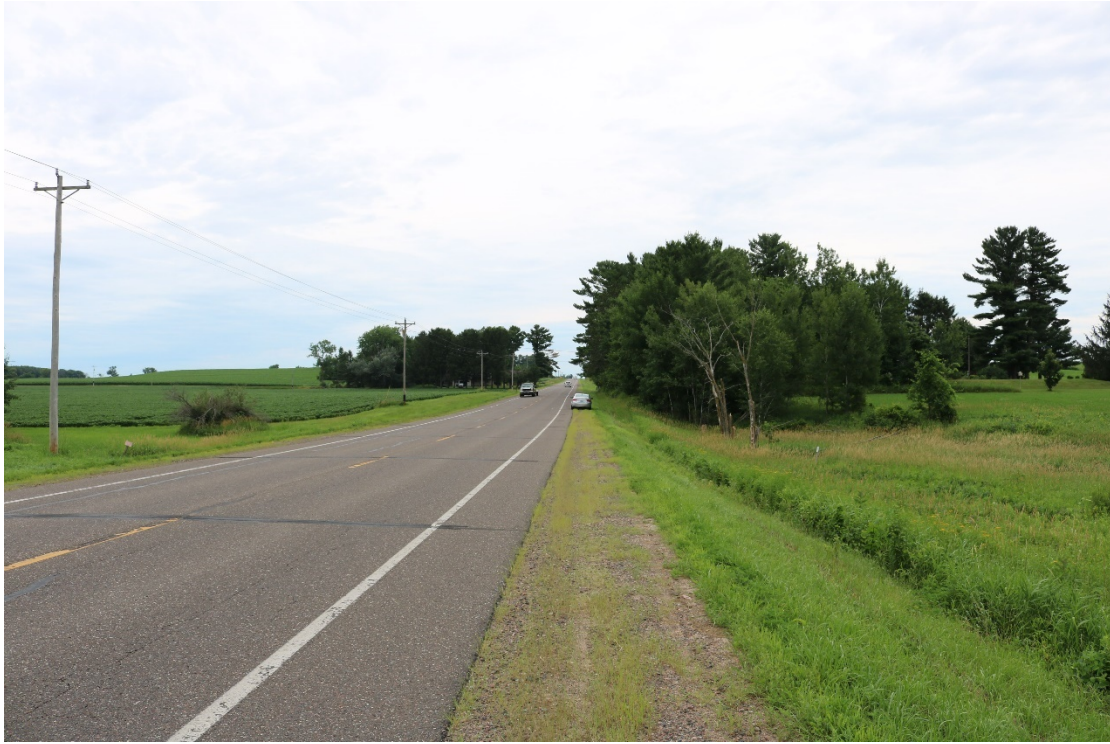
Photo 1

View looking north from south of culvert showing overall view and general roadway condition.

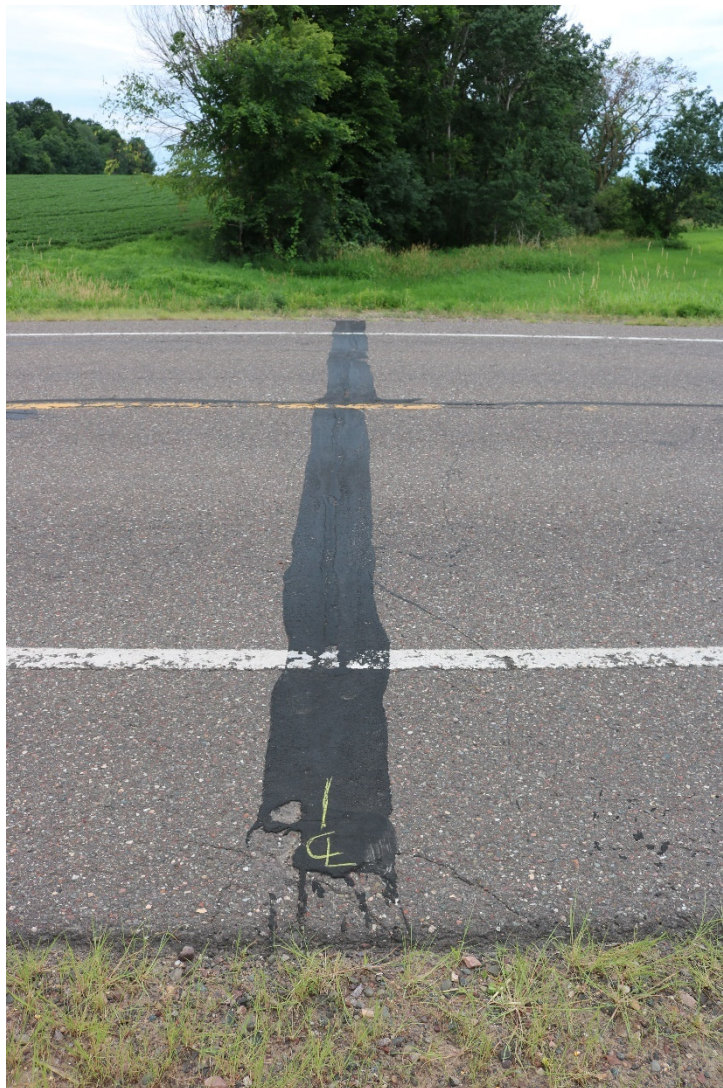
Photo 2

View looking across roadway at centerline of culvert in west (upstream) direction. Note sealed pavement crack directly over culvert.

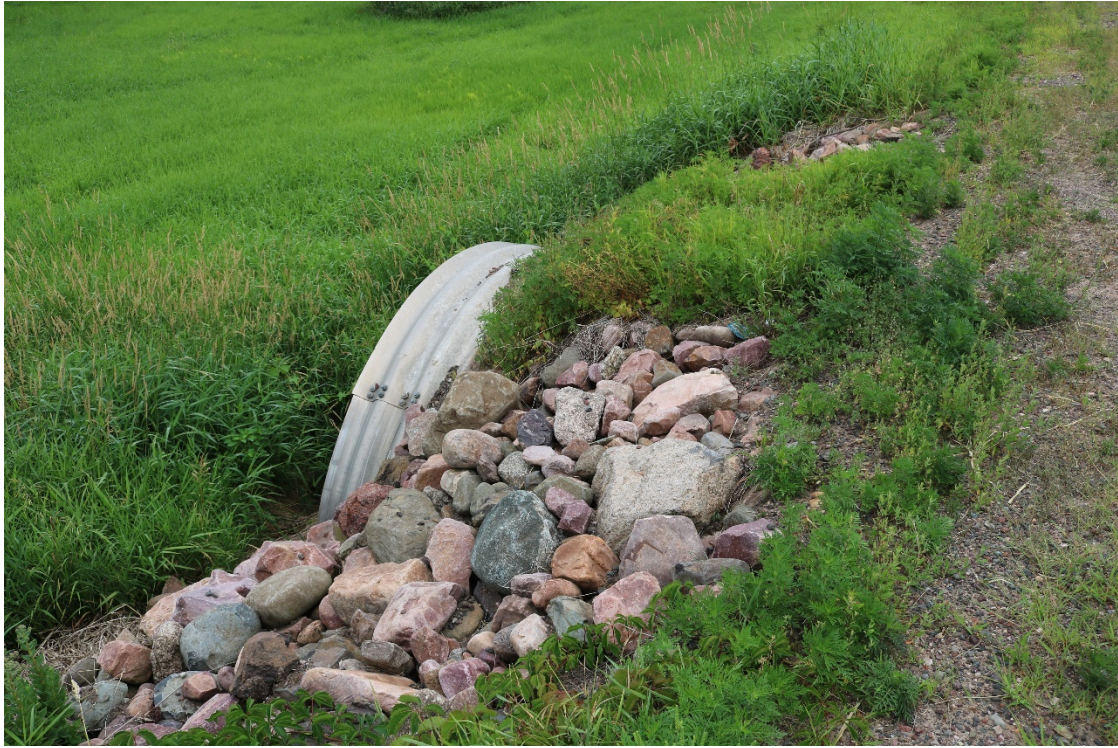
Photo 3

West (upstream)
embankment.

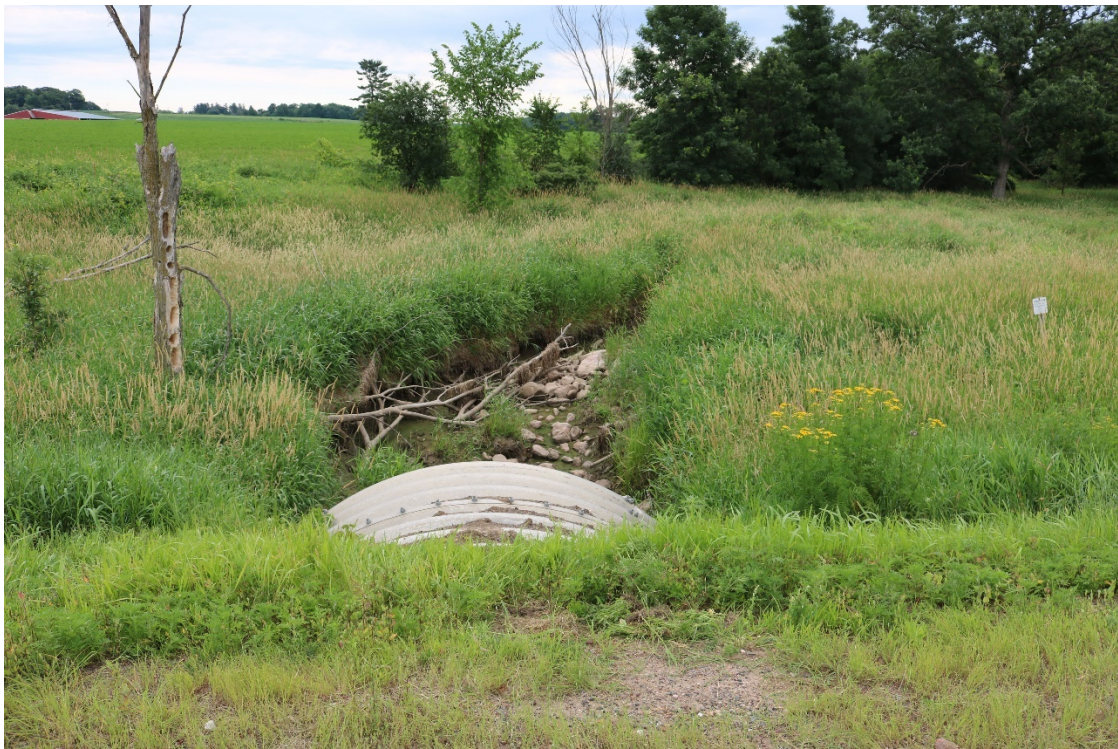
Photo 4

East
(downstream)
embankment.

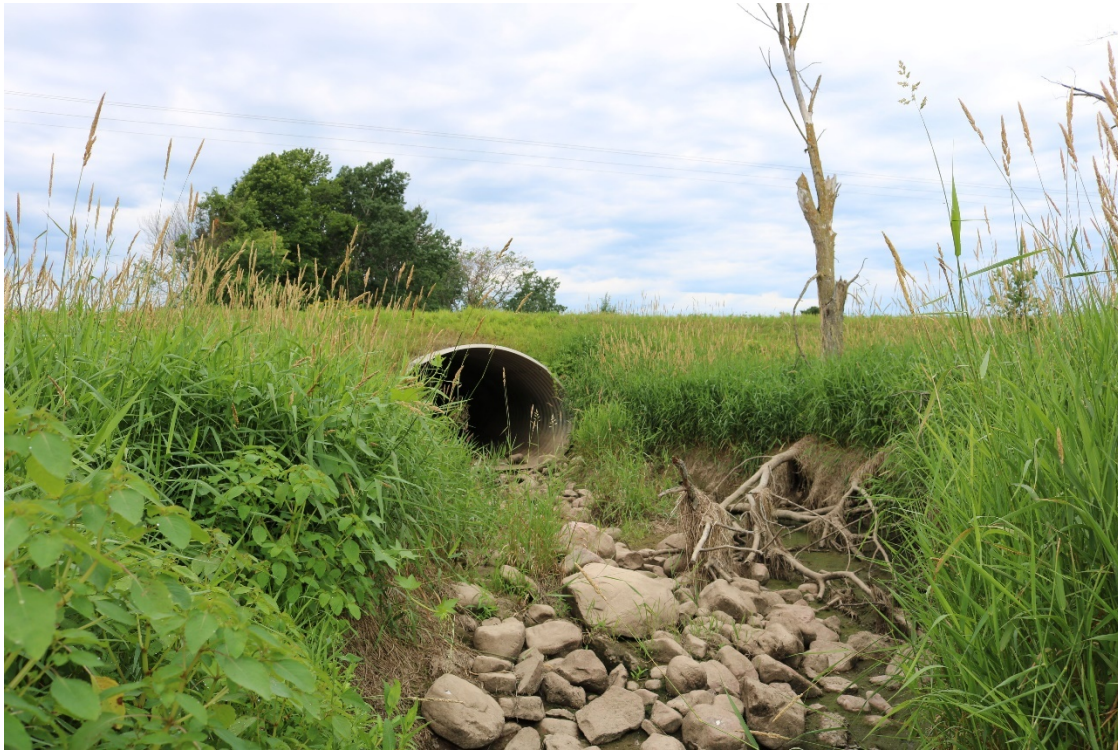
Photo 7

Channel and elevation at downstream end.

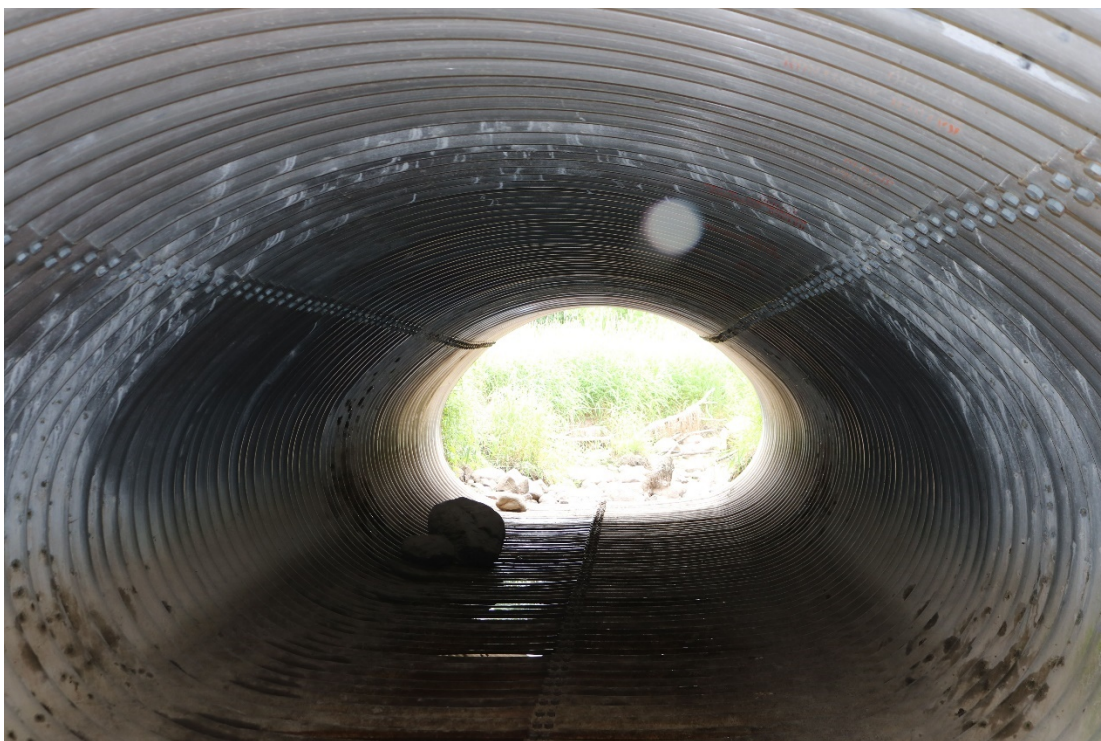
Photo 8

Overview of inside of culvert looking downstream. Note two areas of pitting and white staining approximately below roadway shoulders.

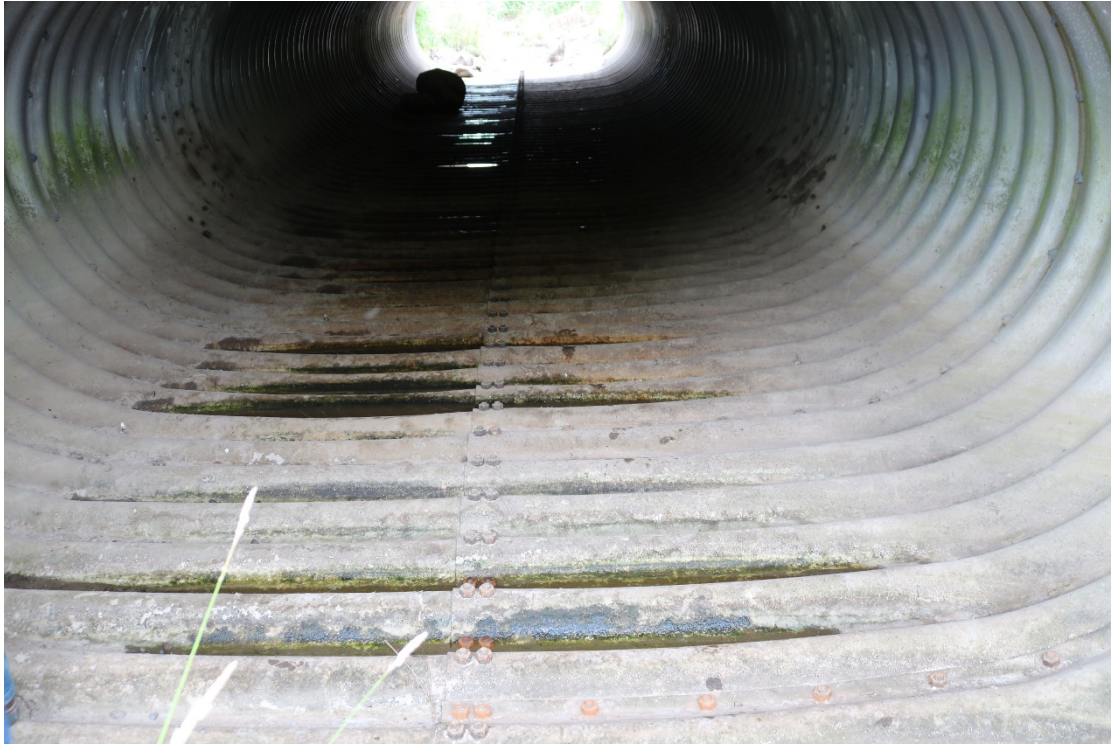
Photo 9

General condition at invert of culvert.

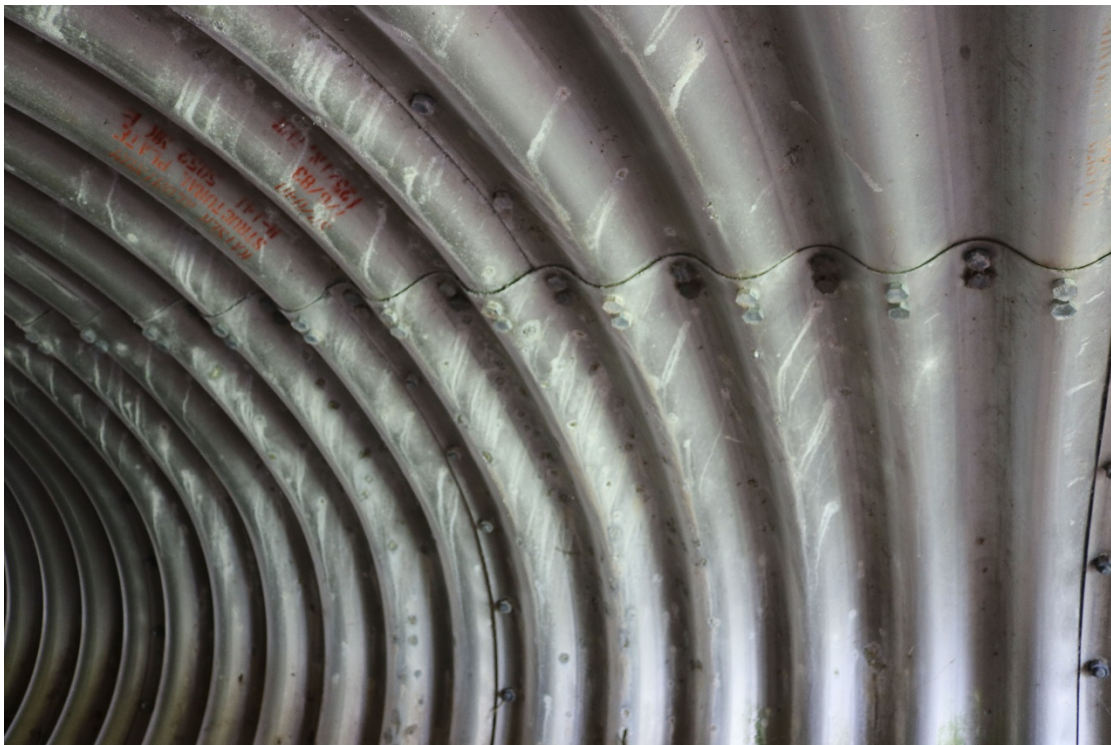
Photo 10

Close-up of one area of corrosion staining and marking on culvert identifying alloy 5052 and 6 July 1983 date.

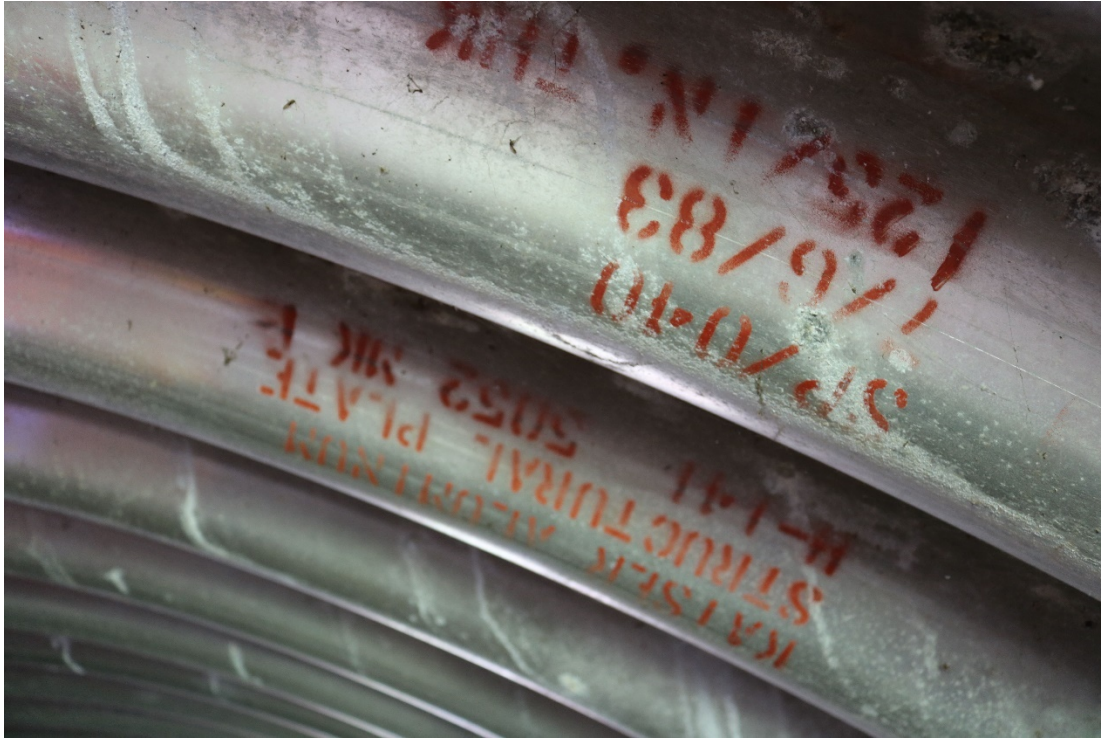
Photo 11
Close-up view of marking.

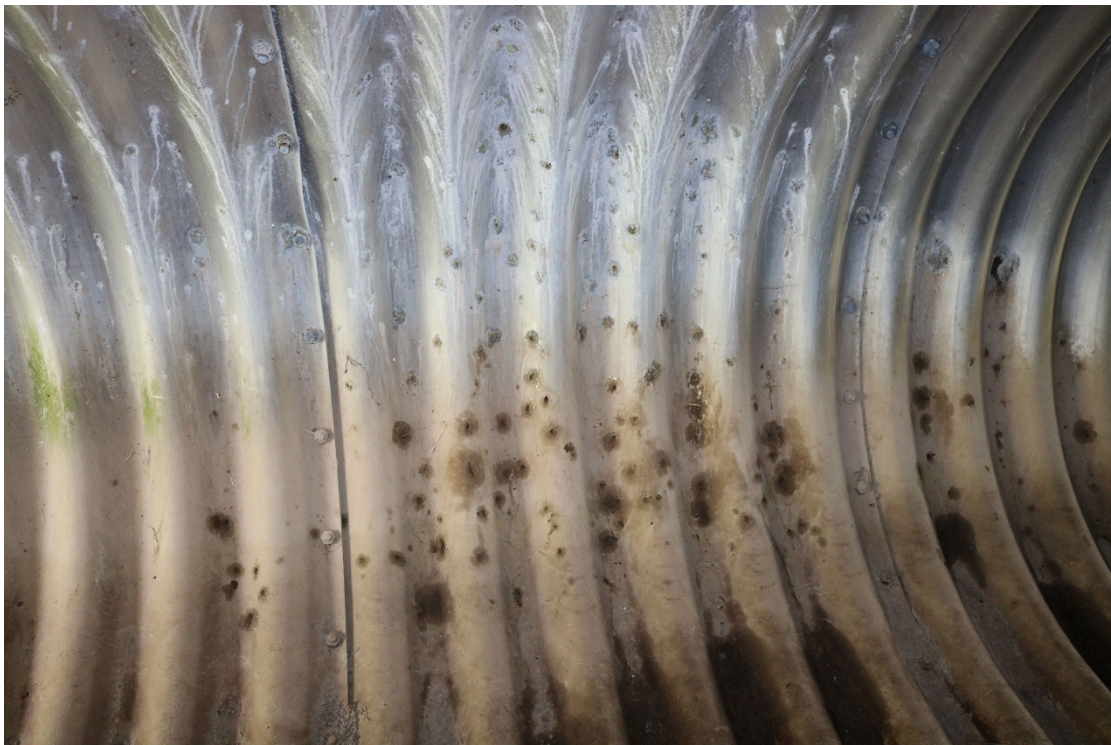
Photo 12
Area of through-wall pitting and corrosion staining at north springline, below west shoulder.

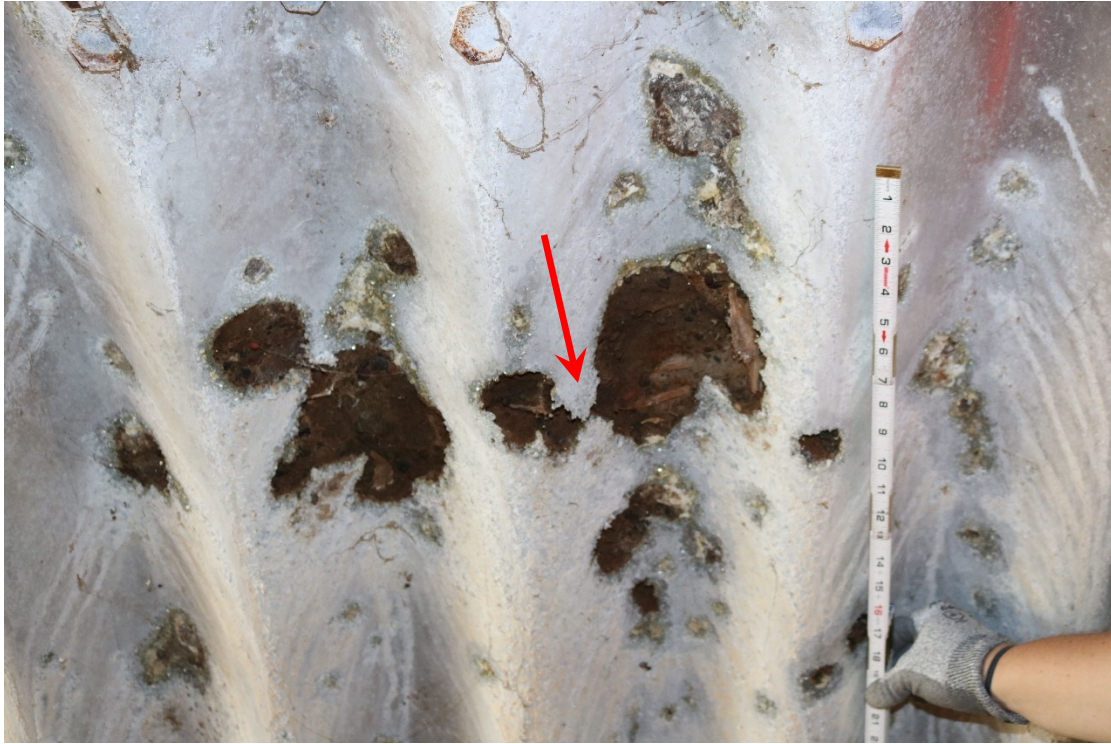
Photo 13

Area of coalesced through-wall pitting with severe corrosion staining and soil visible along north springline below east shoulder. Arrow points to area from which corrosion sample was removed.

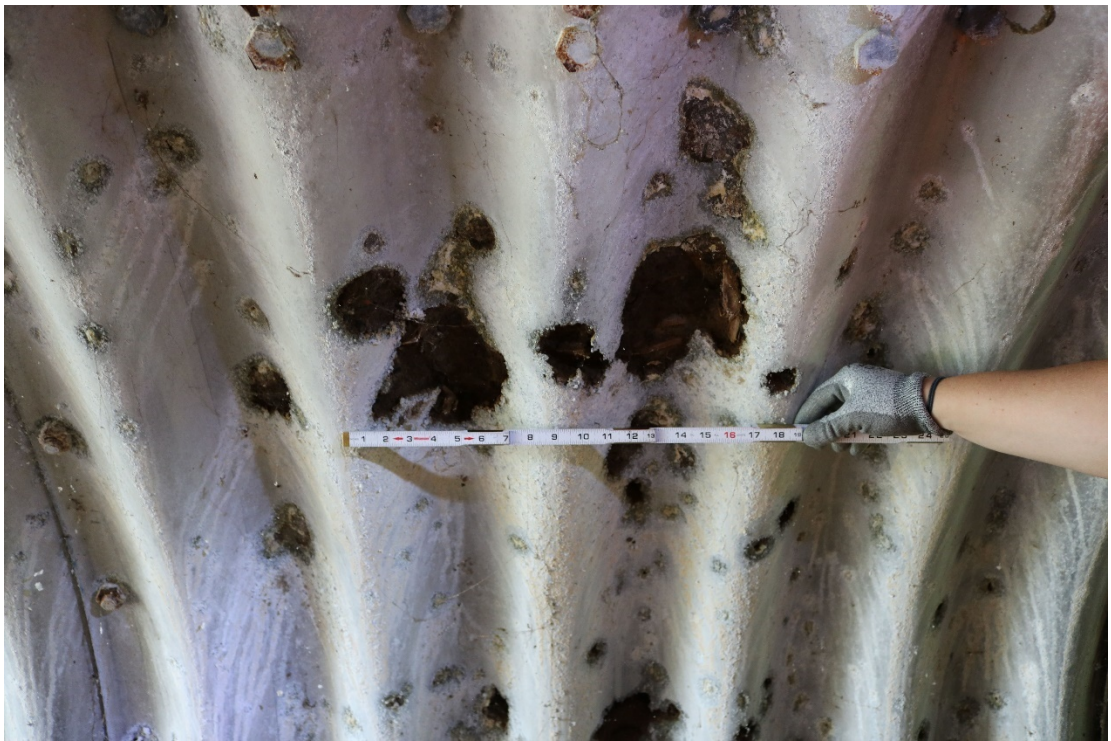
Photo 14

Similar location as Photo 13.

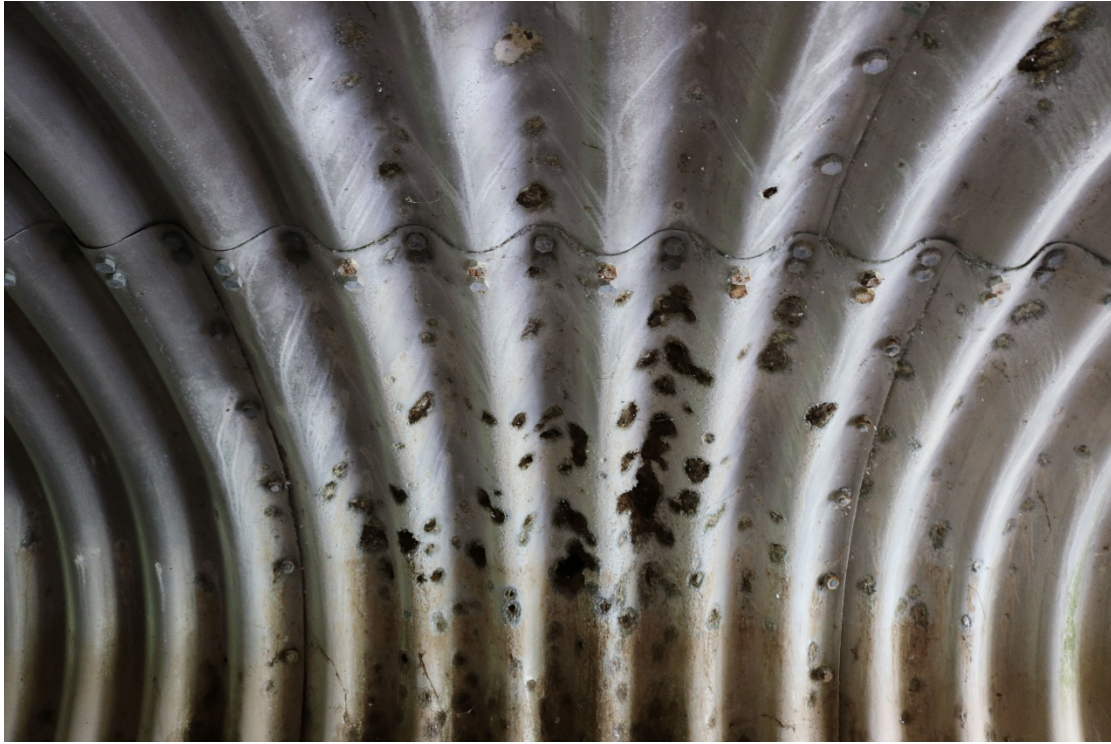
Photo 15

Area of coalesced through-wall pitting with severe corrosion staining and soil visible along south springline below east shoulder

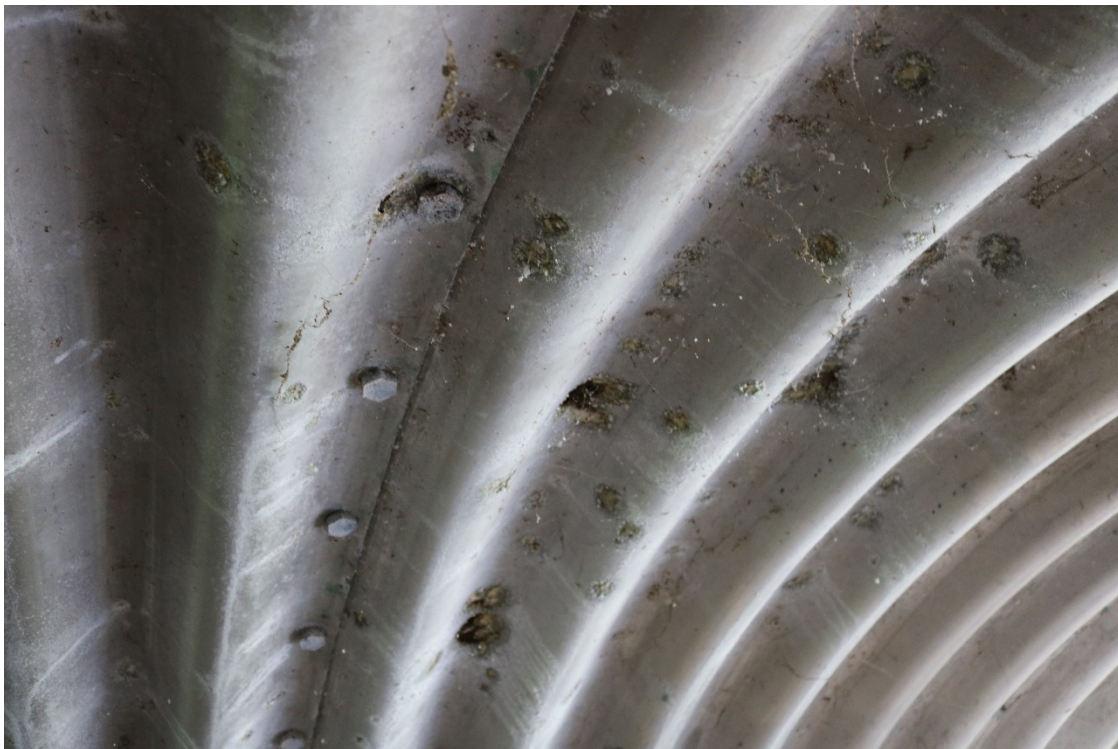
Photo 16

General view of corrosion pits working their way from the exterior to the interior of the structure, and surficial corrosion to galvanized steel bolts.

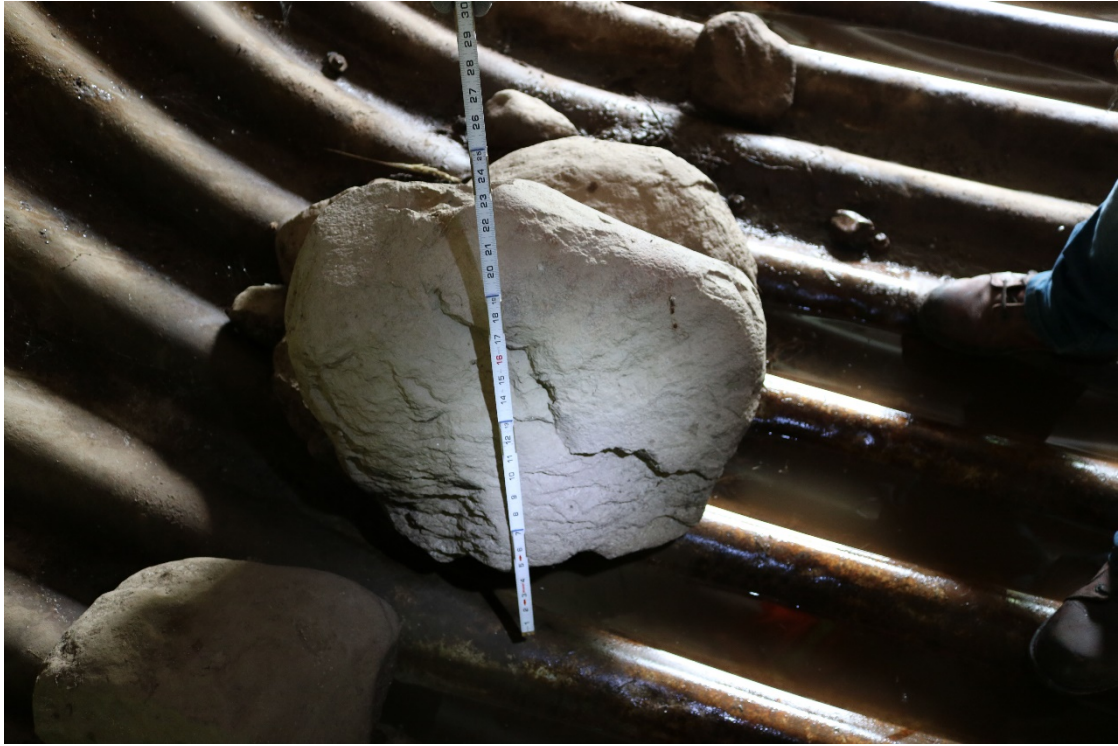
Photo 17
Boulders at invert
of culvert.

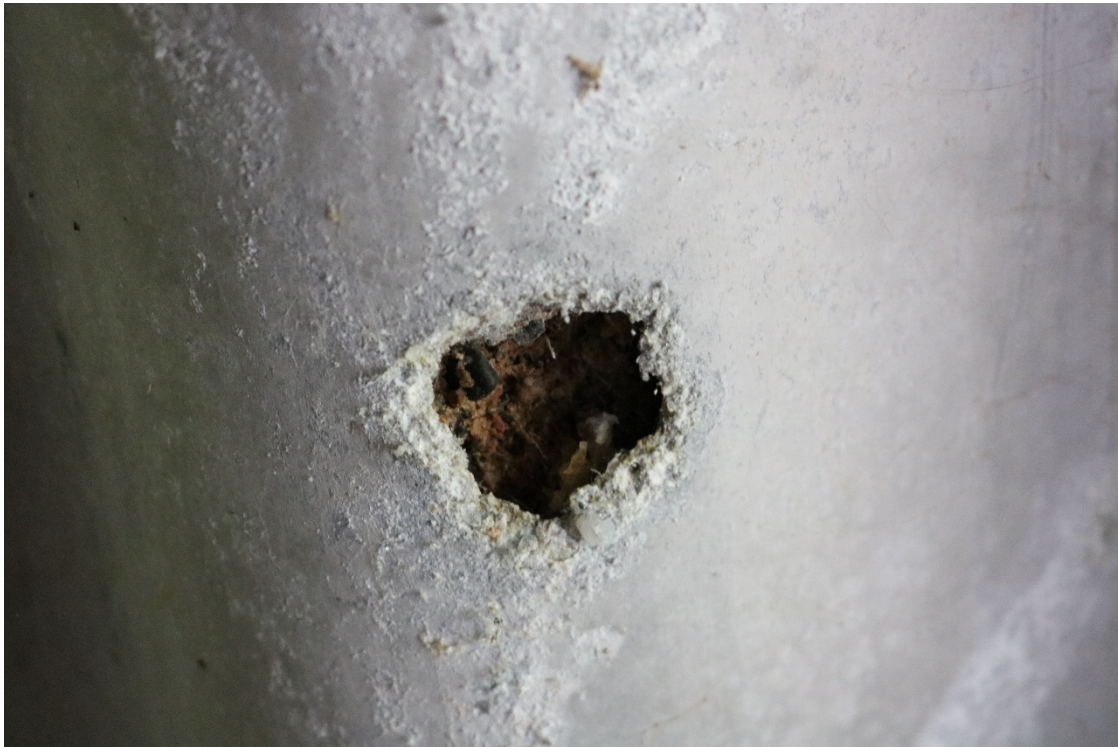
Photo 18
Close-up view of
through-wall pit.
