Performance and Policy Related to Aluminum Culverts in Wisconsin

Simpson Gumpertz & Heger Inc.

WisDOT ID no. 0092-17-05

May 2019

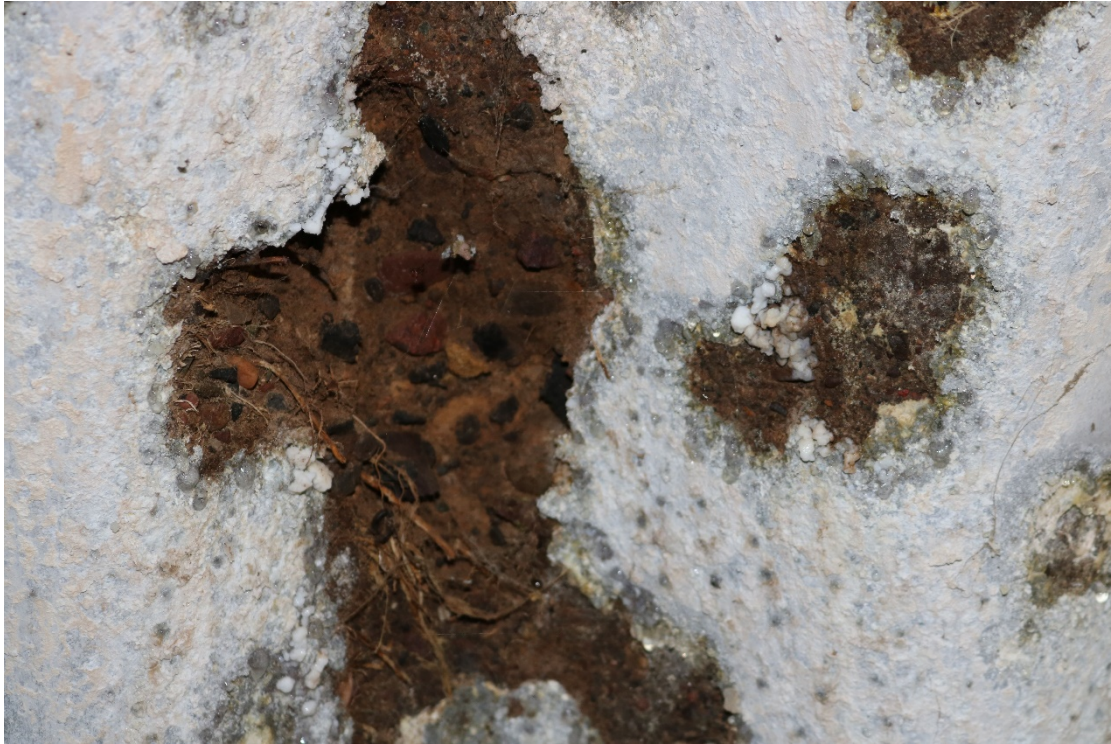
Photo 19
Close-up views of edges of pits with white corrosion products.

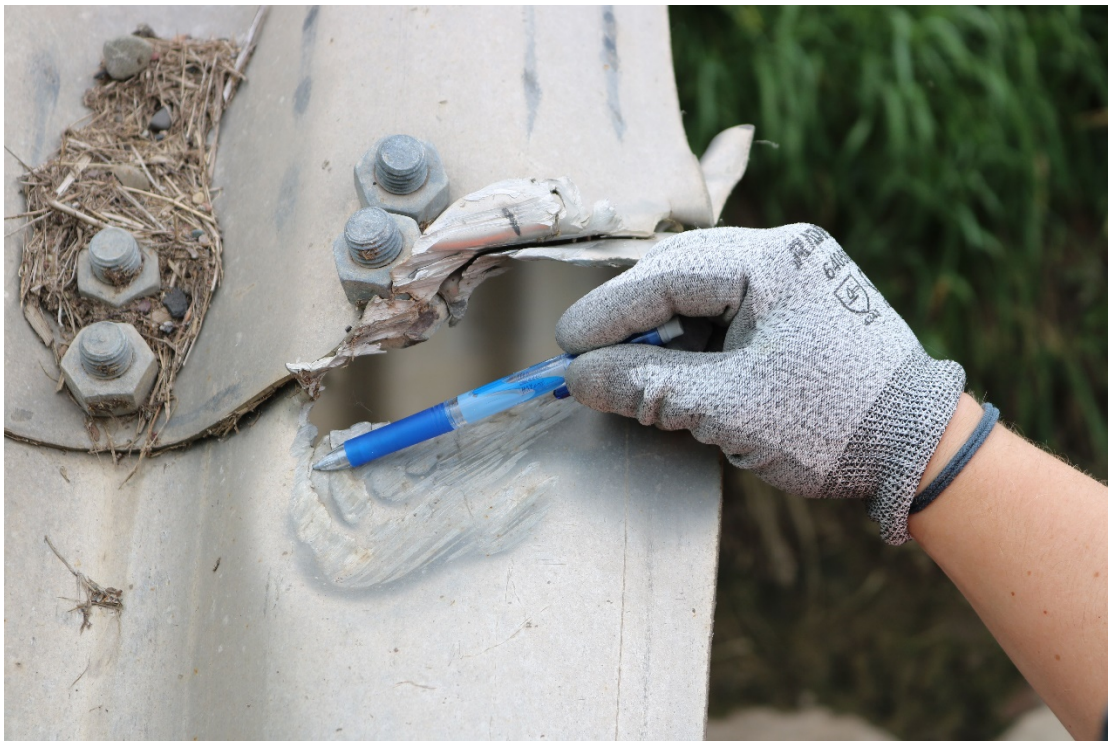
Photo 20
Area of previous damage at east end of culvert from which a small sample was removed for laboratory examination of uncorroded aluminum.

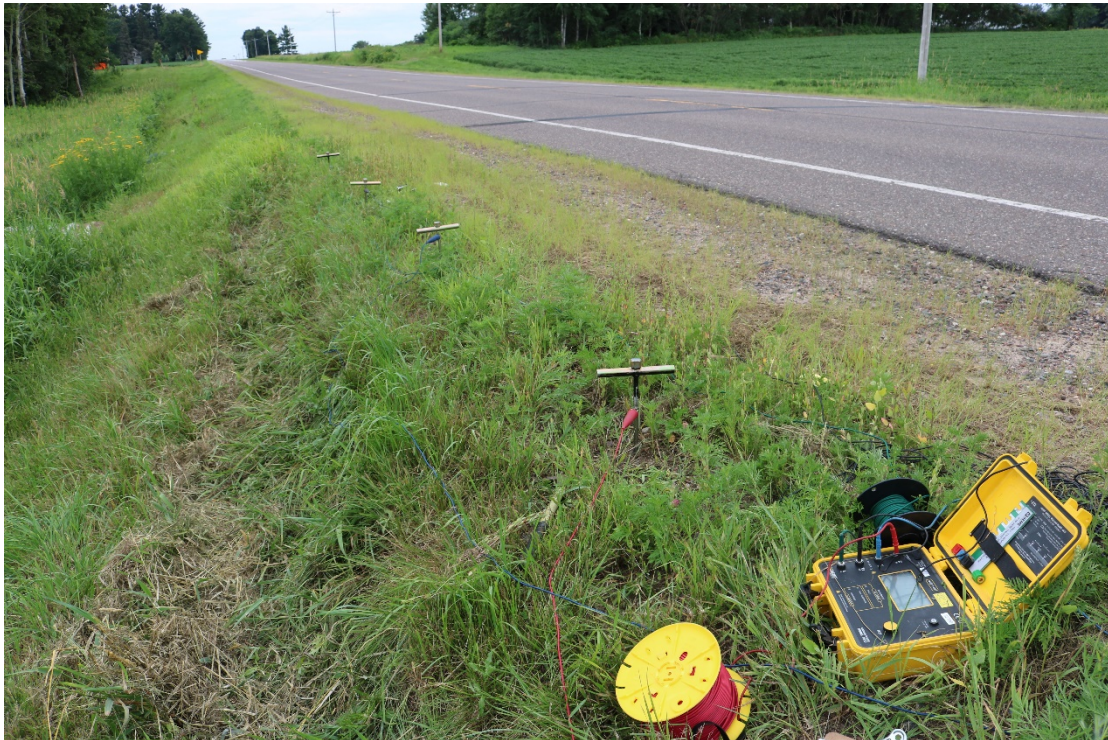
Photo 21

Typical soil resistivity test. View is looking southwest, at northeast of culvert.

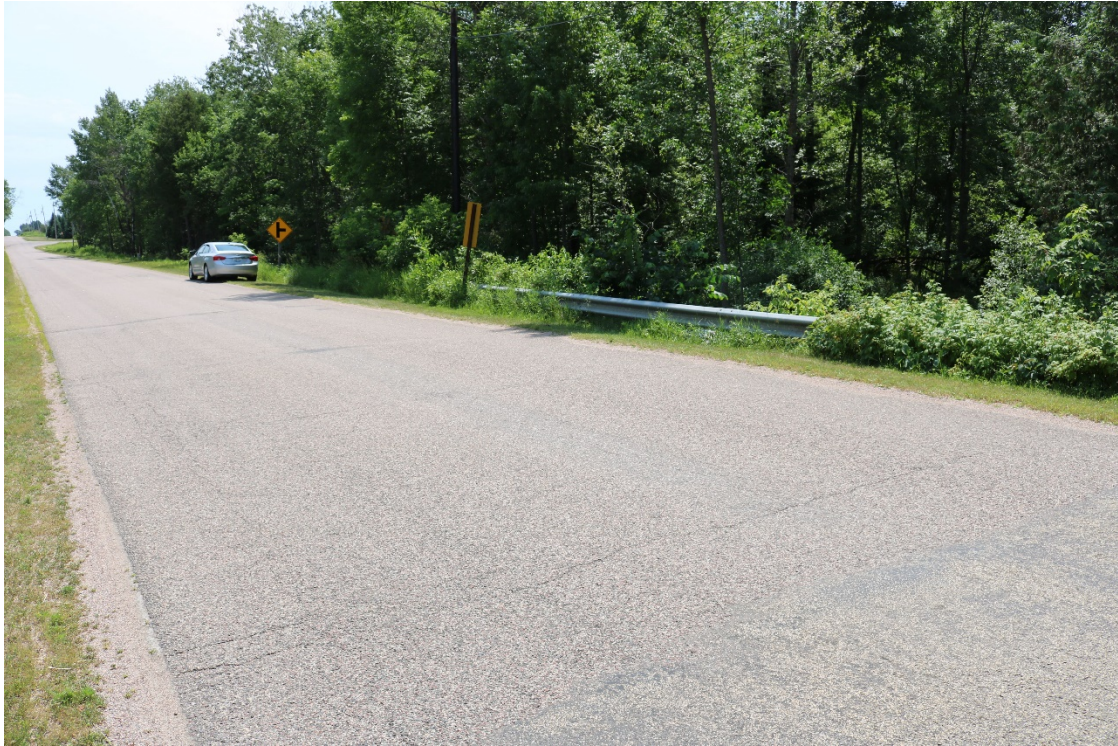
Photo 1

View looking southeast showing cross cracking of pavement in vicinity of culvert with shallow ruts. Downstream end of culvert is beyond barrier.

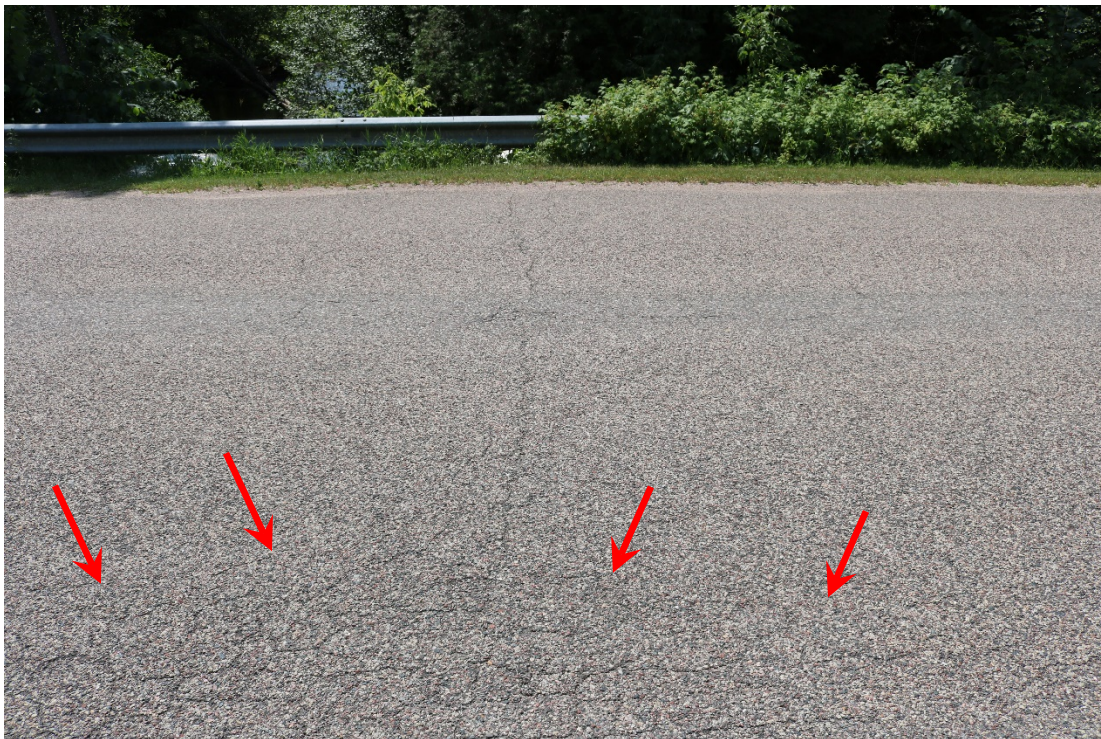
Photo 2

View looking north toward upstream end of culverts showing large cross crack aligned with crown of culvert, and additional alligator-type pavement cracking in foreground (red arrows).

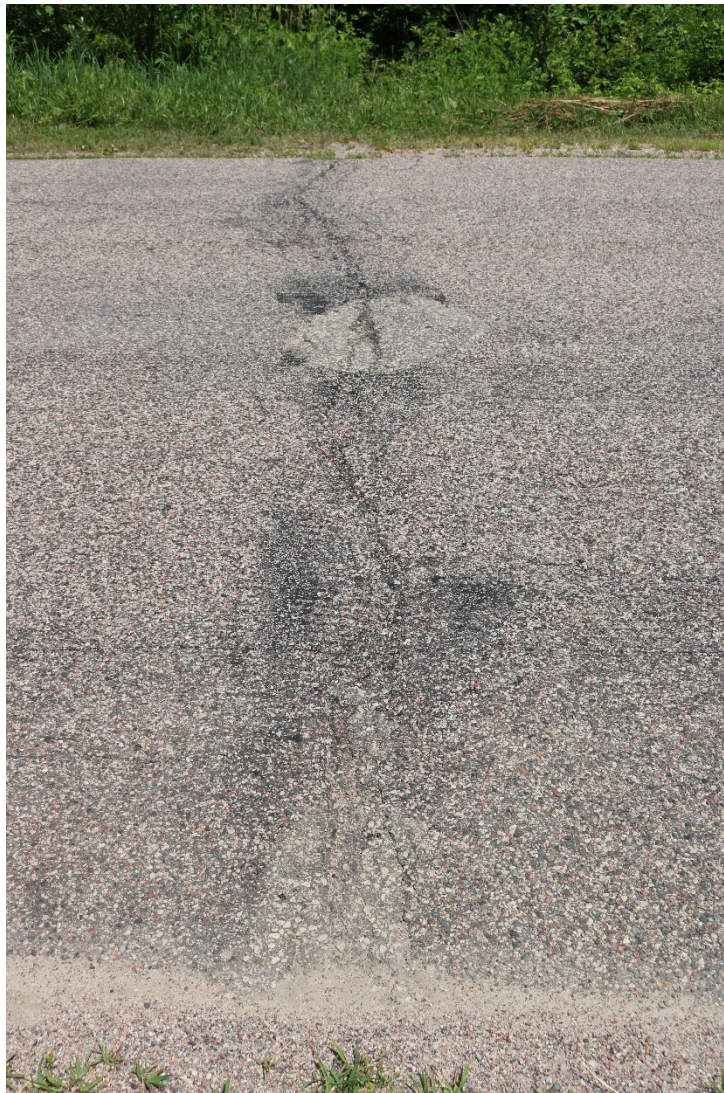
Photo 3

Pavement cross crack in vicinity of culvert.

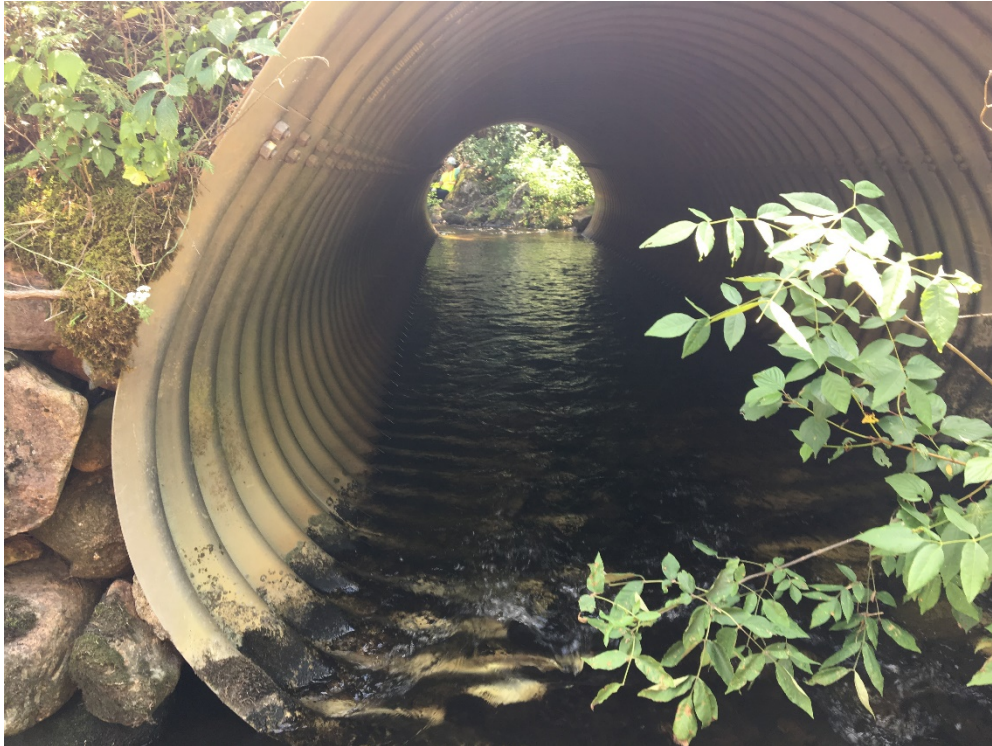
Photo 11

Typical condition along length of culvert looking downstream.

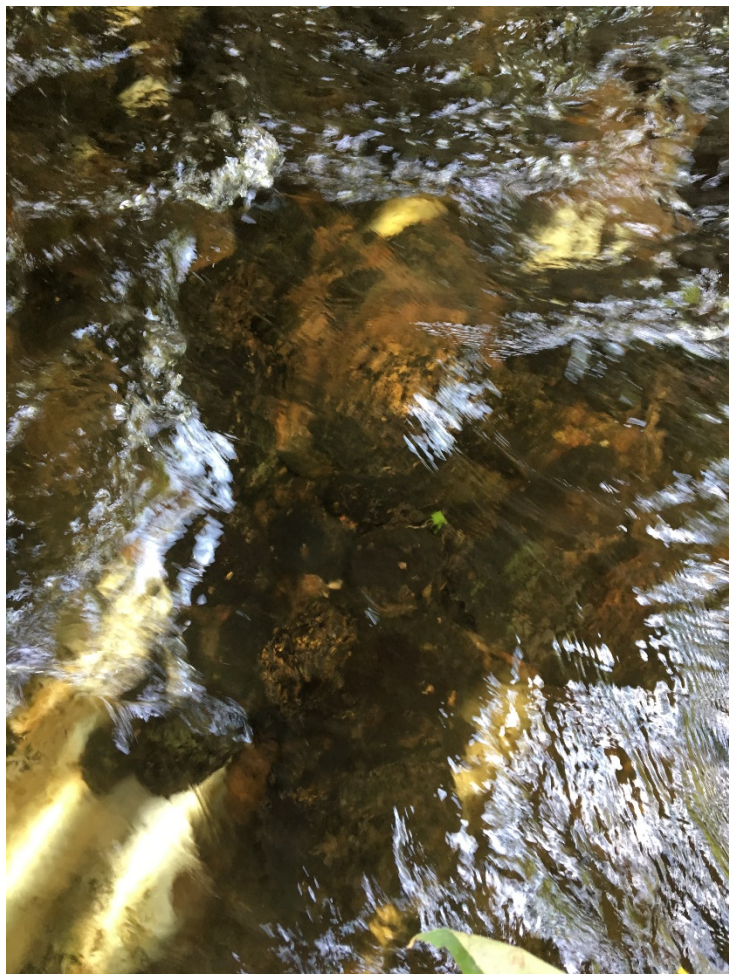
Photo 12

Typical stream flow and bedload during inspection.

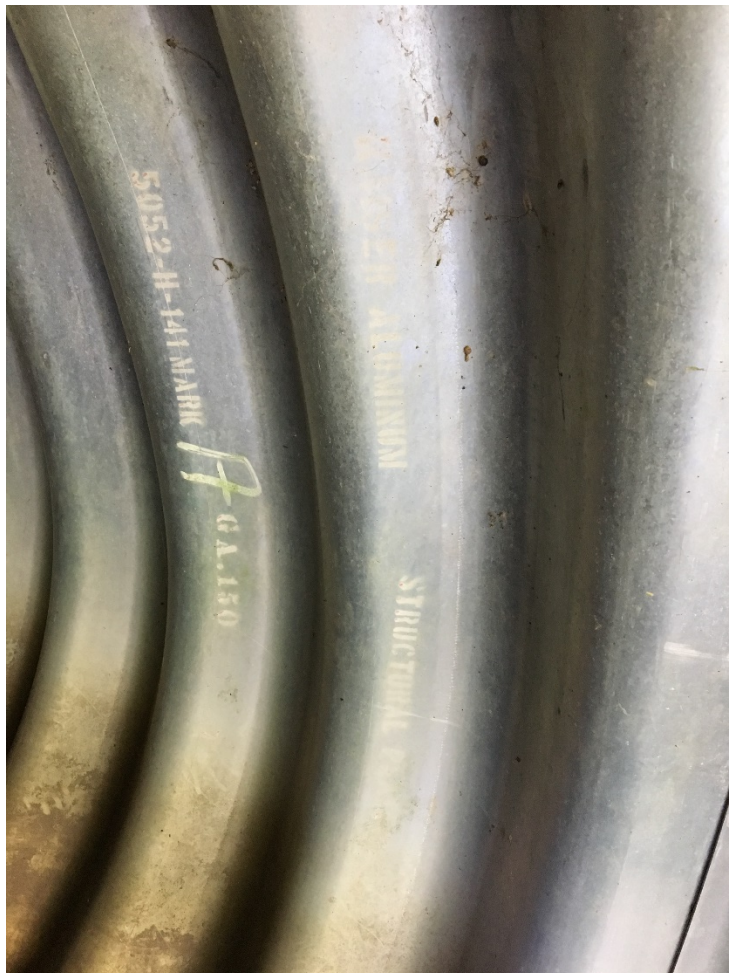
Photo 13

Corrugated aluminum structural plate markings: 5052-H-141 Mark A GA .150 Kaiser Aluminum.

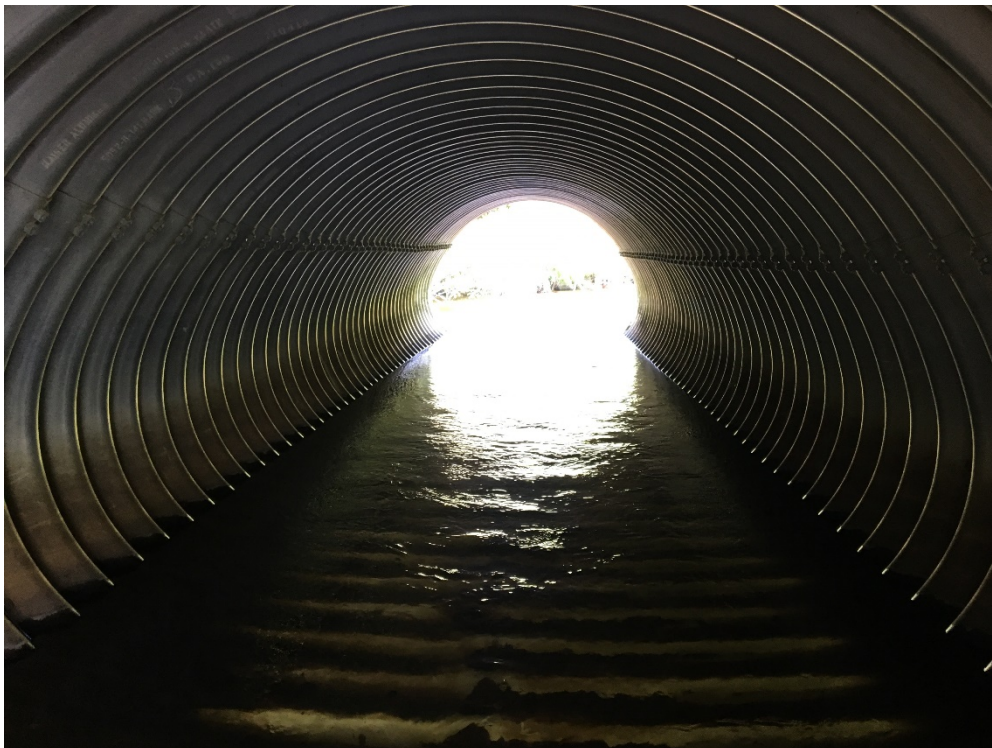
Photo 14

Typical shape inside culvert barrels.

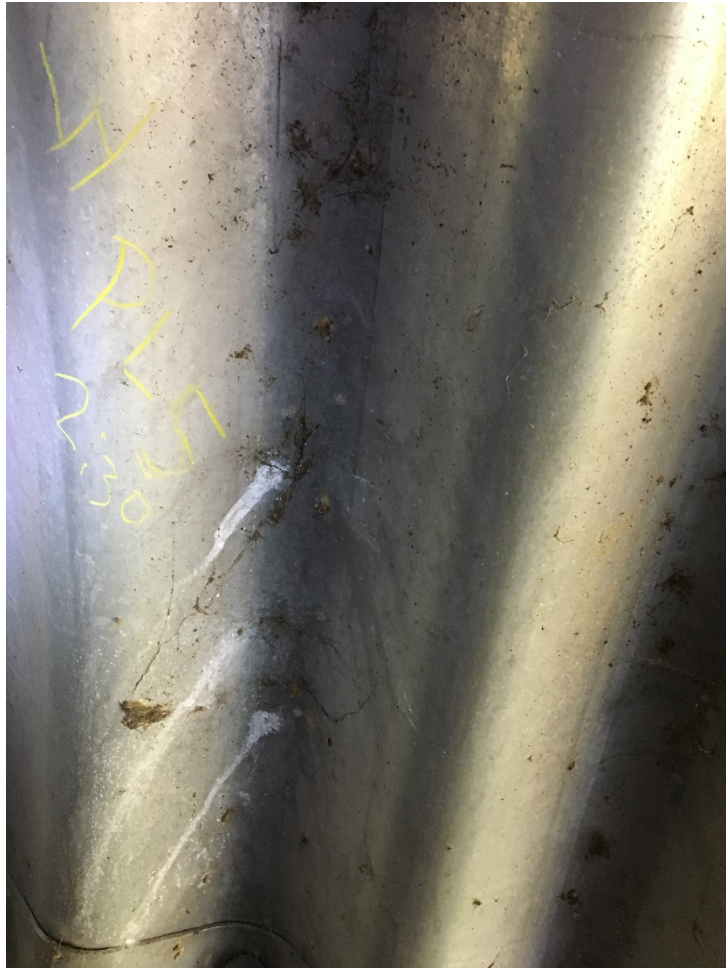
Photo 17

- West culvert: upstream end, Plate 1 = 1 corr, then Plate 2 and on are 6 corr standard plates, all circumf. seams staggered.
- Plate count is by west springline, Plate 5 has 3 white stain spots at 2:30 within 8 in. circ distance; structure is 11 plates long.
- PL 11 is 4 corr long. Bed load = Sandy silt/gravel w/ occasional boulders up to 18 in., plates stamped Kaiser aluminum S.P. 5052- H-141 GA.150 710413.
- Center Culv - Seams staggered similar to west and start same way at U/S end, minimal bed material at invert, gravel and up to 8 in. rocks, 11 plates long, D/S end west side = 4 corr, no visible distress
- East is similar to other 2, bed load is mainly silty sand/gravel w/up to 10 in. rocks, PL 5 has 2 areas w/ white staining, 1 at 10:00, 1 at 2:00, PL 7 has 1 at 12:30, 1 at 11:00

White corrosion staining appearing as evidence of pitting in west barrel, Plate 5, at 2:30 clock position.

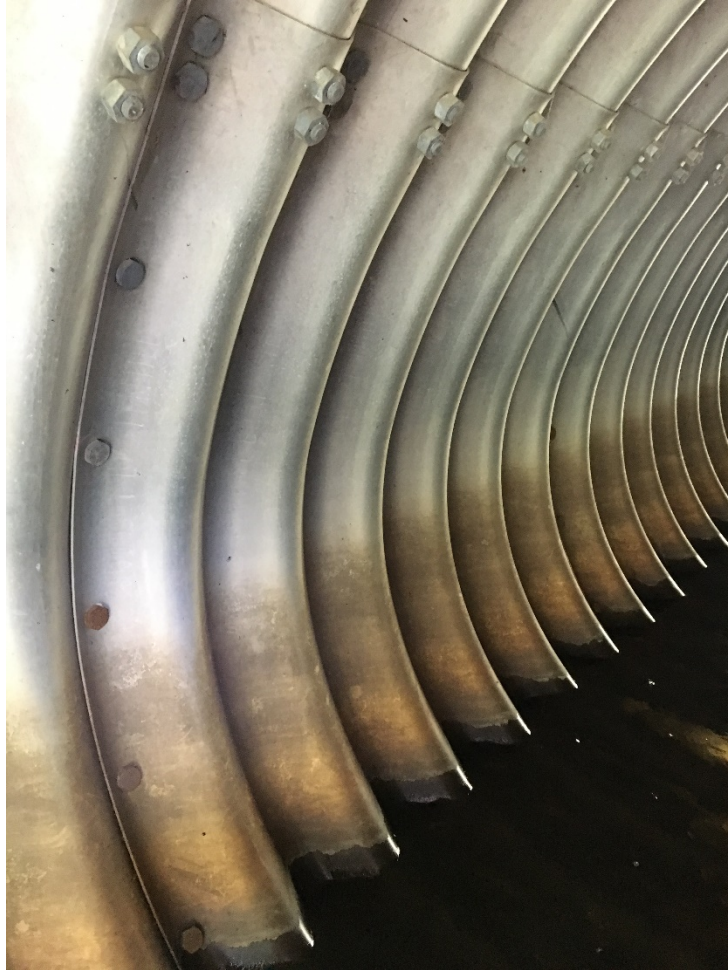
Photo 18

Typical brown staining in lower portion of barrel, and typical fastener condition with minor surface corrosion at high water line fasteners.

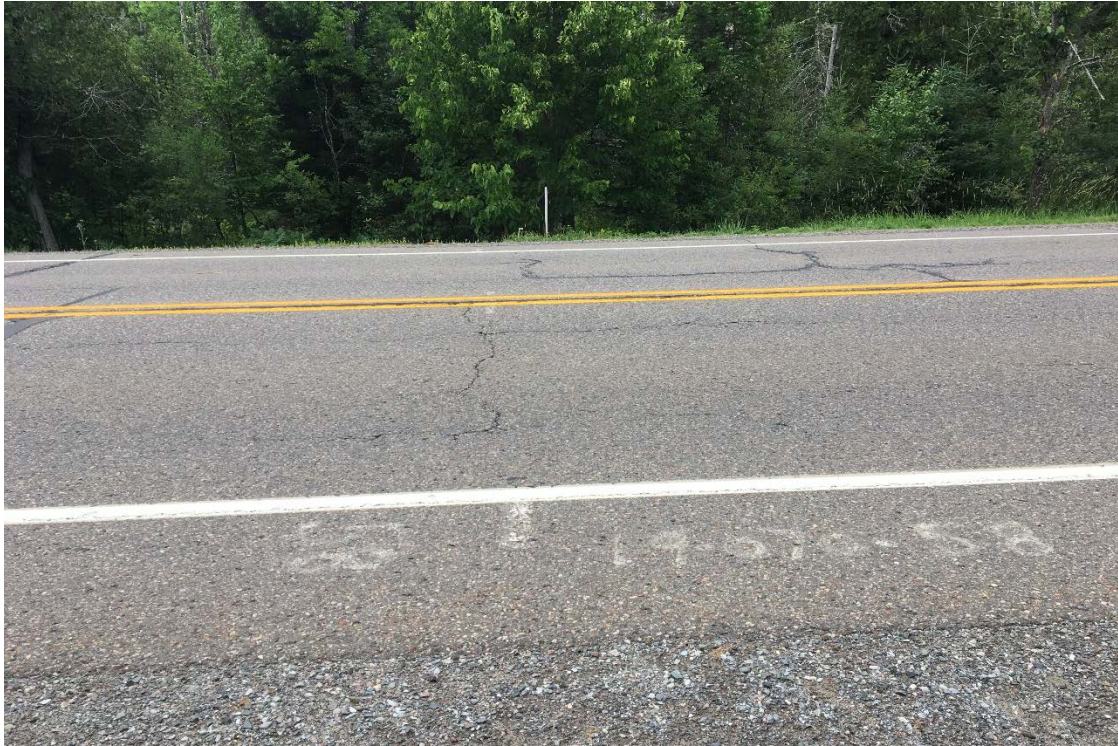
Photo 1

View looking north (downstream) across roadway above culvert. Note unsealed cross crack aligned with culvert (culvert is aligned with white spray paint and culvert marker in distance).

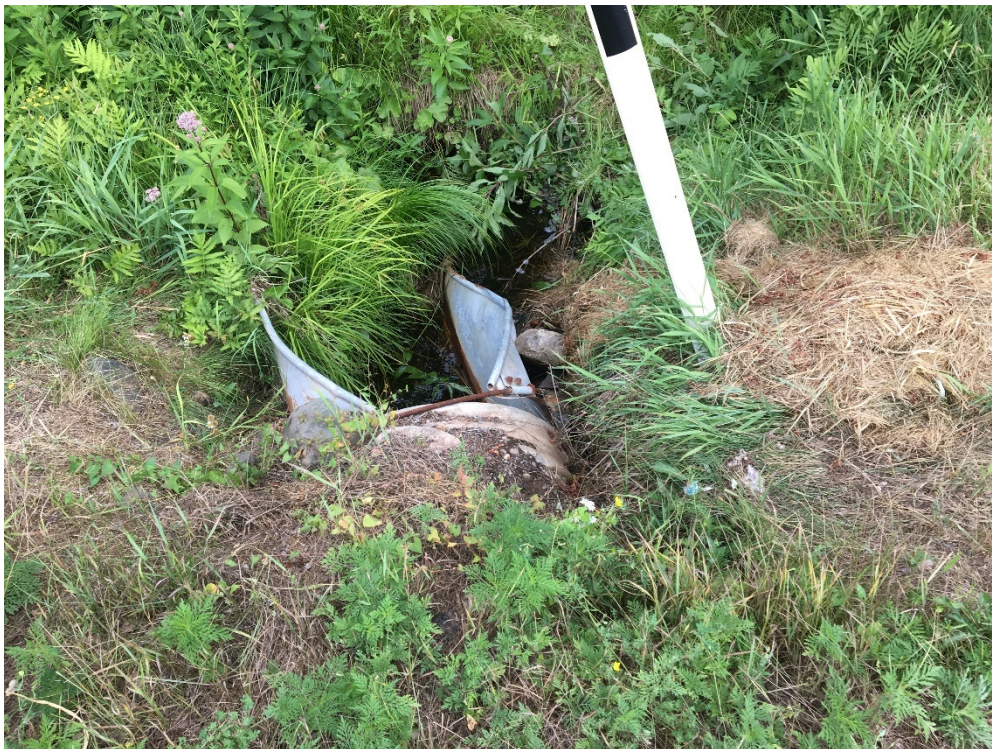
Photo 4

Looking down south (upstream) embankment. Note galvanized end structure, which is corroded through at invert.

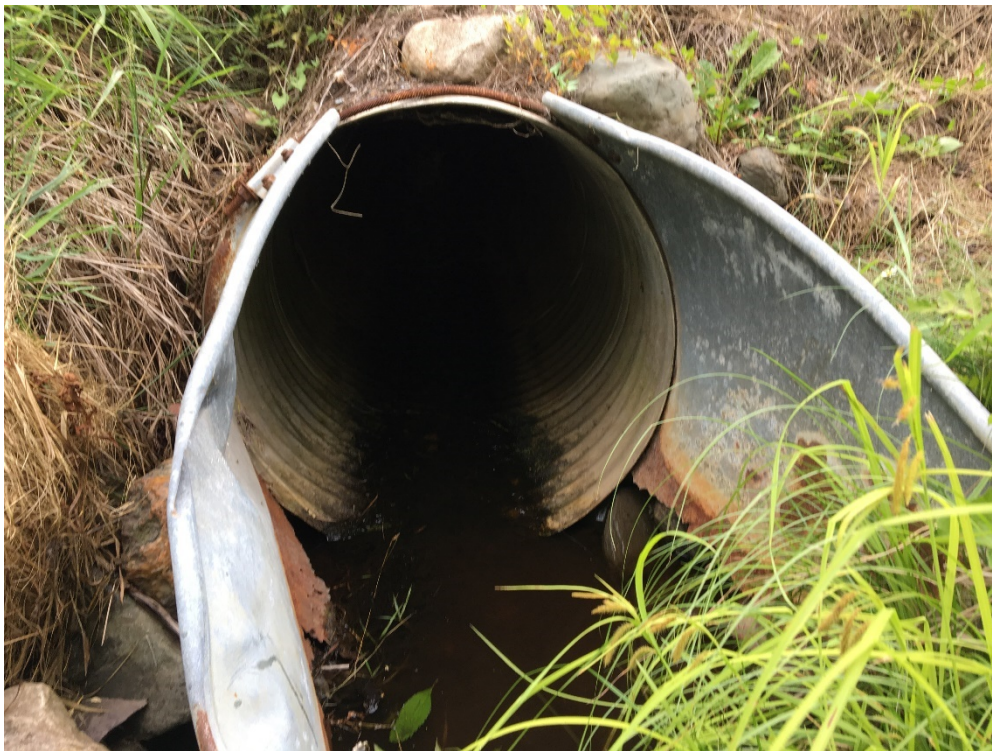
Photo 6

South elevation (looking north). Note corroded invert of galvanized steel end structure.

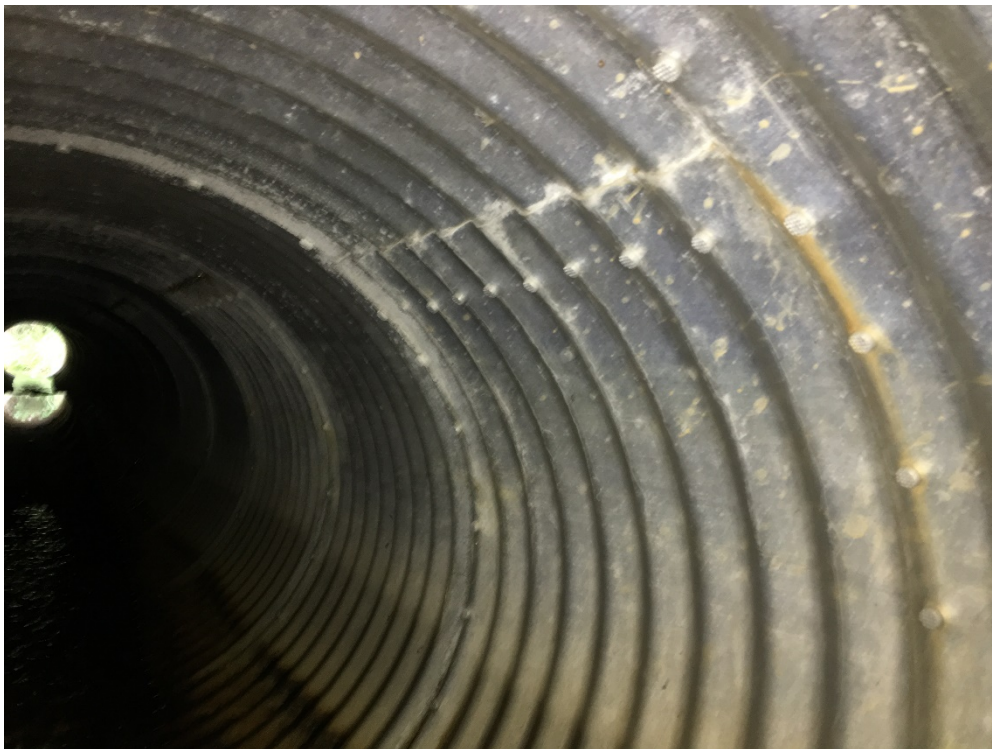
Photo 8

Typical riveted seam with circumferential seams at 24 in. on center, and one longitudinal seam per ring. Some white corrosion staining visible at seams.

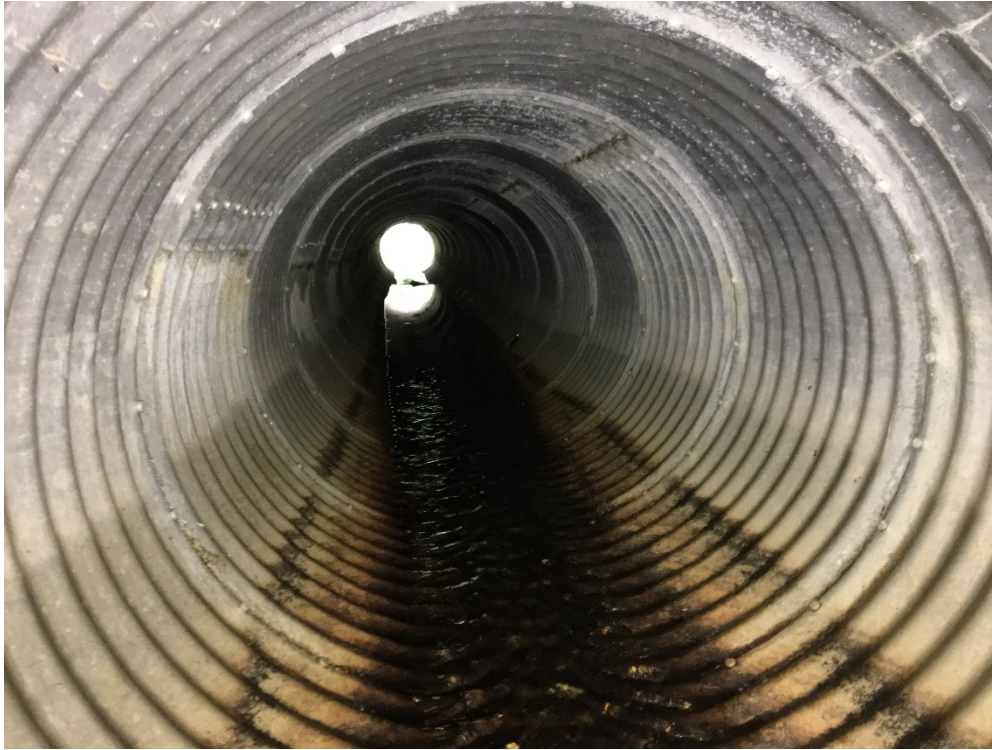
Photo 9

View looking downstream inside culvert showing typical circumferential seams with white staining.

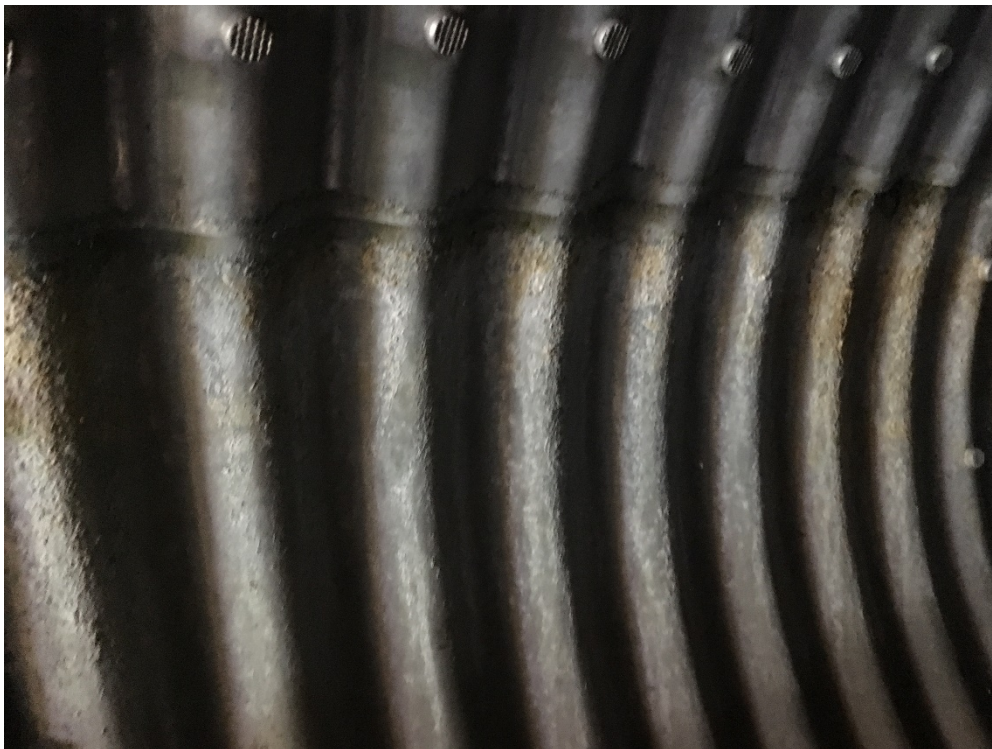
Photo 10

Longitudinal seam, higher portion is lapped over lower portion in photo, and lower portion has evidence of white corrosion products and surficial section loss. Rivets appear to be in good condition at top. Culvert Section 5, approx. 10 ft from upstream end.

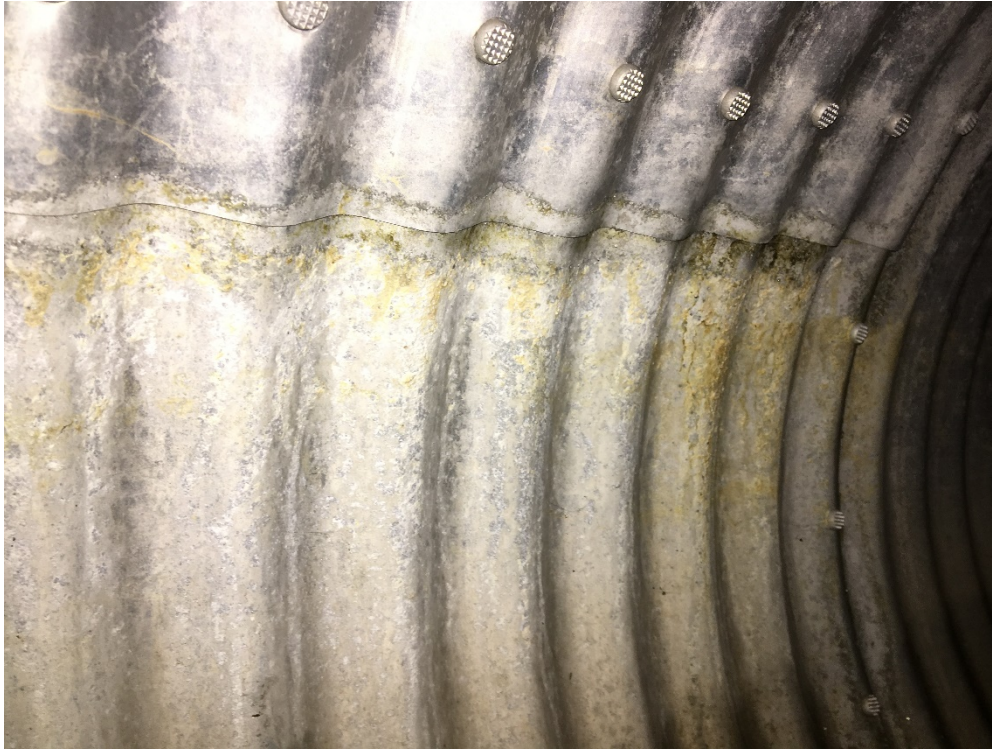
Photo 11

Similar location and view to Photo 10.

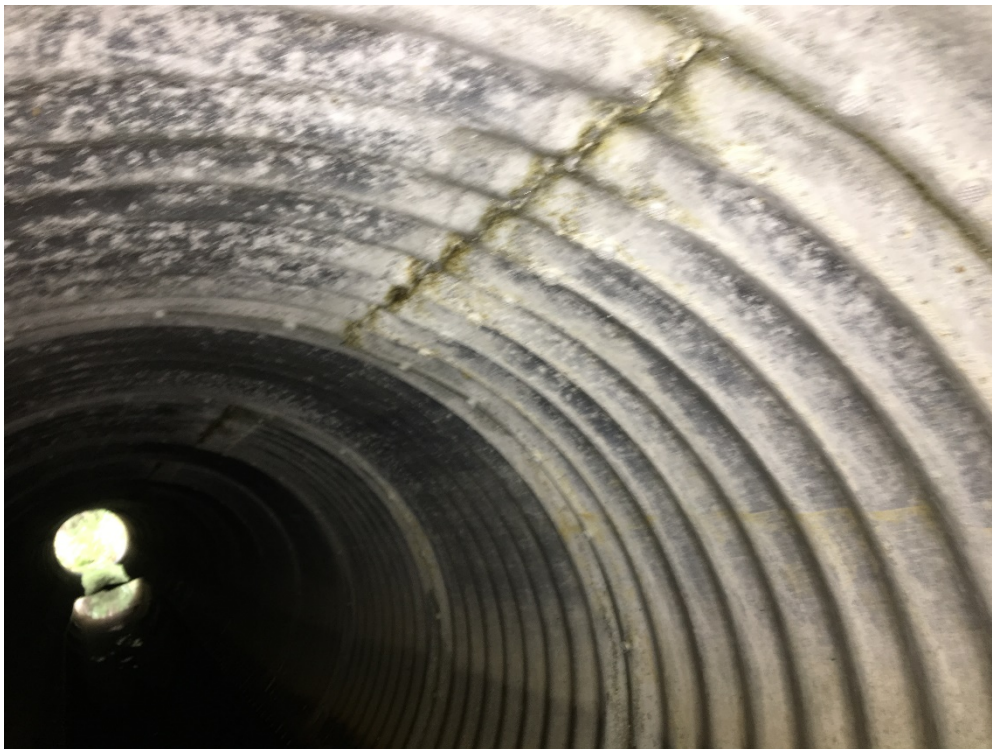
Photo 12

White corrosion staining at longitudinal seam with some surface irregularities/pitting.

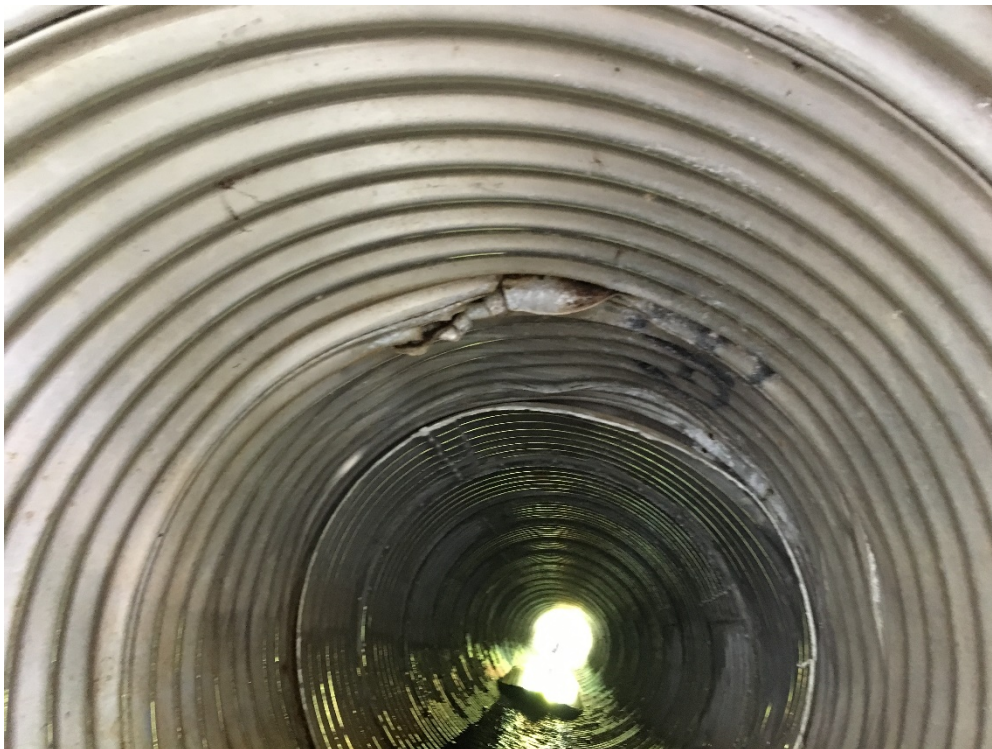
Photo 14

Damage at crown, 1 ft long, near downstream end. Note: Ends of culvert are spiral with crimped seams and appear to have been added on, perhaps with roadway widening; the visible damage is in the end section.

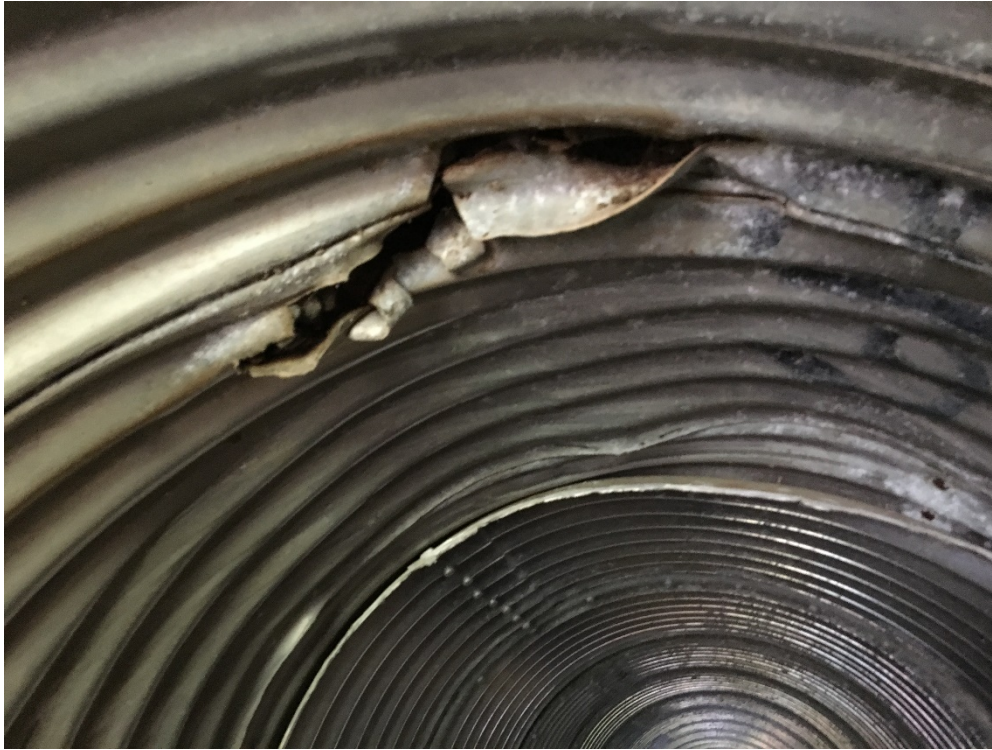
Photo 15
Close up of crown damage near downstream end of culvert.

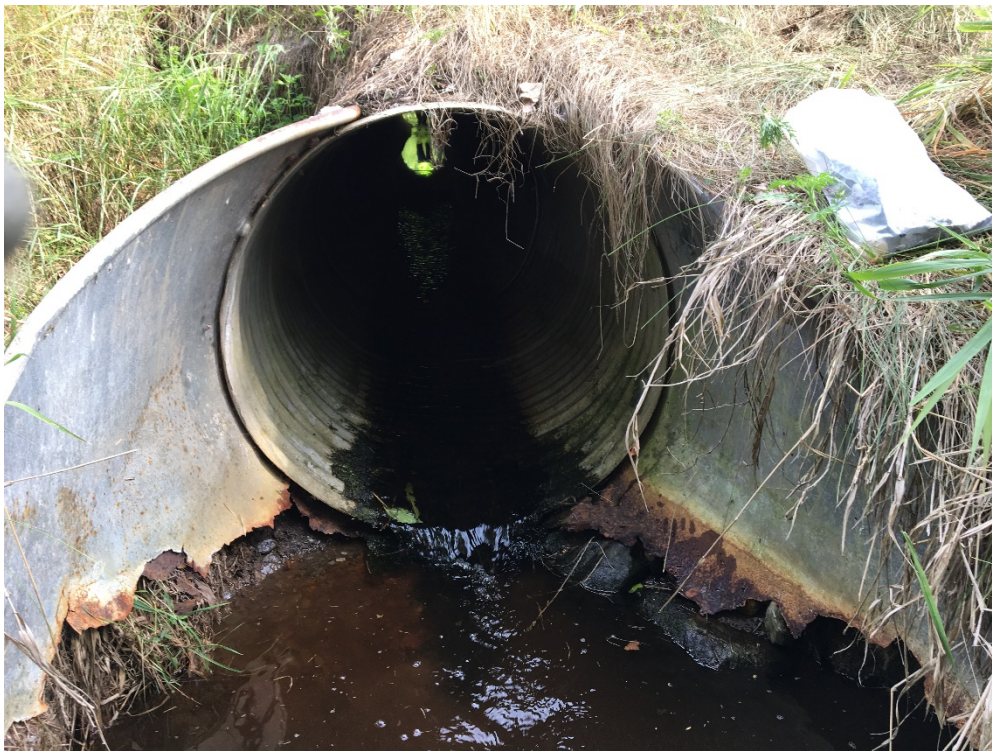
Photo 16
North elevation (looking south/upstream). Note galvanized steel end structure corroded through.

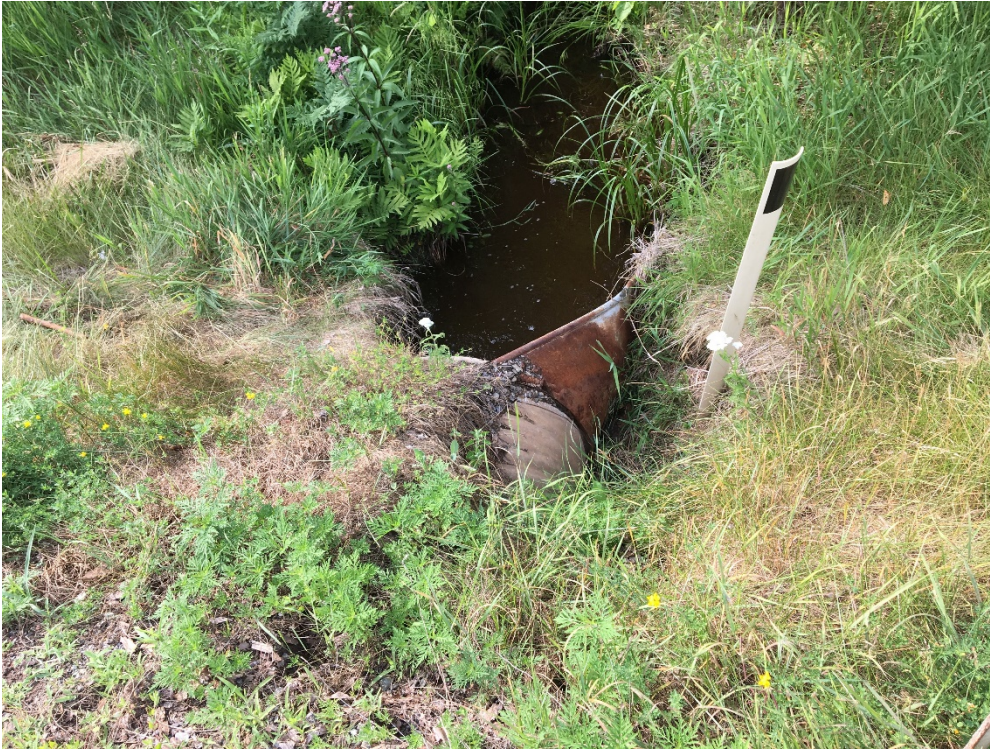
Photo 17

Looking downstream down south embankment. Some erosion visible upstream of end structure.

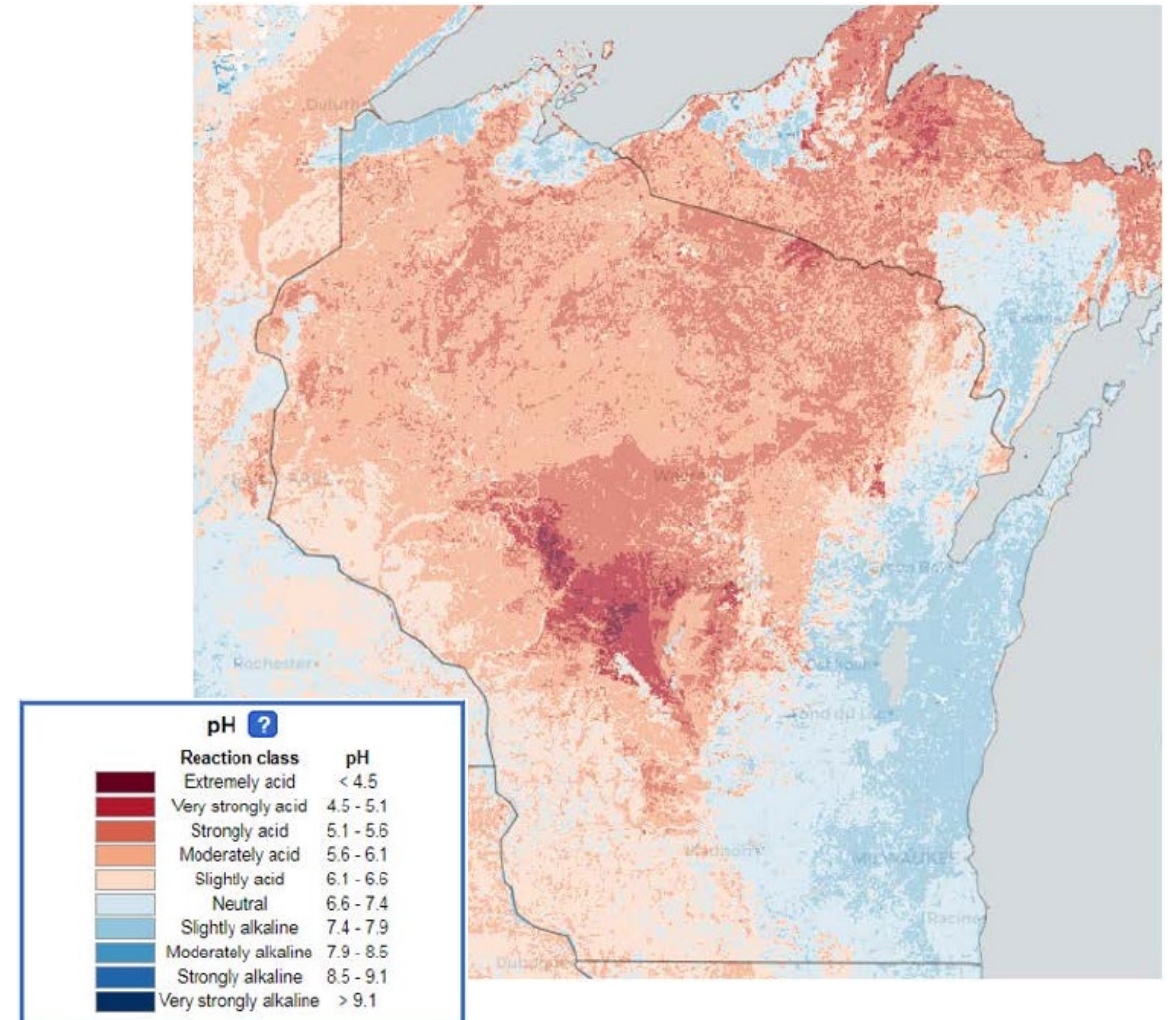
Abrasion Evaluation for Aluminum Culverts

- Classify a site as Abrasion Level 1 to 6 based on bed load and flow velocity from a 2 to 5 yr flood
- Bed load evaluation by visual examination (no lab tests)
- Table at right adapted to aluminum culverts from Caltrans Highway Drainage Manual
 - Caltrans HDM includes additional information for other culvert materials
- A second table is provided in the HDM to link bed load materials/particle sizes, water depths, and non-scour velocities

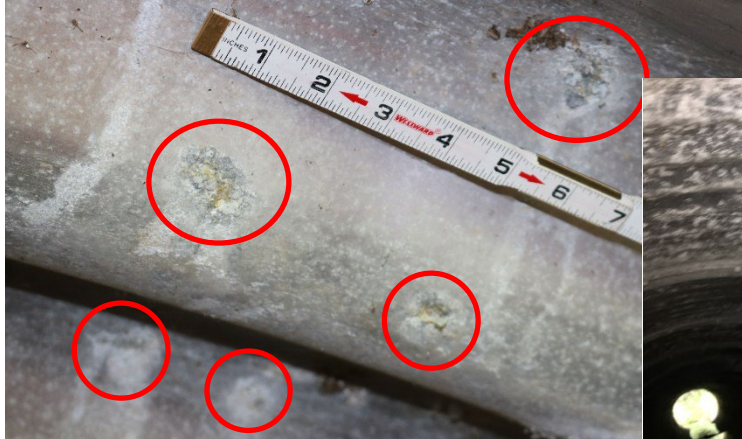
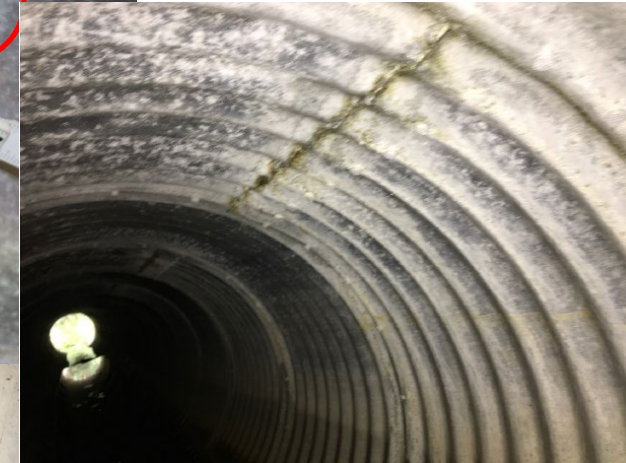
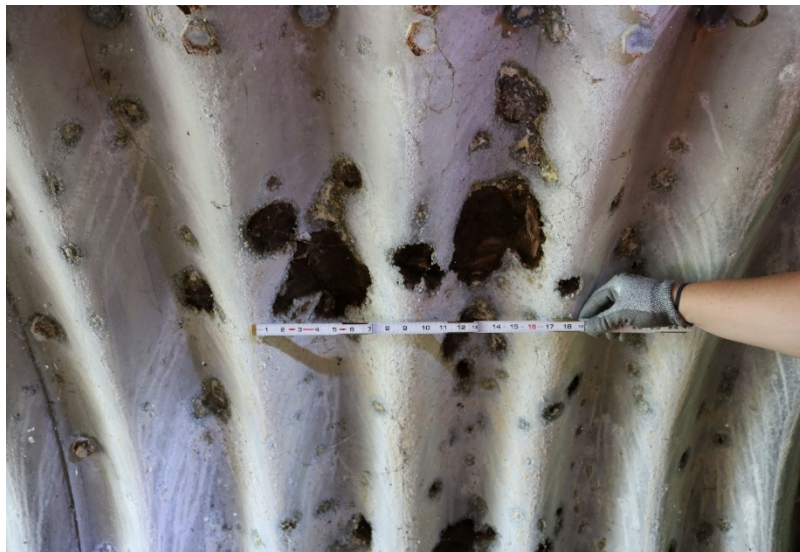
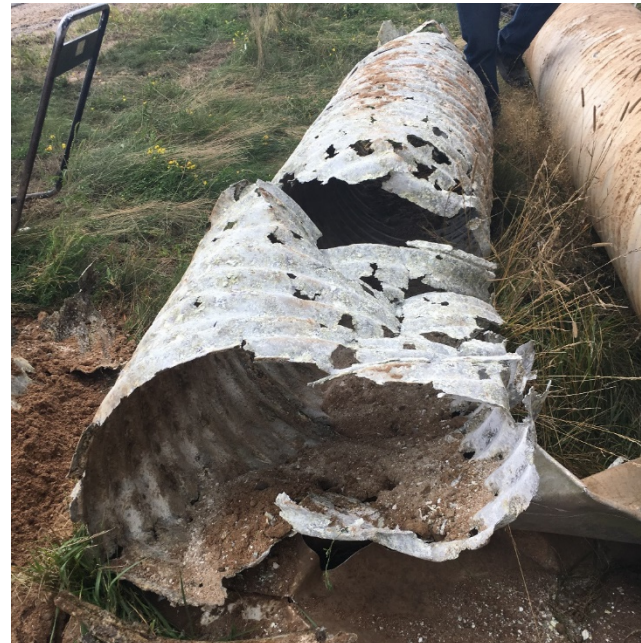
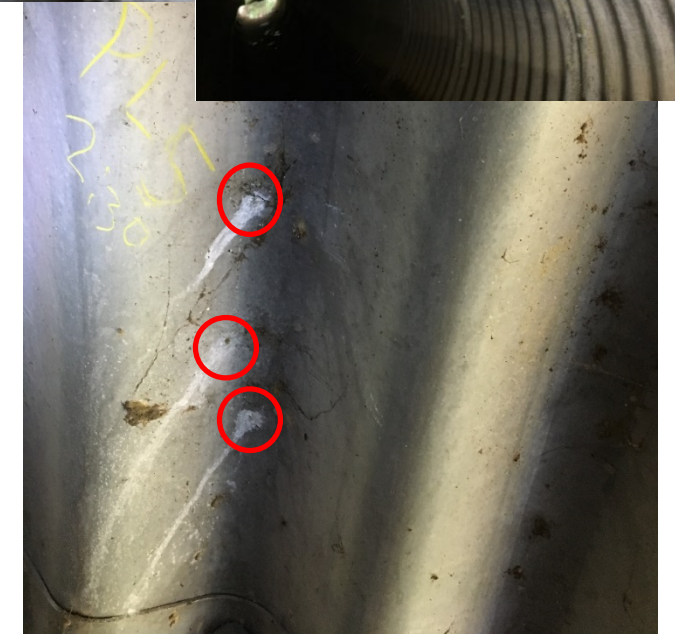
Aluminum Culvert Pitting Corrosion

- Aluminum will corrode by pitting corrosion when exposed to concentrated chlorides.
- Research found a correlation between likelihood of corrosion, prevalence of cracked pavement, and increased culvert age.
- No obvious correlation between likelihood of corrosion and ADT, fill depth, or culvert length.
- Once pits form, they do not stop and will continue to drill their way through the aluminum.
