Performance and Policy Related to Aluminum Culverts in Wisconsin

Simpson Gumpertz & Heger Inc.

WisDOT ID no. 0092-17-05

May 2019

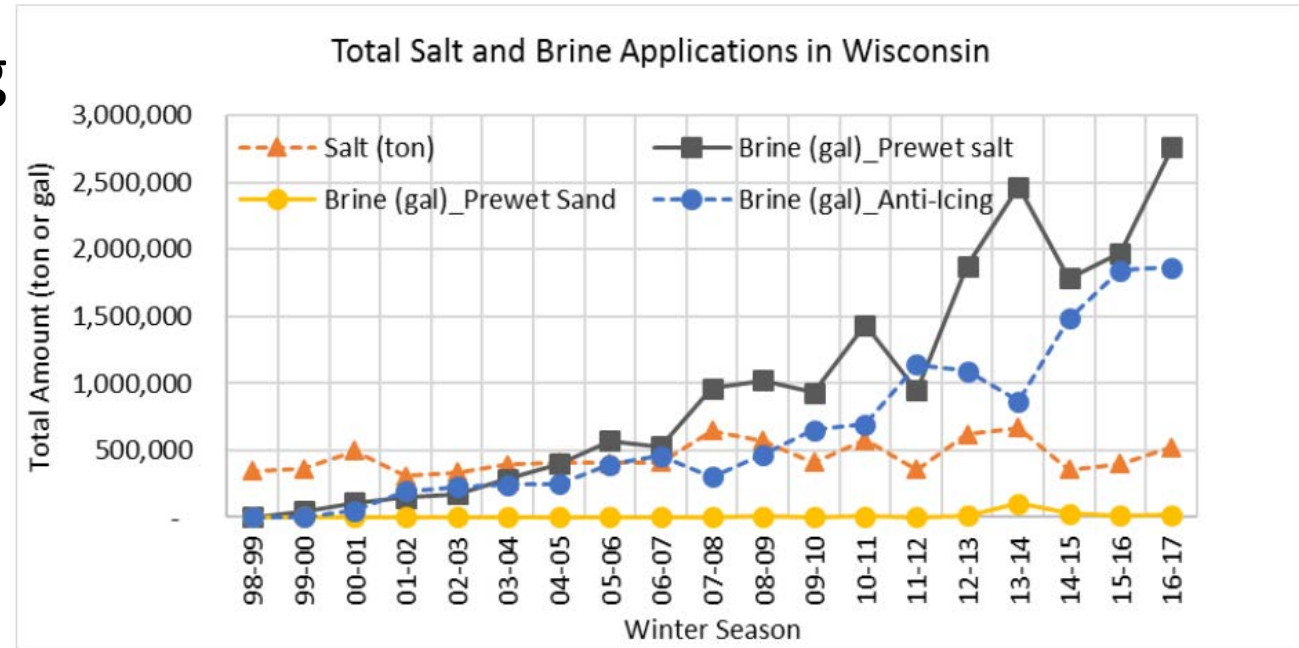
Figure Reference: WHRP Project 0092-17-03

Wisconsin Usage of Chloride-Based Road Treatments

- Usage of chloride-based deicing salts has been steady.
- Usage of chloride-based anti-icing brine has increased.
- Even newer treatments, such as Beet 55 (beet juice), are used as additives to chloride-based salts or brines and the solutions will still be aggressive to aluminum.

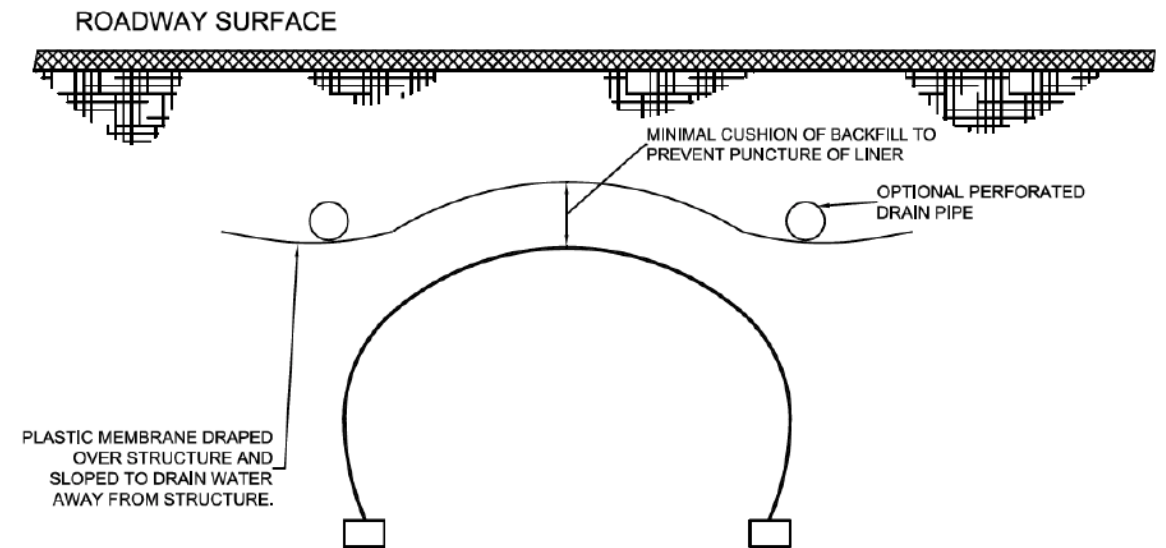
Backfill Isolation Membrane – Concept

- Detail at right conceptually shows a backfill isolation membrane detail from a metal culvert manufacturer.
- Membrane should be extended at least for the trench width and for 10 ft from the edge of pavement or to the end of culvert.
- Backfill below the membrane should have limited chloride content; best practice is for the backfill in contact with the culvert to be free-draining.

- The most economical method to protect aluminum culverts from chloride-based deicing salts that can migrate through soil fill, unpaved shoulders, and cracked pavement is through inclusion of an impermeable isolation membrane in the backfill above the structure and limiting the chloride content of the backfill under the membrane. Also, consider specifying this backfill as free-draining.
