# **Interstate Highway Pavement Sampling Final Phase 2 Report**

PUBLICATION NO. FHWA-HIF-20-085

March 2020

U.S. Department  
of Transportation  
**Federal Highway  
Administration**

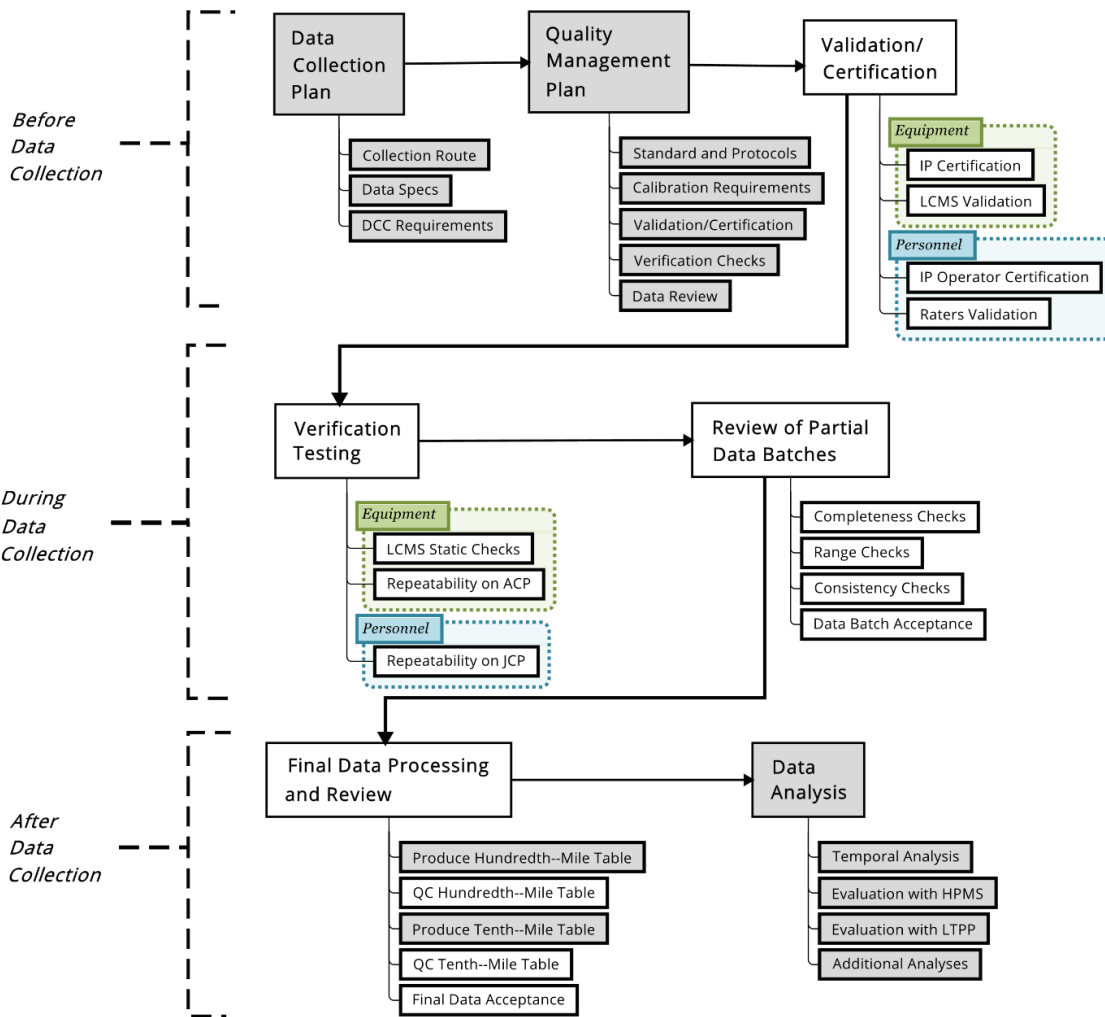
**Figure 1. Illustration. Flowchart of DQMP implementation activities along with other project activities.**

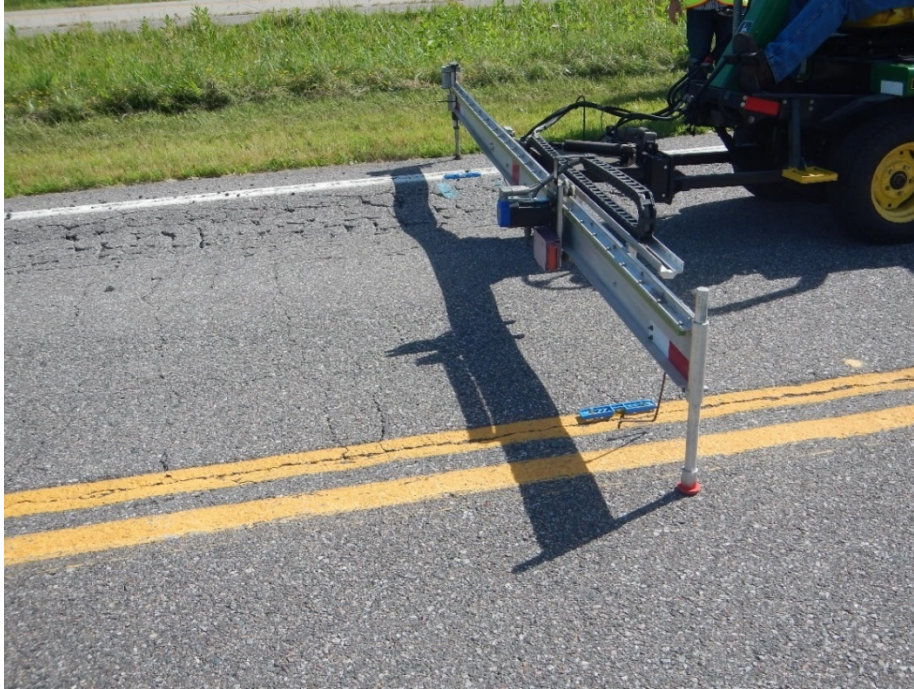
**Figure 3. Picture. Example transverse profile used in rut depth validation.**

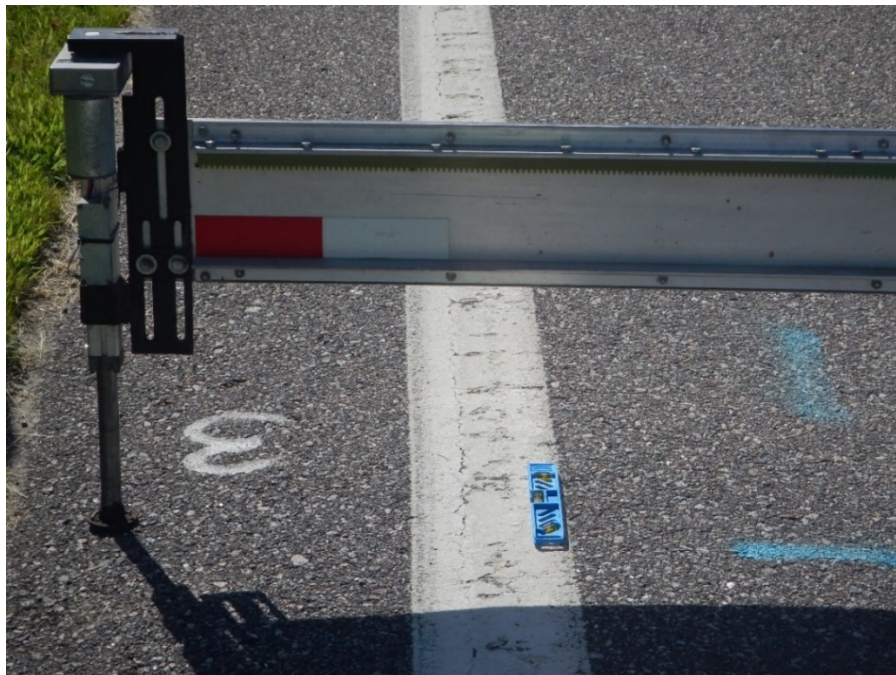
**Figure 4. Picture. Marker for edge of lane.**

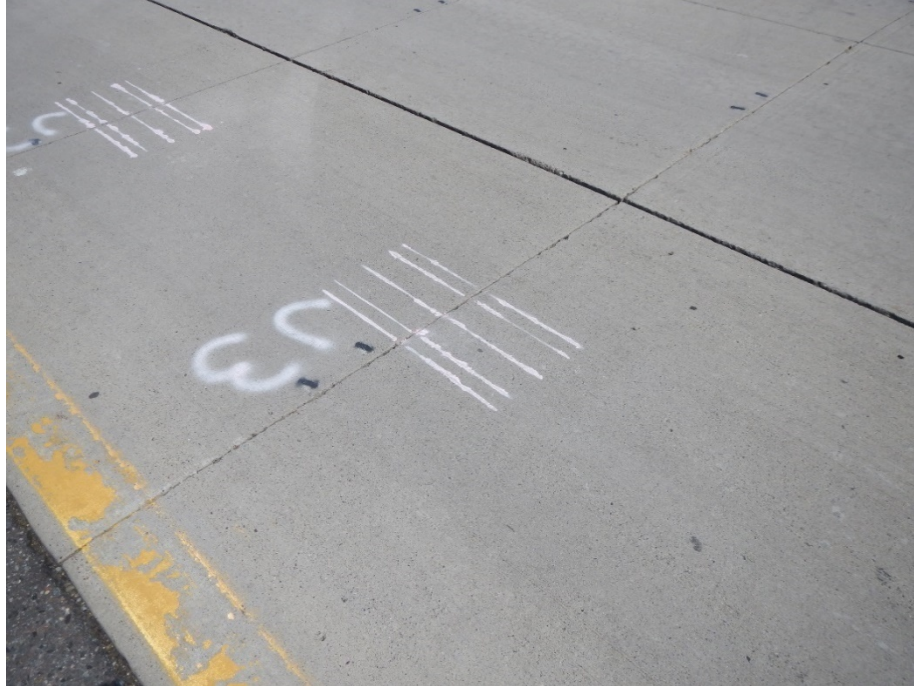
**Figure 5. Picture. Joints 2 and 3 used in faulting validation.**

Reference faulting data were collected at the centerline of the outside wheelpath, 4 inches to either side of the centerline of the wheelpath, and 6 inches to either side of the centerline of the wheelpath. For each of these locations the faultmeter was aligned such that its feet were located 1.6 inches prior to the joint and 1.4 inches after the joint, as illustrated in Figure 6. A set of three repeat measurements were performed at each of these locations such that a total of 15 faulting measurements were collected using the faultmeter at each joint. The reference faulting value corresponding to each location and joint used in the validation data analysis was computed as the mean of all faulting measurements taken at the three inner locations (i.e., centerline and 4 inches to either side of the centerline) for all three runs.

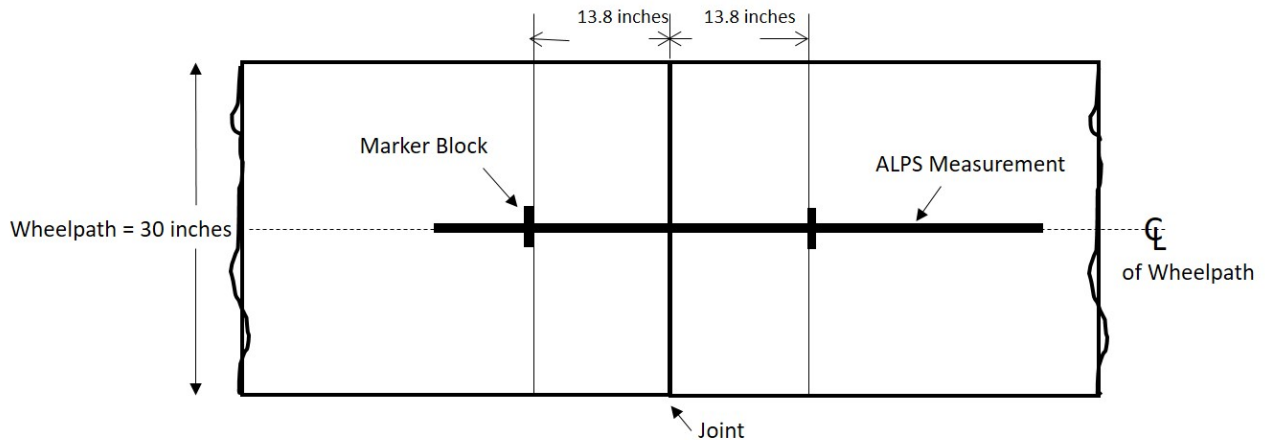
**Figure 8. Illustration. Layout of longitudinal ALPS measurement for faulting validation.**

In addition to the two sets of transverse profile measurements, the ALPS was used to collect a longitudinal profile across a joint at one joint location. For this measurement, the ALPS was aligned along the centerline of the wheelpath. Markers were placed 13.8 inches to either side of the joint and within the measurement of the ALPS device such that they could be used to locate the joint within the data. The layout of this measurement is provided in Figure 8.

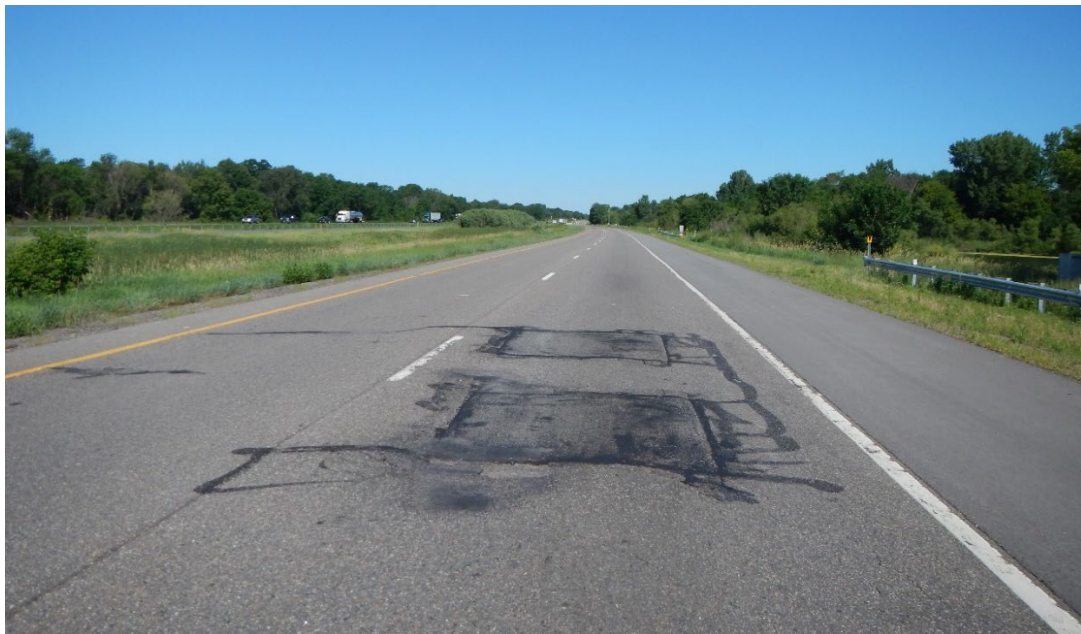
**Figure 9. Picture. Overview of Cell 4 used in percent cracking validation.**

The first site selected was cell 4 of the MnROAD facility. An overview of this section is provided in Figure 9. This section presented approximately 16 percent cracking. This section is 496 feet long and was placed in October 2008 according to MnROAD documentation. The DCC completed 10 runs along this site at approximately 55 mph.

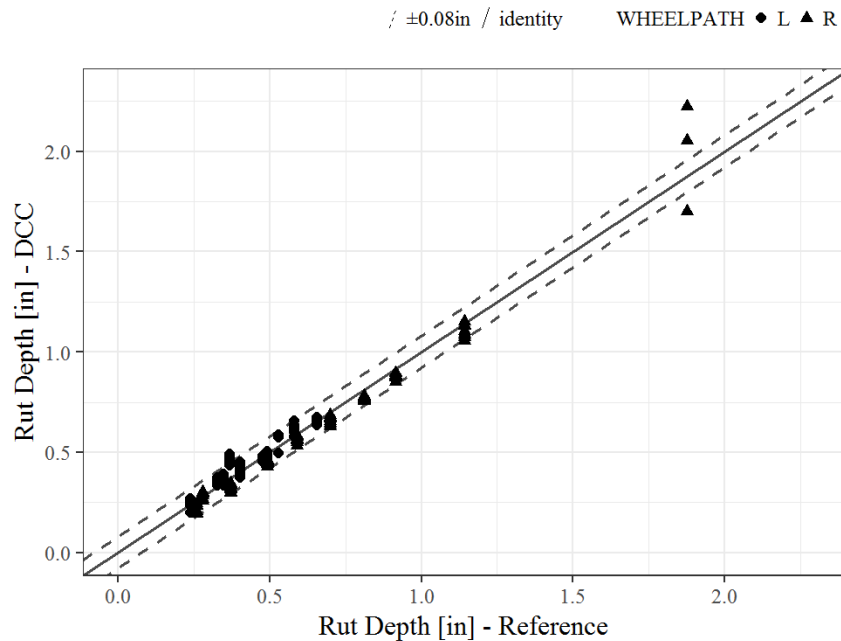
**Figure 10. Plot. Rut depth validation data.**

The scatterplot in Figure 10 shows the reference and DCC rut depth values collected at each wheelpath of the 10 selected transverse profiles. The acceptance criteria for rut depth bias was  $\pm 0.08$  inches and precision within  $\pm 0.08$  inches of the mean with a 90 percent confidence level. The estimated bias from data was  $-0.008$  inches, with a 90 percent confidence interval between  $-0.014$  and  $-0.002$  inches. In addition, 90 percent of the observed differences between the measured values and their mean value were within  $-0.027$  and  $0.032$  inches. The DCC LCMS equipment passed the DQMP validation checks for accuracy and precision of rutting data.

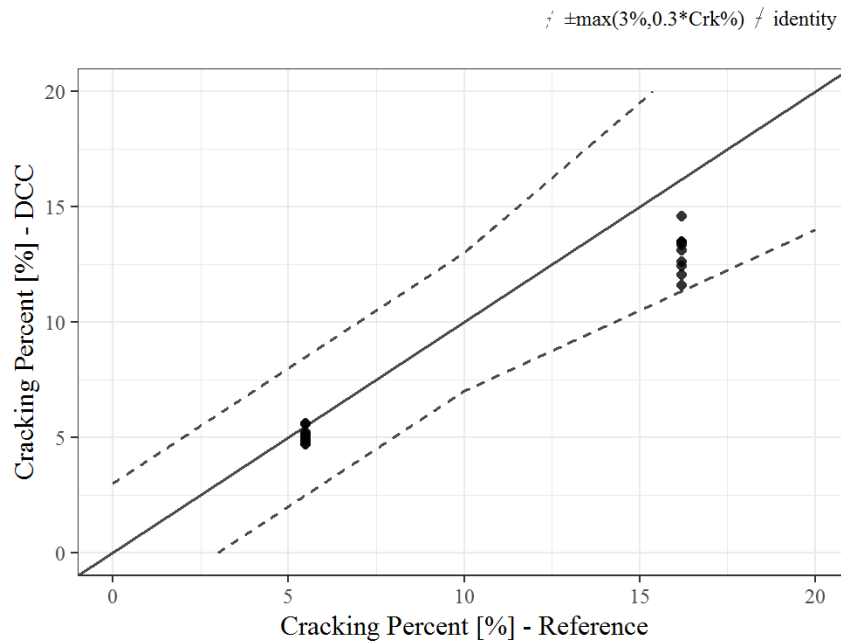
was higher; the acceptable bias for the two validation sections were 4.86 percent and 3.00 percent, respectively. As shown in Figure 12, all DCC values were within the acceptable bias range (with mean biases of -3.19 percent and -0.40 percent for the two respective validation sections) and the DCC percent cracking values on asphalt pavement surfaces met the DQMP validation check for accuracy.

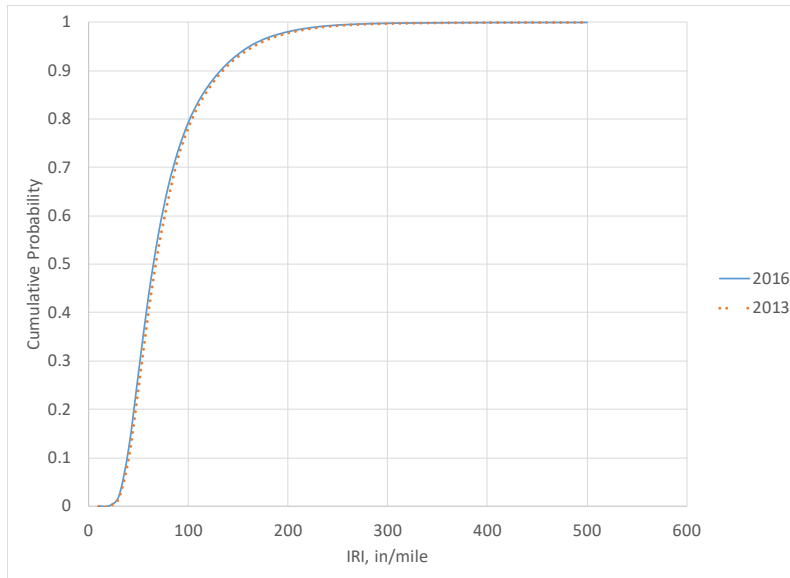
**Figure 19. Graph. Comparison of the distribution of IRI.**

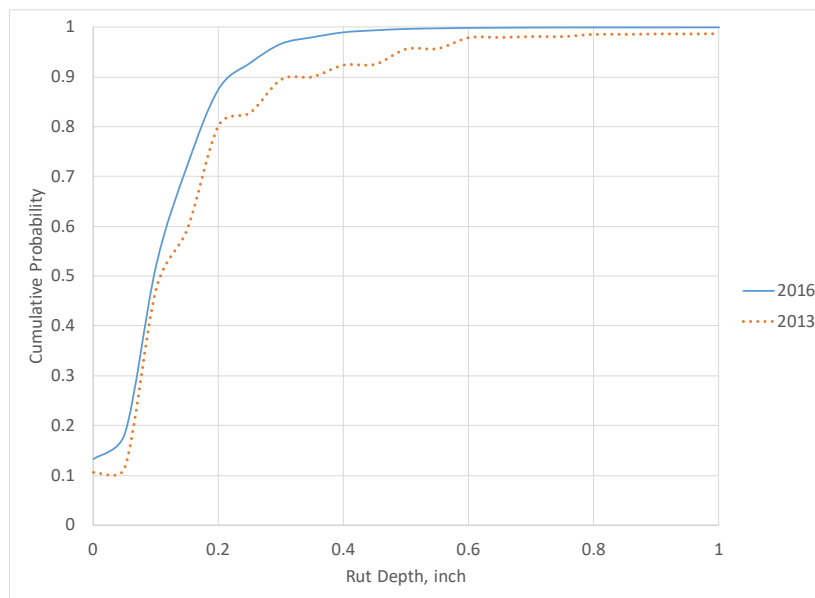
**Figure 20. Graph. Comparison of distribution of rut depth.**

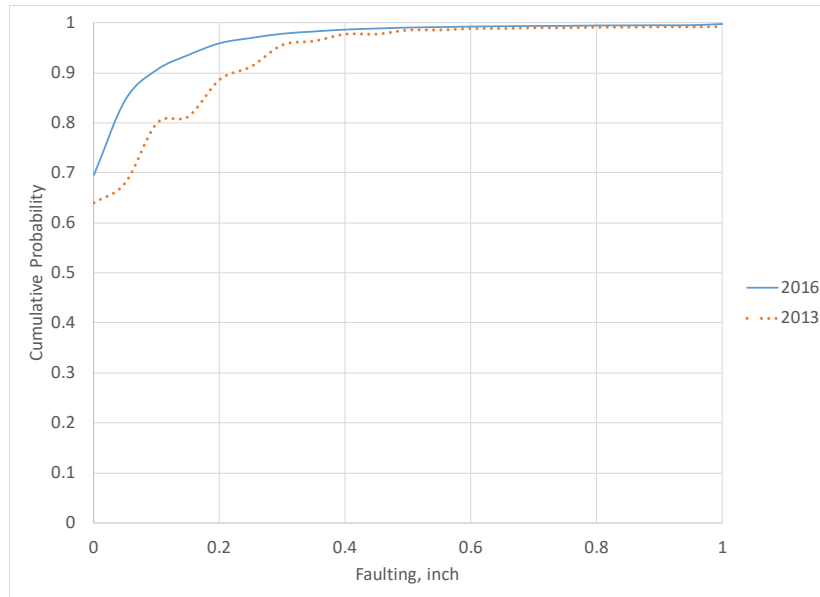
**Figure 21. Graph. Comparison of distribution of faulting.**

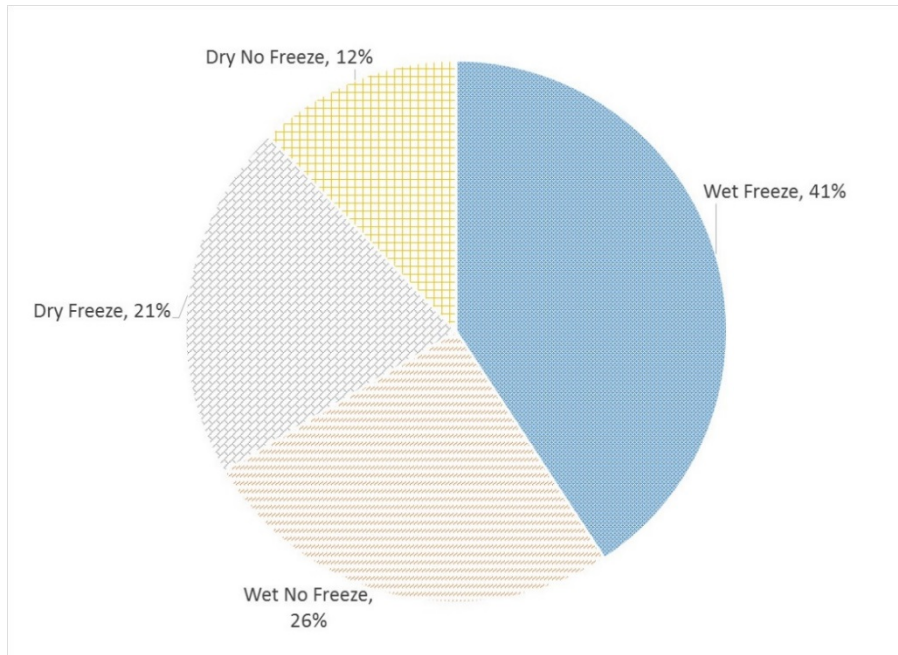
**Figure 26. Chart. 2016 HPMS climate zone composition.**

The route was reviewed to identify how it compares to the full dataset. Figure 26 and Figure 27 provide the comparison of the quantity of the route in each climate zone as compared to the network data. The figures show that the selected route had a smaller percentage in the wet freeze zone than the full dataset.

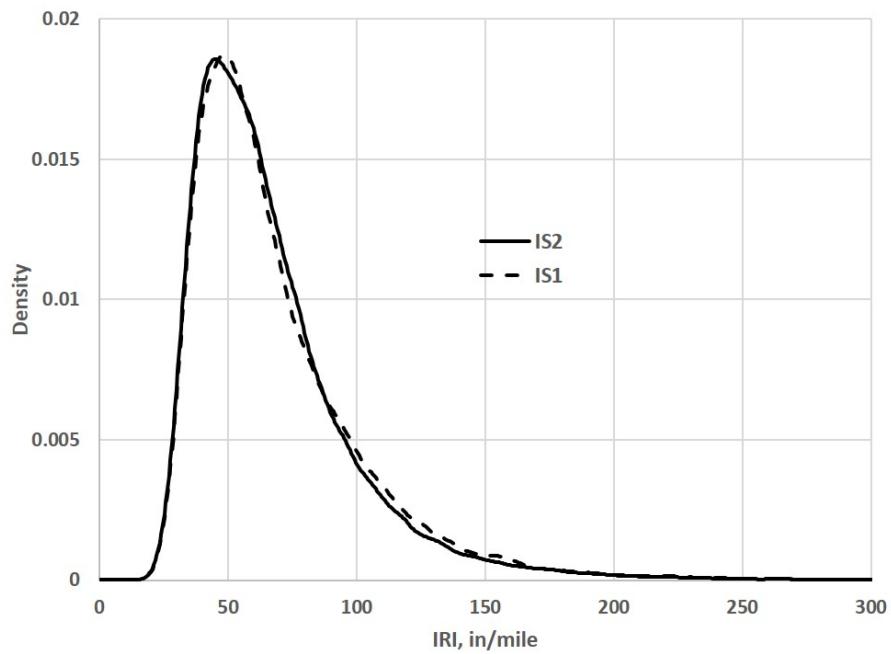
**Figure 32. Plot. Density plots of IRI condition metric for IS1 and IS2 datasets.**

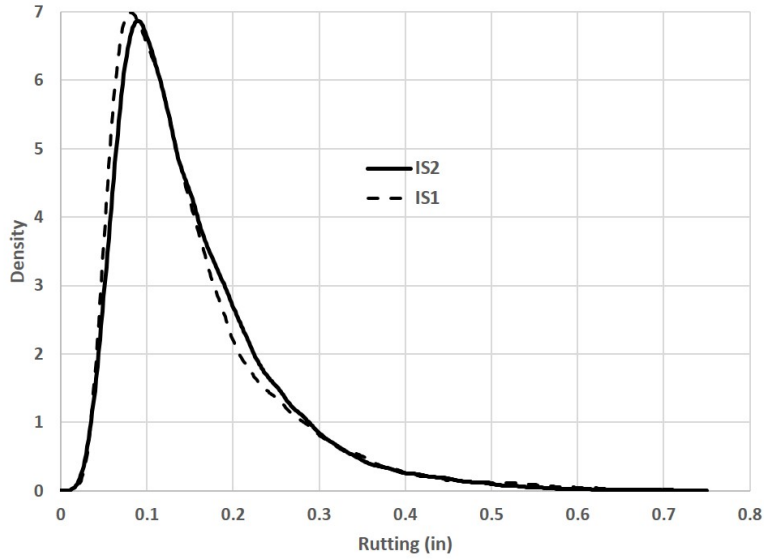
**Figure 33. Plot. Density plots of rutting condition metric for IS1 and IS2 datasets.**

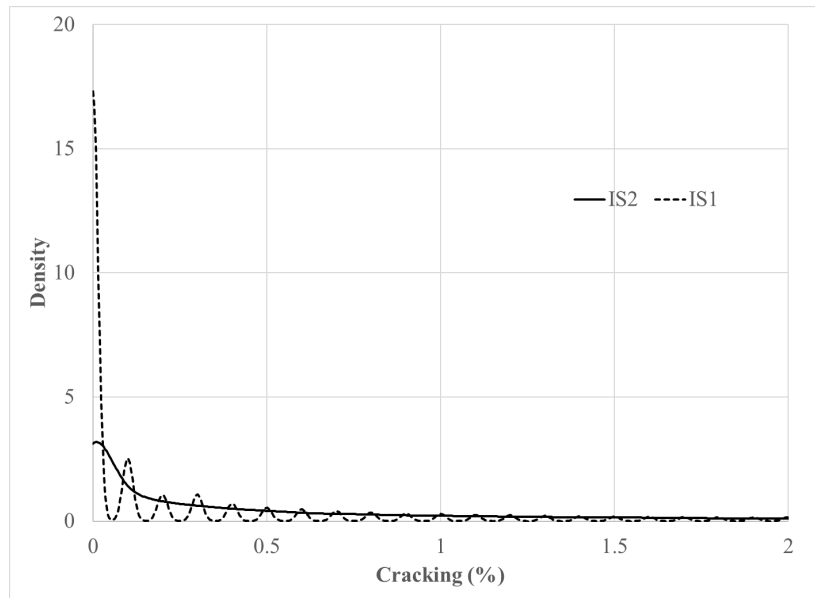
**Figure 34. Plot. Density plots of cracking condition metric for IS1 and IS2 datasets.**

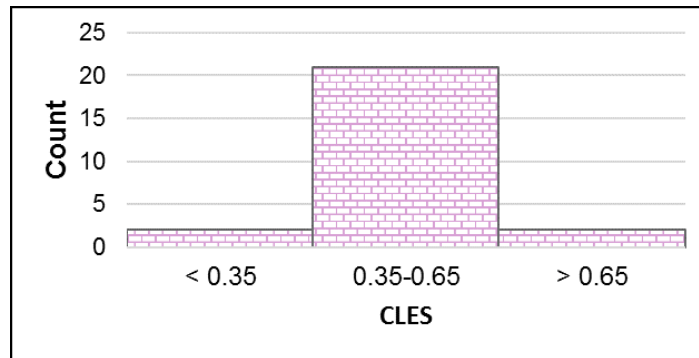
**Figure 36. Chart. State level IRI CLES results.**

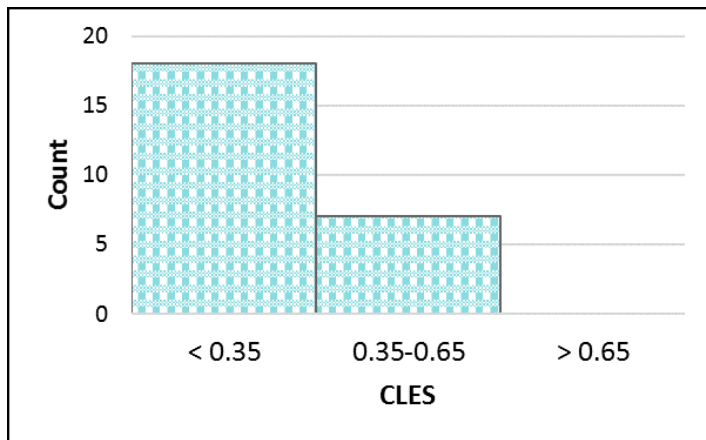
**Figure 37. Chart. State level cracking CLES results.**

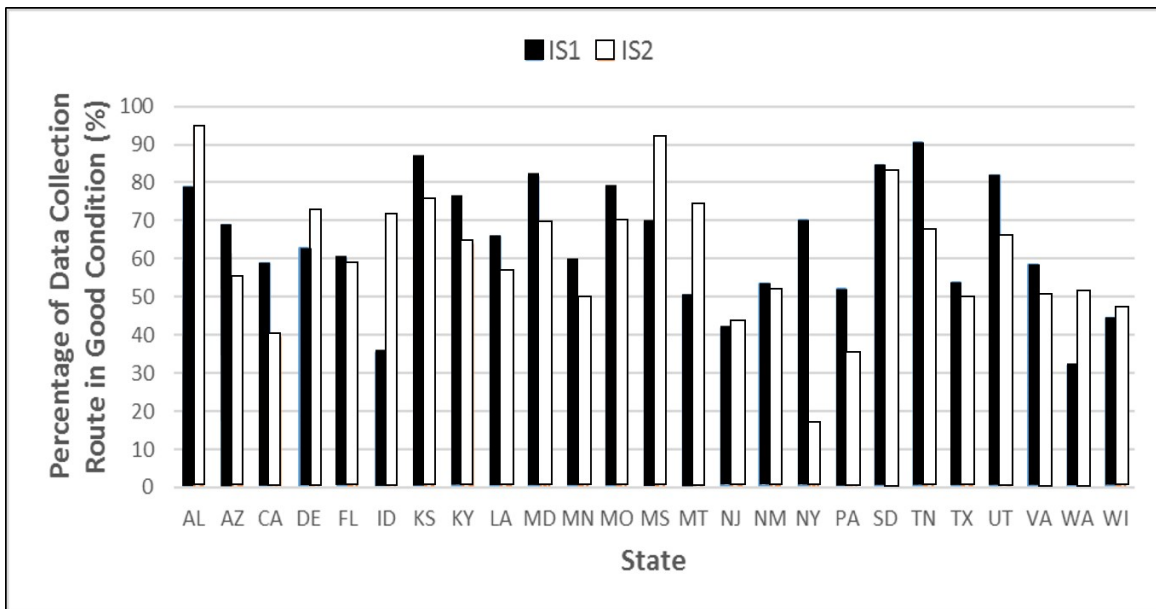
**Figure 40. Chart. Good condition ratings comparison at State level.**

Next, a comparison of the overall condition ratings (and hence performance measures) was performed between the IS1 and IS2 datasets at the State level. The results of this comparison are provided as bar plots in Figure 40, Figure 41, and Figure 42. For each State, the right bar (in white) represents the IS2 result, while the left bar (in black) shows the IS1 result. As shown, significant differences are observed between the IS1 and IS2 overall condition rating results for California, Idaho, New York, and Washington. To understand the difference in the results, a comparison of the total sampled mileage for each State in IS1 and IS2 datasets was performed.

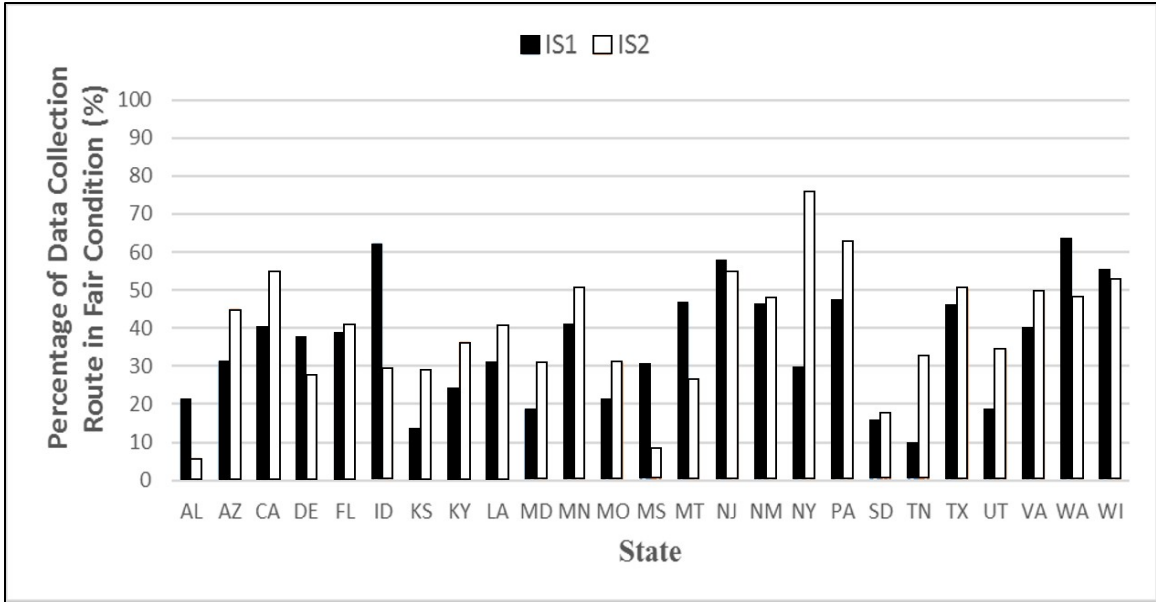
**Figure 41. Chart. Fair condition ratings comparison at State level.**

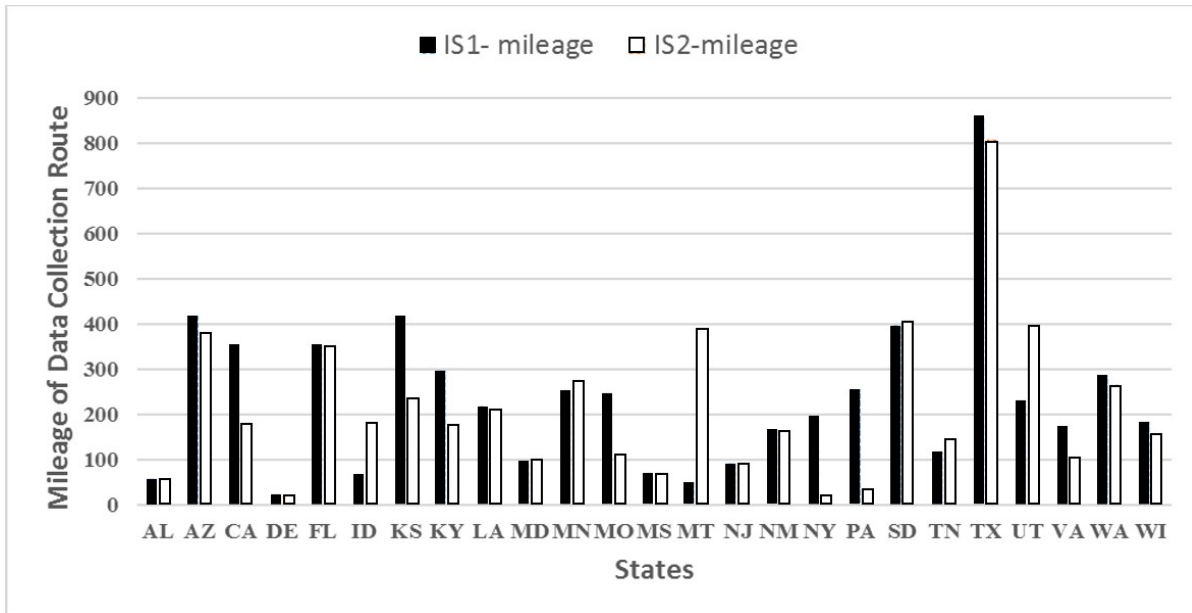
Figure 43 illustrates the results of this comparison. Although significant differences are observed in the total mileage for California, Idaho, and New York, the mileage is the same for Washington. A comparison at the route level was conducted to determine the reason(s) for the differences in the condition ratings. This comparison and the associated results are presented in the next section.

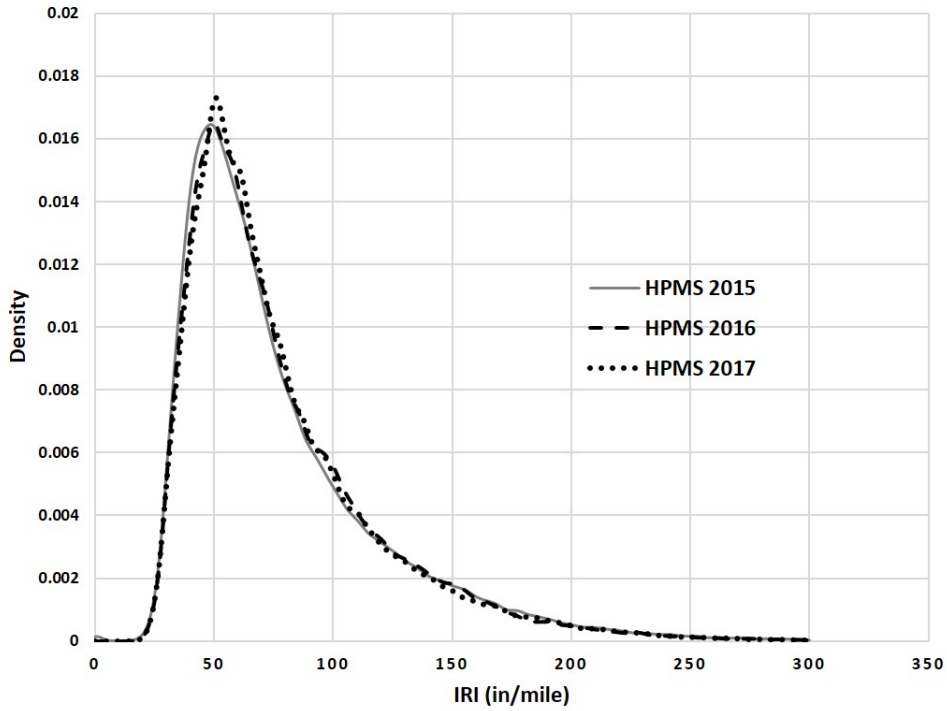
**Figure 52. Plot. Density plots of IRI condition metric for 2015, 2016, and 2017 HPMS datasets.**

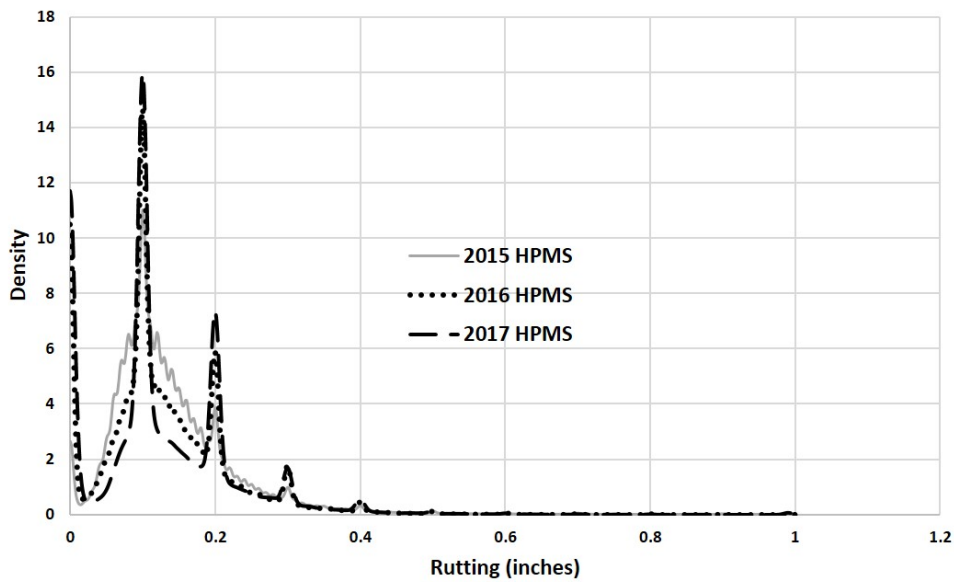
**Figure 53. Plot. Density plots of rutting condition metric for 2015, 2016, and 2017 HPMS datasets.**

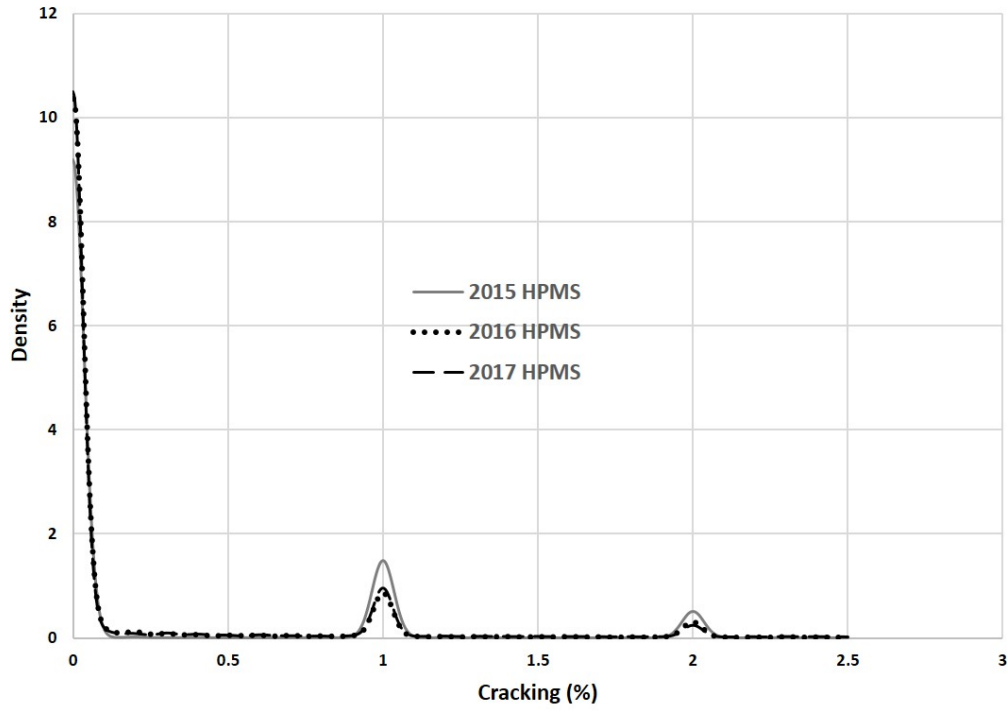
**Figure 54. Plot. Density plots of cracking condition metric for 2015, 2016, and 2017 HPMS datasets.**

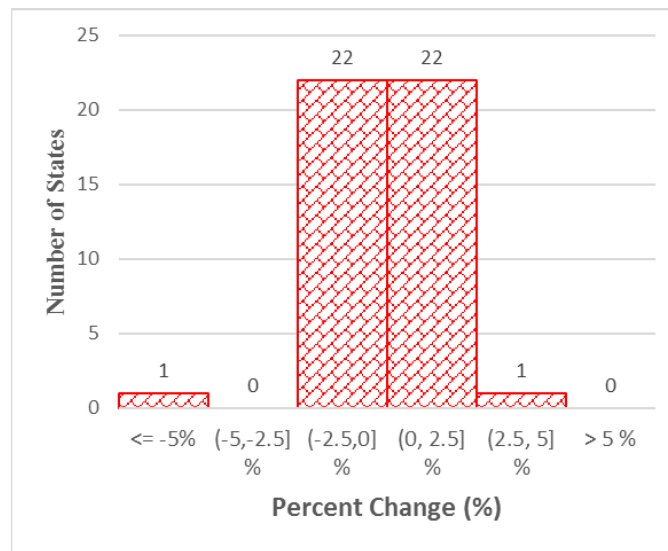
**Figure 57. Chart. Histogram of percent changes in Poor condition from 2015 to 2016.**

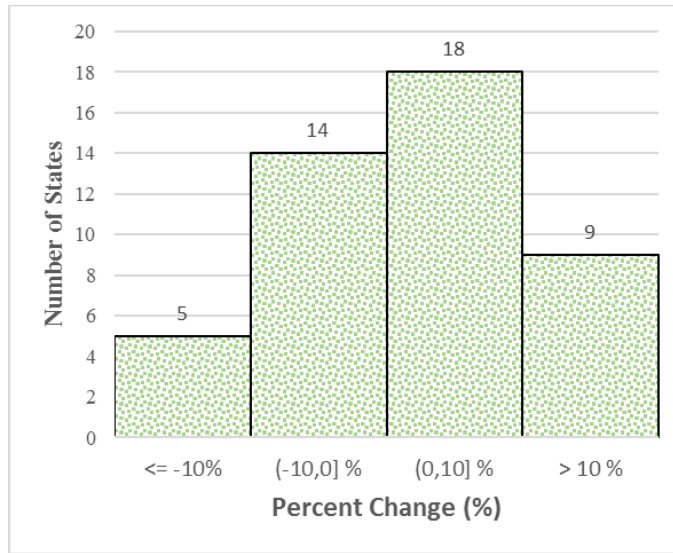
**Figure 58. Chart. Histogram of percent changes in Good condition from 2016 to 2017.**

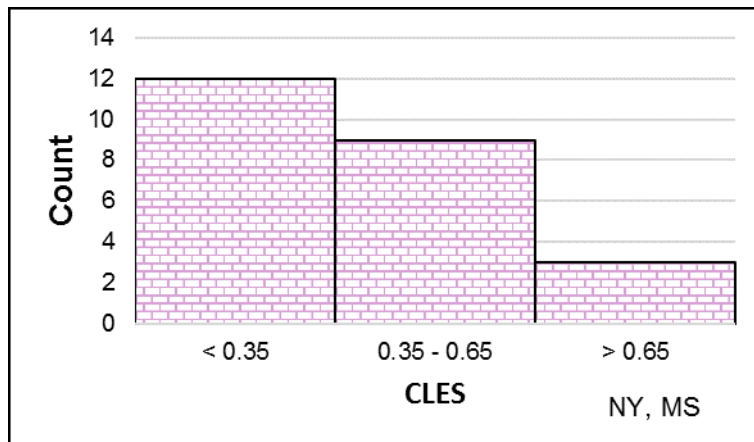
**Figure 62. Chart. CLES results for IS2 and HPMS IRI condition metric.**

In light of the State-level findings, the CLES statistic referenced earlier in this chapter was used to compare the differences between the condition metric distributions for the 2017 HPMS and the IS2 datasets by State (the IS1 dataset was not included in the comparisons). Figure 62, Figure 63, Figure 64, and Figure 65 show the histograms of the calculated CLES values. As shown, the CLES values are presented in terms of three ranges which represent levels of differences. For each condition metric, the States falling in the range of a large CLES value for each condition metric have been identified. For example, Texas shows large differences between the two datasets for the rutting and percent cracking metrics, while Louisiana shows large differences for the rutting and faulting metrics. Florida, on the other hand, shows a large difference for only one condition metric (rutting), while Kansas does not show a significant difference in any of the four condition metrics. It appears that large differences in two or more condition metrics cause a significant difference in the performance measures for a given State while variability in only one condition metric has little to no impact on the performance measures.

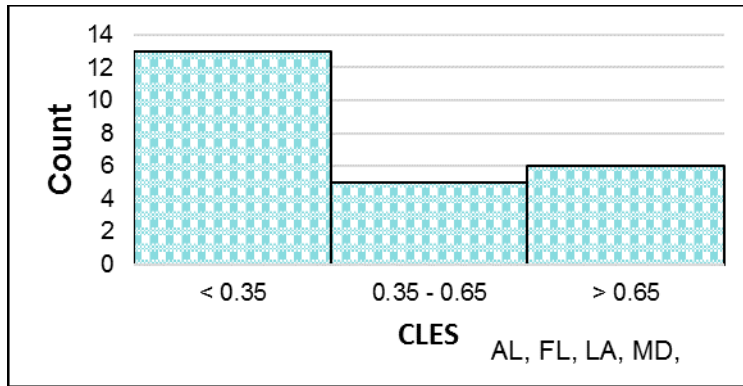
**Figure 63. Chart. CLES results for IS2 and HPMS rutting condition metric.**

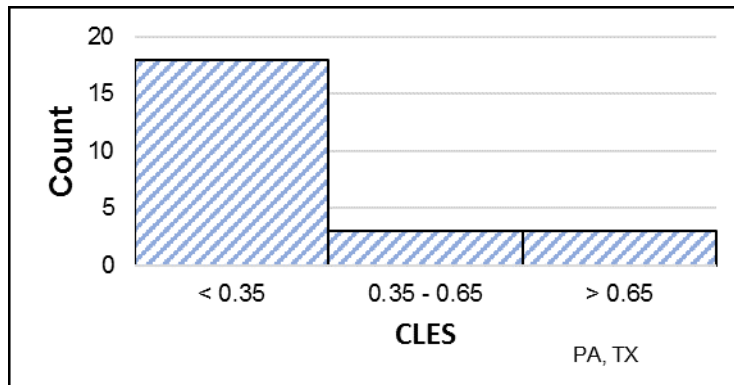
**Figure 64. Chart. CLES results for IS2 and HPMS cracking condition metric.**

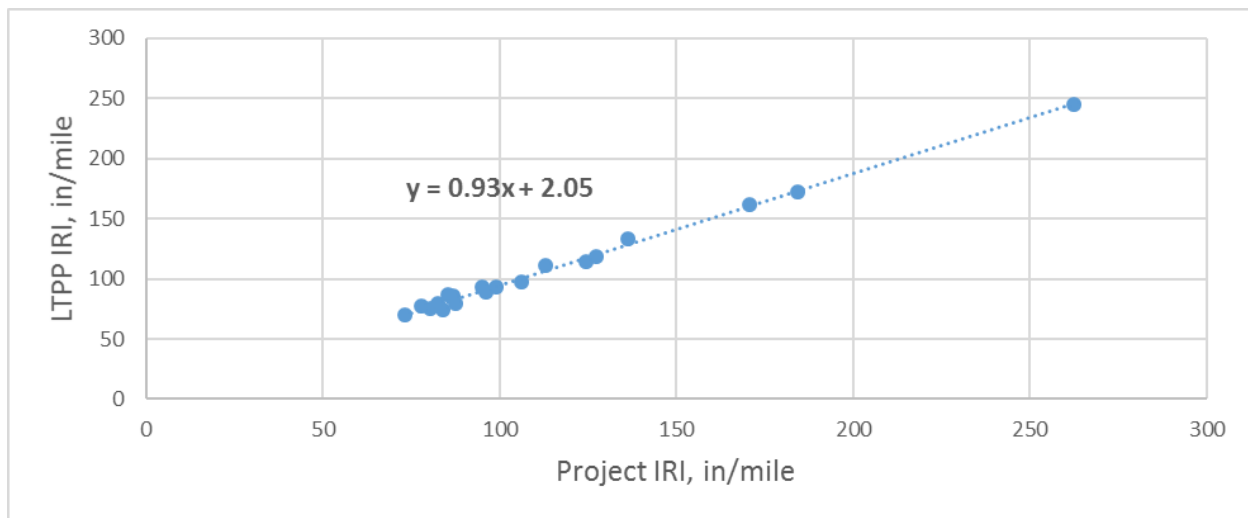
**Figure 73. Plot. Project versus LTPP IRI measurements on jointed concrete pavement test sections.**

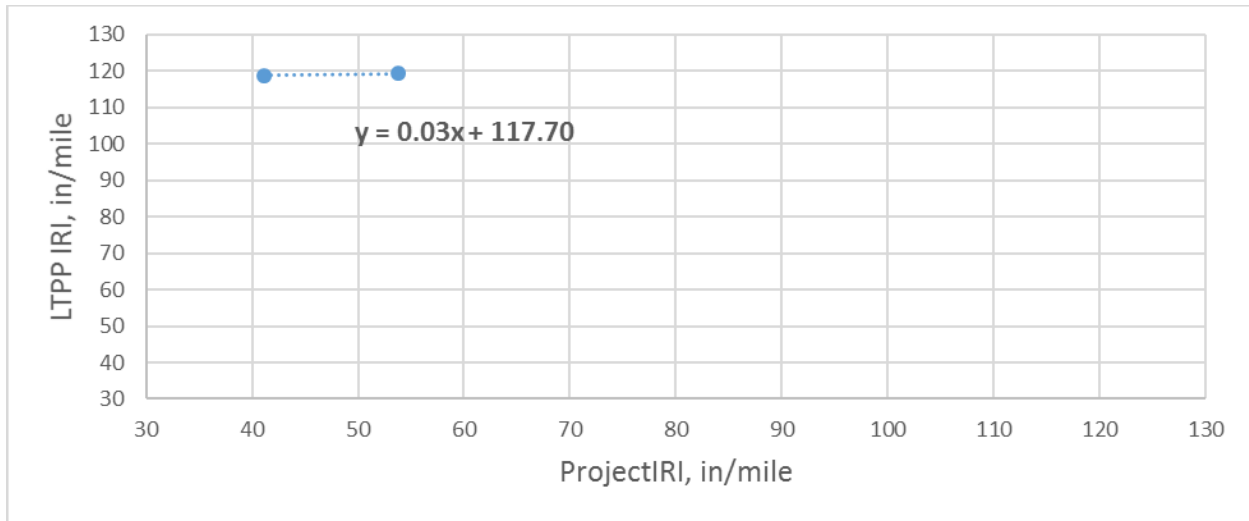
**Figure 74. Plot. Project versus LTPP IRI measurements on asphalt pavement test sections.**

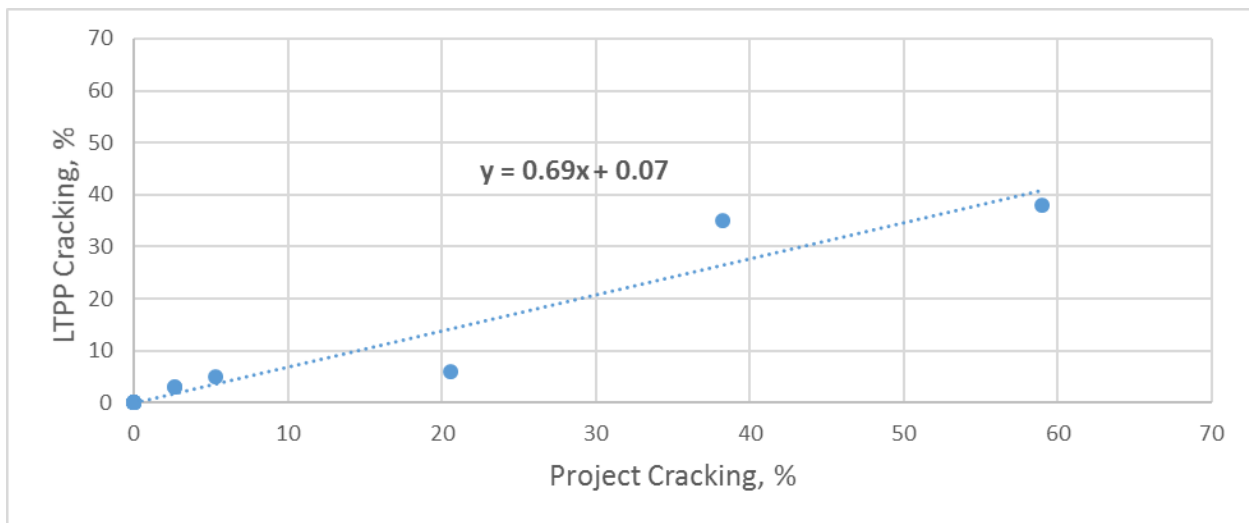
**Figure 75. Plot. Project versus LTPP cracking measurements on jointed concrete pavement test sections.**

In this project, jointed concrete pavement percent cracking was assessed using a semi-automated approach in which manual raters calculated percent cracking through visual inspection of pavement surface images collected at highway speeds by an LCMS. The number of joints and the number of half-width transverse cracks observed on the images were compared to the manual cracking maps, which were created by raters through visual inspection of the sections and stored in the LTPP 2016 dataset. These comparisons helped in assessing the reliability of the automated method used in the project. Among nineteen jointed concrete pavement sections, only one section showed a difference in the number of observed transverse cracks. Although the statistical analyses indicate potential bias between the two datasets, it appears that the differences in the collected data between the two datasets are unimportant based on a visual review of the images collected. In other words, the observed differences in the cracking data on all but one of the jointed concrete pavement sections were within expected error levels.

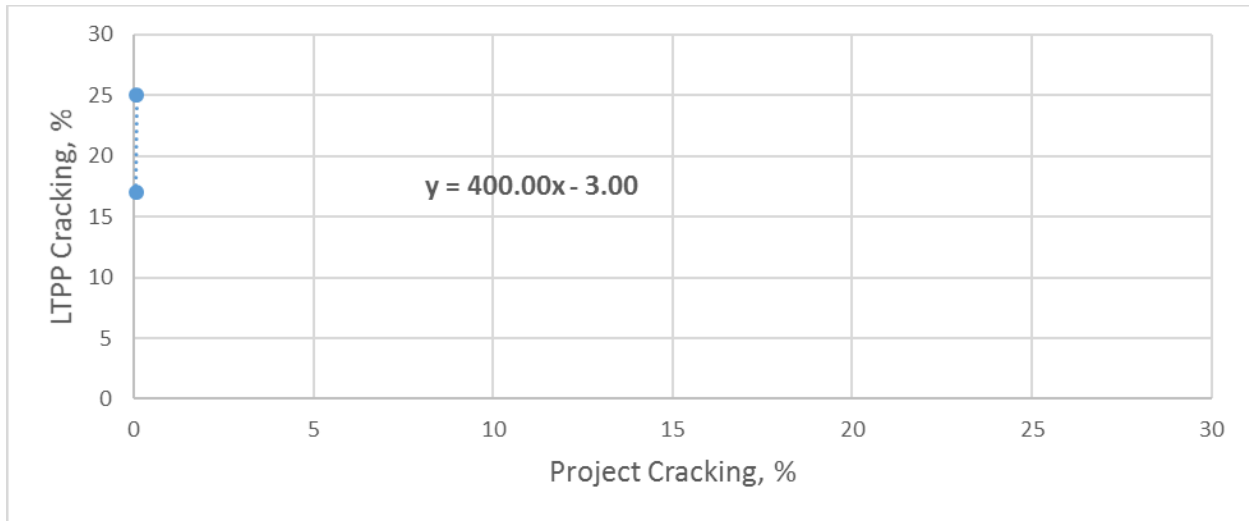
**Figure 76. Plot. Project versus LTPP cracking measurements on asphalt pavement test sections.**

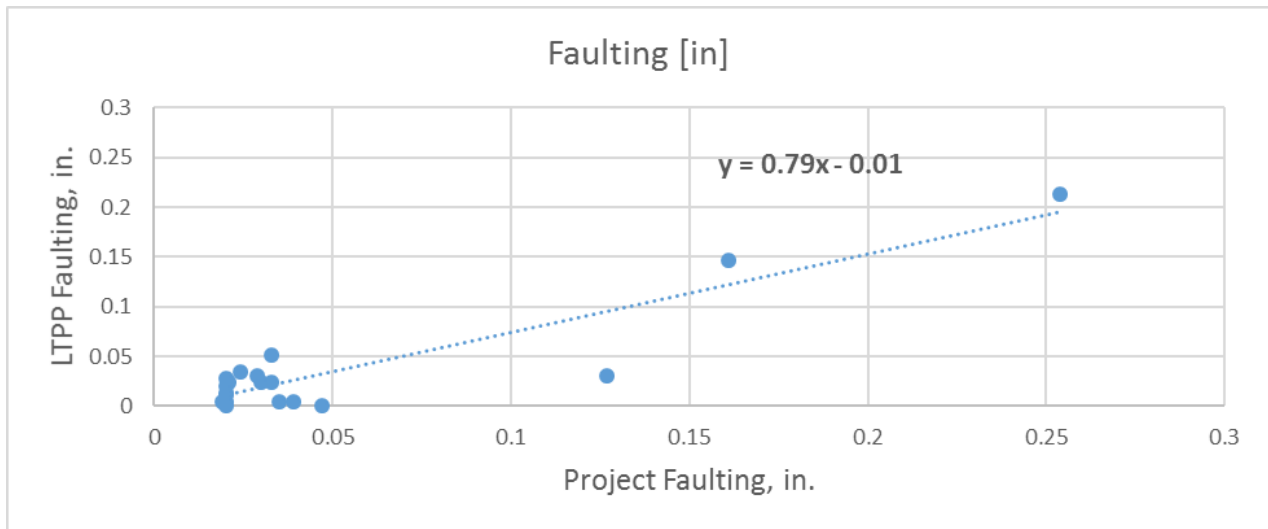
**Figure 77. Plot. Project versus LTPP faulting measurements on jointed concrete pavement test sections.**

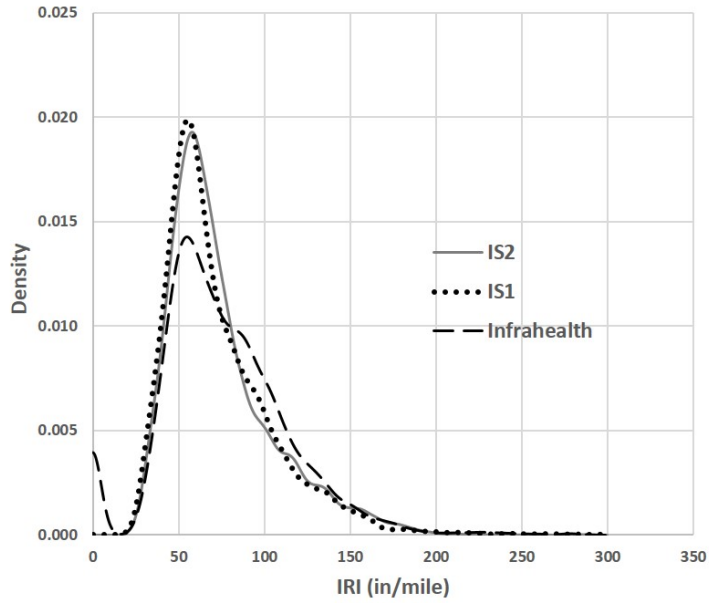
**Figure 79. Plot. Density plots of IRI condition metric for IS1, IS2, and InfraHealth datasets.**

Figure 79, Figure 80, Figure 81, and Figure 82 show density plots to simultaneously visualize the three datasets in question. Using these plots, the shape, level of skewness, multimodality, and the maximum value of the datasets were compared. As shown, the IRI and faulting density plots show that the InfraHealth data have a different shape compared to the IS1 and IS2 datasets, while for the rutting and cracking density plots the three datasets have similar shapes. The IS1 and IS2 rutting distributions show a higher dispersion than the InfraHealth distributions.

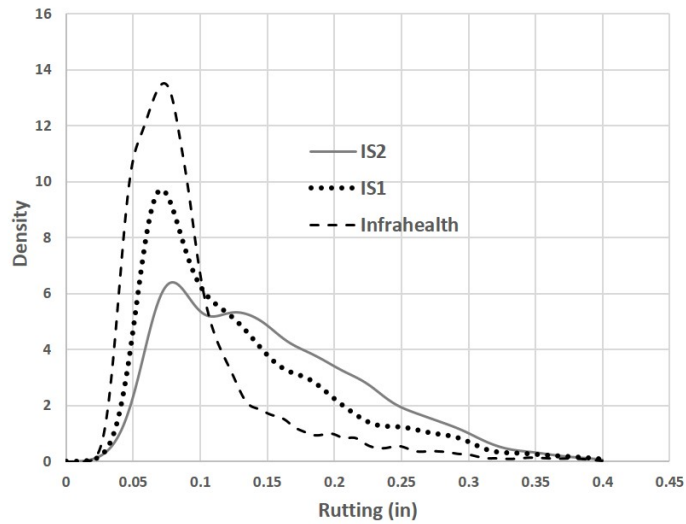
**Figure 80. Plot. Density plots of rutting condition metric for IS1, IS2, and InfraHealth datasets.**

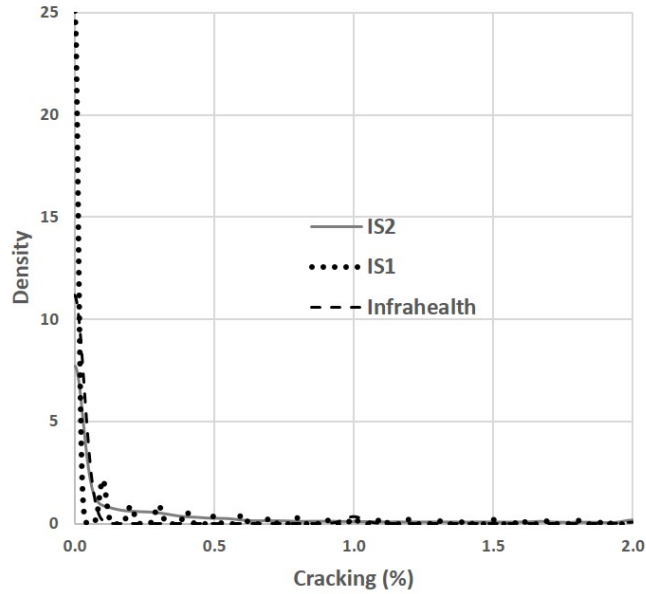
**Figure 81. Plot. Density plots of cracking condition metric for IS1, IS2, and InfraHealth datasets.**
