# Vermont Demonstration Project: Rehabilitation of Culverts in South Burlington and Colchester

Final Report  
June 2013

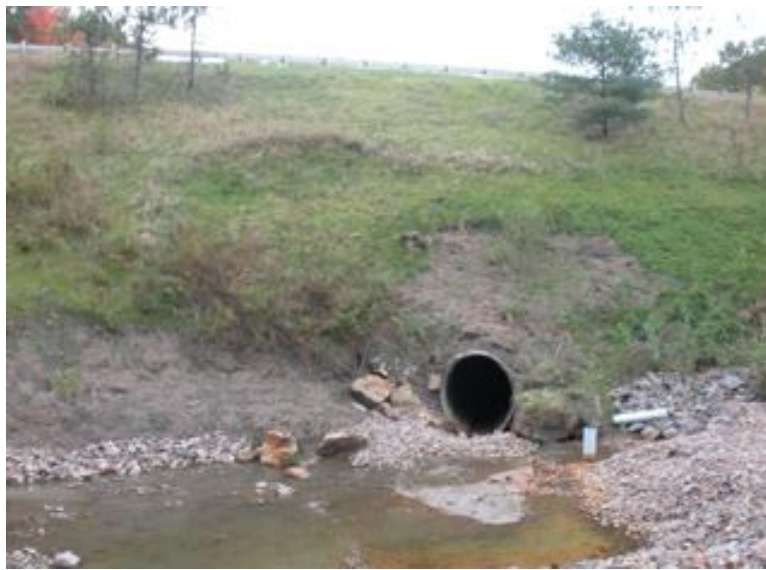
Figure 1 – Culvert Location Relative to Crest of Embankment

The purpose of this project was to rehabilitate two structurally deficient culverts located beneath Interstate 89 in South Burlington and Colchester, VT, and increase their hydraulic capacity. The South Burlington culvert with a nominal diameter of 72 inches and 287 feet long is located at mile marker 89.636 about 0.8 mi north of Exit 14, and the Colchester culvert with a nominal diameter of 110 inches and 313 feet long is located at mile marker 95.183 about 2.7 mi south of Exit 17. The crest of the embankment at both locations is approximately 40 feet above the culvert invert elevation. Figure 1 shows culvert location relative to the crest of the embankment and Figure 2 shows typical condition of the existing culvert at each site.

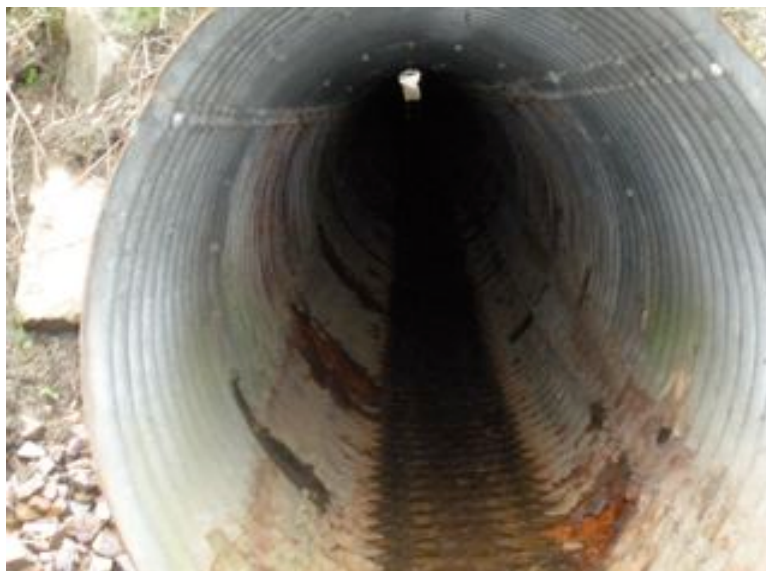
Figure 2 – Typical Condition of Existing Culverts

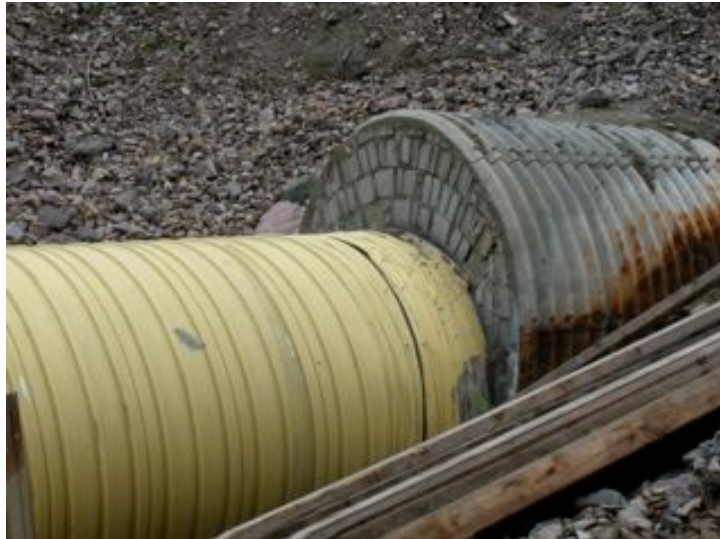
Figure 3 - Slip Liner in Existing Culvert at Colchester site

The initial plan was to rehabilitate the existing culvert at each site using a slip liner and adding capacity by inserting a 60-in diameter culvert alongside the existing culvert using trenchless technology. The successful bidder presented a value engineering proposal to line the culverts with larger liners and eliminate the need for the parallel pipe at each location and the trenchless technology associated with it. The project team accepted the contractor's proposal of using an 84-in. slip liner at the Colchester site primarily because it met AASHTO hydraulic guidelines, the geography at the location allowed for vast storage upstream and reduction in project costs by approximately \$281,000. Figure 3 shows the slip liner in the existing culvert at Colchester and Figure 4 provides an end view of the inserted liner.

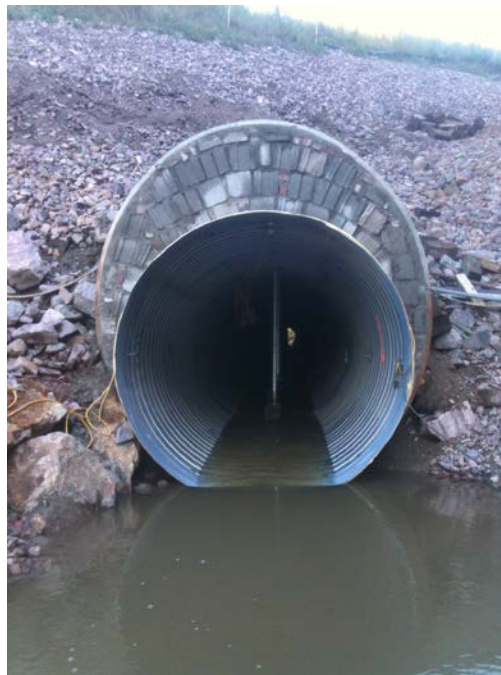
Figure 4 - End View of Slip Liner at Colchester Site

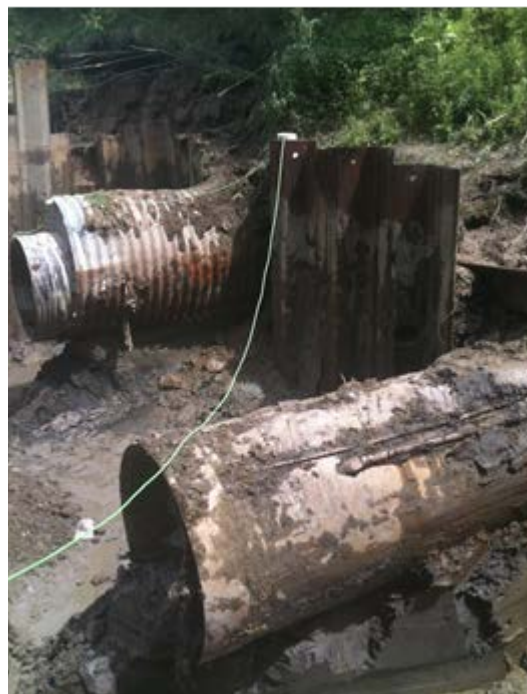
Figure 5 – Steel Casing and Existing Culvert with Liner

The contract called for performing a pilot bore to help achieve the line and grade of 1.37 percent during pipe ramming. The contractor used a directional drill attached to a 24-in steel casing. This 24-in casing served as a guide for the 60-in diameter steel casing. The directional drilling worked acceptably well, but the 24-in casing encountered an obstruction and deflected. The deflection sheared off the drill just ahead of the attachment point. The 24-in casing and the directional steel were abandoned as a guide. The drill steel was removed. The 24-ft steel casing was left in place (about 84 ft into the embankment) until the 60-in steel casing was inserted to a point beyond the leading edge of the 24-in casing. The 24-in casing was removed before continuing with the insertion of the 60-in casing. The 60-in steel casing was inserted successfully, free of any guidance. Figure 5 shows the steel casing in relation to the existing culvert with liner inserted and Figure 6 shows completed headwall with the two openings.

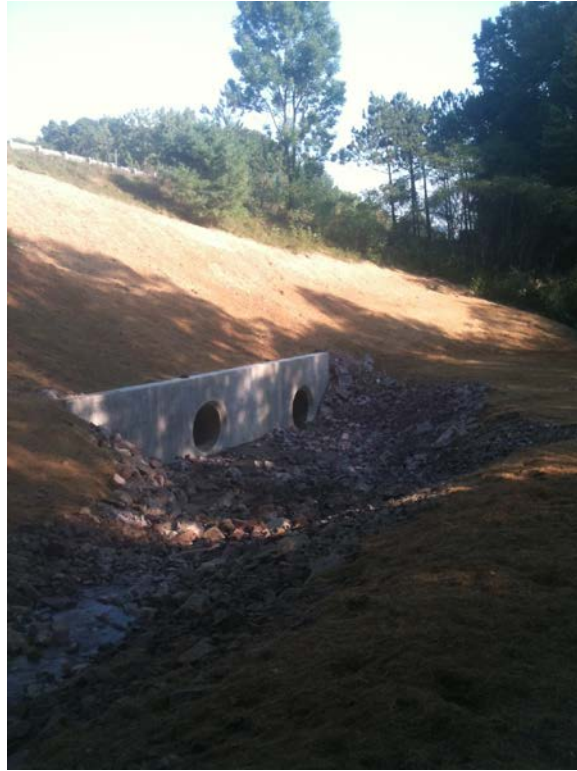
Figure 6 – Headwall with two openings.

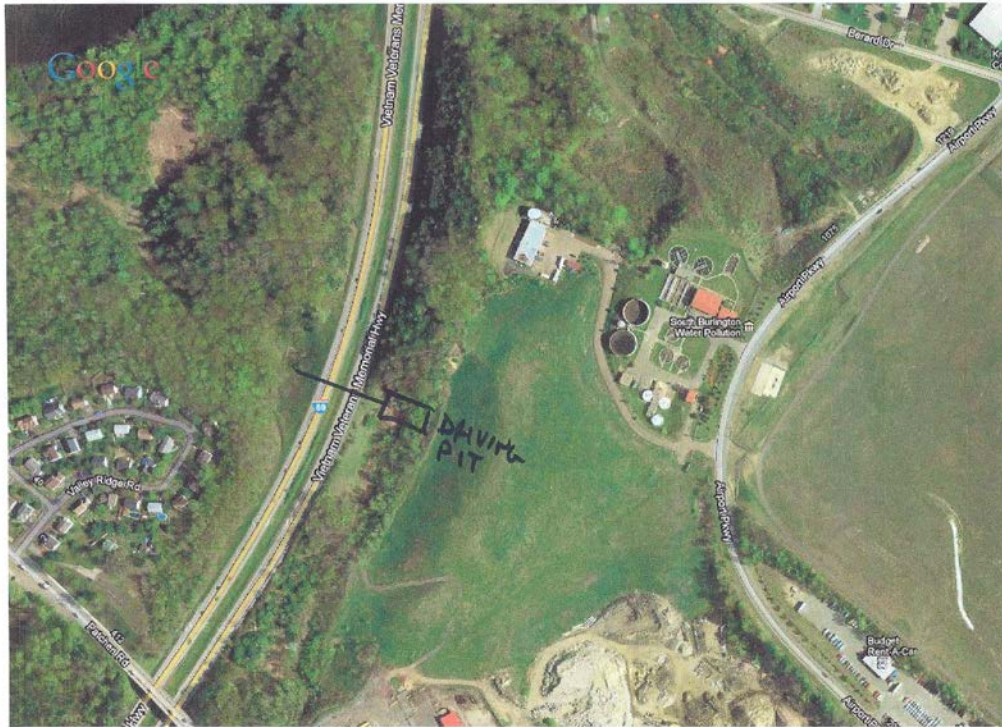
Figure 8. Aerial view of site.

location would be 287 ft long and have 40 ft of cover. Figure 8 shows the site, figure 9 shows the layout plan, and figure 10 shows the profile of the existing and new culverts.

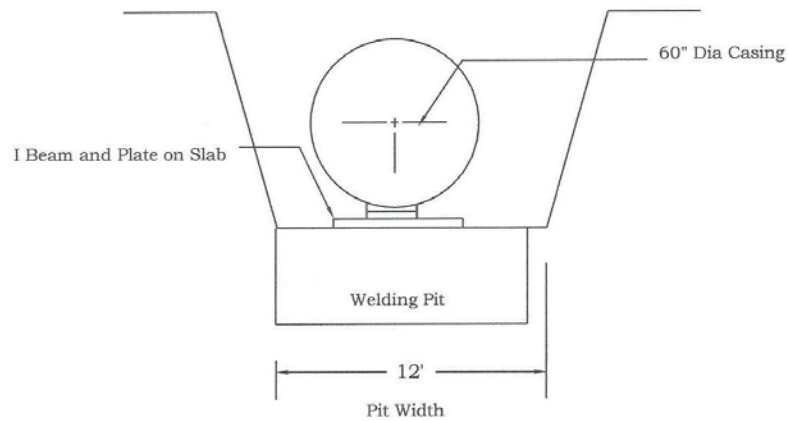
Pipe Ramming Pit  
Taurus Pipe Rammer  
American Augers 36-600

Figure 12. Schematic of pipe ramming pit.

Before Boretch mobilized the site, the contractor completed the stream diversion, dewatering of the ramming site, excavation and support of the embankment toe by sheet pile walls, and construction of a concrete slab for the trenchless equipment setup. The site layout is shown in figure 11, a schematic of the pipe ramming pit in figure 12, and the concrete slab for supporting the pipe ramming equipment in figure 13.

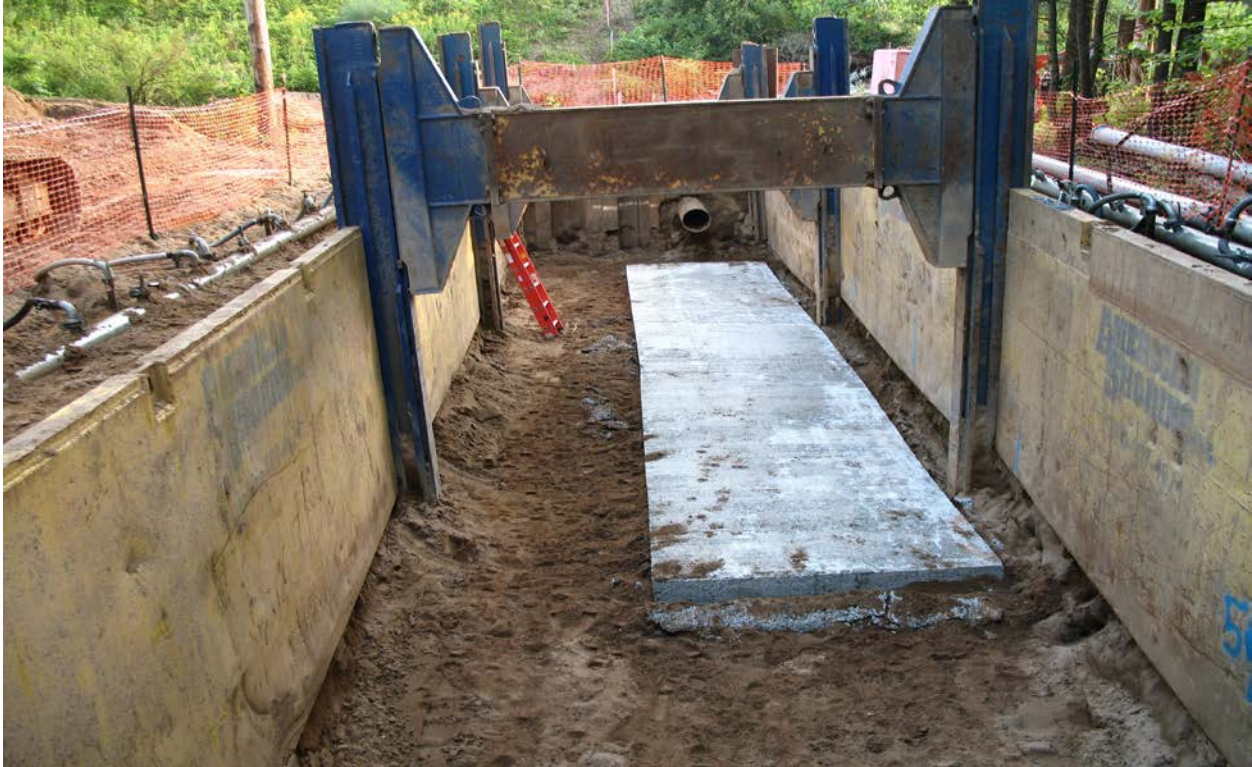
Figure 13. Concrete slab for pipe ramming equipment.

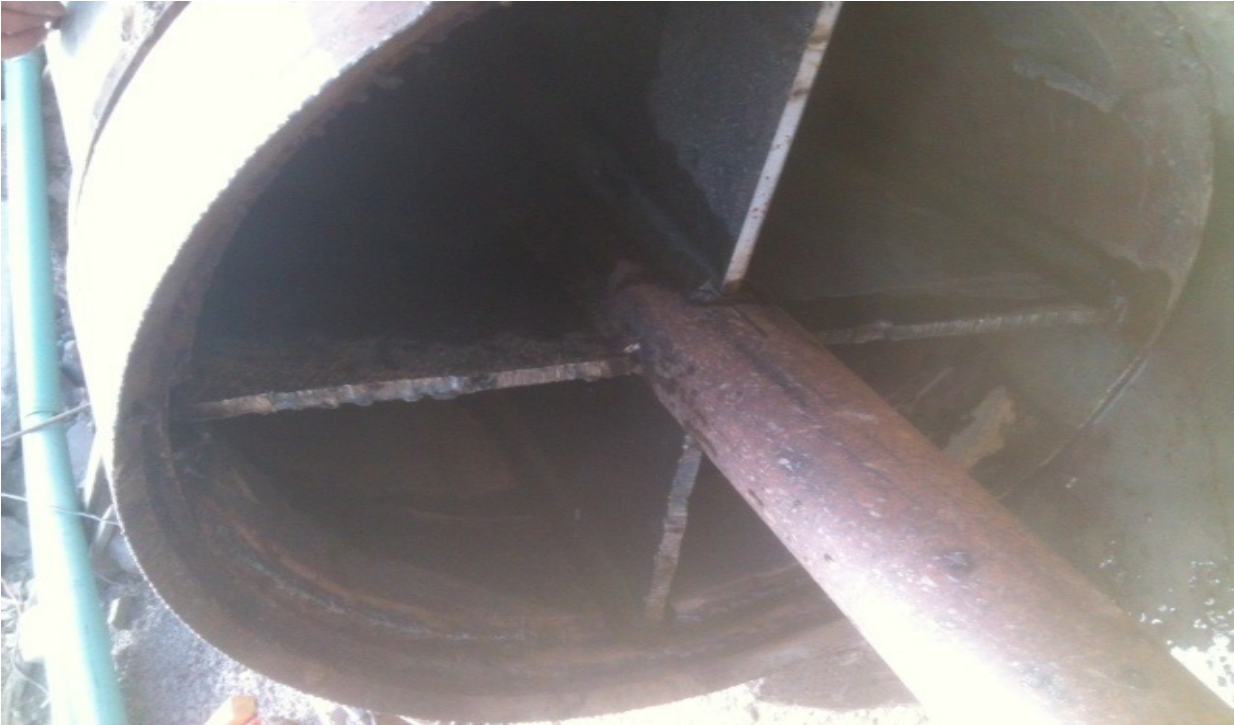
Figure 14. Sprocket assembly.

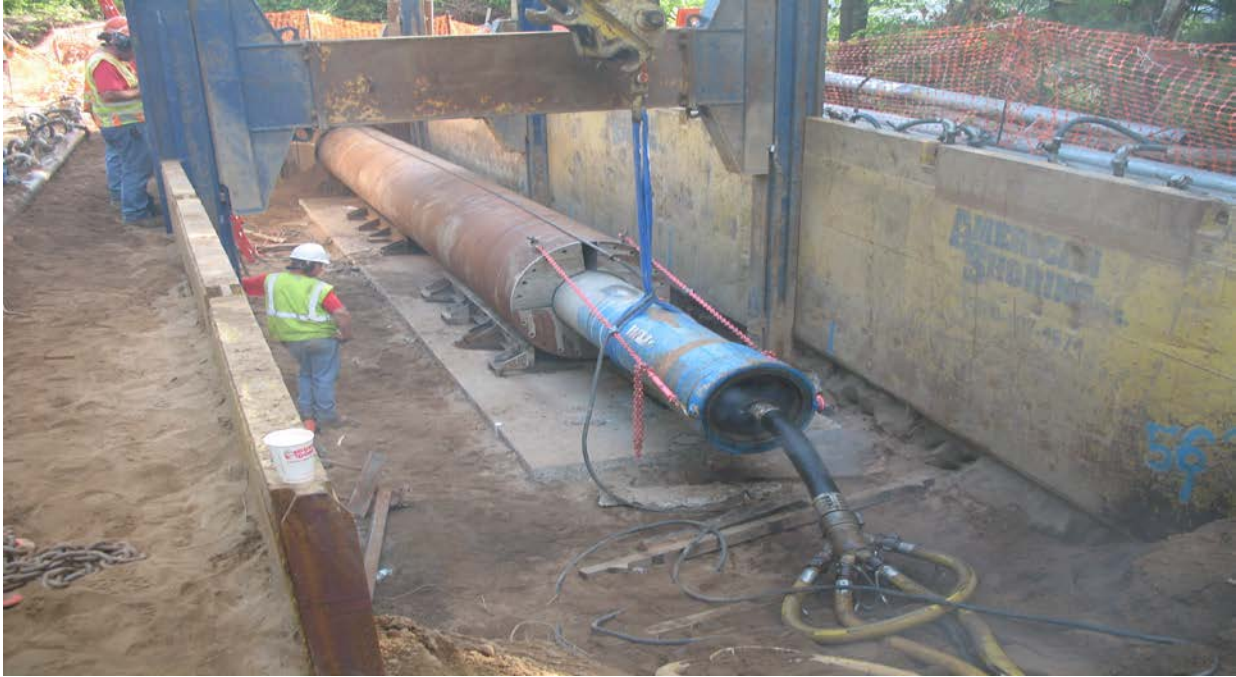
Figure 15. Ramming of pipe using Grundrum Koloss hammer.

The crew rammed the first section of casing (39.82 ft), spliced the second section (31.33 ft), and rammed this section as well. The second and third sections were then spliced and the third section was rammed. At about 80 ft into the embankment, the pile stopped advancing and it was theorized that the sprocket broke away from the drill steel after the casing hit a tree stump. The contractor also found that the pilot tube had broken off. (See graphs on offset and elevation developed from monitoring equipment at the site in figure 16.) At that point the contractor abandoned the plan to jack the 24-in steel casing and began jacking the 60-in diameter, 1-in thick steel casing around the 24-in steel casing and the pilot tube. Because jacking is not steerable, the

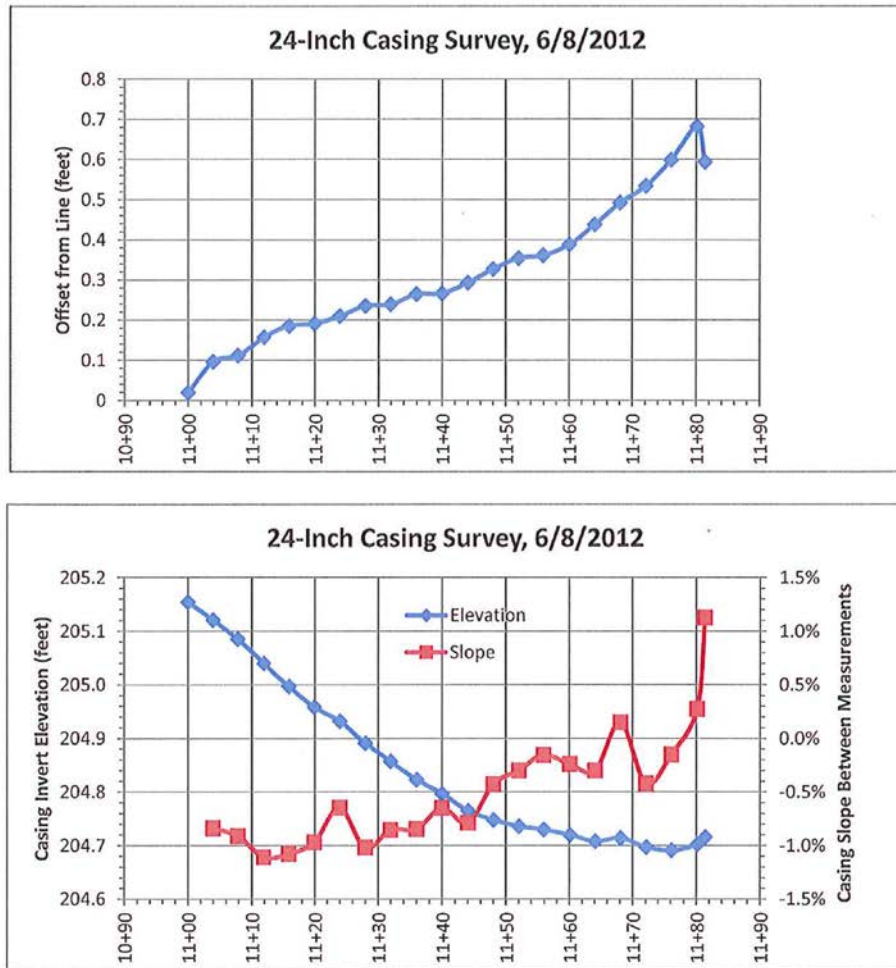
Figure 16. Offset and elevation monitoring graphs.

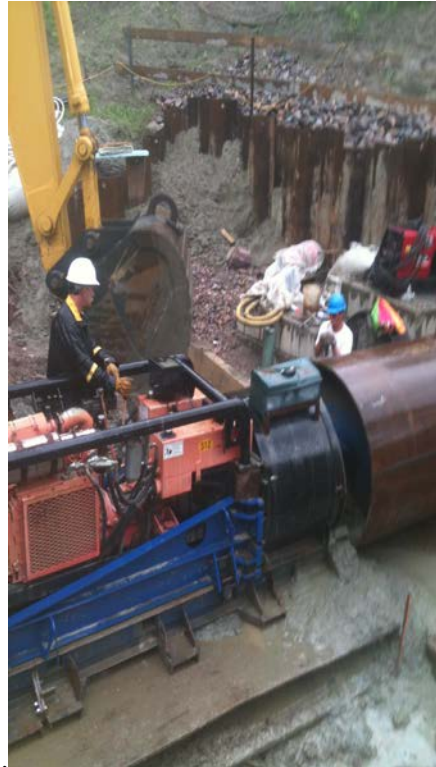
Figure 17. Auger bit removing the spoils from 24-in casing.

The crew cleaned out the 24-in casing using a drill rig with a 24-in auger bit (see figure 17). The drill steel was removed and the 24-in steel casing was left in place until the 60-in casing was inserted beyond the leading edge of the 24-ft casing.

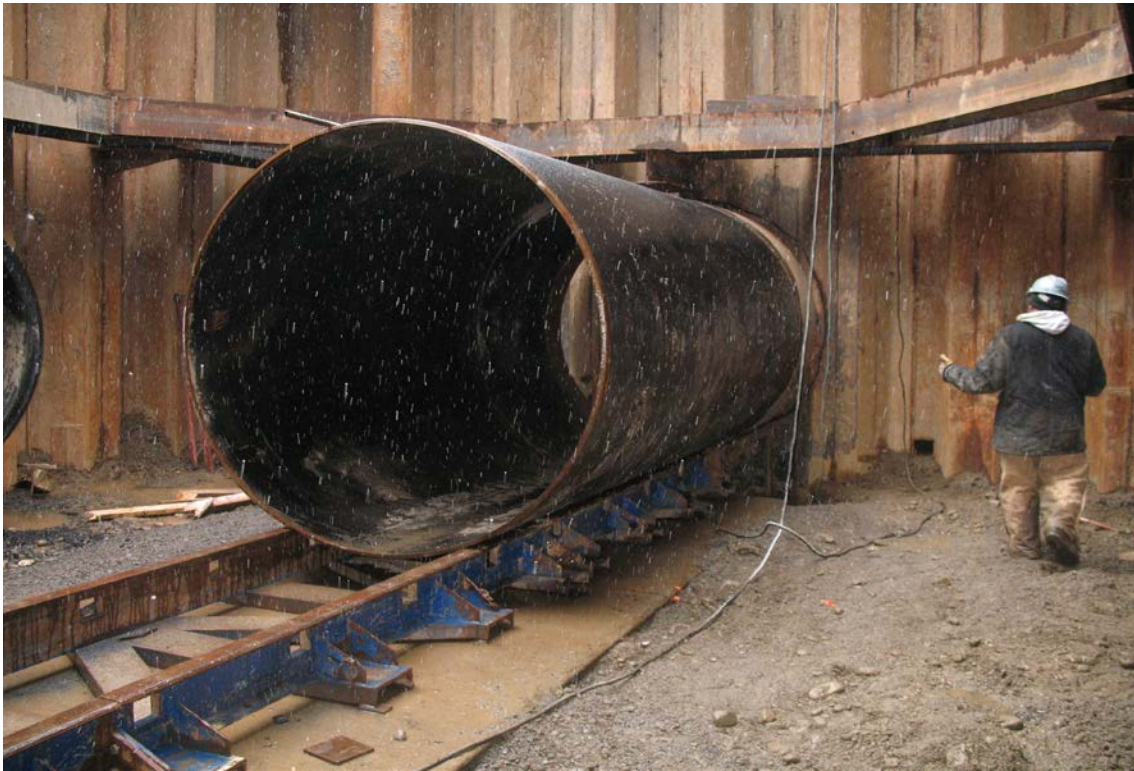
Figure 19. View of 60-in steel casing on guide rails.

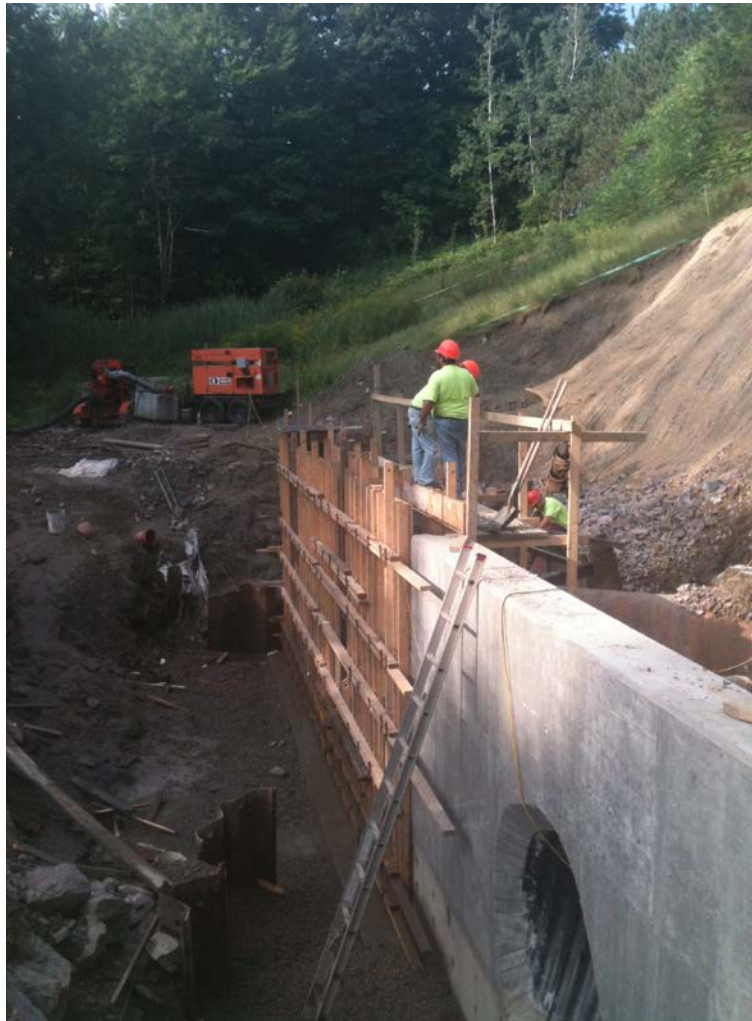
Figure 20. Headwall under construction for additional pipe.

The design of the headwall was modified to accommodate the shift in the centerline of the new pipe. Its construction is shown in figure 20. The outlet end of the pipe was designed to rest on a cradle wall. This also had to be redesigned because of the shift in the centerline. Furthermore, the cradle wall was changed to a full headwall to protect against slope failure (figure 21).

The concrete headwall developed a small crack above the steel casing, probably because of expansion and contraction of the casing. In future contracts, VTrans intends to require that the steel casing be wrapped with expansion material at the ends in the headwall and that a joint be added just above each pipe to control cracking.

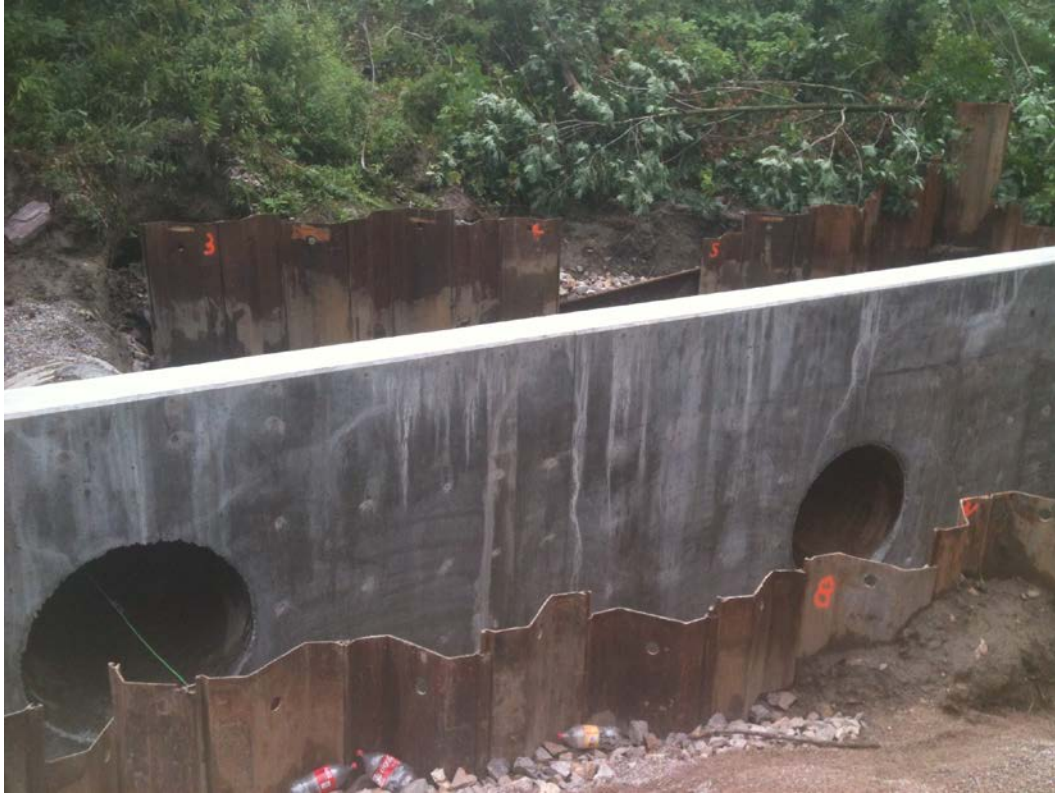
Figure 21. Completed headwall showing both pipes.

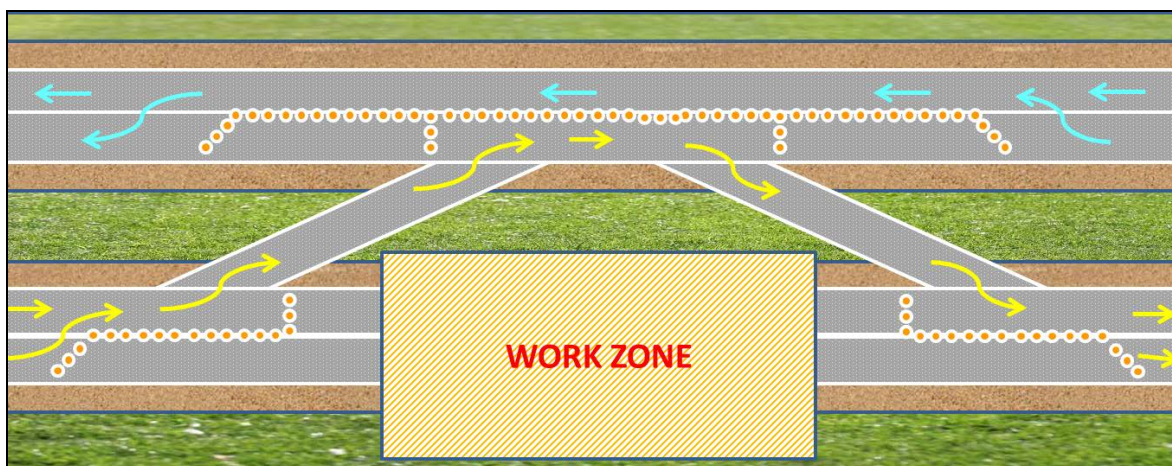
Figure 22. Single lane crossover strategy for the baseline case.

Figure 22 shows the schematic single lane crossover configuration for the baseline case. It is assumed that the traditional case would have taken one construction season (i.e. 180 days) to complete the culvert replacement at each location. The analysis shown below is for the South Burlington location.

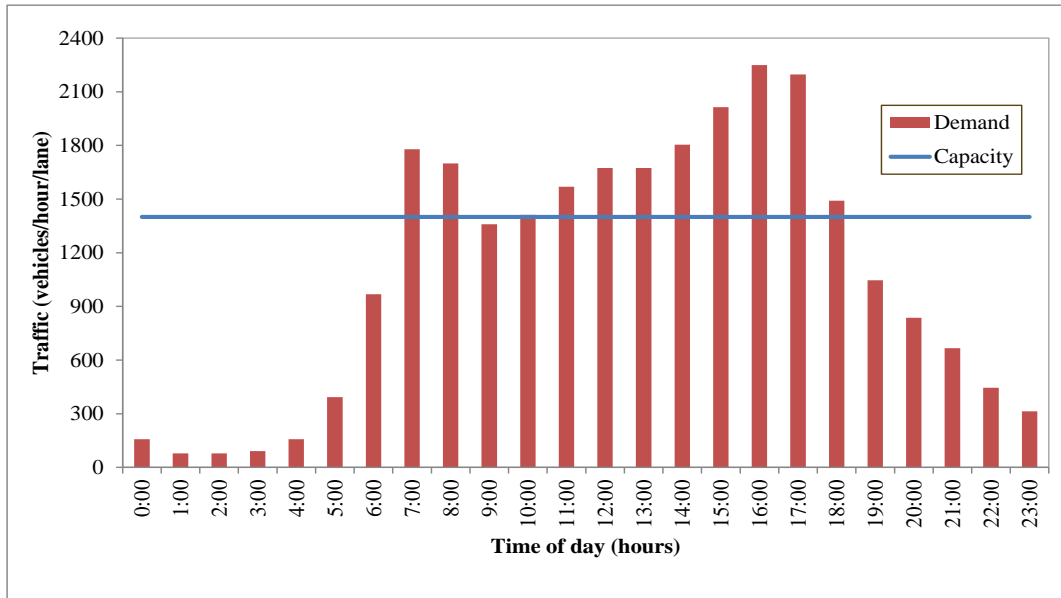
Figure 23. Comparison of hourly traffic demand and capacity in single direction.

The daily user costs were determined to be \$1,543,703 for both directions. The detailed calculations are shown in table 4. Approximately 95 percent of the user costs are attributed to travel time delay costs resulting from the building up of vehicle queue. Assuming that the traditional culvert replacement would have taken 180 days, the total RUC is estimated to be \$277,866,522.
