# Missouri Demonstration Project: Replacement of Three Bridges Using Hybrid- Composite Beam Technology

Final Report  
March 2013

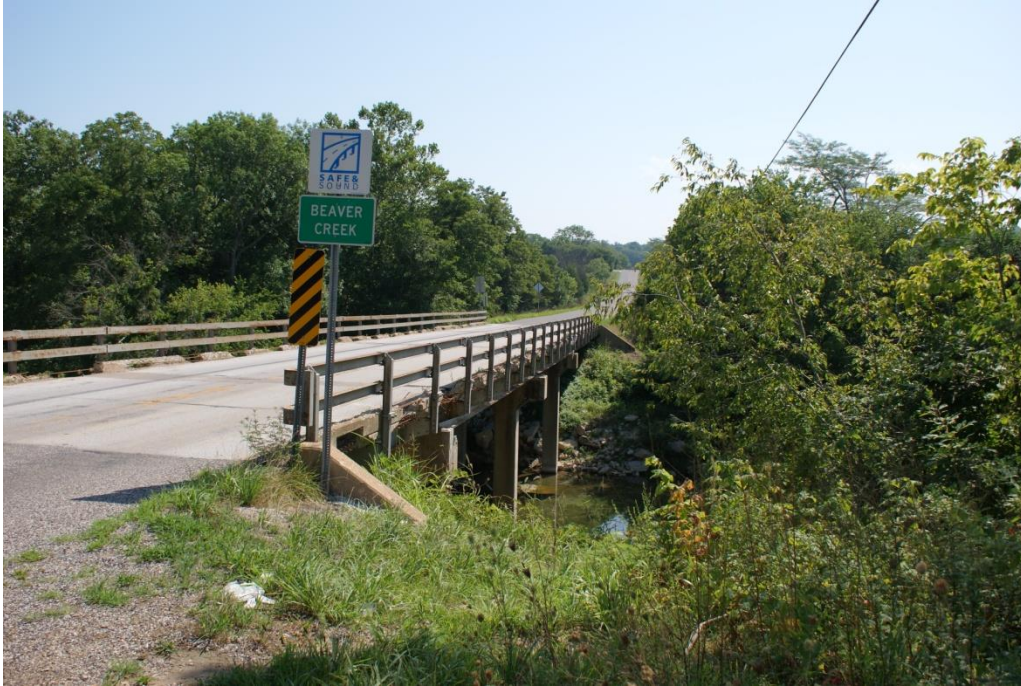
Figure 3. Old structure on MO 76 over Beaver Creek in Douglas County.

Figure 3 shows the original structure, which consisted of a 176-foot (ft), three-span steel I-beam structure built in 1935. At this location, MO 76 is a rural two-lane facility serving about 2,035 vehicles per day (vpd).

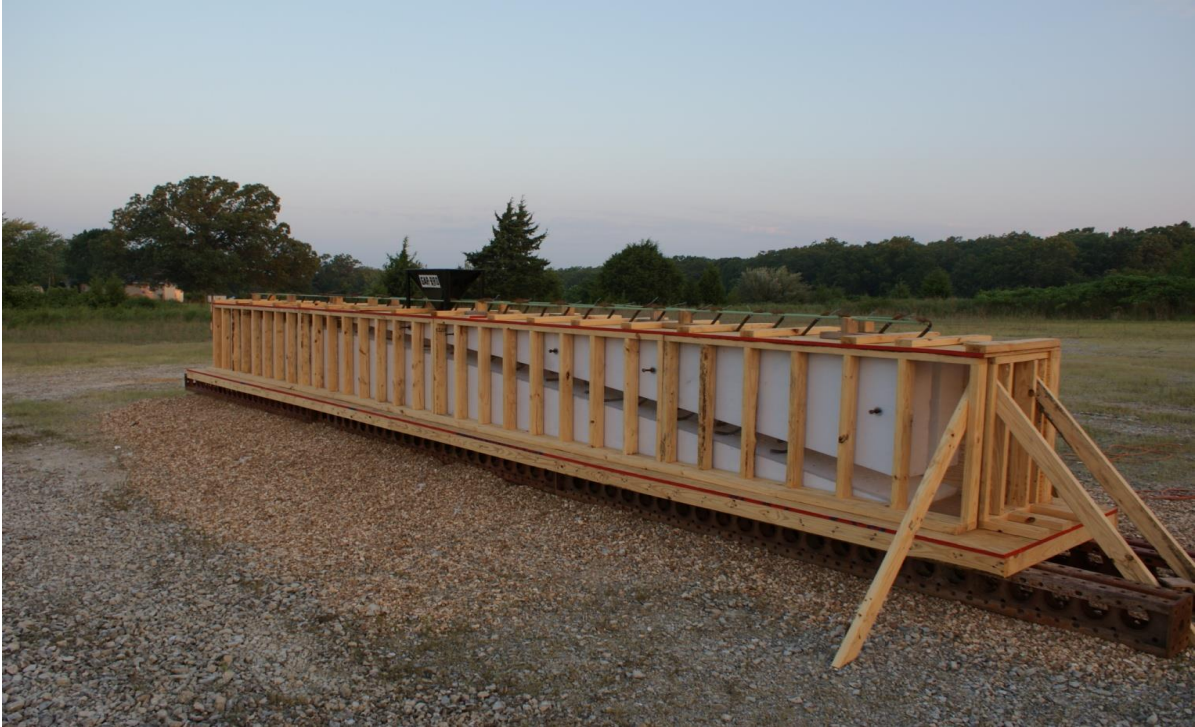
Figure 4. Half-scale mockup of HCB.

The use of HCB technology was new to both MoDOT and the contractors involved in the construction. Likewise, the use of self-consolidating concrete to fill the beam molds was not a standard practice. To gain experience with the materials involved, it was decided to construct a half-scale model of one of the beams with a clear acrylic side so that the movement of the concrete through the mold could be observed. In this way, techniques to facilitate introduction of mix and vibration patterns could be developed. The test pour was conducted on August 2, 2011, at the Mountain Grove facility responsible for delivery of the job mix for the MO 76 project. Figures 4 and 5 show the mockup.

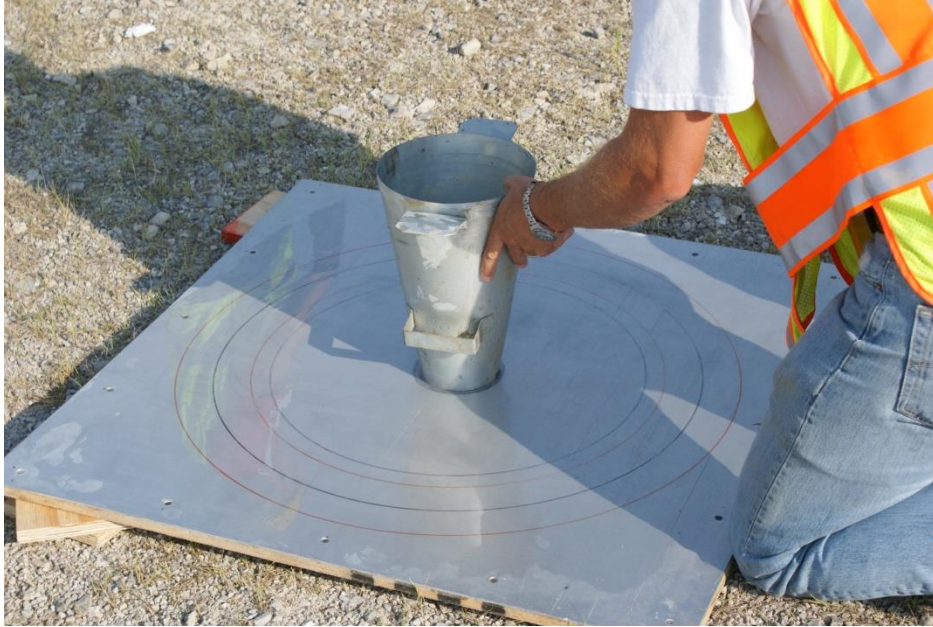
Figure 6. Modified slump test.

Significant time was taken to adjust the mix to the correct slump. The slump test was modified in that the cone was inverted and the diameter of the pool measured after removal. Figures 6 and 7 show the slump testing. Figure 8 shows a second test that involved the placement of a cage around the cone to measure the ability of the aggregate to move around an obstacle.

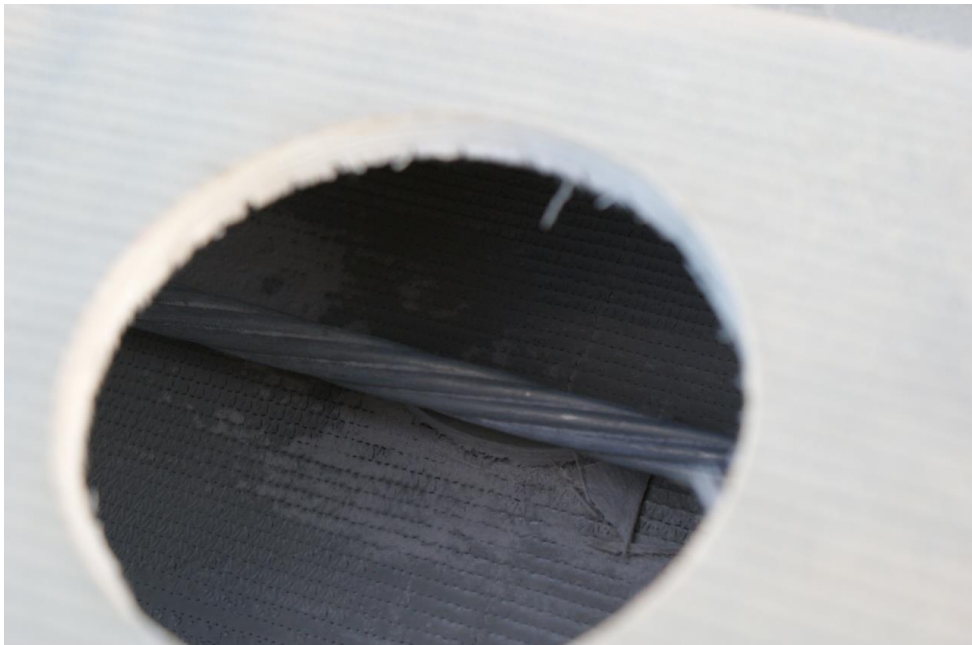
Figure 9. Filler openings located at one-quarter points along the beam top with steel reinforcing strand visible.

Figure 9 shows the openings in the top of the beam used for filling, originally sized at 4 in. As a result of the test pour, the opening was increased to 5 in to increase mix flow. Despite the low viscosity of the mix, substantial vibration was required to fill the beam. As long as the mix was in motion, it tended to continue (figure 10). If for any reason the flow stopped—as when moving from one fill hole to another, for example—vibration was required to start it moving again (figure 11).

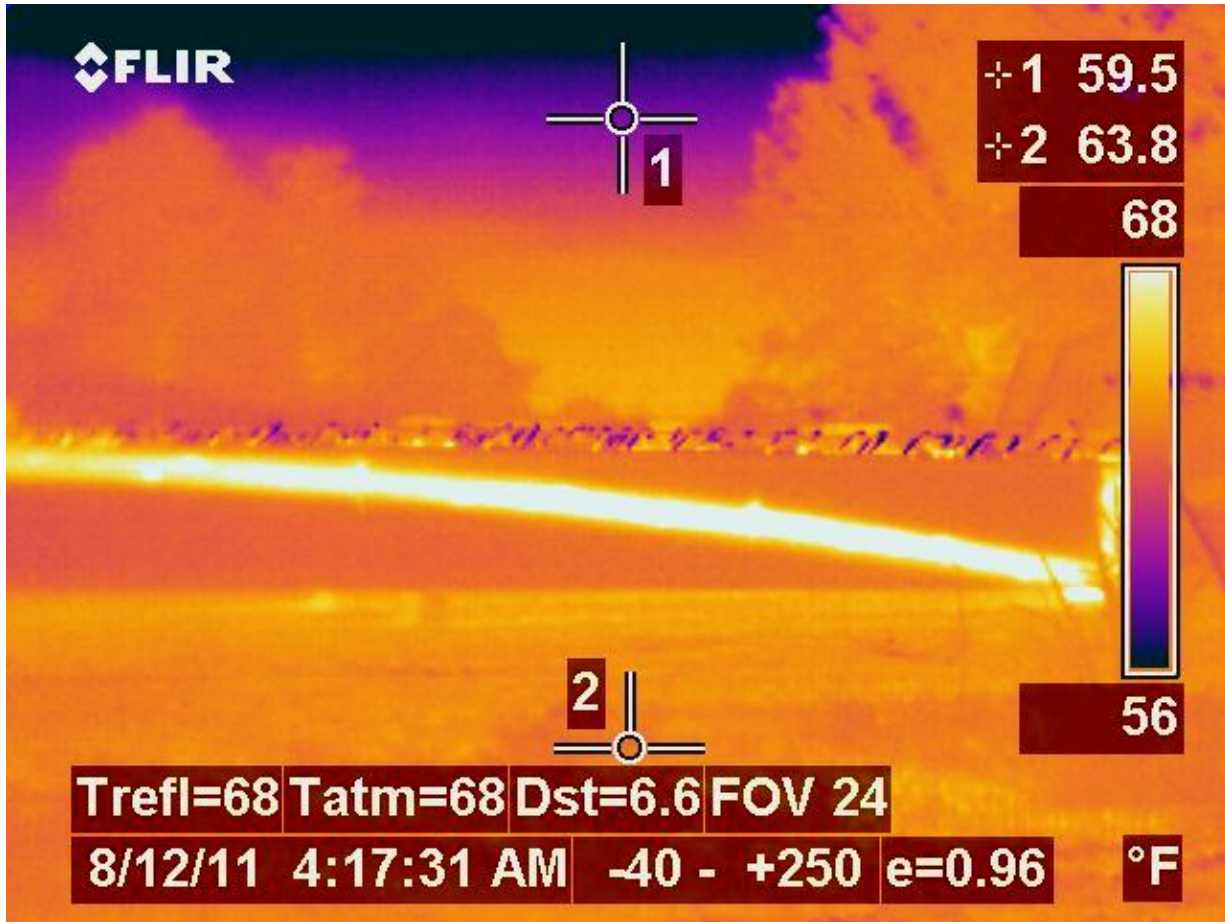
Figure 12. Infrared image of test beam used to detect voids in compression arch pour. (Photo courtesy of Missouri University of Science and Technology)

Figure 12 shows the results of infrared photography used to detect the possibility of voids in the compression arch during filling of the beams.

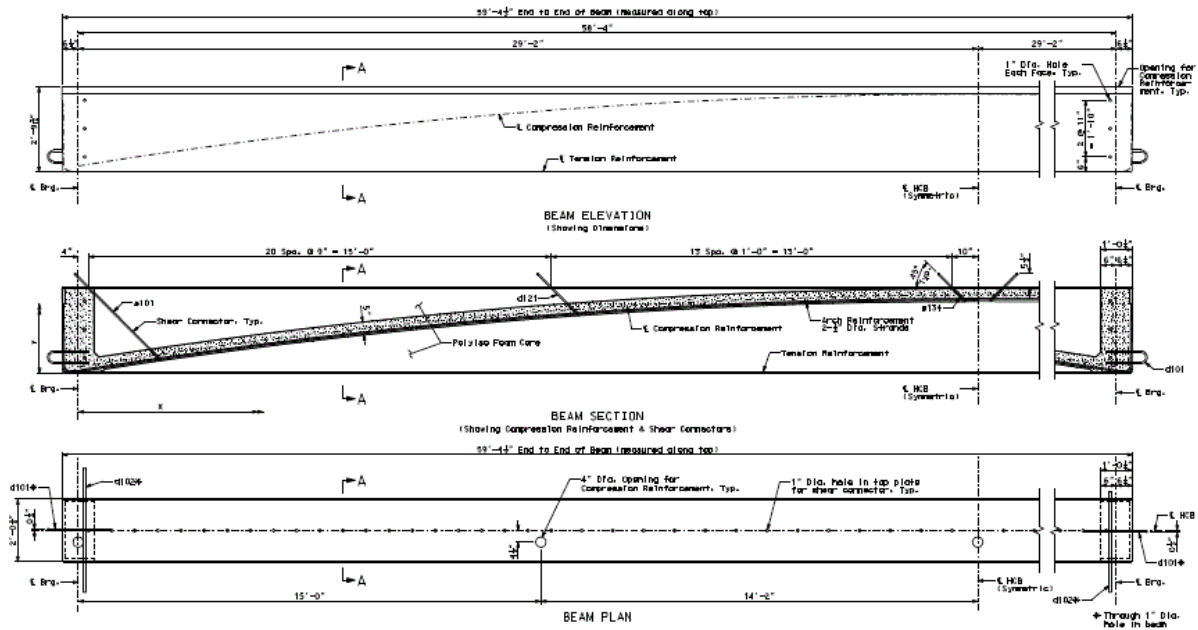
Figure 13. Section view of HCB from construction plans.

Figure 13 shows a cross section of the beams, including the location of the compression arch formed by injection of the self-consolidating concrete.

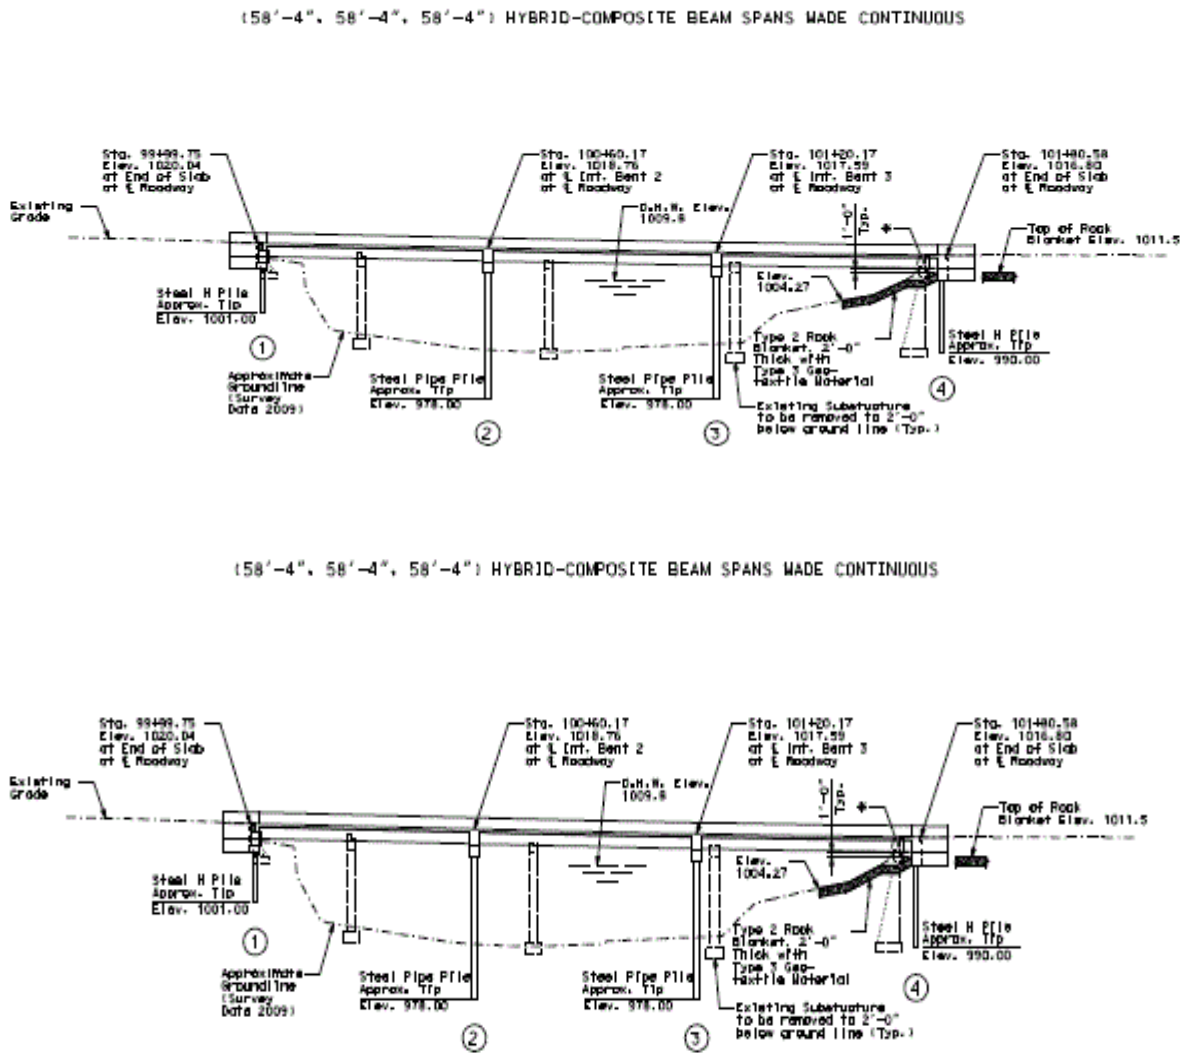
Figure 14. Plan view showing existing and revised pier locations for Douglas County structure.

The existing substructure was determined to be inadequate to use for the proposed widened structure. Figure 14 shows the placement locations of new steel pipe piers.

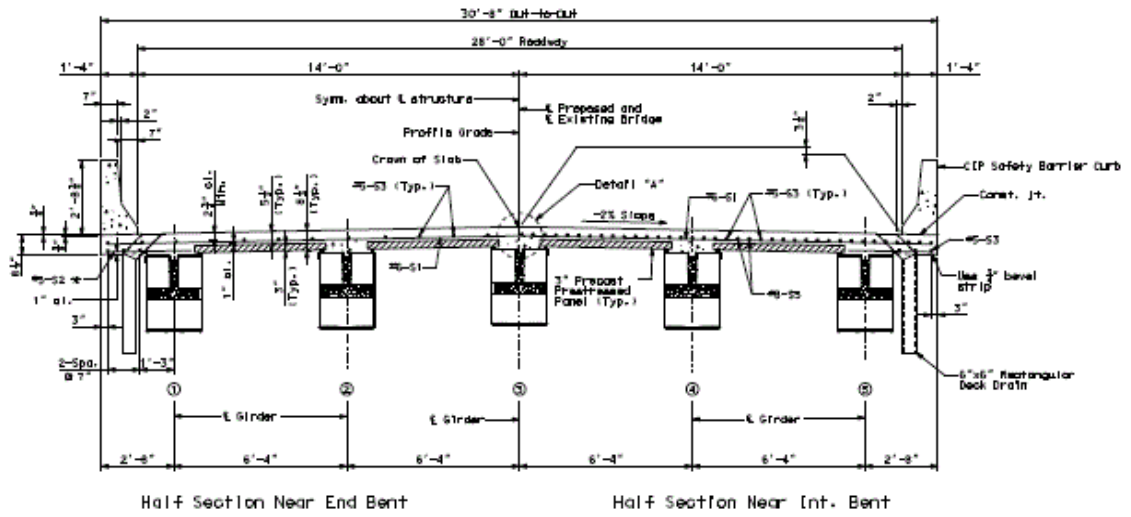
Figure 15. End view cross section of Douglas County structure.

The deck replacement consisted of the placement of five HCBs spaced on 6-ft, 4-in centers. The beams were 58 ft, 4 in long and 2 ft, 9 3/16 in deep. On top of the beams was placed a traditional 8.5-in portland cement concrete (PCC) deck with an overall (out to out) width of 30 ft, 8 in, providing a 28-ft roadway width. Figure 15 illustrates the cross sectional dimensions of the new structure.

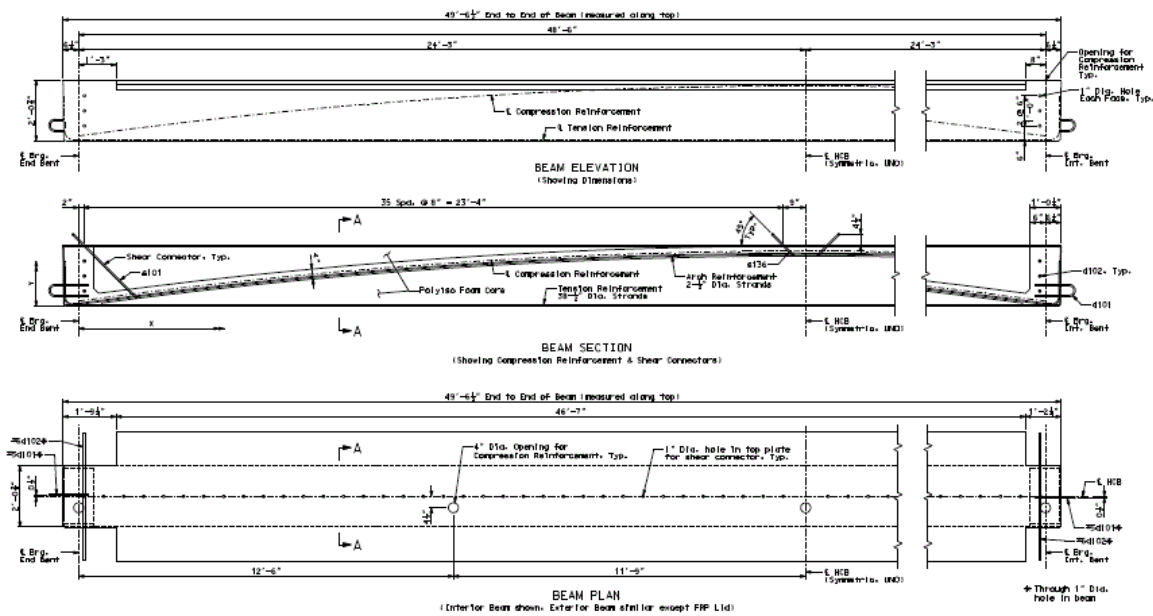
Figure 24. Cross section of HCB for Reynolds County structure.

The weight of the HC beams used on this project was about 3,100 pounds each empty. Filling the compression arch added about 6,800 pounds. The total weight of 9,900 pounds each is about 40 percent less than traditional steel beams.

Figure 24 shows a cross section of the beams, including the location of the compression arch formed by injection of the self-consolidating concrete.

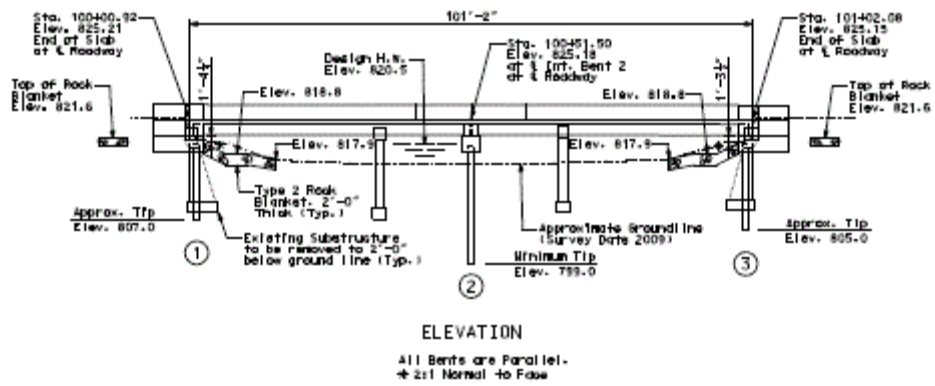
Figure 25. Plan view showing existing and revised pier locations for the Reynolds County structure.

The existing substructure was determined to be inadequate for the proposed widened structure. Figure 25 shows the configuration of the new steel pipe piers that were placed. The number of spans was reduced from three to two.

(48'-6", 48'-6") HYBRID-COMPOSITE BEAM SPANS MADE CONTINUOUS

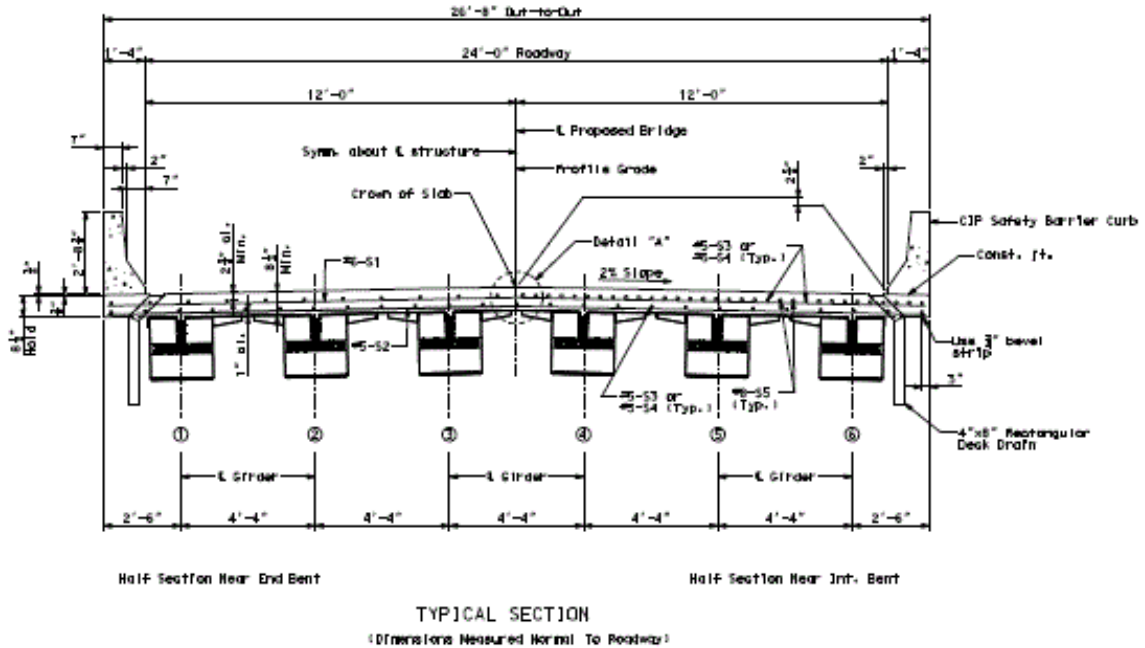
Figure 26. Cross section of HCB on Reynolds County location.

The deck replacement consisted of the placement of six HCBs spaced on 4-ft, 4-in centers for each span. The beams were 48 ft, 6 in long and 2 ft, 5/8 in deep. On top of the beams was placed a traditional 8.5-in PCC deck with an overall (out to out) width of 26 ft, 8 in, providing a 24-ft roadway width. Figure 26 illustrates the cross sectional dimensions of the new structure.

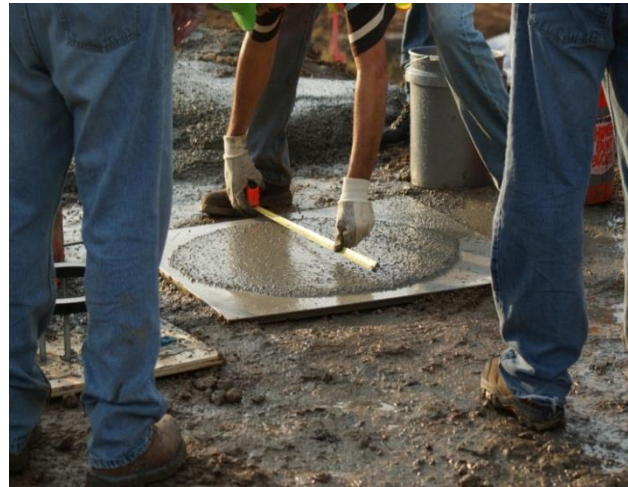
Figure 27. Modified slump test.

Tests were performed on self-consolidating concrete to ensure the mix would flow adequately through forms without forming voids. The slump test was modified in that the cone was inverted and the diameter of the resulting circle of mix was measured (see figure 27). The target diameter was between 30 and 32 in.

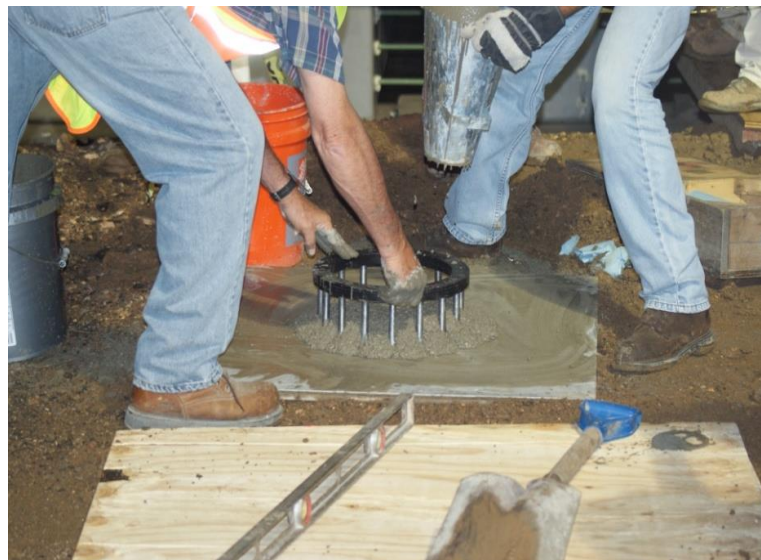
Figure 28. Cage test performed at the Reynolds County site.

Figure 28 shows a second test run with the inverted cone set inside a basket with vertical bars to measure the ability of the mix to flow around obstacles.

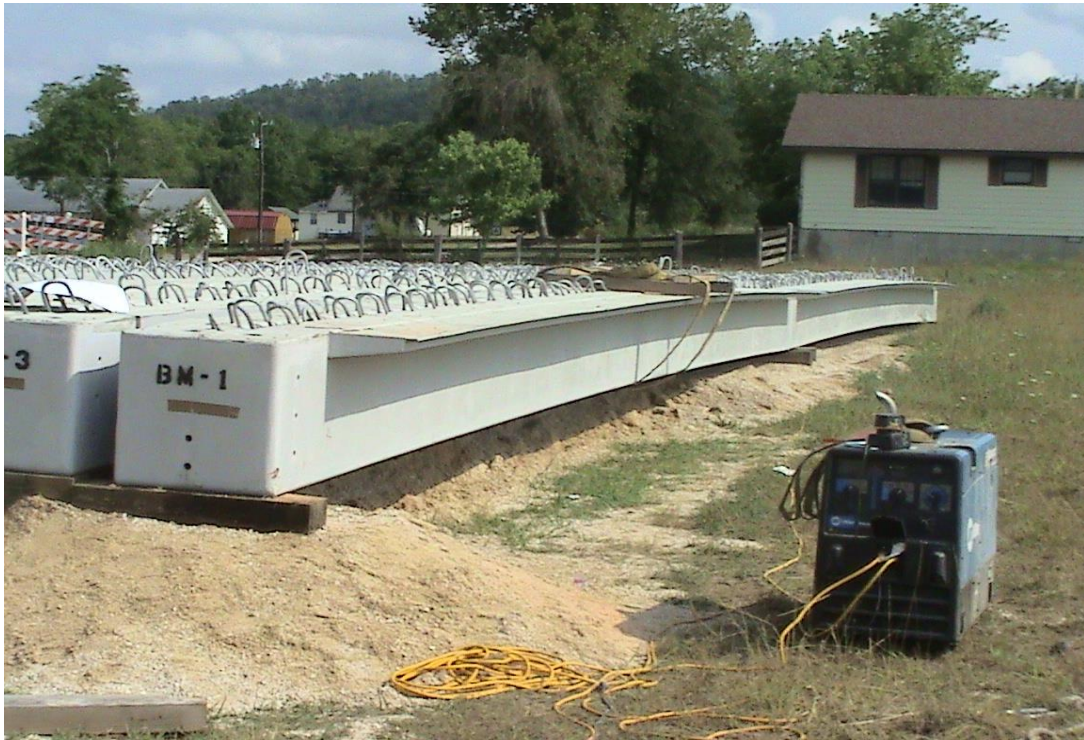
Figure 29. Beams at staging location after insertion of shear steel.

All beams were stockpiled alongside the project for insertion of the shear steel (see figure 29). The lightweight nature of the beams made setting them in place a relatively simple task. Figure 30 shows the beams moved into position using a small track hoe. A slightly larger crane was used to set the beams (see figures 31 and 32) where additional reach was required.

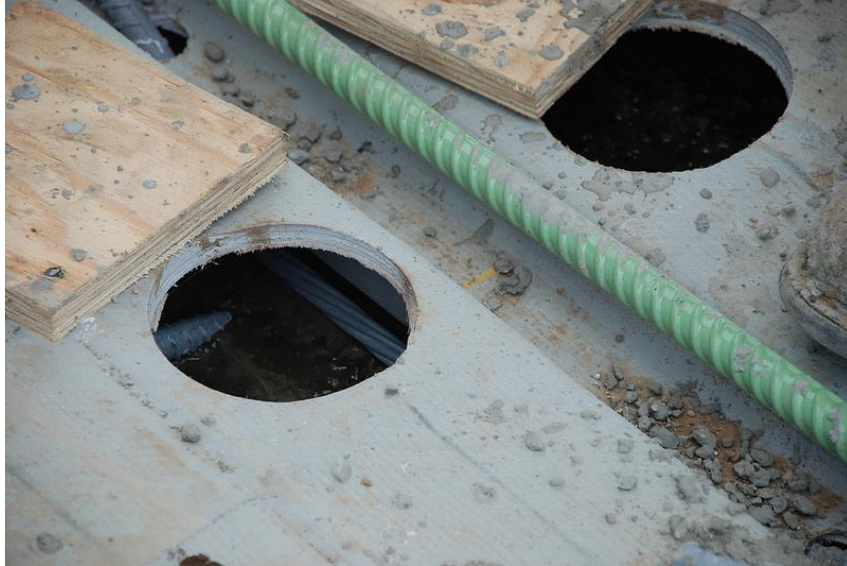
Figure 33. Original 4-in access holes for concrete introduction.

Figure 33 shows how concrete was introduced at quarter points along the beam through 4-in holes. The concrete required substantial vibration to flow into the beam opening. The opening in the beam was expanded with a reciprocating saw with a wood blade so that the hose end would fit completely into the beam. This resulted in much easier flow and eliminated the need for most of the vibration. Figure 34 shows the self-consolidating concrete being pumped into place.

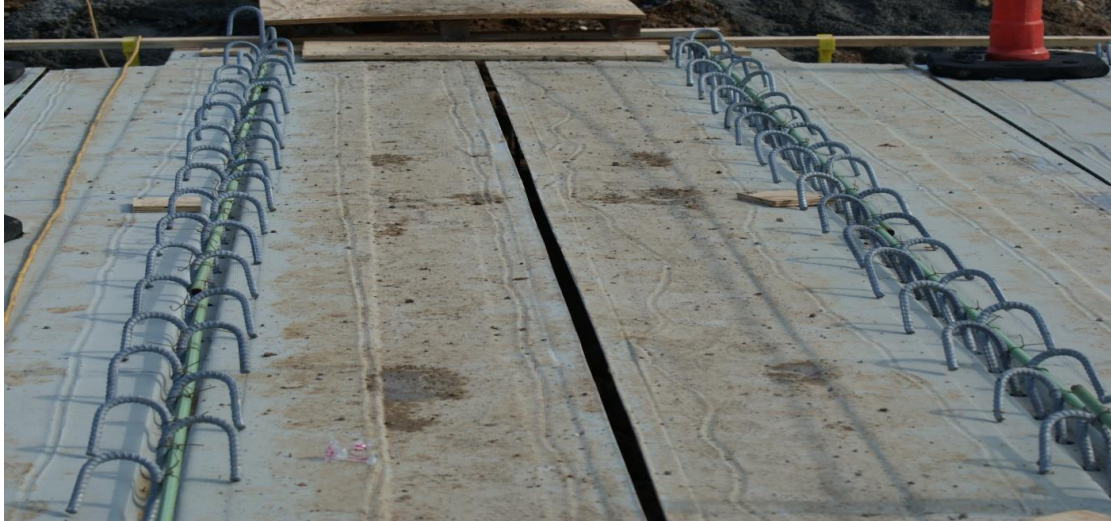
Figure 35. Gap between beam flanges.

Figure 35 shows that, after the concrete set, there was a gap between the beams of about 1 in that required closing before the deck was poured. The fiberglass shell allowed a wooden two-by-four to be placed under the deck and screwed in place with drywall screws to provide the required form.

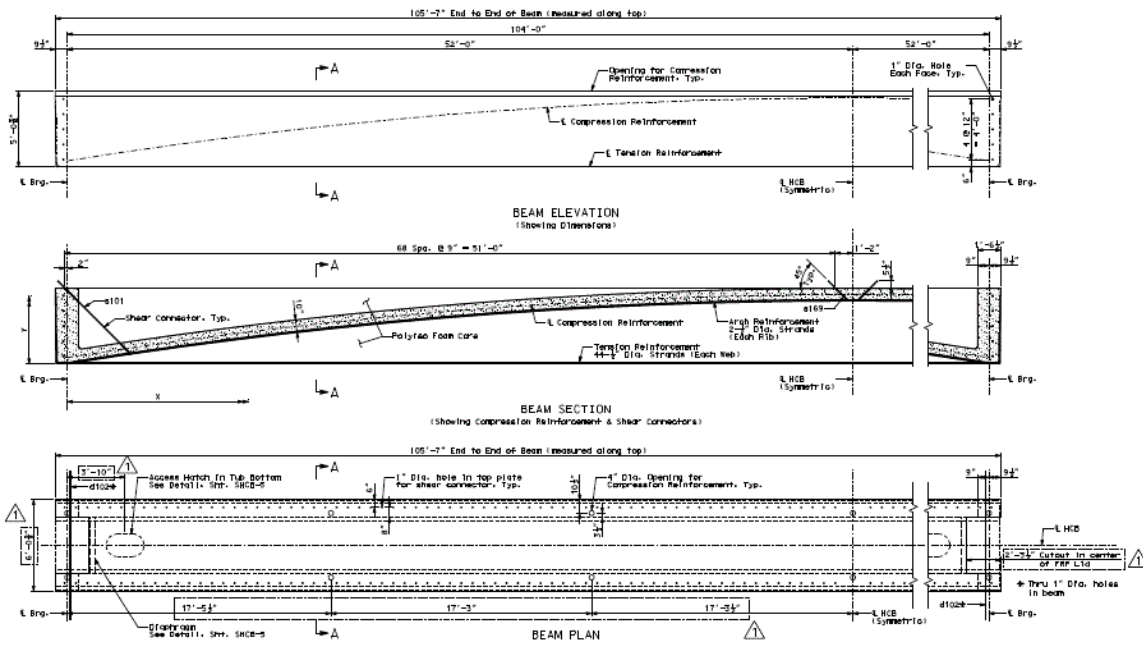
Figure 38. Cross section of HCB for the Dade County structure.

Figure 38 shows a cross section of the beams, including the location of the compression arch formed by injection of the self-consolidating concrete.

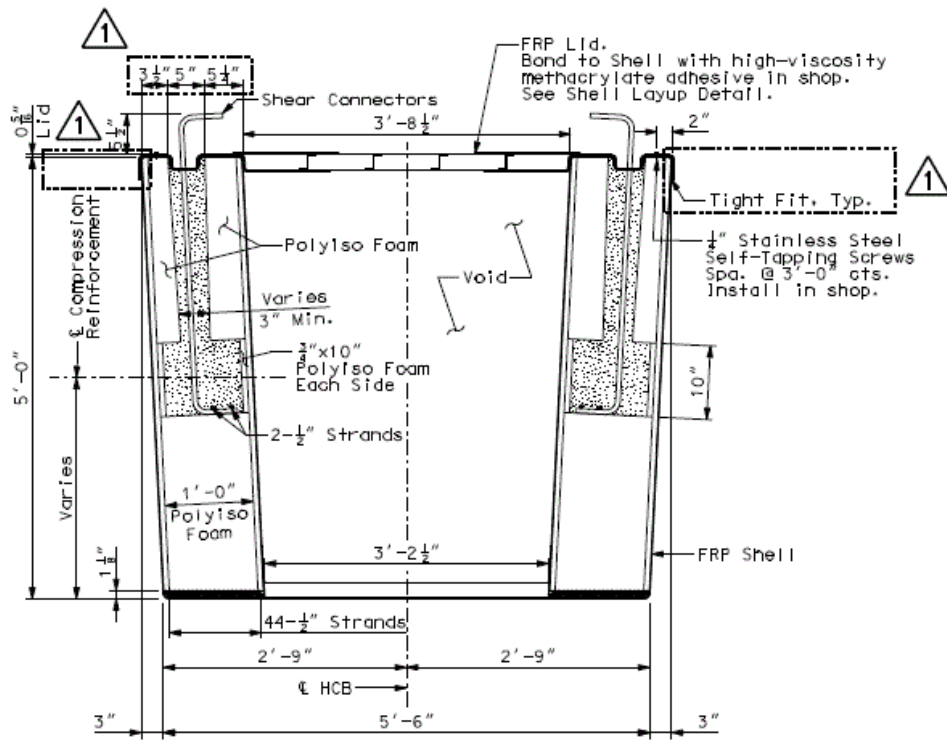
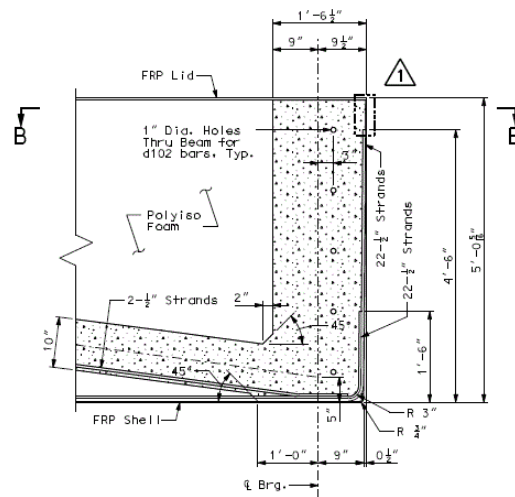
Figure 39. End view cross sections of hybrid-composite box beams showing location of compression arch.

Figure 39 shows the end view cross section of the voided box beam section with the location of shear connectors, compression reinforcement, and foam.

SECTION A-A

CHIMNEY DETAIL

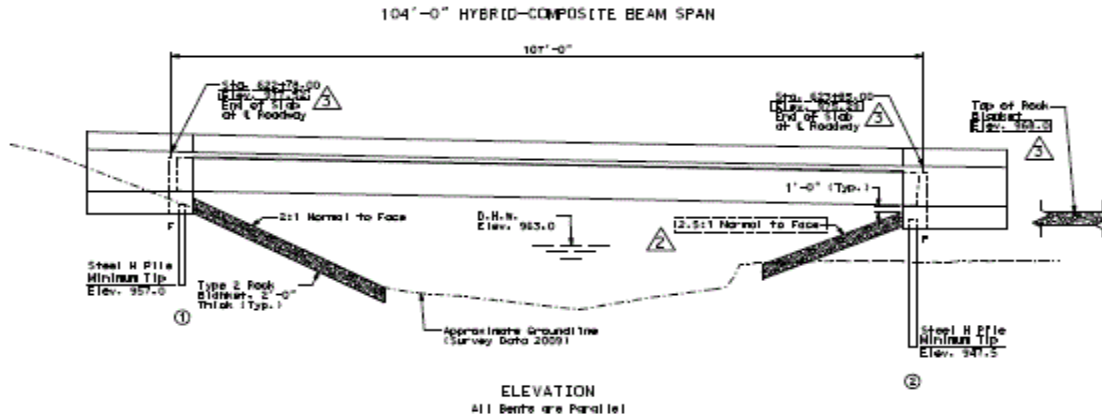
Figure 40. Abutment detail of the Dade County project.

Figure 40 shows the abutment detail of the bridge constructed for this project. As noted earlier, the new bridge was constructed just west of the existing structure.
