**IMPROVING RIGID PAVEMENT SMOOTHNESS USING POLYLEVEL<sup>®</sup>**

Project #: RES2016-18

UTC Report Submitted to TDOT

May 2018

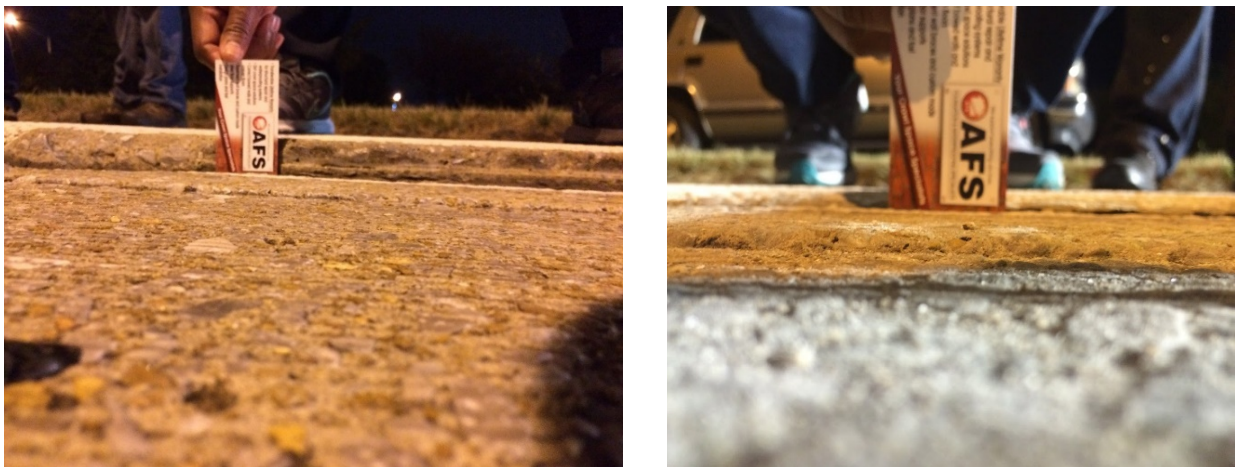
**Figure 3.3 Before and after leveling slabs using PolyLevel<sup>®</sup> material on I-24 West**

The test sections have lane width of 3.65 m (12.00 ft.) slab thickness of 255 mm (10 in.) and joint spacing of 4.57 m (15.00 ft.) Figure 3.2 shows slab faulting on I-24 West section with a faulting of 25 mm (1 in.) before and about 3.80 mm (0.15 in.) after treatment.

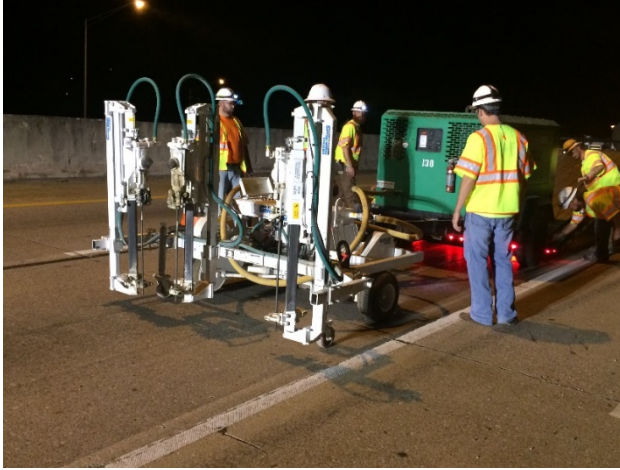
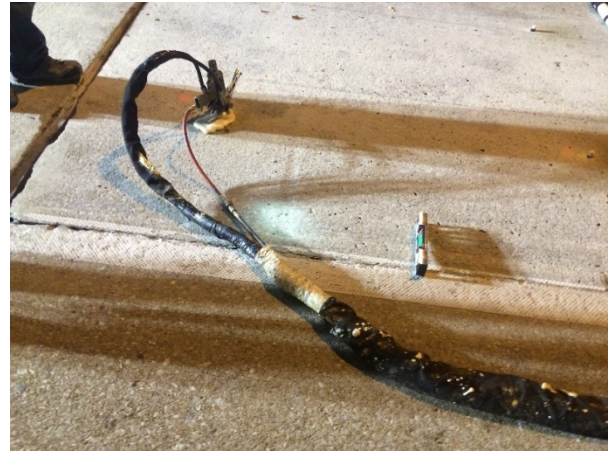
**Figure 3.4 Drilling holes and installation of PolyLevel® materials on I-24 West**

The application of PolyLevel<sup>®</sup> materials involve drilling holes that are about 1.58 cm (5/8 in.) diameter. The main two components of polyurethane materials are mixed in the nozzle and injected at high pressure and temperature under the slab through the holes. As the materials mix they expand and lift the 254-mm (10-in.) rigid pavement slab. Care must be taken to avoid slab overcorrection. Figure 3.4 shows AFS crew drilling the holes with a three-rig drilling machine and applying the PolyLevel<sup>®</sup> material through the holes.

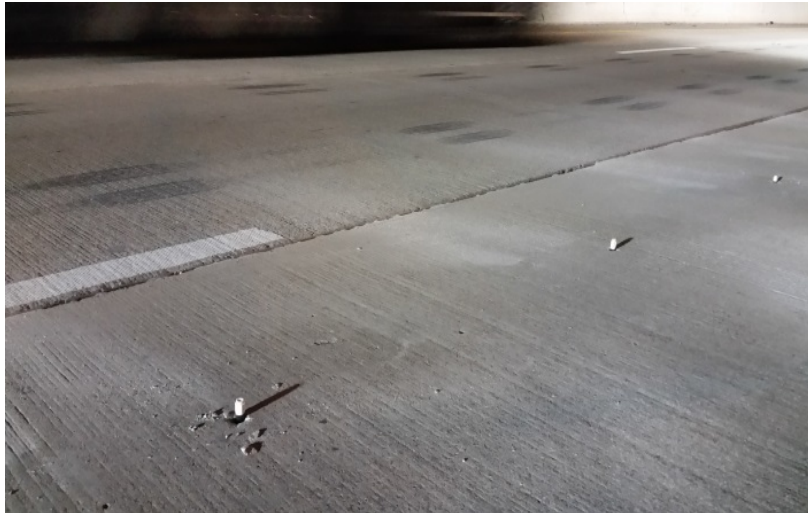
**Figure 3.6 Injection holes on concrete slabs**

Figure 3.5 below shows a view of I-75 North before installation. Figure 3.6 shows the preparation of drilled holes before the application of polyurethane materials. The application of the two-part polyurethane materials via injection nozzle is shown in Figures 3.4 and 3.6. Holes are patched after injection of the material as shown in Figure 3.7. As polyurethane is pumped, it fills the air or water pockets underneath the concrete slab and water or mud is expelled out. A more stable underlying layer results from the process.

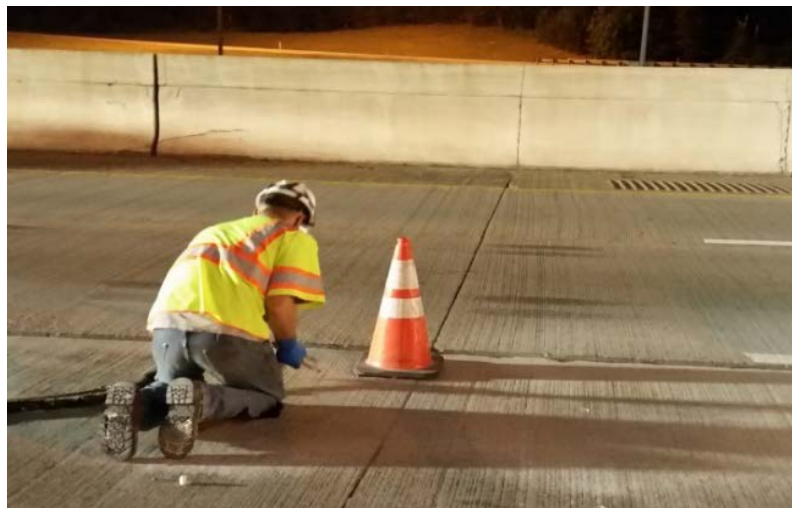
**Figure 3.7 PolyLevel<sup>®</sup> injection on I-75 South**

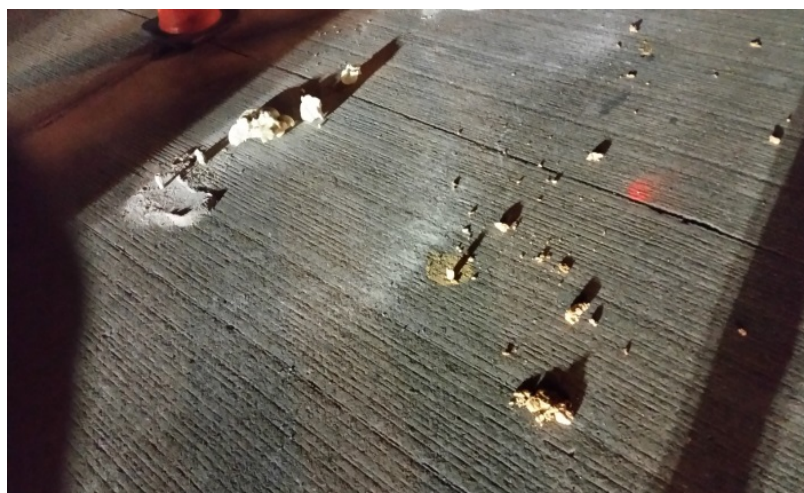
**Figure 3.8 Injected PolyLevel<sup>®</sup> material sipping out mud/water under the slab.**

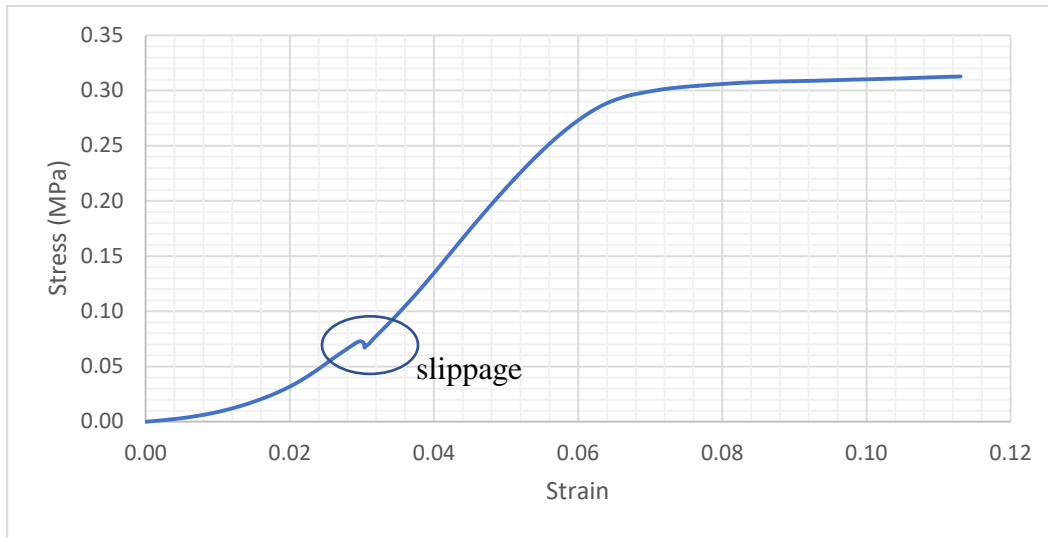
**Figure 5.1 Stress-strain relationship for PolyLevel® material**

The unconfined compressive strength test was conducted in accordance to ASTM D695 to obtain the elastic modulus and yield stress and strain measurements. The test was performed on an Instron 5655 Machine available at the UTC Mechanics of Materials Laboratory on the 55 mm (2 in.) cubes specimens. The results indicate that the materials contained voids due to the slippage observed on the curve before the materials attain a linear relationship. This is expected for foam materials. Results also indicate the material becomes a perfect plastic after it yields (Figure 5.1).

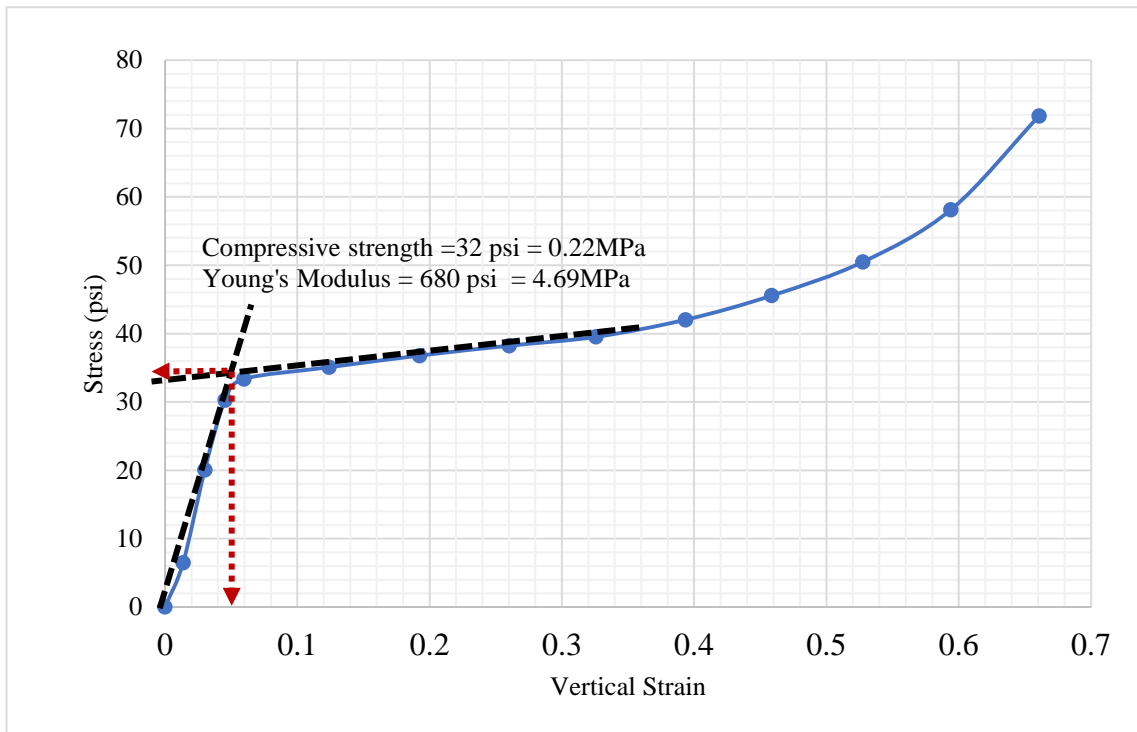
**Figure 5.3 Stress-strain curve**

Figure 5.3 shows the stress-strain relationship of the material. The stress-strain curve shows that the material behaves in elastic, secondary, and tertiary stress-strain behavior (i.e., an elastic-plastic, nonlinear elastic). Poisson's ratio ranges from 0.20 to 0.30 at the linear elastic zones. Figure 5.3 shows the variation of Poisson's ratio measured at different vertical strains. As expected for foam material, the Poisson's ratio increases with increase in vertical strain (reduction in height).

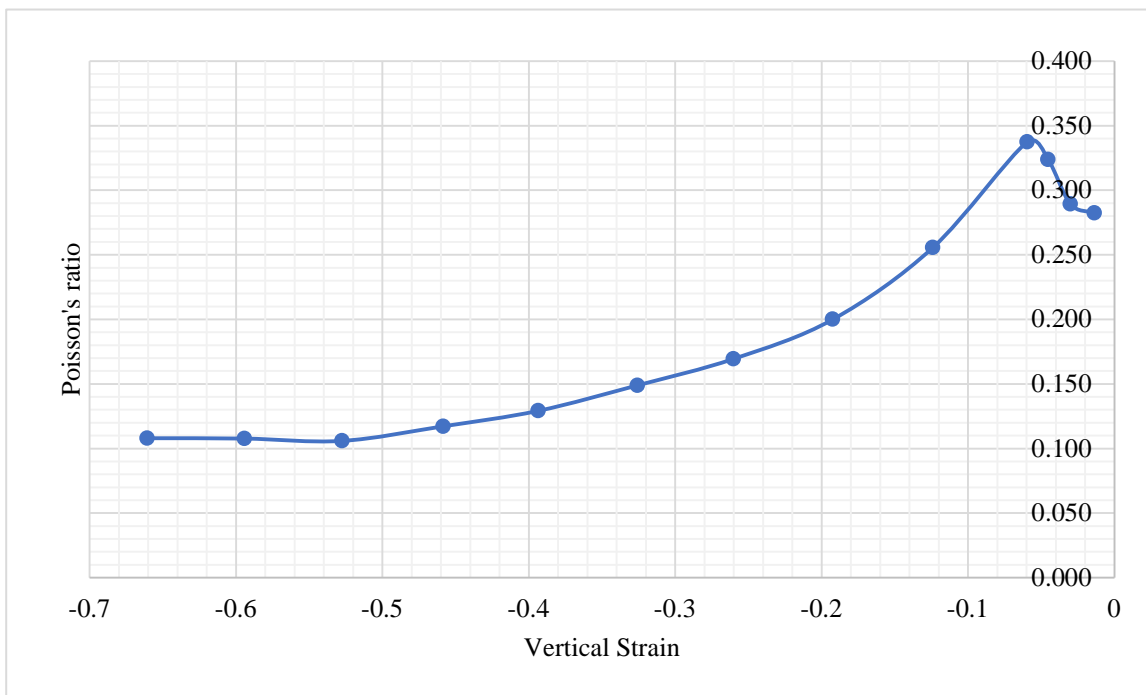
**Figure 5.4 Poisson's ratio-strain relationship**

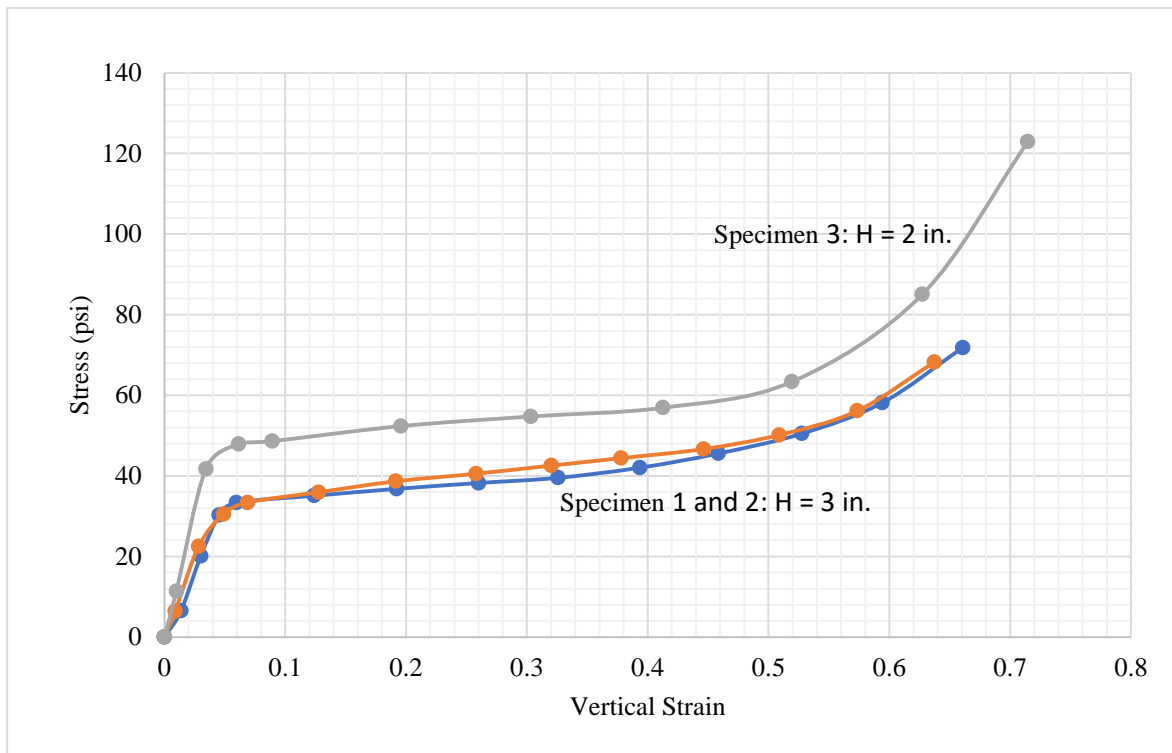
**Figure 5.5 Stress-strain curves comparison**

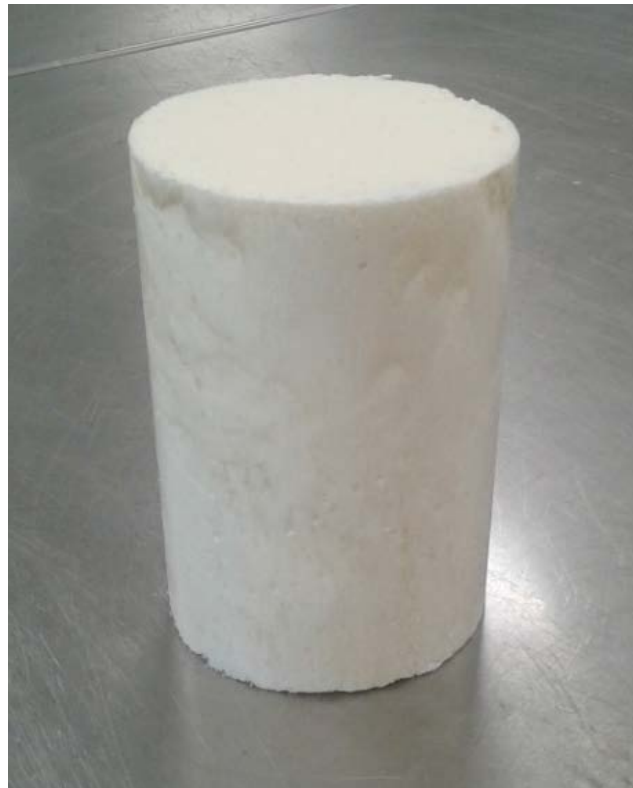
**Figure 5.6 Larger samples**

AFS Foundation availed to UTC larger test samples, 101 mm (4 in.) diameter by 202 mm (8 in.) height (Figure 5.6), that were trimmed to 101 mm (4 in.) diameter by 150 mm (6 in.) height for testing. These were subjected to compressive strength to obtain the elastic modulus and Poisson's ratio (Table 5.3). The Elastic modulus of 40 MPa (4985 psi) and Poisson's ratio ranging between 1.125 to 2.40 were measured. Much higher values of bulk density were obtained from these samples (Table 5.3). with average density of  $91.22 \text{ kg/m}^3$  ( $5.69 \text{ lb./ft}^3$ ) which is much closer to the publish values of  $104 \text{ kg/m}^3$  ( $6.50 \text{ lb./ft}^3$ ), and much better than density measured from the smaller samples (unconfined). Larger sample (semi-confined) yielded density values closer to the published values because the confinement in making larger samples increased the density compared to the smaller unconfined samples. So smaller sample have more air voids and hence lower density.

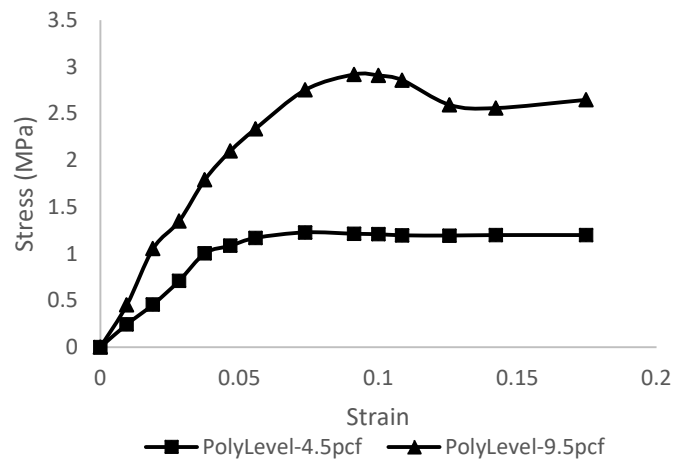
PolyLevel- 4.5pcf PolyLevel® material with a density of  $72.10 \text{ kg/m}^3$  (4.50 pcf.)

Figure 5.12 Stress-strain behavior of PolyLevel® used in FEM modeling

follows [32] and is shown in Figure 5.12.

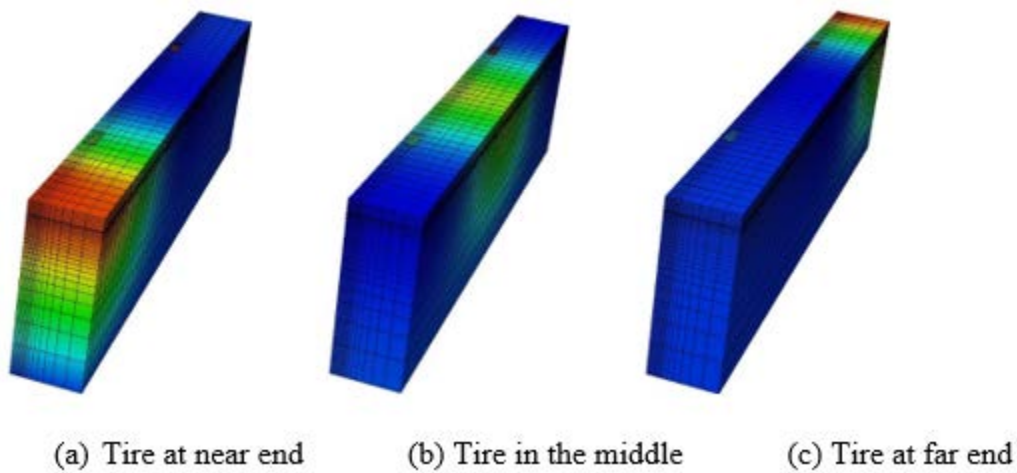
**Figure 5.13 Vertical deflection contours when tire moves from one end of ALF test pavement to the other**

The 0.2 m (0.66 ft.) wide strip is defined in Abaqus CAE, the loads (40 K and 80 K) are specified in FORTRAN subroutine DLOAD that is called by Abaqus to execute the job. Figure 5.13 shows the vertical deflection contour plots when the equivalent contact area (tire) moves from one end of ALF test pavement to the other. The deflections on the top of PolyLevel<sup>®</sup> leveling foams when using different levels of traffic loads (40K and 80K) and different PolyLevel<sup>®</sup> materials (72 kg/m<sup>3</sup> and 152 kg/m<sup>3</sup>) are presented in Figure 5.14.

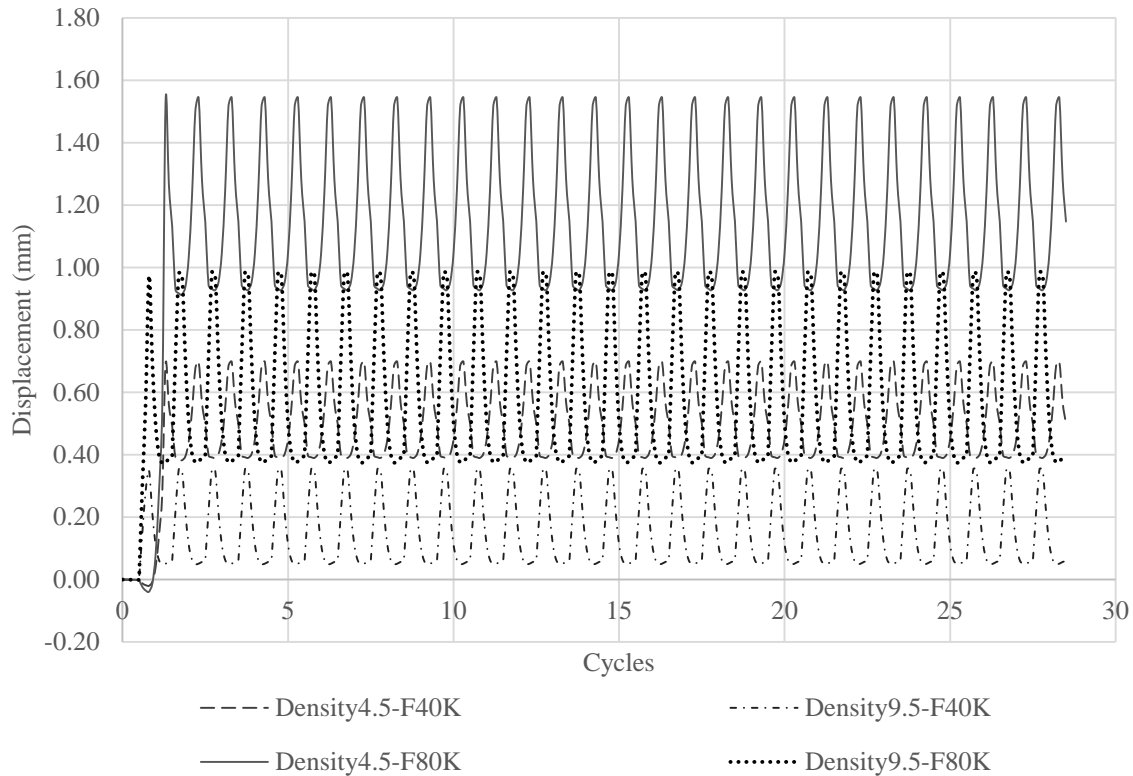
**Figure 5.14 Deflections at the top of PolyLevel<sup>®</sup> leveling patch with cyclic traffic loading**

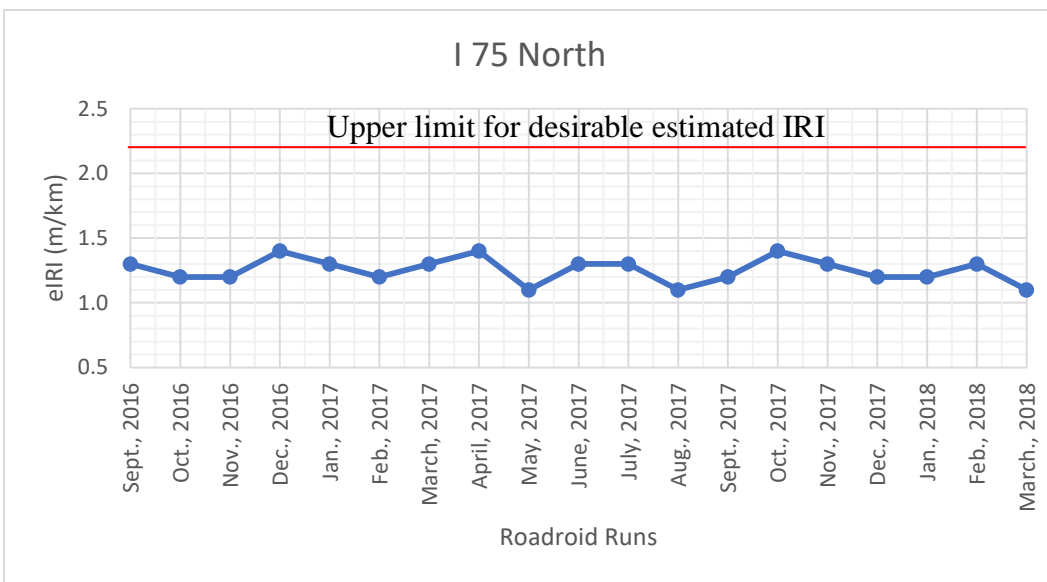
**Figure 6.7 Average IRI variations on I-75 North from Sept. 2019 to March 2018**

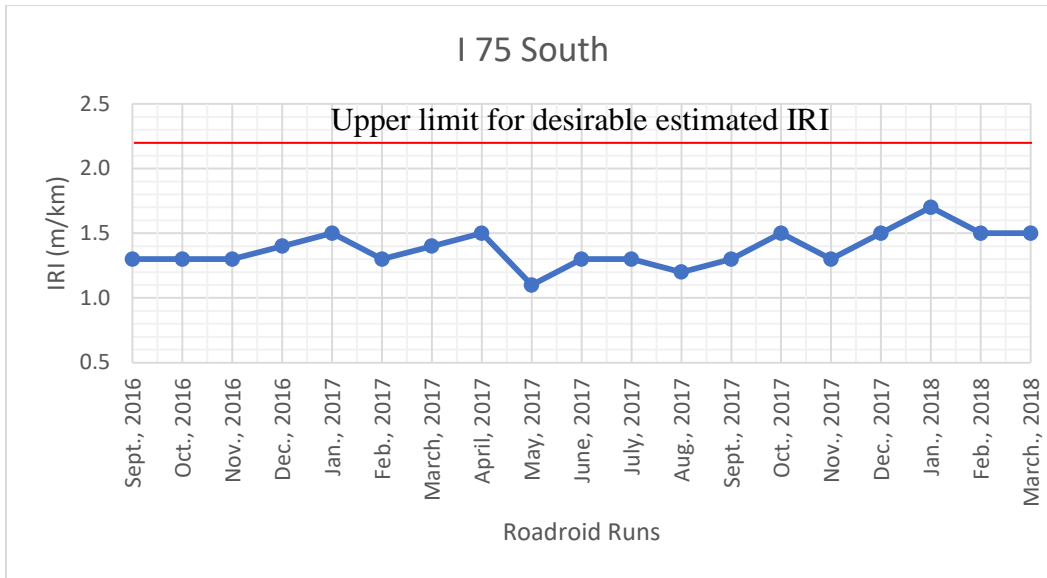
**Figure 6.8 Average IRI variation on I-75 South from Sept. 2016 to March 2018**

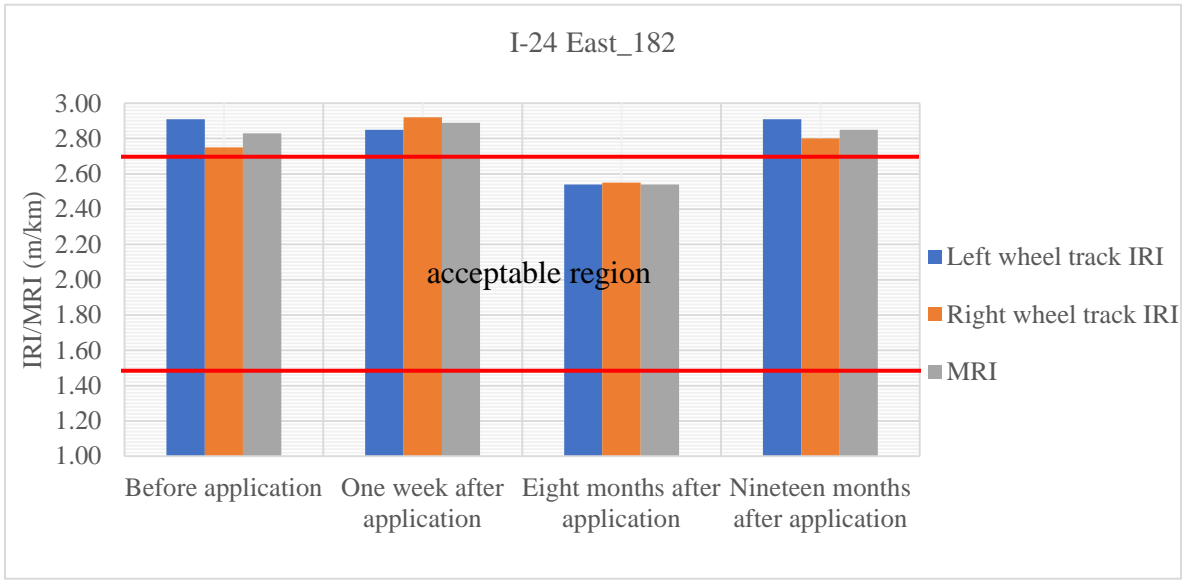
**Figure 6.12 IRI and MRI measurements for I-24 East, between MM182.3 and MM183**

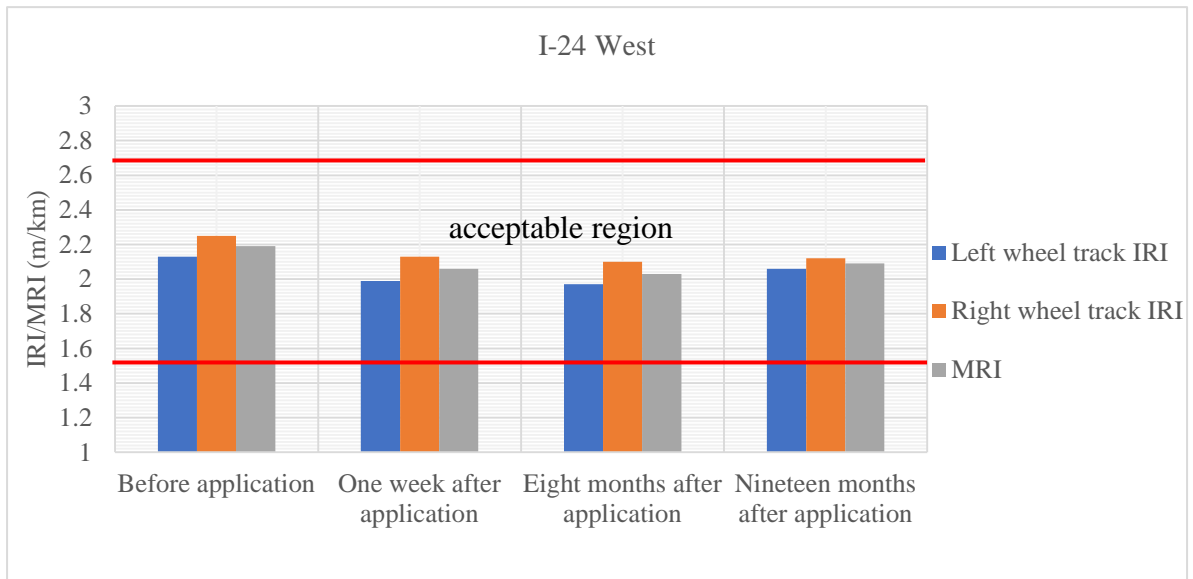
**Figure 6.13 IRI and MRI measurements for I-24 West, between MM 179.5 and MM 178.2**

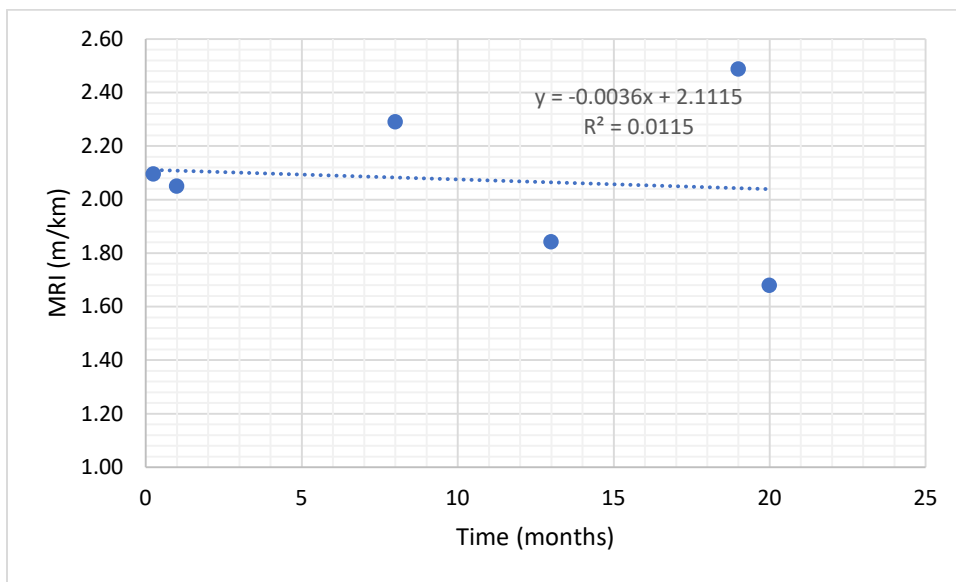
**Figure 6.14 Regression model of averaged MRI versus time**
