# Enhancing Existing Isolated Underpasses With Fencing to Decrease Wildlife Crashes and Increase Habitat Connectivity

Final Report VTRC 20-R28

**ENHANCING EXISTING ISOLATED UNDERPASSES WITH FENCING  
TO DECREASE WILDLIFE CRASHES AND INCREASE HABITAT CONNECTIVITY**

Virginia Transportation Research Council  
(A partnership of the Virginia Department of Transportation  
and the University of Virginia since 1948)

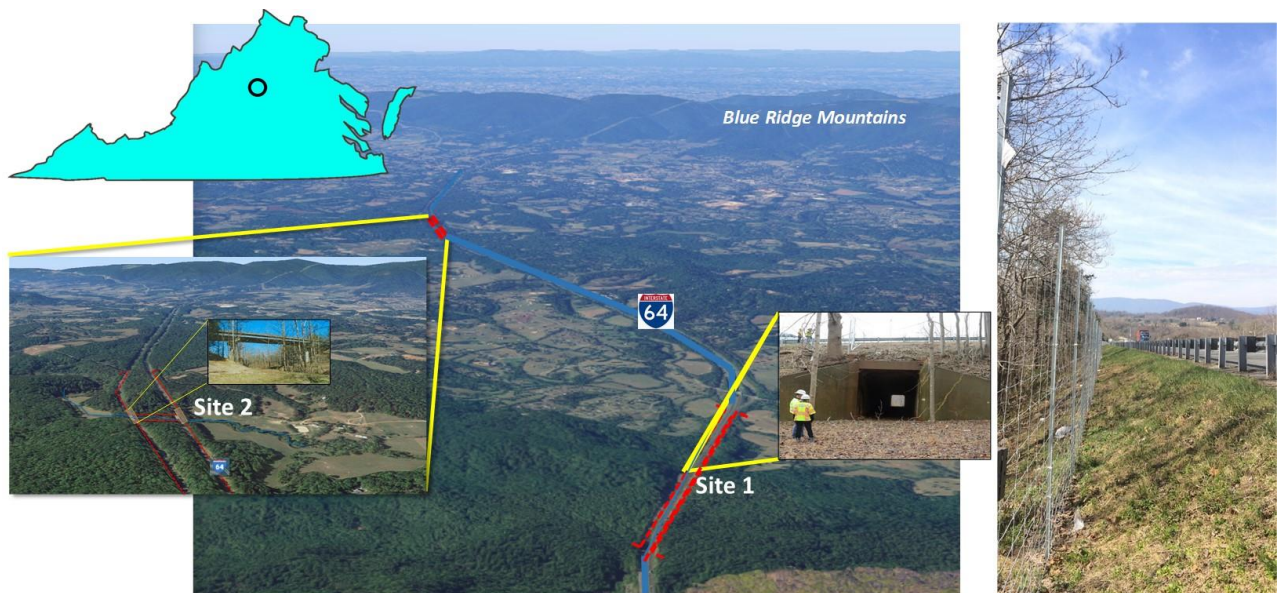
Figure 2. Study Sites: left, underpasses and locations of fencing (dashed red lines); right, photograph of fencing

The fence constructed was an 8-ft-high woven wire fence designed to prevent wildlife from entering the roadway and to guide them toward the underpasses (Figure 2). The spacing between the horizontal wires gradually decreased farther down the fence to prevent smaller animals from passing through.

The installation of approximately 23,000 linear feet of fencing (approximately 1 mi at each site, on both sides of the interstate) was initiated in 2016. Fencing extended from each of the two underpasses (0.5 mi of fencing extending along the roadside east and west from the underpasses). The fencing length decision was based on the same rationale as described previously for the extent of camera placement (i.e., based on a deer's home range size). Although one study suggested that fencing lengths of at least 5 km (3.1 mi) can maximize DVC reductions (Huijser et al., 2016), another study found no detectable association between fence length and average effect sizes (Rytwinski et al., 2016). For this study, a length of no greater than approximately 1 mi was selected to allow any deer and other species that approached the fence to be able to reach the underpass rather than to have a situation where the fencing created a complete barrier for species with smaller home ranges.

Fencing was constructed at the edge of the tree line, which varied from several feet to approximately 40 ft from the highway shoulder. This design allowed maintenance staff access to the grassy areas off the roadside to perform routine maintenance activities. Fencing was completed at the Site 1 box culvert underpass in February 2017 and at the Site 2 bridge underpass in January 2018.

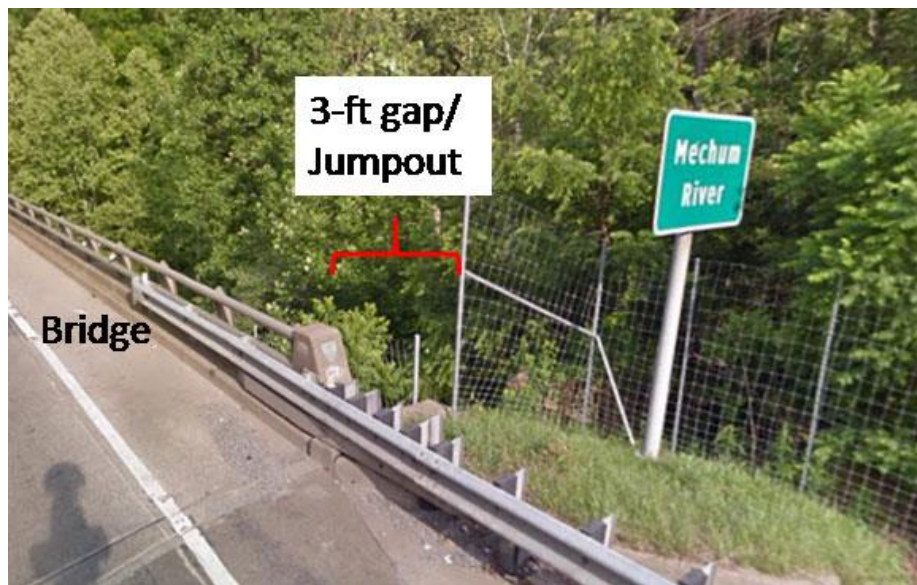
**Figure 3. Fence at Site 2 Underpass. The gap between the fencing and the bridge was designed to serve as a jumpout to allow wildlife on the traffic side of the fence to access the underpass below.**

At the Site 1 box culvert, fencing extended continuously along the interstate above the culvert. At the Site 2 bridge underpass, the fence was designed to tie into each bridge abutment and leave a 3-ft opening to serve as a jumpout for deer or other wildlife that might become trapped on the traffic side of the fence (Figure 3). These sections of the abutment are approximately 4 ft high, making it possible for deer to jump down but unlikely for deer beneath the bridge to jump up to the traffic side of the fence. Fencing then extended just below the bridge abutments, continued downhill and beneath the bridge, and tied into the abutment on the other side of the interstate. Extending the fence beneath the bridge prevented animals below the bridge from entering the median of the interstate.

In addition to the gaps that served as jumpouts at the Site 2 bridge abutments (Figure 3), four jumpouts were incorporated at each site approximately halfway between the underpass and each fence end. These features consisted of shorter sections of fencing to allow escape for any wildlife trapped within the roadway and to prevent animals from entering the roadway through the jumpout.

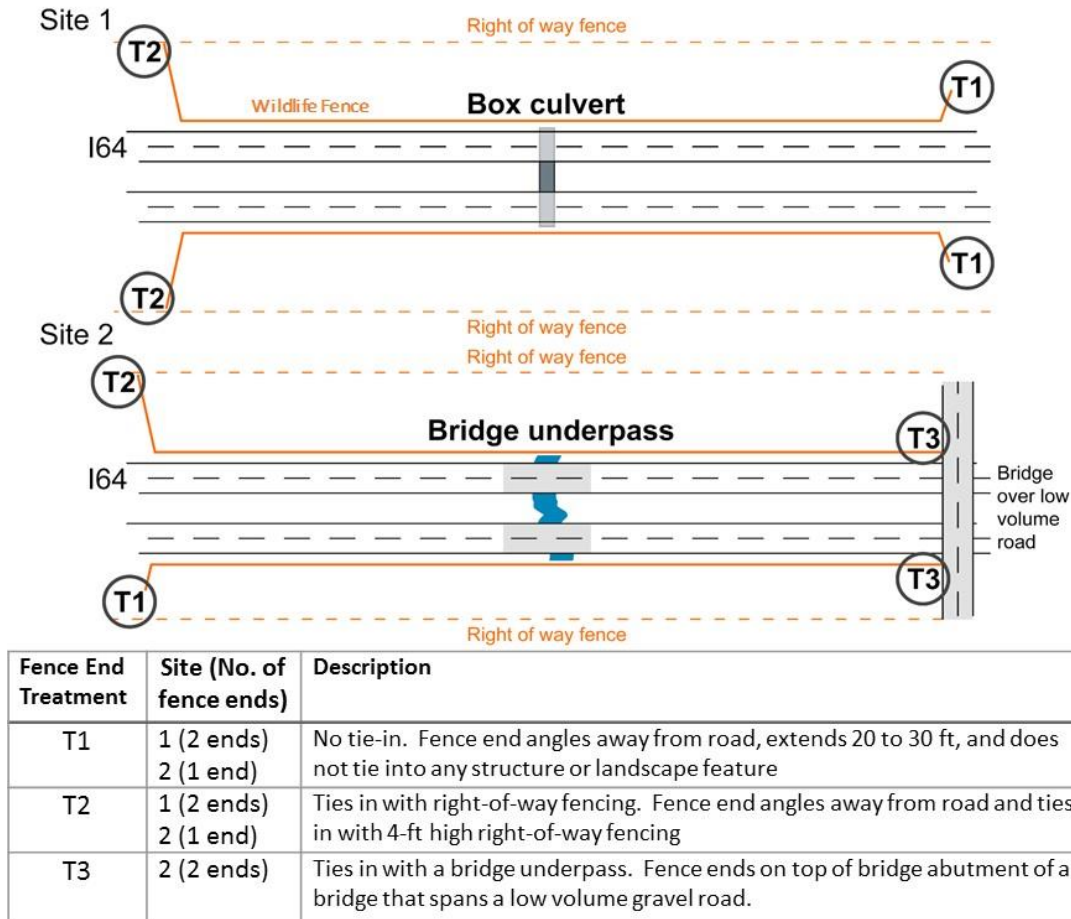
**Figure 4. Fence End Treatments at the Two Study Sites**

Although fence ends should ideally be designed to end at (or tie into) a landscape feature such as steep topography or another natural barrier to prevent deer from circumventing the fence ends, there were no such natural features at the study sites. The ends of the fencing were designed in three different treatments that allowed for a comparison with regard to deer activity and DVCs near the fence ends. Fence ends were designed either to angle away from the road, extend 10 to 20 ft, and end without tying into a feature (Treatment 1); to angle away from the road and tie into the existing 4-ft right-of-way (ROW) fencing (which ran parallel to and approximately 50 ft from the interstate) (Treatment 2); or to remain parallel to the road and tie into a bridge underpass that spanned a low volume gravel road with a low posted speed limit (Treatment 3, Figure 4).

Post-fencing, the difference in roadside deer activity among the fence end treatments that did and did not tie into any features underscores the importance of proper fence end design in minimizing DVC risk. In the pre-fencing study, a statistically significant relationship was found between roadside deer activity and DVCs; DVCs increased as roadside activity increased (Donaldson et al., 2016). Although DVCs did not increase at any of the fence ends in the post-fencing study, there was a high degree of deer activity at the ends that did not tie into a feature. Extending these ends in order to tie them into ROW fencing or another suitable feature would reduce roadside deer activity and the associated risk of DVCs in these areas. In the absence of a tie-in feature, extending fencing beyond wildlife crash hotspots has also been found to decrease the risk of collisions at fence ends (Bissonette and Rosa, 2012).

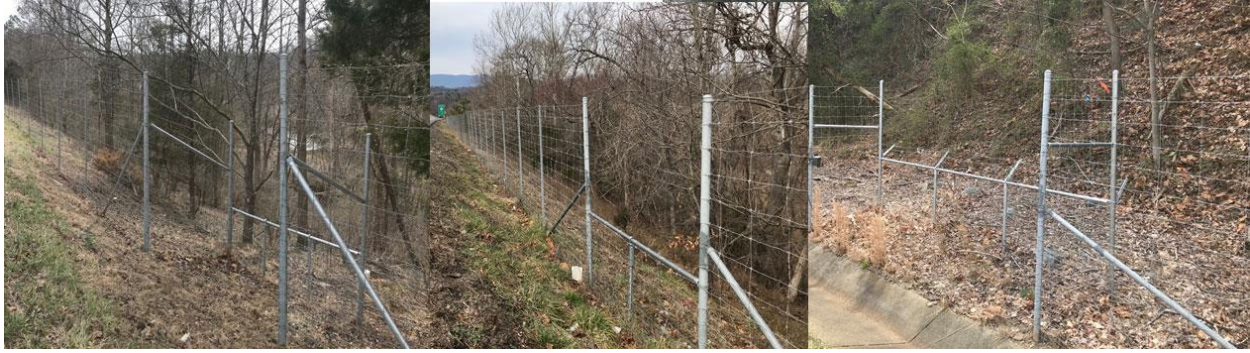
Each jumpout comprised a 4-ft-high 8-ft-wide section of fencing but varied according to whether it (1) was in line with the fencing or funneled farther back from the road, and (2) had a top-mounted angled attachment (Figure 5). Five jumpouts were set back from the road, and the fencing functioned as a short funnel to guide deer to the jumpout. Three jumpouts were in line with the fencing. Three of the jumpouts had a top-mounted angled attachment (a design described in Jared et al. [2017]). The outrigger attachments were used for jumpouts on a level ground and were angled toward the habitat side of the fence, making it unlikely for deer on the habitat side of the fence to jump over them (Jared et al., 2017). The attachments were not used on jumpouts located on a downhill grade. On downhill grades, the height that a deer on the downslope habitat side of the fence would have to jump was deemed too great (i.e., over 4 ft) for such a jump to be a likely occurrence.

**Figure 5. Jumpout Designs at Study Sites: left, jumpout set farther back from the road and on a downslope (with no angled attachment); center, jumpout in line with the fence and on a downslope (with no angled attachment); right, jumpout set farther back from the road on level ground (with the angled attachment)**

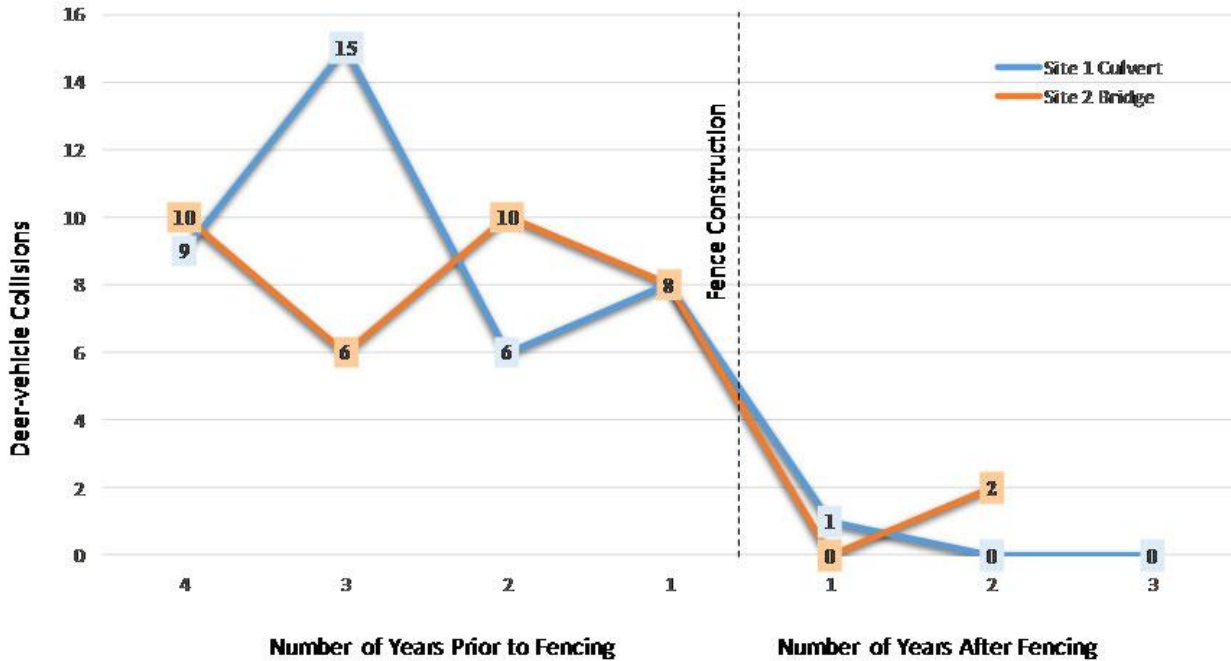
**Figure 6. Deer-Vehicle Collisions Pre- and Post-Fencing at Site 1 and Site 2**

On average, DVCs decreased 92% over the 2 and 3 years post-fencing at Site 2 and Site 1, respectively, for an average reduction of 8.4 DVCs per mile per year (Figure 6). In the 4 years pre-fencing at Site 1, the 1-mi interstate segment averaged 9.5 DVCs per year. In the 3 years post-fencing, there was an average of 0.3 DVCs per year (1 DVC occurred the first year post-fencing), representing a 96.5% reduction in DVCs.

In the 4 years pre-fencing at Site 2, the 1-mi interstate segment averaged 8.5 DVCs per year. In the 2 years post-fencing, there was an average of 1 DVC per year (2 DVCs occurred the second year post-fencing), representing an 88% reduction in DVCs at Site 2. These reductions were statistically significant at each site ( $p < 0.05$ ).

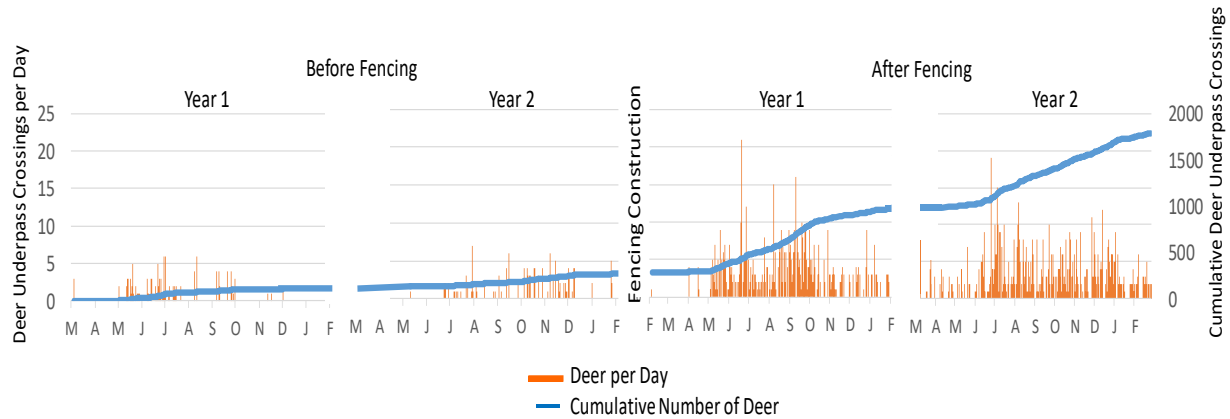
**Figure 7. Deer per Day and Cumulative Number of Deer at Site 1.** Deer per day (represented by the y axis on the left) and cumulative number of deer (represented by the y axis on the right) over the 2-yr pre-fencing and 2-yr post-fencing monitoring studies at the Site 1 box culvert. Months in each graph are represented on the x axes, beginning the month camera monitoring was initiated in the pre- and post-fencing studies.

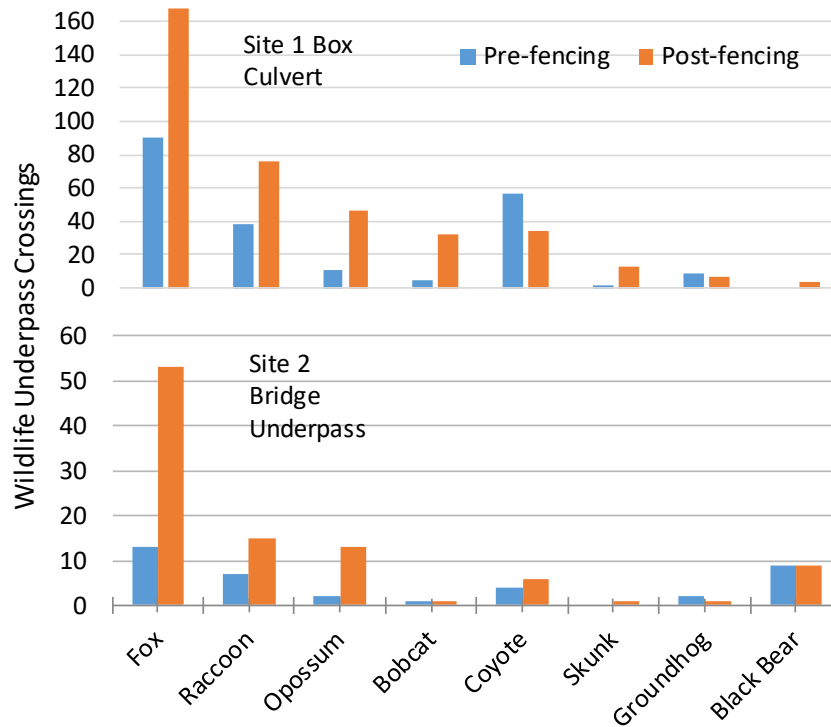
The number of wildlife crossings through the underpasses increased post-fencing for most species (i.e., black bear, bobcat, fox, opossum, and skunk). For species smaller than deer, there was more use of the Site 1 box culvert than the Site 2 bridge underpass both pre- and post-fencing (Figure 8).

**Figure 8. Wildlife Crossings per Year Pre- and Post-Fencing at Site 1 and Site 2 Underpasses.** Note that different scales are used for each site.

Post-fencing at the box culvert, the number of wildlife crossings by species other than deer increased 81% (from 210 crossings per year pre-fencing to 381 per year post-fencing). Post-fencing at the Site 2 bridge underpass, the average number of wildlife crossings increased 165% (from an equivalent of 37 crossings per year pre-fencing to 98 per year post-fencing).

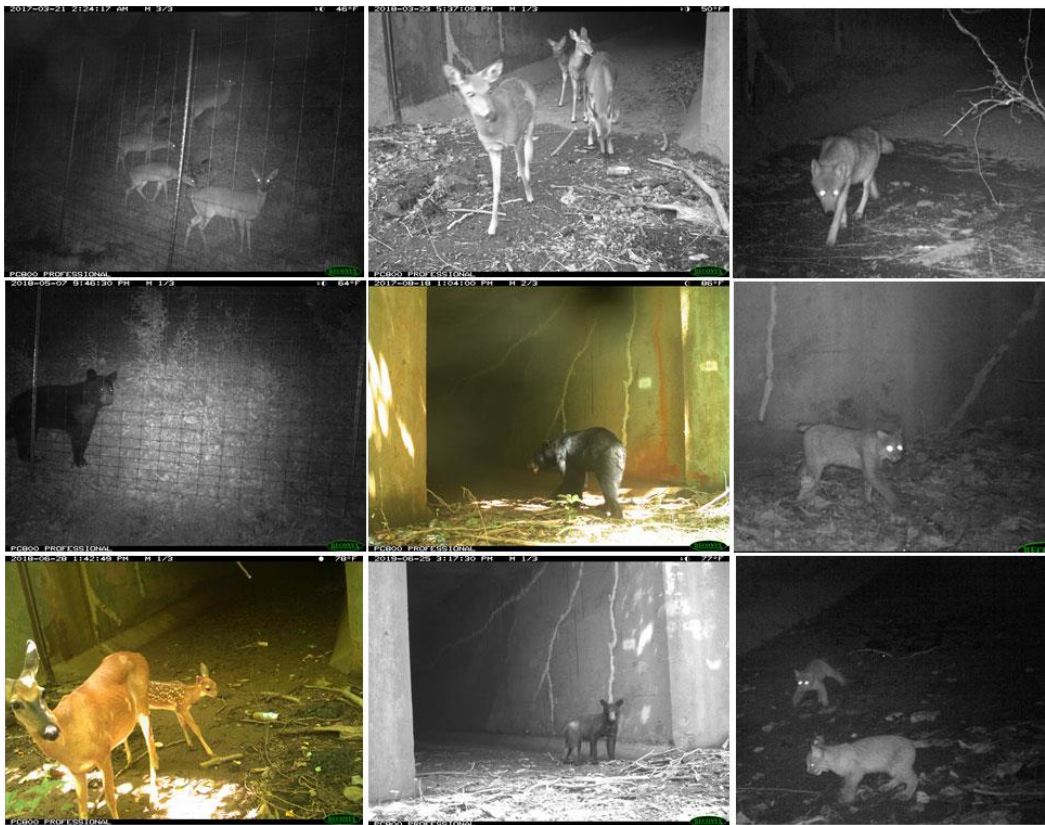
Black bears crossed through the culvert on eight occasions over the 2-yr post-fencing monitoring period. This is noteworthy given the fact that they had neither approached nor crossed through the box culvert during the pre-fencing study (Donaldson et al., 2016) and they had approached the box culvert and retreated (rather than crossing through) on three occasions during an earlier 1-yr monitoring study (Donaldson, 2007). Numerous crossings by deer, coyote, and bobcats occurred by adults with their young, though the numbers of these instances were not calculated given the difficulty in distinguishing between offspring and unrelated young adults in some cases (Figure 9).

**Figure 9. Camera Images of Deer and Bear Behind the Fence and Crossing Through the Site 1 Box Culvert. Also illustrated are coyote (top right), bobcat and bobcat kittens (center right and bottom right), and bear cub (bottom center).**

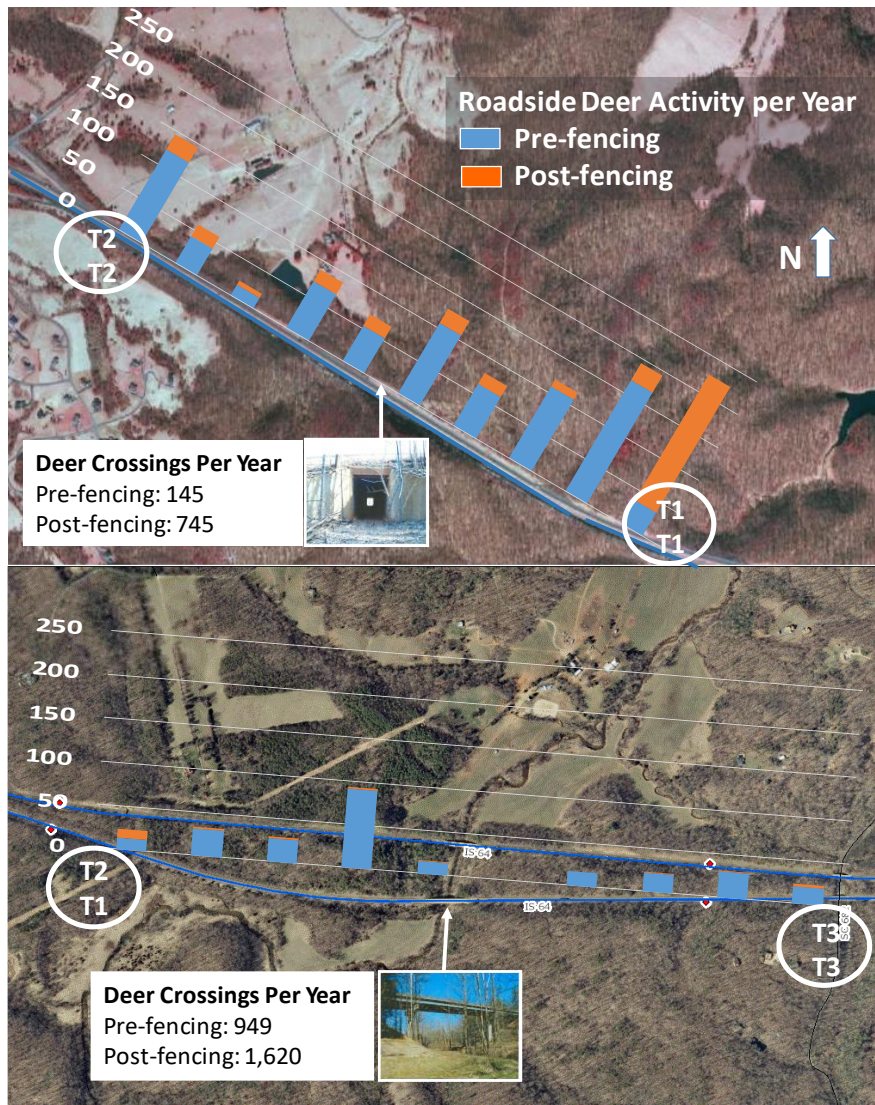
feature or ROW fencing (T1 treatments; see the caption of Figure 10 for treatment descriptions). At Site 1, which had a 58% reduction in roadside deer activity, more than one-half (55%) of the post-fencing roadside activity occurred at the eastern fence ends (both of which were T1 treatments that did not tie into any feature). At Site 2, where three of the four fence ends tied into ROW fencing or another bridge underpass, roadside deer activity was reduced 87% after fencing installation. Despite the high deer activity at Site 1's T1 treatments (approximately 180 per year), deer activity at the underpass was much greater, with 745 crossings per year.

**Figure 10. Roadside Deer Activity per Year.** Roadside deer activity per year at camera locations (blue and orange bars), fence end treatments (white circles), and deer crossings per year through the underpasses. T1 = fence end does not tie into any structure or landscape feature (n = 3, average deer activity/yr = 124); T2 = fence end ties in with right-of-way fence (n = 3, average deer activity/yr = 11.8); T3 = fence end ties in with a bridge underpass that spans a low volume road (n = 2, average deer activity/yr = 3.6).

As mentioned previously, there was not a significant increase in DVCs within 0.5 km or 0.8 km of these ends despite the higher deer activity. Deer activity counts at the T1, T2, and T3 fence ends were 124 per year, 11.8 per year, and 3.6 per year, respectively.
