Connected Vehicle Pilot Deployment Program Performance Measurement and Evaluation – Tampa (THEA)

Phase 3 Evaluation Report

Final Report – March 5, 2020

Publication Number: FHWA-JPO-20-829

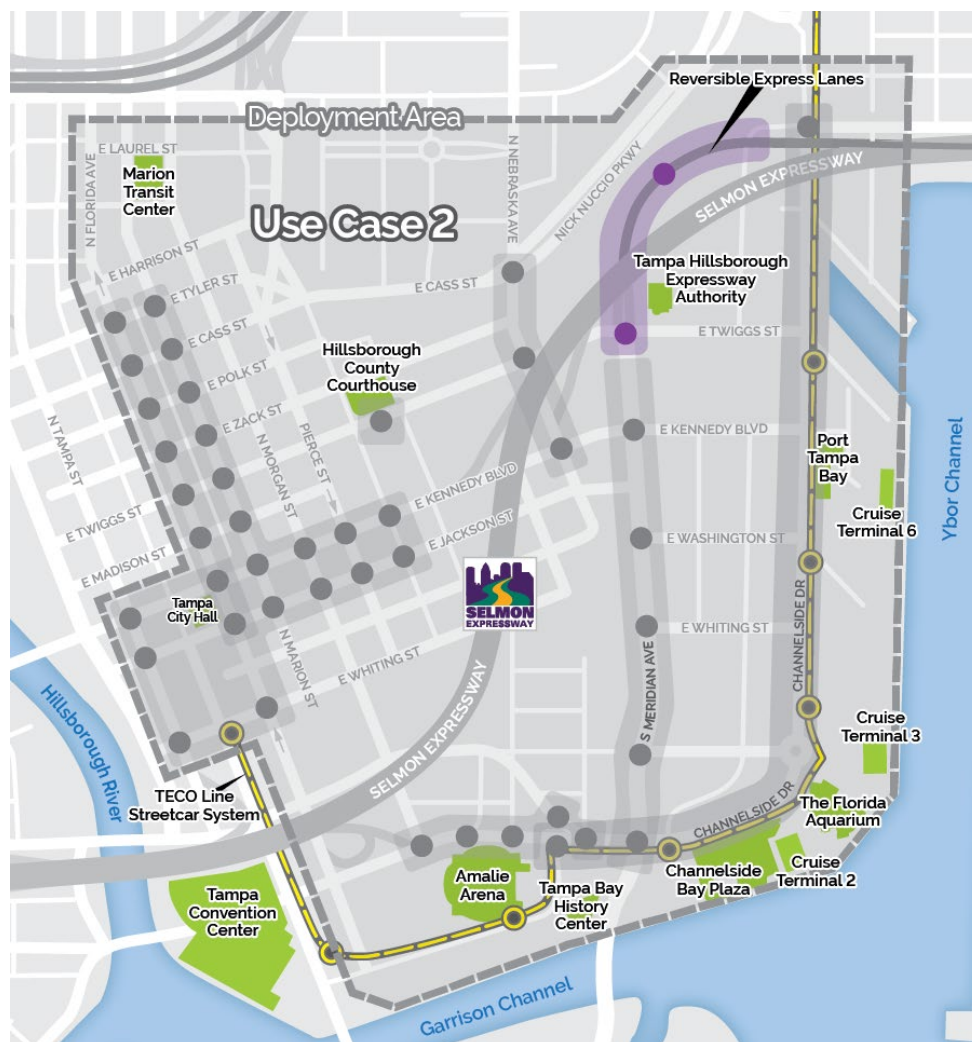
Figure 2-2. Use Case 2 – Routes and Roadside Equipment

At the exit of the REL onto East Twiggs Street, there is a relatively easy opportunity for a driver to become confused and attempt to enter the REL going the wrong way. There are no gates or barriers at the westbound downtown terminus of the REL to prevent drivers from entering the REL going the wrong way. Drivers who are traveling on East Twiggs Street approaching the intersection where the REL ends and Meridian Street begins can mistakenly (or knowingly) enter the REL going the wrong way. Drivers approaching this intersection coming from downtown can inadvertently (or knowingly) make a left turn onto the REL exit. Conversely, drivers on East Twiggs Street approaching this intersection going toward downtown can inadvertently make a right turn onto the REL exit. Finally, drivers approaching the intersection on Meridian Avenue can potentially veer slightly to the left onto the REL exit. Each of these possibilities is a safety concern. Figure 2-2 shows the UC2 route. The goal of this use case was to deploy the Wrong-Way Entry (WWE) and I-SIG CV applications. As described in section 6.2.5, the I-SIG application was not successfully deployed.

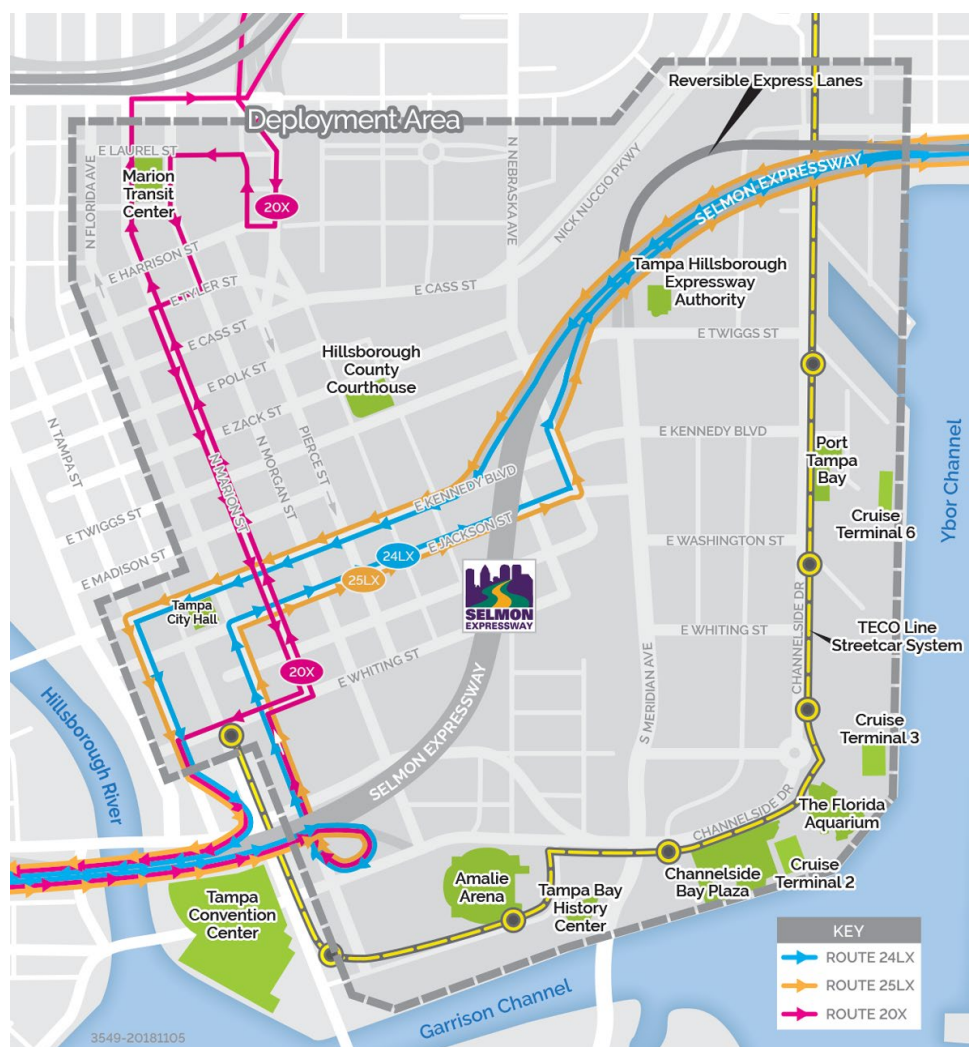
As the express service departs the controlled-access highway system and enters the downtown grid, the buses experience congestion. When congestion occurs, the buses are unable to reach their stops promptly, causing them to fall behind schedule and compromising mobility. CV technology was used to address these mobility concerns. Buses and traffic signals communicated, and if a bus was behind schedule, the traffic signal system either gave the bus priority or flushed the queue, allowing the bus to reach its stop and assuming there were no other higher priorities. The buses on the routes described here benefitted from TSP while in the study area in this use case. Figure 2-5 shows the bus routes included in UC4.

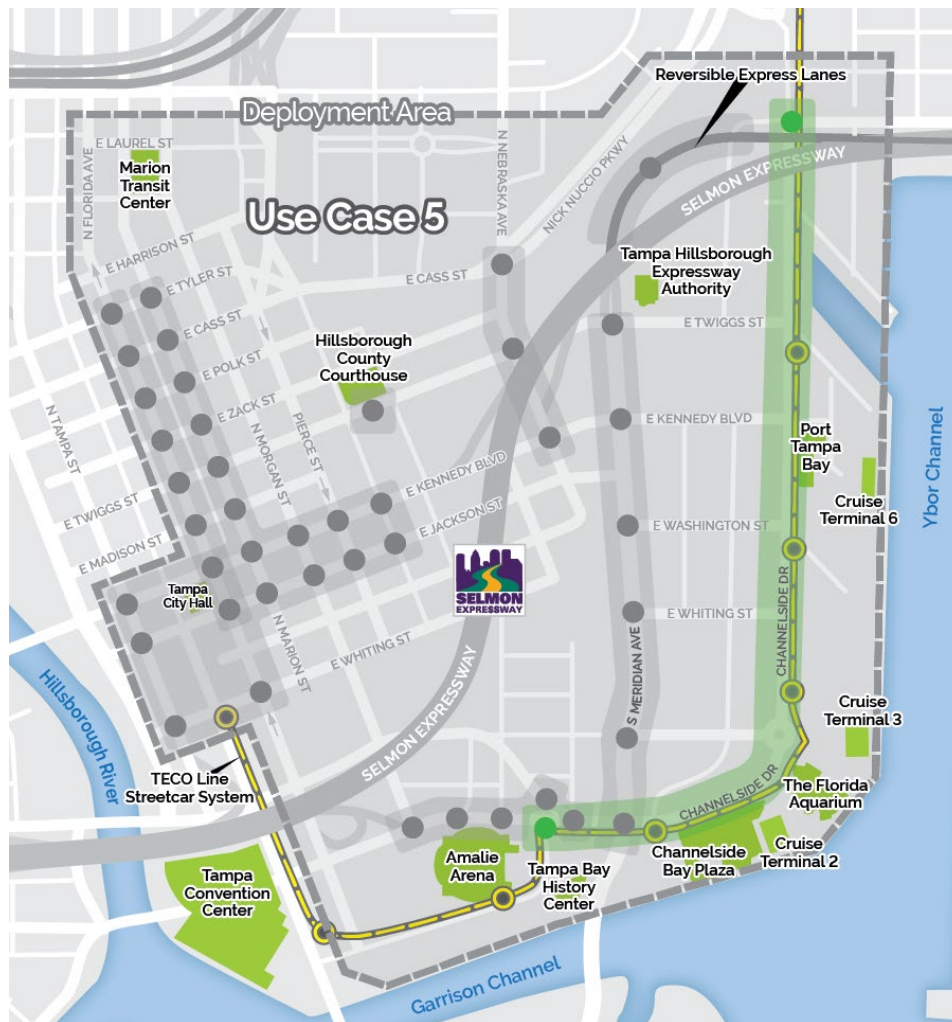
The Tampa Electric Company (TECO) Streetcar runs along Channelside Drive from the Amalie Arena area up Channelside Drive, north, and past the Selmon Expressway. The streetcar is a steel wheel on steel rail fixed-guideway system in a dedicated right-of-way. An overhead catenary powers it and the streetcar crosses intersections at grade. As a result, at various stops along the streetcar route, vehicles may have to turn right in front of a stopped or moving streetcar. As pedestrians disembark the streetcar and the streetcar prepares to depart, a vehicle may turn right in front of the streetcar. This situation occurs at signalized and non-signalized intersections, none of which have a right turn protected movement. CV technology was used to provide information to streetcar operators and drivers to improve safety around these locations. Figure 2-6 shows the UC5 route. The goal of this use case was to deploy the Vehicle Turning Right in Front of Transit Vehicle (VTRFTV) CV application.

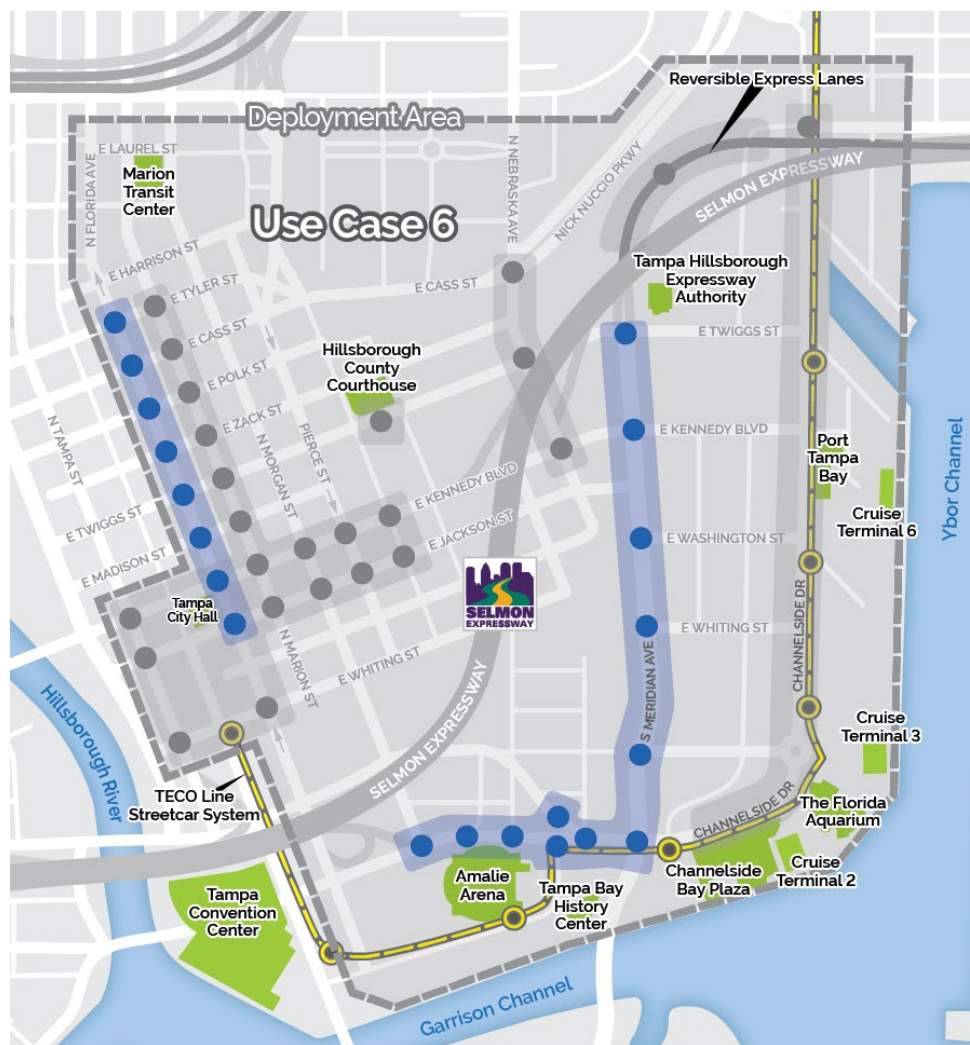
Meridian Avenue has significant congestion and delay during morning peak hour periods. This congestion is due to many MAFB commuters exiting the Selmon Expressway at downtown and traveling through downtown arterial routes to reach the Base entrance. As some of these commuters use surface roads through downtown, they interact with other traffic and pedestrians, increasing the likelihood of conflicts. In addition to Meridian Avenue, Florida Avenue (sections within the study area) experiences similar issues for downtown commuters. I-SIG was the CV application primarily planned to be used in this use case, but as described in section 6.2.5, the I-SIG application was not successfully deployed during Phase 3. Figure 2-7 shows the two corridors for this use case.

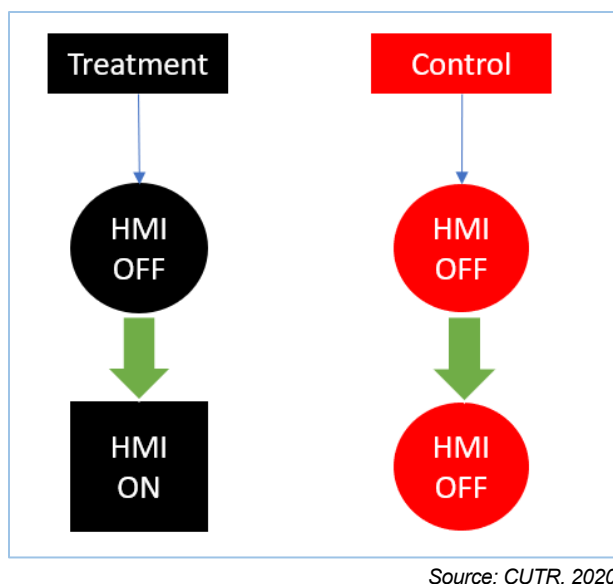
Figure 3-3. Initial Participant Assignment

Figure 3-3 shows the initial group assignment setup of participants. The treatment group would initially have a silent period with HMI off and then HMI would turn on so they could see the warnings. The control group was set to have HMI off during the entire duration of the Pilot.

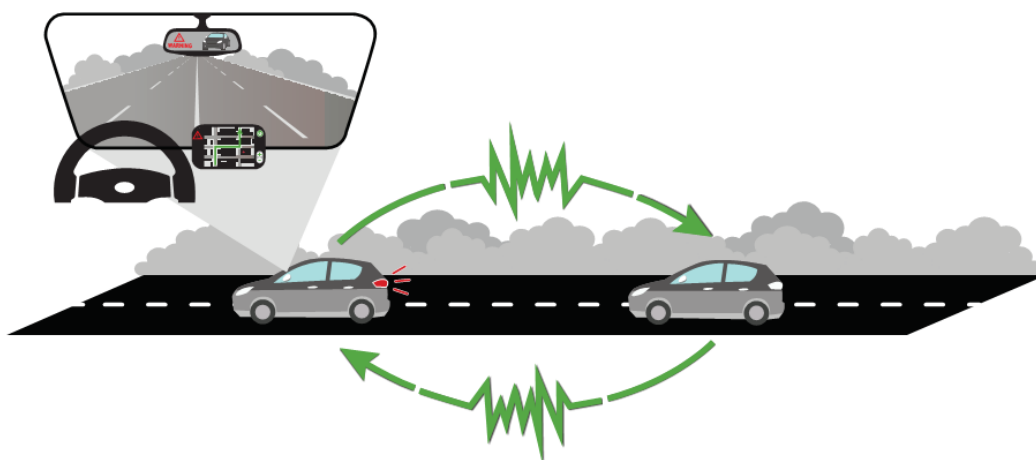
The Forward Collision Warning (FCW) application alerts the driver to help avoid or mitigate the severity of crashes into the rear end of other vehicles on the road. FCW works lane by lane, responding to a direct and imminent threat ahead of the host vehicle. Anywhere two equipped vehicles interact, FCW deploys and provides a driver alert if the right conditions occur as follows: one vehicle is following the other and the lead vehicle brakes causing the closing distance to decrease (as calculated), which warrants an alert of a potential collision. Figure 6-3 and Figure 6-4 illustrate the FCW's functional architecture.

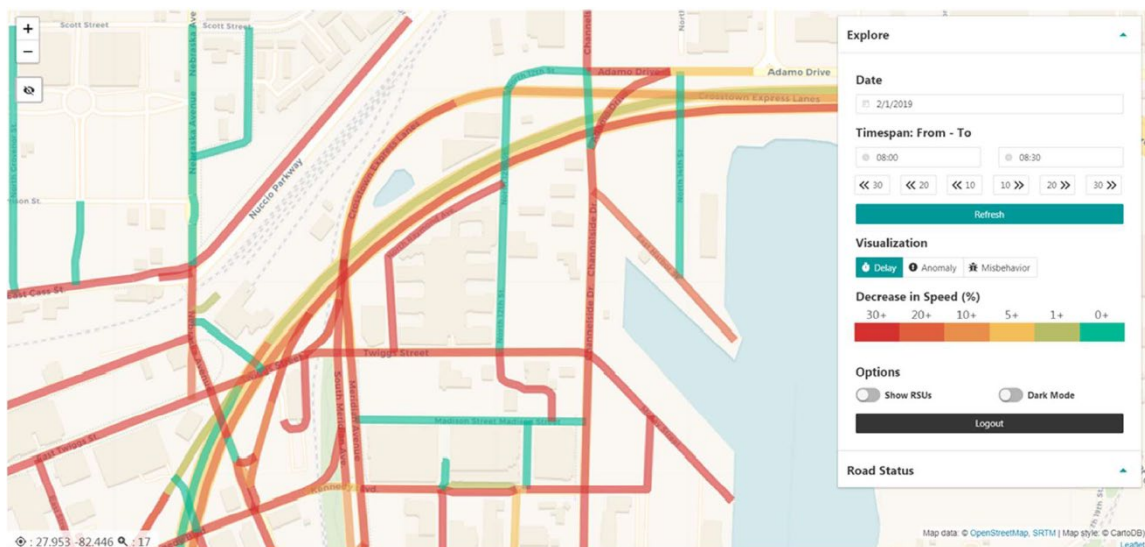
Figure 6-11 shows BSMs analyzed between 8:00 and 8:30 a.m. to display the percent decrease in speed of participant vehicles, color coded by location. The UC1 requirement to measure queues per lane was deferred as cars in lanes with longer queues unpredictably moved to other lanes with shorter queues. Under the new approach, the queue length estimate fed to the ERDW application is the longest queue measured across all REL lanes.

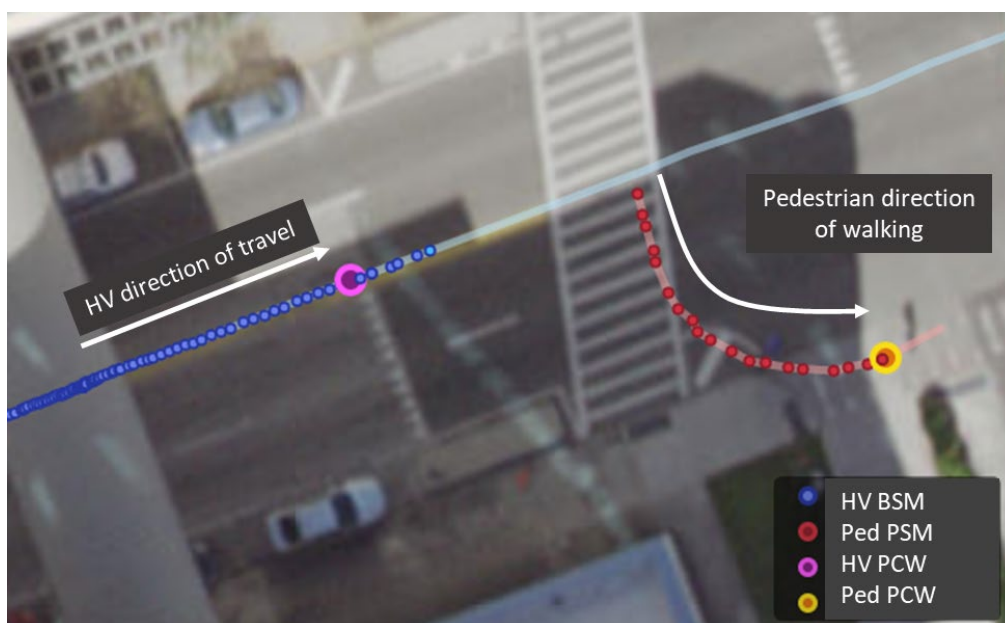
Figure 6-15. LiDAR Failure to Track Pedestrian on Crosswalk

After becoming operational at the site, several issues surfaced. The LiDAR system seemed to not track pedestrians until they were located halfway through the crosswalk. The two LiDAR sensors had to work harmoniously to detect pedestrians crossing the road from one side and finishing on the other side. One of the LiDAR sensors failed and therefore could not track pedestrians until they were halfway through the crosswalk. Figure 6-15 shows an example of a pedestrian trajectory tracked for only half of the crosswalk.

After this issue was identified, the sensor vendor replaced the LiDAR sensor with a different model, but the old sensor software driver was incompatible with the output format of the new sensor, requiring further development and regression testing.

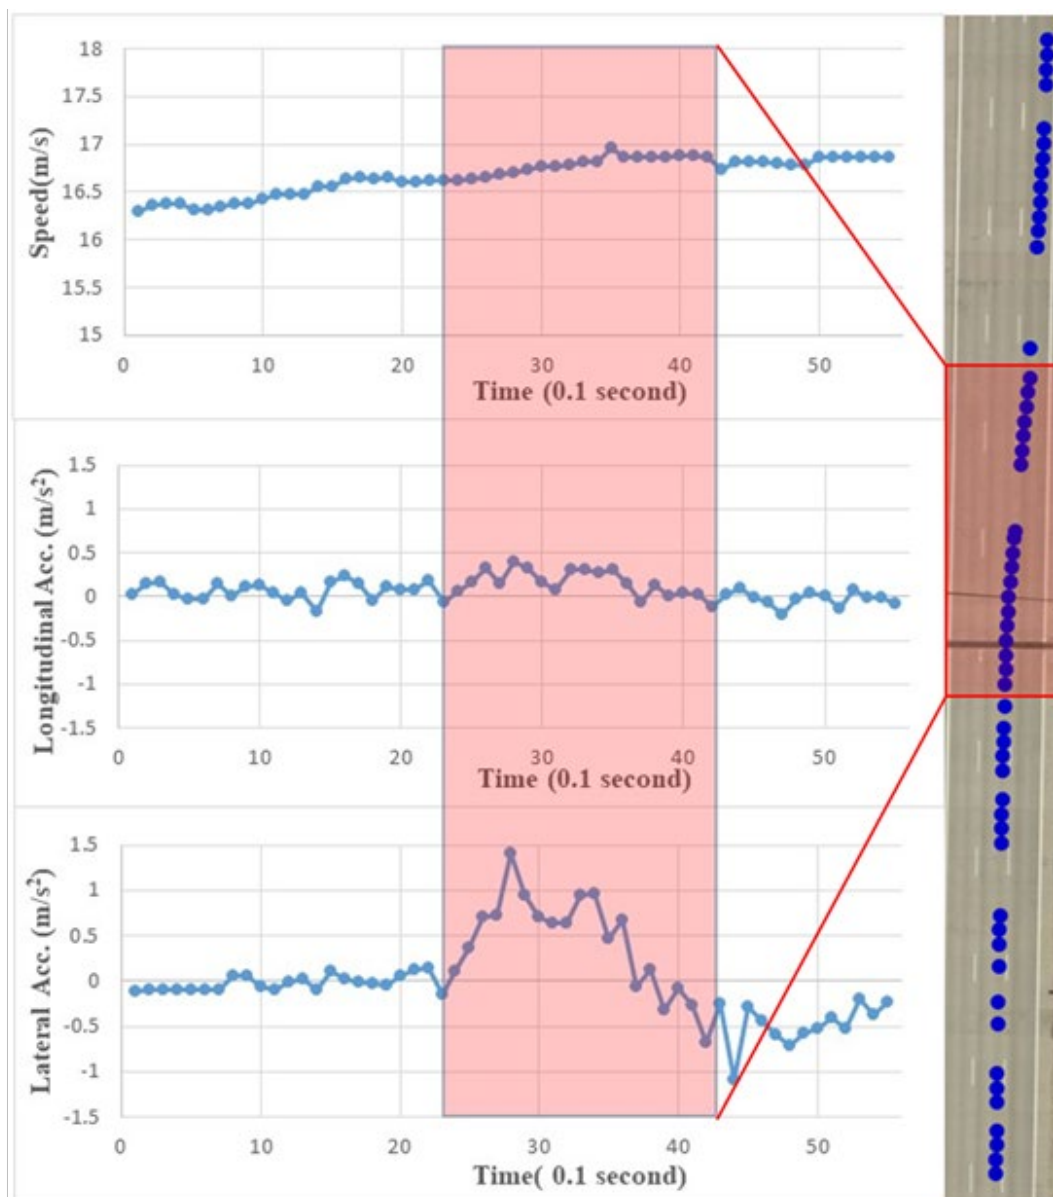
Figure 6-27 presents a snapshot of a test vehicle trajectory and speed at 0.1-second intervals, showing longitudinal and lateral acceleration while performing a lane change maneuver. In this instance, the test vehicle was engaging in a maneuver to avoid a test cone used to represent road debris on the REL. The figure highlights the lane change moments in the red-shaded area to indicate a noticeable change in lateral acceleration and no considerable change in longitudinal acceleration. In fact, the speed graph indicates that the driver was increasing speed while changing lanes.

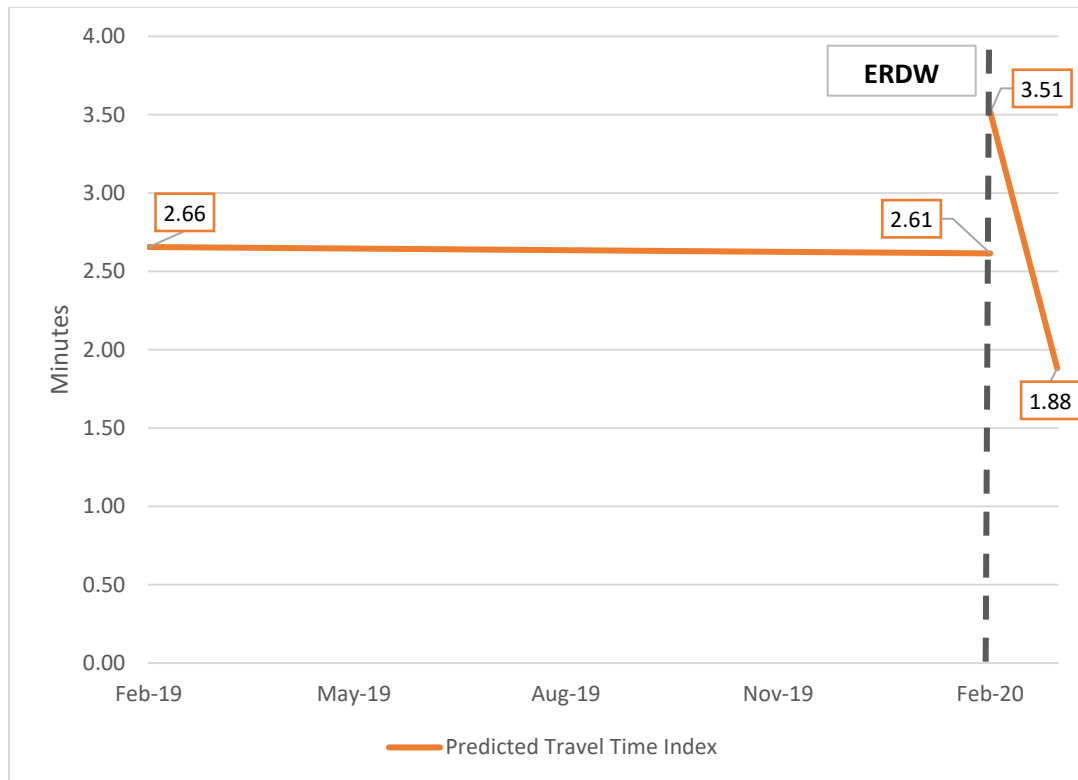
Figure 7-6 reports the adjusted predictions of the effect of the ERDW deployment on travel times at specific values of the sample. The marginal effects are reported assuming no adverse weather conditions (i.e., no rain), limiting the impact before the onset of the pandemic, and Tuesday as the representative weekday. At the beginning of the analysis period (February 2019), the estimated TTI is about 2.7. After the deployment of the ERDW application in March 2020, the estimated TTI is about 1.9.

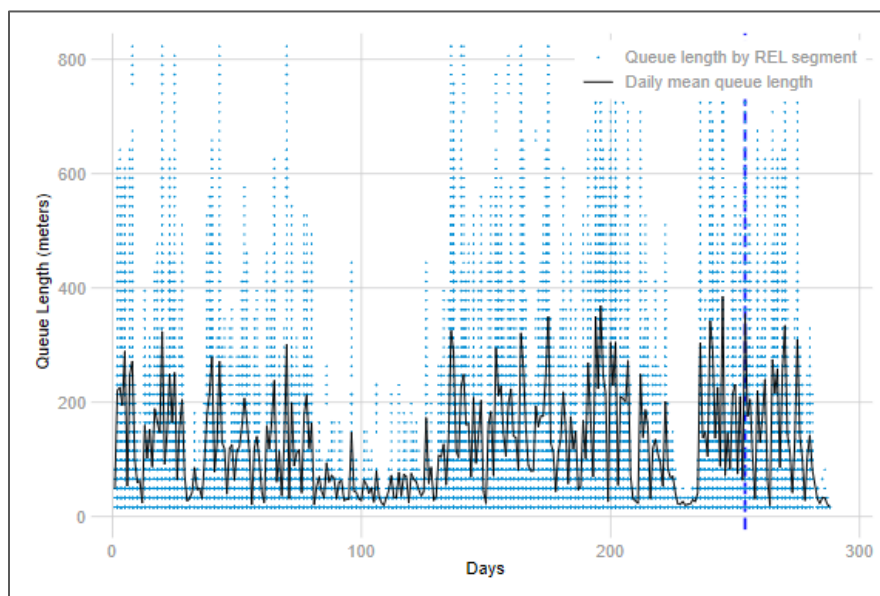
Figure 7-12 reports the queue length estimation over the analysis period. Each point on the graph represents a queue length value estimated in step 5 of the process. The black line represents the average queue length observed daily. The vertical dash line indicates the start of the ERDW deployment (February 3, 2020).

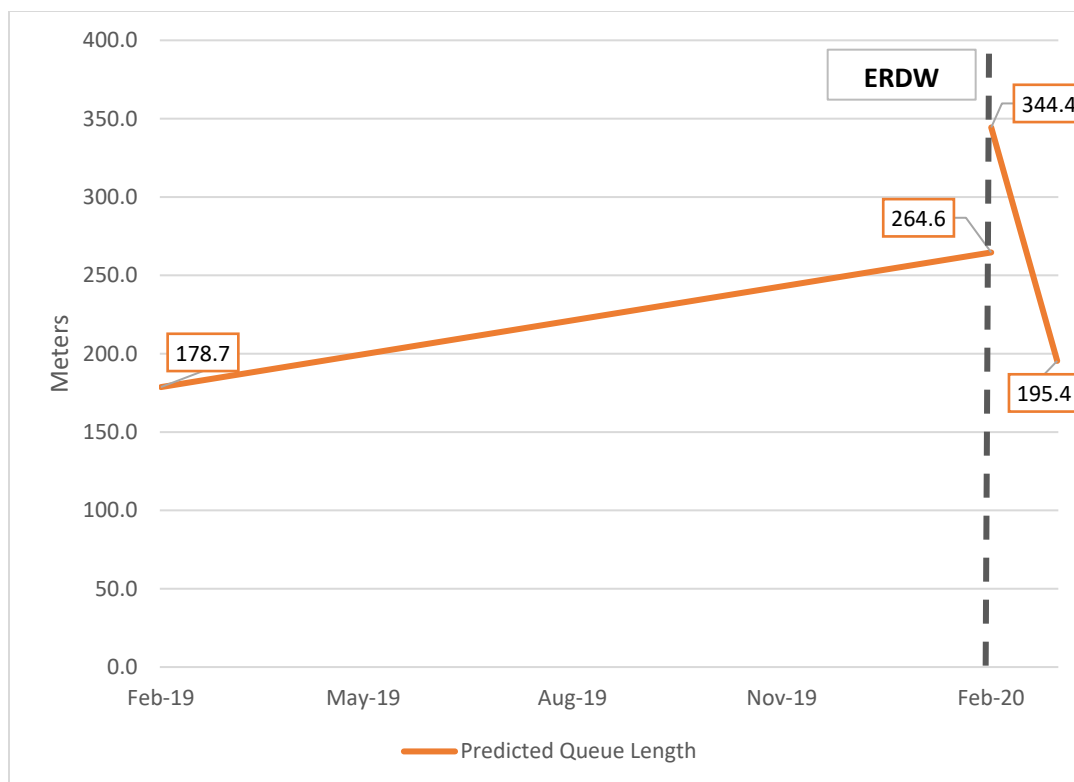
To relate the impact of the ERDW application, Figure 7-13 reports the adjusted predictions of the effect of the ERDW deployment on queue length at specific values of the sample. The marginal effects are reported assuming no adverse weather conditions (i.e., no rain), limiting the impact before the onset of the pandemic, and Tuesday as the representative weekday.

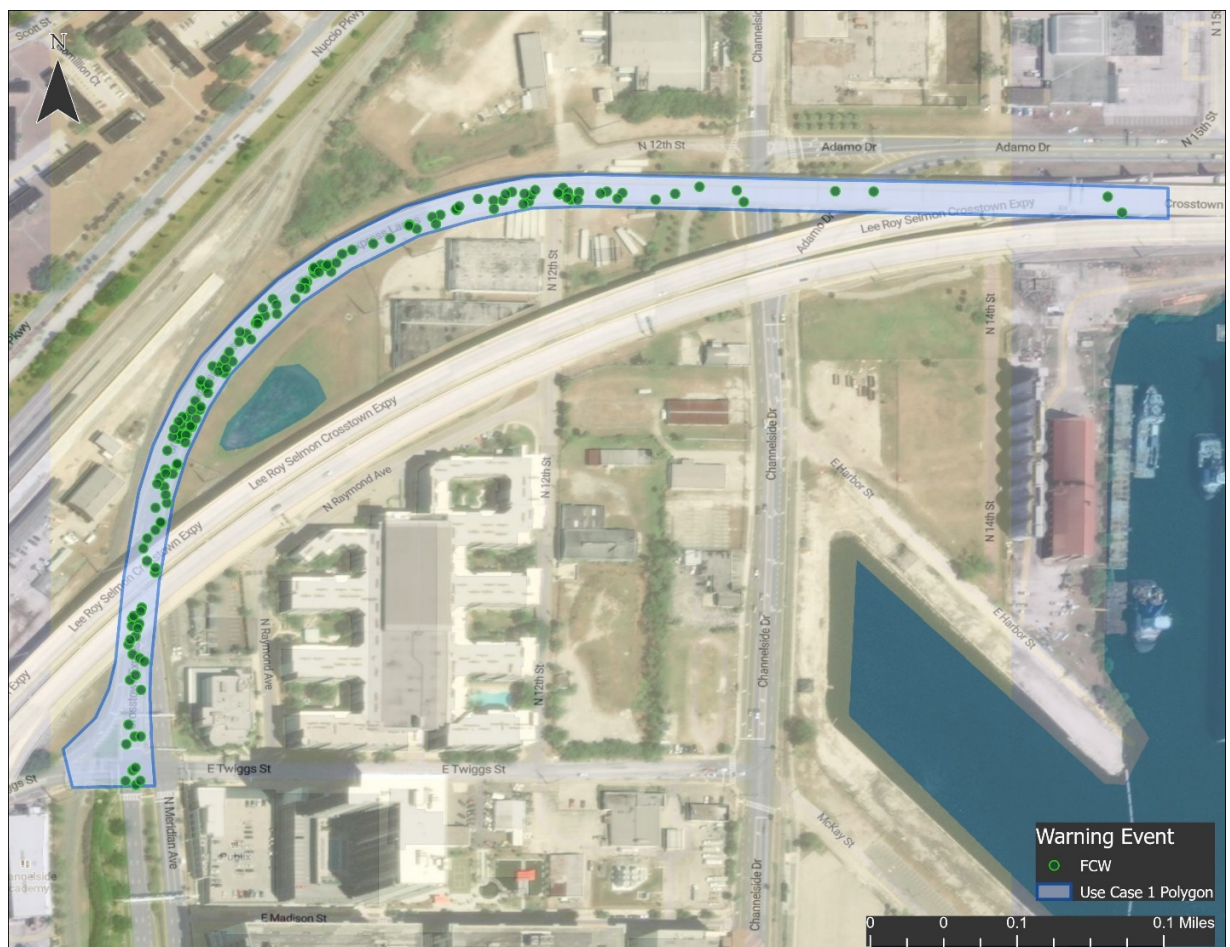
During the analysis period, 61 participant vehicles deployed 150 Forward Collision Warnings within UC1. Figure 7-14 maps the FCW events in the UC1 segment. The research team created a BSM event profile for each warning, consisting of 30 seconds before and after the moment of warning. The events can be replayed and analyzed via the THEA CV Pilot Dashboard as a precursory step to data-driven evaluation [16].

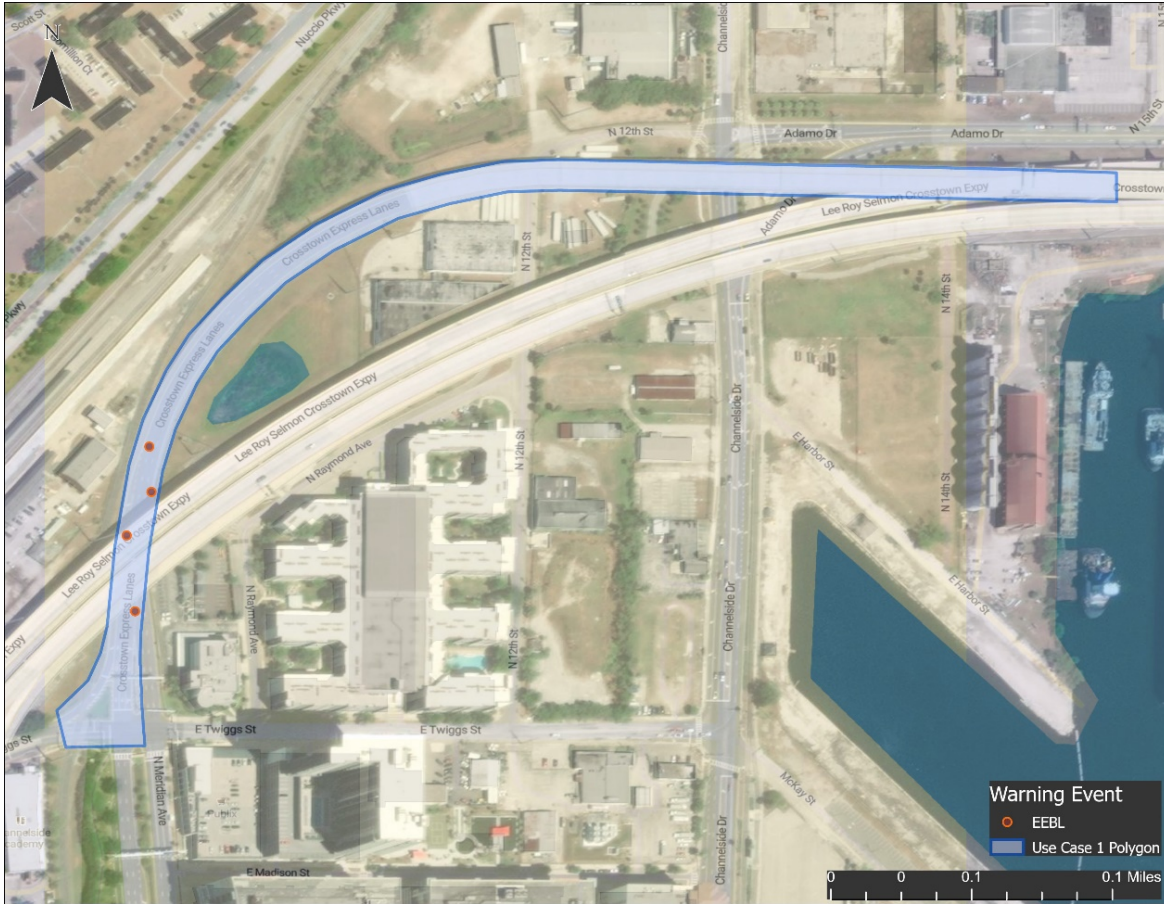
The approach to evaluate Electronic Emergency Brake Light follows the same steps adopted to evaluate FCW. A BSM event profile was created for each EEBL warning to visually check the conditions under which it was triggered. To deploy the EEBL warning, the host vehicle determines if the remote vehicle sending the hard-braking information is in the lane ahead, the left lane, or the right lane. This allows for a width of three lanes instead of one, which is how the FCW works. During the analysis period and location of this use case, only four EEBL warnings were triggered and recorded. Figure 7-17 maps the EEBL warnings in the UC1 study area.

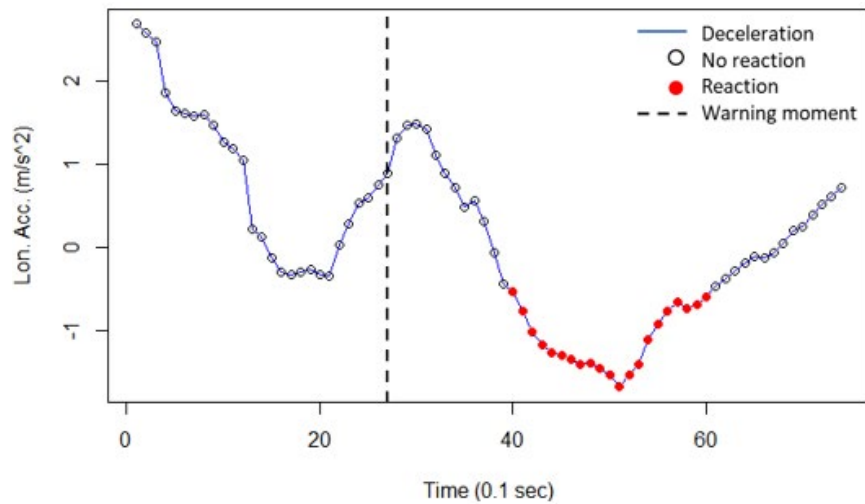
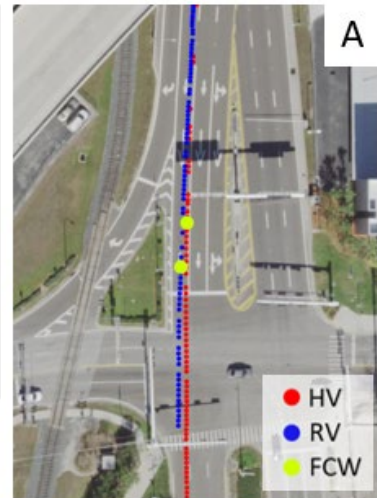
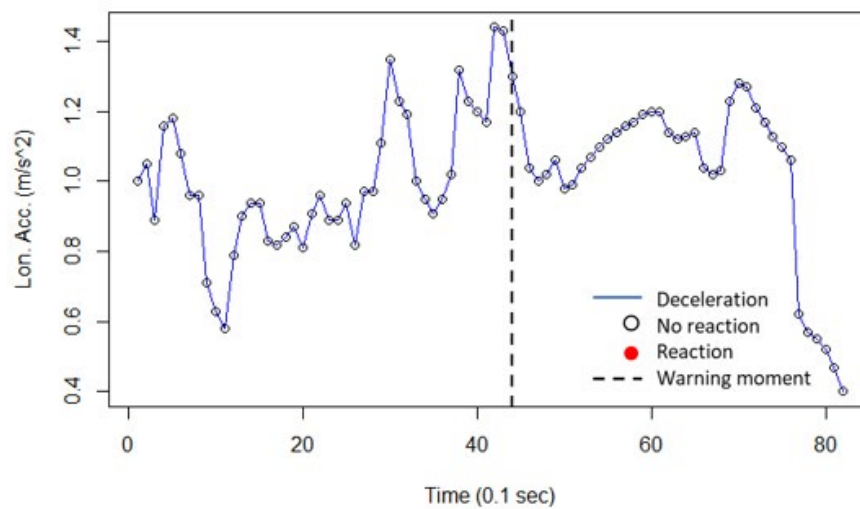
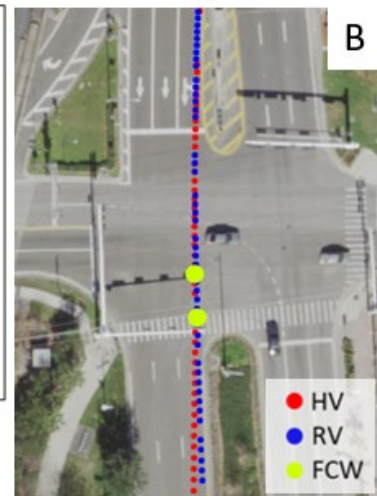
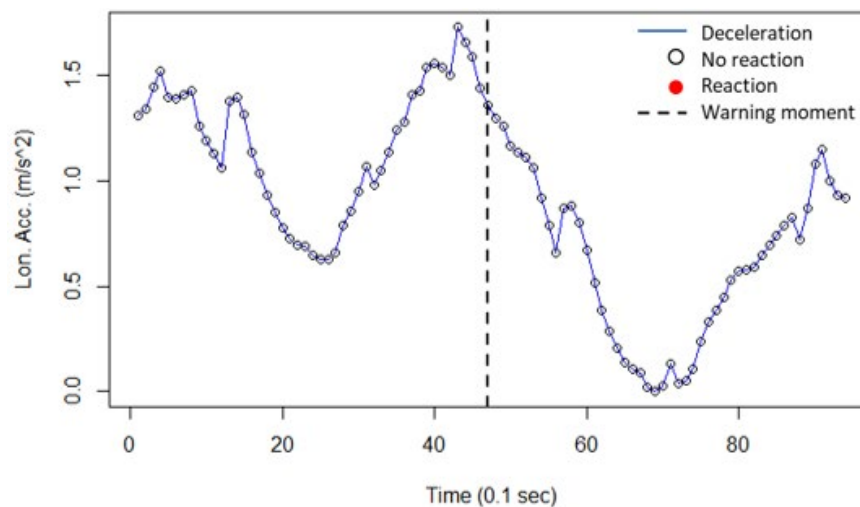
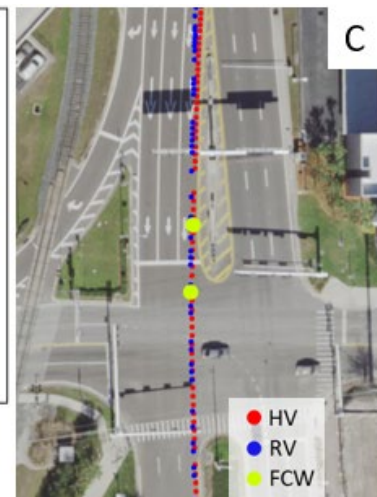
Figure 7-22 (A-D) displays the results of the data mining algorithm applied to the four TP Forward Collision Warnings triggered by participant vehicles assigned to the control group with the HMI disabled. The driver in Figure 7-22 (A) reacted after the warning moment, the drivers in Figure 7-22 (B-C) did not react, and in Figure 7-22 (D), the driver reacted before the warning moment. The mixed reaction results could be due to the specific conditions under which the warning was generated (yet not displayed). The speed might have been at the lowest threshold turning the application into operational mode, but the driver did not perceive it as a conflict situation. Also, the perception-reaction time of drivers differs and therefore the reaction to conflicts might vary from driver to driver.
