# **DEVELOPMENT AND TESTING OF A BRIDGE RAIL FOR LOW-VOLUME ROADS**

## **MIDWEST ROADSIDE SAFETY FACILITY**

MwRSF Research Report No. TRP-03-407-20

September 3, 2020

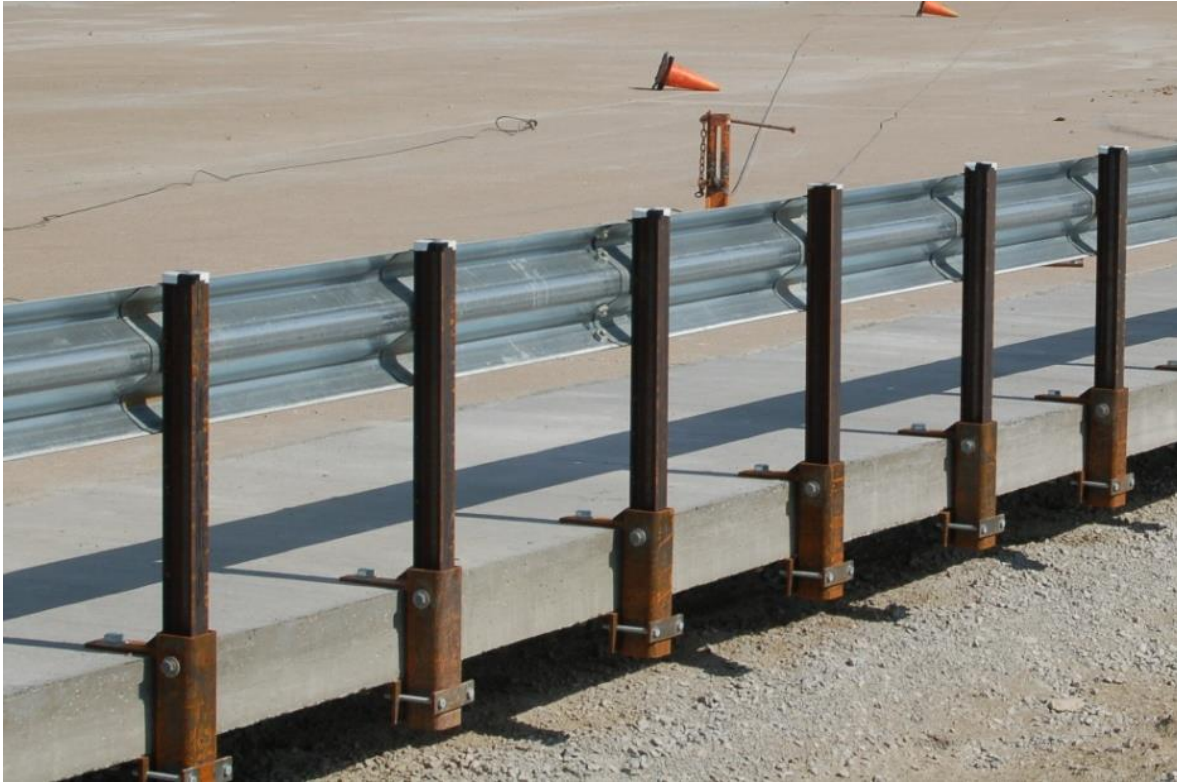
Figure 1. MGS Bridge Rail Test Installation [3]

Two W-beam bridge rails have previously been designed for use on low volume roads that satisfy MASH TL-2 and TL-3 safety standards. Both systems utilized a 31-in. tall W-beam rail supported by S3x5.7 weak posts, thereby limiting both the loads transferred to the bridge deck and the associated risk for deck damage. The first system, the Midwest Guardrail System (MGS) Bridge Rail, was a MASH TL-3 side-mounted system that was supported by steel sockets placed adjacent to the side of the deck [3], as shown in Figure 1. The system utilized a 37.5-in. post spacing, and the sockets were attached to the bridge deck with a 1-in. diameter bolt that went through the thickness of the deck. A steel angle was mounted below the deck to provide additional length for the force couple which resisted post bending. The system was full-scale crash tested according to MASH test designation nos. 3-10 and 3-11 with a small car and pickup truck, respectively.

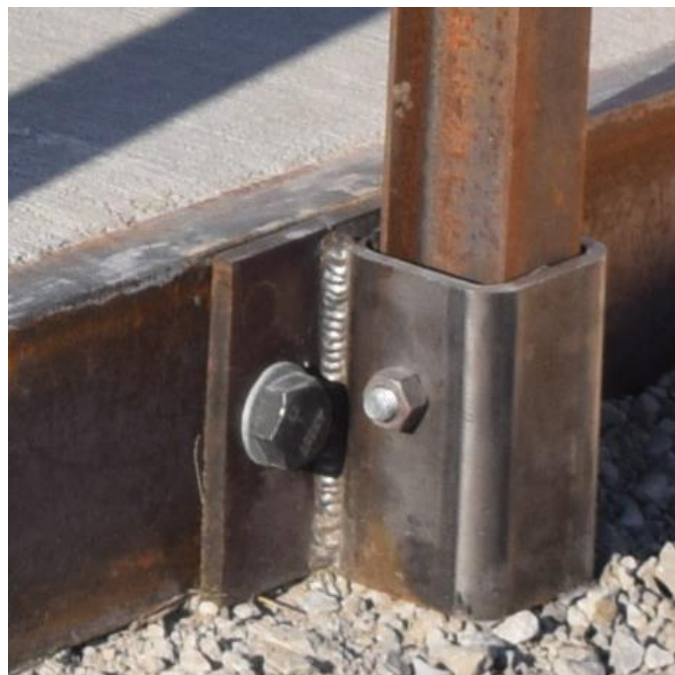
Figure 11. Coupling Nut and Threaded Rod Attachment of Socket Assembly to Deck

One of the objectives of the project was that the deck edge remained smooth without any hardware extending outward that would interfere with formwork. Thus, the socket assembly had to be bolted on from the outside with an internally threaded component cast within the deck. To satisfy these constraints, a new post-to-deck attachment method was developed using coupling nuts and threaded rods. Coupling nuts are commonly used to connect the ends of threaded hardware and directly transfer loads from one component to the other. For the new bolted attachment, holes were drilled in the web of the channel and coupling nuts were placed on the inside surface of the channel. Threaded rods were partially inserted into the coupling nuts and extended into the deck. These components would be embedded into the bridge deck when the concrete is poured. This allows the socket assemblies to be easily attached to the edge of the deck by bolting through the mounting plate and side channel and into the coupling nut, as shown in Figure 11.

During an impact, this new post-to-deck attachment design directly transfers the tensile loads from the attachment bolts through the coupling nuts and into the threaded rod anchors. The impact loads are never transferred to the channels (except for compression as part of the force couple resisting the moment created from post bending), so there would be minimal risk of damage to the side channels or the deck. Finally, the coupling nuts, threaded rods, and bolts would all be standard hardware, so only the socket assembly would need to be fabricated as part of the socket-to-deck attachment.

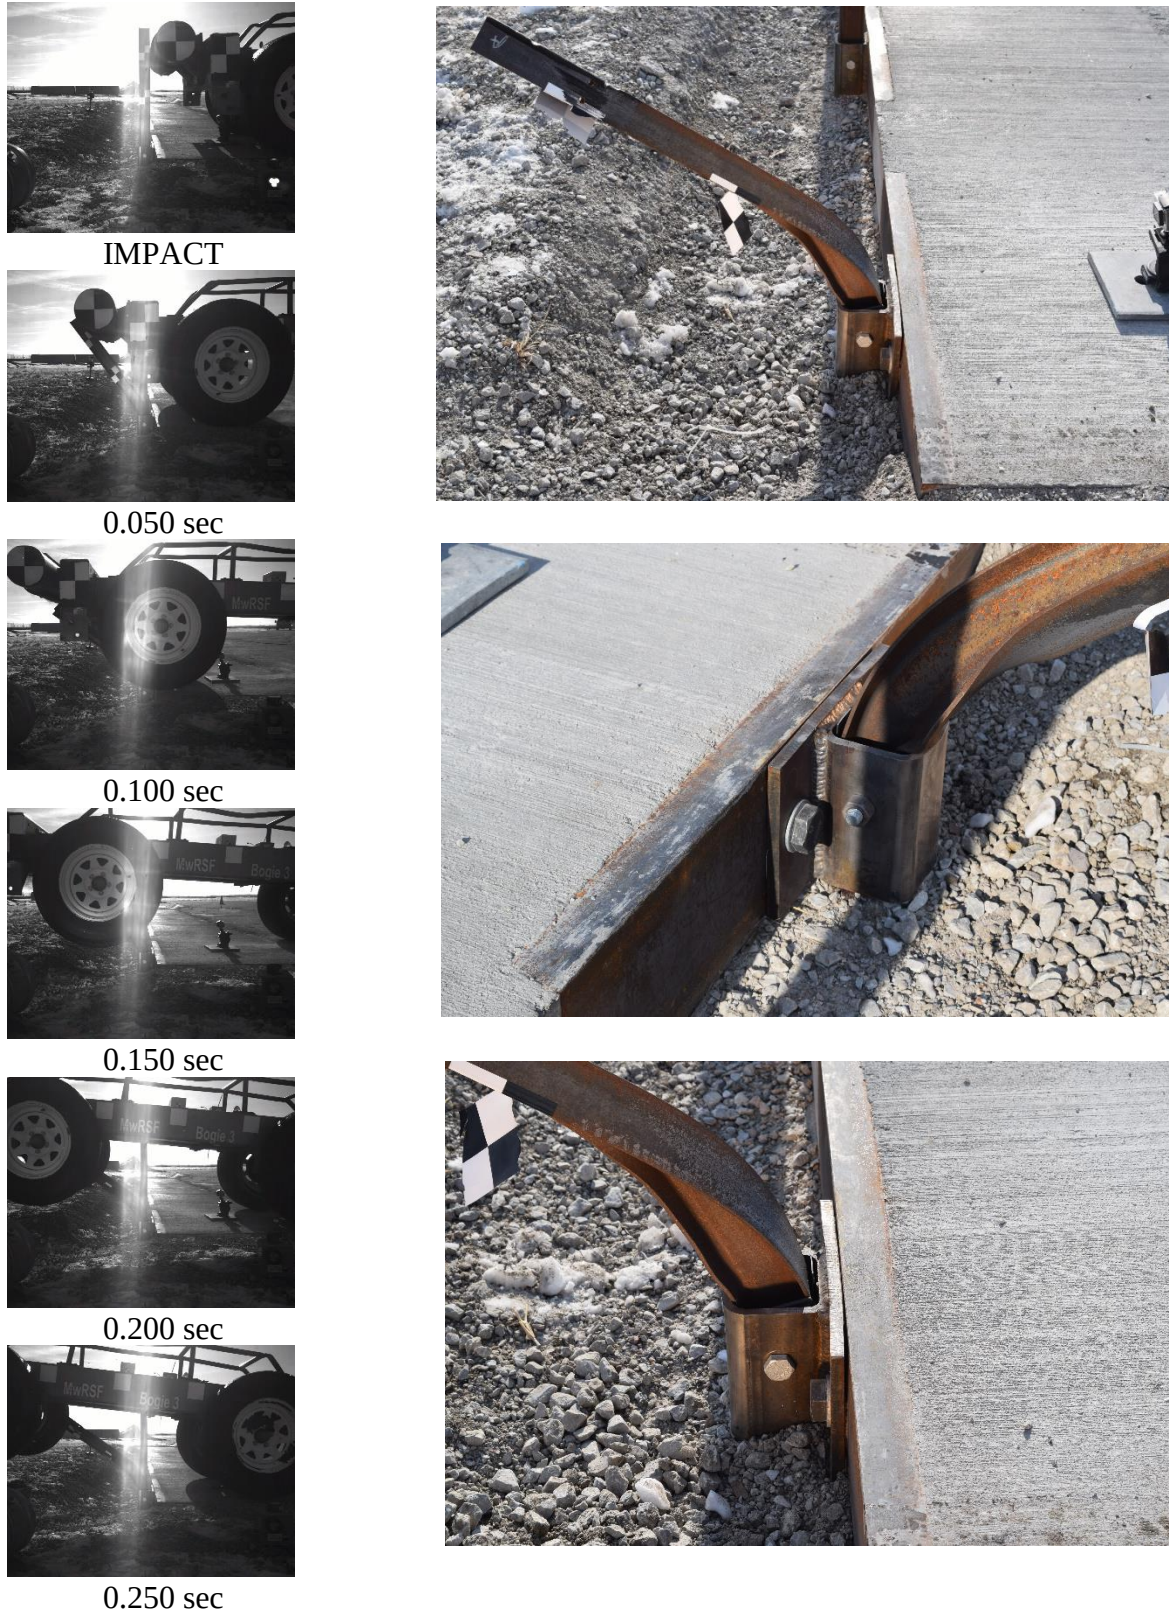
Figure 38. Time-Sequential and Post-Impact Photographs, Test No. N2B-1

The test article for test no. N2B-1 used Deck Location A and Channel Assembly A. The test article consisted of a bolted socket attachment utilizing 1-in. diameter bolts and a 7-in. thick simulated CIP bridge deck. See Section 3.2 for further details. Test no. N2B-1 was conducted with the bogie impacting the S3x5.7 post at a height of 25 in. and an angle of 90 degrees (through the strong axis of the post) at a speed of 21.2 mph. The impact caused the post to deflect backward as a plastic hinge formed in the post near the top of the socket and the post twisted. The bogie ultimately overrode the post at a displacement of 30.2 in. No damage occurred to the bridge deck, socket assembly, or attachment hardware. Time sequential photographs and post-test photographs are shown in Figure 38.

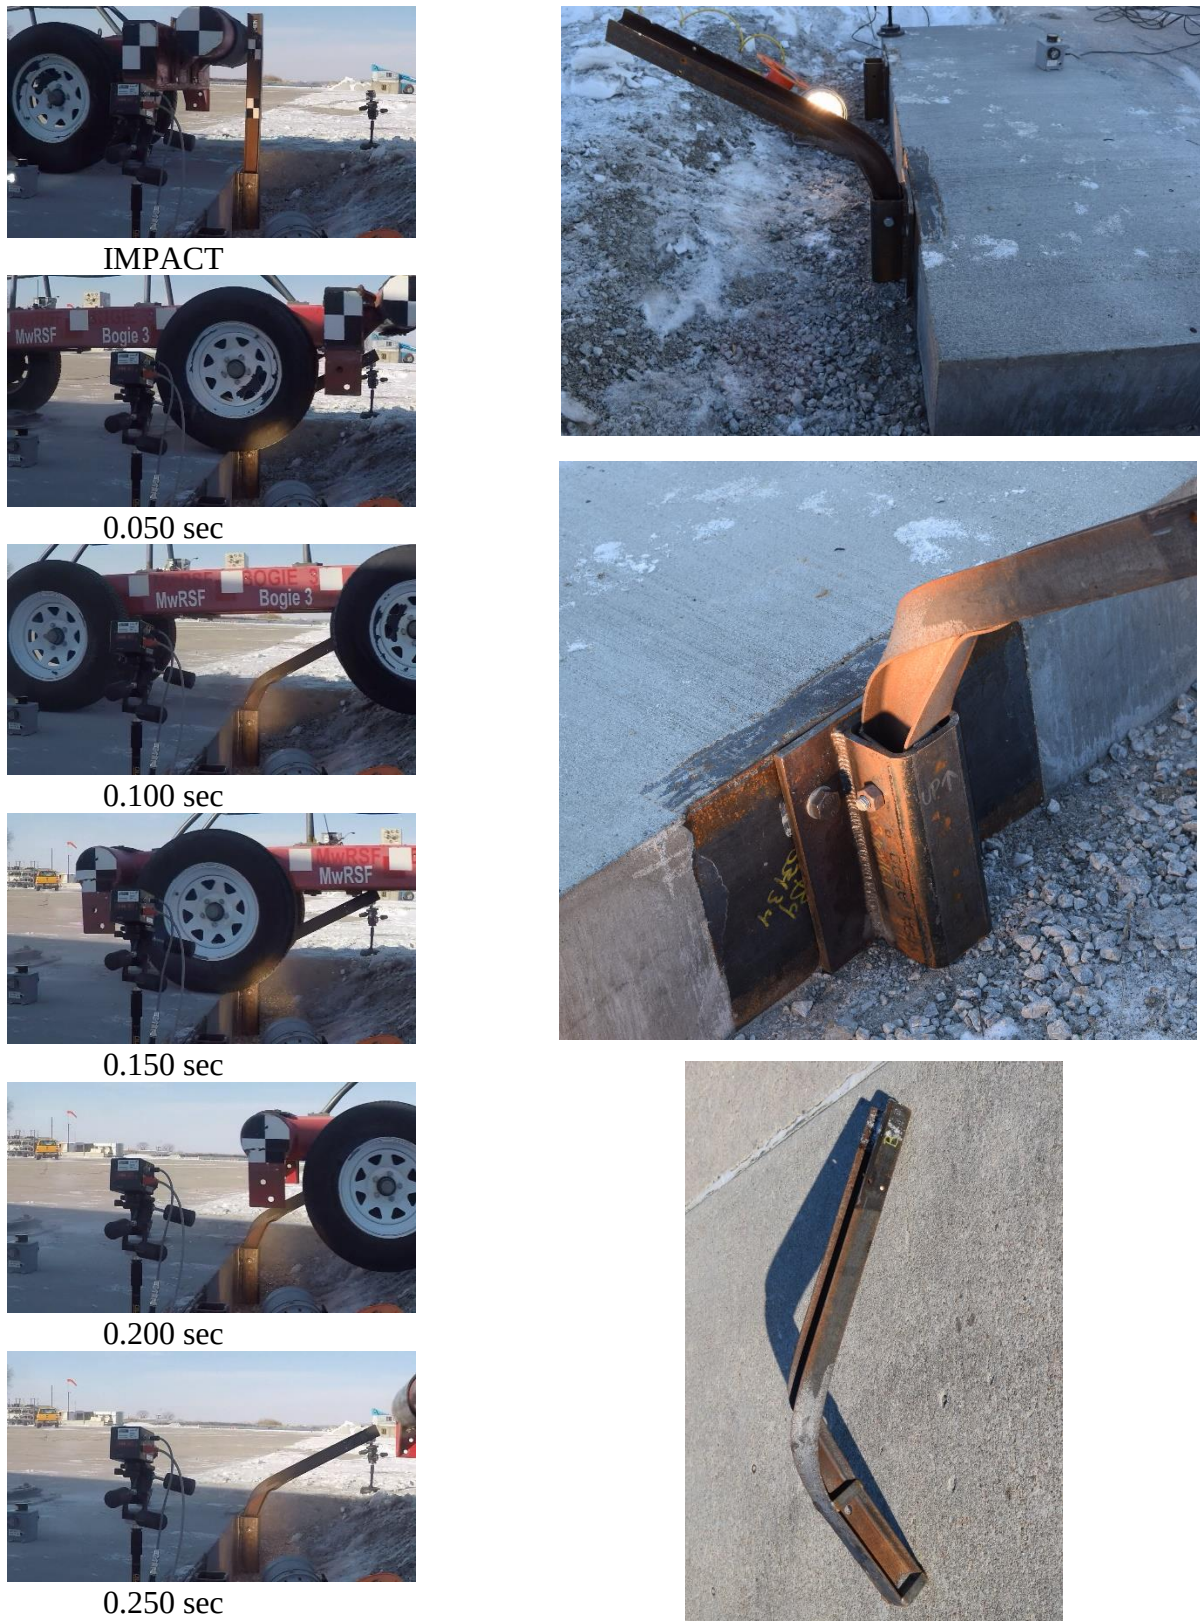
Figure 40. Time-Sequential and Post-Impact Photographs, Test No. N2B-2

The test article for test no. N2B-2 used Deck Location G and Channel Assembly F. The test article consisted of a bolted socket attachment utilizing  $\frac{3}{4}$ -in. diameter bolts and a 12-in. thick simulated precast beam-slam bridge deck. See Section 3.2 for further details. Test no. N2B-2 was conducted with the bogie impacting the S3x5.7 post at a height of 25 in. and an angle of 90 degrees (through the strong axis of the post) at a speed of 21.4 mph. The impact caused the post to deflect backward as a plastic hinge formed in the post near the top of the socket and the post twisted. The bogie ultimately overrode the post at a displacement of 29.6 in. No damage occurred to the deck, socket assembly, or attachment hardware. Time sequential photographs and post-test photographs are shown in Figure 40.

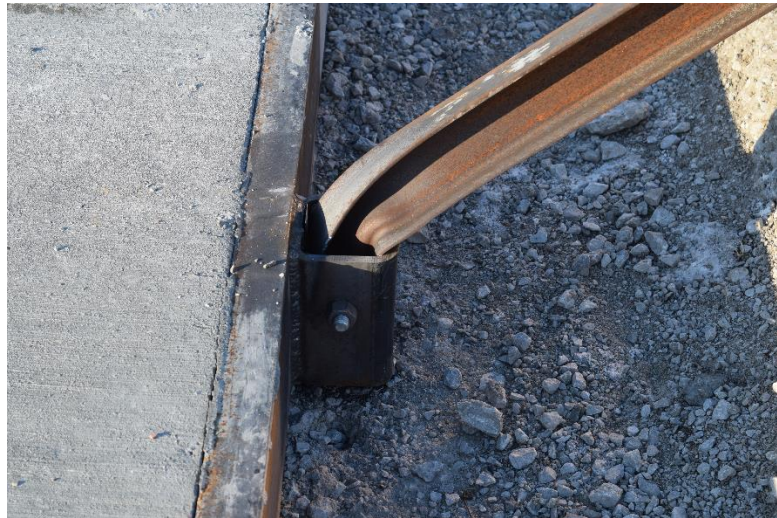
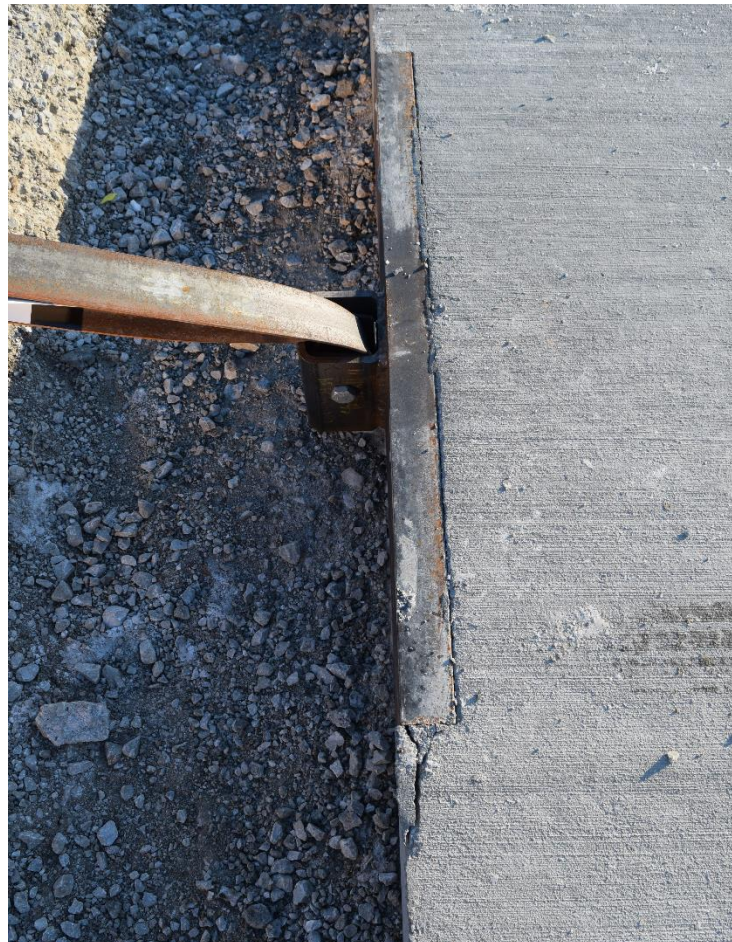
Figure 42. Time-Sequential and Post-Impact Photographs, Test No. N2B-3

The test article for test no. N2B-3 used Deck Location B and Channel Assembly B. The test article consisted of a welded socket attachment to the 7-in. thick simulated CIP bridge deck. The channel was anchored to the deck using straight segments of ASTM A706 rebar. See Section 3.2 for further details. Test no. N2B-3 was conducted with the bogie impacting the S3x5.7 post at a height of 25 in. and an angle of 90 degrees (through the strong axis of the post) at a speed of 21.2 mph. The impact caused the post to deflect backward as a plastic hinge formed in the post near the top of the socket. The bogie ultimately overrode the post at a displacement of 30.6 in. Due to the impact loads, the top flange of the socket had begun to pry away from the deck, and a 1/8-in. wide crack was found between the channel and the concrete. Additionally, some concrete spalling was found on the top edge of the deck adjacent to the channel. The socket and welds remained undamaged. Time sequential photographs and post-test photographs are shown in Figure 42.

Throughout all six tests, only test no. N2B-3, where the top flange of the channel was pulled outward  $\frac{1}{8}$  in. and minor concrete spalling was observed adjacent to the channel, resulted in any damage to the simulated decks. Thus, the straight rebar anchorage design did not provide

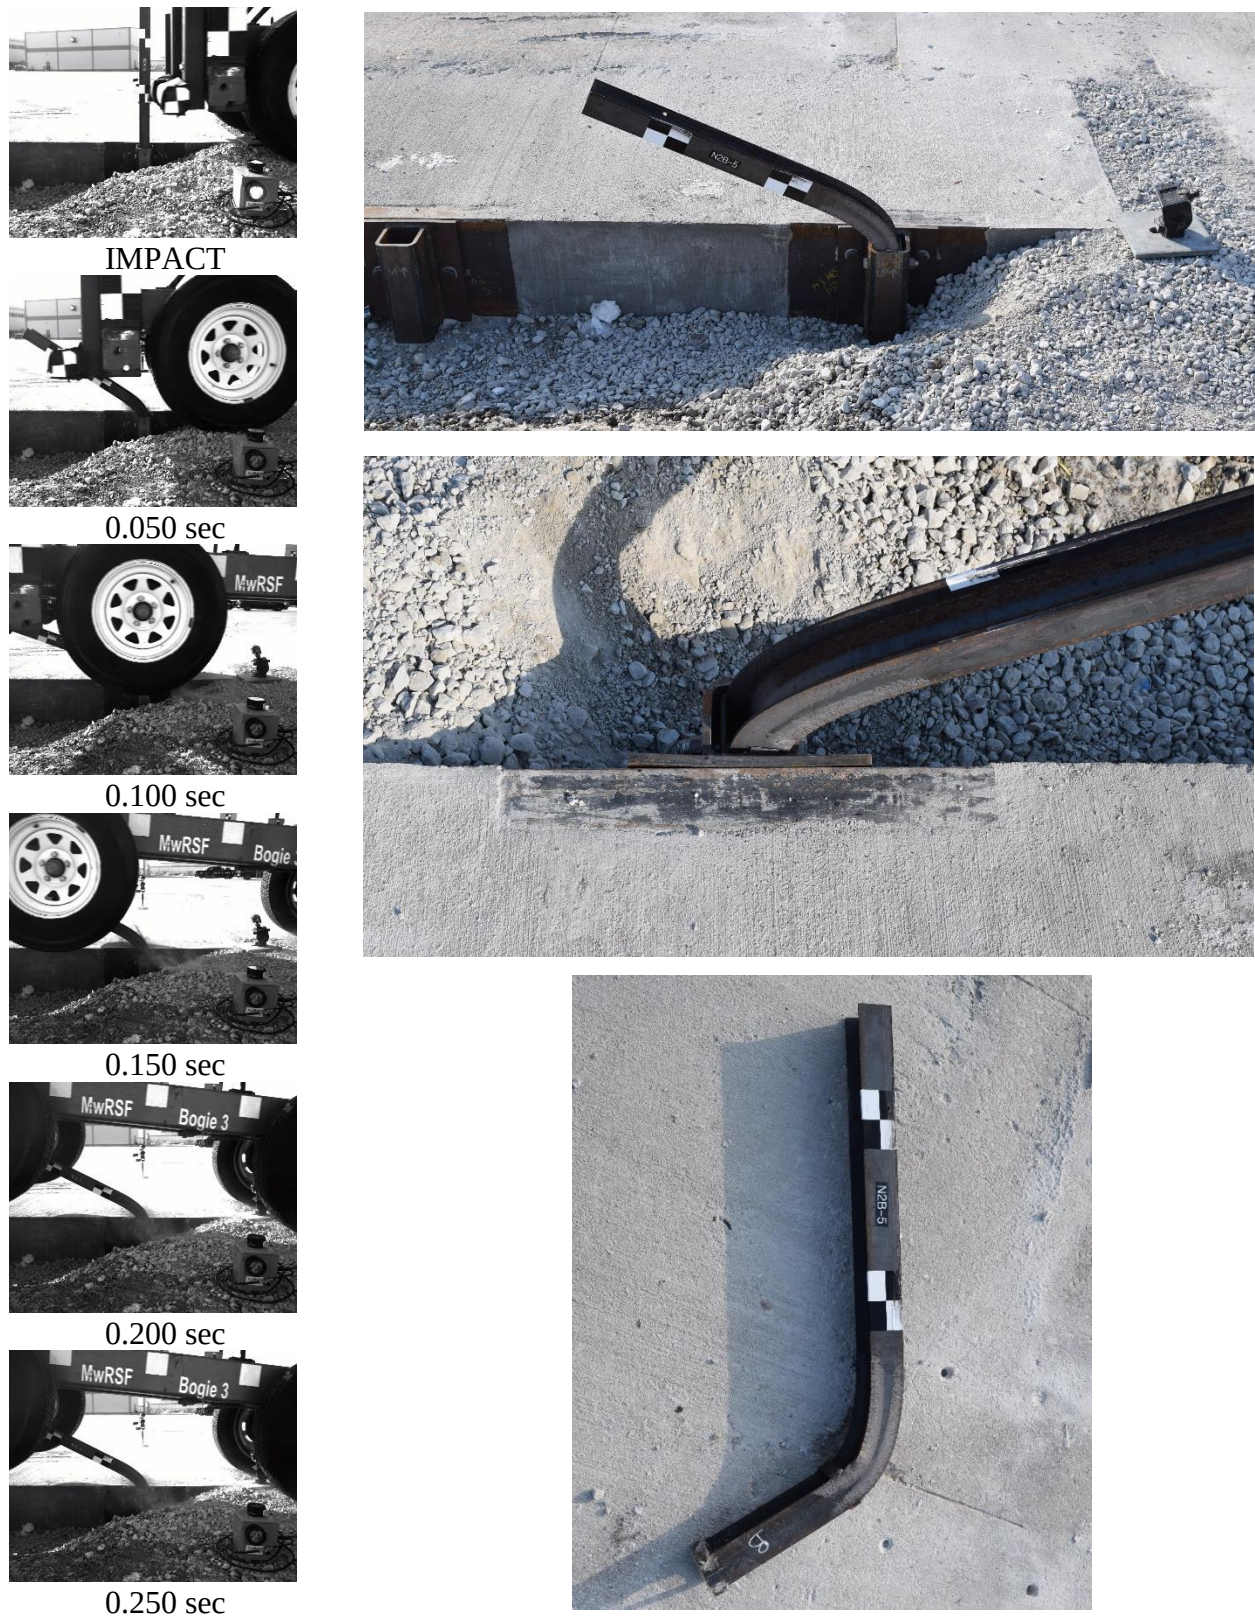
Figure 46. Time-Sequential and Post-Impact Photographs, Test No. N2B-5

The test article for test no. N2B-5 used Deck Location G and Channel Assembly F. The test article consisted of a bolted socket attachment utilizing  $\frac{3}{4}$ -in. diameter bolts and a 12-in. thick simulated precast beam-slab bridge deck. See Section 3.2 for further details. Test no. N2B-5 was conducted with the bogie impacting the S3x5.7 post at a height of 12 in. and an angle of 0 degrees (through the weak axis of the post) at a speed of 20.1 mph. The impact caused the post to deflect downstream as a plastic hinge formed in the post near the top of the socket. The bogie overrode the post at 34.0 in. of displacement. No damage occurred to the deck, socket assembly, or attachment hardware. Time sequential photographs and post-test photographs are shown in Figure 46.

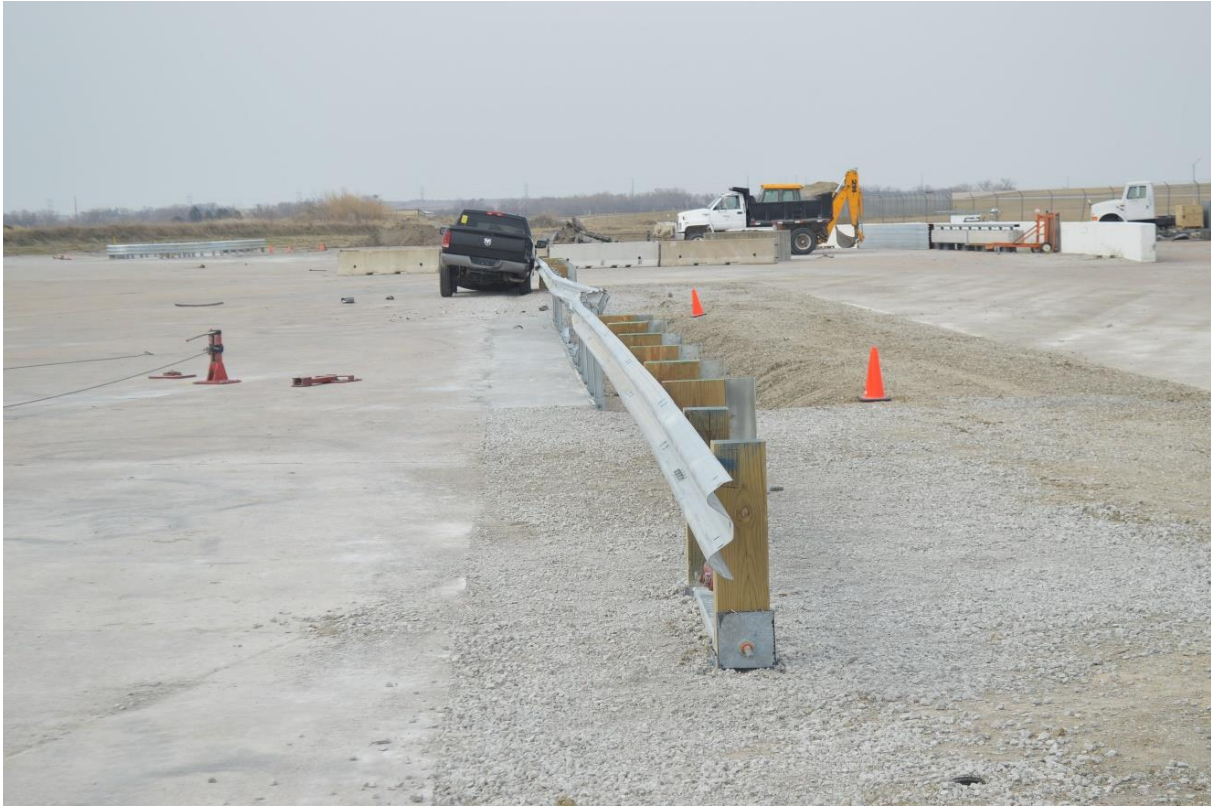
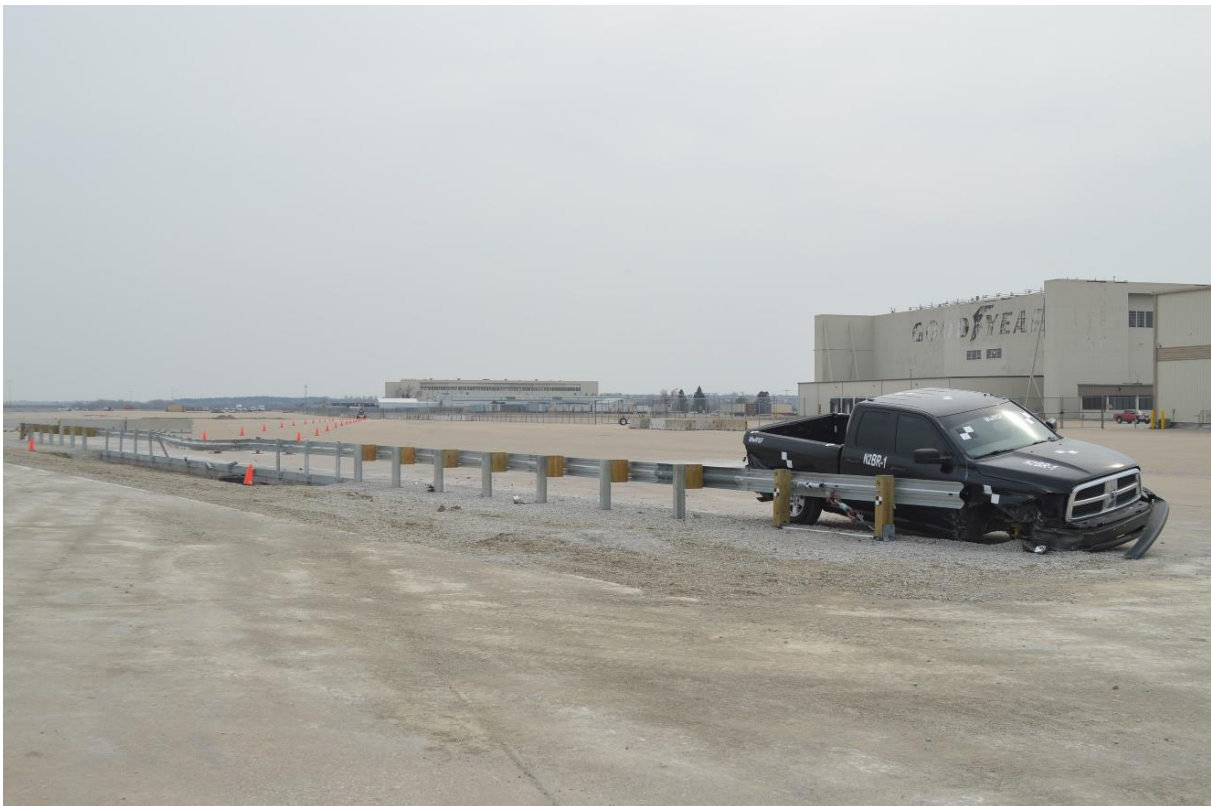
Figure 91. Vehicle Trajectory Marks and Final Position, Test No. N2BR-1

A detailed description of the sequential impact events is contained in Table 7. Sequential photographs are shown in Figures 88 and 89. Documentary photographs of the crash test are shown in Figure 90. The vehicle trajectory and final position are shown in Figure 91.

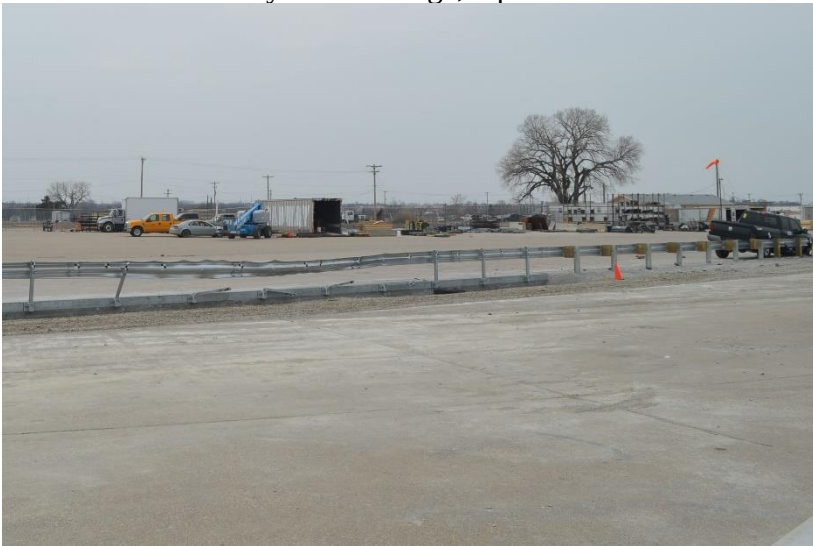
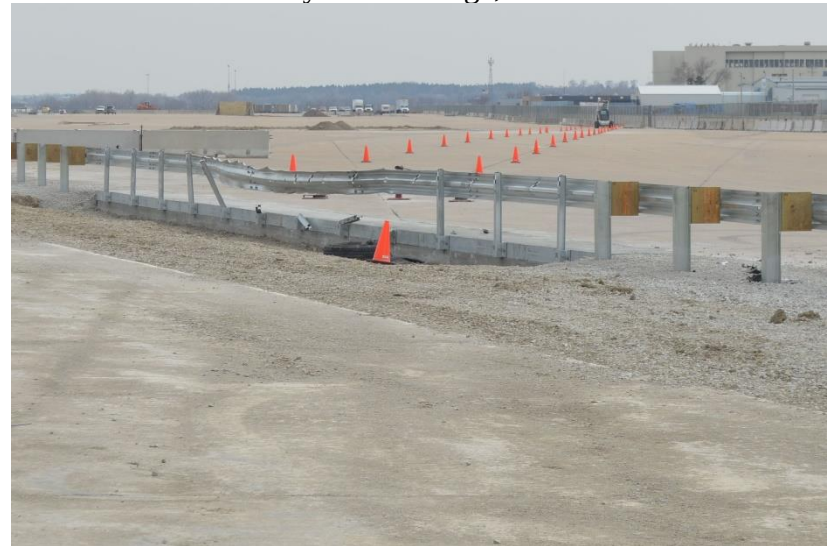
Figure 92. System Damage, Test No. N2BR-1

The maximum lateral permanent set of the barrier system was 20 in., which occurred on the guardrail located at mid-span between post nos. 14 and 15, as measured in the field. The maximum lateral dynamic barrier deflection was 32.6 in. measured on the guardrail at mid-span between post nos. 14 and 15, as determined from high-speed digital video analysis. The working width of the system was found to be 38.4 in., also determined from high-speed digital video analysis.

Overall System Damage, Upstream View

Overall System Damage, Front View

Overall System Damage, Upstream Behind View

Overall System Damage, Downstream Behind View

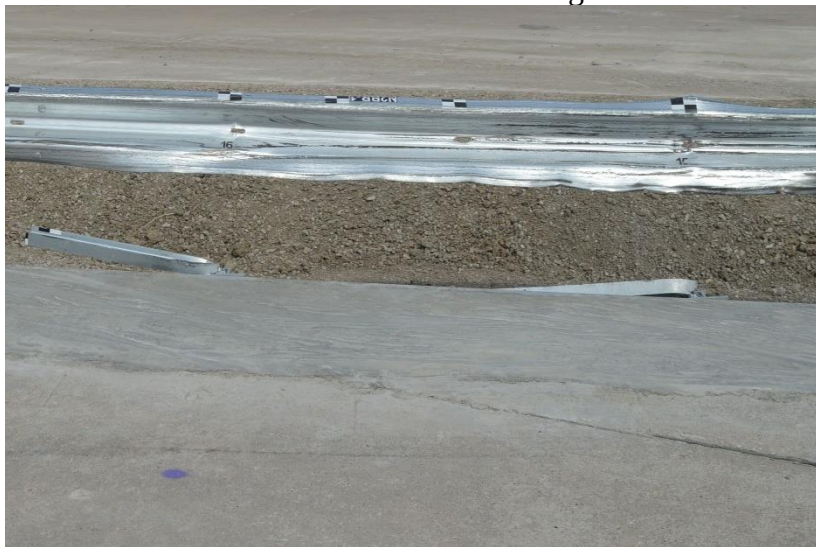
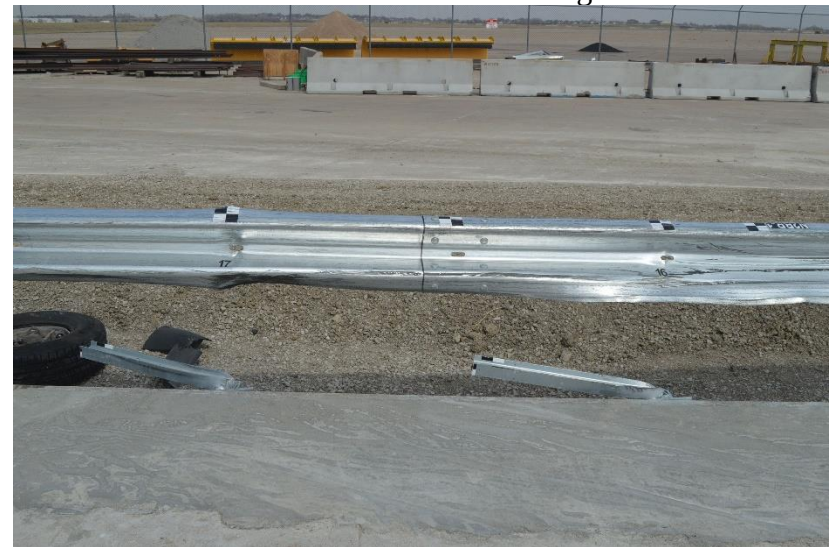
Figure 93. System Damage, Front-Side Views, Test No. N2BR-1

Post Nos. 13 and 14 Damage

Post Nos. 14 and 15 Damage

Post Nos. 15 and 16 Damage

Post Nos 16 and 17 Damage

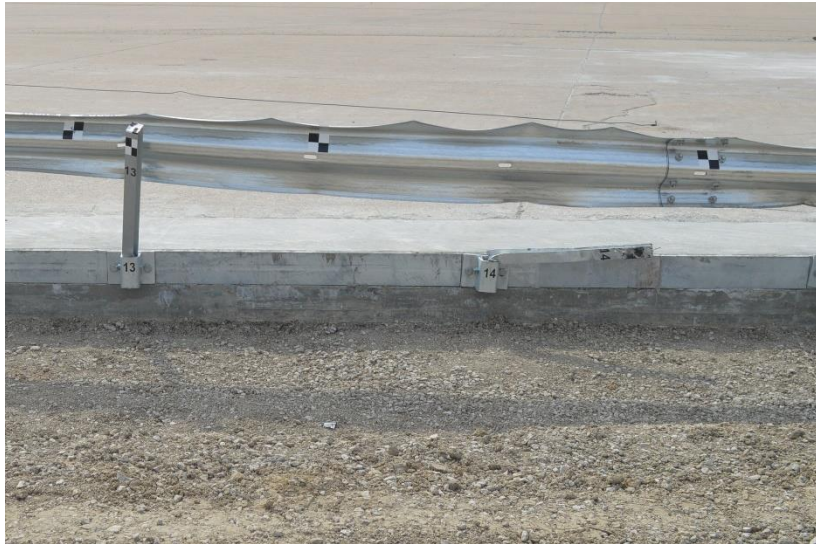
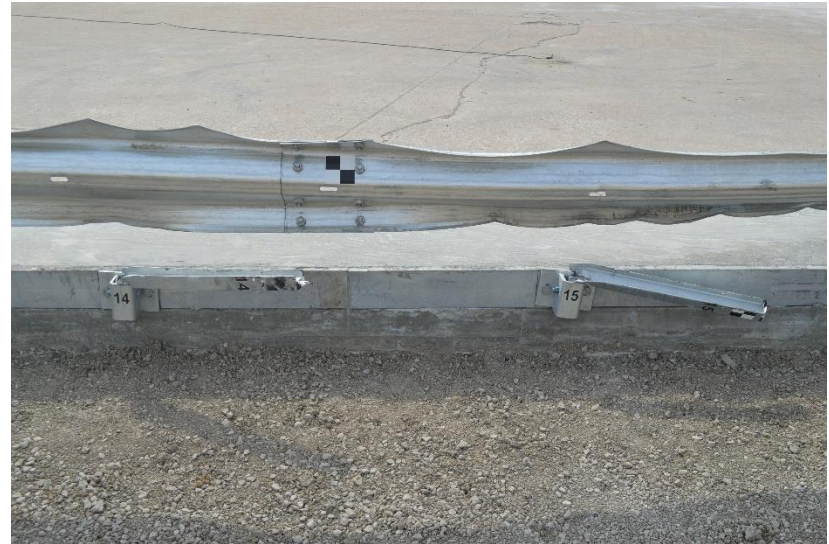
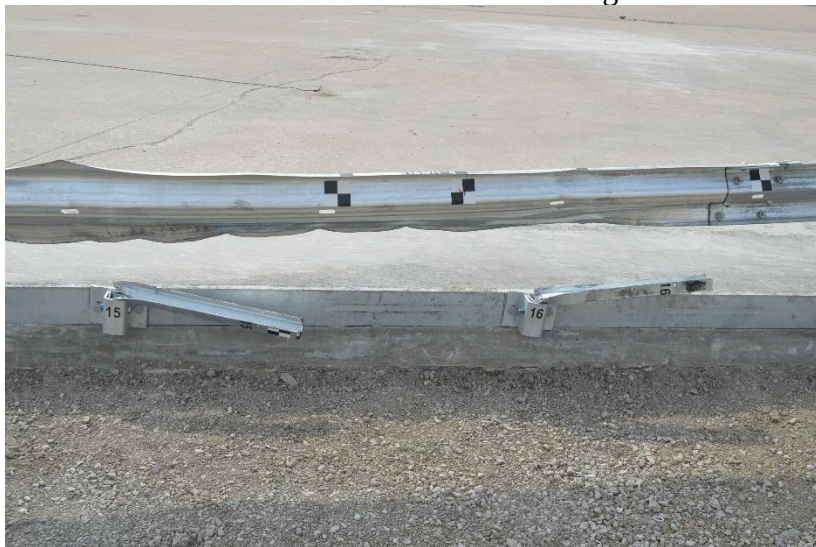
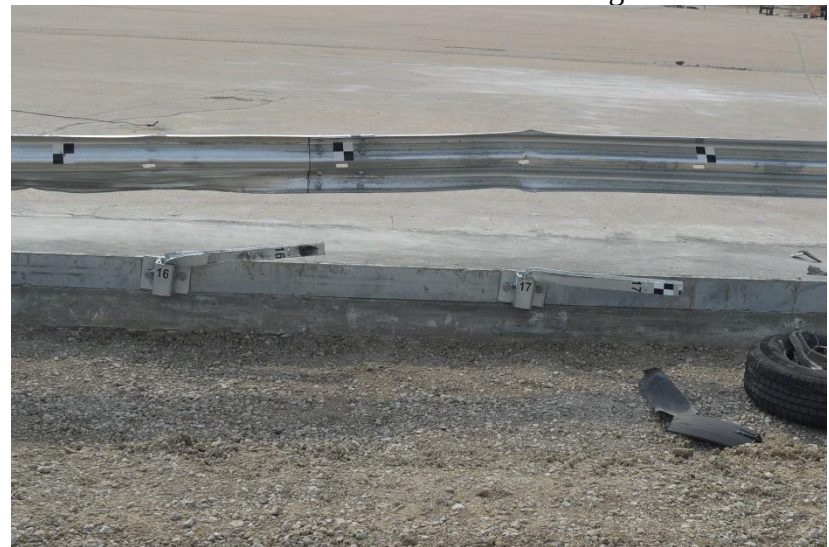
Figure 94. System Damage, Back-Side Views, Test No. N2BR-1

Post Nos. 13 and 14 Rear Damage

Post Nos. 14 and 15 Rear Damage

Post Nos. 15 and 16 Rear Damage

Post Nos. 16 and 17 Rear Damage

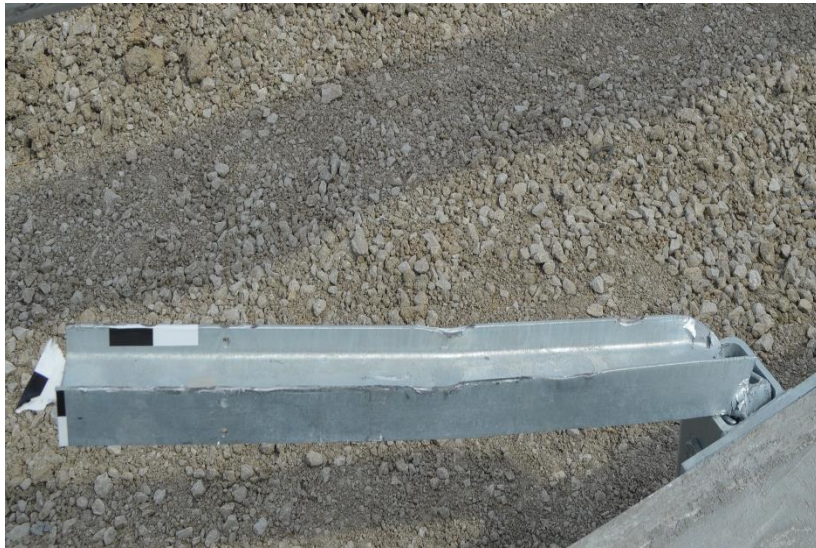
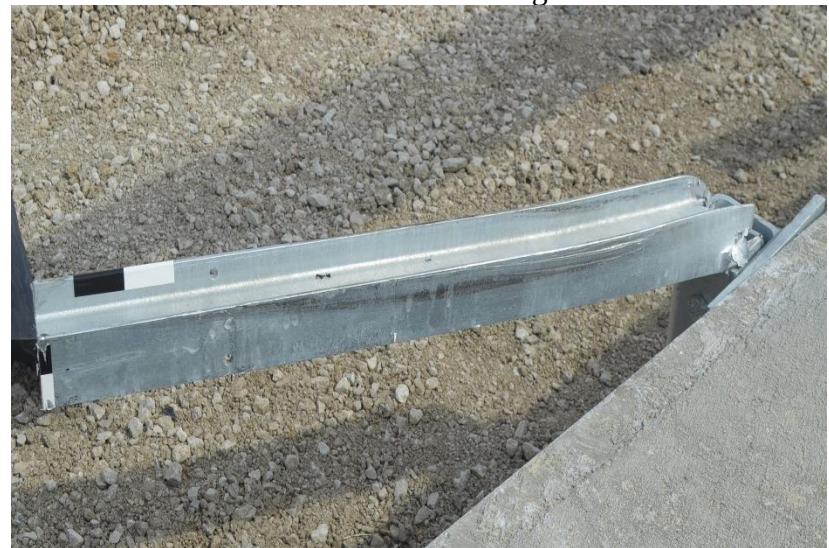
Figure 95. System Damage, Post Bending and Tearing, Test No. N2BR-1

Post No. 14 Tearing

Post No. 17 Tearing

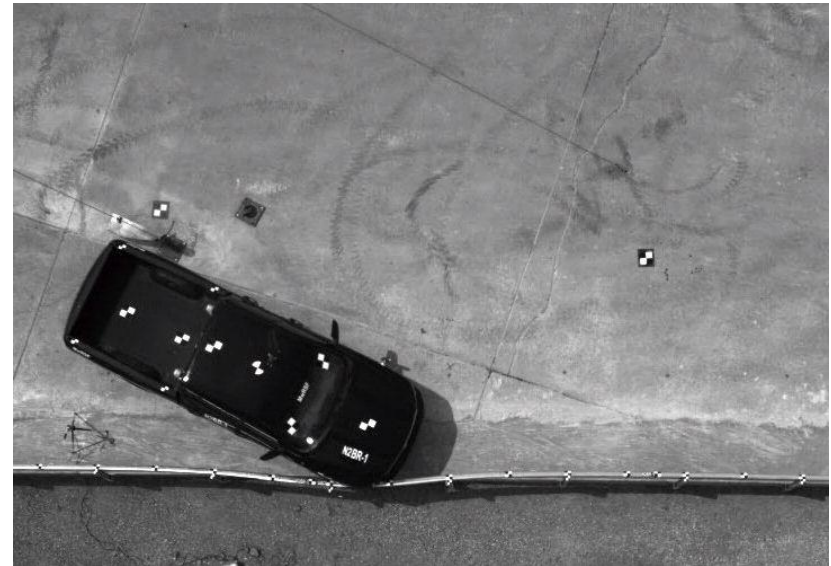
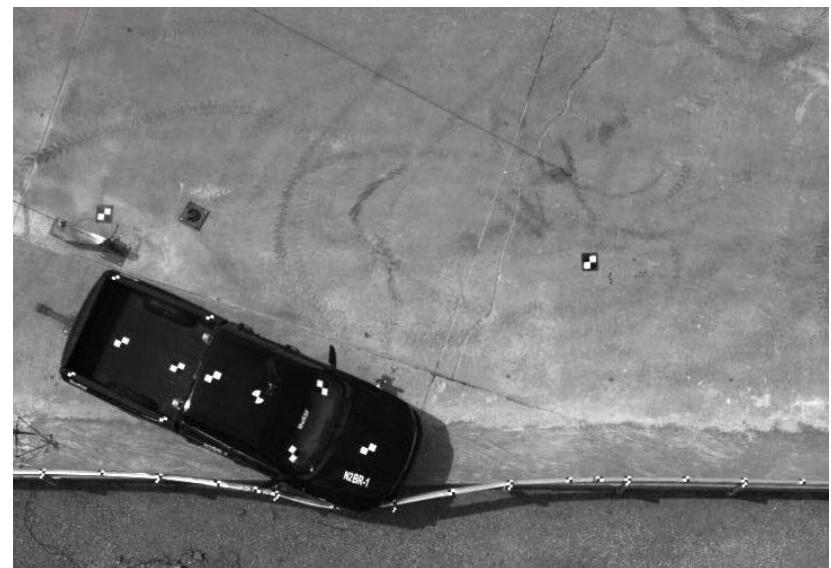
Figure 100. Sequential Figures from BARRIER VII Simulation and Test No. N2BR-1

The BARRIER VII simulation matched the results of the full-scale crash test rather well over the first 0.400 sec of the impact. The vehicle parallel time and speed were very similar, the system displacements were nearly identical, and the maximum pocketing angles were within 2 degrees. Post failure was defined in the BARRIER VII simulations as post displacements greater than 15 in. BARRIER VII determined 4 posts failed according to this failure criteria, and post nos. 14 through 17 had bent completely over in the physical test. A graphical comparison of the simulation to the physical test is shown in Figures 100 through 106. After approximately 0.400 s, the model began to deviate from the full-scale test. BARRIER VII is known for having difficulties simulating system rebound and restoration forces. As such, the results do not match up as well as the vehicle exits the system. Fortunately, all the evaluation metrics for the simulations (e.g., maximum displacements and pocketing angles) occur before the vehicle reaches parallel and starts to exit the system. Therefore, based on the comparison to the physical test described herein, the model of the new TL-2 bridge rail was considered validated.
