Laboratory Evaluation of Waterborne Coatings on Steel

Publication No.: FHWA-RD-03-032

March 2003

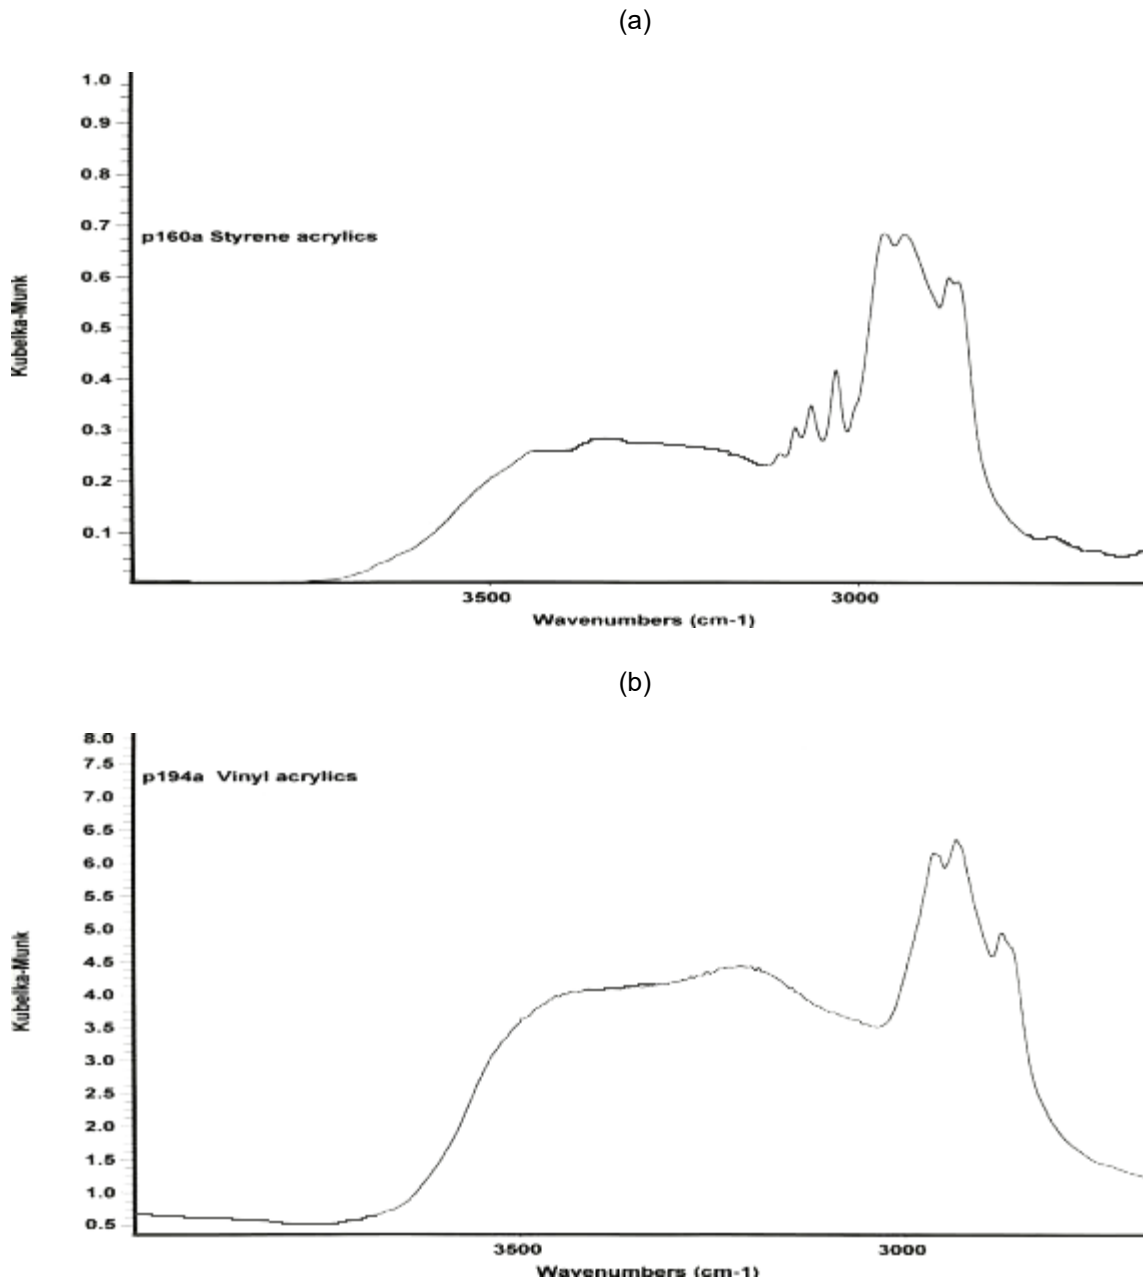
Figure 1. FTIR spectrum of (a) styrene modified acrylics, (b) unmodified (vinyl) acrylics using diffuse reflectance sample accessory.

Most of the primers and topcoats were characterized for their resin type by FTIR analyses. Their chemical nature of aromatic (AR) to aliphatic (AL) ratio, so called "aromaticity," was calculated from the ratio of reflectance peak areas at wavenumber of 3000-3100 cm^{-1} to that at wavenumber of 2800-3000 cm^{-1} . The measurement of this ratio is a fairly sensitive technique for estimating aromaticity of organic materials. The aromatic content seen in these acrylic samples is attributed to styrene modification of the acrylic. The typical FTIR spectra of styrene modified acrylics and unmodified acrylics are shown in figures 1a and 1b respectively; several distinct FTIR reflectance peaks were observed for styrene at the wavenumber between 3000 and 3100 cm^{-1} . The AR/AL ratios of the primers and topcoats are shown in table 5. The AR/AL ratio in primers 3, 4, and 7 were relatively high; they were calculated to be 6, 4, and 5, respectively, showing more aromatic character, i.e., higher styrene acrylics content. On the other hand, the ratio of AR/AL was found to be zero for systems 5 and 6, revealing their saturated structure of unmodified acrylics. All the epoxy primers 8, 9, 10, and 13 were found to be highly aromatic; the

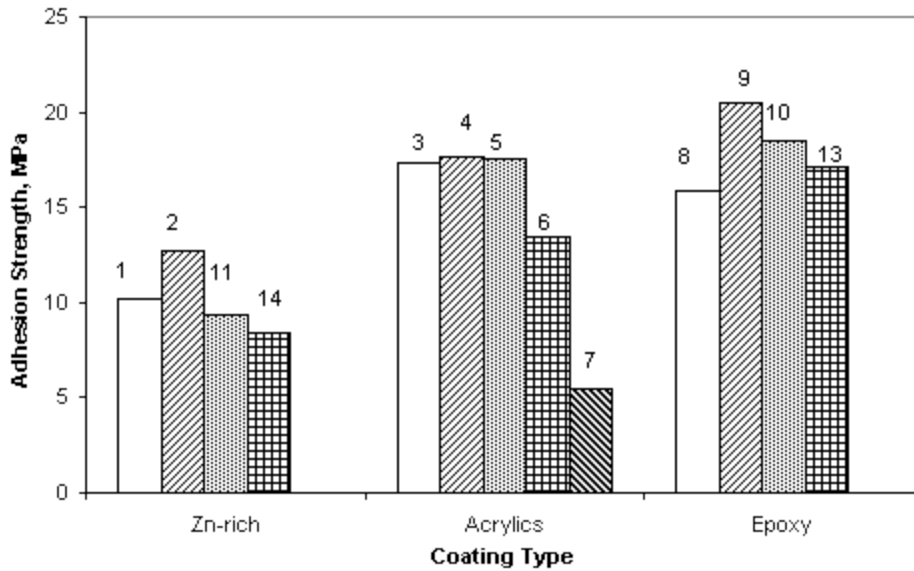
Figure 2. Adhesion strength of waterborne primers before test.

The pencil hardness of all the topcoats was found to be similar (HB or 2B), with the exception of system 7. This system contained a fairly soft polymer with a hardness of only 6B. The hardness measurements are presented in table 6. The adhesion strengths of each whole-coating system and each primer before weathering tests were measured, and the values are illustrated in figures 2 and 3, respectively. There are no significant differences between the adhesion strength of the whole-coating systems and their primers. Nevertheless, primer 6 showed more than twice the adhesion strength of the entire system 6, which displayed weak topcoat cohesive strength in the pull-off test. For comparison, the adhesion strengths of acrylic and epoxy systems were all high (above 14 mega pascal (MPa)) except systems 6 and 7, which had lower adhesion strength. In the case

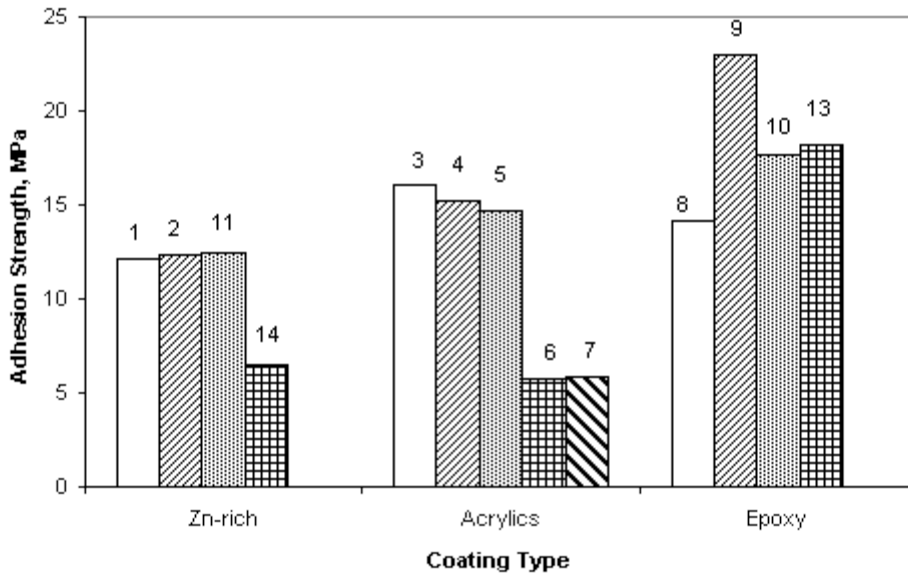
Figure 3. Adhesion strength of waterborne coating systems before test.

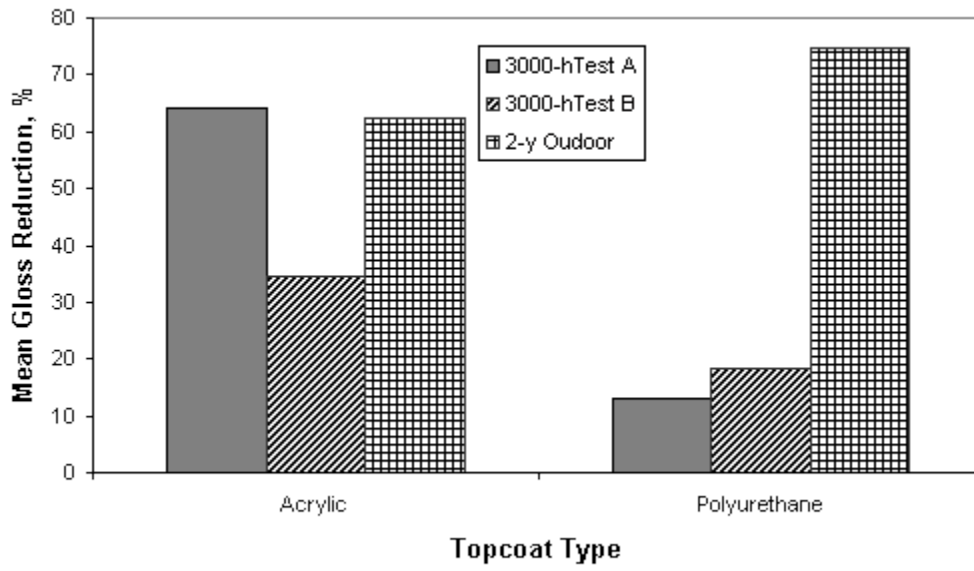
Figure 4. Comparison of topcoat gloss reduction by three test methods.

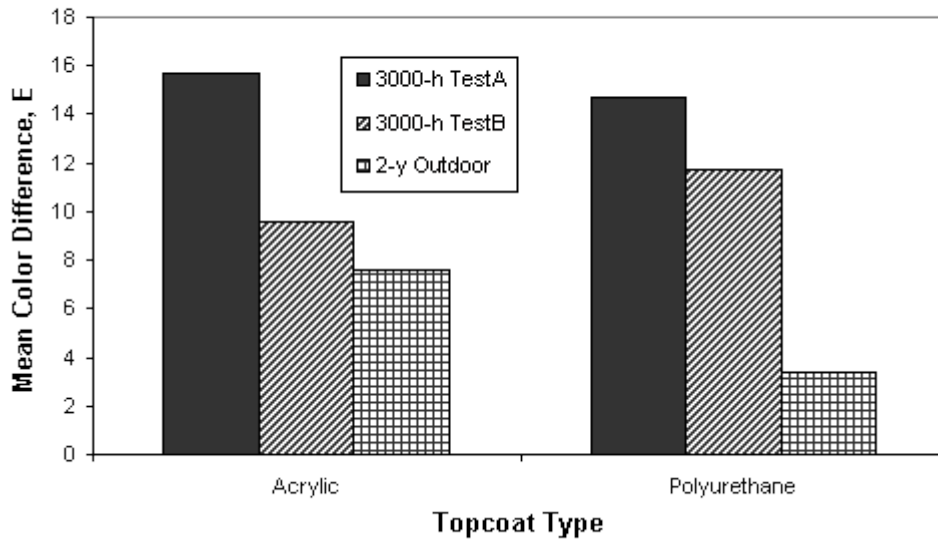
Figure 5. Comparison of topcoat color change by three test methods.

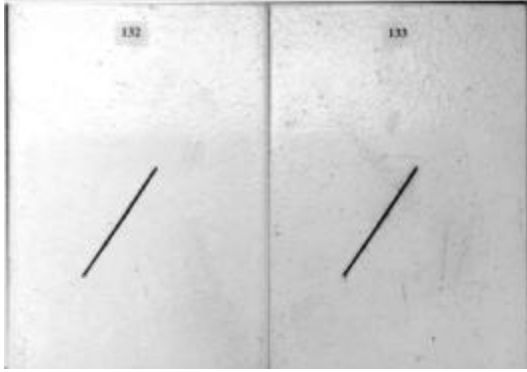
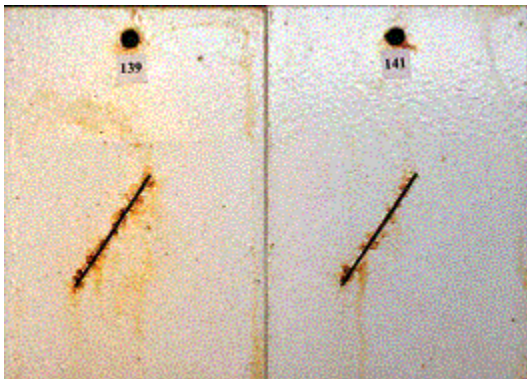
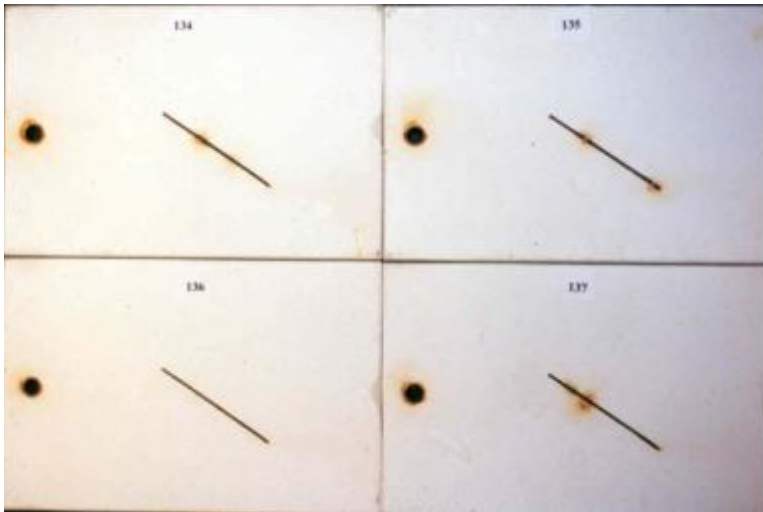
Figure 6. Coating conditions of system 2 after exposures.
a. 3,000-h test A b. 3,000-h test B c. 2-y outdoor exposure

- Zinc-rich systems—Organic zinc-rich system 1 and inorganic zinc-rich system 11 developed measurable creepages in the 3,000-h test A, creepages did not occur in the 2-y outdoor exposure test. The rust creepages generated in test A are believed to result from zinc sulfate formation, which is caused by the reaction of zinc dust and ammonium sulfate. On the other hand, zinc-rich systems 1 and 11 developed a lesser amount of scribe creepage after 3,000-h test B when compared with 3,000-h test A. Among all the zinc-rich coating systems, system 14 performed best and showed no creepage after all three tests. The moisture-cured zinc-rich coating system (system 2) did not perform as well at the scribe as either the epoxy zinc-rich system (system 1) or the inorganic zinc-rich systems (systems 11 and 14); it developed about 2-mm rust creepage in all the tests. The coating conditions of the moisture-cured urethane system after two 3,000-h laboratory tests and 2-y outdoor exposure are shown in figure 6. The performance of the one-component moisture-cured zinc-rich urethane system at the scribe is obviously poorer than the two-component zinc-rich systems; as an example the coating conditions of system 1 (also organic zinc-rich) after the tests are shown in figure 7. It seems that zinc-rich MCU primer (primer 2) is less effective in protecting steel from corrosion than zinc-rich primers in systems 1, 11, and 14. The reason for this difference is unclear. However, one-component zinc-rich MCU primer was also found to perform poorer than two-component zinc-rich epoxy primer by Kalendova.⁹ The creepage growth for all the zinc-rich coating systems as a function of test time after the laboratory tests and the outdoor exposure are plotted in figures 8, 9, and 10; all the scribe creepage increased linearly with test time. The incubation times for creepage formation are longer for test B than for test A, indicating that zinc-rich systems perform better in a salt-rich environment than in an acidic salt environment.

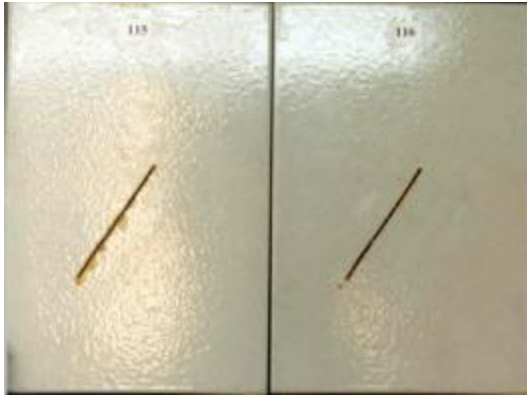
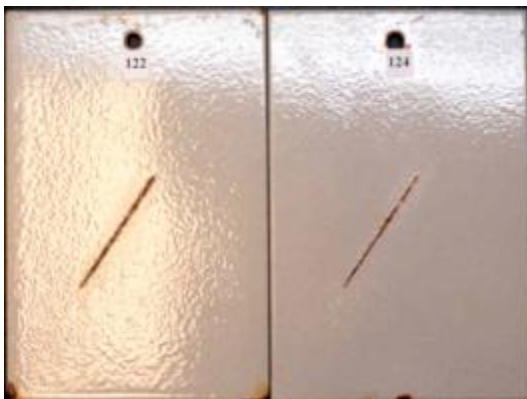
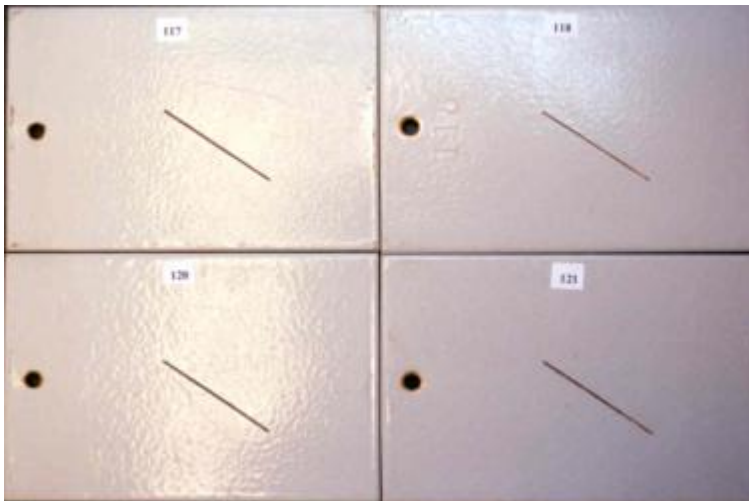
Figure 7. Coating conditions of system 1 after exposures.
a. 3,000-h test A b. 3,000-h test B c. 2-y outdoor exposure

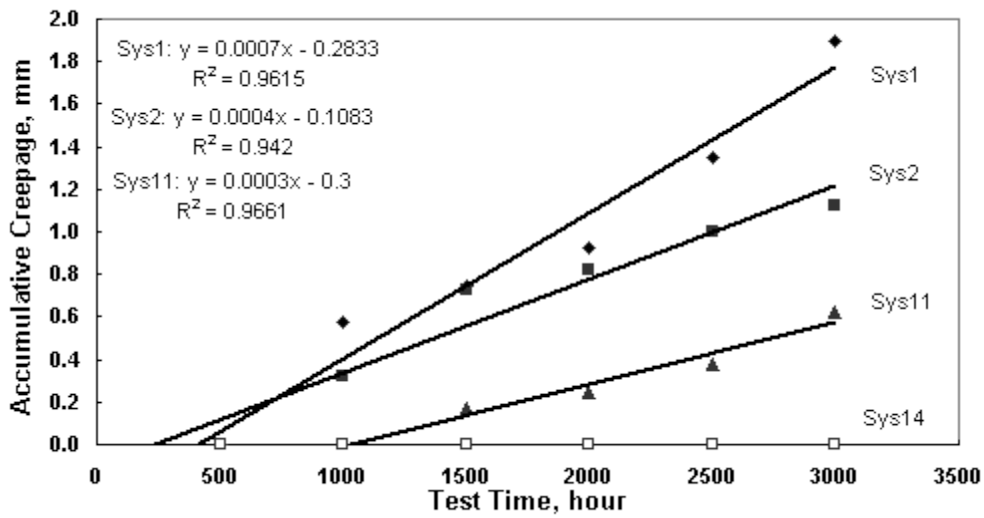
Figure 8. Plot of scribe creepage of zinc-rich coating systems over SP 10 surfaces versus laboratory test time after test A.

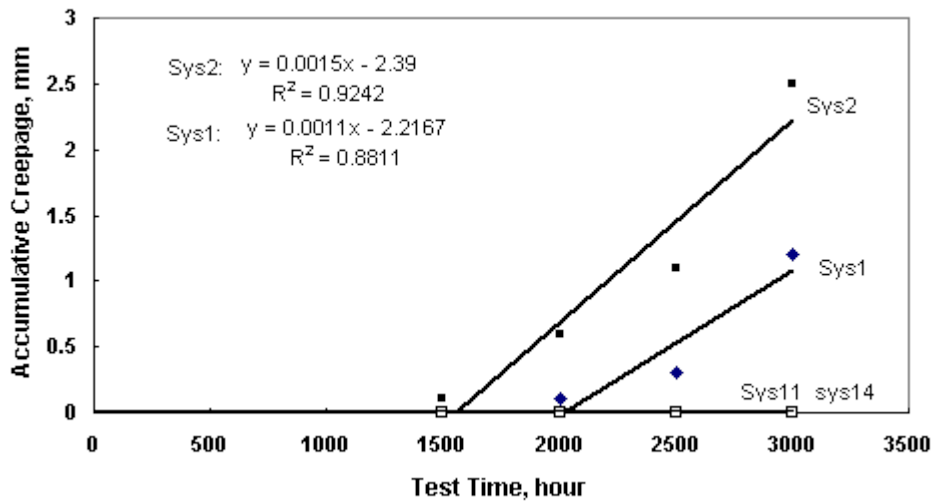
Figure 9. Plot of scribe creepage of zinc-rich coating systems over SP 10 surfaces versus laboratory test time after test B.

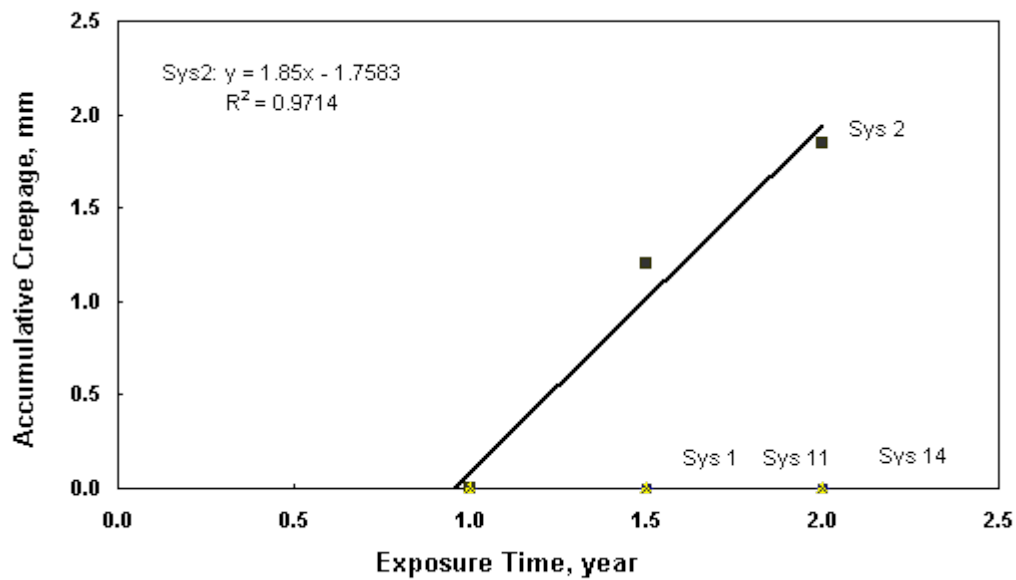
Figure 10. Plot of scribe creepage of zinc-rich coating systems over SP 10 surfaces versus outdoor exposure time.

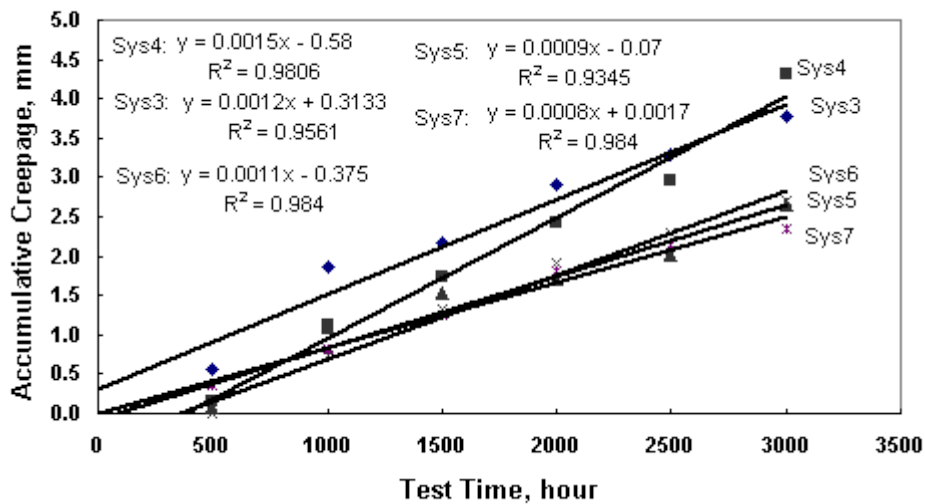
Figure 11. Plot of scribe creepage of acrylic coating systems over SP 10 surfaces versus laboratory test time after test A.

- Waterborne acrylic systems—Acrylic systems 3-7 developed much larger creepage at the scribe than did zinc-rich systems. The creepage growth of the acrylic systems with test time is plotted in figures 11, 12, and 13. Styrene modified acrylics and unmodified acrylics (such as vinyl acrylics) displayed two levels of performance, the coating resistance of styrene modified acrylics (systems 3 and 4) at scribe are lower than that provided by unmodified (vinyl) acrylics (systems 5 and 6). The different coating conditions of typical styrene acrylics (system 3) and vinyl acrylics (system 5) after three tests are shown in figures 14 and 15. However, system 7 did not fit either of these two groups exactly. Its performance is similar to vinyl acrylics in test A while it is close to the performance of styrene modified acrylics in test B. It is of interest that system 7's performance fell between two acrylic types in the outdoor exposure. As a result, this soft

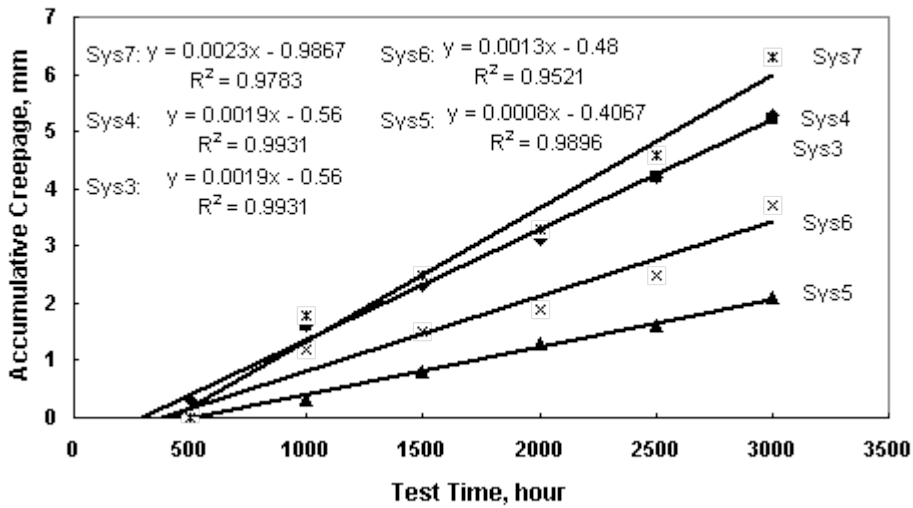
Figure 12. Plot of scribe creepage of acrylic coating systems over SP 10 surfaces versus laboratory test time after test B.

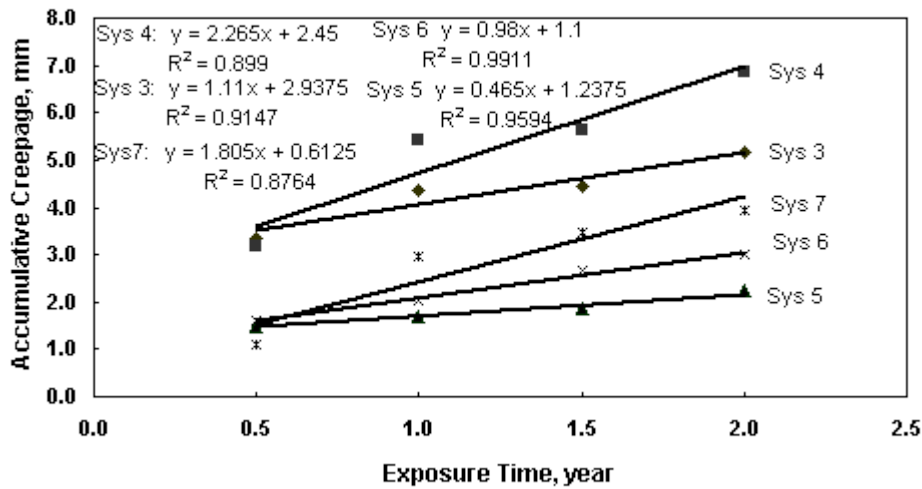
Figure 13. Plot of scribe creepage of acrylic coating systems over SP 10 surfaces versus outdoor exposure time.

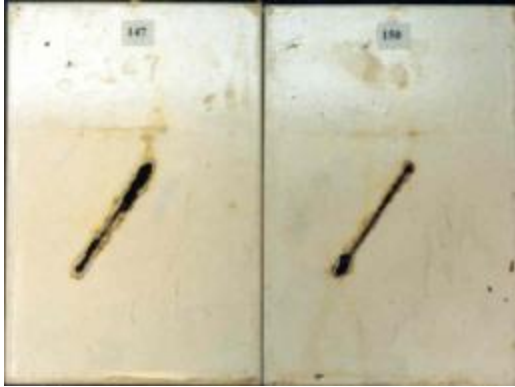
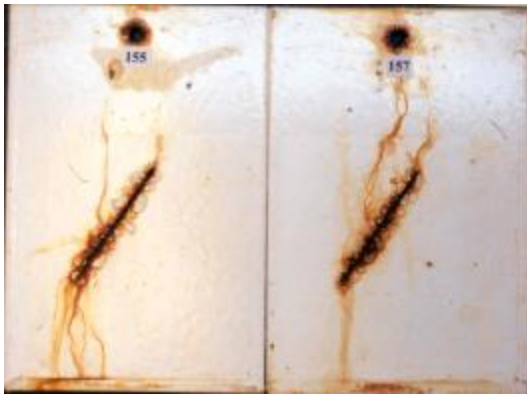
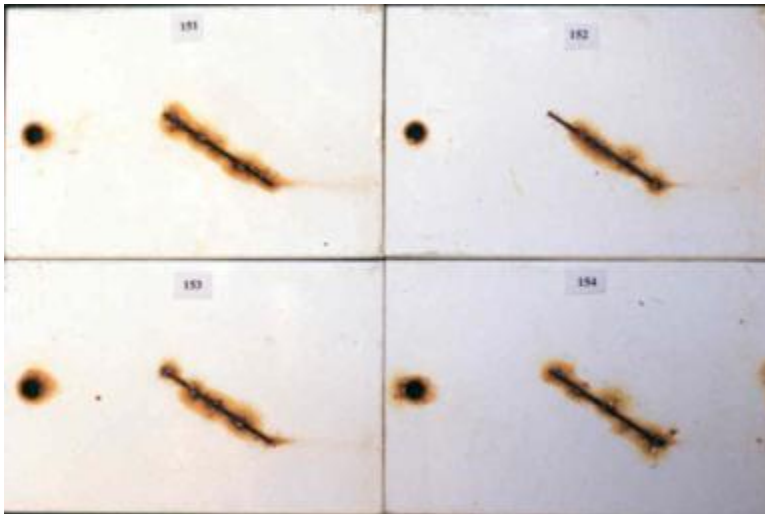
Figure 14. Coating conditions of system 3 after exposures.
a. 3,000-h test A b. 3,000-h test B c. 2-y outdoor exposure

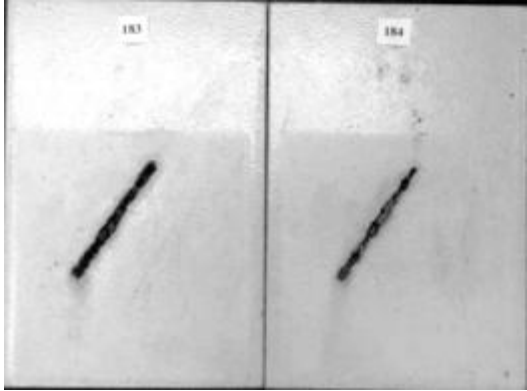
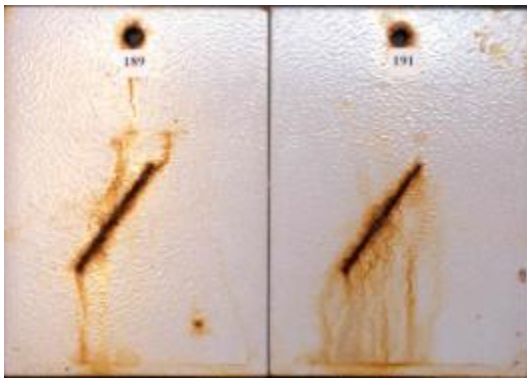
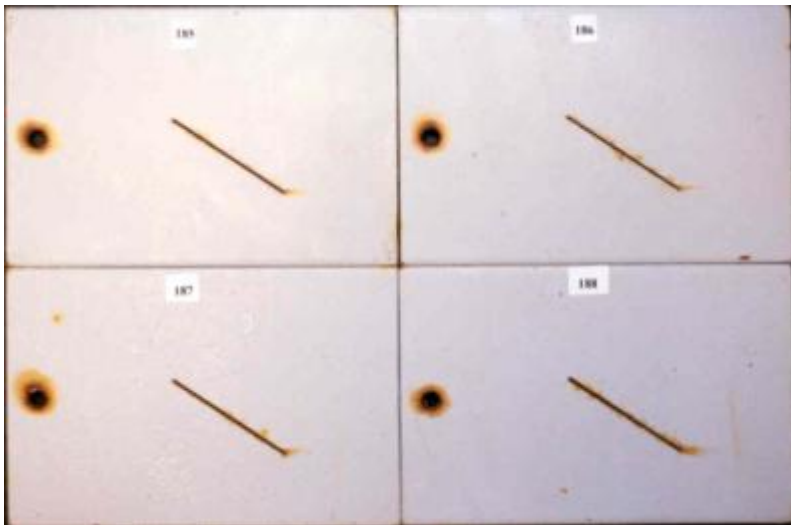
Figure 15. Coating conditions of system 5 after exposures.
a. 3,000-h test A b. 3,000-h test B c. 2-y outdoor exposure

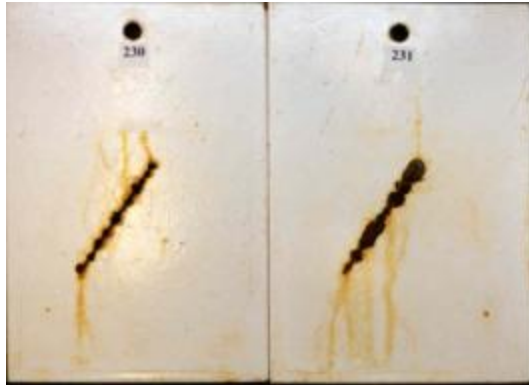
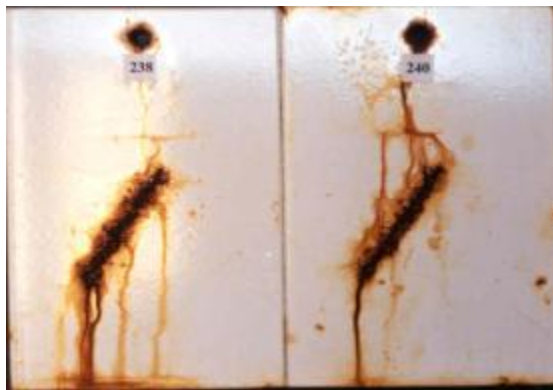
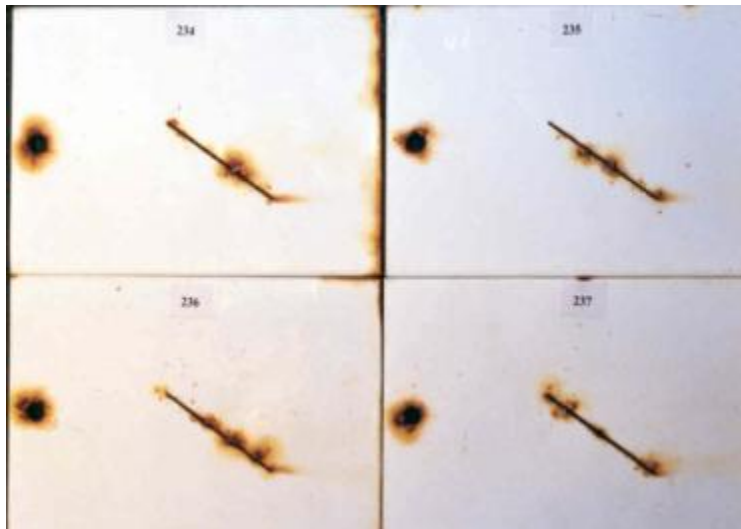
Figure 16. Coating conditions of system 8 after exposures.
a. 3,000-h test A b. 3,000-h test B c. 2-y outdoor exposure

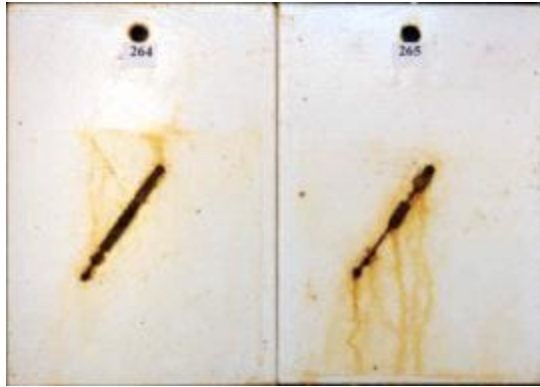
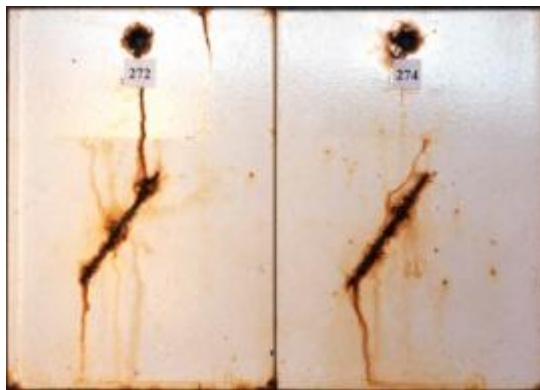
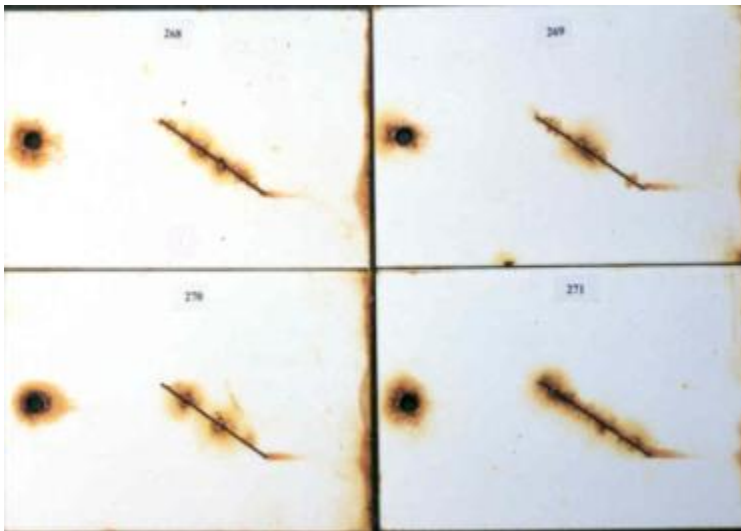
Figure 17. Coating conditions of system 10 after exposures.
a. 3,000-h test A b. 3,000-h test B c. 2-y outdoor exposure

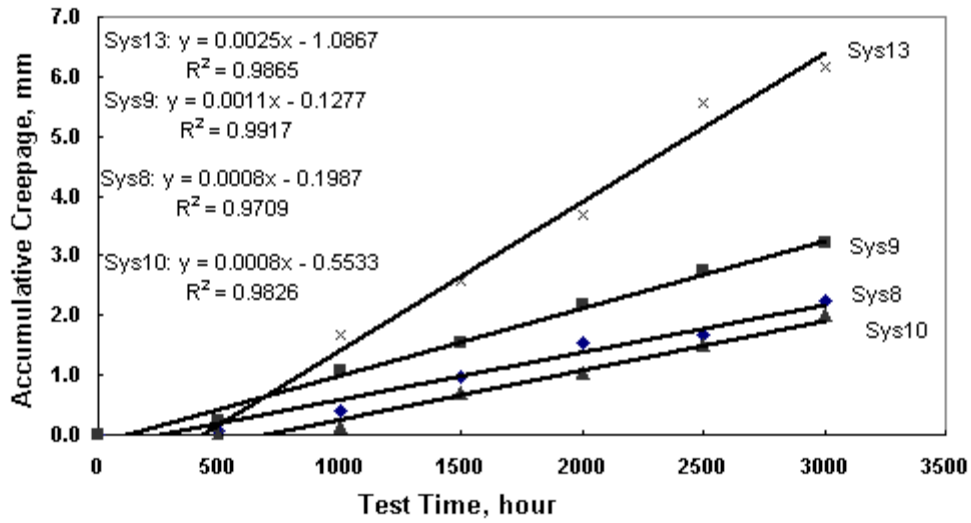
Figure 18. Plot of scribe creepage of epoxy coating systems over SP 10 surfaces versus laboratory test time after test A.

comparison, the creepage growth for all the epoxy systems versus test time are plotted in figures 18, 19, and 20. In all the tests, systems 8 and 10 performed better at the scribe than system 9, and even better than system 13. A substantial amount of scribe creepage developed by system 13 after three tests is demonstrated in figure 21. Figure (a) shows the exposed rust surface after the developed creepage area was scraped off by a knife after 3,000-h test A; the distance of undercutting was found to be exactly same as that of visible creepage on the coating surface that was measured prior to coating removal. The low corrosion resistance of system 13 at the scribe may be attributed to the presence of zinc phosphate in primer 13 or poor coating formulation. Using zinc phosphate may not be necessary for the formulation, because epoxy adheres to steel strongly itself; zinc phosphate, in contrast may interfere with epoxy's adhesion to steel.

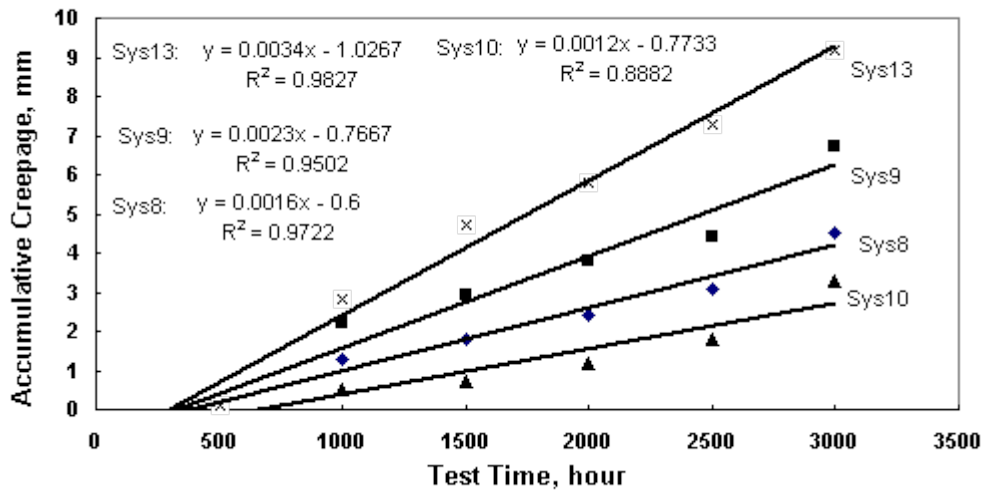
Figure 19. Plot of scribe creepage of epoxy coating systems over SP 10 surfaces versus laboratory test time after test B.

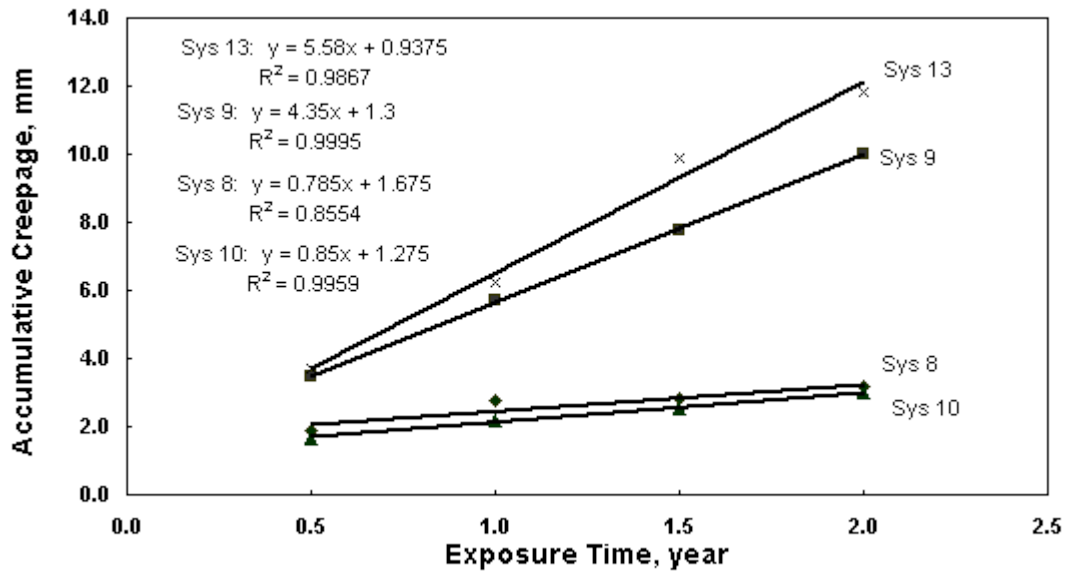
Figure 20. Plot of scribe creepage of epoxy coating systems over SP 10 surfaces versus outdoor exposure time.

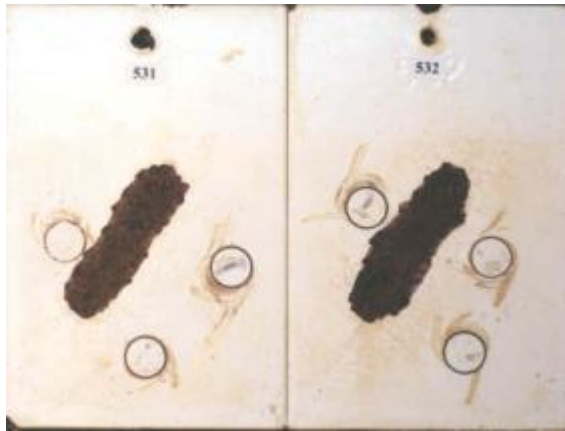
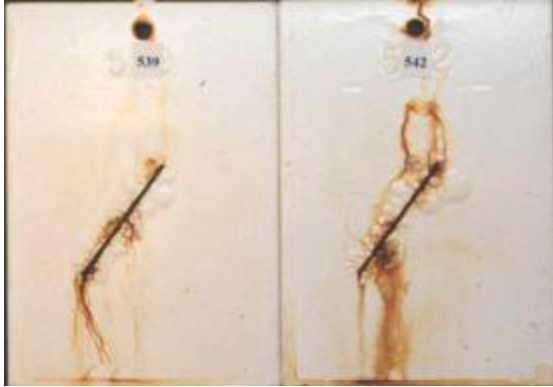
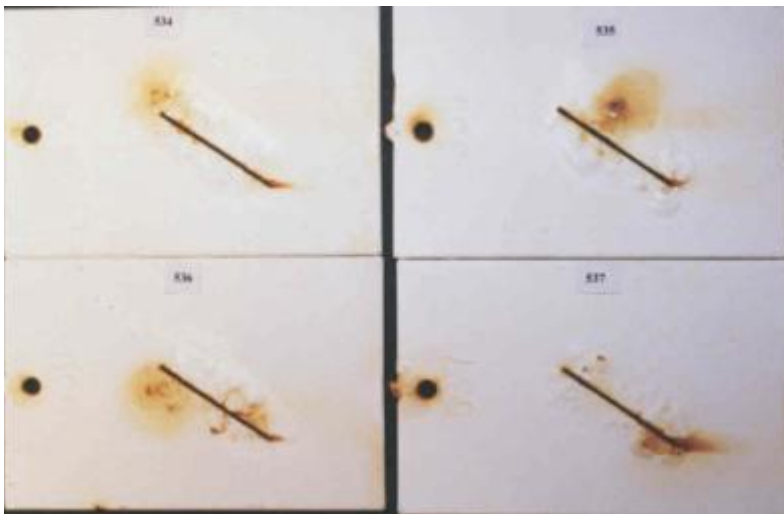
Figure 21. Coating conditions of system 13 after exposures.
a. 3,000-h test A b. 3,000-h test B c. 2-y outdoor exposure

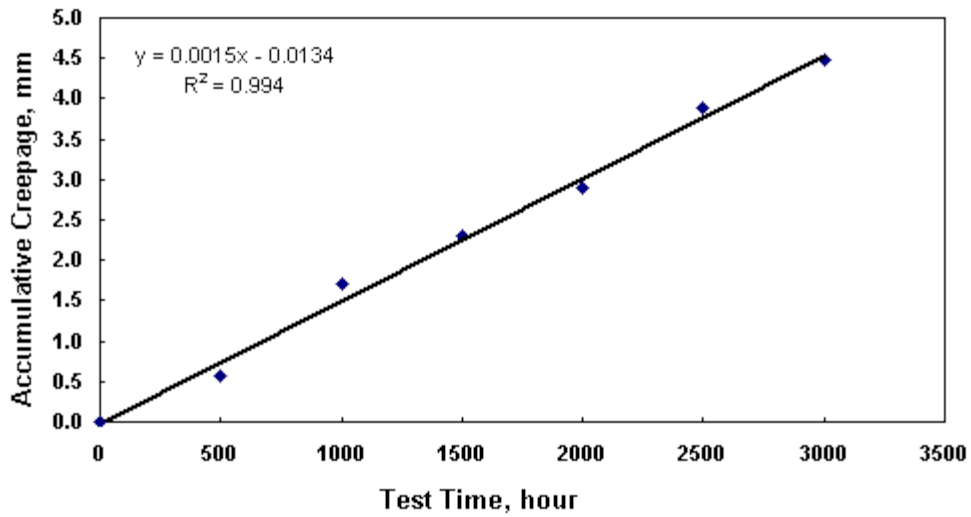
Figure 22. Plot of scribe creepage of polyurethane coating system (system 12) over SP 10 surfaces versus laboratory test time after test A.

- Waterborne polyurethane system—Only one waterborne polyurethane system was included in this study, so the test results may not be very representative for this class of coating. System 12 performed more poorly than acrylic and epoxy systems, as shown in figures 22, 23, and 24 after the tests. The scribe creepage developed on this coating system was found to be 5.6 and 7.0 mm after 3,000-h test A and 3,000-h test B respectively; the linearity of their developed scribe creepage with test time was excellent. However, the plot of scribe creepage developed by System 12 versus the outdoor exposure time did not show as good linearity as those obtained by the rest of coating systems.

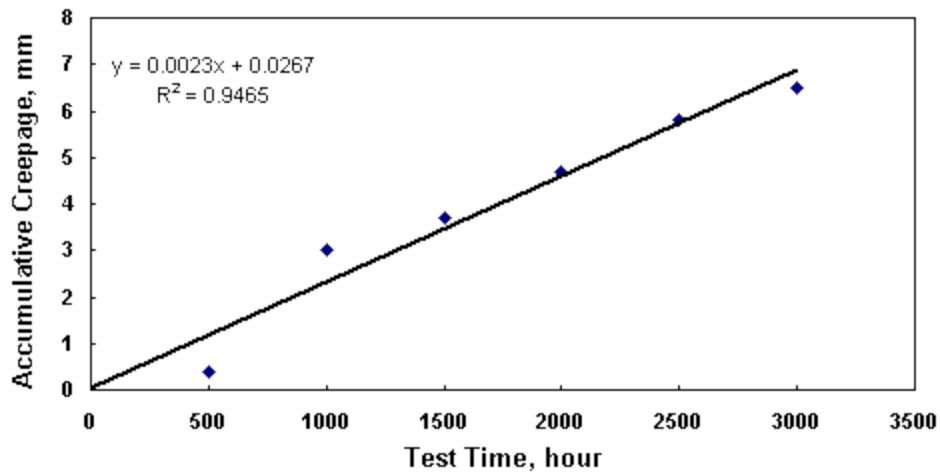
Figure 23. Plot of scribe creepage of polyurethane coating system (system 12) over SP 10 surfaces versus laboratory test time after test B.

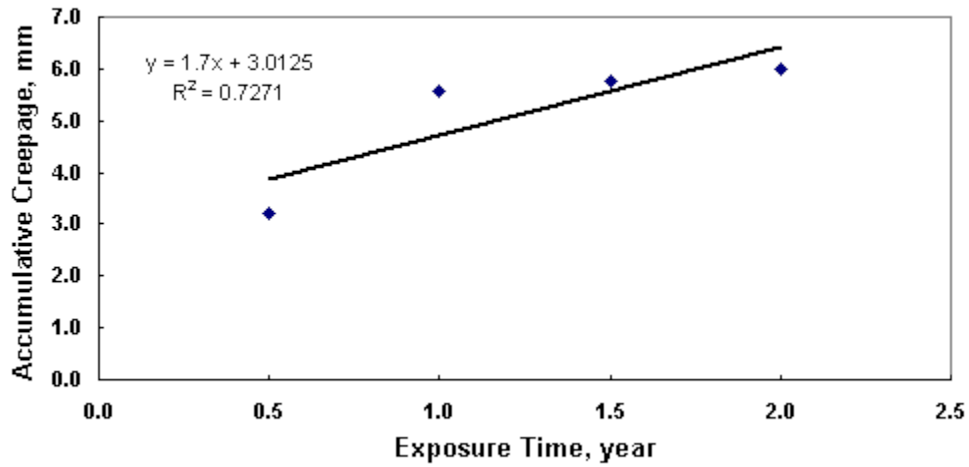
Figure 24. Plot of scribe creepage of polyurethane coating system (system 12) over SP 10 surfaces versus outdoor exposure time.

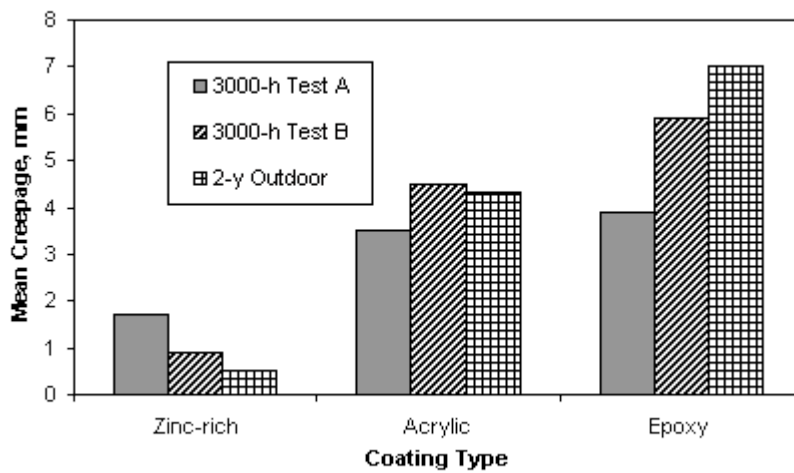
Figure 25. Comparison of mean scribe creepage developed by different coating types in three test methods.
