Automated and Connected Vehicle (AV/CV) Test Bed to Improve Transit, Bicycle, and Pedestrian Safety: Phase II Technical Report

Technical Report 0-6875-01-R1

TEXAS A&M TRANSPORTATION INSTITUTE
COLLEGE STATION, TEXAS

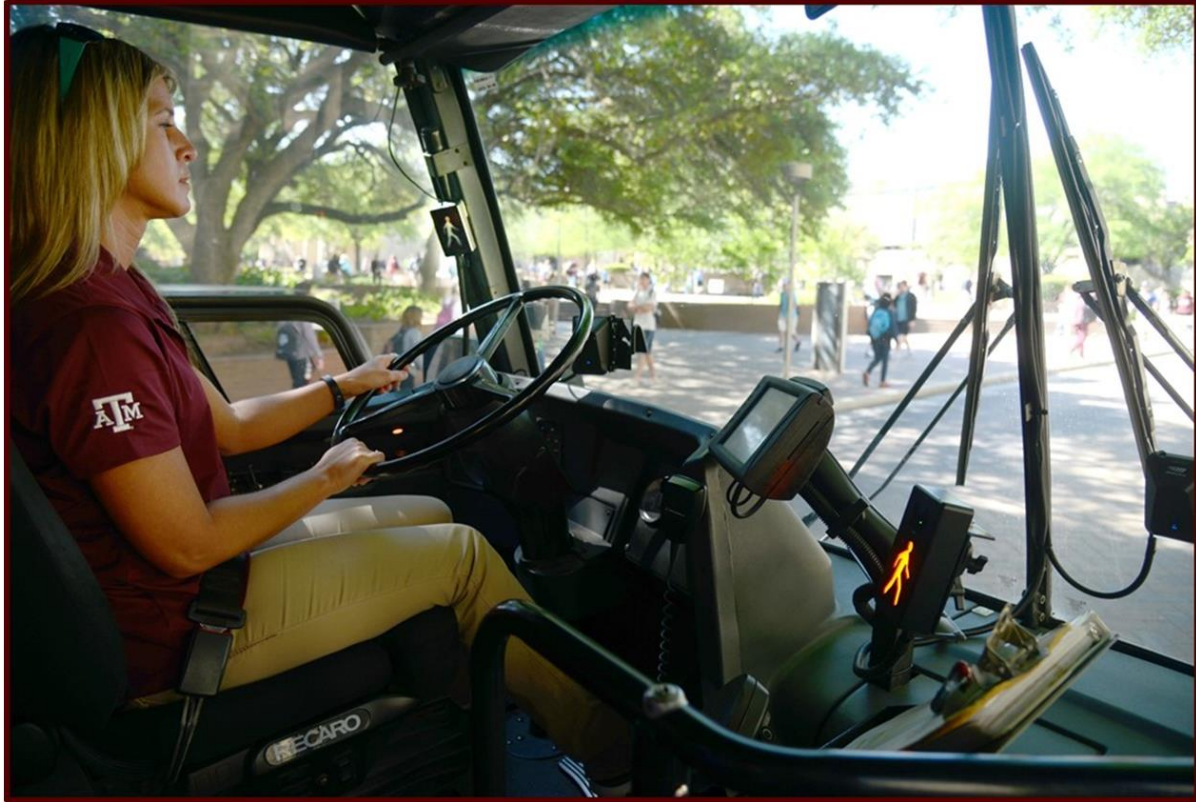
Figure 1. Rosco Mobileye Shield+™ Display on Texas A&M University Bus.

As part of Phase I, TTI partnered with TxDOT, Texas A&M University Transportation Services, and the technology firms Mobileye and Roscoe to pilot the Mobileye Shield+™ collision-warning system on one Texas A&M bus. TTI purchased the system, Texas A&M Transportation Services provided the bus, and the TxDOT project funding supported the assessment of the pilot. The Phase I final report documents the operation of the Mobileye Shield+™ and the pilot. The system continues to operate in regular service on bus 120.

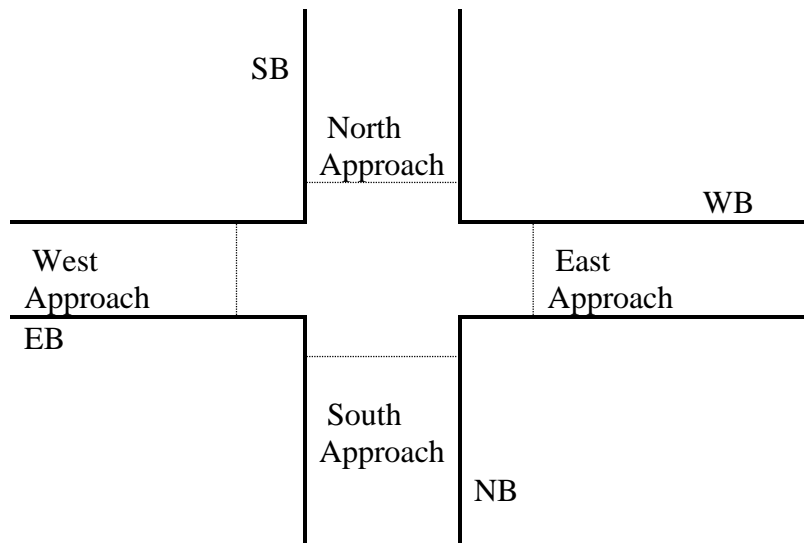
Figure 8. Smart Four-Way Intersection.

This section presents the use cases and alert scenarios for the smart intersection. Figure 8 provides an orientation to a typical four-way signalized roadway intersection used to develop the use cases. Table 1 contains the basic information on the use cases, including the bus location and action, the pedestrian location and action, and comments about the potential bus/pedestrian interaction. The situations when a pedestrian is not present are also noted. No alert of the turning bus is provided in these situations. More detailed descriptions are provided for each use case, including figures illustrating the location of the connected transit bus, the path of the bus, the location of the pedestrian, the pedestrian waiting area, and the street crossing conflict zone. The use cases noted by an asterisk (*) were included in the proof-of-concept test described in Section VI.

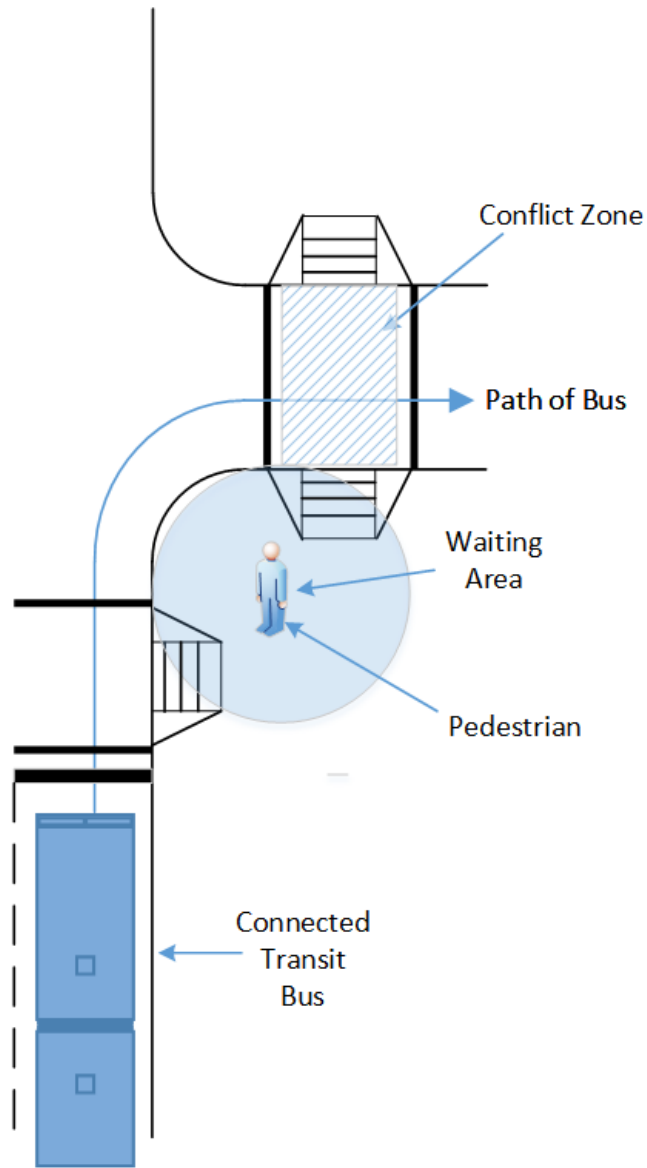
Figure 9. Use Case 1A: Right-Turning Bus with a Pedestrian in the Pedestrian Detection Zone.

This use case represents the base condition defining normal operations of the smart intersection. As illustrated in Figure 9, in this scenario, a connected bus approaches the intersection from the south, heading northbound. The bus route requires the bus to make a right turn at the intersection and travel eastbound on the cross street. The bus, equipped with a dedicated short range communication (DSRC) onboard radio unit (OBU), broadcasts Part I of the basic safety message (BSM). Part I of the BSM contains information about the position of the bus (latitude and longitude) and the speed and heading of the bus, as well as other information associated with the current route and turning movements of the bus based on data from the transit agency's automated routing and scheduling system. In addition to Part I of the BSM, the bus would also broadcast the elements containing the agency and bus identification number. This information is contained in Part II of the BSM. Since Part II is optional, the transit agency would have to configure their equipment to provide this information.

The smart intersection application will continue to broadcast the alert until either 1) the pedestrian leaves the pedestrian detection zone or 2) the bus completes its turn and the rear of the bus clears the intersection. Once the bus clears the intersection, the application deactivates the alert messaging system and returns to processing incoming BSMs to locate other potential conflicts between buses and pedestrians. As described in Use Case 1B, if the application does not detect a pedestrian in the pedestrian detection zone, the application does not activate the PAS.

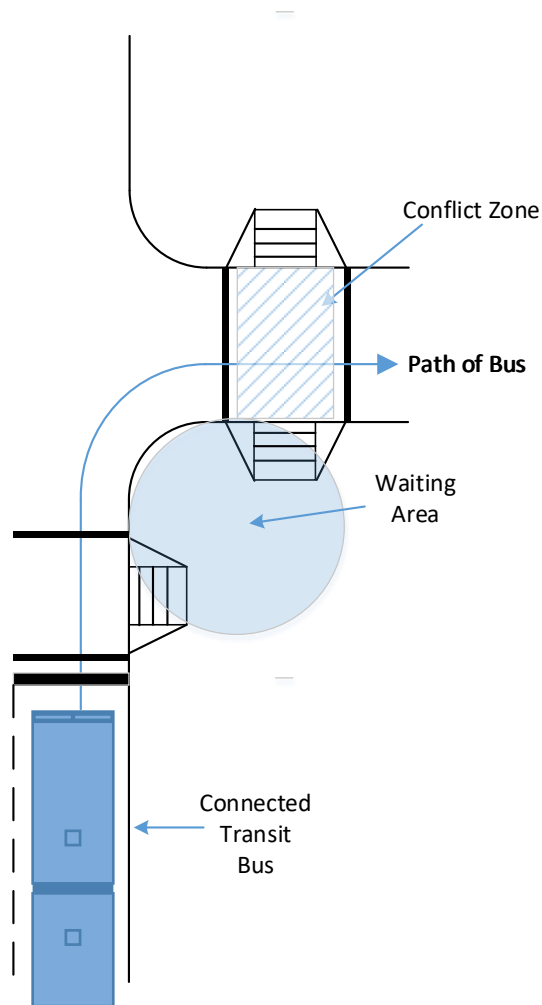
Figure 10. Use Case 1B: Right-Turning Bus with No Pedestrian in the Waiting Area or Conflict Zone.

As illustrated in Figure 10, in this variation of Use Case 1 no pedestrian is present in the waiting area or the crosswalk conflict zone. As in Use Case 1, the BSMs of all connected vehicles approaching the intersection are being monitored. When the system detects that it has received an enhanced BSM from a bus, the system compares the agency and bus information contained in the enhanced BSM message to the route and bus trip information provided by the TMC to determine if the route of the bus requires it to turn right at the intersection. If the application determines that the bus is going to turn right, the application then determines if there is a pedestrian located in the pedestrian detection zone. In this use case, no pedestrian is detected in the pedestrian zone. As a result, the PAS is not activated, and no alert is provided to the bus operator.

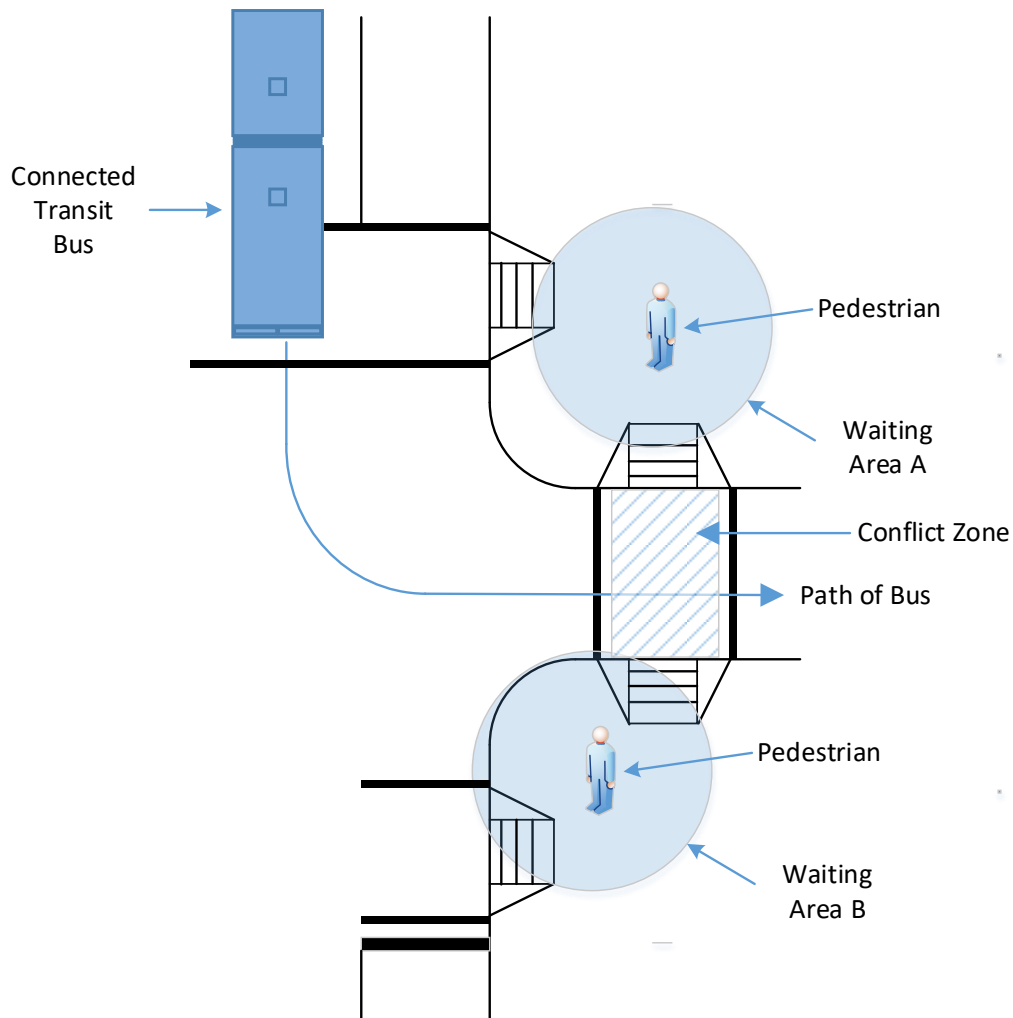
Figure 11. Use Case 2A: Left-Turning Bus with a Pedestrian Located in the Pedestrian Detection Zone on the Opposite Corner.

This use case involves a left-turning bus and a pedestrian waiting to cross the street on the opposite corner, as illustrated in Figure 11. As in the other use cases, the bus approaching the intersection would be broadcasting its enhanced BSM, which includes agency and bus identification information. The application would use this information along with the route and bus trip information received from the TMC to determine that the bus will turn left at the intersection. The detection system would alert the application that a pedestrian is located in the pedestrian detection zone. The application would issue an alert indicating that a bus is approaching the crosswalk and that pedestrians should watch for a left-turning bus. The application could also send an RSA message to the bus driver indicating to watch for pedestrians in the opposing crosswalk.

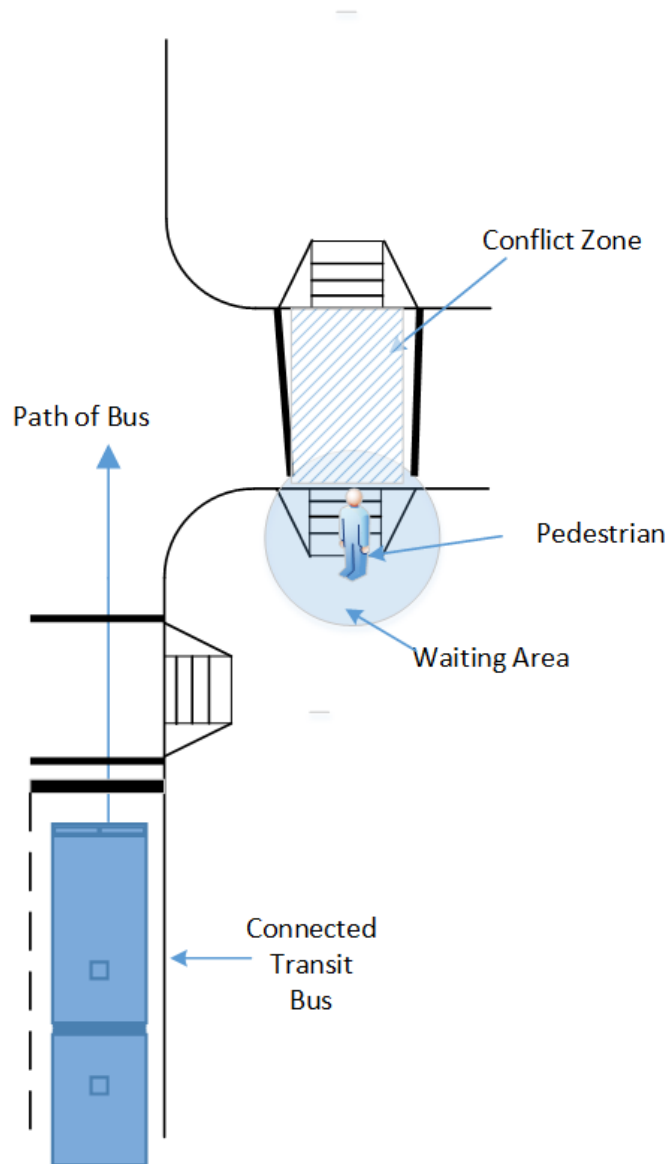
Figure 12. Use Case 3A: Through Bus with a Pedestrian Located in the Pedestrian Detection Zone.

This use case is similar to Use Case 1A except that instead of turning right, the route of the bus is straight through the intersection. Figure 12 illustrates this use case. As the bus approaches the intersection, the application, using the enhanced BSM from the bus, compares the agency and vehicle ID of the bus to the route and bus trip information uploaded by the TMC and determines that the route of the approaching bus does not require it to make a right turn at the intersection. As the bus is not expected to turn right at the intersection, the application would not activate the pedestrian alert system when a pedestrian is located in the pedestrian detection zone.

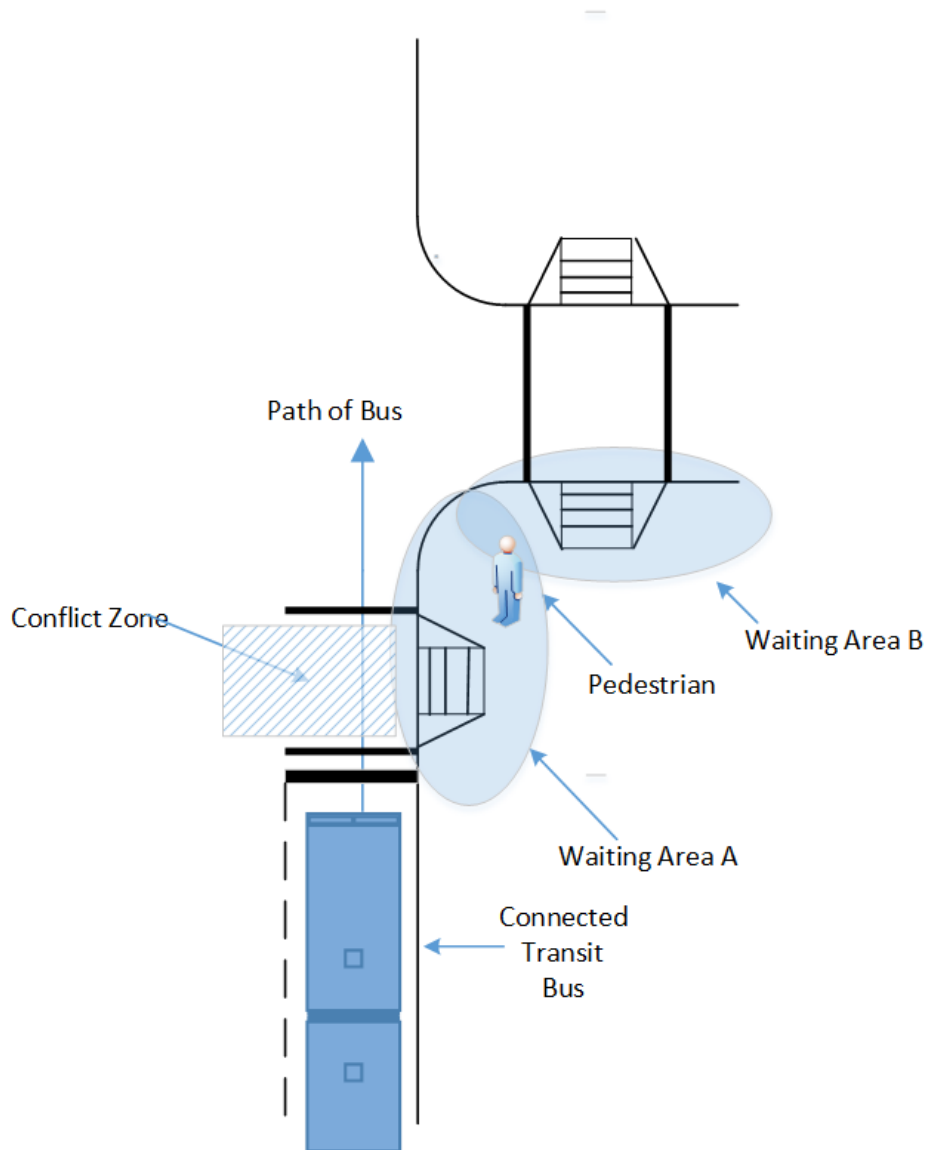
Figure 13. Use Case 3B: Through Bus with Two Pedestrian Detection Zones.

An alternative to Use Case 3A is overlapping pedestrian detection zones — one on each leg of the intersection. Figure 13 illustrates this use case. The pedestrian detection system would be configured to determine whether the pedestrian is located in Pedestrian Detection Zone A, facing the path of the through bus, or Pedestrian Detection Zone B. If the pedestrian is located in Pedestrian Detection Zone A, an alert would be issued. If the pedestrian is located in Pedestrian Detection Zone B, no alert would be issued.

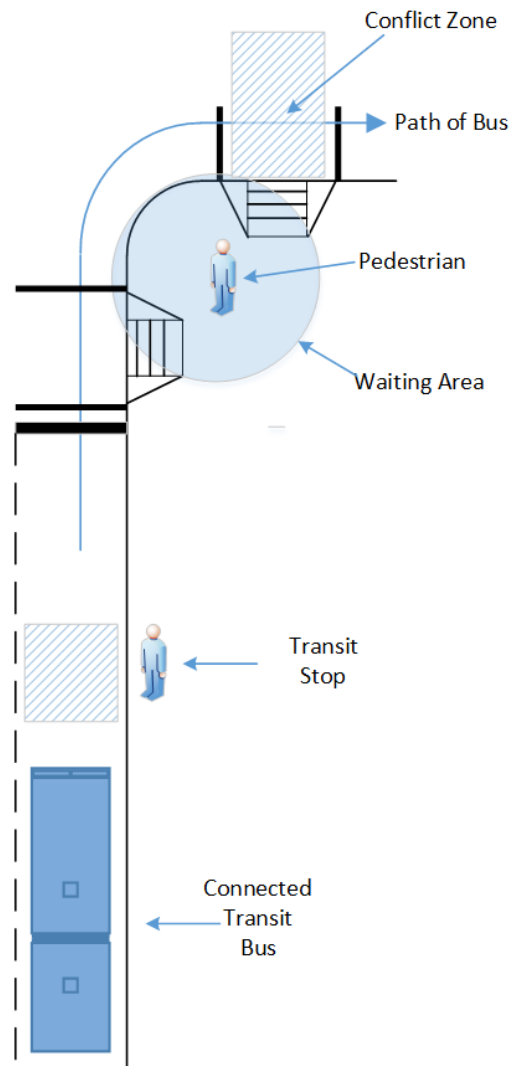
Figure 14. Use Case 4A: Turning Bus Stopping at a Nearside Bus Stop before Initiating Turn.

As illustrated in Figure 14, in this use case, a connected bus approaching an intersection stops at a nearside bus stop before reaching the intersection. The system detects that it has received an enhanced BSM from the bus and compares it to the route and bus trip information uploaded by the TMC; the system then determines that the bus will be turning right at the intersection but that there is a nearside bus stop. In this use case, no alert message would be triggered as the bus approaches the bus stop. Once the bus completes discharging and/or loading passengers at the bus stop and begins moving forward, the application detects that the bus is no longer stopped at the bus stop but is now approaching the intersection to begin its turn. The application would then use information from the pedestrian detection system to determine whether a pedestrian is located within the pedestrian detection zone. The appropriate alerts would be issued to the pedestrian and the bus operator if a pedestrian was detected in the zone.

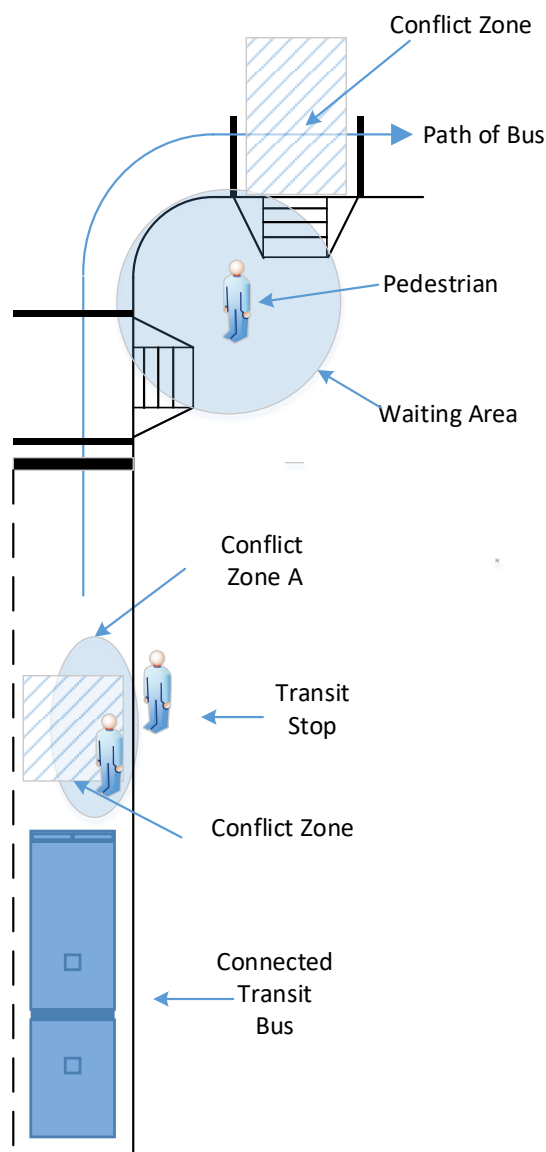
Figure 15. Use Case 4B: Turning Bus Stopping at a Nearside Stop with Two Pedestrian Detection Zones.

Figure 15 presents an alternative to Use Case 4A. Two distinct pedestrian detection zones are established in this use case — one covering the intersection and one covering the bus stop. In this use case, separate alerts would be issued for pedestrians located in each detection zone. As the bus approaches the bus stop, the system would alert pedestrians near that bus stop that a bus is approaching. The pedestrian detection zone could be designed only to cover the pedestrian located in the street or very near the edge of the roadway. This alert would continue until the doors of the bus opened. Once the doors of the bus are closed and the bus moved up to the intersection, a separate alert would be issued for pedestrians located in the detection zone near the intersection.

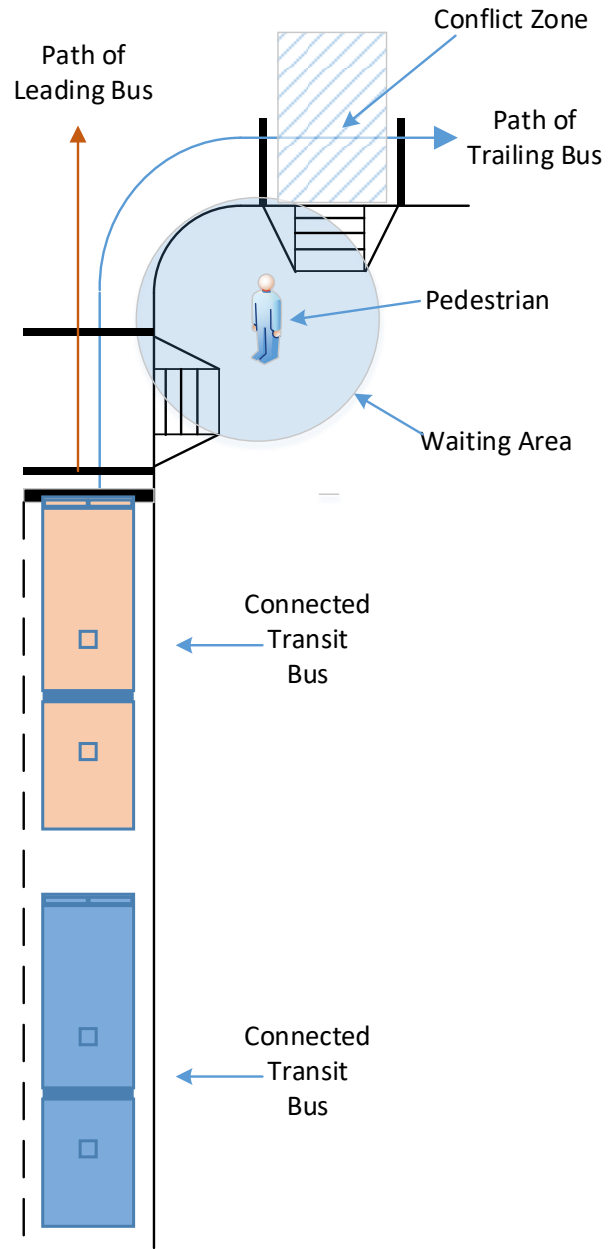
Figure 16. Use Case 5A: Two Buses Approaching the Intersection in the Same Direction.

In this use case, two buses are approaching the intersection in the same direction. The route for one of the buses is traveling straight through the intersection, while the route of the other bus is turning right at the intersection. These buses may or may not stop at the nearside bus stop. Using the enhanced BSM information from each bus, the application would determine the maneuver for each bus and issue the appropriate alert at the appropriate time if a pedestrian is located in the detection zone. No alert would be provided for the through bus, while an alert for the right-turning bus would be provided if a pedestrian is detected in the intersection detection zone. Figure 16 illustrates this use case. The leading bus is traveling straight through the intersection while the trailing bus is turning right at the intersection. The application would wait to issue the alert for the right-turning bus until the through bus has entered the intersection. The application would issue an alert if a pedestrian is in the detection zone when the trailing bus reaches the intersection.

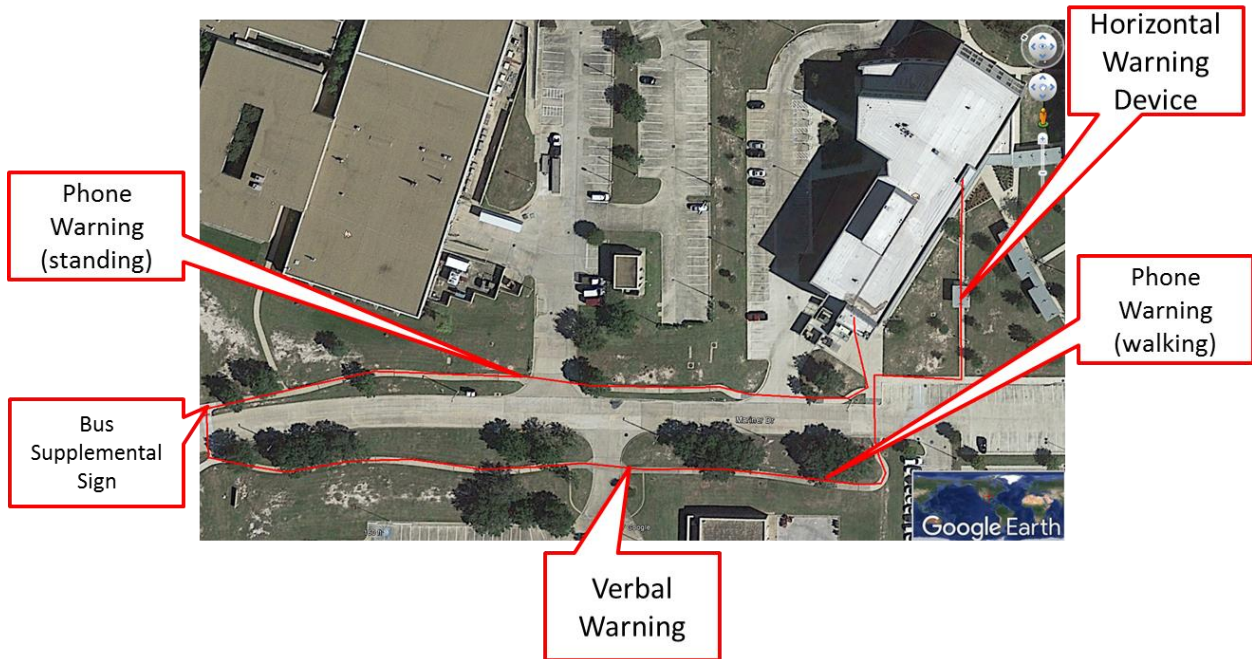
Figure 17. Preliminary Pilot Test Course and Location of Pedestrian Alert Devices.

As illustrated in Figure 17, the preliminary pilot test involved test subjects encountering alerts from different devices while walking with a TTI researcher on a short course of sidewalks adjacent to the TTI State Headquarters and Research Building (SHRB) on the Texas A&M University West Campus in College Station. The four devices used to provide alerts to the test subjects included a warning sign projected on the sidewalk, a ringing smartphone, an audible warning, and a supplemental bus warning sign on a traffic signal. These warning devices were selected to mimic the technologies anticipated to be developed and used in the proof-of-concept pilot at the RELLIS Campus.

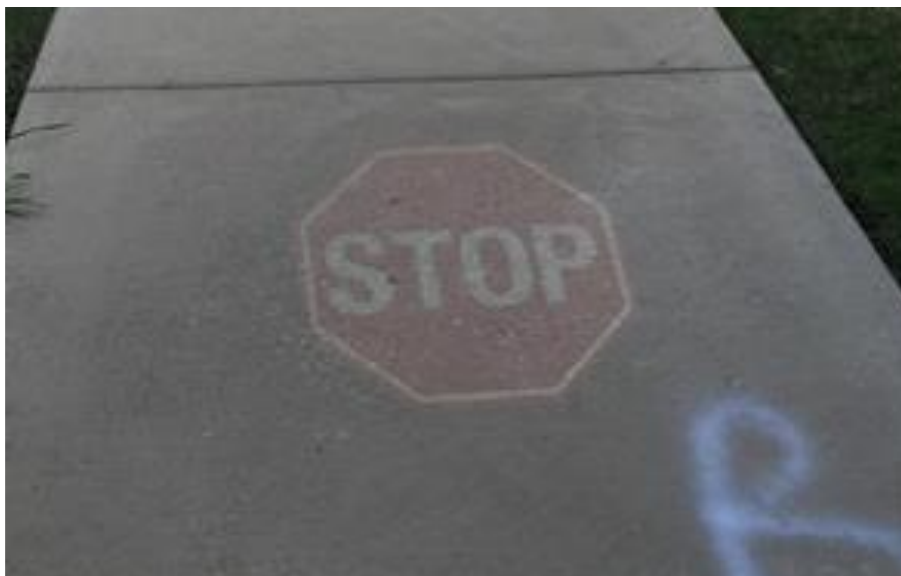
Figure 18. Projected Warning Sign.

A projected warning sign on the sidewalk was the first alert encountered by the pilot test subjects. A Gobo projector was used to display a stop sign on the sidewalk. Figure 18 illustrates the projected stop sign, which was placed in a shaded area to ensure its visibility.

In general, test subjects graded the projected warning sign and the supplemental bus warning sign as the more effective devices. Test subjects were asked to grade the supplemental bus warning sign given ideal conditions (i.e., visible message). The effectiveness of the projected warning sign and the smartphone app was graded lower by test subjects.

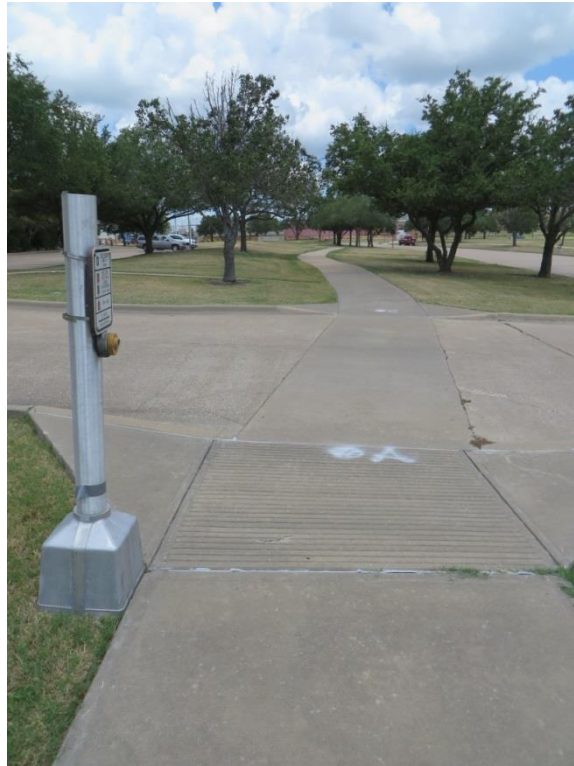
Figure 19. Audible Warning Message Set-Up.

As illustrated in Figure 19, a push button and a traffic pole were installed along the course sidewalk. A Bluetooth speaker on the top of the traffic pole projected the message “bus turning” when the test subject pushed the button. The verbal message was activated by TTI researchers when the test subject pushed the button. Located at a driveway along the walking route, the audible warning was the third device encountered by test subjects.

Possible concerns limiting the effectiveness of the audible warning suggested by test subjects were that people wearing headphones might not hear the warning and that traffic noise may block out the warning. The major potential concern with the effectiveness of the supplemental bus warning sign was that pedestrians might not look up to see the sign above the pedestrian signal. One test subject suggested placing the supplemental bus warning sign to the left of the pedestrian walk signal.

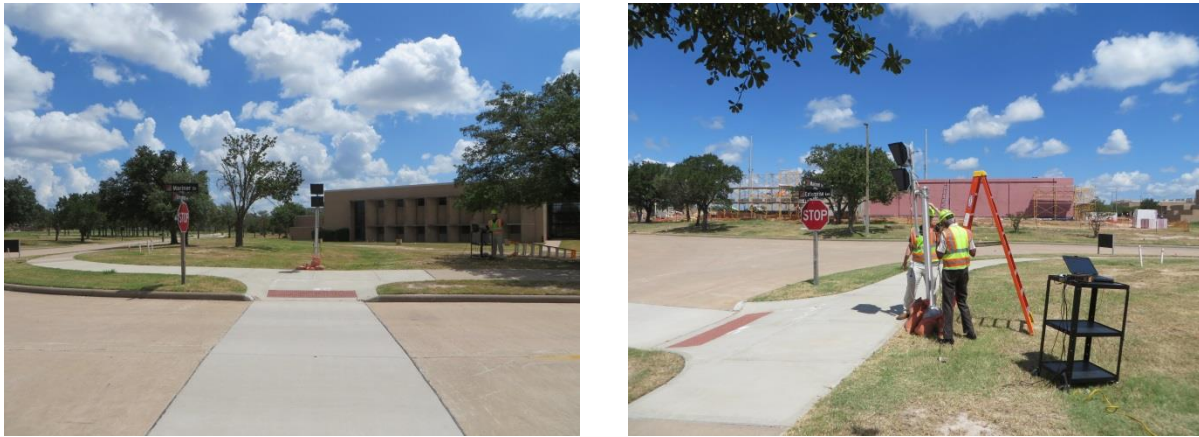
(a) (b)
Figure 20. Supplemental Bus Warning Sign.

Once the sign was installed outdoors, however, this message was difficult to read due to sunlight. To make the sign more visible, the message was changed to display the word BUS in yellow letters, with the background alternating between black and yellow in order to simulate a flashing pattern. Two TTI researchers assisted with this alert device. One researcher operated the signal, and one researcher monitored traffic to be sure it was safe for the test subject to cross the street. The sign turned out to be difficult for test subjects to see due to sun glare during the preliminary pilot.

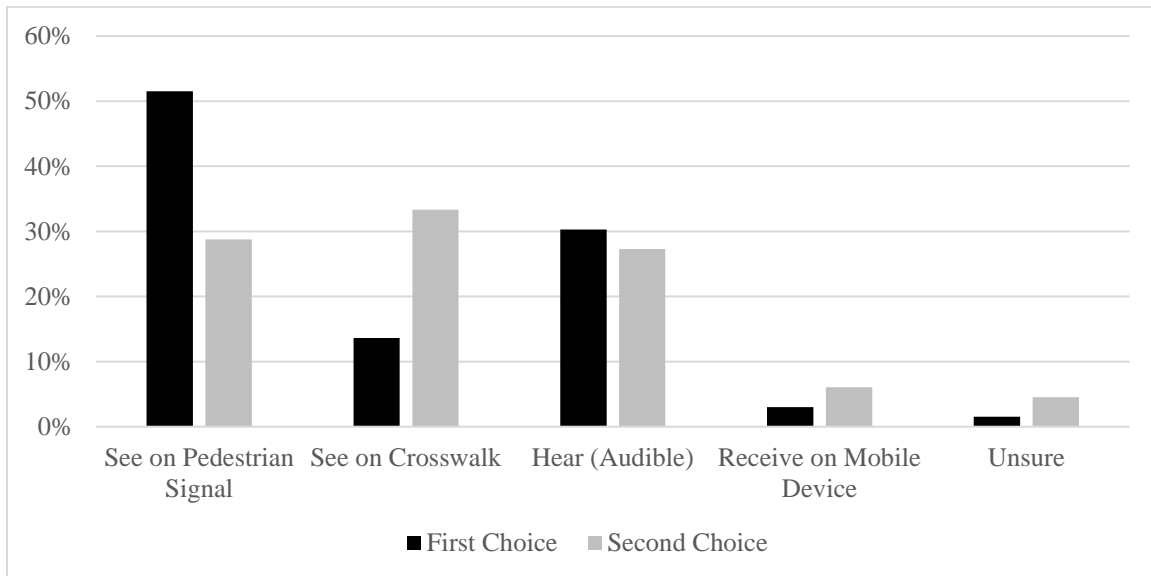
Figure 24. Survey Participants’ First and Second Choices for Warning Format.

When asked for a second choice of warning format, 22 participants (33 percent) selected “see the warning on the crosswalk,” 19 participants (29 percent) selected “see the warning on or near the pedestrian signal,” 18 participants (27 percent) selected “hear the warning message,” and four (6 percent) selected “receive the warning on a mobile device.” Three participants were not sure which warning format was their second choice. Figure 24 presents participants’ first and second choices.

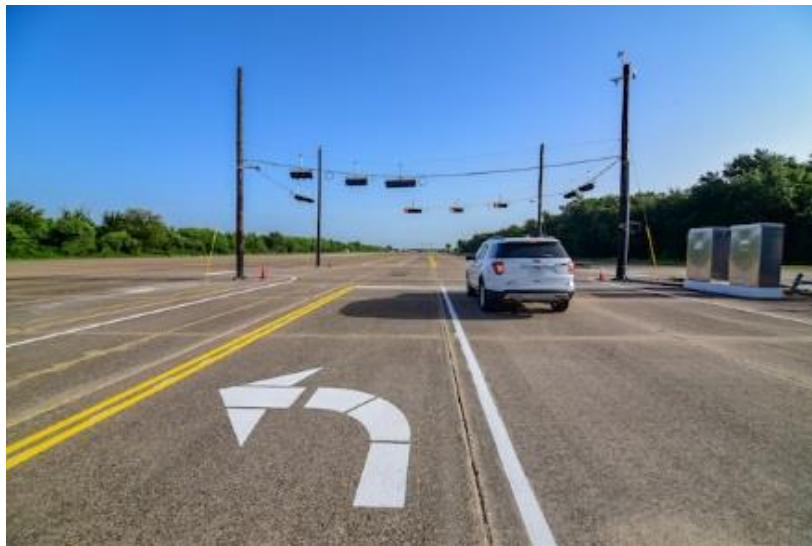
As illustrated in Figure 26, the traffic signal is a four-legged high speed intersection using span wire across four wooden poles. These poles are 32 feet in height and can accommodate multiple detection and communication equipment for testing. Currently the intersection has protected-permitted operations in the north-south direction using flashing yellow arrows and permitted operations in the east-west direction. The intersection is equipped with an Econolite Cobalt Controller in an Econolite TS-2 Cabinet. A second interconnected cabinet beside the signal controller cabinet contains additional research equipment.

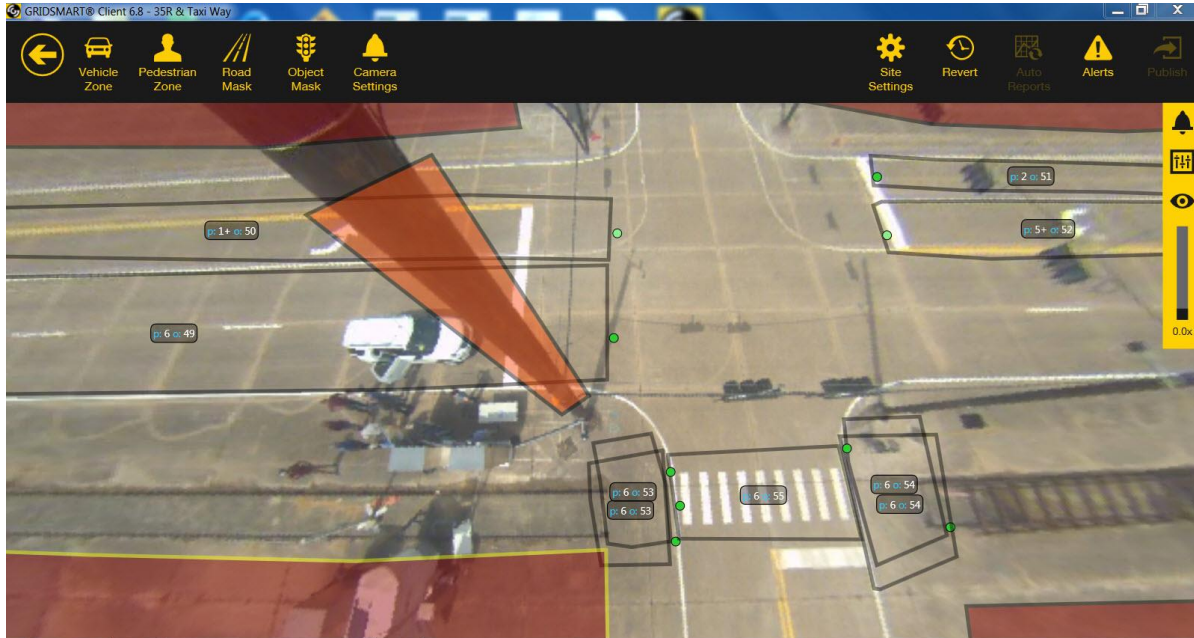
camera, and vision-based tracking algorithms to detect various pedestrians and vehicles at an intersection. Figure 27 illustrates the GRIDSMART vision-based tracking feature. A Savari DSRC Roadside Unit is also installed to support research in connected infrastructure. The intersection also has a painted crosswalk and Polara Accessible Pedestrian System (APS) on both ends of the cross walk. The entire intersection is powered by a 3000 watt Honda generator.

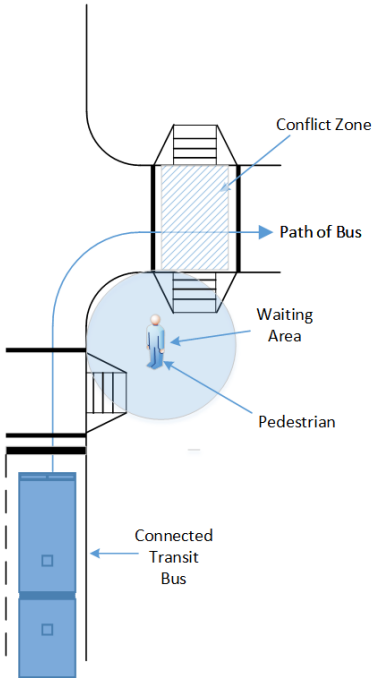
Test Case No. and Title	Use Case 1A: Right-Turning Connected Bus with a Pedestrian Present in the Pedestrian Detection Zone.	
Verification Phase	II — Field Test Verification	
Test Objectives	<ul style="list-style-type: none"> • To test the basic functionality of the CV-TPAS system — that CV-TPAS provided alerts to a pedestrian waiting in the pedestrian detection zone when an approaching bus was turning right at the intersection. • To verify that the system provided alerts via visual, audible, and smartphone to pedestrians located at the intersection. • To verify that the system returned to standby state after the event is over. 	
Requirements Verified	1.1, 1.2, 1.3,1.4, 1.5, 1.7,1.8, 1.9, 2.1, 2.2, 2.3, 2.4, 2.6, 2.7, 3.1, 3.3, 3.6, 4.1, 4.2, 4.6, 5.1, 5.2, 6.1, 6.2, 6.4, 7.1, 7.2, 7.4, 7.5	
Brief Description	<p>This test represents the base operational scenario. In this scenario, a connected bus (CB) approached the intersection from the south heading northbound. The route of the bus required the bus to make a right turn at the intersection and travel eastbound on the cross street. When the bus was within range of the RSU, the following occurred:</p> <ul style="list-style-type: none"> • The bus transmitted its BSM to the CV-TPAS system at the intersection. • The system determined if the route of the bus required it to turn right. • The system detected that a pedestrian was located in the pedestrian detection zone. • As the bus executed a right turn at the intersection, the system performed the following: <ul style="list-style-type: none"> ○ Activated an audible alert to the pedestrian in the pedestrian detection zone; ○ Activated the pedestrian warning device located at the crosswalk; and ○ Activated the smartphone app. • As the rear of the bus passed through the crosswalk, the system performed the following: <ul style="list-style-type: none"> ○ Deactivated the audible alert to the pedestrian in the pedestrian detection zone; ○ Deactivated the pedestrian warning device located at the crosswalk; and ○ Deactivated the smartphone app. • The system returned to the standby mode.

<p>The diagram illustrates the test scenario at an intersection. A 'Connected Transit Bus' is shown in the bottom lane, moving northbound. It is turning right onto an eastbound cross street. The bus's path is indicated by a blue arrow labeled 'Path of Bus'. A 'Conflict Zone' is shown as a shaded area where the bus's path intersects with the pedestrian's path. A 'Pedestrian' is shown in a 'Waiting Area' on the crosswalk, within a circular 'Pedestrian Detection Zone'. A blue line represents the communication link between the bus and the CV-TPAS system.</p>

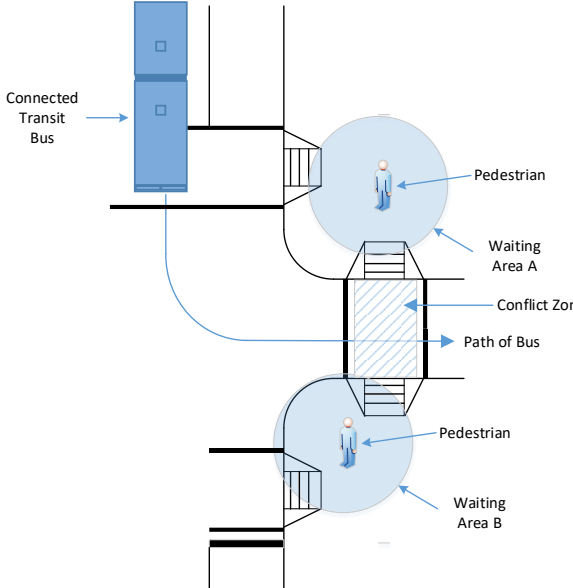
Test Case No. and Title	Use Case 2A: Left-Turning Bus with Pedestrian Located in the Pedestrian Detection Zone (Opposite Corner).	
Verification Phase	II — Field Test Verification	
Test Objectives	<ul style="list-style-type: none"> • To test the basic functionality of the system — that the system provided an alert to a pedestrian in the pedestrian detection zone that a left-turning bus was approaching the intersection. • To verify that the system provided alerts via visual and audible warnings and smartphone app to a pedestrian located at the intersection. • To verify that the system returned to standby state after the event is over. 	
Requirements Verified	1.1, 1.2, 1.3, 1.4, 1.5, 1.7, 1.8, 1.9, 2.1, 2.2, 2.3, 2.4, 2.6, 2.7, 3.1, 3.3, 3.6, 4.1, 4.2, 4.6, 5.1, 5.2, 6.1, 6.2, 6.4, 7.1, 7.2, 7.4, 7.5	
Brief Description	<p>In this scenario, a vehicle approached the intersection from the north heading southbound. The route of the vehicle required it to make a left turn at the intersection and travel eastbound on the cross street. When the vehicle was within range of the RSU, the following occurred:</p> <ul style="list-style-type: none"> • The bus transmitted its BSM to the system at the intersection. • The system determined if the route of the bus requires it to turn left. • The system detected that a pedestrian was located in the pedestrian detection zone. • As the vehicle executed a left turn at the intersection, the system performed the following: <ul style="list-style-type: none"> ○ Activated an audible alert to the pedestrian in the detection zone; ○ Activated the supplemental bus sign located at the crosswalk; and ○ Activated the smartphone app. • As the rear of the bus passed through the crosswalk, the system performed the following: <ul style="list-style-type: none"> ○ Deactivated an audible alert to the pedestrian in the pedestrian detection zone; ○ Deactivated the supplemental bus sign located at the crosswalk; and ○ Deactivated the smartphone app. • The system then returned to the standby mode.

<p>The diagram illustrates the test scenario at an intersection. A 'Connected Transit Bus' is shown on the northbound approach, turning left onto the eastbound cross street. The bus's path is indicated by a blue arrow labeled 'Path of Bus'. Two circular 'Pedestrian Detection Zones' are shown at the opposite corners of the intersection, labeled 'Waiting Area A' and 'Waiting Area B'. Each zone contains a pedestrian icon. A 'Conflict Zone' is marked with a hatched rectangle at the intersection. A blue line connects the bus to the detection zones, representing the system's communication. The bus is shown in the process of turning, with its rear end passing through the crosswalk.</p>
