# Evaluation of the Virginia Department of Transportation's Current Practices for Tracking Storm Drain Cleaning Operations to Support Pollutant Removal Crediting

**Final Report VTRC 21-R25**

**EVALUATION OF THE VIRGINIA DEPARTMENT OF TRANSPORTATION'S  
CURRENT PRACTICES FOR TRACKING STORM DRAIN CLEANING  
OPERATIONS TO SUPPORT POLLUTANT REMOVAL CREDITING**

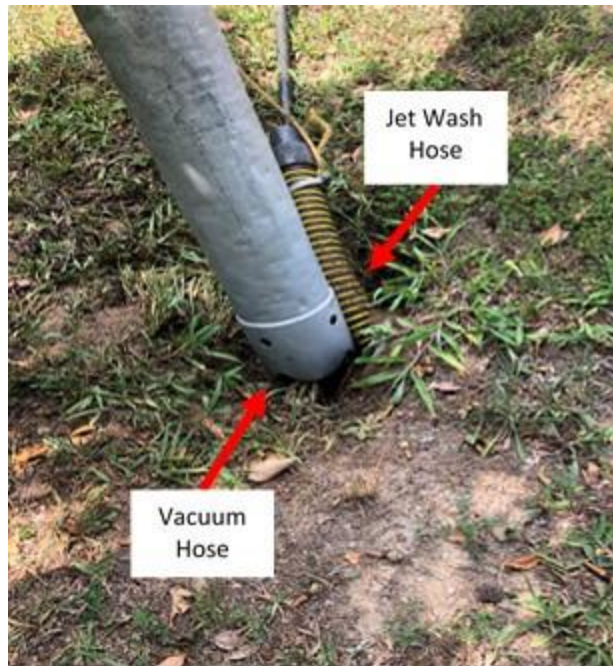
**Figure 4. Clean-out of the Driveway Pipe Shown in Figure 3. Here the jet wash hose is used to loosen and flush out material although the vacuum hose collects it.**

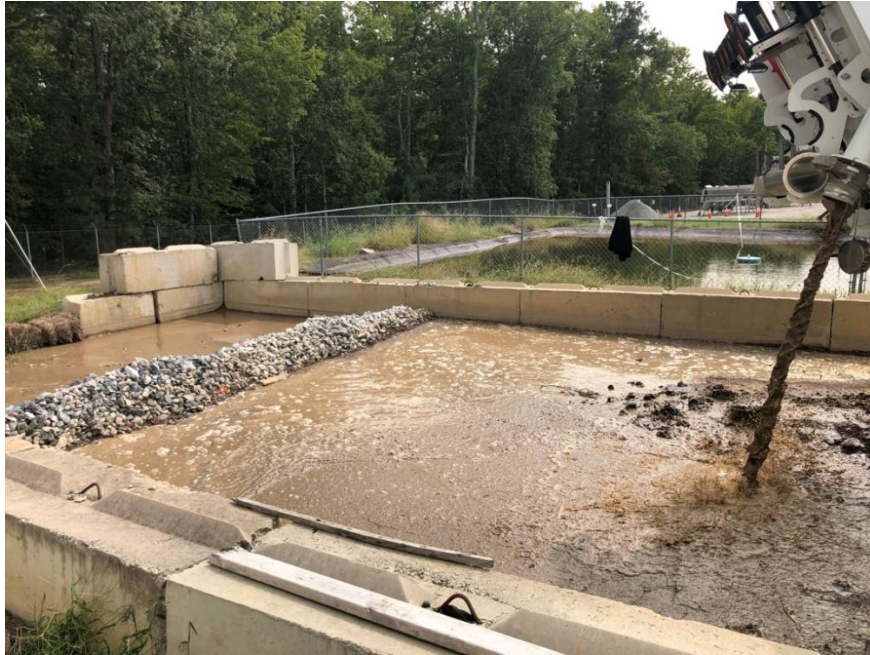
**Figure 5. A Typical Dewatering Pad Used to Drain Material Collected During Storm Drain and Pipe Clean-Outs**

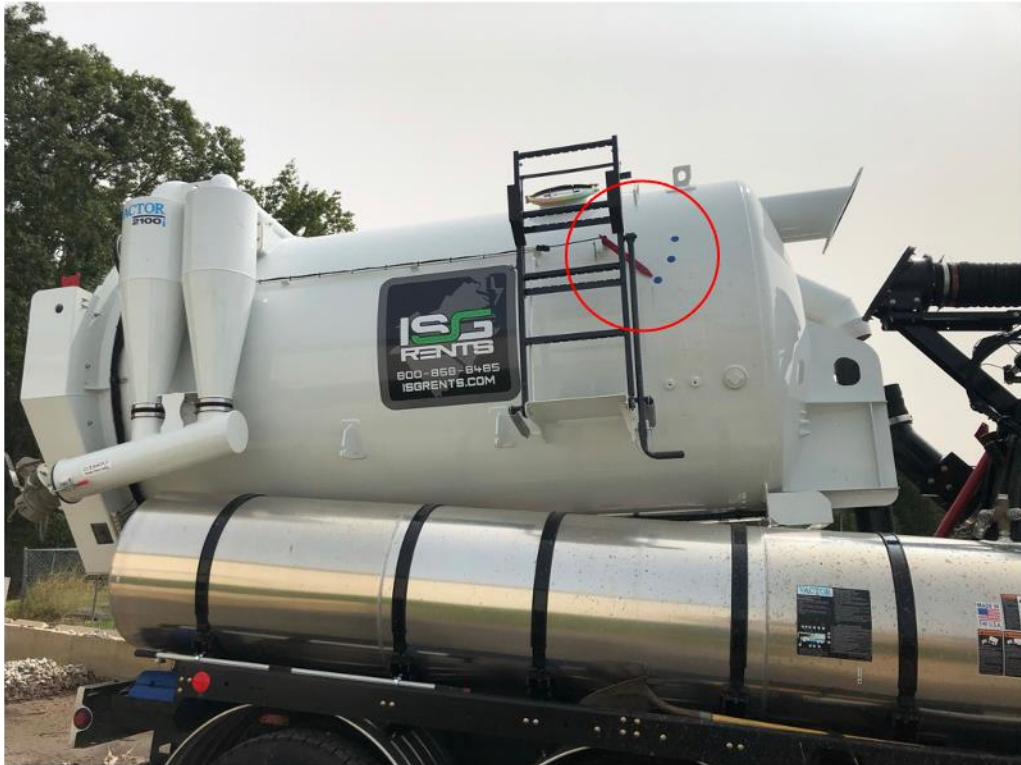
**Figure 8. Side View of a Typical Vacuum Truck With Available Capacity Indicator Circled in Red**

Although vac trucks commonly have a system of monitoring the available capacity remaining in the collection tank, this system is rudimentary at best. As can be seen in Figure 8, this gauge provides only an indication of whether the collection tank is full, one-half full, or empty. This does not make using the gauge to track the amount of material removed per storm drain or pipe a viable option, even when accounting for the added water.
