DOT/FAA/AM-09/23
Office of Aerospace Medicine
Washington, DC 20591

Evaluation of the Effects of Hydrogen Peroxide on Common Aviation Structural Materials

December 2009

Final Report

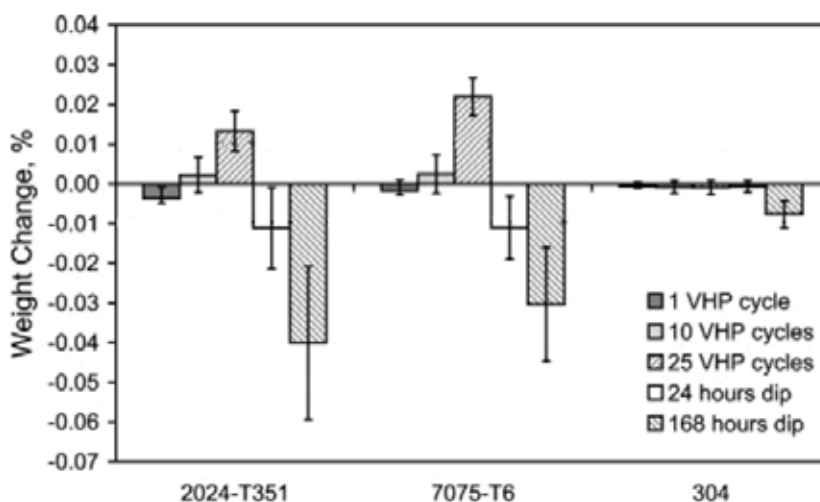
Figure 1. Metallic sample weight changes due to VHP and dip exposures. Error bars represent ± 1 standard deviation. (7)

No discernable differences were seen on the surfaces of the metallic samples after exposure to hydrogen peroxide (vapor or dip exposures). Specimens of 2024-T351, 7075-T6 and 304 stainless steel were weighed before and after hydrogen peroxide exposure, and the net weight change data are shown in Figure 1 (7). As seen in Figure 1, no statistically significant weight changes were observed for the stainless steel samples under any exposure condition. Both aluminum alloys exhibited a slight, but measurable weight gain after 25 VHP cycles (0.01-0.02%) suggesting a modest amount of superficial oxidation. Some weight loss (0.03-0.04%) was seen for the aluminum alloys after dip exposure to the 35% hydrogen peroxide liquid. Gale et al. (7) note that although the overall surface composition of the samples was not modified by the liquid hydrogen

1. Measurable, albeit small, weight losses were seen with 2024-T351, 7075-T6, and 304 stainless steel samples after 168 hr exposures to 35% liquid hydrogen peroxide solutions; 25 cycles of 4.8-hr exposures to 450 ppm vapor phase hydrogen peroxide perhaps caused slight oxidation of the 2024-T351 and 7075-T6 samples.

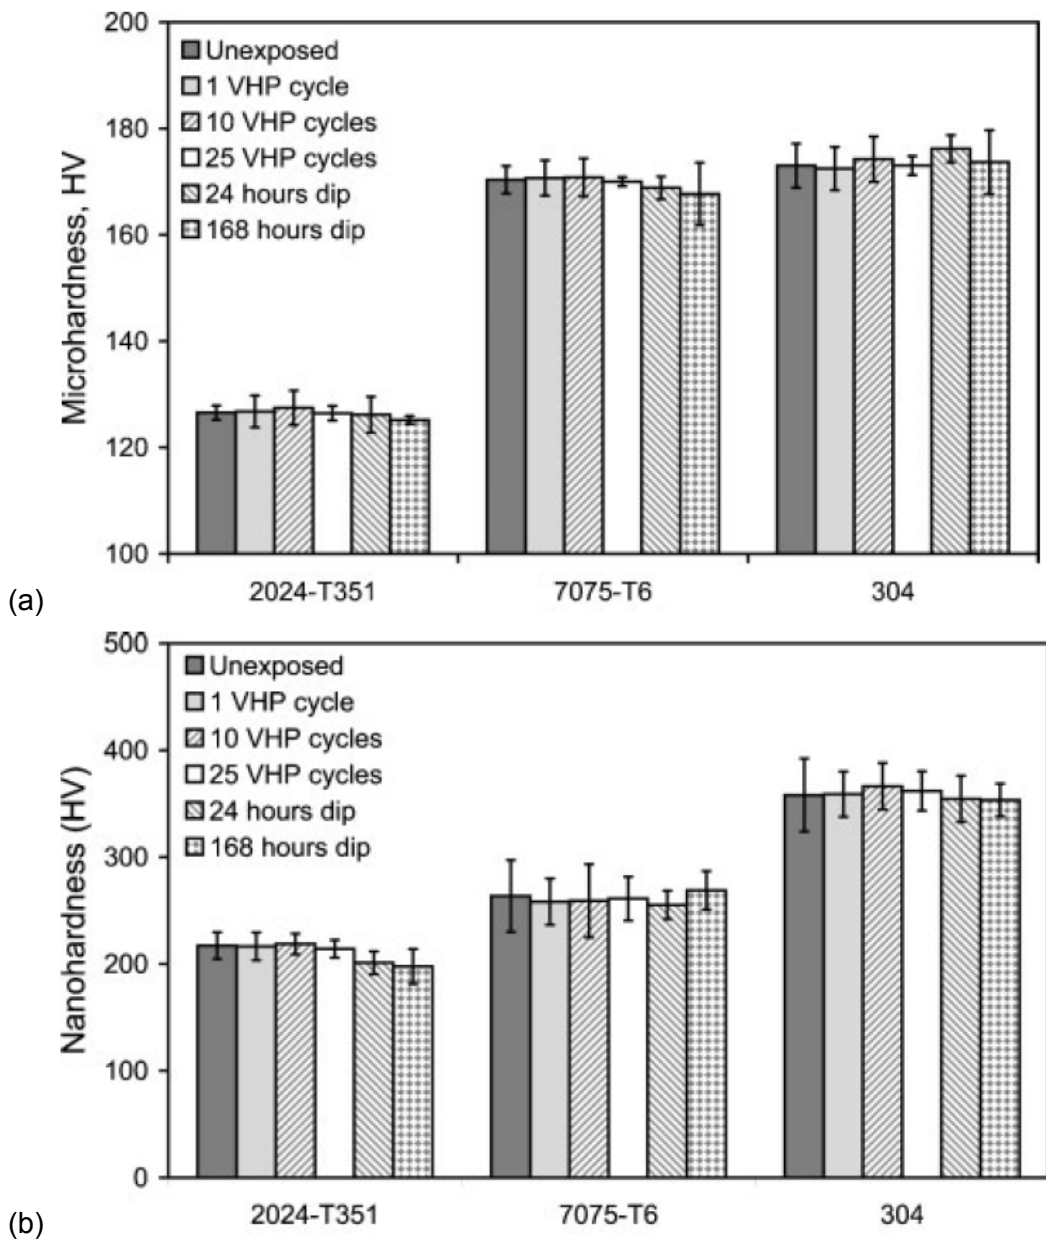
Figure 2. (a) Sample microhardness changes due to VHP and dip exposures.
 (b) Sample nanohardness changes due to VHP and dip exposures.
 Error bars represent ± 1 standard deviation. (7)

Surface hardness data are shown in Figures 2a and 2b. No changes in surface hardness using the Vickers measurement (Figure 2a) or the nanoindenter (Figure 2b) were seen for any of the alloys or hydrogen peroxide exposure conditions except for some slight but statistically significant softening observed in the nanohardness data of the 2024-T351 dip-tested samples.

2. The surface hardnesses of samples of 2024-T351, 7075-T6, and 304 stainless steel were unaffected by the various exposures to vapor phase and 35% liquid phase hydrogen peroxide.

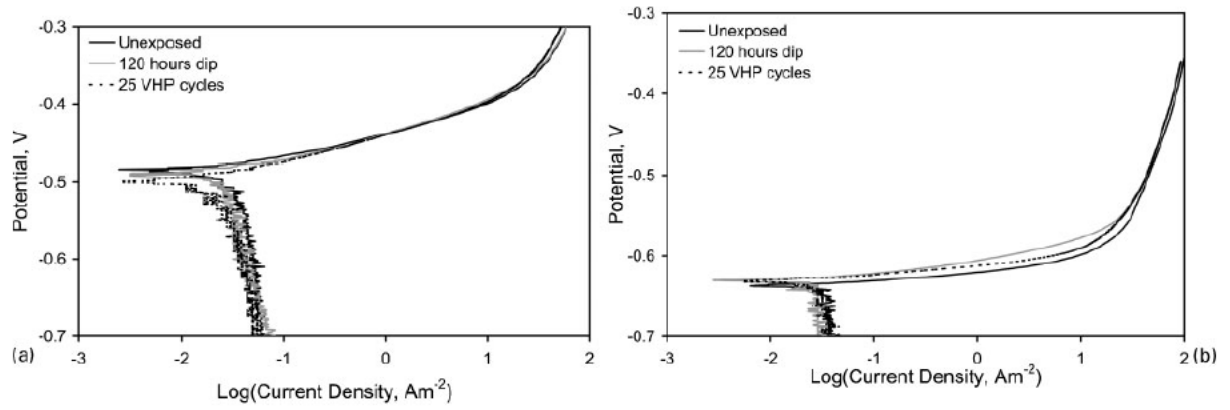
Figure 3. Cyclic voltammetry in 0.1M NaCl solution and Ag-AgCl reference electrode.

(a) 2024-T351, (b) 7075-T6. (7)

Cyclic voltammetry corrosion results are shown in Figure 3 for the 2024-T351 and the 7075-T6 aluminum samples. The potential of -0.5V exhibited by the 2024-T351 aluminum alloy agreed with literature data for samples tested under the same conditions but without prior exposure to hydrogen peroxide.(8) The shapes of the curves shown in Figure 3 were not significantly influenced by any of the hydrogen peroxide exposures, and the corrosion behavior of the alloys appears to have been unaffected by any of the hydrogen peroxide exposures.

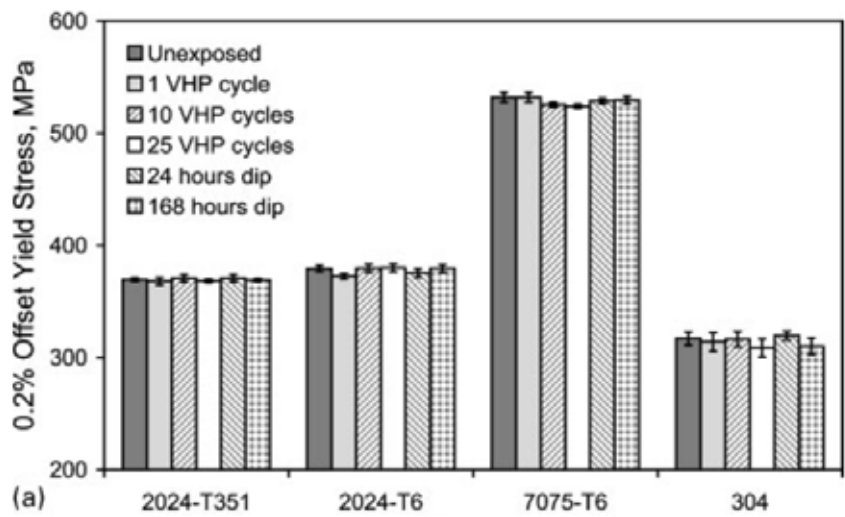
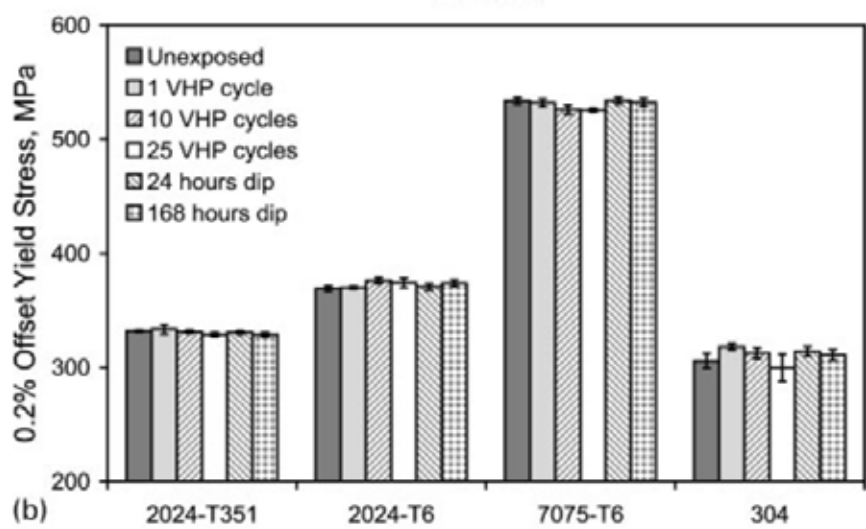
Figure 4. Effect of hydrogen peroxide exposure on the 0.2% offset yield strength of the alloys indicated.

Sample orientation: (a) longitudinal (b) transverse

Figures 4, 5, and 6 show the tensile data of the various metallic samples after the indicated exposures to vapor phase or liquid phase hydrogen peroxide. Tensile samples were taken from the sheet materials in either the longitudinal orientation or the transverse orientation. Examination of the tensile data of the aluminum alloys did not reveal any statistically significant effects of the hydrogen peroxide exposures (vapor or dip). Other than a slight decrease in the measured % elongation to failure of the transverse samples of the annealed 304 stainless steel (for reasons presently unclear), the 304 samples also did not exhibit any statistically significant affects of the hydrogen peroxide exposures.

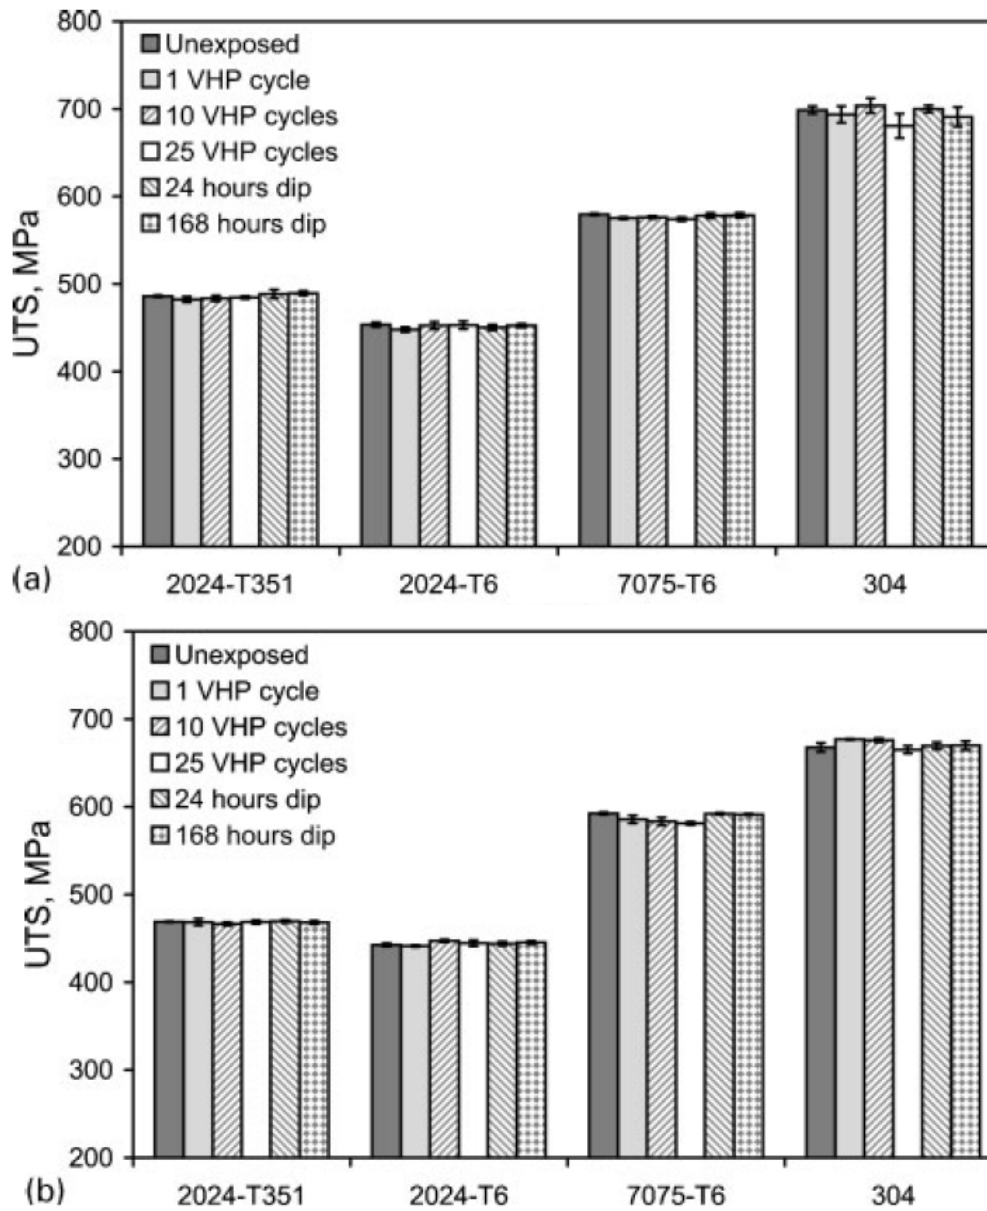
Figure 5. Effect of hydrogen peroxide exposure on the ultimate tensile strength of the alloys indicated.

Sample orientation: (a) longitudinal (b) transverse

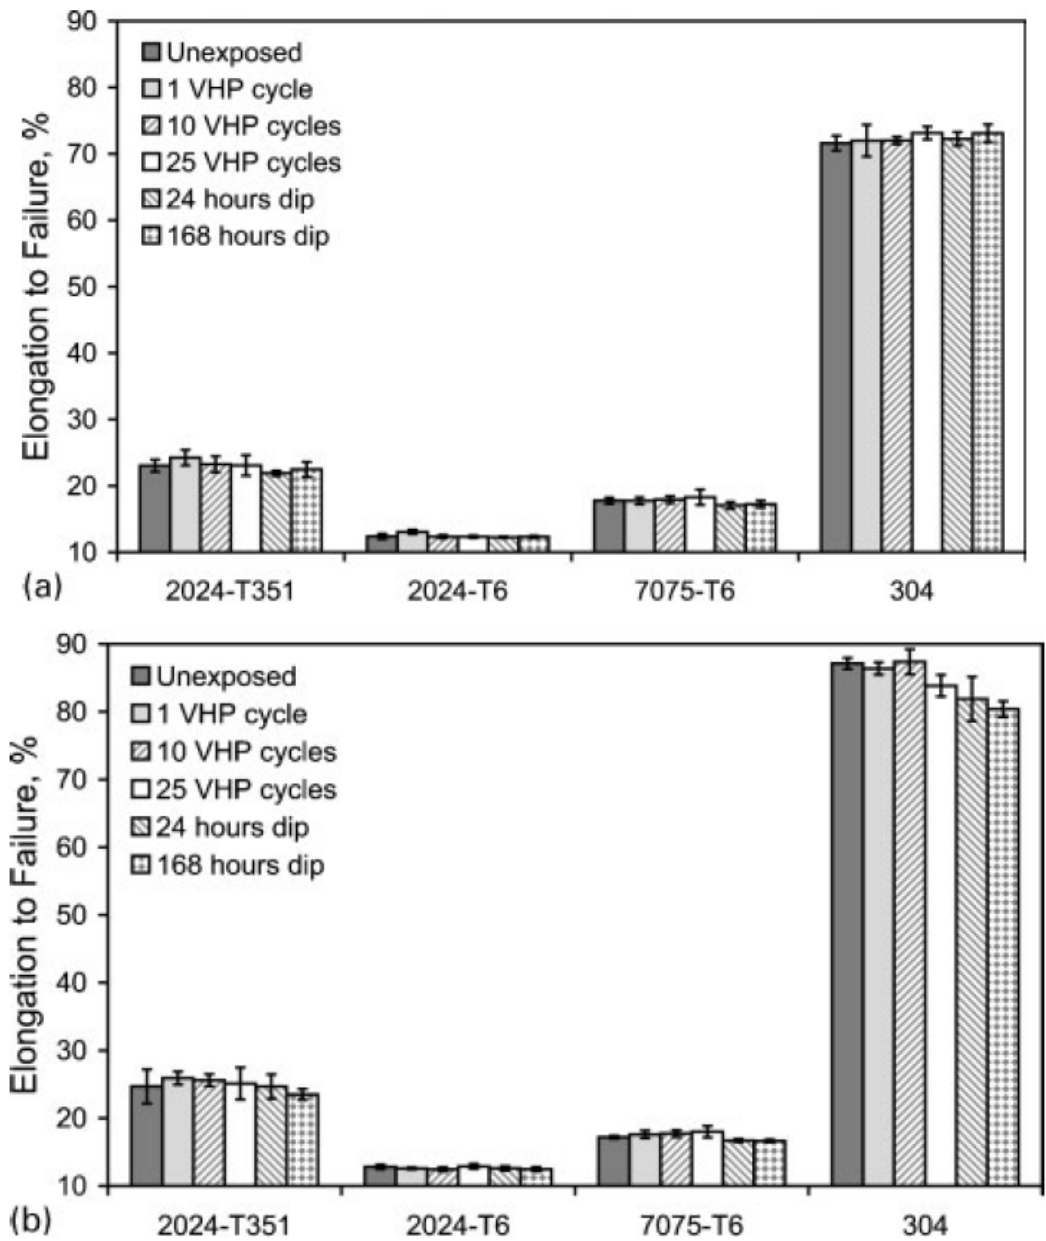
Figure 6. Effect of hydrogen peroxide exposure on the % elongation to failure of the alloys indicated.

Sample orientation: (a) longitudinal (b) transverse

3. Although some slight reductions in the % elongation to failure of transverse samples of 304 stainless steel were found, overall the tensile properties (0.2% offset yield strength, ultimate tensile strength and % elongation to failure) of samples of 2024-T351, 2024-T6, 7075-T6, and 304 stainless steel were unaffected by the various exposures to vapor phase and 35% liquid phase hydrogen peroxide.

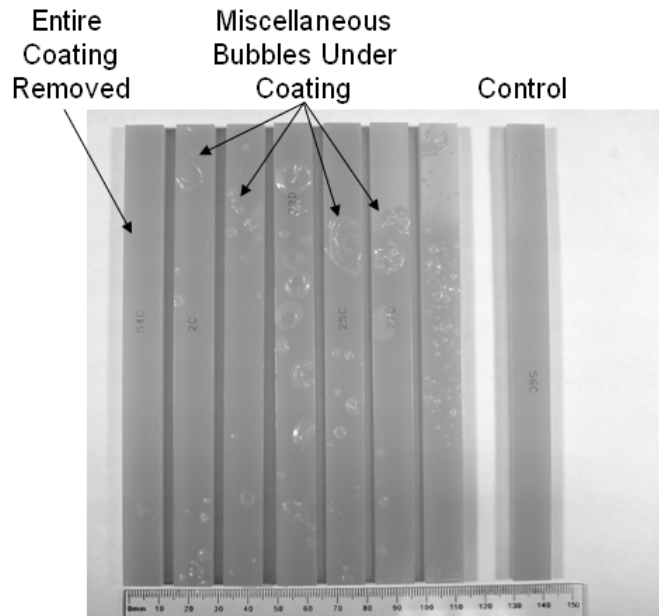
Figure 7. Various glass fiber/epoxy FR4 printed circuit board composite samples after 168 hr exposure to 35% liquid hydrogen peroxide. Control sample was not exposed.

No visual differences were seen on the surfaces of either the CF/E, CF/GF-E, or uncoated FR4 samples after exposure to hydrogen peroxide (vapor or dip exposures). However, exposing the FR4 samples with the conformal coating to 35% liquid hydrogen peroxide for 168 hr caused significant blistering and loss of the acrylic coating, as shown in Figure 7. The net changes in weight for the various samples are shown in Figure 8. The carbon fiber/epoxy material exhibited no significant weight change after 10 VHP exposures but approximately 0.065 % increase in weight after the 168 hr liquid exposure followed by vacuum drying. The carbon fiberglass fiber/epoxy material exhibited increases in weight after vacuum drying of about 0.015% after 10 VHP exposures and 0.035% after the 168 hr liquid exposure.

The FR4 samples (coated and uncoated, longitudinal or transverse orientations) displayed negligible weight changes after a single VHP cycle but about 0.02% decrease in weight after 10 VHP cycles. The 168-hr dip exposures caused increases in weight of about 0.07% for the uncoated samples and approximately 0.03% for the coated (transverse orientation) samples, indicating perhaps either some residual absorbed liquid or some slight oxidation of the samples. The dip exposures of the longitudinally oriented samples shown in Figure 7 caused highly variable weight losses consistent with the blistering of the conformal coating, as shown in Figure 7.

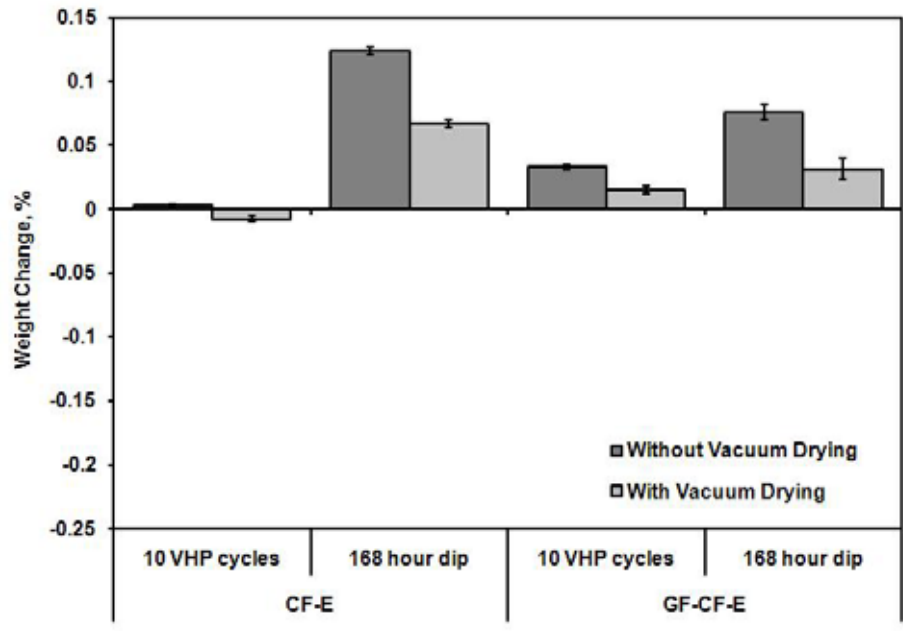
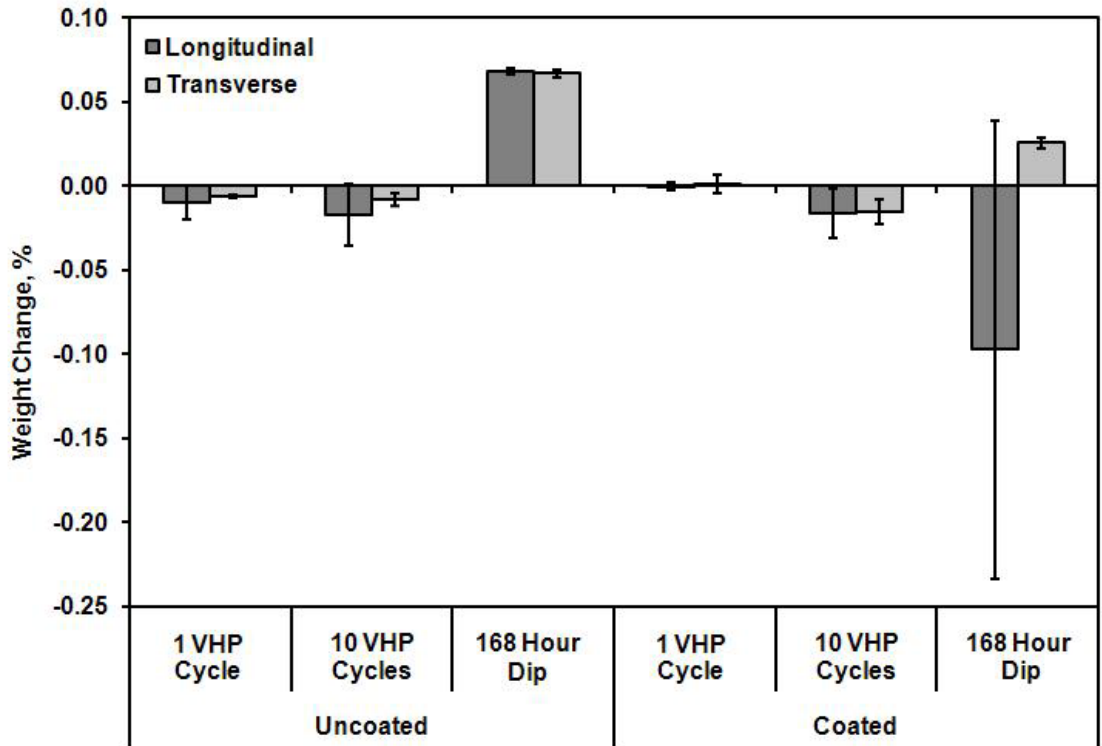
Figure 8. Composite sample weight changes due to VHP and dip exposures. (a) Carbon and glass fiber - epoxy structural composites, (b) glass fiber/epoxy FR4 printed circuit board composite. Error bars represent +1 standard deviation.

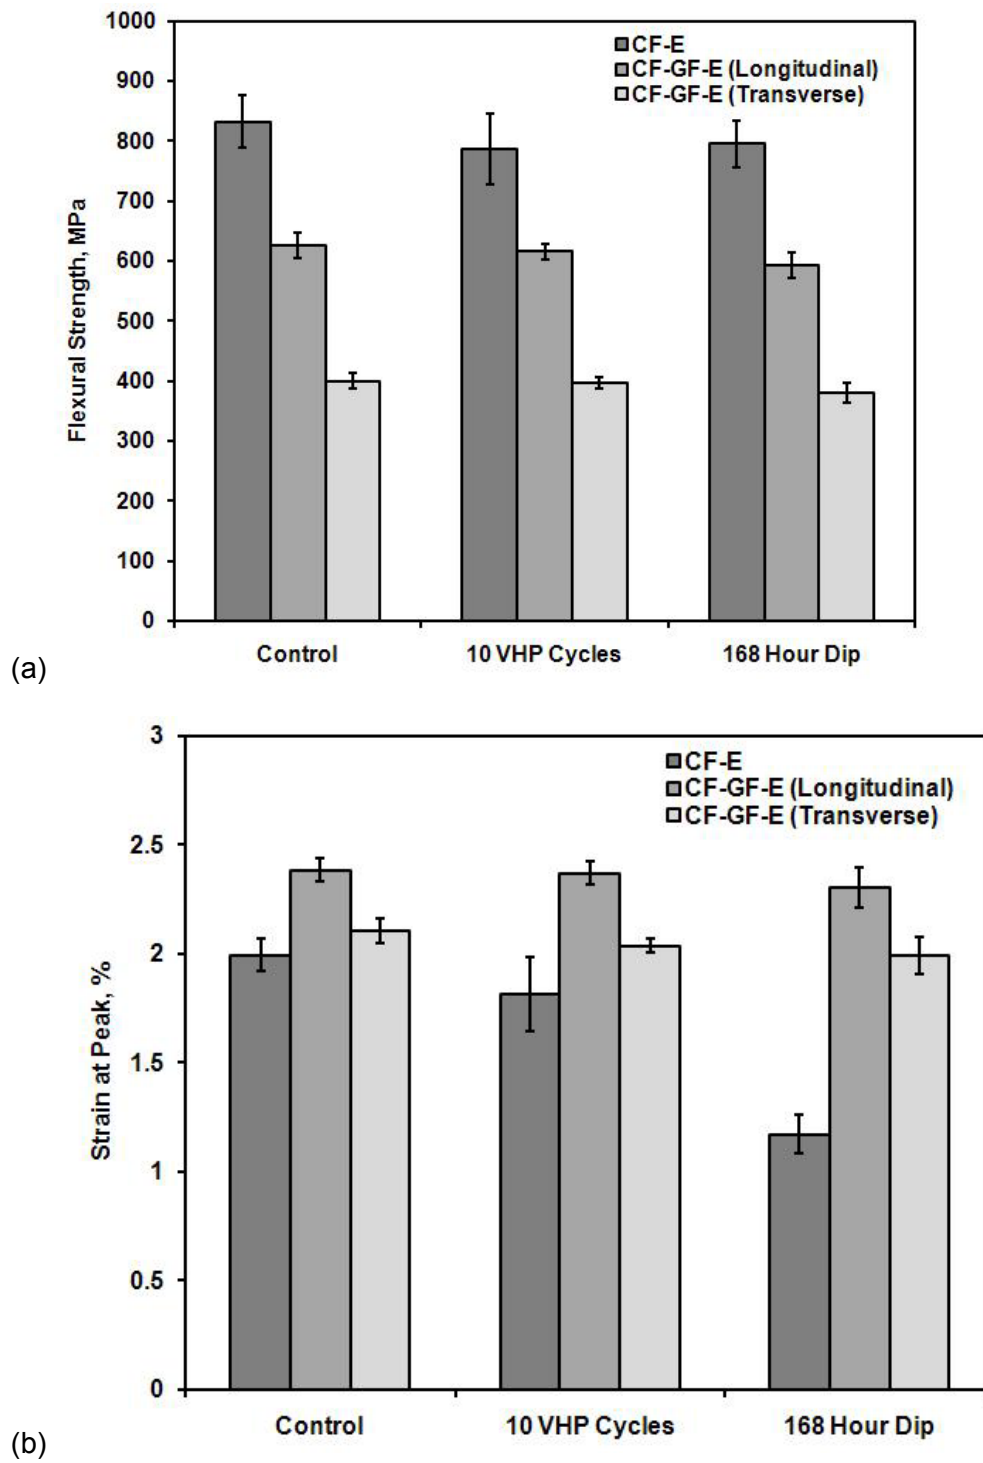
Figure 9. Effect of hydrogen peroxide exposure on the carbon and glass fiber - epoxy structural composites. (a) flexural strength, (b) strain at peak load Error bars represent ± 1 standard deviation.

The flexural properties of the carbon and glass fiber/epoxy structural composites are shown in Figure 9. The carbon fiber/epoxy material exhibited no significant change in flexural strength or strain at peak load after 10 VHP cycles. However, statistically significant decreases in flexural strength and especially strain at peak load were exhibited after 168 hr dip exposures to 35% hydrogen peroxide. The failure modes of these samples were characterized by increased amounts of delamination of the reinforcement fabrics, as shown in Figure 10. The decrease in peak load strain is particularly troubling, as it indicates increased brittleness of this material. This tendency to delaminate and the blistering tendency of the acrylic coating of the FR4 materials may be the result of diffusion of H₂O₂ molecules to the interfaces of these materials and then generation of microbubbles of either oxygen or water vapor, or both, during decomposition of the hydrogen peroxide.

Although the transverse direction flexural strength and strain at peak load of the carbon fiberglass fiber/epoxy material were lower than those measured in the longitudinal direction, as seen in Figure 9(b), no

significant changes were seen after exposure to either 10 VHP cycles or the 35% liquid hydrogen peroxide for 168 hr.

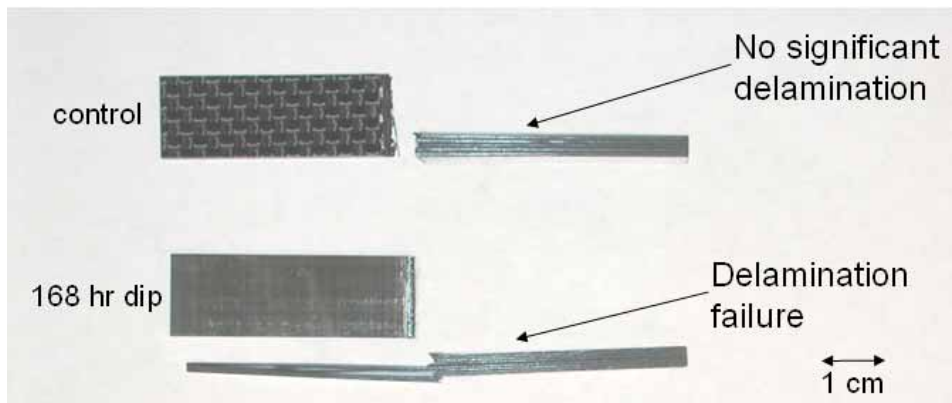
Figure 10. Typical carbon fiber epoxy samples after flexural testing: control sample was not exposed while lower sample was exposed to 35% liquid H_2O_2 for 168 hr.

8. Degradations in strain at peak load after 168 hr exposure to 35% liquid hydrogen peroxide were seen in the carbon fiber epoxy material and the transverse samples of FR4 printed circuit board material. The mechanical degradation in the CF-E samples was correlated with an increase in delamination during testing. It is recommended that condensation be avoided during application of vapor phase hydrogen peroxide.

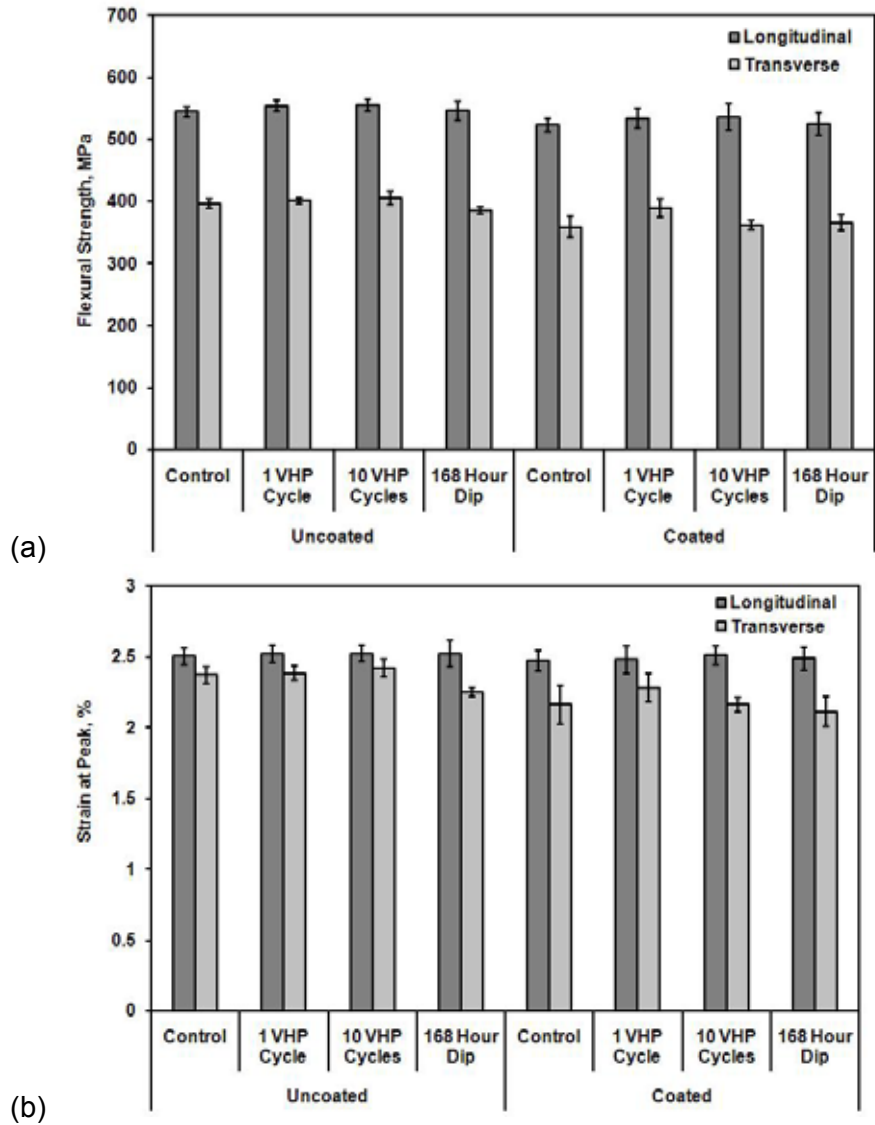
Figure 11. Effect of hydrogen peroxide exposure on the flexural properties of the glass fiber/epoxy FR4 printed circuit board composite. (a) flexural strength, (b) strain at peak load. Error bars represent ± 1 standard deviation.

The flexural properties of the FR4 printed circuit board composites are shown in Figure 11. As noted above for the carbon fiberglass fiber/epoxy material, the flexural properties measured in the transverse direction were consistently lower than those measured in the longitudinal direction. No statistically significant differences were found in either the flexural strength or the strain at peak load as a result of FR4 exposure to hydrogen peroxide vapor or liquid, except for slight degradation of the FR4 transverse sample strain at peak load after 168 hr dip exposures to 35% hydrogen peroxide.

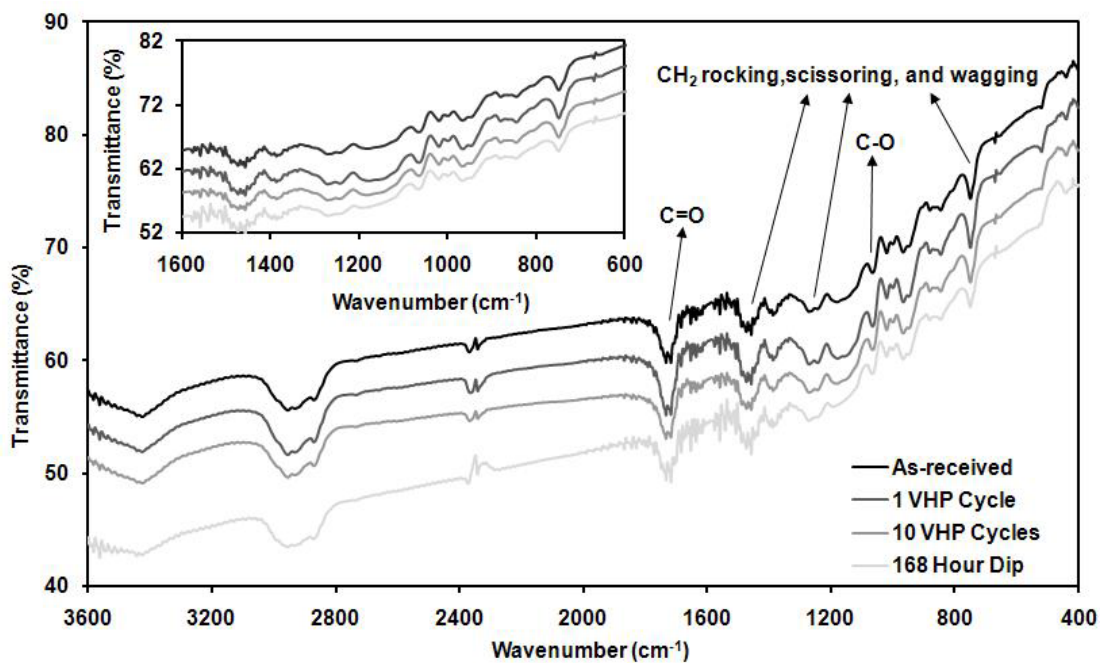
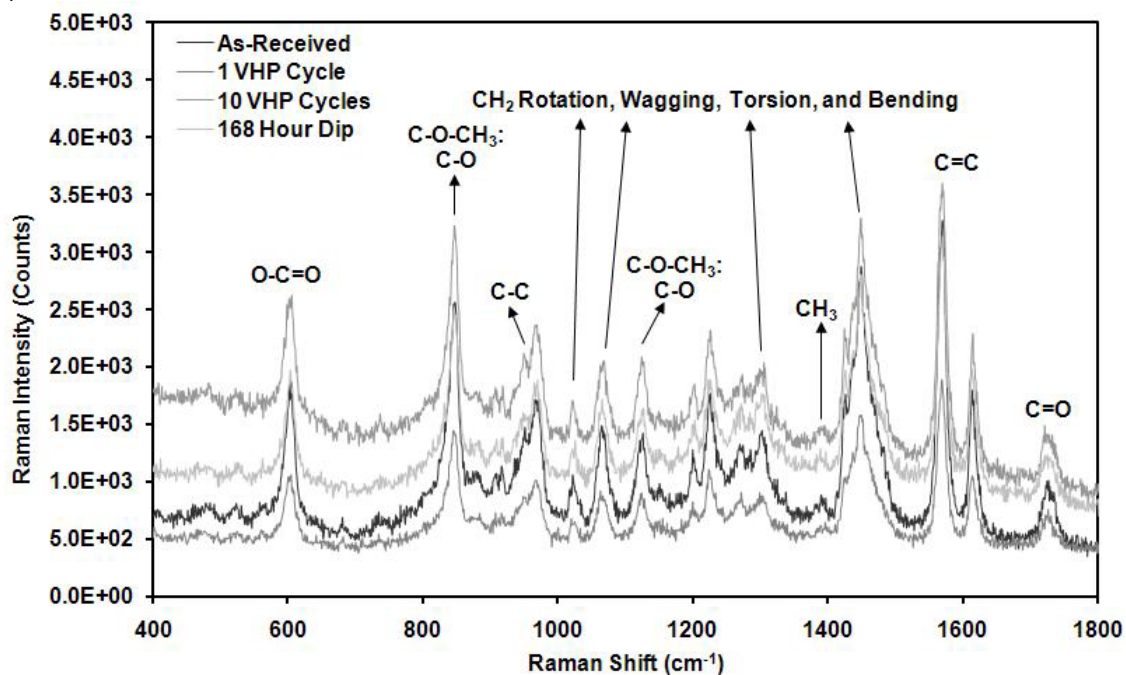
Figure 12. (a) FTIR and (b) Raman spectroscopy of the acrylic conformal coating from the glass fiber/epoxy FR4 printed circuit board composite.

FTIR and Raman spectroscopy were used to examine potential changes due to hydrogen peroxide exposure on the chemical structure of the acrylic conformal coating on the glass fiber/epoxy FR4 printed circuit board composite (see Figure 12), as well as the epoxy matrices of the carbon fiber/epoxy composite and the FR4 material (see Figure 13). The analyses showed no detectable compositional-based changes due to hydrogen peroxide exposures. The usual characteristic bands observed in the spectra are noted in Figures 12 and 13.

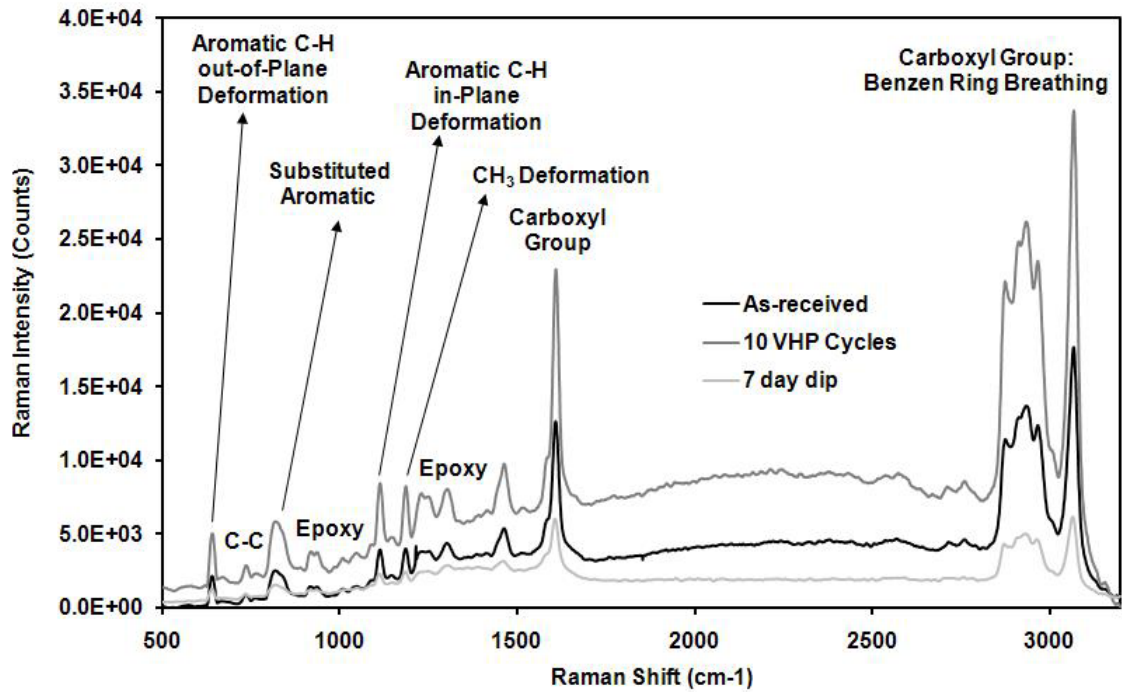
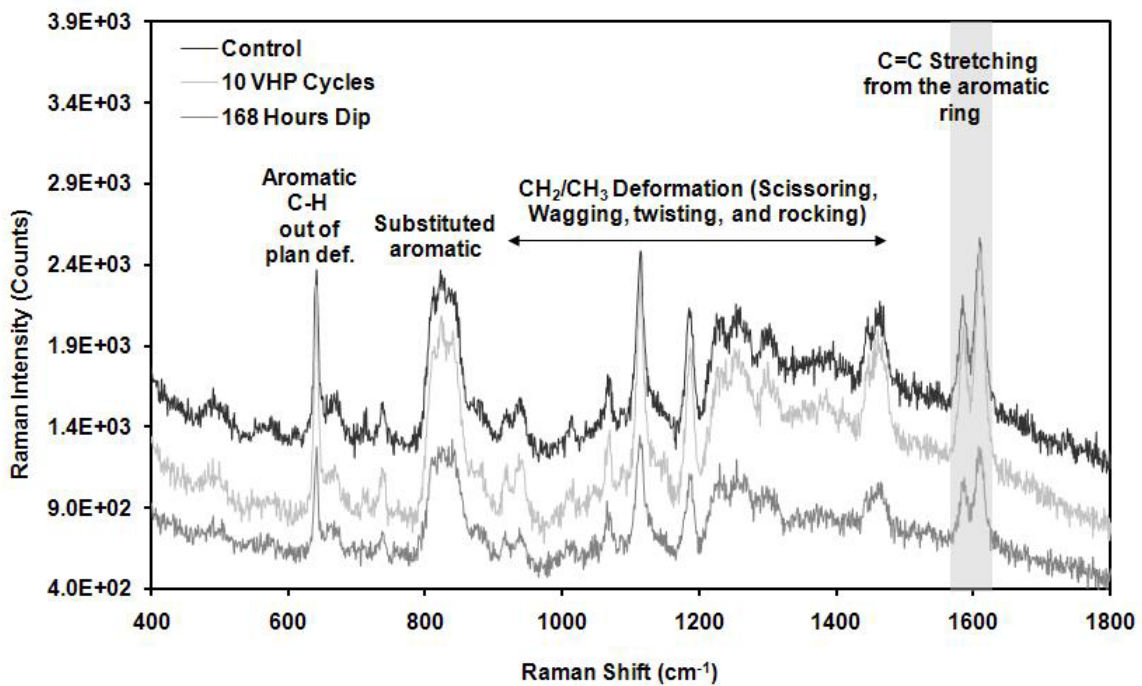
Figure 13. Raman spectroscopy of the epoxy matrix from the (a) carbon fiber/epoxy structural composite and (b) glass fiber/epoxy FR4 printed circuit board composite.

9. No changes were seen in the chemical structure, as characterized by FTIR and Raman spectroscopy, of the acrylic conformal coating of the FR4 composites or the epoxy matrices of the carbon fiber/epoxy composite and the FR4 material.
