*Iowa Department of Transportation  
Research Project Number TPF-5(193) Supplement #131*

# **IN-SERVICE PERFORMANCE EVALUATION OF CONCRETE SLOPED END TREATMENTS IN IOWA**

MwRSF Research Report No. TRP-03-421-20

October 12, 2020

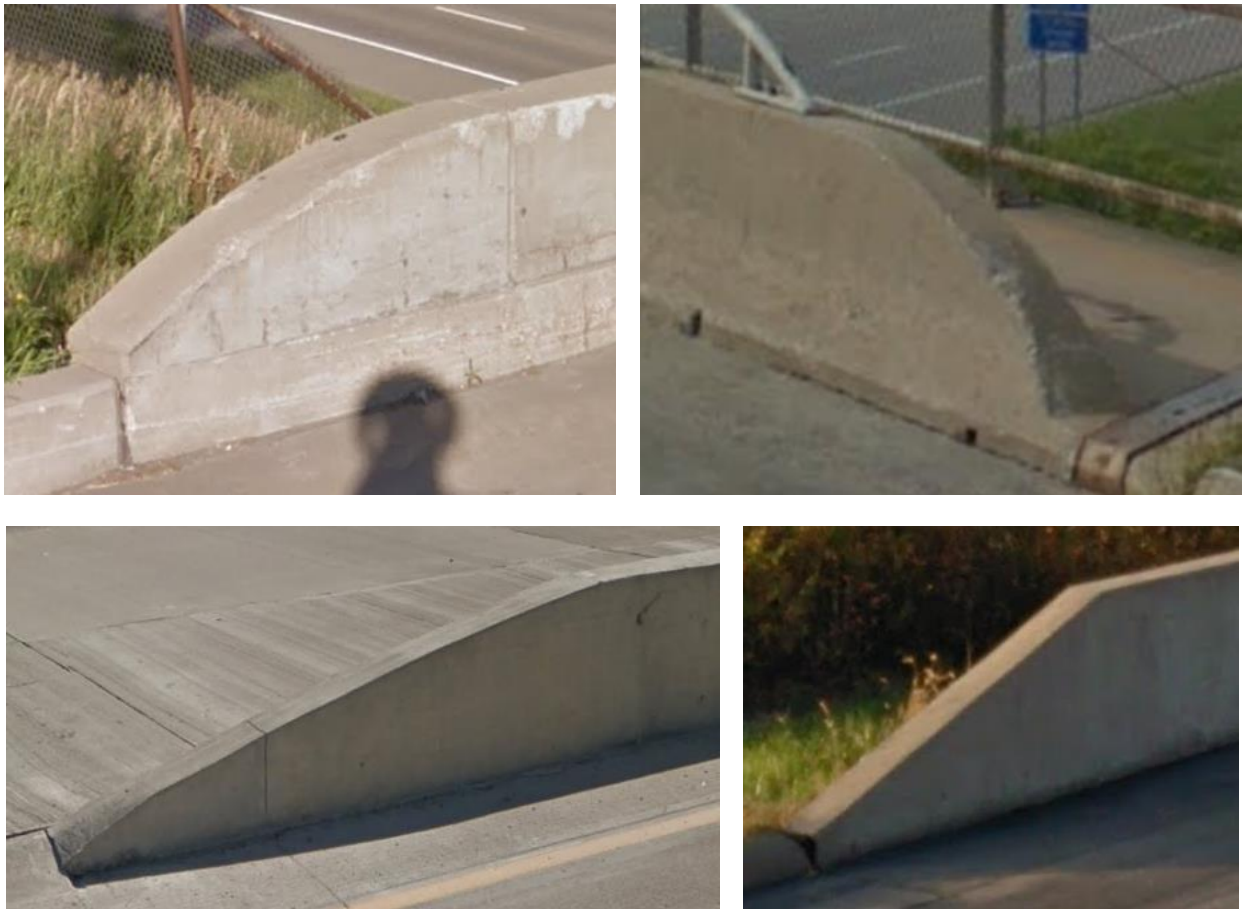
Figure 1. Examples of Concrete Sloped End Treatments in Iowa [1]

Concrete barrier sloped end treatments (SETs) are used in many states, such as Iowa, for terminating the ends of concrete barriers. Historically, sloped end treatments offered a safety benefit as compared to terminating concrete barriers with blunt ends. Sloped end treatments are also generally inexpensive to install and require no routine maintenance and minimal repair. Sloped end treatments can be cast in place, horizontally doweled into an existing concrete barrier end, attached to a concrete road or bridge surface, and installed in conjunction with a curb. Examples of sloped end treatments from the state of Iowa, collected using Google Earth and Street View [1], are shown in Figure 1.

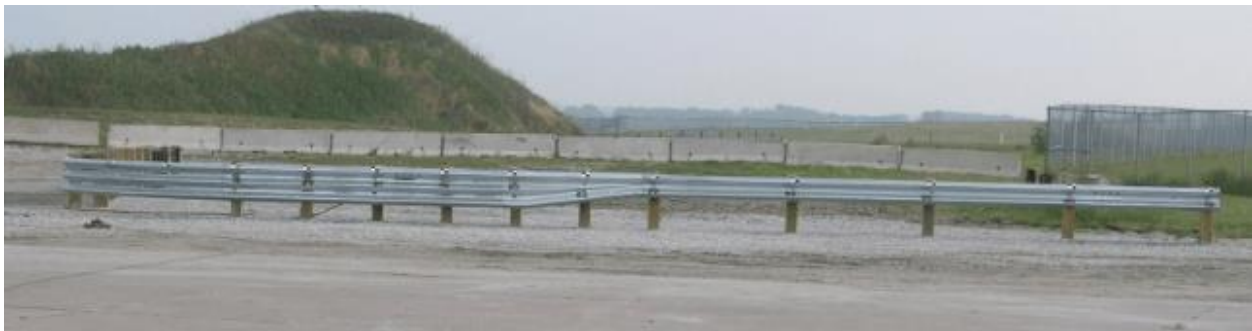
Figure 5. Short Radius Guardrail [26]

For some situations, such as bridge rails near entrances and entrance ramps with no sidewalks, short radius guardrail may be a potential concrete barrier end treatment option. A short radius guardrail system, as shown in Figure 5, was developed at the Midwest Roadside Safety Facility (MwRSF) and evaluated according to MASH Test Level 3 (TL-3) criteria [26]. Although this system was determined to be unsuccessful at MASH TL-3, analysis indicated the system was likely to be successful when impacted at MASH TL-2 conditions.

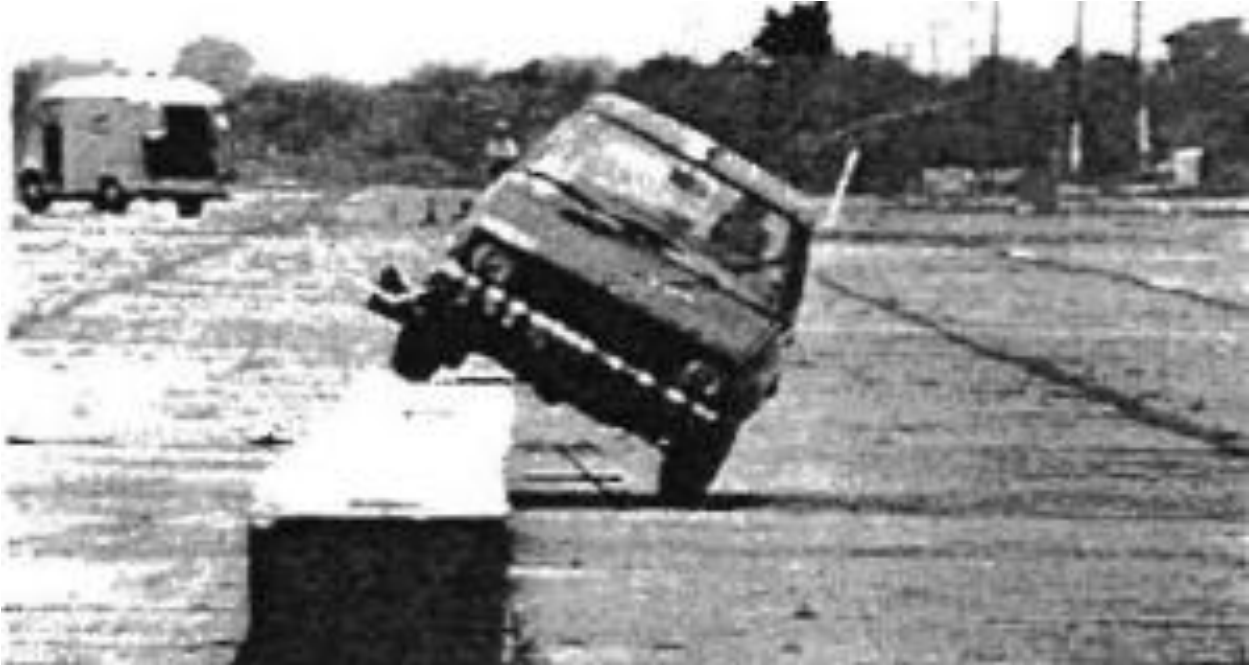
Figure 18. Right Side of Vehicle Riding Along Top of Concrete Barrier, Test No. 1949A-2 [4]

Test no. 1949A-1 impacted the sloped end treatment 6.5 ft from the end of the treatment at an angle of 16.3 degrees and a speed of 44.7 mph. The sloped end treatment redirected the vehicle, and the vehicle exited the system at a speed of 37.4 mph and an angle of 6.1 degrees. Test no. 1949A-2 impacted the sloped end treatment end-on at a speed of 45.1 mph with the centerline of the right wheels aligned with the centerline of the sloped end treatment. The right-side wheels of the vehicle rode along the top of the concrete barrier, as shown in Figure 18, then the vehicle lost contact with the barrier and exited the system. Test no. 1949A-3 impacted the sloped end treatment end-on at a speed of 46.5 mph with the centerline of the vehicle aligned with the centerline of the sloped end treatment. The vehicle rode atop the barrier, as shown in Figure 19, before coming to rest. Thus, the sloped end treatment was determined to be successful according to NCHRP Report No. 230 test criteria.

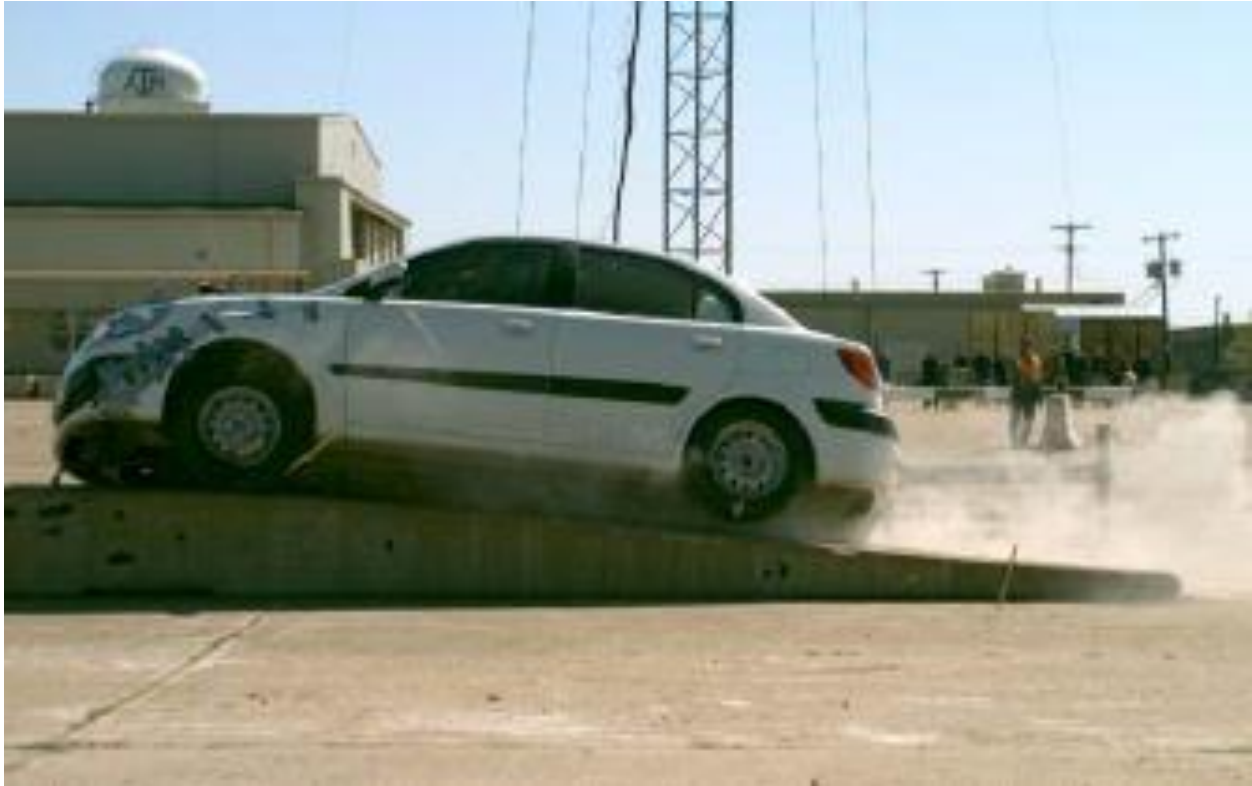
Figure 22. Vehicle Riding Up Sloped End Treatment, Test No. 490023-5 [8]

In 2013, TTI re-tested a modified, non-pinned version of the sloped end treatment according to MASH TL-2 impact conditions [8]. Test no. 490023-5 was performed with the car impacting the sloped end treatment 33 in. from the end at a speed of 43.9 mph and an angle of 15.2 degrees. During this test, the vehicle rode up the end treatment, shown in Figure 22, and came to rest on the non-traffic side of the barrier.

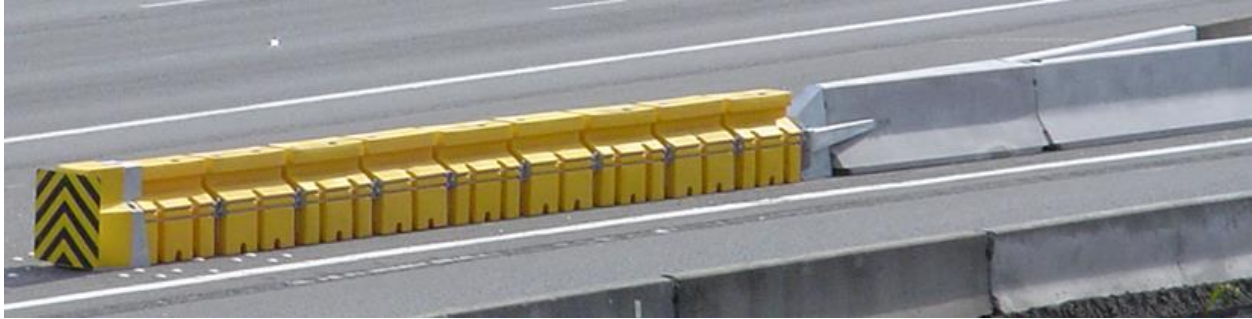
Figure 47. ABSORB 350 [57]

The ABSORB 350, a non-redirective, gating crash cushion, shown in Figure 47, is manufactured by Barrier Systems. Three versions of this device were evaluated according to NCHRP Report No. 350 test conditions, and each has a height of 32 in. and a width of 24 in. The length of the TL-1 version was not listed. The TL-2 version received FHWA eligibility letter no. CC-66A and has a length of 14 ft – 5 in. The TL-3 version is 32 ft long and received FHWA eligibility letter nos. CC-66 and CC-66C.

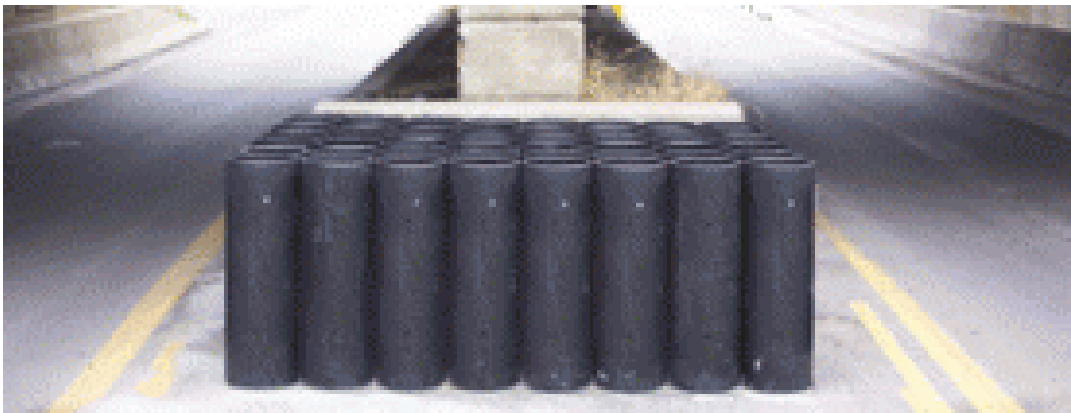
Figure 57. EASI-Cell [32]

The crash cushion EASI-Cell, shown in Figure 57, is a non-redirective, gating device designed by Energy Absorption Systems, Inc. It received FHWA eligibility letter no. CC-71 for TL-1 test conditions. The EASI-Cell is 39 in. tall, 51.5 in. wide, and 8 ft – 6 in. long.

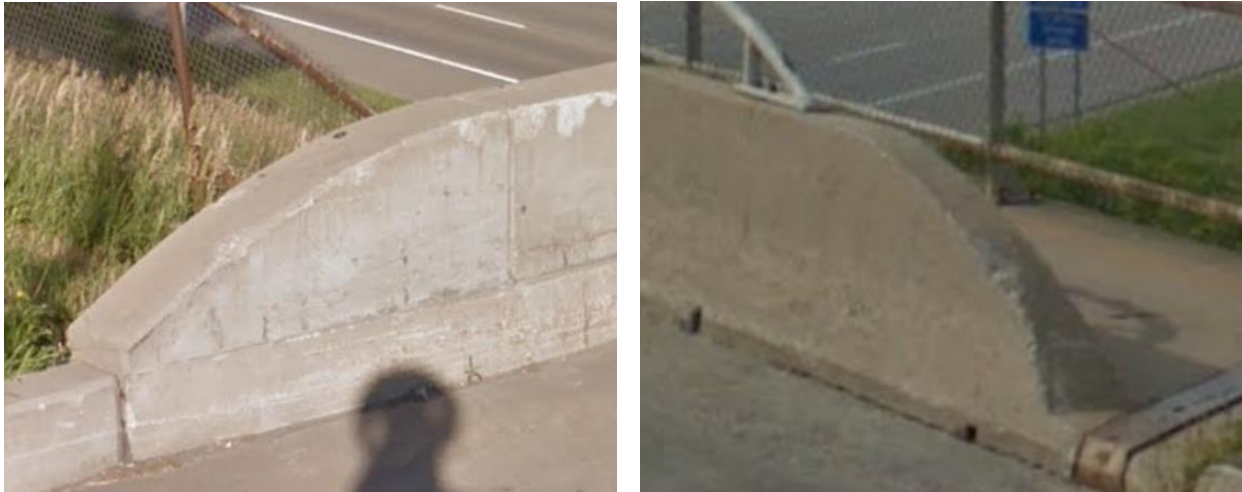
Many variations of sloped end treatments were found in Iowa during the Google Earth and Street View visual survey [1]. Taper geometries were either straight or round, and overall sloped end treatment length varied. Sloped end treatments with rounded tapers are shown in Figure 59 (a) and sloped end treatments with straight tapers are shown in Figure 59 (b).

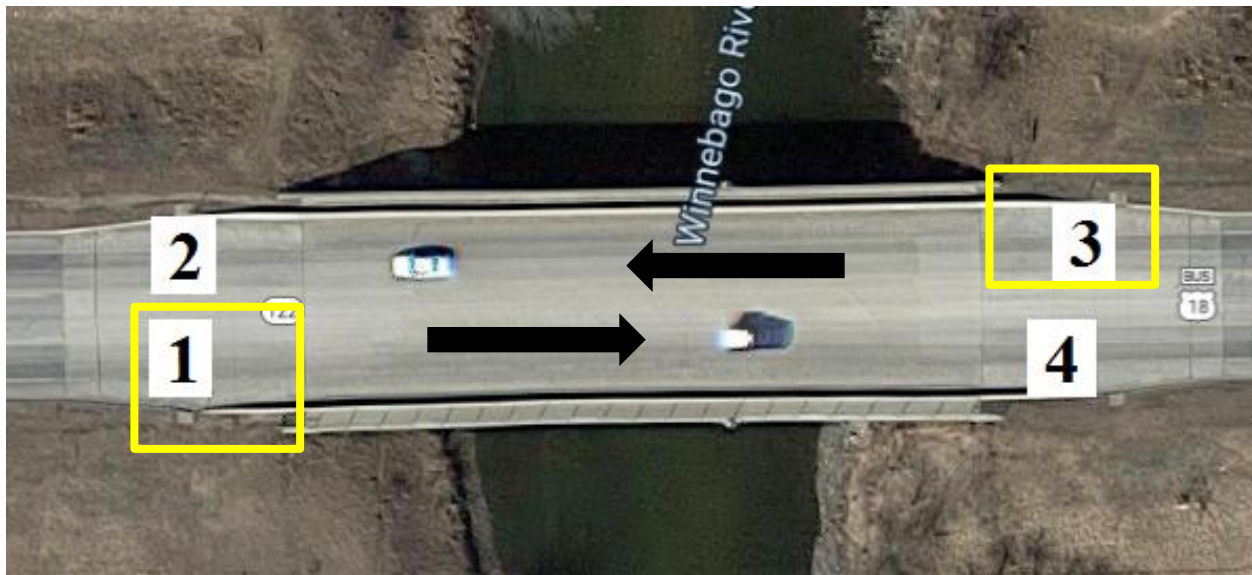
Figure 142. Sloped End Treatments on Two-Way Traffic Road

Removal costs for 274 sloped end treatments were calculated. Crash cushion costs included installation costs for 274 cushions and repair and crash costs for 18 crashes. Costs are shown in Table 69, and B/C is shown in Table 70. The three largest B/Cs are highlighted, and only one was greater than 1. Because none of the B/C ratios were greater than 2.0, this treatment configuration was deemed not cost-effective.

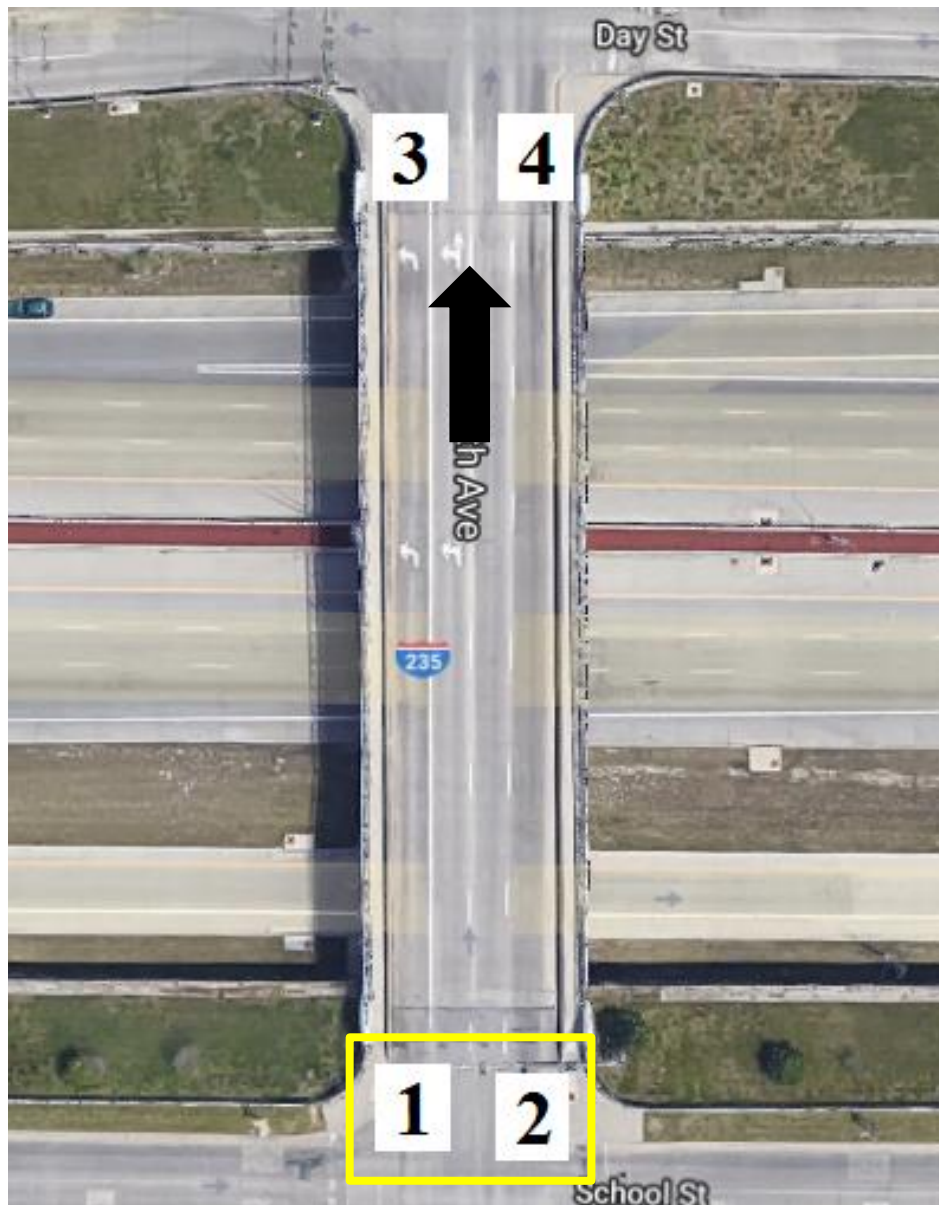
Figure 143. Sloped End Treatments on One-Way Traffic Road

The next group of sloped end treatment installations included approaches on one-way traffic roads. For example, sloped end treatment nos. 1 and 2 are shown in Figure 143 may be replaced with crash cushions. A total of 35 SETs had these attributes, and seven crashes occurred for this set of 35 SETs. Therefore, for sloped end treatments, crash costs for 23 crashes and removal costs for 35 treatments were calculated. For crash cushions, installation costs were calculated for 35 crash cushions, and repair and crash costs were calculated for seven crashes. Costs are shown in Table 71, and B/Cs are shown in Table 72. The three largest B/Cs are highlighted. All B/Cs ranged between 0.64 and 2.69.

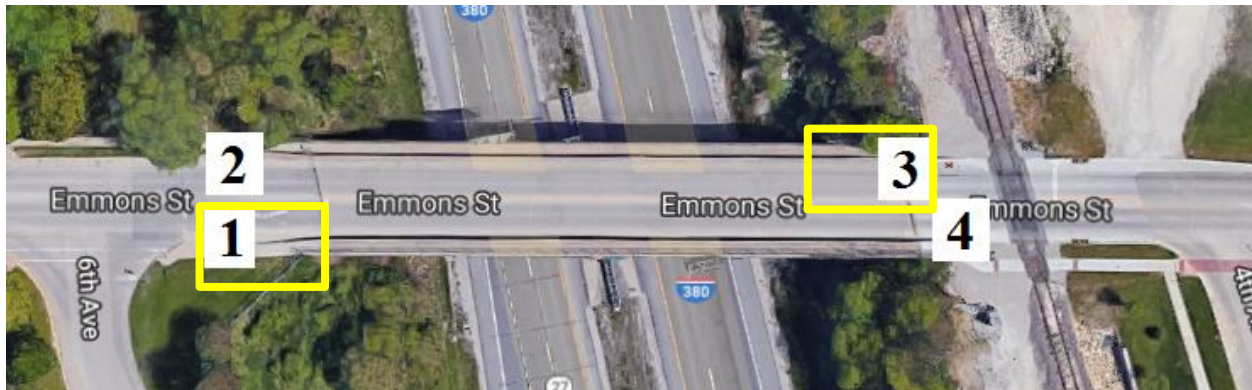
Figure 144. Sloped End Treatments on Bridge with Ramp

For this group of sloped end treatments, bridges near ramps with one- and two-way traffic were considered and are designated as sloped end treatment nos. 1 and 3 in Figure 144. All approach sloped end treatments on these bridges were included for a total of 110 sloped end treatments and 18 crashes. Therefore, installation, repair, and crash costs for 110 crash cushions and 18 crashes were calculated for crash cushions, and crash costs for 12 crashes were calculated for sloped end treatments. Results are shown in Tables 73 and 74. B/Cs for this subgroup ranged between 0.52 and 2.27. The three highest B/Cs are highlighted, which were found for the GREAT, Hex-Foam Sandwich, and QuadTrend crash cushions.
