CHLORIDE CONCENTRATION AND BLOW-THROUGH ANALYSES FOR CONCRETE BRIDGE DECK REHABILITATION USING HYDRODEMOLITION

Utah Department of Transportation Research & Innovation Division

Final Report November 2020

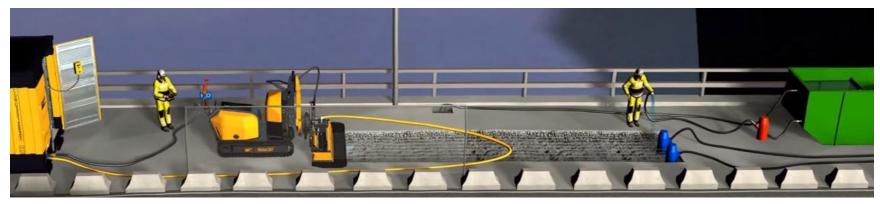
Figure 1-1: Schematic of hydrodemolition equipment.

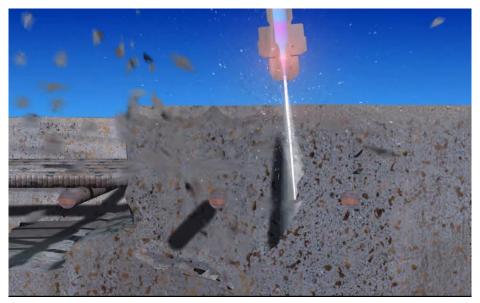
Figure 1-2: Schematic of concrete removal below the top mat of reinforcing steel using hydrodemolition equipment.

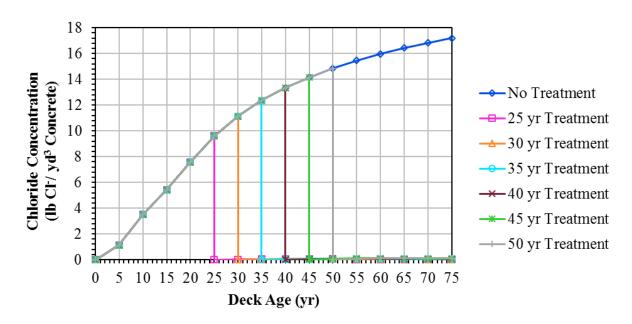
Figure 4-1: Simulated chloride concentrations at the top mat of reinforcement for a deck with a 2.0-in. OCD and a 3.375-in. removal depth with an applied surface treatment.

The full sets of figures are provided in Appendices D through G. For each treatment year, these figures were used to determine the maximum chloride concentration that would occur at

both mats of reinforcing steel after hydrodemolition and the deck age at which these maximum values occurred. In addition, when the maximum chloride concentration was greater than the threshold of 2.0 lb of chloride per cubic yard of concrete, the deck age at which the threshold was reached was also determined.

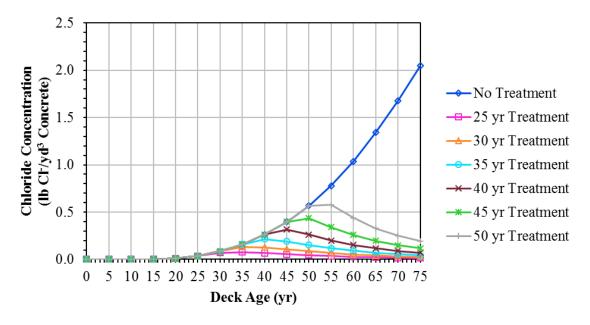
Figure 4-2: Simulated chloride concentrations at the bottom mat of reinforcement for a deck with a 2.0-in. OCD and a 3.375-in. removal depth with an applied surface treatment.

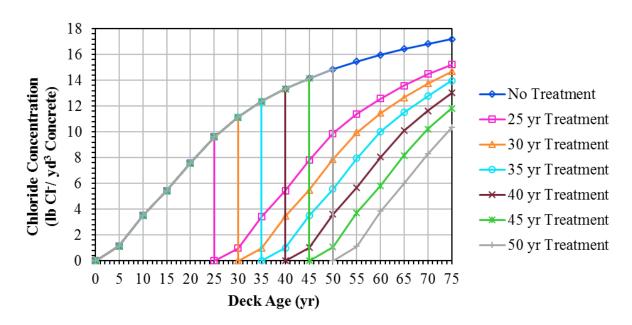
Figure 4-3: Simulated chloride concentrations at the top mat of reinforcement for a deck with a 2.0-in. OCD and a 3.375-in. removal depth without an applied surface treatment.

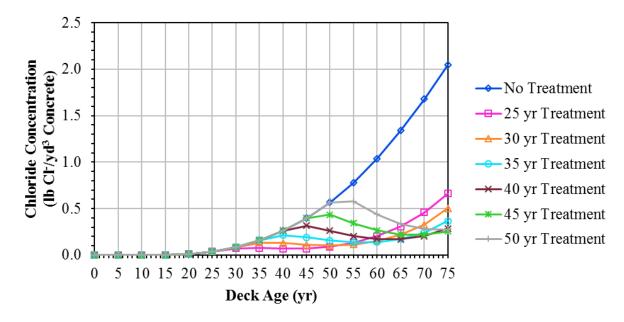
Figure 4-4: Simulated chloride concentrations at the bottom mat of reinforcement for a deck with a 2.0-in. OCD and a 3.375-in. removal depth without an applied surface treatment.

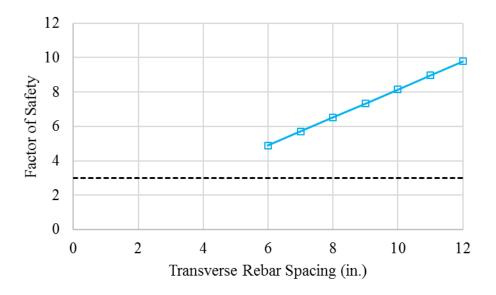
Figure 4-5: Main effect of transverse rebar spacing.

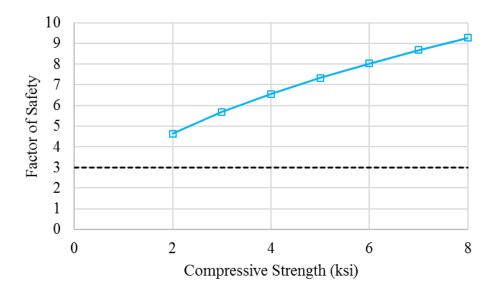
Figure 4-6: Main effect of concrete compressive strength.

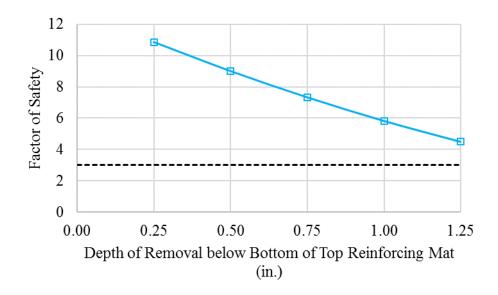
Figure 4-7: Main effect of depth of removal below bottom of top reinforcing mat.

reinforcing mat corresponds to a remaining concrete thickness above the bottom reinforcing mat of 2.0 in. The orifice size was held constant at 0.10 in. because that was the orifice size used by the majority of the survey respondents, and the results of the earlier experimentation (in terms of the main effect of each input variable) support selection of this value for minimizing the occurrence of blow-through. A jet angle of 10 degrees with respect to the vertical axis of the nozzle was selected as an average value for most hydrodemolition projects.

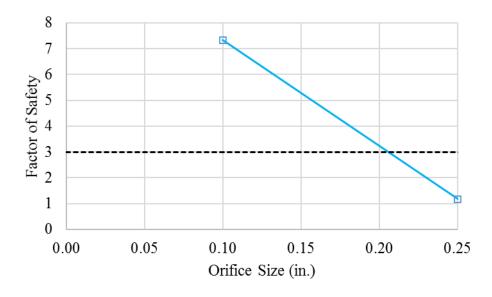
Figure 4-8: Main effect of orifice size.

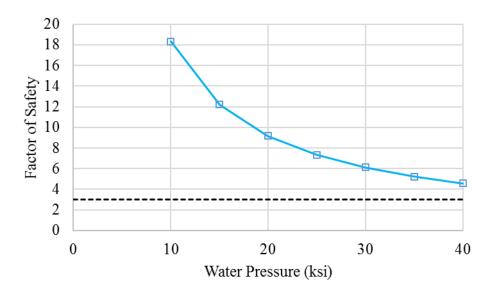
Figure 4-9: Main effect of water pressure.

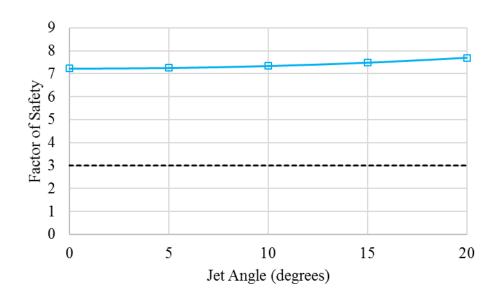
Figure 4-10: Main effect of jet angle.

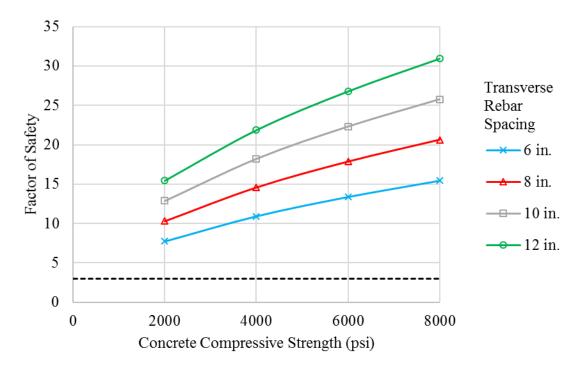
Figure 4-11: Interaction between concrete compressive strength and transverse rebar spacing for water pressure of 10 ksi.

The interactions are presented in Figures 4-11 to 4-14, in which a dashed horizontal line again marks a factor of safety of 3.0. While a factor of safety less than 1.0 did not occur in these analyses of interactions, a factor of safety less than 3.0 occurred for four combinations of the input parameters. The specific values of transverse rebar spacing, concrete compressive strength, and water pressure in those combinations are presented in Table 4-10. The values typically represent low transverse rebar spacing, low concrete compressive strength, and high water pressure. These combinations, and equivalent combinations not explicitly analyzed, should be avoided in practice to minimize the occurrence of blow-through during hydrodemolition. Furthermore, because the analysis performed in this research does not directly account for the possibility of cracking within the simulated concrete beam, the actual factors of safety may be considerably lower than those calculated and reported in Figures 4-5 to 4-14. In all cases, the governing mode of failure for each parameter investigated in the experiment was the bending moment in the orientation where the length of the concrete beam is greater than the width of the concrete beam.

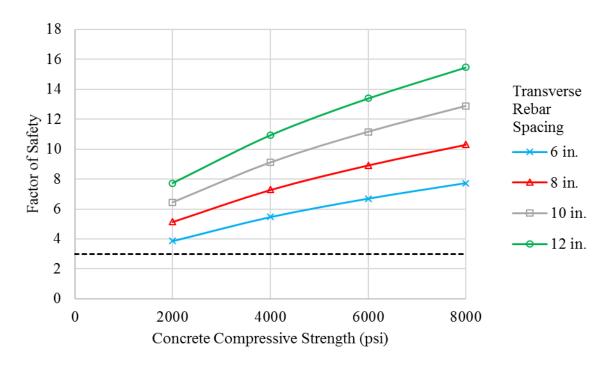
Figure 4-12: Interaction between concrete compressive strength and transverse rebar spacing for water pressure of 20 ksi.

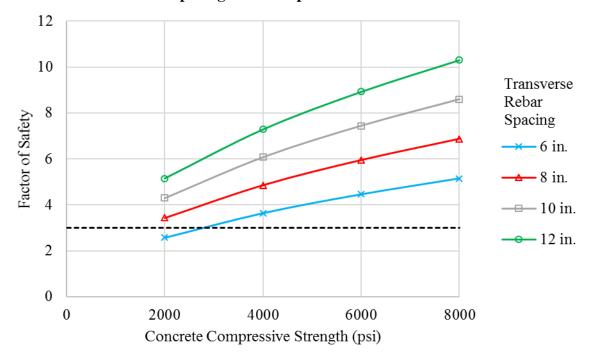
Figure 4-13: Interaction between concrete compressive strength and transverse rebar spacing for water pressure of 30 ksi.

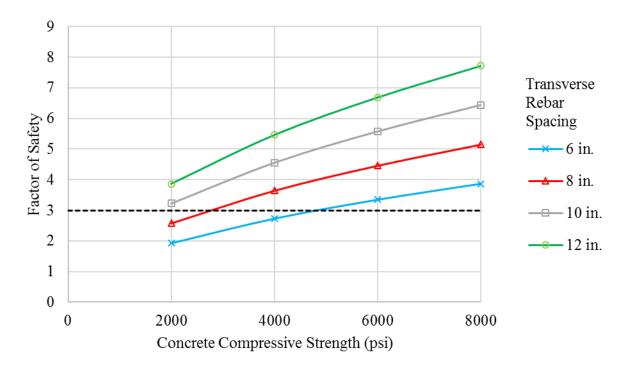
Figure 4-14: Interaction between concrete compressive strength and transverse rebar spacing for water pressure of 40 ksi.

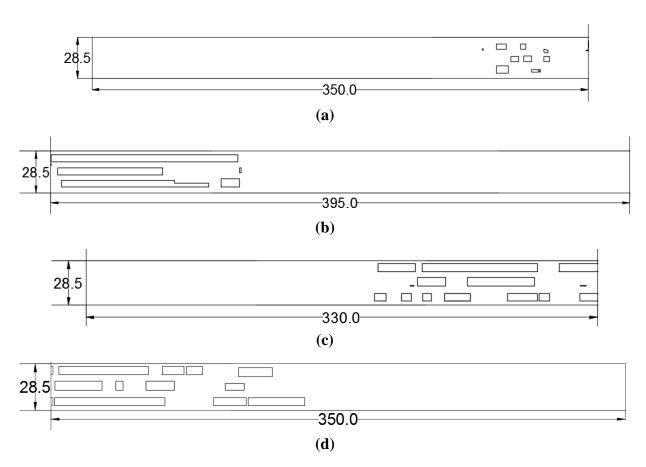
Figure 4-15: Blow-through map for case study #1: (a) 0-350 ft, (b) 350-745 ft, (c) 745-1,075 ft, and (d) 1,075-1,425 ft.

The extent of blow-through that occurred during hydrodemolition of the bridge deck investigated for case study #1 is shown in Figure 4-15, in which the areas that experienced blow-through are outlined. The blow-throughs were concentrated in areas between girders where the bottom of the deck was unsupported. Analysis showed that approximately 10.8 percent of the total bridge deck area experienced blow-through during hydrodemolition, which is a significant

amount considering that the total bridge deck area is high at 40,613 ft². An example of the extensive blow-through damage on the bridge deck in case study #1, photographed after hydrodemolition, is shown in Figure 4-16.

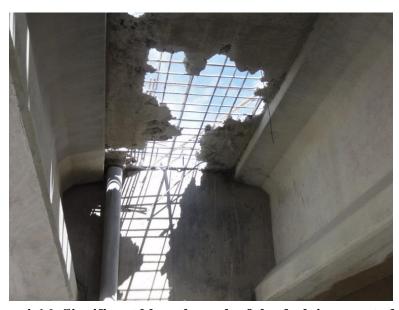
Figure 4-16: Significant blow-through of the deck in case study #1.

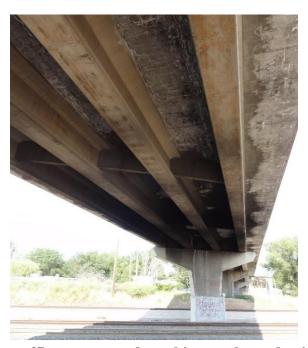
Figure 4-17: Significant efflorescence and cracking on the underside of the deck in case study #1.

the deck; extensive cracking and efflorescence on the bottom of the deck may indicate a higher probability of blow-through during hydrodemolition.

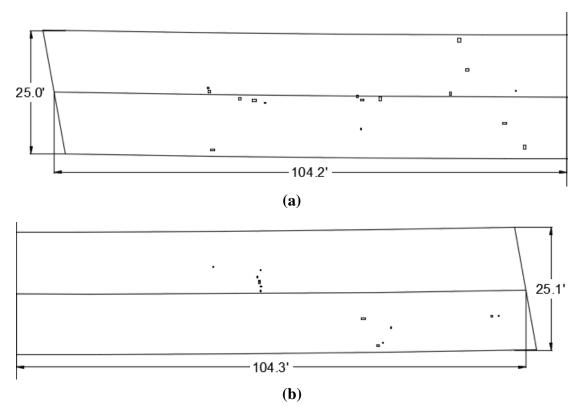
Figure 4-18: Blow-through map for case study #2: (a) 0-104.2 ft and (b) 104.2-208.5 ft.

The extent of blow-through that occurred during hydrodemolition of the bridge deck investigated for case study #2 is shown in Figure 4-18, in which the areas that experienced blow-through are outlined. Analysis showed that less than 1.0 percent of the total bridge deck area experienced blow-through during hydrodemolition, which is an insignificant amount considering that the total bridge deck area is low at 5,210 ft². An example of the minimal blow-through damage on the bridge deck in case study #2, photographed after hydrodemolition, is shown in Figure 4-19.

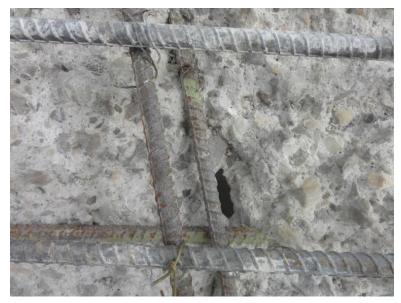
Figure 4-19: Insignificant blow-through of the deck in case study #2.

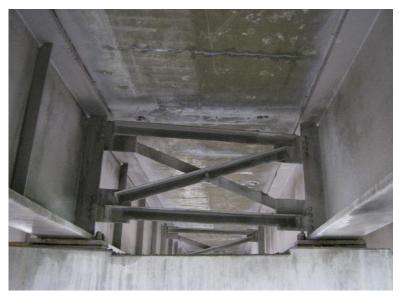
Figure 4-20: Insignificant efflorescence and cracking on the underside of the deck in case study #2.

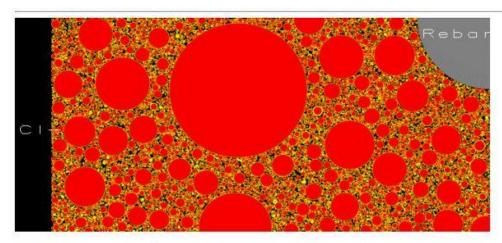
Prediction of a Chloride Ion Penetration Profile for a Concrete

Prediction is based on a one-dimensional finite difference solution of Fick's second law of diffusion, with a variable external chloride concentration and a two-layer representation of the concrete. Surface treatment option has been added in 2006 and mill and fill option added in 2007 in collaboration with Prof. Guthrie of Brigham Young University.

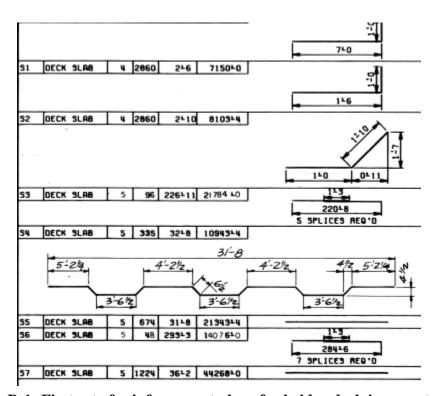
Figure B-1: First set of reinforcement plans for bridge deck in case study #1.

Figures B-1 and B-2 show the sections of the bridge plans that were used to determine identifiers for the bar sizes used for the blow-through analyses for case study #1. Figures B-3 and B-4 show the bridge plans that were used to determine bar sizes for transverse reinforcement and longitudinal reinforcement, respectively. Figures B-5 through B-13 show the blow-through analysis outputs for each of the nine scenarios that were analyzed for case study #1.

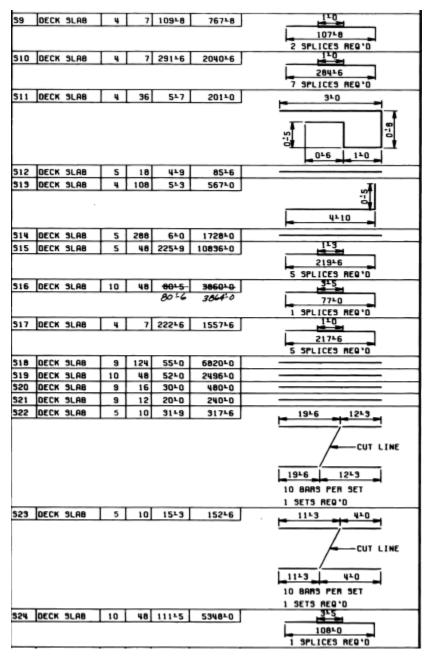
Figure B-2: Second set of reinforcement plans for bridge deck in case study #1.

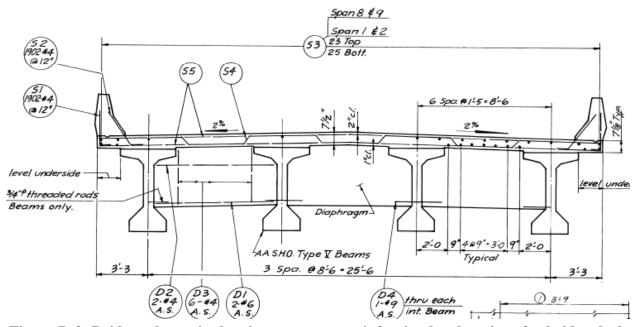
Figure B-3: Bridge schematic showing transverse reinforcing bar locations for bridge deck in case study #1.

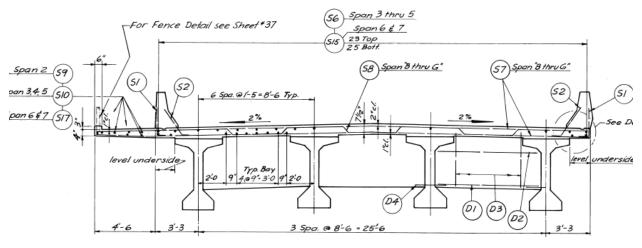
Figure B-4: Bridge schematic showing longitudinal reinforcing bar locations for bridge deck in case study #1.

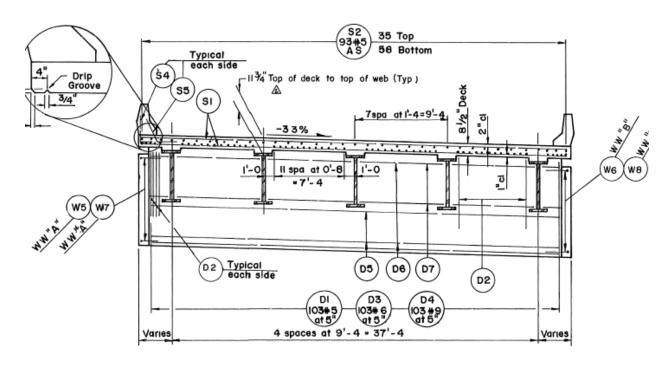
Figure C-2: Bridge schematic showing transverse reinforcing bar locations, deck thickness, and cover depths for bridge deck in case study #2.

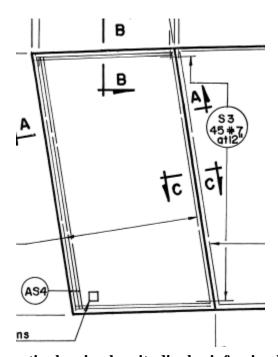
Figure C-3: Bridge schematic showing longitudinal reinforcing bar locations for bridge deck in case study #2.

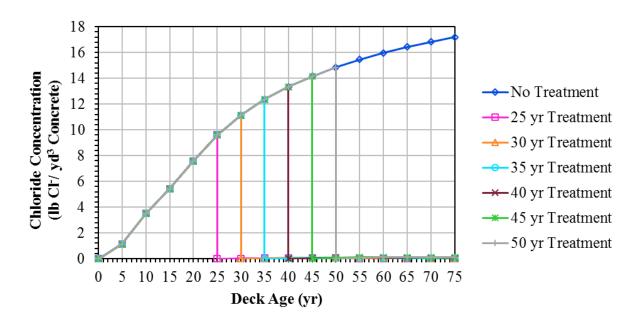
Figure D-1: Simulated chloride concentrations at the top mat of reinforcement for a deck with 2.0-in. OCD and a 3.375-in. removal depth with an applied surface treatment.

Figures D-1, D-2, and D-3 show the numerical modeling results for the top mat of reinforcing steel in a concrete bridge deck with a 2.0-, 2.5-, or 3.0-in. OCD, respectively, with an applied surface treatment.

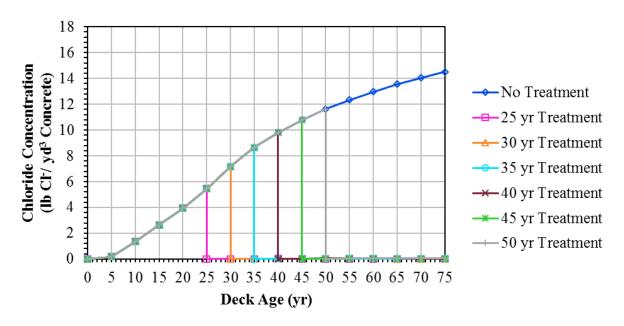
Figure D-2: Simulated chloride concentrations at the top mat of reinforcement for a deck with 2.5-in. OCD and a 3.875-in. removal depth with an applied surface treatment.

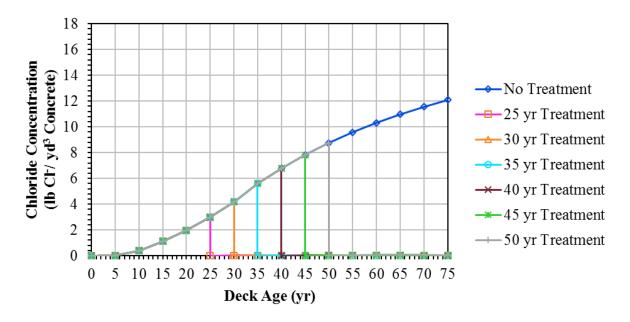
Figure D-3: Simulated chloride concentrations at the top mat of reinforcement for a deck with 3.0-in. OCD and a 4.375-in. removal depth with an applied surface treatment.

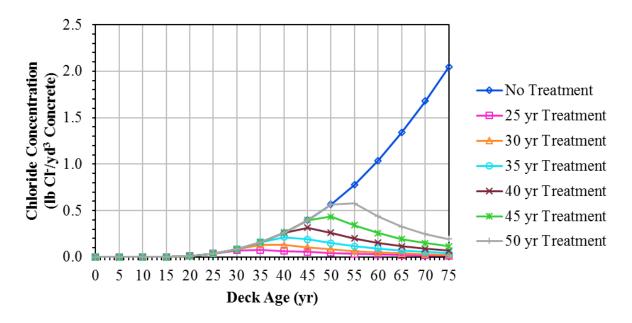
Figure E-1: Simulated chloride concentrations at the bottom mat of reinforcement for a deck with 2.0-in. OCD and a 3.375-in. removal depth with an applied surface treatment.

Figures E-1, E-2, and E-3 show the numerical modeling results for the bottom mat of reinforcing steel in a concrete bridge deck with a 2.0-, 2.5-, or 3.0-in. OCD, respectively, with an applied surface treatment.

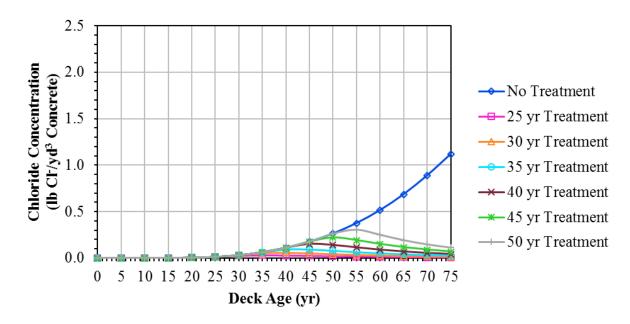
Figure E-2: Simulated chloride concentrations at the bottom mat of reinforcement for a deck with 2.5-in. OCD and a 3.875-in. removal depth with an applied surface treatment.

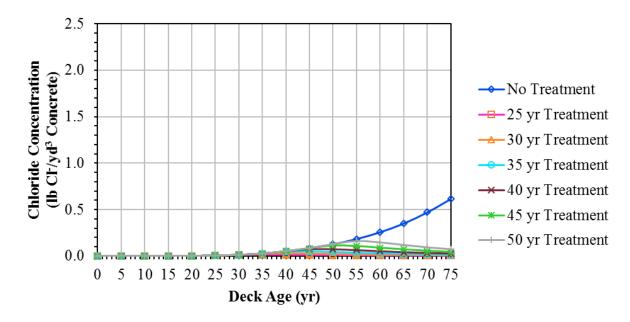
Figure E-3: Simulated chloride concentrations at the bottom mat of reinforcement for a deck with 3.0-in. OCD and a 4.375-in. removal depth with an applied surface treatment.

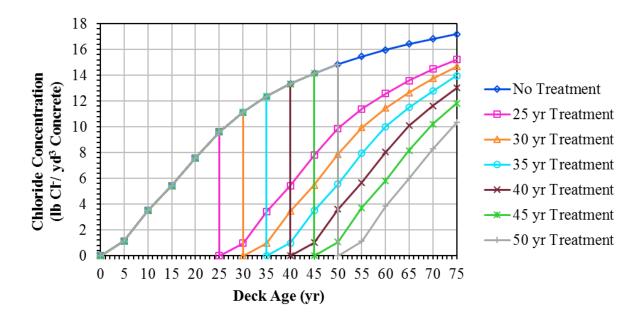
Figure F-1: Simulated chloride concentrations at the top mat of reinforcement for a deck with 2.0-in. OCD and a 3.375-in. removal depth without an applied surface treatment.

Figures F-1, F-2, and F-3 show the numerical modeling results for the top mat of reinforcing steel in a concrete bridge deck with a 2.0-, 2.5-, or 3.0-in. OCD, respectively, without an applied surface treatment.

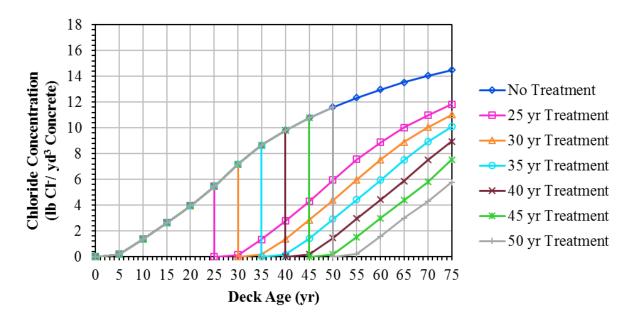
Figure F-2: Simulated chloride concentrations at the top mat of reinforcement for a deck with 2.5-in. OCD and a 3.875-in. removal depth without an applied surface treatment.

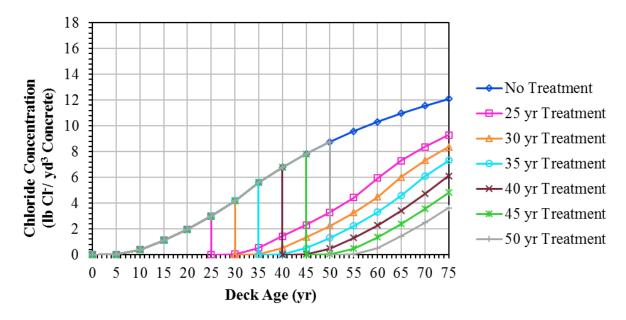
Figure F-3: Simulated chloride concentrations at the top mat of reinforcement for a deck with 3.0-in. OCD and a 4.375-in. removal depth without an applied surface treatment.

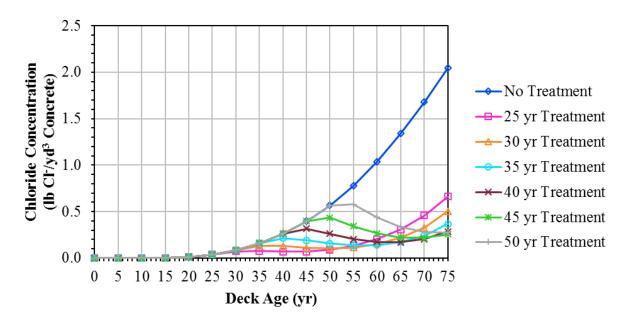
Figure G-1: Simulated chloride concentrations at the bottom mat of reinforcement for a deck with 2.0-in. OCD and a 3.375-in. removal depth without an applied surface treatment.

Figures G-1, G-2, and G-3 show the numerical modeling results for the bottom mat of reinforcing steel in a concrete bridge deck with a 2.0-, 2.5-, or 3.0-in. OCD, respectively, without an applied surface treatment.

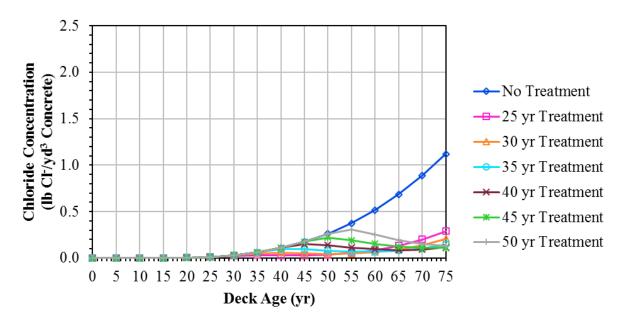
Figure G-2: Simulated chloride concentrations at the bottom mat of reinforcement for a deck with 2.5-in. OCD and a 3.875-in. removal depth without an applied surface treatment.

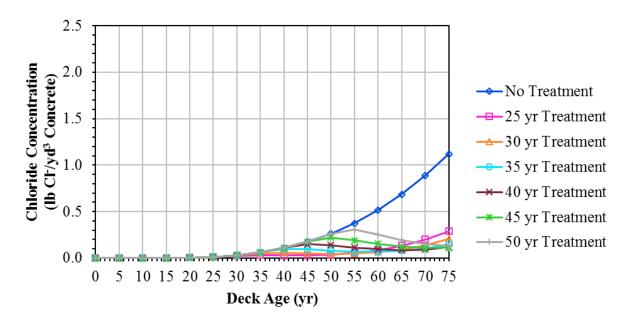
Figure G-3: Simulated chloride concentrations at the bottom mat of reinforcement for a deck with 3.0-in. OCD and a 4.375-in. removal depth without an applied surface treatment.
