PUBLIC ROADS

A JOURNAL OF HIGHWAY RESEARCH

VOL. 9, NO. 4

JUNE, 1928

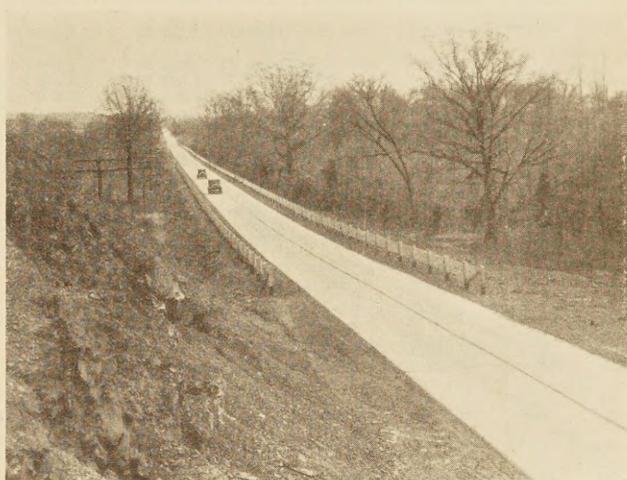
A TYPICAL SECTION OF THE ROAD

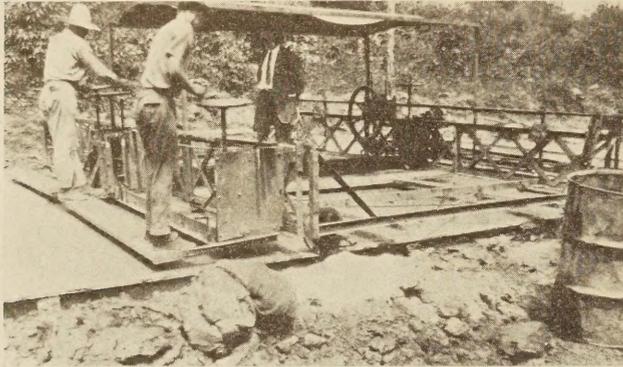
USING THE FLEX-PLANE APPARATUS

chines. It was used to install both longitudinal and transverse grooves and was adjustable so that it could be used on pavements up to 24 feet in width.

When a longitudinal groove was being installed a spading tool which operates as the machine is propelled forward first opened a preliminary groove by displacing or pushing aside the coarse aggregate. After the

machine has been moved forward a distance of 10 feet a V-shaped metal form was forced into the depression by means of a mandrel and two compression screws on the machine. The mandrel was then raised and moved out of line. The machine was again propelled forward and another form placed. These two forms are then connected and held in horizontal alignment by an expanding bar. In the installation of a transverse groove a form is set on a mandrel and forced into the undisturbed pavement surface by means of

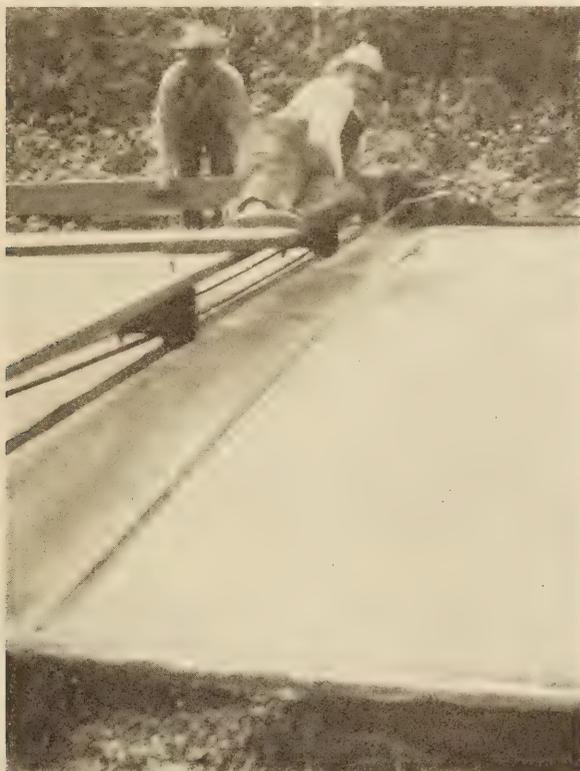
FINISHING LONGITUDINAL AND TRANSVERSE PLANES OF WEAKNESS WITH STEEL STRIPS IN PLACE

Planes of weakness.—The planes of weakness or impressed grooves were approximately 2½ inches deep by one-fourth inch wide at the base and from one-half inch to 1 inch wide at the top and were installed with a special machine, the Flex-Plane. The machine bridged the pavement slab and traveled on the side forms immediately behind the hand screeds or finishing ma-

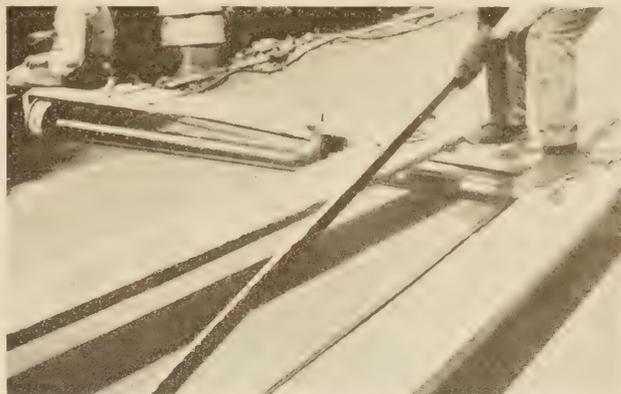
REMOVING STRIP FROM LONGITUDINAL PLANE OF WEAKNESS

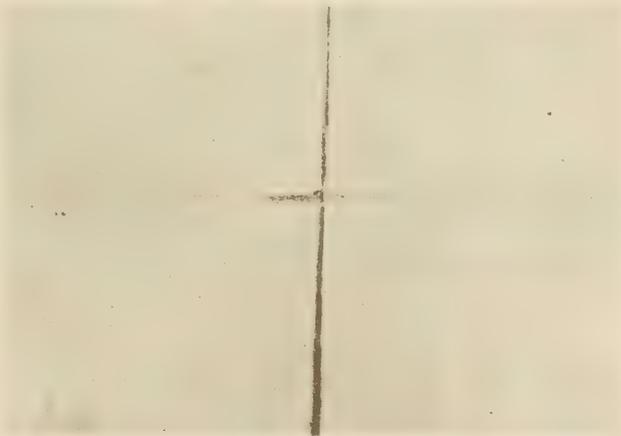
LONGITUDINAL PLANE OF WEAKNESS JUST AFTER REMOVAL OF STRIP

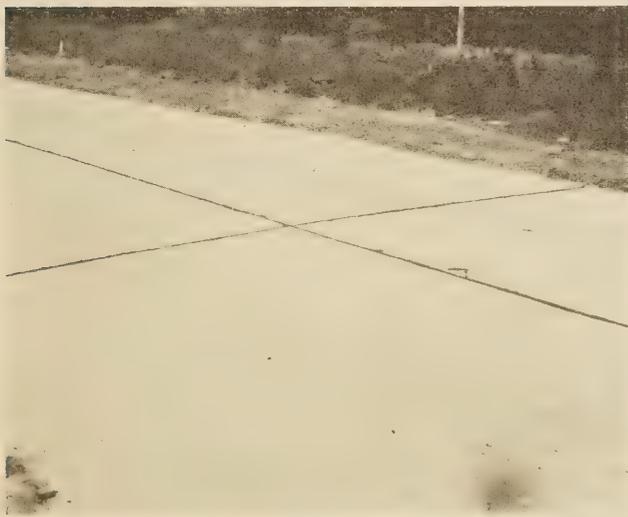
TRANSVERSE AND LONGITUDINAL PLANES OF WEAKNESS

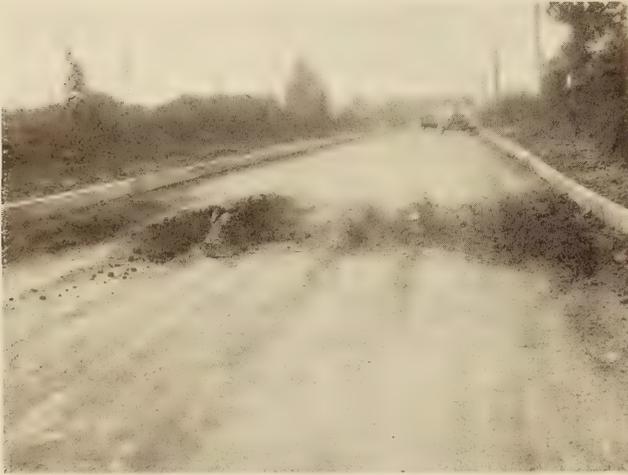
The accompanying illustration shows a subgrade condition resulting from the variable stability of the soil encountered in certain locations. All such outstanding conditions that existed or developed in the grade during the course of construction were fully described and classified and it is expected that information concerning the influence of such conditions upon slab behavior will be obtained from these locations.

BADLY RUTTED SECTION OF SUBGRADE

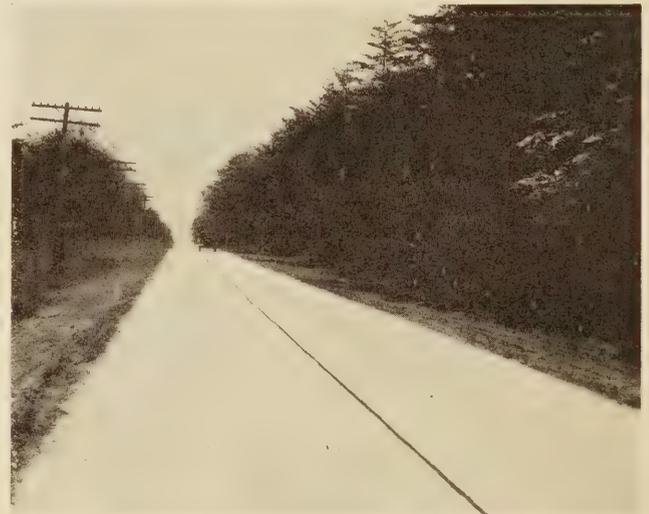
TYPICAL CONDITION OF PAVEMENT IN MAY, 1928

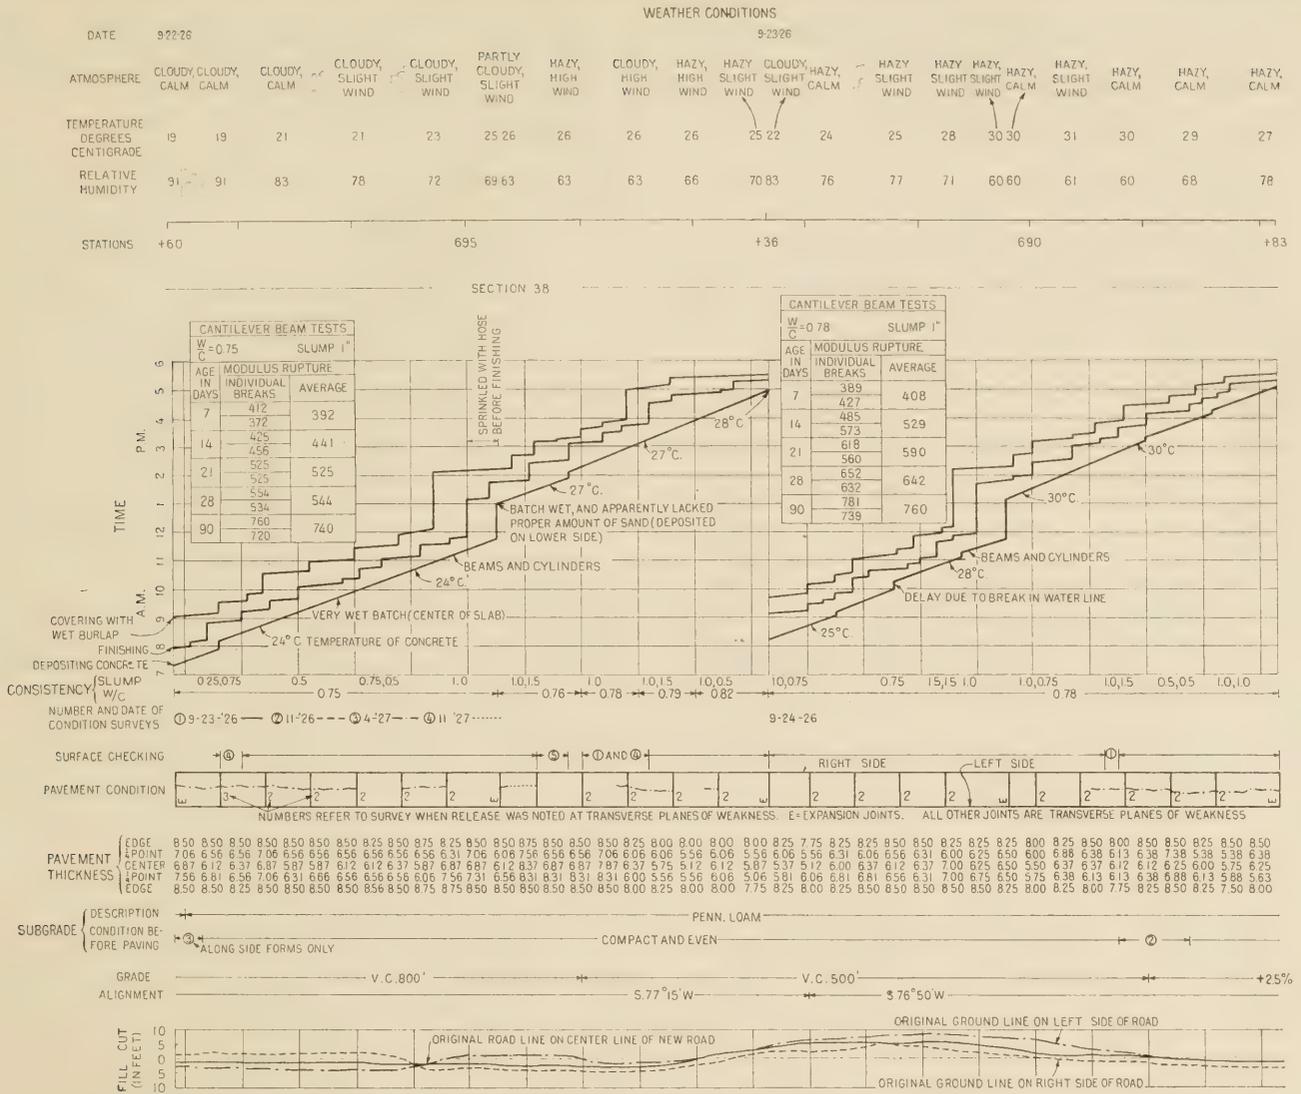
FIG. 1.—TYPICAL RECORD OF CONSTRUCTION OPERATIONS AND CONDITIONS. THE CONDITION OF THE SUBGRADE AND SURFACE CHECKING ARE EACH INDICATED BY CODE NUMBERS, THE KEY TO WHICH IS NOT GIVEN

These records give in detail the time of depositing the concrete and the time of finishing and covering the pavement with wet burlap. They give the slump, the water-cement ratio, and the temperature of the concrete at the time of depositing. The condition of the atmosphere as regards wind, clearness, humidity, and temperature when the concrete was poured is shown. They indicate the thickness of the slab at 25-foot intervals and contain information on the subgrade such as a description of the soil type and condition of the grade immediately prior to paving. The depth and extent of the cuts and fills at the center line of the road and the relative position of the ground line on either side are shown by a profile. They give a picture of the condition of the pavement at 24 hours after the curing periods and at subsequent periods.

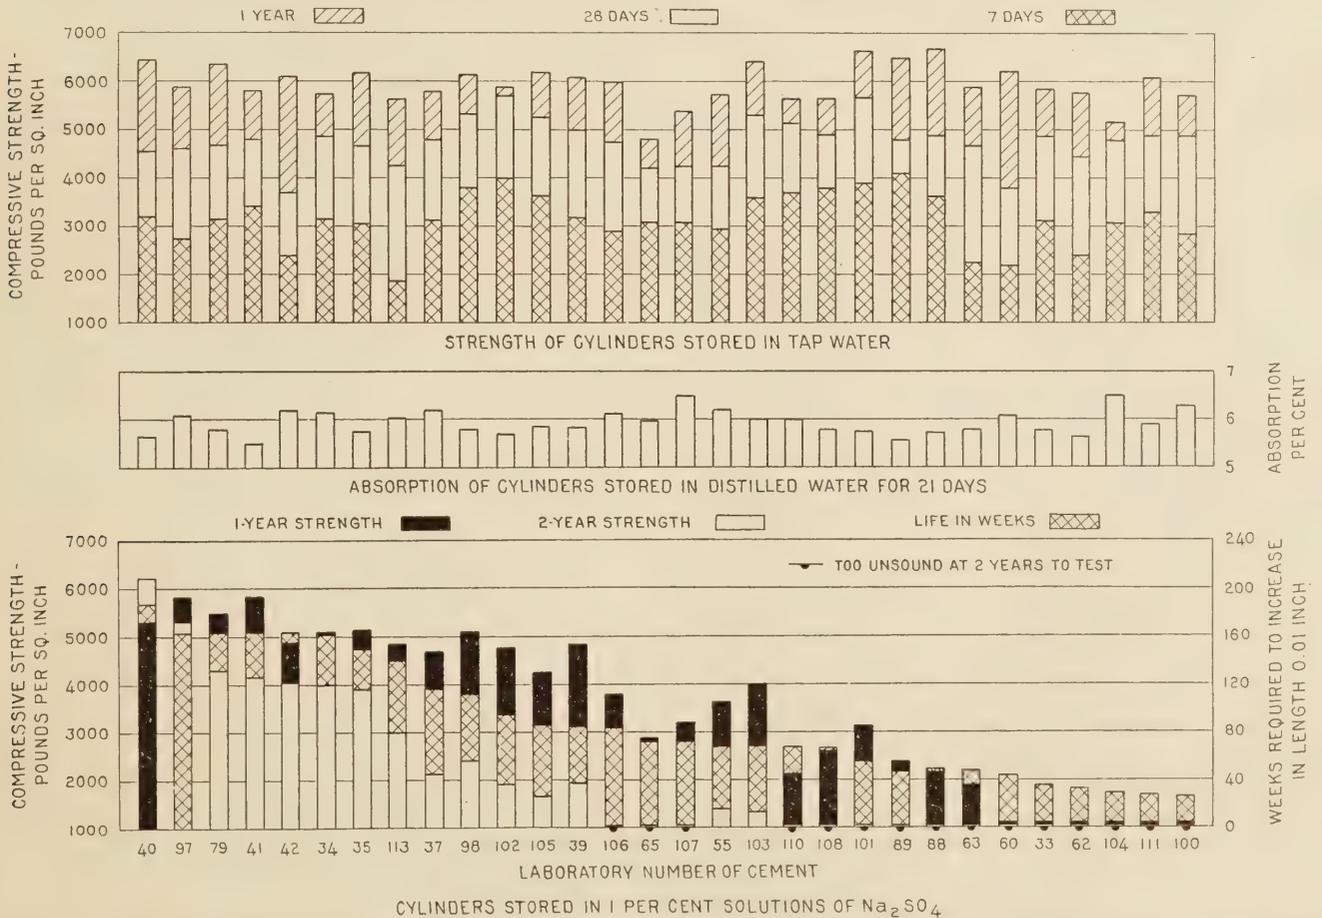
FIG. 1.—STANDARD PORTLAND CEMENTS FROM DIFFERENT PLANTS COMPARED TO SHOW INFLUENCE ON STRENGTH OF CONCRETE, ABSORPTION OF CONCRETE, AND RESISTANCE TO A 1 PER CENT SOLUTION OF SODIUM SULPHATE

Results of tests of the cylinders stored in the laboratory solutions are compiled in Table 2 and shown graphically in Figure 1. Figure 2 illustrates the wide range of condition of cylinders of different series at two years. Results of tests of the cylinders stored in Medicine Lake are given in Table 3. The strength ratios of cylinders at one year, for both exposure conditions, have been calculated assuming normal strength to be that of the check cylinders from the laboratory tank. These results for the 22 cements subjected to the two different exposure conditions are set forth in Table 4.

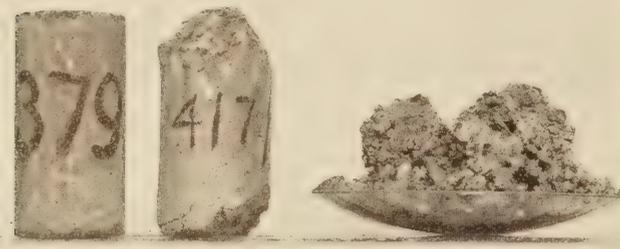
FIG. 2.—CONDITION OF CYLINDERS FROM SERIES 379, 417, AND 406 AT END OF TWO YEARS, SHOWING WIDE DIFFERENCES IN RESISTANCE TO SULPHATE WATER

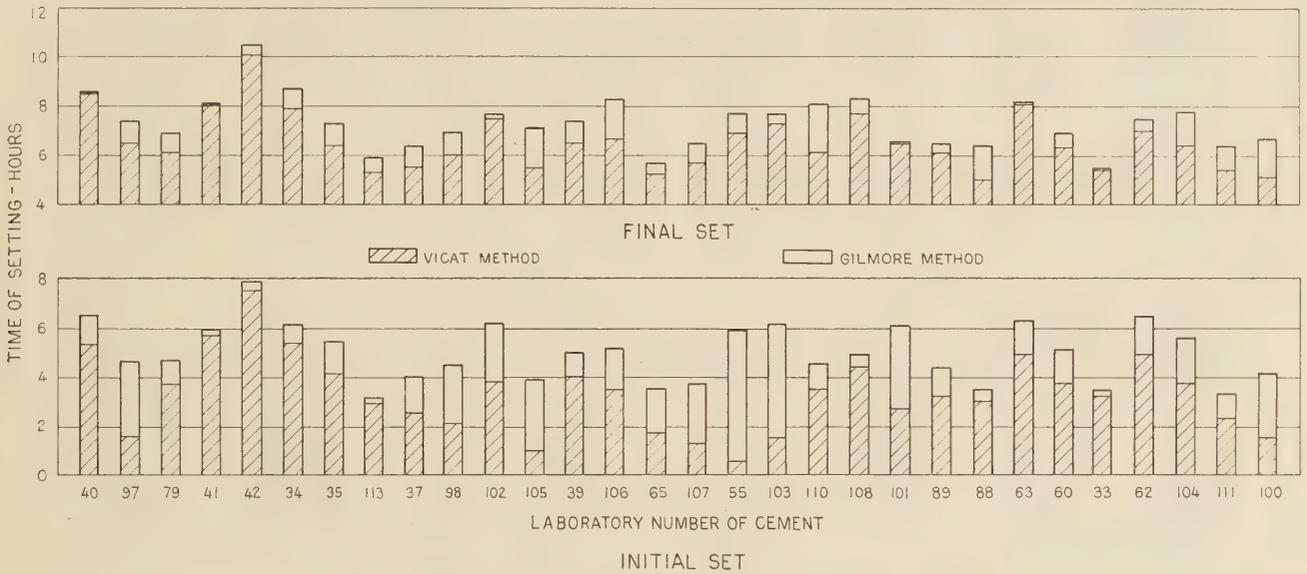
FIG. 3.—RESULTS OF STANDARD TESTS FOR TIME OF SETTING

Results of the standard physical tests of the 30 cements are shown in Figures 3, 4, and 5, and it requires but cursory study to see the futility of using any of the standard physical tests as an index of the behavior of any particular Portland cement in resisting the action of sulphate-bearing waters.

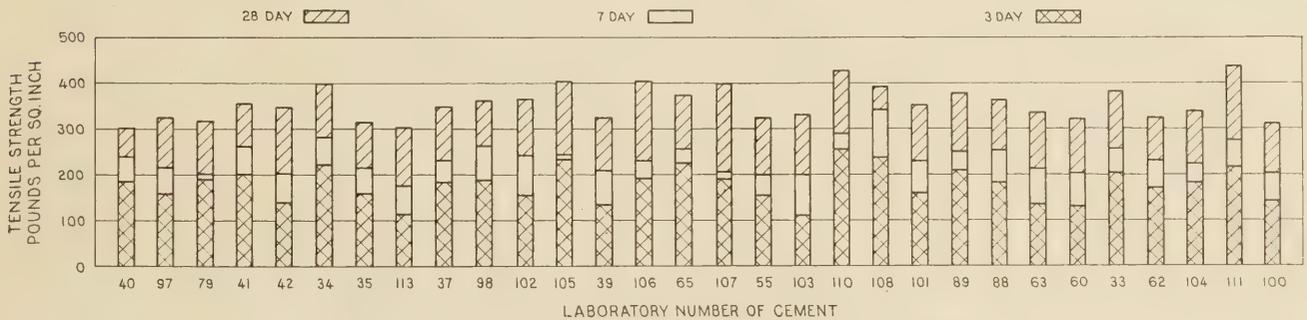
FIG. 4.—RESULTS OF STANDARD TENSILE TESTS OF BRIQUETS

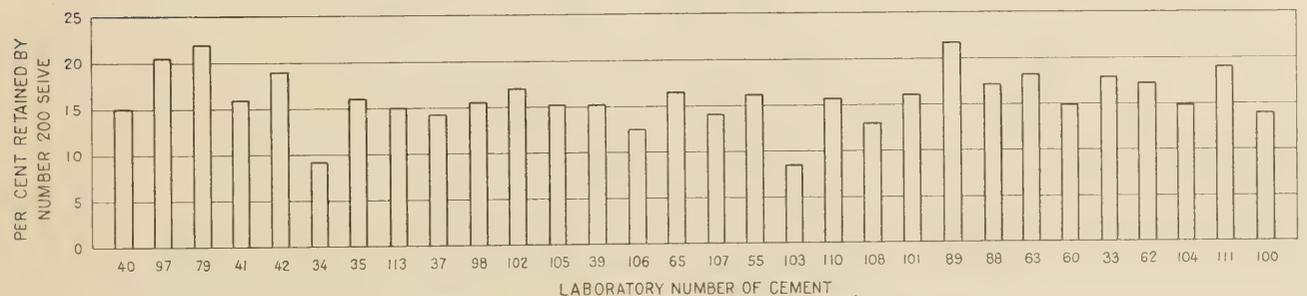
FIG. 5.—RESULTS OF STANDARD FINENESS TESTS OF CEMENT

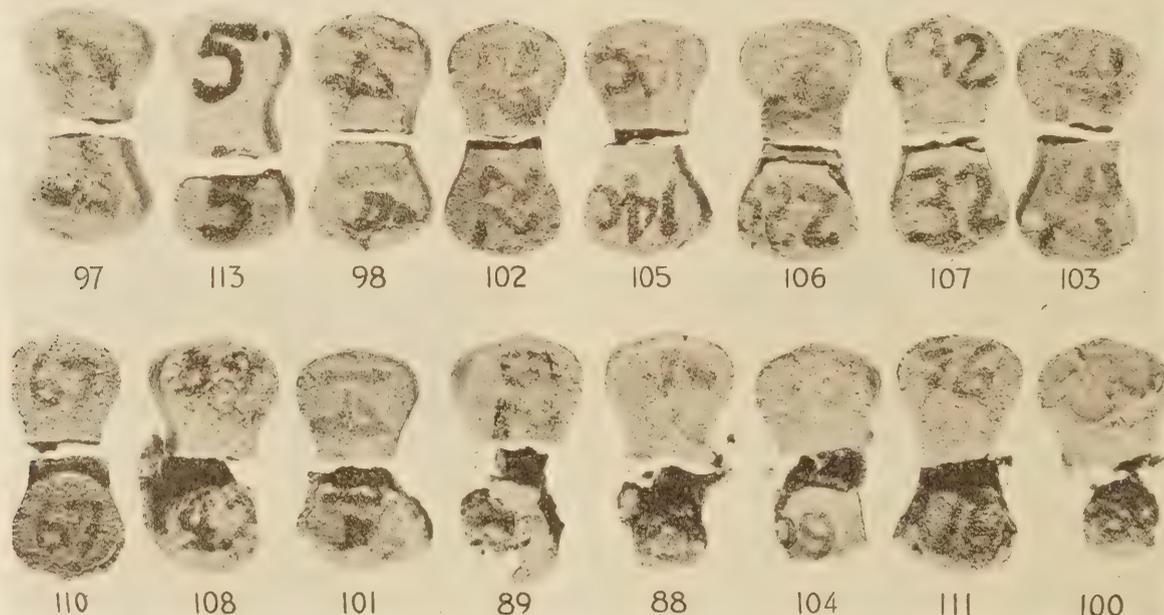
FIG. 6.--CONDITION OF BRIQUETS AFTER IMMERSION IN 1 PER CENT SULPHATE SOLUTIONS FOR SIX MONTHS. IN EACH CASE THE UPPER HALF OF BRIQUET WAS IMMERSIED IN MAGNESIUM SULPHATE SOLUTION AND THE LOWER HALF IN SODIUM SULPHATE SOLUTION. BRIQUETS MADE WITH STANDARD CEMENT FROM 16 DIFFERENT PLANTS ARE SHOWN

Figure 6 shows briquets from the laboratory solutions at six months, in all cases the upper half coming from a 1 per cent magnesium sulphate solution and the lower half from a 1 per cent sodium sulphate solution. It is evident from this illustration that deterioration had progressed much further in the sodium sulphate solution at six months than had action in the magnesium sulphate solution. Considered alone from the standpoint of an accelerated test, immersion in a 1 per cent sodium sulphate solution is the most promising.

In the lower half of Figure 7 the ratings at six months of the half briquets from the 1 per cent solutions of sodium sulphate (see fig. 6) on the basis of visual appearance are compared with the strength ratios at one year of cylinders in which the same cements were used.

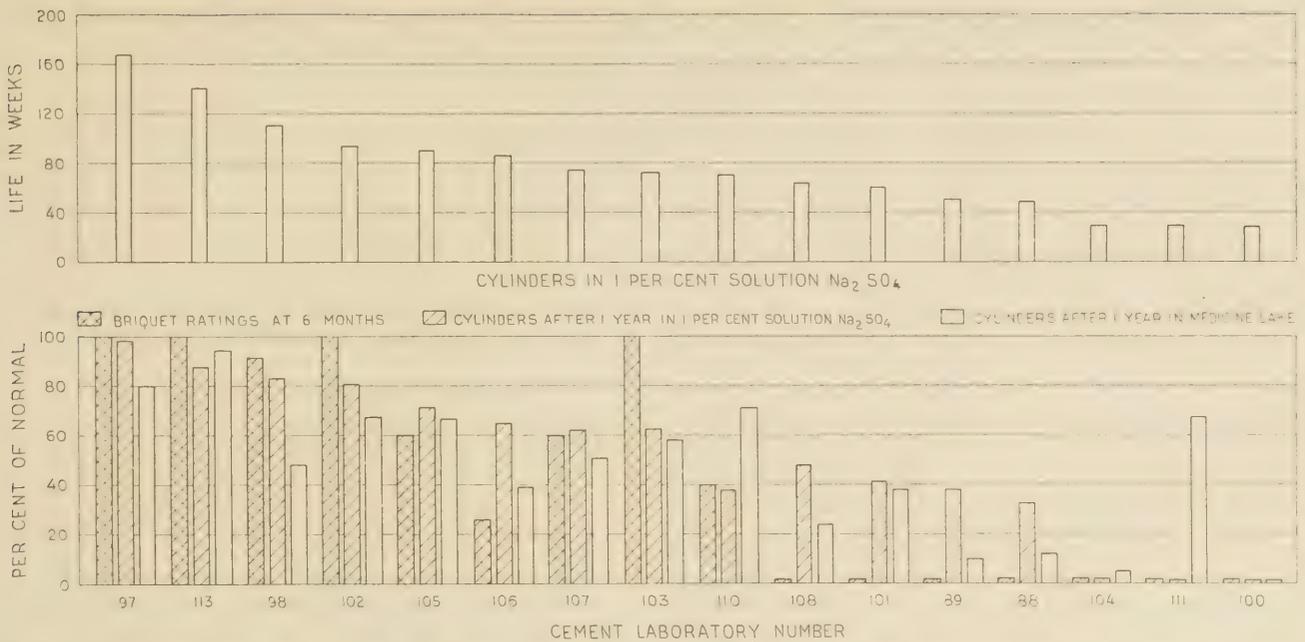
FIG. 7.—RESISTANCE TO THE ACTION OF SULPHATE WATER BY STANDARD PORTLAND CEMENTS FROM 16 PLANTS AS DETERMINED AFTER DIFFERENT CONDITIONS OF EXPOSURE. NOTE THE GENERAL RELIABILITY OF THE BRIQUET RATINGS BY VISUAL INSPECTION AS COMPARED WITH THE CHANGE OF VOLUME AND COMPRESSION TESTS OF THE CYLINDERS

(See Table 4.) Study of Figure 7 justifies the statement that the acceptance or rejection of any of these 16 cements on the basis of the appearance of the briquets at six months would not have been very far wrong, when the action of the cylinders under both exposure conditions is considered. These comparisons are based on tests of specimens made entirely independently of each other without having in mind at the time a correlation of the data. They are in no sense selected tests, as the only reason for choosing the particular 16 cements used is that they were the only Portland cements on which the tests under three conditions of exposure had been made.

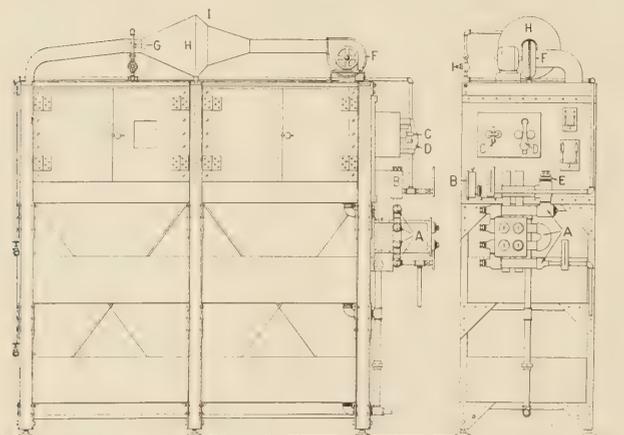
FIG. 1.—MOIST CLOSET AND STORAGE TANKS WITH HUMIDIFYING AND TEMPERATURE CONTROL APPARATUS

The tanks and moist closet shown in Figure 1 are made of soapstone and supported by a steel frame.

The second feature of interest is the fuse plug (fig. 1, E) which protects the heating coils against burning out. In the past the coils have burnt out by overheating resulting from stoppage of the valves or pipe line with sediment or from the water supply being shut off without the knowledge of the laboratory personnel. When either happens the water in the pipe coils quickly reaches the boiling point and the heating element is destroyed. To prevent this, the

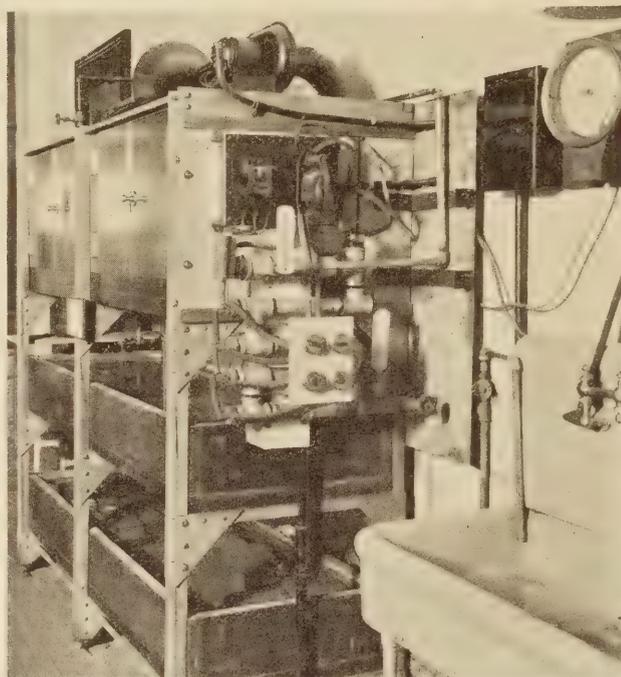
FIG. 2.—GENERAL VIEW OF CLOSET AND STORAGE TANKS

Three-inch channels were used as the main members of the frame and the assembly was joined and stiffened with gusset plates and tension rods. The completed apparatus is thoroughly rigid and shows no structural weakness. Leveling screws were necessary on each foot because of the unevenness of the laboratory floor. Figure 2 shows a view of the complete installation.

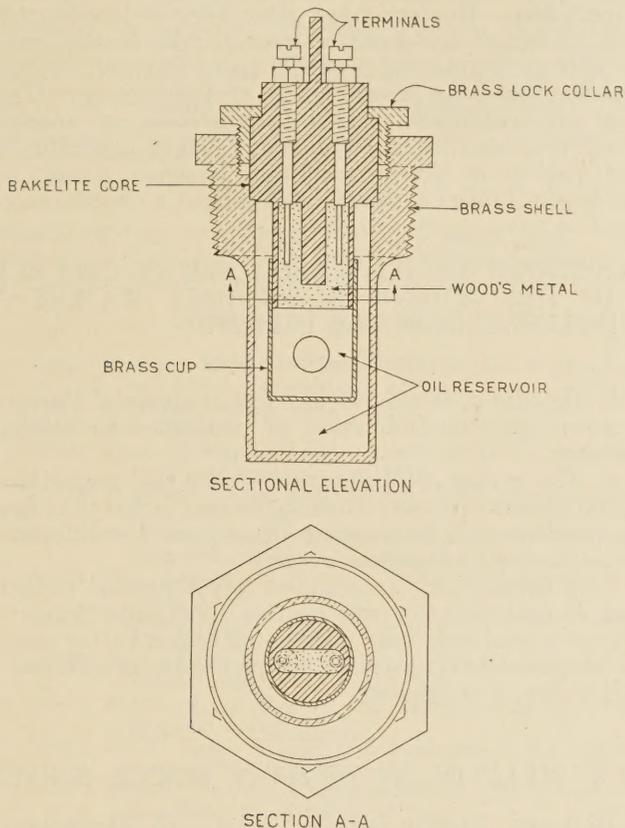
FIG. 3.—DETAILS OF FUSE PLUG

fuse plug is inserted in the pipe coil just beyond the last heating element. This plug, shown in Figure 3, is inserted in one side of the line from the main switch to the heating coils. It consists of a brass shell, threaded to screw in a 2-inch standard tee, a bakelite center core, and a brass lock collar which holds the bakelite core in position. Brass terminals are mounted in the bakelite core and project into the interior opening. Contact is made between the two terminals by Wood's metal, an alloy of bismuth, lead, tin, and cadmium, which melts at about 60½° C.

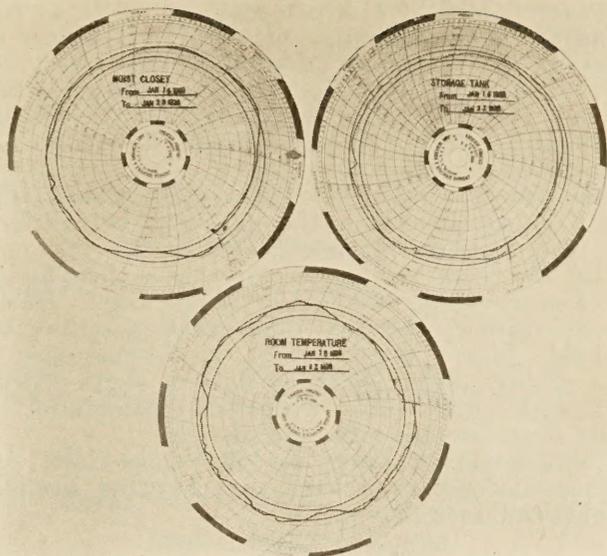
FIG. 4.—TYPICAL TEMPERATURE RECORDS
