PUBLIC ROADS

A JOURNAL OF HIGHWAY RESEARCH

VOL. 13, NO. 8

OCTOBER, 1932

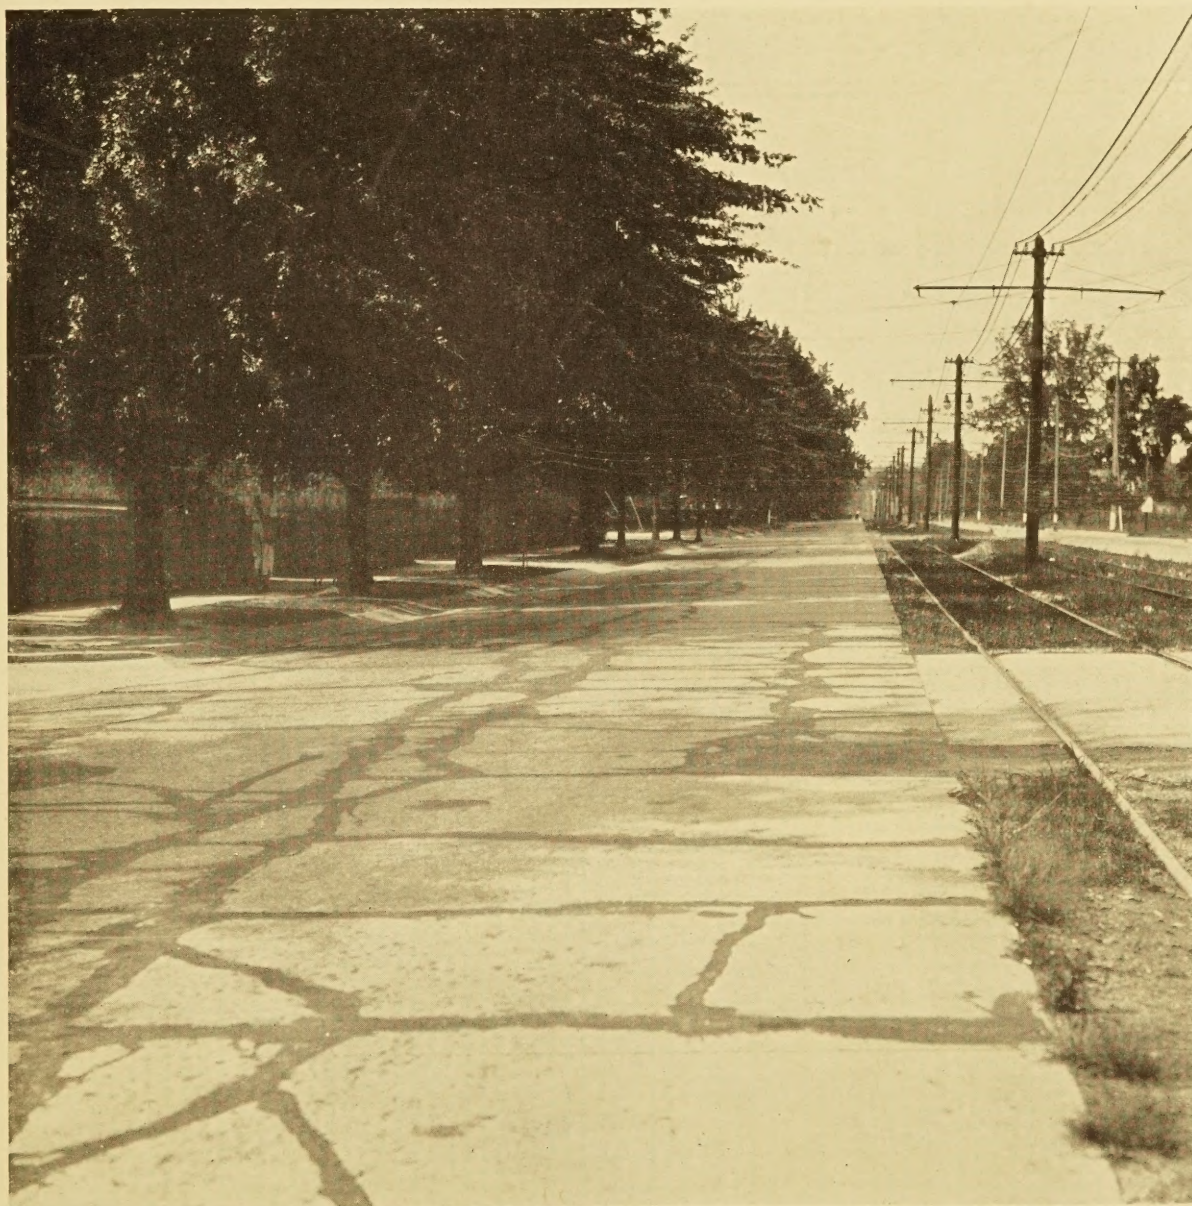
A PORTLAND CEMENT CONCRETE PAVEMENT IN ITS TWENTIETH YEAR

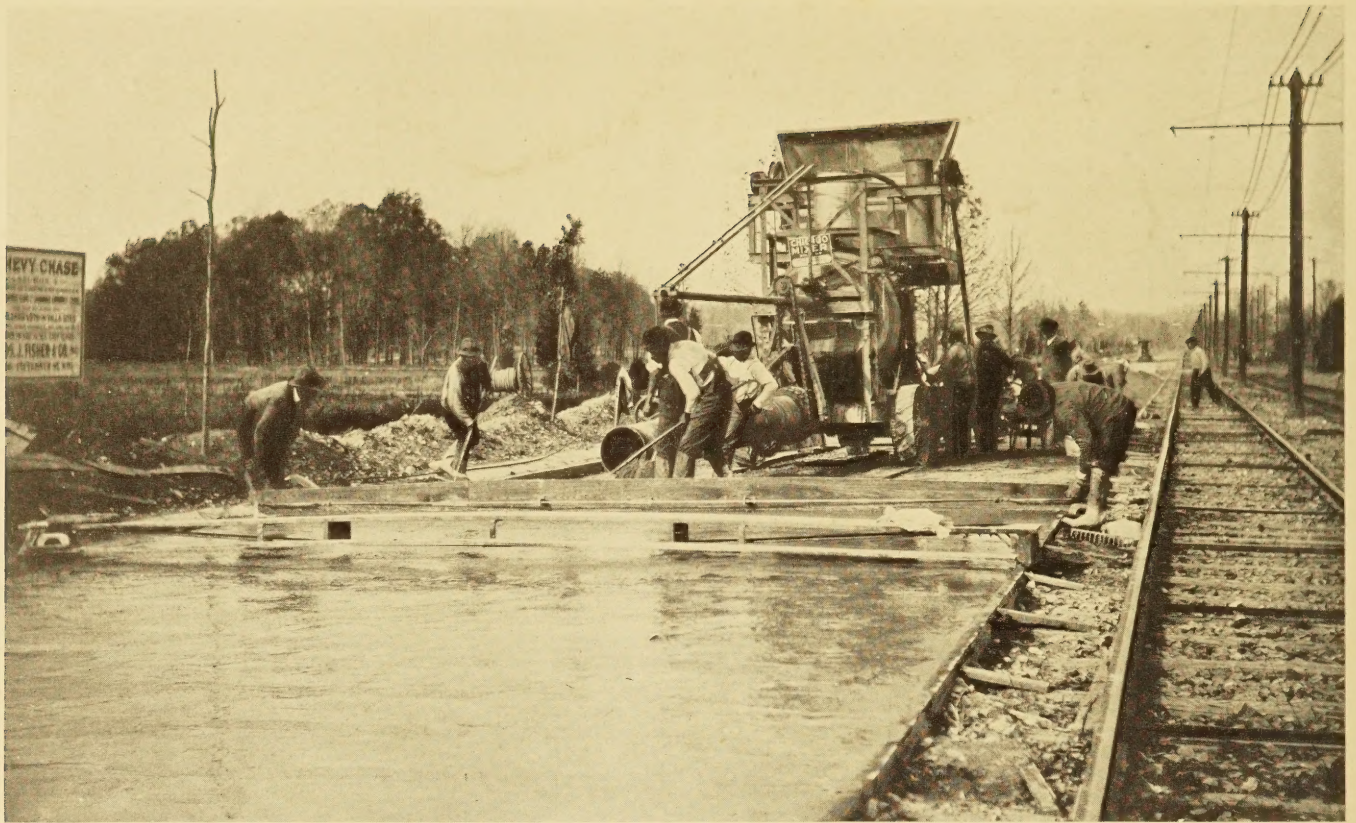
CONCRETE CONSTRUCTION ON CONNECTICUT AVENUE EXPERIMENTAL ROAD, NOVEMBER, 1912

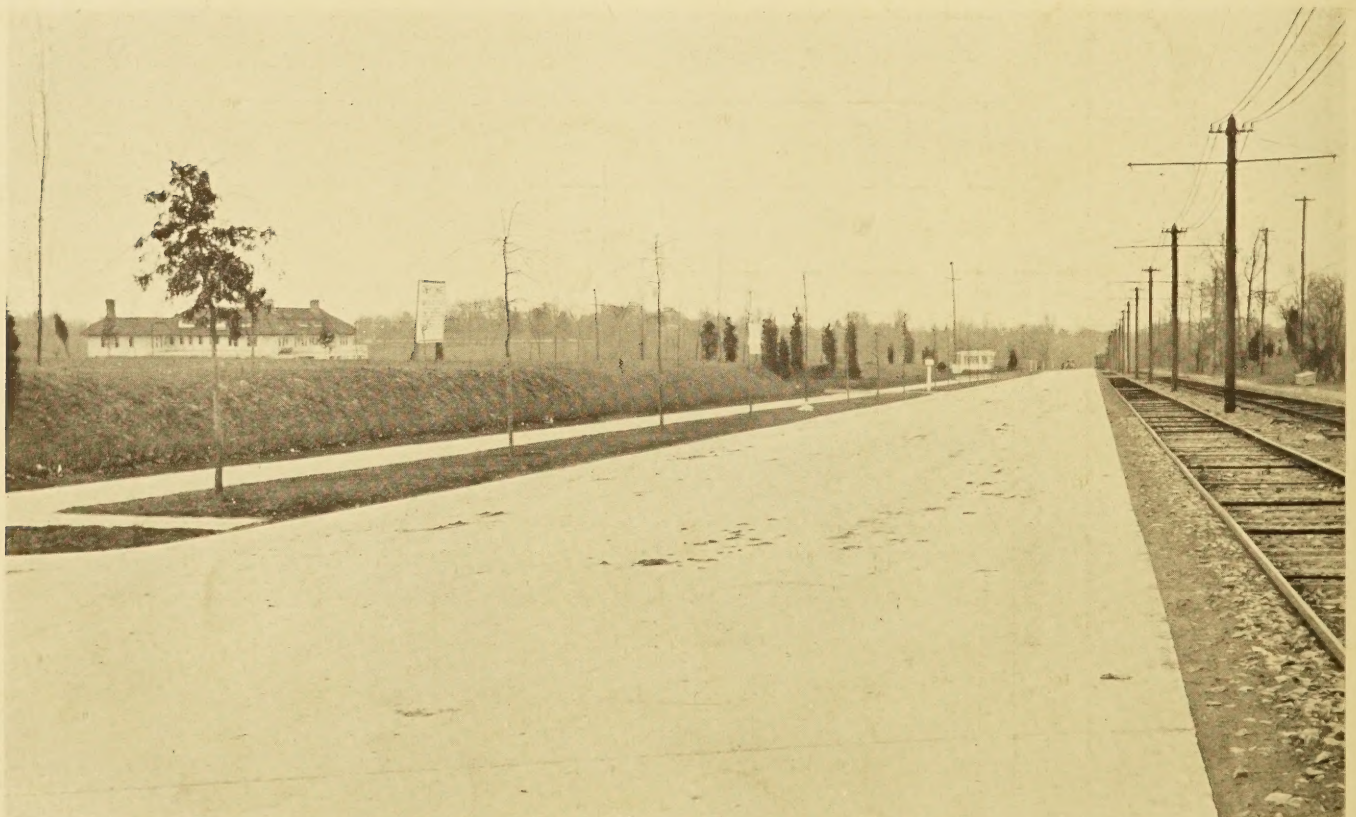
CONDITION OF CONCRETE SURFACE IN APRIL, 1914

The subgrade on which the Connecticut Avenue experimental road was constructed is a silty loam with varying percentages of mica. Excessive mica causes detrimental elasticity in soils, and this fact may account in part for the large amount of cracking which has occurred in the concrete sections.

It is also believed that defective drainage has had a great deal to do with the deterioration of the concrete. In February, 1929 (see PUBLIC ROADS, vol. 11, No. 4, June, 1930), immediately after a heavy rain, it was noted that a considerable volume of water was flowing to the surface of the concrete sections through the cracks. This condition was found throughout the concrete portion of the experiment, although it was most severe on experiment 3. It was also observed that the sewers were not receiving any flow from either side drain or through the cross drains. Upon digging down into the French drains it was found that wherever one of the utility companies had made a cut through the drain line, it had failed to replace either tile or stone and had backfilled the trench with earth, thereby effectively destroying the drainage system. It was learned from the records of the sanitary commission that most of the service connections were made in 1922. It is also a fact that the cost of maintaining the concrete sections has materially increased since that year. The total cost of maintenance to date, including the surface treatment in 1922, amounts to 37.71 cents per square yard.
