PUBLIC ROADS

A JOURNAL OF HIGHWAY RESEARCH

VOL. 13, NO. 9

ROAD IMPACT PRODUCED BY A HEAVY MOTOR BUS

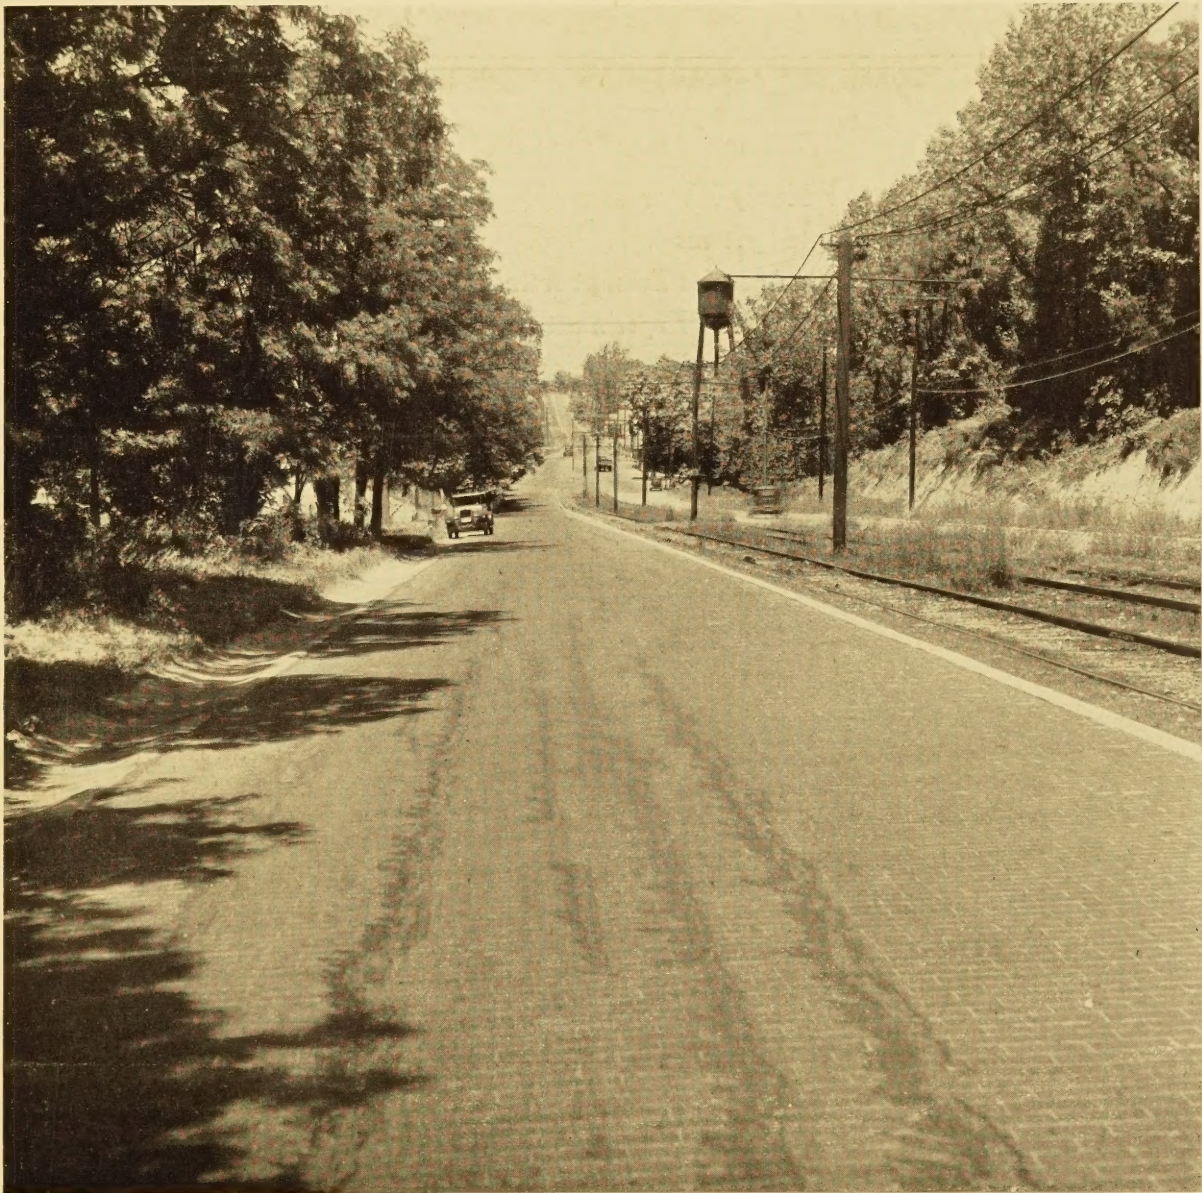
A BRICK PAVEMENT 19 YEARS AFTER ITS CONSTRUCTION

Experiment No. 6, the most northerly portion of the Connecticut Avenue experimental road, was constructed of vitrified brick on a foundation of 1:3:7 gravel concrete. The photographs on the back cover of this issue show the method of construction and the appearance of the surface shortly after completion. The front cover shows the condition of the pavement in the summer of 1932 after 19 years of service.

The brick section remains in excellent condition, showing little wear and no indication of failure under a traffic of approximately 3,000 vehicles per day.

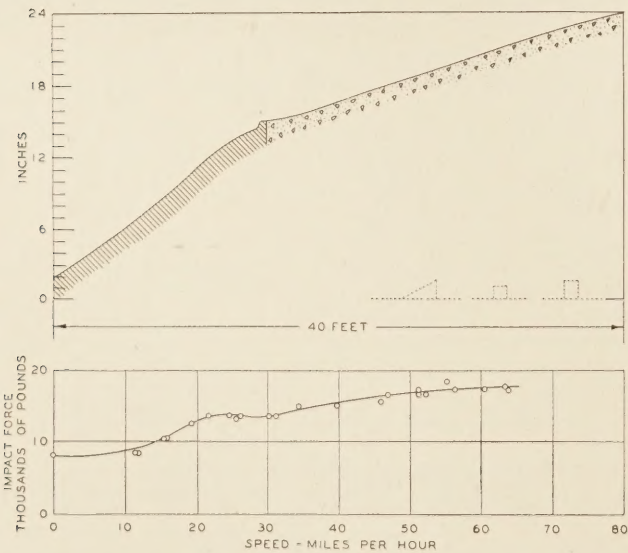
FIGURE 13.—IMPACT REACTIONS PRODUCED ON A CONCRETE BRIDGE BY THE SHARP RISE TO THE BRIDGE FROM A ROAD AT A LOWER GRADE

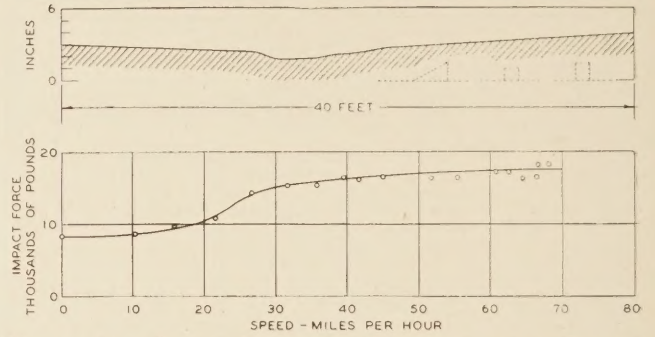
FIGURE 14.—IMPACT REACTIONS PRODUCED ON A BITUMINOUS PAVEMENT BY SETTLEMENT OF BACK-FILL OVER A CULVERT PIPE

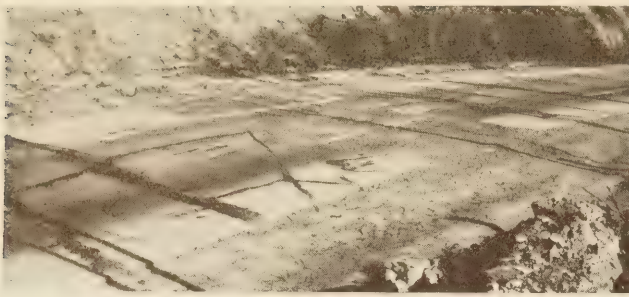
FIGURE 20.—IMPACT REACTIONS PRODUCED ON A CONCRETE ROAD AT A SHARP VERTICAL CURVE AT THE TOP OF A HILL

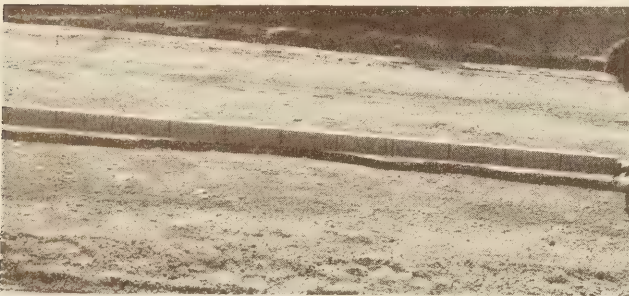
FIGURE 21.—IMPACT REACTIONS PRODUCED ON AN OILED GRAVEL ROAD BY CORRUGATIONS ON A STEEP GRADE

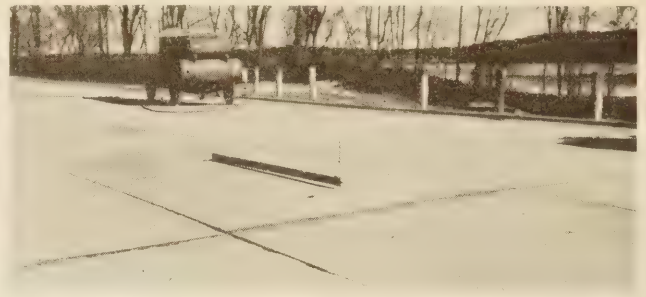
FIGURE 22.—IMPACT REACTIONS CAUSED BY THE UNEVEN SETTLEMENT OF FILL UNDER A NEW CONCRETE PAVEMENT. THE MASONRY UNDERPASS OF A GRADE SEPARATION LIES DIRECTLY UNDER THE HUMP IN THE GRADE

The natural obstructions used in the second phase of the program represent the worst which could be found at places where reasonable speeds could be attained in an area of more than 1,100 square miles, involving about 400 linear miles of primary and secondary roads in the vicinity of Washington, D. C. Tests were conducted at 28 locations throughout the full range of safe speeds possible at each. The load condition was the same as in the tests involving artificial obstructions. The dual 9.75-24 inch tires were used in tests at all locations, and in one case (fig. 22) additional tests were made with the single 12.75-24 inch tire.

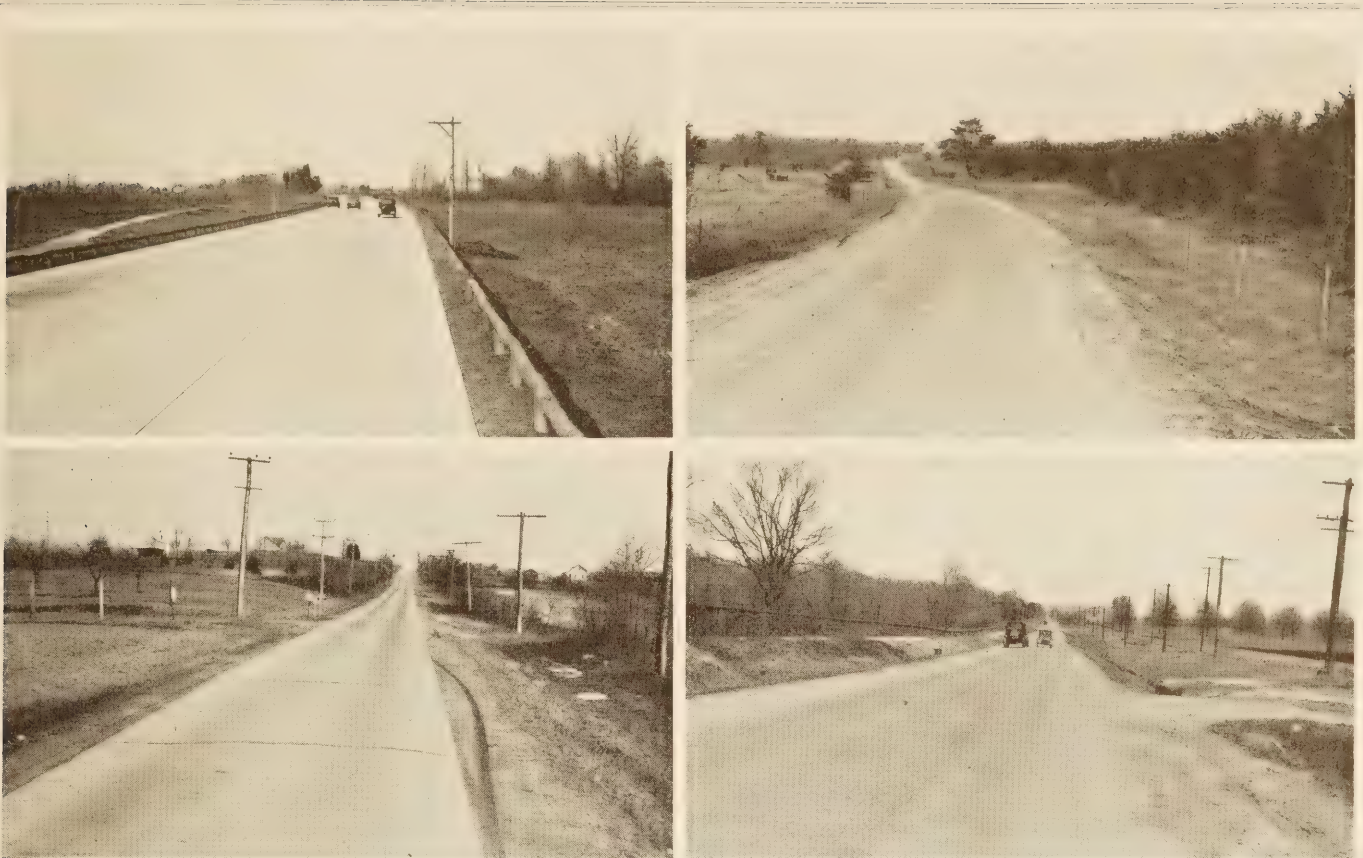
UPPER.—THE SMOOTHEST CONCRETE SURFACE TESTED
LOWER.—THE ROUGHEST CONCRETE SURFACE TESTED

UPPER.—THE SMOOTHEST BITUMINOUS SURFACE TESTED
LOWER.—THE ROUGHEST BITUMINOUS SURFACE TESTED

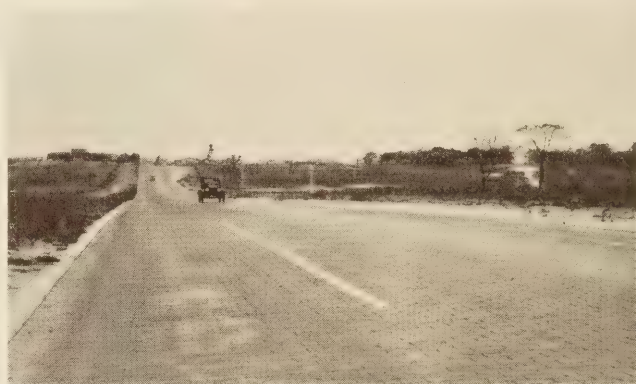
40-FOOT BRICK PAVEMENT NORTH OF AKRON, OHIO

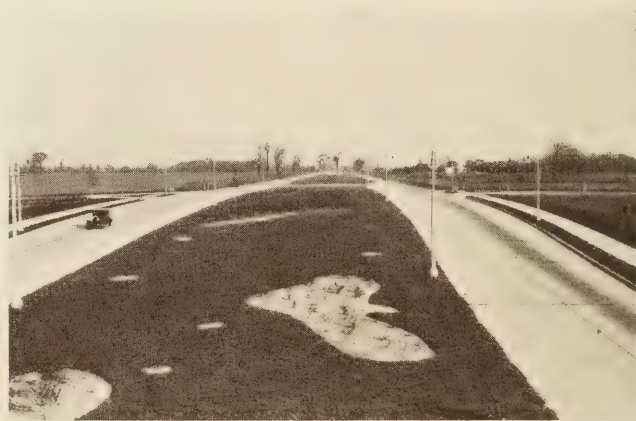
DUAL HIGHWAY BETWEEN DETROIT AND ANN ARBOR, MICH.

The dual road, in which the opposing traffic streams are separated by parkway or car tracks, has distinct advantages from the standpoint of safety, in addition to the opportunities for landscape treatment afforded by a central parkway. The increased width of right of way required and the cost of improving the separat-

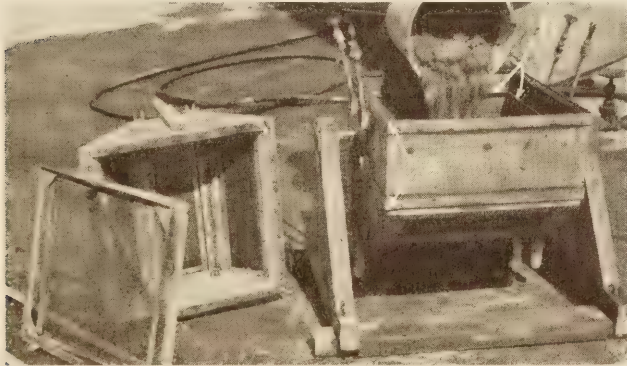
FIGURE 1.—THE SAMPLE OF FRESH CONCRETE TO BE ANALYZED IS PLACED ON THE NO. 4 SIEVE WHICH IS DIRECTLY BELOW THE PERFORATED PIPE AND ATTACHED TO BASE FRAME "A." ANOTHER SIEVE IS PLACED ON CLEATS "B" ABOVE THE PIPE

As may be seen in Figures 1 to 4, this machine consists of an octagonal drum mounted on a frame. No.

The sample of fresh concrete is placed in the inner compartment on the lower No. 4 sieve which is attached to the base frame. The upper No. 4 sieve is then placed in position, and frame C, which holds this sieve firmly in place, inserted; thus confining the coarse aggregate so that it will not wear out the No. 100 sieve inserted in the top cover. The cover is then clamped in position, the water turned on, and the drum revolved and shaken until all material that will pass the No. 100 sieve has been washed out. By holding the drum so that the No. 4 sieves are in a horizontal plane and shaking the apparatus the fine aggregate is washed down through these sieves and is separated from the coarse aggregate. The fine aggregate is then removed in the bottom cover. After removing the upper No. 4 sieve and re-

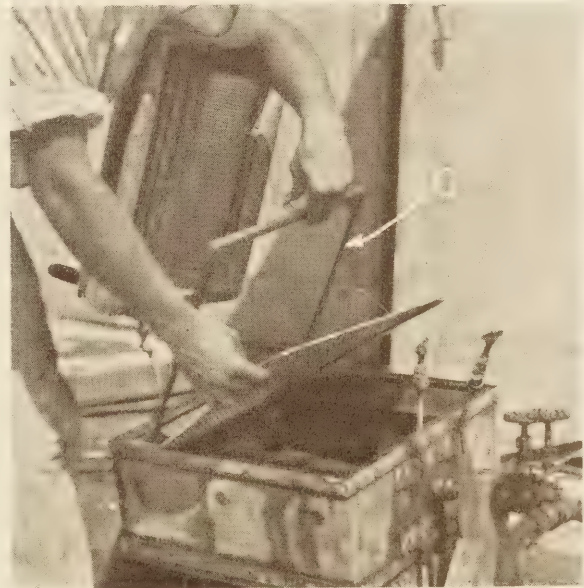
FIGURE 2.—FRAME C IS PLACED OVER THIS NO. 4 SIEVE. THIS FRAME COMES IN CONTACT WITH THE TOP COVER AND HOLDS THE SIEVE FIRMLY IN PLACE. THE TOP COVER IS THEN CLAMPED IN POSITION AND THE WATER TURNED ON

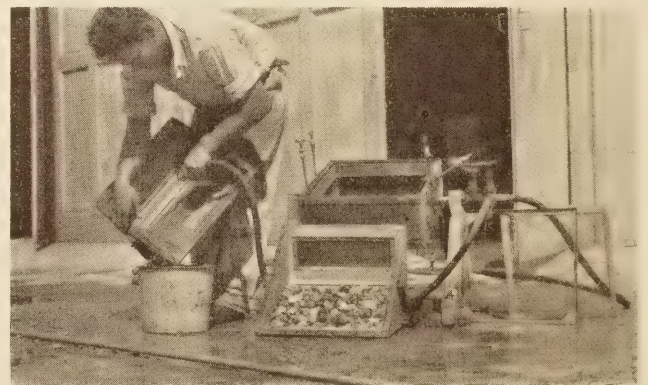
FIGURE 4.—AFTER ALL MATERIALS PASSING THE NO. 100 SIEVE HAVE BEEN WASHED OUT, THE COARSE AND FINE AGGREGATES ARE SEPARATED AND REMOVED FROM THE MACHINE. THE FINE AGGREGATE IS BEING REMOVED FROM THE BOTTOM COVER. THE COARSE AGGREGATE IS IN THE TOP COVER

volving the drum, with the top cover in place, the coarse aggregate is removed in the top cover. This machine is also used for determining the following correction factors (solids passing and retained on the 2-size sieves) which must be applied in the analysis: Fine aggregate passing the No. 100 sieve; fine aggregate retained on the No. 4 sieve; coarse aggregate passing the No. 100

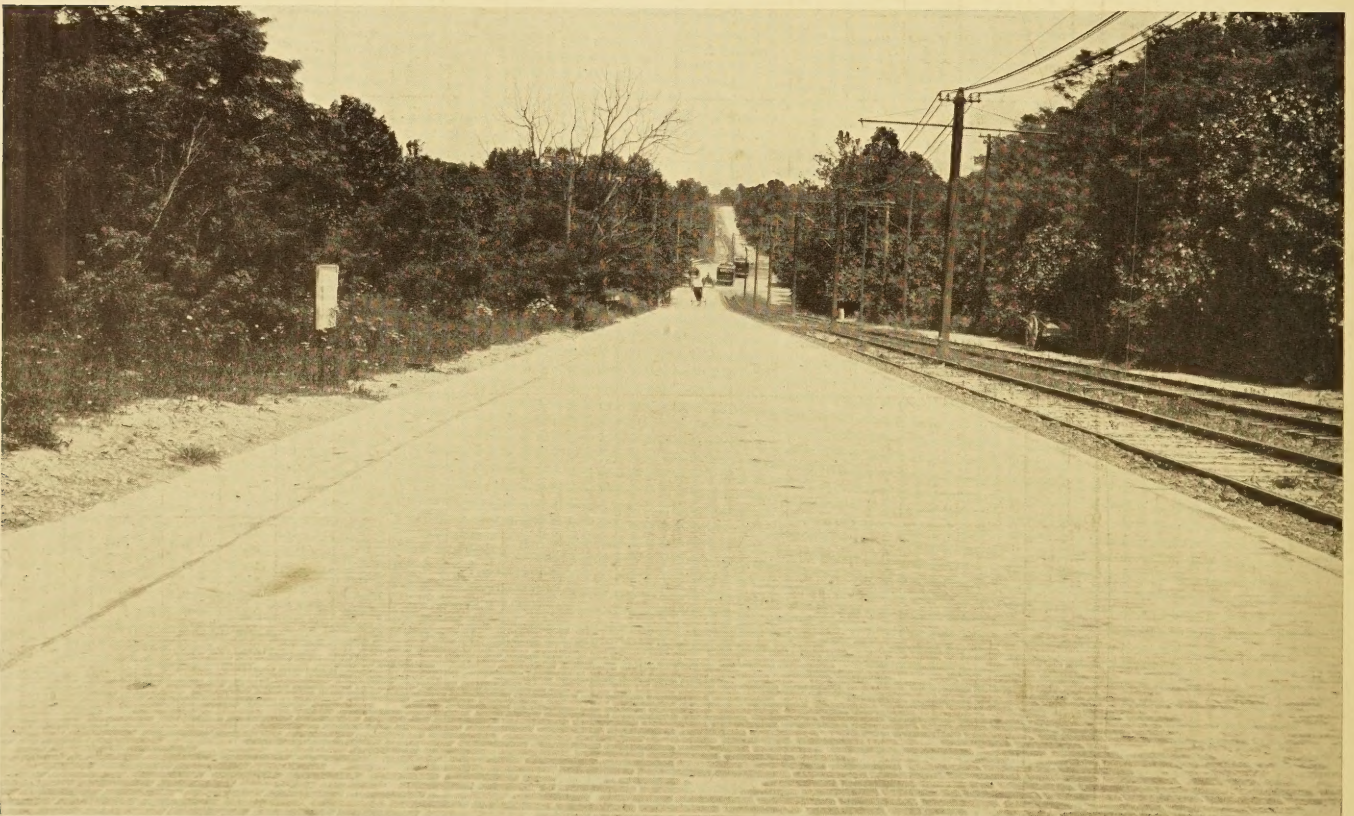
CONDITION OF BRICK SURFACE IN JUNE, 1913
