Public Roads

A JOURNAL OF HIGHWAY RESEARCH

October 1971/Vol. 36, No. 10

Experience to Date with Impact Attenuators

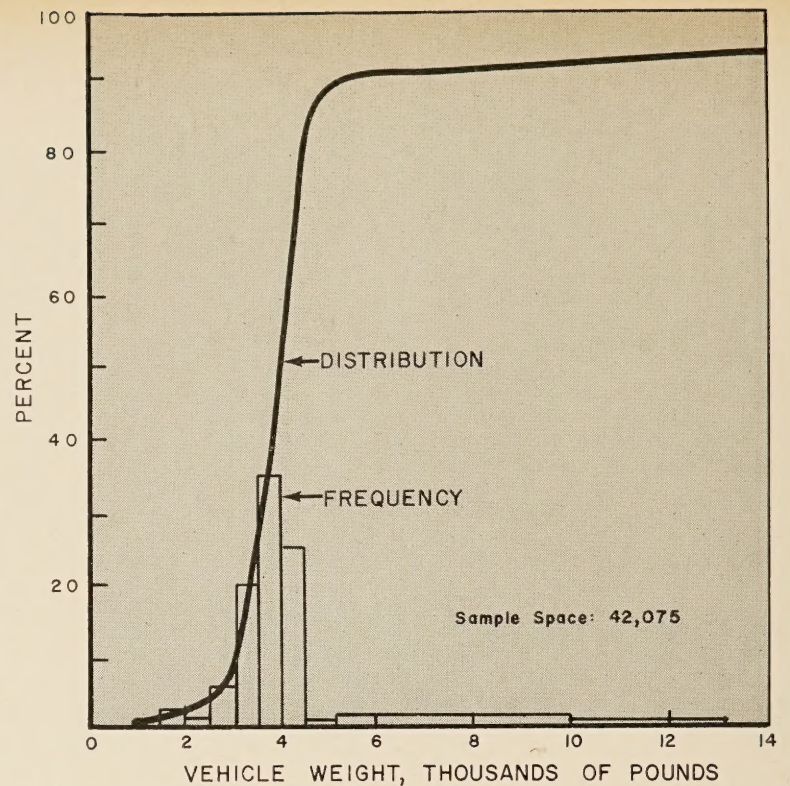
Figure 1.—Vehicle weight distribution from selected Michigan Freeway data (1968).

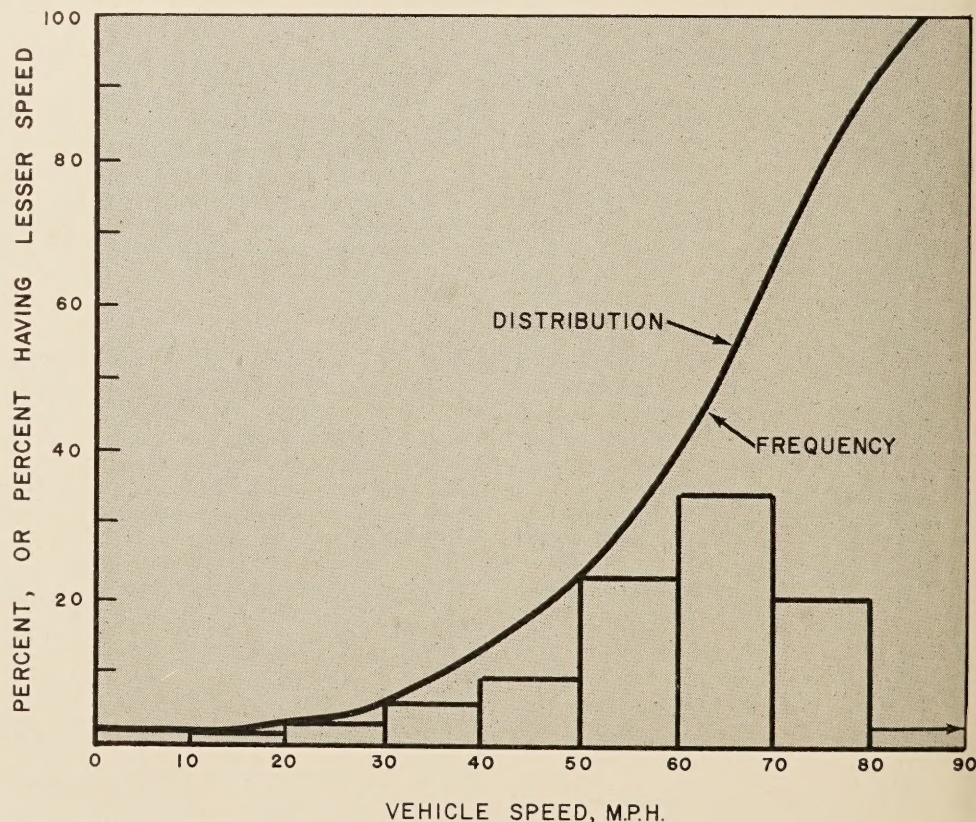
Figure 2.—Estimated impact speed in 5,237 passenger-car single-vehicle accidents.

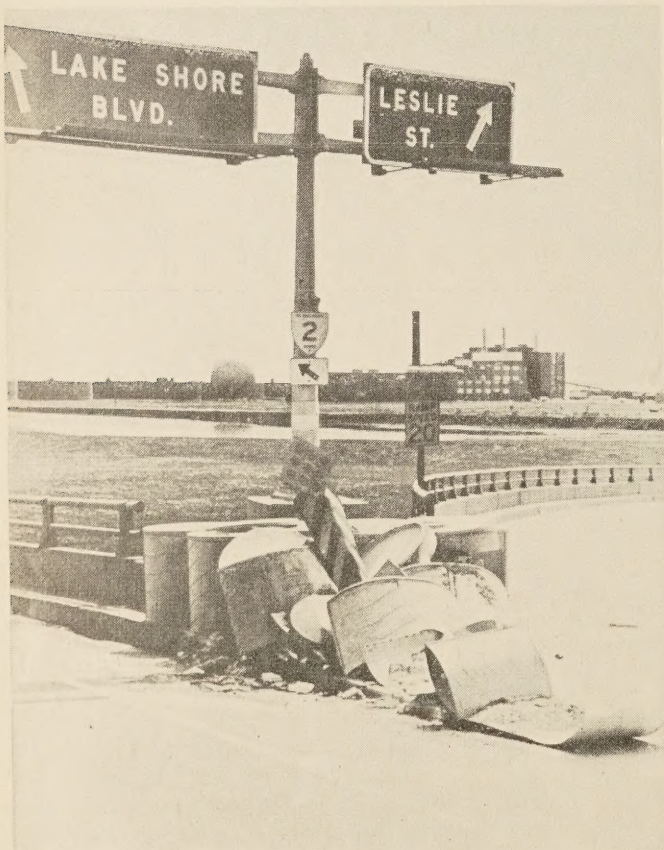
Figure 14.—Typical accident damage to Fitch Inertial barrier.

Damage to a vehicle after an actual accident with this barrier, where the driver sustained minor head bruises, is shown in figure 13. Figure 14 illustrates typical barrier damage

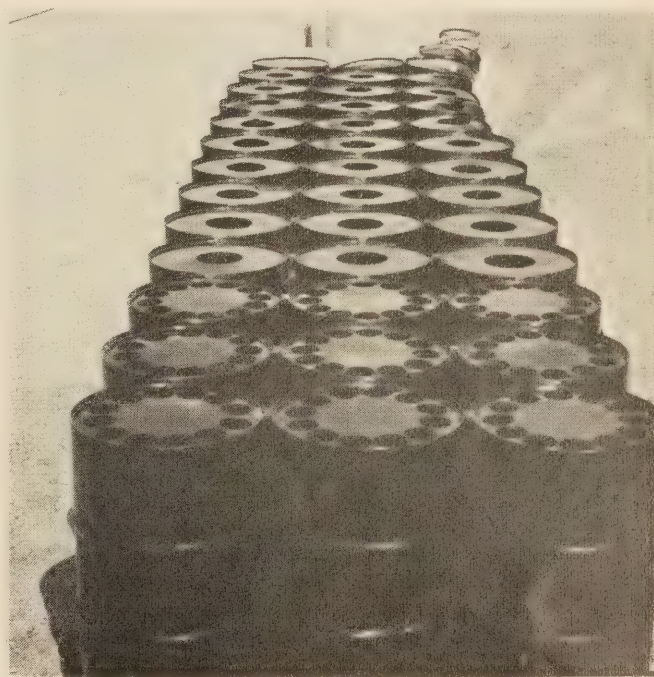
Figure 25.—A 57-m.p.h., 20° test with a 4,200-lb. vehicle of a barrier designed for median bridge piers.

Figure 24 illustrates the hazard of the unshielded bridge pier in a median. Figures 25 and 26 show a steel drum designed for such locations by FHWA with the assistance of the Texas Transportation Institute (24). In this test a 4,200-lb. test vehicle that crashed into the barrier at 57 m.p.h. and 20° was successfully redirected. The dummy in the driver's seat was aimed at the center of the simulated bridge pier. The fendering system used in this design can also be used for steel-drum designs for elevated gores. It should be helpful in avoiding vehicle contact with the rigid back-up wall and in decreasing pocketing.

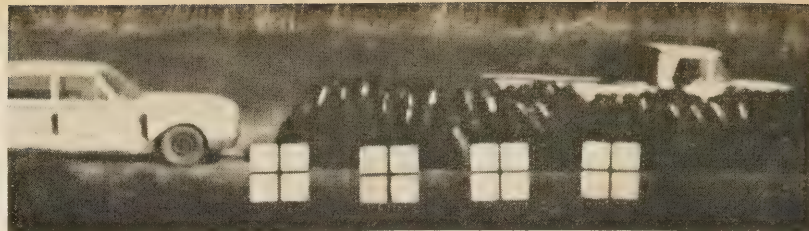
Figure 28.—42-m.p.h. head-on impact with a prototype old-tire barrier.
