Side Impact Test and Analyses of a DOT-113 Surrogate Tank Car with Water

1. REPORT DATE (DD-MM-YYYY) December 2021	2. REPORT TYPE Technical Report		3. DATES COVERED (From - To) June 2020
4. TITLE AND SUBTITLE			ONTRACT NUMBER
Side Impact Test and Analyses of	a DOT-113 Surrogate Tank Car with V	Water D	TFR53-11-D-00008
	C	5b. Gi	RANT NUMBER
		5c. PF	ROGRAM ELEMENT NUMBER

The overall goal of the DOT-113 side impact test series is to analyze the side impact performance of a DOT-113 tank car carrying liquefied natural gas (LNG) under typical service conditions.

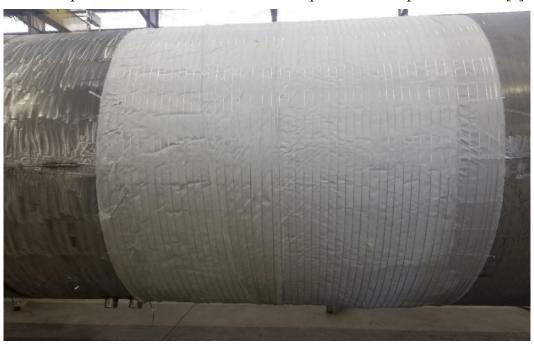
The two tanks were nested together and separated by a 6-inch gap. The inner tank had a section approximately 100 inches long, wrapped in MLI, and centered on the impact region (see Figure 1); however, the annular space was not held under vacuum, i.e., openings were present in the outer tank to maintain atmospheric conditions in the annular space. The MLI was added to the impact region to investigate if it would play a noticeable structural role in the side impact. The previously tested DOT-113 tank car used perlite and a vacuum in the annular space, and post-test modeling demonstrated that perlite contributed to the structural response of the impacted tank car [3].

Figure 1. T304 Stainless Steel Inner Tank Wrapped in MLI

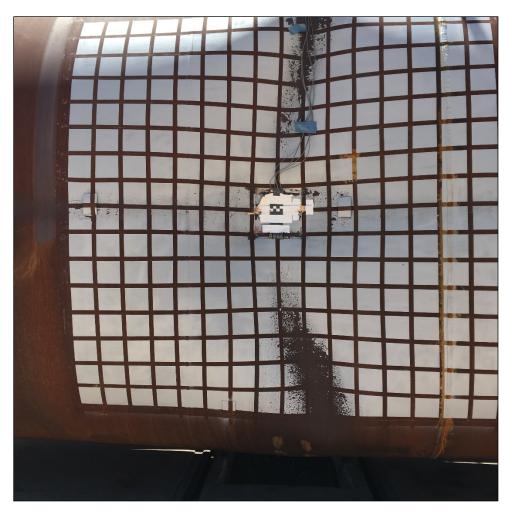
Figure 19 shows the damage to the impacted side of the tank car. Figure 20 shows a detailed view of the impact zone on the outer tank. The impactor footprint is apparent in this figure. The upper left, lower left, and lower right corners of the impactor have transferred paint onto the outer tank. In the upper right corner of the impactor, some evidence of local plastic flow can be seen. Figure 21 shows the post-test position of the tank car relative to the supporting wall.

Figure 19. Tank Car After the Impact (impact side)

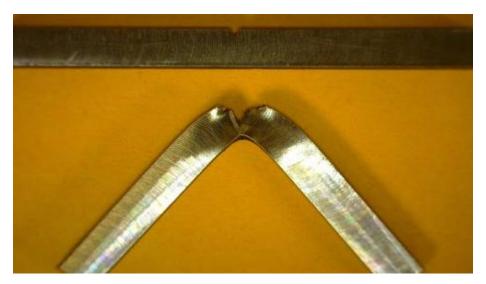
Figure 37. Pre- (top) and Post-test (bottom) CVN Specimens

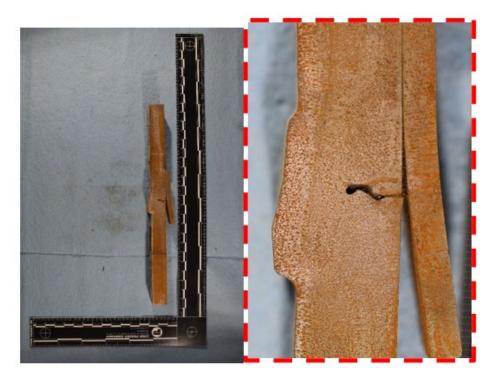
Figure B53. Closure Weld Specimen Rejected Due to Lack of Fusion Defect in Weld

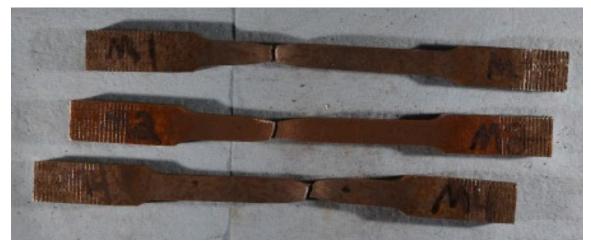
Figure B56. Post-test Parent Material ASTM-E8 Tensile Coupons

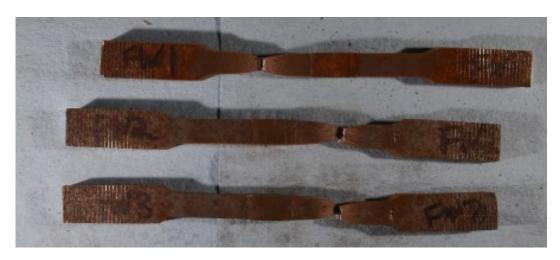
Figure B57. Post-test Factory Weld ASTM-E8 Tensile Coupons

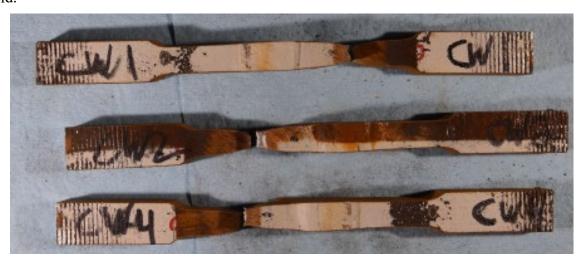
Figure B58. Post-test Closure Weld ASTM-E8 Tensile Coupons

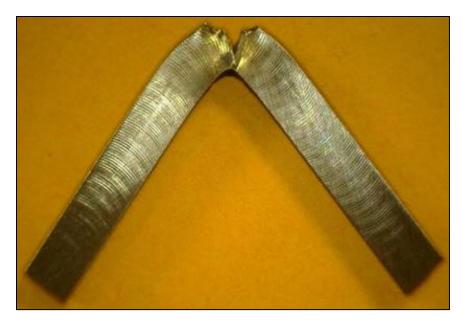
Figure B96. View of Exemplar Post-test CVN Coupon

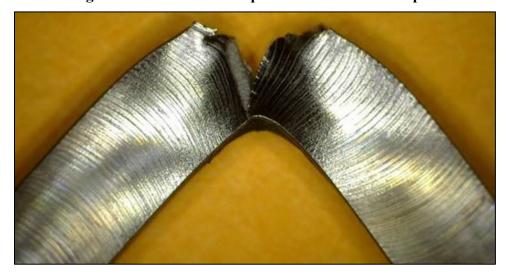
Figure B97. View of Exemplar Post-test CVN Coupon Fracture Surface

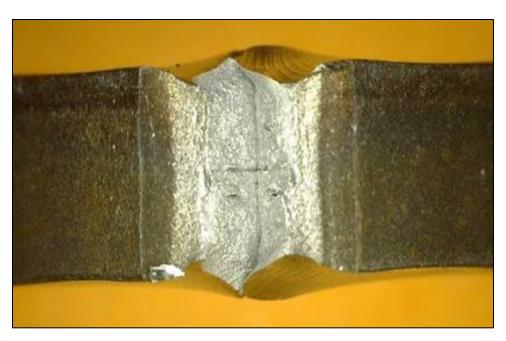
Figure B98. View of Fracture Surface Interior
