# Traffic Control Device Analysis, Testing, and Evaluation Program: FY2020 Activities

Technical Report 0-6969-R3

TEXAS A&M TRANSPORTATION INSTITUTE  
COLLEGE STATION, TEXAS

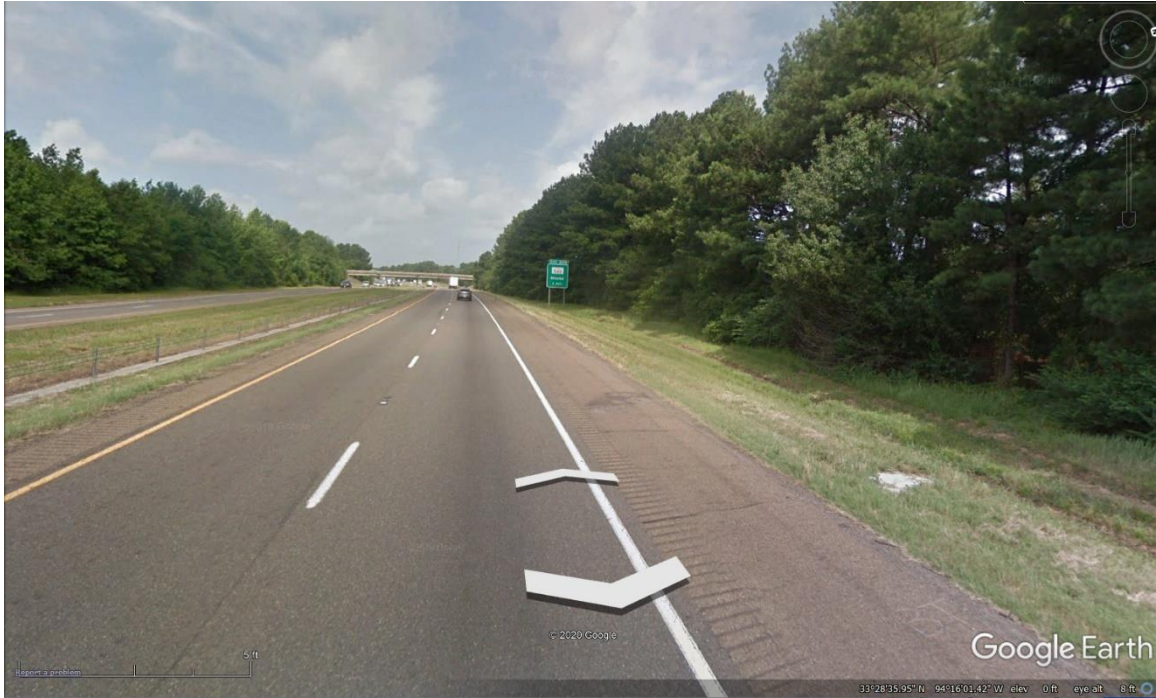
**Figure 3. Atlanta District I-30 Curve in Street View**  
*(Source: © 2020 Google Earth).*

In March 2020, the Atlanta District installed RRPMs along the edges of a horizontal curve on Interstate (I) 30 between Farm-to-Market (FM) 560 and FM 1398 in Bowie County near Hooks, Texas (see Figure 2 and Figure 3). The Pharr District installed amber RRPMs on the outside edge of horizontal curves on U.S. Highway (US) 281 in Hidalgo County (see Figure 4 and Figure 5). The Pharr District placed the RRPMs adjacent to the yellow edge line between the milled rumble strips in the curves and tangent leading up to the curve. The other tangent sections in the corridor did not have supplemental RRPMs on the left shoulder.

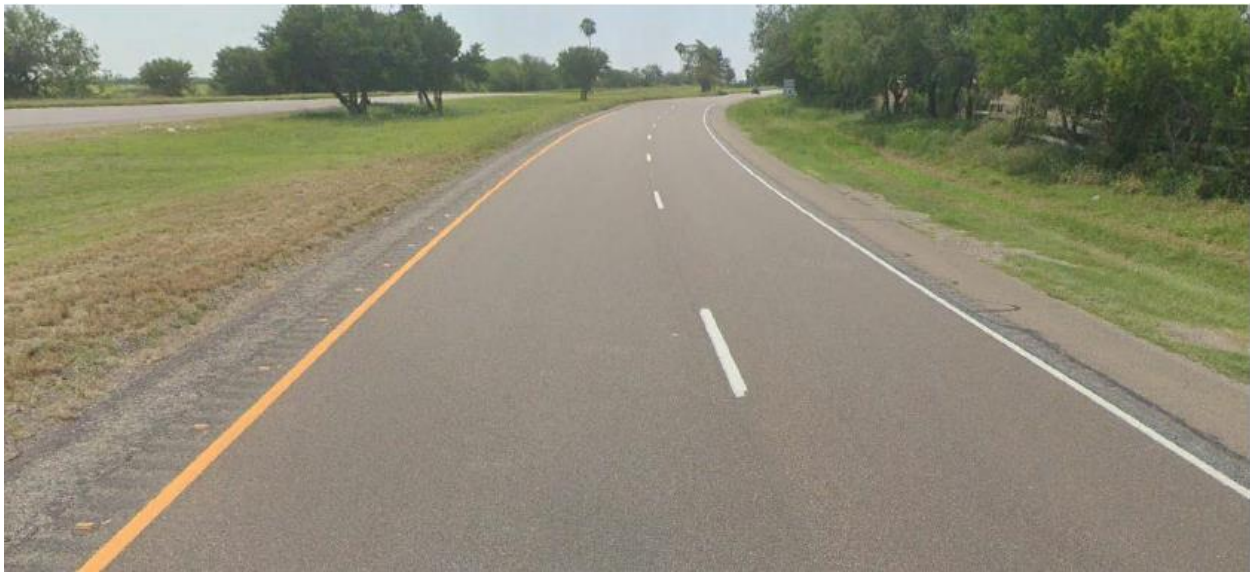
**Figure 5. Pharr District US 281 Corridor in Street View**  
*(Source: © 2020 Google Earth).*

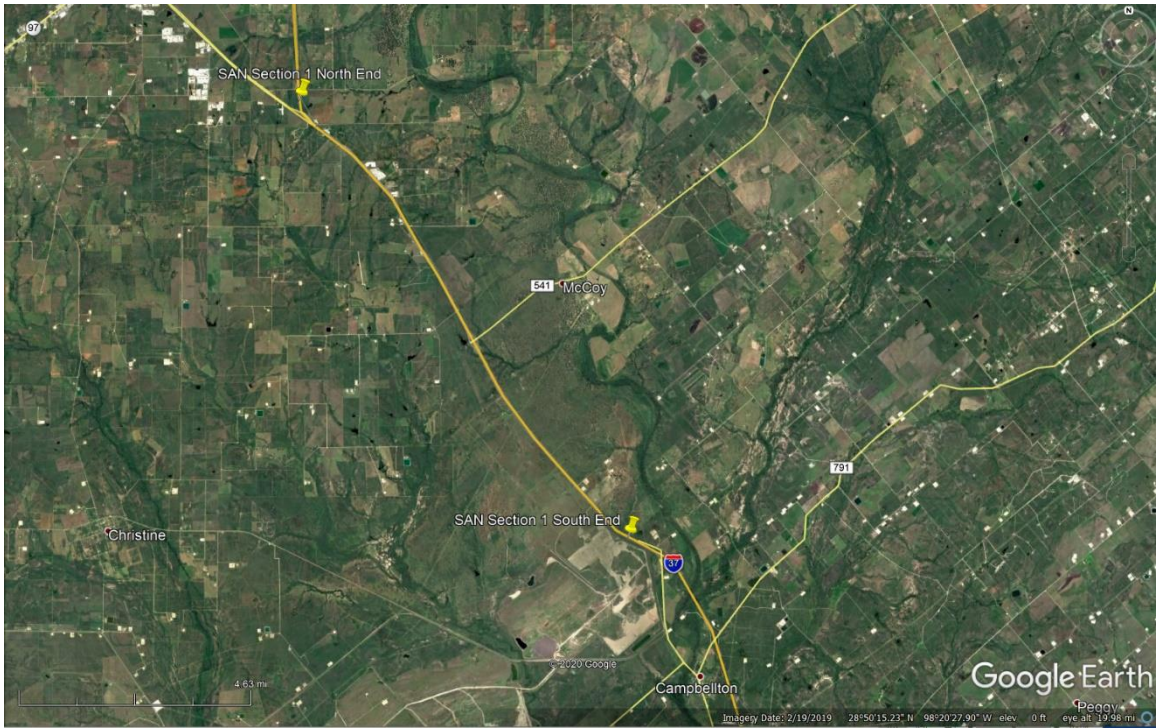
**Figure 6. San Antonio District I-37 Corridor**  
(Source: © 2020 Google Earth).

The San Antonio District installed Type II-A-A RRPMs (i.e., two reflective faces oriented 180 degrees to each other, each of which must reflect amber light) along curved sections of I-37 between Spur 199 and Campbellton (approximately 11 miles) (see Figure 6 and Figure 7). The San Antonio District RRPM application was like that of the Pharr District except that the RRPMs were placed directly on the yellow edge line. The I-37 application appears to be for the southbound travel direction only (based on Google Earth images). The San Antonio District also installed Type I-C RRPMs (i.e., one face that reflects white light) on the following two-lane roads in Medina County:

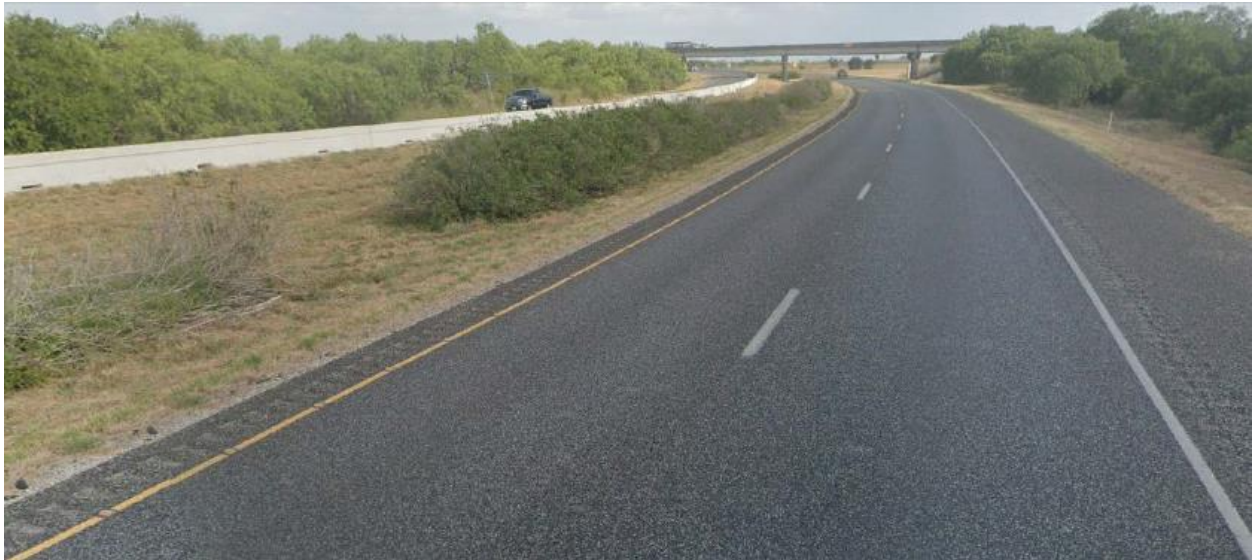
**Figure 7. San Antonio District I-37 Corridor in Street View**  
(Source: © 2020 Google Earth).

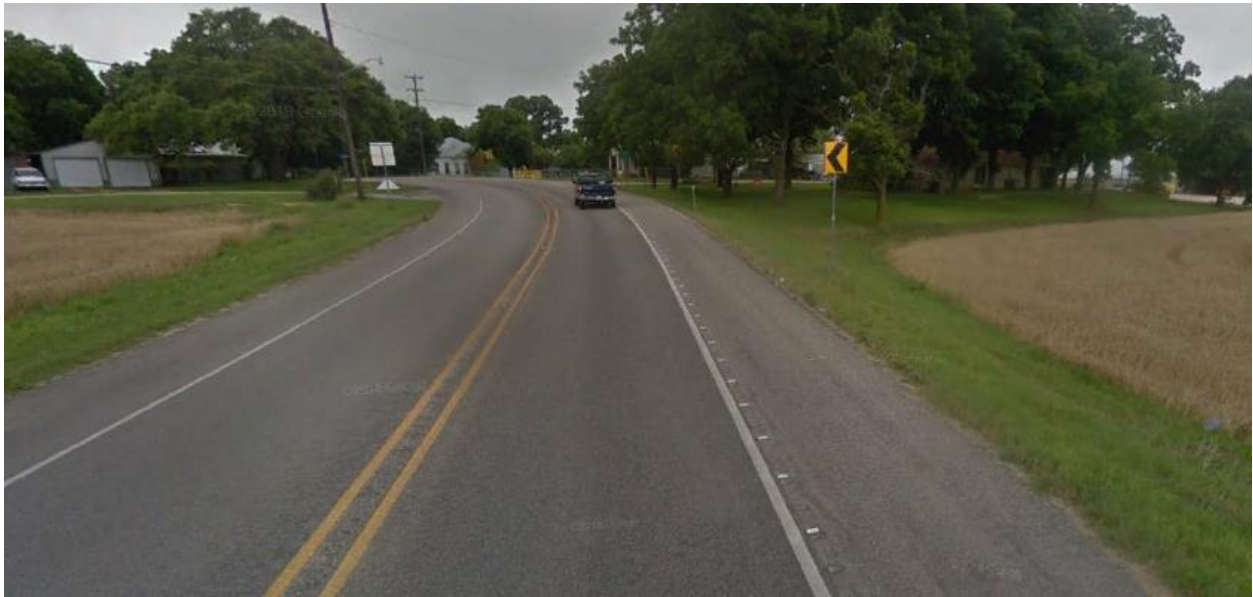
**Figure 9. San Antonio District FM 471 Curve near Lacoste in Street View**  
*(Source: © 2020 Google Earth).*

- FM 471 southbound going into LaCoste, Texas (see Figure 8 and Figure 9).
- FM 471 northbound just south of private road (PR) 3810 (see Figure 10 and Figure 11).

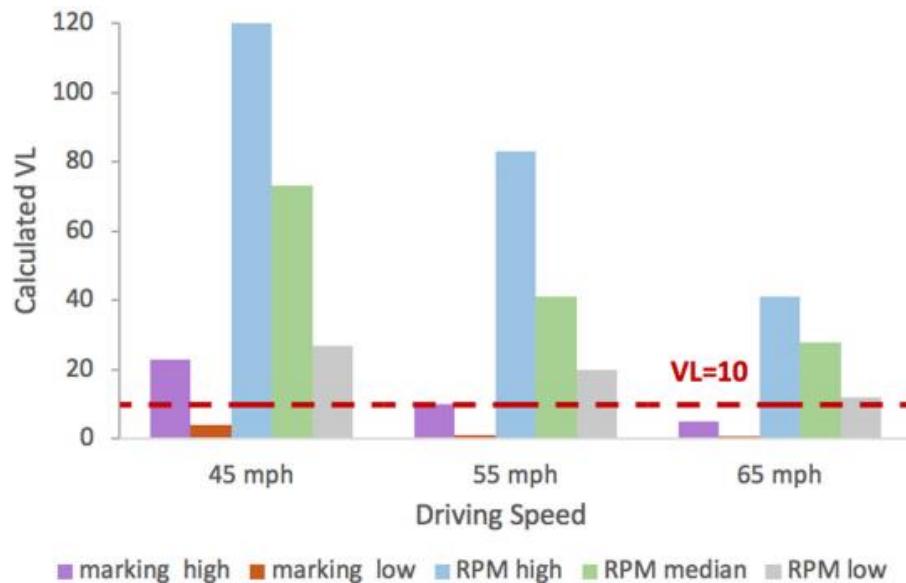
**Figure 13. Comparison of VL between RRPMs and Markings.**

The research team collected luminance data at the various detection distances to determine the participants' luminance demand. This information was used to validate and run the VL model. The target must meet or exceed a VL of 10 for the target to be adequately visible for a 65-year-old driver. Figure 13 provides the average results for the various treatments considered. The calculated VL is based on the needed preview time for the given travel speed and the luminance provided by the treatment. The RRPMs exceed the VL of the markings.

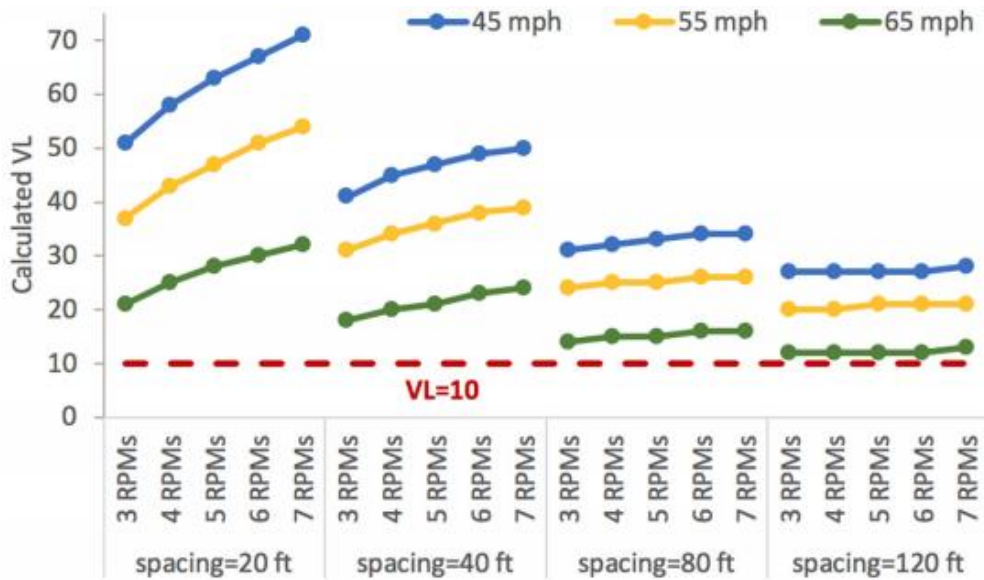
Figure 14. RRPM VL Based on Low-Level Luminance.

maintains a VL of 10 for both the low-level luminance and half the low-level luminance. The 65-mph VL line is below 10 for the 80-ft spacing at the half luminance level. This means that the 40-ft spacing will result in an adequate level of visibility for a longer period of time than the 80-ft spacing. This is because the closer spacing of the RRPMs will provide higher visibility levels as the RRPMs degrade because there are more in view. The 40-ft spacing will also put twice as many markers on the road, so the loss of individual markers will have less impact on reducing visibility.

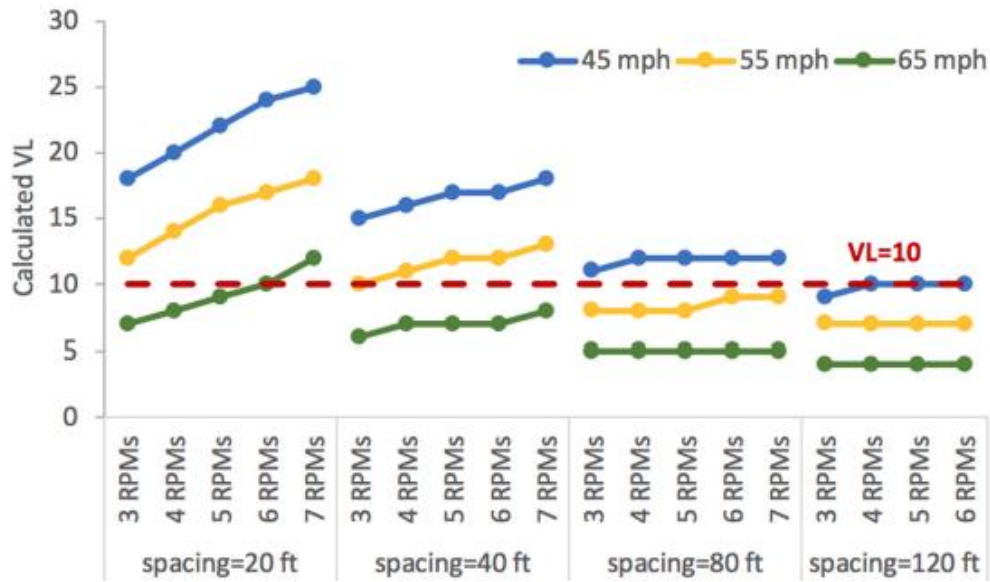
Figure 16. RRPM VL Based on Half the Low-Level Luminance and Glare.

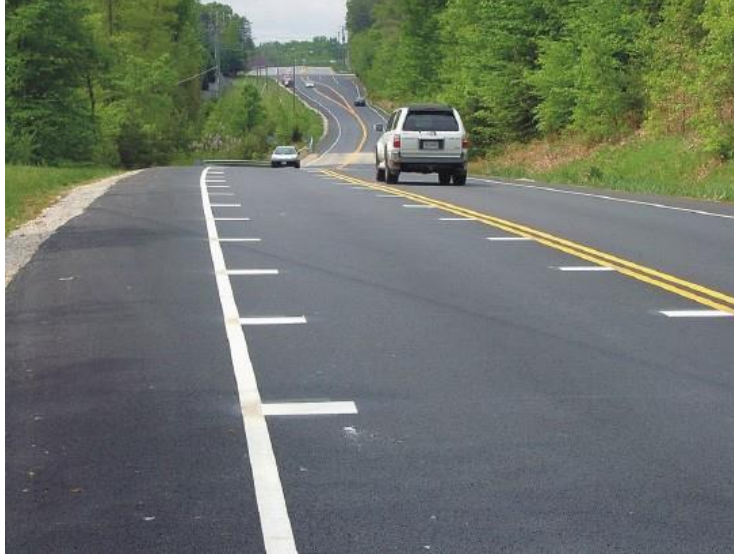
**Figure 17. Texas MUTCD–Compliant Optical Speed Bars (22).**

Several types of optical speed bars have been evaluated in the field (22). Figure 17 shows an optical speed bar installation that is compliant with the Texas MUTCD. Figure 18 shows three other (non-Texas MUTCD-compliant) types that were listed by Boodlal et al. (in Appendix B of their report) (22). All types of optical speed bars serve the purpose of encouraging drivers to reduce speed by creating the optical illusion that the driver is going faster than the desired or comfortable speed for the roadway site, or the illusion of acceleration when deceleration is the appropriate action. It has also been suggested that optical speed bars may encourage speed reduction by creating the illusion of increased motion or lane narrowing, or just a basic visual alert (23).

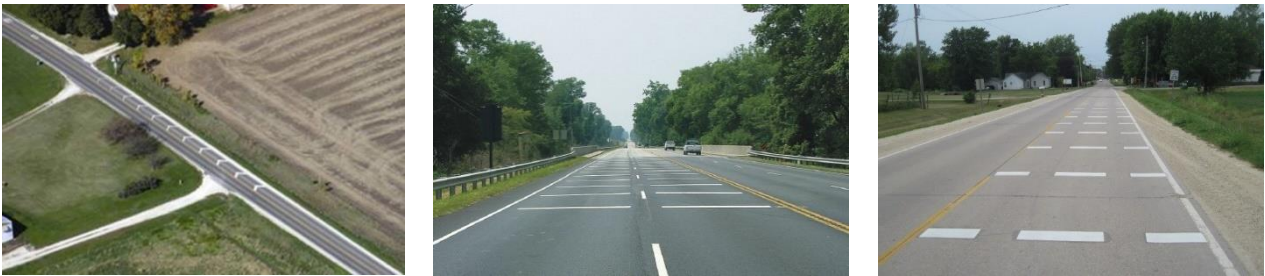
**Figure 18. Other Types of Optical Speed Bars (22).**

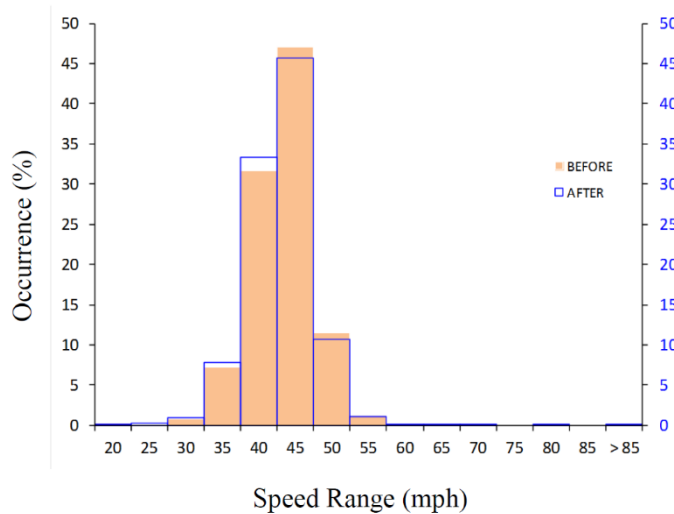
**Figure 19. Distribution of Speeds at Optical Speed Bar Test Sites (25).**

More recently, Frierson (25) conducted a field evaluation of several curve safety treatments, including optical speed bars, and found results like those in Table 1. He found a slight shifting in the speed distribution toward lower speeds as shown in Figure 19. Frierson described the speed distributions as “not significantly different” between the before and after time periods.

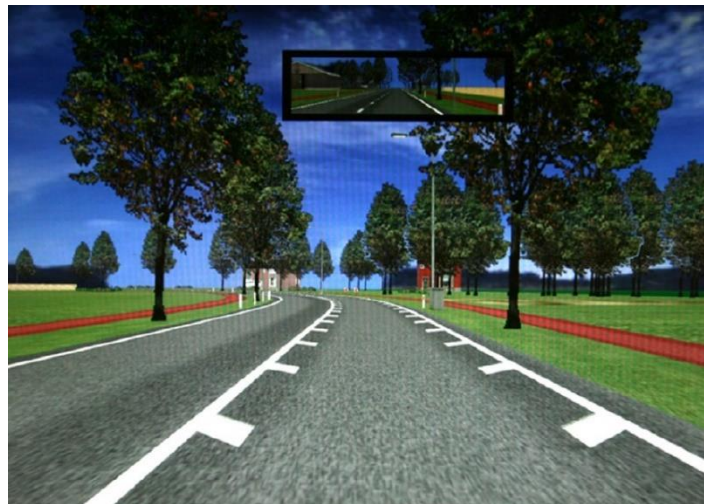
**Figure 20. Herringbone-Pattern Optical Speed Bars (23).**

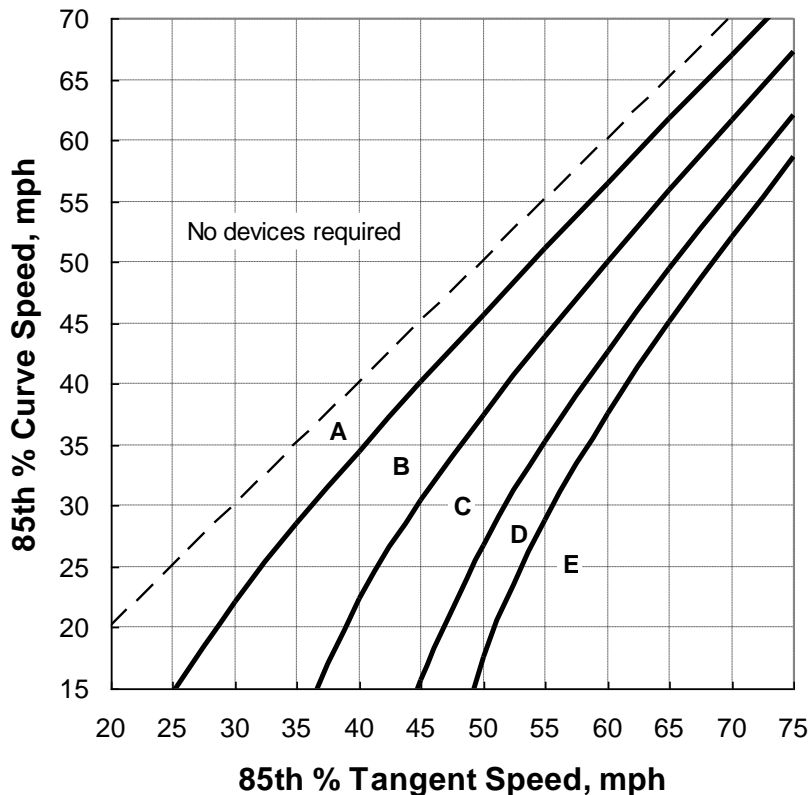
**Figure 22. *Horizontal Curve Signing Handbook* Guidelines for Choosing Curve Traffic Control Devices (32).**

The *Horizontal Curve Signing Handbook* (32) provides guidelines for selecting curve traffic control devices based on the difference of the squared values of the approach tangent speed and the curve speed (or the difference in kinetic energy between approach tangent and curve midpoint). Figure 22 illustrates this concept. This guidance framework provides curve severity categories and suggests using more devices for more severe curves as explained in Table 6. For example, the guidance calls for delineators for curves with severity category C and Chevrons for curves with severity category D.

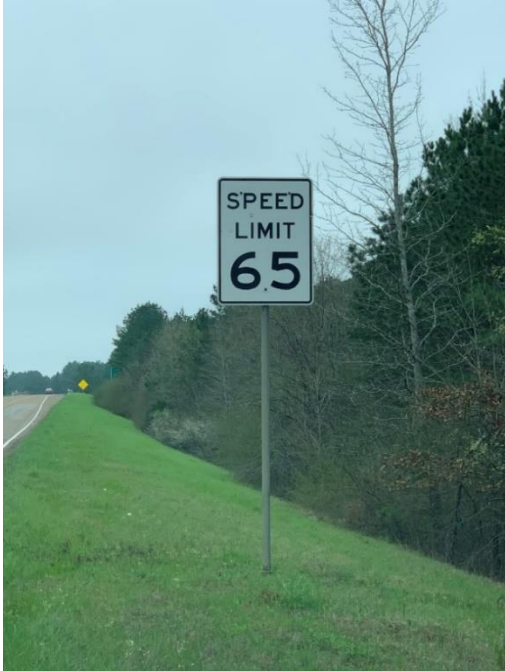
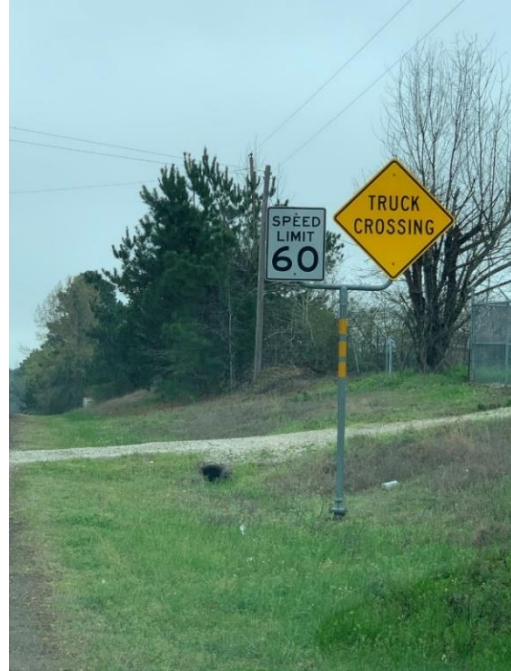
**a. SL 390 Speed Limit.**

**b. FM 1998 Speed Limit.**

**Figure 24. Speed Limits on the Major- and Minor-Street Approaches.**

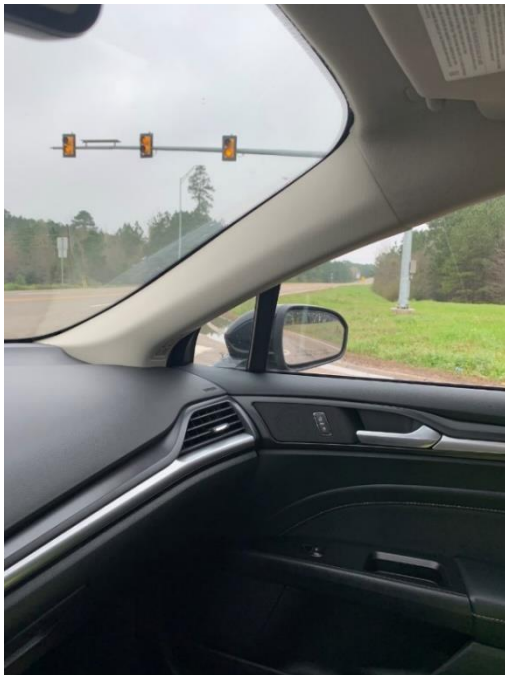
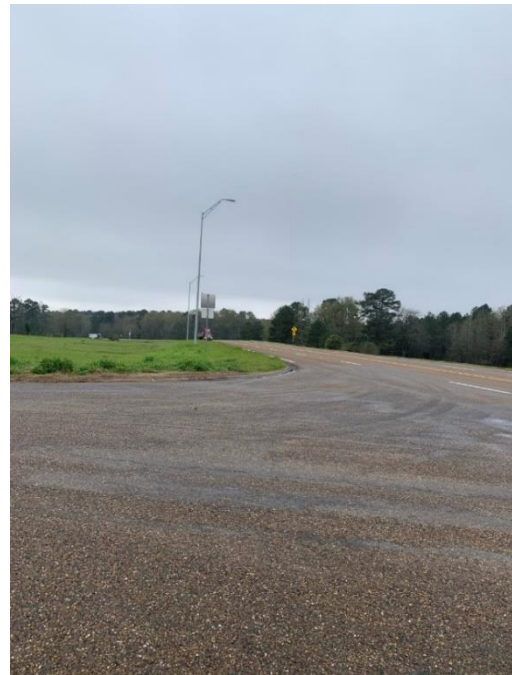
**a. View of Southbound Traffic.**

**b. View of Northbound Traffic.**

**Figure 25. Driver's View at the Stop Lines on the Westbound Approach.**

The intersection of SL 390 (major street) and FM 1998 (minor street) is east of the city of Marshall. This intersection is characterized by a slight skew. SL 390 is a north-south arterial with a horizontal curve on the northbound approach (see Figure 23). In addition, all approaches to the intersection are high speed (i.e., a 65-mph speed limit on SL 390 and a 60-mph speed limit on FM 1998) (see Figure 24). On the FM 1998 westbound and eastbound approaches, sight distance restrictions limit the visibility of the major street traffic (see Figure 25 and Figure 26, respectively).

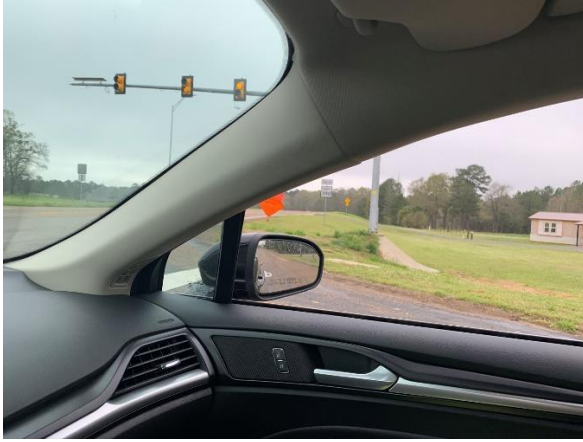
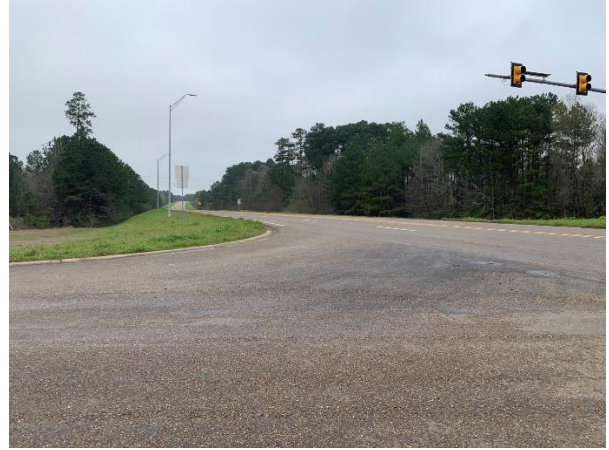
**a. View of Southbound Traffic.**

**b. View of Northbound Traffic.**

**Figure 26. Drivers at the Stop Lines on the Eastbound Approach.**

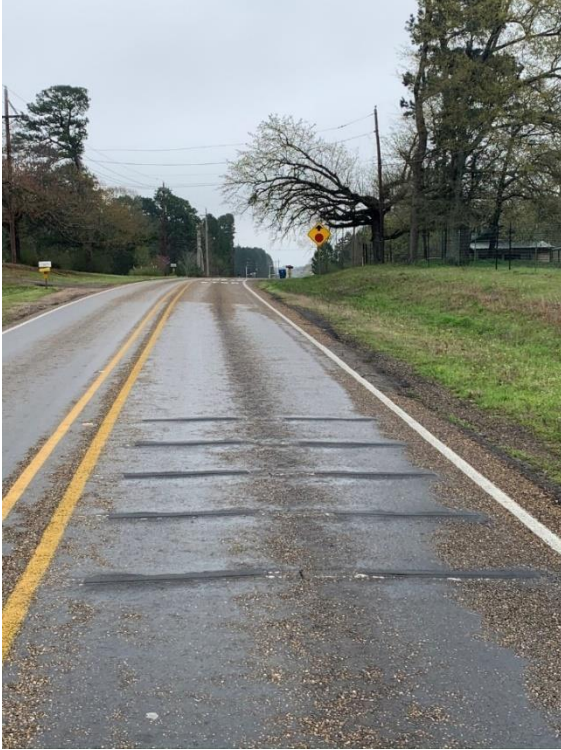
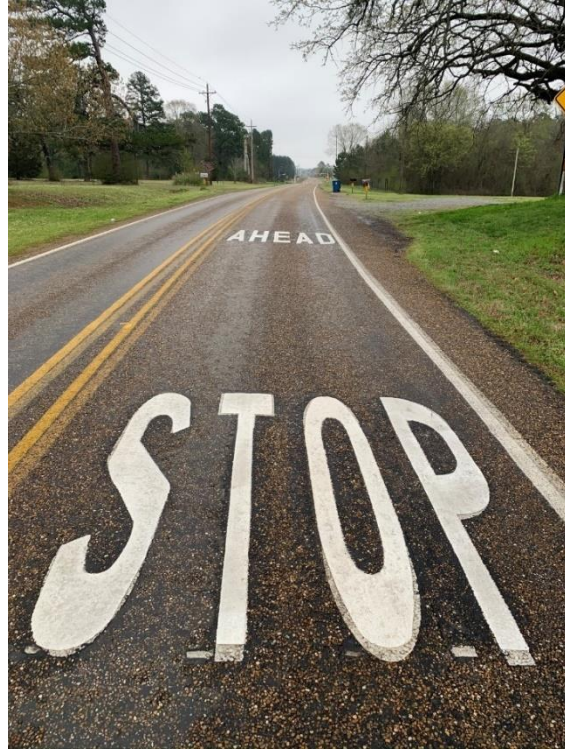
**a. Transverse Rumble Strips and Stop Ahead Sign.**

**b. STOP AHEAD Pavement Markings.**

**Figure 27. Example of Treatments on the Minor-Street Approaches.**

Before the implementation of the ICWS, the minor street included two sets of transverse rumble strips, STOP AHEAD pavement markings, and Stop Ahead signs (W3-1) on the approaches (see Figure 27); and STOP pavement markings, STOP signs, and two overhead stop beacons at the intersection (see Figure 28). Each overhead stop beacon consisted of two signal sections with a flashing circular red signal indication in each signal section. The major-street approaches included two overhead warning beacons at the intersection (see Figure 29). Each overhead warning beacon consisted of two signal sections with a flashing circular yellow signal indication in each signal section. All the overhead beacons were installed on span wire with luminaire lighting on the two strain poles at the intersection.

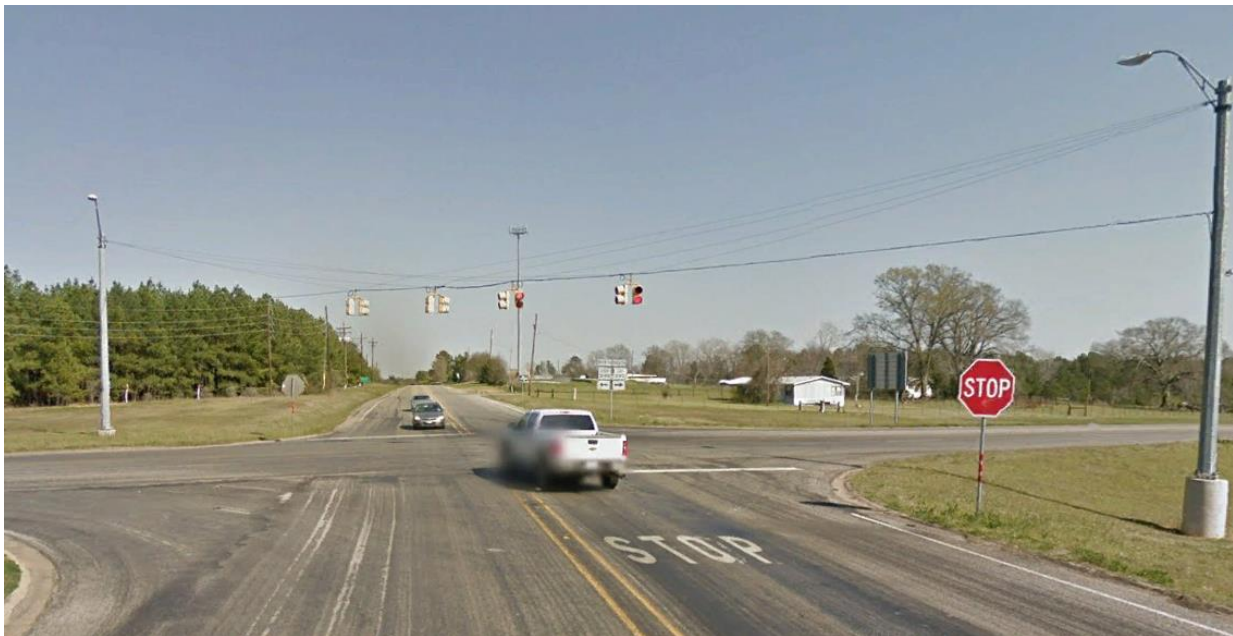
**Figure 28. Minor-Street Approach before ICWS**  
*(Source: © 2020 Google Earth).*

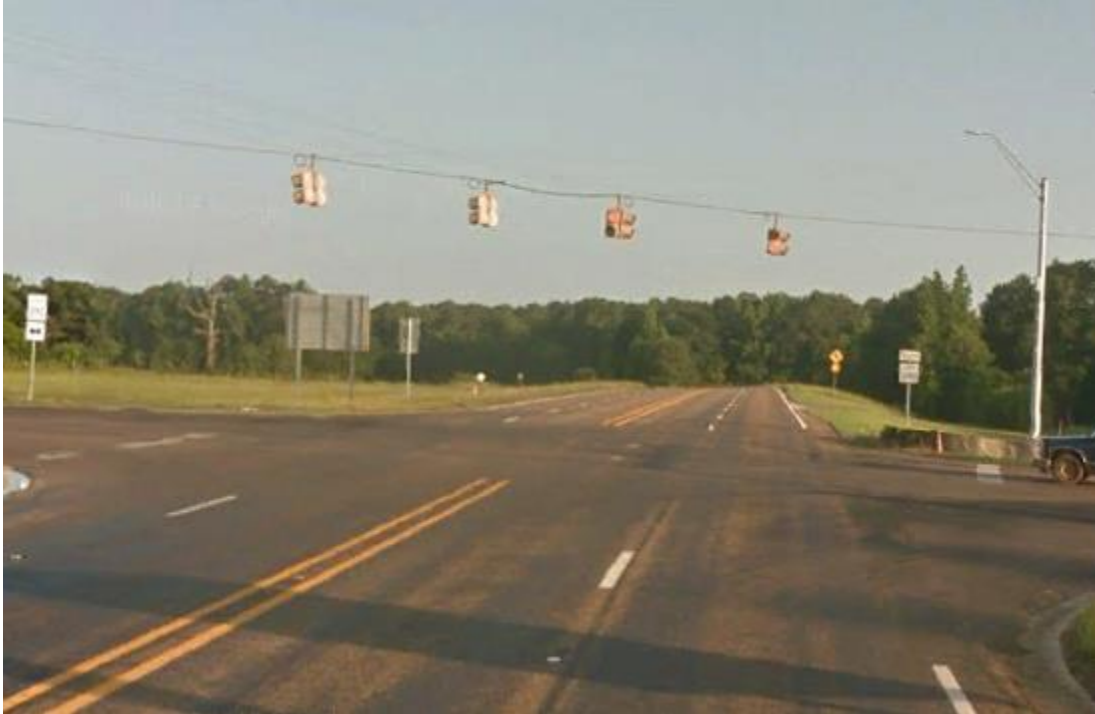
**Figure 29. Major-Street Approach before ICWS**  
(Source: © 2020 Google Earth).

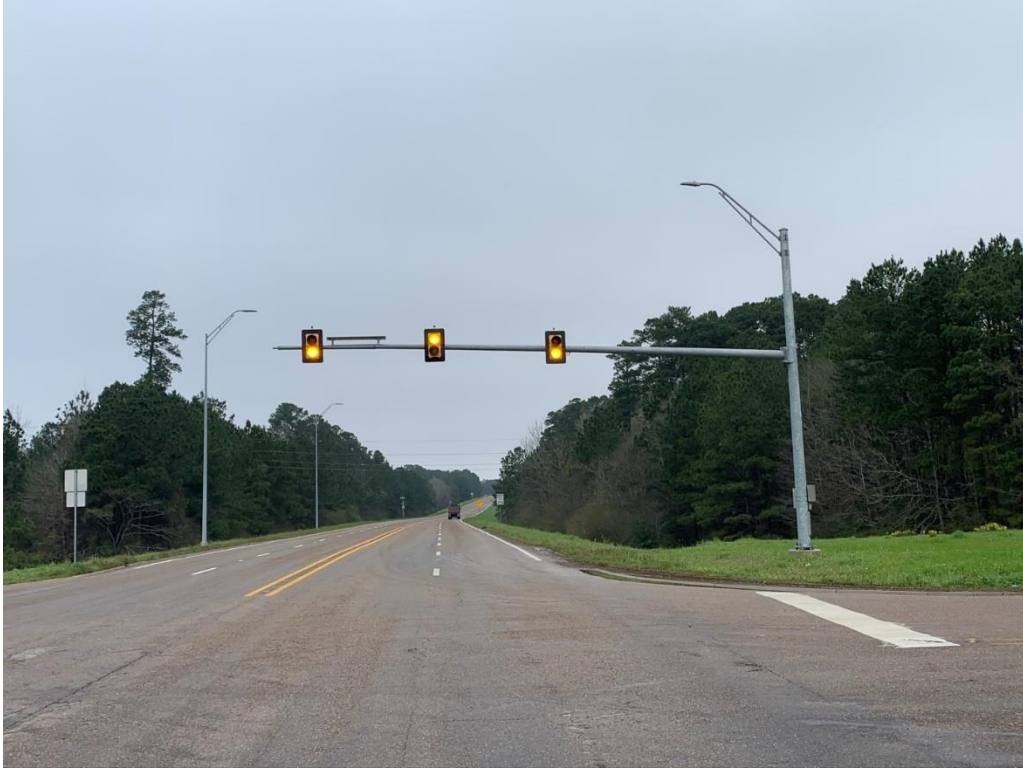
**Figure 30. Intersection Improvements on SL 390.**

At the intersection, the district installed overhead flashing beacon assemblies on mast arms on all four approaches. The overhead flashing beacons were moved from span wire to mast arms to improve their visibility. Three flashing warning beacons were installed on the SL 390 (major-street) approaches (see Figure 30), and two flashing stop beacons were installed on the FM 1998 (minor-street) approaches (see Figure 31). The district also improved lighting by installing luminaires on all four signal poles at the intersection and an additional two luminaires on the major-street approaches to the intersection. A supplemental plaque (CROSS STREET DOES NOT STOP) was also installed on each of the STOP signs on the minor street.

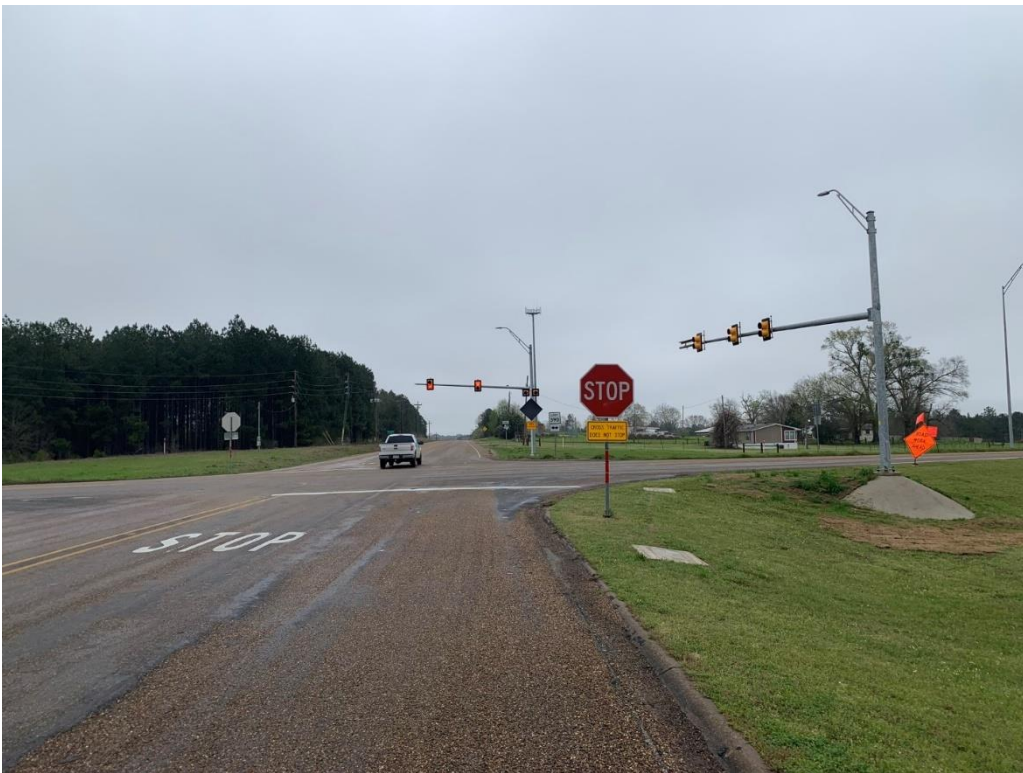
**Figure 31. Intersection Improvements on FM 1998.**

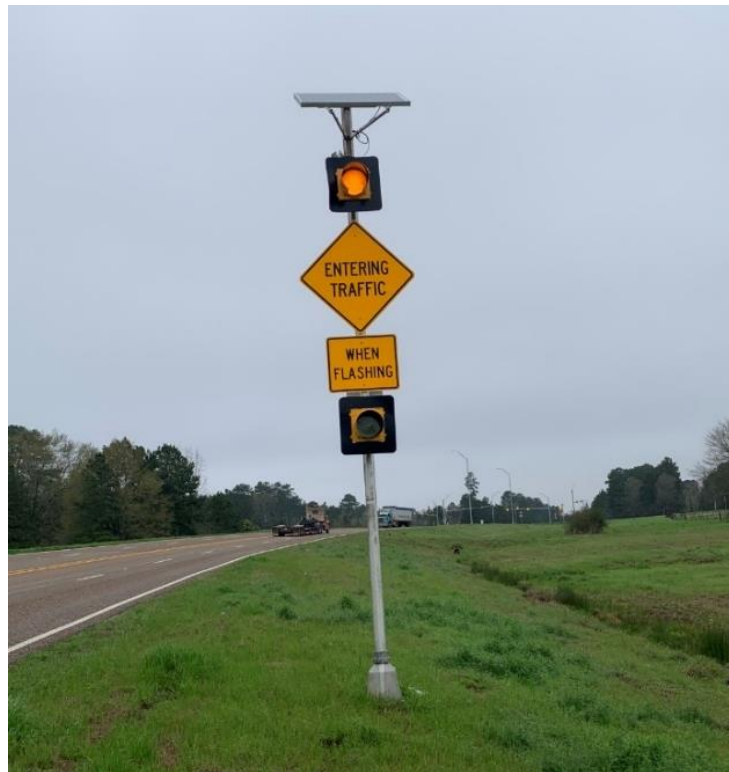
**Figure 32. Example of a Solar-Powered RFBA on the Major Street.**

The ICWS on the major-street approaches includes an ENTERING TRAFFIC warning sign with a WHEN FLASHING plaque and a roadside flasher beacon assembly (RFBA) at 500 ft from the intersection (see Figure 32). The RFBA is powered by a solar panel and includes a small pole-mounted cabinet with a wireless receiver. A sensor installed on the mast arm at the intersection (see Figure 33) detects a vehicle on the minor street approaching the intersection. The ICWS receives the vehicle actuation and transmits a signal to the RFBA on the major street to start flashing the warning beacons on the RFBA. The ICWS uses a timer to extend the call for a fixed interval to enable the vehicle approaching on the minor street to come to a stop and then clear the intersection. If another vehicle is detected on the minor street approaching the intersection before the beacons on the RFBA stop flashing, the beacons on the RFBA continue to flash for an additional duration. Thus, the objective of the ICWS and RFBA is to detect vehicles approaching on the minor street and warn the vehicles approaching on the major street about the presence of these vehicles. The activation and duration of the warning are based on field observations and account for the travel time of the approaching vehicle on the minor street to come to the intersection and then clear the intersection.

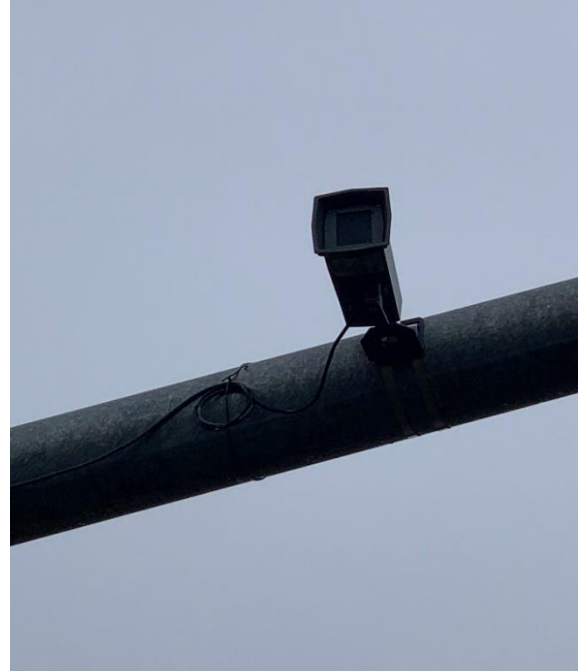
**a. Mast Arm with Sensor.**

**b. Sensor Installed on Mast Arm.**

**Figure 33. Example of a Sensor to Detect Vehicles Approaching on the Minor Street.**

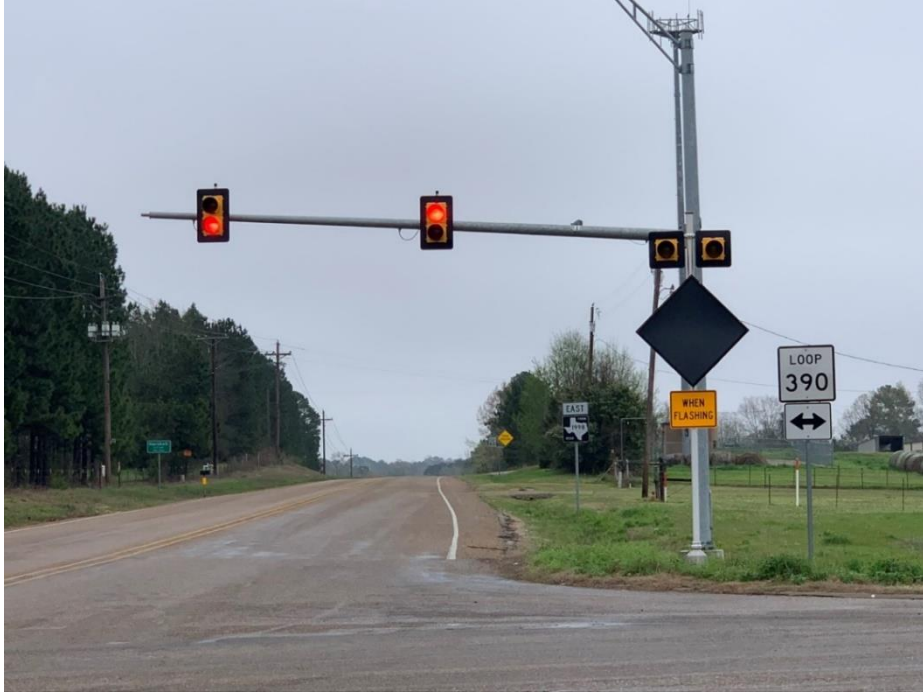
**Figure 34. Example of a Warning Sign Assembly on the Minor Street (System Not Activated).**

On the minor-street approaches, the ICWS includes a diamond-shaped, LED blank-out sign with a static WHEN FLASHING plaque and two flashing warning beacons (see Figure 34). This sign assembly is located on the opposite side of the intersection from approaching minor-street traffic. A sensor installed on the RFBA (see Figure 35) detects vehicles approaching the intersection on the major street and sends the actuation via a radio signal to the ICWS. The ICWS then activates the blank-out sign (i.e., displays TRAFFIC APPROACHING) and beacons to warn the approaching minor-street vehicles (see Figure 36). The ICWS uses a delay timer to ensure that the warning beacons flash and the sign displays the TRAFFIC APPROACHING message until the major-street vehicle passes through the intersection. The delay timer is based on the travel time from the RFBA to the intersection and was calibrated based on field observations.

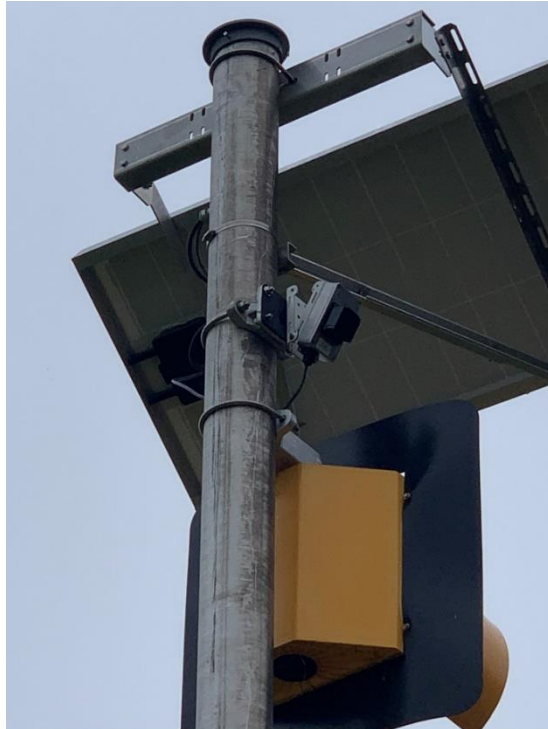
**Figure 35. Example of a Sensor on the RFBA to Detect Vehicles Approaching on the Major Street.**

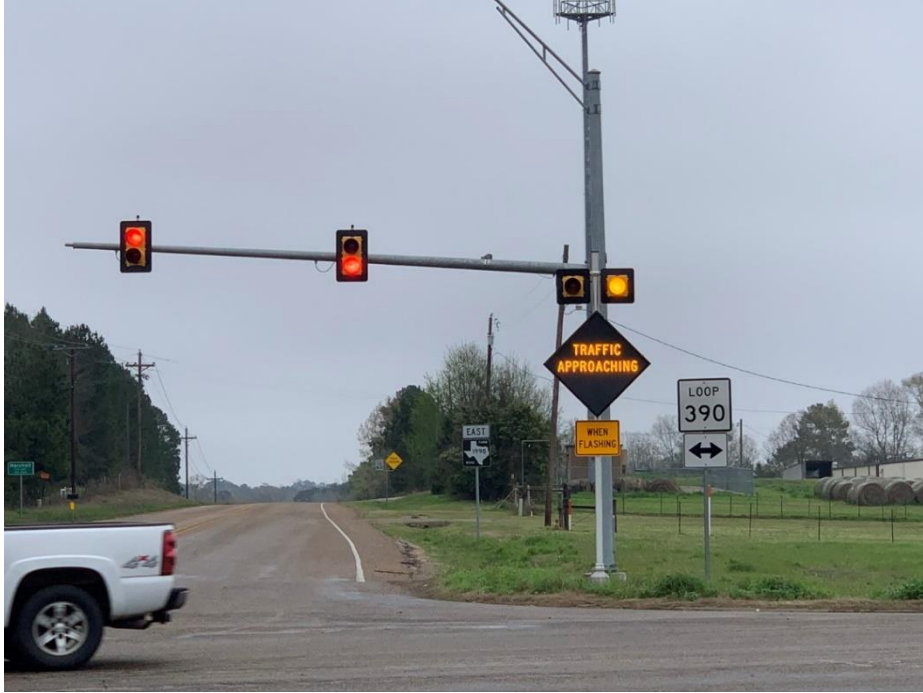
**Figure 36. Example of a Warning Sign Assembly on the Minor Street (System Activated).**

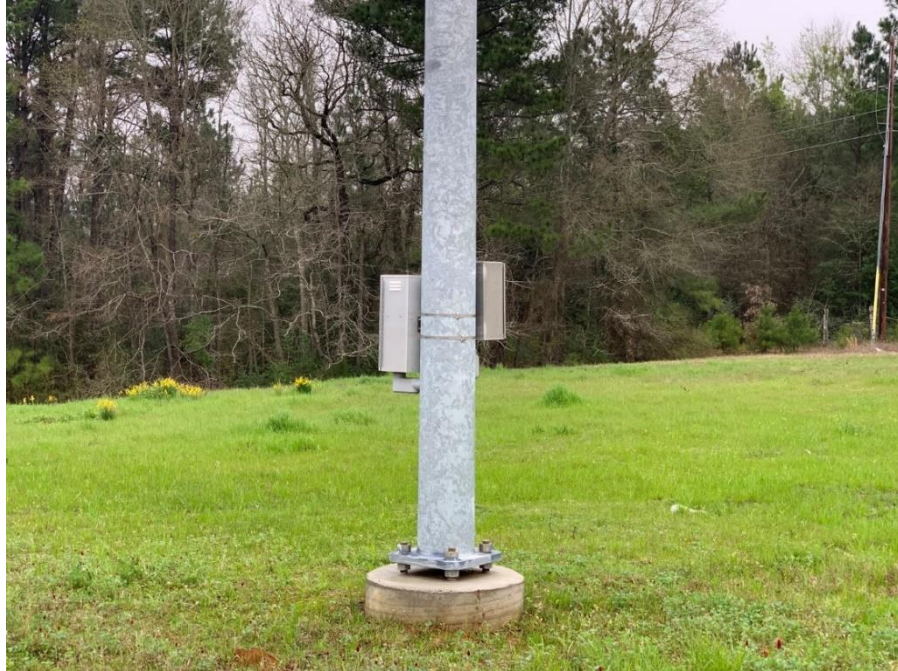
**Figure 37. Equipment Integrated at the Intersection.**

The installation of the entire ICWS was a turnkey contract based on a proposal generated by the TxDOT Atlanta District. Primary equipment installed at the intersection included vehicle sensors and radio equipment for communication. The Marshall ICWS uses MS Sedco sensors to detect vehicles approaching the intersection. MS Sedco sensors are microwave motion sensors that can detect vehicles in motion. While the actuation from the sensors on the minor street is brought back via hardwire, actuations from the sensors on the major street are brought back via wireless communication to a cabinet at the intersection and integrated into the ICWS (see Figure 37). Figure 38 is a schematic of the ICWS.

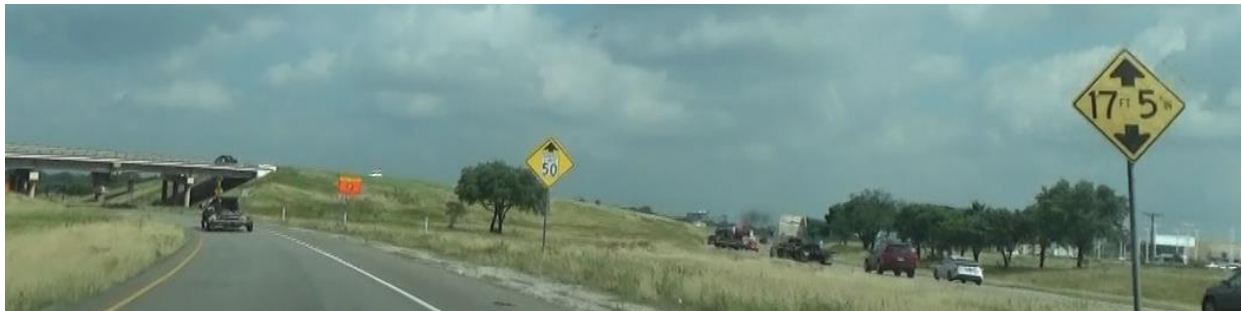
**Figure 41. Closely Spaced Signs at Site 1.**

As shown in Table 16, in each work zone the minimum distance between signs (considering both permanent and work zone) was 68 ft or less. At Site 1, researchers noted several closely spaced signs along an exit ramp approaching the work zone. In this case, the work zone signs were added to an area that already had closely spaced permanent signs (see Figure 41). Along this ramp, a total of 16 signs were placed along a segment of roadway that was 1865 ft in length. Nine of the signs were permanent, while an additional seven signs were work zone signs. The average spacing was 116 ft.

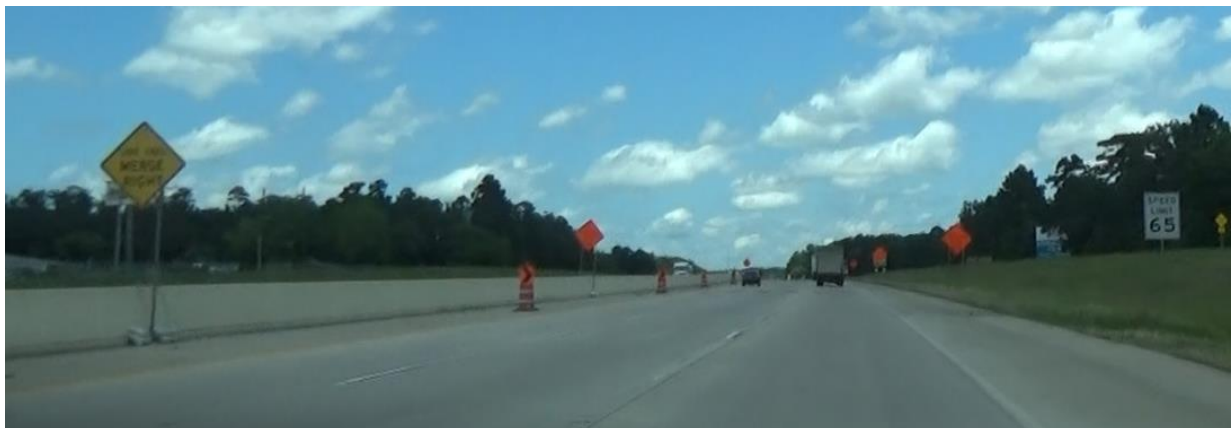
**Figure 42. Closely Spaced Signs at Site 3.**

At Site 3, researchers noted several closely spaced signs near a commercial vehicle inspection station located within the work zone (see Figure 42). In this case, 11 work zone signs were added to an area that only had three permanent signs along a segment of roadway that was 1751 ft in length. The average sign spacing for this segment was 125 ft.

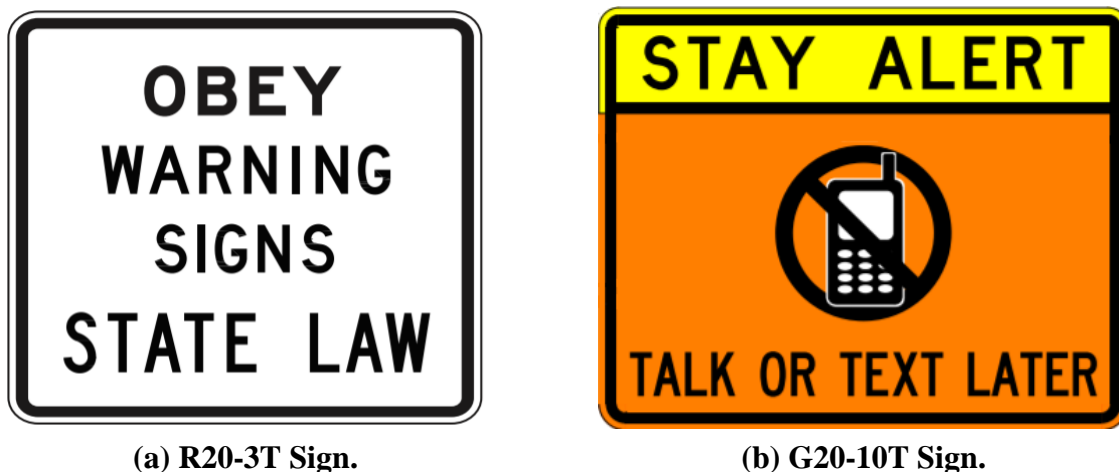
**Figure 43. R20-3T and G20-10T Signs (2, 100).**

The most sign-cluttered areas in the work zones tended to be in the project limit signage area. Figure 39 shows a sample layout. The first two signs in the series are the OBEY WARNING SIGNS/STATE LAW (R20-3T) sign (shown in Figure 43a) and the STAY ALERT/TALK OR TEXT LATER (G20-10T) sign (shown in Figure 43b). The effectiveness of these signs is not known, but their necessity and value should be considered. The *Texas Driver Handbook* requires drivers to obey all warning and regulatory signs (98), while current state law prohibits the use of wireless communications devices for texting while driving (99). The use of multiple general warning signs at the beginning of each work zone might mask other warning and regulatory signs in the same area that direct the driver to take specific actions, such as reducing speed or changing lanes.

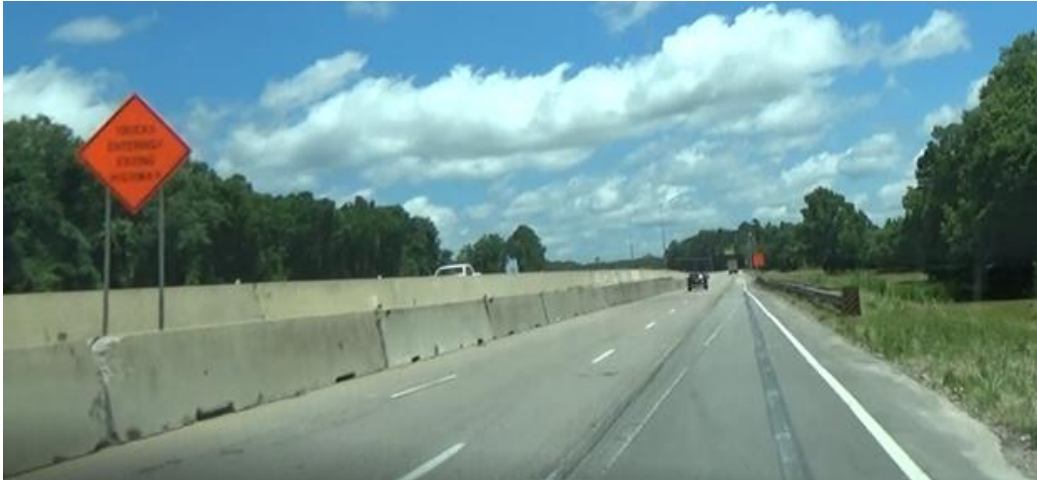
**Figure 44. Trucks Entering/Exiting Highway Sign at Site 3.**

work vehicles entering and exiting the travel lanes. Figure 44 shows a sign used at Site 3 (TRUCKS ENTERING/EXITING HIGHWAY), and Figure 45 shows a sign used at Site 4 (TRUCKS ENTERING/EXITING ROADWAY). The sign legend and layout were different for each sign.
