# Traffic Control Device Analysis, Testing, and Evaluation Program: FY2020 Activities

Technical Report 0-6969-R3

TEXAS A&M TRANSPORTATION INSTITUTE  
COLLEGE STATION, TEXAS

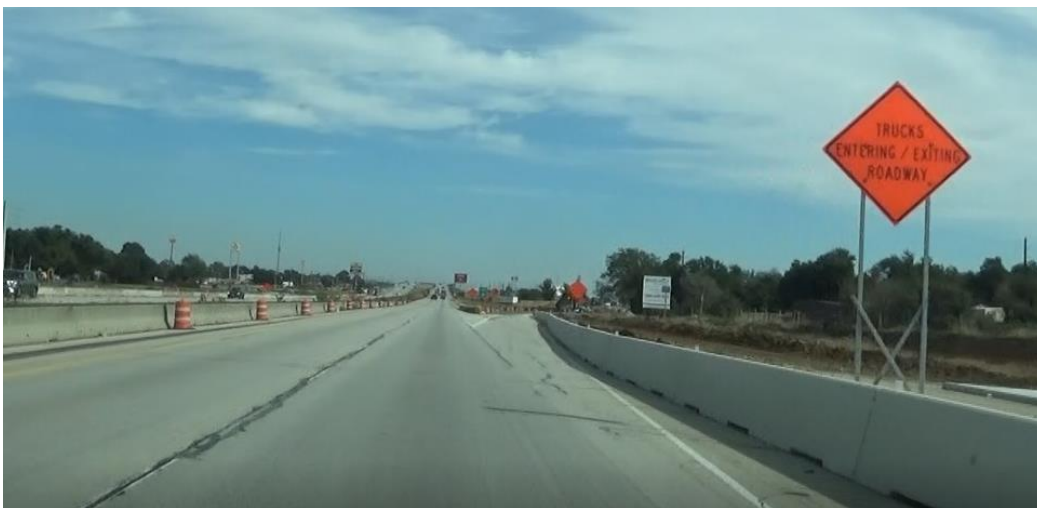
**Figure 45. Trucks Entering/Exiting Roadway Sign at Site 4.**

work vehicles entering and exiting the travel lanes. Figure 44 shows a sign used at Site 3 (TRUCKS ENTERING/EXITING HIGHWAY), and Figure 45 shows a sign used at Site 4 (TRUCKS ENTERING/EXITING ROADWAY). The sign legend and layout were different for each sign.

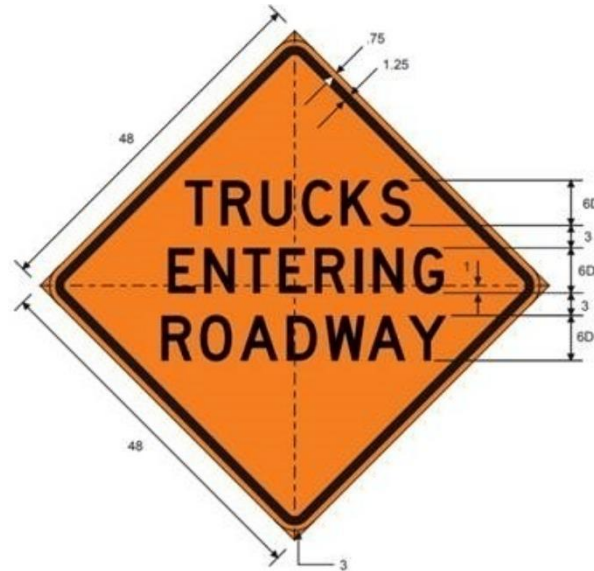
**Figure 46. Trucks Entering Roadway Sign (CW27-1T) (100).**

Figure 46 shows a detailed drawing of the CW27-1T sign from TxDOT's *Standard Highway Sign Designs for Texas* manual (100). The sign legend height is 6 inches, and the overall sign dimensions are 48 inches by 48 inches, which are the same dimensions that the Texas MUTCD specifies for freeways and expressways. While the legend height and dimensions of the signs in Figure 44 and Figure 45 are not known, the legend does contain more information than the sign shown in Figure 46. Adding words to the sign legend may have reduced the legend height, making it more difficult for drivers to read these signs, especially at higher speeds. While the dual message sign may provide more flexibility for the contractor, it also provides less specific information for drivers.

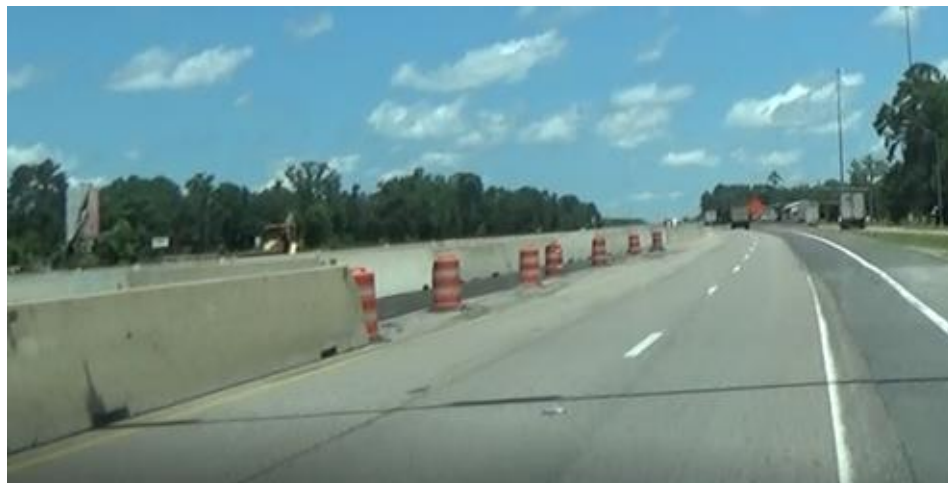
**Figure 47. Truck Entrance at Site 3.**

While measurements of the specific geometries at each truck access point were not possible with the data collection methods used by the team, researchers observed that some access points had little or no acceleration lane for work vehicles entering the open traffic lanes. At Site 3, researchers found that there was an opening in the concrete barrier (see Figure 47) located just downstream of the sign shown in Figure 44. The geometric design of the opening indicated that it was for trucks entering the open traffic lane, but the access point was blocked with channelizing drums and did not appear to be in use on the day this work zone was visited. The credibility of the truck access point warning sign may be diminished if the sign remains in place while the access point is not in use. The TxDOT BC Temporary Sign Notes Standard Sheet BC (4)-14 (0) (101) states that when sign messages may be confusing or do not apply, the signs shall be removed or completely covered.

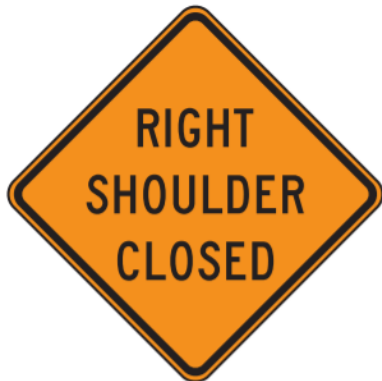
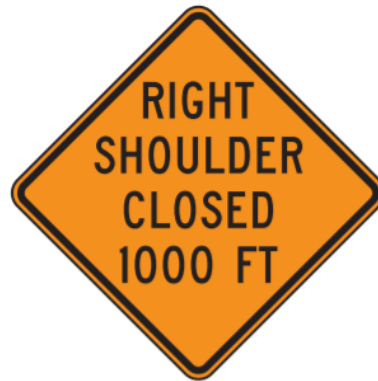
(a) CW21-5a Sign.

(b) CW21-5b Sign.

**Figure 48. Texas MUTCD Warning Signs for Shoulder Closures (2).**

Researchers found signage inconsistencies in areas where shoulder widths were reduced and/or the shoulder was closed. Typically, the minimum shoulder width on freeways and expressways is 10 ft. When a work zone is present, the contractor often uses a concrete traffic barrier to provide separation between the live traffic lanes and the work space. Placement of this barrier often reduces the shoulder width significantly. As shown in Figure 48, the Texas MUTCD includes two warning signs for shoulder closures.

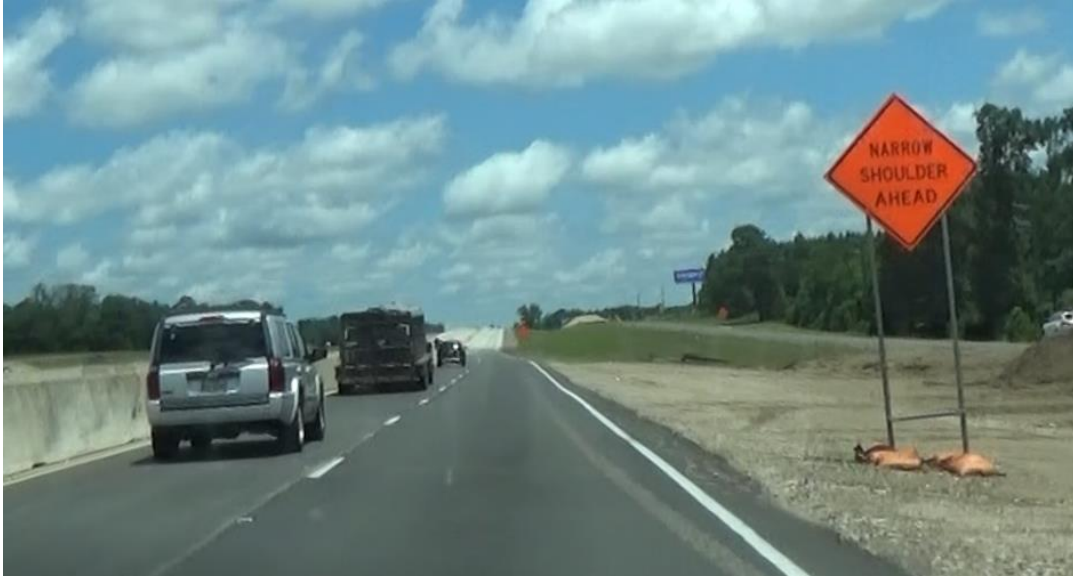
Researchers found several examples where alternative signs were used to indicate that the shoulder was narrow, unpaved, reduced, or closed (see Figure 49, Figure 50, and Figure 51 for examples). At Site 3, a NARROW SHOULDER AHEAD sign was located approximately 400 ft upstream of an unpaved shoulder (see Figure 49). Approximately 800 ft downstream of this sign and 400 ft after the unpaved shoulder began was an UNPAVED SHOULDER sign (see Figure 50). The placement of these signs may not have provided an accurate advance warning for the condition.

**Figure 49. Narrow Shoulder Ahead Warning Sign at Site 3.**

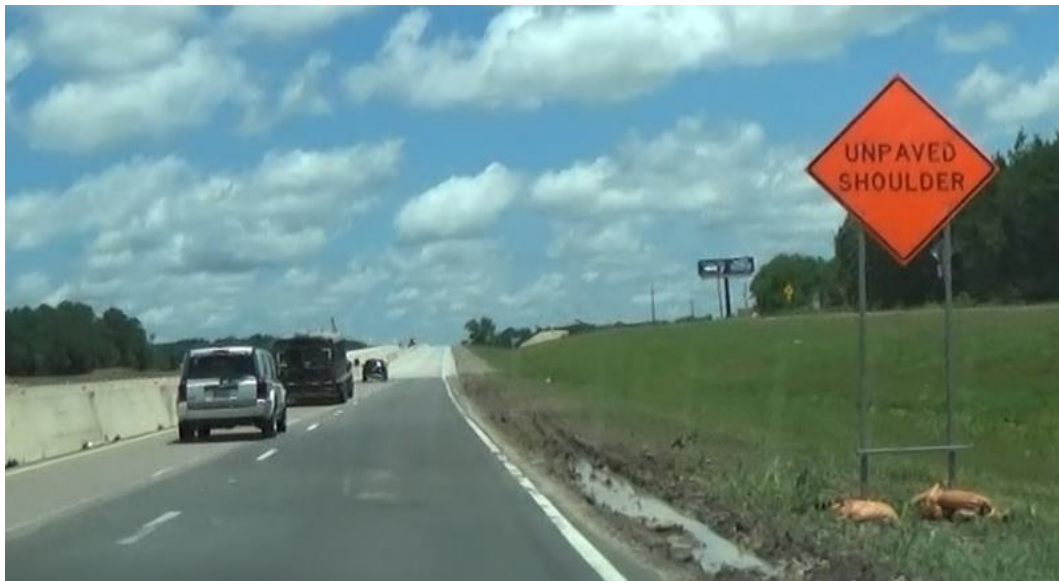
**Figure 50. Unpaved Shoulder Warning Sign at Site 3.**

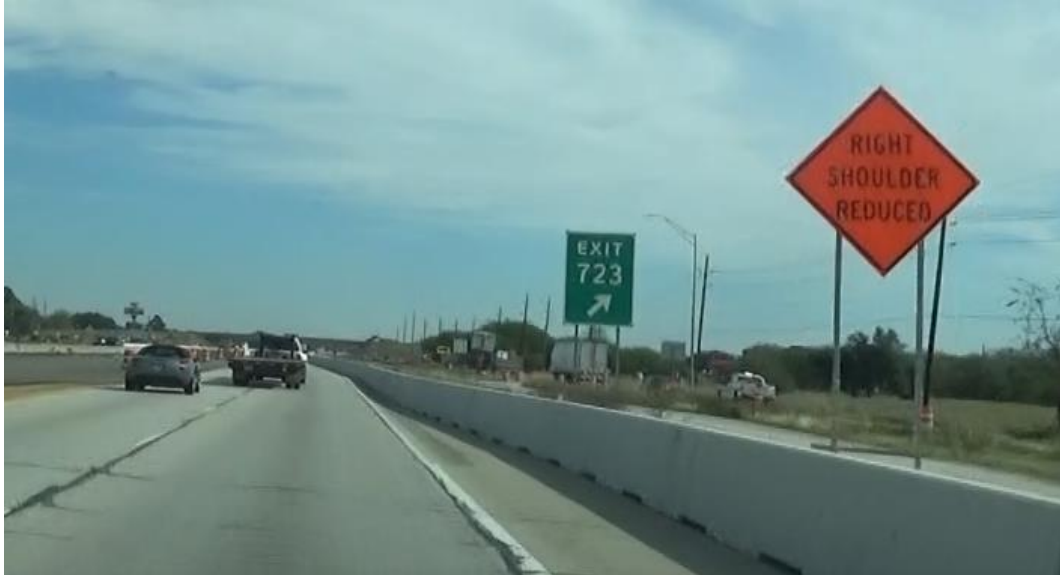
**Figure 51. Right Shoulder Reduced Warning Sign at Site 4.**

At Site 4, a RIGHT SHOULDER REDUCED sign was used to warn drivers that the shoulder width was changing (see Figure 51). The shoulder was less than 10 ft wide at the sign and was approximately 2 ft wide about 100 ft downstream of the sign. A RIGHT SHOULDER CLOSED warning sign was used for a similar condition located elsewhere in the work zone at Site 4.

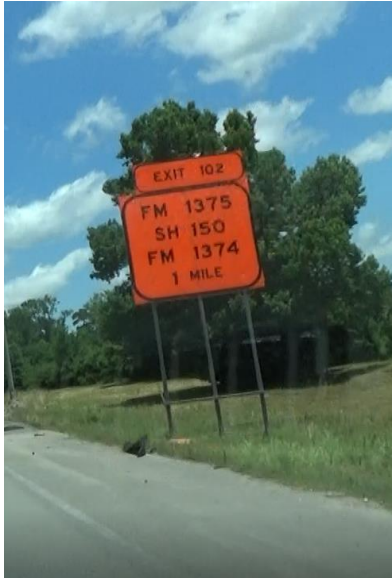
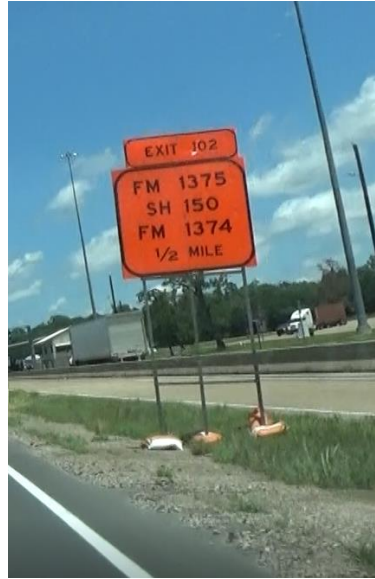
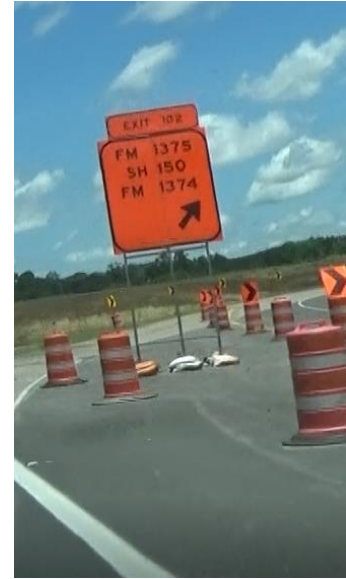
(a) First Advance Guide Sign.

(b) Second Advance Guide Sign.

(c) Exit Direction Sign.

Figure 53. Placement of Exit Direction Sign in Exit Gore.

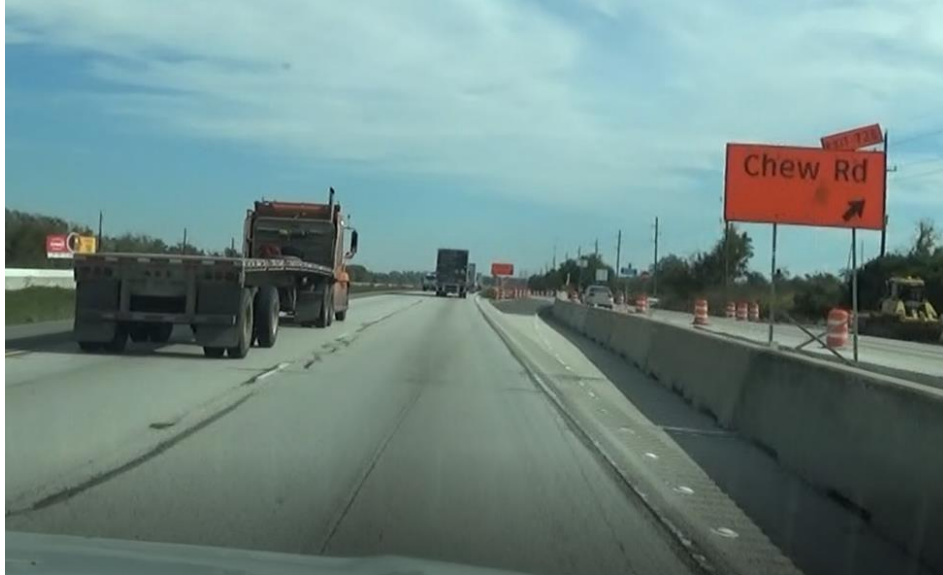
In another example, researchers found that the advance guide sign was missing from an exit sign sequence. Figure 55 shows the exit direction and exit gore signs for the Chew Road exit, but no advance guide sign was present to provide information about the upcoming exit.

**Figure 55. Exit Direction and Exit Gore Signs at Site 4.**

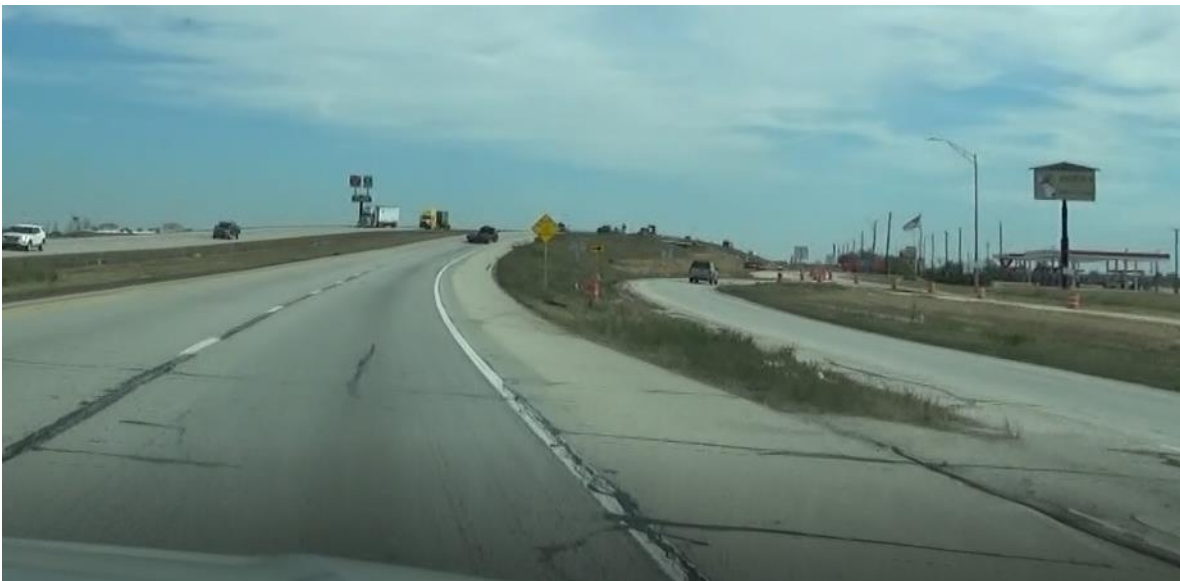
**Figure 56. Exit Gore Sign Missing at Site 4.**

In yet another example, researchers found that the exit gore sign was missing from an exit sign sequence. Figure 56 shows the exit gore sign missing from one of the exits at Site 4.

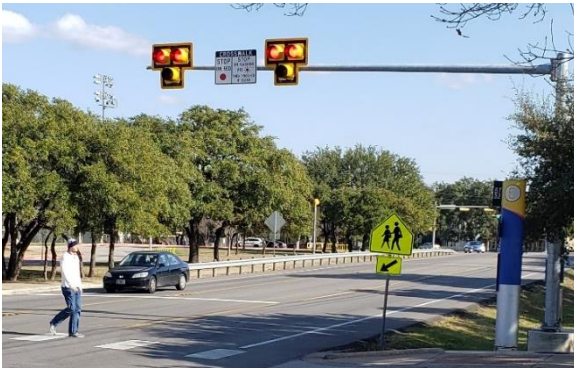
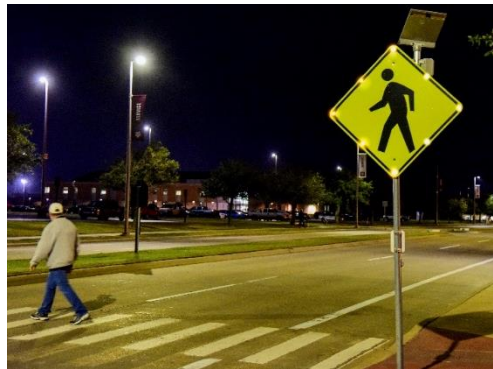
(a) PHB.

(c) LED-Em.

**Figure 57. Examples of Treatments.**

- Pedestrian hybrid beacon (PHB) (see the example in Figure 57a).
- Rectangular rapid flashing beacon (RRFB) (see the example in Figure 57b).
- Light-emitting diode embedded (LED-Em) pedestrian/school crossing sign (see the example in Figure 57c).

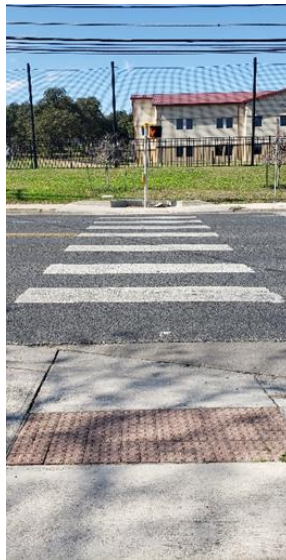
For this research effort, researchers began collecting data in November 2019 and completed the data collection in February 2020. Data from a previous effort (collected May 2019) were also included in the statistical analysis. The video camera was arranged to capture the crosswalk markings and the pedestrian crossings along with the treatment, as possible (see the example in Figure 58).

**Figure 58. Example of Video Camera View.**

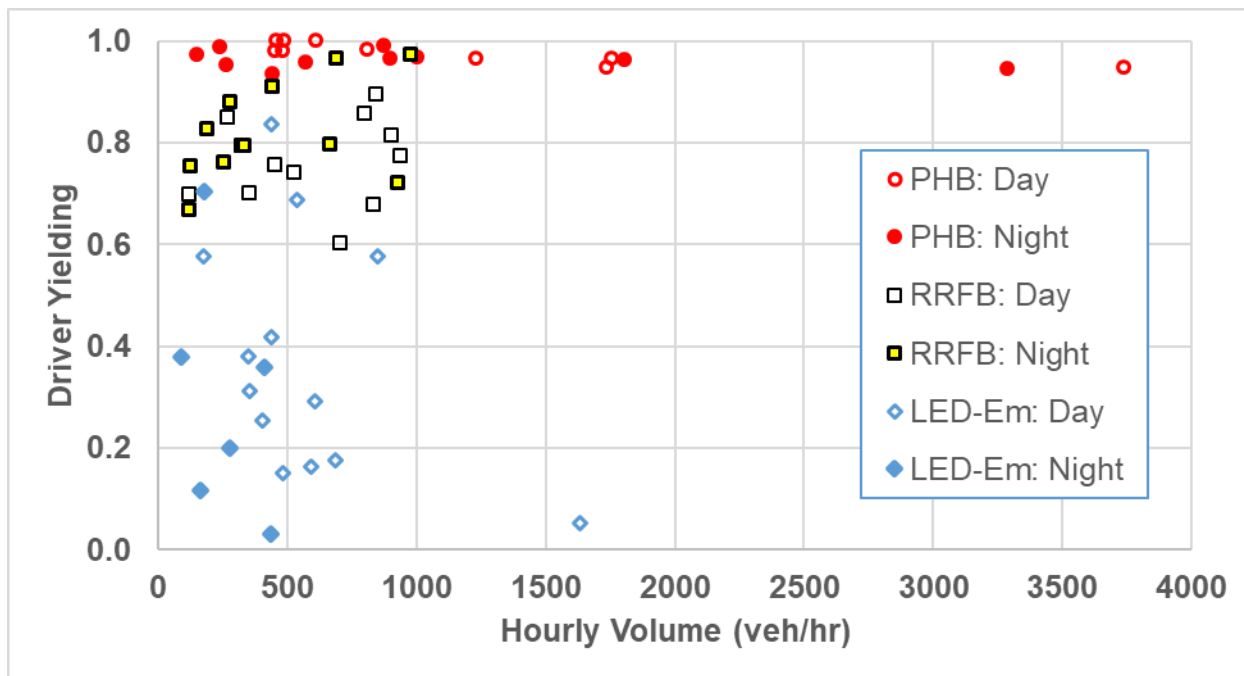
**Figure 59. Driver Yielding by Treatment, Light Level, and Site.**

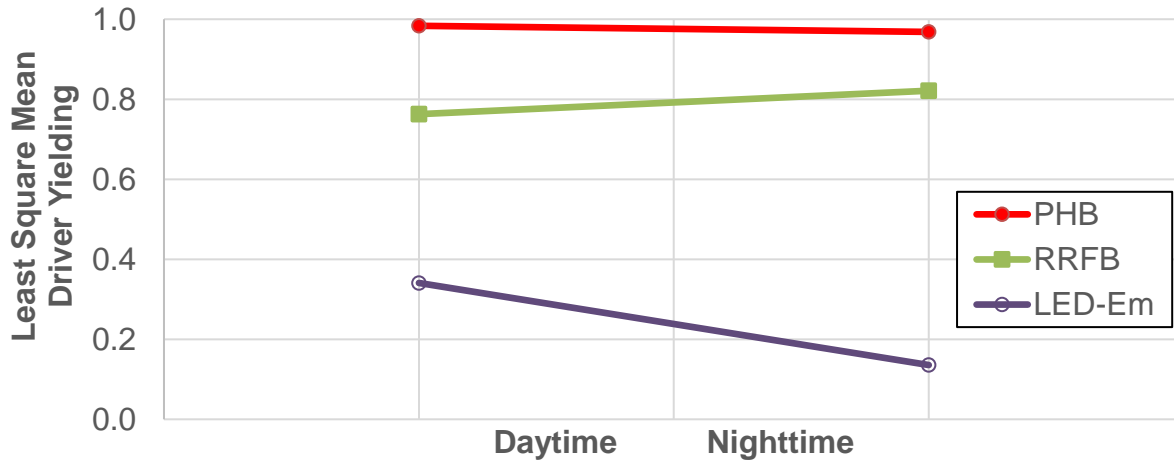
**Figure 60. LSM Driver Yielding for Daytime and Nighttime by Treatment Type.**

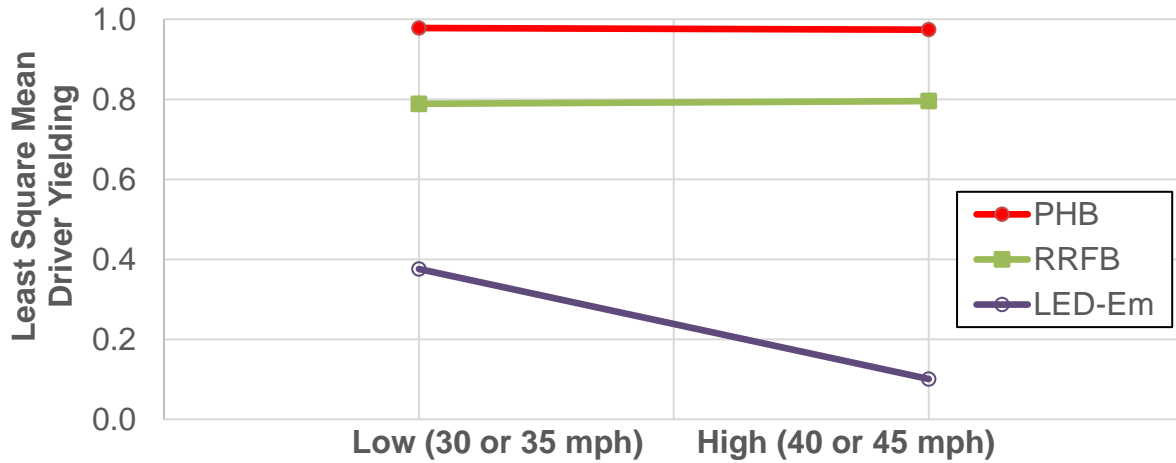
**Figure 61. LSM Driver Yielding for Speed Limit Groups by Treatment Type.**

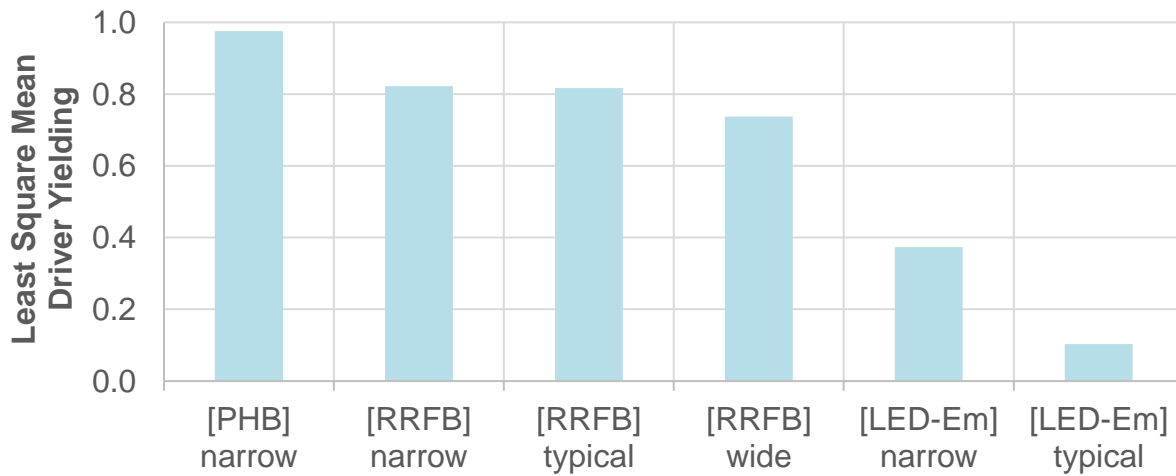
**Figure 62. LSM Driver Yielding for Lane Width Group by Treatment Type.**

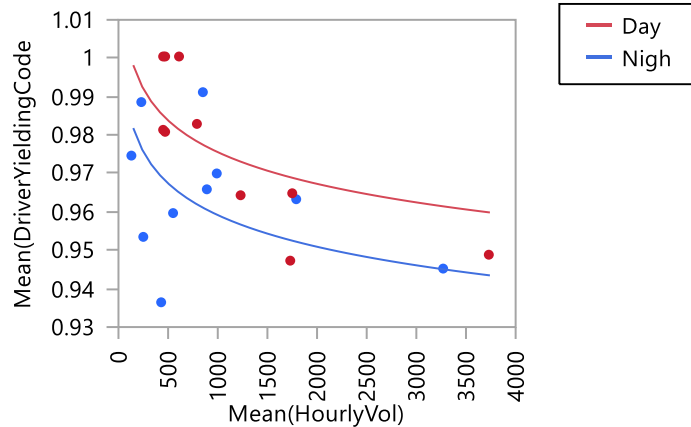
**Figure 63. Regression Plot for Mean Driver Yielding for PHB by Light Level.**
