University of Florida (UF) Testbed Initiative – Alternative Transportation Safety Systems

Final Report

Prepared by: University of Florida

October 2020

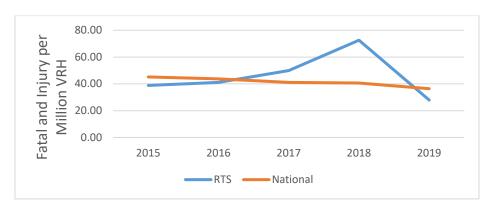
Figure 3-1 – Nationwide and RTS fatal + injury rate

Table 3-1 and Figure 3-1 present National Transit Database (NTD) safety information from 2015–2019. RTS experiences higher collisions and fatal and injury rates than the national average. When normalized by vehicle revenue hours, RTS is involved in 39.5% more incidents that result in pedestrian and bicyclist injuries. This is while the fatal and injury rate (person/million VRH) for RTS is 11.6% higher than the national average.

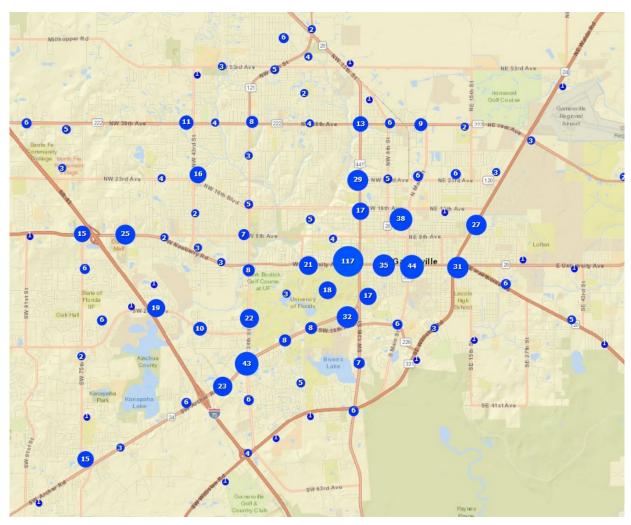
Figure 3-2 – Pedestrian and bicycle crash numbers by segment and intersection

Signal Four Analytics crash data from 2013–2017 were reviewed. The crash data revealed that there were about 1,002 total crashes involving pedestrians and bicyclists in the five-year period, including 135 fatal and serious injury crashes (Figure 3-4). The crash trend indicates a reduction in overall pedestrian and bicycle crashes in 2014 (174) and 2015 (179); however, there was a rising trend with increased crashes in 2016 (226) and 2017 (219) which is consistent with the national trend. Upon further screening, the map below shows the crash numbers by segment and intersection, which helped correlate the historical high crash locations with RTS bus routes.

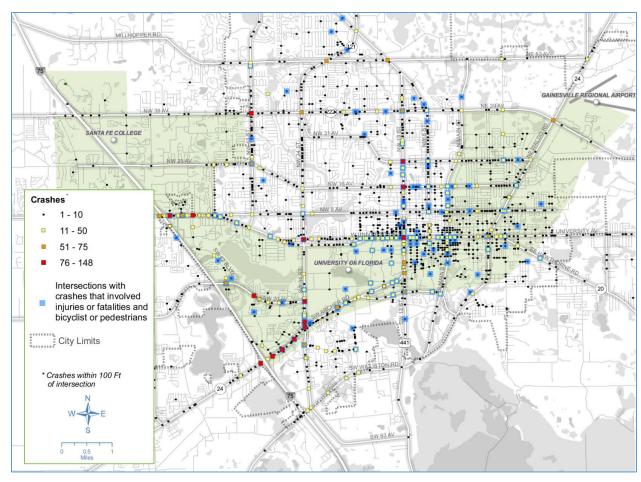
Figure 3-7 – Crashes involving pedestrians and pedestrian injuries and fatalities by intersection, 2009–2011

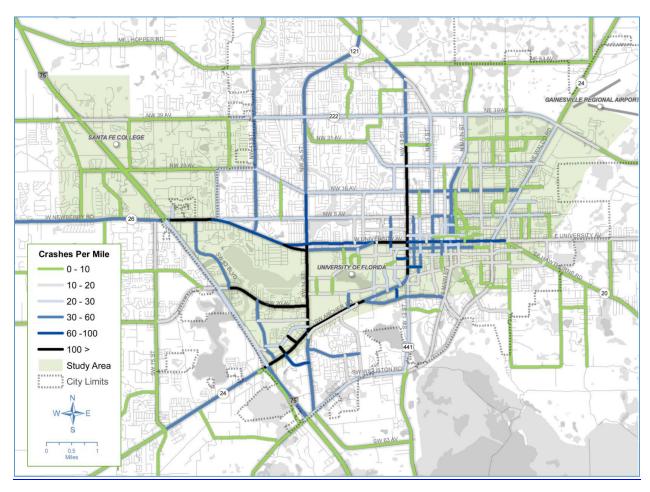
Figure 3-8 – Vehicle crashes per road segment mile, 2009–2011

The selected city routes were considered for their interaction with campus, but also for their overlap with the four high volume corridors surrounding campus. Figure 3-8 shows the crash frequency for the roadways surrounding the UF campus. Within the corridor, a total number of 12,260 crashes were identified in the three-year period along all of the major roadways, including Archer Rd, SW 20th Ave, SW 34th St, SW 13th Street, and University Ave.

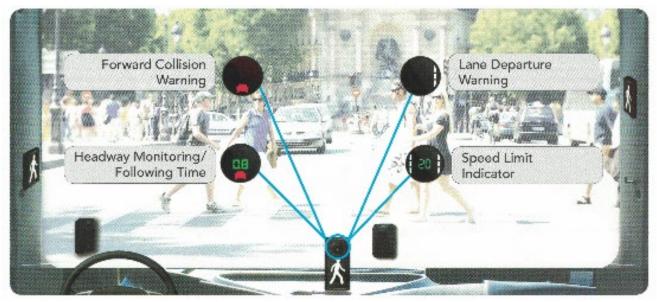
The Mobileye Shield+ system includes three driver alert displays (Figure 4-1). The center-mounted display provides alerts for speed limits, lane departure, forward collision, and headway monitoring. The two side-mounted displays produce a solid amber indication to alert drivers to pedestrian or bicycle presence around the bus, and a red blinking alert is accompanied by a beeping sound to alert the driver of an imminent collision. The system consists of two interior-mounted smart sensor cameras and two exterior housings with smart sensor cameras. A telematics system is able to log the location and time of a triggered warning.

Figure 4-1 – View of smart sensors and driver displays

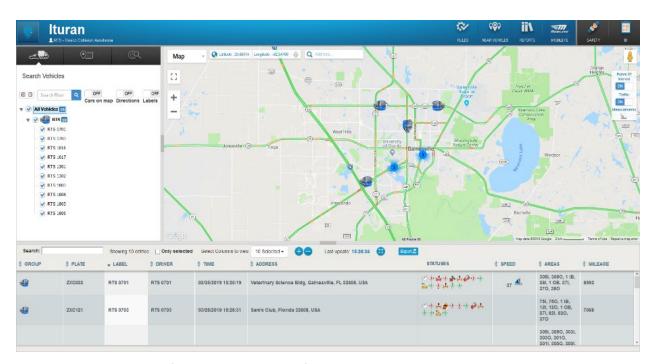
Figure 4-3 – Screenshot of the Ituran Web interface showing active buses

Following the installation of equipment on the buses, the research team was trained on the usage of the Ituran telematics system (Figure 4-3). The Ituran Web interface is able to create reports about warnings generated by the system, such as pedestrian collision and headway monitoring warnings. A full list of warnings is provided in Table 4-2. The Web application can also generate heatmaps to identify increased areas of pedestrian interaction (Figure 4-4) and a street level view (Figure 4-5) of logged warnings. After initially evaluating the data that are being reported, it was determined that there was an issue with telematics reporting on buses 1804 and 1017. There was also an identified issue with the center display on bus 1805. Both issues were resolved by a visit from Rosco technicians on March 5, 2019.

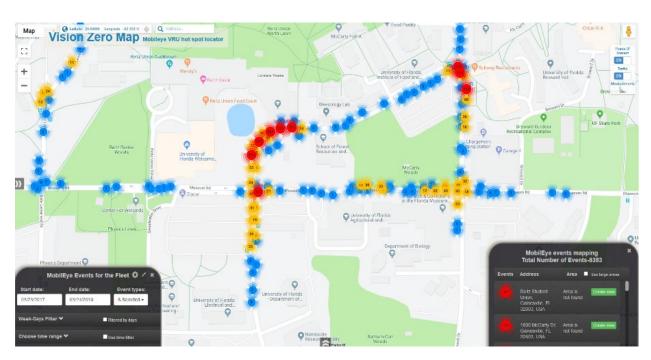
Figure 4-4 – Screenshot of the Ituran Web interface showing a heatmap of generated warnings

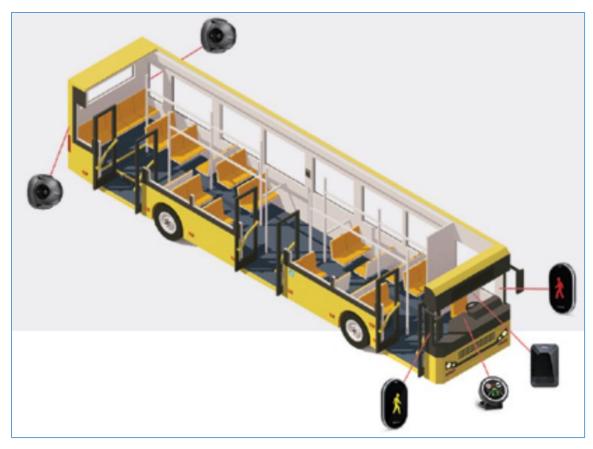
Figure 4-6 – Mobileye Shield+ cameras and alert displays (Image: Mobileye)

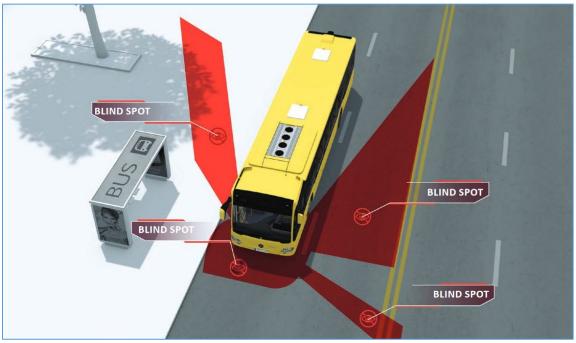
Figure 4-7 – Bus driver blind spots (Image: Mobileye)

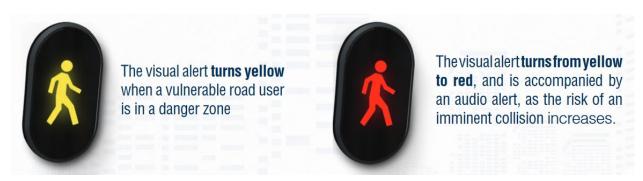
The center-mounted display provides alerts for speed limits, lane departure, forward collision, and headway monitoring. The two side-mounted displays produce a solid amber indication to alert drivers of pedestrian or bicycle presence around the bus, and a red blinking alert is accompanied by a beeping sound to alert the driver of an imminent collision; as shown in Figure 4-8. The system consists of two interior-mounted smart sensor cameras and two exterior housings with smart sensor cameras. A telematics system is able to log the location and time of a triggered warning.

Figure 4-8 - Mobileye alert displays

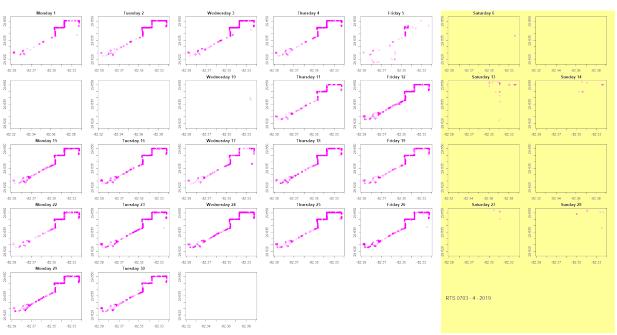
Figure 5-2 - Example of day-by-day plots of alerts

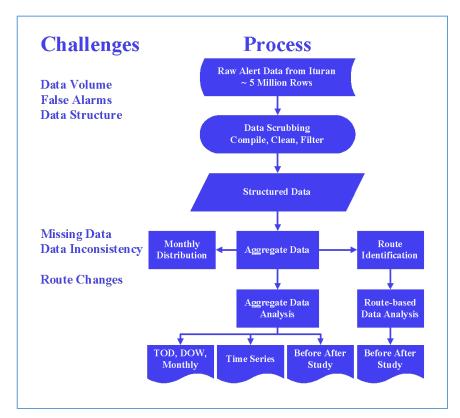
Figure 5-3 shows an overview of the data scrubbing process and the associated challenges at every stage. The challenges with data volume, false alerts, and data structure were outlined with examples in the earlier section. The following sections focus on the challenges and solutions of the aggregate analysis and route-based analysis.

Figure 5-3 – Data scrubbing procedure and challenges

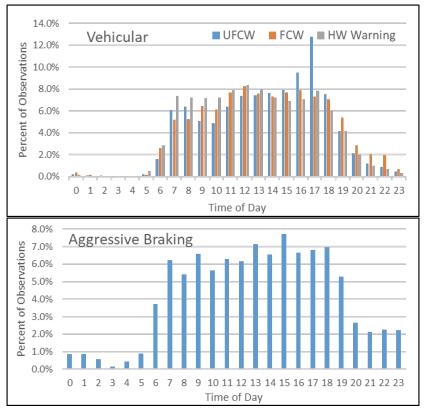
Figure 5-4 shows the hourly distribution of (a) pedestrian-related, (b) vehicular, and (c) aggressive braking alerts. Vehicular and aggressive braking follow the same pattern. Pedestrian-related alerts between 9 p.m. to 6 a.m. are lower in comparison to the other two categories (vehicular and aggressive braking). During 9 p.m. to 6 a.m., the traffic flow and pedestrian demand are considerably lower than in the daytime. The UFCW peak is between 4 p.m. to 6 p.m. This is due to the afternoon peak when the

Figure 5-4 – Hourly distribution of alerts: (b) Vehicle; (c) Aggressive braking

Hourly peaks were expected in each of three periods: morning, noon, and afternoon. However, the plots in Figure 5-4 are all bell-shaped. This could be due to the nature of demand in Gainesville as a college town. Various conflict speed filters were used to see if there was any different trend for conflicts.

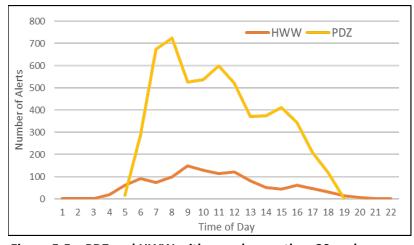
Figure 5-5 shows the distribution of PDZs and HWWs (headway warnings) with speed more than 20 mph (the remaining conflicts were less than 200 observations). As shown in Figure 5, both HWW and PDZ have a pattern with three peaks.

Figure 5-5 – PDZ and HWW with speed more than 20 mph

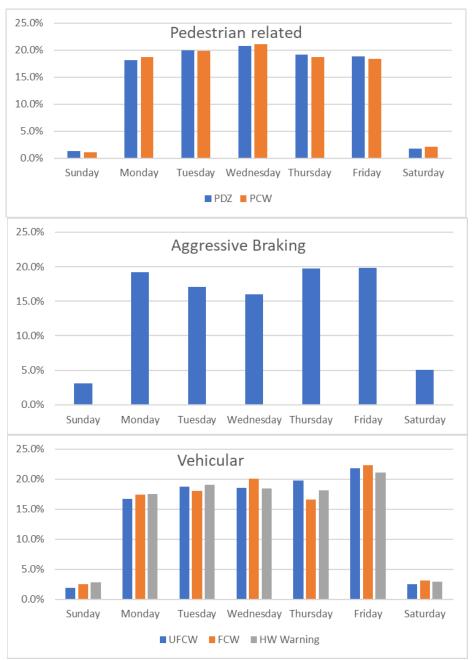
Figure 5-6 – Daily distribution of pedestrian, vehicular, and aggressive braking alerts

Figure 5-6 shows the weekday distribution of the alerts. The number of alerts on the weekends are lower than the weekdays due to lower demand on weekends generally. The nature of Gainesville as a college town amplifies the demand difference between weekdays and weekends because the University is closed on weekends. The proportion of alerts on weekdays fluctuates between 17% and 22%.

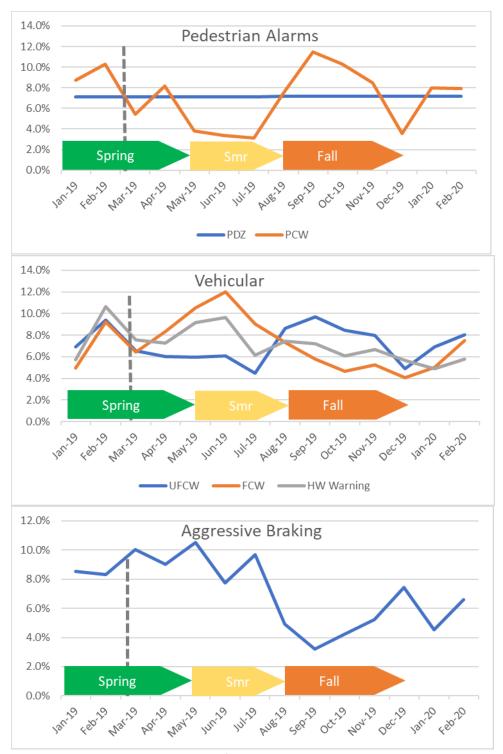
Figure 5-8 – Monthly distribution of pedestrian, vehicular, and aggressive braking alerts

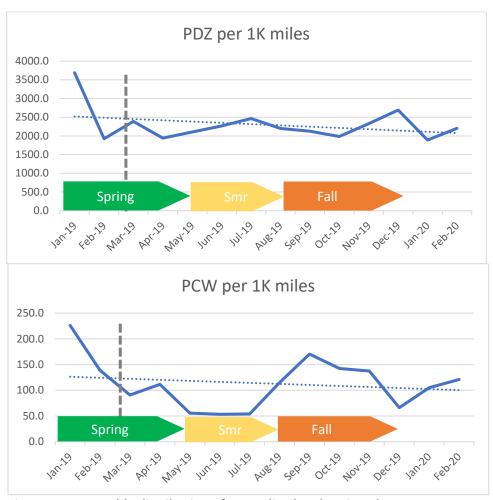
Figure 5-9 – Monthly distribution of normalized pedestrian alerts

As shown in Figure 5-9, there is fluctuation in the PDZ alerts between spring, summer, and fall semester period. Generally, the alerts have been lower in the open period (summer and Fall) when compared to the stealth period. The trend line also shows a downward trend longitudinally over the period of deployment.

The vehicular alerts in Figure 5-10 showed a decreasing trend, as well as pedestrian alerts in Figure 5-9. The comparison of decreasing trend slope is possible; however, in the next section, the stealth and open mode will be compared.

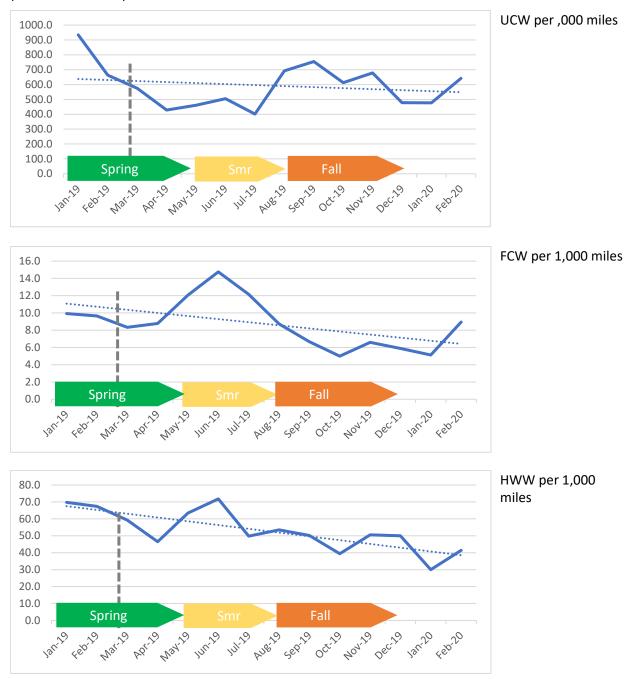
Figure 5-10 – Monthly distribution of normalized vehicular alerts

Trends in the UFCW and FCW distributions are complementary because the UFCW alerts are for speeds lower than 19 mph and FCW alerts are for speeds higher than 19 mph. The maximum of FCW is in June (summer semester).

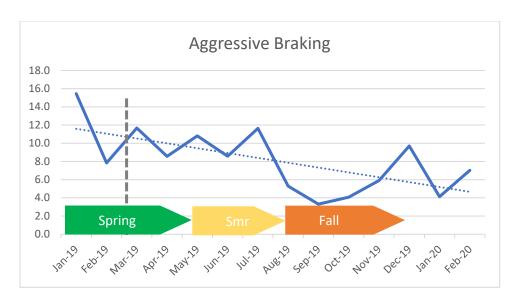
Figure 5-11 – Monthly distribution of normalized aggressive braking alerts

In Figure 5-11 there is a considerable decreasing trend in aggressive braking. Interestingly, the lowest normalized aggressive braking is in September when student demand is highest and when buses are in their fullest condition.

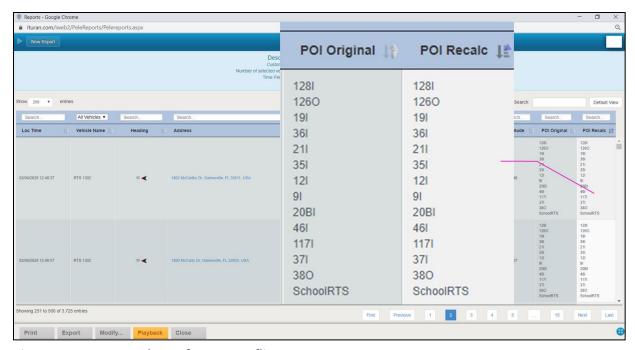
Figure 5-12 – Routes shown for one conflict

As shown in Figure 5-12, each conflict from the Mobileye Ituran includes all the routes passing through that point; however, it does not provide unique route-based data. As an alternative, the methodology mentioned in the Data Collection and Processing section was developed to identify the routes of vehicles. Five routes during weekdays were selected for analysis. An example of the collected route data is shown in Table 5-11. Each row includes the route, travelled miles, and stealth indicator for each vehicle on each day.

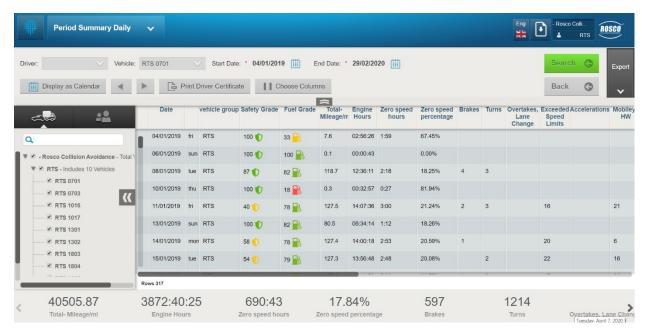
Figure 5-13 – Example of day-to-day results from Ituran Safety tab

The Ituran alerts from Mobileye were correlated with the selected five routes. For this option, day-by-day data from the Ituran Safety tab (Figure 5-13) were used. This approach was undertaken because the data were already aggregated for each vehicle by day. However, the initial analysis showed that the numbers from this tab (period summary daily) were about 5 percent in excess of the data used in aggregate analysis. Using the period summary daily data from Ituran could have biased the results. It should be noted that in the route-based analysis section, the latitude and longitude of each individual alert was required to define each vehicle's daily route (see also Table 5-3) and, as such, the day-by-day data from the Ituran Safety tab could not be used for both aggregate and route-based analyses.

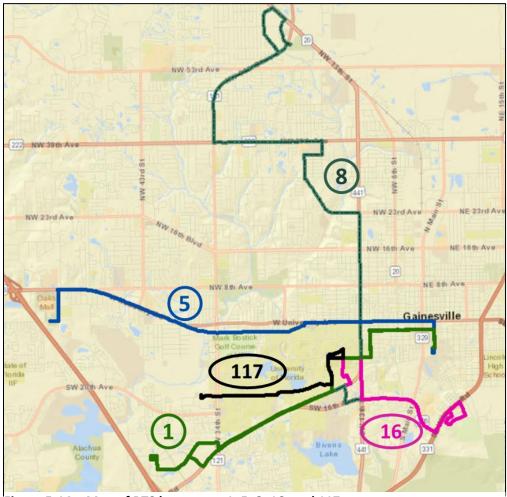
Figure 5-14 – Map of RTS bus routes 1, 5, 8, 16, and 117

Figure 5-14 and Figure 5-15 show the five routes that are the focus of this section. Gator Locator is a Web interface that shows the location and route of each RTS bus. The next sections focus on the evaluation of pedestrian, vehicular, and aggressive braking alerts.

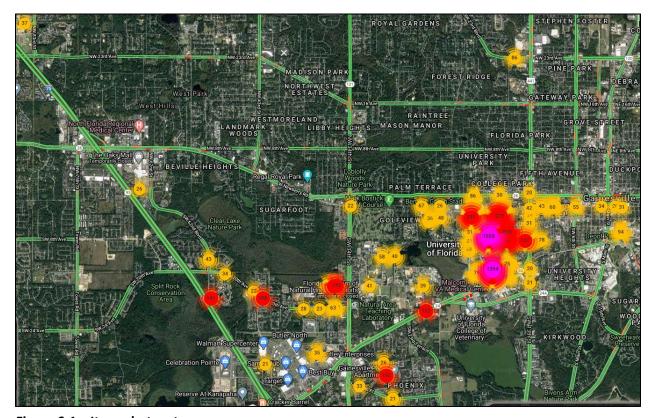
Figure 6-1 – Ituran hotspots

The purpose of this section is to identify potential risk factors for high conflict locations. Ituran includes a visualization tool that shows locations with high conflicts, called hotspots in this study. Figure 6-1 shows the hotspots from the Ituran Web interface. In this figure, locations with highest conflict alert observations are indicated with pink color and lowest with yellow.

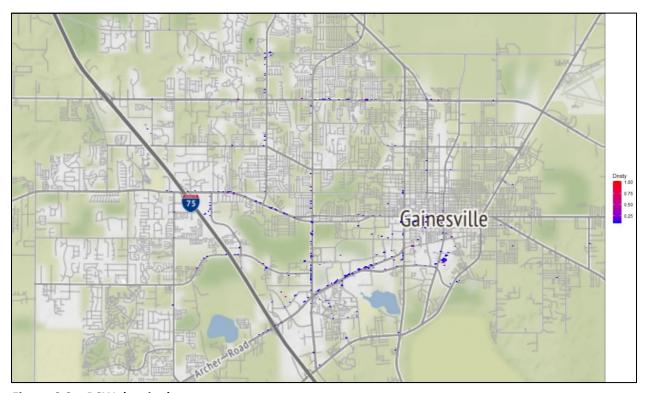
Figure 6-2 – PCW density heatmap

The purpose of the normalizing methodology was to find locations with severe risk factors that also have high demand. For this goal, the Gainesville map was divided into 400 horizontal and 400 vertical bins (160,000 bins). In each bin, the numbers of PCWs and PDZs were found, and the ratio of PCW to PDZ

was calculated. This ratio is named PCW density. For visualization purposes, a heatmap of the PCW density was plotted, as shown in Figure 6-2. It is obvious that the locations highlighted are scattered all over the map. So, these locations are not the ones with just high demand.

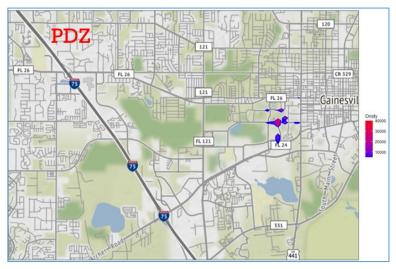
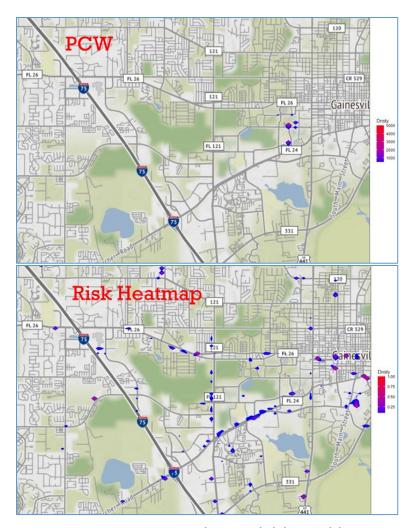
Figure 6-3 shows PDZ, PCW, and PCW density heatmap using a grid of 100×100 bins. As shown, PCW and PDZ heatmaps are similar. The density risk heatmap shows the hotspots that possibly have more risk factors – significantly more locations are identified using the heatmap.

Figure 6-3 – Density heatmaps (100×100): (a) PDZ

Figure 6-3 – Density heatmaps (100×100): (b) PCW; (c) PCW

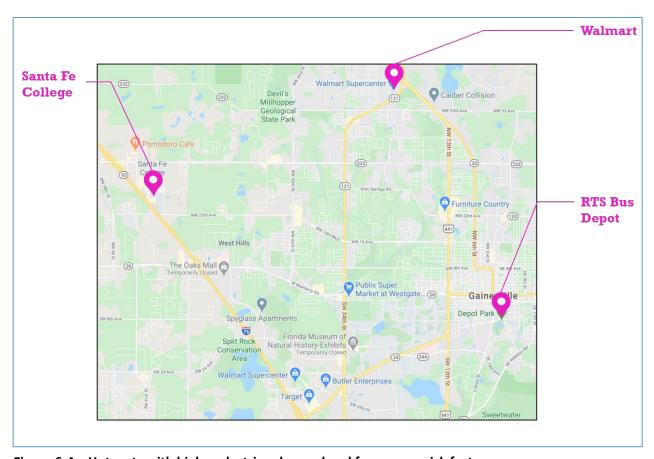
Figure 6-4 – Hotspots with high pedestrian demand and few severe risk factors

The hotspots in this section are locations that (1) have more than five pedestrian collision warnings in the data collection period and (2) have a PCW density more than 0.2. Using the mentioned filters, 21 hotspots were found. When adjacent hotspots were combined as one (three clusters with 3, 2, and 2 hotspots, respectively), 17 hotspots remained for further review. Of these 17 hotspots, three were locations with high pedestrian demand and few severe risk factors: the RTS bus depot, Santa Fe College, and Walmart. These three locations are shown in Figure 6-4. Excluding these three locations left 14 hotspots for further review.

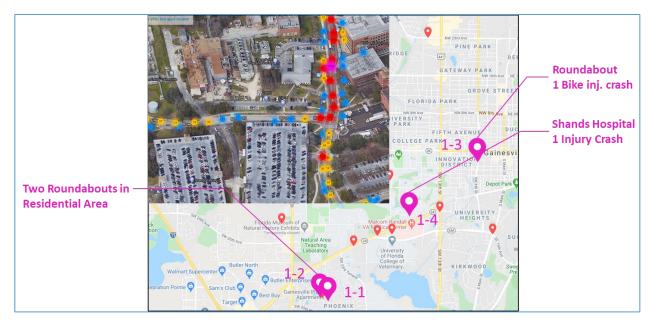
The 14 hotspots exhibited obvious risk factors. As indicated in Figure 6-5, three of these locations were roundabouts. Two of the roundabouts, 1-1 and 1-2, are in residential areas, implying relatively high pedestrian demand. The next hotspot in Figure 6-5 is close to Shands Hospital and also has high pedestrian demand. This location is a 3-leg intersection that is close to three curves on its legs. From field review, it was evident that there was a surge in pedestrian exposure due to the parking lot SW of this intersection.

Figure 6-5 – Hotspots 1: three roundabouts and Shands Hospital

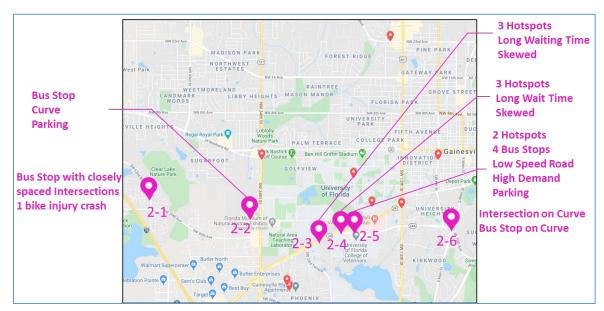
Figure 6-6 shows the next six hotspots. At hotspot 2-1, indicated in Figure 21 and shown in an aerial view in Figure 6-7, there is a bus stop between two closely located intersections. At Hotspot 2-2, there is a bus stop on a curve that is located close to parking lots on both sides of the road. An aerial view of hotspot 2-2 is shown in Figure 6-8.

Figure 6-6 – Hotspots 2: Set of 6 hotspots

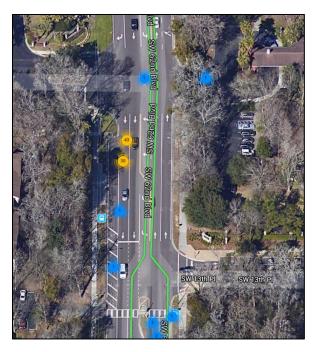
Figure 6-7 – Aerial view of hotspot 2-1

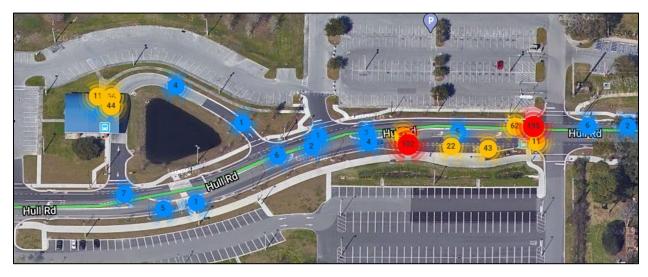
Figure 6-8 – Aerial view of hotspot 2-2

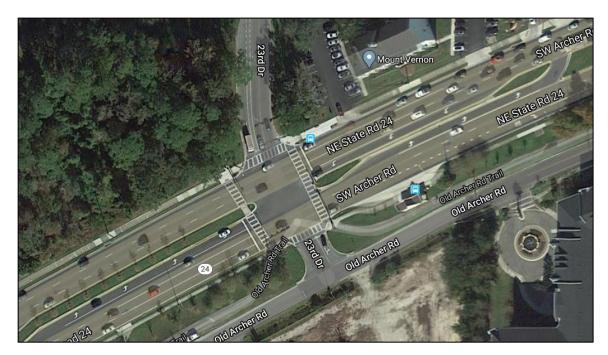
Hotspot 2-3 is at a skewed intersection, as shown in Figure 6-9. This hotspot is the aggregate of three hotspots. There is a long waiting time for the pedestrians who want to cross Archer Road. Hotspot 2-4 (aerial view in Figure 6-10) is located close to 2-3; its risk factors are similar to 2-3.

Figure 6-9 – Aerial view of hotspot 2-3

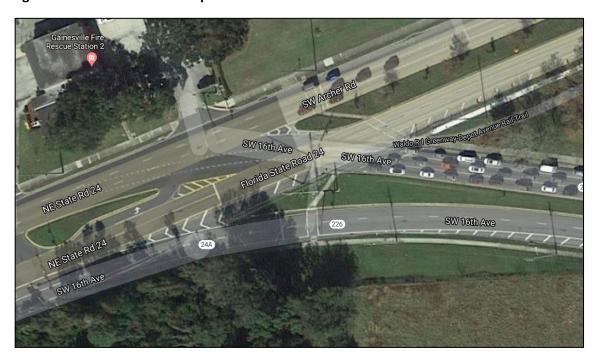
Figure 6-10 – Aerial view of hotspot 2-4

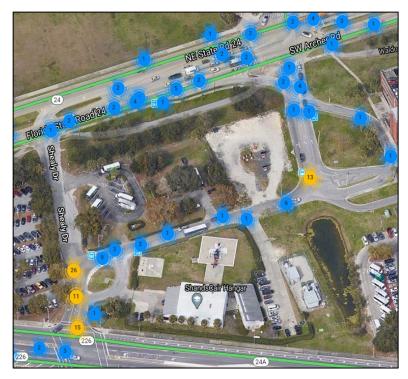
Hotspot 2-5 (aerial view in Figure 6-11) is the aggregation of two hotspots. This location is a low speed road, but with high pedestrian demand. There are four bus stops close to each other in adjacent of a parking lot. At hotspot 2-6, there are two bus stops adjacent to an intersection on curve, as shown in Figure 6-12.

Figure 6-11 – Aerial view of hotspot 2-5

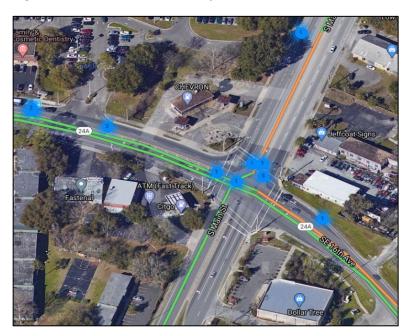
Figure 6-12 – Aerial view of hotspot 2-6

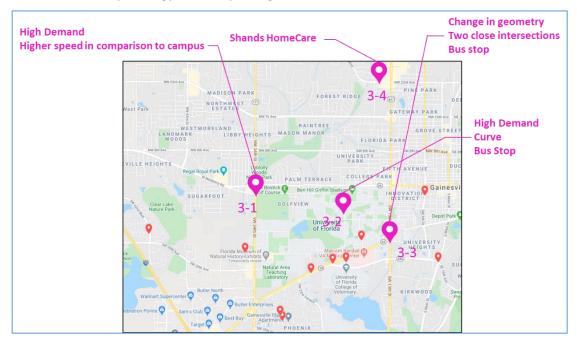
Figure 6-13 shows the last four hotspots. The aerial views of these hotspots are shown in Figure 6-14 to Figure 6-17. Hotspot 3-1 is located at an intersection with speed limits of 35 and 45 mph. These speeds are higher than its vicinity on campus. Hotspot 3-2 is on campus with high demand. There is a bus stop on a reverse curve adjacent to a parking lot. Hotspot 3-3 includes a bus stop in between of two intersections. There is a change in the road geometry from undivided to divided. Hotspot 3-4 is close to a branch of Shands Hospital, a gym, and a parking lot.

Figure 6-13 -Hotspots 3: Set of four hotspots

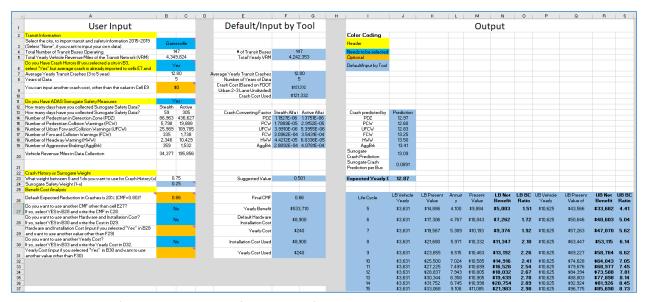
Figure 8-1 – Benefit-cost analysis tool's user interface

The tool input parameters include transit data, safety information, and monetary values of crash and investments. Using the input information and predefined values for conflict conversion factors, the tool computes the net benefit and benefit-to-cost ratio. The output is per bus with ADAS system installed. Figure 8-1 shows the user interface of the spreadsheet-based tool.

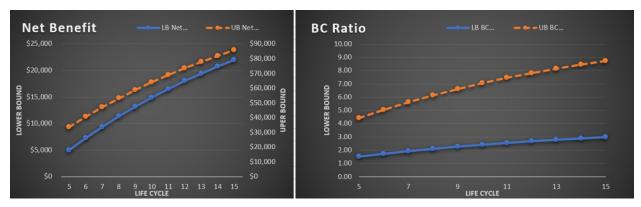
Figure 8-2 – Visual output of the tool

The tool also provides two visual outputs: net benefit and benefit-to-cost ratio diagrams as shown in Figure 8-2. The lower bound (LB) and upper bound (UB) are shown in these two diagrams, based on the life cycle of the system. As with every investment, the longer the service life, the higher the return. Practically, the true values fall in between the LB and UB, and these bounds assists the analyst in using their engineering judgement to decide if the investment is warranted.

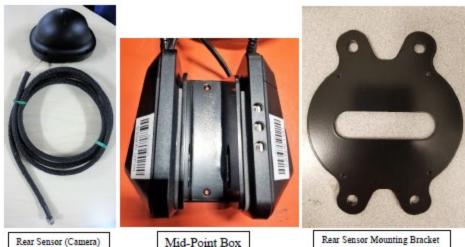
Midbox Kit

Rear Sensor (Camera)

Mid-Point Box

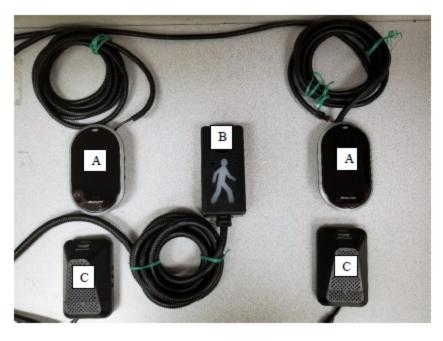
A – Left & Right Pedestrian Display B – Center Display (Eyewatch) C – Corner & Master Camera

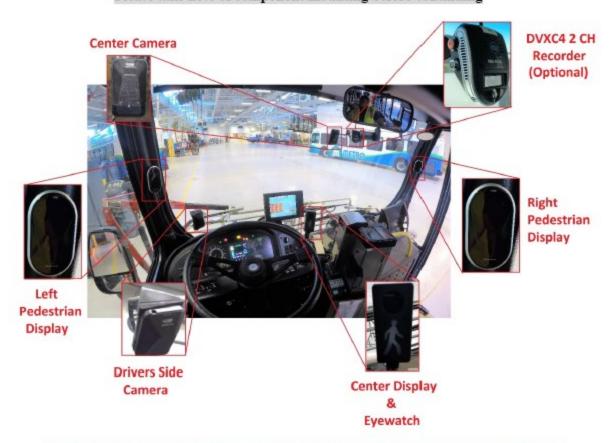
5.1 - Front Branch Overview

Please take note of component mounting before continuing

Component placement MUST be verified & approved by the fleet manager before permanently mounting

Mounting all windshield components before routing the harness will allow you to store cable slack away from the driver

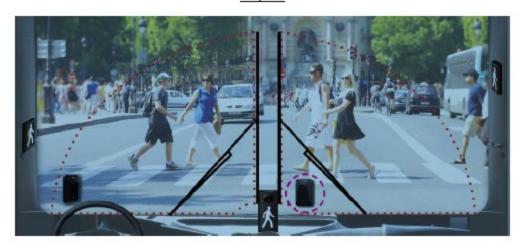
5.2 - Front Branch Components:

Make sure all front Sensors (Cameras) are mounted INSIDE the wiper swipe line <u>using the appropriate</u> <u>template</u>

The Front Branch will be all windshield mounted components (Photo A)

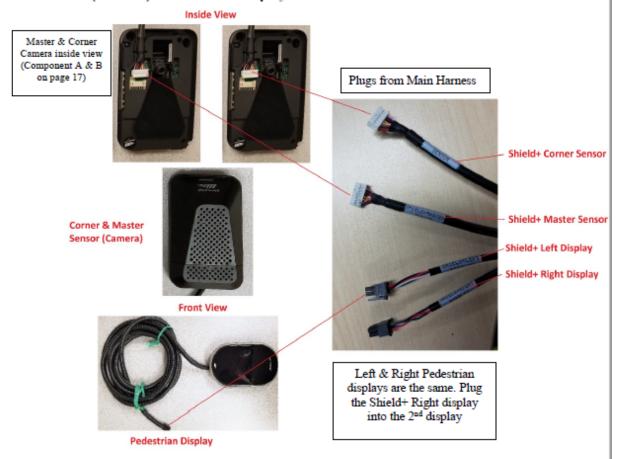
The front sensors have to be adjusted for calibration after the install. Leave the covers removed from the sensor until calibration is complete

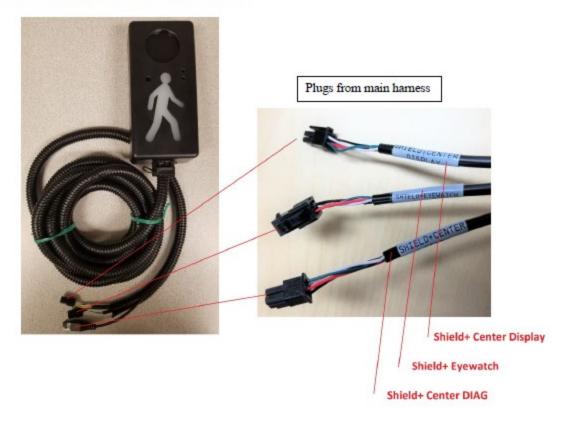
Displays Mounted in line with the driver mirrors, facing the driver

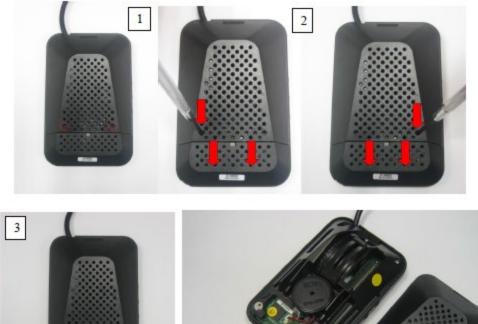
5.5 - Front Sensor Cover Removal

- Push down on the tabs located on the left and right side of the sensor (Photo 1 & 2)
 Remove the lower cover of the sensor (Photo 3)
 Using a small Philips screwdriver remove the two screws on the left & right side of the sensor

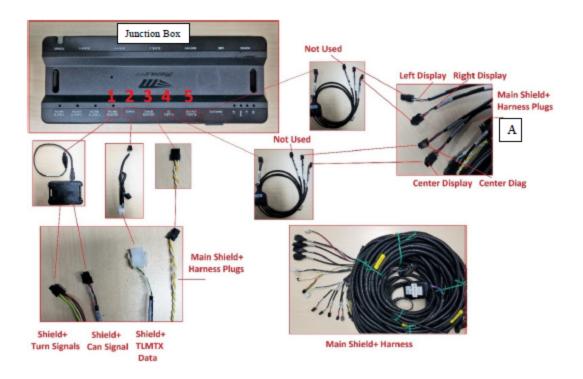
Once all front branch components are mounted, follow the diagram below for component connections to the junction Box

The Main Shield+ Harness Plugs (Photo A) is showing the Middle Branch connectors.

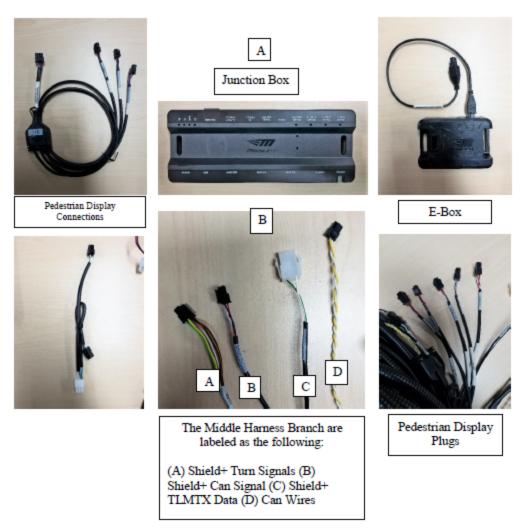
6.2 - Middle Branch Components:

These components are usually mounted inside the electrical cabinet. These cabinets can be located in the
front, middle, or rear of the bus as describes in the panel removal section 4.1. Photo A are all components
mounted and connected in the middle harness section. Photo B are the connections from the harness

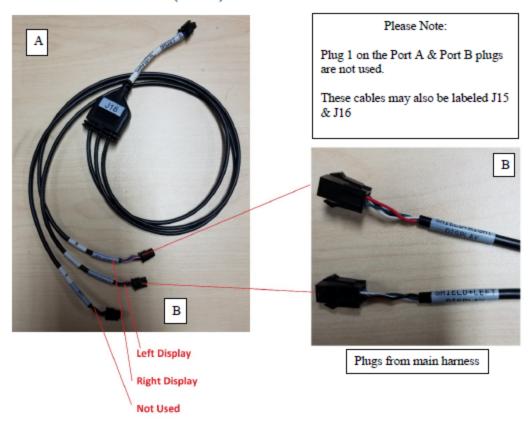
Connect the Plug on the main harness (Photo B) labeled Left Display & Shield+ Right Display to Port A & Port B (Photo A)

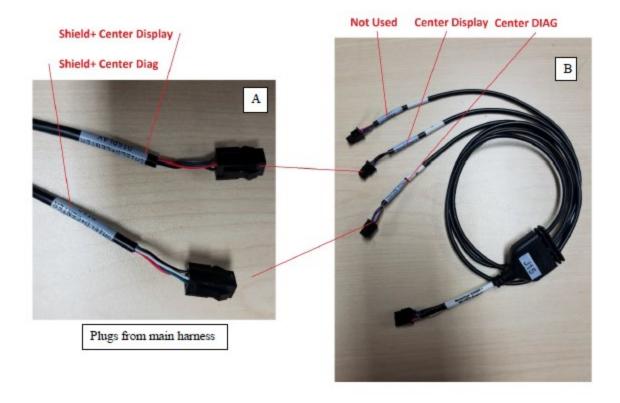
Connect the Shield+ Center Display & Shield+ Center Diag plugs (Photo A) to the Center Display & Center Diag plugs on the J15 (Port A) Cable (Photo B)

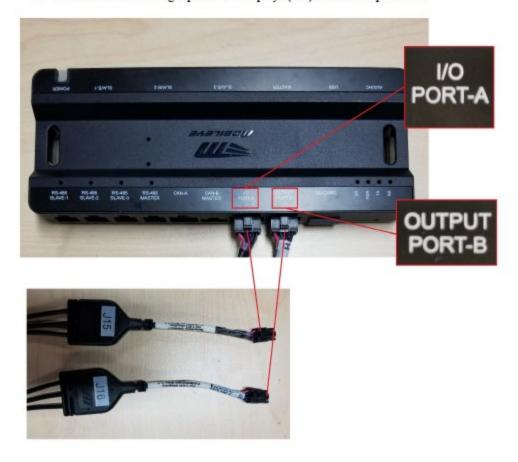
- Connect the J15 (Port A) & J16 (Port B) plugs into the Junction Box
- · Connect the center display & Eyewatch (J15) into the I/O Port A
- . Connect the Left & Right pedestrian displays (J16) into the Output Port B

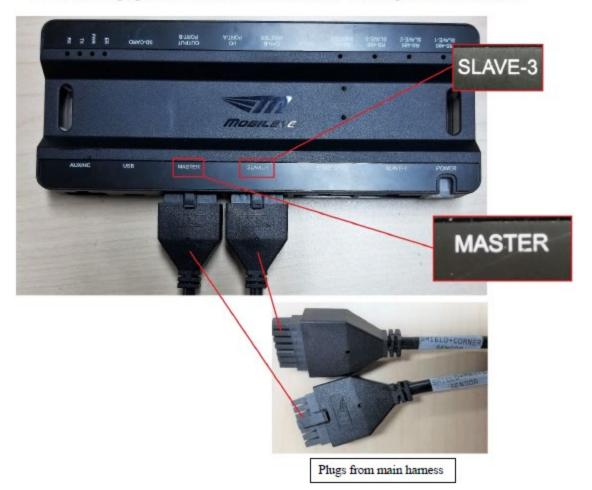
- Connect the plug labeled "Shield+ Master Sensor" to the "Master port on the junction box
 Connect the plug labeled "Shield+ Comer Sensor" to the "Slave 3" port on the Junction Box

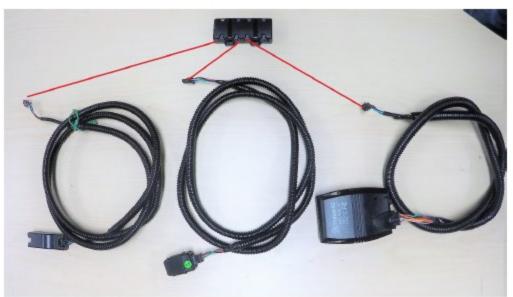
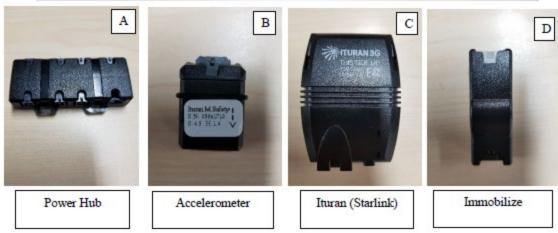
The Telematic components are located above the driver in the overhead destination sign compartment

. Connect all telematic components (Photo B, C & D) to the power Hub (Photo A)

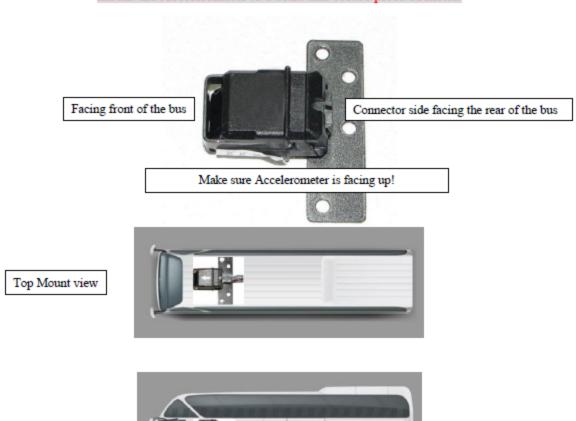
Mount the Accelerometer horizontal with the connector facing the rear of the bus. Make sure to mount the Accelerometer to a solid and secure piece of metal.

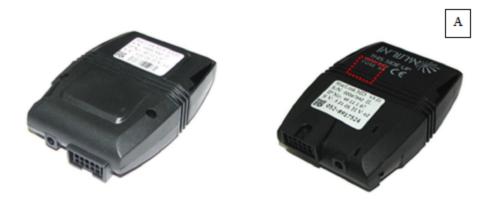
7.3 - Starlink

- For the best reception please install the StarLink device in the top part of the front dashboard.
- · Make sure that the GPS side face up
- Make sure that there is no metallic surface above the Starlink
- Make sure the Starlink is facing the correct way (A)
- · Connect the Starlink to the power hub as shown in the picture on section 7.1

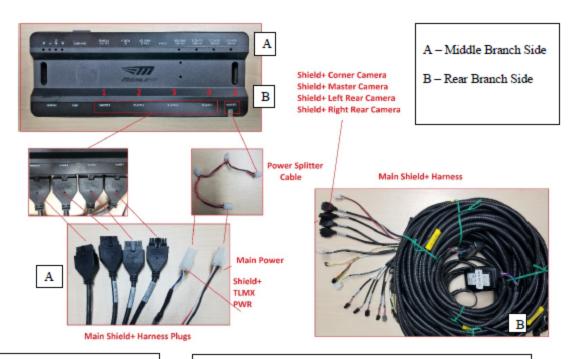
8.1 - Rear Branch Connection Complete Overview

The Main Shield+ Harness Plugs (Photo A) is showing the rear branch connectors.

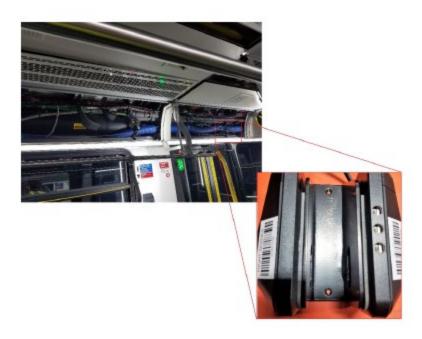
Coax Coupler

The Mid-Point box should be mounted in the rear of the bus, no more than 17 feet from the rear cameras

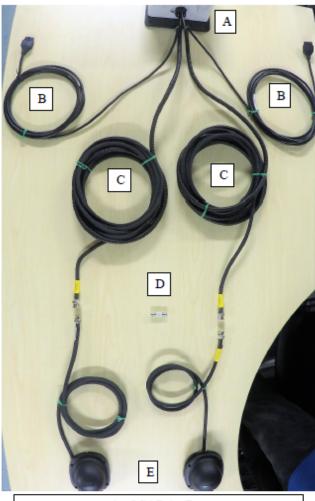
A - Mid Point Box

Plug B will connect to main harness routed through the vehicle

Plug C will connect to the rear sensors (Cameras)

"D" is the Coax Coupler that will connect the coax cable on the rear sensor to the coax cable on the Mid-point box (Will be attached when harness is put together

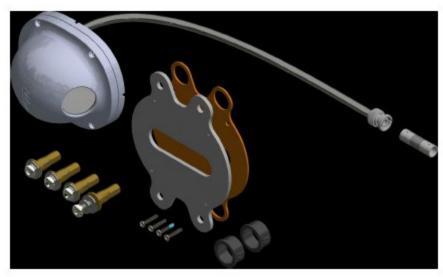
8.3.2 Rear Camera Complete Overview

Rosco will provide a vehicle specific template for exact component location. Please see section 12 for all vehicle specific template part numbers

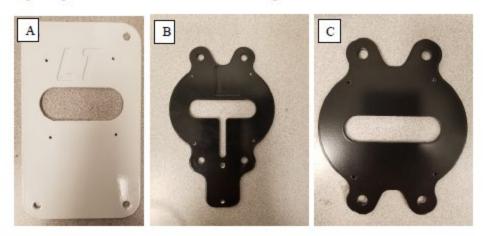
Rear Sensor (Camera) Mounting Continued:

Depending on the vehicle there are several mounting brackets to use for rear sensor installs

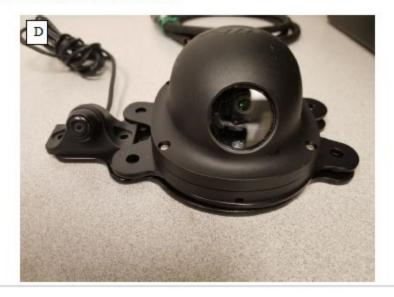
Each bracket is used for left & right-side sensors by using the opposite sides of the bracket

- A MTA bus
- B Rear sensor with AUX camera
- C Standard rear sensor bracket
- D Rear sensor with AUX camera mounted

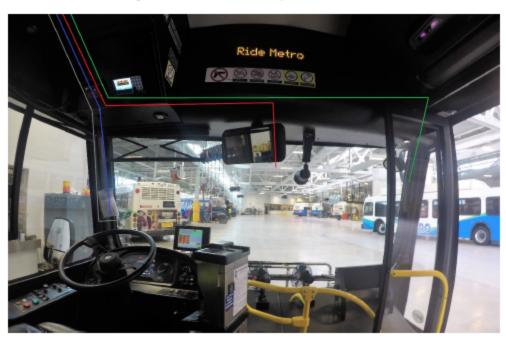
- For the corner camera & pedestrian display (Drivers Side), route the cable up the A-Pillar into the above compartment, and into the electrical box (Gray & Blue)
- · Route the center display and master camera up through the above compartment (Red & Green)

Always use a grommet and loom when routing cables. Make sure the harness is secured with a zip tie and does not cause any distraction to the driver

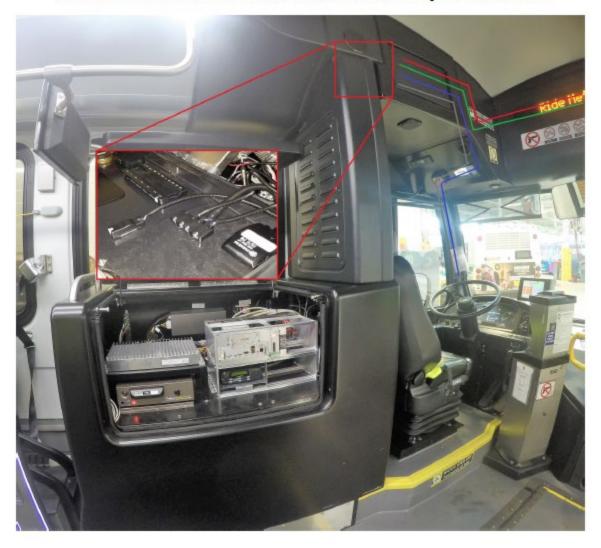
Front Harness Routing (Continued):

Front harness branch routed to Electrical cabinet where Shield+ components are mounted

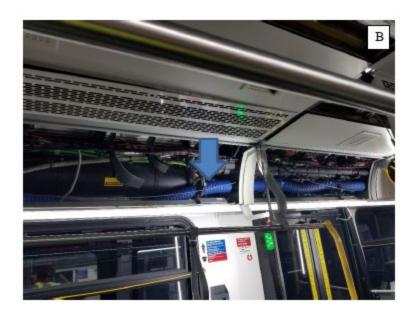
- With all side panels removed, route the cable along the factory harness (Photo A)
- Secure the Shield+ Harness to the factory harness with zip ties every 12 inches
- Make sure to not interfere with factory heating & Ac vents when routing wires (Photo B)

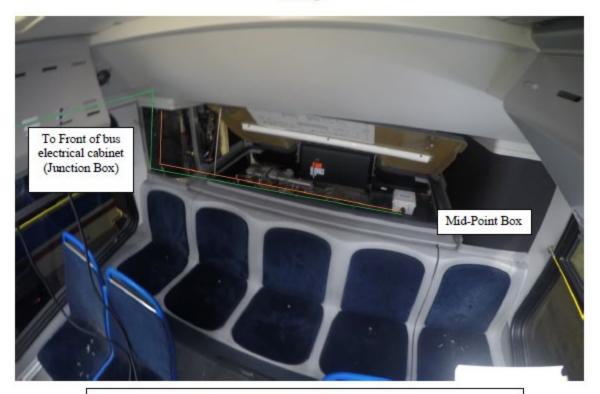
The photos below show different mounting locations for rear mounted components & wire routing

Orange – Rear camera cable to Mid-Point Box Green – Extension cable from Mid-Point Box to junction box

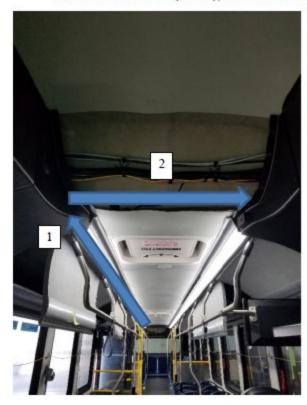
Rear Harness Routing (Continued):

- Route cables from rear to Front (Arrow 1)
- Cross over from curb side to drivers' side by removing the center panel (Arrow 2)
 When on the driver's side (Photo 3), route cables into the two junction boxes (A&B)

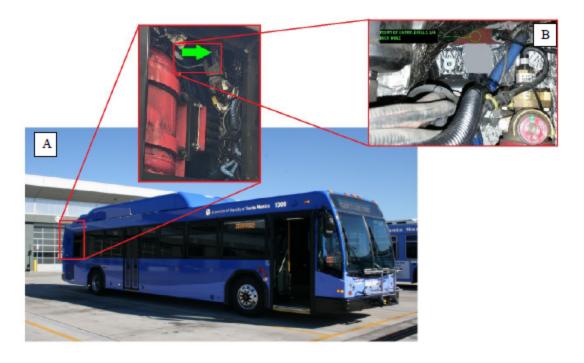
10.1 - Rear Sensor (Camera) Entry Point:

- 1. Open any engine access door panel to access area where the entry point will be drilled.
- 2. This will be located on the side or rear of the bus (Photo A shows side entry)
- Identify entry point location & check both side of the firewall to ensure no damage to existing harnesses or hoses. (Photo B)
- 4. Drill a pilot hole first to confirm entry hole will be in the right location.

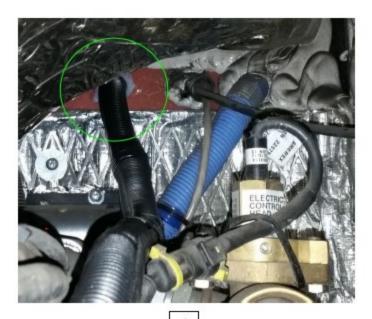
- · Run the wires through pre-drilled hole
- · Seal the hole from both sides using Black Sikaflex 221 (Photo A)

The roadside harness MUST be protected by heat/fire resistance jacket due to the amount of heat generated by the exhaust. Run harness under and away from the exhaust system by follow existing OEM harness in the area

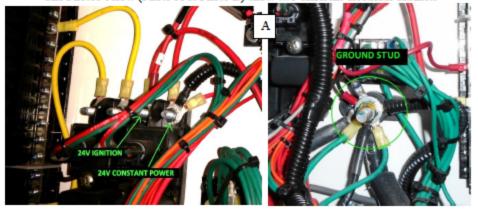
- · Crimp ring terminals on the Constant, Ignition, & Ground wires
- . The Photos below (Photo A & Photo B) show two different electrical cabinets

If Splicing into a harness always use the Military Splice method and solder. NEVER USE TTAPS on power connections as they are not an MECP approved method

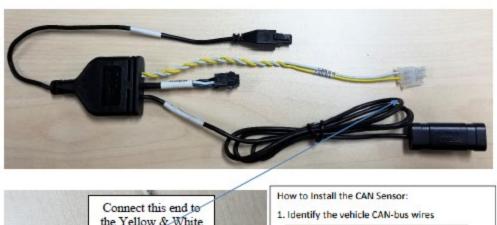
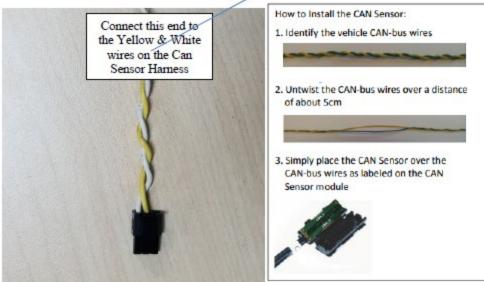
CAN SENSOR2 HARNESS

The CAN Bus network is an integral part of the harness. Connect the labeled harness wires to the corresponding terminals as follows and as shown in the pictures below:

Plug this end into the junction box

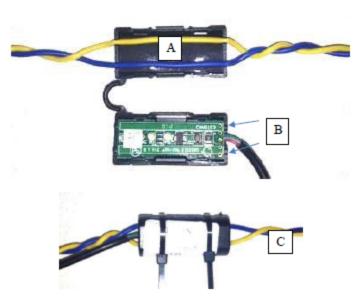
- . Locate the Vehicles CAN wires and untwist them to fit in the CAN sensor (A)
- · Position the wires in the grove of the connector
- Pay attention to the CAN HI & CAN LOW markings on the circuit board (B)
- Secure the CAN sensor with zip ties to secure the connection (C)

Connect the plug from the main harness labeled Shield + Eyewatch to the plug Eyewatch Output on the CAN sensor harness (A)

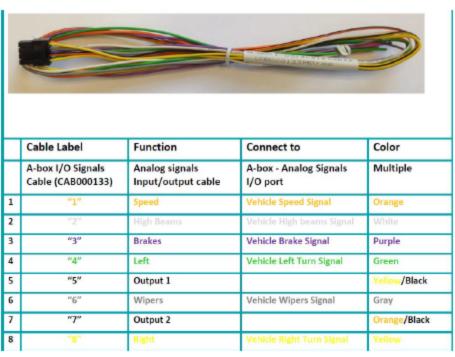
The E-box enables easier installation on vehicle with a limited variety of signals on the CAN-bus and/or with no CAN-bus and allows us to upgrade from an older Mobileye system using the existing wiring/connections.

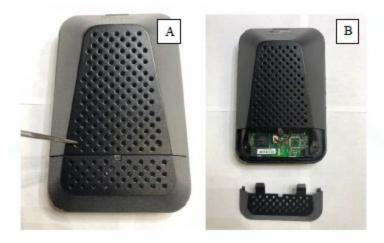
17.1 - Turning off Front Sensor Audible Alerts

- Remove the cover from the Front sensor by pushing in the tabs as shown below (Photo A)
- Remove the lower cover (Photo B)
- Unplug the 2-pin white connector from the circuit board (Photo C)
- When the plug is disconnected (Photo D) cover the LED with tape if it's going to be a distraction to the
 driver

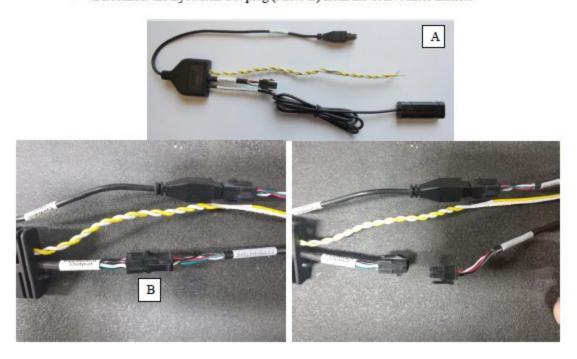
17.3 - Turning off Eyewatch Alert Display

- Locate the CAN Sensor Harness (Photo A)
 Disconnect the Eyewatch Out plug (Photo B) from the CAN sensor harness

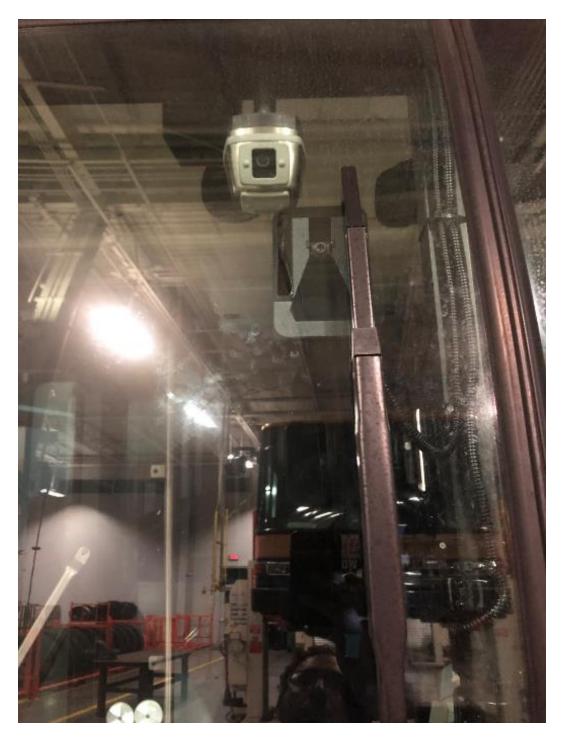
Figure D-1 – Placement of master sensor

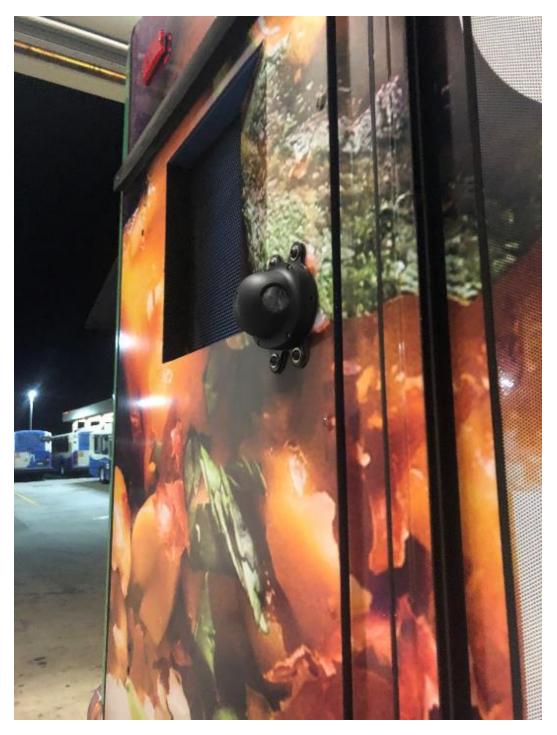
Figure D-2 – Curbside rear sensor placement

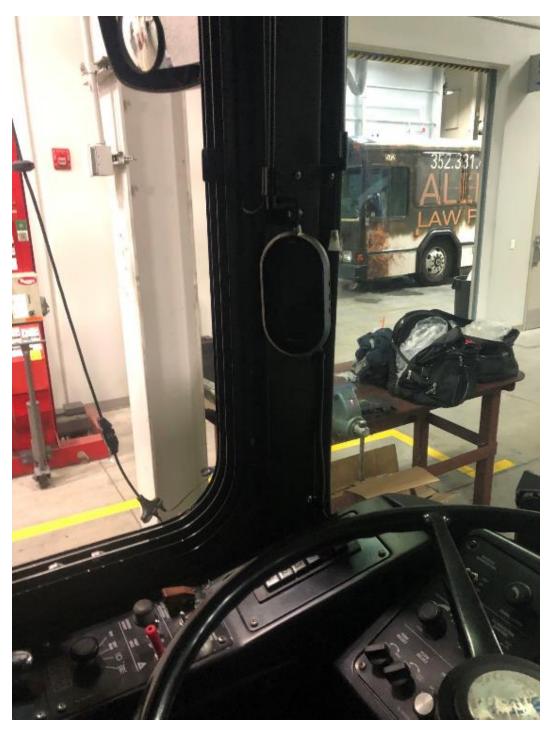
Figure D-3 – Left pedestrian display placement
