University of Florida (UF) Testbed Initiative – Alternative Transportation Safety Systems

Final Report

Prepared by: University of Florida

October 2020

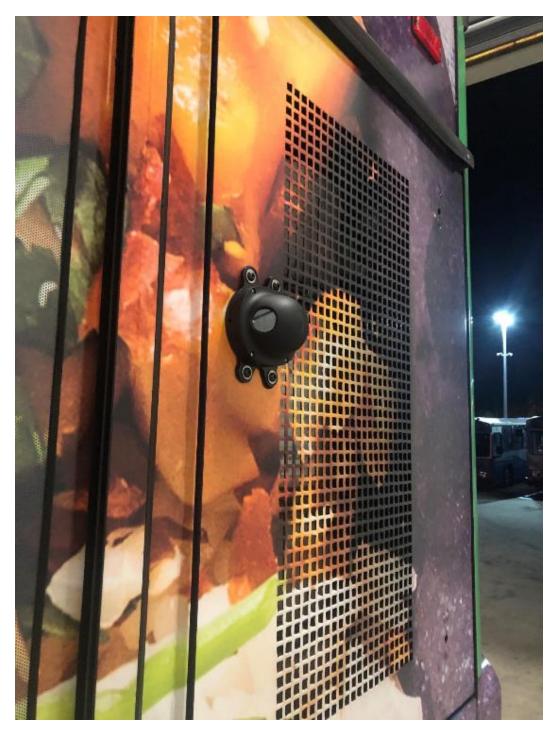
Figure D-4 – Street-side rear sensor placement

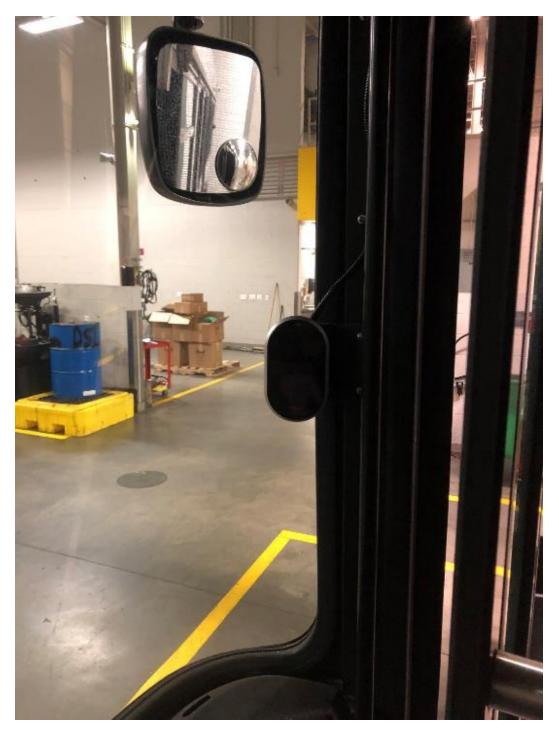
Figure D-5 – Right side pedestrian display placement

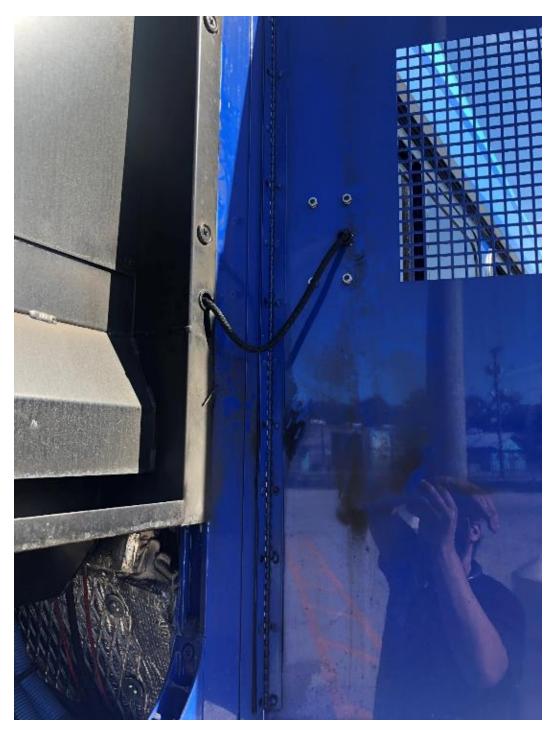
Figure D-6 – Curbside rear sensor routing

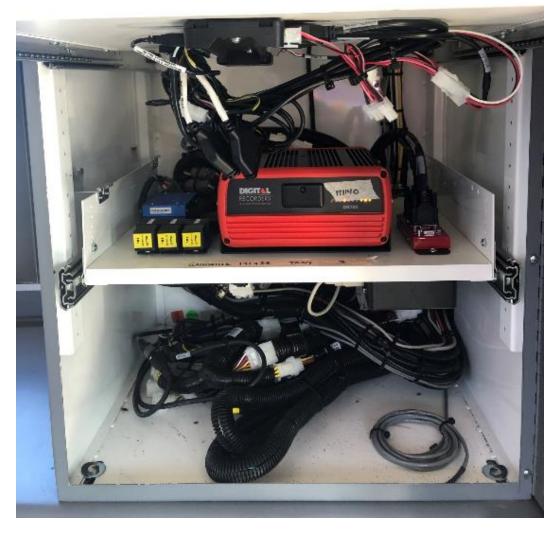
Figure D-7 – Junction box under shelf

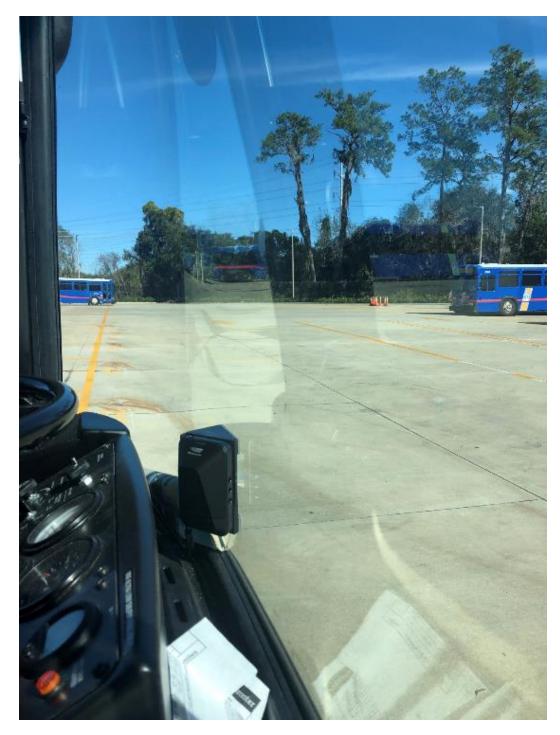
Figure D-8 – Left corner sensor placement

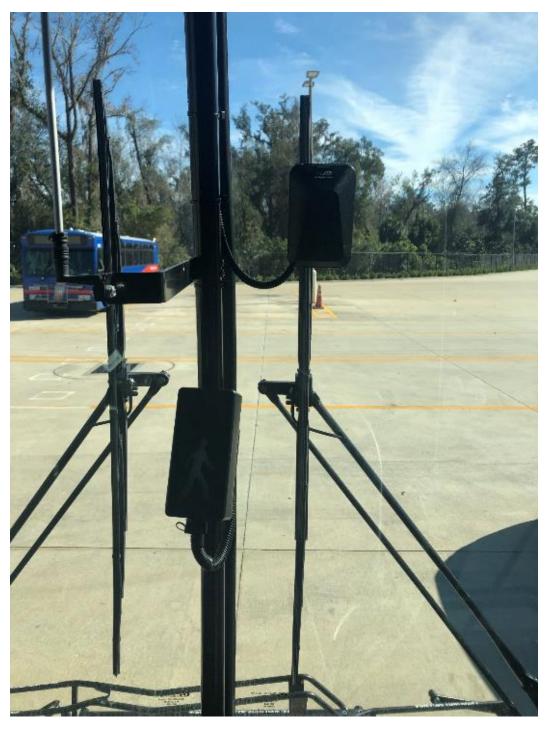
Figure D-9 – Master sensor and creator display

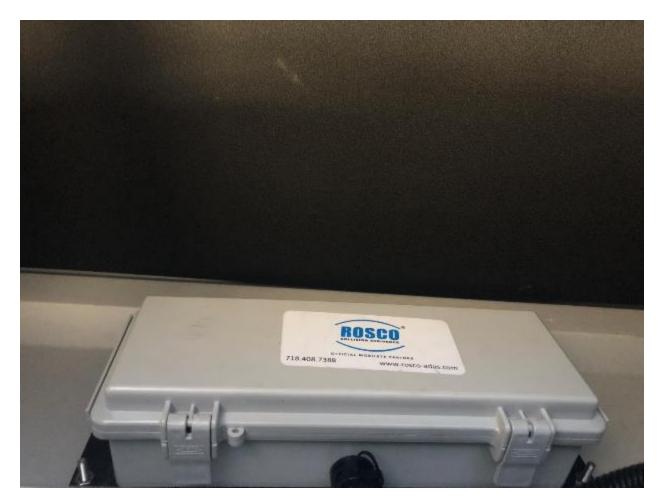
Figure D-10 – Midpoint box

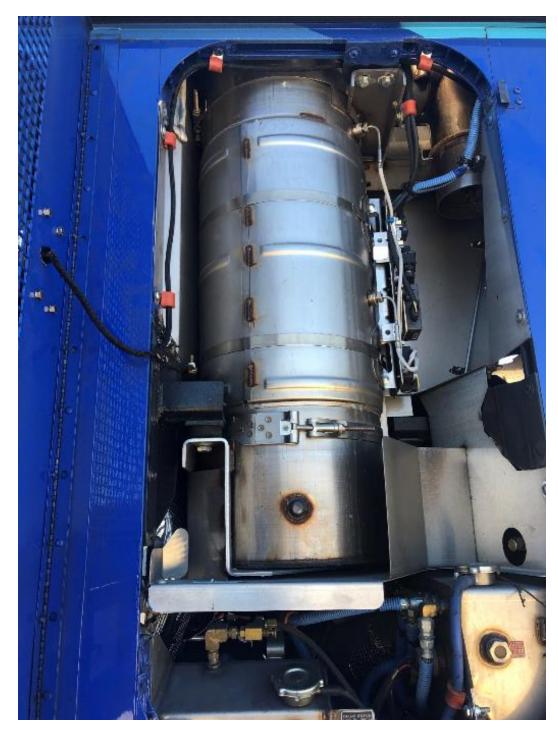
Figure D-11 – Roadside rear sensor harness routing
