Louisiana Transportation Research Center

Final Report 620

Improving the Use of Crack Sealing to Asphalt Pavement in Louisiana

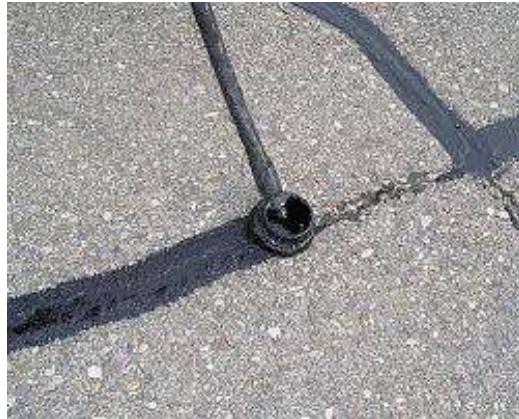
Figure 1
Typical crack sealing application

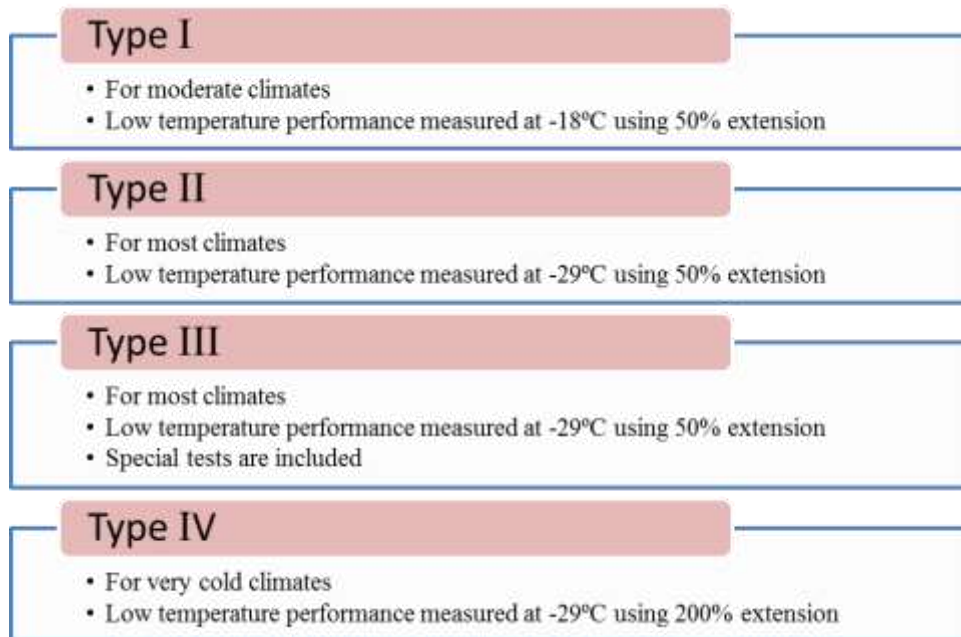
Figure 2
ASTM D6690 Sealant material types [12]

Emulsified asphalt materials are specified in ASTM D 977-13, while hot-poured sealant materials are specified in ASTM D 6690-15, which classifies hot-poured sealant materials into four major groups according to their material specifications; see Figure 2 [12].

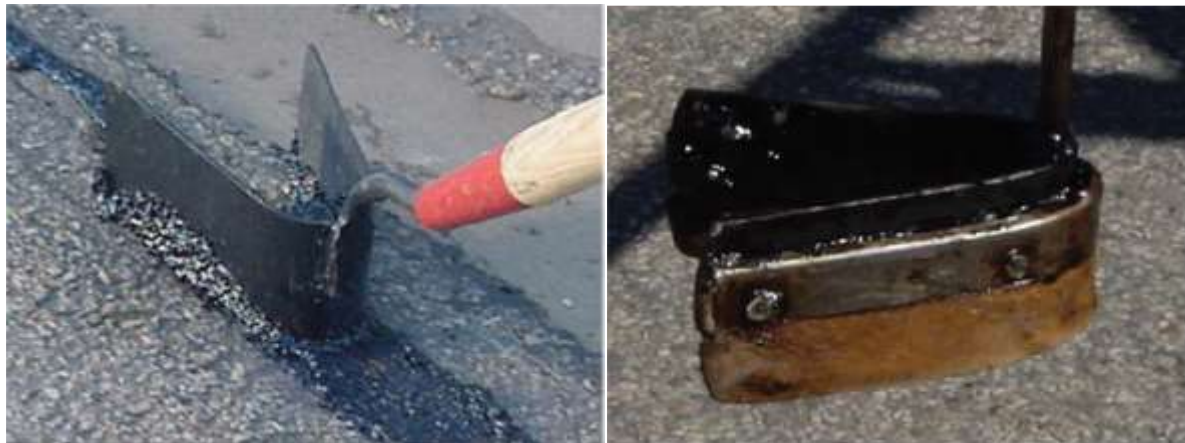
Figure 4

process. For instance, cold-poured sealants require a rubber-faced squeegee, while hot-poured sealants necessitate all-metal squeegee as shown in Figure 4. Adequate amount of blotter material is applied immediately after the finishing process to protect the uncured crack treatment from tracking by traffic. Common blotter materials include blotter sand, release agent, and plastic/paper [4, 13]. A recent NCHRP survey indicated that most of the states do not use blotter materials (blotter sand, release agents or plastic/paper). Alternatively, dishwashing soap or toilet paper are used if tracking by traffic becomes a serious problem on a specific project [13].

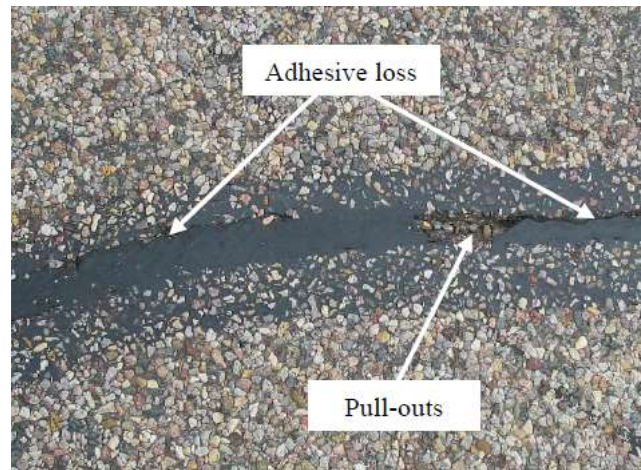
Figure 5

Sealed cracks showing two modes of failures: adhesive loss and pull-out [29]

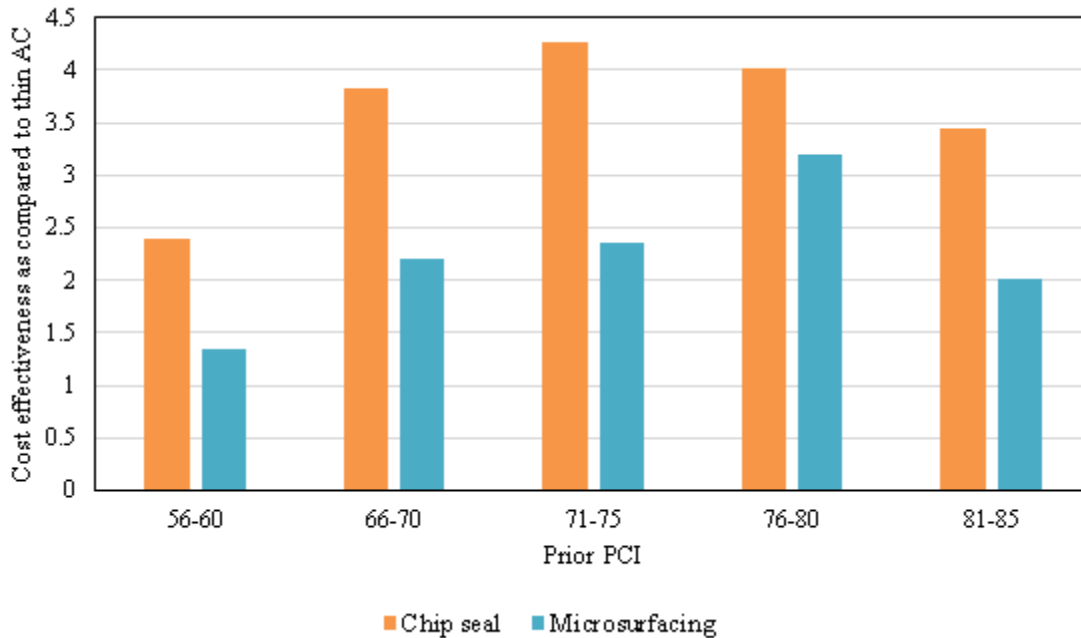
Figure 8
Relative cost effectiveness for chip seal and microsurfacing [43]

Rajagopal evaluated the cost-effectiveness of 225 chip seal and 214 microsurfacing projects [43]. The study found that on average chip seals are more economically beneficial than microsurfacing treatments when compared to the costs of thin asphalt. The treatments were also found more beneficial when applied to pavements having a prior PCI of 71 to 75. Results are shown in Figure 8.

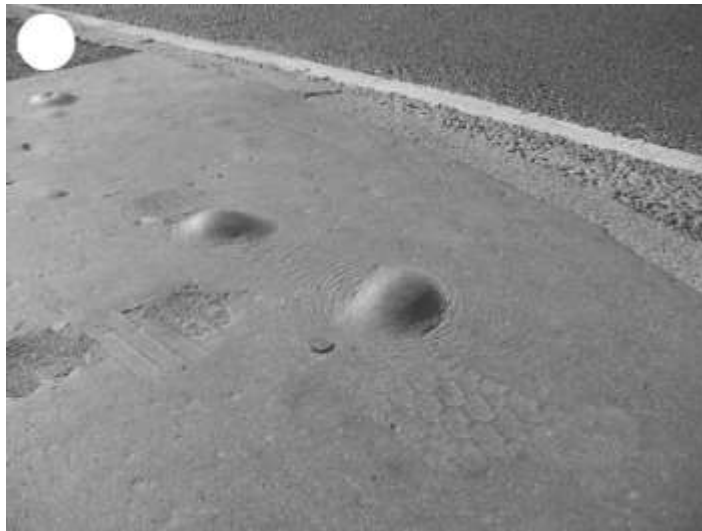
Figure 11
Blistering in asphalt pavements [58]

Pavement Failure. As early as 1949, McKesson recognized the detrimental effects of seal coats when entrapment of moisture occurs [58]. Ground water and water entering the roadbed from the shoulders, ditches, and other surface sources, are carried upward underneath the pavement by capillary action. Above the capillary fringe, water moves as a vapor and, if unimpeded at the surface, it passes to the atmosphere; this is known as drainage by evaporation. If the seal coat constitutes a vapor seal, the water condenses beneath the surface in cool weather. When the pavement absorbs solar heat, the water is again vaporized and, if not free to escape, significant vapor pressure results. This pressure forces the moisture up into the pavement and through the surface. Blistering in asphalt pavements, shown in Figure 11, is a well-known example of the effect of entrapped moisture and moisture vapor [58].

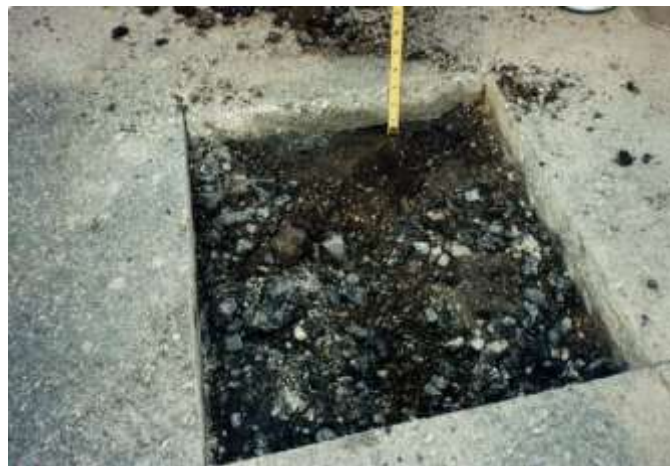
Figure 12
Pavement stripping in Pennsylvania [61]

A research effort was conducted in Pennsylvania to study the stripping phenomenon considering the subsurface drainage in the total pavement system [61]. The authors presented three case histories of water damage to asphalt overlays constructed over rigid pavements during a period of 10 years. Samples of pavement layer were obtained for field observations. The in-situ observations seemed to support McKesson's findings in many cases when the pavement was impervious as water and/or water vapor were entrapped underneath the pavement surface causing severe stripping as shown in Figure 12.

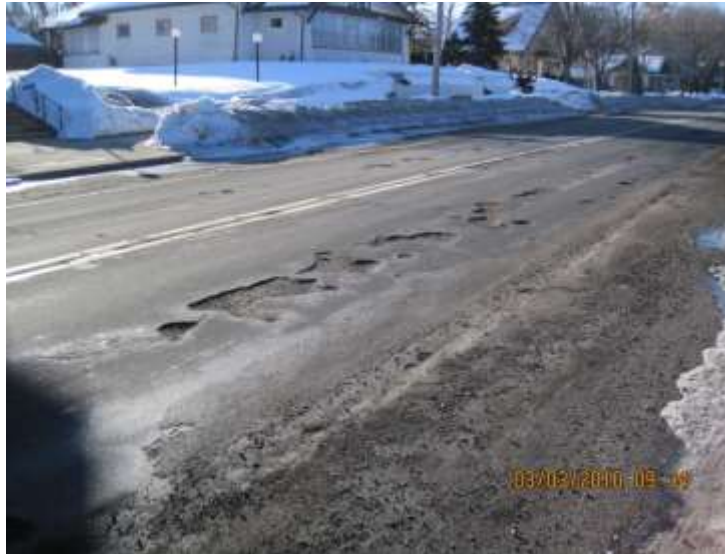
Figure 13
Stripping failure in HMA treated with chip seal [64]

in AC was caused by high air voids or low density. Consequently, they offered preliminary recommendations including the use of fog seal instead of chip seal for existing roads with low density and high air voids. They believed that fog seals could prevent water infiltration into the pavement but would allow water vapor to escape through the surface. However, they emphasized the need of additional laboratory tests to validate this recommendation [64].

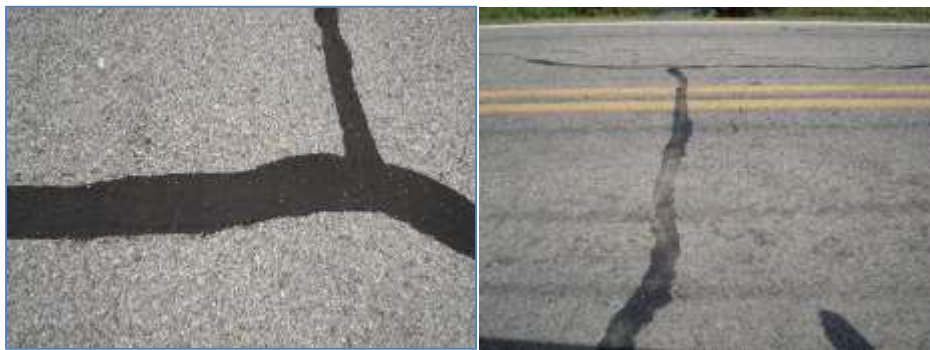
The research team conducted a laboratory evaluation of the most common sealant materials in Louisiana to ensure their suitability for hot and humid climate such as the one encountered in the state. The two most common sealant materials in Louisiana are hot-poured rubberized asphalt (manufactured by Crafcoc) and cold-applied asphalt emulsion (CRS-2). Figure 17 shows both crack sealant materials as constructed in District 58.

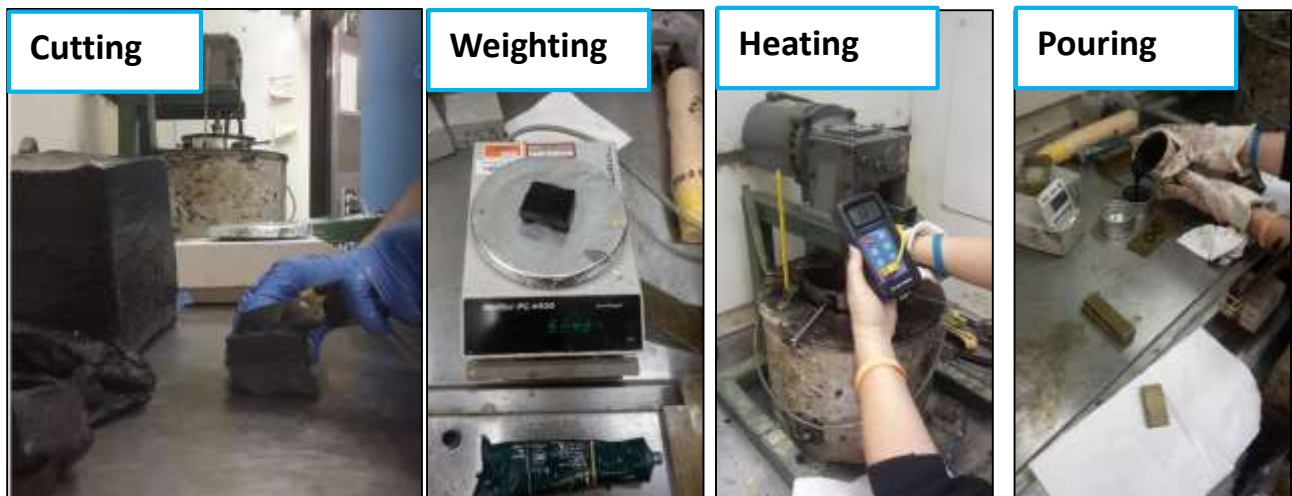
Figure 18
Main steps followed in crack sealant sample preparation

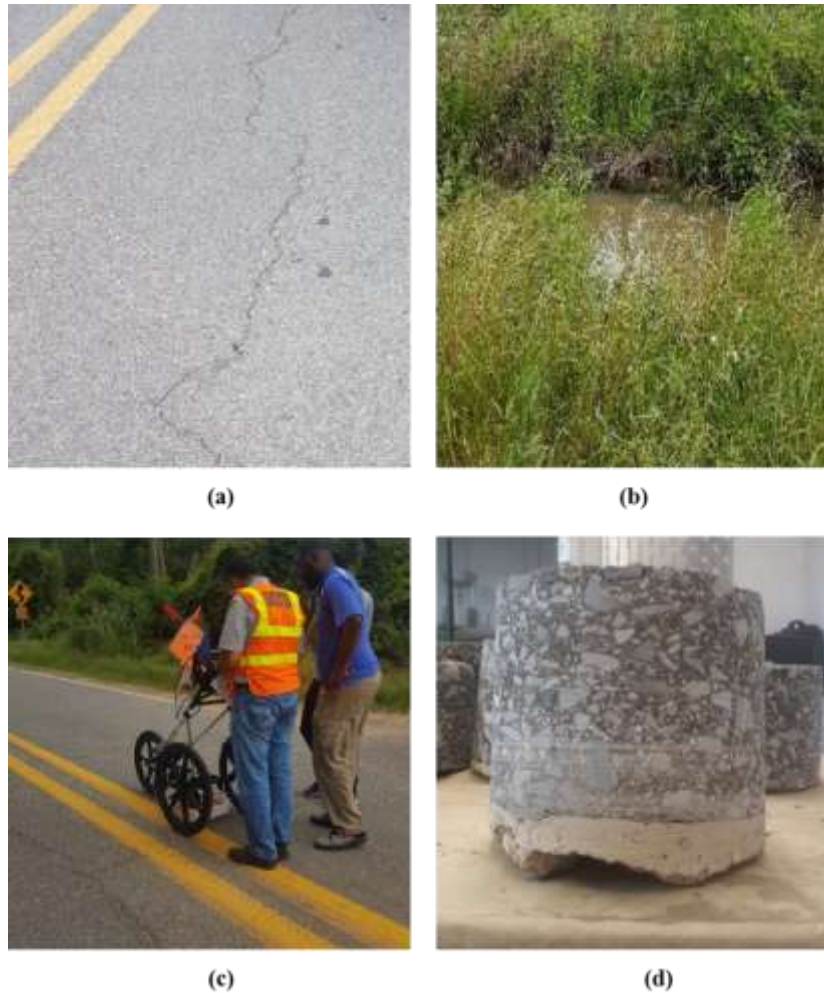
Figure 22
Illustration of main tasks conducted in the site visit

Crack sealing was applied to the last 0.5 mile of the section, leaving the first 1.5 miles untreated. Another site visit was made the following year along the entire section, and the aforementioned activities were repeated during the second visit. Furthermore, two tests were conducted in the laboratory to assist in the interpretation of the results, namely, the Lottman test (AASHTO T-283) and the falling head permeability test.

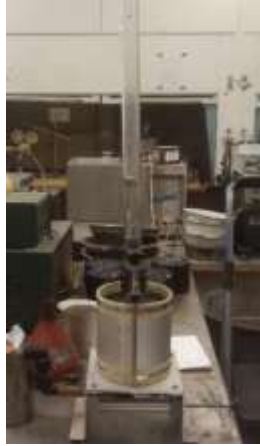
Figure 24
Falling head permeability test

The falling head permeability test apparatus shown in Figure 24 was used to determine the saturated hydraulic conductivity (permeability), K_{sat} , of three asphalt cores extracted from the test section during the initial site visit. The test was conducted in accordance to Florida's test method FM 5-565 after soaking the asphalt cores in water for two hours.

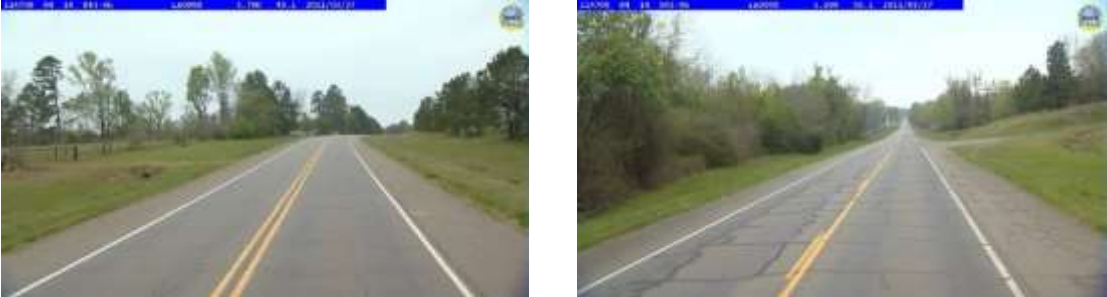
Figure 33
Pavement section before (left) and after (right) crack sealing

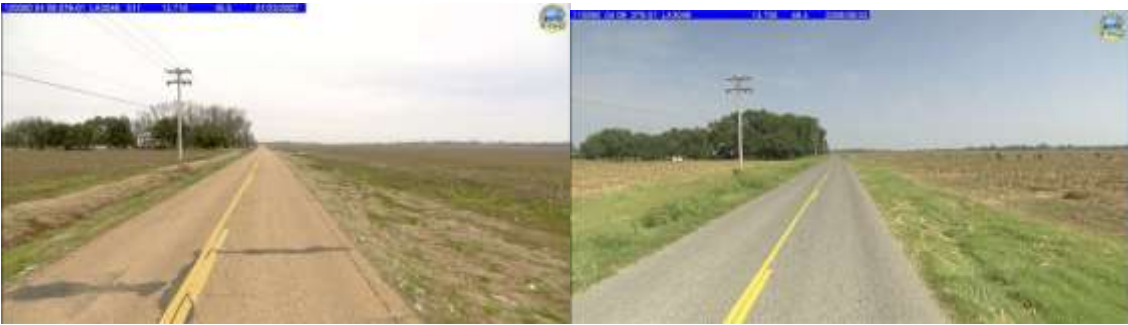
Figure 34
Pavement section before (left) and after (right) chip seal

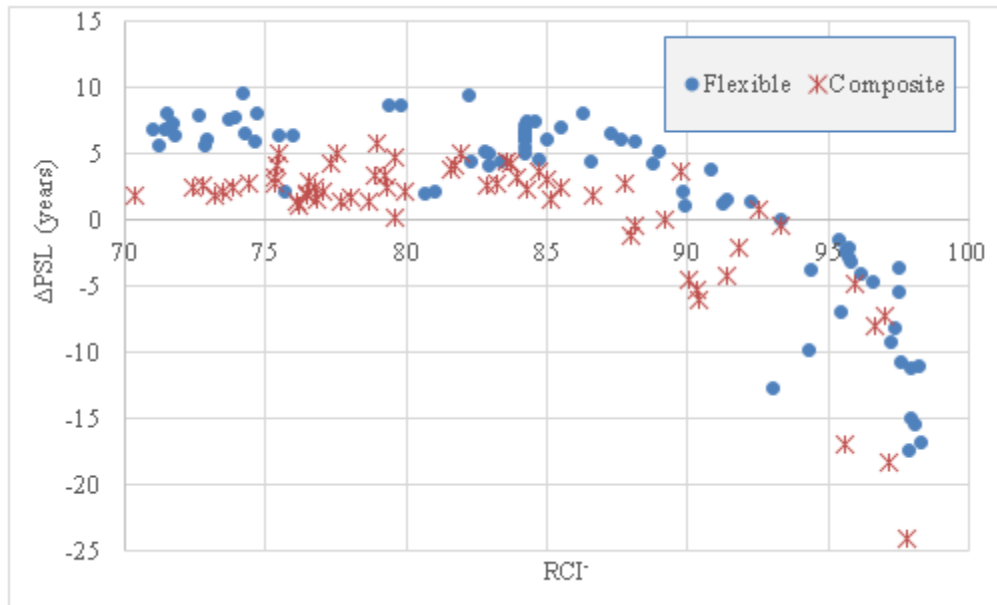
Figure 41
 Δ PSL versus RCI for Data Set 4

No clear trend was observed when Δ PSL was plotted against ADT for Data Set 4, possibly because the sections had different initial RCI. Therefore, the evaluation of traffic volume on Δ PSL was limited to points having exactly the same RCI, which are included in Data Set 5 in Table 16. Figure 43 presents Δ PSL versus RCI for different traffic levels. The results indicated that the benefits of crack sealing, in terms of Δ PSL, were greater for lower ADT, which agrees with previous studies [28].

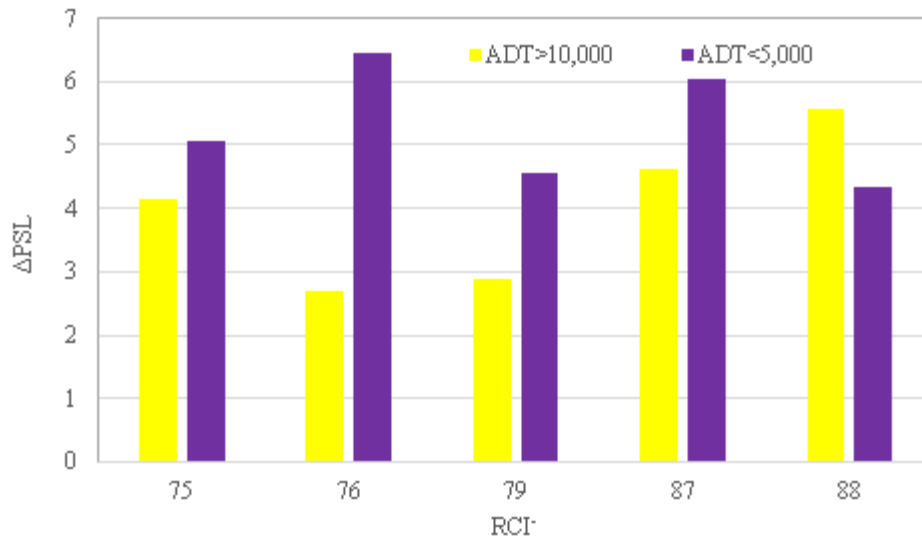
Figure 43
ΔPSL versus RCI for different traffic levels

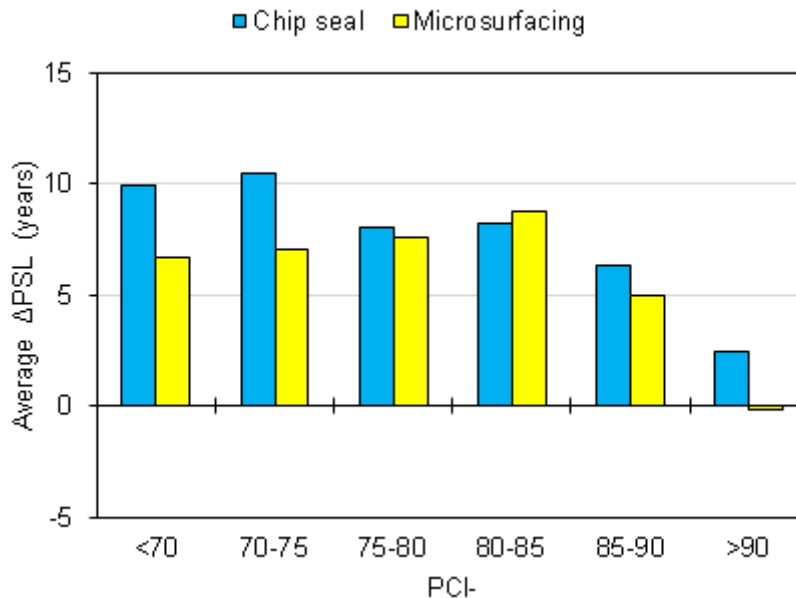
Figure 51
Average Δ PSL as a function of pretreatment condition of the pavements

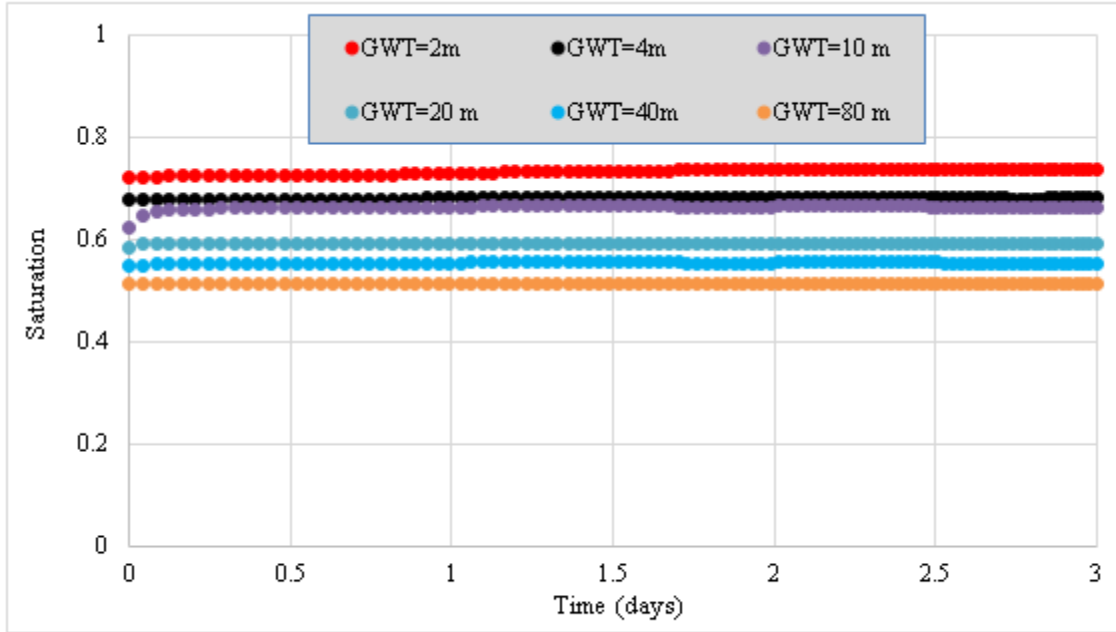
Figure 67
Saturation versus time for the crack-sealed model at different GWT depth

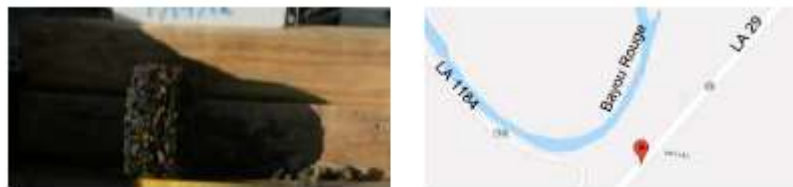
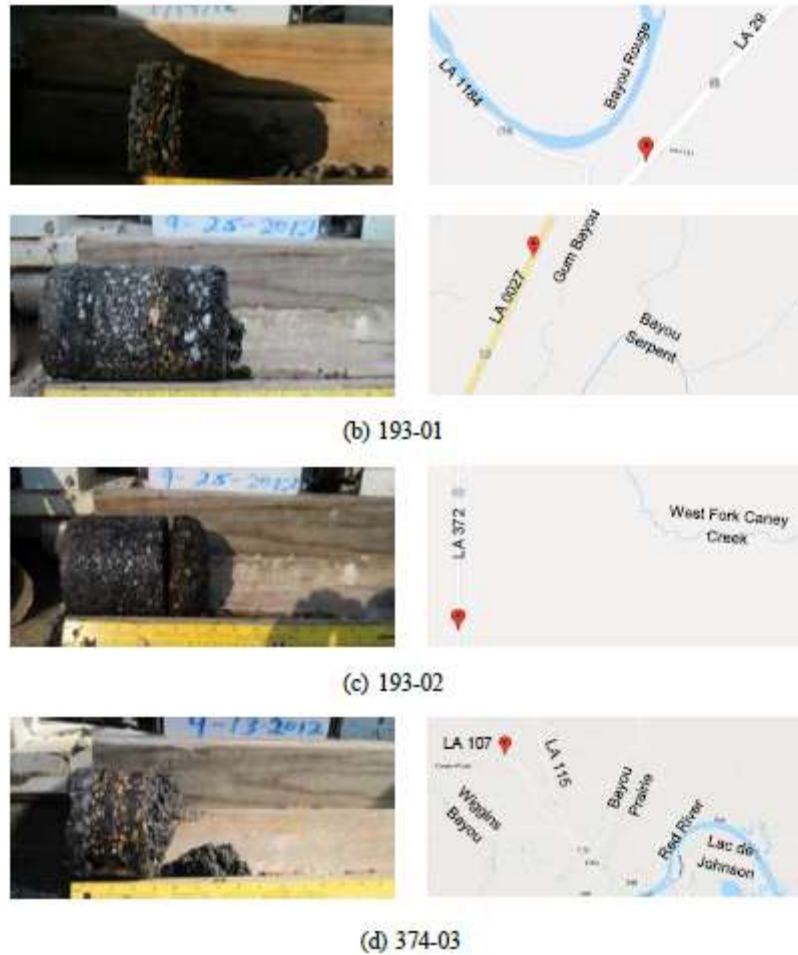
Figure 73
Moisture damaged sections with microsurfacing

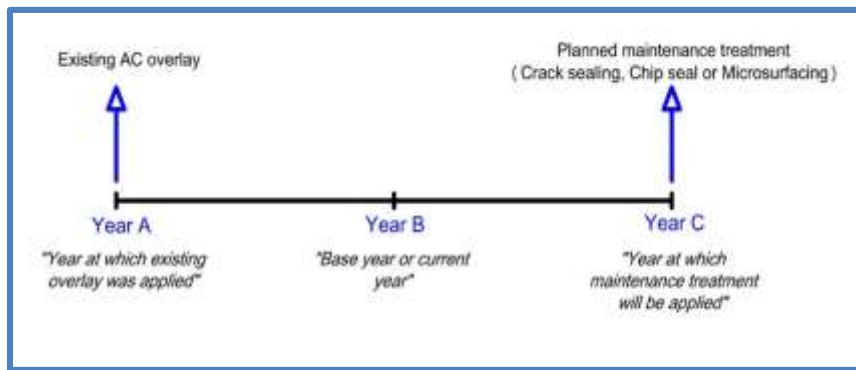
Figure 74
Illustration of years' definitions in the input data
