Implementation of Porous Concrete in Sidewalks in New Jersey

Final Report
March 2022

Center for Advanced Infrastructure and Transportation (CAIT)
Rutgers, the State University of New Jersey
100 Brett Road
Piscataway, NJ 08854

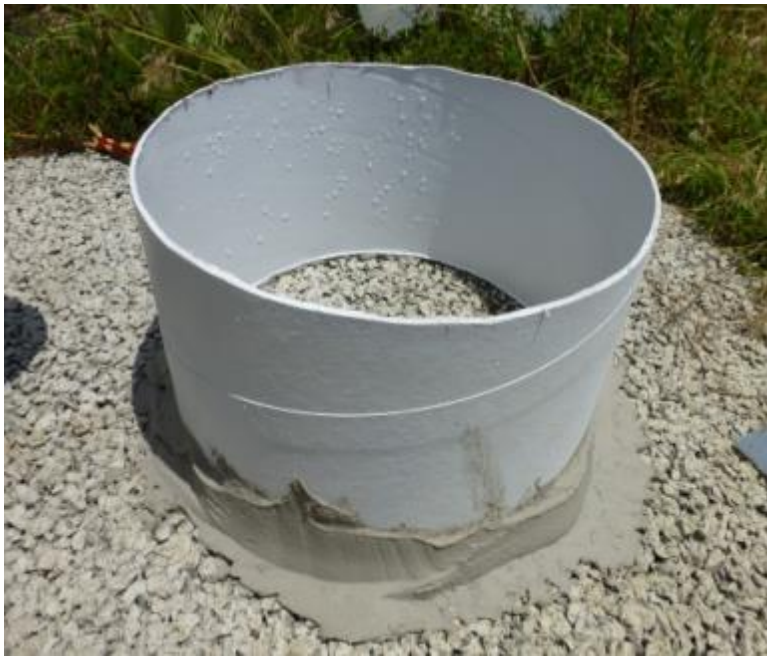
Figure1. Infiltration Test setup

At this location the visual inspection showed no signs of raveling and it looked like the sidewalk was well maintained. The average infiltration rate of three tests on the site was approximately 300 in/hr. Fig. 1 shows the infiltration test and Figs 2 and 3 show the sidewalk surface.

The infiltration tests are carried in accordance with ASTM C 1701⁽¹⁵⁾. The test requires 12 in diameter PVC pipe – at least 2 in high. The PVC pipe will be placed tight on top of the porous concrete surface and sealed using a sealant to prevent water from seeping from the sides. A total of 40 lbs of water poured into the PVC at a rate such that the water height inside the PVC pipe does not exceed 0.5 in to

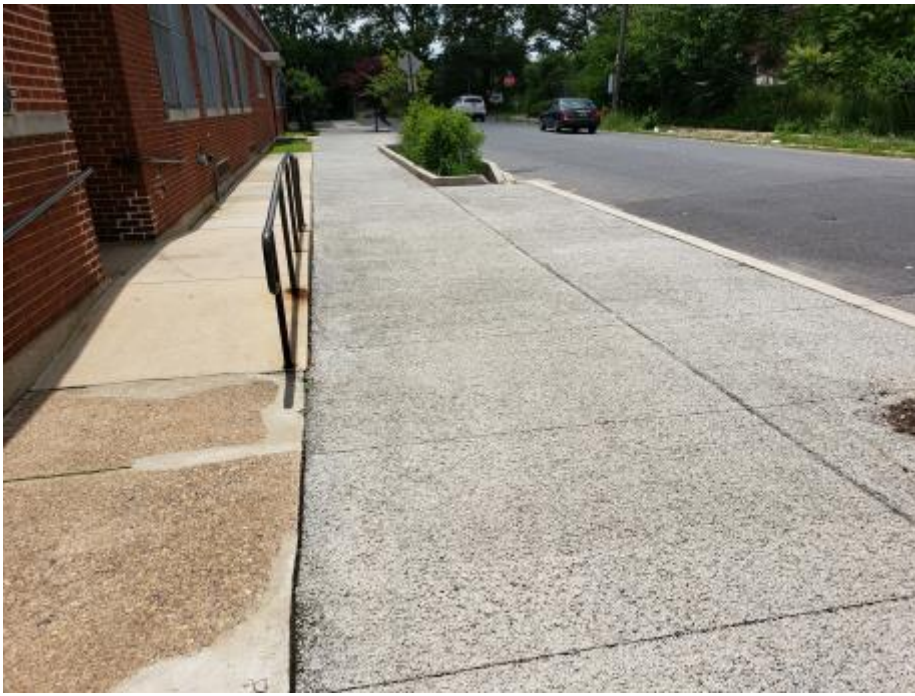
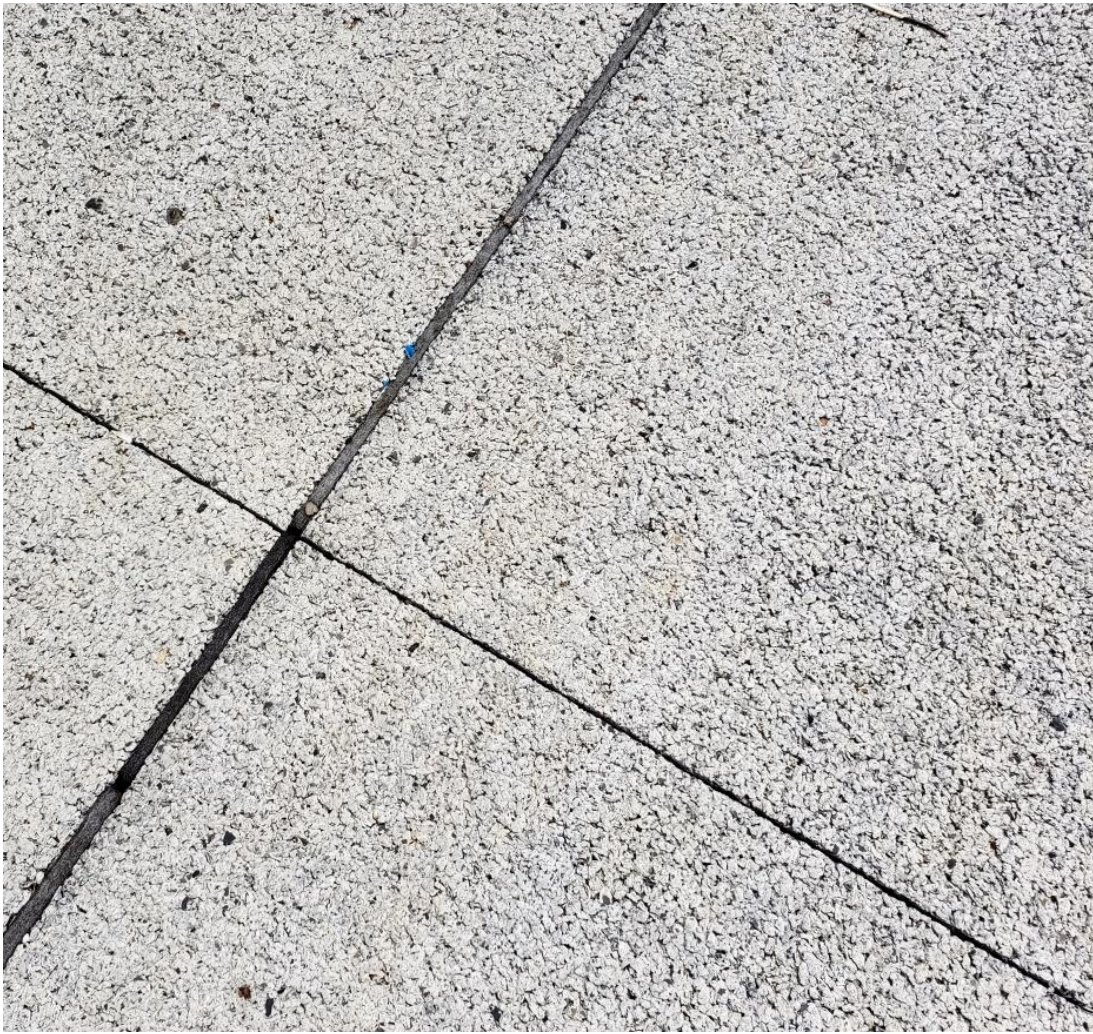
Figure 2. Porous concrete surface of well-maintained porous concrete sidewalk
(Location A)

Figure 3. Porous concrete surface of well-maintained porous concrete sidewalk
(Location A)

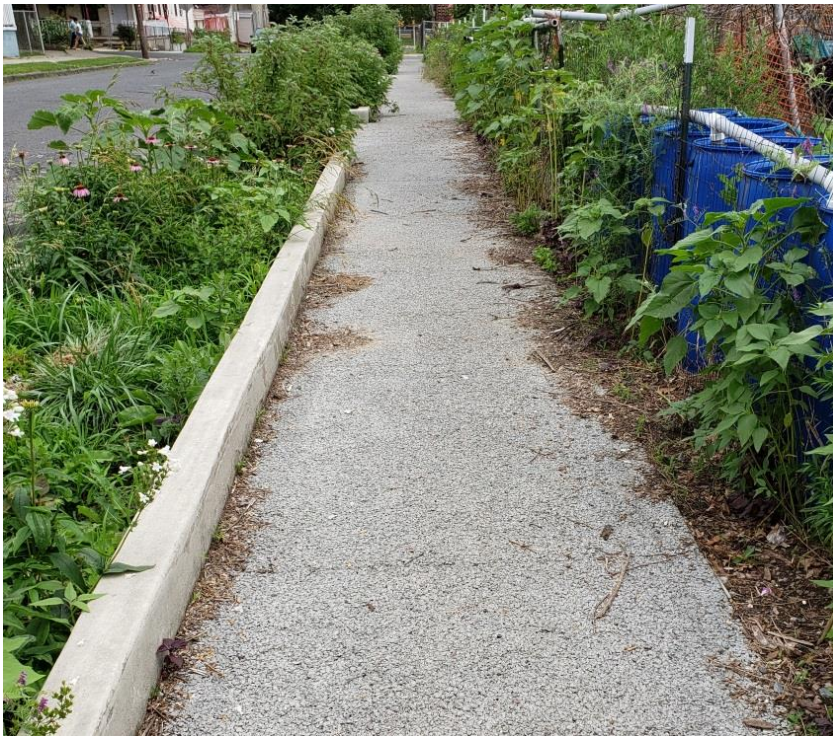
Figure 4. Porous concrete surface of well-maintained porous concrete sidewalk (Location B)

At this location the visual inspection showed no signs of raveling, but the sidewalk did look like it was well maintained as debris and dirt was visible on the surface and some grass has appeared very close of the sides of the sidewalk. The average infiltration rate of three tests on the site was approximately 200 in/hr. Fig. 4 shows show the sidewalk surface at this location. A crack was also observed at this site as shown in Fig. 5.

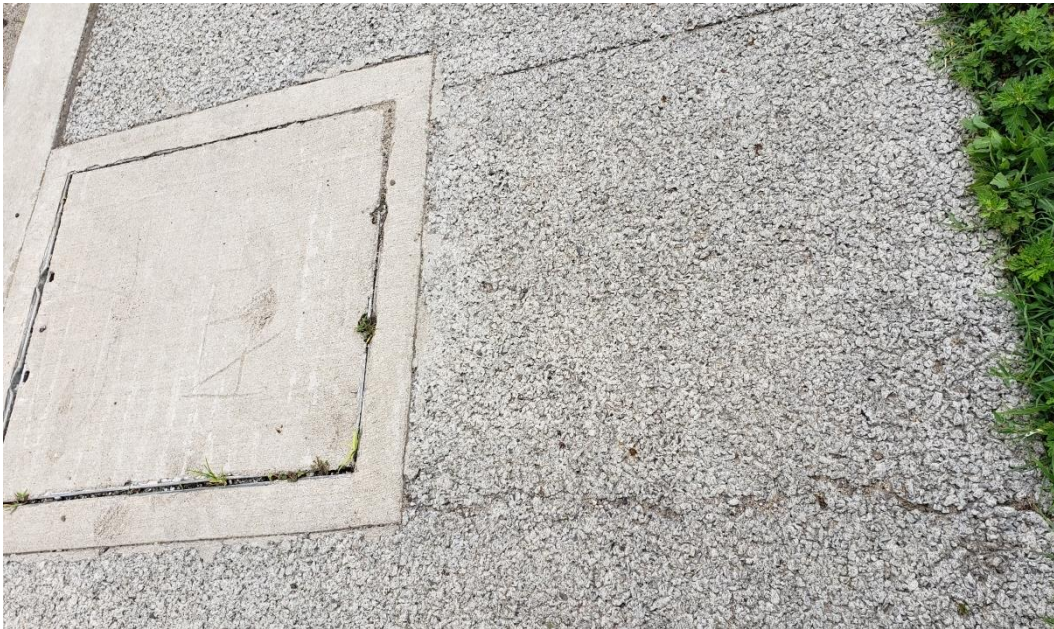
Figure 5. Porous concrete surface showing a crack initiating from the corner of the utility manhole (Location B)

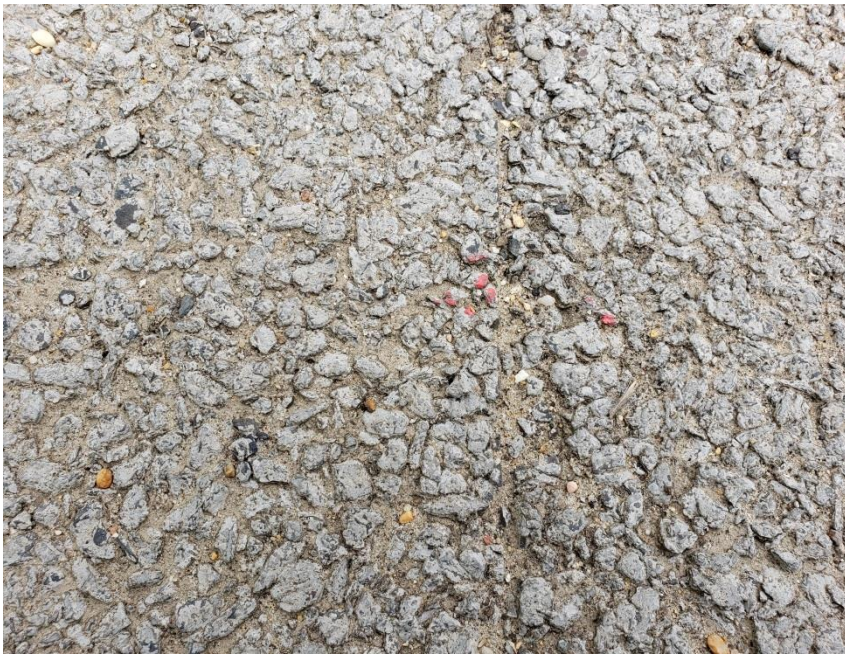
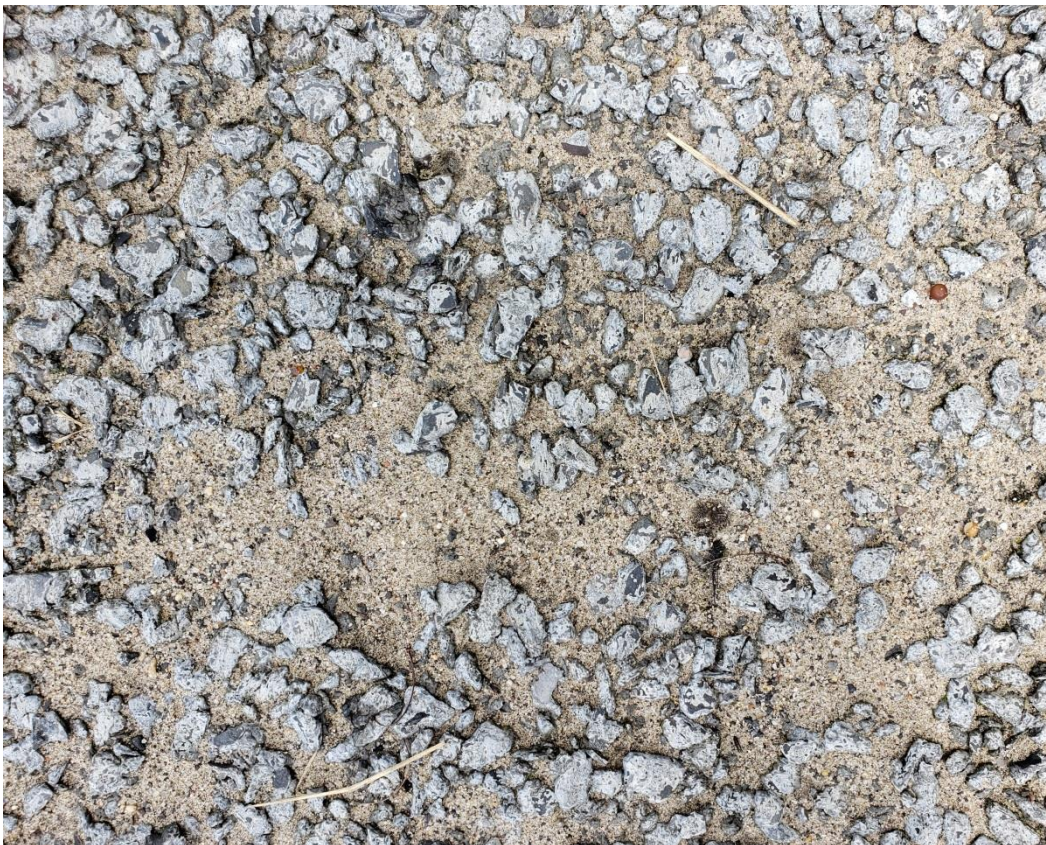
Figure 6. Medium to severe raveling and clogging (Location C)

Figure 7. Severe clogging and severe raveling (Location C)

At this location the visual inspection showed severe raveling and clogging in several location of the sidewalk as can be seen in Figs 6 and 7. A lot of sand and debris has accumulated between the voids over the years. Lack of periodic maintenance leads to the severe clogging. The average infiltration rate of three tests on the site was less than 60 in/hr.

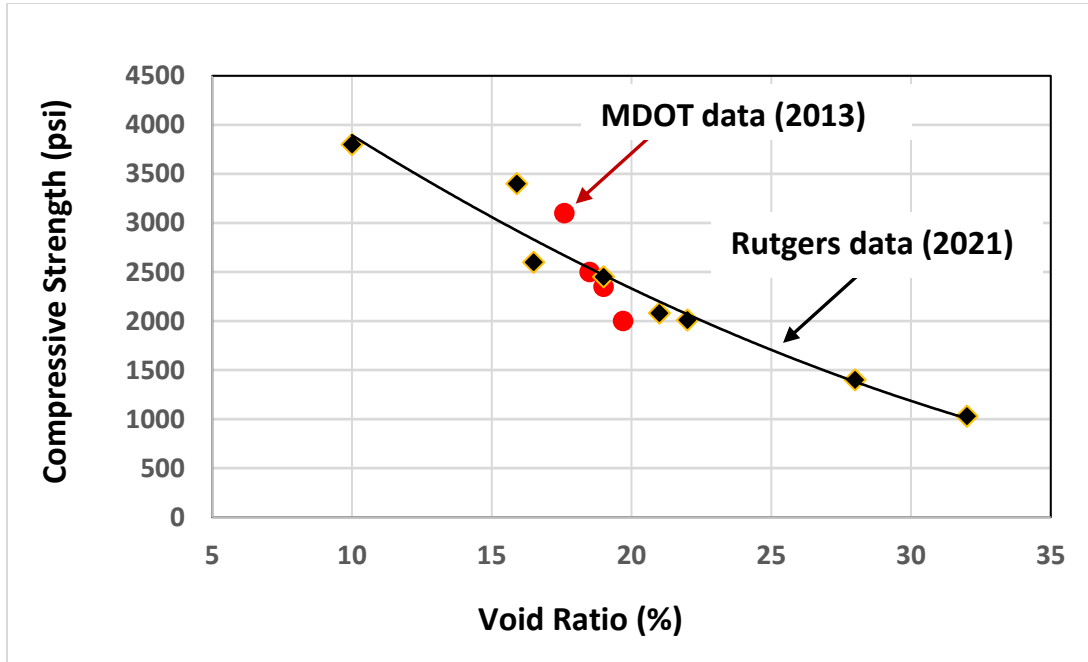
Figure 9. Correlation between compressive strength and void ratio (including data from MDOT Report MD-13-SP009B4F by Amade and Rogge, 2013⁽²⁰⁾)

The correlation between the compressive strength and void ratio is shown in Fig. 9. The data includes testing several mixes with and without sand and with and without rodding to vary the void ratio. The correlation also includes data from a study performed by Amde and Rogge for MDOT⁽²⁰⁾.

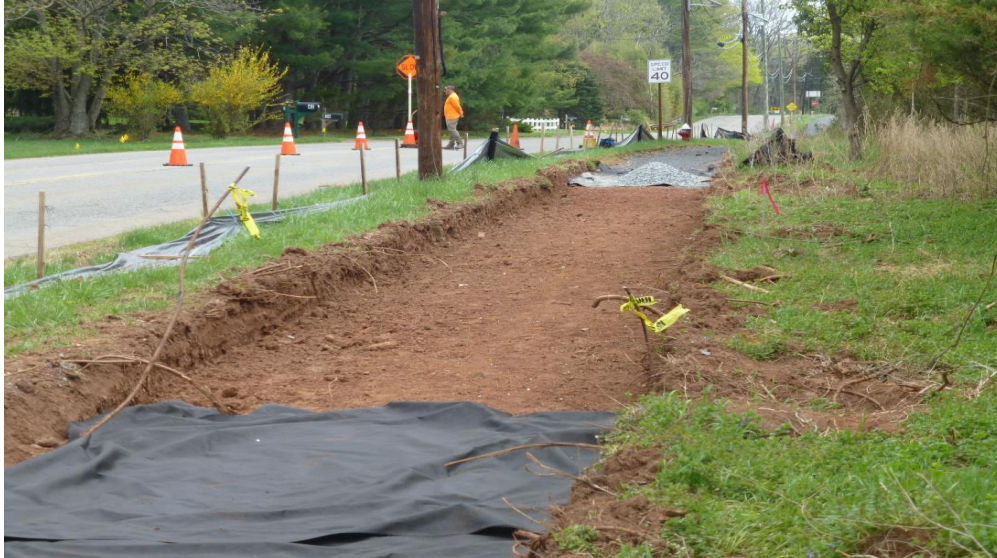
Figure 13. Excavation and placement of geotextile membrane

The contractor excavated about 18 in of the soil to reach the required subgrade surface. The excavation was followed by placement of the non-woven geotextile membrane. Fig. 13 shows excavation for the sidewalk and placement of the non-woven geotextile fabric. Fig. 14 shows the installation of the aggregate storage layer.

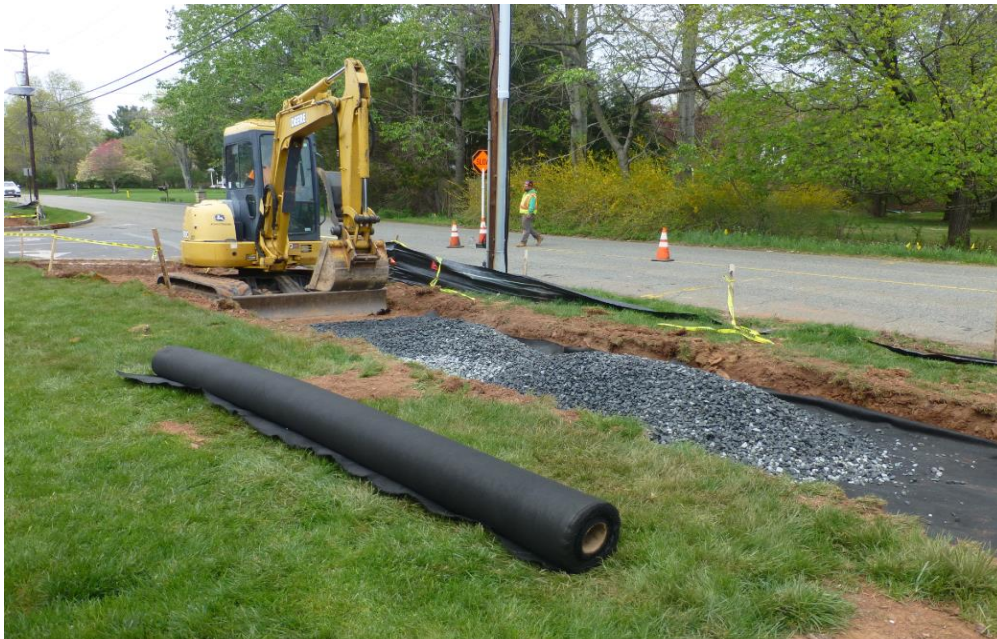
Figure 14. Placement of aggregate layer (storage layer)

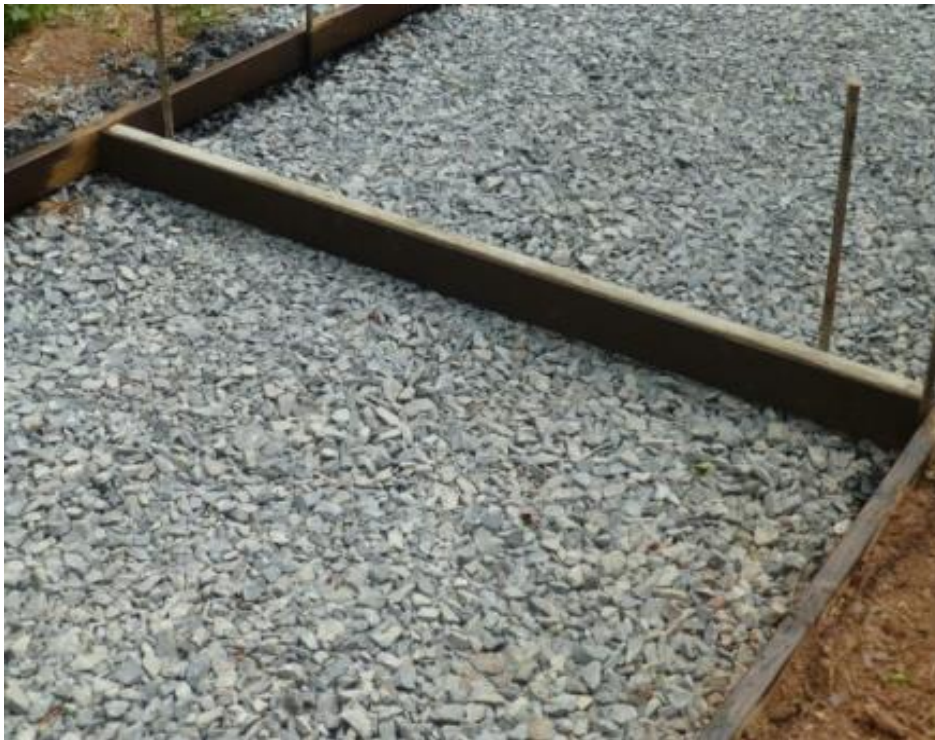
Figure 15. Location of expansion joint (every 15 ft)

Expansion joints were placed every 20 ft per NJDOT specifications Section 606 as shown in Fig. 15. The porous concrete was discharged from the ready mix truck as shown in Fig. 16. Initially, the porous concrete seemed to be stiff and was not flowing under its own weight on the belt. Later when more quantities were discharged and with

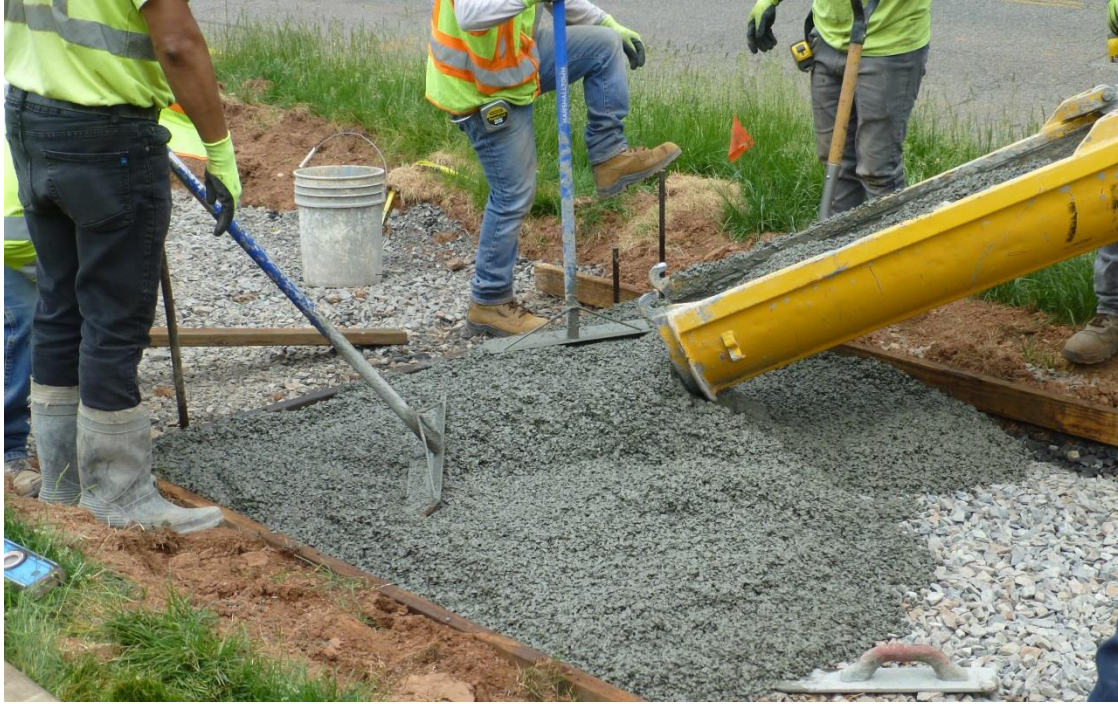
Figure 16. Discharging porous concrete from ready mix truck

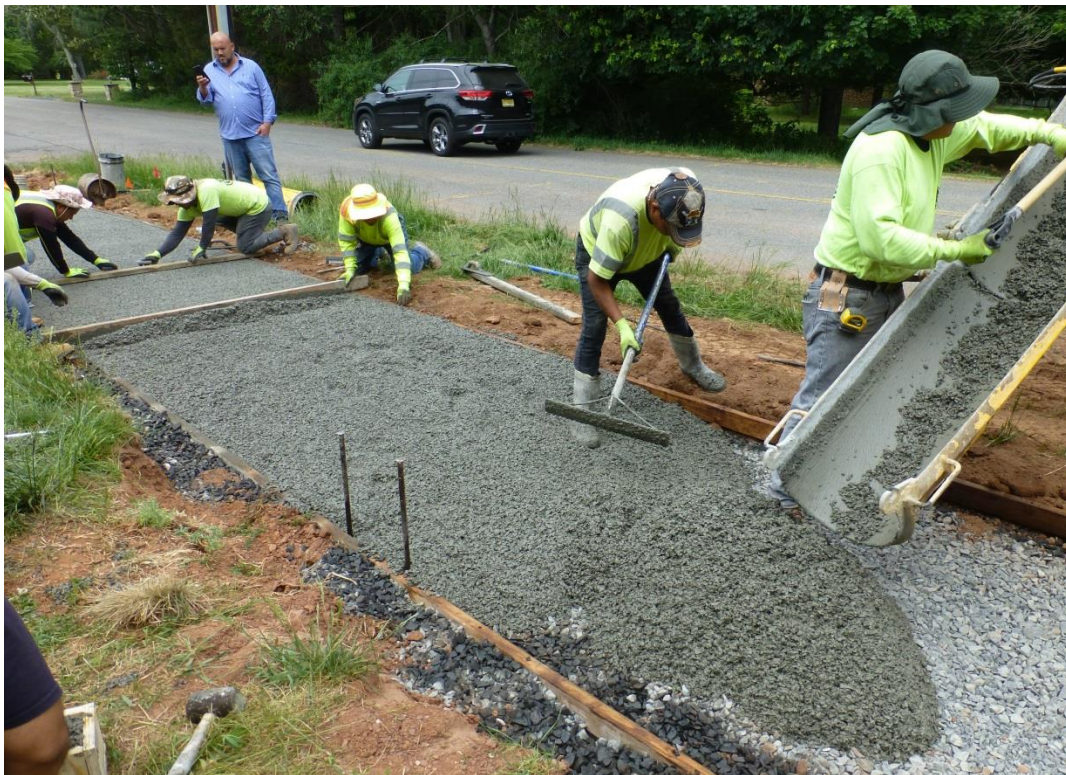
Figure 17. Porous concrete placement

Some of the field crew will spread the concrete and other members of the crew will use a 2x4 lumber piece to do the finishing as shown in Fig. 17. The finished surface of the porous concrete sidewalk is shown in Fig 18. A close-up photo of the finished surface of the porous sidewalk is shown in Fig. 19. Once the placement and finishing operations were completed, the field crew used polyethylene sheets to cover and cure the finished surface as shown in Fig. 20.

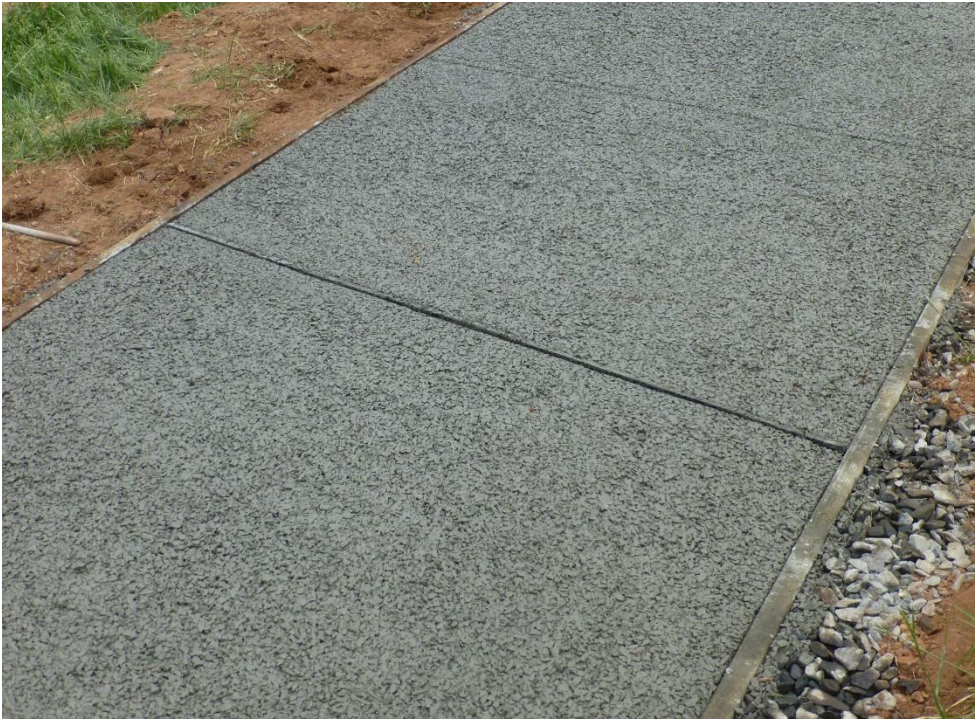
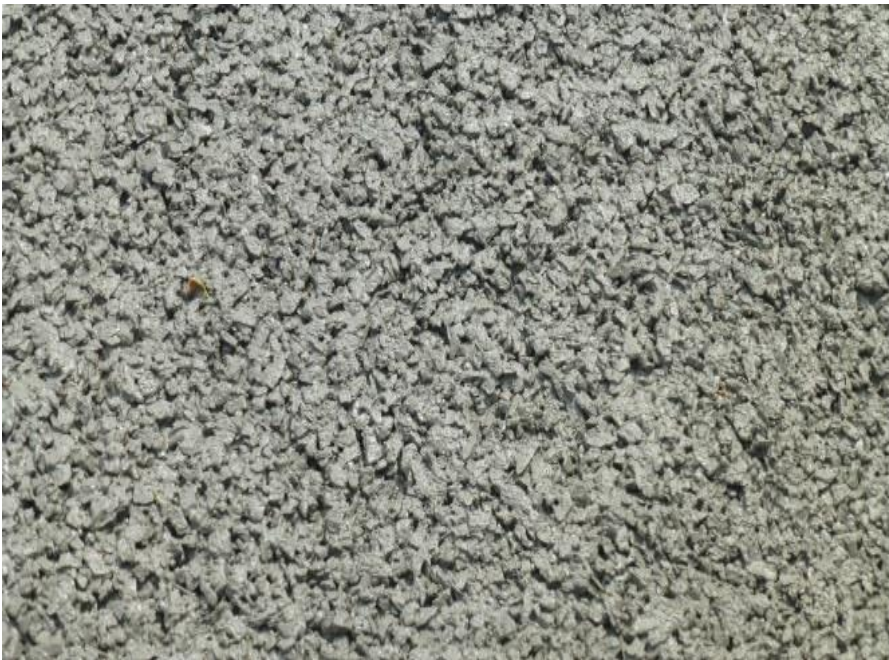
Figure 18. Finished porous concrete surface

Figure 19. Closeup of finished porous concrete surface

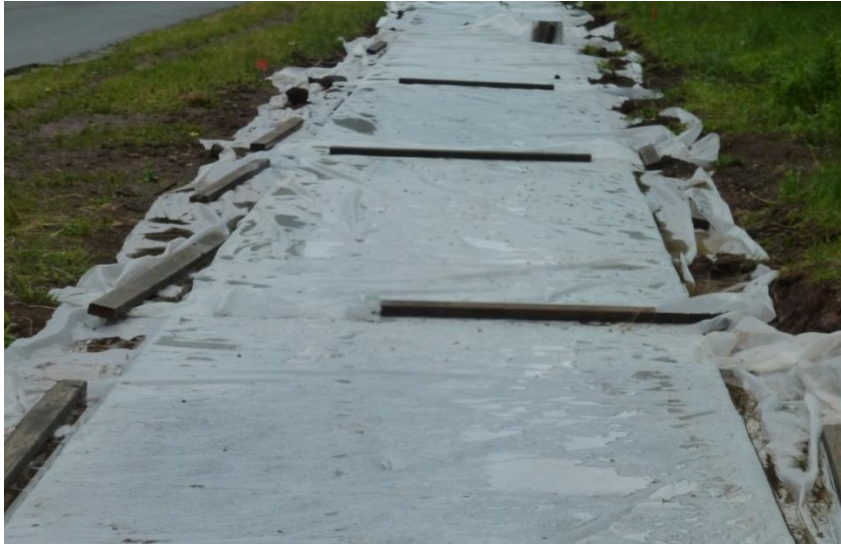
Figure 20. Curing of porous sidewalk using polyethylene sheets

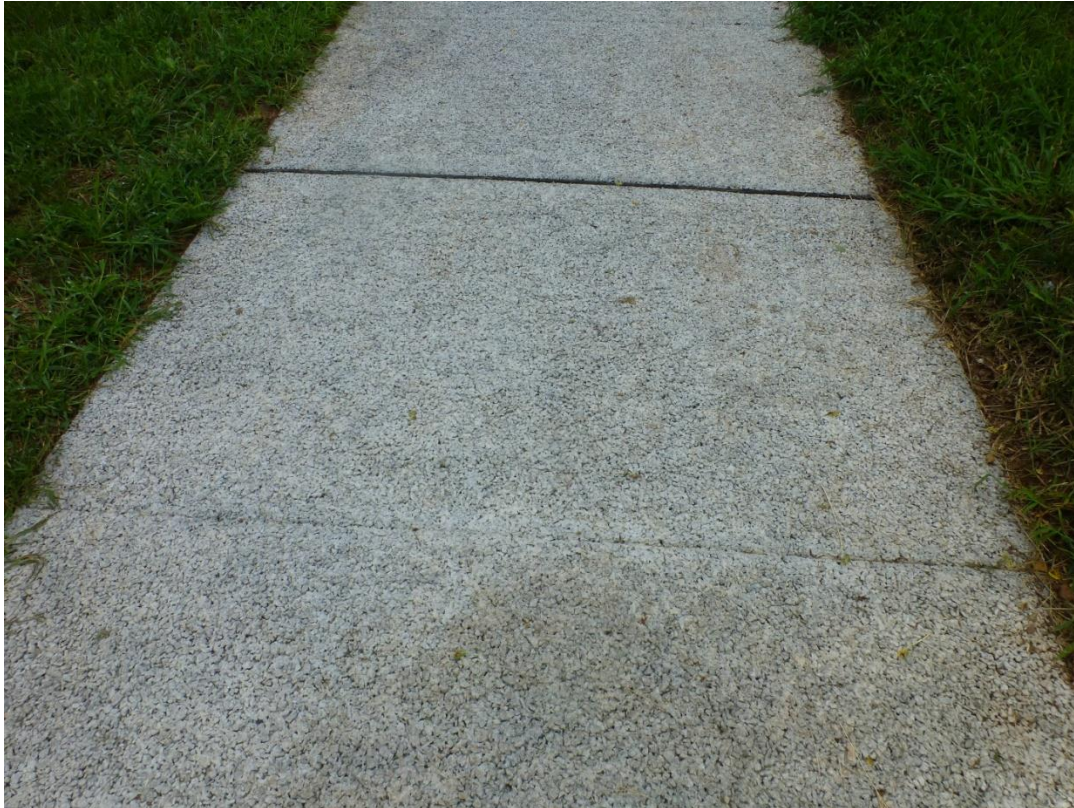
Figure 21. Baseline photo of finished sidewalk surface

Monitoring and testing of the sidewalk started about a month after the construction is completed. The monitoring and testing included visual inspection and infiltration tests to establish a baseline for future comparisons. Visual inspection will provide information on clogging and raveling. Infiltration rate will provide information on clogging. A sample baseline photo is shown in Fig. 21.

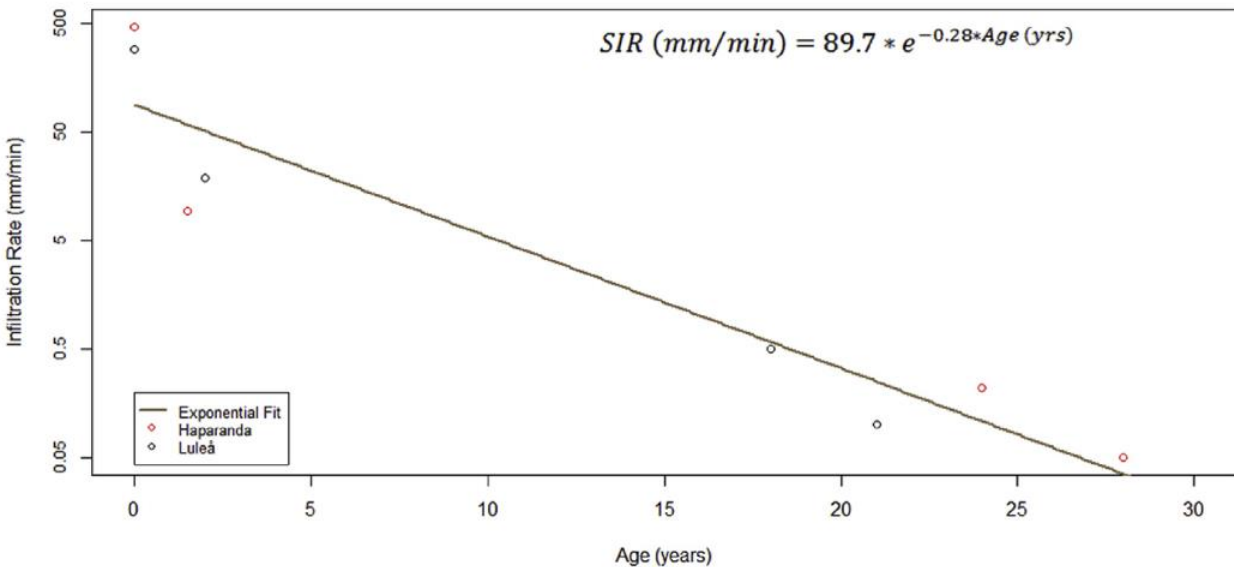
Figure 24. Variation of infiltration rate with age of pavement for pervious asphalt pavements in Sweden (Reported in a paper by Winston, et al, 2016)⁽²⁴⁾

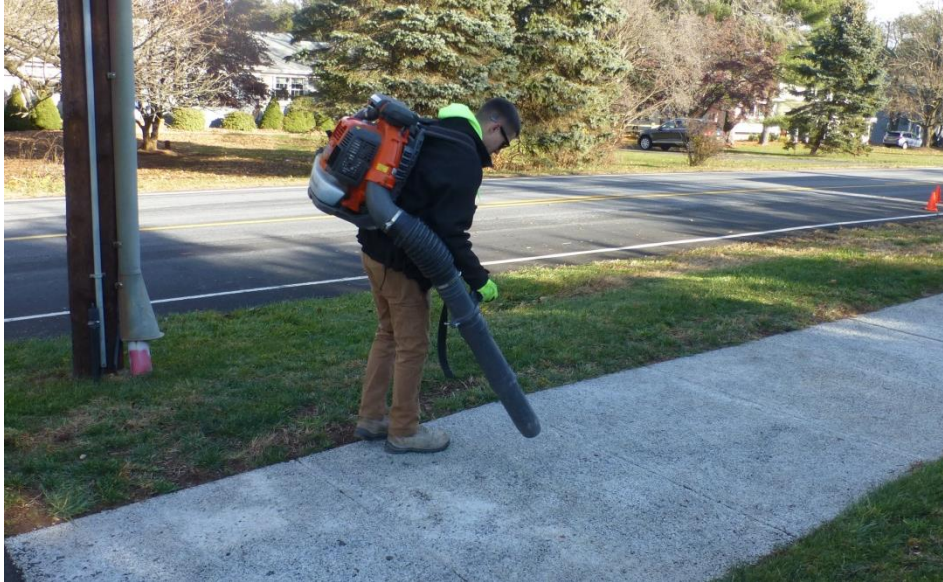
Figure 26. Cleaning the porous sidewalk using handheld air blower

They recommend cleaning the pavement surface at least twice a year using the regenerative air or vacuum sweeping. Fig. 26 shows cleaning using an air blower and Fig. 27 shows cleaning using 'walk behind' vacuuming machines.

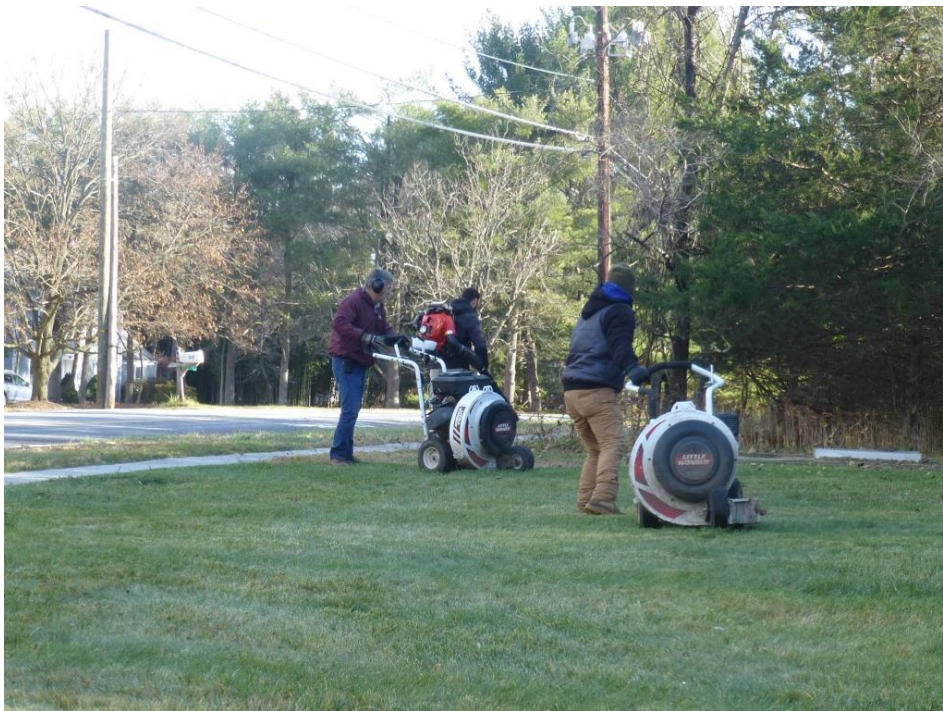
Figure 27. Cleaning the porous sidewalk using 'walk behind' vacuuming machines.

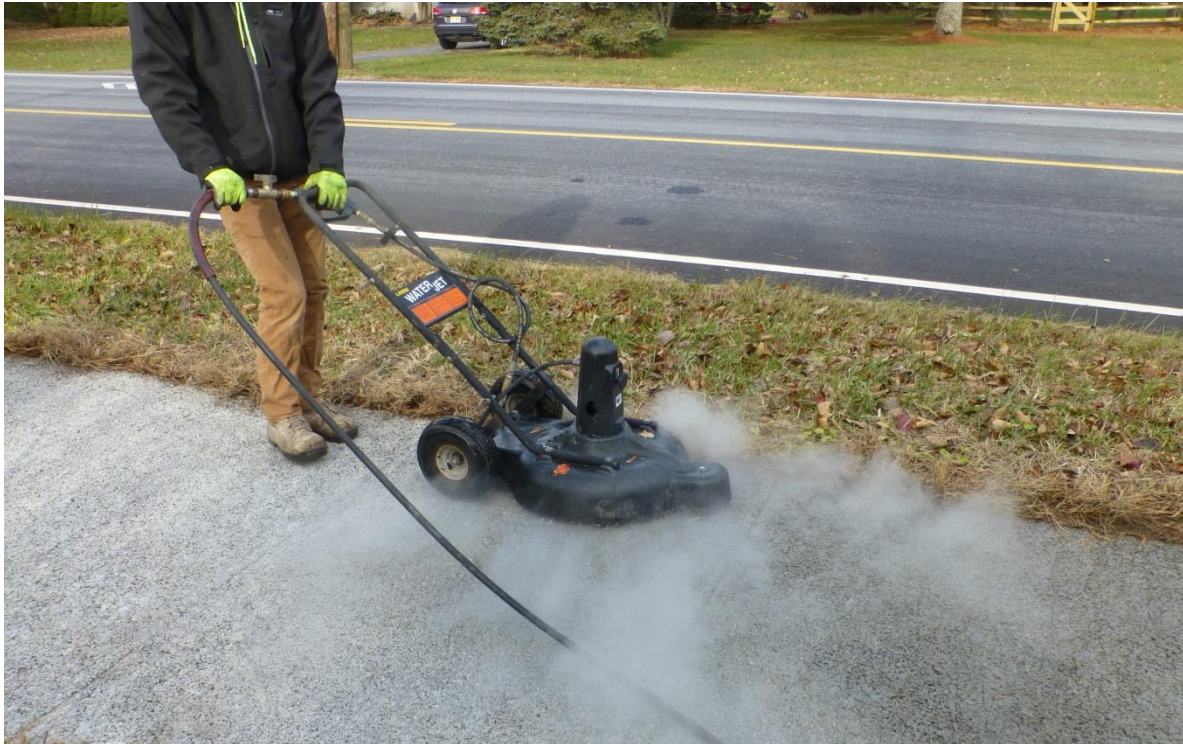
Figure 28. Pressure washing with water pressure of about 2000 psi

Pressure washing should be used when there is significant clogging in the sidewalk or the pavement. As mentioned earlier in this section, this sidewalk looks very good and did not show any signs of clogging but we wanted to evaluate pressure washing for future needs if necessary. Initially we tried low pressure in the range of 2000 psi and it seems that it can be effective in removing low to medium clogging. Fig. 28 shows pressure washing using water pressure in the range of 2000 psi. We also did pressure washing using water pressure levels between 3000 psi to 3500 psi. The field observations showed that this pressure level (3000 psi to 3500 psi) is sufficient to remove significant clogging. Fig. 29 and 30 shows pressure washing with pressures between 3000 psi to 3500 psi. While higher pressures were not used in pressure washing in the field, it seems that higher pressures could cause raveling and separation of aggregates from the surface. The positioning of high pressure nozzle from surface of the porous surface has an effect on the pressure level and therefore, the operator has to be experienced in how close the nozzle should be close to the surface to maintain the required pressure level.

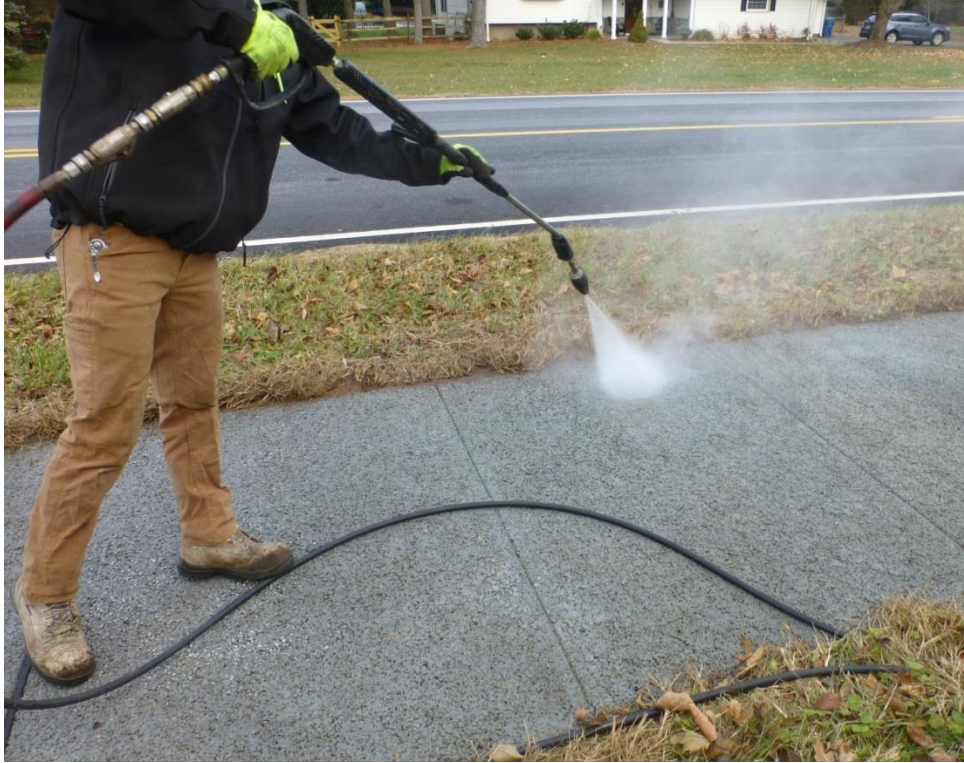
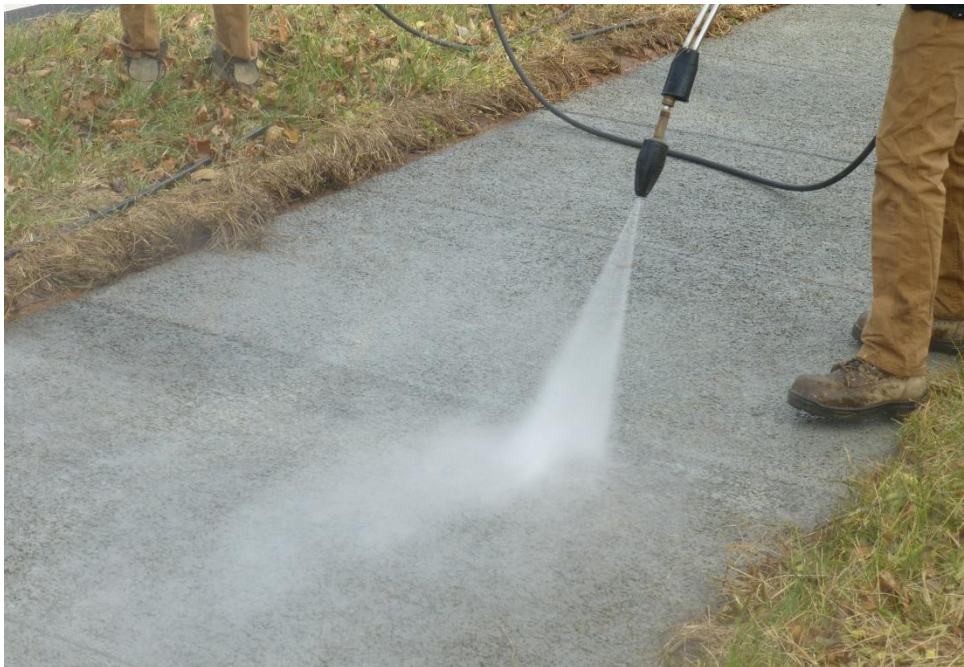
Figure 29. Pressure washing with water pressure ranging from 3000 psi to 3500 psi

Figure 30. Pressure washing with water pressure ranging from 3000 psi to 3500 psi

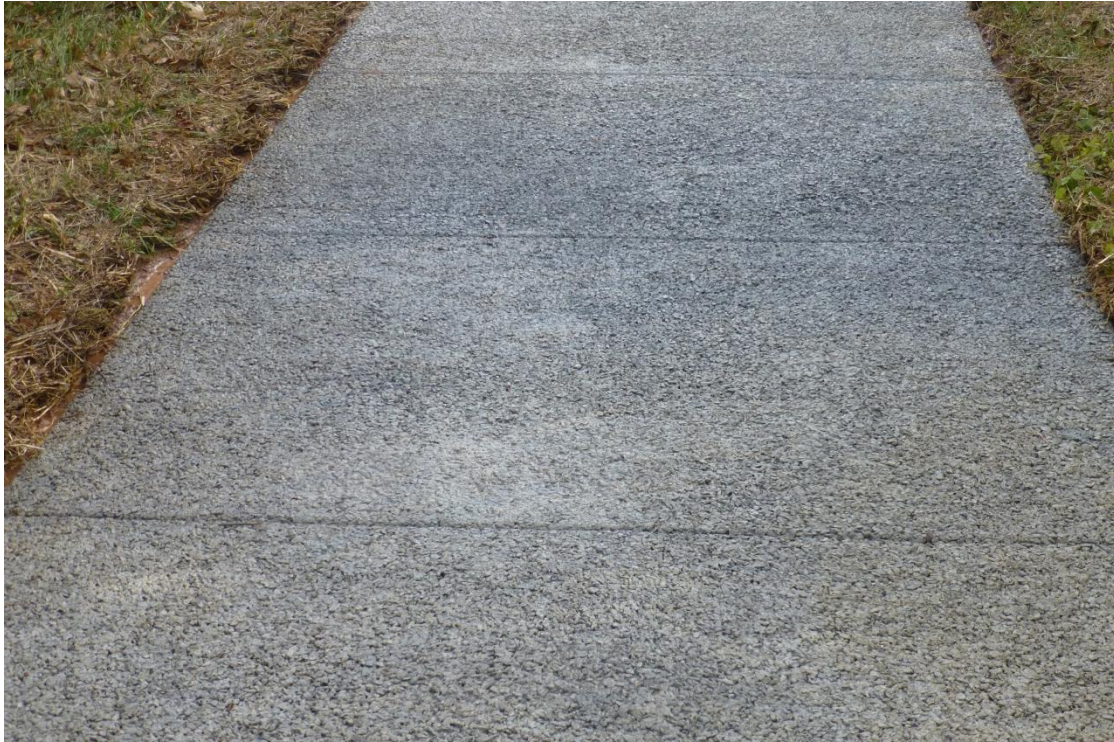
Figure 31. Finished porous concrete sidewalk after pressure washing

Fig. 31 shows the porous sidewalk surface after pressure washing. Visual inspection showed the sidewalk surface texture is very similar to the surface after the sidewalk was cured 6 months earlier. Infiltration tests carried out few days after the pressure washing

showed similar infiltration rates similar to the base line readings (about 330 in/hr for Mix 1 and about 220 in/hr for Mix 2)

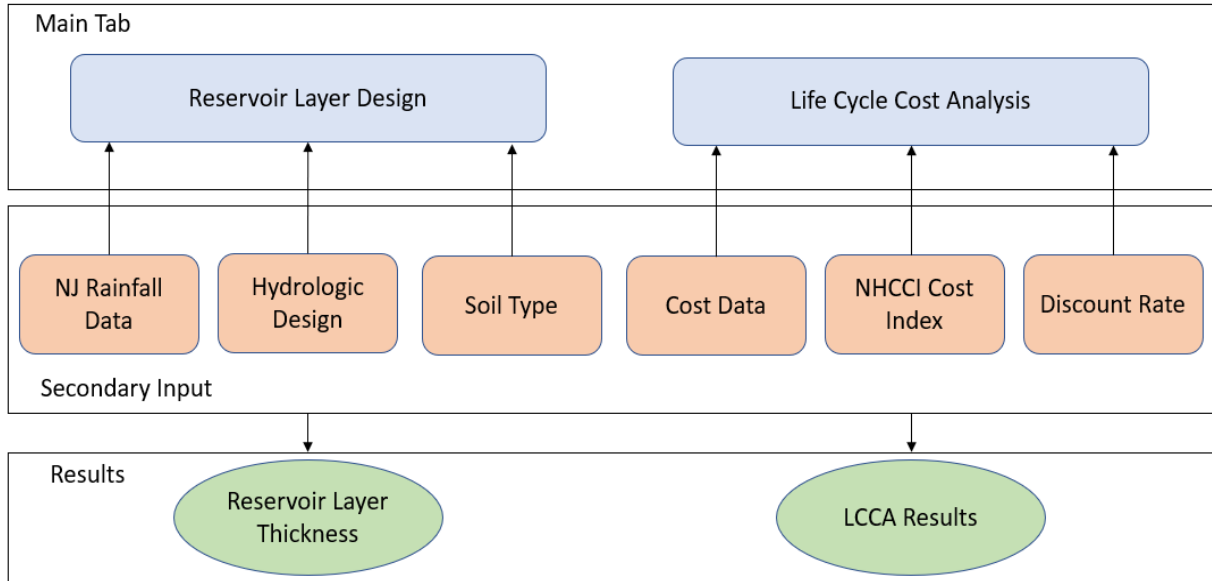
Figure 32. LCCA tool architecture

The proposed pervious concrete Hydrologic Design and LCCA tool was developed based on Microsoft Excel platform consisting of multiple excel worksheets including main input, secondary input, calculations, and results. The worksheets not only provide interactive interface primarily designed for non-technical users but also maintain the flexibilities for advanced users to alter embedded functions and to update the secondary inputs. It is noted that the inputs are at a project level. The tool combined the hydrologic design of the reservoir layer and the life cycle cost analysis. The figure below shows the system architecture of the developed tool.
