# Rapid Repair of Cracks on the Embankment Slopes Using Bio-Cement

Project No. 20GTLSU11

Lead University: Louisiana State University

**Final Report**  
**October 2021**

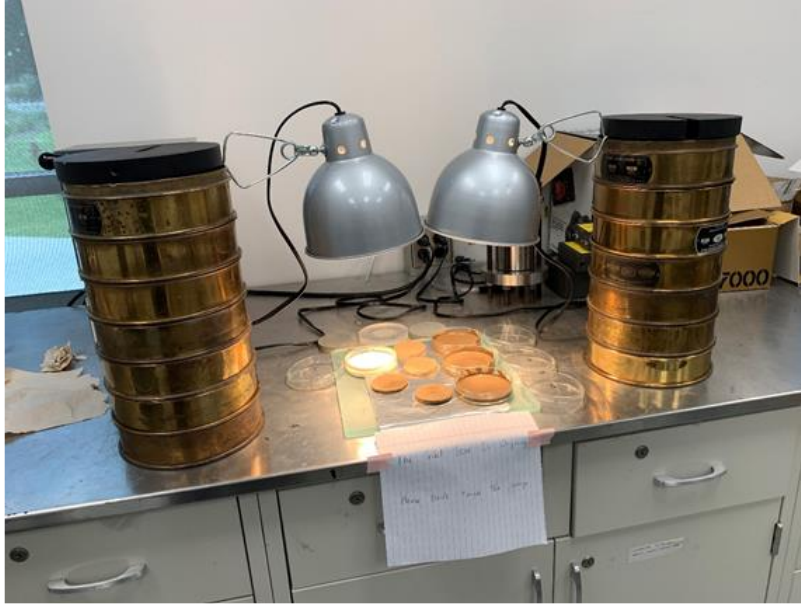
Figure 4. Setup of the cyclic wetting and drying tests.

The silt was air-dried for 24 hours and passed through sieve No. 16 (opening size=1.18 mm). The passing silt was then mixed with deionized water to achieve a water content at liquid limit (around 42% water content). After homogenization, the silt was poured into the 150-mm diameter Petri dishes, lightly compacted, and carefully leveled to a uniform thickness of 5 mm as shown in Figure 4. Three similar samples were tested simultaneously to check the variability of the results.

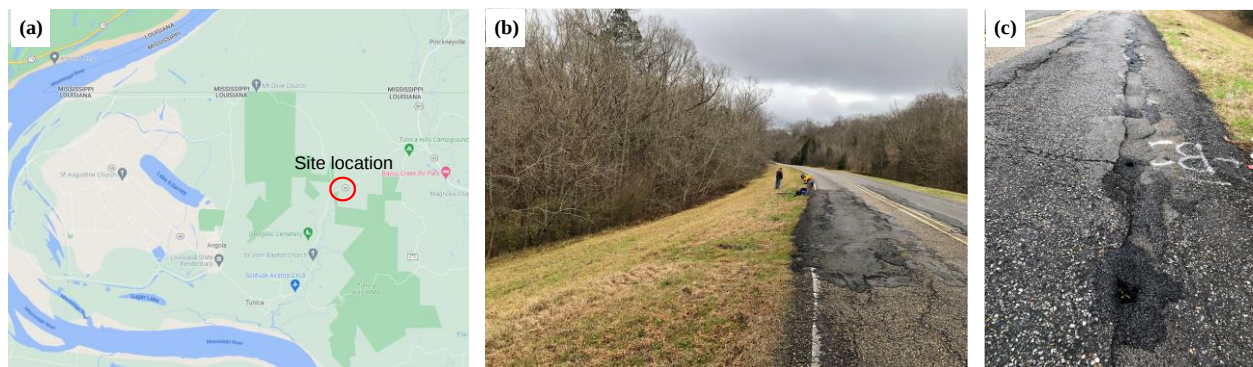
Figure 22. (a) Field test site location, (b) highway embankment slope, and (c) cracks on the highway.

The research team is planning a field test of using bio-cement to seal slope cracks and increase slope stability. The site is located along Highway 66 in St. Francisville, Louisiana (Figure 22a). The highway embankment slope at the site has been showing slope stability issues since 2017. The current site conditions are shown in Figures 22b and c. Surface cracks were observed on the highway (Figure 22c). Two inclinometers were installed at the site for monitoring the slope movement. The research team plans to percolate bio-grout solutions into the cracks on the highway embankment. Initially, 10 gallons of bio-grout solutions will be percolated into the cracks. Inclinometer measurements will be regularly performed to monitor the slope movement after bio-grout treatment.
