Test Procedure for Validation of Automated Distress Data: Technical Report

Technical Report 0-6835-R1

TEXAS A&M TRANSPORTATION INSTITUTE
COLLEGE STATION, TEXAS

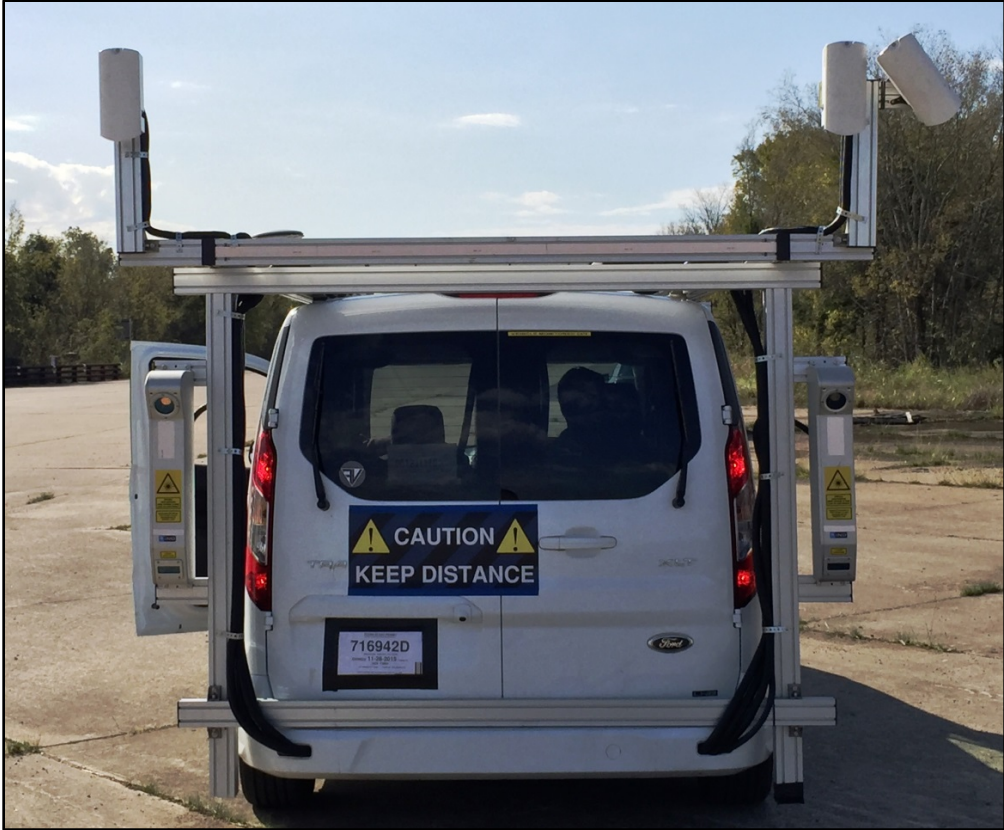
Figure 1. Scanning Lasers Mounted on Each Side of D-Vision Test Vehicle.

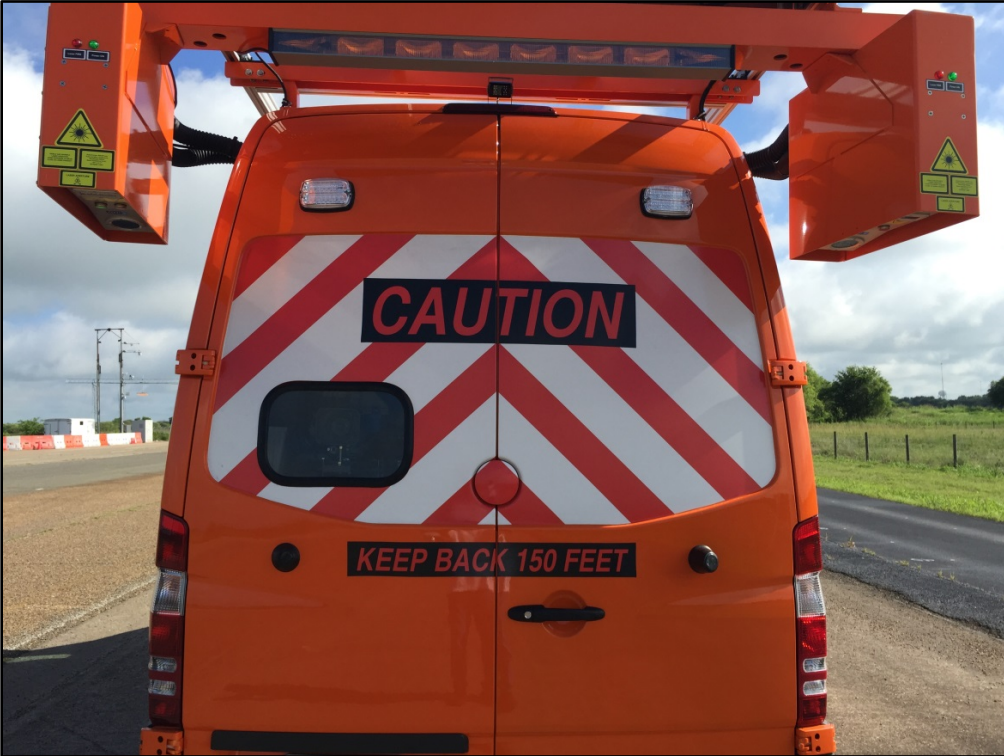
Figure 2. Scanning Lasers Mounted on Top Left and Top Right of ARAN Unit.

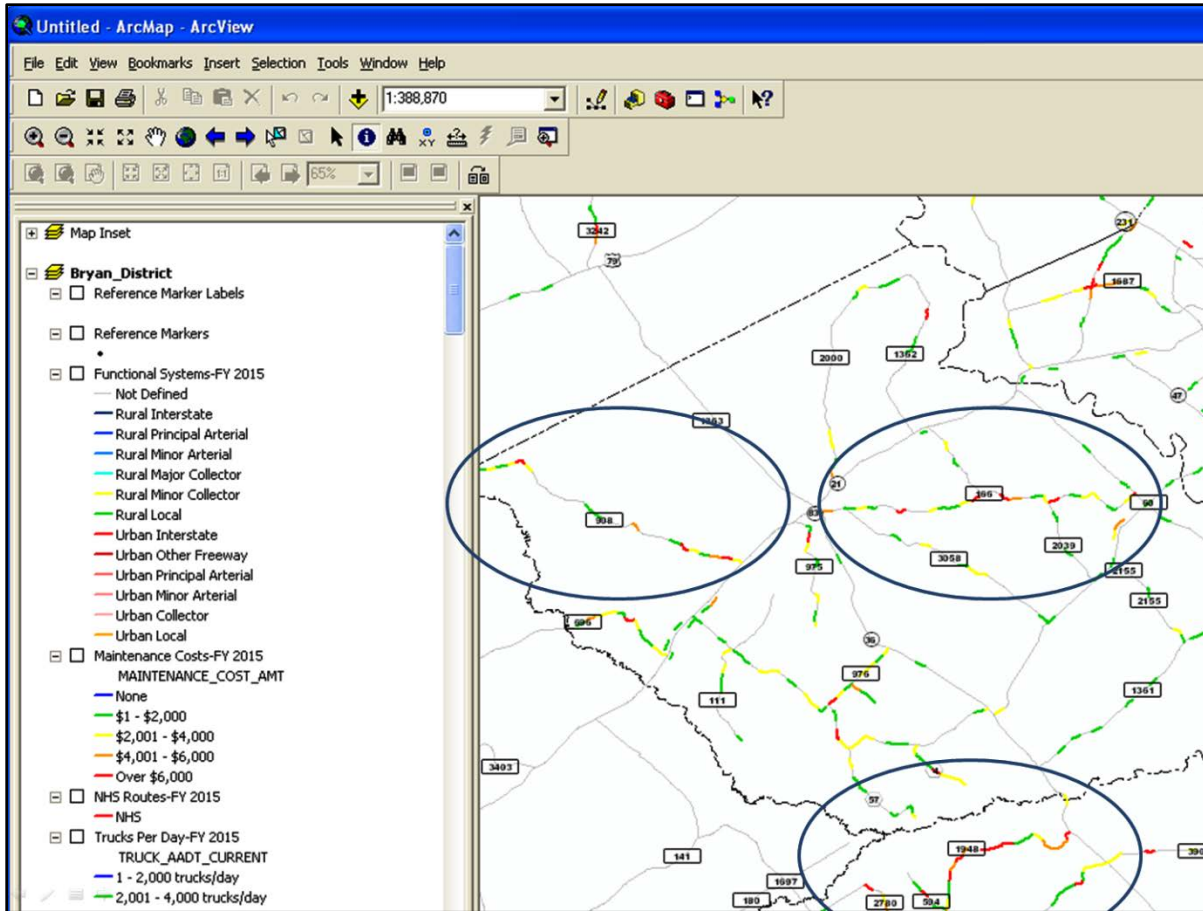
Figure 3. Illustration of PMIS Query Results on Bryan District Data.

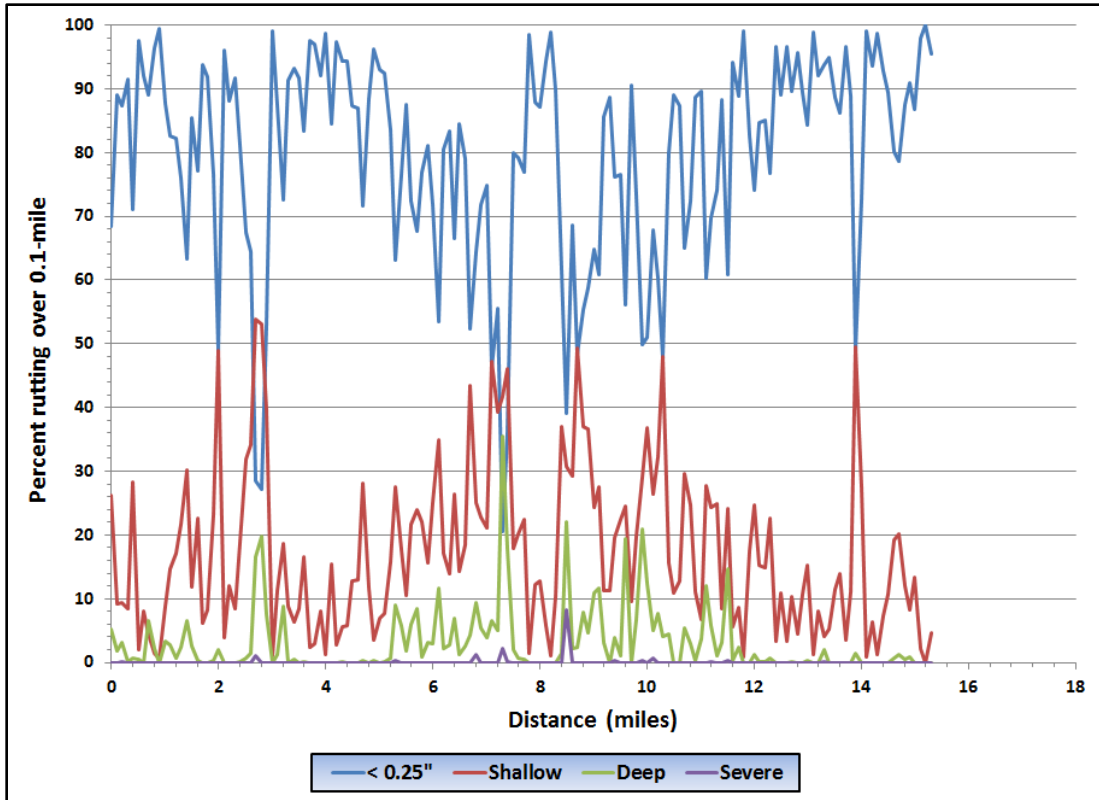
Figure 4. Percentages of Different Levels of Rutting on Eastbound Lane of FM 166.

Figure 4 and Figure 5 illustrate the results from the continuous interval analysis using the rutting data collected along both travel lanes of FM 166. Researchers used this information to identify test sections where reference rut measurements were collected to assess the accuracy of the computed rut depths from automated rut measurement systems. For this purpose, researchers established ten 550-ft reference test sections along FM 166. Table 33 identifies these test sections where researchers collected reference measurements with the straightedge in accordance with ASTM E 1703. The following sections present the evaluation of test data from automated rut measurement systems.

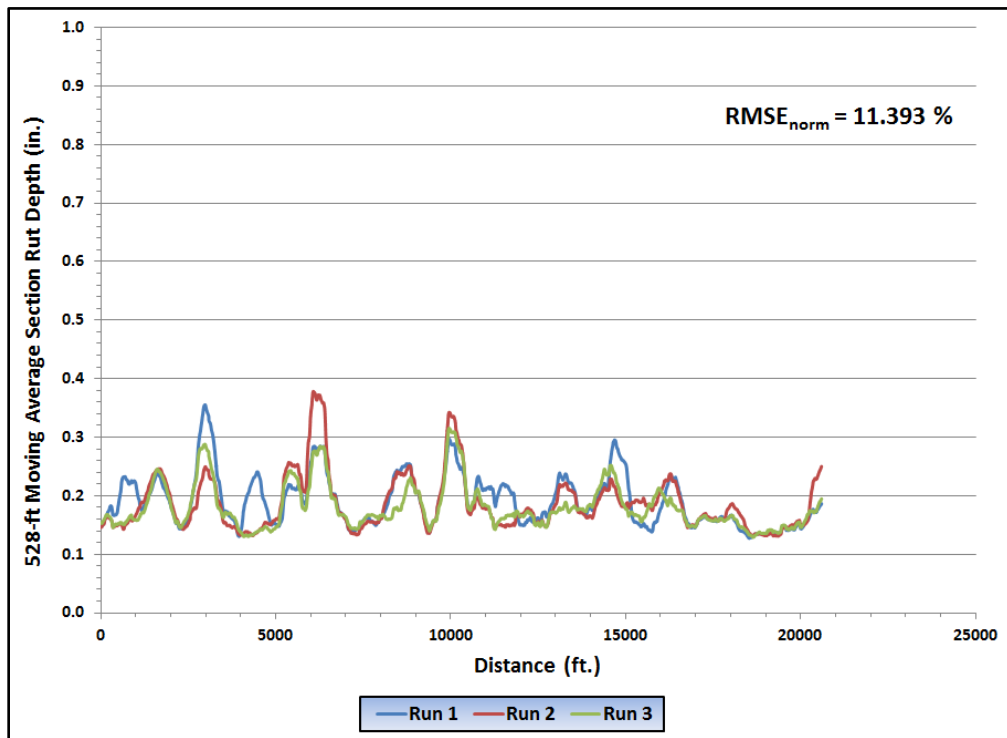
Figure 8. Continuous 528-ft Average Section Rut Depths from Repeat Runs of Vendor I on FM 908 NB Test Segment (TRM 604 to TRM 600).

To quantify the repeatability of the rutting statistics shown in Figure 6 to Figure 15, researchers determined the point-to-point variance of corresponding 528-ft continuous rutting statistics computed using the data from repeat runs. The square root of the average variance was then calculated and normalized with respect to the overall mean value of the given rutting statistic. Researchers refer to this measure of repeatability as the normalized root-mean-square error ($RMSE_{norm}$) in Figure 6 to Figure 15. Lower values of $RMSE_{norm}$ indicate better repeatability of the test data.

Comparing Figure 6 to Figure 10 with Figure 11 to Figure 15 shows a noticeable difference in the repeatability of the computed rut depths between Vendor I and Vendor II. Specifically, the test data from Vendor II shows better repeatability based on the rutting statistics used in this evaluation. A similar observation was made using the data collected on the other FM 908 test segments. This finding is apparent from Table 34, which summarizes the normalized root-mean-square error statistics determined from the rutting data collected along FM 908.

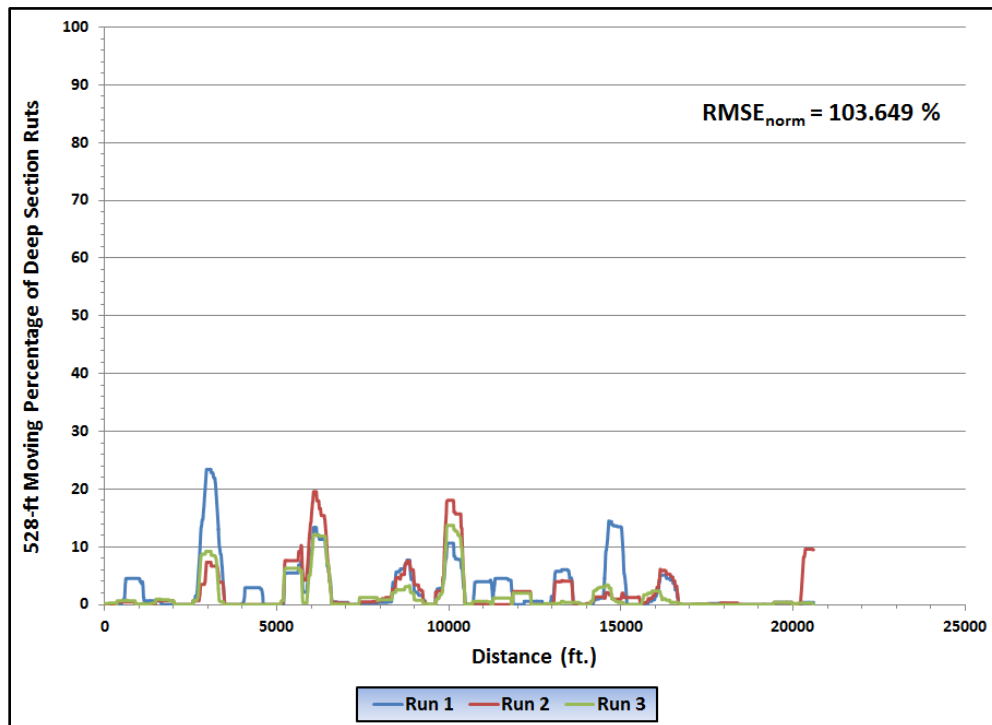
Figure 10. Continuous 528-ft Percentages of Deep Rutting from Repeat Runs of Vendor I on FM 908 NB Test Segment (TRM 604 to TRM 600).
