Cargo Compartment Fire Protection in Large Commercial Transport Aircraft

July 1998

DOT/FAA/AR-TN98/32

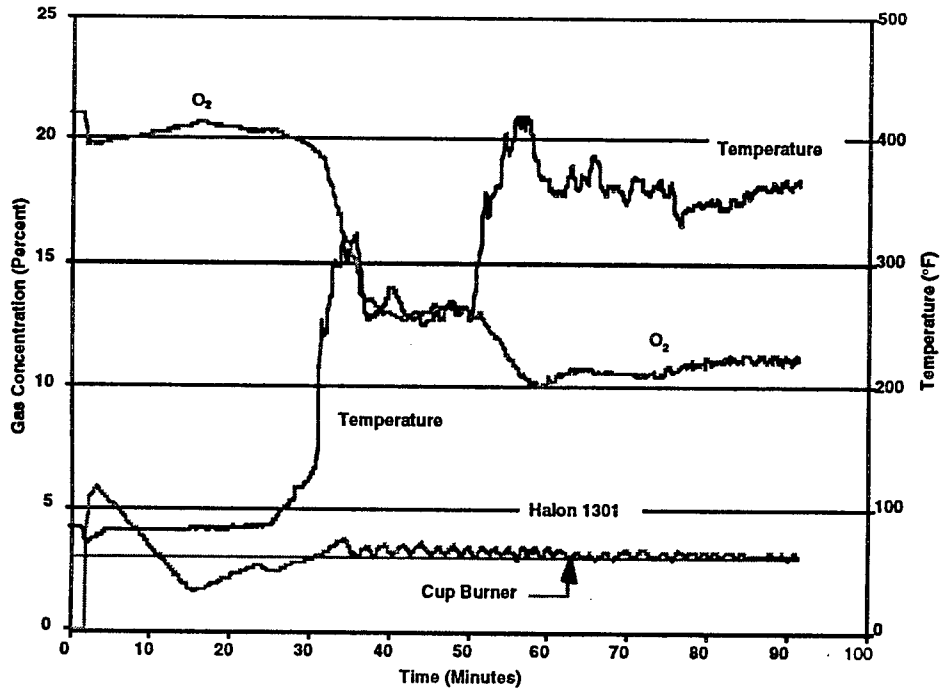
FIGURE 1. GAS AND TEMPERATURE PROFILES IN CARGO COMPARTMENT DURING BULK-LOADED FIRE SUPPRESSION TEST WITH HALON 1301

The results of these 90-minute tests were generally similar to previous shorter duration tests conducted with these agents. [8] The cargo compartment ceiling temperatures ranged from 300 to 450°F while the fires were suppressed and the oxygen concentrations were reduced to 10% to 15%. The depletion of oxygen was caused both by smoldering fires and the displacement of air by suppression agents. Figures 1 and 2 show the ceiling temperatures, oxygen concentrations, and agent concentrations measured in the cargo compartment for the tests with Halon 1301 and HFC-125, respectively. One anomaly was observed during the test with HFC-125. Shortly after the concentration from the initial discharge had decayed down to the cup burner value of 8.8% and the metering system had started, there was an ignition of combustible gases in the smoke layer above the cardboard boxes. The flame front progressed along the entire length of the compartment at the ceiling level. This caused a sharp rise in ceiling temperature and a drop in oxygen concentration. The fire was suppressed for the duration of the test after this event. A similar event had previously been observed in a test using HFC-125 with a containerized fire load. This type of behavior had not been observed with Halon 1301 or other gaseous candidate replacement agents. Further testing is planned in an attempt to understand this anomaly.

Of particular interest for these longer duration tests was the generation and accumulation of agent decomposition products in both the cargo compartment and in the normally occupied passenger cabin area above it. Figure 3 shows the hydrogen fluoride (HF) concentrations in the cargo compartment for the two tests. The values in the graph are the average concentrations of HF over each 10-minute interval. The higher concentrations of HF between 20 and 40 minutes with HFC-125 are due mainly to the open flame that was present when the combustible gases along the ceiling ignited. This open flame produced significantly more decomposition products than the smoldering suppressed fire. Previous testing showed higher concentrations of HF even where there was no ignition of combustible gases when HFC-125 was used as the suppression agent rather than Halon 1301. This result is expected because not only does HFC-125 contain more fluorine per molecule than Halon 1301, but higher concentrations of HFC-125 are also

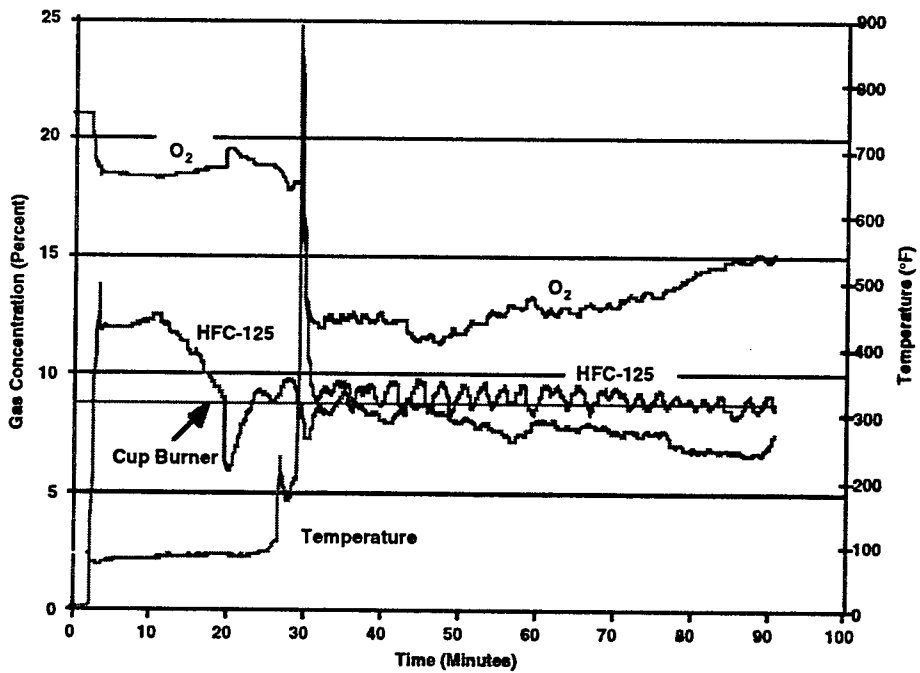
FIGURE 2. GAS AND TEMPERATURE PROFILES IN CARGO COMPARTMENT DURING BULK-LOADED FIRE SUPPRESSION TEST WITH HFC-125

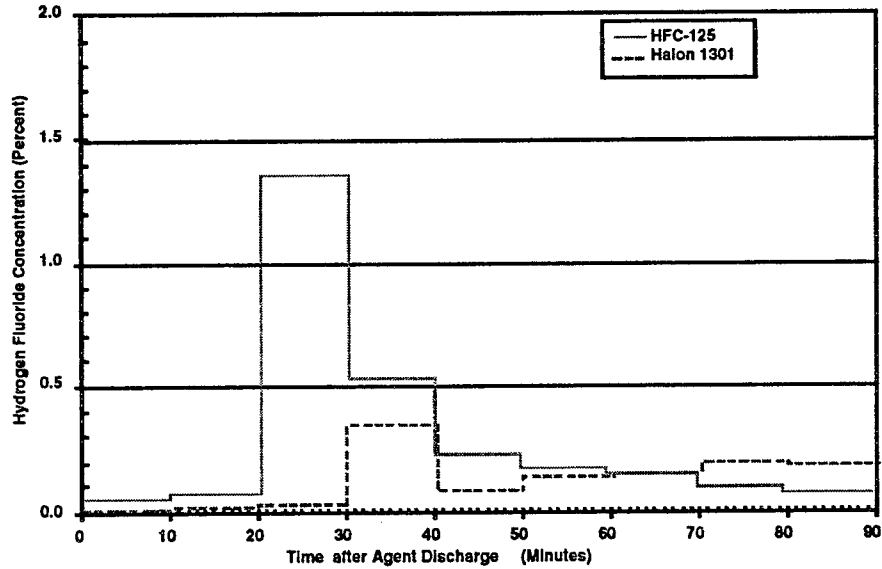
FIGURE 3. HYDROGEN FLUORIDE PROFILES IN CARGO COMPARTMENT DURING BULK-LOADED FIRE SUPPRESSION TESTS WITH HALON 1301 AND HFC-125

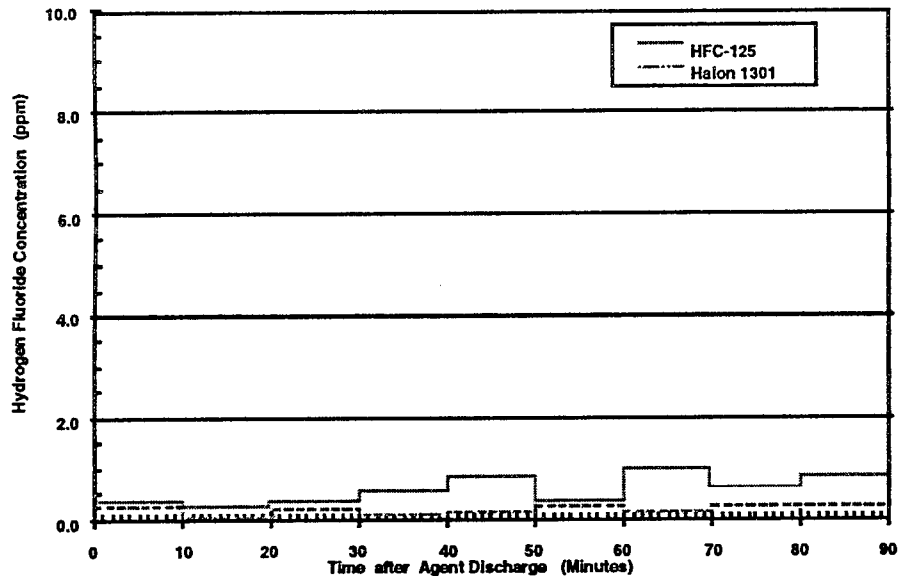
required compared to Halon 1301. Figure 4 shows the HF concentrations in the passenger cabin above the cargo compartment. HF concentrations are again higher in the test with HFC-125 for the same reasons as stated above. However, the data show that there is not a significant accumulation of HF in the cabin area. The fuselage ventilation system exhausts the decomposition products out of the cabin at a rate similar to the inflow rate of these products. The measured levels for both tests were well below the maximum Occupational Safety and Health Administration (OSHA) 15-minute exposure limit of 6 parts per million (ppm) and the Immediately Dangerous to Life and Health (IDLH) limit of 30 ppm.

FIGURE 4. HYDROGEN FLUORIDE PROFILES IN PASSENGER CABIN DURING BULK-LOADED FIRE SUPPRESSION TESTS WITH HALON 1301 AND HFC-125

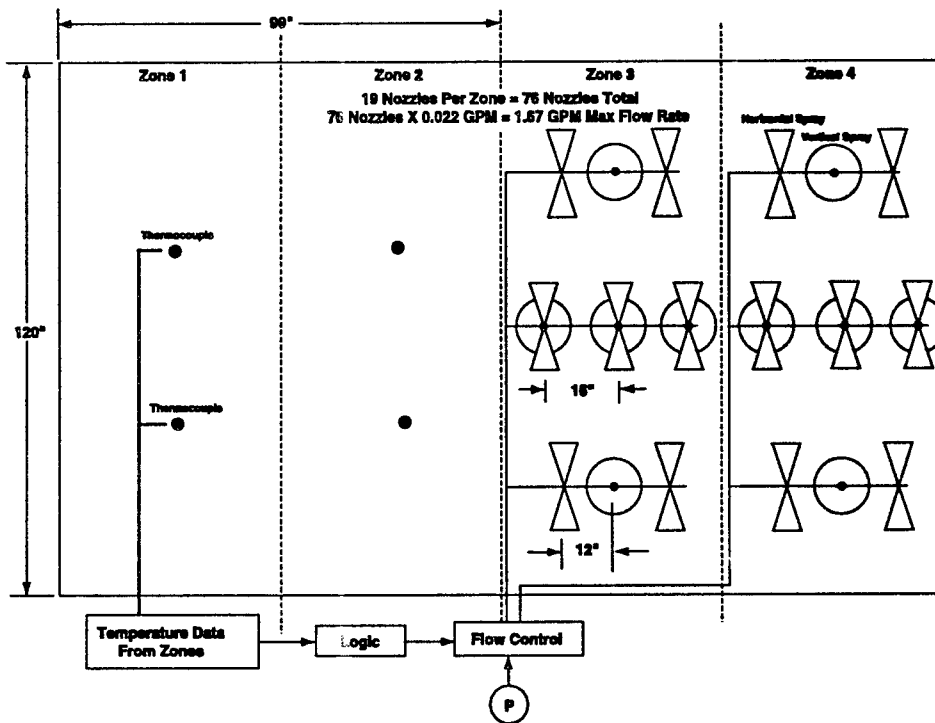
The water mist system was supplied by Environmental Engineering Concepts (EEC). These systems are commercially available under the trade names Microcool® and Enviromist® Fog Systems and are primarily used for environmental cooling and vegetable hothouse humidification. The system used for the cargo compartment testing was co-designed by the FAA and EEC and consisted of a high-pressure pump, four zone control valves, and the basic piping and nozzles. The water mist system, designed to minimize the amount of waste water by applying the mist to the areas of the fire, was divided into four zones that could be individually activated (see figure 5). Each zone contained 19 nozzles and covered an area of approximately 4 by 10 feet. The nozzles were oriented to spray mist both horizontally and vertically (down) to maximize mixing and coverage. The mist was automatically controlled by two thermocouples mounted in the ceiling of each zone. The control of the spray activation could be adjusted prior to each test. During the test, when either of the zone thermocouples exceeded the preset value, a signal was sent to open the zone control valve, discharging the mist in that zone. The water mist pressure was adjustable from 800 to 1200 psi, as supplied by an electrically driven pump.

FIGURE 5. WATER MIST SYSTEM SCHEMATIC

A B727 aft cargo compartment test article was used to evaluate a high-pressure water mist system. The test article measured approximately 120 inches wide by 200 inches long at the ceiling (the floor of the compartment covered significantly less area due to the curvature of the fuselage). The compartment volume was approximately 550 cubic feet. The ceiling and sidewall were constructed of the original fiberglass cargo liners; the forward and aft bulkheads were made of aluminum. Two thermocouples trees were installed along the compartment centerline with three probes each located at 1-, 2-, and 3-foot levels. Video and photographic equipment were placed in the aft bulkhead to monitor test progress.

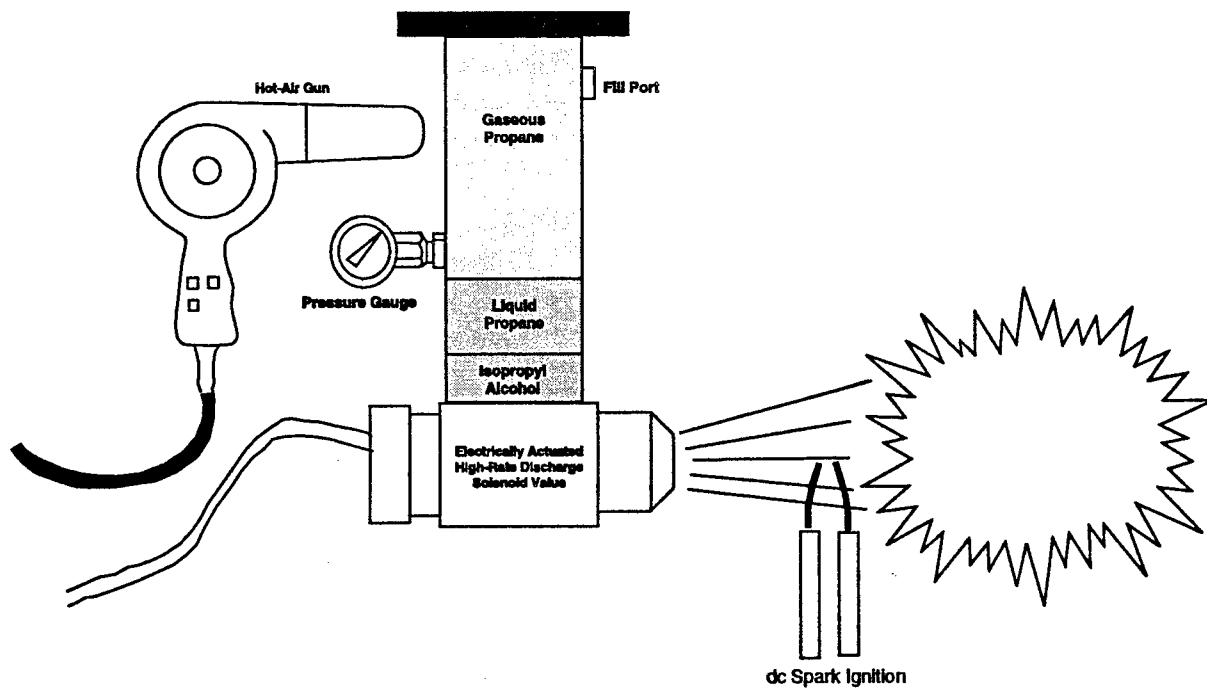
The initial simulator design was a steel pipe pressure vessel mated to a high-rate discharge (HRD) electrically actuated solenoid valve (see figure 6). The vessel contained ports and valves to transfer the base product (initially isopropyl alcohol) and hydrocarbon propellant (typically propane). The contents are heated by blowing a hot-air gun against the surface of the steel vessel, effectively raising the pressure of the contents. When the pressure was sufficient to burst a standard strength can, approximately 210 psig, the contents were released over a set of direct current (dc) spark igniters. A high-voltage transformer produced the electric spark to bridge the 1.2-cm gap between the pair of electrodes.

FIGURE 6. EXPLODING AEROSOL CAN SIMULATOR

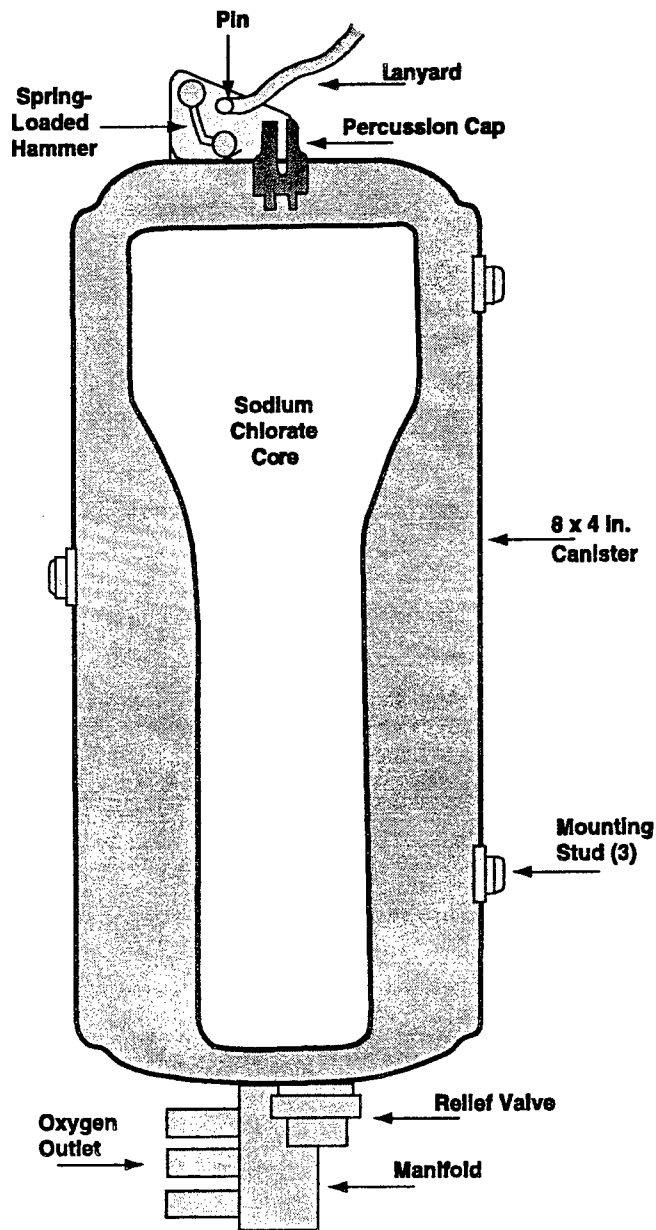
Most commercial transport aircraft use oxygen canisters to supplement or replace cabin air for passenger breathing in the event of a cabin depressurization. Figure 7 shows the design of a common oxygen canister. The main components are the chemical core composed of sodium chlorate and iron particles, a stainless steel housing, a means of initiating the chemical reaction (such as a spring-loaded hammer striking a percussion cap), and outlets for the gaseous oxygen generated. Because the oxygen-producing reaction is exothermic, the steel housing is insulated from the chemical core to maintain the temperature of the housing below 500°F. As discussed earlier, the activation of improperly packaged and shipped oxygen canisters in the forward cargo compartment was the probable cause of the fatal ValuJet in-flight fire. [5]

FIGURE 7. CHEMICAL OXYGEN GENERATOR

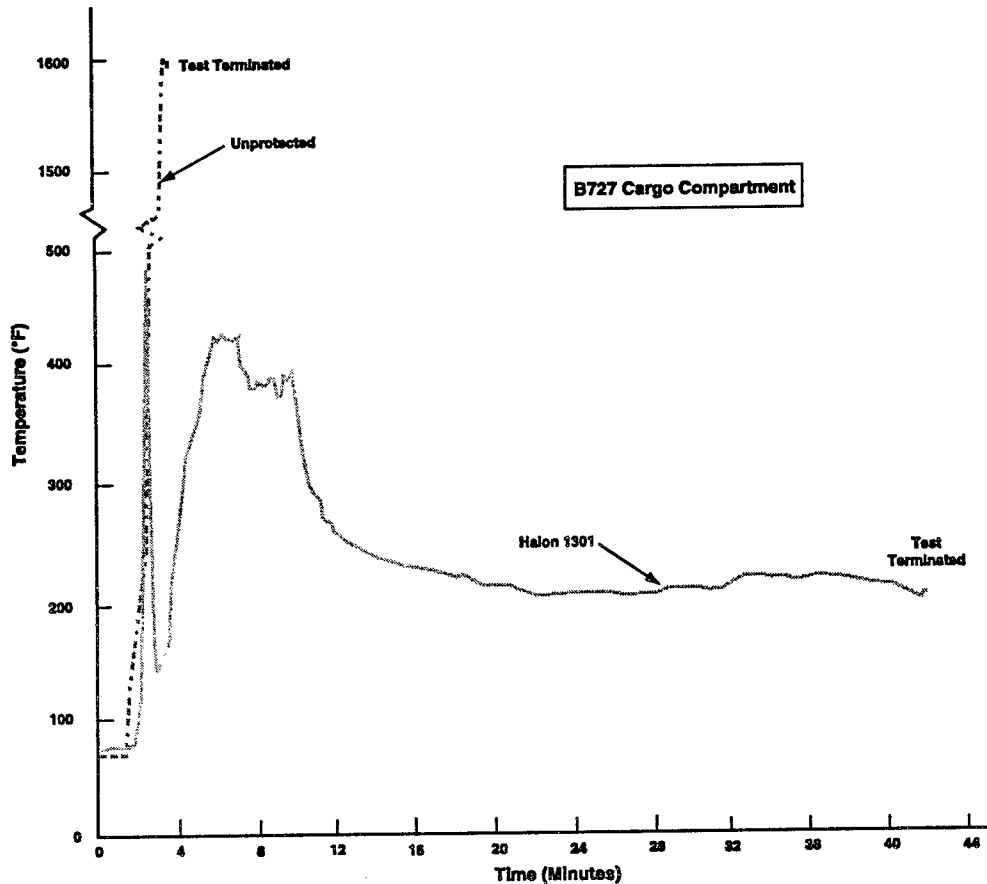
The third test was a repeat of test two without using any suppression agent. Temperatures at the ceiling rapidly reached the point where the liner would be breached and the test was immediately terminated (see figure 8).

FIGURE 8. COMPARISON OF CEILING TEMPERATURES DURING A CARGO FIRE INVOLVING 12 OXYGEN CANISTERS WITH HALON 1301 SUPPRESSION AND UNPROTECTED

The second test was similar to the first with the following exceptions. Only 12 generators were used; all were stored in one cardboard box. Only a single layer of boxes filled with shredded paper was used. In this test the fire was detected much faster than in the first test (see figure 8). Temperatures at the ceiling never exceeded 500°F. As in the first test, upon discharge of Halon 1301 the visible flaming was immediately extinguished. However, in this test the ceiling temperature was maintained at about 400°F for approximately 10 minutes and decreased to approximately 200°F for the next 30 minutes. After the fire was extinguished, it was discovered that only 2 of the 12 generators had activated.

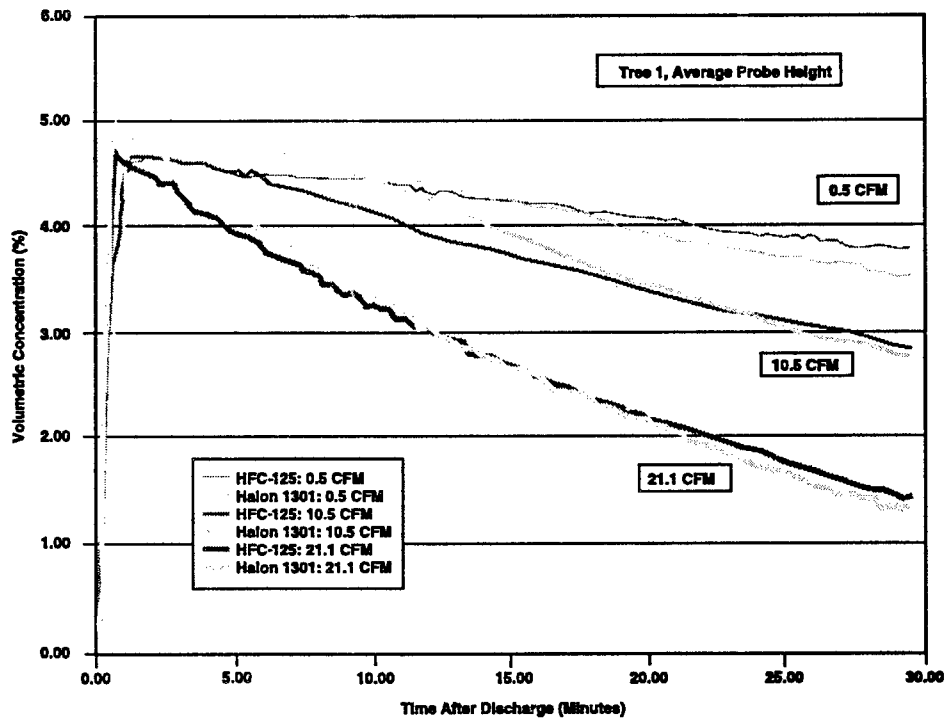
A comparison of the HFC-125 and Halon 1301 concentration histories at the three leakage rates for the sampling tree nearest the leak duct is shown in figure 9. The data represents the average concentration measured at the six sampling heights and from replicate tests at each leakage rate. The higher peak concentrations of Halon 1301 were expected due to the difference in charged weight; 5.8 pounds and 4.45 pounds for Halon 1301 and HFC-125, respectively. Also, the Halon 1301 decays faster than HFC-125 due to its higher vapor density; however, the difference in decay rate lessens as the leakage rate increases. It appears that HFC-125 can be used as a simulant for Halon 1301 provided that suitable conversion equations are used to correlate the concentrations of Halon 1301 and HFC-125.

FIGURE 9. AGENT CONCENTRATION HISTORY AT DIFFERENT LEAK RATES

Discharge tests with HFC-125 and Halon 1301 were conducted and compared in a 300-cubic foot cargo compartment. The air leakage rate in the test article could be set at 0.5, 10.5, or 21.1 cubic feet per minute (CFM). The main instrument was a Heat Technology Laboratory (HTL)

Halonyzer, a 12-channel continuous gas analyzer calibrated for HFC-125 in air and Halon 1301 in air. Gas samples were taken from six sampling tree elevations at two locations. To obtain similar storage bottle discharge characteristics for both agents, the bottle was filled with the equivalent liquid fraction, as used previously, [14] and pressurized with nitrogen to 375 pounds per square inch absolute (psia).
