# Fracture Critical Steel Twin Tub Girder Bridges: Technical Report

Technical Report 0-6937-R1

TEXAS A&M TRANSPORTATION INSTITUTE  
COLLEGE STATION, TEXAS

Report 0-6937-R1  
Project 0-6937  
Project Title: Fracture Critical Steel Twin Tub Girder Bridges

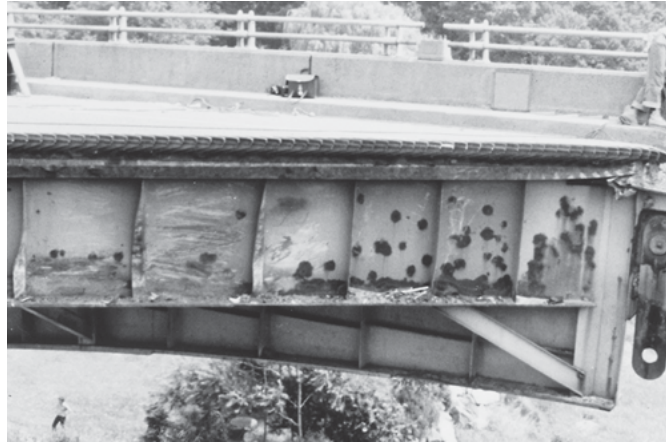
**Figure 2.2. Collapse of the Mianus River Bridge (Fisher 1997).**

In 1983, the Mianus River Bridge collapsed due to fatigue of the material, as shown in Figure 2.2 (Barker and Puckett 2013). The Mianus River Bridge was a “pin and hanger” bridge design that was commonly used in the year of construction because of the cheaper construction costs. The bridge collapsed after 25 years of service. Due to corrosion of storm drains that were installed 10 years before the collapse, the pin and hanger assemblies moved and shifted the weight to the outside hanger, which then had to carry all the weight, resulting in a fatigue crack. This fatigue crack caused the hanger to separate from the upper pin, and subsequently, the span of the bridge collapsed, and the span fell into the river. The Mianus River Bridge disaster should have been avoided because it had regular, but insufficient inspections. After the collapse of the Silver Bridge over the Ohio River, the Mianus River Bridge was inspected 12 times, with the last inspection only one year before the collapse. The inspectors only inspected the bridge visually from the ground with binoculars, so they could not identify the lateral displacement of the

hangers. They noted “heavy rust on the top pins from water leaking through the expansion joints,” (Barker and Puckett 2013) but this was not relevant enough to foresee the collapse.

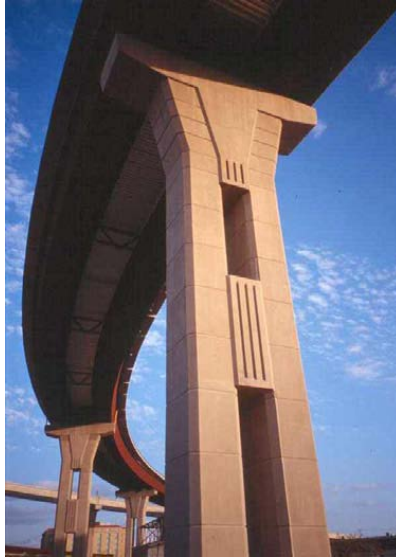
**Figure 2.4. STTG Bridge, I-35/US 290 Interchange, Austin, Texas (Coletti et al. 2005).**

Figure 2.4 presents a typical STTG bridge of the type that has become popular in Texas because they offer a solution for long-span and/or curved highway bridges in addition to providing an aesthetic structural option. STTG bridges consist of two steel girders that are the primary members for transmitting the dead load and live load to the substructure. On the other hand, concrete decks and stringers are secondary members that create a load path between girders (Daniels et al. 1989). Because of their fracture critical designation, STTG bridges require a hands-on inspection every two years. This rigorous inspection may include the testing of welds, nondestructive evaluation, and visual assessment. Procedures of nondestructive evaluation of steel members may “include dye penetrant, magnetic particle, or ultrasonic techniques” (TxDOT 2013a).

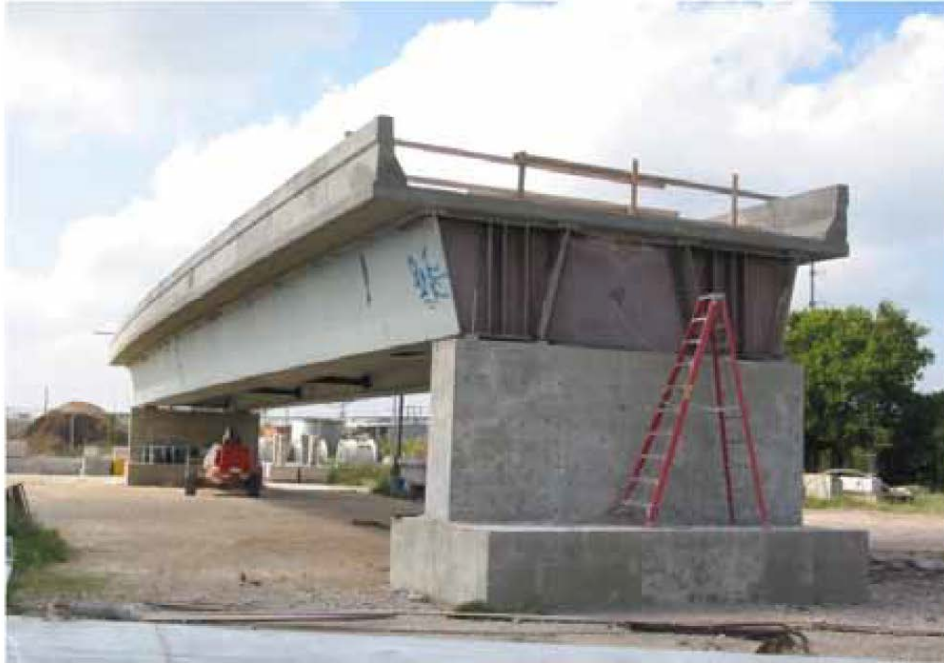
**Figure 3.1. The FSEL Test Bridge (Barnard et al. 2010).**

The FSEL test bridge was originally used as a section of an exit ramp in Houston, TX. After taken out of service a portion of the bridge was used for the FSEL test bridge. The FSEL test bridge was designed to represent the worst case configuration, with respect to redundancy. The bridge was set up in a simply supported manner and all external braces that could have assisted in load transfer following a girder failure were also removed according to common TxDOT practice. Furthermore, the railing was constructed with expansion joints that significantly reduce any load carrying capability that might contribute to stiffening the girders. Finally, the bridge was constructed with a tight radius of curvature in the horizontal plan; an equivalent HS-20 truck load was applied on the exterior girder at the location of the mechanically induced girder fracture. An image of the full-scale destructive test setup of the twin steel box-girder bridge is located in Figure 3.1.

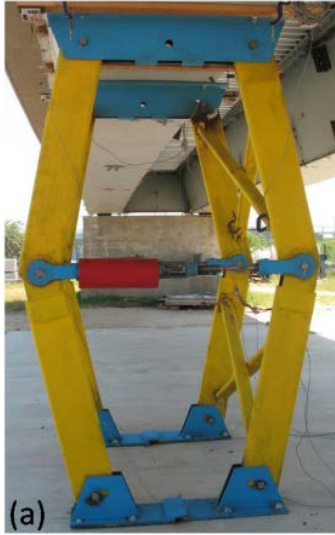
**Figure 3.13. Scissor Jack with Explosive Tie Assembly (Neuman 2009).**

The first step in testing the third load case involved repositioning the bridge to the approximate height of where it stood prior to the bottom flange being fractured during the second load case. In the fully supported position, an oxy-acetylene torch was used to extend the fracture from the bottom flange, and it was terminated 10 in. below the top flange weld. Following the cutting of the web, the concrete girders and wooden underpinning were once again strategically placed on the bridge per AASHTO standards at a location of maximum moment, with the outer girder 2 ft from the interior edge of the T501 railing, as shown in Figure 3.12. To appropriately simulate a sudden fracture of the tension flange and web, a special support system had to be installed that could quickly and simultaneously collapse, which was accomplished by using a scissor jack with cross tie supports, or tension tie assemblies, equipped with an explosive charge that would simultaneously fail. The tension tie assembly can be seen in Figure 3.13.

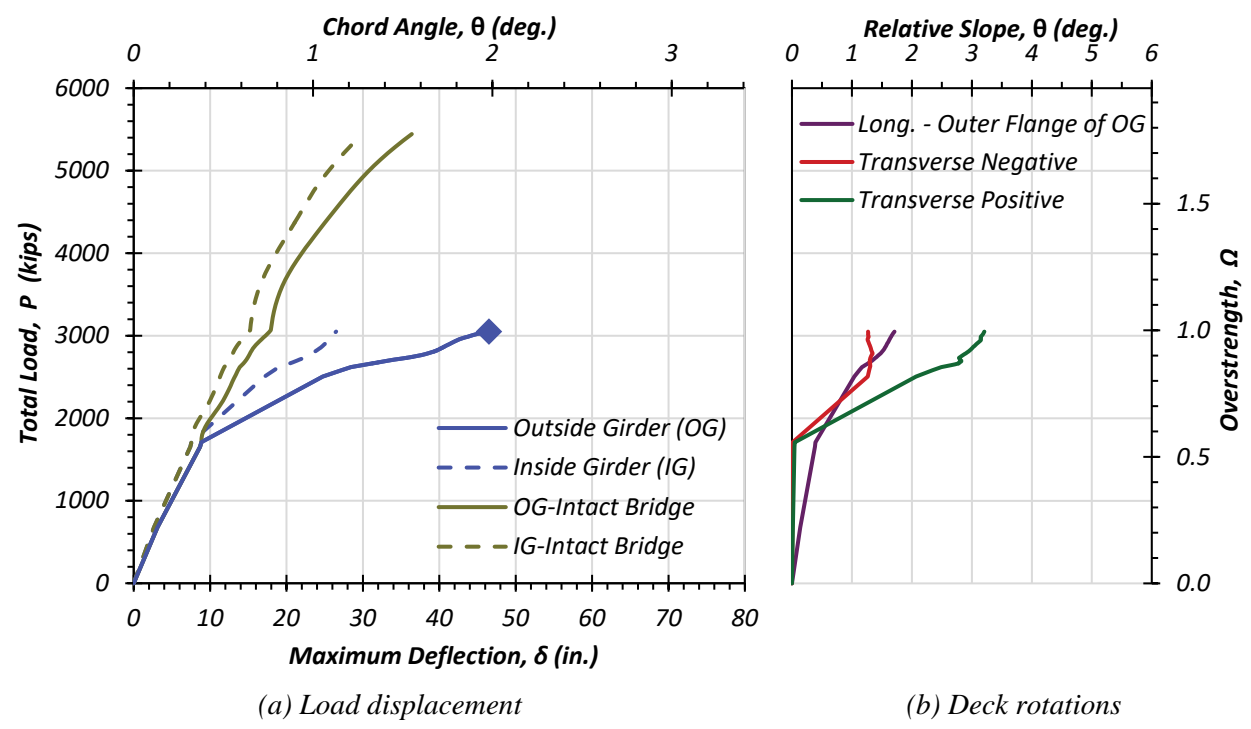
**Figure 4.33. FEM Deflection Profile of Bridge 8, Span 1, with Fractured Outside Girder.**

Note:  $\delta$  is along the centerline of the outside girder,  $\Omega$  is the load normalized by factored design load.

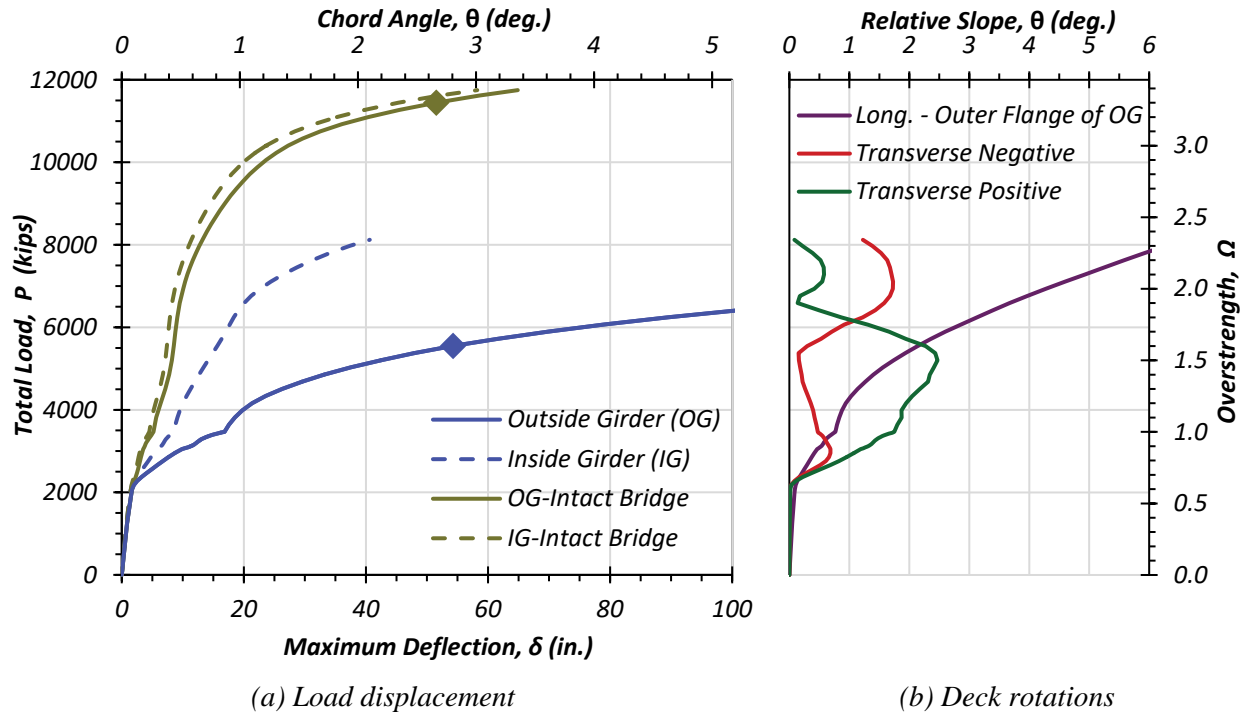
**Figure 4.53. FEM Deflection Profile of Bridge 11, Span 3, with Fractured Outside Girder.**

Note:  $\delta$  is along the centerline of the outside girder,  $\Omega$  is the load normalized by factored design load.

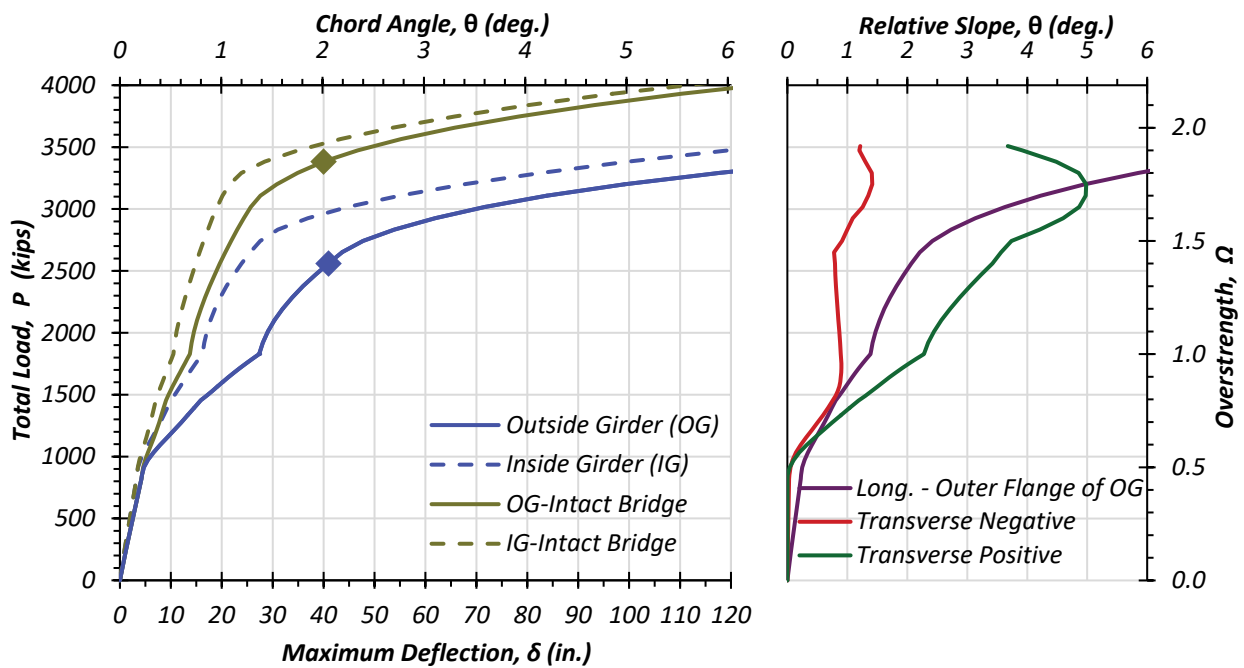
Figure 4.63. FEM Deflection Profile of Bridge 13, Span 2, with Fractured Outside Girder.

(a) Load displacement

(b) Deck rotations

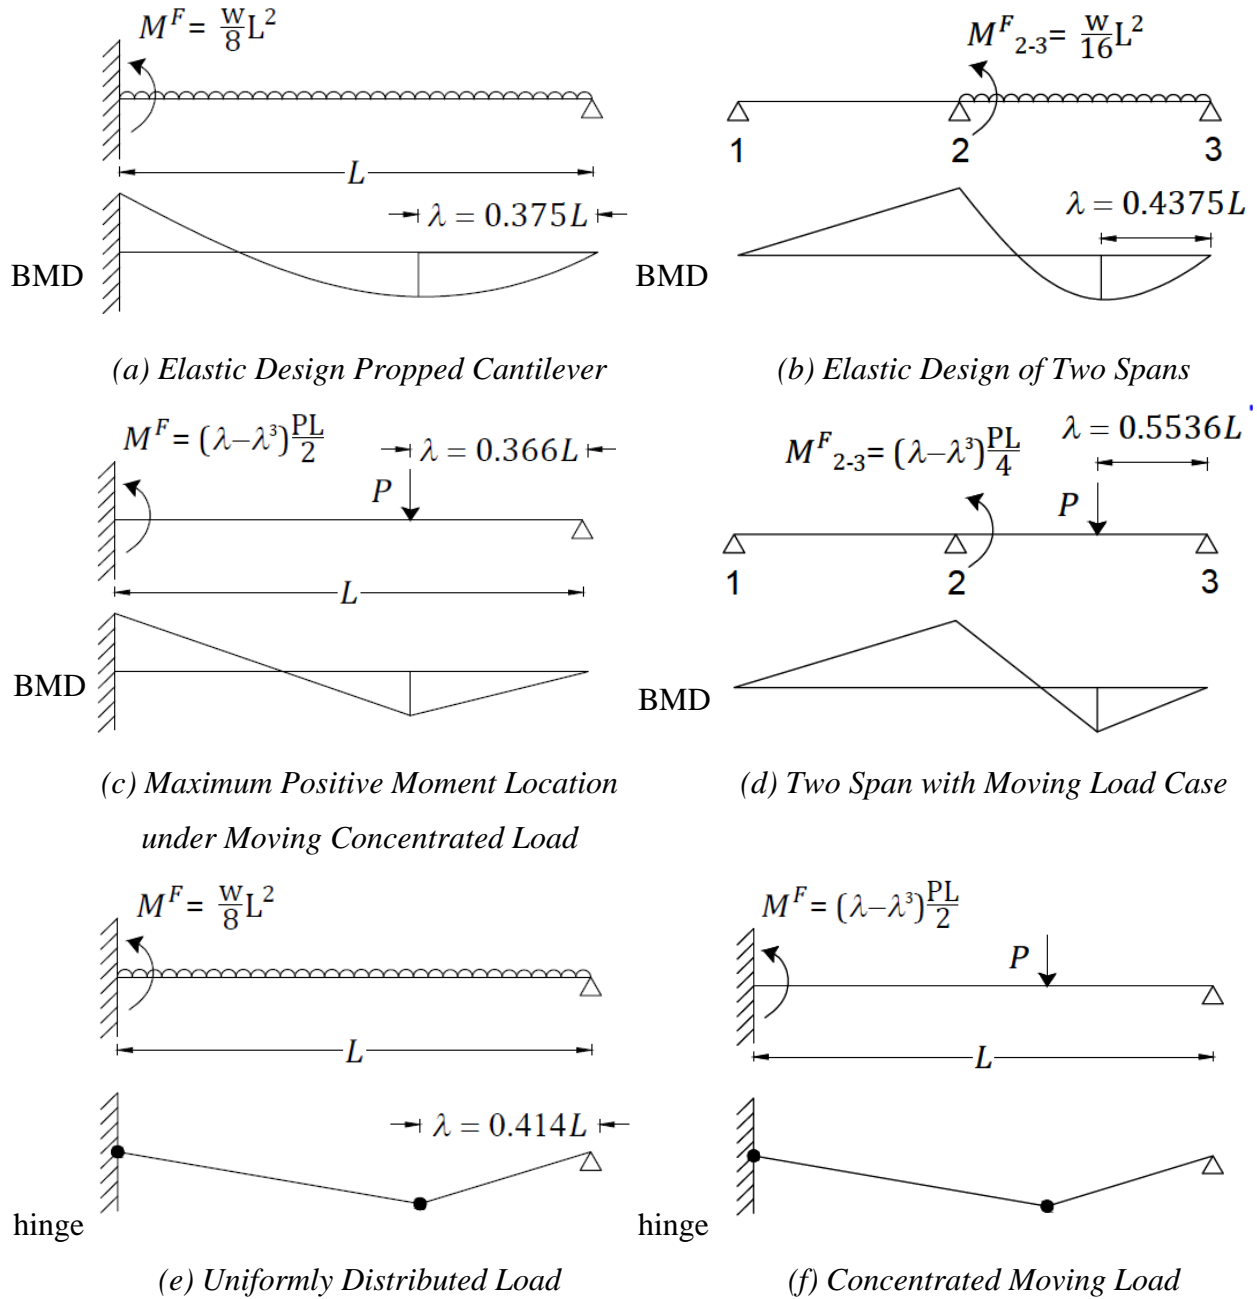
Figure 5.14(a) and (b) respectively show the extreme cases for a multi-span bridge with full fixity (where  $M^F = wL^2/8$ ) and for a two-span structure with partial fixity where only one span is fully loaded. For an elastic design, moment capacities are proportionately tuned to the elastic bending moment diagram. Thus, for Figure 5.14(a) and (b),  $\lambda = 0.375$  (full fixity) and  $\lambda = 0.4375$  (partial fixity), respectively. Figure 5.14(c) and (d) present the location of the maximum positive moment under the moving concentrated load with full fixity (where  $M^F = (\lambda - \lambda^3)PL/2$ ) and partial fixity for a two-span structure. The maximum positive moment occurs where  $\lambda = 0.366$  (full fixity) and  $\lambda = 0.5536$  (partial fixity).

**Figure 5.14. Different Scenarios Used to Determine the Location of Maximum Positive Moment for Collapse Analysis.**

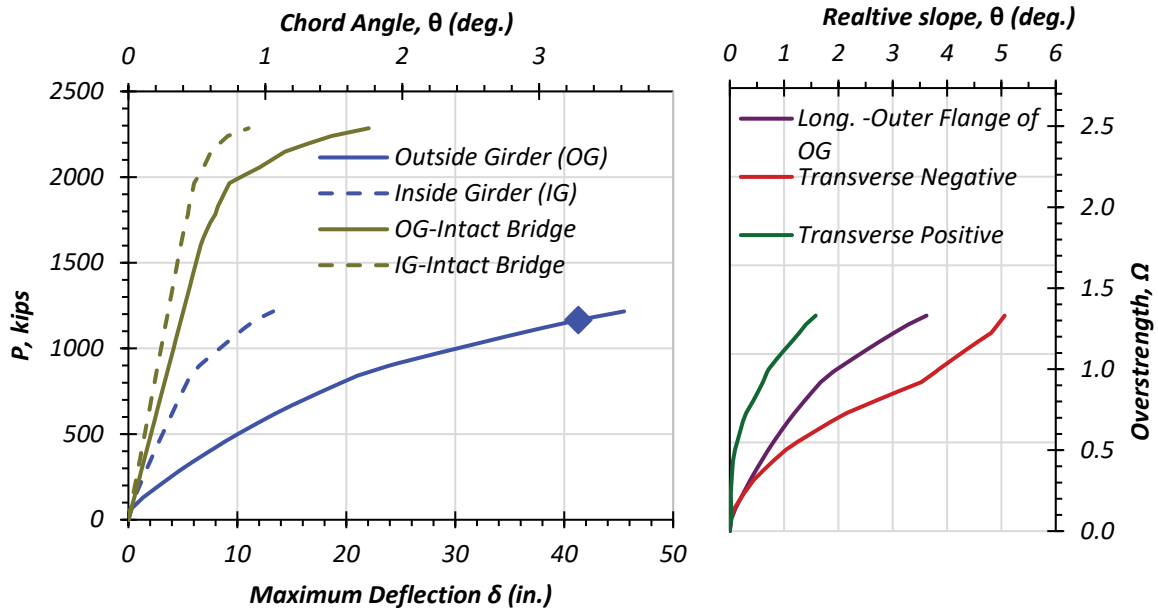
**Figure 6.8. Grillage Deflection Profile of FSEL Bridge with Activated Hinges.**

Note:  $\delta$  is along the centerline of the girder,  $\Omega$  is the load normalized by factored design load.

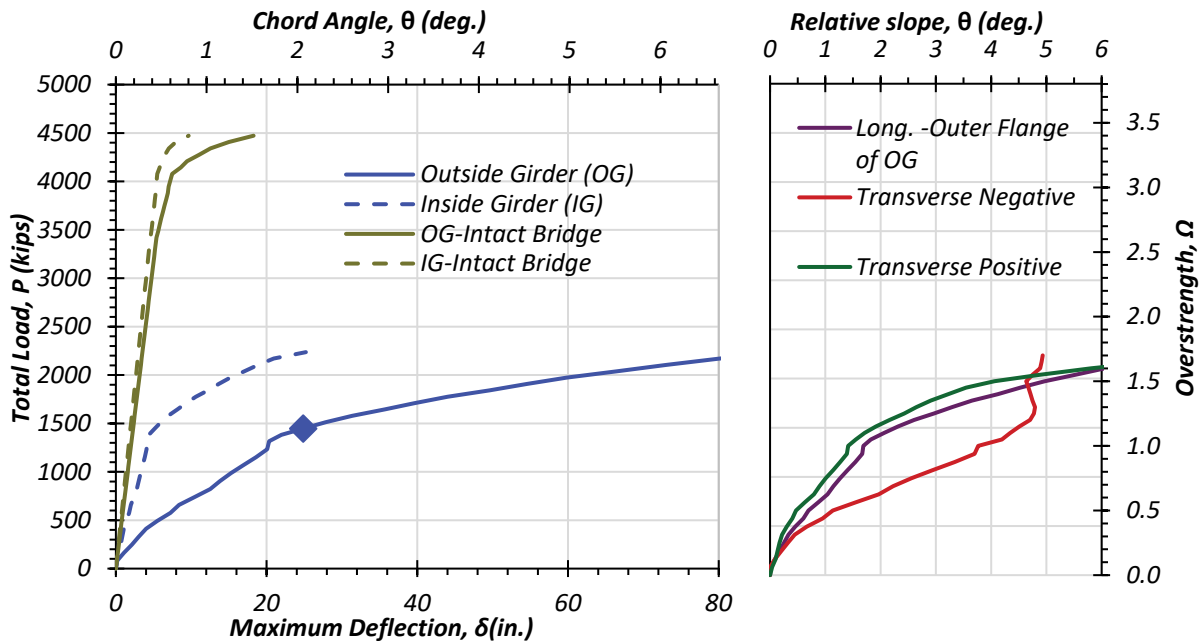
**Figure 6.12. Grillage Deflection Profile of Bridge 2 with Activated Hinges.**

(a) Load displacement

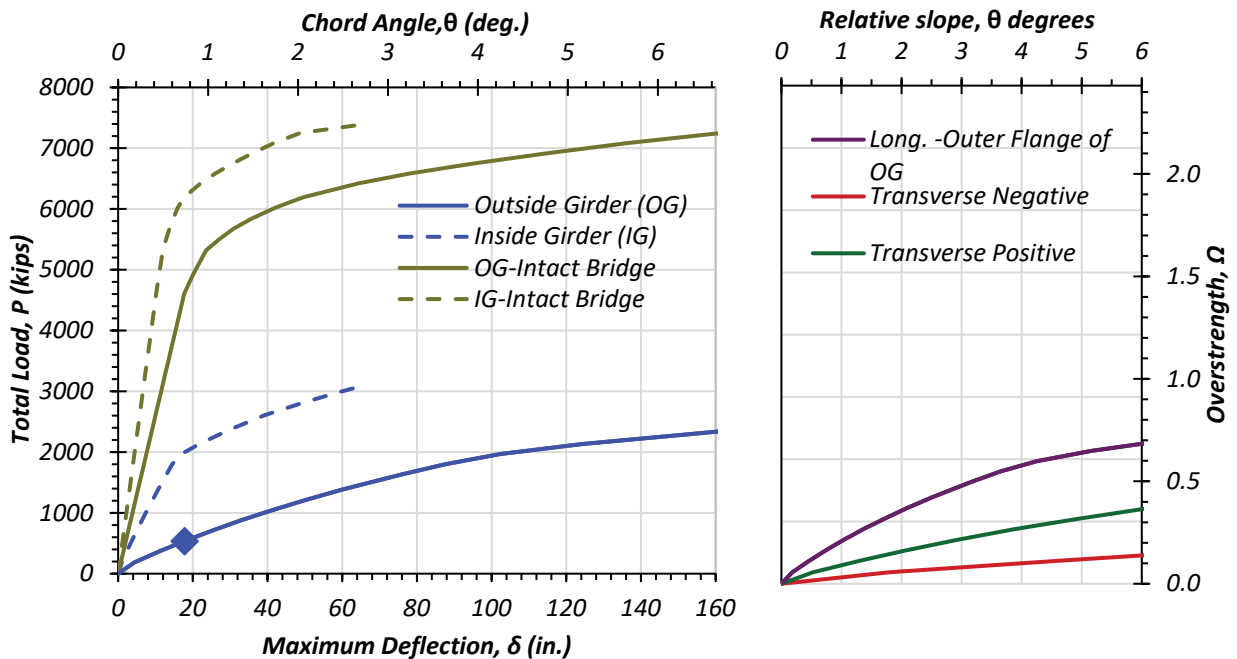
**Figure 6.14. Grillage Deflection Profile for Bridge 3 with Activated Hinges.**

(a) Load displacement

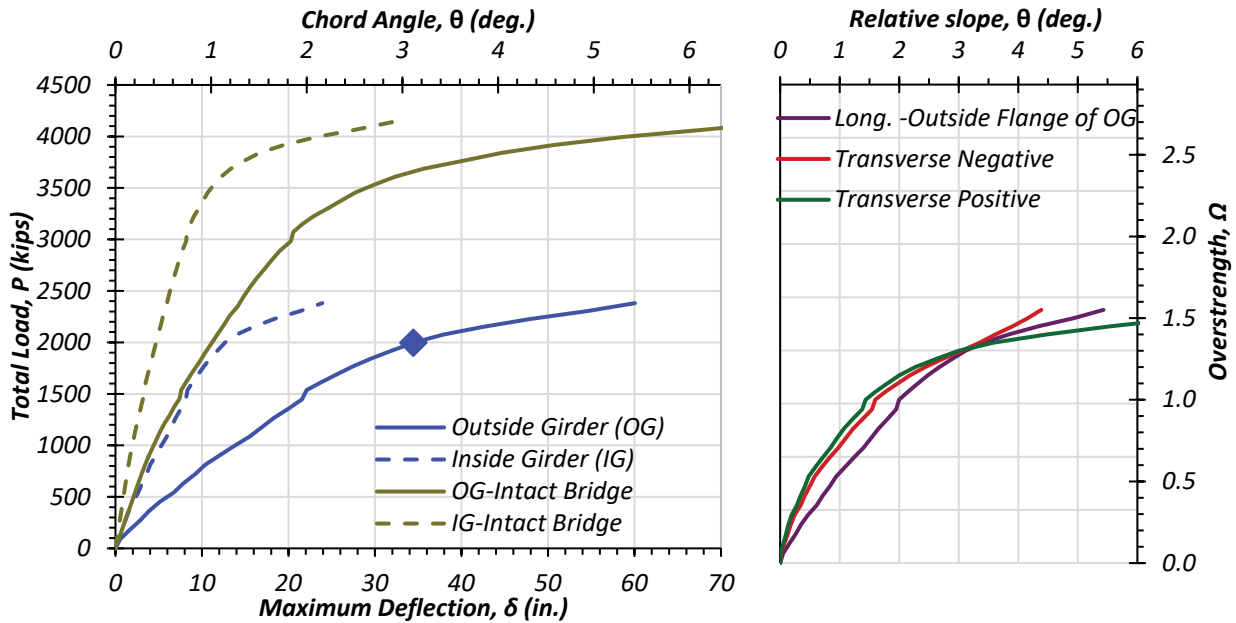
**Figure 6.16. Grillage Deflection Profile for Span 2 of Bridge 4 with Activated Hinges.**

(a) Load displacement
