MICHIGAN DEPARTMENT OF TRANSPORTATION  
MDOT

CONCRETE SURFACE TEXTURING STUDY

Testing and Research Section  
Construction and Technology Division  
Research Project 71C-0013 (Phase 2)  
Research Report No. R-1423

Lansing, Michigan  
May 2004

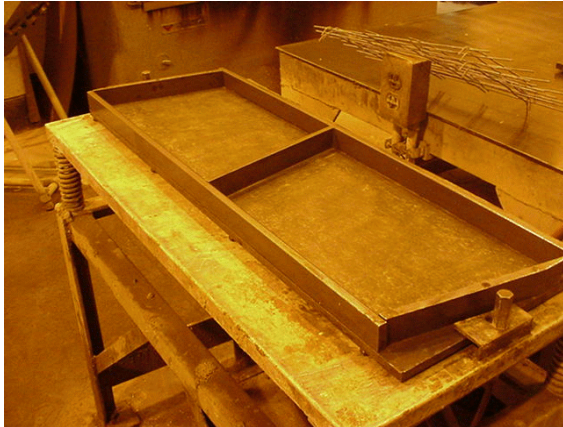
Wear track slab forms

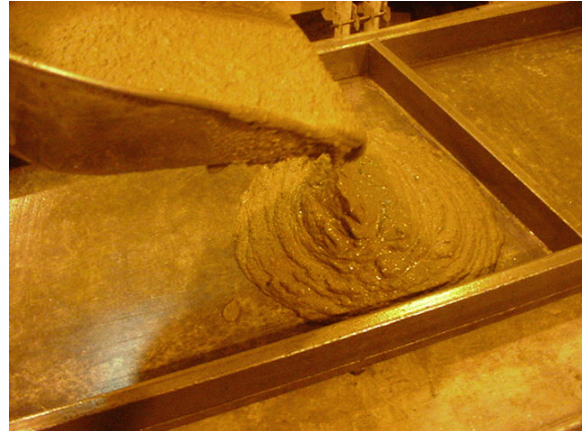
2NS concrete mixture being placed in form

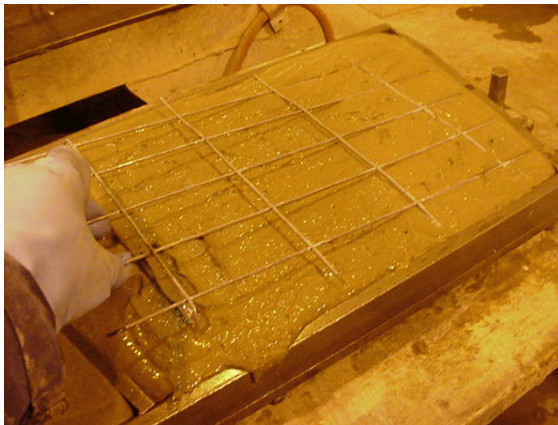
Wire mesh is placed in the filled form

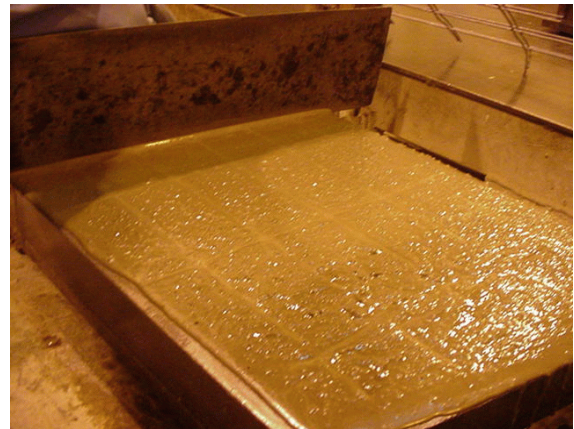
The excess concrete is struck off

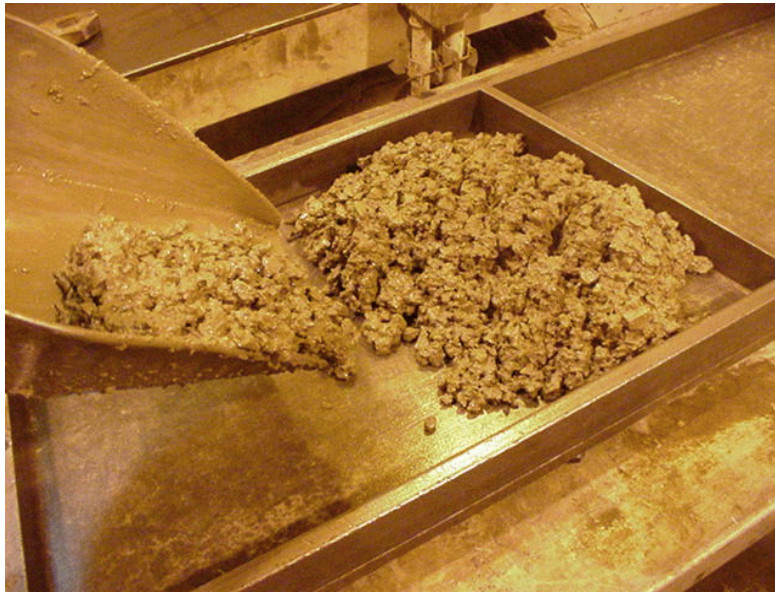
26A concrete mixture being placed in form

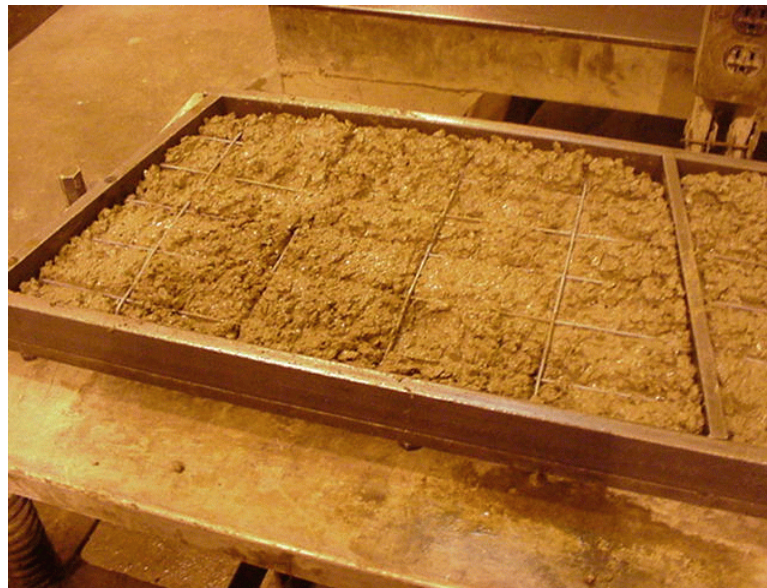
Wire mesh is placed on the first layer of concrete

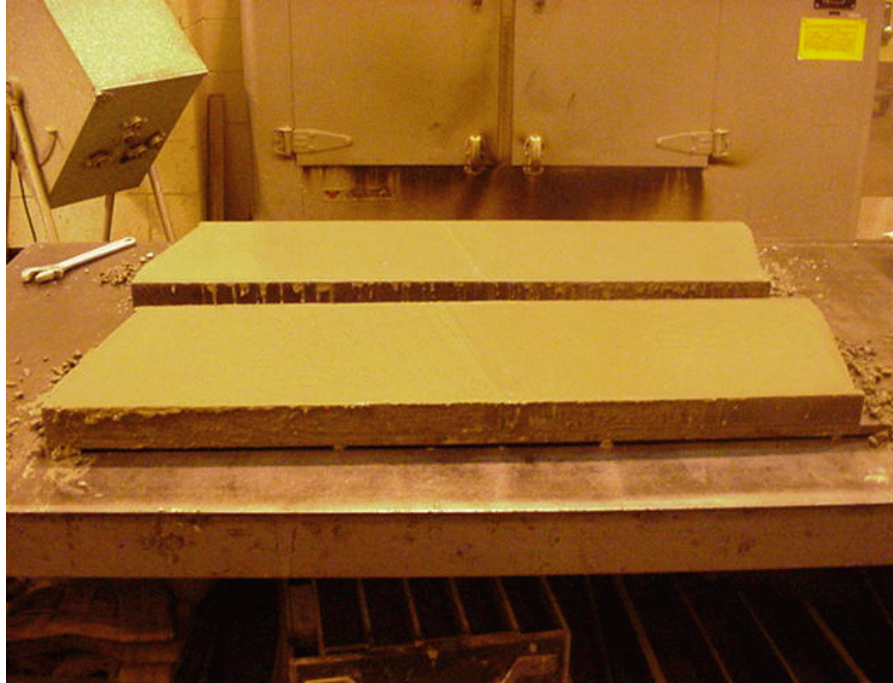
The remaining concrete is placed, consolidated, and struck off  
The slabs are then given a smooth finish with a steel trowel

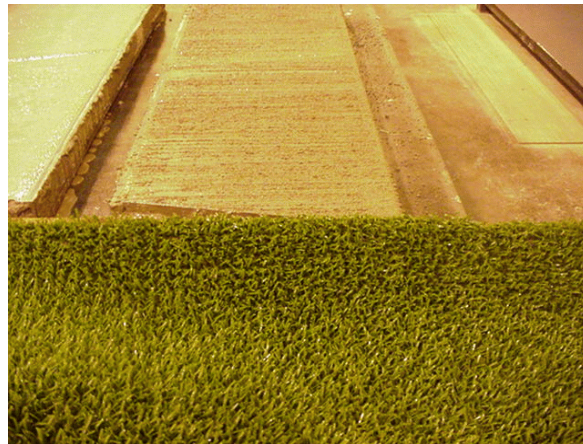
The slabs were left undisturbed to begin curing. They were periodically observed. When bleed water no longer appeared on the surface, and prior to initial set of the concrete, the slabs were given their final texture. The astroturf is dragged transversely across the surface of the slab to achieve the texture.

Transverse astroturf drag finish

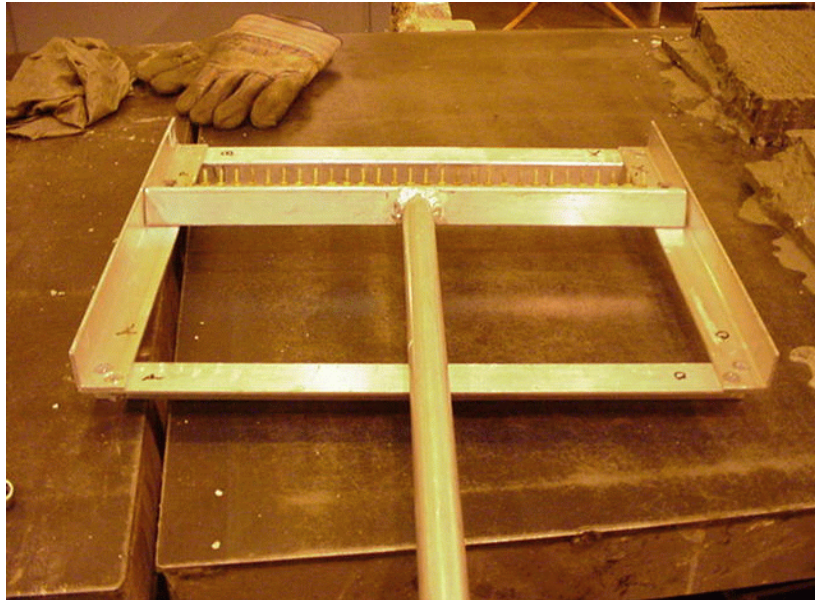
A tining tool and jig were designed and built by Construction & Technology machine shop personnel to ensure consistency in tining depth, and orientation on the slab surface.

Tining tool and jig

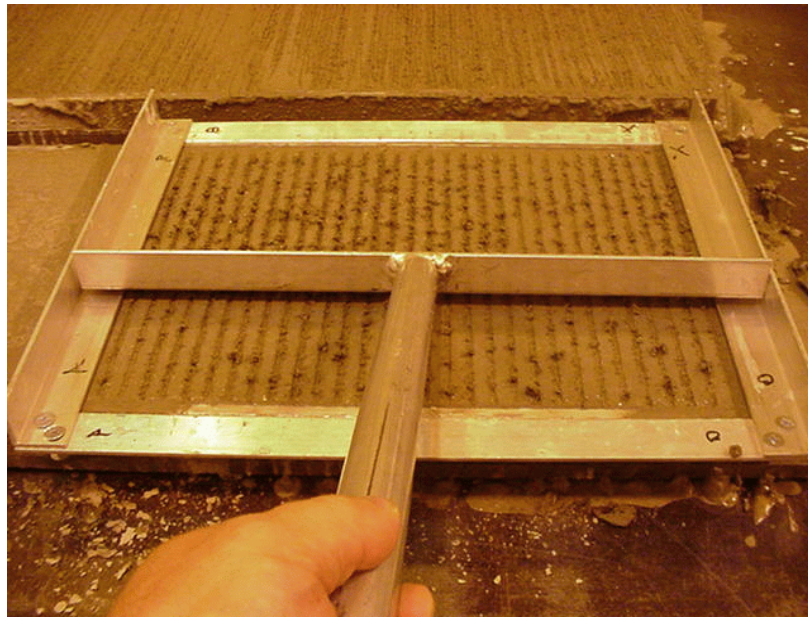
Tining is achieved by placing the jig over the form and pulling the tining tool transversely across the slab surface

- The tining technique used to texture the transversely tined slabs tended to damage the slab surface and did not represent the actual tining method that is used in actual concrete construction. The tining tool was inserted into the slab surface and then pulled through the concrete, resulting in the tearing of the surface, and a rather inconsistent surface.

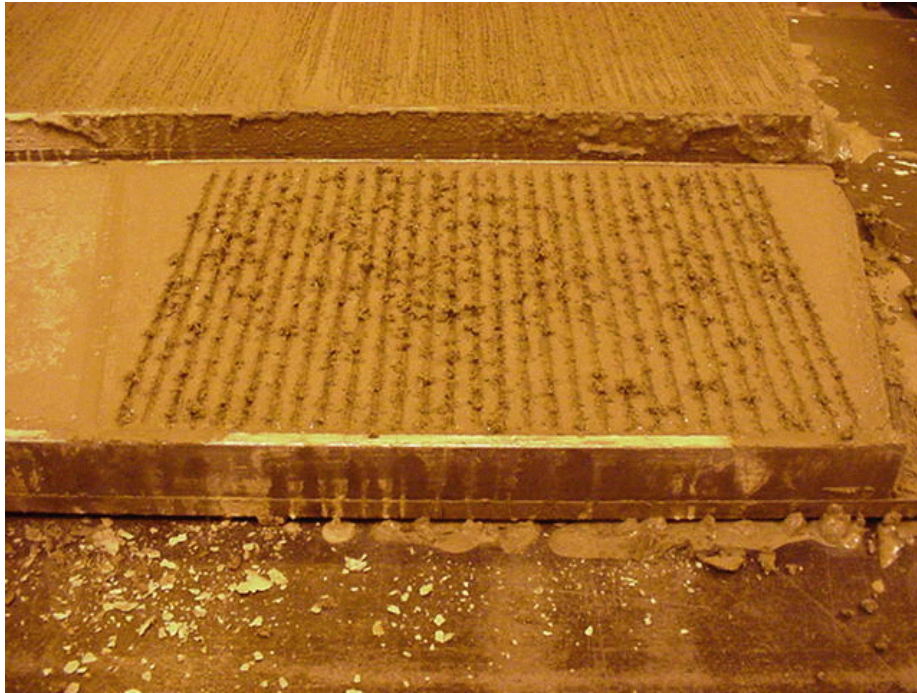
Transversely tined surface

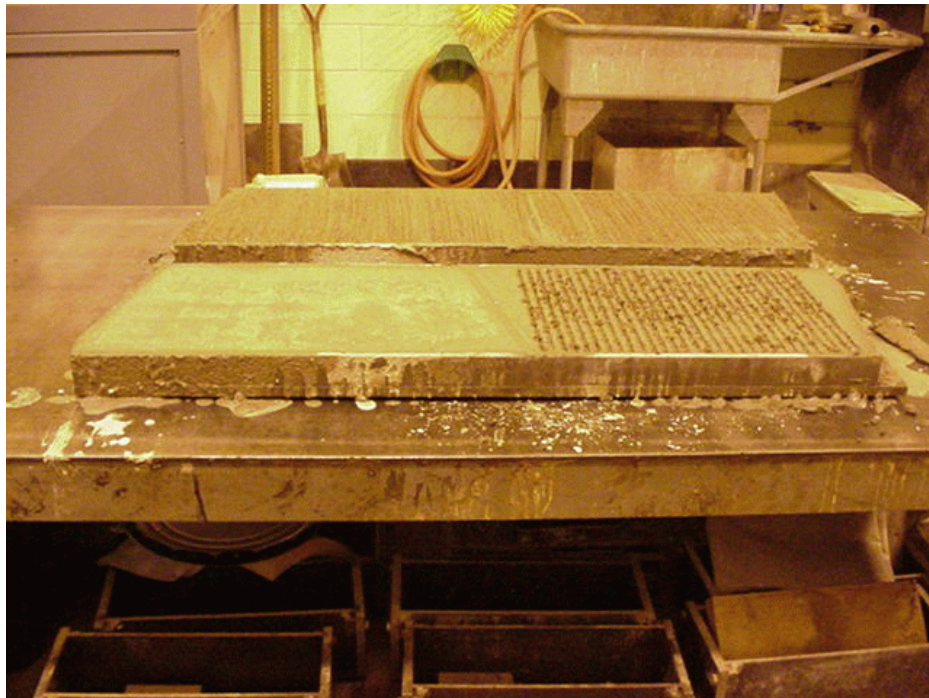
Smooth trowel finish ( bottom left ), transversely tined finish ( bottom right ), astroturf drag finish ( top )

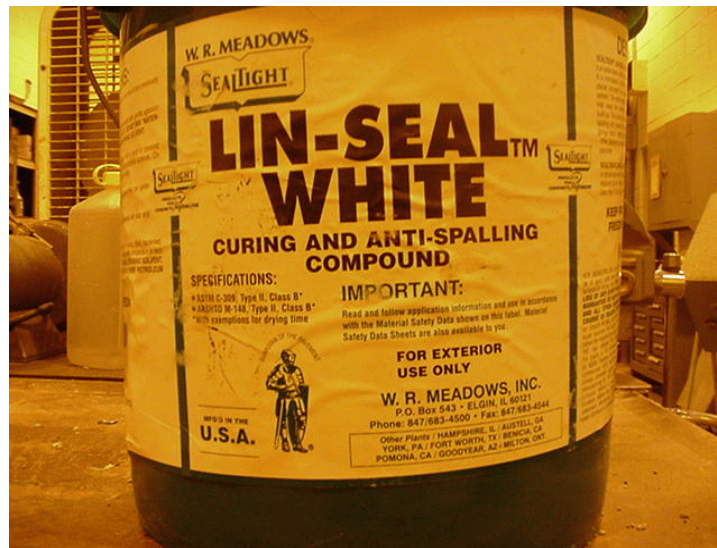
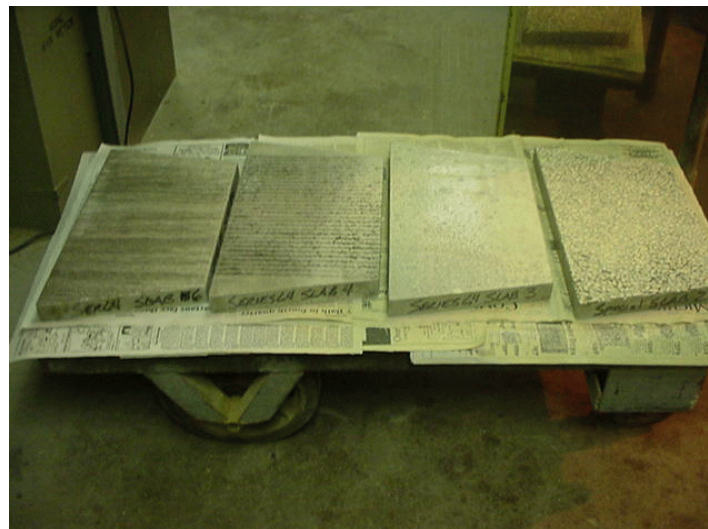
White pigmented curing compound (above) was spray applied (below) to slabs 2 through 16

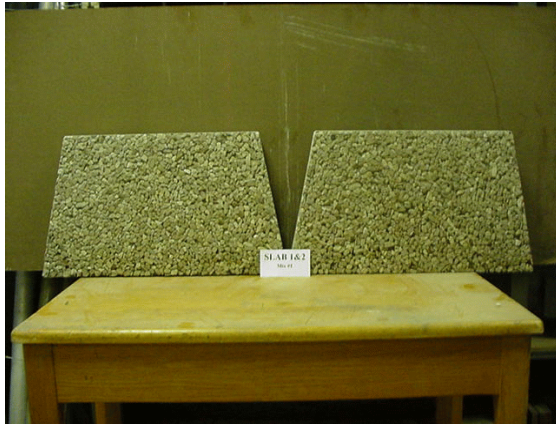
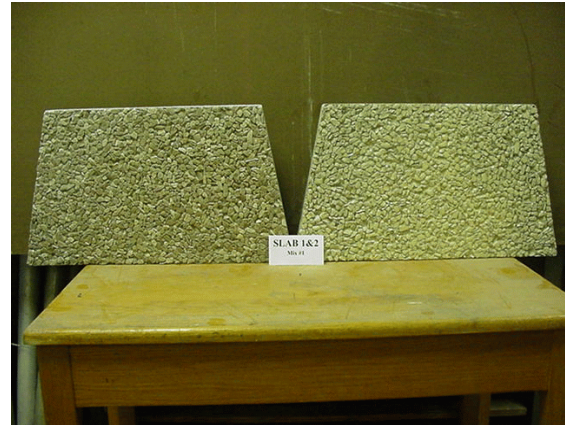
### **Slabs 1 & 2**

Control slabs 1 and 2

Slab 2 (right) is coated with curing compound

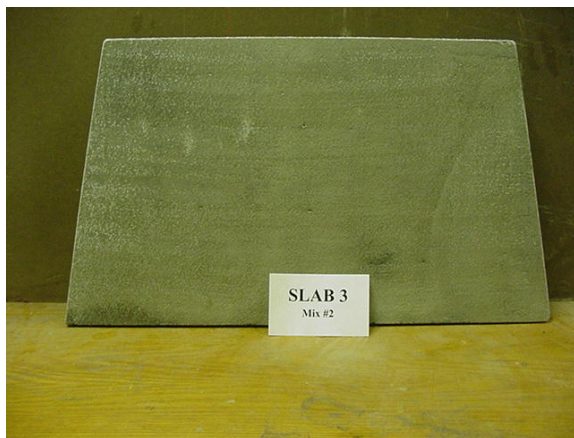
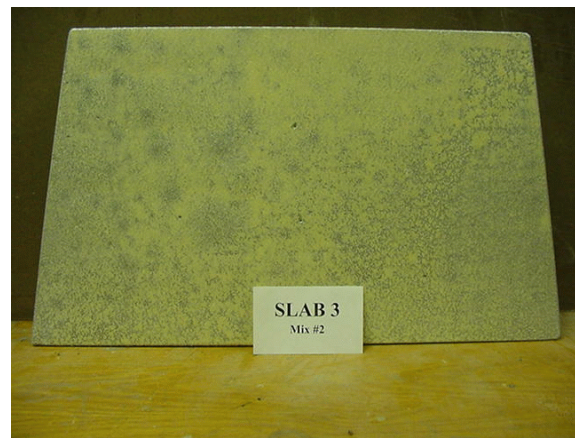
### **Slab 3**

Photo at left shows slab 3 smooth trowel finish, at right is slab 3 with curing compound applied

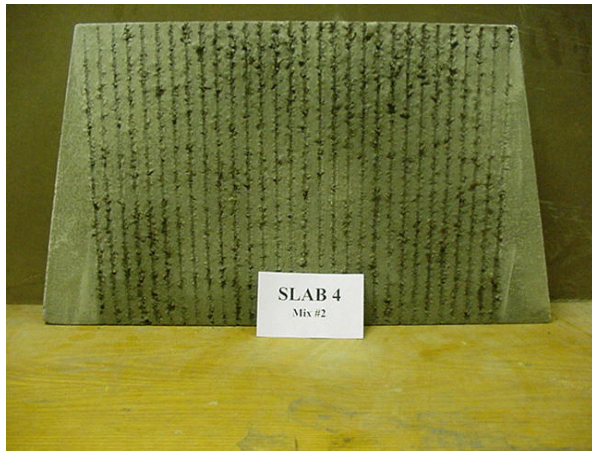
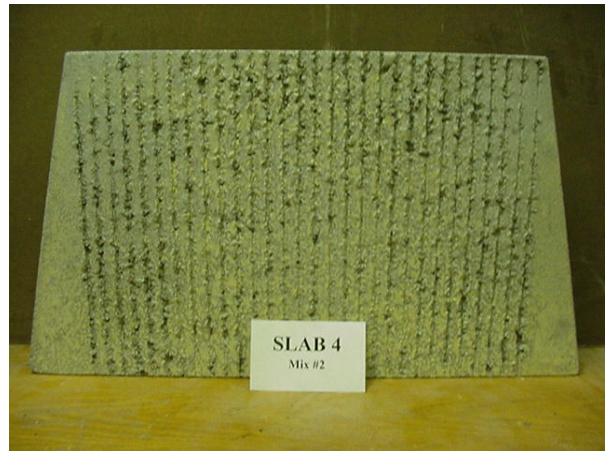
### Slab 4

Slab 4 tined finish (left), and slab 4 with curing compound (right)

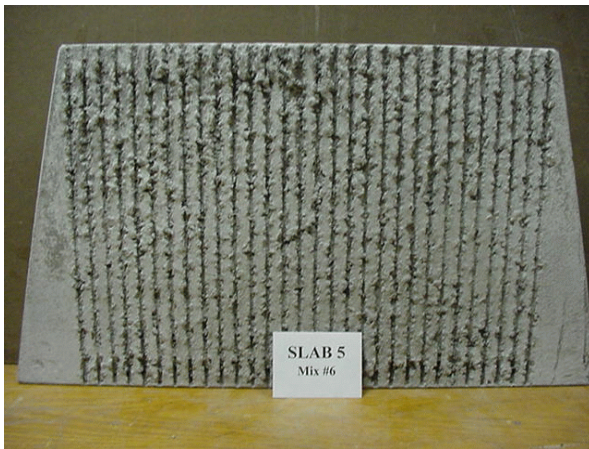
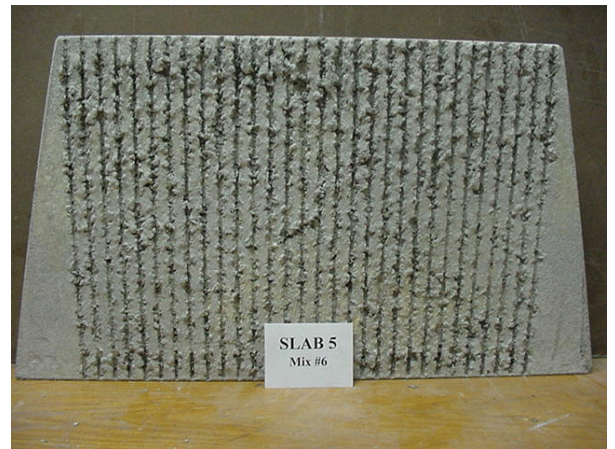
### Slab 5

Tined surface texture on slab 5

Slab 5 coated with curing compound

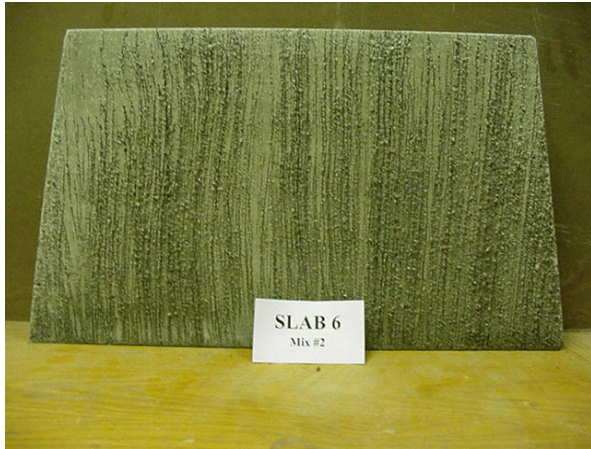
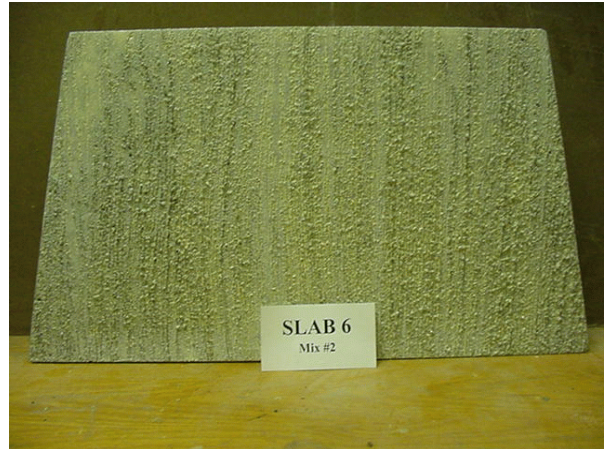
### Slab 6

Slab 6 with astroturf drag finish (left) and coated with curing compound (right)

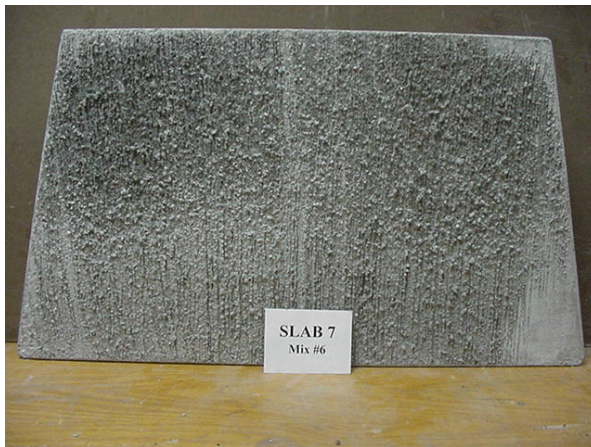
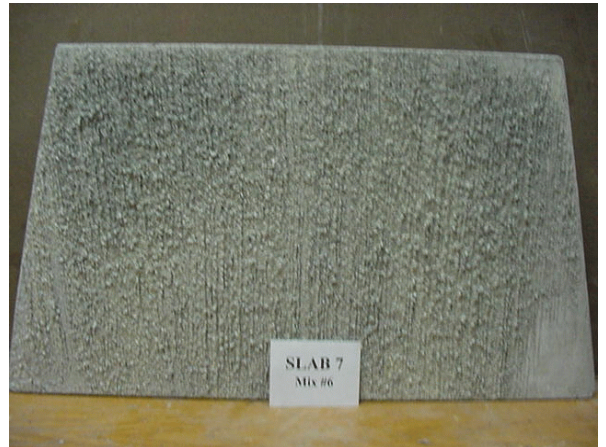
### Slab 7

Slab 7 with transverse astroturf drag texture (left), and coated with white curing compound (right)

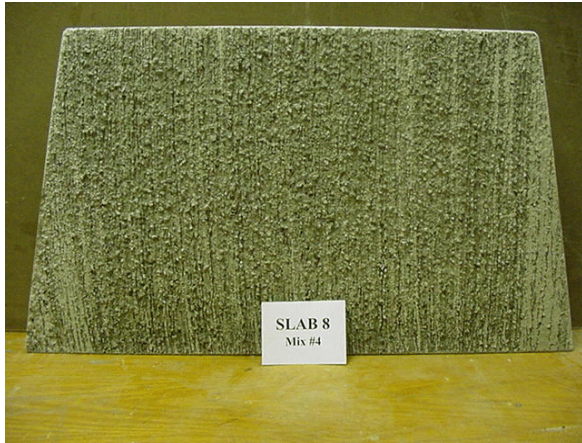
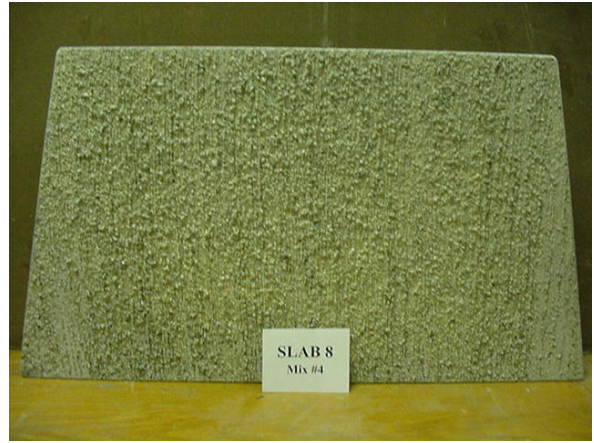
### Slab 8

Slab 8 (left) with astroturf drag texture and coated with curing compound (right)

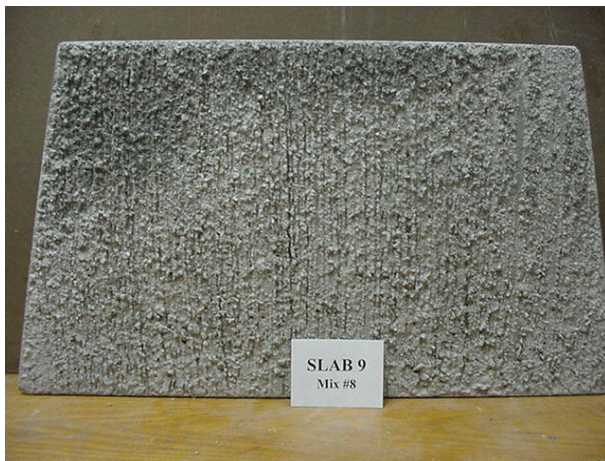
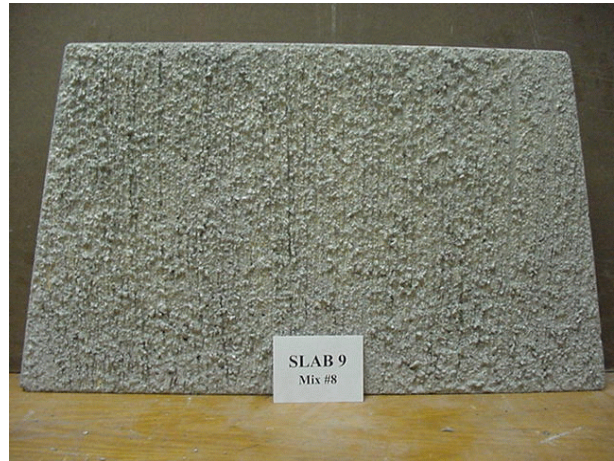
### Slab 9

Astroturf drag texture on slab 9

Slab 9 coated with curing compound

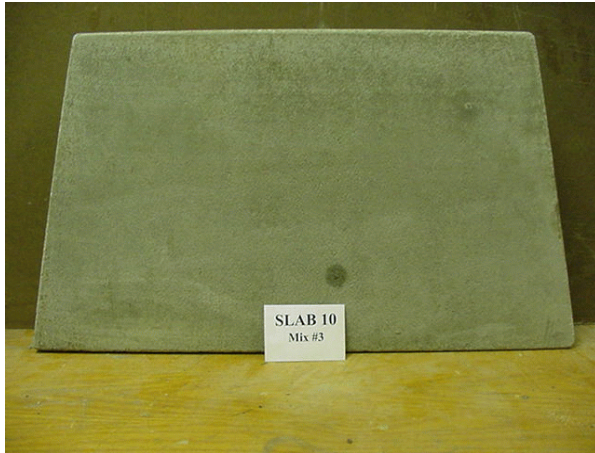
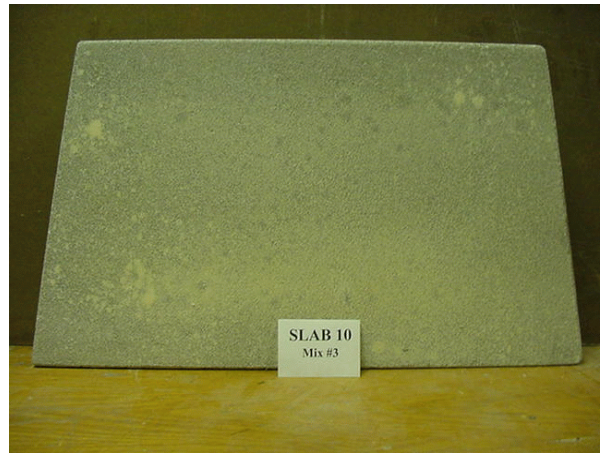
### Slab 10

Slab10 has a smooth trowel finish (left). Slab 10 with white pigmented curing compound (right)

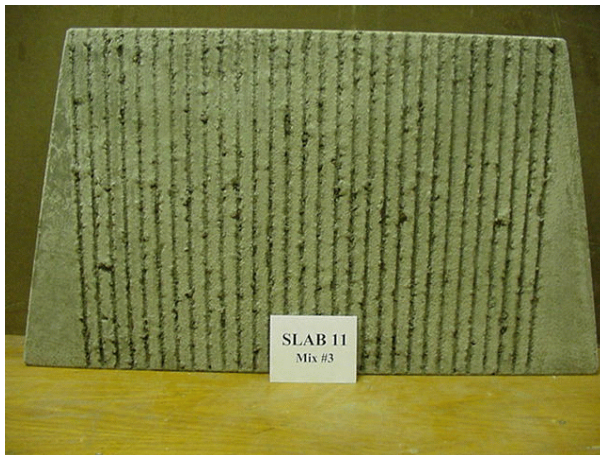
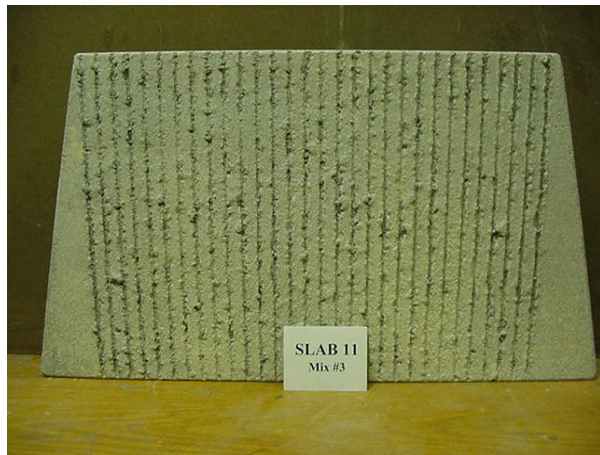
### Slab 11

At left, slab 11 shows a tined surface texture, and at right, slab 11 with a coating of curing compound

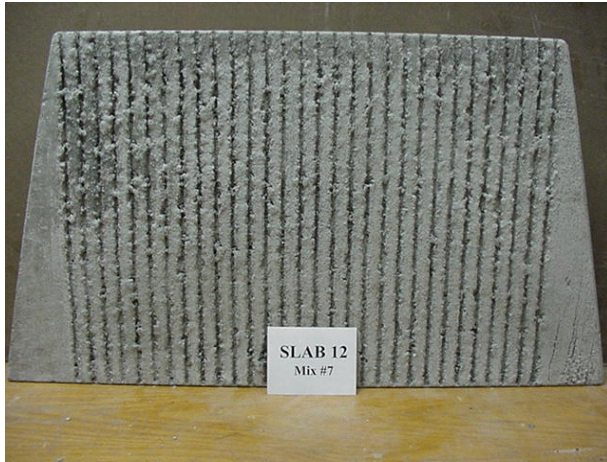
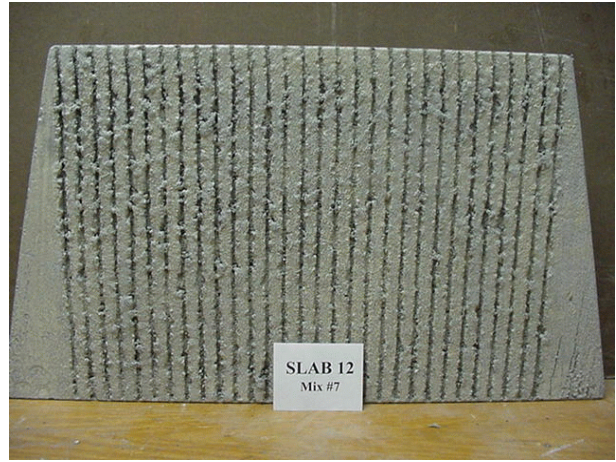
## Slab 12

Slab 12 has a tined surface texture (left), and the same slab coated with white pigmented curing compound (right)

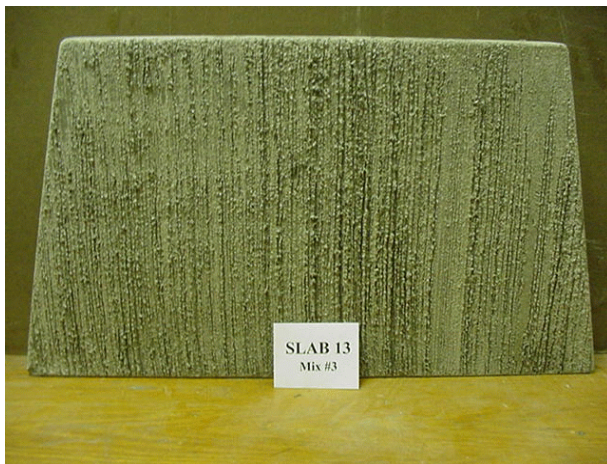
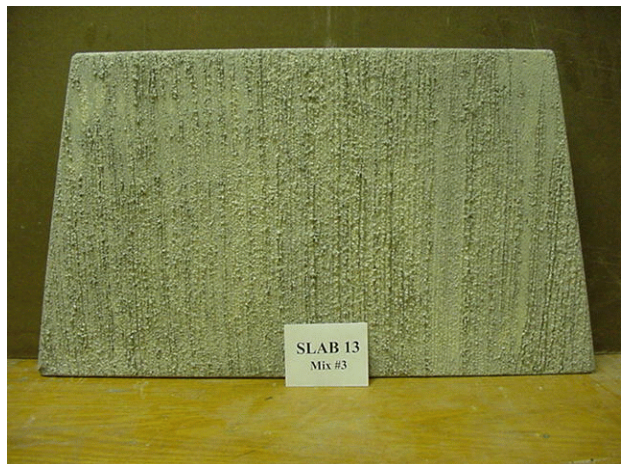
## Slab 13

Slab 13 with astroturf drag texture

Slab 13 with white curing compound

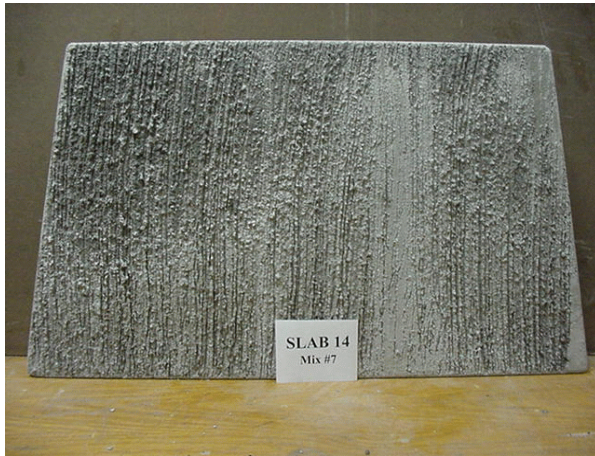
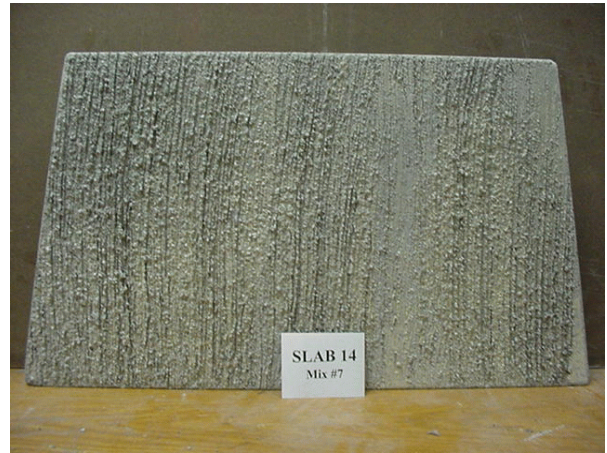
### Slab 14

Slab 14 with astroturf drag texture

Slab 14 coated with curing compound

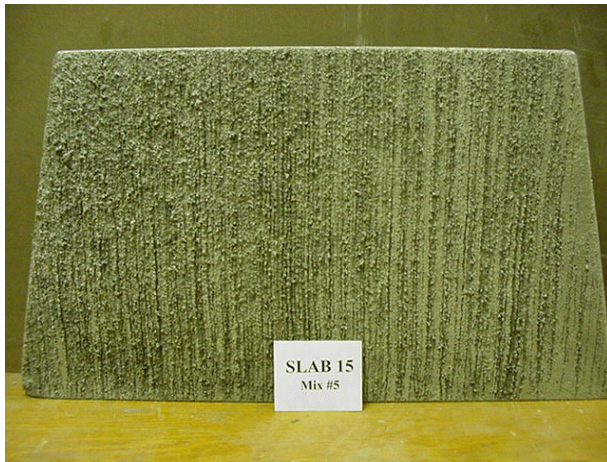
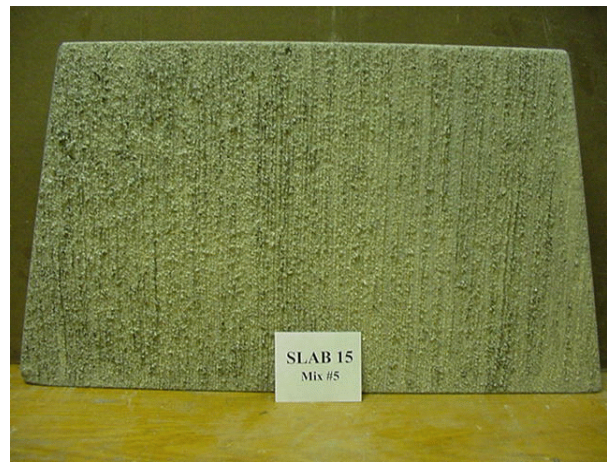
### Slab 15

At left is slab 15 with an astroturf drag surface texture, and, at right, is slab 15 coated with curing compound

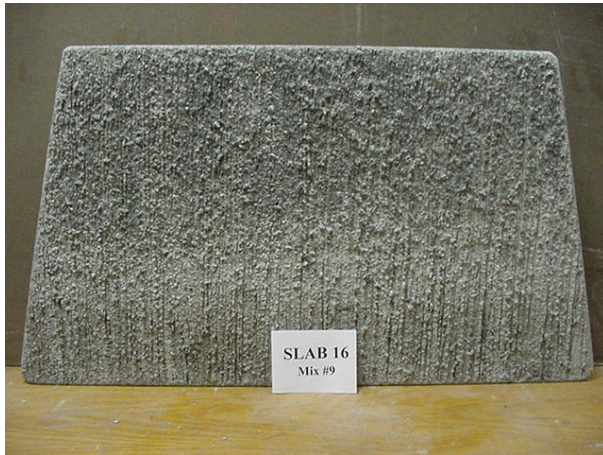
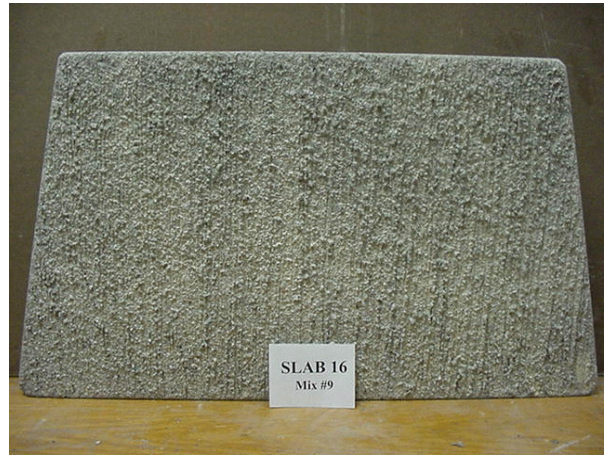
## Slab 16

Astroturf drag finish on slab 16 (left), and slab 16 coated with curing compound (right)

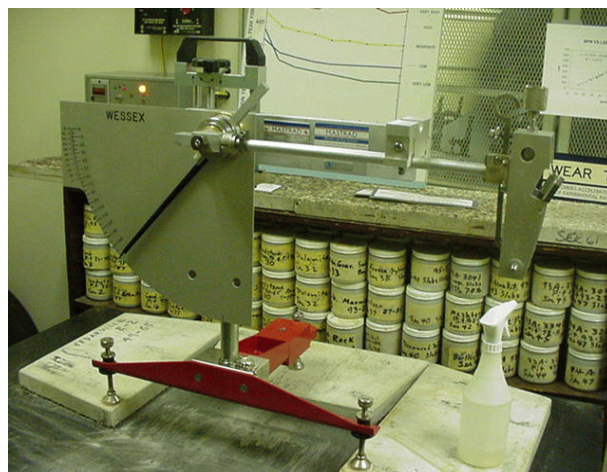
Prior to skid testing, slabs 1 through 16 were tested by the British Pendulum test method. Each slab was again tested by this method after 0.5 million wheel passes, and four million wheel passes on the wear track. Wear track testing progressed in the normal method, with slabs 1 through 16 being tested for skid resistance every 0.5 million wheel passes, until a total of four million wheel passes was reached.

British Pendulum Tester

Remarks: British Pendulum test results represent the average of five test drops on each slab, following ASTM E 303 Standard Method of Test for Surface Frictional Properties Using the British Pendulum Tester.

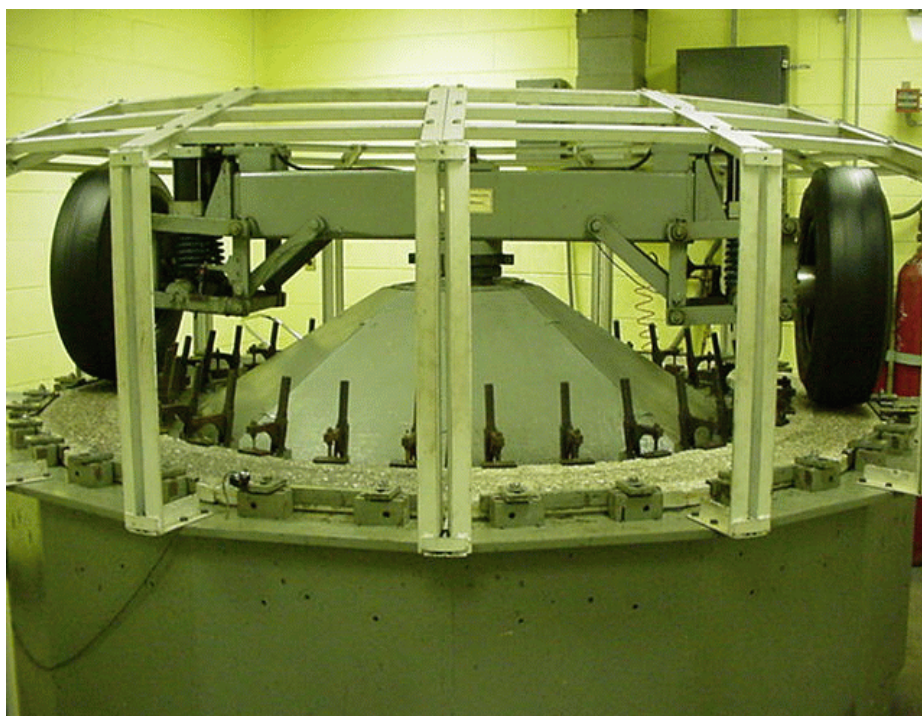
The Wear Track

In 1974, the MDOT circular wear track was constructed for the initial purpose of testing quarried carbonates and high-carbonate gravel for resistance to tire-polishing. Initially, quarried carbonates and high-carbonate gravel from selected sources were evaluated. Later investigations have included the effects of tire-polishing on glacial gravels, slags, blends, rock type constituents of glacial gravels, and fine aggregates, (1, 2, 3, 4, 5). The wear track also has been used to evaluate the polishing characteristics of paving bricks and concrete pavers.

As the standard protocol, the test slabs were polished on the wear track for a total of four million wheel passes, in increments of one-half million wheel passes. Initial friction measurements and subsequent measurements were obtained after each half-million wheel pass increment using the wear track friction tester. At four million wheel passes of polishing, the slopes of the polishing curves generated by the test slabs containing crushed limestone fine aggregate and 26A limestone coarse aggregate showed a continuous decrease. For additional information, wear track polishing of these test slabs was extended to 10 million wheel passes. At ten million wheel passes, the slopes of the polishing curves indicated that additional polishing could be expected. British Pendulum tester measurements were obtained for the initial one-half million, and four million wheel pass increments to correlate the polishing with another method of friction measurement that is widely used to compare polishing resistance.

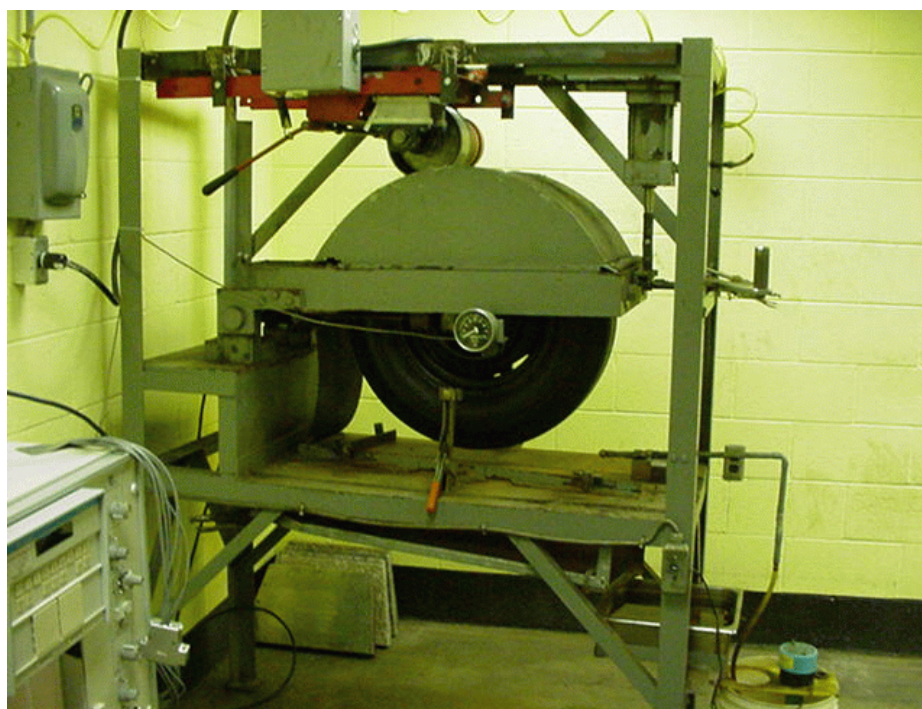
The Skid Drop Tester

Friction tester values obtained with the MDOT tester after four million wheel passes of polishing on the wear track are expressed as Aggregate Wear Index (AWI) numbers on a scale from zero to 1000 units, measured as pounds of initial peak force generated by the friction tester tire in contact with the test slab surface. On the scale, low numbers indicate low resistance to polishing
