MICHIGAN DEPARTMENT OF TRANSPORTATION  
MDOT

CONCRETE SURFACE TEXTURING STUDY

Testing and Research Section  
Construction and Technology Division  
Research Project 71C-0013 (Phase 2)  
Research Report No. R-1423

Lansing, Michigan  
May 2004

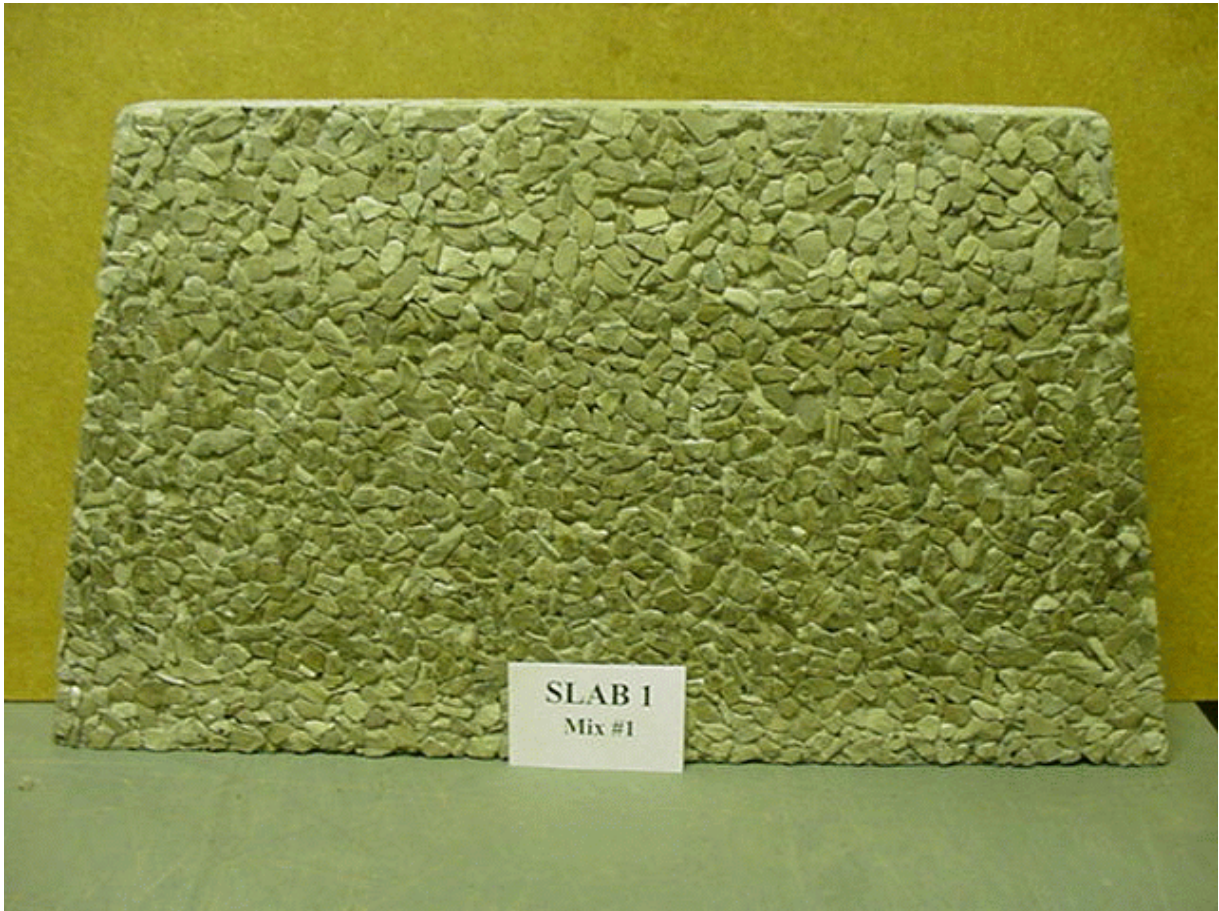
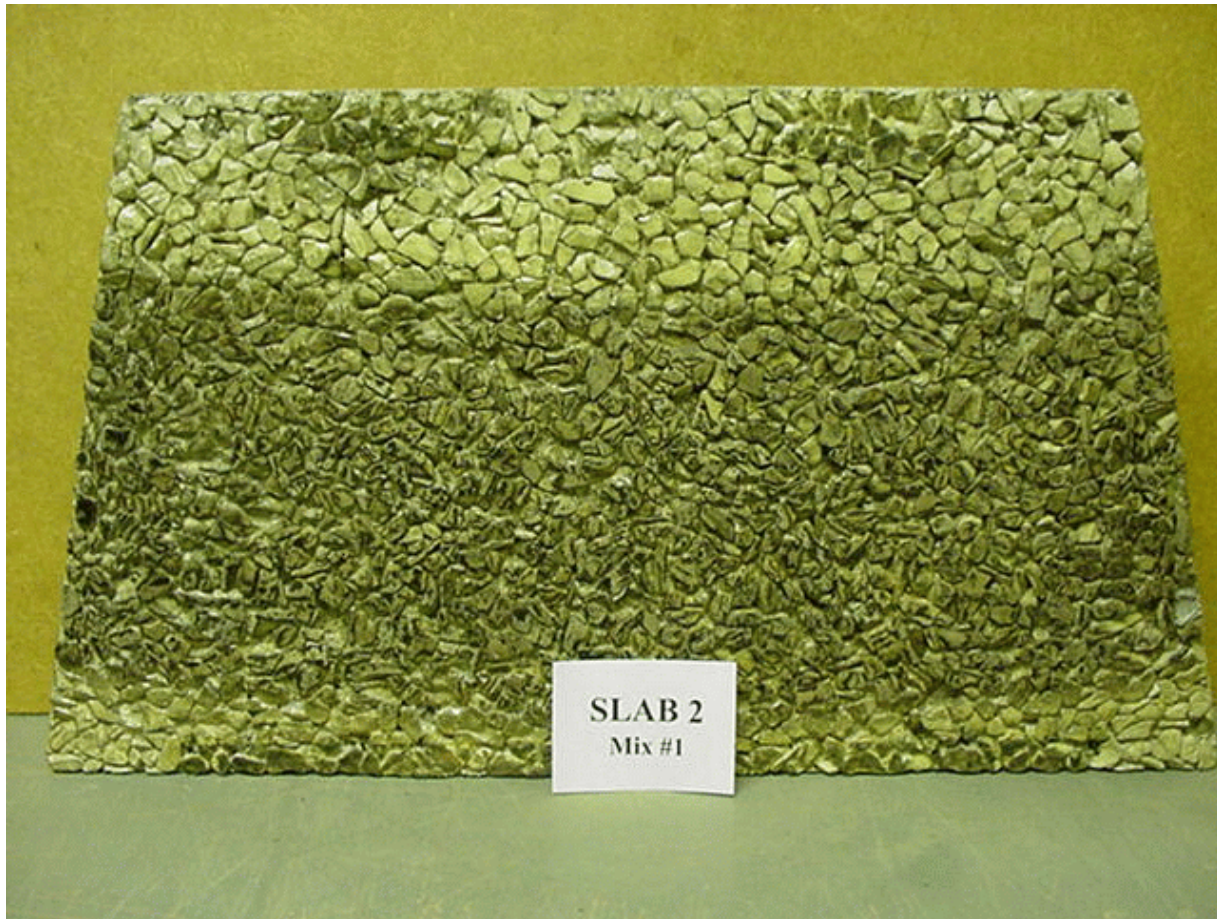
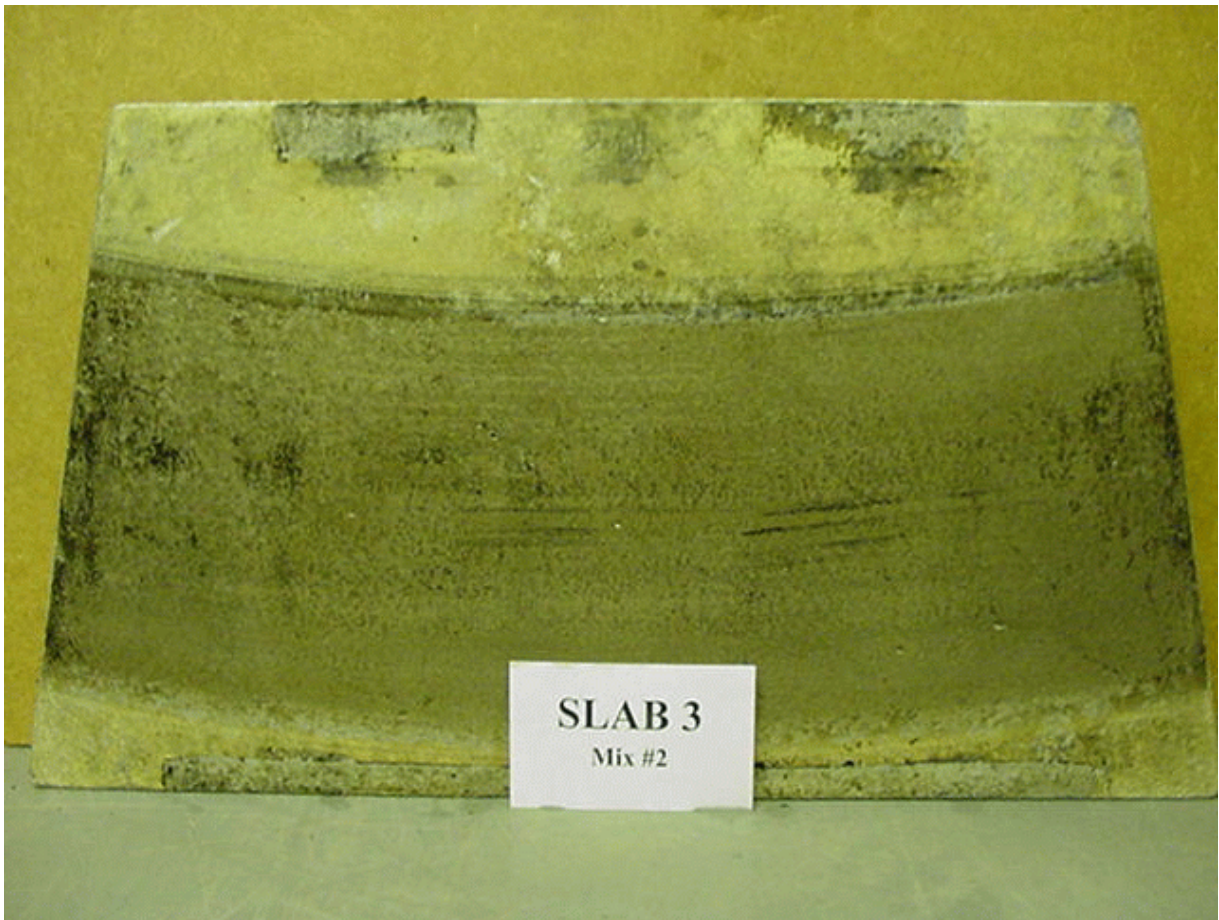
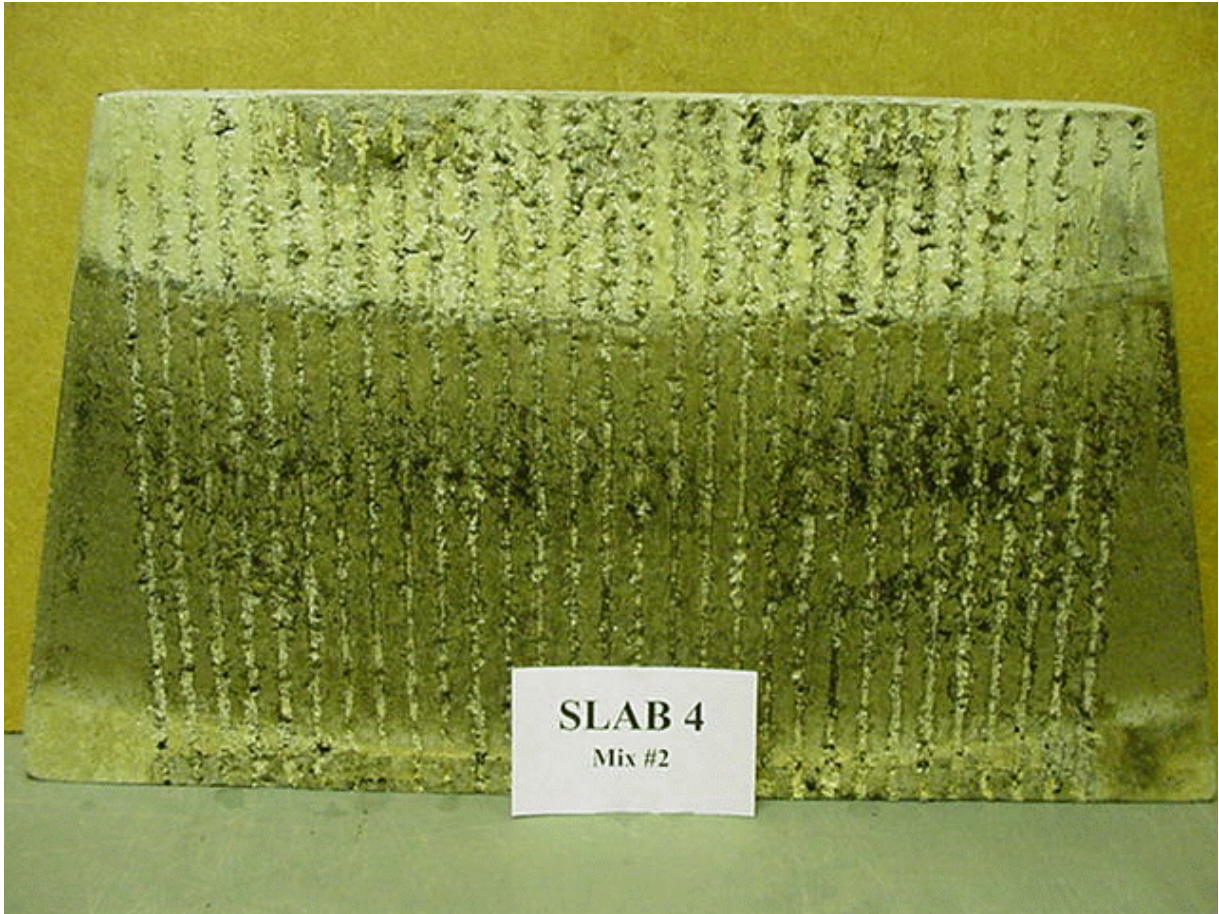
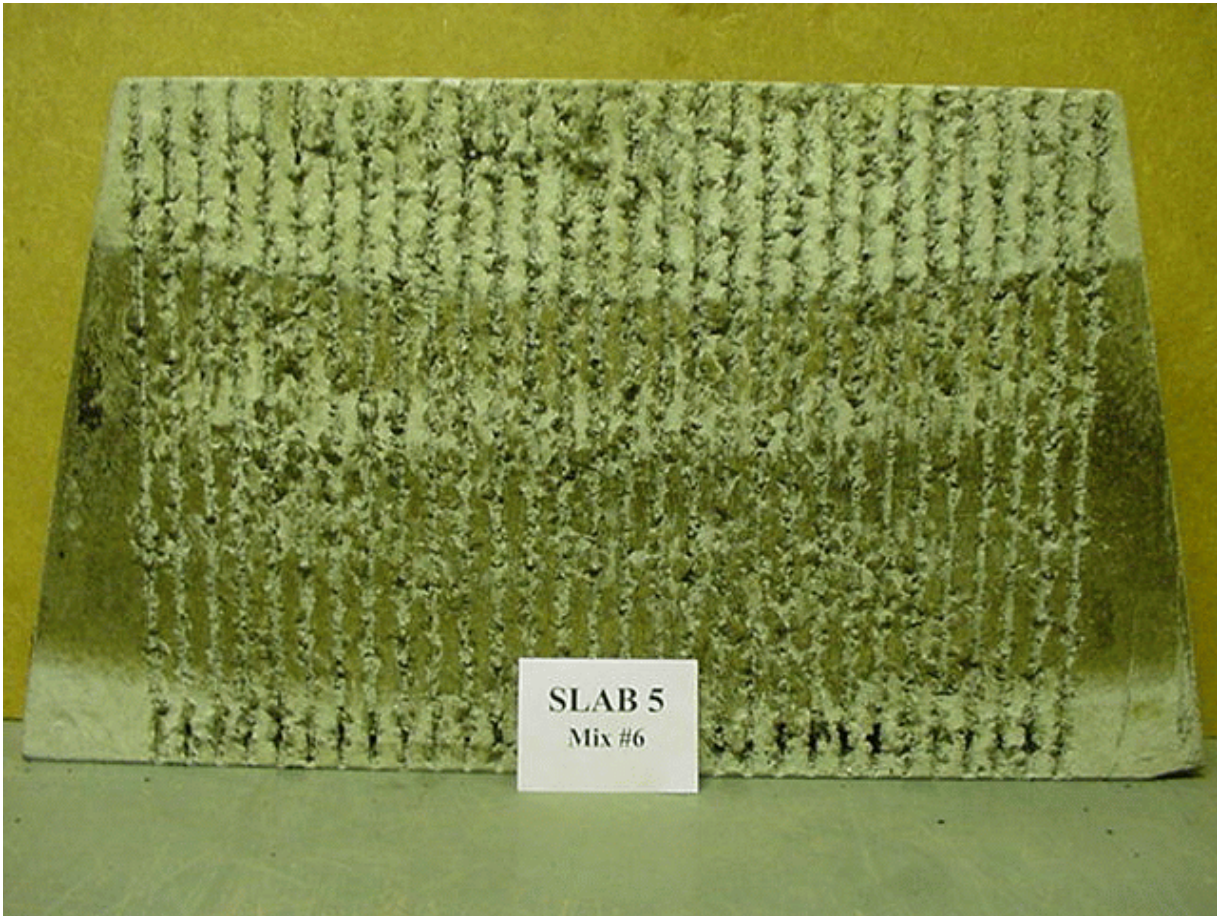
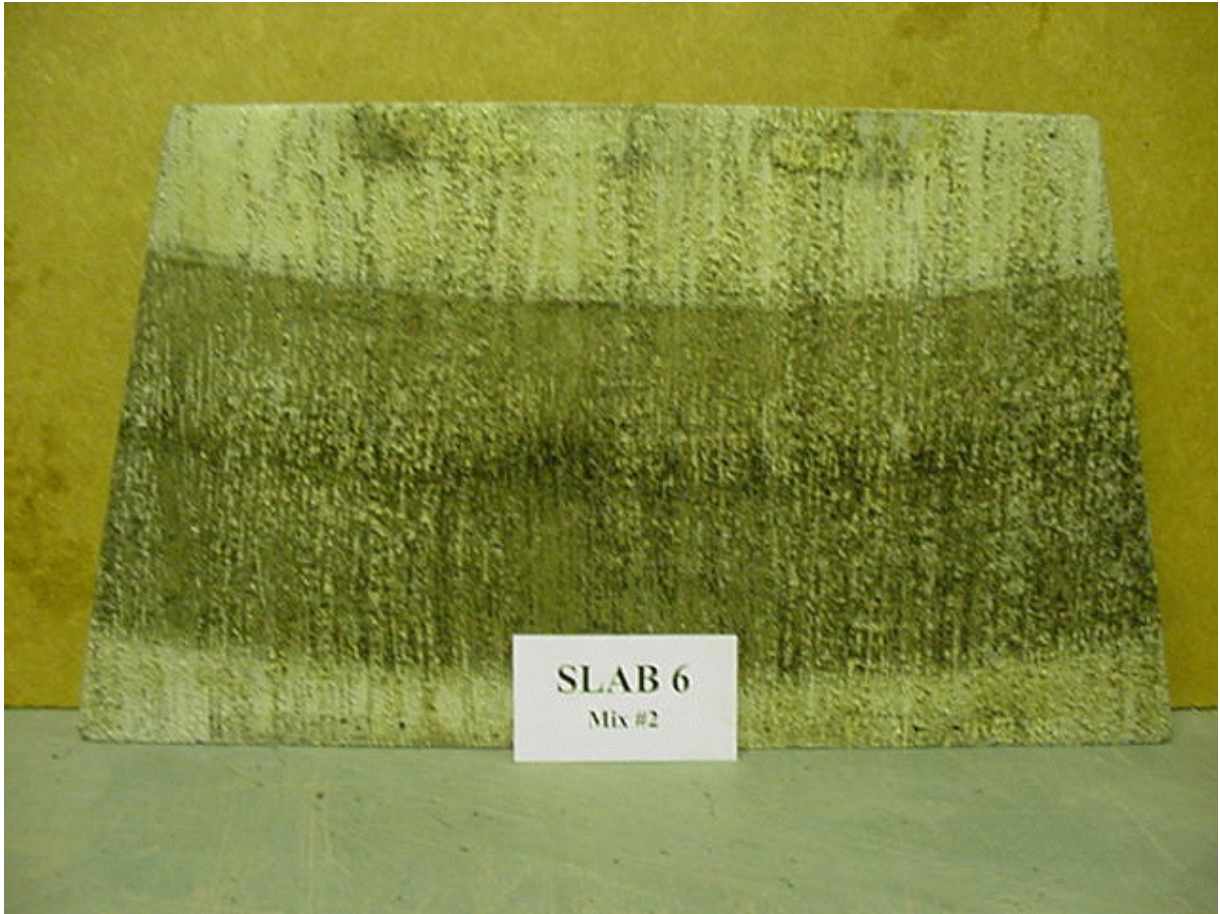
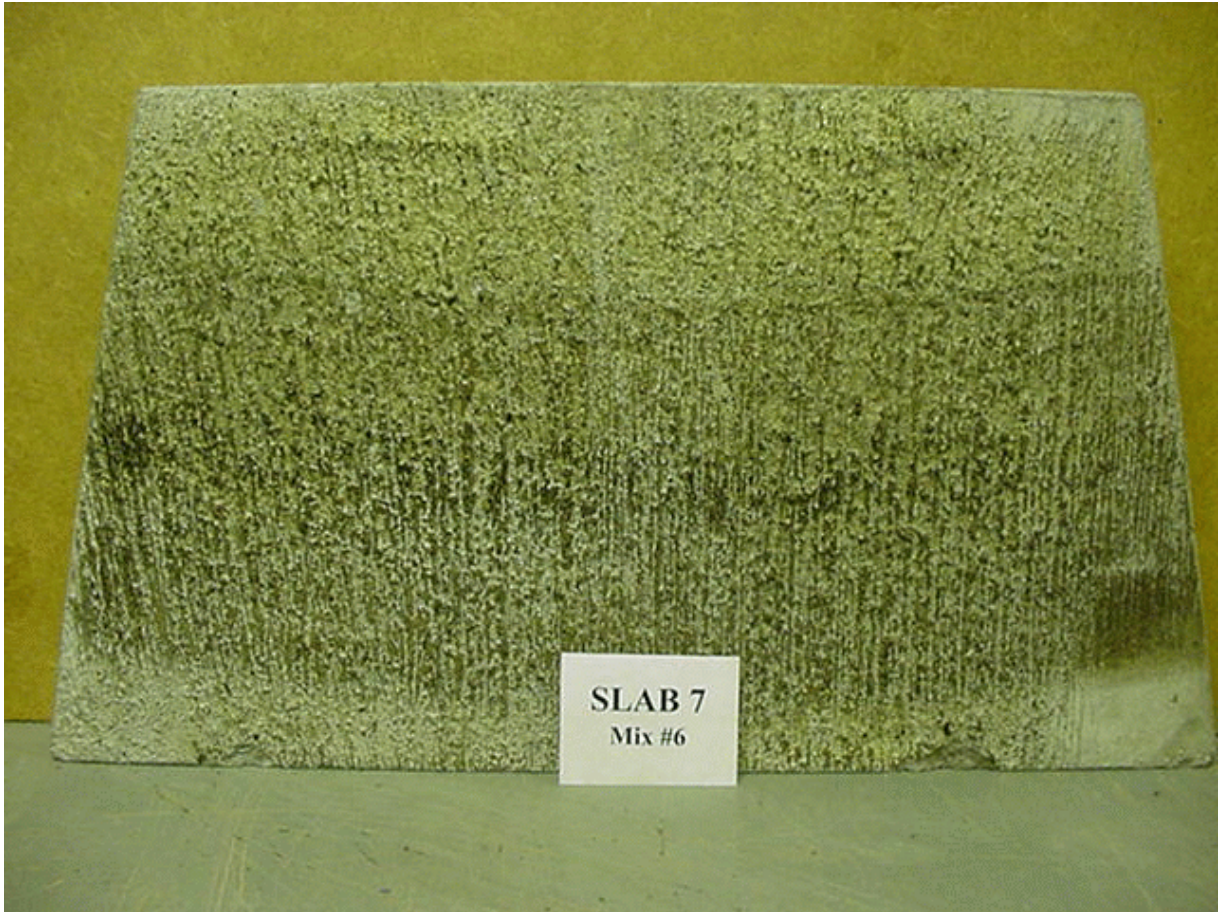
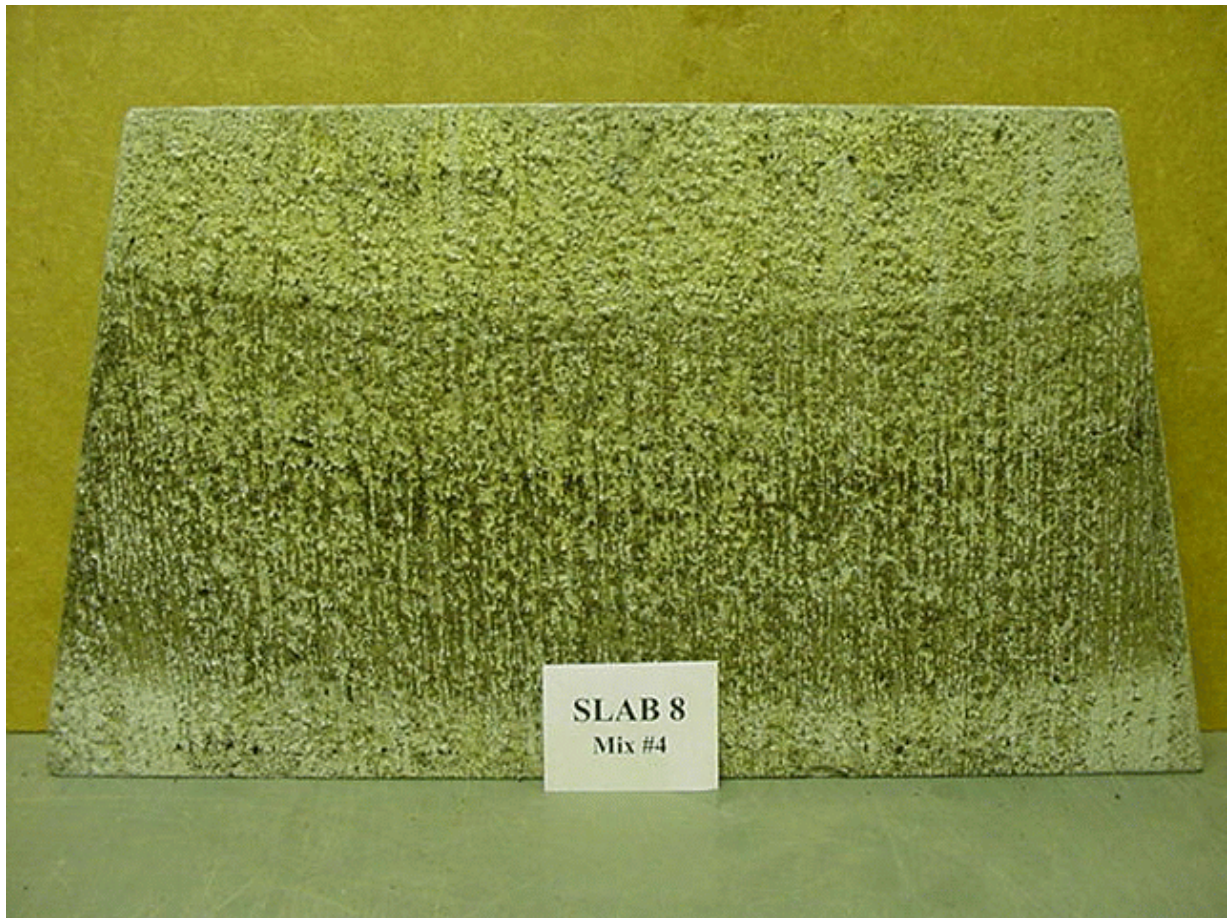
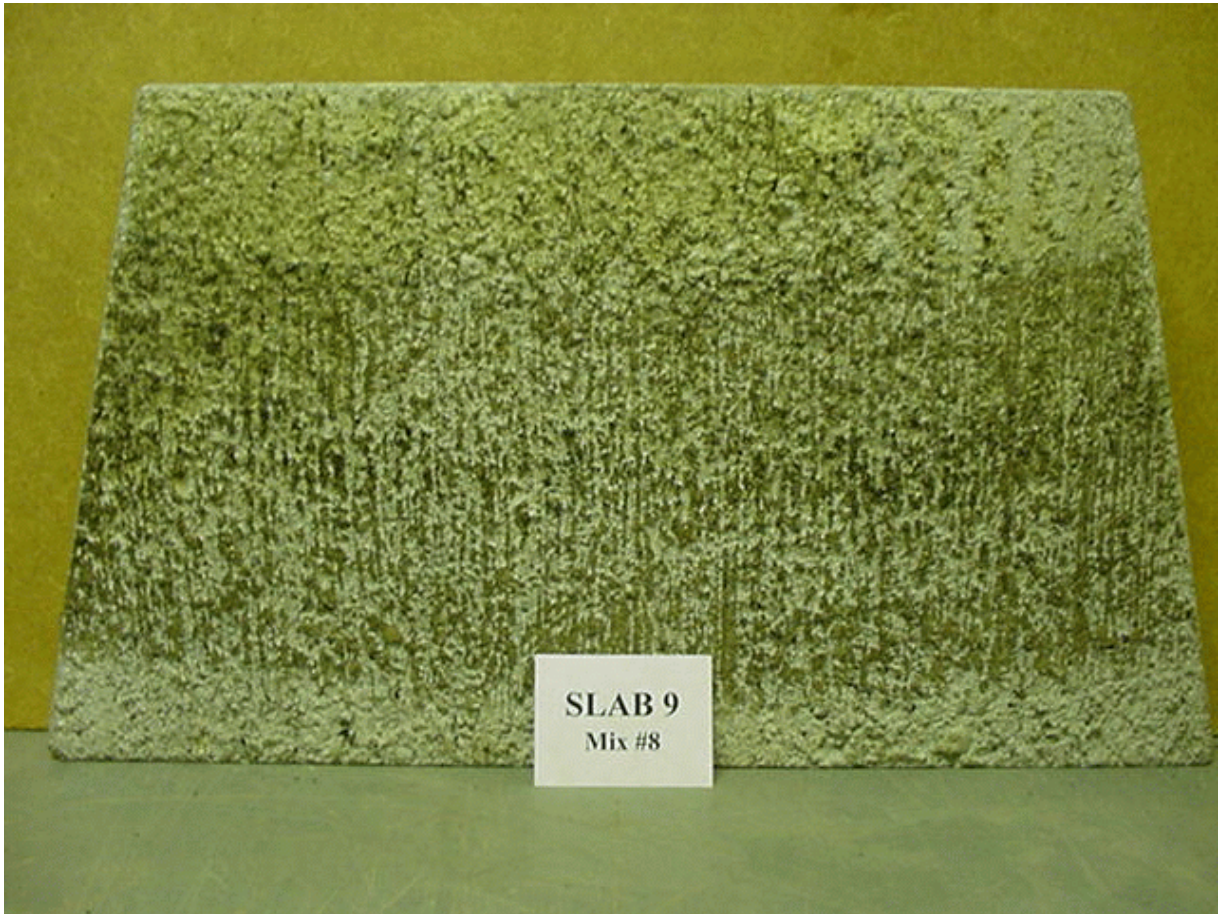
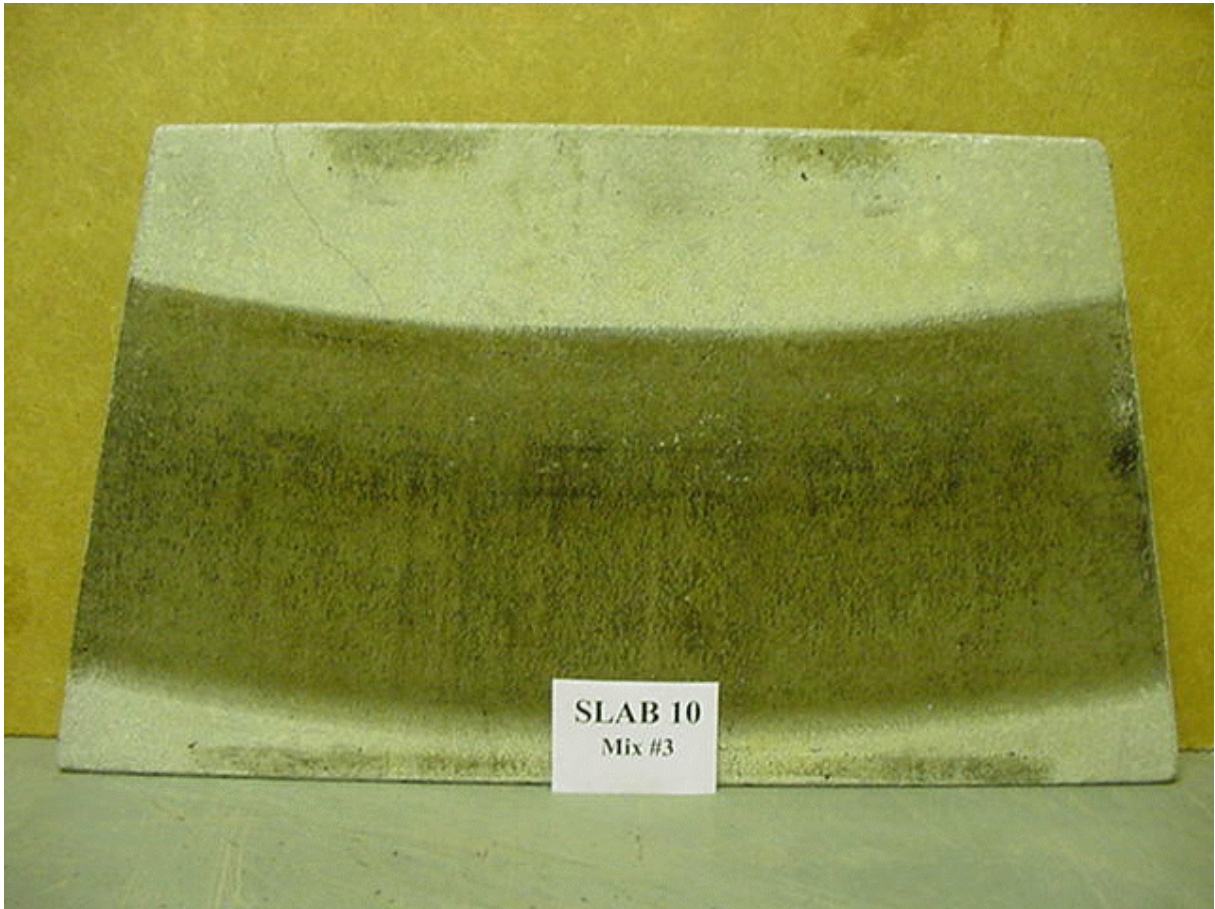
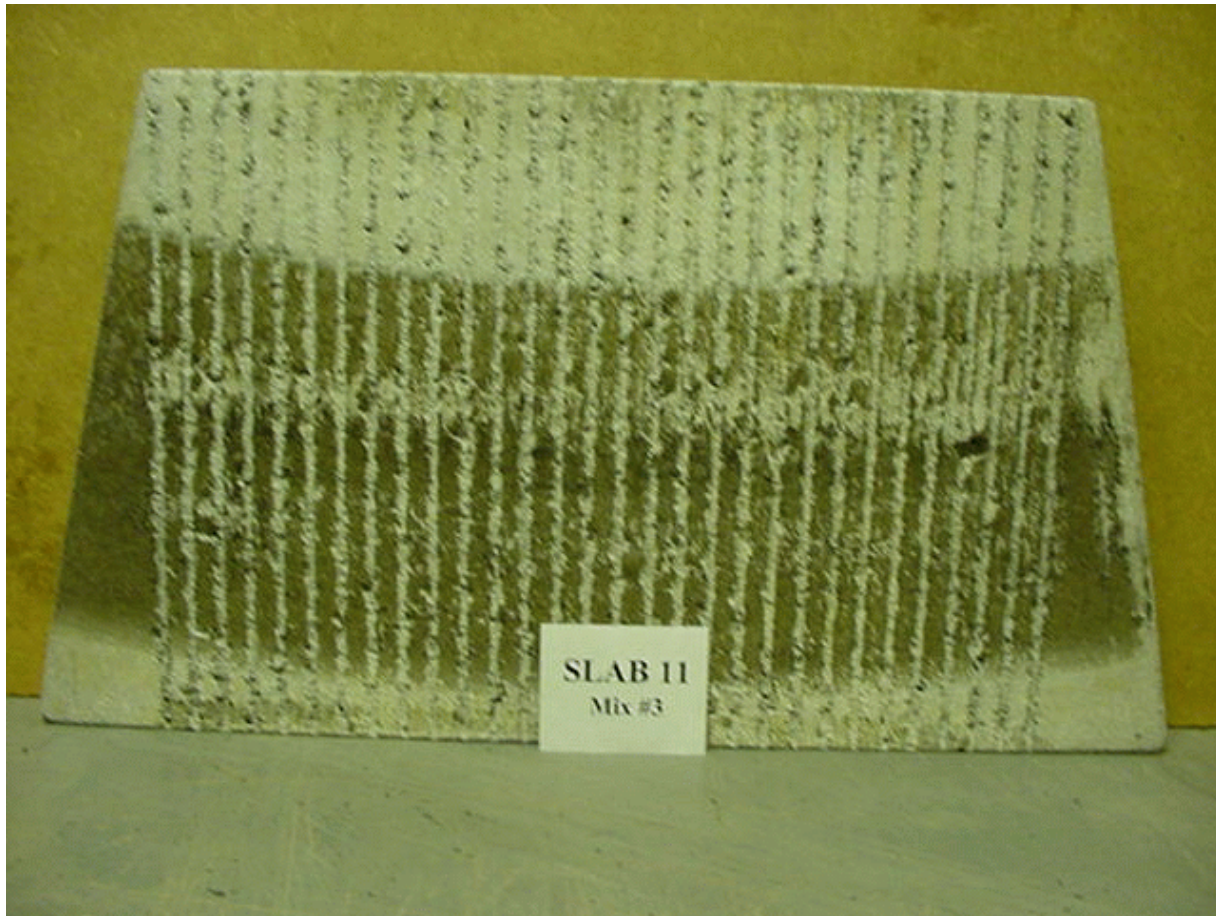
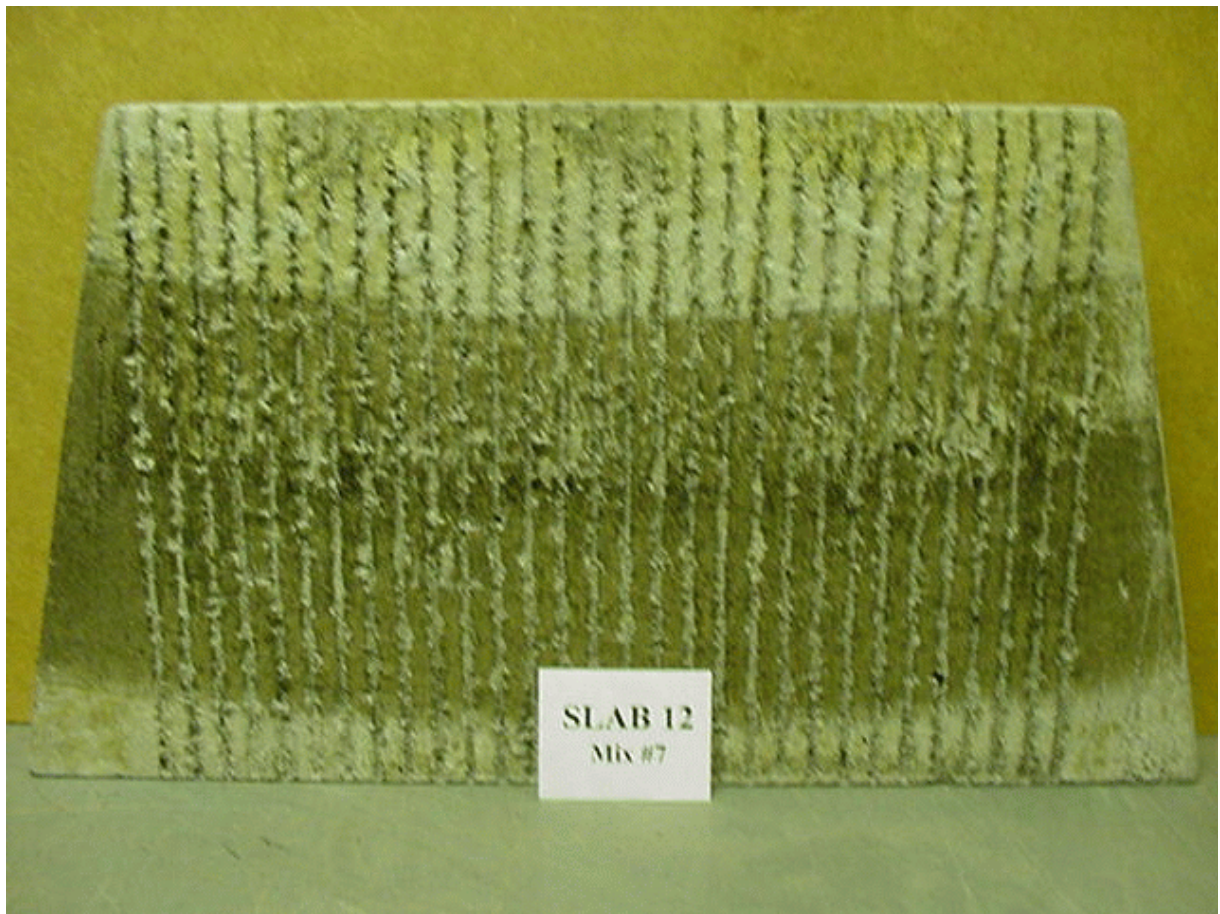
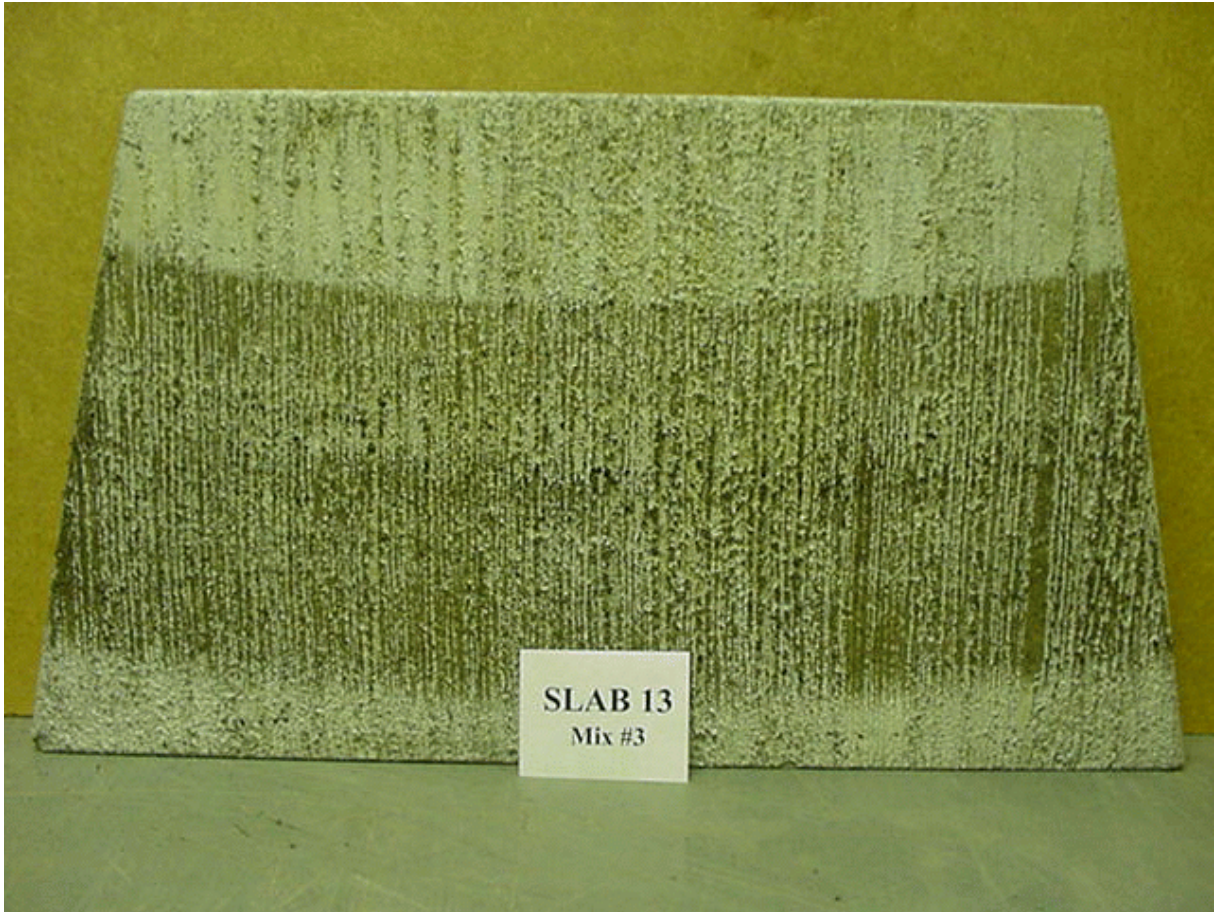
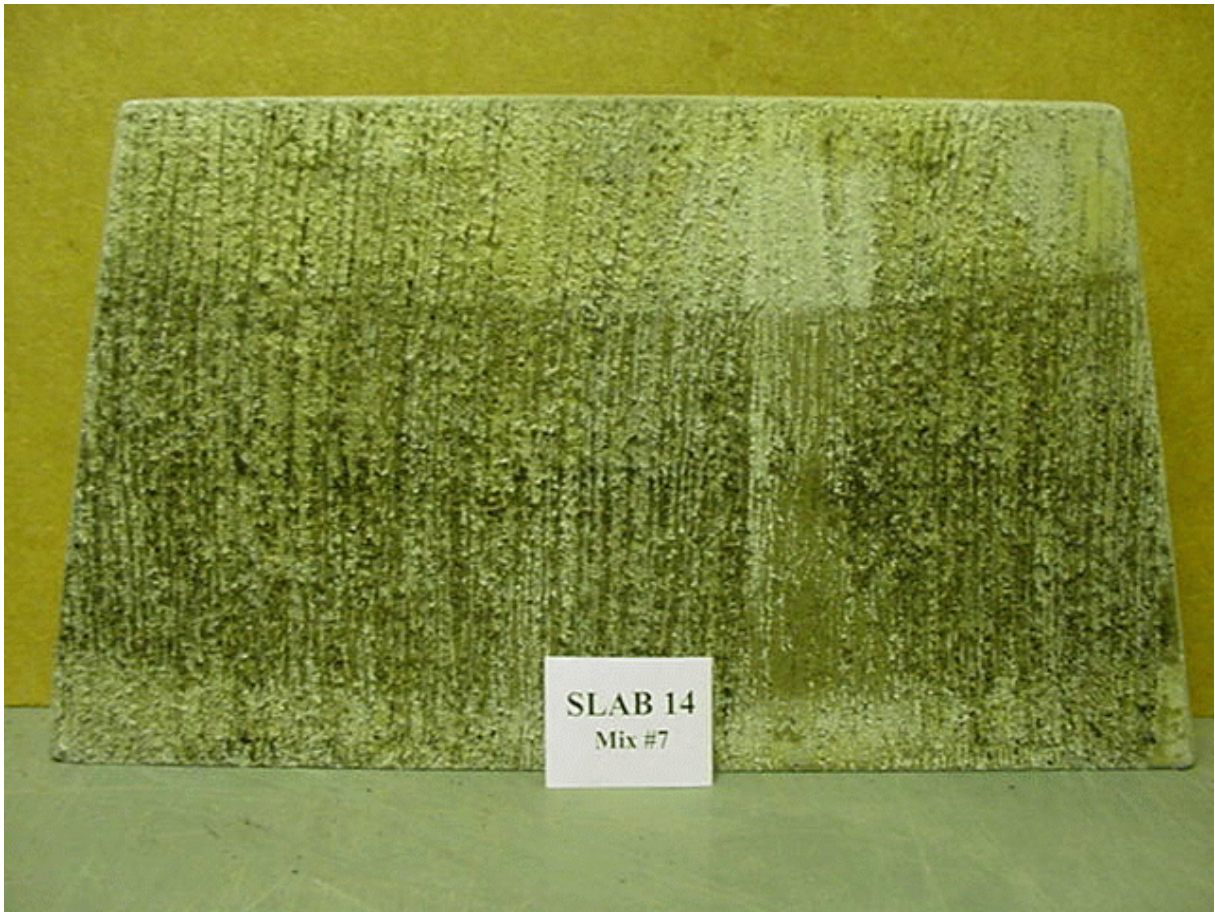
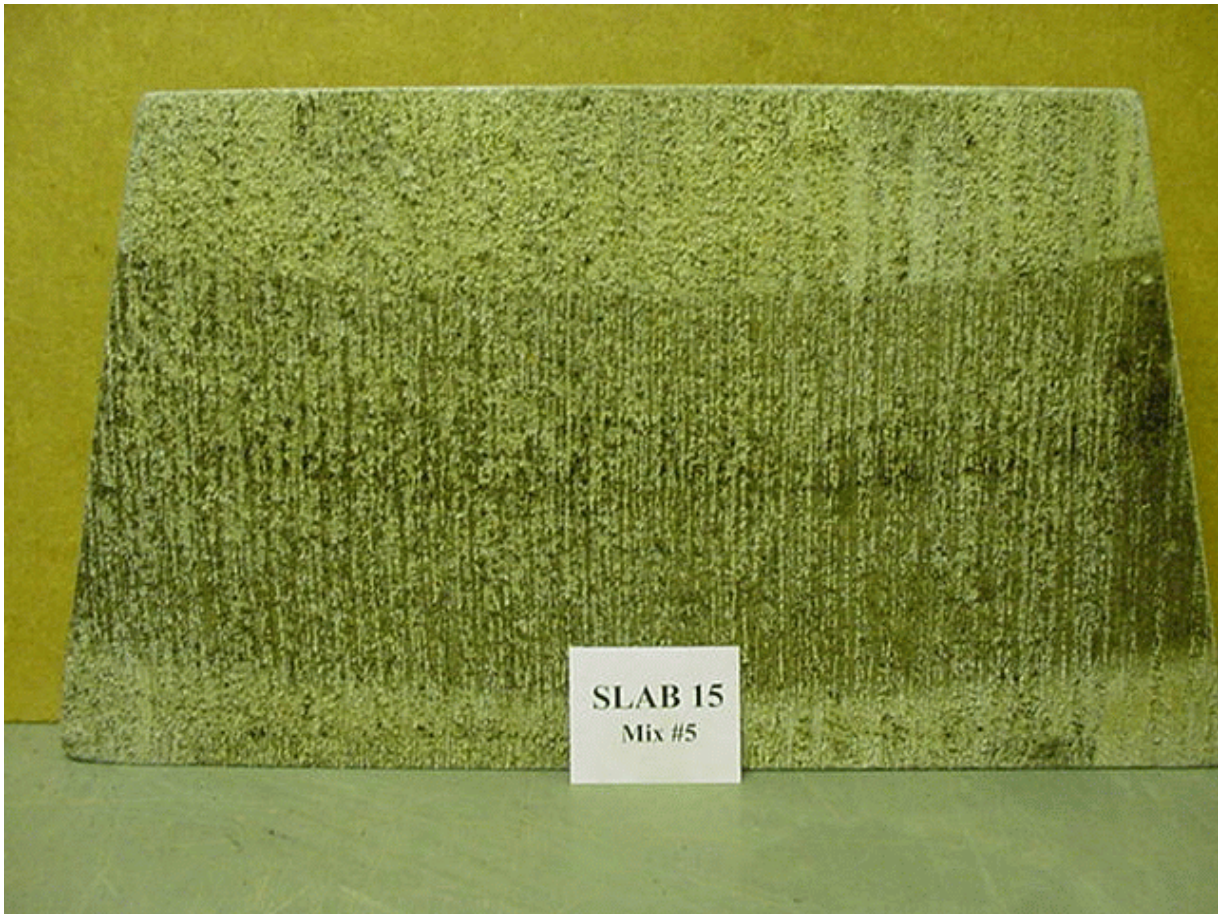
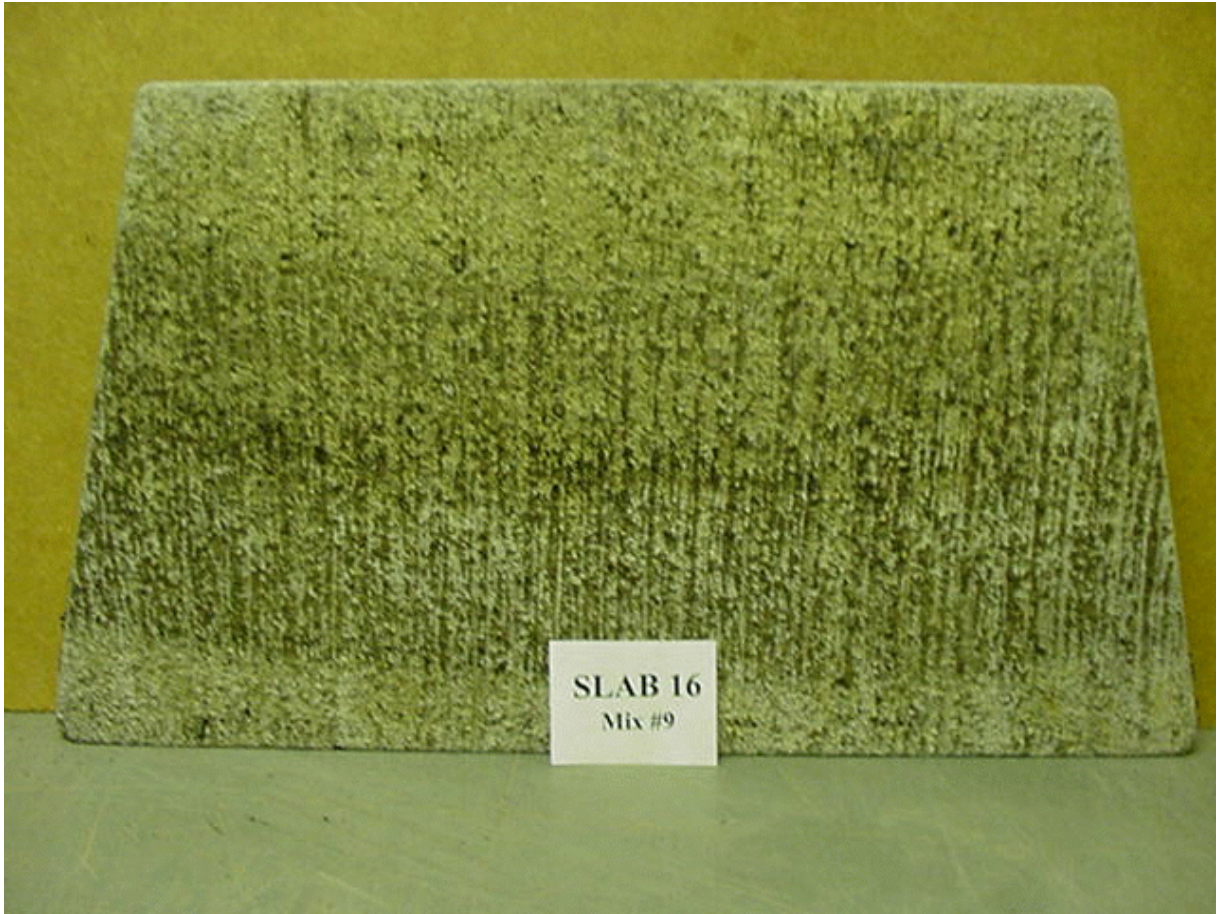
The following photographs document the condition of the slabs after four million wheel passes.

<b>Wear Track Series 064 - Friction Testing Summary</b>				
<i><b>Slab Number</b></i>	<i><b>Mix Number</b></i>	<i><b>Texturing Method</b></i>	<i><b>Friction Test Results At 4 Million Wheel Passes</b></i>	
			<b>British Pendulum Test</b>	<b>Aggregate Wear Index (AWI)</b>
1	1	None	32	200.6
2	1	None	26	168.9
3	2	Smooth Troweled	33	184.8
4	2	Transverse Tining	43	287.8
5	6	Transverse Tining	52	345.5
6	2	Astroturf Drag	48	333.4
7	6	Astroturf Drag	57	403.3
	4	Astroturf Drag	56	364.5
9	8	Astroturf Drag	52	370.9
10	3	Smooth Troweled	31	220.5
11	3	Transverse Tining	49	408.1
12	7	Transverse Tining	44	421.2
13	3	Astroturf Drag	75	483.0
14	7	Astroturf Drag	63	469.4
15	5	Astroturf Drag	60	501.1
16	9	Astroturf Drag	64	507.6
