# **Technical Report 19-01**

Live Load Testing and Load Rating of Five Skewed Reinforced Concrete T-Beam Bridges

University of Maine's Advanced Structures and Composites Center Report Number: 19-09-1613

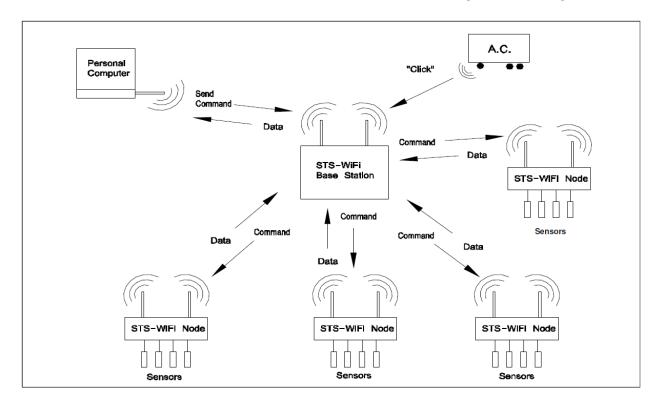
Figure 2: BDI STS-Wi-Fi network setup for bridge sensor setup.

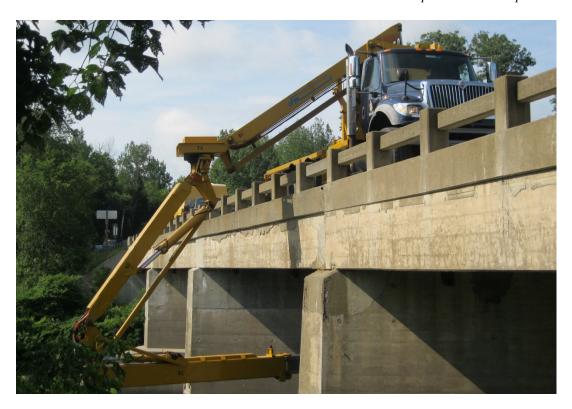
Figure 3: MaineDOT UBIT used to install sensors

Strain transducers were mounted under the bridges using a MaineDOT Under Bridge Inspection Truck (UBIT) as shown in Figure 3. The sensors were mounted to the girders by first grinding the concrete to be as flat as possible, then using LOCTITE 410 rubberized instant adhesive with LOCTITE SF7453 accelerant to attach the strain transducer mounting tabs to the cleaned concrete. All structures had three strain gages mounted to each girder at midspan - one to the bottom of the slab, one at mid-depth of the web, and one at the web bottom face at mid-span - to measure load distribution and peak flexural strains in each girder. Strain transducers were also installed near the ends of selected girders (generally exterior and central girders as the number of remaining transducers allowed) to determine the extent of any rotational restraint at the supports. Strain sensor layout varied slightly for some bridges, with individual sensor layouts shown in the appendices A.2.2 for Bridge 5489, A.3.2 for Bridge 5109, A.4.2 for Bridge 2390, A.5.2 for Bridge 2879, and A.6.2 for Bridge 3748.

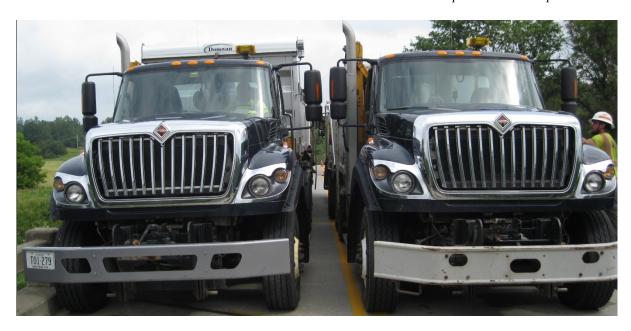
Figure 4: Maine DOT three axle trucks used for loading

The vehicles used for this testing were Maine DOT standard three-axle dump trucks as shown in Figure 4. Each truck wheel or pair of wheels was weighed using state patrol certified portable scales as shown in Figure 5. Various load cases were applied to each bridge, with each test given a specific identification code with the format: "Test Configuration\_Centerline\_Test Position\_Test Number". Test configurations included two trucks, one in each lane ("SBS"), four trucks, two in each lane arranged to produce maximum moment ("MAX"), and four trucks, two in each lane arranged to produce less than maximum moment ("ALT"). Centerline refers to the longitudinal centerline by which truck positions were measured. It was not immediately obvious as to whether positioning trucks relative to the skewed centerline (Figure 6) or perpendicular centerline (Figure 7) would produce larger moments, so both centerline configurations were tested for all configurations. Centerline code "S" refers to tests relative to the skew centerline, and "U" refers to tests with trucks measured relative to the perpendicular centerline. Test positions included load close to the first curb ("1"), load close to the bridge centerline ("2"), and load close to the opposite curb ("3"). Test number refers to the test index if a certain load case was repeated. Not all bridges were subjected to all load cases.

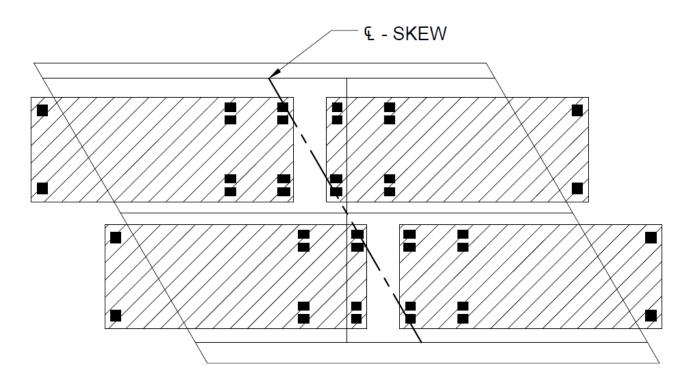
Figure 6: Truck positioning relative to skew centerline

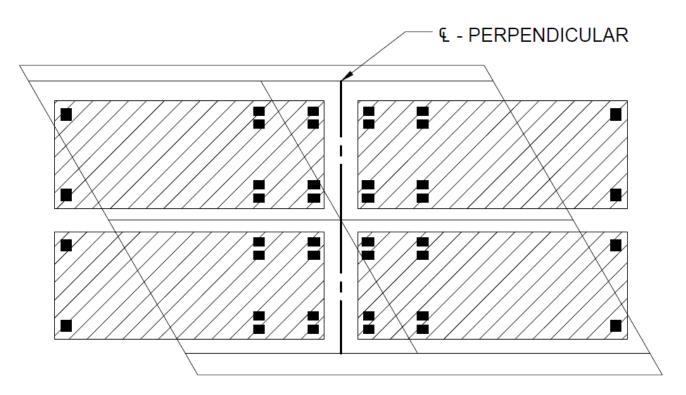
Figure 7: Truck positioning relative to perpendicular centerline

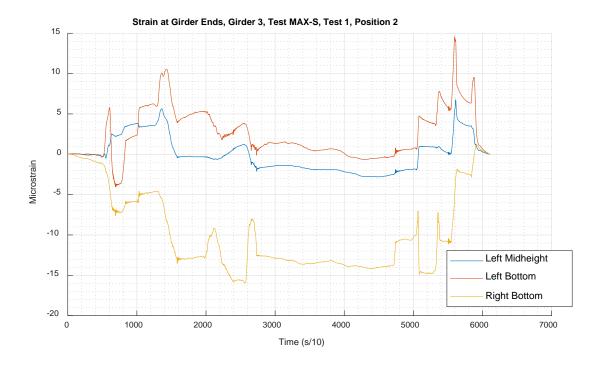
Figure 9: Bridge 3848 – MAX\_S\_2\_1, center girder strains at ends

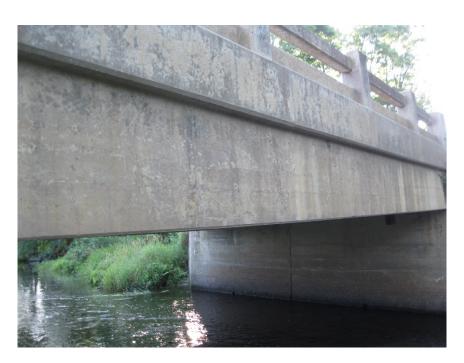
Figure 10: Bridge 5489 general condition

cases. As shown in Table 2, strain measured at the ends of the girders indicate that the central girder and one of the exterior girders experienced a small amount of unintended fixity as evidenced by the negative strains recorded near the abutments. Original design drawings indicate the presence of dowel bars attaching one abutment to the superstructure. These, along with friction between the superstructure and opposing abutment may contribute to this small, apparent fixity.

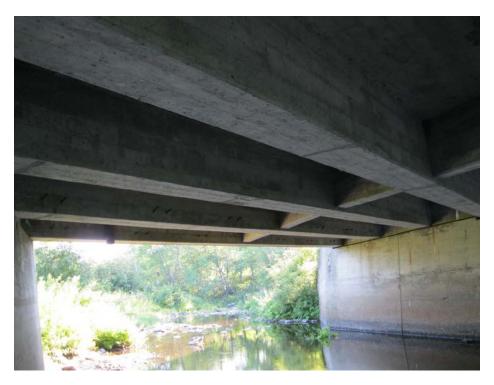
Figure 11: Bridge 5109 general condition

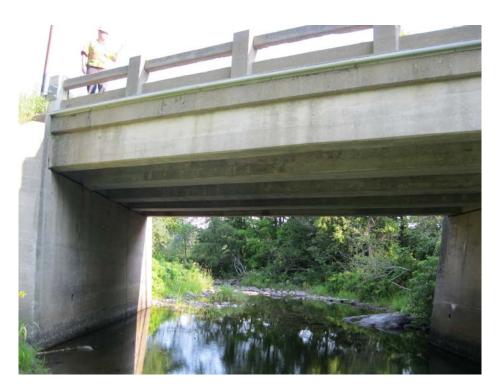
Figure 12: Bridge 2390 general condition

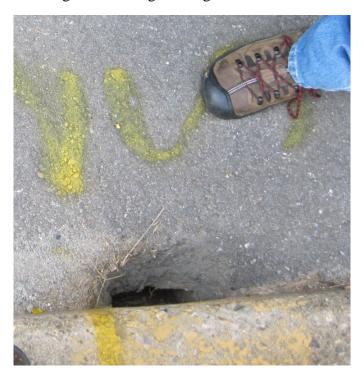
Figure 13: Thick asphalt overlay

- 3. Unity No. 2390: On August 4, 2018 93.2% of HL-93 flexural service loading with impact was produced for this under maximum loading. The initial rating factors per AASHTO were 0.757 for interior girders and 1.05 for exterior girders. Live load testing results allowed the rating factors to be increased to 0.838 for interior girders and 1.15 for exterior girders, meaning that the operating rating factor was unable to be raised above 1.0. This is likely due to the thick asphalt wearing surface overlay.

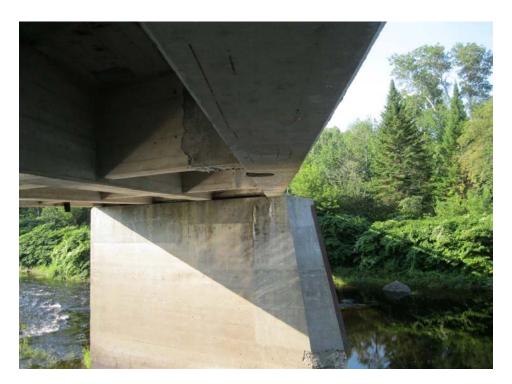
Figure 14: Bridge 2879 general condition

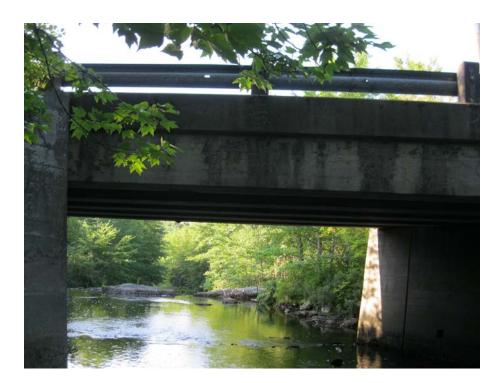
Figure 15: Bridge 3848 general condition

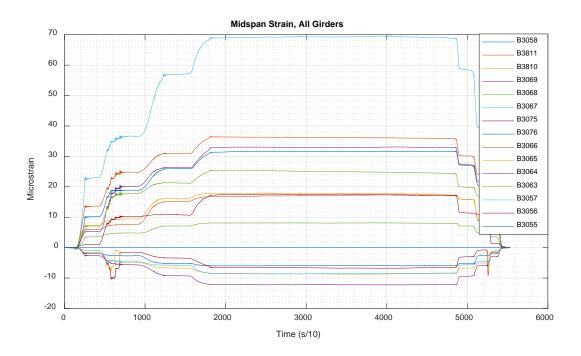
Figure 27: Bridge 5489 MAX\_U\_2\_1 strains – Midspan

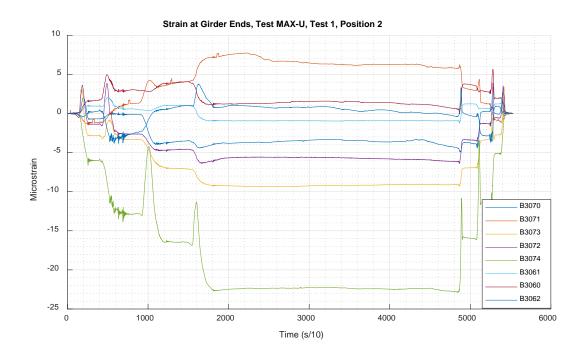
Figure 28: Bridge 5489 MAX\_U\_2\_1 strains – Ends

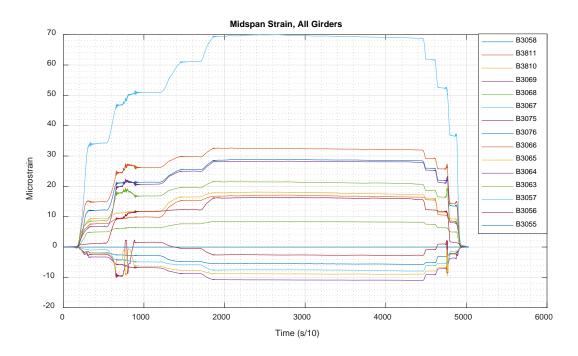
Figure 31: Bridge 5489 ALT\_U\_2\_1 strains – Midspan

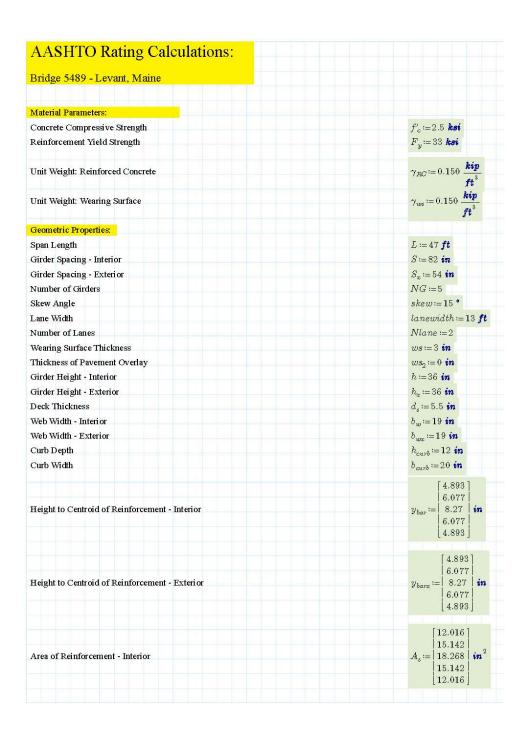
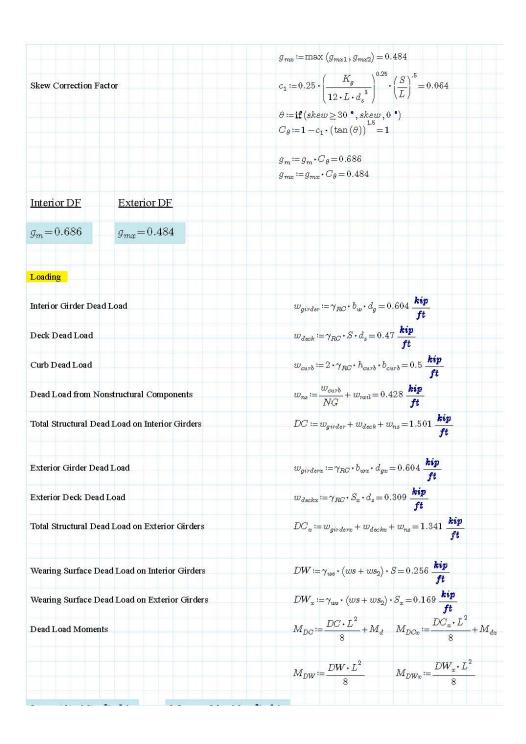
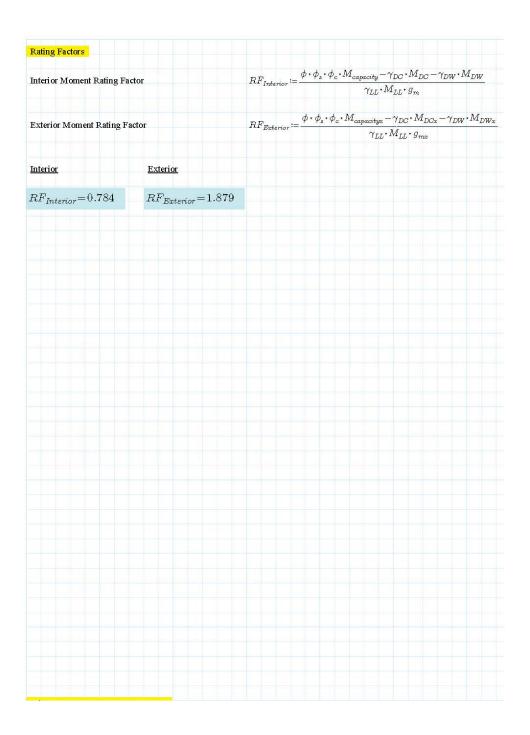
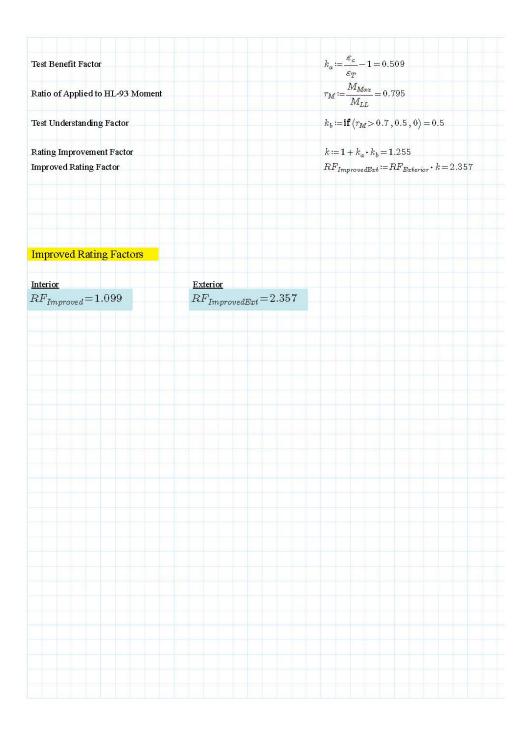
Figure 33: Bridge 5489 calculations

Rating Factor Improvements	
Concrete Compressive Strength - Larger is More Conservative	$f_c' := 5$ ksi
Concrte Elastic Modulus	$E_c\!\coloneqq\!1820$ kei $\cdot\sqrt{rac{f'_c}{ksi}}\!=\!\left\langle4.07\cdot10^3 ight angle$ kei
Interior Girders	
Maximum Recorded Strain	$\varepsilon_T \coloneqq 87.2 \cdot 10^{-6}$
Maximum Applied Moment per Lane	$M_{Max} \coloneqq 738.7 \;  extbf{ft \cdot kip}$
Uncracked Section Modulus	$S_{unc}\coloneqq9507$ in $^3$
Cracked Section Modulus	
	$S_{cr}\coloneqq 4565$ in $^3$
Section Behavior	Behavior := "Uncracked"
Section Modulus Effective for Behavior	$S_{e} \coloneqq \mathbf{if}  \langle Behavior = \text{``Uncracked''}, S_{unc}, S_{c}$
Calculated Strain	$\varepsilon_c \coloneqq \frac{M_{Max} \cdot g_m}{S_s \cdot E_c} = 1.572 \cdot 10^{-4}$
Test Benefit Factor	$k_{\alpha} \coloneqq \frac{\varepsilon_{c}}{\varepsilon_{T}} - 1 = 0.803$
Ratio of Applied to HL-93 Moment	$r_{M} \coloneqq \frac{M_{Max}}{M_{LL}} = 0.795$

Test Understanding Factor	$k_b := \mathbf{if} \langle r_M > 0.7, 0.5, 0 \rangle = 0.5$
Rating Improvement Factor	$k := 1 + k_a \cdot k_b = 1.401$
Improved Rating Factor	$RF_{Improved}\!\coloneqq\!RF_{Interior}\cdot k\!=\!1.099$
Exterior Girders	
Maximum Recorded Strain	$\varepsilon_T \!\coloneqq\! 63.5 \cdot 10^{-6}$
Maximum Applied Moment per Lane	$M_{Max} \coloneqq 738.7  \emph{ft} \cdot \emph{kip}$
Uncracked Section Modulus	$S_{ m unc}\!\coloneqq\!11008$ in $^3$
Cracked Section Modulus	$S_{cr}\!\coloneqq\!3469$ in $^3$
Section Behavior	Behavior := "Uncracked"
Section Modulus Effective for Behavior	$S_e \coloneqq \mathbf{if} \left\langle Behavior = \text{``Uncracked''}, S_{unc}, S_e \right\rangle$
Calculated Strain	$\varepsilon_c \coloneqq \frac{M_{\text{Max}} \cdot g_{\text{mx}}}{S_e \cdot E_c} = 9.583 \cdot 10^{-5}$

Assuming the conservative concrete compressive strength of 5 ksi, the strains recorded indicate the sections remained uncracked. This is supported by the observed neutral axis depths, which are consistently lower in the section than would be predicted for an uncracked section, as can be seen in Table 3. The high level of applied load and low recorded strains allowed interior and exterior girder rating factors to be increased to 1.10 and 2.36 respectively.

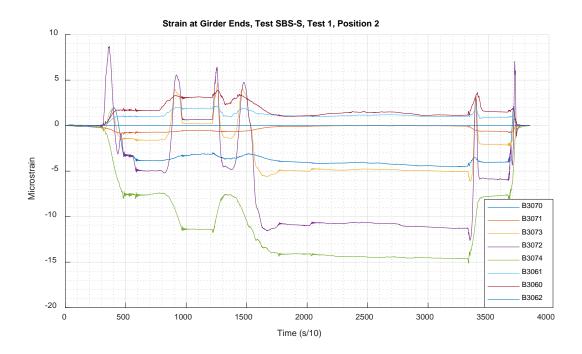
Figure 40: Bridge 5109 SBS\_S\_2\_1 strains - Ends

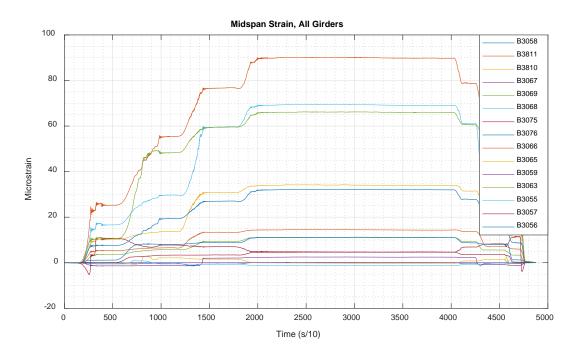
Figure 45: Bridge 5109 MAX\_U\_2\_1 - Midspan

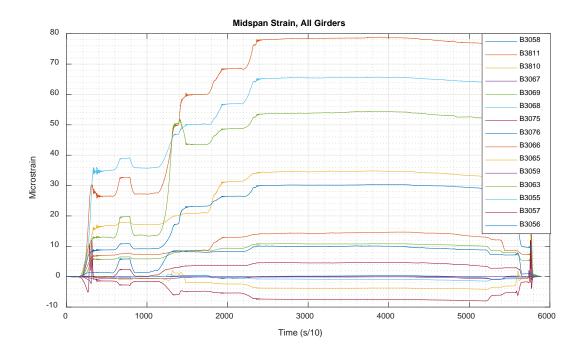
Figure 47: Bridge 5109 ALT\_S\_2\_1 - Midspan

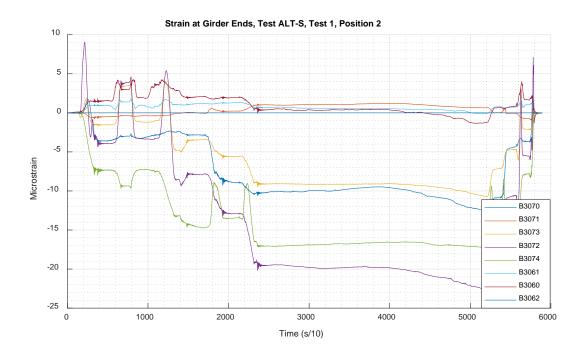
Figure 48: Bridge 5109 ALT\_S\_2\_1 - Ends

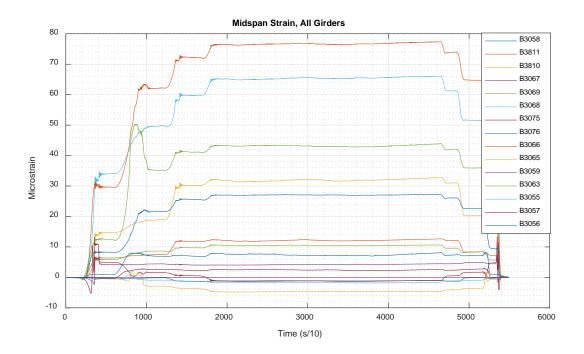
Figure 49: Bridge 5109 ALT\_U\_2\_1 - Midspan

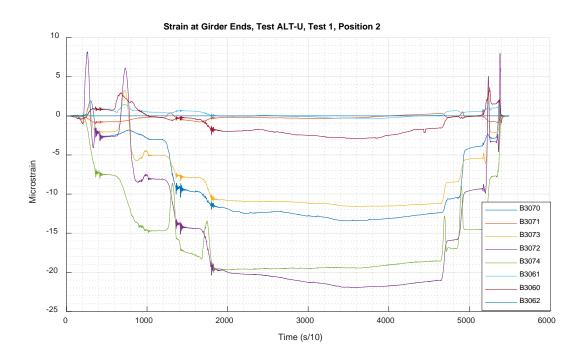
Figure 50: Bridge 5109 ALT\_U\_2\_1 – Ends

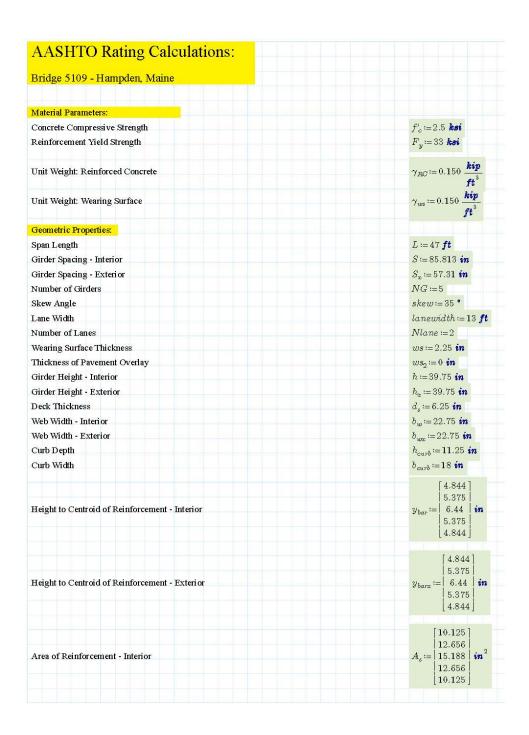
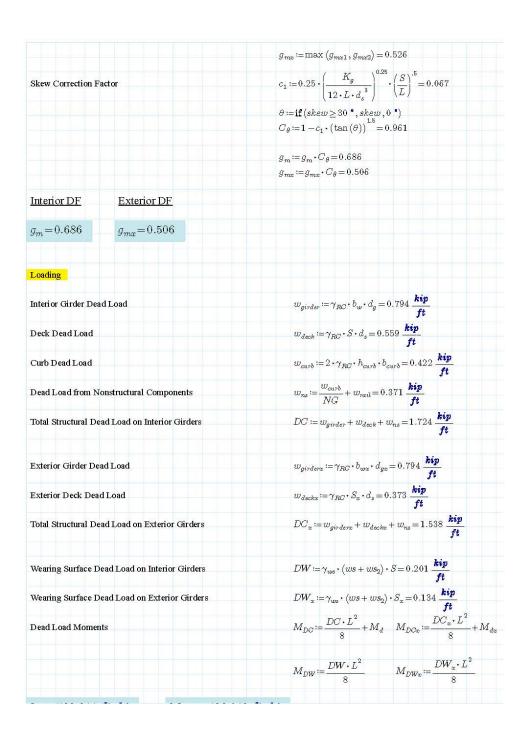
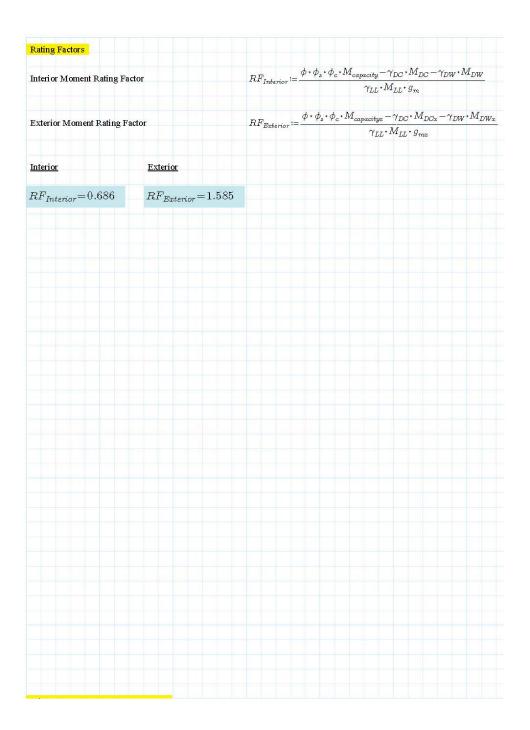
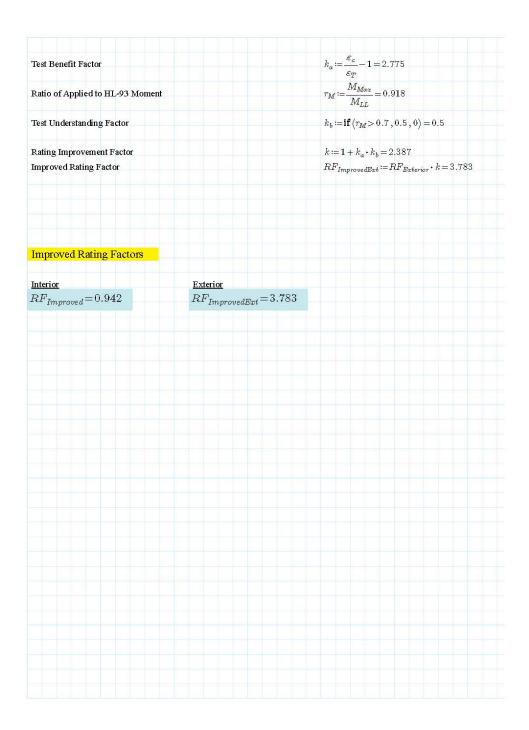
Figure 51: Bridge 5109 calculations

Rating Factor Improvements		
Concrete Compressive Strength - Larger is More Conservative	$f_c' \coloneqq 5$ ksi	
Concrte Elastic Modulus	$E_c\!\coloneqq\!1820$ kei $\cdot\sqrt{rac{f'_c}{ksi}}=\left\langle 4.07\cdot 10^3 ight angle$ kei	
Interior Girders		
Maximum Recorded Strain	$\varepsilon_T \coloneqq 90.50 \cdot 10^{-6}$	
Maximum Applied Moment per Lane	$M_{Max}\!\coloneqq\!830.05~ extbf{\textit{ft}}\cdot extbf{\textit{kip}}$	
Uncracked Section Modulus	$S_{unc}\coloneqq 10619$ in $^3$	
Cracked Section Modulus		
	$S_{cr} := 3672 \text{ in}^3$	
Section Behavior	Behavior:="Uncracked"	
Section Modulus Effective for Behavior	$S_e \coloneqq \mathbf{if} \left( Behavior \texttt{= "Uncracked"}, S_{unc}, S_c \right)$	
Calculated Strain	$\varepsilon_c \coloneqq \frac{M_{Max} \cdot g_m}{S_e \cdot E_c} = 1.581 \cdot 10^{-4}$	
Test Benefit Factor	$k_a \coloneqq \frac{\varepsilon_c}{\varepsilon_T} - 1 = 0.747$

Ratio of Applied to HL-93 Moment	$r_{M} \coloneqq \frac{M_{Max}}{M_{LL}} = 0.893$	
Test Understanding Factor	$k_b := \mathbf{if} \left< r_M > 0.7, 0.5, 0 \right> = 0.5$	
Rating Improvement Factor	$k := 1 + k_a \cdot k_b = 1.374$	
Improved Rating Factor	$RF_{Improved} \coloneqq RF_{Interior} \cdot k = 0.942$	
Exterior Girders		
Maximum Recorded Strain	$\varepsilon_T \coloneqq 34.5 \cdot 10^{-6}$	
Maximum Applied Moment per Lane	$M_{Max}$ := 853.3 $ft \cdot kip$	
Uncracked Section Modulus	$S_{\mathrm{unc}} \coloneqq 9767 \; in^3$	
Cracked Section Modulus	$S_{cr} \coloneqq 3552   \mathbf{in}^3$	
Section Behavior	Behavior := "Uncracked"	
Section Modulus Effective for Behavior	$S_{e} \coloneqq \mathbf{if} \big\langle Behavior = \text{``Uncracked''}, S_{unc}, S_{e} \big\rangle$	
Calculated Strain	$\varepsilon_c \coloneqq \frac{M_{Max} \cdot g_{mx}}{S_e \cdot E_c} = 1.302 \cdot 10^{-4}$

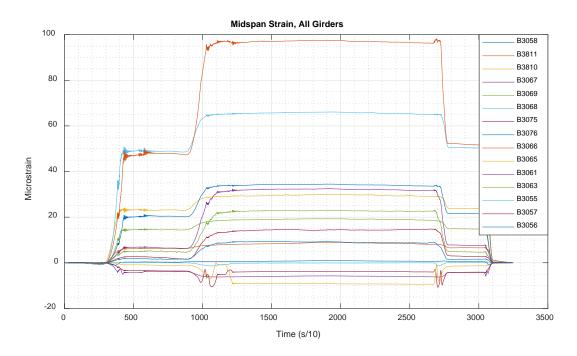
Figure 57: Bridge 2390 SBS\_S\_2\_2 strains - Midspan

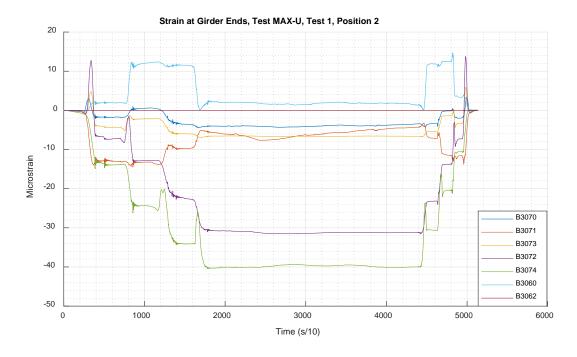
Figure 64 Bridge 2390 MAX\_U\_2\_1 strains – Ends

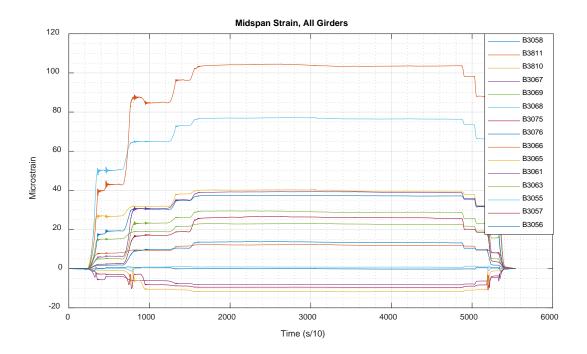
Figure 65: Bridge 2390 ALT\_S\_2\_1 strains - Midspan

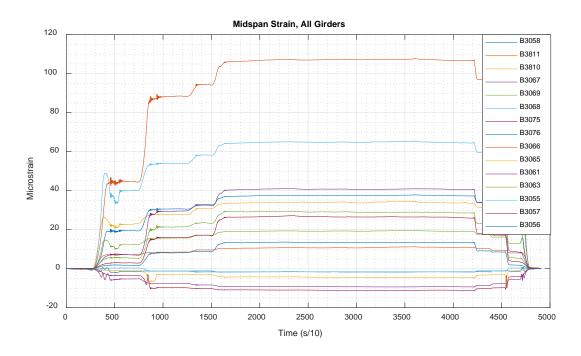
Figure 67: Bridge 2390 ALT\_U\_2\_1 strains - Midspan

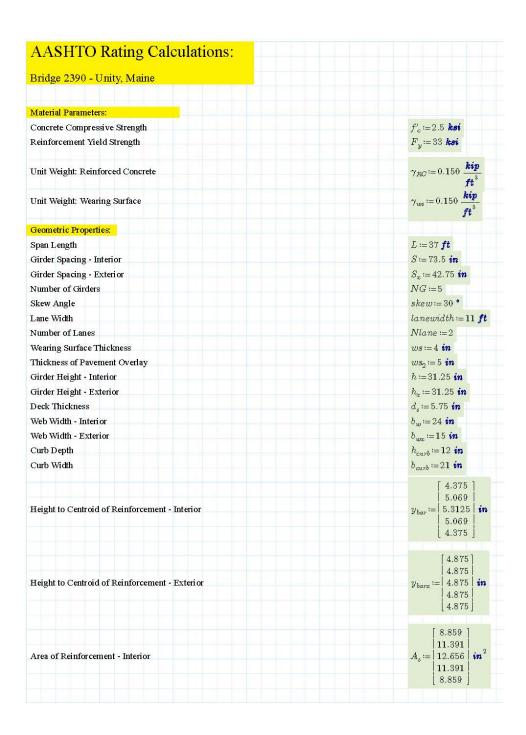
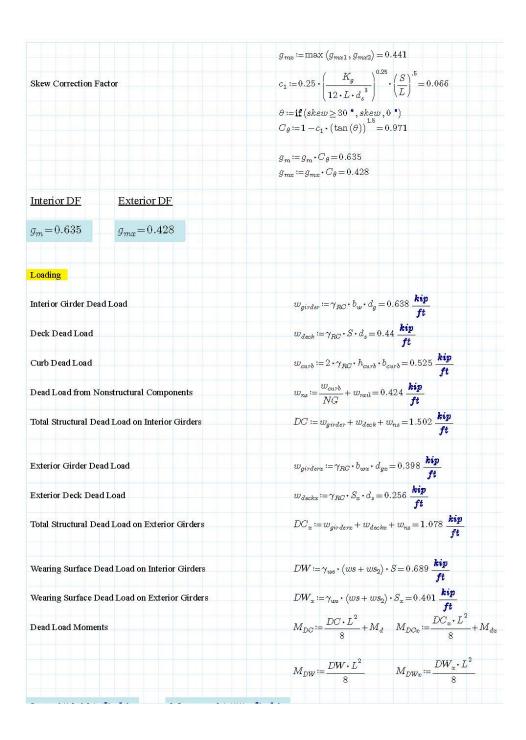
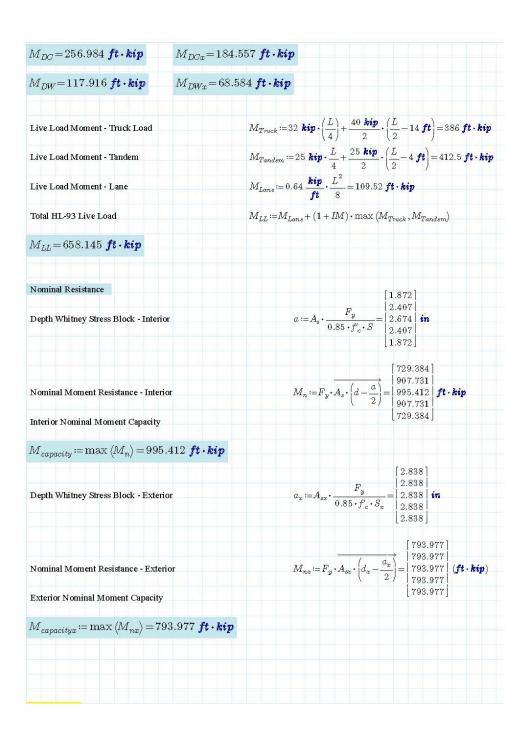
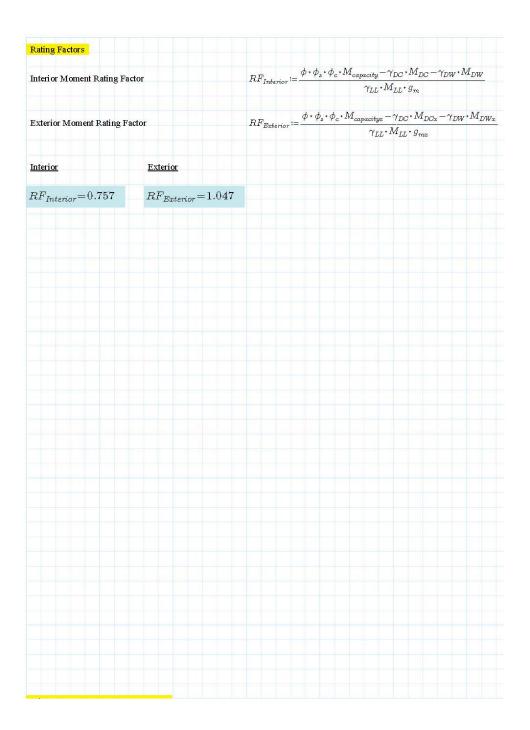
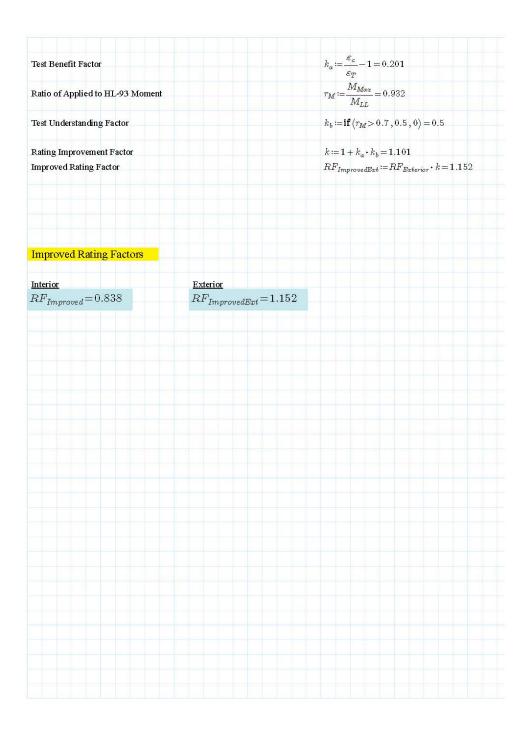
Figure 69: Bridge 2390 calculations

Rating Factor Improvements		
Concrete Compressive Strength - Larger is More Conservative	$f_c'\!\coloneqq\! 5$ kei	
Concrte Elastic Modulus	$E_c \coloneqq 1820 \text{ kei} \cdot \sqrt{\frac{f_c'}{\text{ksi}}} = \left<4.07 \cdot 10^3 \right> \text{ ksi}$	
Interior Girders		
Maximum Recorded Strain	$\varepsilon_T \!\coloneqq\! 112.56 \cdot 10^{-6}$	
Maximum Applied Moment per Lane	$M_{Max} \coloneqq 613.45 \; \textit{ft} \cdot \textit{kip}$	
Uncracked Section Modulus	$S_{unc}\coloneqq 8415$ in $^3$	
Cracked Section Modulus		
	$S_{cr}\!\coloneqq\!2764$ in $^3$	
Section Behavior	Behavior := "Uncracked"	
Secti on Modulus Effective for Behavior	$S_e \coloneqq \mathbf{if}  \langle Behavior = \text{``Uncracked''} ,  S_{\text{unc}} , S_{\text{cl}}$	
Calculated Strain	$\varepsilon_c \coloneqq \frac{M_{Max} \cdot g_m}{S_\varepsilon \cdot E_c} = 1.366 \cdot 10^{-4}$	
Test Benefit Factor	$k_a \coloneqq \frac{\varepsilon_c}{\varepsilon_T} - 1 = 0.213$

Ratio of Applied to HL-93 Moment	$r_{M} \coloneqq \frac{M_{Max}}{M_{LL}} = 0.932$	
Test Understanding Factor	$k_b := \mathbf{if} \langle r_M > 0.7, 0.5, 0 \rangle = 0.5$	
Rating Improvement Factor	$k := 1 + k_a \cdot k_b = 1.107$	
Improved Rating Factor	$RF_{Improved} := RF_{Interior} \cdot k = 0.838$	
Exterior Girders		
Maximum Recorded Strain	$\varepsilon_T \coloneqq 79.28 \cdot 10^{-6}$	
Maximum Applied Moment per Lane	$M_{Max}\!\coloneqq\!613.45 extit{ft\cdot kip}$	
Uncracked Section Modulus	$S_{unc}\!\coloneqq\!8132$ in $^3$	
Cracked Section Modulus	$S_{cr}\coloneqq 2071$ in $^3$	
Section Behavior	Behavior := "Uncracked"	
Section Modulus Effective for Behavior	$S_{e}\!\coloneqq\!\mathbf{if}\langle Behavior\!=\!\text{``Uncracked''}, S_{\mathit{unc}}, S_{c}$	
Coloulated Strain	M <sub>Max</sub> · g <sub>mx</sub> _ 0 522 10 <sup>-5</sup>	
Calculated Strain	$\varepsilon_c \coloneqq \frac{M_{Max} \cdot g_{mx}}{S_e \cdot E_c} = 9.522 \cdot 10^{-5}$

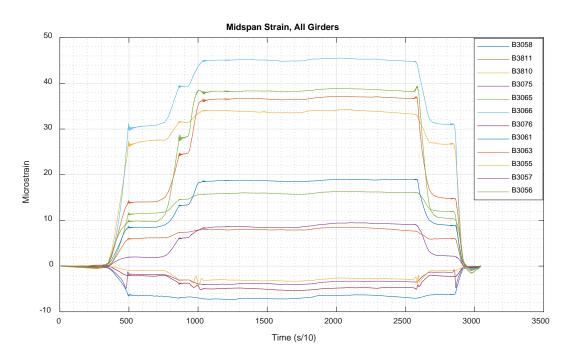
Figure 75: Bridge 2879 SBS\_S\_2\_1 strains - Midspan

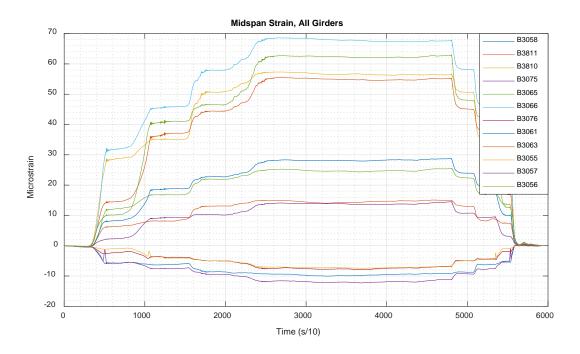
Figure 83: Bridge 2879 ALT\_S\_2\_1 strains - Midspan

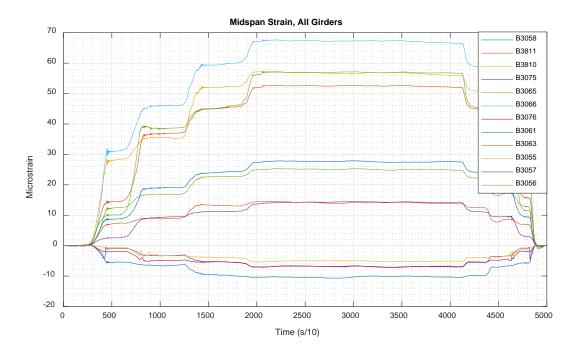
Figure 85: Bridge 2879 ALT\_U\_2\_1 strains - Midspan

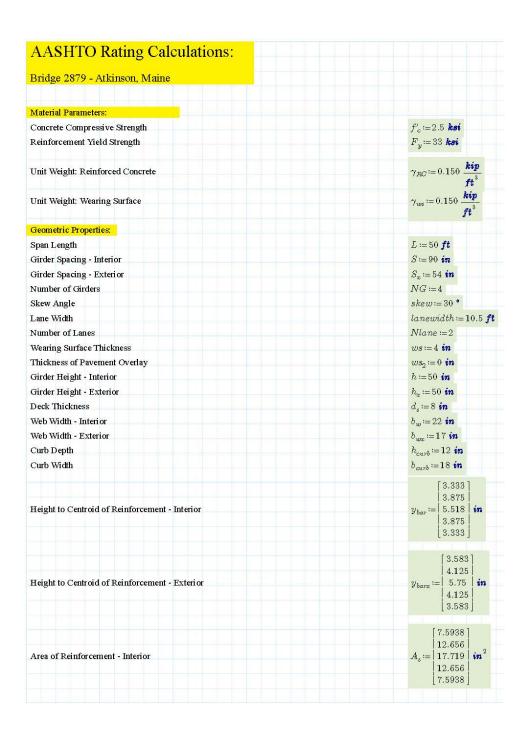
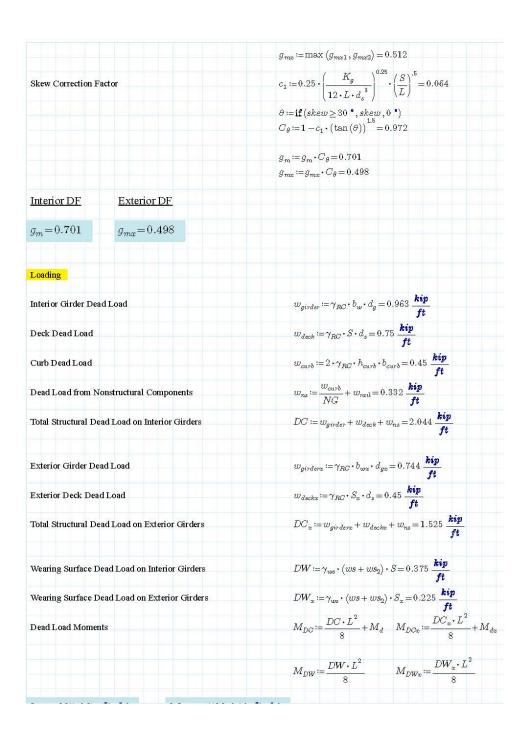
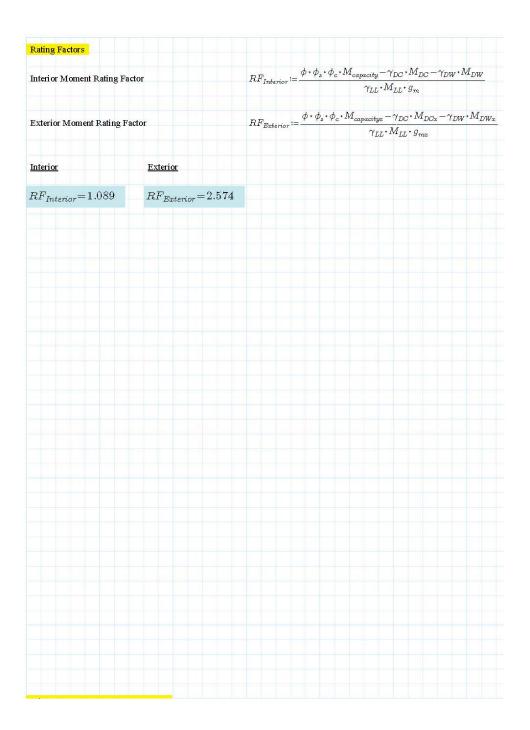
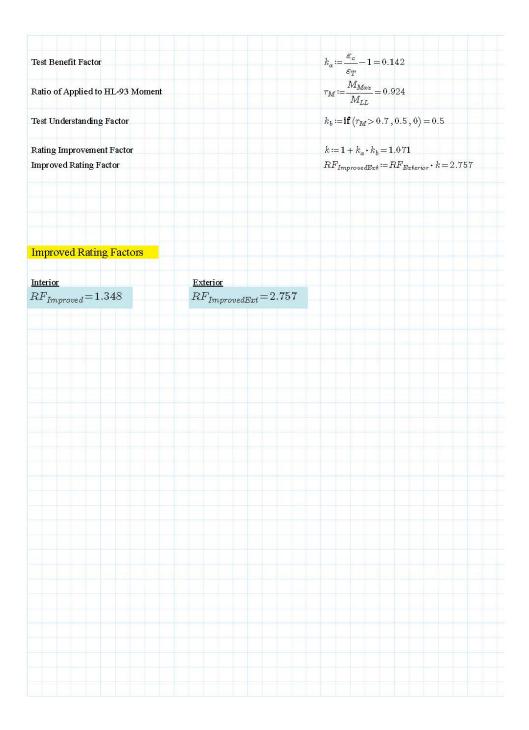
Figure 87: Bridge 2879 calculations

Rating Factor Improvements		
Concrete Compressive Strength - Larger is More Conservative	f'c:=5 <b>ksi</b>	
Concrte Elastic Modulus	$E_c \coloneqq 1820 \text{ kei} \cdot \sqrt{\frac{f'_c}{h_{ci}}} = \langle 4.07 \cdot 10^3 \rangle \text{ kei}$	
Interior Girders	· Not	
Maximum Recorded Strain	$\varepsilon_T \coloneqq 62.49 \cdot 10^{-6}$	
Maximum Appli ed Moment per Lane	$M_{Max} = 946.9 \;  extbf{ft} \cdot  extbf{kip}$	
Uncracked Section Modulus	$S_{unc}\coloneqq 21210$ in $^3$	
Cracked Section Modulus	$S_{cr}\coloneqq 8413$ in $^3$	
Section Behavior	$S_{cr} \coloneqq 8413$ en $Behavior \coloneqq \text{``Uncracked''}$	
Section Modulus Effective for Behavior	$S_s \coloneqq \mathbf{if}  \langle Behavior = \text{``Uncracked''} , S_{unc} , S_s $	
Calculated Strain	$\varepsilon_c \coloneqq \frac{M_{\mathit{Max}} \cdot g_m}{S_\varepsilon \cdot E_c} = 9.223 \cdot 10^{-5}$	
Test Benefit Factor	$k_{\alpha} \coloneqq \frac{\varepsilon_c}{\varepsilon_T} - 1 = 0.476$

Ratio of Applied to HL-93 Moment	$r_M\!:=\!\frac{M_{Max}}{M_{LL}}\!=\!0.924$	
Test Understanding Factor	$k_b := \mathbf{if} \langle r_M > 0.7, 0.5, 0 \rangle = 0.5$	
Rating Improvement Factor	$k := 1 + k_a \cdot k_b = 1.238$	
Improved Rating Factor	$RF_{Improved} \coloneqq RF_{Interior} \cdot k = 1.348$	
Exterior Girders		
Maximum Recorded Strain	$\varepsilon_T \coloneqq 77.32 \cdot 10^{-6}$	
Maximum Applied Moment per Lane	$M_{Max}\!\coloneqq\!946.9~ extbf{\textit{ft}}\cdot extbf{\textit{kip}}$	
Uncracked Section Modulus	$S_{\mathit{unc}} \coloneqq 15738 \mathrm{in}^3$	
Cracked Section Modulus	$S_{cr}\!\coloneqq\!4196$ in $^3$	
Section Behavior	$Behavior \coloneqq \text{``Uncracked''}$	
Section Modulus Effective for Behavior	$S_e \coloneqq \mathbf{if} \langle Behavior = \text{``Uncracked''}, S_{unc}, S_{out} \rangle$	
Calculated Strain	$\varepsilon_c \coloneqq \frac{M_{Max} \cdot g_{mx}}{S_e \cdot E_c} = 8.831 \cdot 10^{-5}$

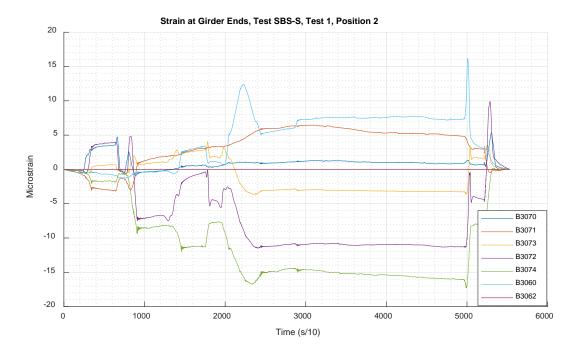
Figure 94: Bridge 3848 SBS\_S\_2\_1 strains – Ends

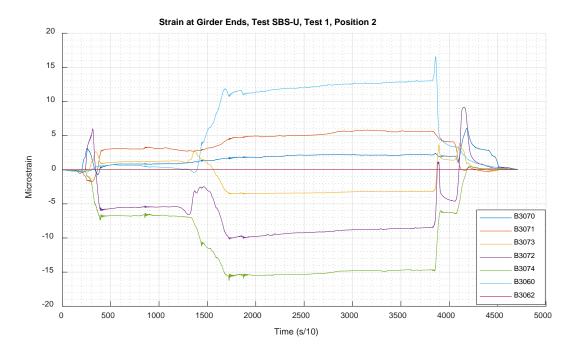
Figure 96: Bridge 3848 SBS\_U\_2\_1 strains - Ends

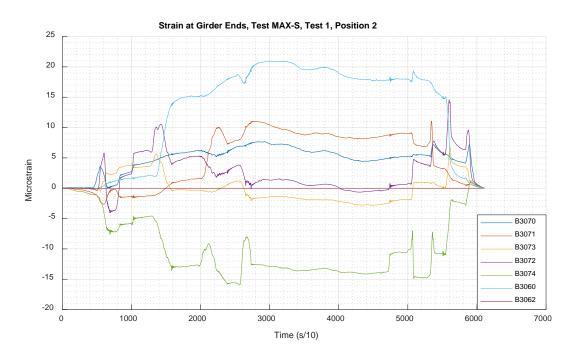
Figure 98: Bridge 3848 MAX\_S\_2\_1 strains - Ends

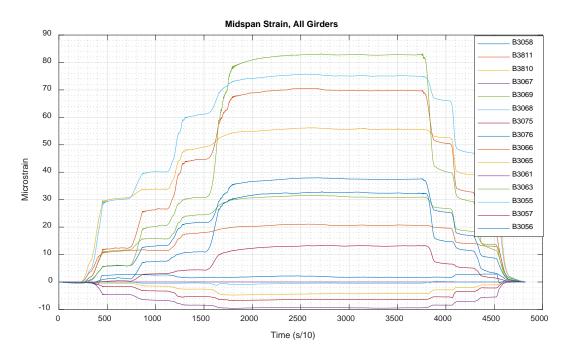
Figure 99: Bridge 3848 MAX\_U\_2\_1 strains - Midspan

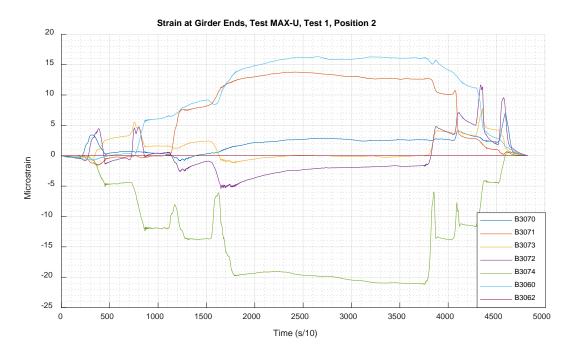
Figure 100: Bridge 3848 MAX\_U\_2\_1 strains – Ends

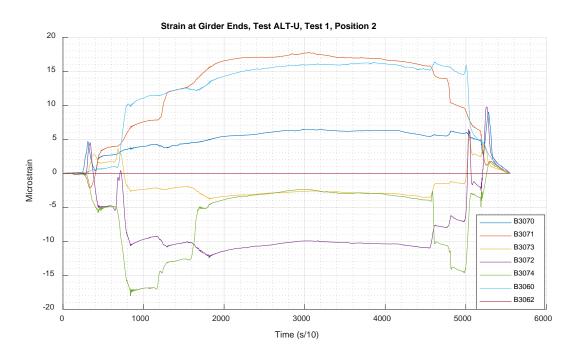
Figure 104: Bridge 3848 ALT\_U\_2\_1 strains - Ends

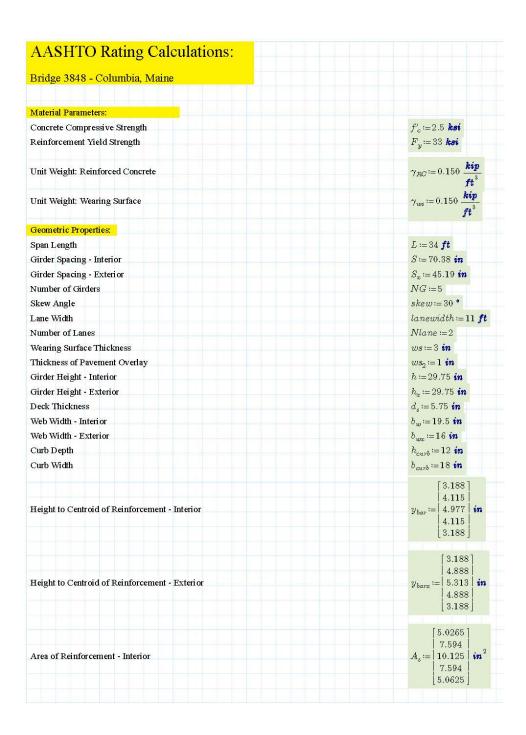
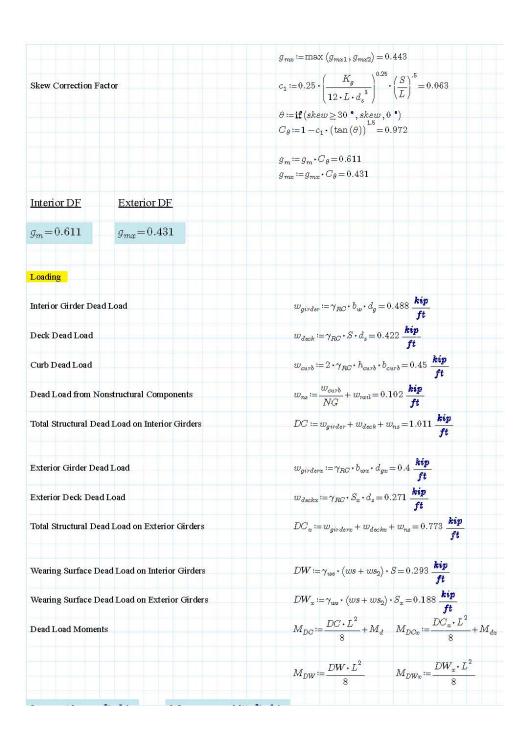
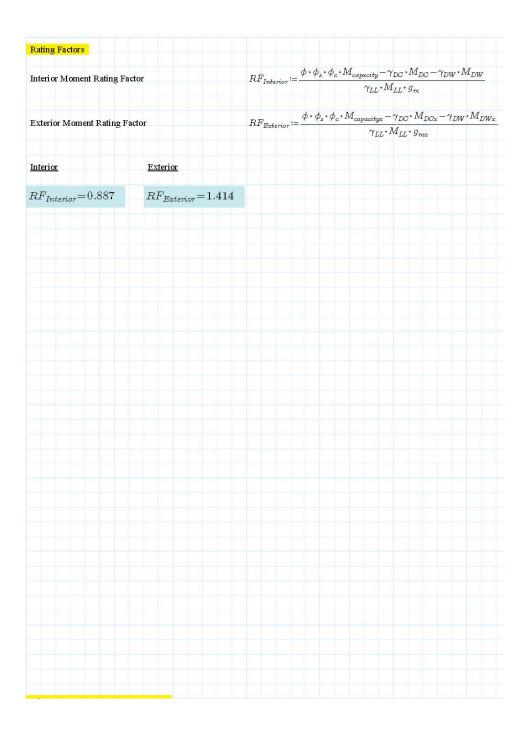
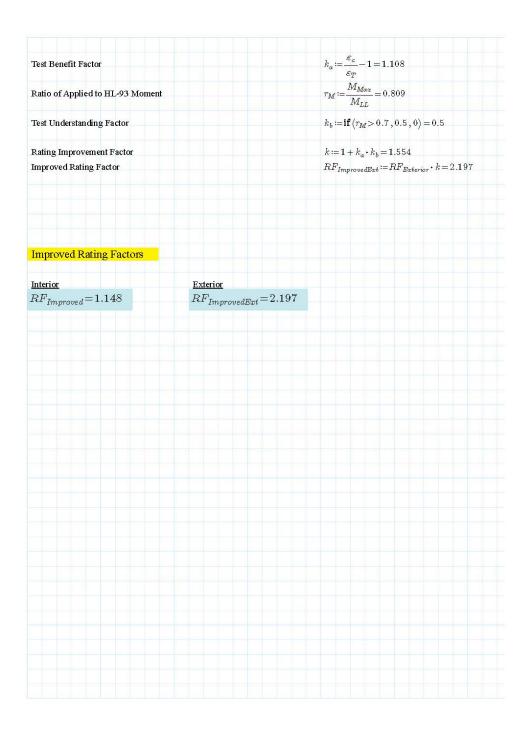
Figure 105: Bridge 3848 calculations

Rating Factor Improvements		
Concrete Compressive Strength - Larger is More Conservative	$f_{c}^{\prime}\!\coloneqq\!5$ kei	
Concrte Elastic Modulus	$E_c\!\coloneqq\!1820$ kei $\cdot\sqrt{rac{f'_c}{ksi}}\!=\!\left\langle4.07\cdot10^3 ight angle$ kei	
Interior Girders		
Maximum Recorded Strain	$\varepsilon_T := 89.35 \cdot 10^{-6}$	
Maximum Applied Moment per Lane	$M_{Max}\!\coloneqq\!478.1~ extbf{ft}\cdot extbf{kip}$	
Uncracked Section Modulus	$S_{unc}\coloneqq 6065$ in $^3$	
Cracked Section Modulus		
	$S_{cr}\coloneqq 1991$ in $^3$	
Section Behavior	Behavior := "Uncracked"	
Section Modulus Effective for Behavior	$S_e \coloneqq \mathbf{if} \left( Behavior \texttt{= "Uncracked"}, S_{unc}, S_c \right)$	
Calculated Strain	$\varepsilon_c \coloneqq \frac{M_{Max} \cdot g_m}{S_e \cdot E_c} = 1.419 \cdot 10^{-4}$	
Test Benefit Factor	$k_{\alpha} \coloneqq \frac{\varepsilon_{c}}{\varepsilon_{T}} - 1 = 0.589$
