# **Effectiveness of Exterior-Beam Rotation-Prevention Systems for Bridge Deck Construction—Phase II**

Saint Louis University

Research Report No. FHWA-ICT-19-011

**ICT PROJECT R27-179**

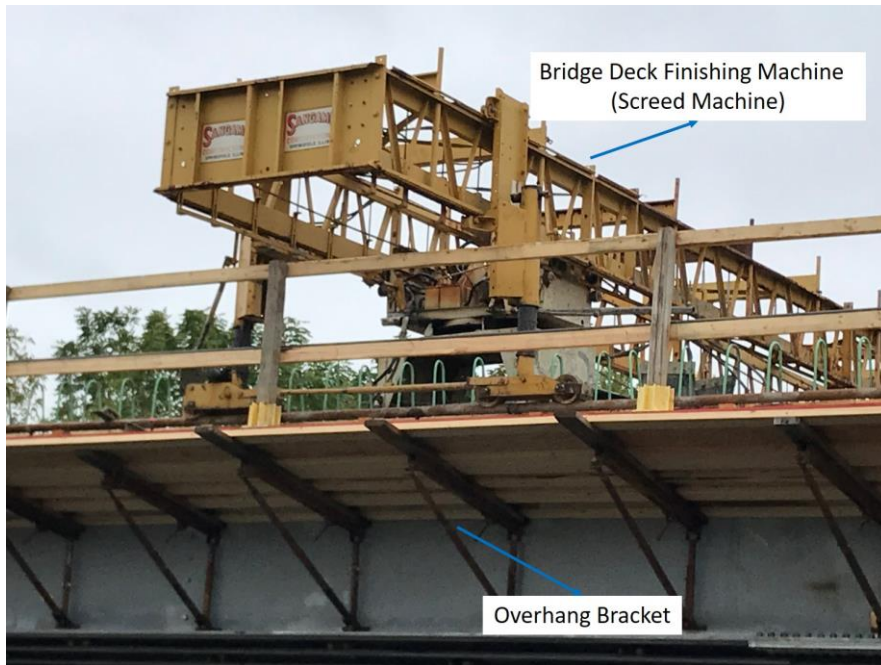
**Figure 1. Construction of deck overhang.**

The bridge deck is generally designed to extend past the exterior girders to increase the width of the deck without increasing the required number of girders. The construction of the bridge deck is often finished with overhang brackets generally spaced 3 to 6 ft apart along the exterior girder to support the construction loads coming from the fresh concrete, the bridge deck finishing machine, and other construction live loads (shown in Figure 1). In some cases, these loads on the overhang brackets can result in torsional moments acting on the exterior girders, causing excessive exterior-girder rotation. This rotation may cause bridge failure due to global and local instabilities during deck construction (Gupta et al., 2006; Lackey, 2017; Mohammadi et al., 2016; Shokouhian and Shi, 2015; Winkler et al., 2017). Furthermore, the rotation in the exterior girder may cause some potential maintenance issues, such as a thin deck with reduced concrete cover over reinforcement bars, and may lead to long-term corrosion and cracking in the deck (Ashiquzzaman et al., 2016; Clifton and Bayrak, 2008; Fasl, 2008).

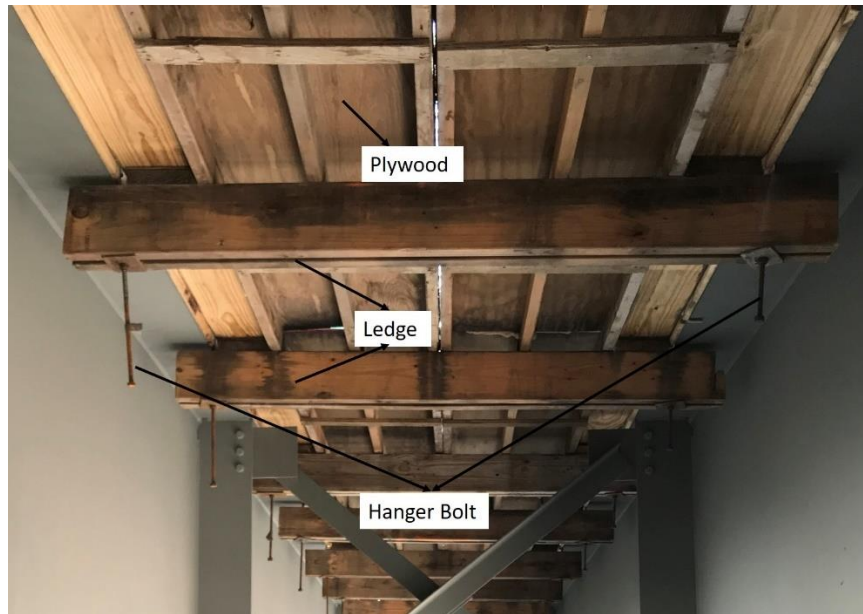
**Figure 4. Interior formwork.**

During bridge deck construction, a formwork system is often used to shape the fresh concrete, as well as support the construction loads. Although several manufacturers, such as Dayton Superior and Meadow Burke, offer different types of formwork systems, the formwork system typically includes interior formwork supporting the fresh concrete between two girders, and the overhang formwork for the overhang portion of the bridge deck (Dayton Superior, 2017; Meadow Burke, 2018). The interior formwork mainly consists of plywood, ledge timbers, and hanger bolts, as shown in Figure 4. The fresh concrete of the bridge deck is placed directly on top of the plywood, which is supported by the ledge timbers. The hanger bolts connecting the ledge timbers with the bridge girders transfer the construction loads to the bridge girder system.

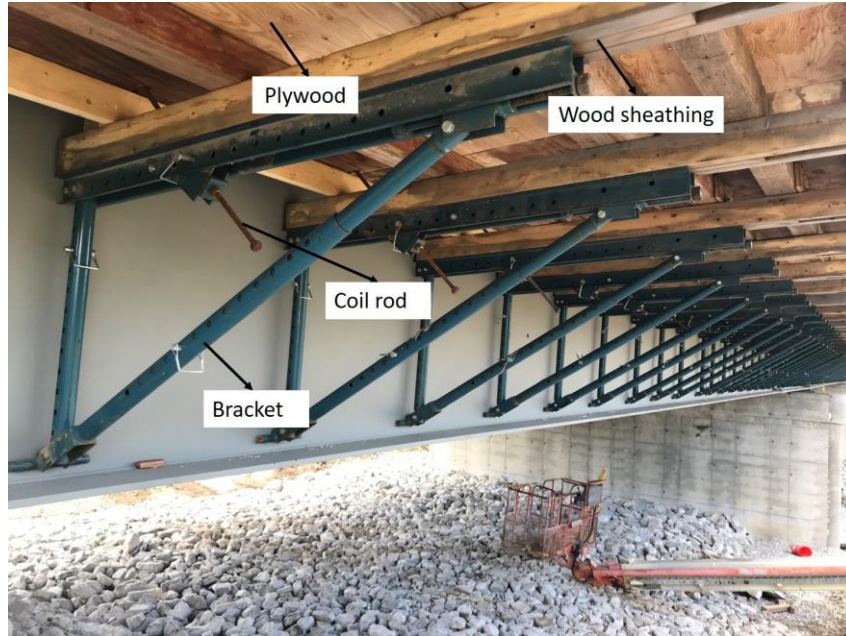
The overhang formwork system, shown in Figure 5, consists of plywood sheathing and timber joists supported on steel brackets usually placed 3 to 6 ft apart along the exterior girder (Clifton and Bayrak, 2008; Dayton Superior, 2017). The overhang brackets are typically connected to the top flange of the exterior girder using coil rods and react against the bottom of the girder web.

**Figure 5. Overhang formwork.**

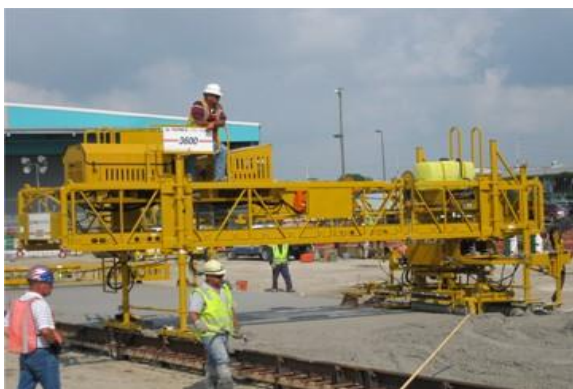
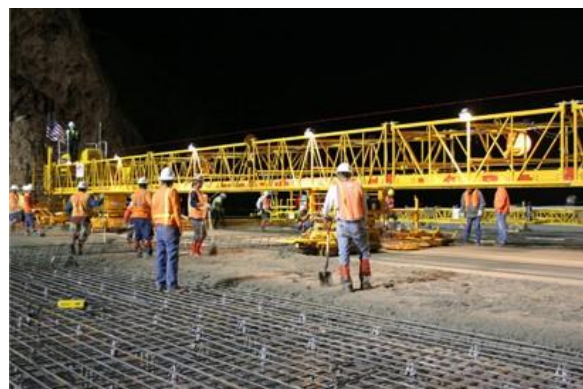
**Figure 6. Bridge deck finishing machines.**

Phase I of this study showed that the weight of the bridge deck finishing machine is one of the primary contributors to excessive rotation of the exterior girder (Ashiquzzaman et al., 2016; Yang et al., 2010). The bridge deck finishing machine, which is a truss spanning the width of the bridge, strikes off the freshly poured concrete and smooths the concrete surface by moving a roller unit back and forth across the deck. Some finishing machines that are commonly used in the state of Illinois are the Bidwell 3600 and Bidwell 4800, as shown in Figure 6. The basic specifications of both models are shown in Table 1.

(a) Bidwell 3600

(b) Bidwell 4800

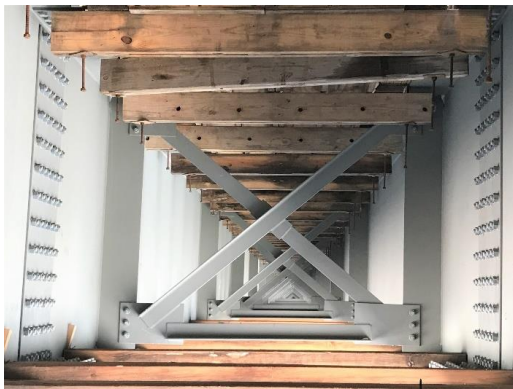
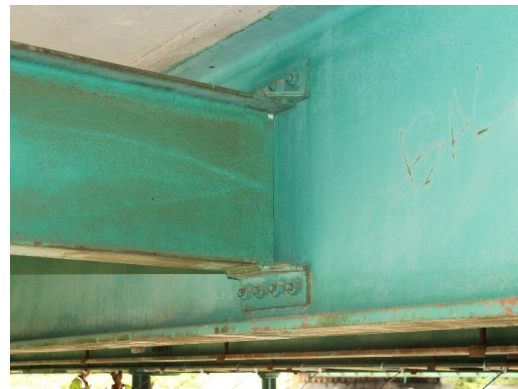
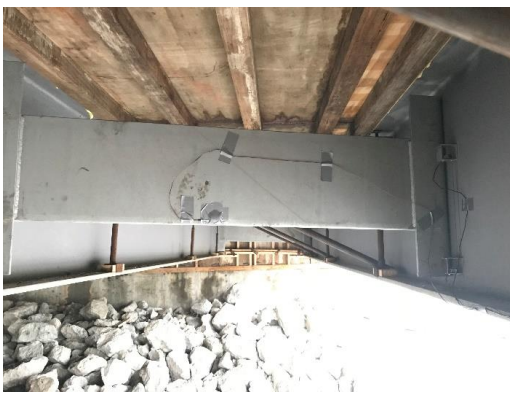
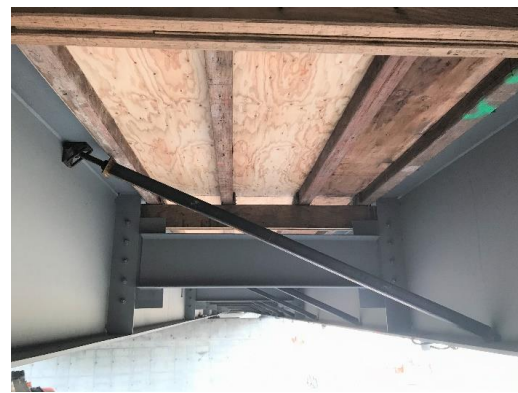
**Figure 13. Different types of permanent bracing systems and connections.**

(a) Cross-frame with full-depth connecting plate

(b) Diaphragm with angle steel connection

(c) Diaphragm with partial-depth connecting plate

(d) Diaphragm with full-depth connecting plate

The types of bracing systems and the connections between these systems and the girders may also influence the  $B/D$  ratio (Hraib et al., 2018, 2019). Four types of permanent bracing systems widely used in bridge design are shown in Figure 13. The cross-frame (shown in Figure 13a) typically braces

the entire depth of the girder section and provides adequate stiffness to prevent exterior-girder rotation. However, when diaphragms are used, the effectiveness of the bracing system at resisting transverse rotation strongly depends on the relative depth between the girder and the depth of the connecting plates. When the diaphragms are connected to the girders using steel angles (Figure 13b) or partial-depth connecting plates (Figure 13c), distortion of the girder web may occur, resulting in different rotation values between the web and flanges of a girder. In this case, the top flanges may still suffer a transverse rotation greater than the allowable limit. However, when using a full-depth connecting plate between the diaphragms and girders (shown in Figure 13d), the diaphragms provide resistance to the transverse rotation of the girders because the connection plates are welded to the web and flanges. Therefore, it is necessary to take the types of bracing systems and connections between the bracing system and the girder into consideration when determining the B/D ratio.

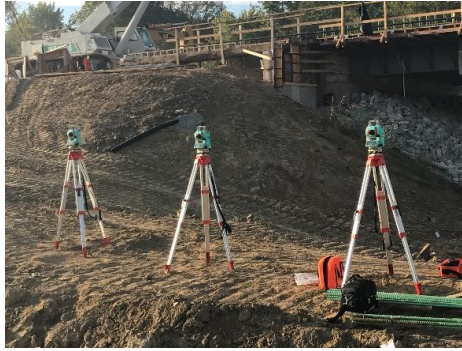
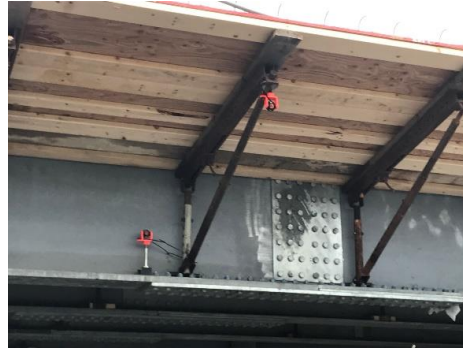
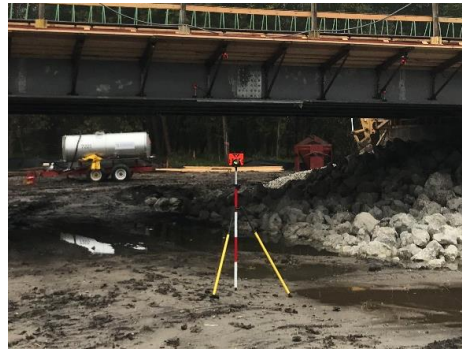
**Figure 21. Deflection measurement.**

Three total stations were utilized for each bridge to measure vertical deflections of exterior girders, as shown in Figure 21. Two prisms (reflectors) were employed to record deflections of the overhang formwork and the girder at each instrumented section. Additionally, a reference point was also established using a single prism located at a steady point (shown in Figure 21c). The main purpose for using the total station readings was to measure deflections of the exterior girders during the deck-slab construction and to validate the FE models.

(a) Total station

(b) Location of prisms

(c) Reference point

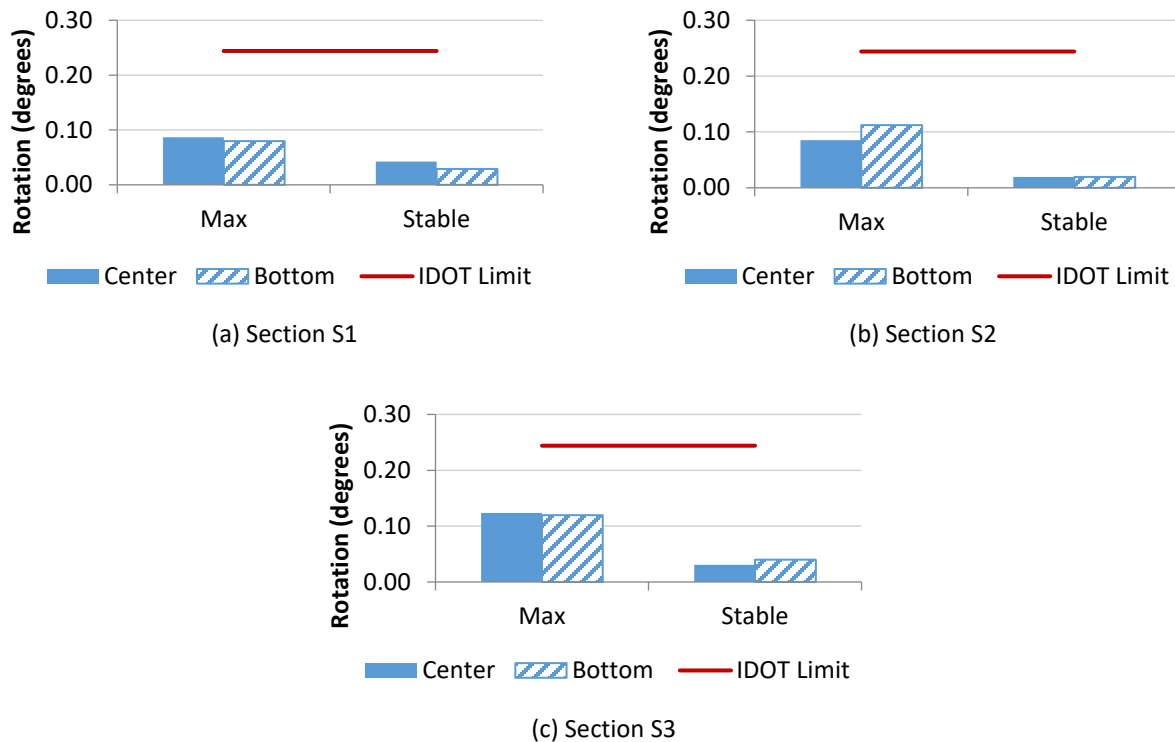
The maximum and stable rotation values of the exterior girder at each instrumented section of Lawrence Bridge are illustrated in Figure 26. The results indicated that the maximum rotation ( $0.12^\circ$  at both the center and bottom of the web) of the exterior girder during deck construction occurred at S3, located approximately at the center between two cross-frames. At the center of the web, sections S1 and S2 had the same rotation value of  $0.09^\circ$ . However, the maximum rotation at the bottom of the web ( $0.08^\circ$  at S1 and  $0.12^\circ$  at S2) had a difference of 20%, compared with the values at the center of the web, due to distortion of the girder. The stable rotation ranged from  $0.02^\circ$  to  $0.04^\circ$ , and the values at the center of the web were close to the data recorded at the bottom of each section.

**Figure 26. Maximum and stable rotations of exterior girder for Lawrence Bridge.**

Although temporary bracing systems were not used during deck construction of Lawrence Bridge, the maximum rotation ( $0.12^\circ$ ) was 50% below the IDOT limit ( $0.24^\circ$ ). In this bridge, cross-frames were fully braced along the depth of the girders; and the maximum spacing of these cross-frames (B) was greater than four times the girder's depth (D). As such, this bridge validates use of that criterion, recommended in Phase I of this project, in limiting the rotation of the exterior girders.

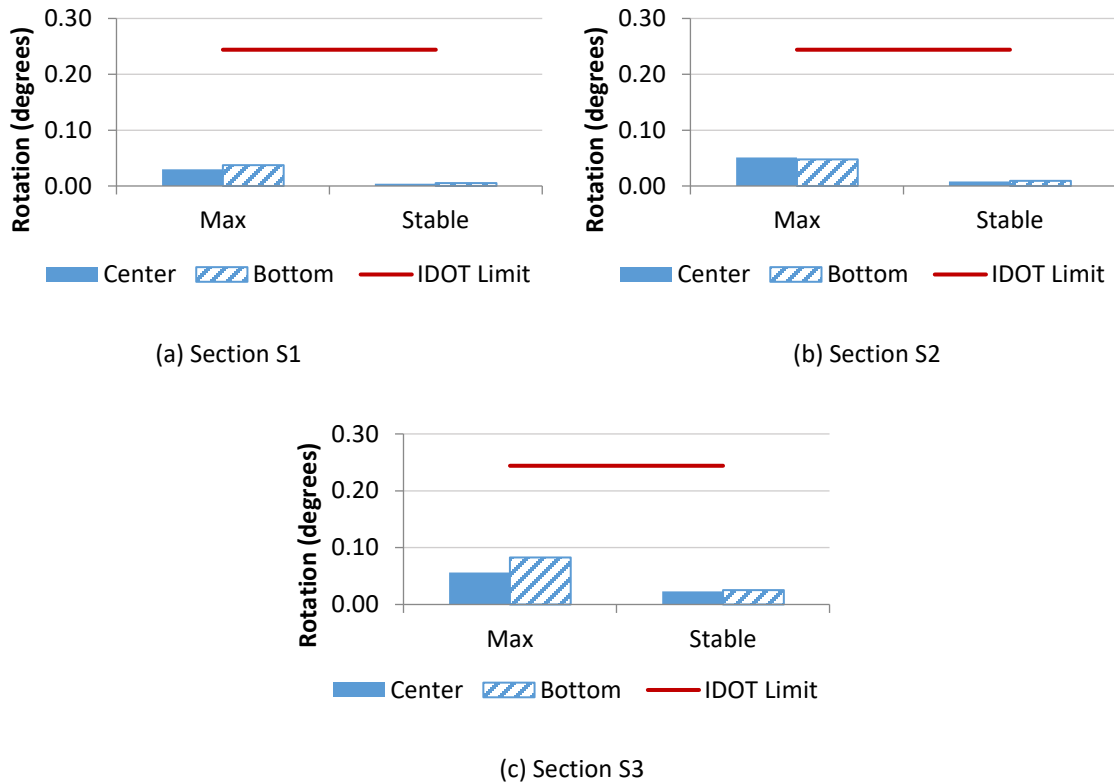
As shown in Figure 27, the interior girder had significantly lower rotation values, compared to the exterior girder. The maximum rotation value for the interior girder was measured as  $0.08^\circ$  at S3. However, the stable rotation at the interior girder showed very small values, ranging between  $0.01^\circ$  and  $0.02^\circ$ .

**Figure 27. Maximum and stable rotations of interior girder for Lawrence Bridge.**

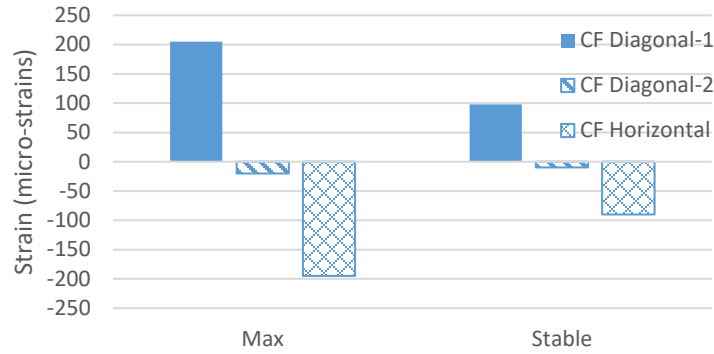
Because Lawrence Bridge did not utilize any temporary bracing system, strain gages were used to measure the strains in the cross-frame, as well as the bottom flanges of the exterior and interior girders at S2. The maximum and stable strain values recorded in the diagonal and horizontal members of the cross-frame are illustrated in Figure 28. The results showed that the horizontal cross-frame member was in compression, while one of the diagonal chords was in tension and the other had almost zero strain. This pattern aligns with the behavior of X-shaped cross-frames with a bottom chord when the girder is subjected to torsional moments. The stable strain followed the same trend but with values lower than the maximum by 50%.

**Figure 28. Field measurement of strain values in the cross-frame for Lawrence Bridge.**

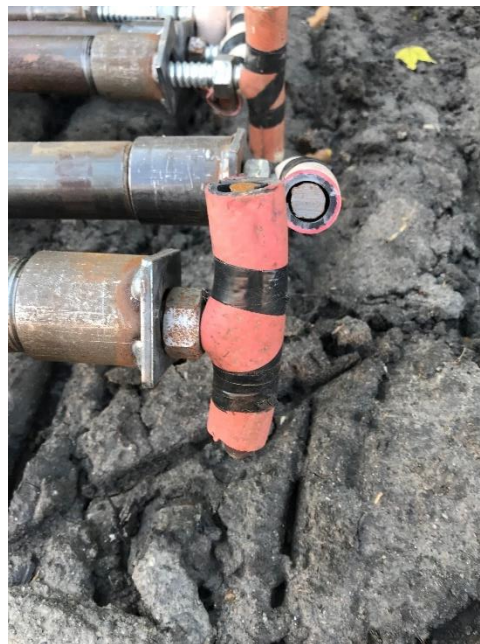
Figure 52. Protective rubber at the ends of the pipes used in McDonough Bridge.

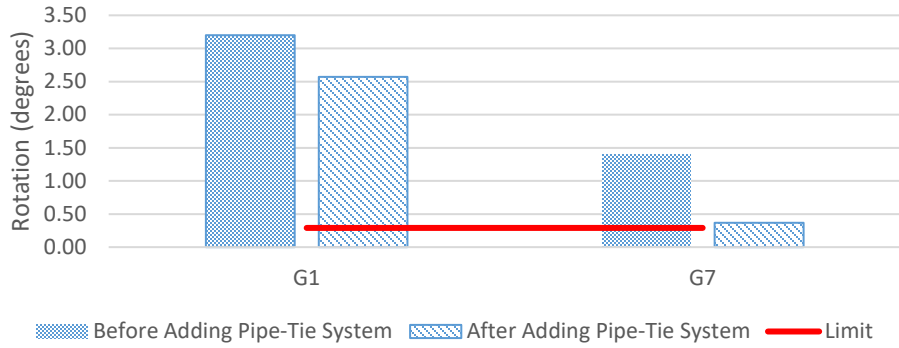
The maximum rotation of Madison-II Bridge is shown in Figure 67. The results indicated that before adding the pipe-tie system, maximum rotation in the exterior girder G1 (W33x130 section) was 3.2°. However, the corresponding value for exterior girder G7 (W36x182 section) was recorded as 1.06°. It was noticed that the maximum rotation in G1 was more than three times as large, compared with the maximum rotation in G7. This behavior is mainly caused by differential deflection of the girders during and after pouring of the concrete deck. Due to the relatively smaller section of W33x130 compared with the other girders, deflection in G1 is higher than that in the rest of girders. Moreover, adding the pipe-tie system led to a reduction of only 20% in maximum rotation of G1. The low reduction in rotation is because the rotation of G1 is mainly caused by differential deflection caused by the different moment of inertia between G1 and G2, rather than the torsional moment acting on the overhang. However, the system was able to reduce rotation by 74% in G7 because differential deflection is not the primary reason for exterior-girder rotation.

**Figure 67. Maximum rotation for Madison-II Bridge.**

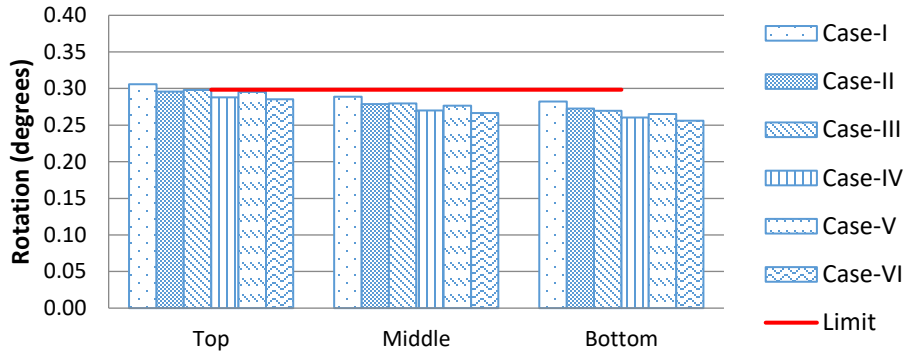
Comparison of the maximum rotation values of the bridge models with different sizes of ties and pipes is shown in Figure 71. The results indicated that maximum rotation values were reduced approximately 3% when using #5 rebar instead of #4 rebar for transverse ties. Also, around 3% difference in rotation values was observed when a larger round-pipe section was implemented during deck construction. The square pipe showed very similar performance when compared with the round pipe of similar size; less than 1% difference was found, based on the results of FE analysis of the two pipe sections. Thus, the size of transverse ties and diagonal pipes has minimal effect on the prevention of exterior-girder rotation.

**Figure 71. Comparison of maximum rotation values.**
