## **At-Grade Busway Study**

**L. David Shen, Hesham Elbadrawi, Fang Zhao and Diana Ospina  
Principal Investigators  
Florida International University**

December 1997

Lehman Center for Transportation Research  
College of Engineering and Design  
Florida International University  
The State University of Florida at Miami  
Miami, FL 33199  
TEL: (305) 348-3055  
FAX: (305) 348-4057

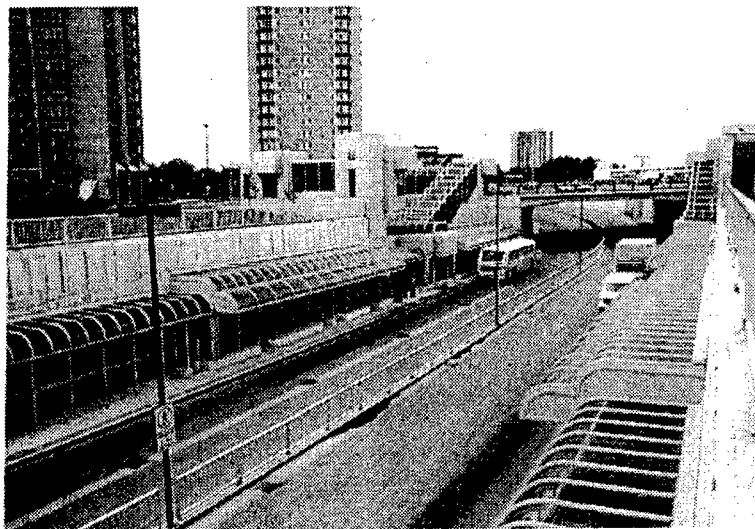
**Figure 2.2 - On-line Transit Station**

length. Different types of grade separation for the Ottawa Transitway system are shown in **Figures 2.2 and 2.3**. The only exceptions are the 1.4 mile (2.25 km) downtown section, which consists of concurrent flow reserved bus lanes, and the 2.3 miles ( 3.7 km) of parkway operation in mixed traffic. Buses operate up to their maximum speed of about 55 mph (90 km/hr), but restricted to 30 mph (50 km/hr) in station areas.

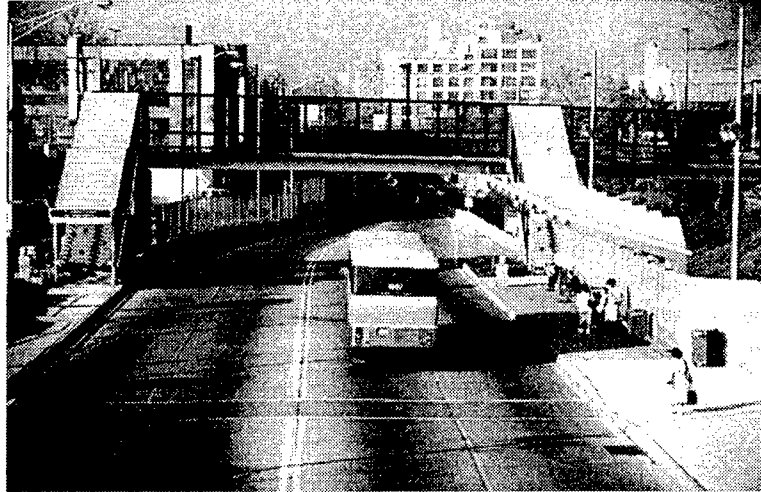
**Figure 2.7 - Pittsburgh's East Busway**  
(Source: NCHRP Synthesis 185)

The total separation of bus traffic from other vehicular traffic, shown in **Figure 2.7**, gives the Martin Luther King, Jr. East Busway a safety advantage over any other bus transit facility in the United States (Wohlwill 1996).

Three pedestrian overpasses were constructed at high volume station areas (shown in **Figure 2.7**). Grade separated street crossings and platform pull off lanes at stations add safety features that were incorporated in this facility. Along most of the two 12-foot-wide (4.0 m) busway lanes, 8-foot-wide (2.5 m) concrete shoulders have been constructed. This design allows the safe passing of disabled vehicles, snow removal and storage, and operational clearance. Special speed restrictions are enforced in areas where shoulders do not exist. The busway is only accessible at station areas due to the security fencing along the route. Air and noise pollution was also reduced by designing the busway with an average one percent and maximum four percent grade (Wohlwill 1996). The pull-over capabilities at each station further reduce pollution by minimizing stopping and starting of buses. PAT also allows police and emergency vehicles access to the busway. These are some of the precautions that have helped make the East Busway a safe and efficient means of travel.

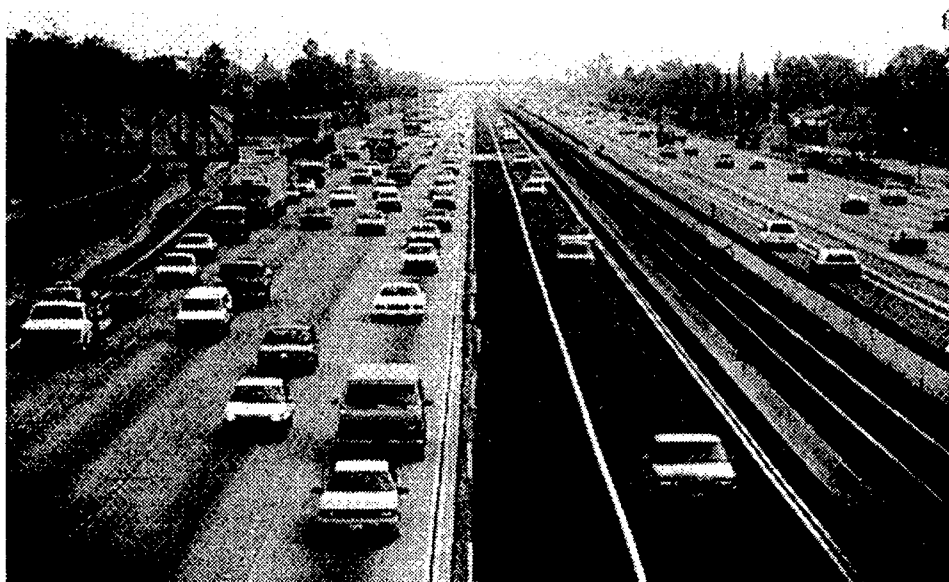
**Figure 2.16 - El Monte HOV Lanes**

The El Monte Busway consists of two distinct sections. The eastern (outermost) seven miles (11.2 km) of the busway is located in the median strip of the freeway. This section consists of one 17-foot (5.2 m) lane in each direction separated from the main lanes by 10-foot (3 m) paved shoulders with stanchions. The remaining four miles of the busway run parallel and adjacent to the north side of the freeway, and consists of two 25-foot (7.6 m) wide lanes separated from the freeway by a concrete barrier, as shown in **Figure 2.16**.

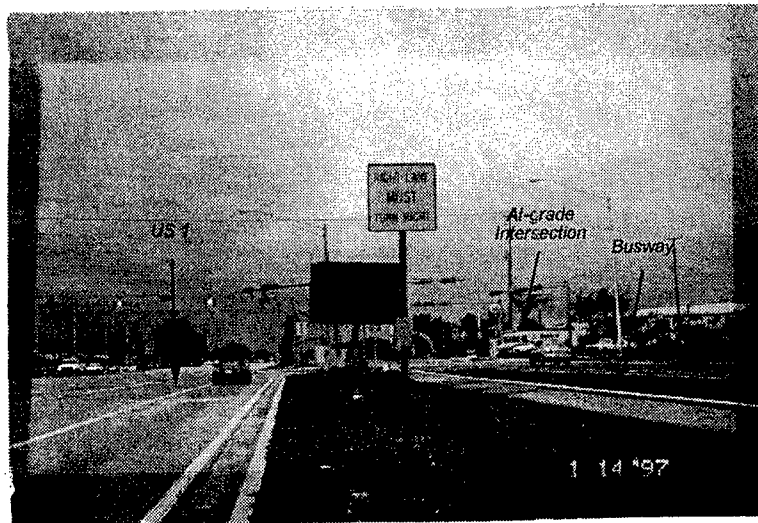
**Figure 4.10 - New Exclusive Right Turn along US 1**

The busway intersects with 20 major signalized intersections, of which 11 are within a 50 to 80 feet separation distance between the busway and the pavement edge of US 1. At these intersections, the busway and US 1 operate as a single signalized intersection (combined intersection). In order to operate the busway safely, exclusive right turn lanes with right turn signals along the US 1 southbound were added at most of the intersections to provide an exclusive right turn movement as shown in **Figure 4.10**. Another safety measure was the conversion of northbound left turns to restrictive protection phasing. The close separation distance between the busway and the US 1 edge of pavements and the installation of a portable message sign during the early periods of operation with NO TURN ON RED indication to warn the motorists with the new signal configurations and the operation of the busway is also shown in **Figure 4.10**. Side street operations were also converted to directionally separated phasing. Programmable signal heads were installed at the side streets to prevent the motorists confusion between busway and US 1 signal heads.

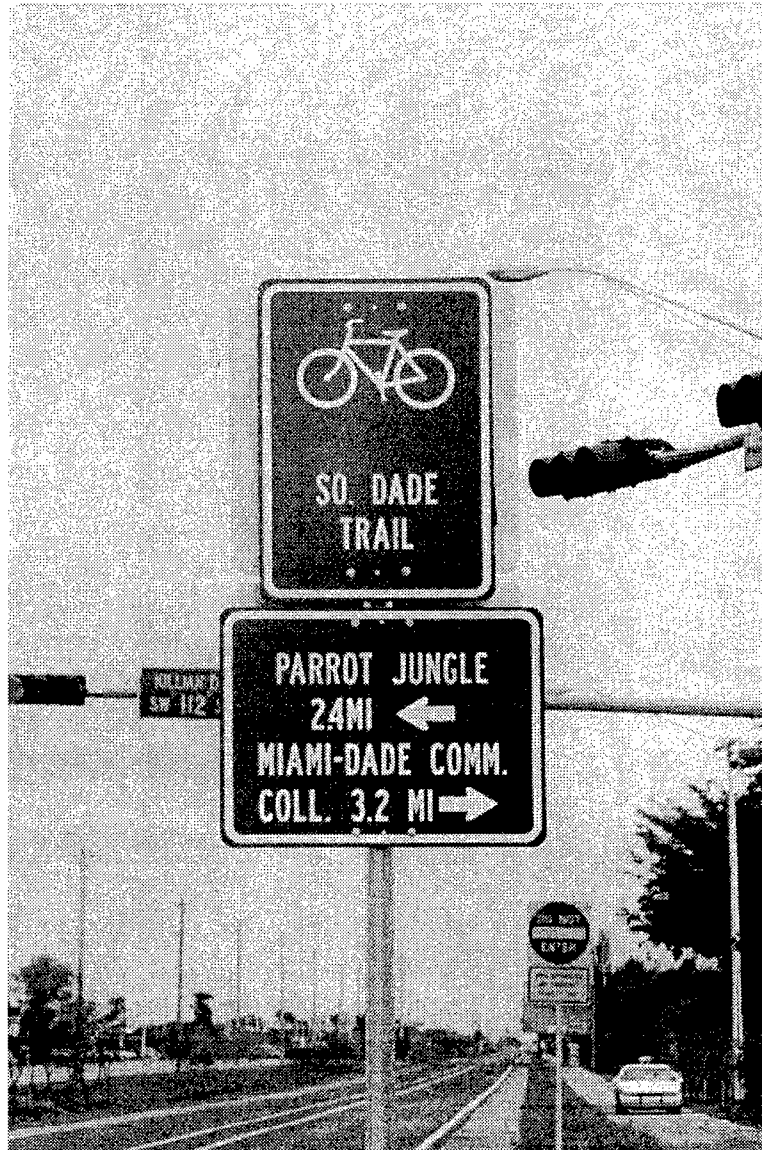
**Figure 4.11 - Bike Path Information at SW 112 Street**

A 10-foot bicycle path is also provided west of the busway. In addition of providing for the north-south movement of non-motorized traffic, the South Dade Trail collects and distributes pedestrians and bicyclists to and from the busway stations. An example of signs on the bike path to inform cyclists of major activities that are accessible by bicycles is shown in **Figure 4.11**. Pedestrian signal are also installed to control movements of non-motorized traffic across the streets that intersect with the Busway.

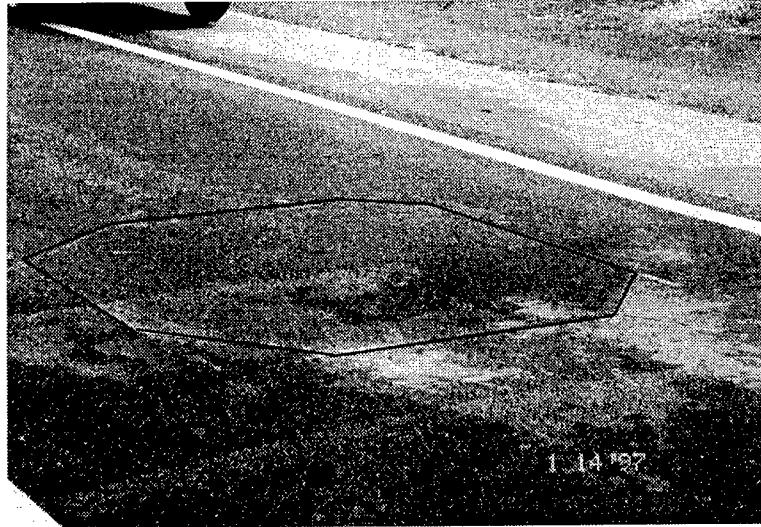
**Figure 4.12 - Advanced Vehicle Detectors Installed on the Busway**

Advanced vehicle motion detectors are installed on the at-grade busway to allow express buses to travel from Dadeland South Station to Cutler Ridge Station without stopping. The advanced vehicle detectors shown in **Figure 4.12** are placed at 600 feet and 375 feet before the intersection to allow an approaching bus, if arriving during the allowable preemption window, to proceed through the intersection without stopping (Fowler 1995). Sufficient time is given for the preemption phase to terminate and clear before a bus reaches the dilemma zone. Thus express buses can travel the entire length of the at-grade busway without making a local stop.

3. A speed of 40 mph is used to program the advanced vehicle detectors, so when a bus passes over the detectors traveling at 40 mph, the bus will have a green signal when reaching the intersection. As it was observed, bus drivers usually exceed the posted speed limit on the busway (40 mph) trying to catch up with the schedule, thus eastbound vehicles arriving to the busway intersection at the dilemma zone do not have enough time to clear the intersection to allow the buses to pass.
