Consultant Support for Intelligent Compaction and Paver-Mounted Thermal Profiling Projects in 2020-2021

May 2022
Final Report

Project number TR202021
MoDOT Research Report number cmr 22-006

The Transtec Group, Inc.

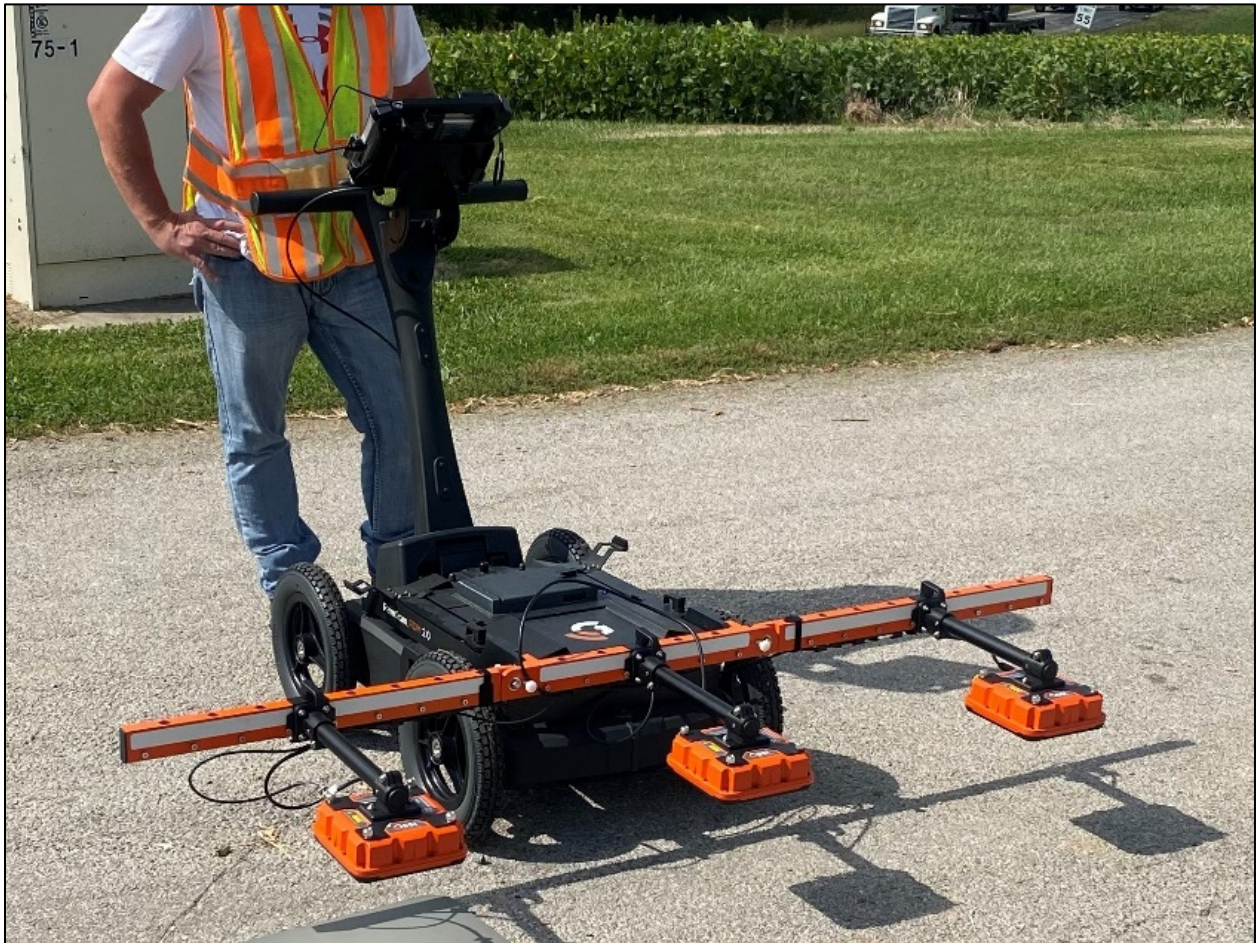
Figure 1. Photo. RDM 2.0 DPS equipment

The FHWA Equipment Loan Program at the Mobile Asphalt Technology Center (MATC) (FHWA, 2020B) agreed to loan MoDOT a unit of the GSSI PaveScan Rolling Density Meter (RDM) 2.0 (GSSI, 2020) for field testing and evaluation during the 2021 construction season. The RDM 2.0 uses three GPR antennas mounted to a pushcart, as illustrated in Figure 1.

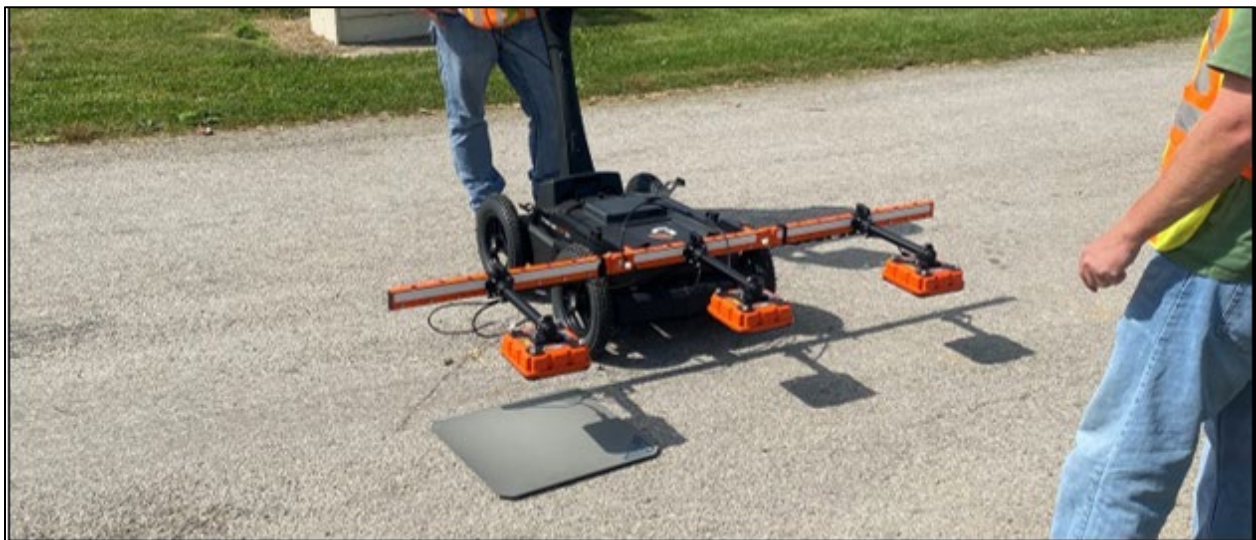
Figure 2. Photo. RDM 2.0 metal plate calibration.

A metal plate calibration must be performed with an airwave calibration (GSSI 2020). The metal plate calibration involves activating the sensors one at a time over a metal plate, as shown in Figure 2. The display will notify the user when the metal plate calibration is completed.

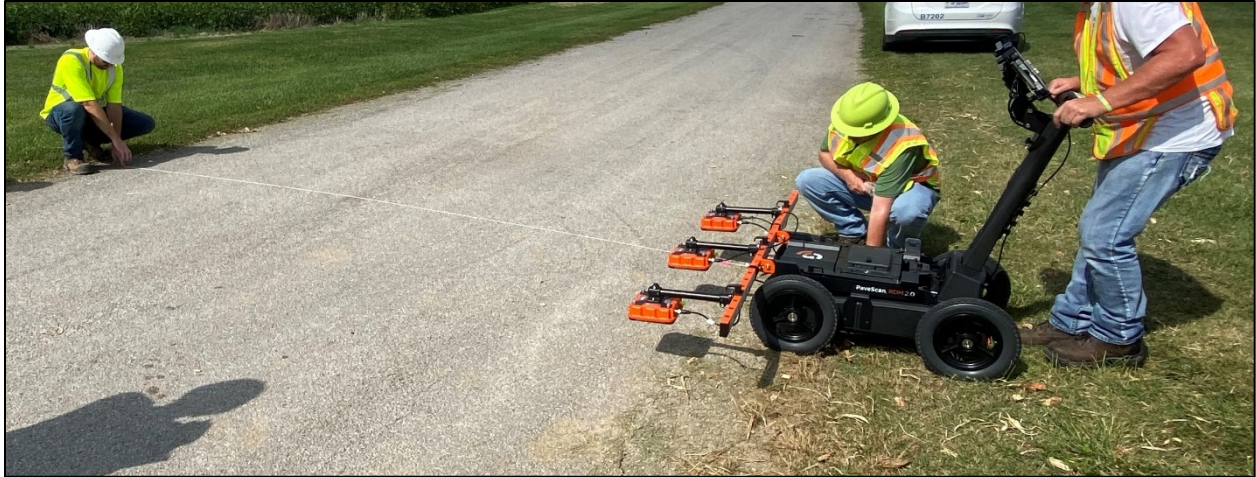
Figure 3. Photo. RDM 2.0 line calibration.

Line calibrations are performed using a string line to mark a 10-foot straight line transversely across the calibration site. Each sensor collects data along the 10-foot line, and a laser line is mounted on each sensor to help keep the sensor on the line. The median dielectric value is compared for each sensor, and the dielectric values should be within 0.08 of each other (MATC 2021). An example of line calibration performance is shown in Figure 3.

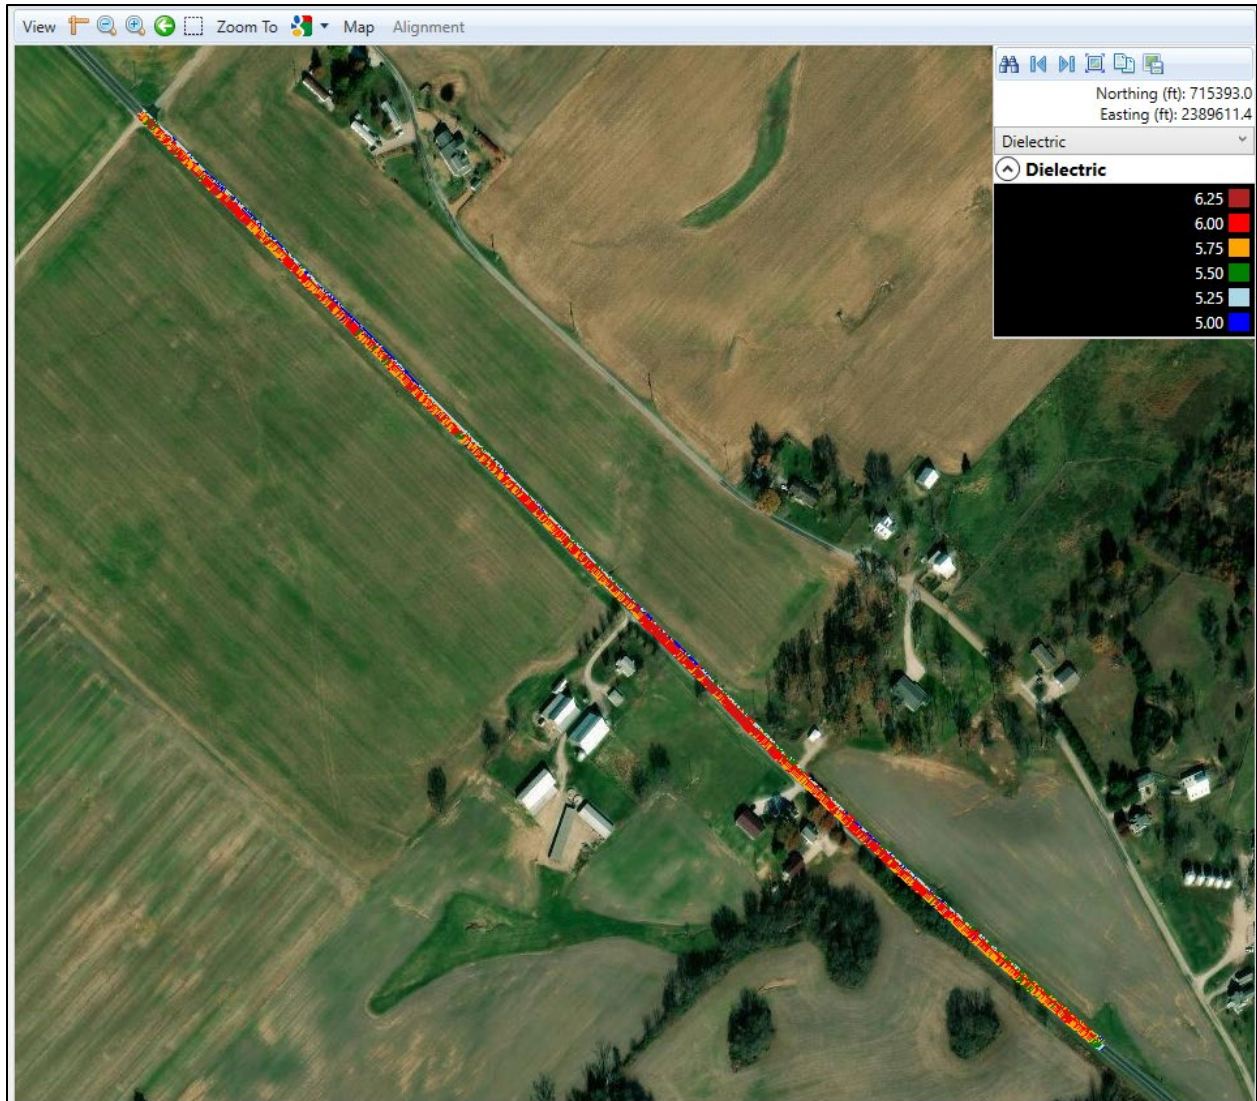
Figure 5. Screenshot. The extent of dielectric data collected using the RDM 2.0 on Project Code 4

Approximately 3,200 feet of data were collected on Project Code 4. The extent of collected data is shown in Figure 5.

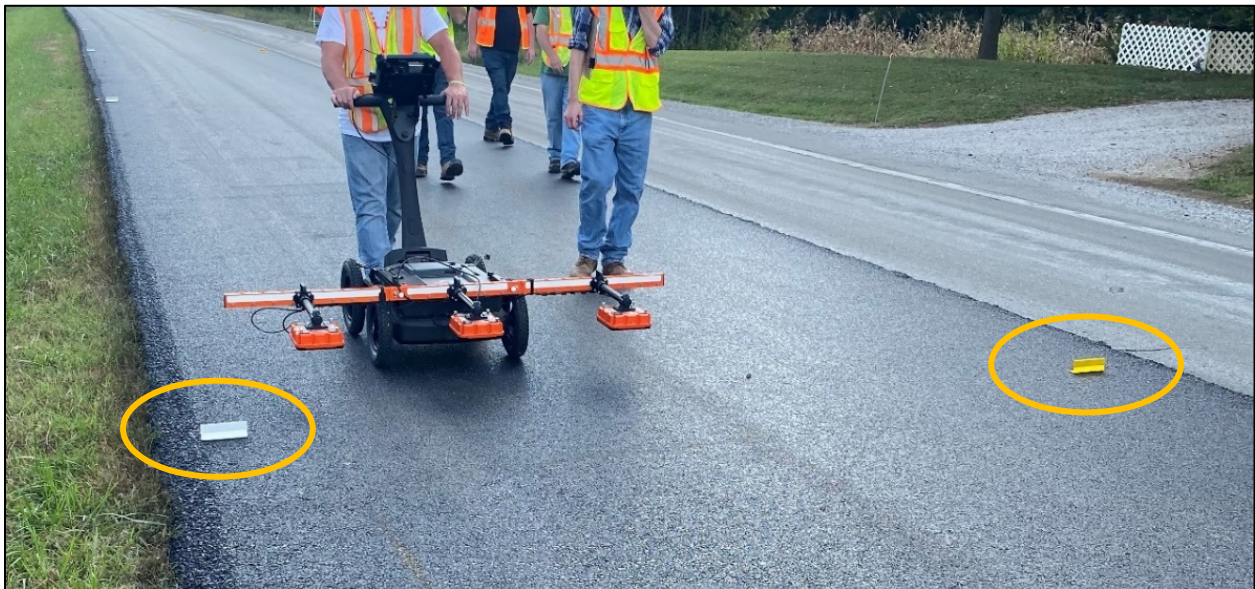
Figure 6. Photo. Temporary lane markings on either side of the pavement interfere with RDM readings (false low density, out of range density).

The DPS equipment was set up with a 2-foot sensor offset for a total collection width of 4 feet. The 2-foot offset was the preferred setup because the contractor's temporary lane markings were placed inside the lane, as shown in Figure 24. The temporary lane markings caused erroneous readings, and therefore, only 8 feet of the total width of the mat was collected. Veta has filtering capabilities to remove such obstructions after data collection. Therefore, it is recommended that full-width data be collected in the future. There is some error in GPS and human-induced wander, and therefore, each 4-foot width varies by location. The data wander is further illustrated under section 4.2.3.2.

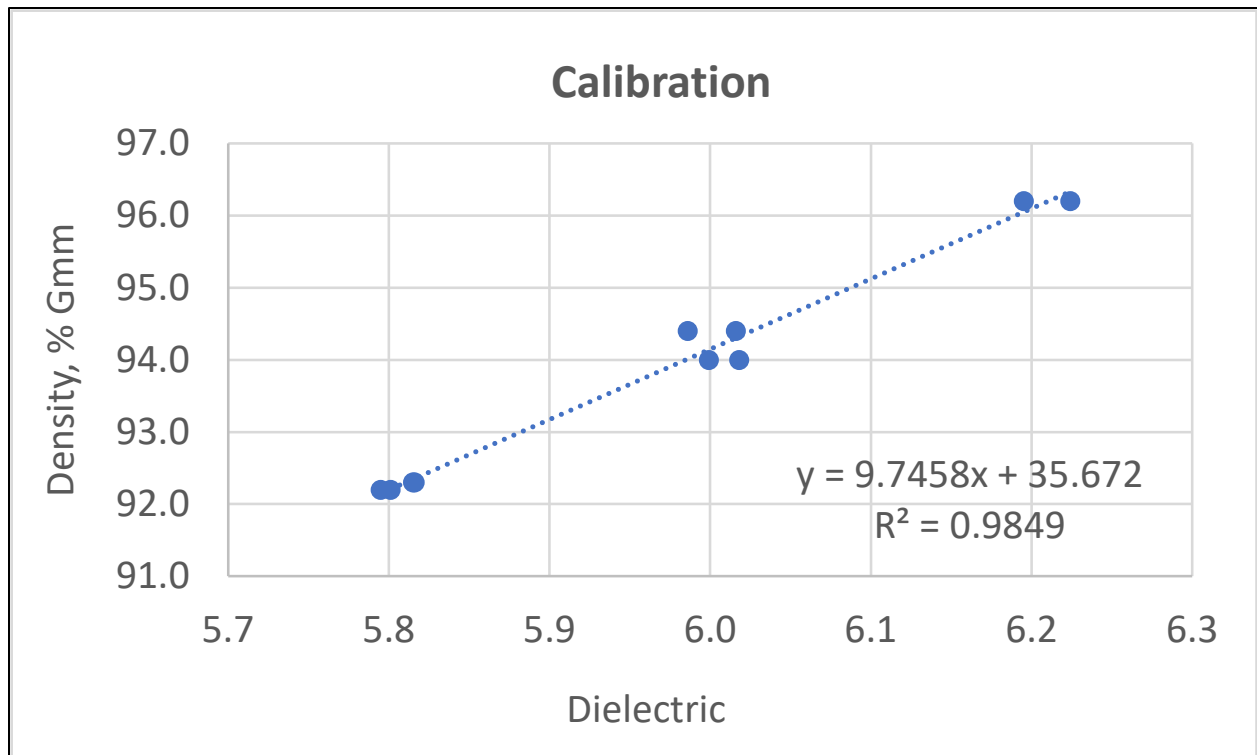
Figure 9. Graph. Calibration data from gyratory samples.

The contractor made gyratory samples using loose mix sampled that day and provided them to MoDOT. The DPS equipment was used to measure the dielectric constants of the gyratory samples. The gyratory sample air voids (relative density) and corresponding dielectric measurements were plotted, and a linear trend line was obtained, as shown in Figure 9. According to the manufacturer, density correlations should include a low, mid, and high relative density range, as illustrated in Figure 9.

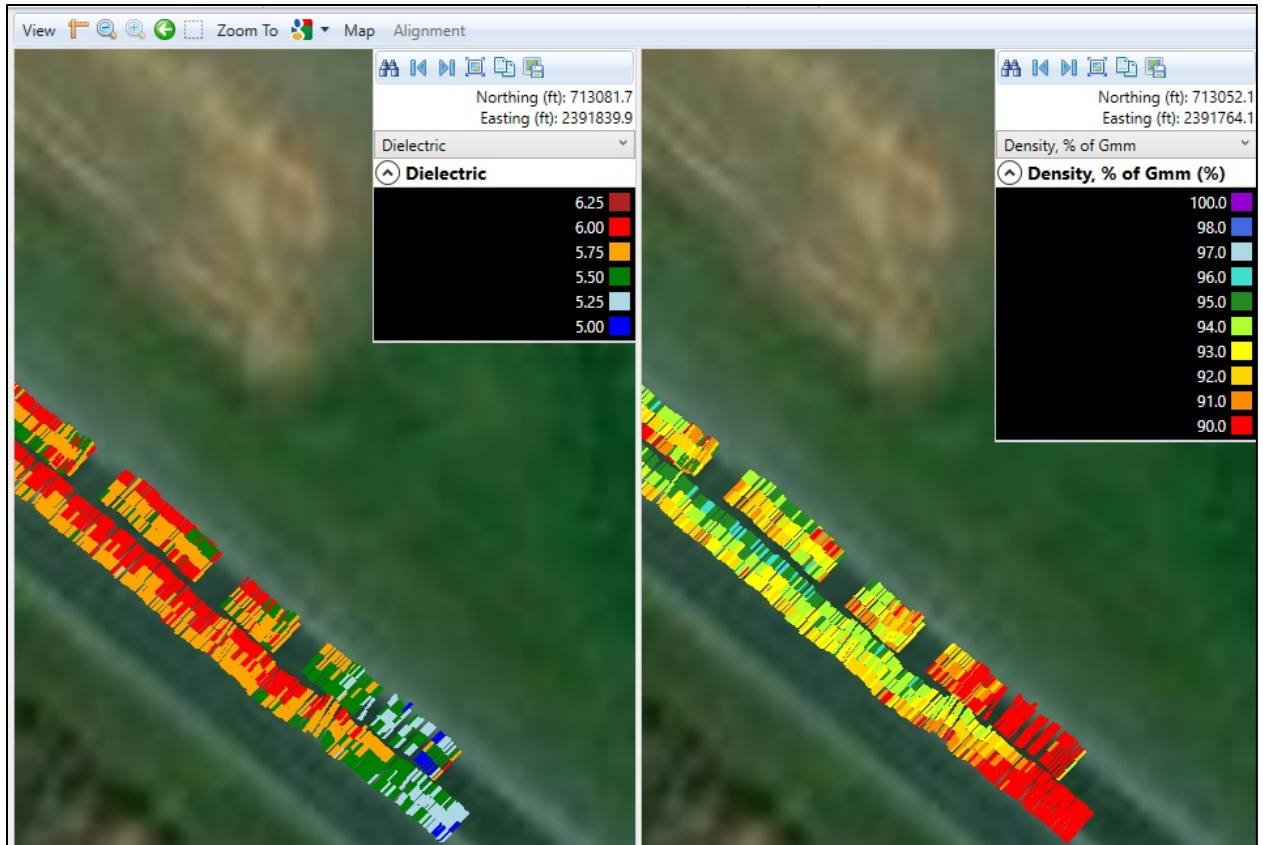
Figure 10. Screenshot. Relatively low dielectric data at the start of paving at the transverse joint.

Low dielectric data was observed at the beginning of the panel at the transverse joint. The low dielectric data is illustrated in Figure 10. A photo of the transverse joint is shown in Figure 11. The contractor's IC data was imported to the project to troubleshoot the low density at the transverse joint. The data showed that the optimum pass count was met. However, the temperature data showed that the temperatures during breakdown rolling were relatively cool compared to the rest of the production temperatures. Therefore, the data shows that this area was not rolled at the optimum temperatures, as illustrated in Figure 12. It is not uncommon to have cooler temperatures at the start of paving since the equipment at startup is at ambient temperatures. However, the effects of cooler start temperatures are not easily identified or quantified if ICTs are not used.

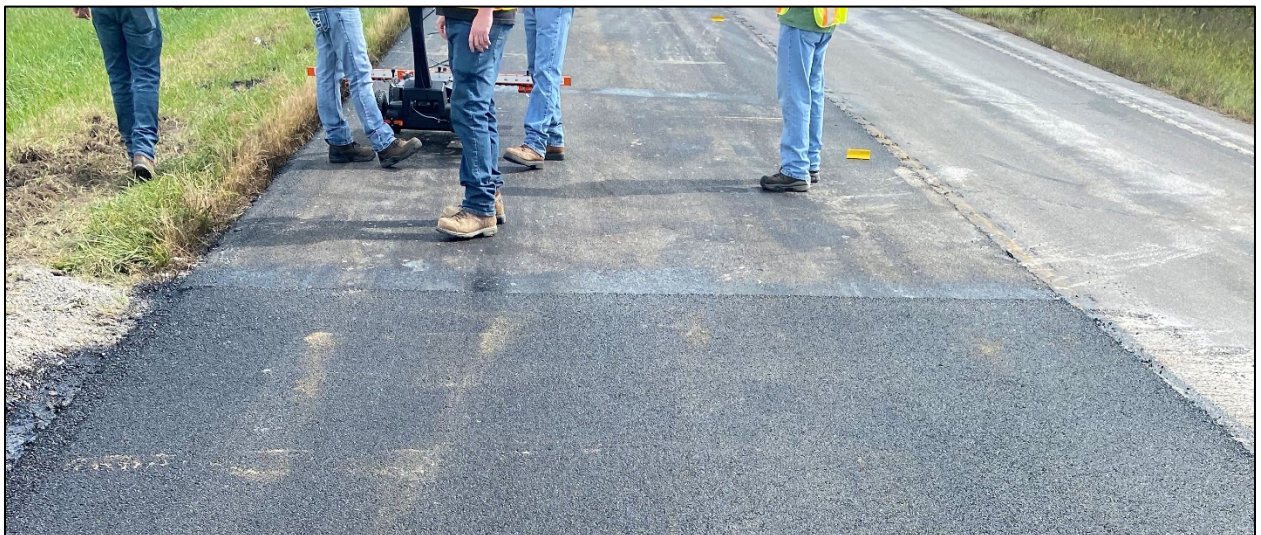
Figure 11. Photo. The transverse joint.

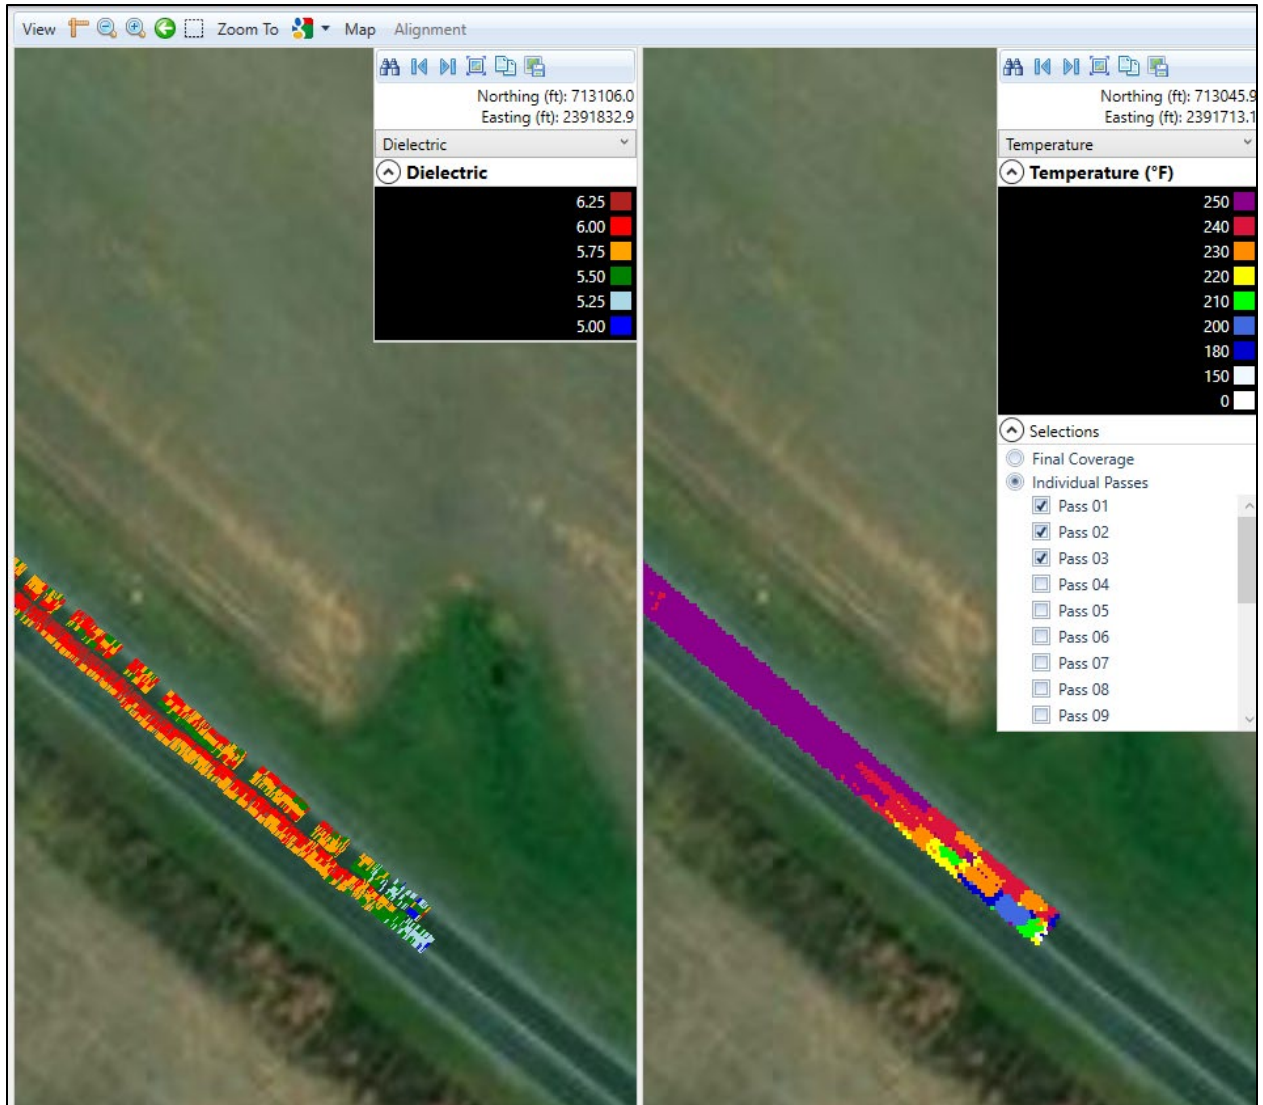
Figure 12. Screenshot. Cooler breakdown temperatures relative to the rest of production, with corresponding lower dielectric values.

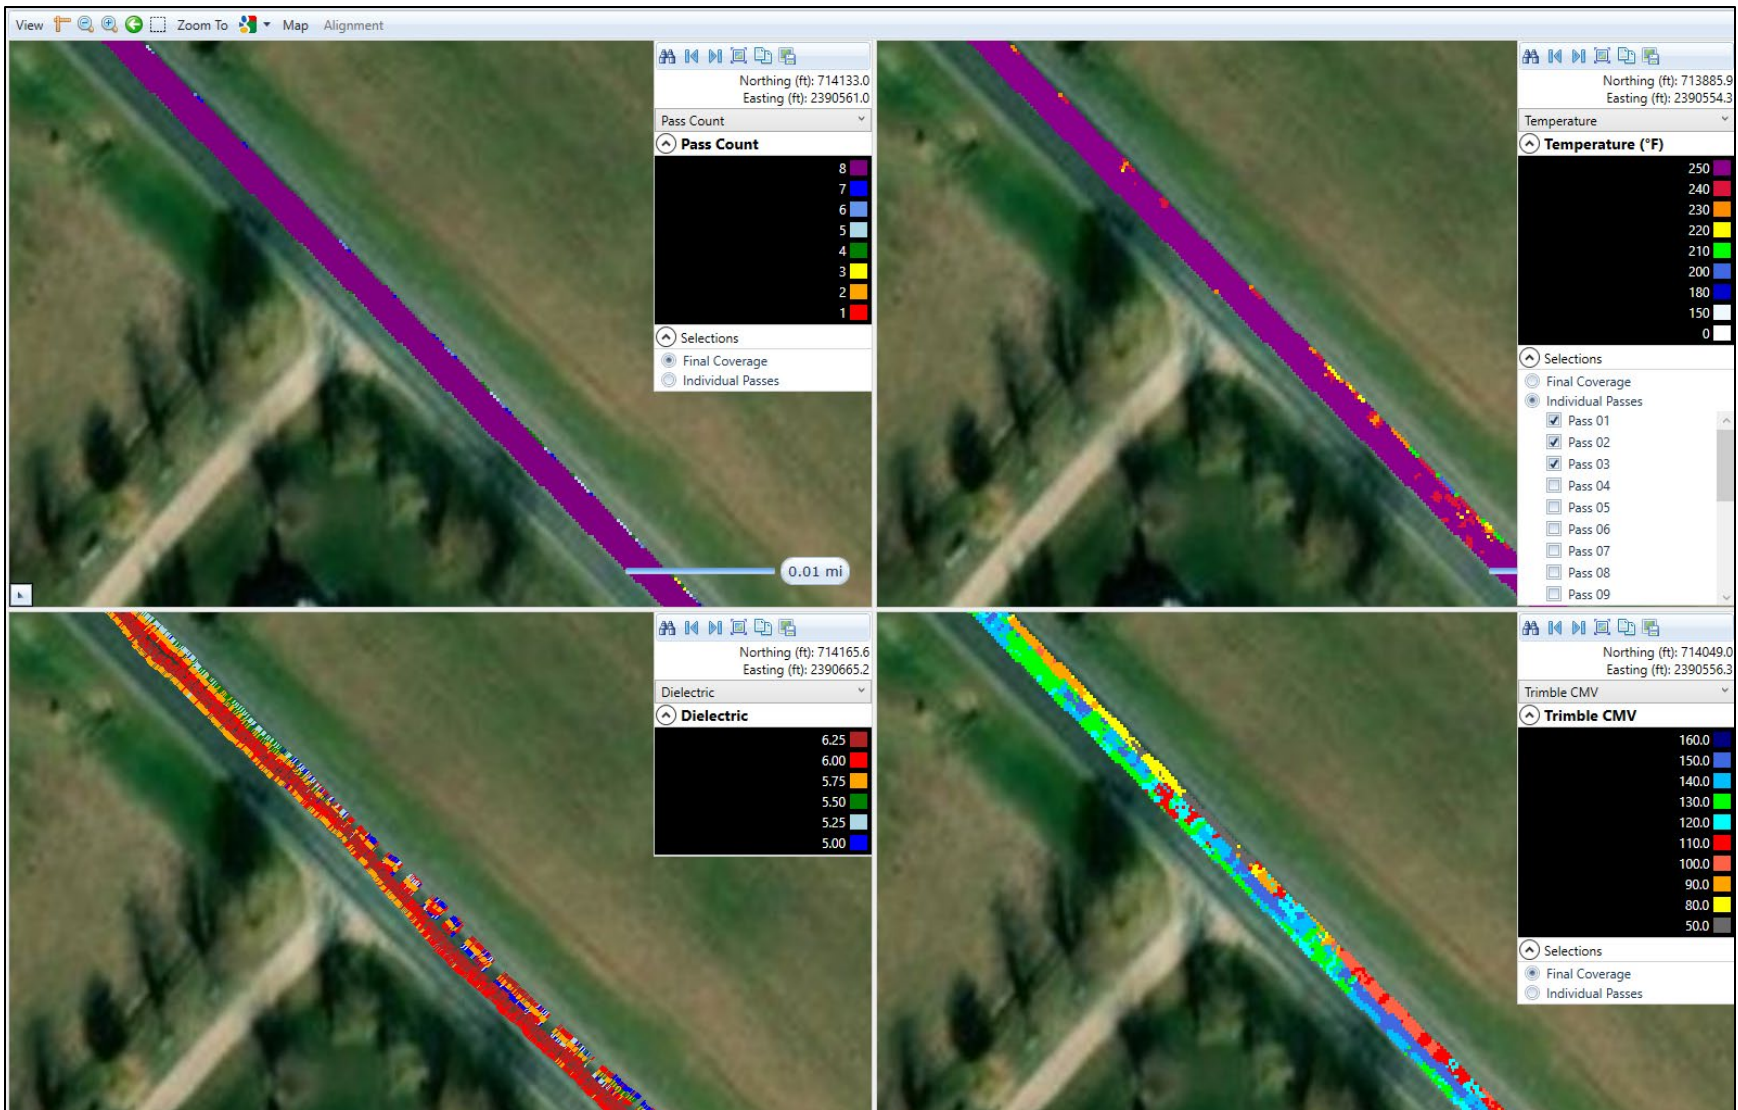
Figure 14. Screenshot. IC pass count (top left), IC temperature (top right), DPS (lower left), and IC ICMV (lower right) data.

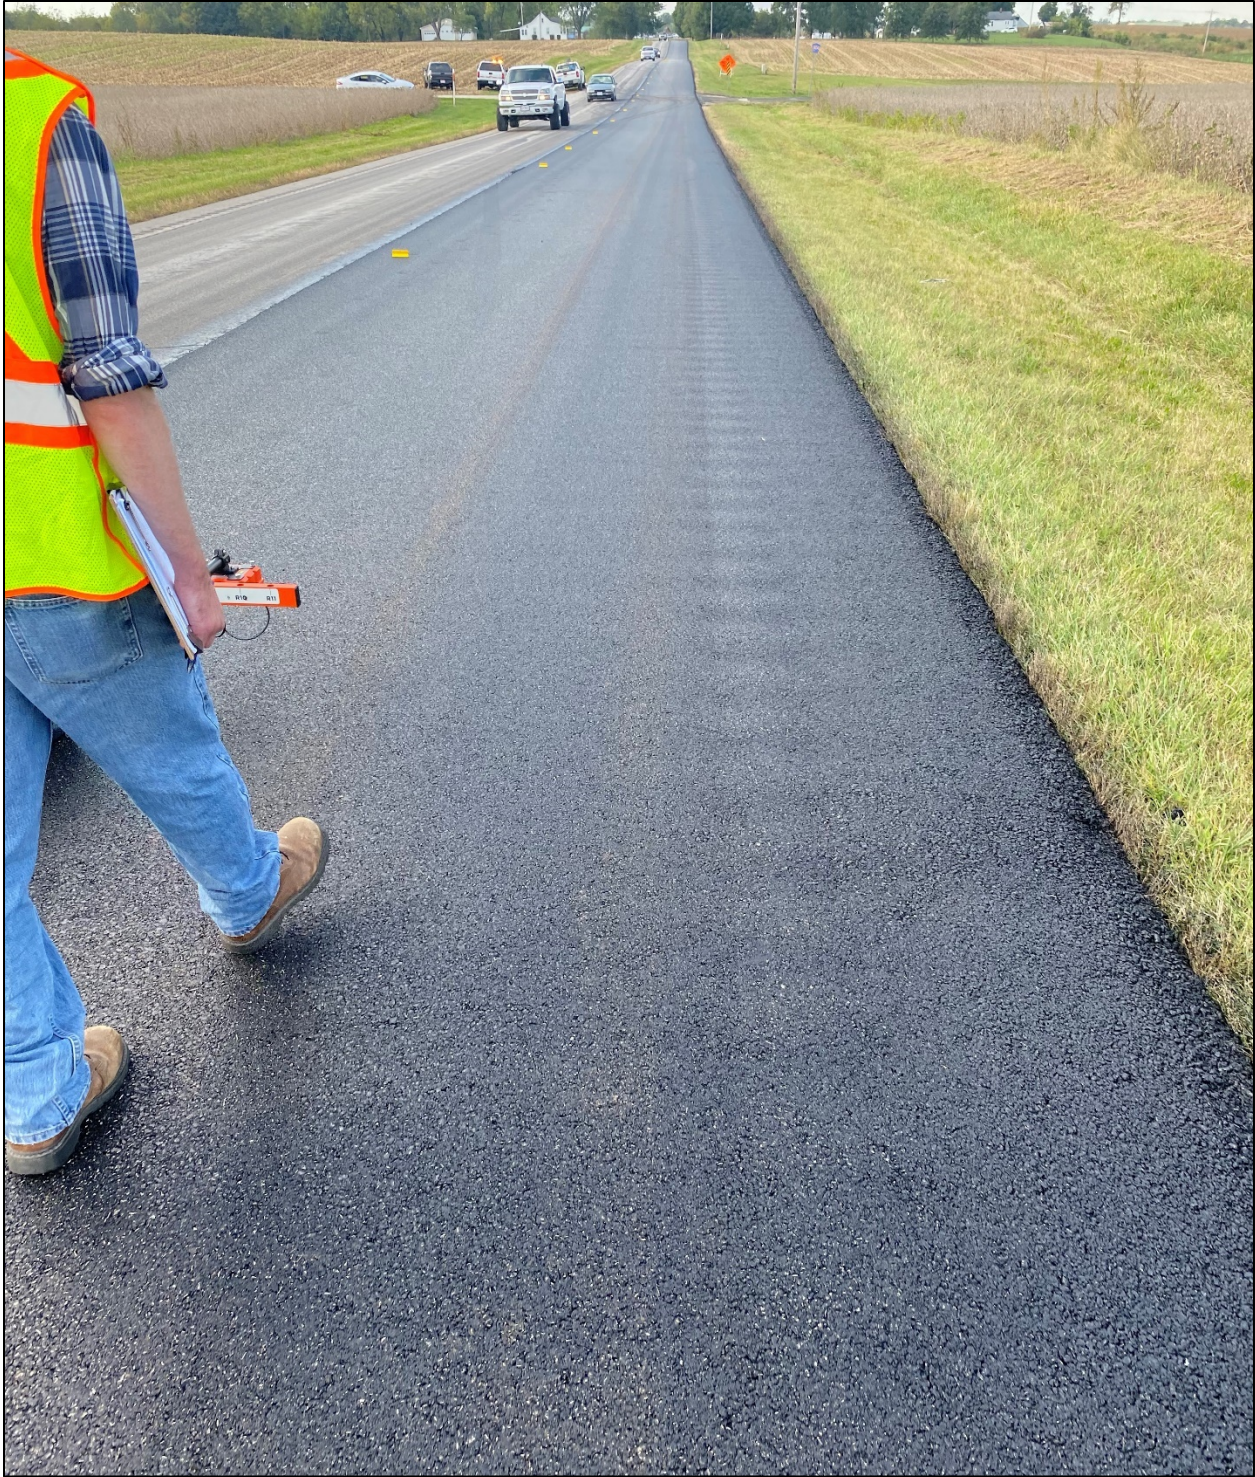
Figure 15. Photo. Rumble strips are shown reflecting through the overlay.

Also, the overlay was placed over the existing rumble strip. The rumble strips are reflected through the overlay, as shown in Figure 15. Paving over the rumble strips could contribute to the lower stiffness values as compaction efforts will vary across the high and low elevations of the existing surface.

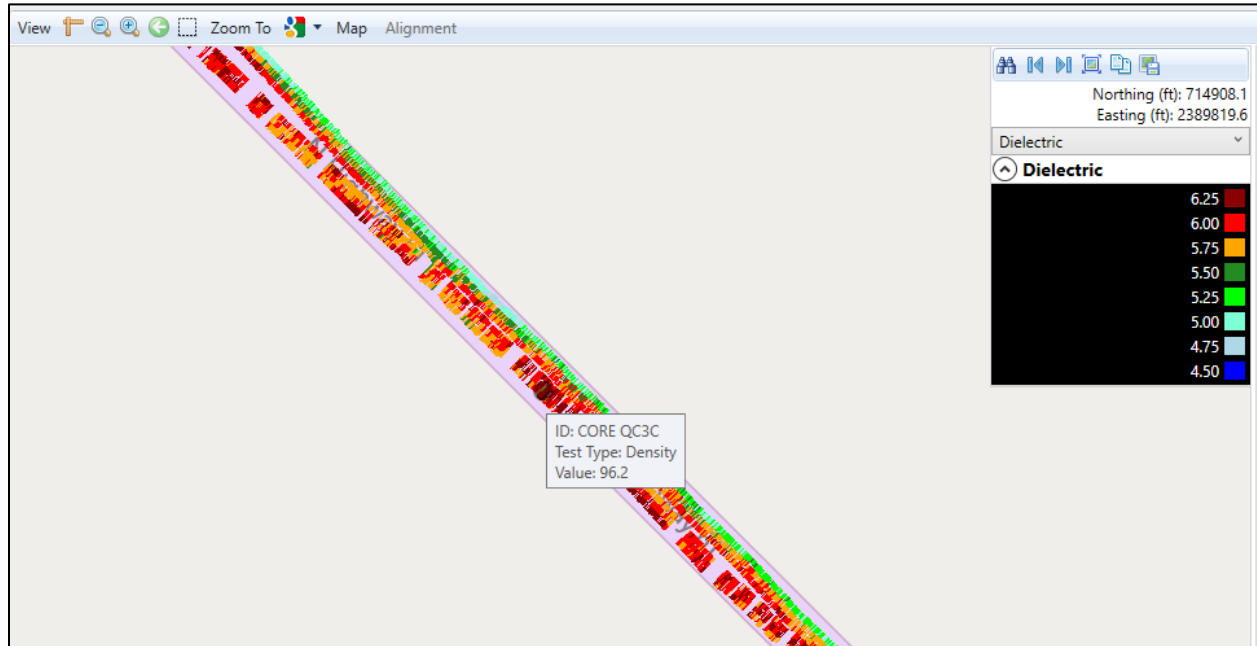
Figure 16. Screenshot. Location of single acceptance core.

DPS data was collected over a length of 3,200 feet. This section has only one core used for acceptance testing, as illustrated in Figure 16.

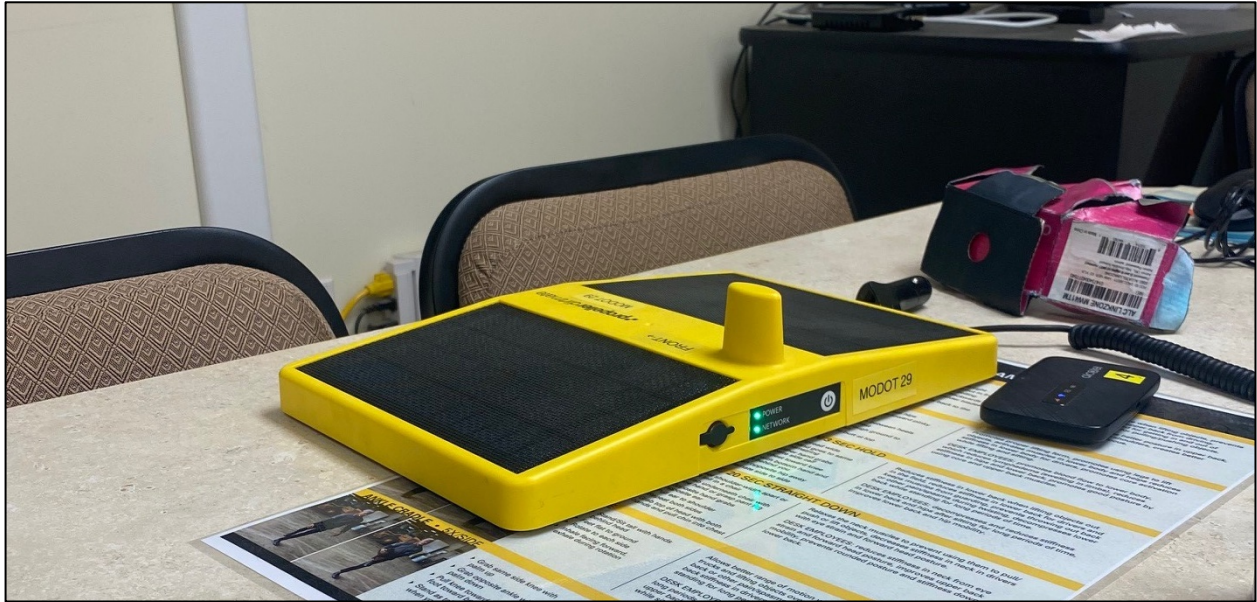
Figure 18. Photo. Propeller DirtMate.

following morning to troubleshoot. It was recommended that MoDOT mark the mounting location of the DirtMate on the roller so that it could be placed in the same location after troubleshooting. The DirtMate is illustrated in Figure 18, and the hotspot is illustrated in Figure 19.

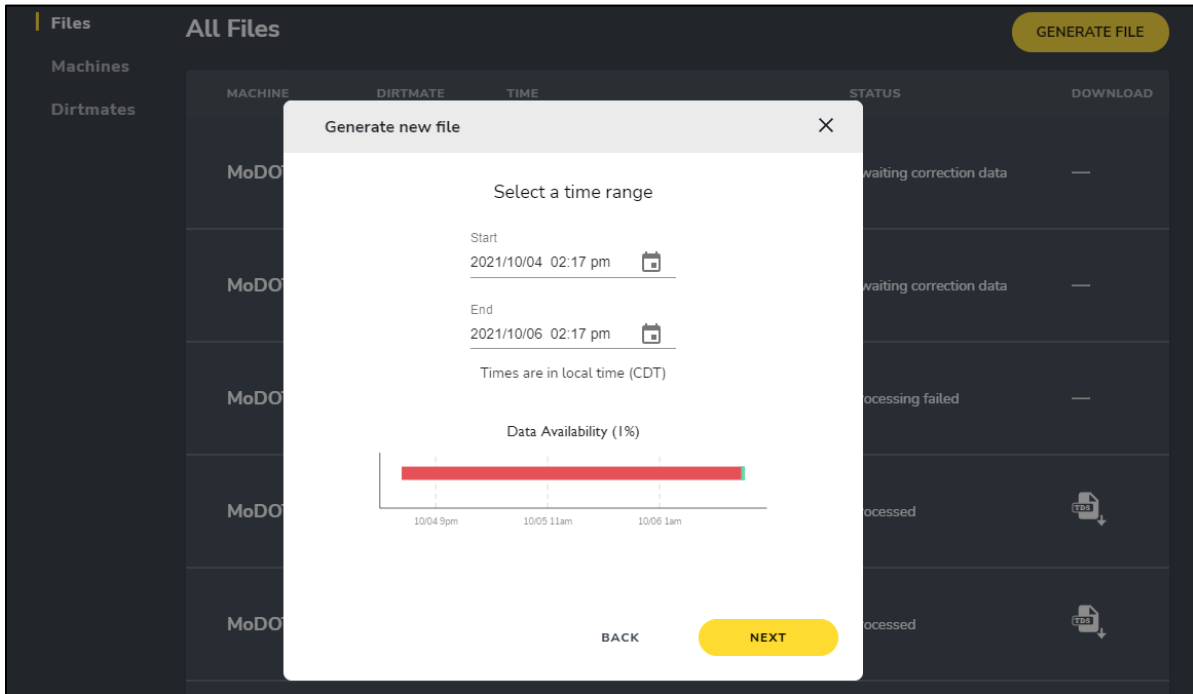
Figure 20. Screenshot. Propeller site shows only 1% of data available from 10/04/2021 to 10/06/2021.

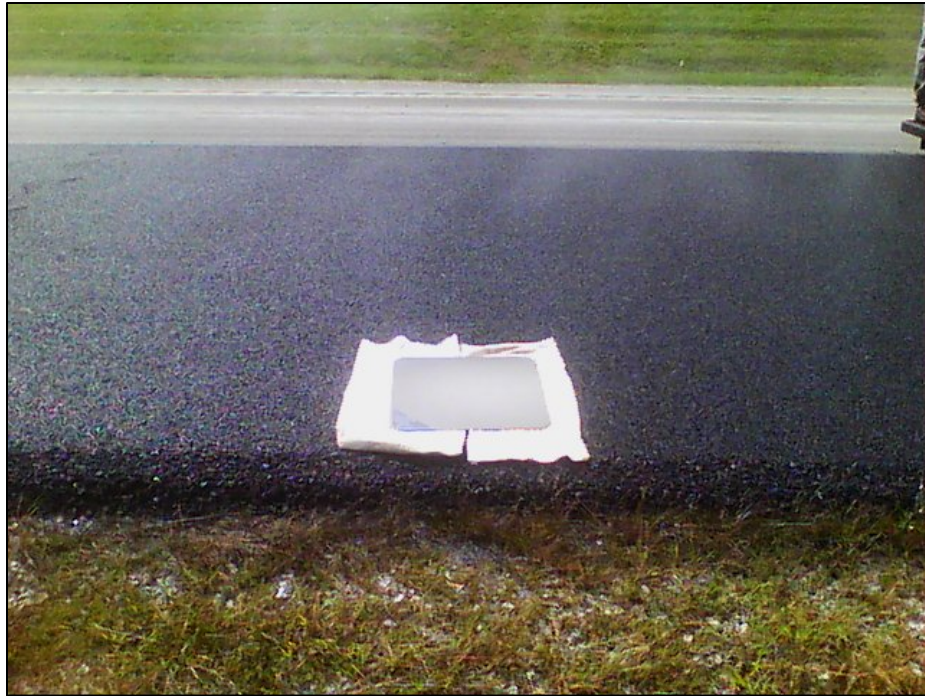
Figure 24. Photo. Improved reference object met the dimensions required and stayed below 150°F during testing.

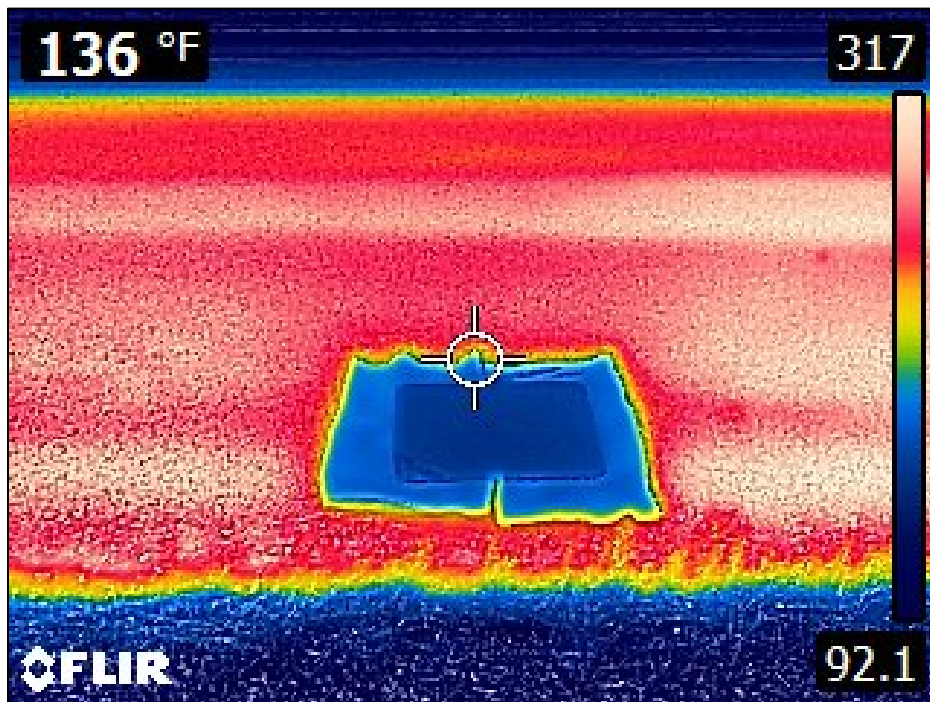
Figure 25. Photo. Example FLIR photo was taken according to the directions in the instruction file.

This rate is more frequent than recommended. However, it was convenient to take several photos for training purposes. The photos were saved to SharePoint under the project file, and an example FLIR photo is shown in Figure 25.

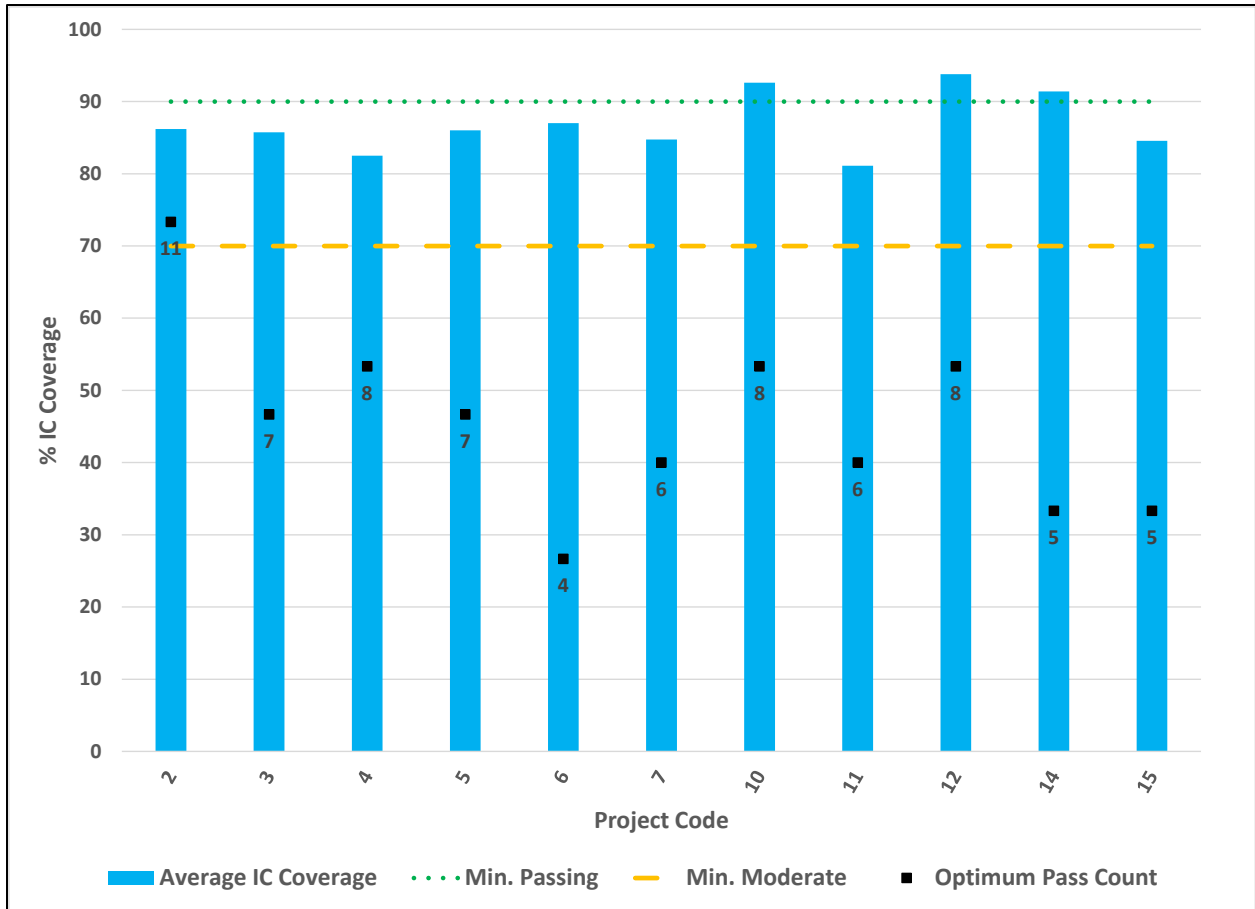
A summary of the 2021 IC coverage (% of the optimum pass) is shown in Figure 26. The chart shows the average IC coverage, the segment classification thresholds, and the optimum pass count for each project.

Figure 26. Chart. Average IC coverage per project and optimum pass counts.

- Three projects are above the 90 percent (passing) threshold, eight are between the 70 (moderate) and 90 percent thresholds, and no projects are below the 70 percent threshold.
- Optimum pass counts range from four to eleven. There is no clear trend between optimum pass count and IC coverage.

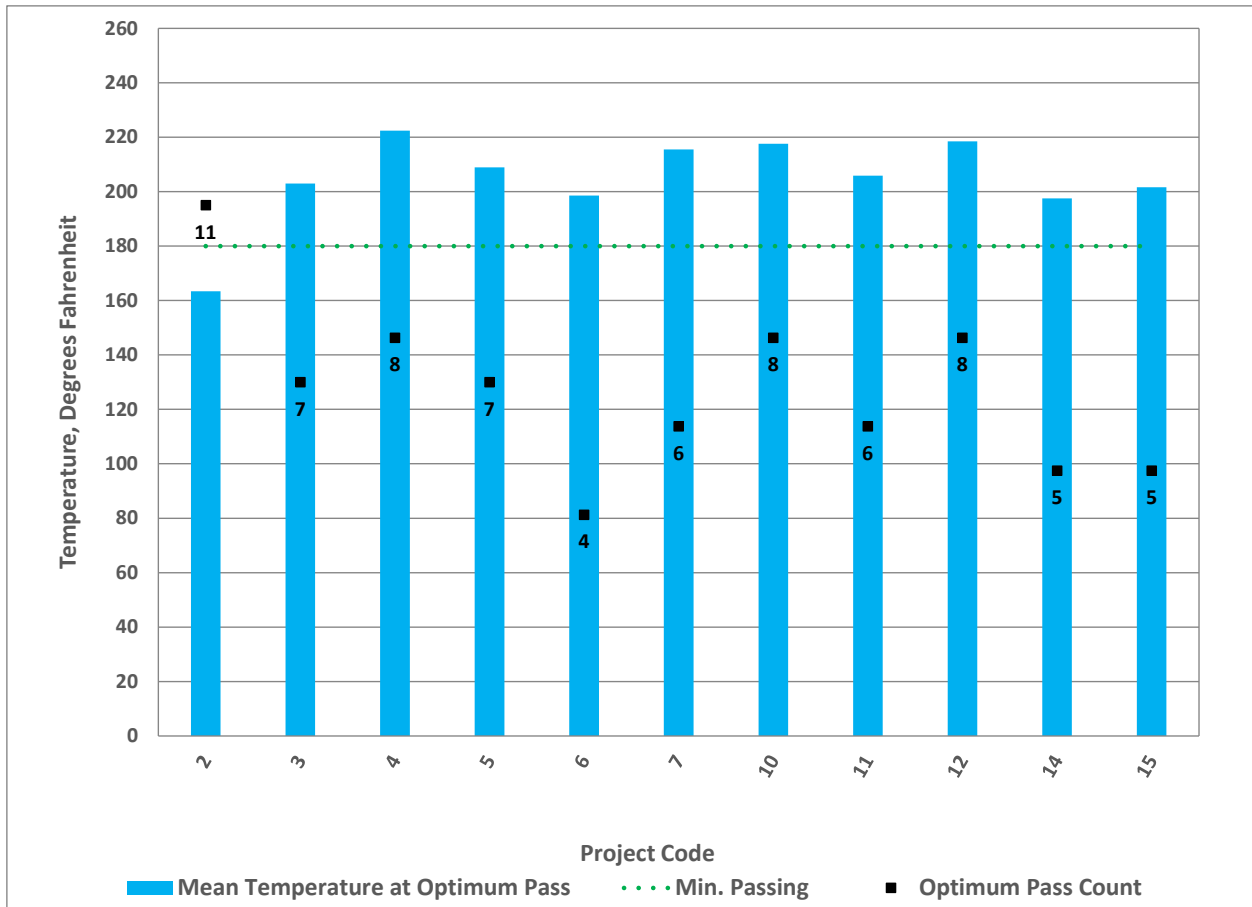
Figure 27. Chart. The average mean temperature at optimum pass count per project and optimum pass counts.

A summary of the average MTOP for each project in 2021 is shown in Figure 27.

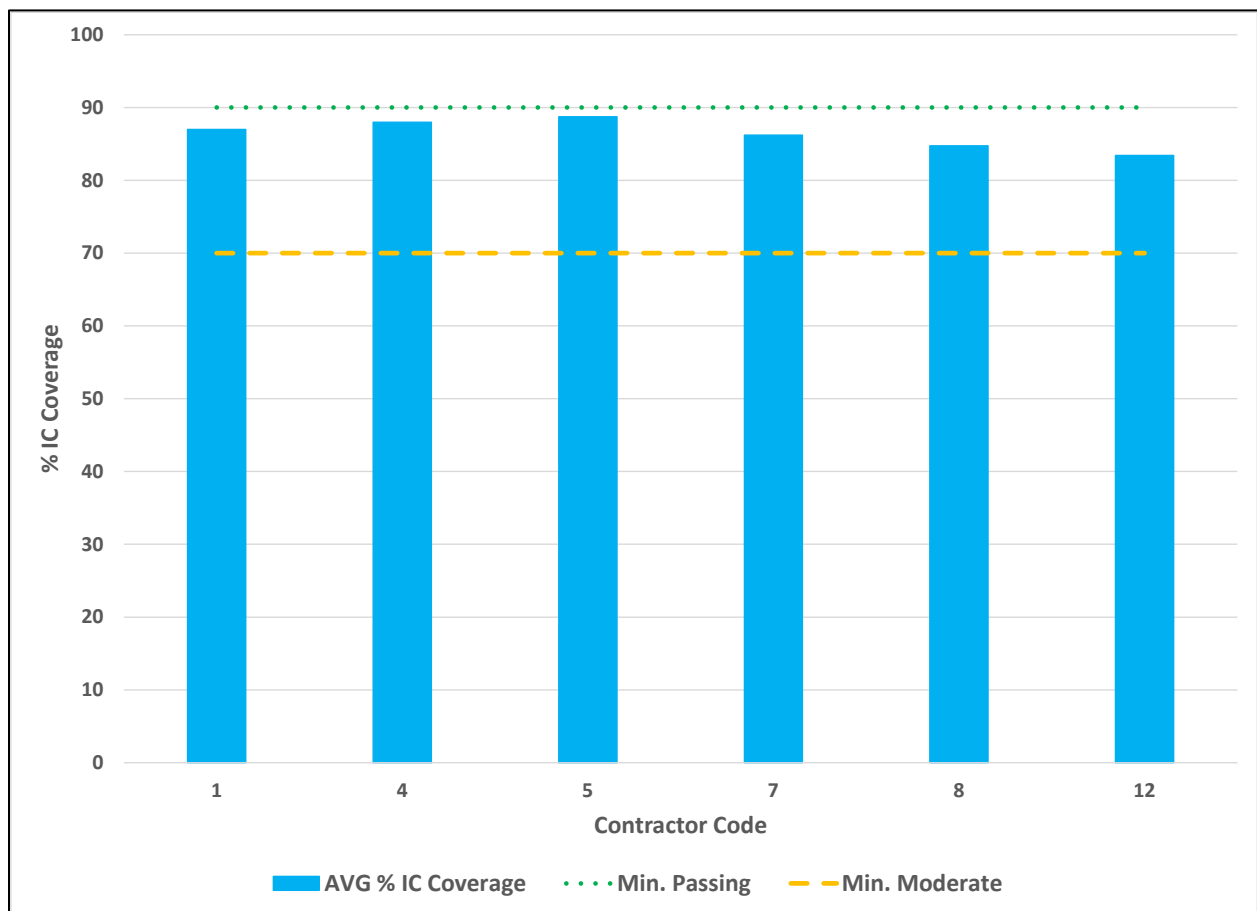
A summary of the IC coverage (% of the optimum pass) is shown in Figure 28. The chart shows the average IC coverage for each contractor (average of results for all 2021 projects completed by the contractor).

Figure 28. Chart. Average IC coverage per contractor.

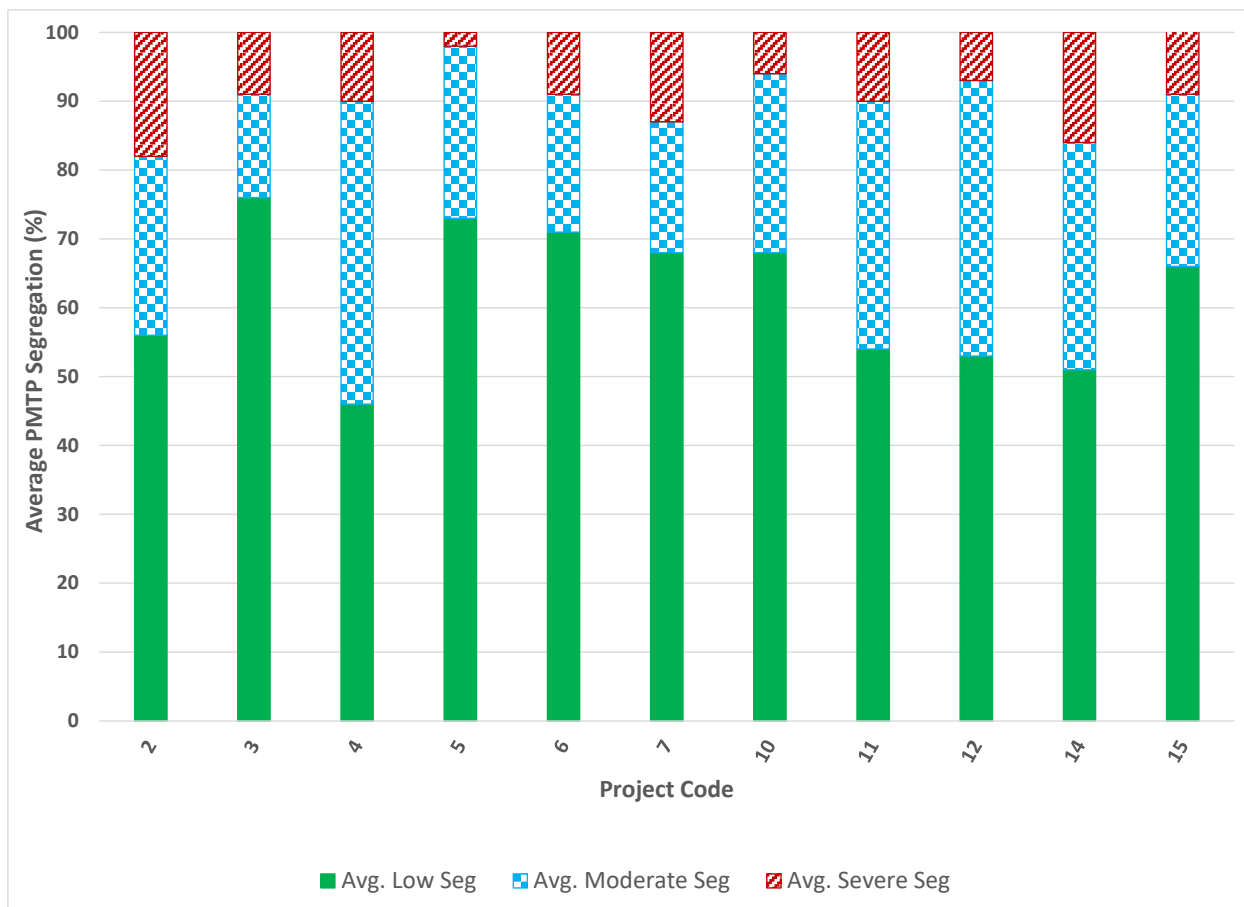
A summary of the PMTP results is shown in Figure 29. The chart shows the overall average thermal segregation category for each 2021 project.

Figure 29. Chart. Average thermal segregation classification for each project.

- Seven projects had less than 10 percent severe segregation.
- Four projects had between 10 and 20 percent severe segregation.
- No projects had more than 20 percent severe segregation.
- Three projects had over 70 percent low segregation.
- One project had less than 50 percent (half) low segregation
